# Draft Recreational Use Attainability Analysis for Black Fork Creek (0606D) in the Neches River Basin

By Leah Taylor  
Texas Institute for Applied Environmental Research  
Submitted to TCEQ September 2021

Prepared for  
Texas Commission on Environmental Quality  
P.O. Box 13087  
Austin, Texas 78711-3087

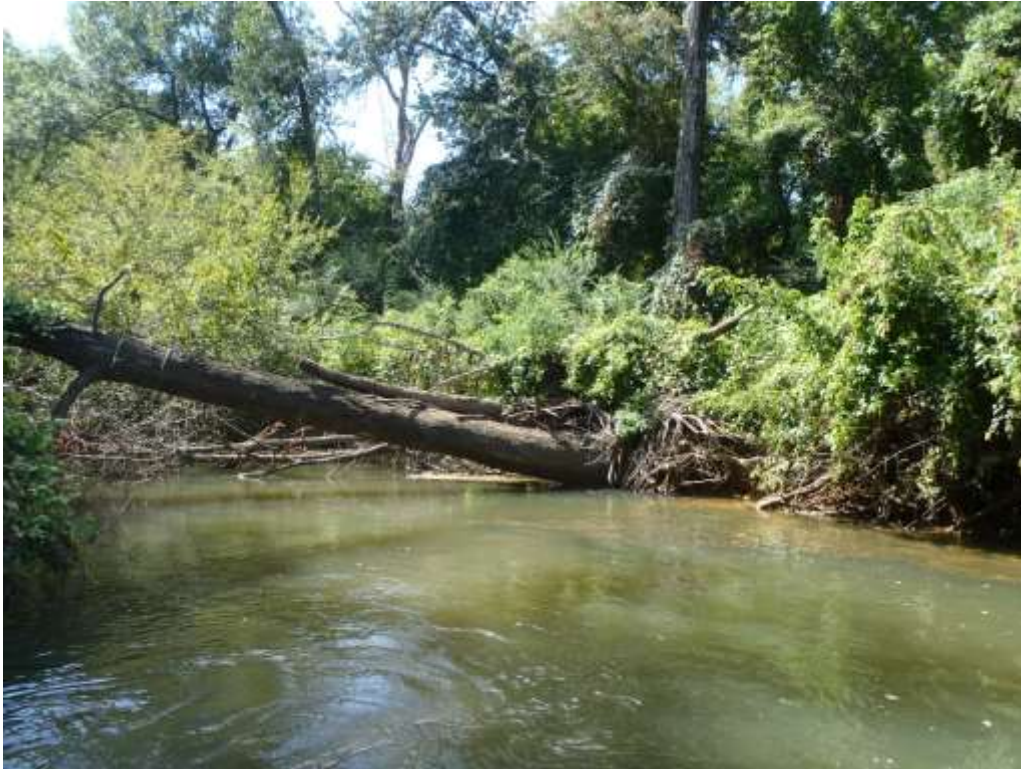
**Figure 4.2** Photograph of Black Fork Creek Site BF01 taken on August 3, 2020. The downstream view of the 0-m transect

Site BF01 was wadeable with average thalweg ranging from 0.59 m to 0.61 m between surveys. Figure 4.2 illustrates the typical observed width of the creek at this site, approximately 10 m. Widths ranged from 7 m to 13 m during the two surveys (Tables 4.6 and 4.7).

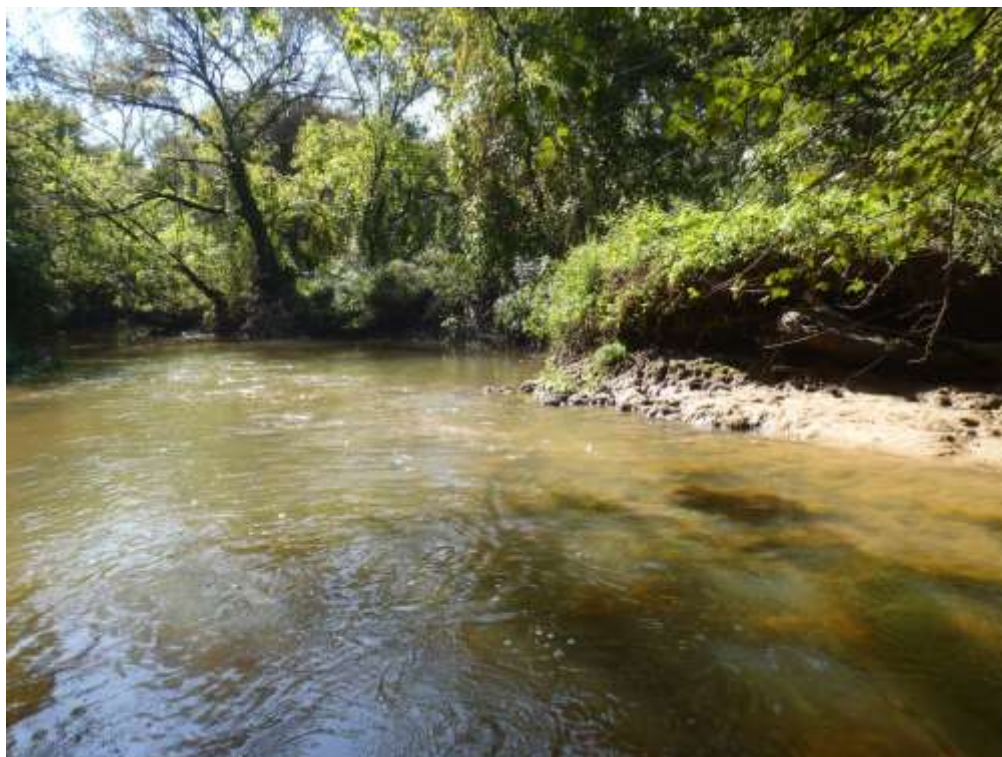
**Figure 4.3** Photograph of Black Fork Creek Site BF01 taken on October 6, 2020. The downstream view of the 300-m transect

The stream flow type was observed as perennial at the time of both surveys (Table 4.5). Aquatic vegetation and algae cover was rare at this site for each surveys. The deepest thalweg depth measured during the first survey at the 0-m and 30-m transects was greater than 1.20 m and the shallowest was 0.13 m at the 180-m transect during the first survey. No pools were observed during either survey at this site.

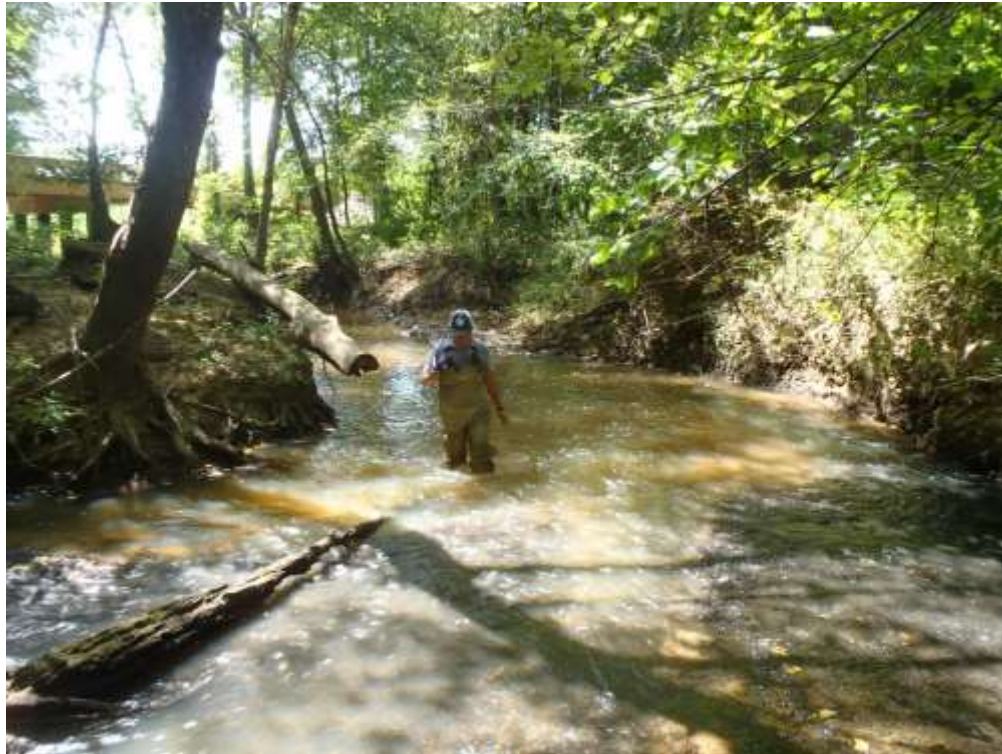
**Figure 4.4** Photograph of Black Fork Creek Site BF02 taken on August 3, 2020. Photograph shows the downstream view of the 150-m transect. TIAER personnel in photo.

The riparian zone at Site BF02 was forest with thick vegetation on both the right and left banks (Table 4.4). When TIAER personnel arrived at the site during the second survey, a Smith County maintenance crew was present cutting the thick vegetation along the bridge. Banks were vegetated with larger trees and a larger shaded understory (Figures 4.4 and 4.5) throughout this site. The stream was wadeable during both surveys with average thalweg depths ranging from 0.41 m to 0.50 m. The stream was designated as perennial during both surveys (Table 4.5). Channel widths ranged

from 8.5 m to .75 m throughout the reach during both surveys with a typical observed width of 4.5 m (Tables 4.6 and 4.7).

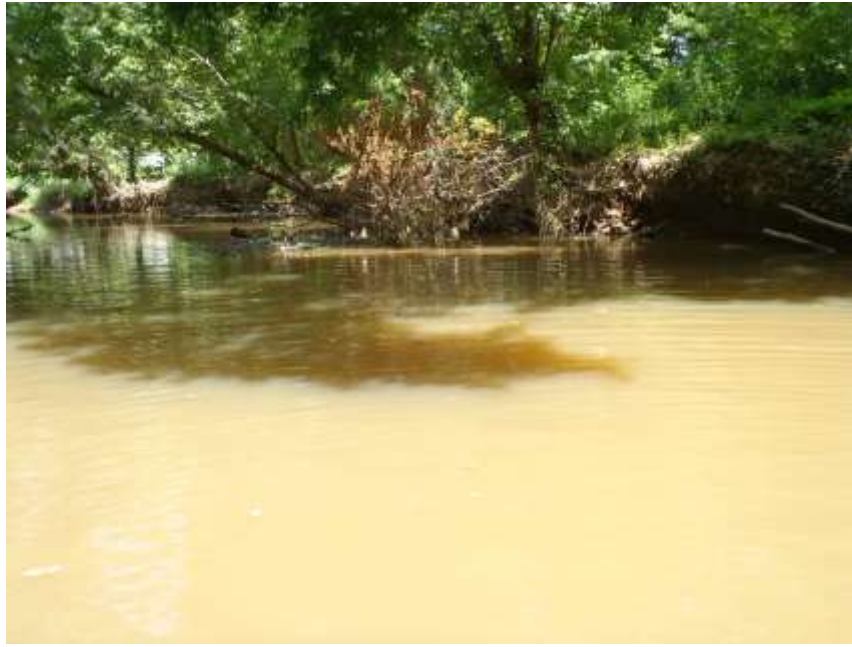
**Figure 4.6** Photograph of Black Fork Creek Site BF03 taken on August 3, 2021, the upstream view of the 150-m transect.

The stream banks were densely vegetated (as seen in Figure 4.6) at BF03. Channel obstructions at this site included log jams and tree branches. Additionally, given the depth of the stream at this site, it was difficult to navigate, primarily wading along the edges. Aquatic vegetation and algae cover were rarely observed during each survey. The water was brown or tan in color with no surface scum observed.

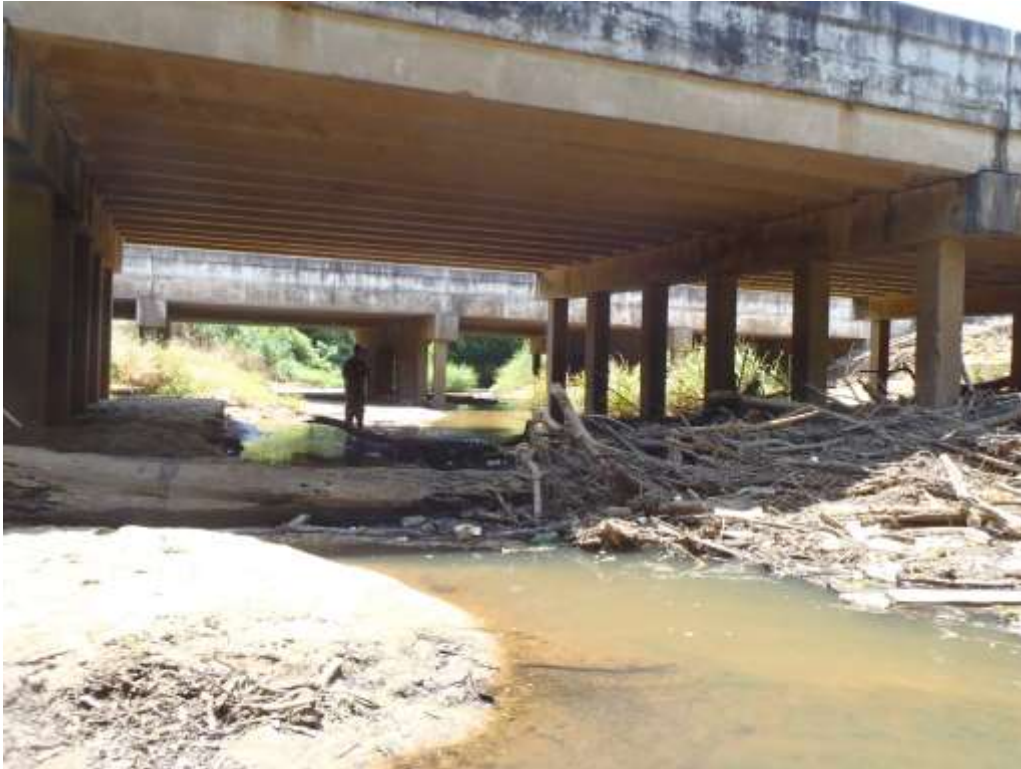
**Figure 4.7** Photograph of Black Fork Creek Site BF04 taken on August 3, 2020. The downstream view of the 150-m transect.

The riparian area was forest with thick vegetation and slippery slopes on both the right and left banks (Table 4.4). Areas of this site had large piles of debris, specifically under the bridge crossing (Figure 4.7). Banks were steep, slippery, and overgrown with vegetation.

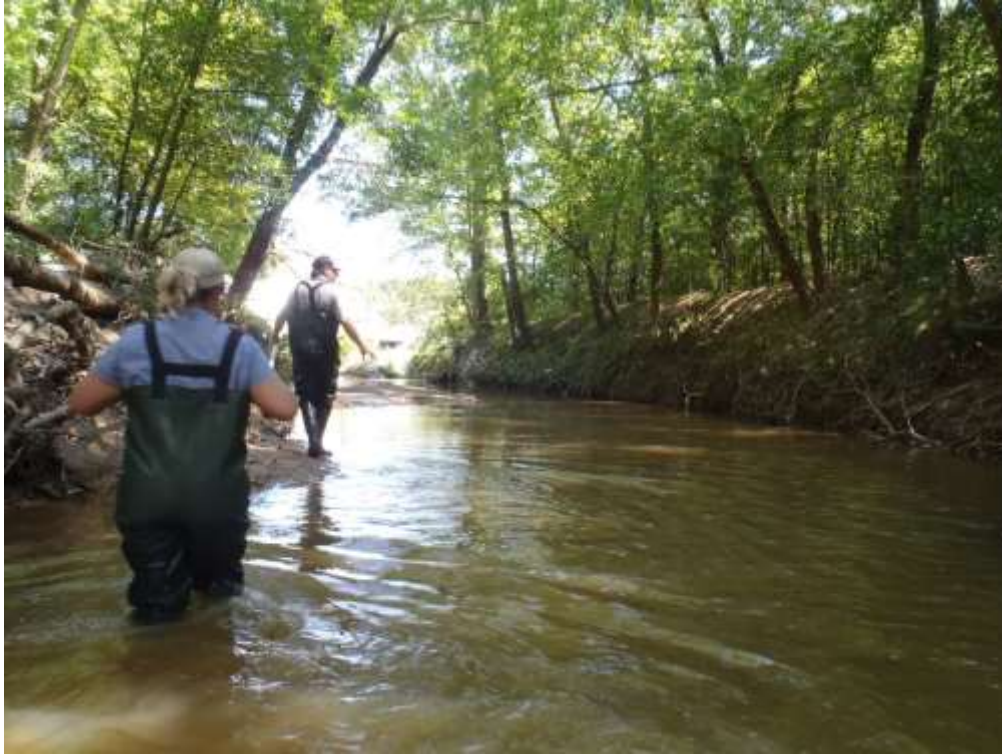
**Figure 4.8** Photograph of Black Fork Creek Site BF04 taken on October 6, 2020. The downstream view of the 300-m transect.

Site BF04 was wadeable with average thalweg ranging from 0.43 m to 0.65 m between surveys. Figure 4.8 illustrates the typical observed width of the creek at this site, approximately 7 m (TIAER personnel in photo). Widths ranged from 2 m to 11 m during each surveys (Tables 4.6 and 4.7) with a typical average of 7 m.

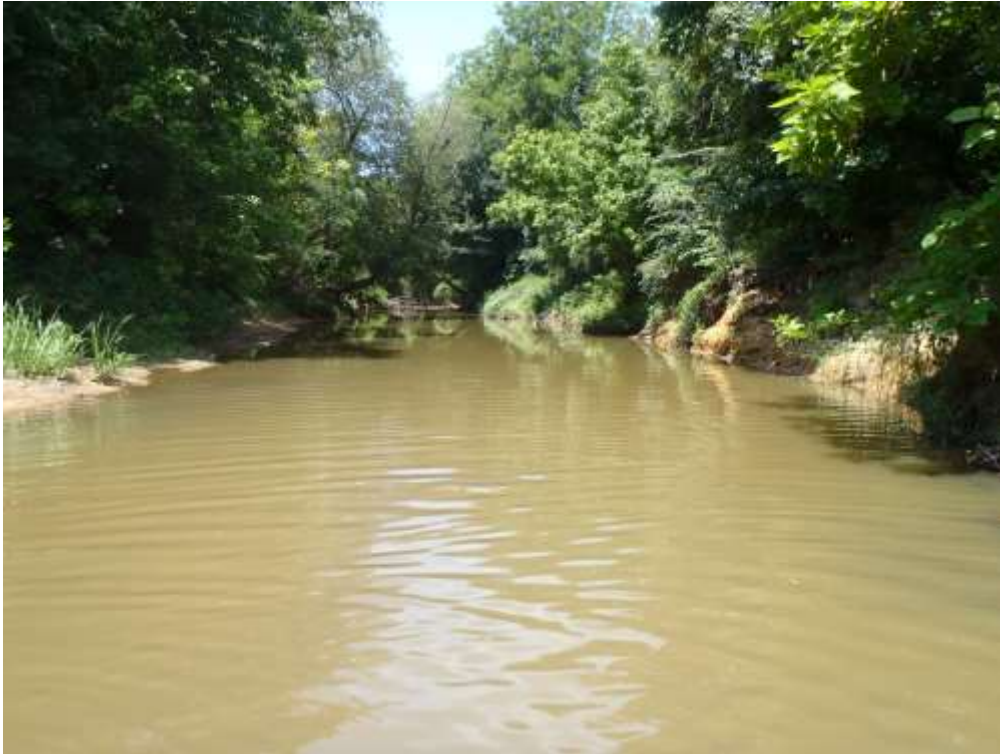
**Figure 4.10** Photograph of pool at Black Fork Creek Site BF05 taken on August 3, 2020.  
Photograph shows the upstream view of the 150-m transect.

The riparian zone at Site BF05 was forest with thick vegetation along both banks (Table 4.4). The stream was wadeable during both surveys with one pool present during the first survey (Figure 4.10). The pool that TIAER personnel encountered during the first survey was 107 m long and 13 m wide with a maximum depth of 0.90 m. Average thalweg depths were 0.48 m to 0.56 m between the first and second surveys respectively. The stream is observed as perennial (Table 4.5). Channel widths ranged from 0.6 m to 16 m throughout the reach during both surveys with a typical observed width of 8 m (Tables 4.6 and 4.7). Figure 4.11 depicts the typical channel width during each survey.

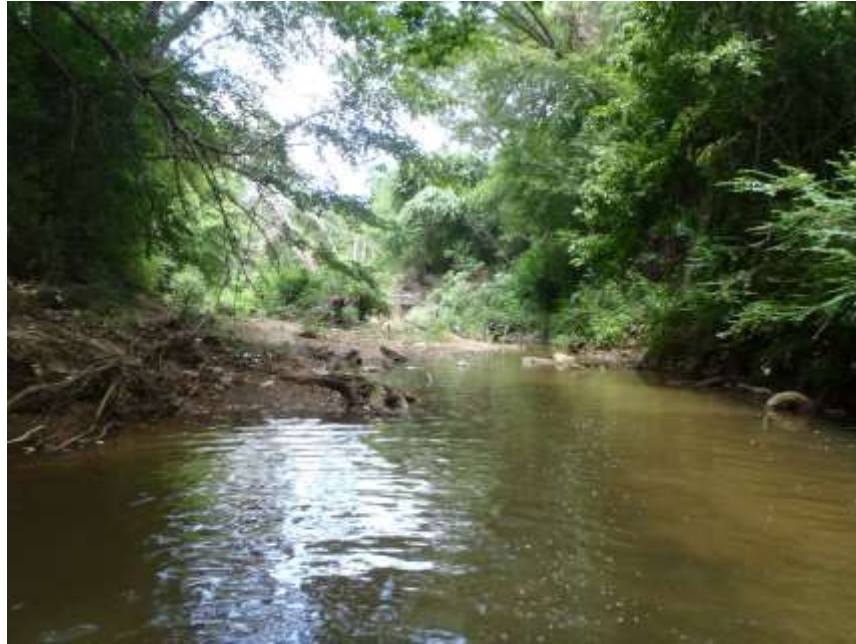
**Figure 4.12** Photograph of Black Fork Creek Site BF06 taken on August 3, 2020, the downstream view of the 150-m transect.

The stream banks were densely vegetated (as seen in Figure 4.12) at BF06. The stream channel was relatively clear of downed logs and twig debris except the rare encounter during the second survey. Additionally, there was a pipeline running across the stream at this site. Aquatic vegetation and algae cover was observed during both the first and second surveys but was rare. The water was clear in color and surface during both surveys except for the rare scum encountered among the logjams during the second survey.
