Draft Recreational Use Attainability Analysis for Honey Grove Creek (0202L) in the Red River Basin

By Leah Taylor
Texas Institute for Applied Environmental Research
Submitted to TCEQ September 2021

TIAER Publication TR2202

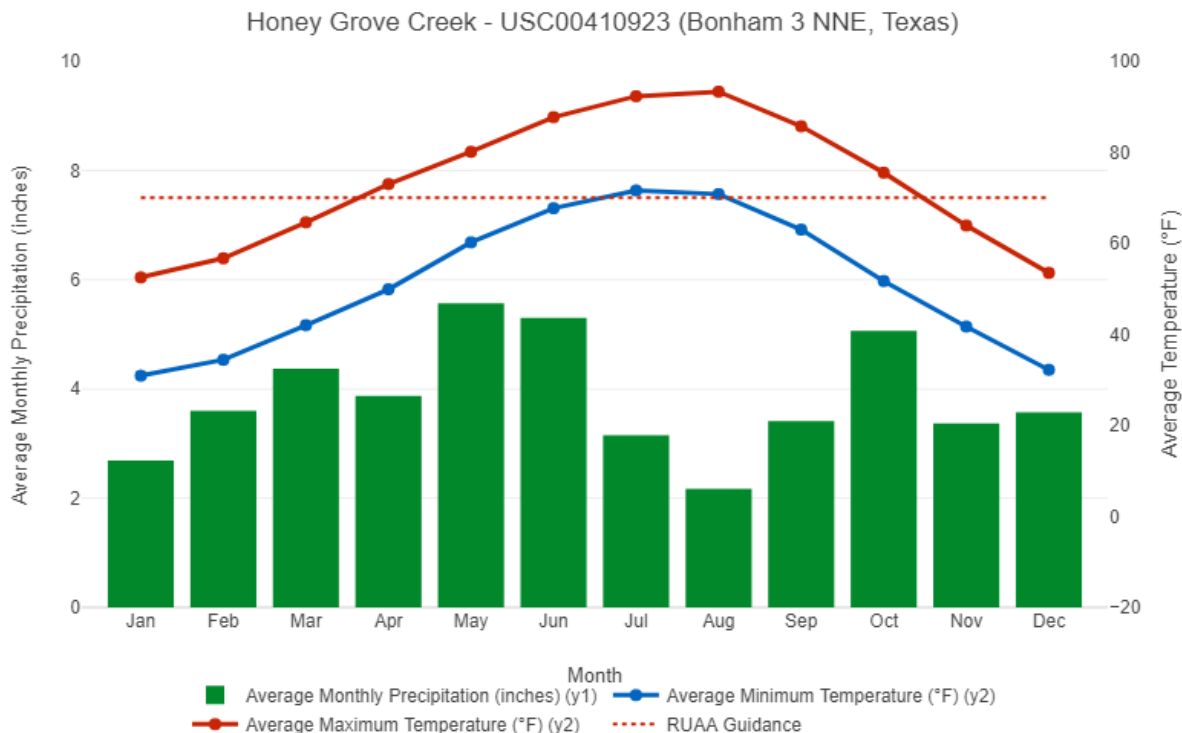
Figure 3.1 Monthly average precipitation for Bonham, Texas

Annual precipitation for the Honey Grove Creek watershed was based on data obtained from the National Oceanic and Atmospheric Administration's website (NOAA, 2015) for Bonham 3 NNE, Texas (Station USC00410923). It is important to note that this station is not within the Honey Grove Creek watershed boundaries. However, it is the nearest station with climate normal available for both precipitation and temperature. Normal precipitation (1981-2010) for Station USC00410923 averages 46.13 inches per year with a peak rainfall typically occurring in the months of May and June (Figure 3.1).

Average maximum temperatures for Station USC00410923 rise above 70°F beginning in month April and ending in October (Figure 3.1). March through October are the months notes as generally suitable for assessing recreational use, but only if temperatures reach above 70°F (TCEQ, 2014b).

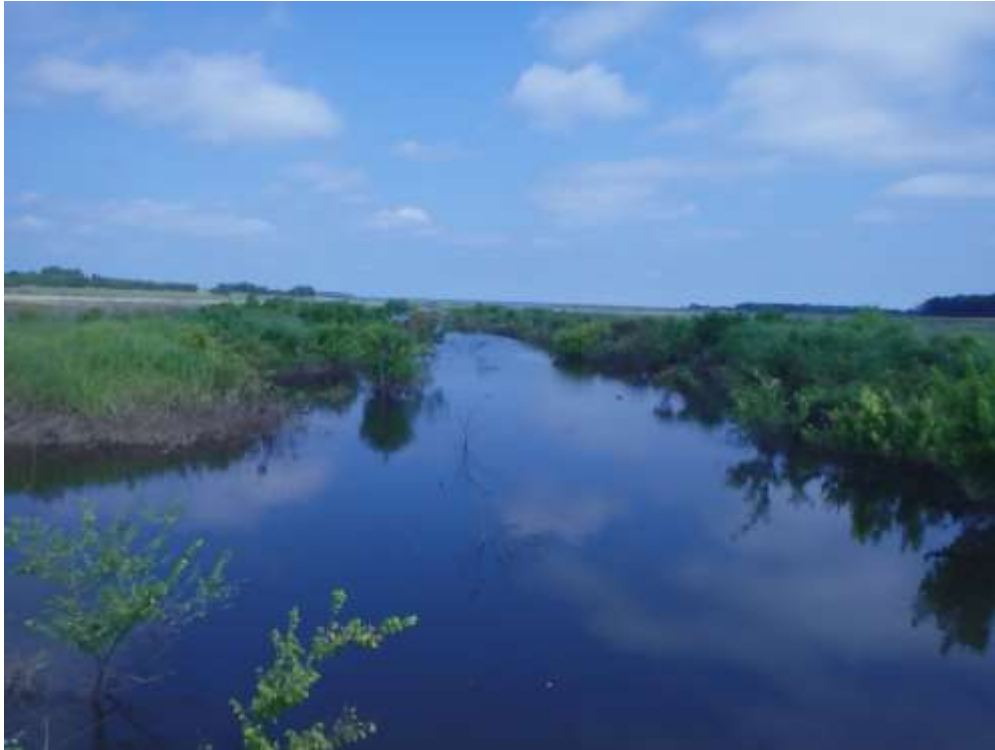
Figure 4.2 Photograph of Honey Grove Creek Site HG01 taken on June 23, 2021
The downstream view at the bridge crossing on PR 2765.

Honey Grove Creek at site HG01 was visited on June 23 and August 25, 2021. When TIAER field personnel arrived at this site, depths were too deep to safely access the stream (Figures 4.2 and 4.3). During TCEQ and TIAER’s initial project development, it was discovered that portions of the then to be developed Bois D’ Arc Lake would include portions of Honey Grove Creek. TCEQ and TIAER decided to move forward with completing the RUAA on the water body knowing there was the chance this HG01 would not be accessible when it was time to conduct field surveys.

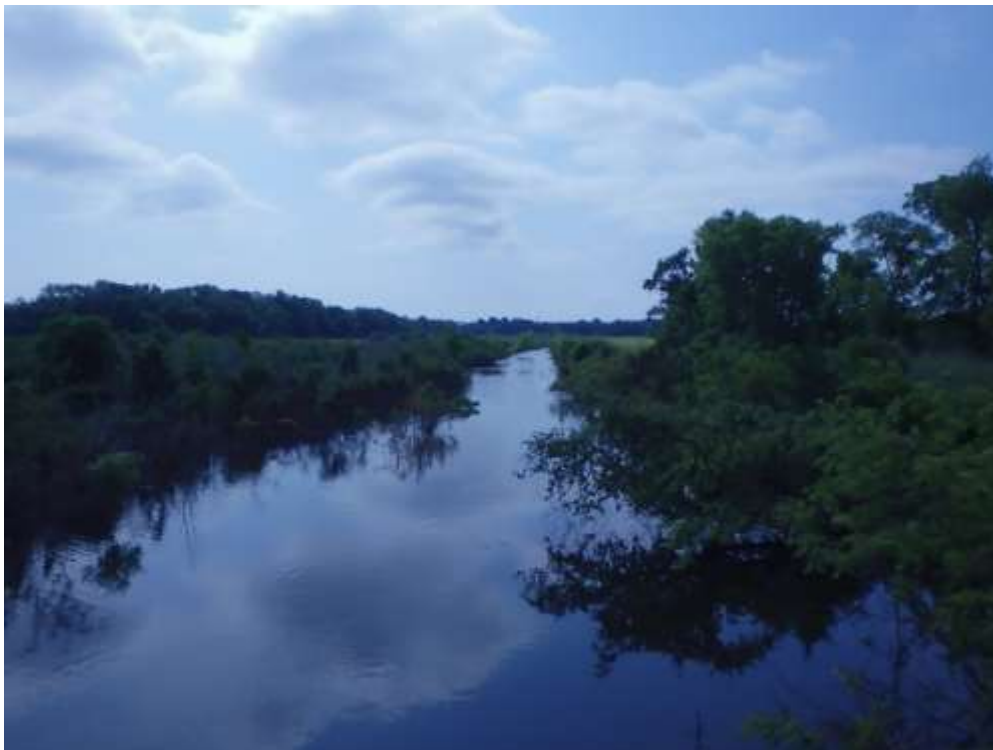
Figure 4.3 Photograph of Honey Grove Creek Site HG02 taken on June 23, 2021
The upstream view at the bridge crossing on PR 2765.

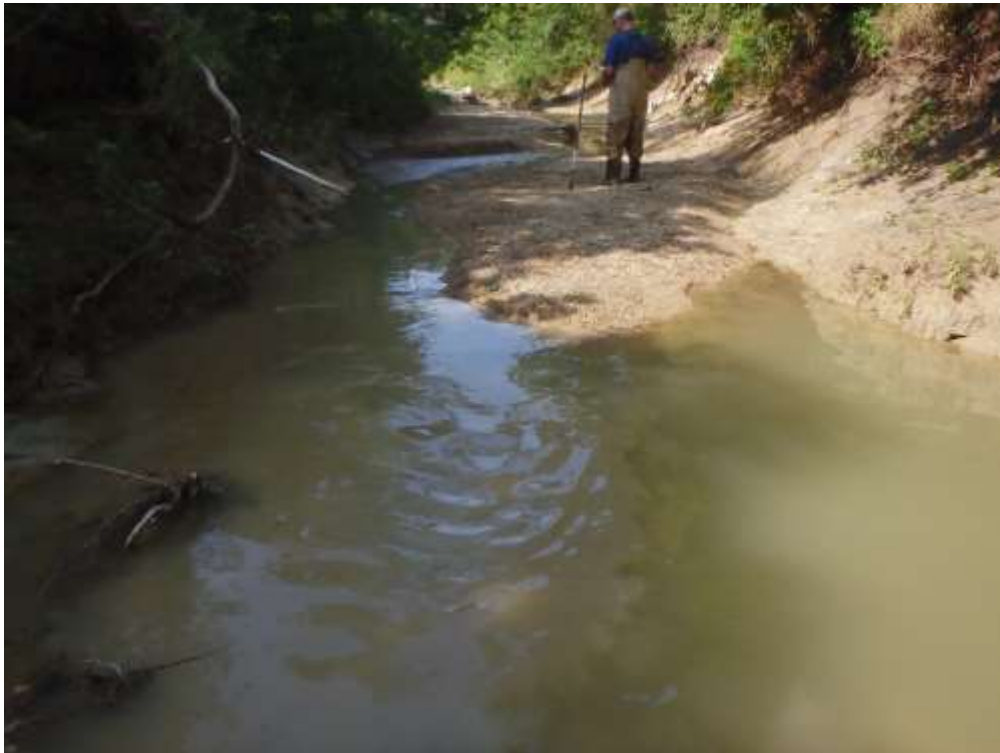
Figure 4.4 Photograph of Honey Grove Creek Site HG02 taken on June 23, 2021

Photograph shows the upstream view of the 0-m transect. TIAER personnel in photo.

Site HG02 was wadeable with average thalweg ranging from 0.28 m and 0.38 m between surveys. Figure 4.4 illustrates the typical observed width at this site, approximately between 3.5 m and 4 m. Widths ranged from 0.40 m to 7 m during the two surveys (Tables 4.6 and 4.7).

Honey Grove Creek at this site primarily passes through a forest riparian zone that led to a pasture riparian zone on the left bank in the upstream portion of the site (Table 4.4). The general appearance of the stream at this location is shown in Figures 4.4 and 4.5.

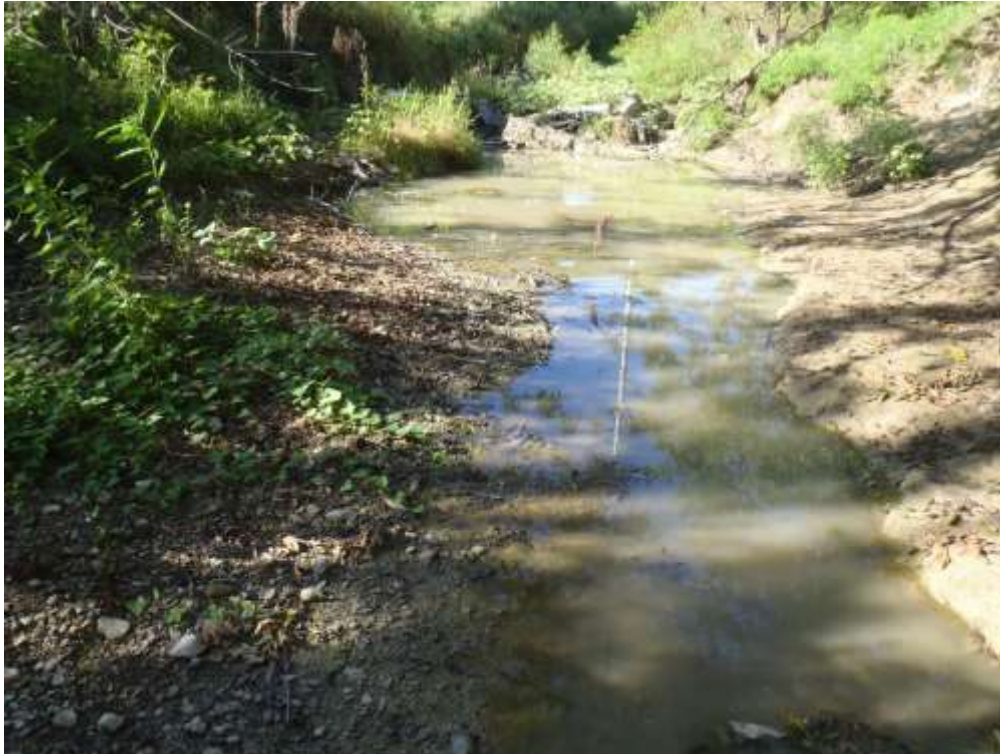
Figure 4.5 Photograph of Honey Grove Creek at Site HG02 taken on June 17, 2021

Photograph at the 150-m transect facing downstream.

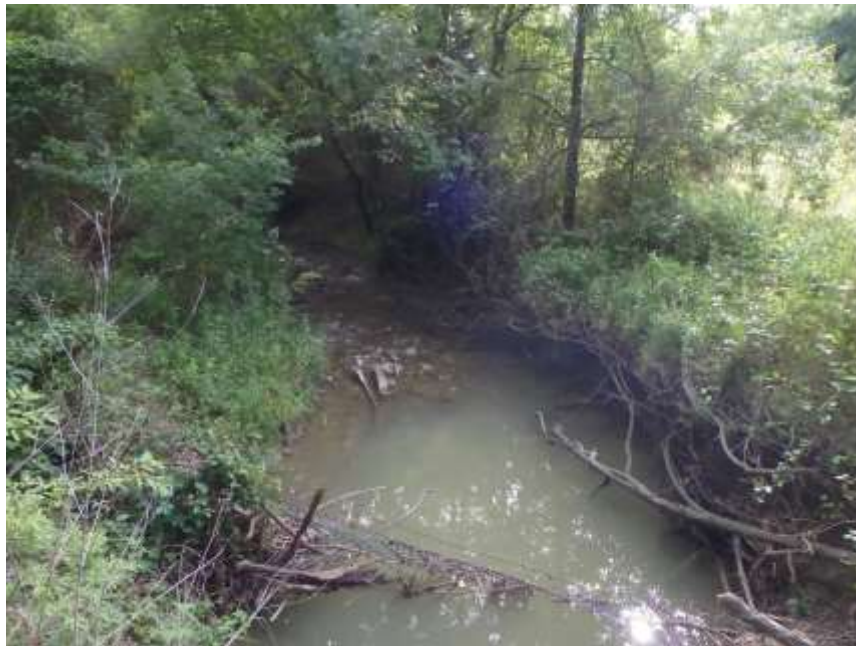
The stream banks were densely vegetated (as seen in Figure 4.6) at HG03. The stream channel was relatively clear of downed logs and twig debris. Aquatic vegetation and algae cover were absent during both surveys. The water was clear during the first survey and, again, the stream was dry during the second survey (Figure 4.7).

Figure 4.6 Photograph of Honey Grove Creek Site HG03 taken on June 23, 2021, the downstream view of the 150-m transect

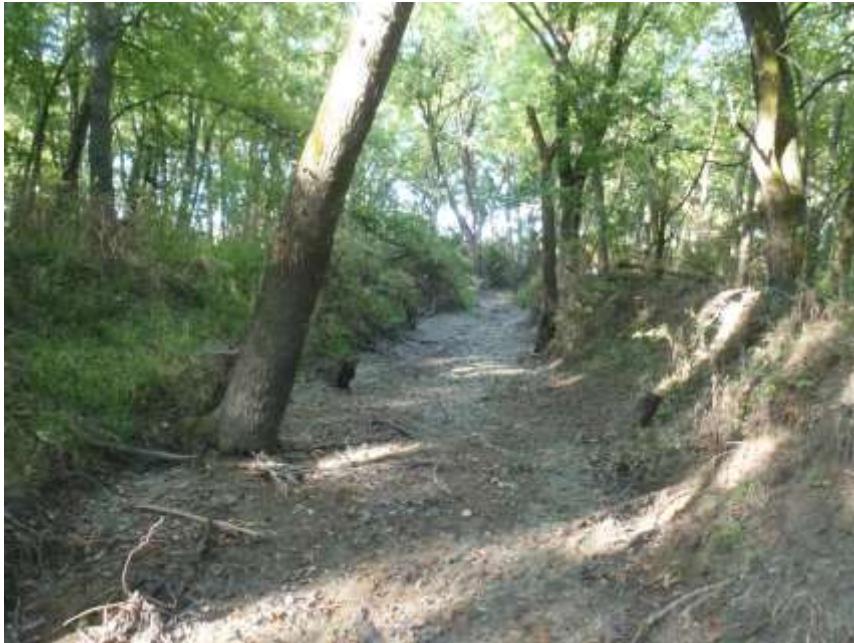
Figure 4.7 Photograph of Honey Grove Creek Site HG03 taken on August 25, 2021, the upstream view of the 300-m transect

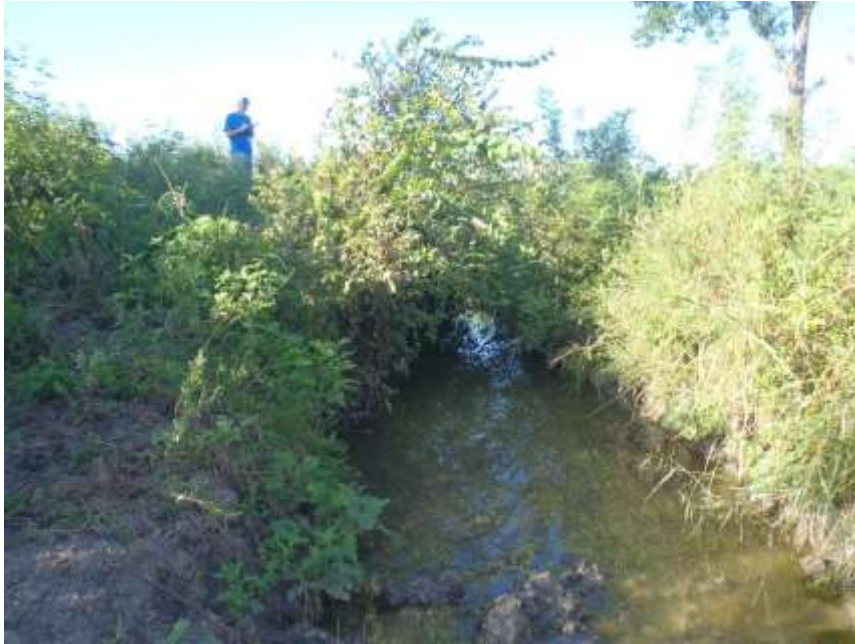
Figure 4.8 Photograph of Honey Grove Creek Site HG04 taken on August 25, 2021, the upstream view of the 150-m transect

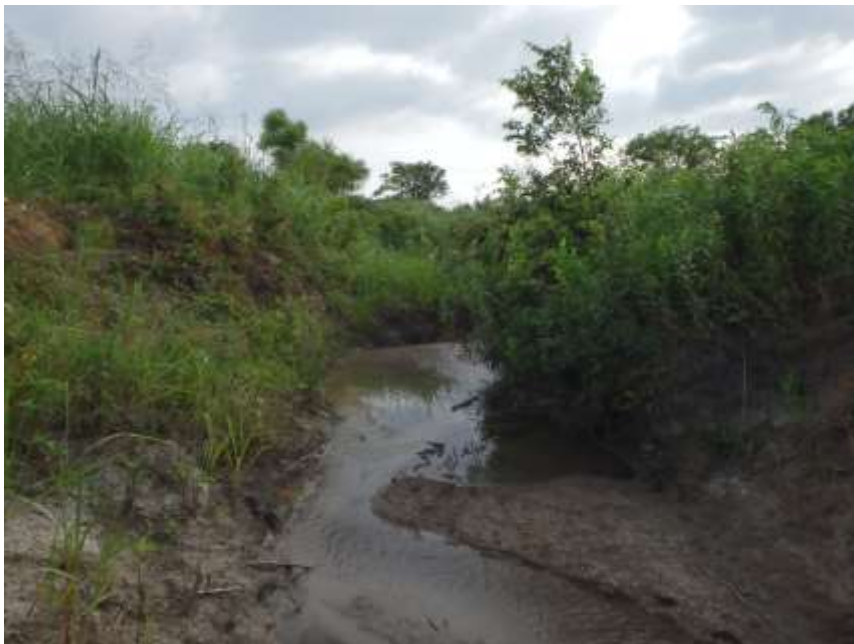
The stream flow type was observed as normal during the first survey, but the stream was not flowing during the second survey. Figure 4.9 illustrates the typical observed width of the creek at this site, approximately 1 m. Widths ranged from 1.7 m to 0 m between the two surveys (Tables 4.6 and 4.7).

Figure 4.9 Photograph of Honey Grove Creek Site HG03 taken on June 23, 2021, the downstream view of the 300-m transect
