Recreational Use Attainability Analysis for Honey Grove Creek (0202L) in the Red River Basin

By Leah Taylor
Texas Institute for Applied Environmental Research
Submitted to TCEQ December 2021

Prepared by:
Leah Taylor
Texas Institute for Applied Environmental Research
Tarleton State University
Stephenville, Texas

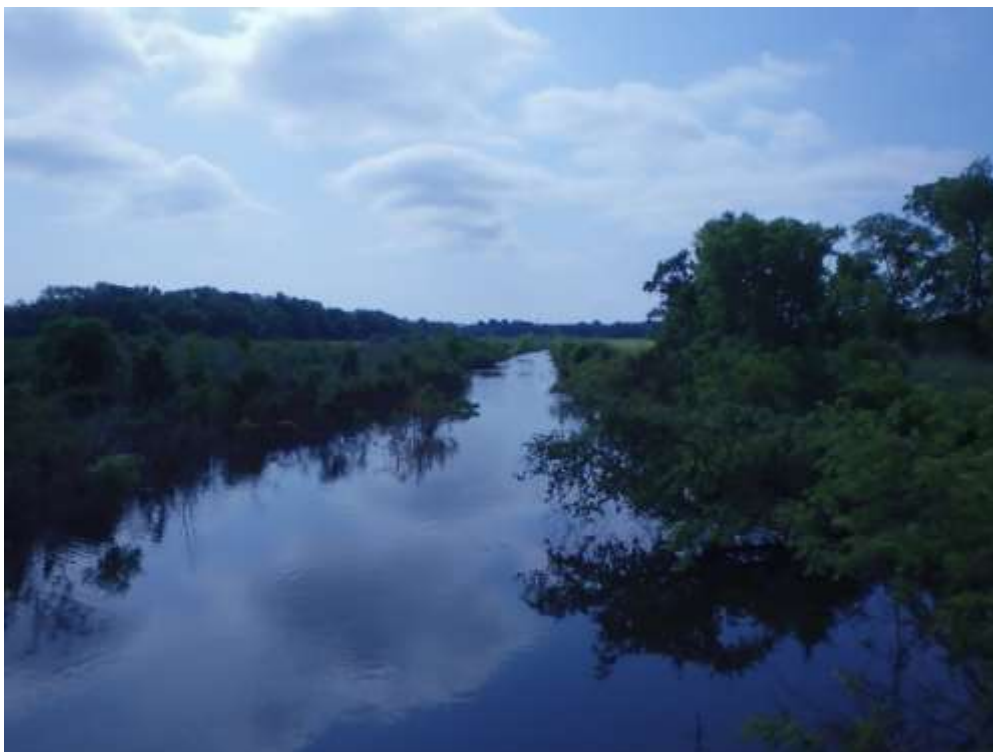
Figure 4.3 Photograph of Honey Grove Creek Site HG02 taken on June 23, 2021
The upstream view at the bridge crossing on PR 2765.

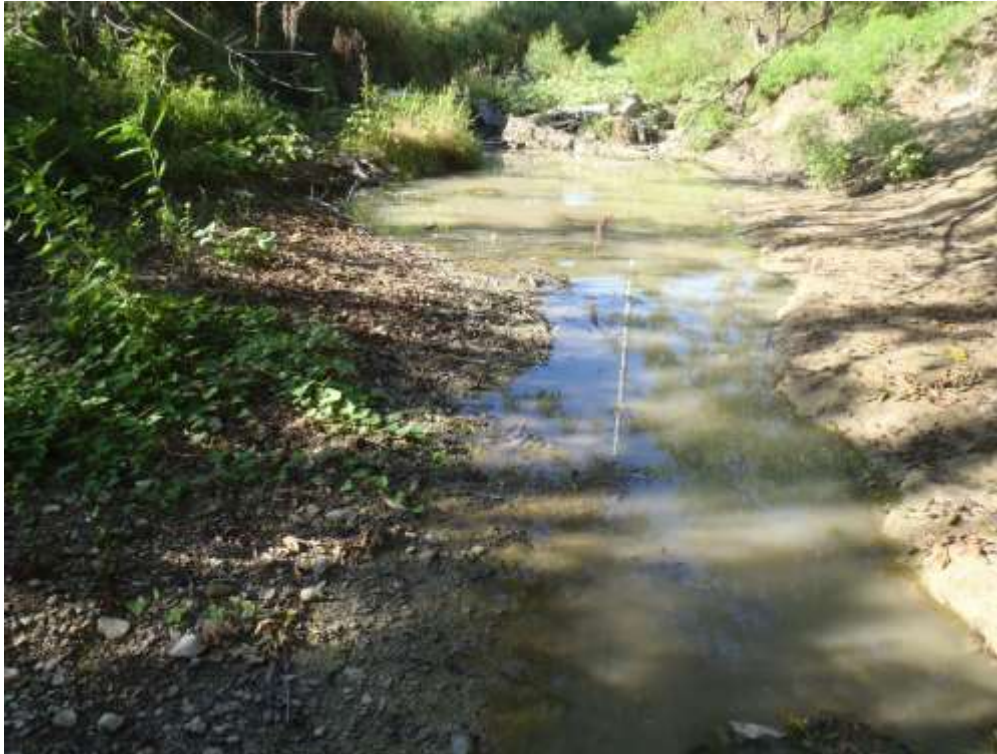
Figure 4.5 Photograph of Honey Grove Creek at Site HG02 taken on June 17, 2021

Photograph at the 150-m transect facing downstream.

Honey Grove Creek at this site primarily passes through a forest riparian zone that led to a pasture riparian zone on the left bank in the upstream portion of the site (Table 4.4). The general appearance of the stream at this location is shown in Figures 4.4 and 4.5.
