# Recreational Use Attainability Analysis for The Unnamed Tributary of Buffalo Creek (0214F) in the Red River Basin

Prepared for:  
Texas Commission on Environmental Quality  
P.O. Box 13087  
Austin, Texas 78711-3087

Prepared by:  
Texas Institute for Applied Environmental Research  
Tarleton State University  
Stephenville, Texas

October 2021

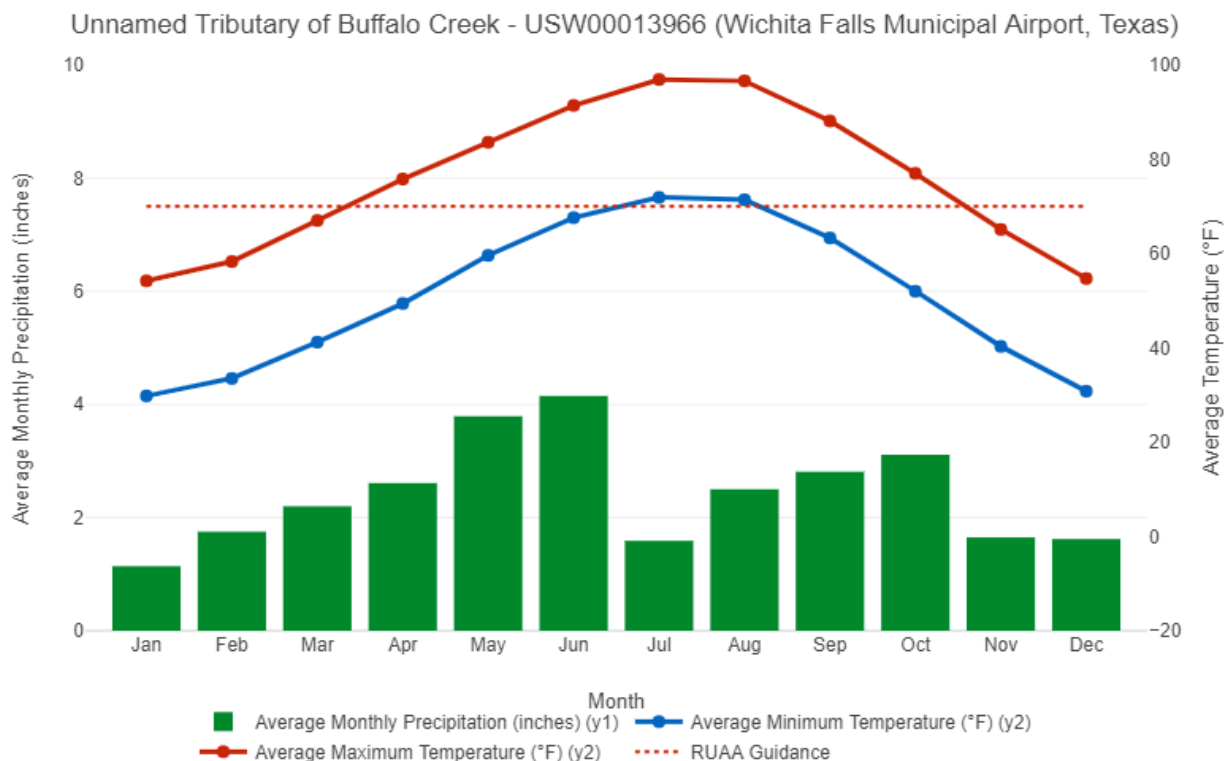
Annual precipitation for the Unnamed Tributary of Buffalo Creek watershed was based on data obtained from the National Oceanic and Atmospheric Administration's website (NOAA, 2015) for Wichita Falls, Texas (Station USW00013966). It is important to note that this station is not within the Unnamed Tributary of Buffalo Creek watershed boundaries. However, it is the nearest station with climate normal available for both precipitation and temperature. Normal precipitation (1981-2010) for Station USW00013966 averages 28.92 inches per year with a peak rainfall typically occurring in the months of May and June (Figure 3.1).

Average maximum temperatures for Station USW00013966 rise above 70°F beginning in month April and ending in October (Figure 3.1). March through October are the months notes as generally suitable for assessing recreational use, but only if temperatures reach above 70°F (TCEQ, 2014b).

**Figure 3.1 Monthly average precipitation for Pittsburg, Texas.**

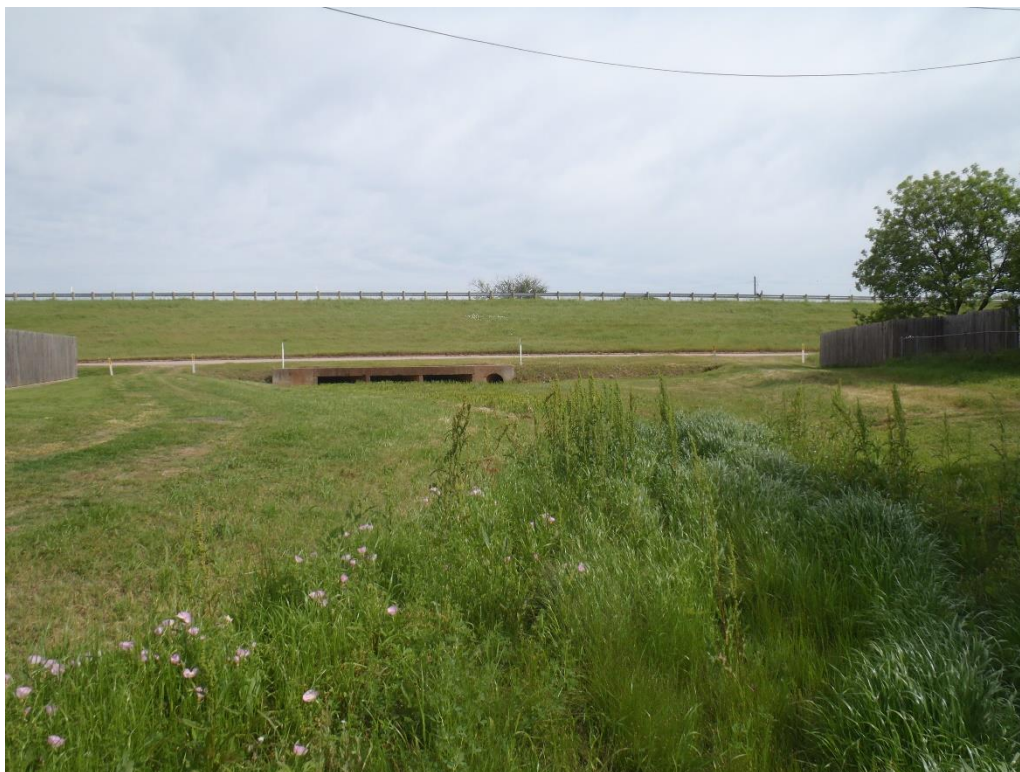
The creek at this site passes through a mowed and maintained corridor. The riparian area was mowed and open leading directly up to the edge of the stream bank. Banks were gentle and approximately 6 inches high in places. The general appearance of the creek at this location is shown in Figures 4.2 and 4.3.

**Figure 4.2** Photograph of the Unnamed Tributary of Buffalo Creek Site UB01 taken on April 27, 2020. The upstream view of the 300-m transect.

Site UB01 was wadeable with average thalweg ranging from 0.04 m to 0 m between surveys. Figure 4.2 illustrates the typical observed width of the creek at this site, approximately 0 m. Widths ranged from 2.3 m to 0 m during the two surveys (Tables 4.6 and 4.7).

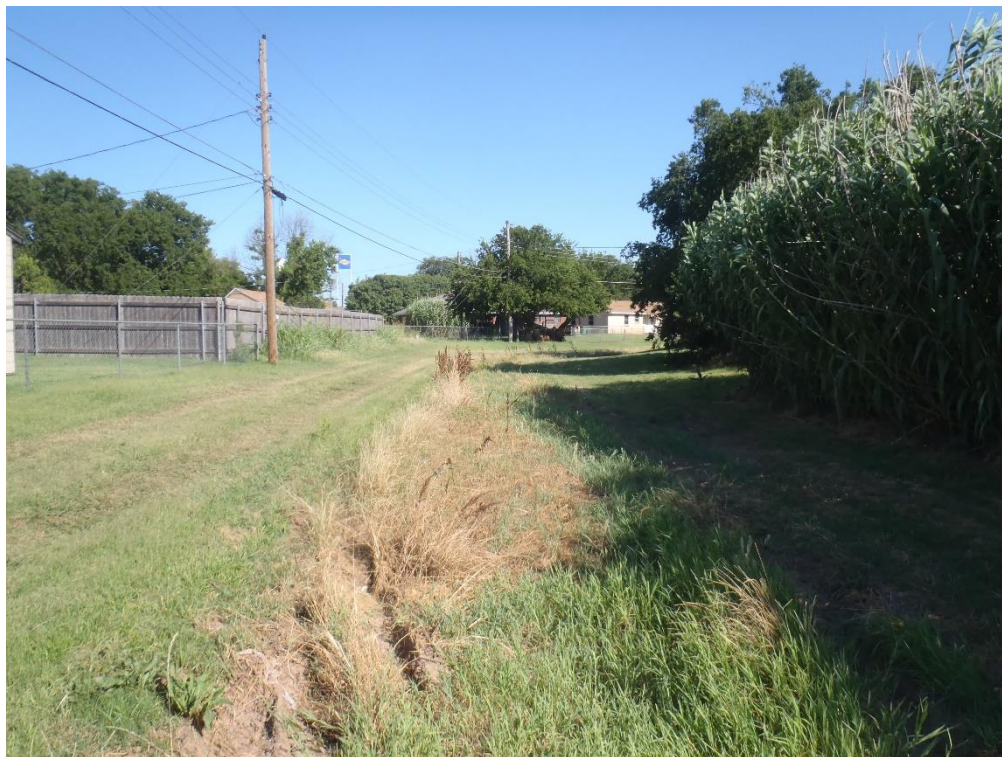
**Figure 4.3** Photograph of the Unnamed Tributary of Buffalo Creek Site UB01 taken on June 17, 2020. The upstream view of the 150-m transect.

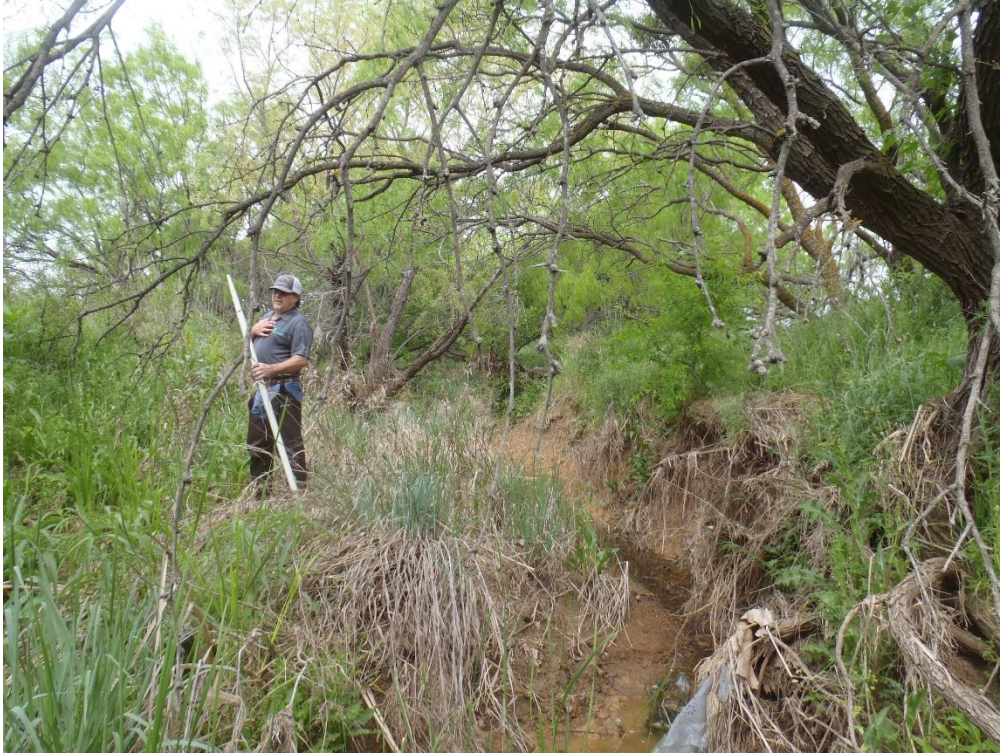
Portions of the stream at UB02 passed through open pasture land with a small riparian area (Table 4.4). However, the banks were vegetated with larger trees and a larger shaded understory (Figure 4.4). The stream was wadeable during both surveys. Average thalweg depths ranged from 0.08 m

**Figure 4.4** Photograph of Unnamed Tributary of Buffalo Creek Site UB02 taken on April 27, 2020. Photograph shows the upstream view of the 150-m transect. TIAER personnel in photo.

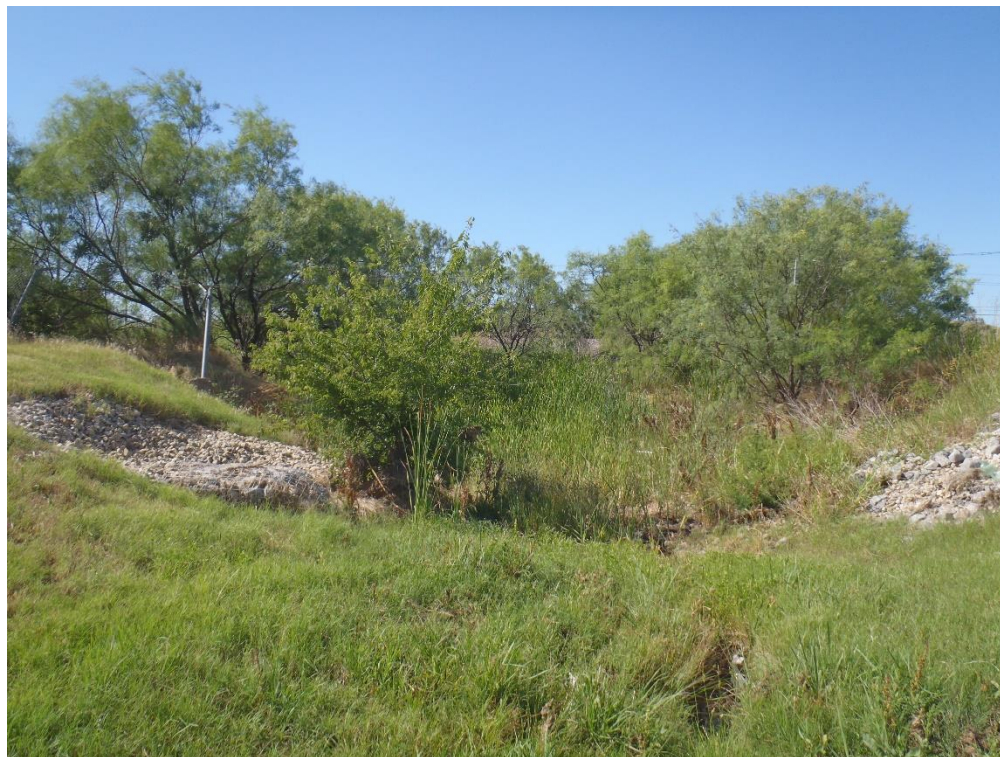
**Figure 4.5** Photograph of the Unnamed Tributary of Buffalo Creek at Site UB02 taken on June 17, 2020. Photograph at the 300-m transect facing upstream.

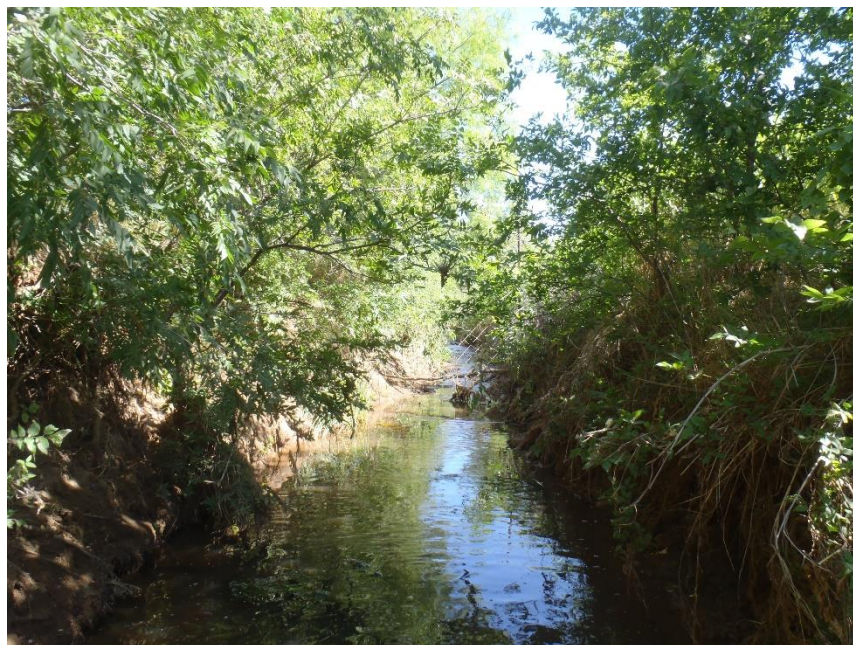
The stream banks were densely vegetated (as seen in Figure 4.6) at UB03. The stream channel was relatively clear of downed logs and twig debris; however, the substrate was slick and slippery to walk. Aquatic vegetation and algae cover was observed during both the first and second surveys. Because this site is downstream of the City of Iowa Park WWTF, a chlorine odor was present during both surveys. The water was clear in color and surface during both surveys with the exception of some scum encounters on the surface during some locations along the 300 m reach during the second survey.

**Figure 4.6** Photograph of The Unnamed Tributary of Buffalo Creek Site UB03 taken on June 17, 2020, the upstream view of the 150-m transect.
