Recreational Use Attainability Analysis for Lower Keechi Creek (0804K) in the Trinity River Basin

By Leah Taylor
Texas Institute for Applied Environmental Research
Submitted to TCEQ August 2023

TIAER Publication TR2203

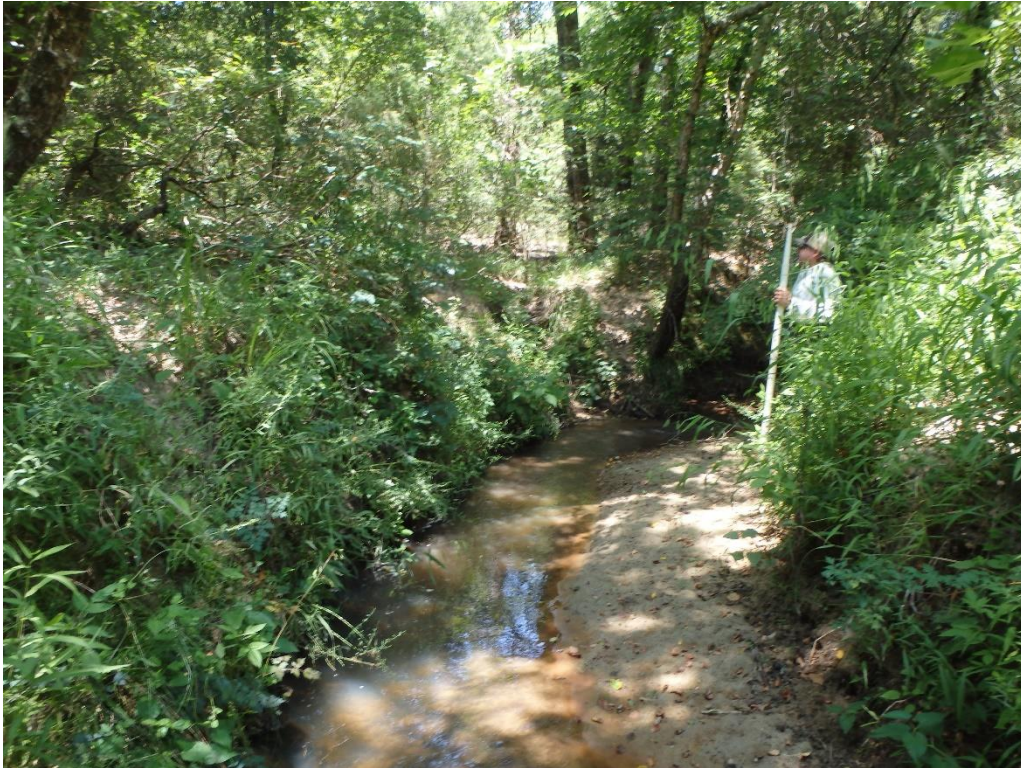
Figure 4.2 Photograph of Lower Keechi Creek Site LK01 taken on June 28, 2022. TIAER personnel in photograph.

The upstream view of the 0-m transect

Site LK01 was wadeable with average thalweg of 0.20 m during the first survey and 0.37 m during the second survey. Figure 4.2 illustrates the typical observed width of the creek at this site, approximately 1.5 m. Widths ranged from 0.5 m to 2.1 m during the two surveys (Tables 4.6 and 4.7).

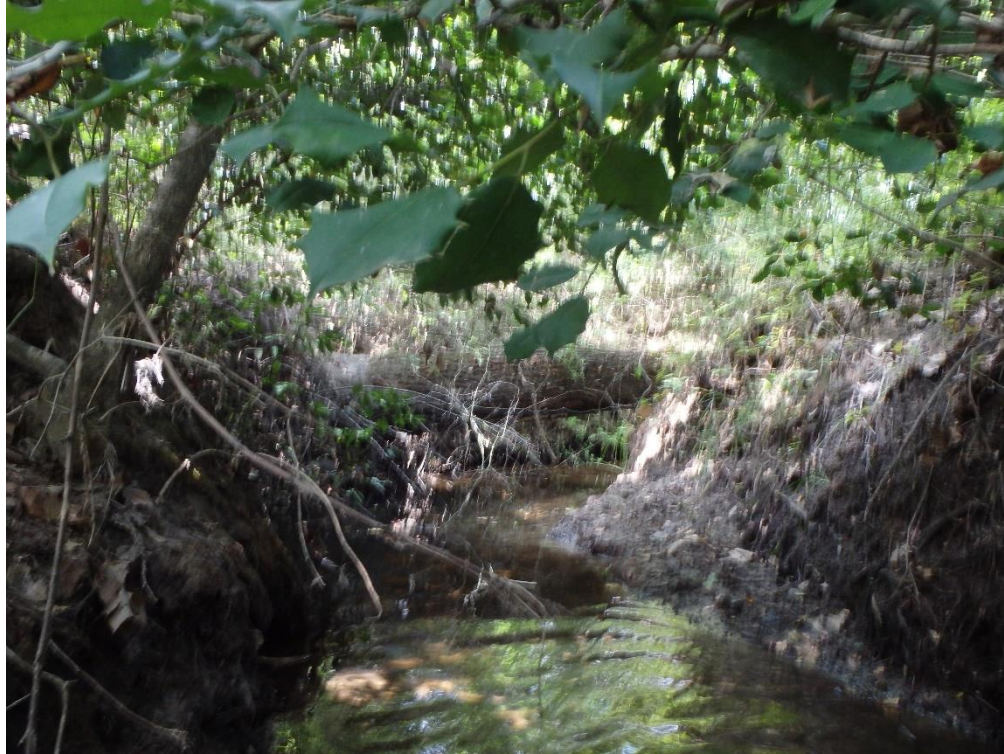
Figure 4.3 Photograph of Lower Keechi Creek Site LK01 taken on September 8, 2022

The upstream view of the 300-m transect

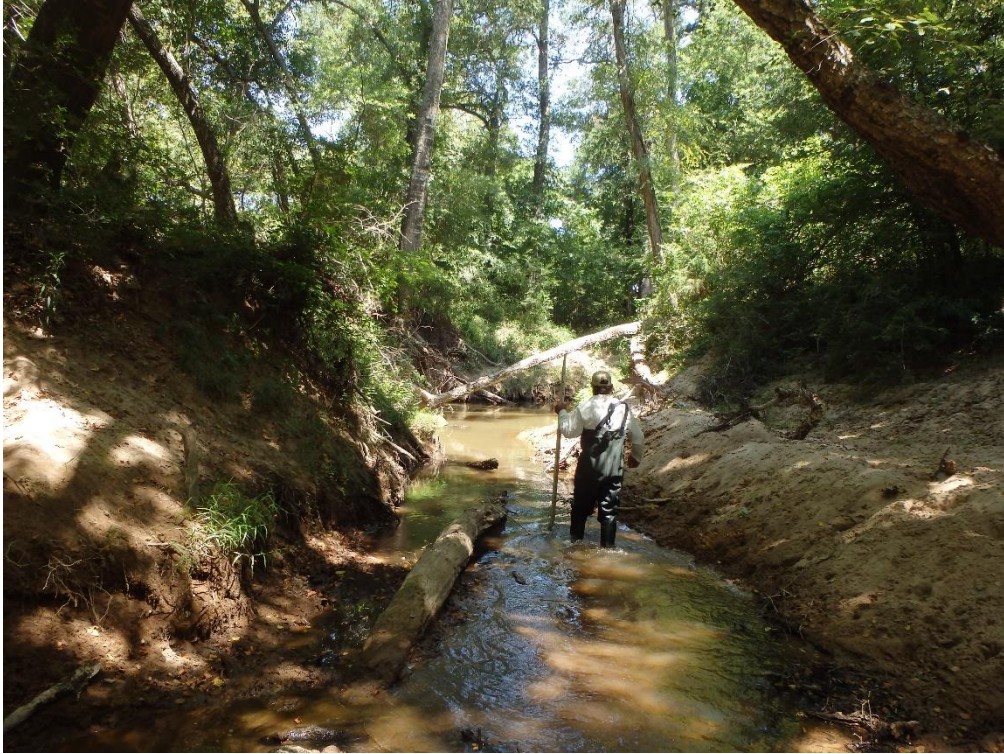
The riparian zone at Site LK02 was forest with thick vegetation and shrub dominated corridor on both the right and left banks (Table 4.4). Banks were vegetated with larger trees and a larger shaded understory (Figures 4.4 and 4.5) throughout this site. The stream was wadeable during both surveys with average thalweg depths ranging from 0.54 m to 0.49 m. The stream was designated as perennial and had normal flow during both surveys (Table 4.5). Channel widths ranged from 1.5 m to 6.0 m throughout the reach during both surveys with a typical observed width of 4.0 m (Tables 4.6 and 4.7).

Figure 4.4 Photograph of Lower Keechi Creek Site LK02 taken on June 28, 2022
Photograph shows the upstream view of the 150-m transect.

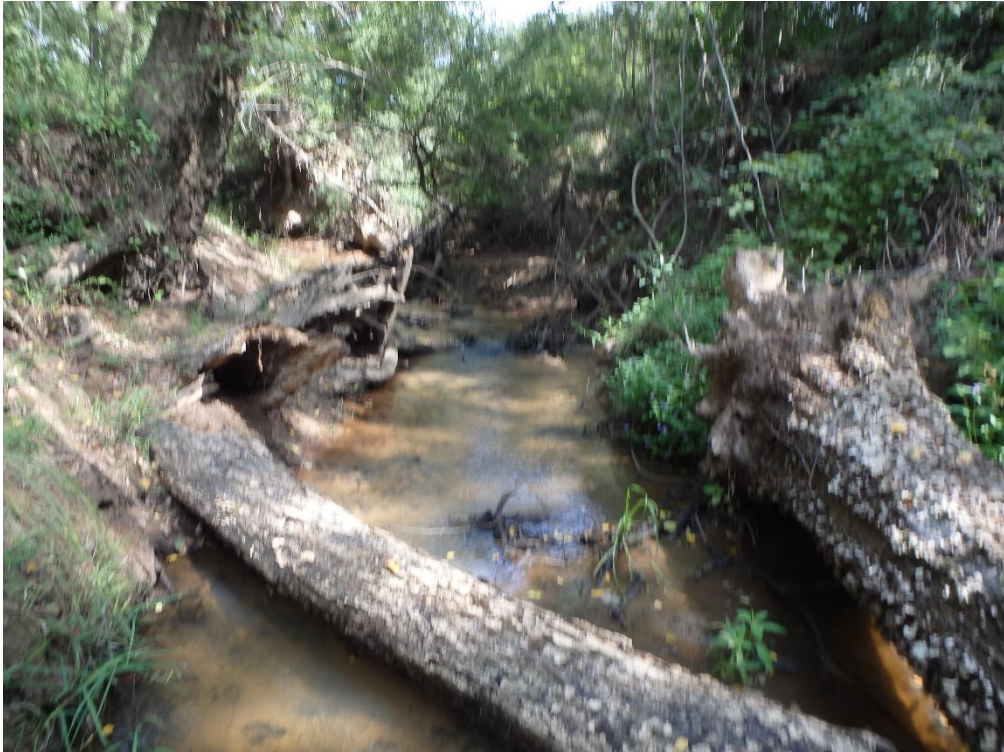
Figure 4.5 Photograph of Lower Keechi Creek at Site LK02 taken on September 8, 2022
Photograph at the 300-m transect facing downstream.

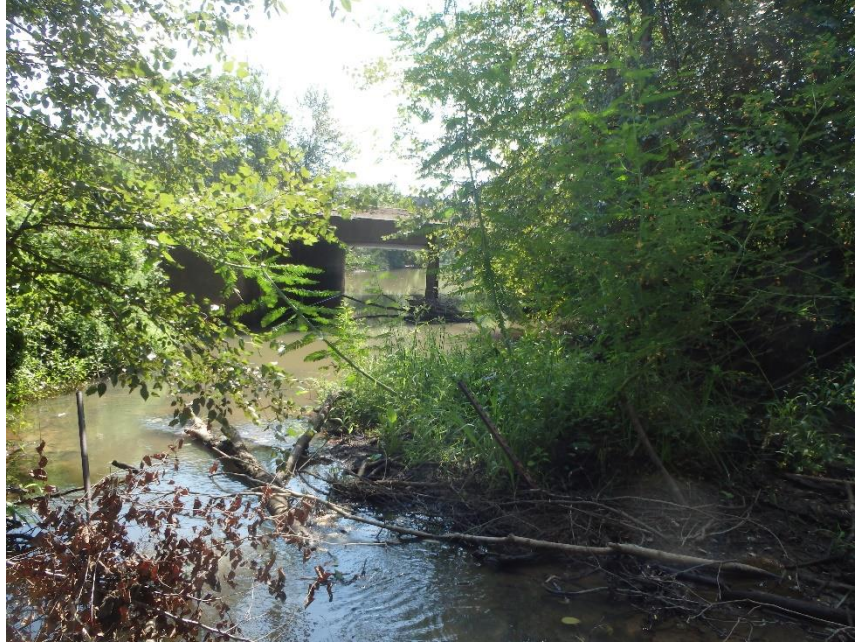
The stream banks were densely vegetated (as seen in Figure 4.6) at LK03. Channel obstructions at this site included submerged log jams, tree branches, and a culvert at the 0-m transect. Aquatic vegetation was absent, algae cover was rare, and the water color was clear during both surveys.

Figure 4.6 Photograph of Lower Keechi Creek Site LK03 taken on September 8, 2022, the downstream view of the 0-m transect

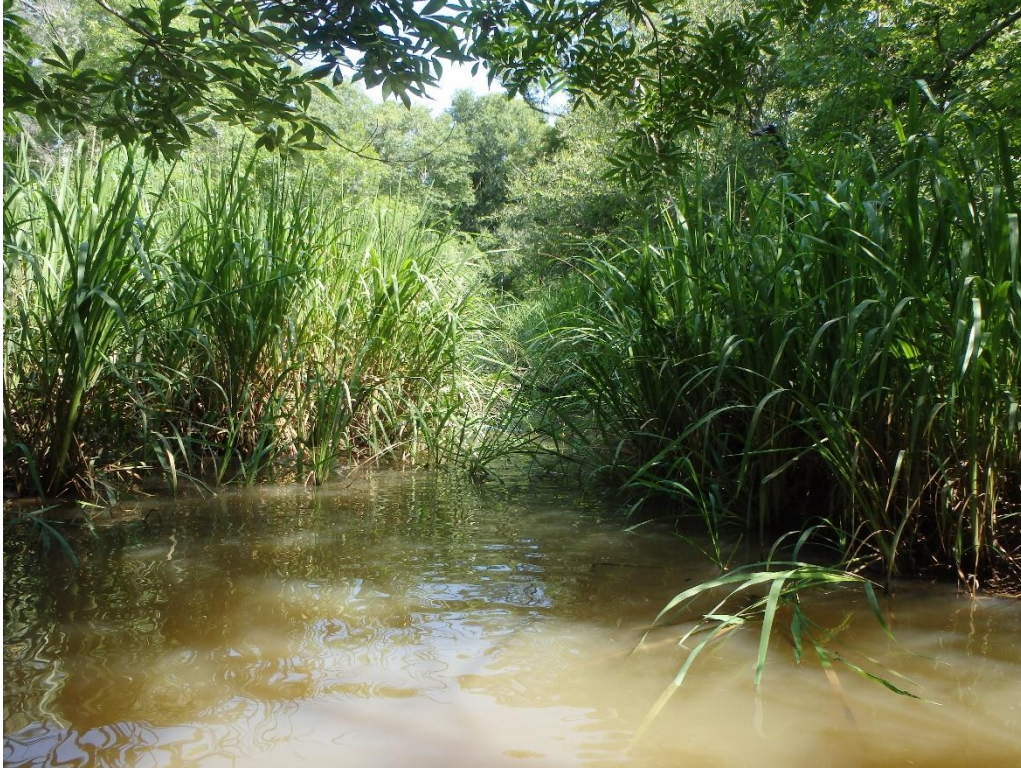
Access to the stream at this site was moderately easy at the road crossing due to the under-bridge access. The riparian area was forest with thick shrub vegetation and slippery slopes on both the right and left banks (Table 4.4). Banks were steep, slippery, and overgrown with vegetation (Figures 4.7 and 4.8).

Figure 4.7 Photograph of Lower Keechi Creek Site LK04 taken on June 28, 2022

The upstream view of the 300-m transect.

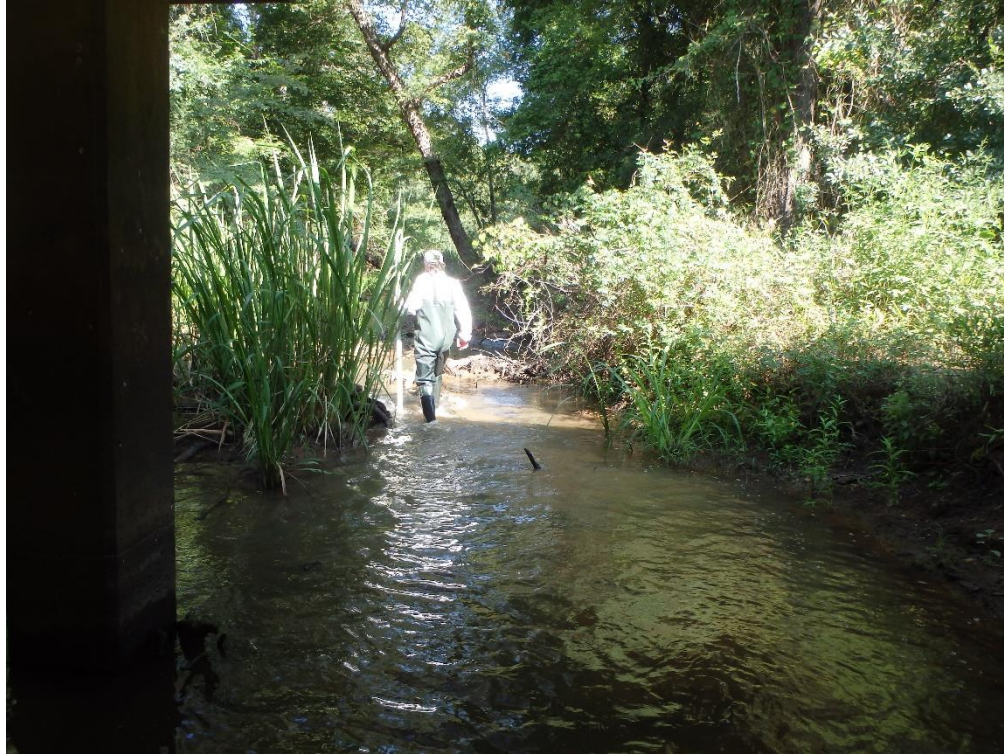
Figure 4.8 Photograph of Lower Keechi Creek Site LK04 taken on September 8, 2022

The upstream view of the 150-m transect.

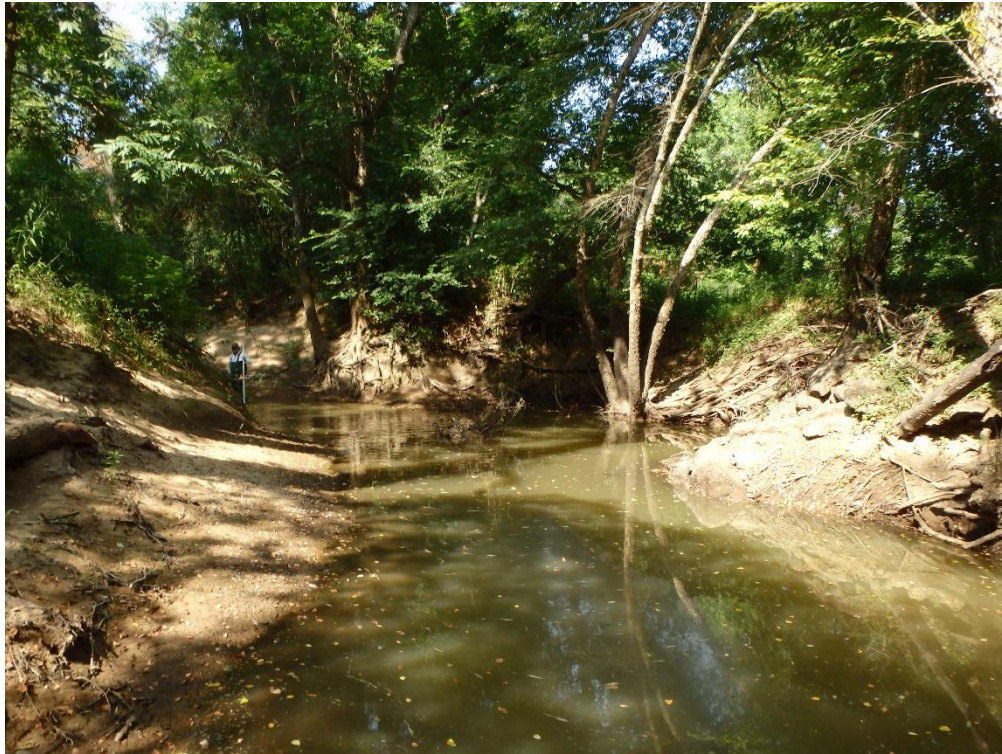
survey and 4.0 m during the second survey (Tables 4.6 and 4.7). Figure 4.9 depicts the typical channel width during each survey.

Figure 4.9 Photograph of typical channel width at Lower Keechi Creek Site LK05 taken on June 28, 2022

Photograph shows the upstream view of the 0-m transect.

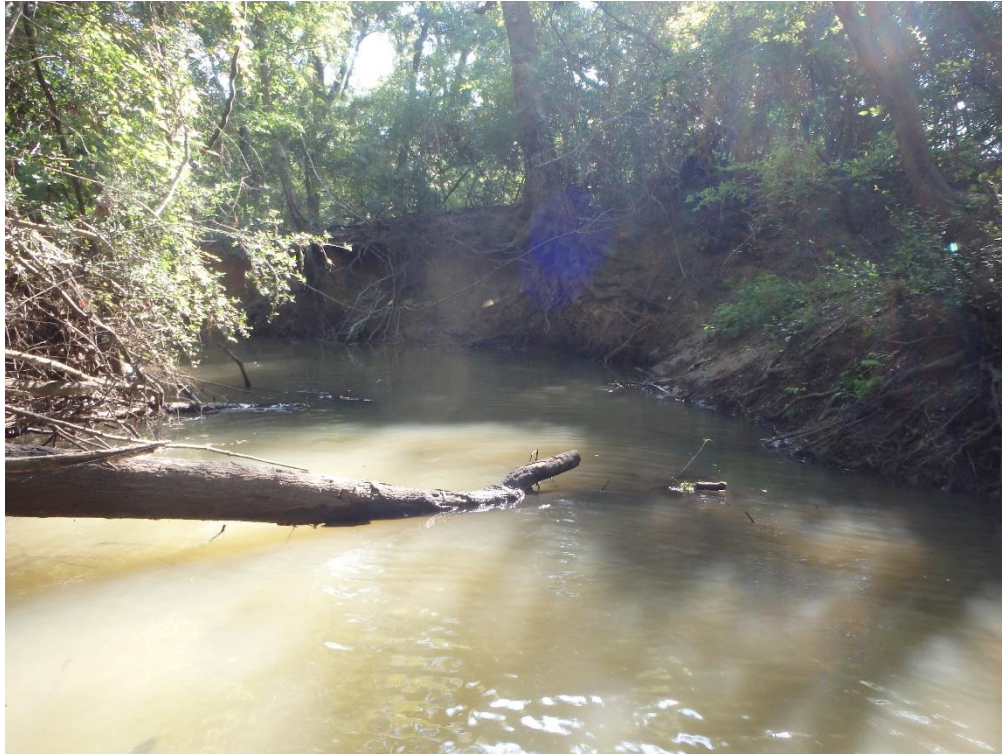
Figure 4.10 Photograph of fallen tree in Lower Keechi Creek on September 8, 2022.

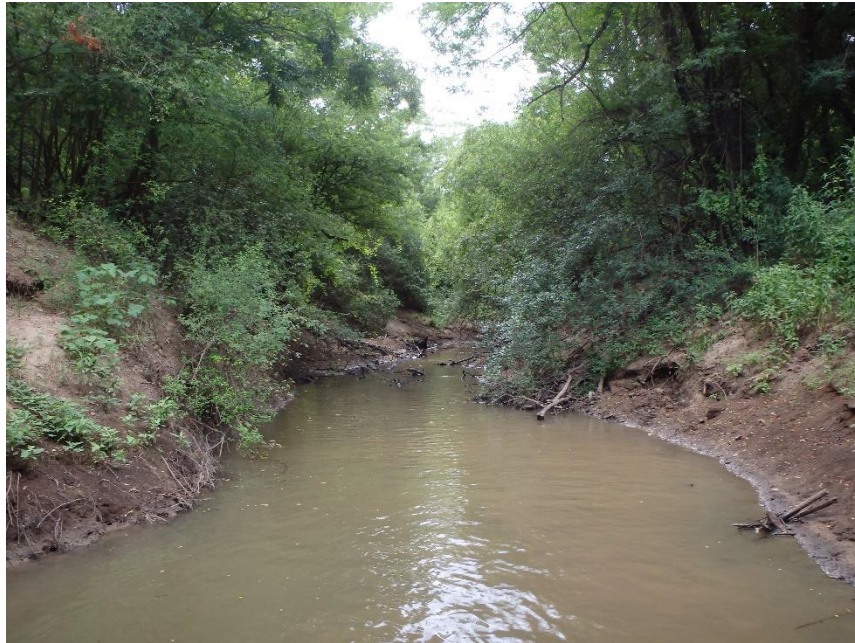
The stream banks were densely vegetated (as seen in Figure 4.11) at LK06. The stream channel was populated with downed logs and twig debris during both surveys (Figure

Figure 4.11 Photograph of Lower Keechi Creek at Site LK06 taken on June 28, 2022, the upstream view of the 150-m transect

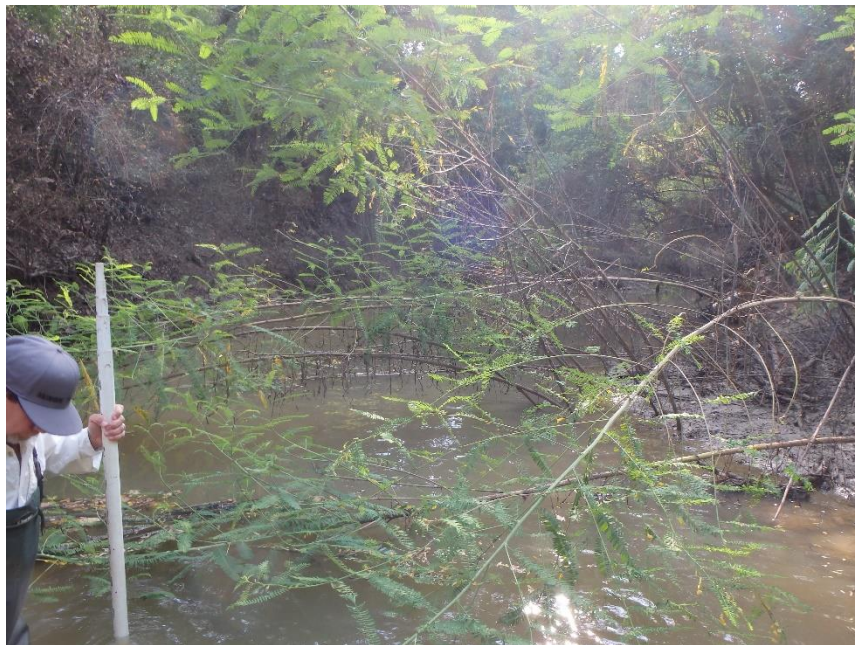
4.12). Aquatic vegetation and algae cover was absent during both surveys. The water was brown in color with a clear surface during both surveys.

Figure 4.12 Photograph of vegetation in Lower Keechi Creek at Site LK06 taken on September 8, 2022
