Draft Recreational Use Attainability Analysis for Lower Keechi Creek (0804K) in the Trinity River Basin

By Leah Taylor
Texas Institute for Applied Environmental Research
Submitted to TCEQ April 2023

TIAER Publication TR2203

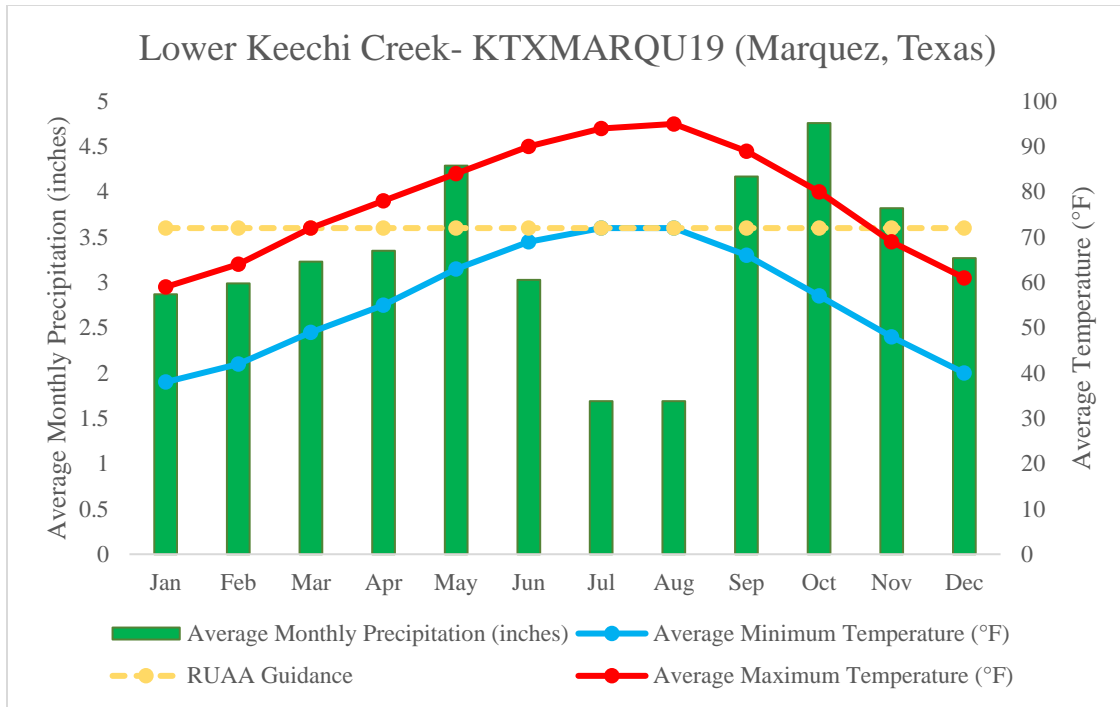
Annual precipitation for the Lower Keechi Creek watershed was based on data obtained from the National Oceanic and Atmospheric Administration's website (NOAA, 2015) for Marquez, Texas (Station KTXMARQU19). It is important to note that this station is not within the Lower Keechi Creek watershed boundaries. However, it is the nearest station with climate data available for both precipitation and temperature. Normal precipitation (1981-2010) for Station KTXMARQU19 averages 39.16 inches per year with a peak rainfall typically occurring in the months of May, September, and October (Figure 3.1).

Average maximum temperatures for Station KTXMARQU19 rise above 70°F beginning in March and ending in November (Figure 3.1). March through October are the months known as generally suitable for assessing recreational use, but only if temperatures reach above 70°F (TCEQ, 2014b).

Figure 3.1 Monthly average precipitation for Marquez, Texas

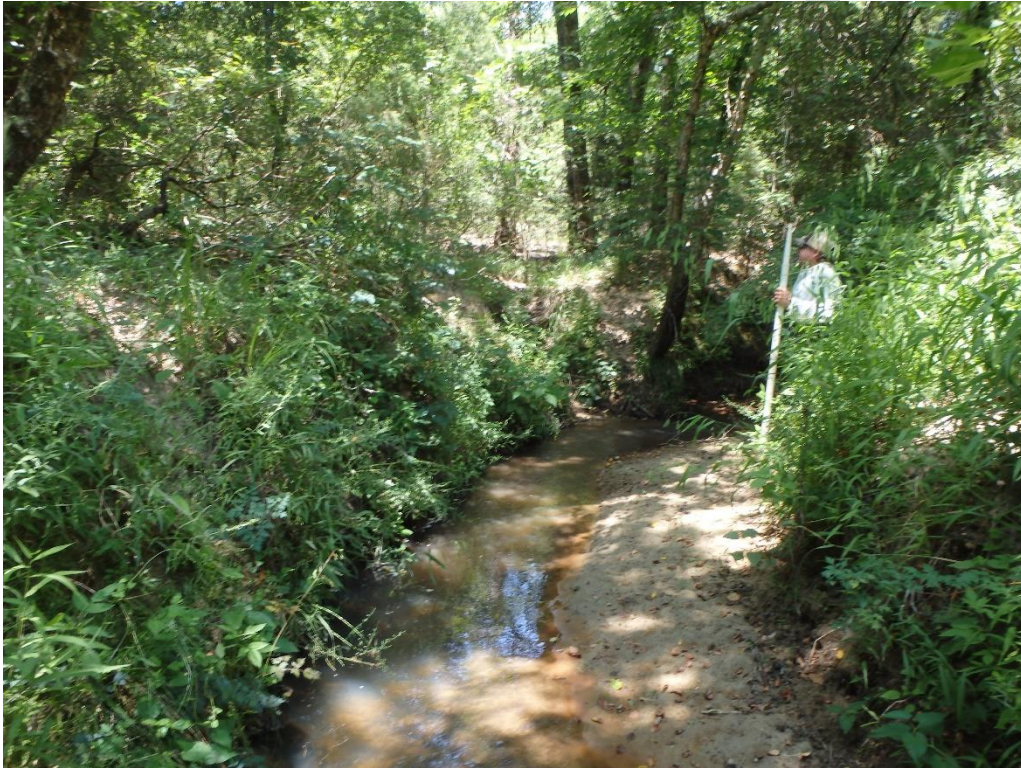
The creek at this site passes through a forest riparian zone that led directly up to the creek. Banks were steep and slippery and had fenced private property on both sides of the stream making access moderately easy. The general appearance of the creek at this location is shown in Figures 4.2 and 4.3.

Figure 4.2 Photograph of Lower Keechi Creek Site LK01 taken on June 28, 2022. TIAER personnel in photograph.

The upstream view of the 0-m transect

Site LK01 was wadeable with average thalweg of 0.20 m during the first survey and 0.37 m during the second survey. Figure 4.2 illustrates the typical observed width of the creek at this site, approximately 1.5 m. Widths ranged from 0.5 m to 2.1 m during the two surveys (Tables 4.6 and 4.7).

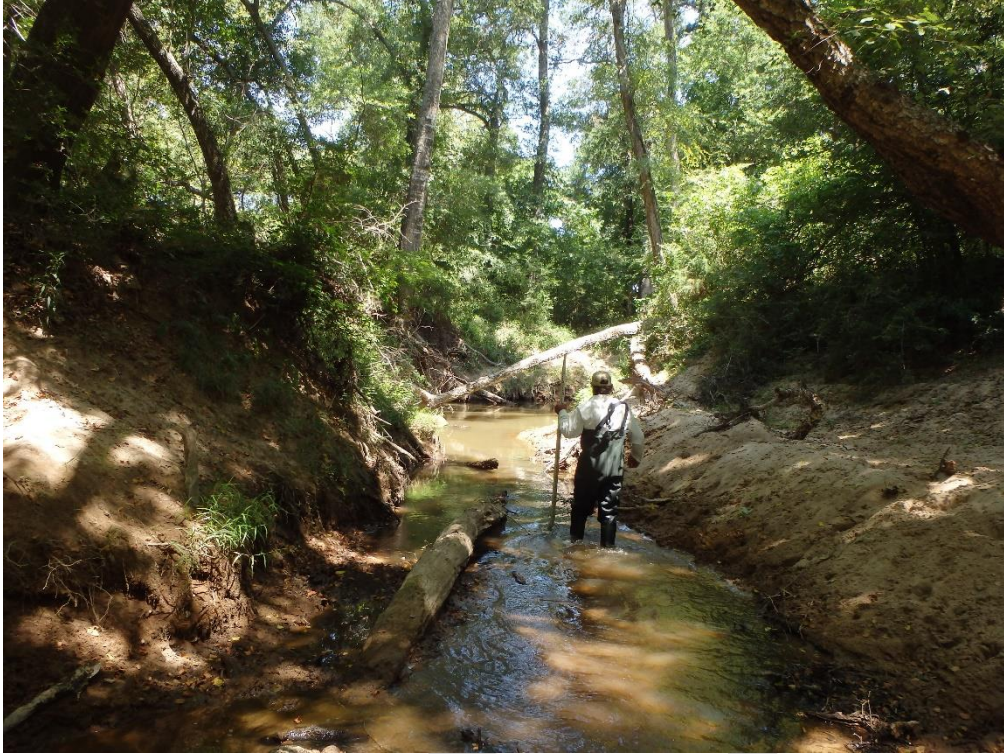
The riparian zone at Site LK02 was forest with thick vegetation and shrub dominated corridor on both the right and left banks (Table 4.4). Banks were vegetated with larger trees and a larger shaded understory (Figures 4.4 and 4.5) throughout this site. The stream was wadeable during both surveys with average thalweg depths ranging from 0.54 m to 0.49 m. The stream was designated as perennial and had normal flow during both surveys (Table 4.5). Channel widths ranged from 1.5 m to 6.0 m throughout the reach during both surveys with a typical observed width of 4.0 m (Tables 4.6 and 4.7).

Figure 4.4 Photograph of Lower Keechi Creek Site LK02 taken on June 28, 2022
Photograph shows the upstream view of the 150-m transect.

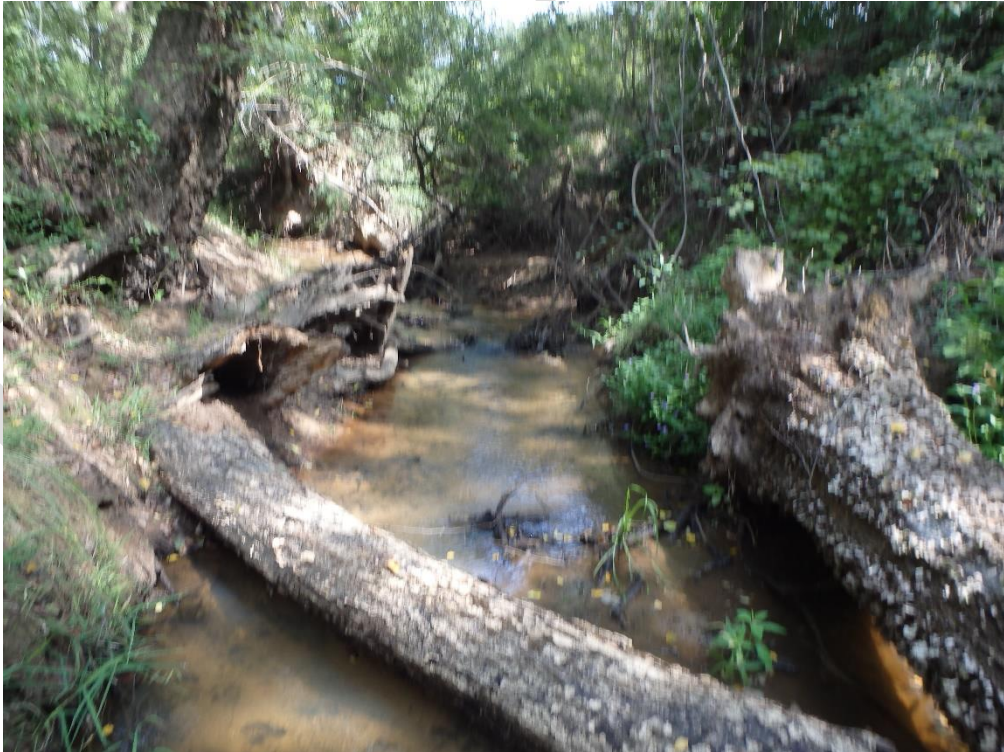
Figure 4.5 Photograph of Lower Keechi Creek at Site LK02 taken on September 8, 2022
Photograph at the 300-m transect facing downstream.

No water dependent birds were observed at this site during either survey (Tables 4.8 and 4.9). Bird droppings were observed in addition to raccoon, hog, and deer tracks. A snake was observed during the first survey and a herd of cattle (greater than 15 head) was present during the second survey. Aquatic vegetation and algae were absent during both surveys. No odor was detected, water color was clear, and the surface clear during each survey. One tire was present in the channel during the first survey, but no other garbage was observed during either survey.

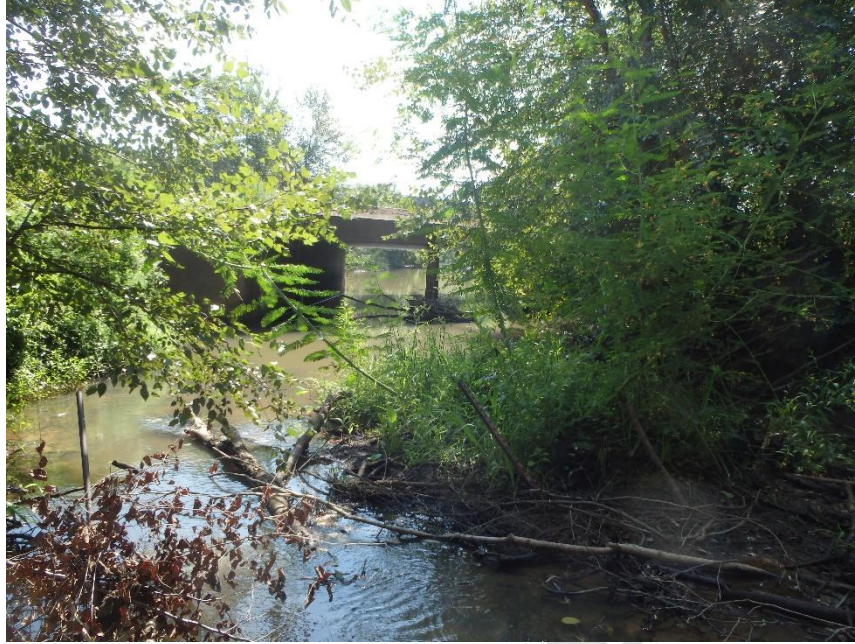
The stream banks were densely vegetated (as seen in Figure 4.6) at LK03. Channel obstructions at this site included submerged log jams, tree branches, and a culvert at the 0-m transect. Aquatic vegetation was absent, algae cover was rare, and the water color was clear during both surveys.

Figure 4.6 Photograph of Lower Keechi Creek Site LK03 taken on September 8, 2022, the downstream view of the 0-m transect

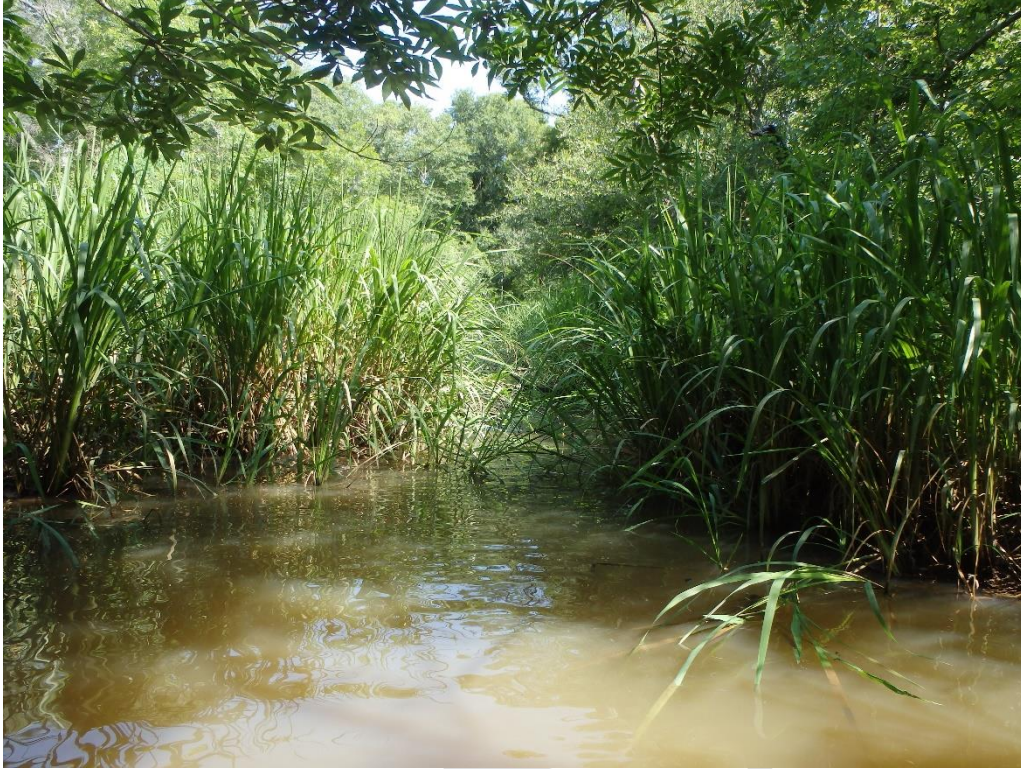
Access to the stream at this site was moderately easy at the road crossing due to the under-bridge access. The riparian area was forest with thick shrub vegetation and slippery slopes on both the right and left banks (Table 4.4). Banks were steep, slippery, and overgrown with vegetation (Figures 4.7 and 4.8).

Figure 4.7 Photograph of Lower Keechi Creek Site LK04 taken on June 28, 2022

The upstream view of the 300-m transect.

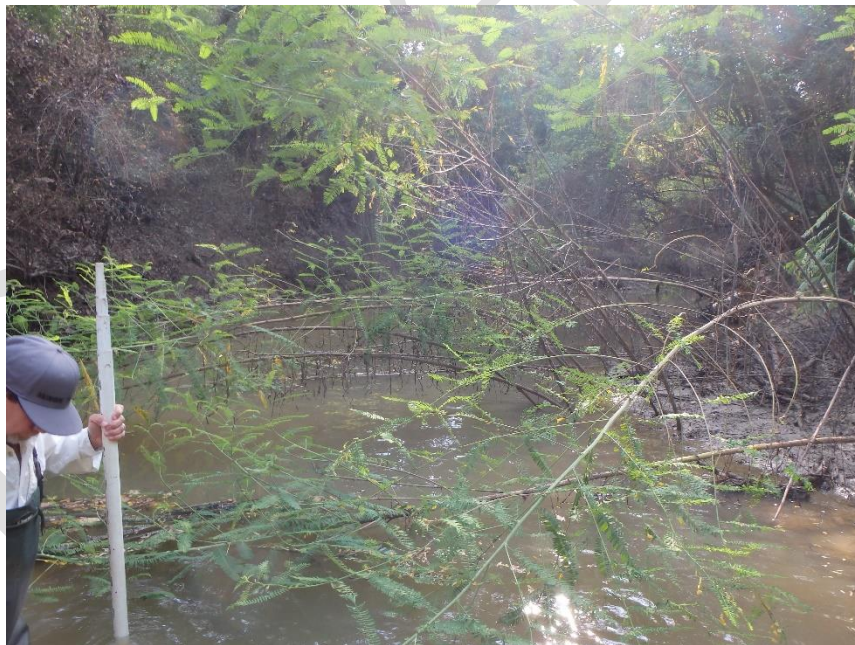
The stream banks were densely vegetated (as seen in Figure 4.11) at LK06. The stream channel was populated with downed logs and twig debris during both surveys (Figure

4.12). Aquatic vegetation and algae cover was absent during both surveys. The water was brown in color with a clear surface during both surveys.

Figure 4.12 Photograph of vegetation in Lower Keechi Creek at Site LK06 taken on September 8, 2022
