# Recreational Use-Attainability Analysis for Ash Creek (0809B), Dosier Creek (0809C), and Derrett Creek (0809D) in the Trinity Creek River Basin

By Leah Taylor  
Texas Institute for Applied Environmental Research  
Submitted to TCEQ April 11, 2025

TIAER Publication TR2502

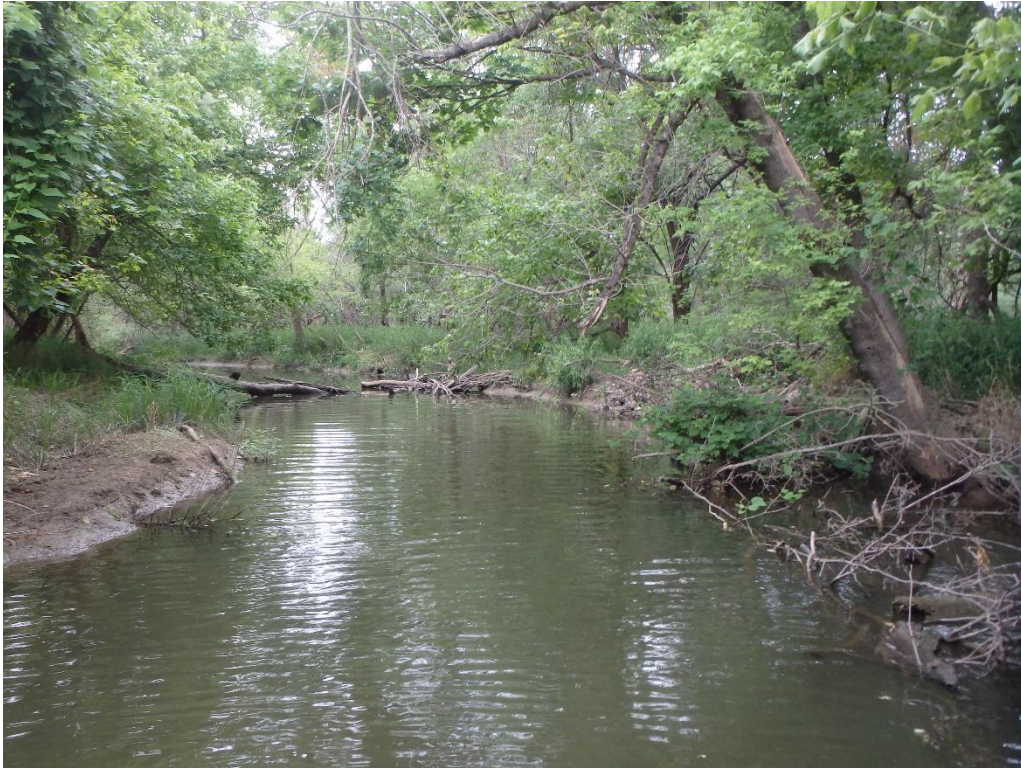
**Figure 4.2** Photograph of Ash Creek Site AC01 taken on June 20, 2024. The upstream view of the 0-m transect.

Site AC01 was wadeable with average thalweg ranging from  $>0.75$  m to 0.46 m between surveys. Figure 4.2 illustrates the typical observed width of the creek at this site, approximately 6 m. Widths ranged from 4.0 m to 8.0 m during the two surveys (Tables 4.6 and 4.7).

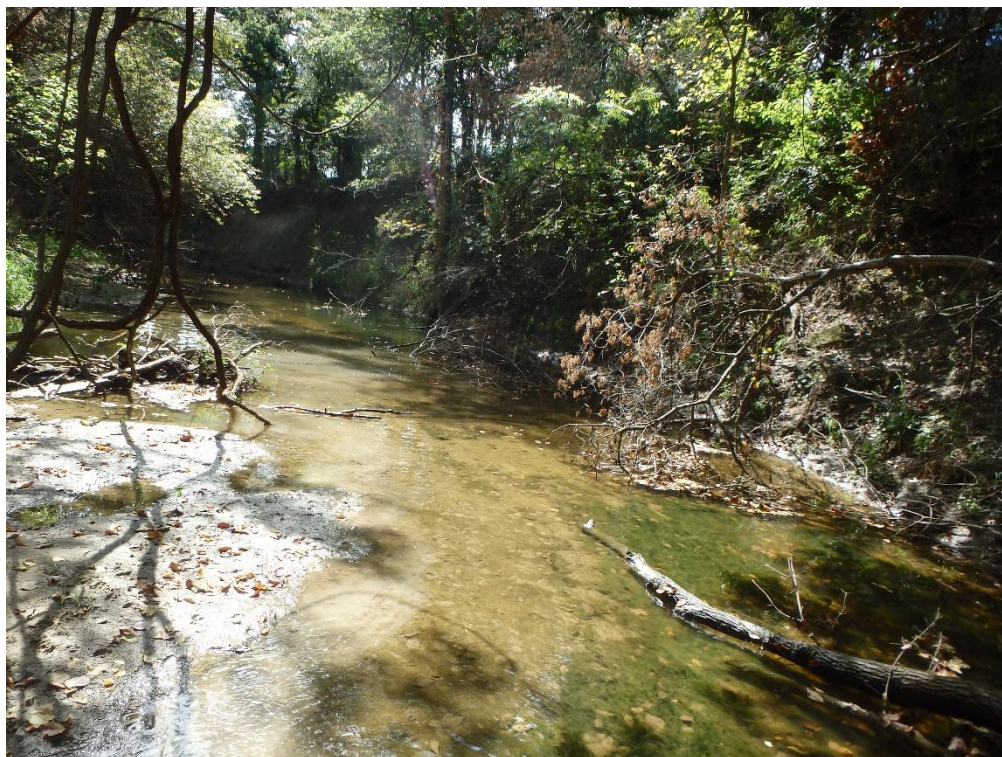
**Figure 4.3** Photograph of Ash Creek Site AC01 taken on September 26, 2024. The downstream view of the 300-m transect

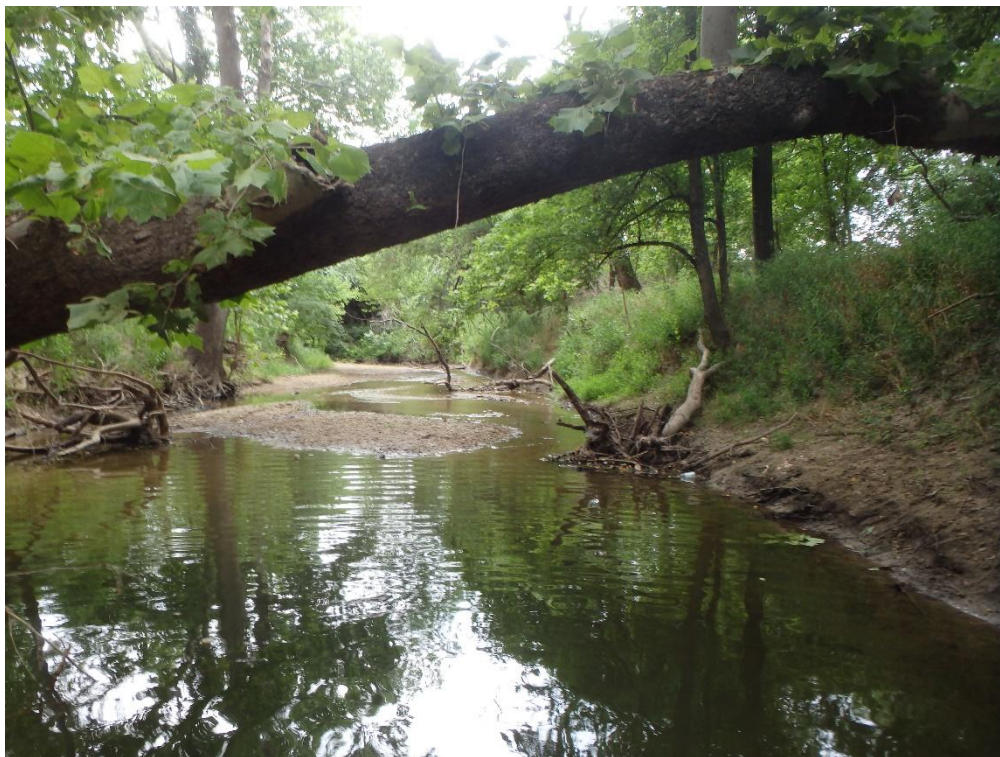
**Figure 4.4** Photograph of Ash Creek Site AC02 taken on June 20, 2024. Photograph shows the downstream view of the 0-m transect.

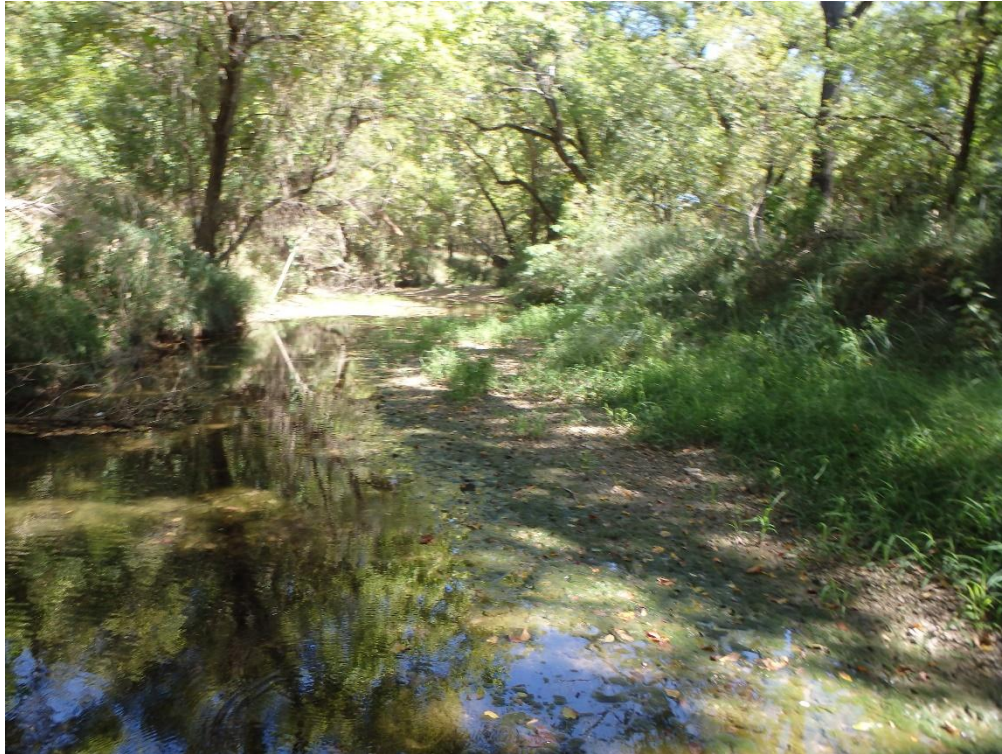
**Figure 4.5** Photograph of Ash Creek at Site AC02 taken on September 25, 2024.  
Photograph at the 300-m transect facing downstream.

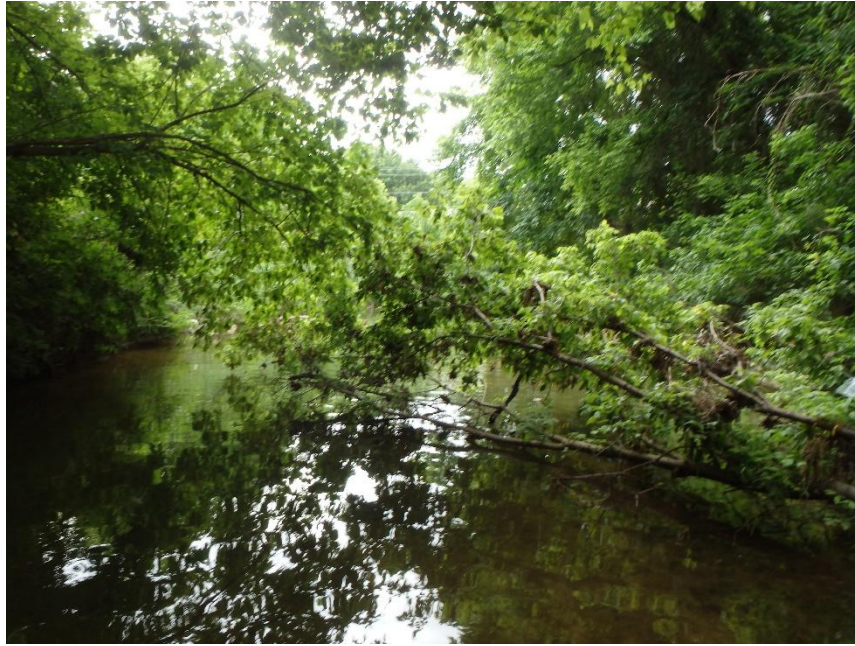
**Figure 4.6** Photograph of Ash Creek Site AC03 taken on June 20, 2024, the downstream view of the 300-m transect.

Banks were vegetated with larger trees and a larger shaded understory (Figures 4.6 and 4.7) throughout this site. Aquatic vegetation and algae cover were both absent during both surveys. The water was clear in color with no surface scum observed during the either survey.

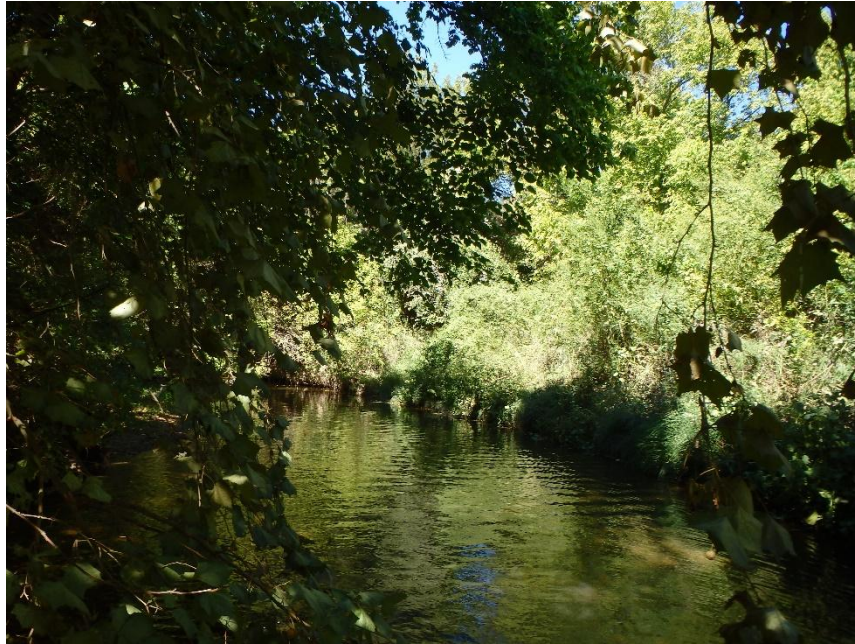
**Figure 4.7** Photograph of Ash Creek Site AC03 taken on September 25, 2024, the upstream view of the 0-m transect.

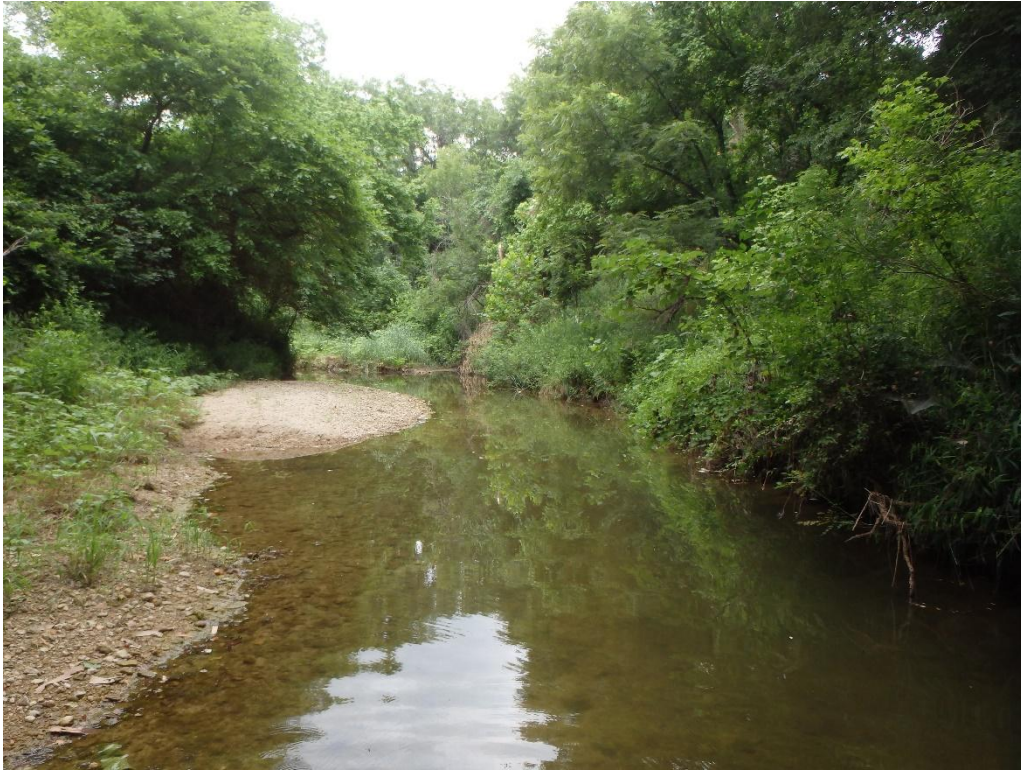
**Figure 4.8** Photograph of Ash Creek Site AC04 taken on June 20, 2024. The upstream view of the 0-m transect.

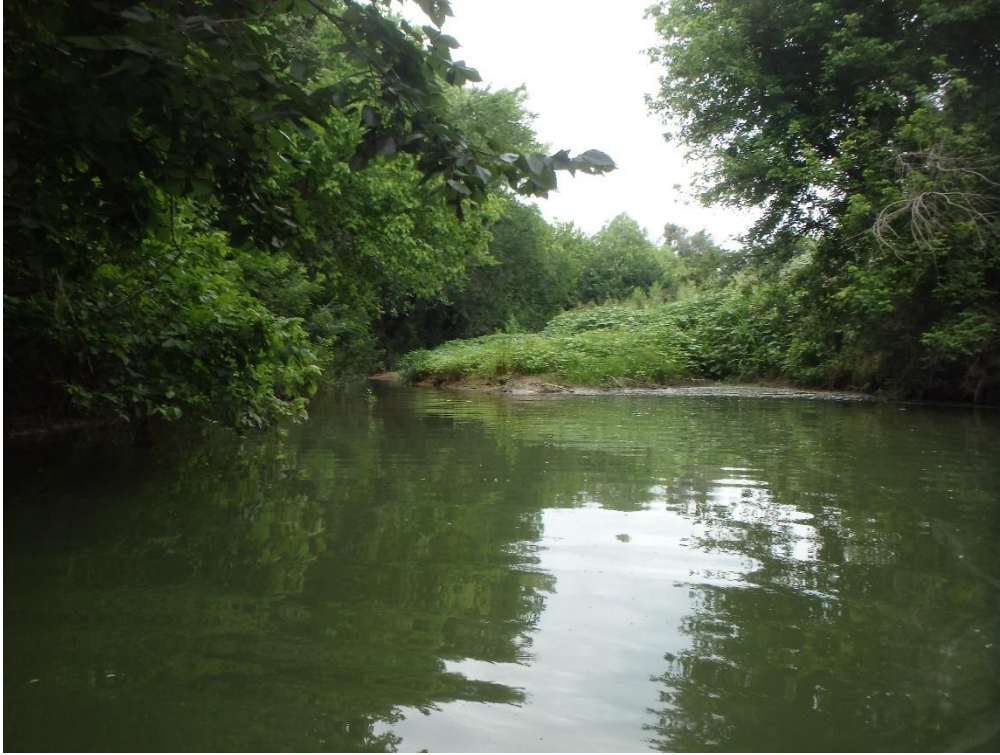
was observed during the first survey, measuring 31 meters in length by 28 meters in width and >1.5 meters depth (Figure 4.10 and Table 4.8). Two substantial pools were observed during the second survey. The first measuring 13 meters in length by 12 meters in width and >1.5 meters in depth, the second measures 10 meters in length by 5 meters in width and 0.35 meters in depth (Table 4.9).

**Figure 4.10** Photograph of Ash Creek Site AC05 taken on June 20, 2024. Photograph shows the upstream view of the 300-m transect.

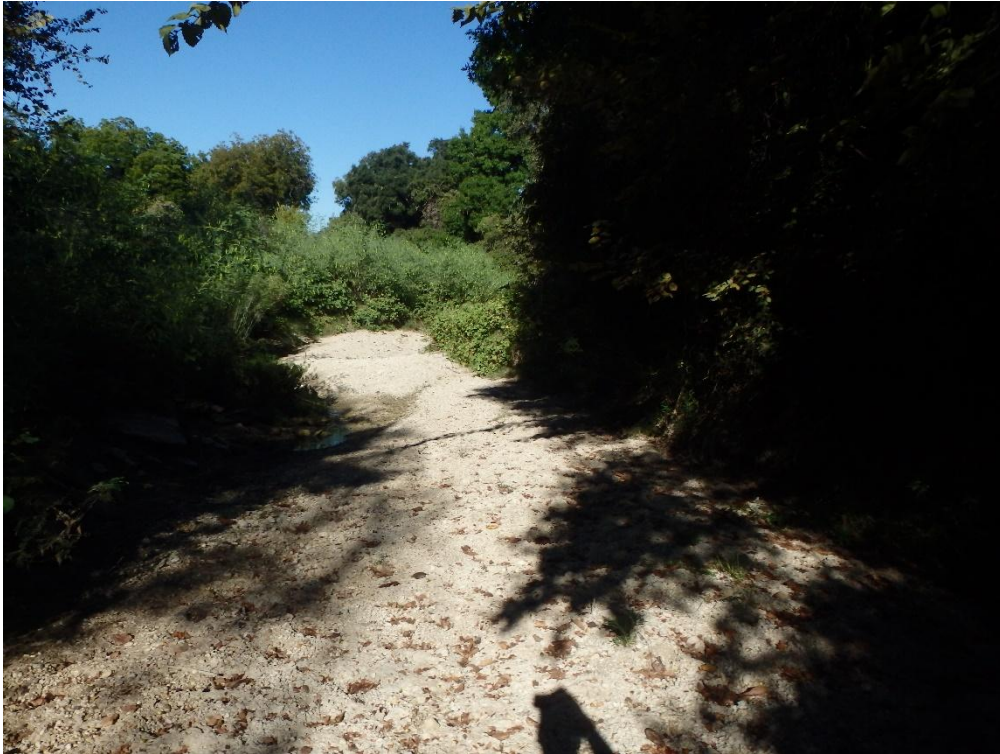
**Figure 4.11** Photograph of Ash Creek at Site AC05 taken on September 26, 2024.  
Photograph at the 0-m transect facing upstream.

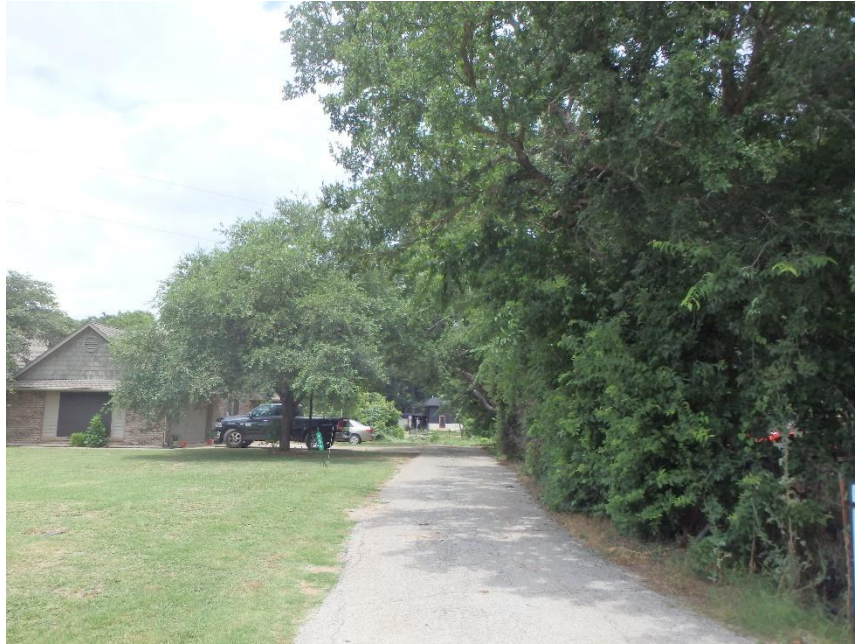
Ash Creek at Site AC06 was visited on June 25 and September 26, 2024, but no surveys were performed on either date. Upon arrival to perform the survey TIAER was denied access to Ash Creek at this location by the landowner. Figure 4.12 shows private property access.

**Figure 4.12** Photograph of Ash Creek Site AC06 taken on June 20, 2024, driveway into private property access.

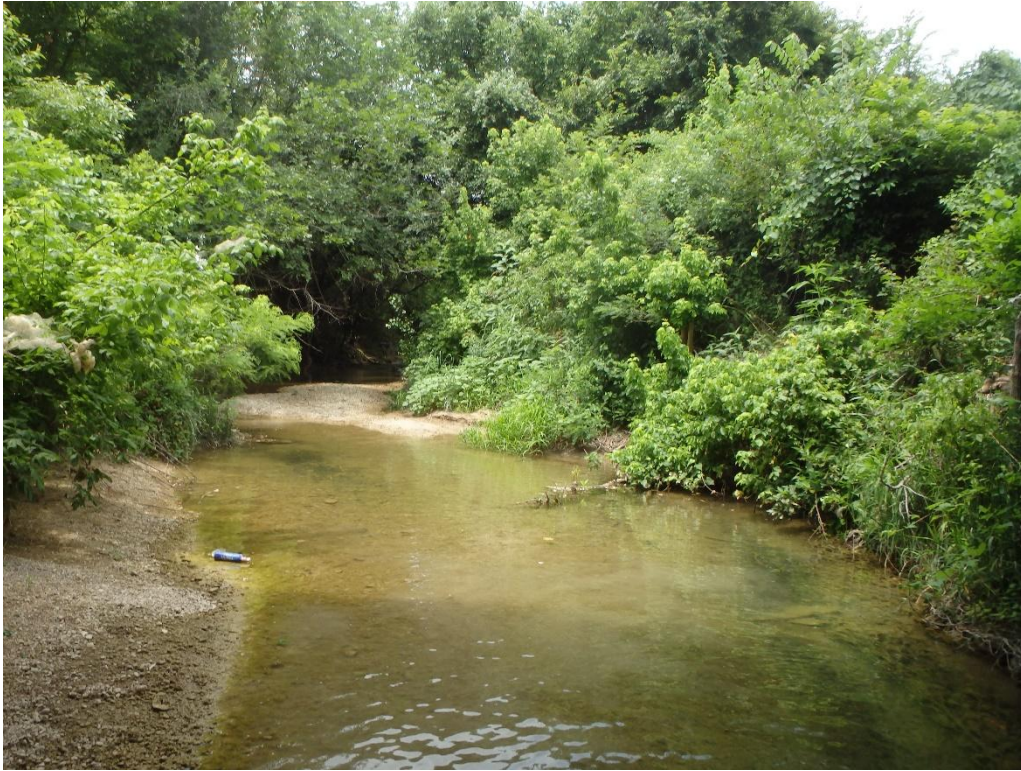
**Figure 4.13** Photograph of Ash Creek Site AC07 taken on June 20, 2024. The upstream view of the 0-m transect.

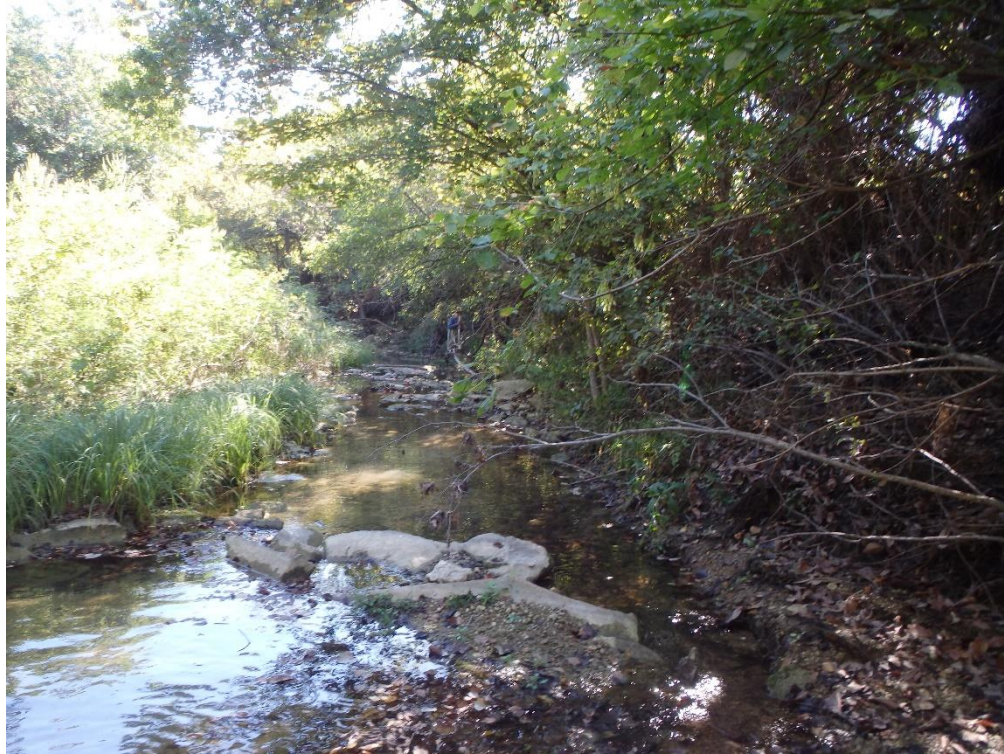
**Figure 4.14** Photograph of Ash Creek Site AC07 taken on September 26, 2024. The downstream view of the 300-m transect

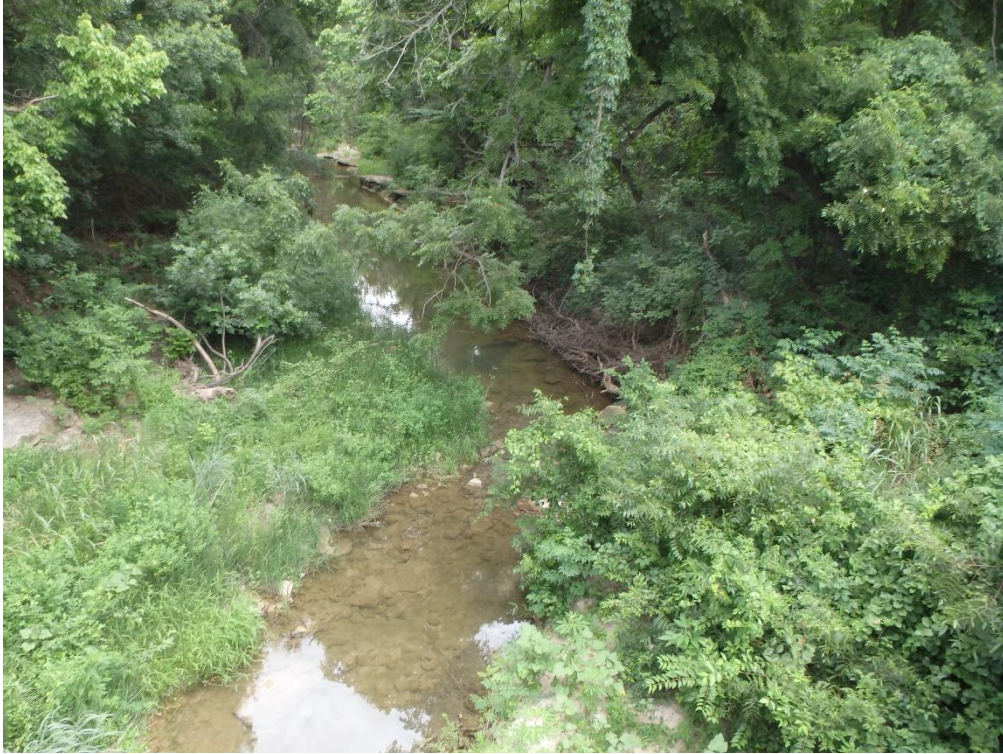
**Figure 4.15** Photograph of Ash Creek Site AC08 taken on June 20, 2024. Photograph shows the downstream view of Ash Creek at Finney Drive in Parker County.

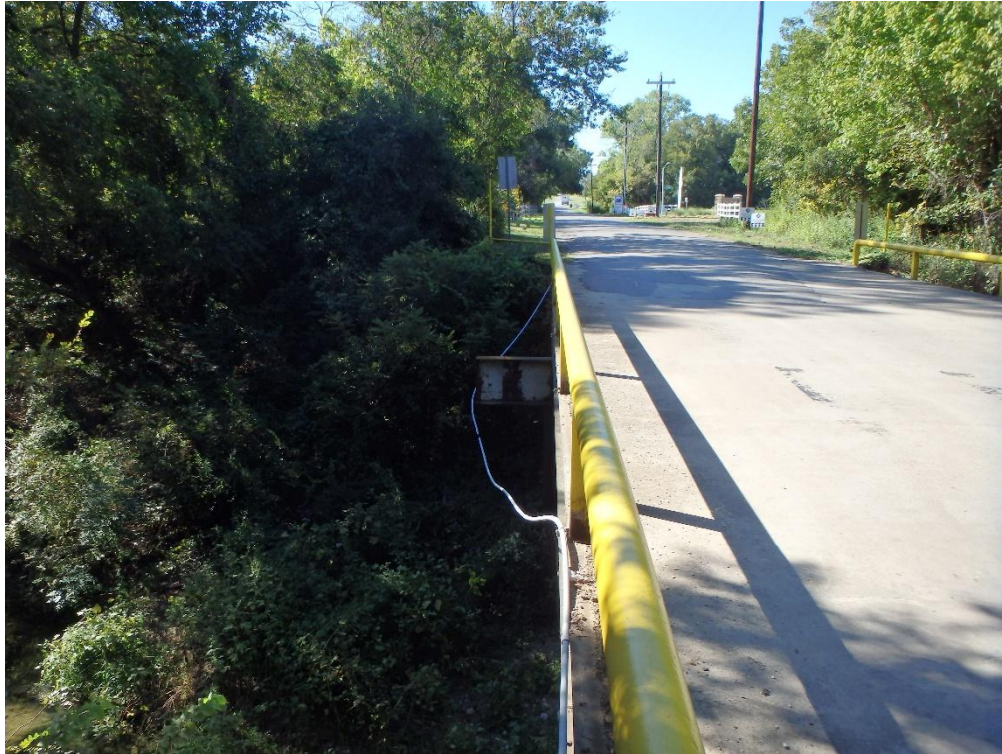
**Figure 4.16** Photograph of Ash Creek at Site AC08 taken on September 26, 2024.  
Photograph at the stream transect with Finney Drive showing no access to the stream.

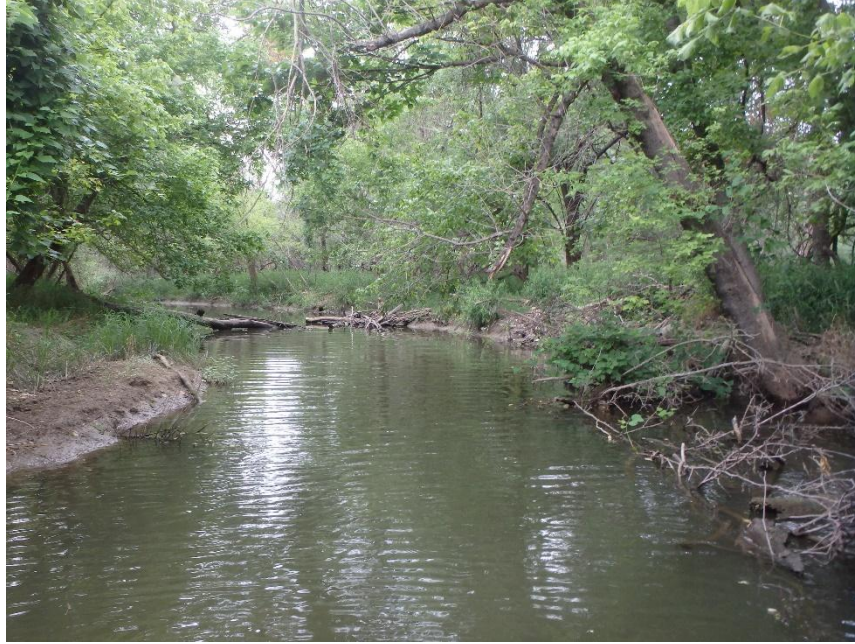
Ash Creek at Site AC09 was visited on June 25 and September 26, 2024. This site was accessed via the bridge crossing on Veal Station Road in Parker County. Access to the stream was moderately easy. The riparian area was forest and shrub with thick vegetation and slippery slopes on both the right and left banks (Figure 4.17 and Table 4.4).

**Figure 4.17 Photograph of Ash Creek Site AC09 taken on June 20, 2024, the right bank view of the 0-m transect. TIAER personnel in the photo.**

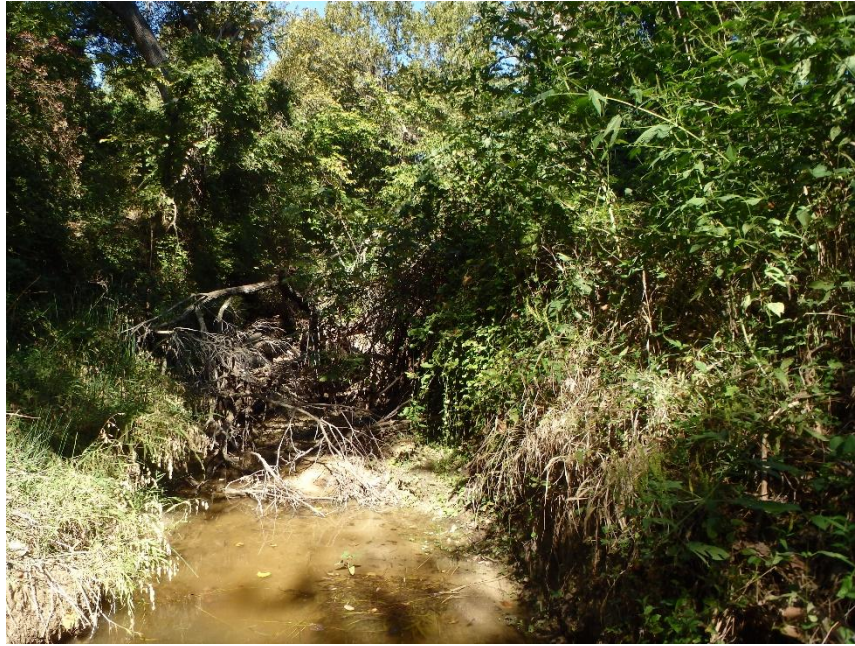
**Figure 4.18** Photograph of Ash Creek Site AC09 taken on September 26, 2024, the upstream view of the 150-m transect.

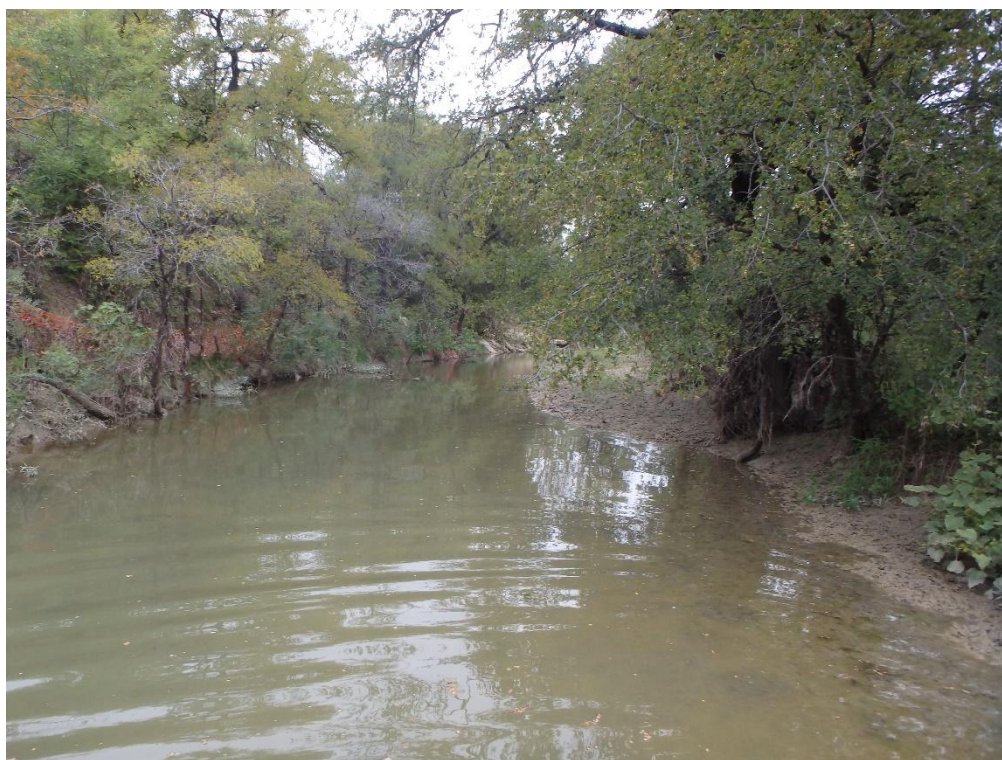
**Figure 5.3** Photograph of Dosier Creek Site DSC01 taken on September 25, 2024. The upstream view of the 300-m transect

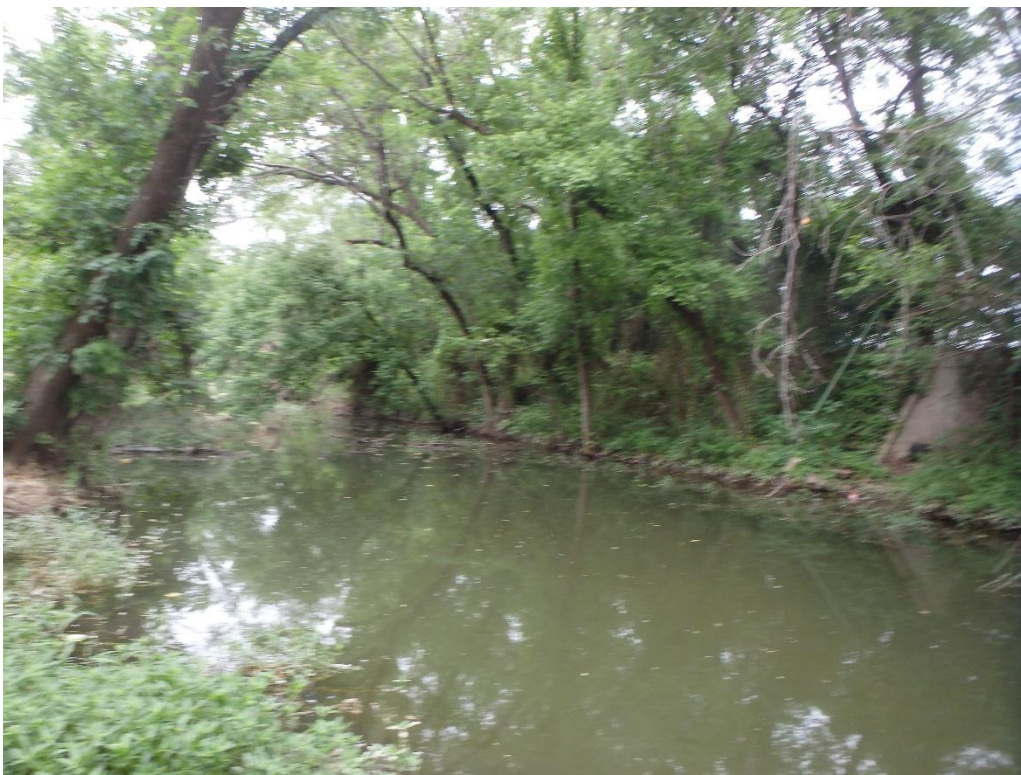
**Figure 6.2** Photograph of Derrett Creek at Site DRC01 taken on June 20, 2024. The upstream view of the 0-m transect.

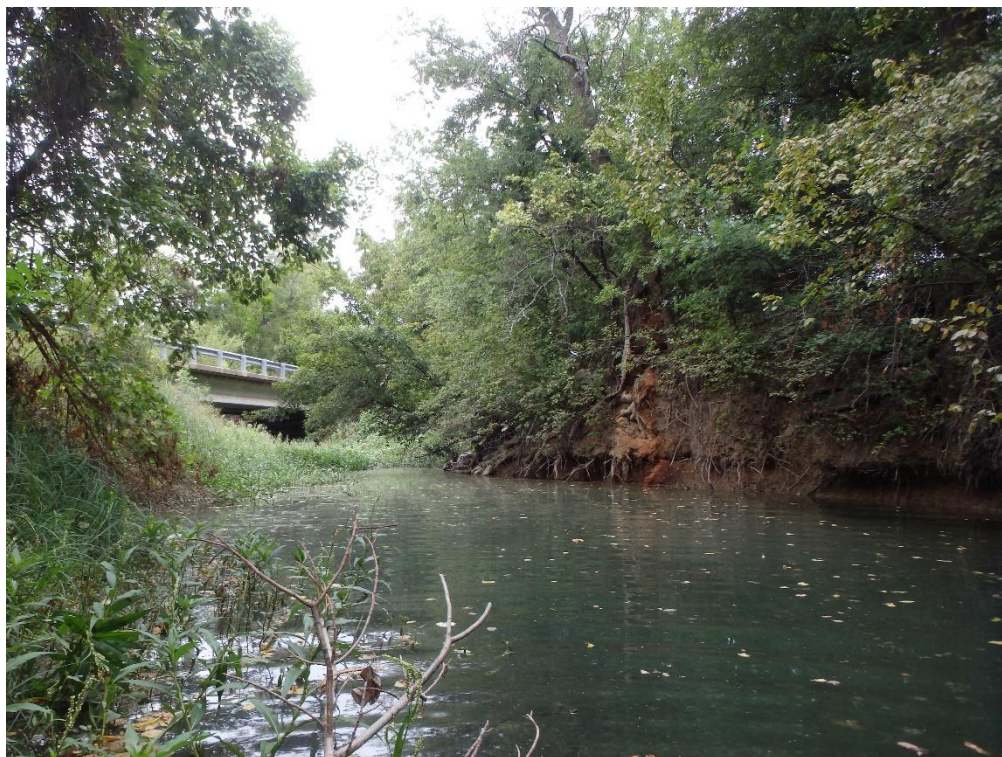
**Figure 6.3** Photograph of Derrett Creek Site DRC01 taken on September 25, 2024. The upstream view of the 300-m transect

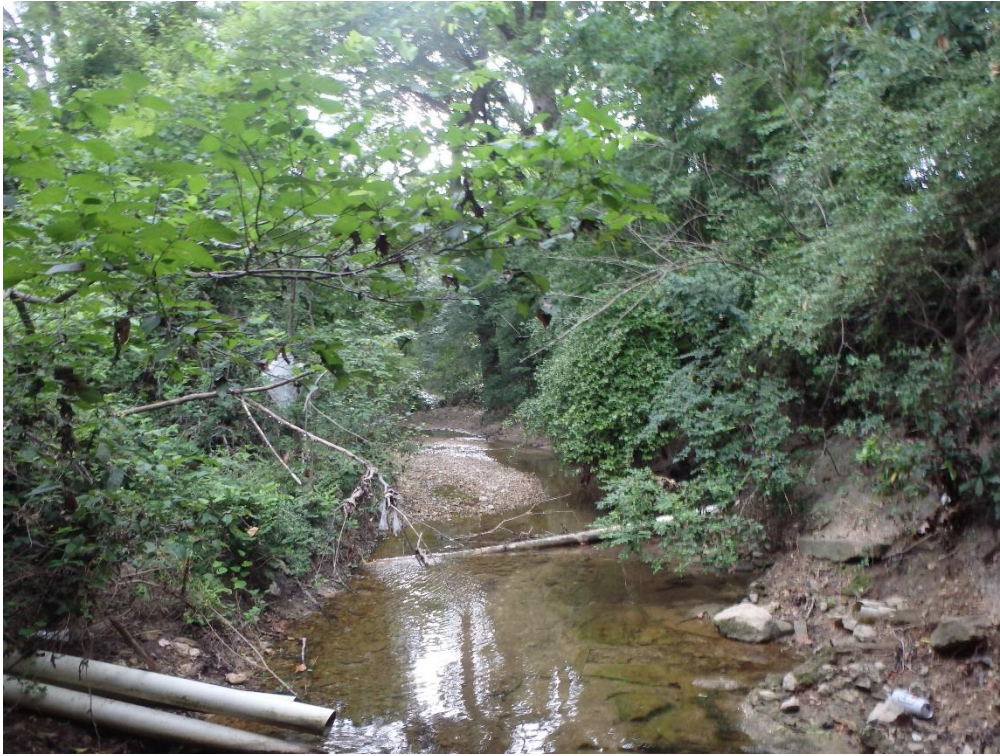
**Figure 6.4** Photograph of Derrett Creek Site DRC02 taken on June 20, 2024. Photograph shows the upstream view of the 300-m transect.

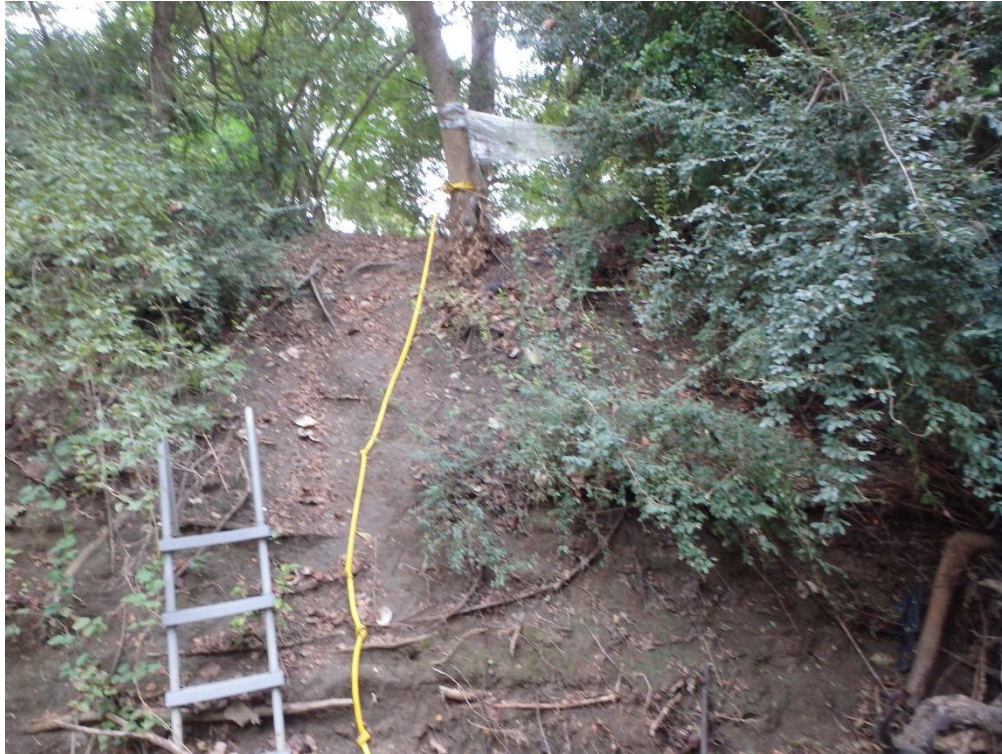
**Figure 6.5** Photograph of Derrett Creek at Site DRC02 taken on September 25, 2024. Photograph at the 0-m transect facing the left bank.

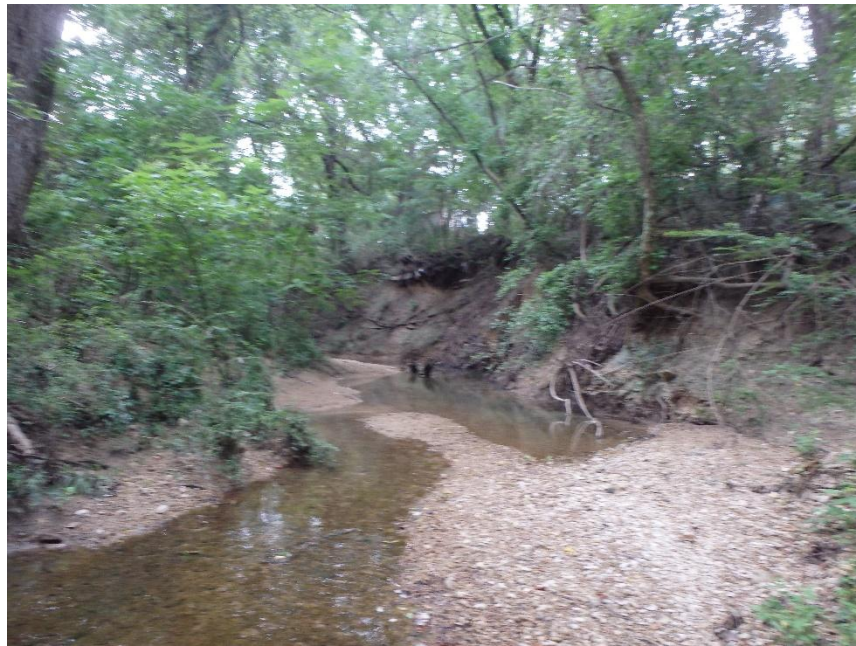
The stream banks were densely vegetated at DRC03. Aquatic vegetation and algae cover were absent during both surveys. The water was brown with no surface scum during both surveys.

**Figure 6.6** Photograph of Derrett Creek Site DRC03 taken on June 20, 2024, the upstream view of the 0-m transect.
