Recreational Use-Attainability Analysis for Ash Creek (0809B), Dosier Creek (0809C), and Derrett Creek (0809D) in the Trinity Creek River Basin

By Leah Taylor
Texas Institute for Applied Environmental Research
Submitted to TCEQ April 11, 2025

TIAER Publication TR2502

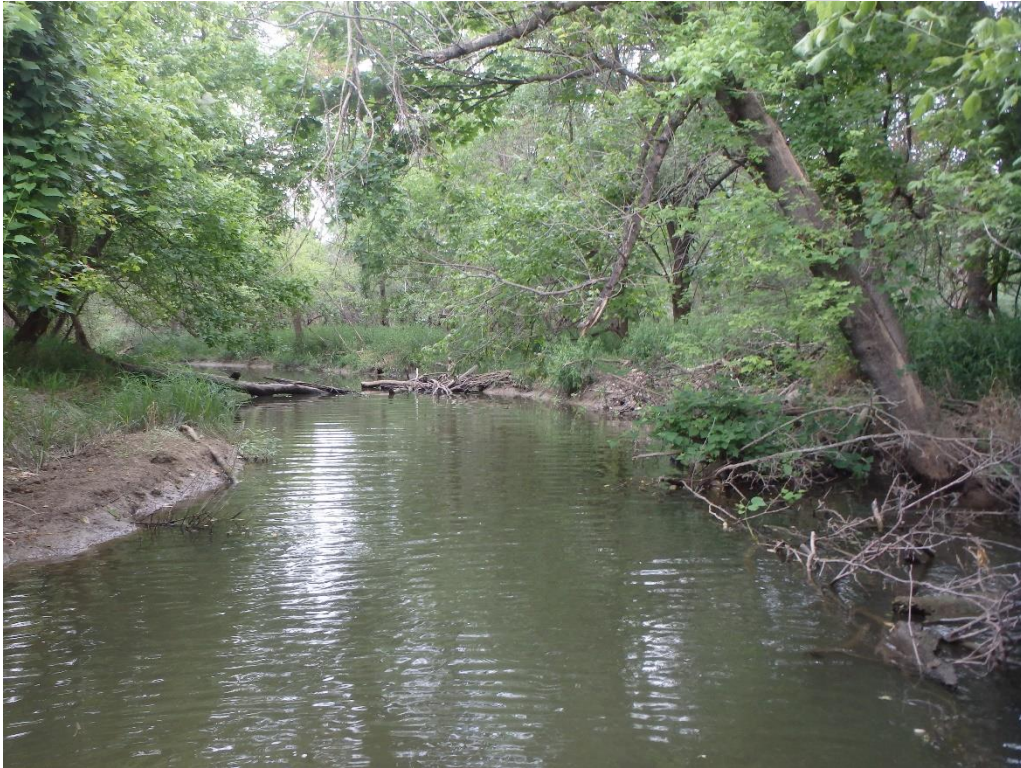
Figure 4.2 Photograph of Ash Creek Site AC01 taken on June 20, 2024. The upstream view of the 0-m transect.

Site AC01 was wadeable with average thalweg ranging from >0.75 m to 0.46 m between surveys. Figure 4.2 illustrates the typical observed width of the creek at this site, approximately 6 m. Widths ranged from 4.0 m to 8.0 m during the two surveys (Tables 4.6 and 4.7).

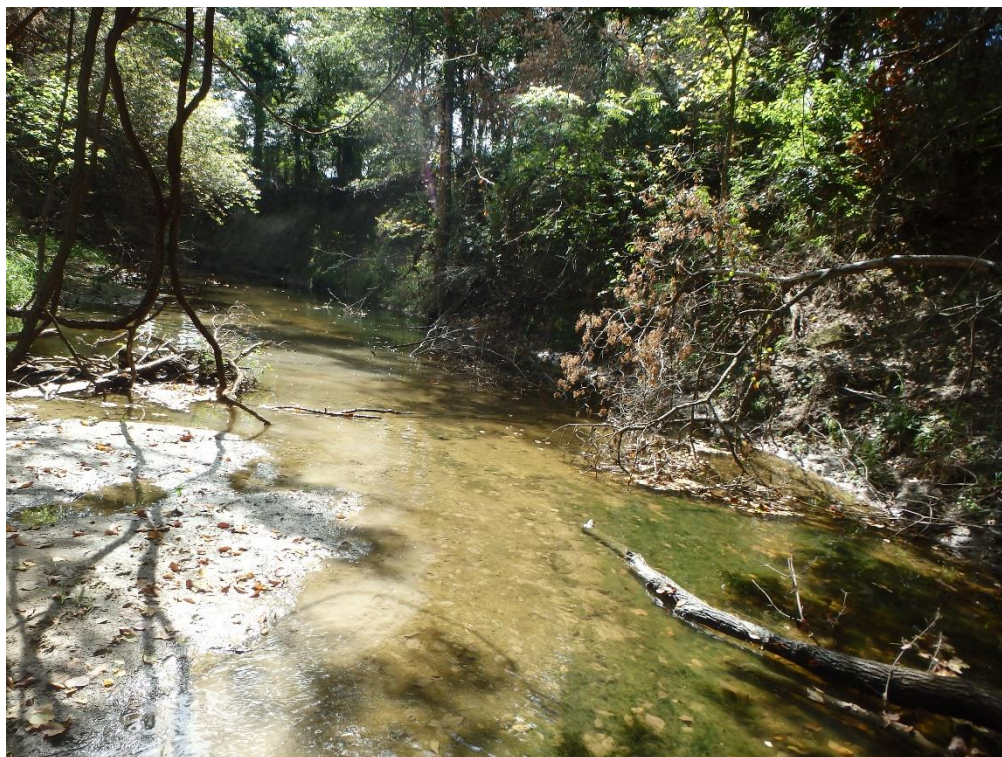
The stream flow type was observed as intermittent with perennial pools at the time of both surveys (Table 4.5). Aquatic vegetation and algae cover were absent at this site for each survey. The deepest thalweg depth measured during the first survey at the 180-m and 210-m transects was >1.2 m and the shallowest was 0.16 m at the 300-m transect during the second survey. No pools were observed during either survey at this site (Tables 4.8 and 4.9).

Figure 4.3 Photograph of Ash Creek Site AC01 taken on September 26, 2024. The downstream view of the 300-m transect

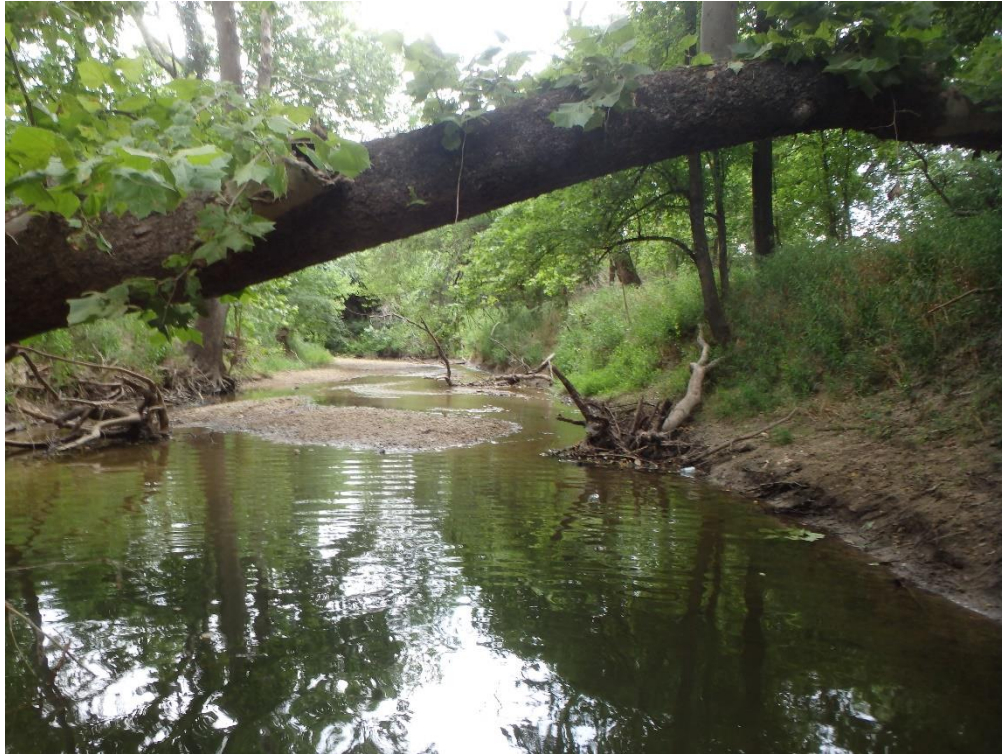
The riparian zone at Site AC02 was forest with thick vegetation on both the right and left banks (Table 4.4). Banks were vegetated with larger trees and a larger shaded understory (Figures 4.4 and 4.5) throughout this site. The stream was wadeable during both surveys with average thalweg depths ranging from 0.43 m to 0.28 m. The stream was designated as intermittent with perennial pools during both surveys (Table 4.5). Channel widths ranged from 10 m to 0.44 m throughout the reach during both surveys with an average width of 2.5 m (Tables 4.6 and 4.7). One substantial pool was observed only during the second survey, measuring 13 meters in length by 10 meters in width and 0.9 meters depth (Table 4.9).

Figure 4.4 Photograph of Ash Creek Site AC02 taken on June 20, 2024. Photograph shows the downstream view of the 0-m transect.

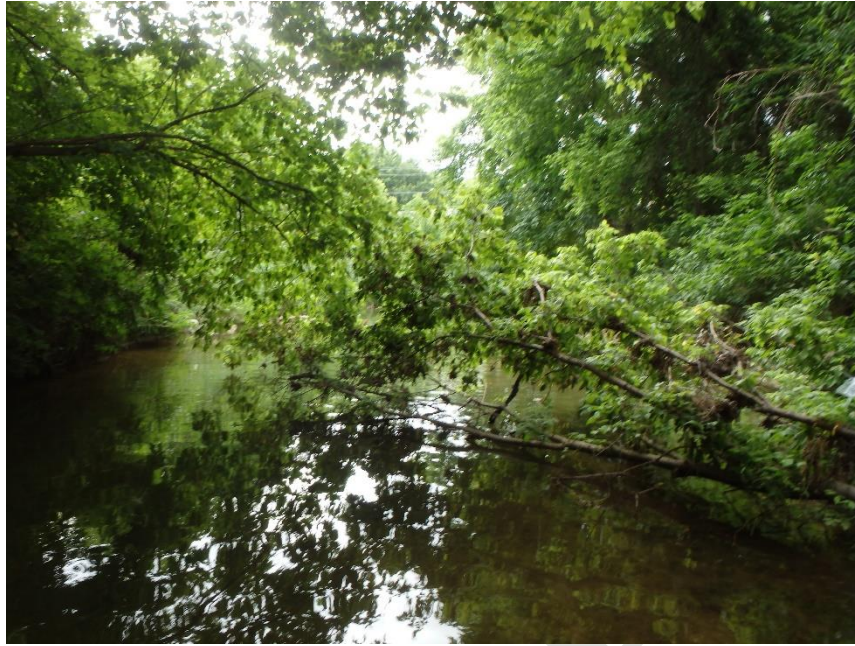
Figure 4.6 Photograph of Ash Creek Site AC03 taken on June 20, 2024, the downstream view of the 300-m transect.

Banks were vegetated with larger trees and a larger shaded understory (Figures 4.6 and 4.7) throughout this site. Aquatic vegetation and algae cover were both absent during both surveys. The water was clear in color with no surface scum observed during the either survey.

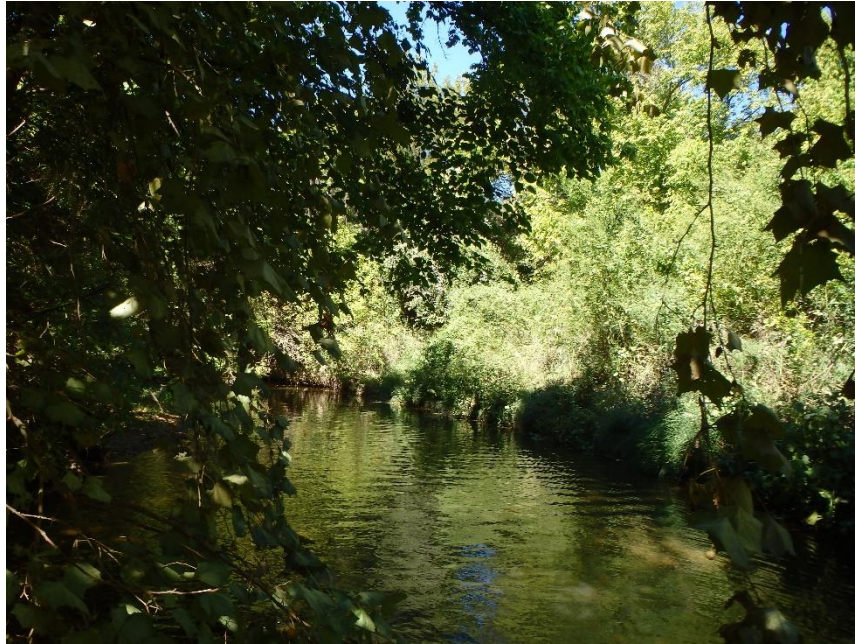
Figure 4.7 Photograph of Ash Creek Site AC03 taken on September 25, 2024, the upstream view of the 0-m transect.

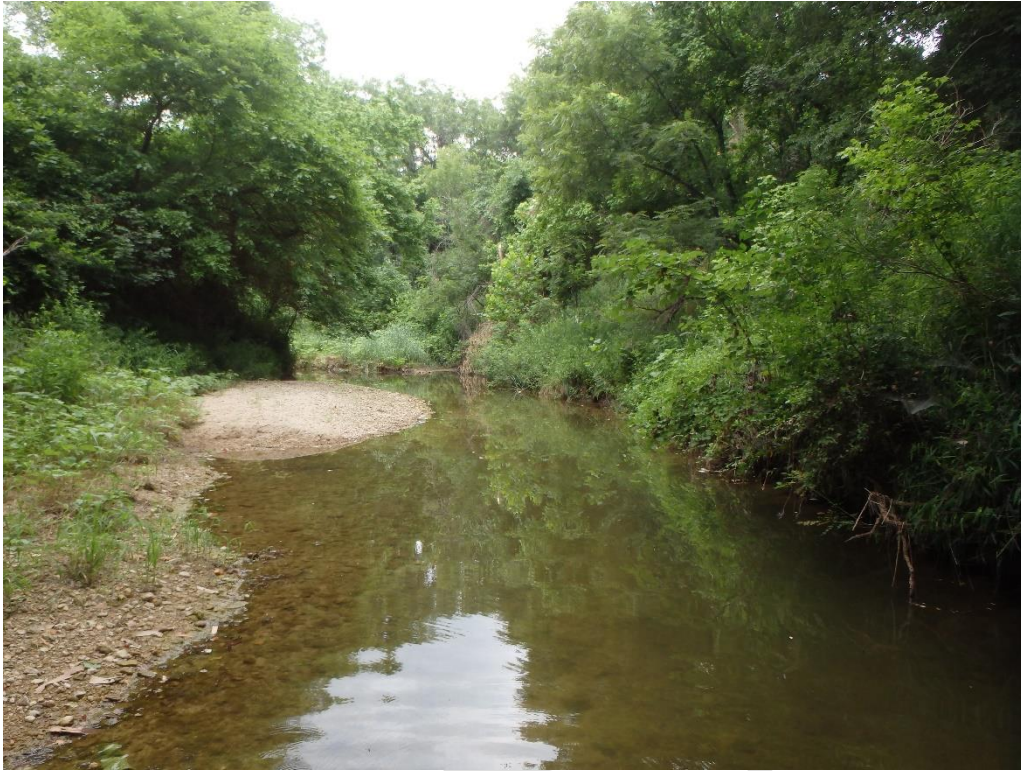
The creek at this site passes through an overgrown shrubbery riparian zone that led directly up to the creek. The general appearance of the creek at this location is shown in Figures 4.8 and 4.9.

Figure 4.8 Photograph of Ash Creek Site AC04 taken on June 20, 2024. The upstream view of the 0-m transect.

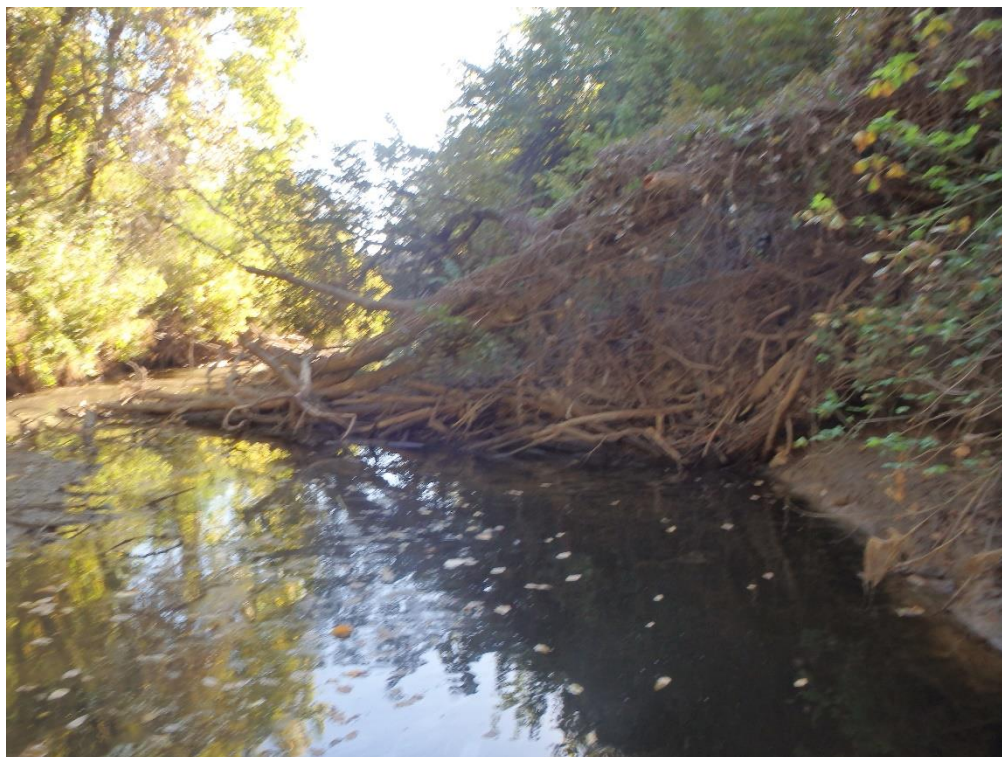
Figure 4.9 Photograph of Ash Creek Site AC04 taken on September 26, 2024. The downstream view of the 150-m transect

Channel obstructions at this site included log jams and tree branches (as seen in Figure 4.9.). No water dependent birds or reptiles or evidence of wildlife were observed during the first survey, but racoon and dog footprints were observed during the second survey (Tables 4.10 and 4.11). Human footprints were also observed at the bridge during the second survey. No large garbage was present during either survey, but typical household garbage (plastics, glass, cans) was observed under the bridge at the road crossing during both surveys.

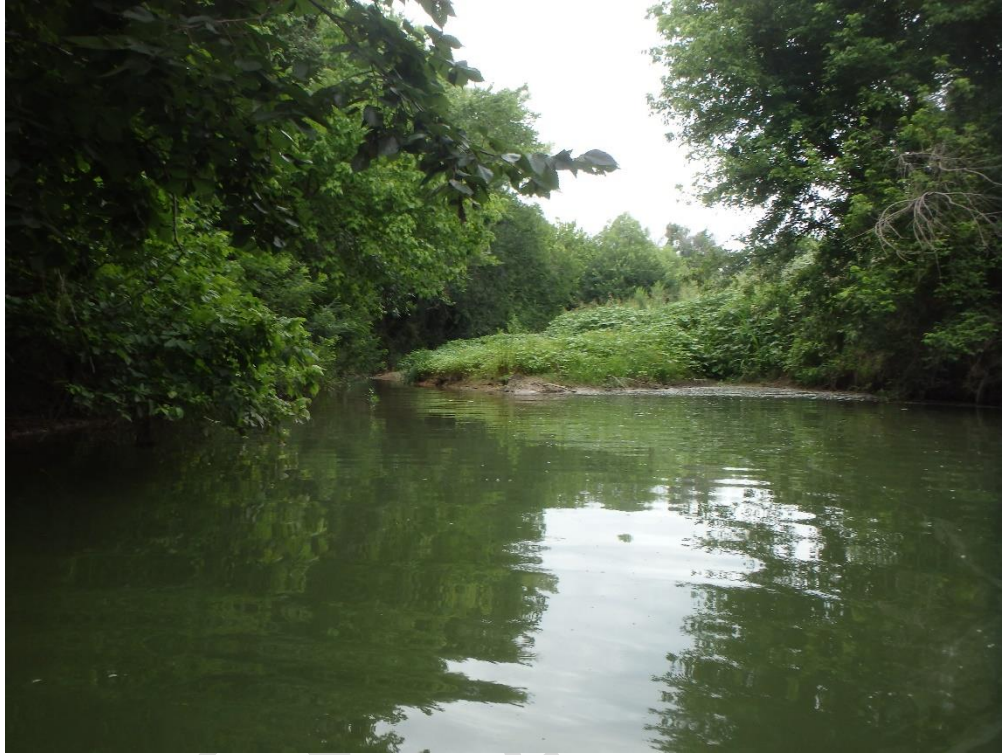
was observed during the first survey, measuring 31 meters in length by 28 meters in width and >1.5 meters depth (Figure 4.10 and Table 4.8). Two substantial pools were observed during the second survey. The first measuring 13 meters in length by 12 meters in width and >1.5 meters in depth, the second measures 10 meters in length by 5 meters in width and 0.35 meters in depth (Table 4.9).

Figure 4.10 Photograph of Ash Creek Site AC05 taken on June 20, 2024. Photograph shows the upstream view of the 300-m transect.

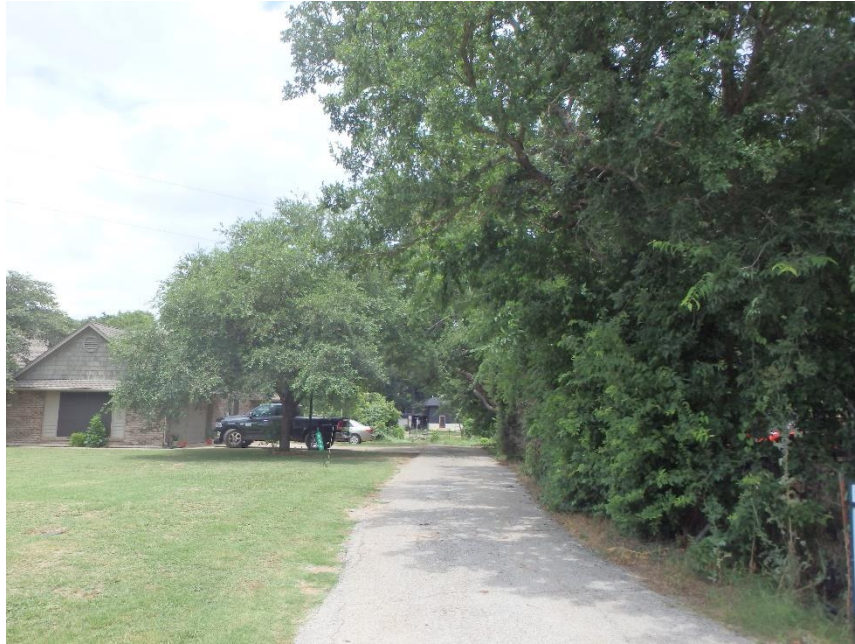
Ash Creek at Site AC06 was visited on June 25 and September 26, 2024, but no surveys were performed on either date. Upon arrival to perform the survey TIAER was denied access to Ash Creek at this location by the landowner. Figure 4.12 shows private property access.

Figure 4.12 Photograph of Ash Creek Site AC06 taken on June 20, 2024, driveway into private property access.

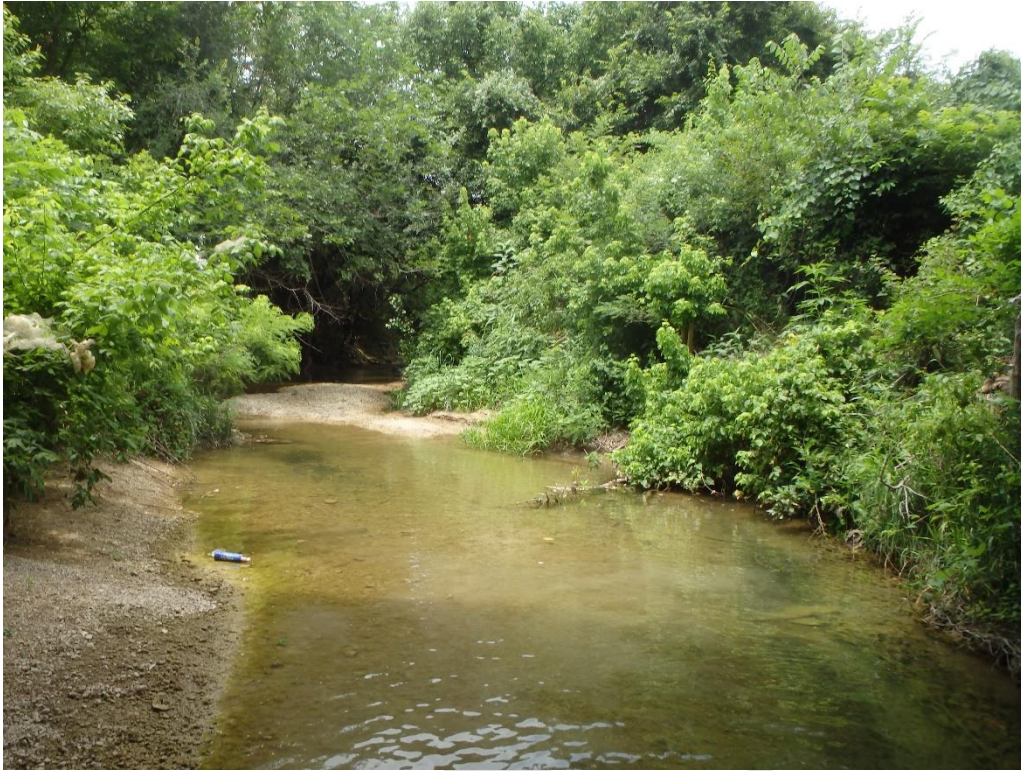
The creek at this site passes through a forest riparian zone that leads directly up to the creek. The general appearance of the creek at this location is shown in Figures 4.13 and 4.14.

Figure 4.13 Photograph of Ash Creek Site AC07 taken on June 20, 2024. The upstream view of the 0-m transect.

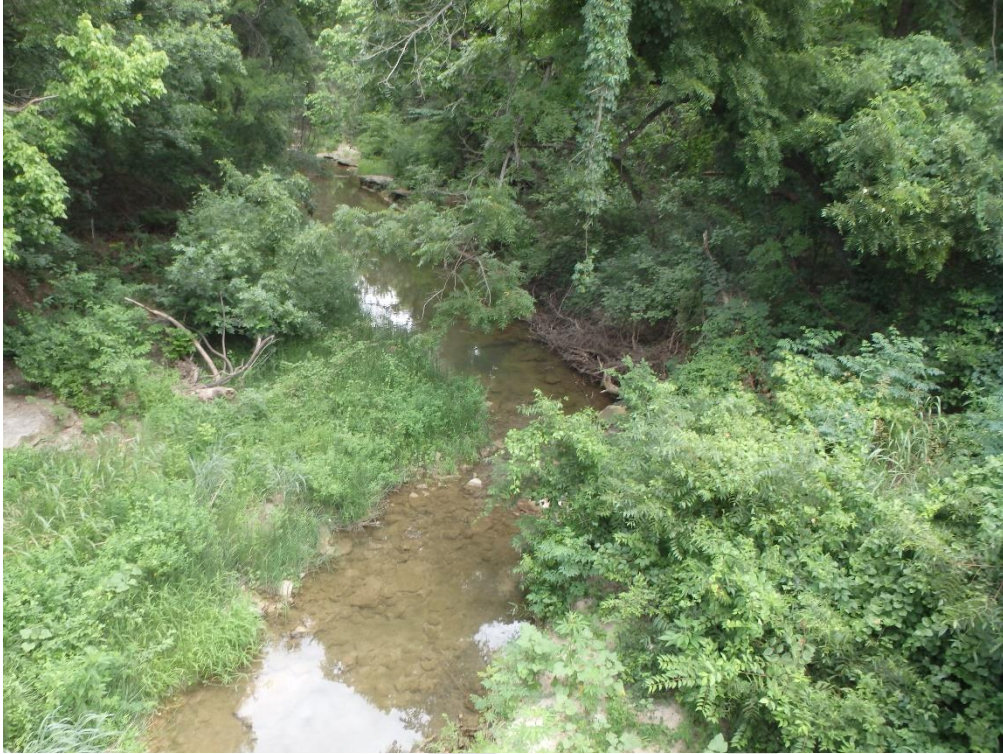
Ash Creek at Site AC08 was visited on June 25 and September 26, 2024; however, no surveys were conducted. The site is publicly accessible at the bridge crossing of Ash Creek and Finney Drive in Parker County. Due to hazardous conditions, including steep, near-vertical banks (Figure 4.16), large tree roots, and an abundance of poison ivy and oak (Figure 4.15), TIAER field personnel deemed access to the stream too dangerous and difficult. No human recreation was observed.

Figure 4.15 Photograph of Ash Creek Site AC08 taken on June 20, 2024. Photograph shows the downstream view of Ash Creek at Finney Drive in Parker County.

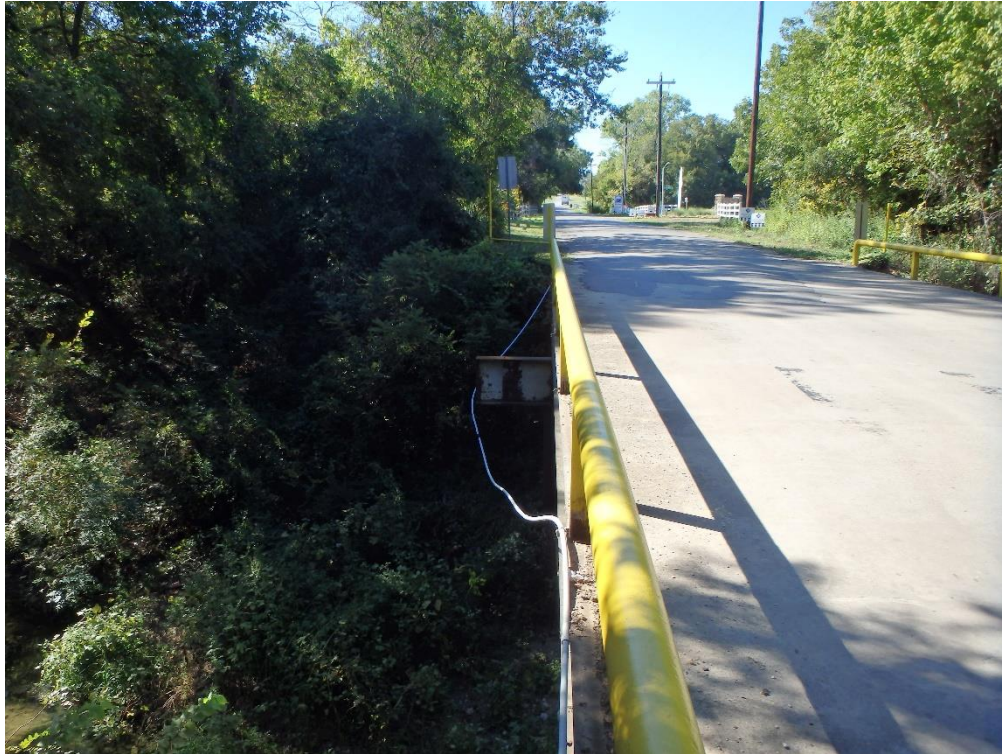
Figure 4.16 Photograph of Ash Creek at Site AC08 taken on September 26, 2024. Photograph at the stream transect with Finney Drive showing no access to the stream.

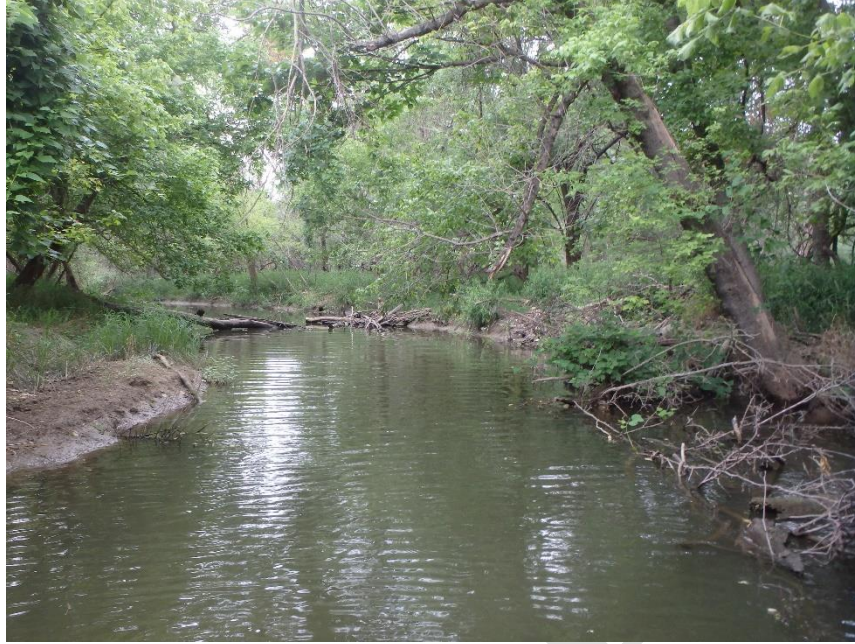
Ash Creek at Site AC09 was visited on June 25 and September 26, 2024. This site was accessed via the bridge crossing on Veal Station Road in Parker County. Access to the stream was moderately easy. The riparian area was forest and shrub with thick vegetation and slippery slopes on both the right and left banks (Figure 4.17 and Table 4.4).

Figure 4.17 Photograph of Ash Creek Site AC09 taken on June 20, 2024, the right bank view of the 0-m transect. TIAER personnel in the photo.

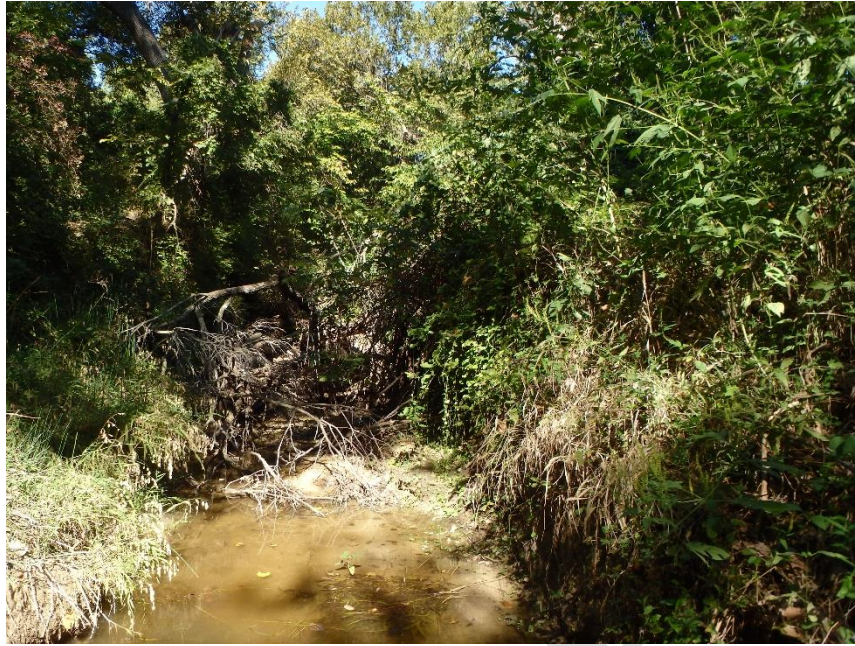
The stream banks were densely vegetated at AC09, and aquatic vegetation and algae cover were both absent during both surveys (Figure 4.19). The water was clear in color with no surface scum observed during the either survey.

Figure 4.18 Photograph of Ash Creek Site AC09 taken on September 26, 2024, the upstream view of the 150-m transect.

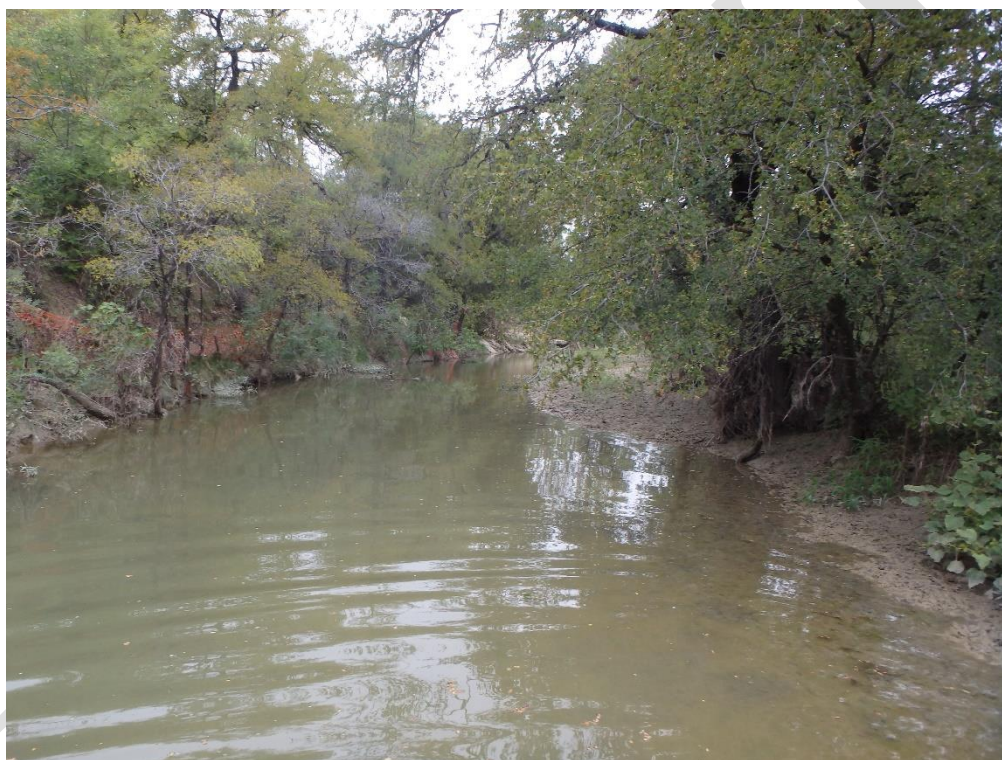
Trash was only observed at the 150 m transect located at the bridge crossing. No evidence of recreation was observed during either survey, however, signs of human presence included graffiti under the bridge at the 150-m transect and ATV tracks.

Figure 5.3 Photograph of Dosier Creek Site DSC01 taken on September 25, 2024. The upstream view of the 300-m transect

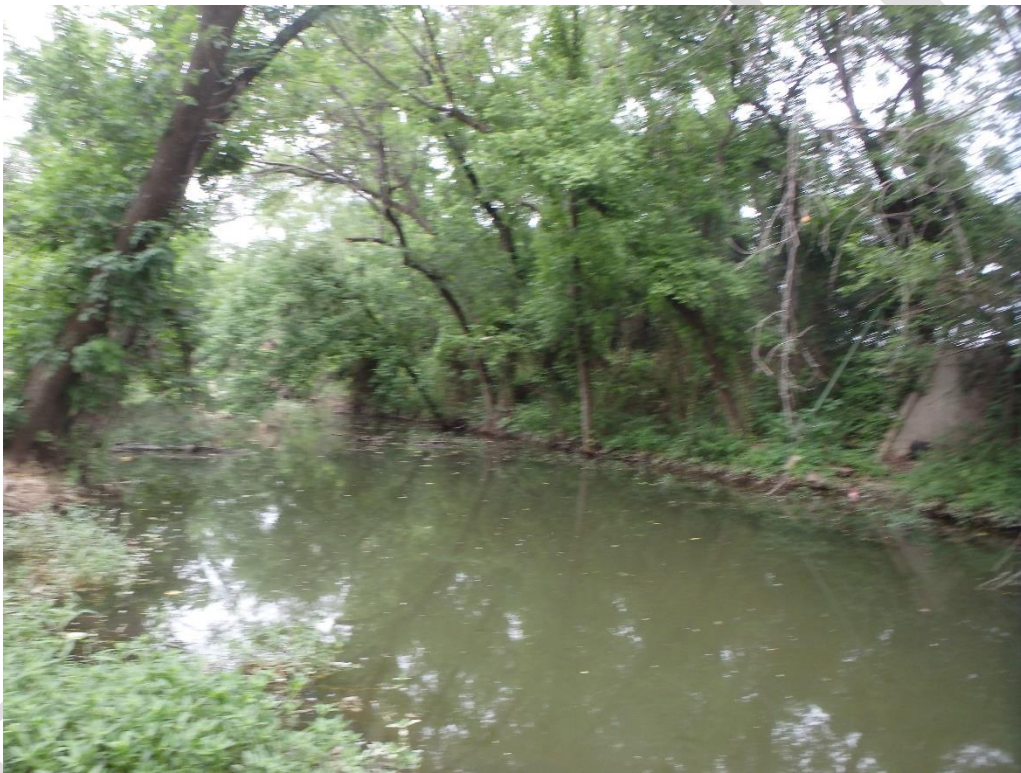
The general appearance of the creek at this location is shown in Figures 6.2 and 6.3.

Figure 6.2 Photograph of Derrett Creek at Site DRC01 taken on June 20, 2024. The upstream view of the 0-m transect.

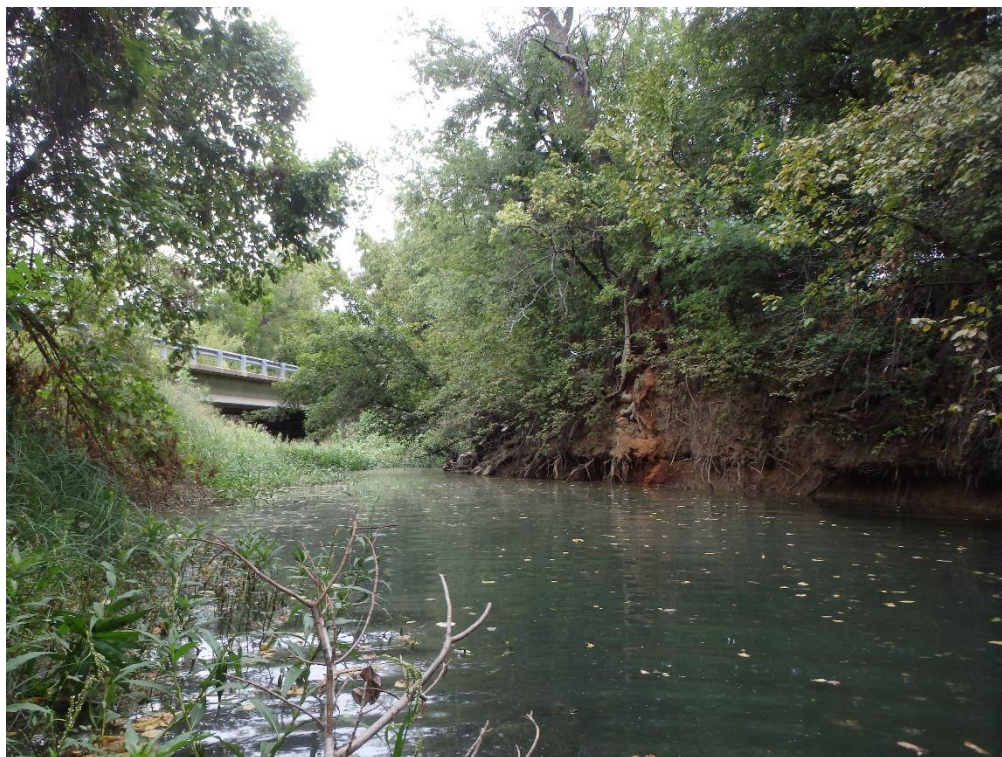
The stream flow type was observed as perennial at the time of both surveys (Table 6.5). Aquatic vegetation and algae cover were absent at this site for each survey. No pools were observed during either survey at this site.

Figure 6.3 Photograph of Derrett Creek Site DRC01 taken on September 25, 2024. The upstream view of the 300-m transect

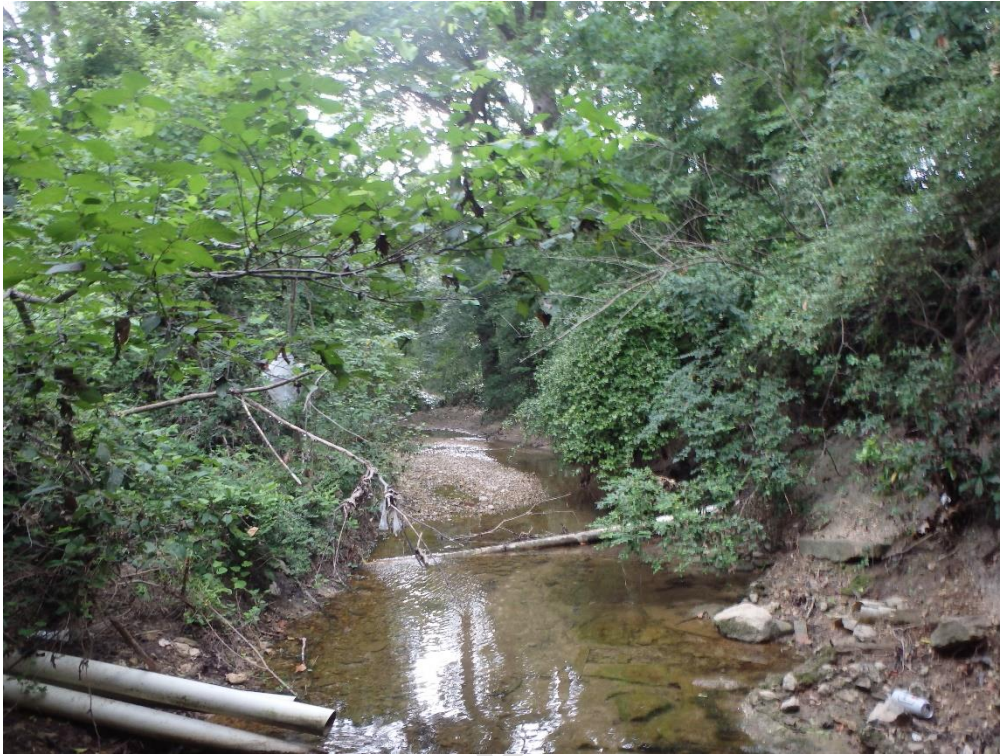
perennial during both surveys (Table 6.5). Channel widths ranged from 0 m to 6 m throughout the reach during both surveys, with a typical observed width of 2.2 m (Tables 6.6 and 6.7).

Figure 6.4 Photograph of Derrett Creek Site DRC02 taken on June 20, 2024. Photograph shows the upstream view of the 300-m transect.

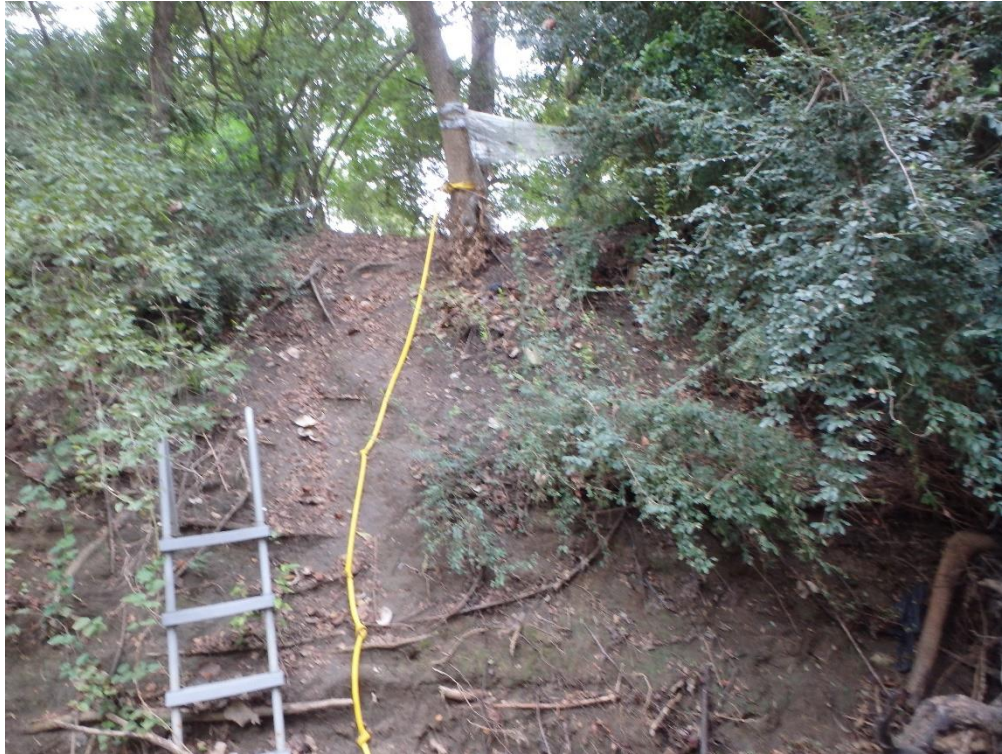
Figure 6.5 Photograph of Derrett Creek at Site DRC02 taken on September 25, 2024. Photograph at the 0-m transect facing the left bank.

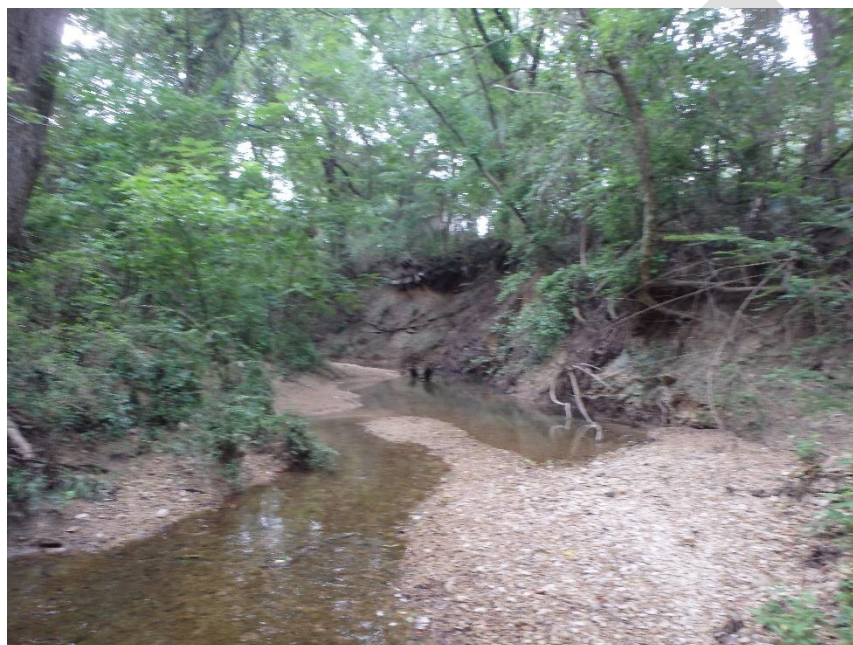
The stream banks were densely vegetated at DRC03. Aquatic vegetation and algae cover were absent during both surveys. The water was brown with no surface scum during both surveys.

Figure 6.6 Photograph of Derrett Creek Site DRC03 taken on June 20, 2024, the upstream view of the 0-m transect.
