**RETROFIT OF AN EXISTING FLOOD CONTROL FACILITY
TO IMPROVE POLLUTANT REMOVAL**

**Final Report to: Nonpoint Source Protection Program CWA §319(h) Texas
Commission on Environmental Quality**

The University of Texas at Austin

July 2014

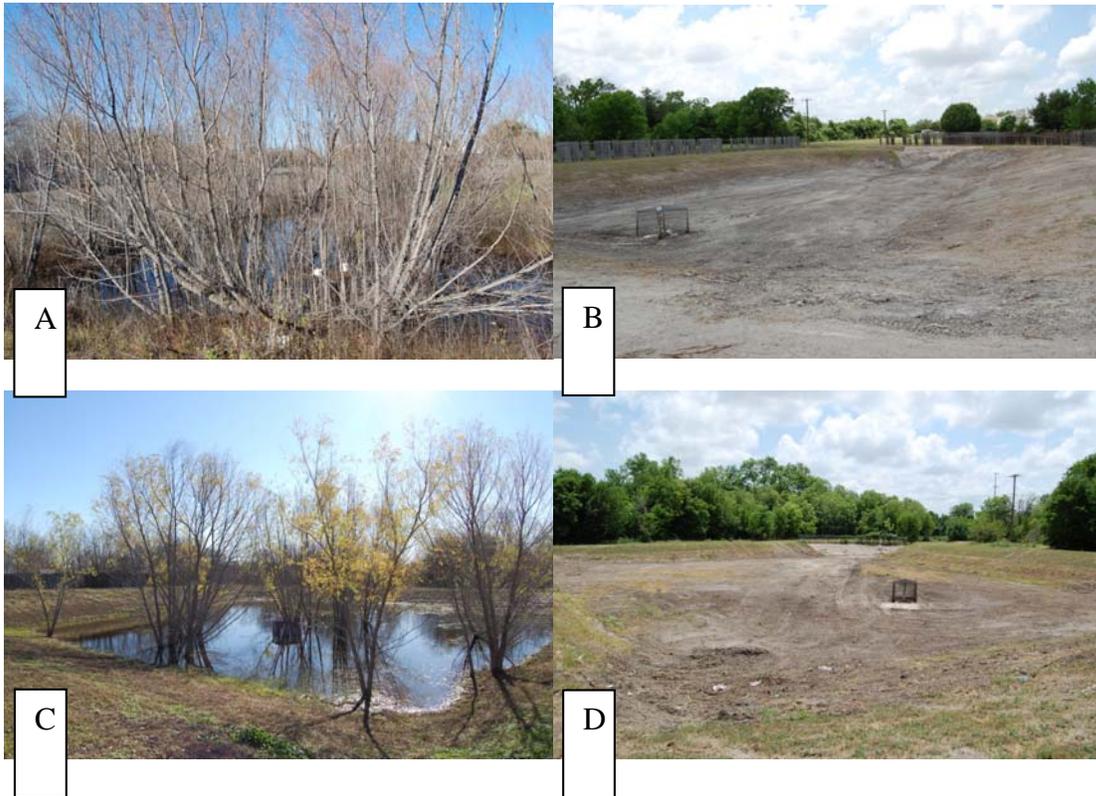
Figure 2. Pon Court and Copperhead Drive Basins, respectively, Before (A, C) and After (B, D) Rehabilitation.

The two basins selected for monitoring had not had adequate maintenance in many years, so both basins needed to be rehabilitated. The rehabilitation consisted of removal of trees, trash, debris, and accumulated sediment. Figure 2 shows both Pon Court basin and Copperhead Drive basin before and after rehabilitation. In addition, the basin outlets were modified to eliminate standing water.

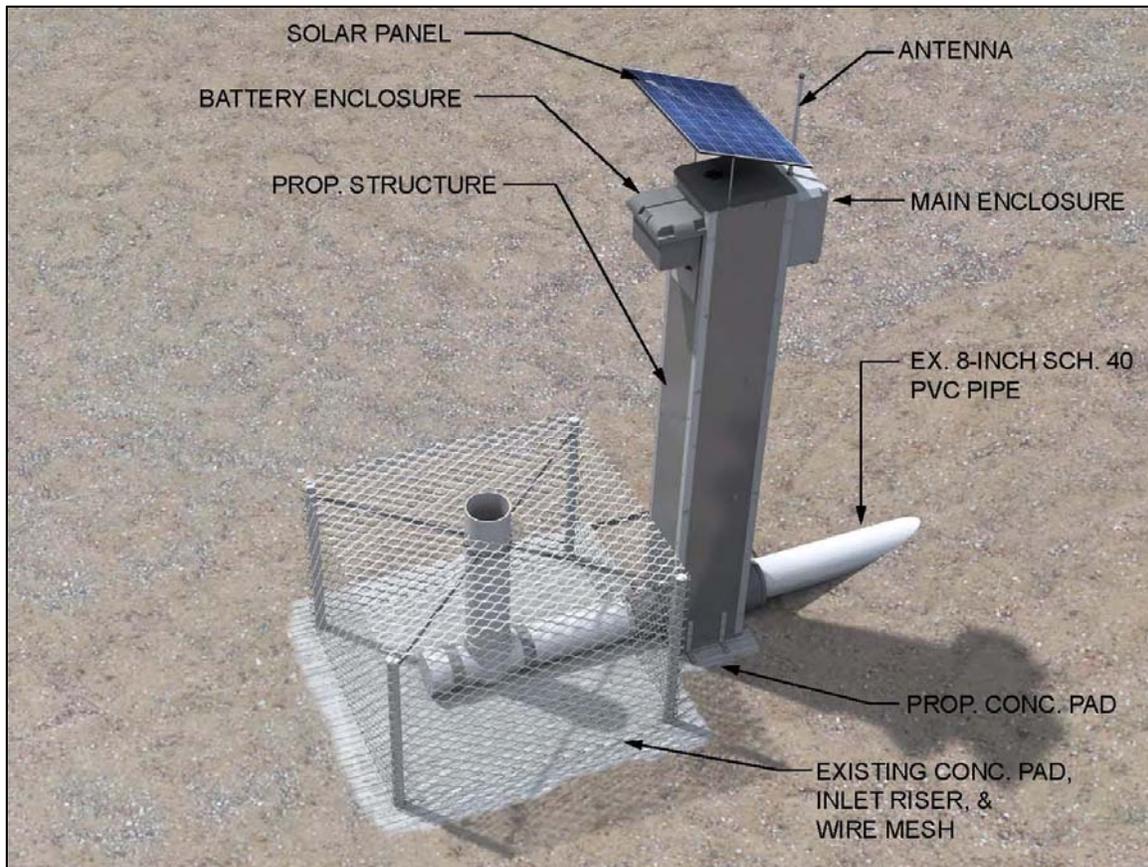
Figure 3. Rendering of the Automated Gate Valve System.

The first step in field construction of the outlet control structure at Pon Court basin consisted of excavating to a depth of twelve inches in front of the existing concrete pad at the basin outlet and pouring a new concrete slab. The new slab was underlain with wire mesh for reinforcement and keyed into the existing concrete slab with concrete anchors. The structure housing the actuated gate valve was mounted onto the new concrete pad with L-brackets and concrete anchors. The control structure that was installed is commonly used in agricultural applications. More detailed information regarding the structure can be obtained from <http://www.agridrain.com/watercontrolproductsinline.asp>. Figure 3 shows a rendering of the structure.

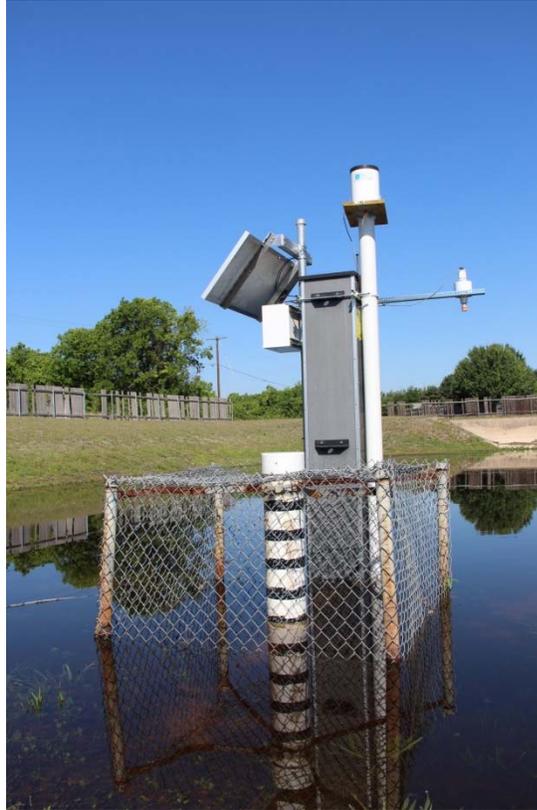
Figure 4. Valve Outlet Structure Installed at Pon Court Detention Basin.

A PVC union was installed to connect the actuated outlet structure to the outlet pipe. An ultrasonic level sensor was mounted externally near the top of the valve structure to record water level readings in the basin. The ultrasonic water level sensor was replaced with a submersible pressure transducer in August 2013 in order to achieve steadier and more reliable water level readings. A battery enclosure was mounted onto the structure, as was a main enclosure housing the electronic components of the setup. A solar panel was mounted near the top of the structure, oriented and angled to capture maximum sunlight and positioned to shade the battery and main enclosures. Electrical cable was run between the solar panel, battery enclosure, main enclosure, water level sensor, and valve actuator. A grounding rod, grounding cables, and corresponding connections to equipment were installed. The existing riser pipe on the basin outlet was capped with PVC, and the holes on the riser pipe were plugged with heavy duty waterproof electrical

tape. Figure 4 shows the field installation of the automated gate valve structure at Pon Court basin.

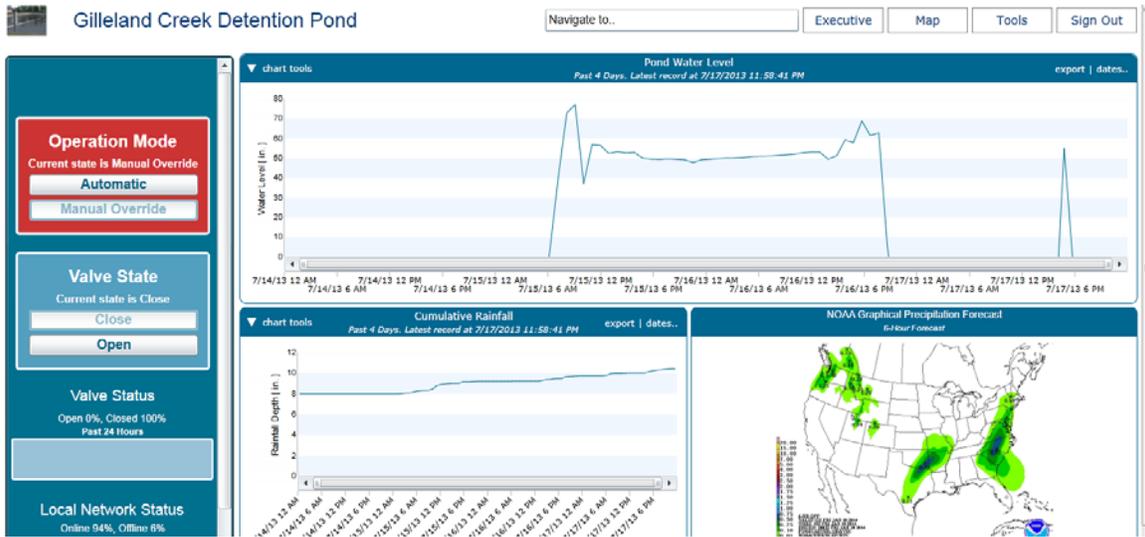
Figure 5. Screenshot of the OptiRTC System for Controlling the Gate Valve Structure from a July 2013 Storm Event.

Once construction and installation of the valve structure were complete, the monitoring and control interface was brought online, which allowed remote viewing of water level and rain gauge data. The online interface also allowed remote operation of the gate valve. OptiRTC, developed by Geosyntec Consultants, acted as the control interface for the structure. Figure 5 below shows a screenshot of the web-based OptiRTC interface for monitoring and operating the control structure.

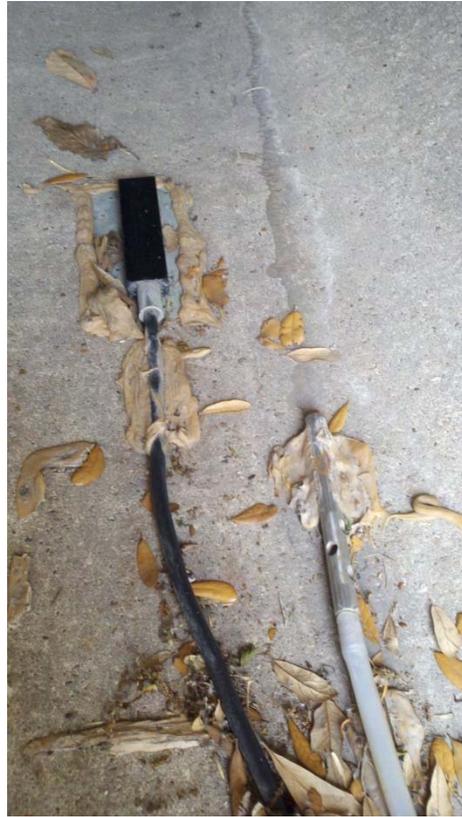
Figure 8. Sampler Tube Intake and Area Velocity Probe at Pon Court Basin Inlet.

One ISCO Signature Flow Meter and one ISCO 3700 Portable Sampler were installed at the inlet to both the Pon Court test basin and the Copperhead Drive control basin. The ISCO Signature Flow Meter measures flow using an area velocity meter. The area velocity probe installed in each of the detention basin inlet pipes records water level and velocity via an ultrasonic sensor. The ISCO Signature Flow Meter then converts the water level and velocity data into a flow rate based on the dimensions of the pipe (circular pipe with a diameter of 48 inches at both basins). The flow rate data is stored by the ISCO Signature Flow Meter, and this data was downloaded via USB connection to a laptop computer using the ISCO Flowlink software interface.

The ISCO 3700 Portable Sampler is a portable programmable liquid sampler that draws stormwater samples through a Teflon-lined suction tube into a nine liter propylene bottle via a peristaltic pump. A stainless steel strainer is attached to the end of the suction tube to prevent debris from clogging the intake. Figure 8 below shows the sampler intake tube with strainer and area velocity probe in the Pon Court basin inlet. At the Copperhead Drive basin, the area velocity meter probe was installed in one of two 48 inch inlet pipes, while the sampler inlet tube with strainer was installed on the concrete pad slightly downstream from where the flow paths from both inlet pipes merge.

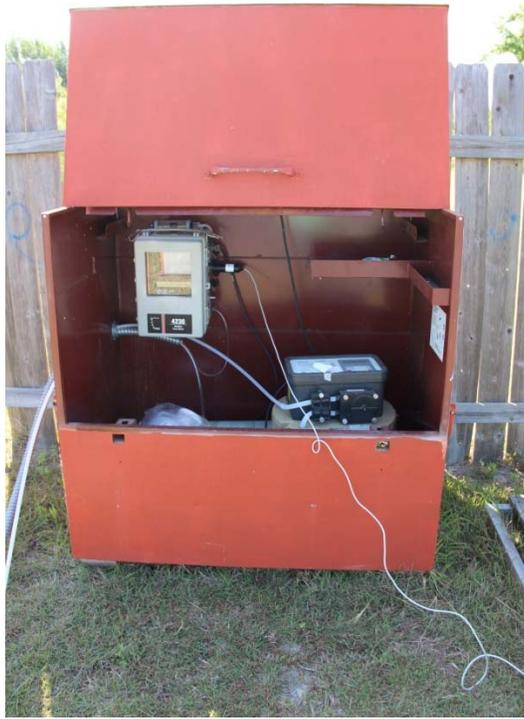
Figure 9. Water Quality Monitoring Equipment at Pon Court Basin Outlet.

One ISCO 4230 Bubbler Flow Meter and one ISCO 3700 Portable Sampler were installed at the outlet of each basin. The ISCO 4230 Bubbler Flow Meter monitors the depth of stormwater runoff in the inlet pipe and calculates a corresponding flow rate in one minute intervals. The level and flow rate data were stored by the bubbler flow meter, and this data was downloaded via USB connection to a laptop computer using the ISCO Flowlink software interface. An ISCO 674 tipping bucket rain gauge was installed near the field box at the Copperhead Drive basin outlet. Rainfall data was sent to the flow meter and subsequently downloaded via ISCO Flowlink.

All equipment was placed in tamper resistant field boxes for security. Figure 9 shows the completed field installation of water quality monitoring equipment at the outlet to Pon Court basin. The power for each set of monitoring equipment was drawn from a deep cycle marine battery which maintained charge via a connection to a solar panel mounted on the top of each field box.

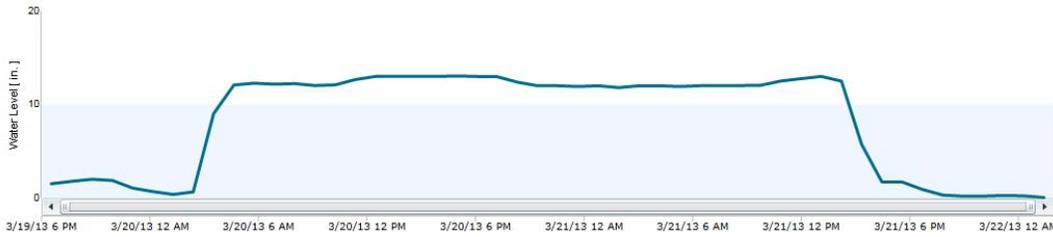
Figure 10. Pon Court Basin OptiRTC Water Level after March 20, 2013 Storm Event.

Figure 10 and Figure 11 show the level versus time data for Pon Court basin following a rain event on March 20, 2013. Figure 10 was developed based on data collected from the OptiRTC water level sensor installed on the outlet control structure, while Figure 11 was developed based on data collected from the bubbler flow meter.

The gate valve on the outlet control structure was closed prior to the rain event and remained closed until March 21, 2013. Based on the OptiRTC readings, the water level in the basin rose from 0 to 13 inches over a period of 10 hours, reaching 13 inches at 12:30pm on March 20, 2013. The water level in Pon Court basin remained nearly constant at 13 inches, only varying by a maximum of 1.2 inches over a period of 2 days. Based on the bubbler flow meter readings, the water level in the basin reached a maximum of 14.51 inches and did not vary by more than 0.49 inches until the gate valve was opened. The water level in the basin began decreasing when the gate valve was opened at approximately 1:00pm on March 21, 2013.

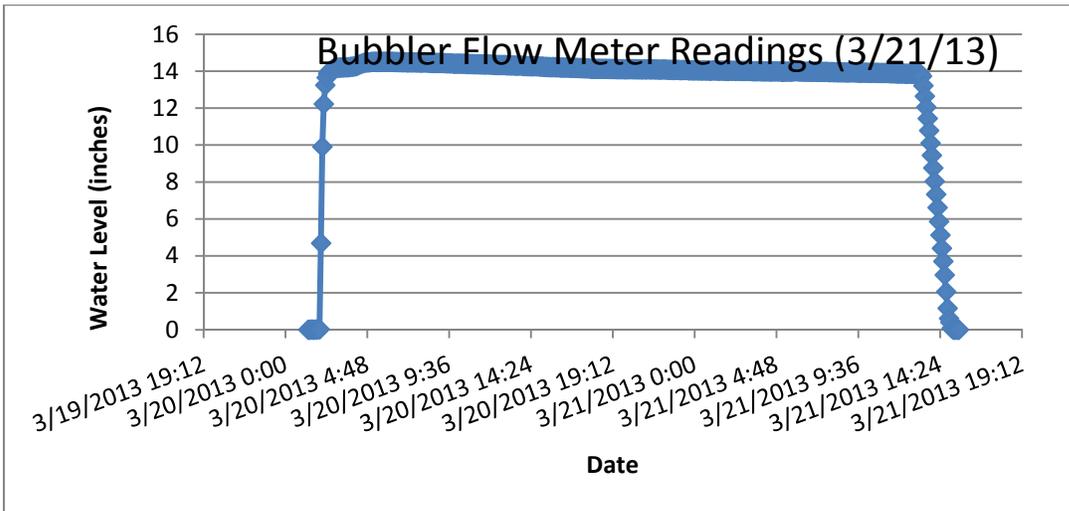
Figure 11. Pon Court Basin Bubbler Flow Meter Water Level after March 20, 2013 Storm Event.

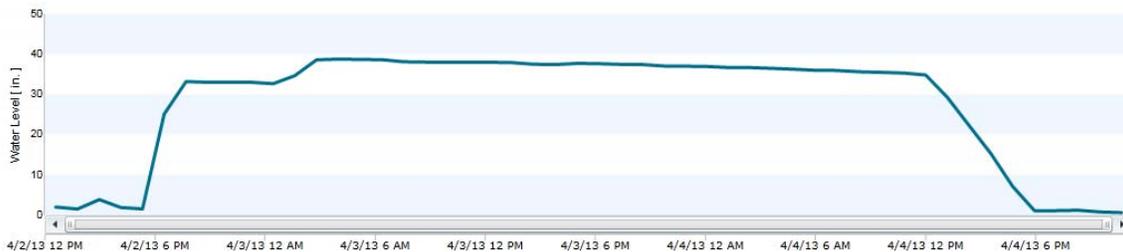
Figure 12. Pon Court Basin OptiRTC Water Level after April 2, 2013 Storm Event.

Figure 12 and Figure 13 show the level versus time data for Pon Court basin following a rain event on April 2, 2013. These data sets confirm the consistency of water level readings within the basin while the gate valve was closed.

The consistency in water level in Pon Court basin indicates that there is no volume loss occurring in the studied detention basins; infiltration and evaporation are both negligible. Thus, for the purposes of calculation and analysis, the influent runoff volumes are equivalent to the effluent runoff volumes within each detention basin.

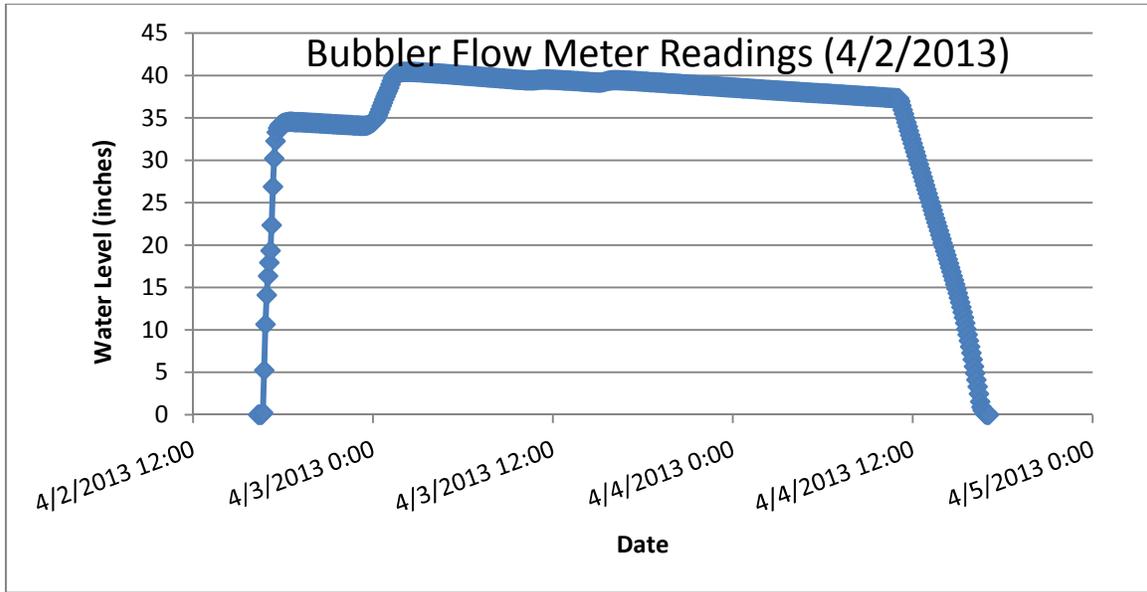
Figure 13. Pon Court Basin Bubbler Flow Meter Water Level after April 2, 2013 Storm Event.
