# Revised Implementation Plan for One Total Maximum Daily Load for Bacteria in Guadalupe River Above Canyon Lake Segment 1806

Prepared by the Upper Guadalupe River Authority and the Bacteria Reduction Plan  
Stakeholder Committee

Water Quality Planning Division, Office of Water

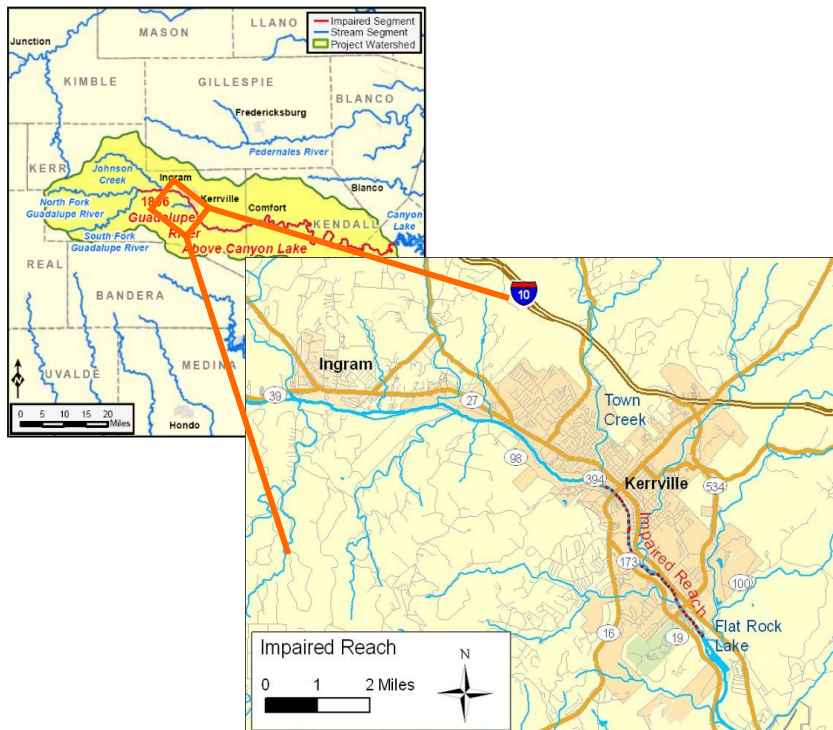
Figure 1. Map of the impaired reach of the Upper Guadalupe River above Canyon Lake

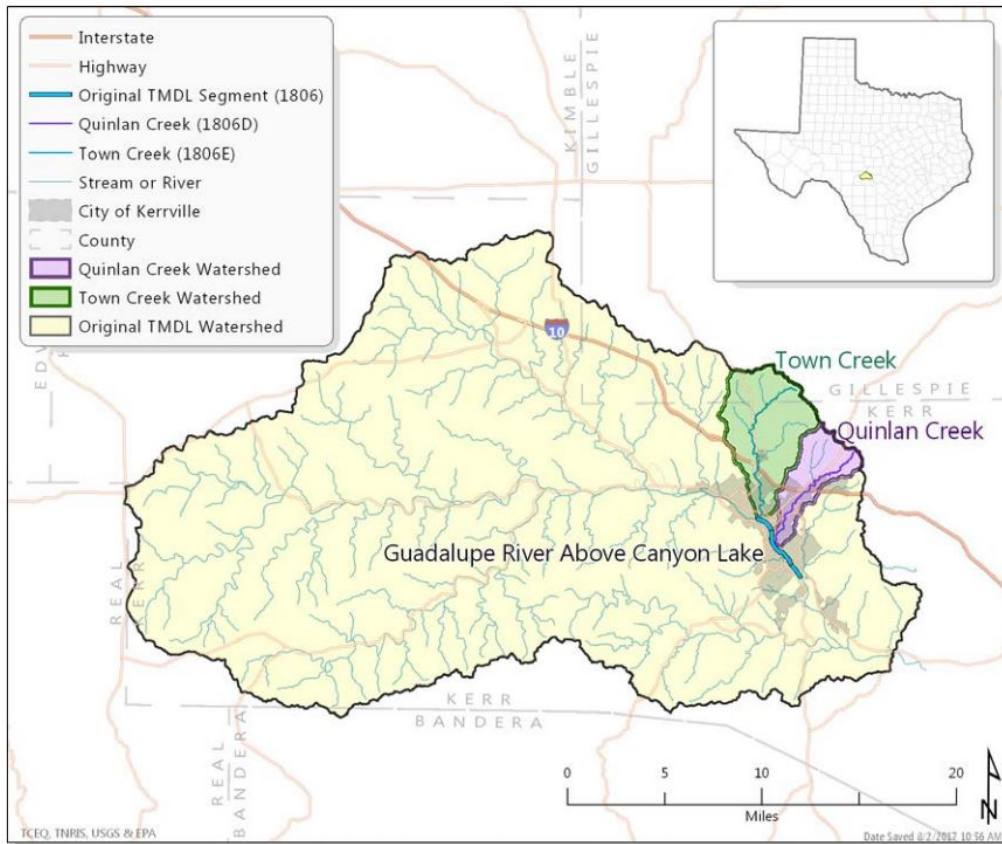
**Figure 2. Map showing the Guadalupe River Above Canyon Lake TMDL watershed and the two watersheds considered in the addendum**

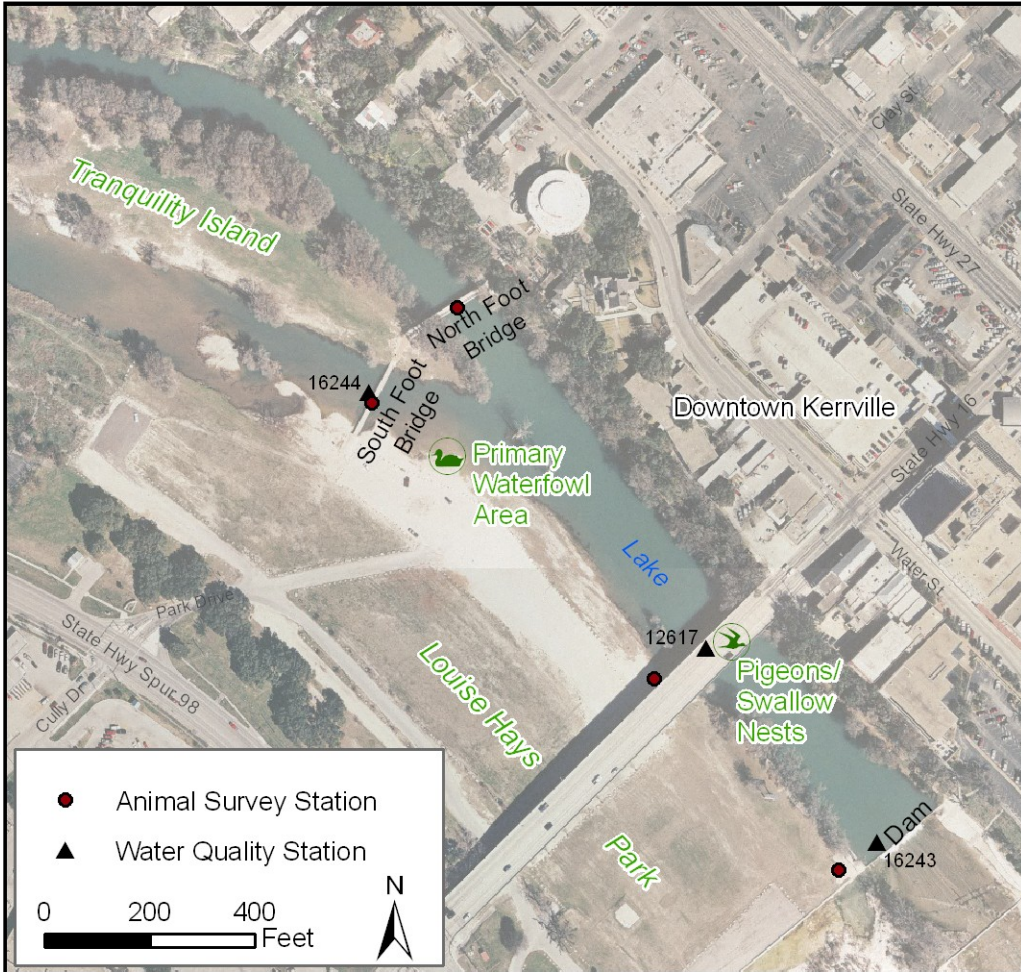
Figure 6. Louise Hays Park Map with monitoring locations indicated

The numbers of waterfowl present along the Guadalupe River have been estimated from routine animal surveys, conducted as part of the Bacteria Reduction Plan and previous studies. In Louise Hays Park, waterfowl were counted between the Tranquility Island foot bridges and the dam. Figure 6 shows the water quality and animal monitoring locations in Louise Hays Park. At Kerrville-Schreiner Park, waterfowl were counted only at the boat ramp. A summary of the results is included in Figure 7 and Figure 8. From July 2008 – December 2017, a total of 273 surveys were conducted at each location.

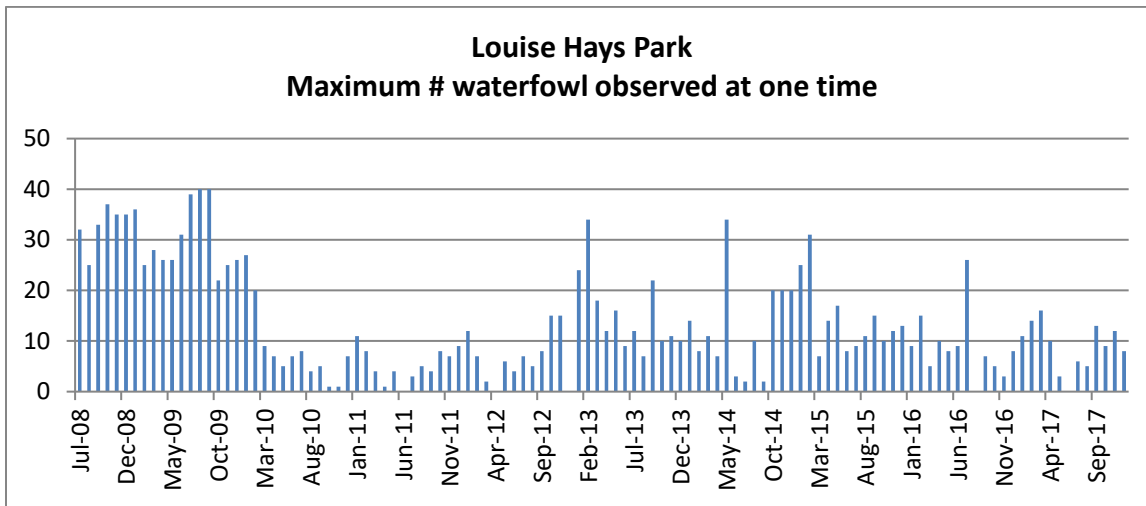
Figure 7. Summarized waterfowl counts at Louise Hays Park

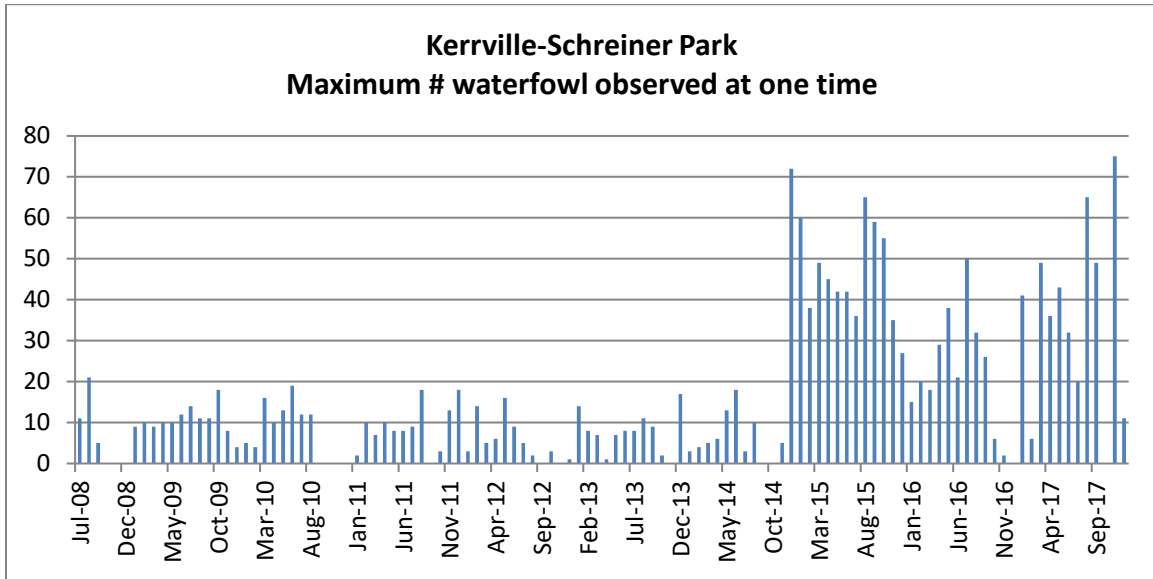
**Figure 8. Summarized waterfowl counts at Kerrville-Schreiner Park**

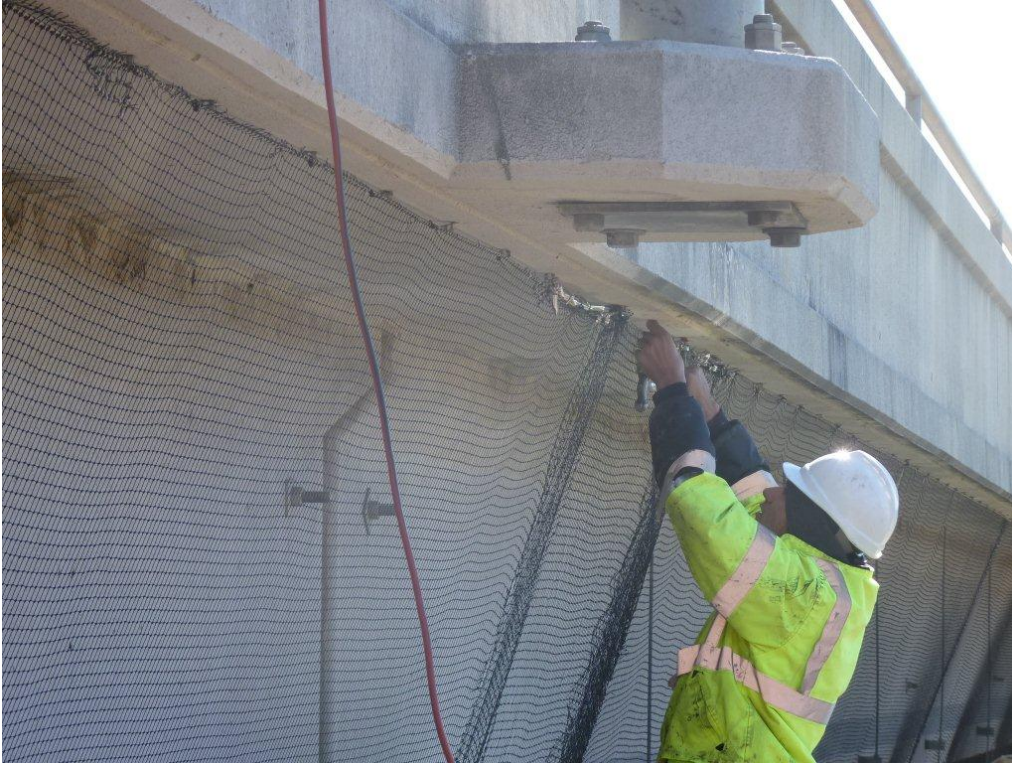
**Figure 12. Installation of bird exclusion netting on Hwy 16 Bridge**

The management measure (install bird exclusion/deterrent devices on bridges directly over the waterway) outlined in the Guadalupe River Above Canyon Lake Implementation Plan (TCEQ 2011) was implemented in the study area to address bacteria contributions from roosting and nesting birds. Plans and specifications were prepared for installation of bird exclusion netting to the sides and underside of the Hwy 16 and Loop 534 bridge spans adjacent to and directly above the water surface. After competitive bids were evaluated, the project scope was limited to installation of bird exclusion netting to the sides and underside of three Hwy 16 bridge spans. A contractor was selected, and the installation was completed in January 2013. The work proved to be difficult and highly specialized, especially due to the need to work high above the water surface. Photos of the installation are shown in Figures 12, 13, and 14.

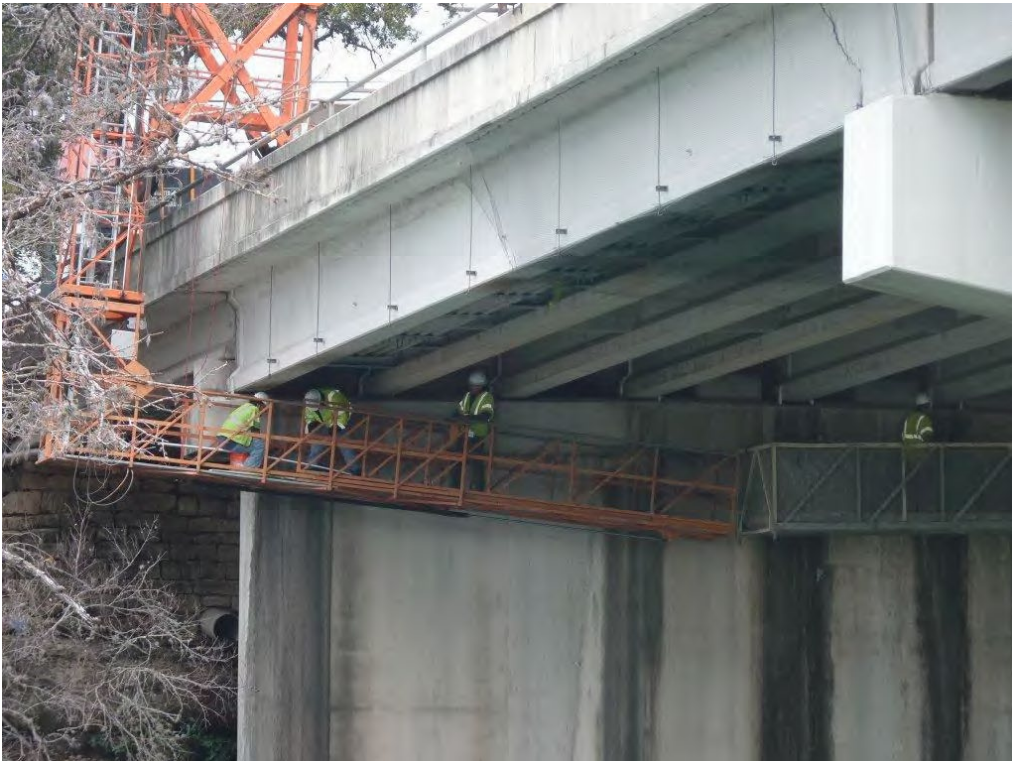
**Figure 13. Netting installation taking place on span of Hwy 16 Bridge over Guadalupe River**

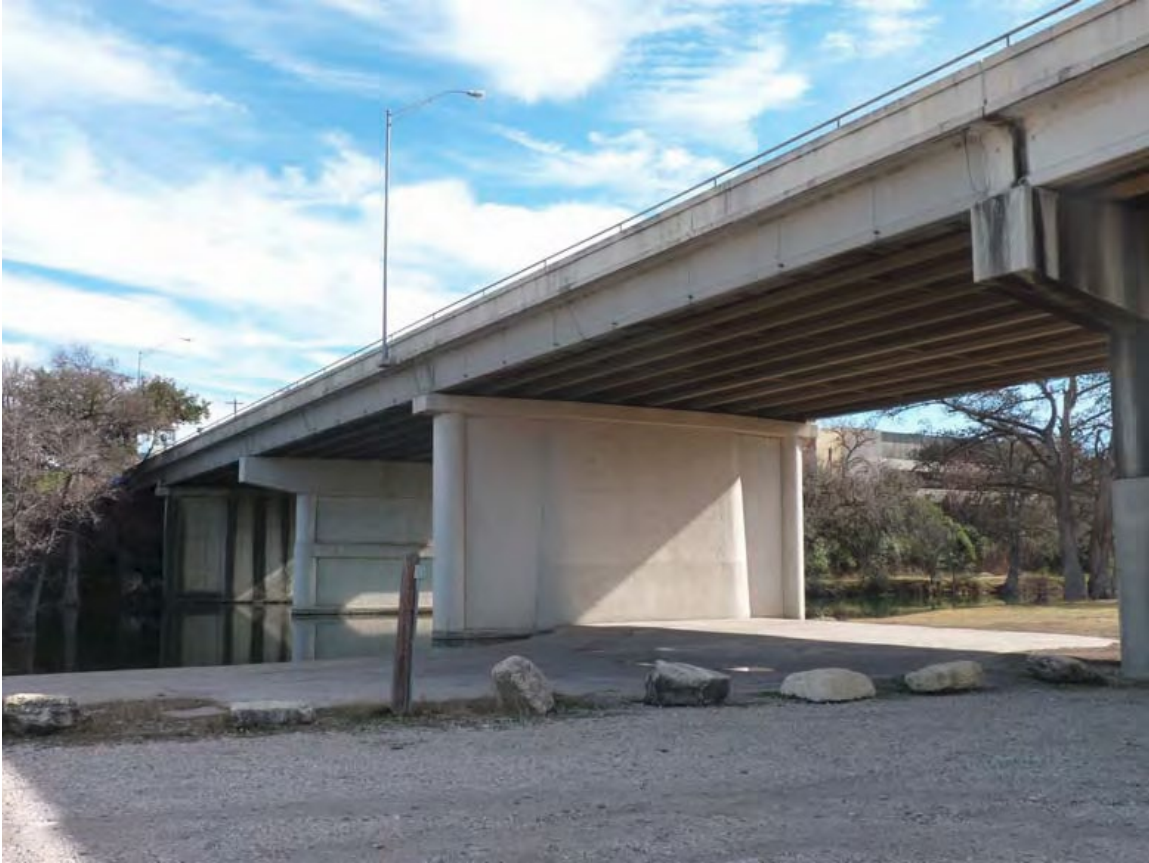
**Figure 14. Final netting system over Spans 2,3, and 4 of Hwy 16 Bridge**

UGRA conducted bi-weekly animal count surveys from 2008-2010 and monthly surveys from 2011 – present. The survey results indicate that the installation of exclusion netting has eliminated both roosting and nesting from the bridge spans where the netting was installed.

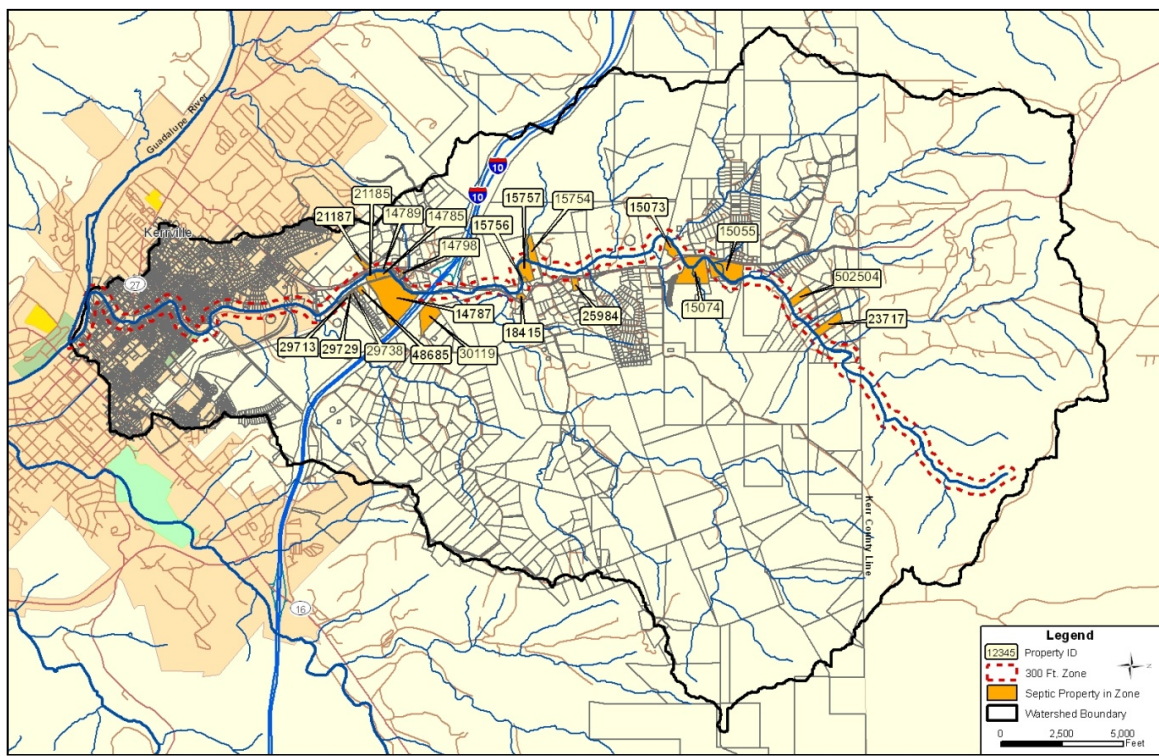
Figure 16. Town Creek septic system priority zone

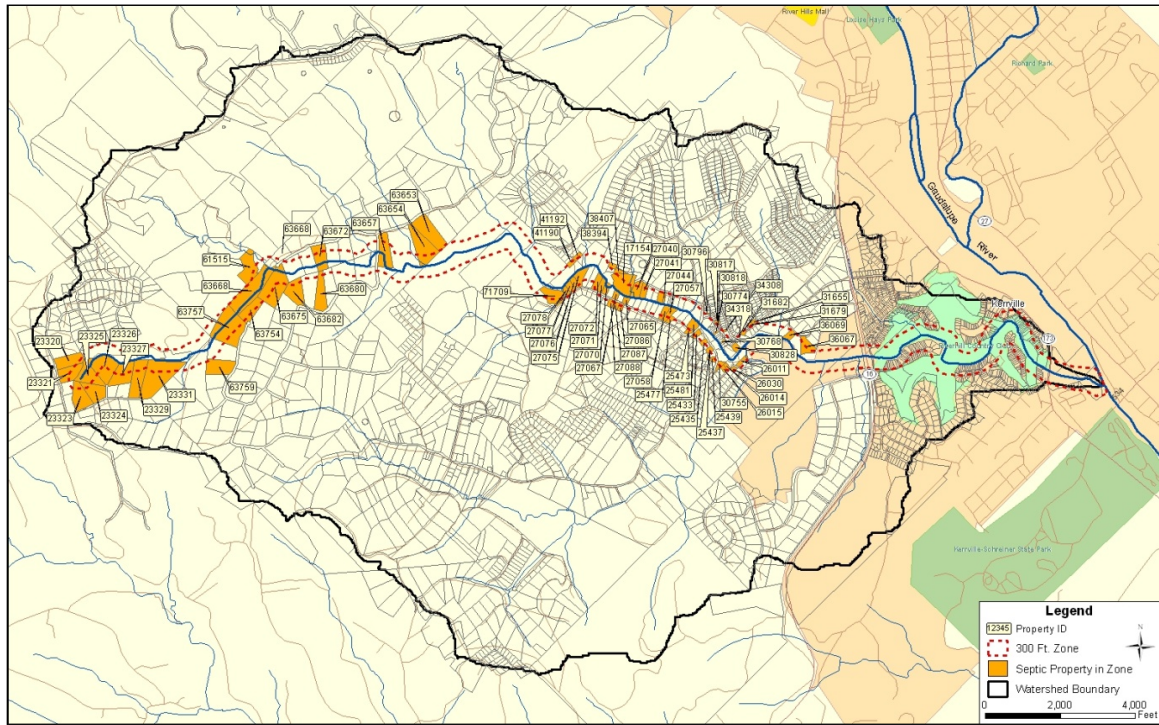
Figure 17. Camp Meeting Creek septic system priority zone

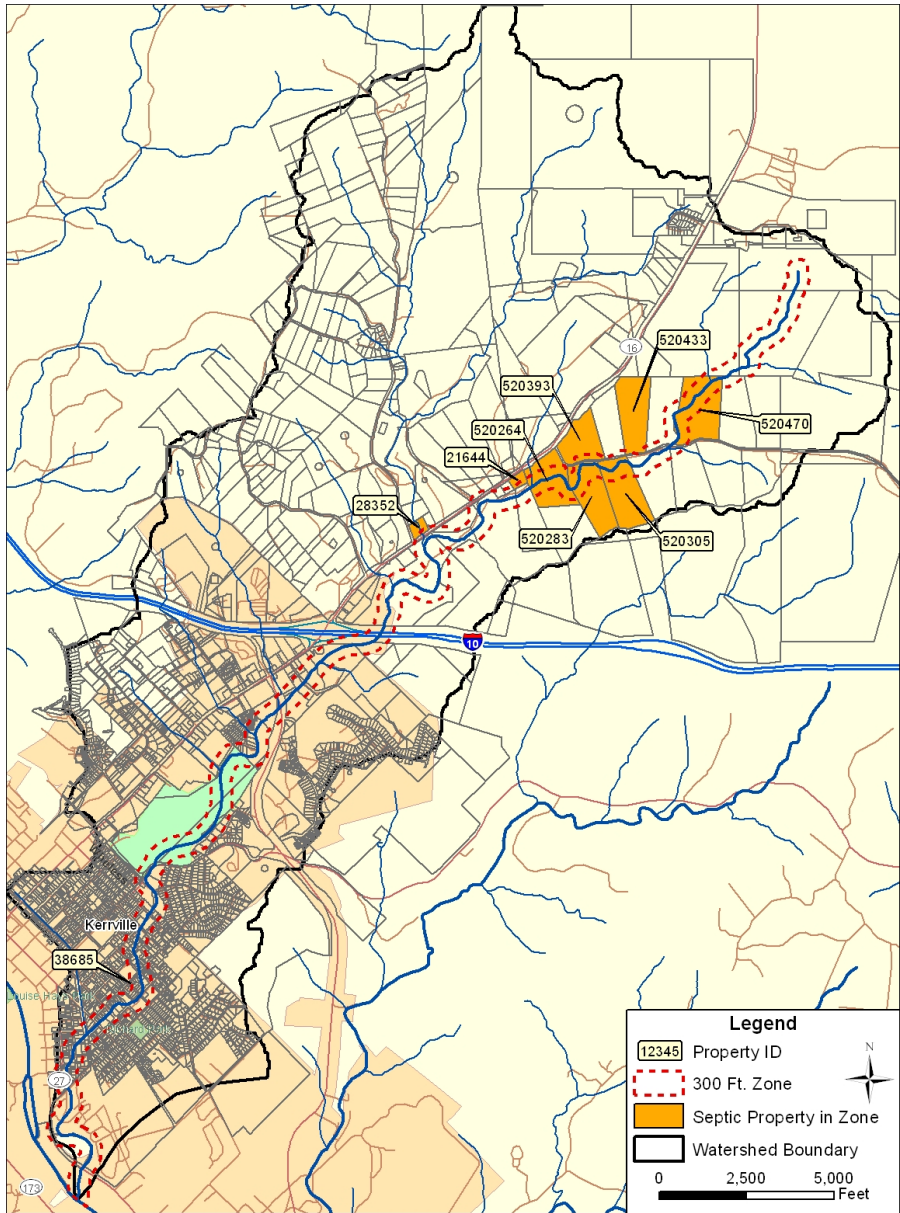
Figure 18. Quinlan Creek septic system priority zone

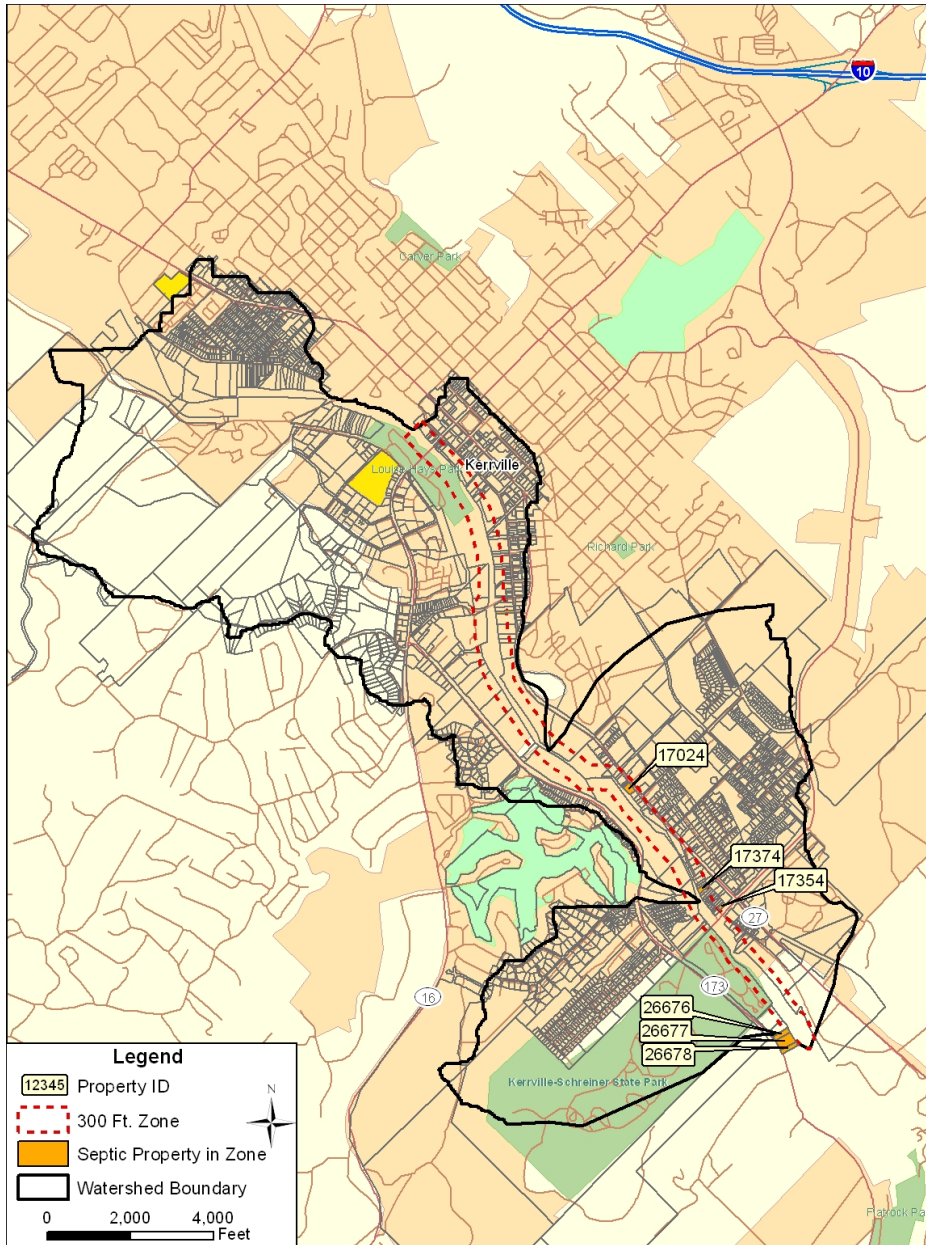
Figure 19. Guadalupe River main stem septic system priority zone

The miscellaneous watersheds that drain directly to the Guadalupe River were also addressed. The priority zone for the mainstem and its miscellaneous watersheds are shown in Figure 19. A total of 84 septic system parcels are located within these watersheds, and of that total, 6 are within the designated priority zone.

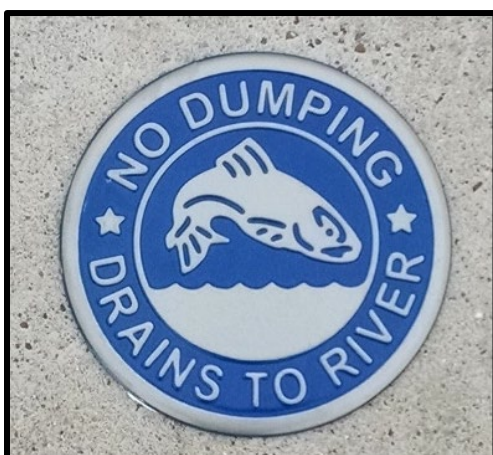
**Figure 22. Storm drain marker installed in Kerrville**

UGRA coordinated with the City of Kerrville and the Texas Department of Transportation (TxDOT) to initiate a storm drain marking program within the City of Kerrville. These signs raise awareness about the connection between storm drains and receiving waters and can help to deter littering, excess fertilizer use, dumping, and other practices that contribute to storm water pollution. The storm drain markers are 4” diameter, stainless steel, and embossed with the message “No Dumping - Drains to River” (Figure 22)

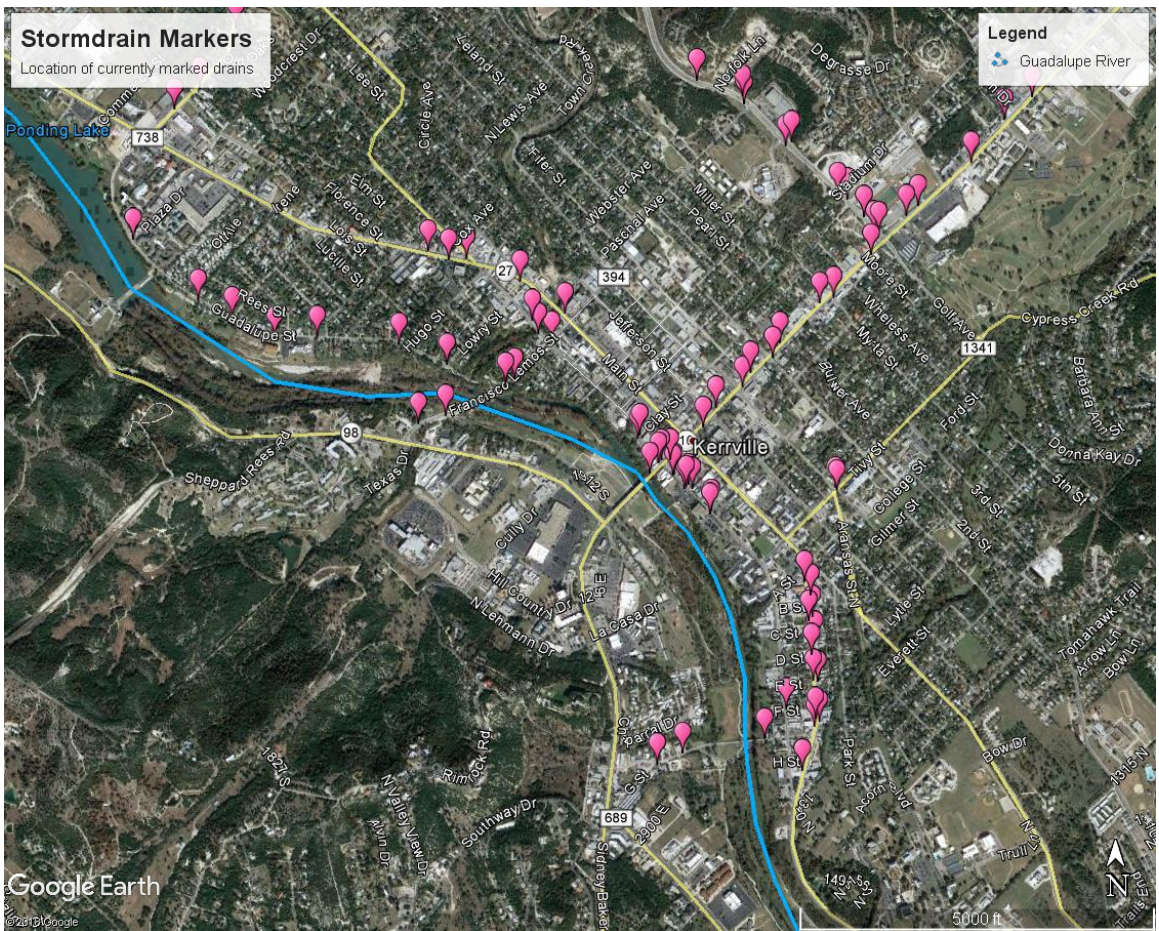
Figure 23. Location of storm drain markers in City of Kerrville

During the first phase of this program, 100 markers were installed in the study area between October 2014 and December 2017. Locations were prioritized by vicinity to the impaired reach of the Guadalupe River as well as the contributing tributaries. Locations were also prioritized to send the message to the maximum number of citizens (for example, in areas of high pedestrian traffic). Locations for the first phase of installation are depicted in Figure 23. Students from Schreiner University in Kerrville installed the majority of the storm drain markers while completing and internship with UGRA (Figure 24).

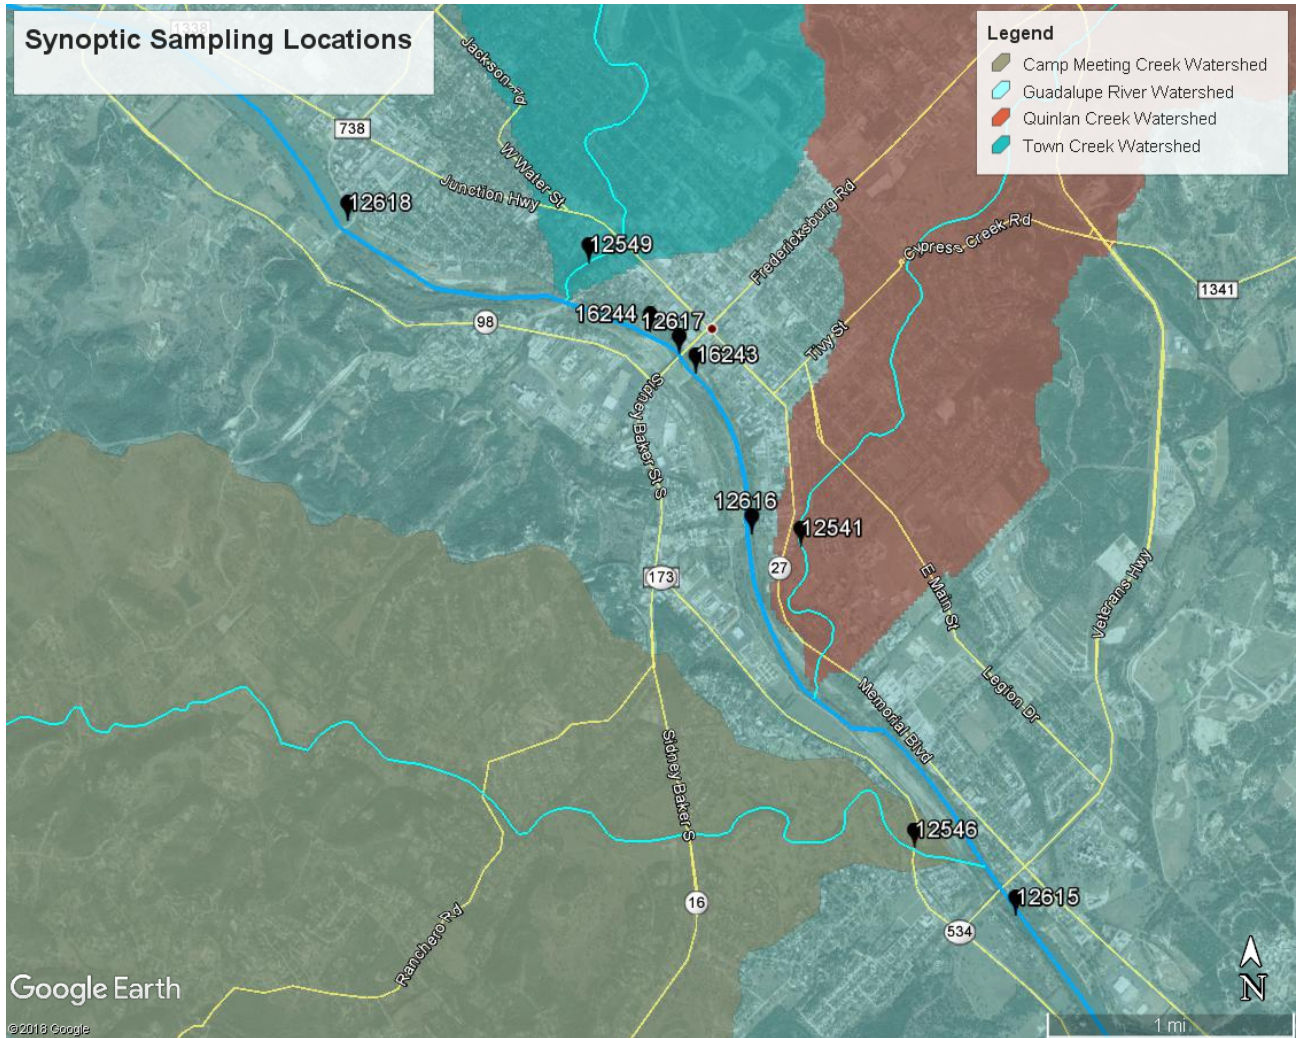
Figure 25. Location of monthly monitoring stations for *E. coli* bacteria
