**Support for Total Maximum Daily Loads (TMDL) for Indicator Bacteria in Oso Bay
Monitoring Report
Fiscal Year 2013 (Year-one) and Fiscal Year 2014 (Year-two)**

**Texas Commission on Environmental Quality
P.O. Box 13087
Austin, Texas 78711-3087**

Brien A. Nicolau and Erin M. Hill
Center for Coastal Studies
Texas A&M University-Corpus Christi
6300 Ocean Drive, Suite 3200
Corpus Christi, Texas 78412

November 2014

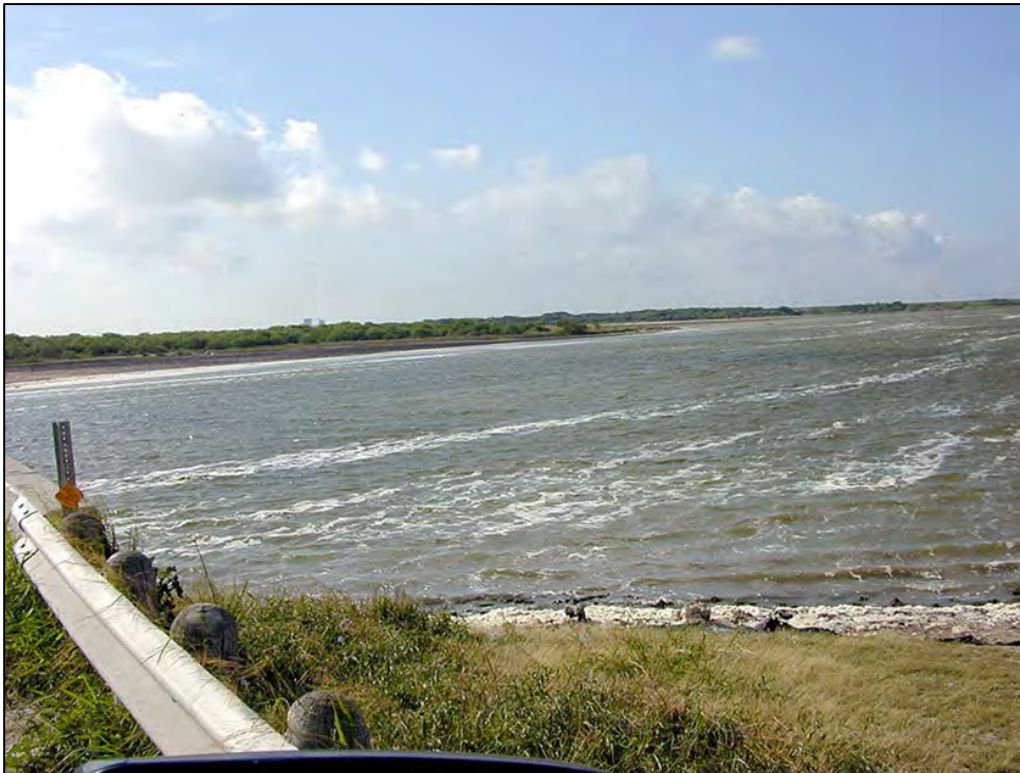
Figure 3.2. Station 13026 – Oso Bay at Yorktown Road.

Located where the Yorktown Road Bridge crosses Oso Bay (see Figure 3.1), this station is approximately 1000 m downstream of the Topaz Energy Group-Barney Davis Energy Center (formally the Central Power & Light Barney M. Davis Power Plant) cooling ponds outfall (Figure 3.2 and Figure 3.3). Clearing of vegetation for the construction of the adjacent bridge resulted in the shoreline being bare or covered in riprap to control erosion. Location of the outfall exerts a substantial influence on the substrate characteristics of the location. A scoured channel exists, with an approximate depth of 2.5 m, in the middle of the bay. This area is composed of a hard clay substrate but nearer the shore, the substrate transitions to a finer clay and silt composition mixed with patches of sand. Patches of the seagrass, *Halodule beaudettei* exists near the cooling pond discharge. The sampling area is adjacent and upstream (south side) of the bridge and water depth in the sample area ranges from 0.20 to 1.3 m. A large amount of tidal flat area exists and due to easy access to the water, anglers often use the bridge and surrounding area heavily, often driving vehicles around the protective barriers and across the tidal flats. This often results in a large amount of debris deposited on the shoreline or along the roadway near the bridge (Figure 3.4). Birds are observed in a limited number utilizing the flats.

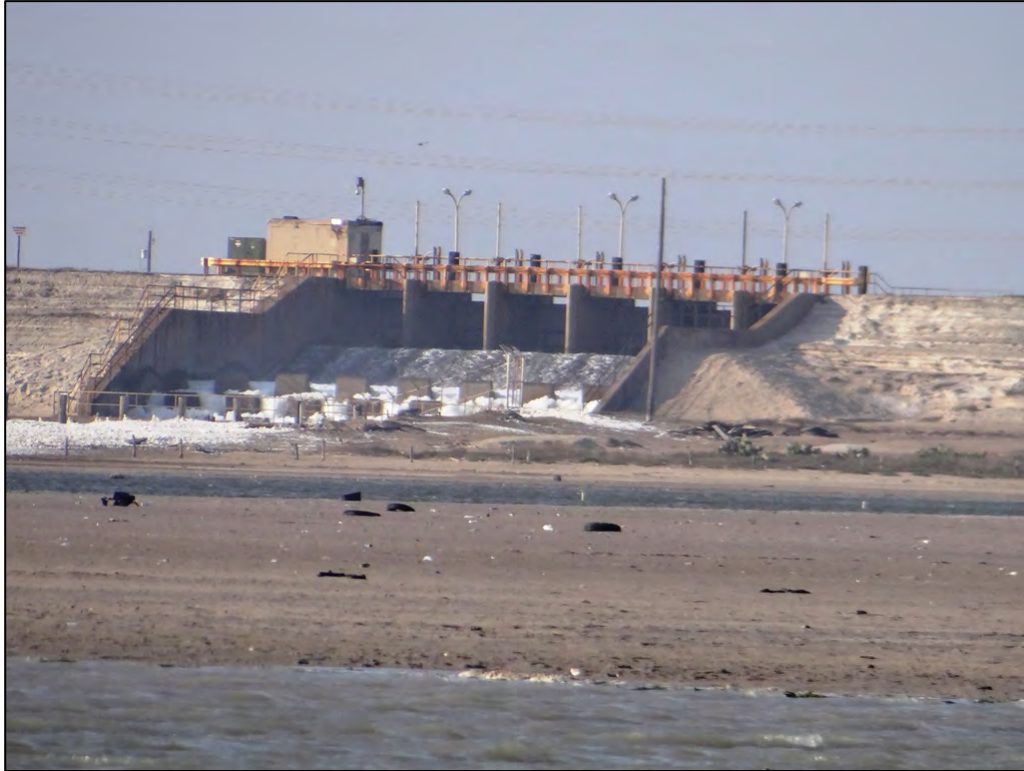
Figure 3.3. Cooling pond outfalls at the Topaz Energy Group-Barney Davis Energy Center.

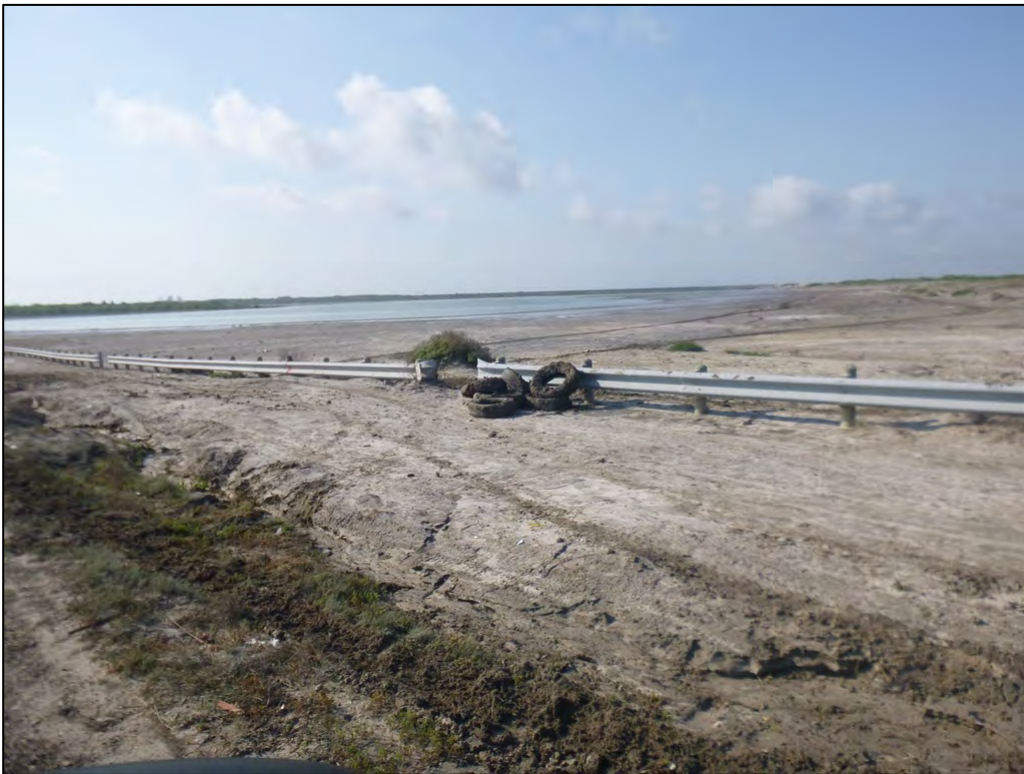
Figure 3.4. Abandoned tires at Station 13026.

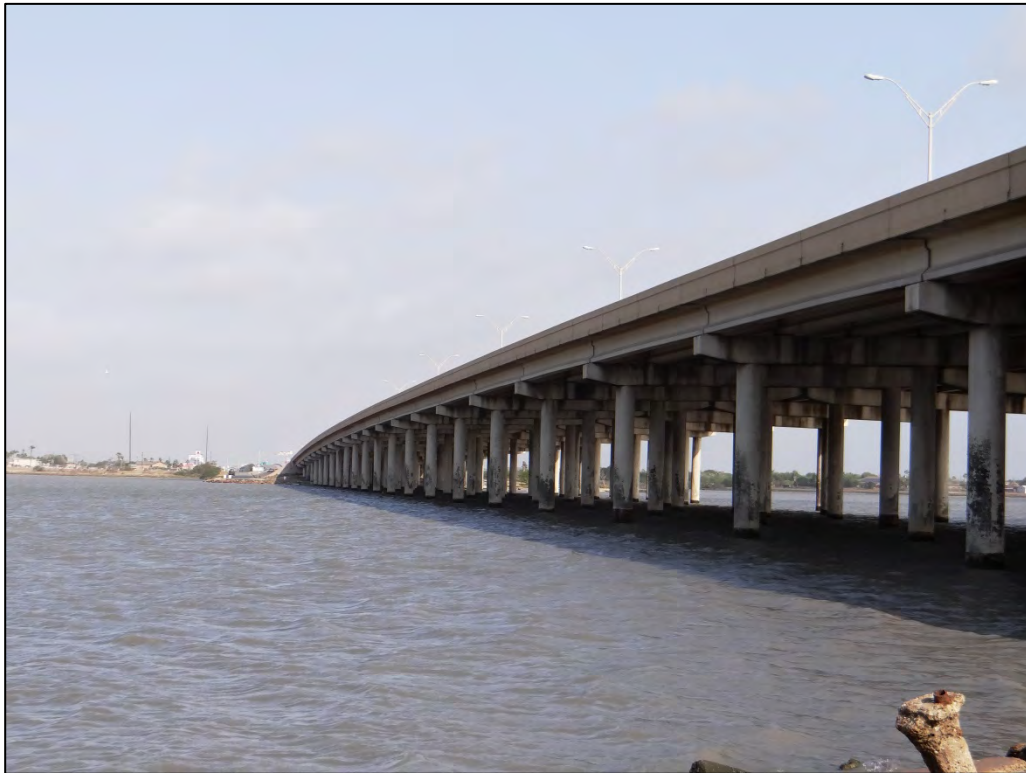
Figure 3.8. Station 13440 - Oso Bay at State Highway 358 (South Padre Island Drive).

Located where State Highway 358 (South Padre Island Drive) crosses Oso Bay (see Figure 3.1), this station is located at mid-bay (Figure 3.8). As with Station 13026, the clearing of vegetation during the construction of the adjacent bridge resulted in the shoreline being bare or covered in riprap to control erosion (Figure 3.9). The sampling area is adjacent to and on the southern side of the bridge. Bottom sediments are primarily a soft clay/sand composition. Water depth within the sampling area ranged from 0.30 to 0.80 m with some areas greater than 1.0 m. Small patches of seagrass composed of *Halodule beaudettei* exist on the northern portion of the location. Prevailing southeasterly winds provide for constant mixing of the water within this area of Oso Bay. Easy access to the water also makes this an attractive spot for anglers and despite trashcans provided by the City of Corpus Christi, there is still a considerable amount of trash and debris deposited on the shoreline in the immediate area (Figure 3.10). Bird use at this station is limited.

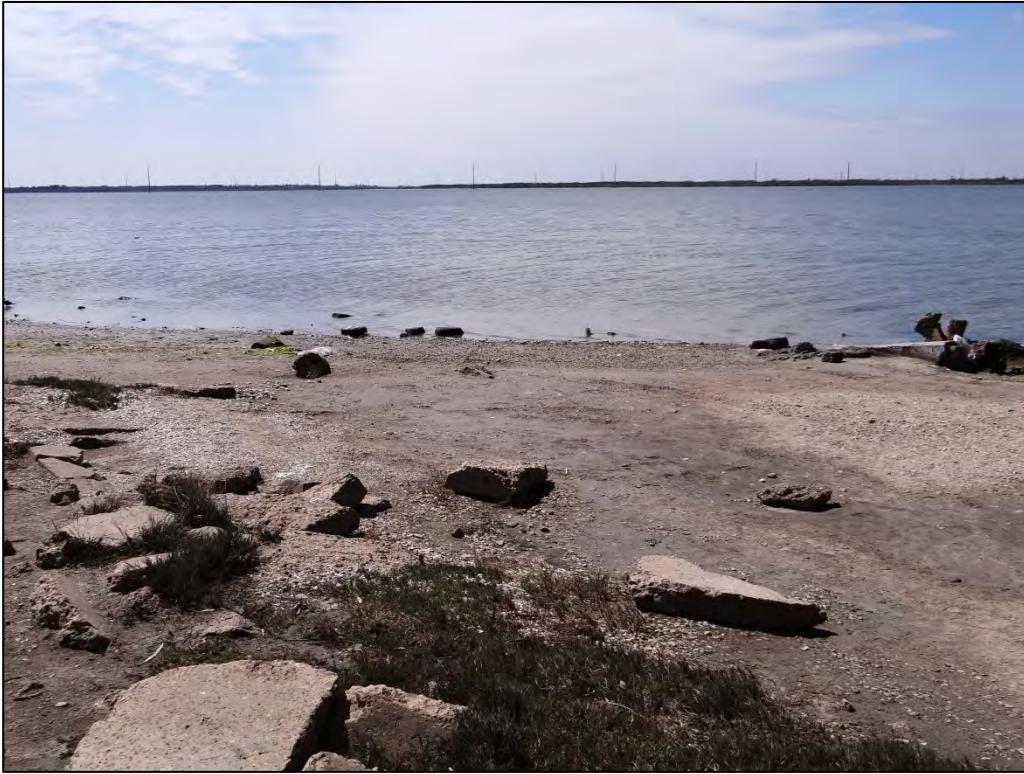
Figure 3.9. Station 13440 – Concrete blocks along shoreline.

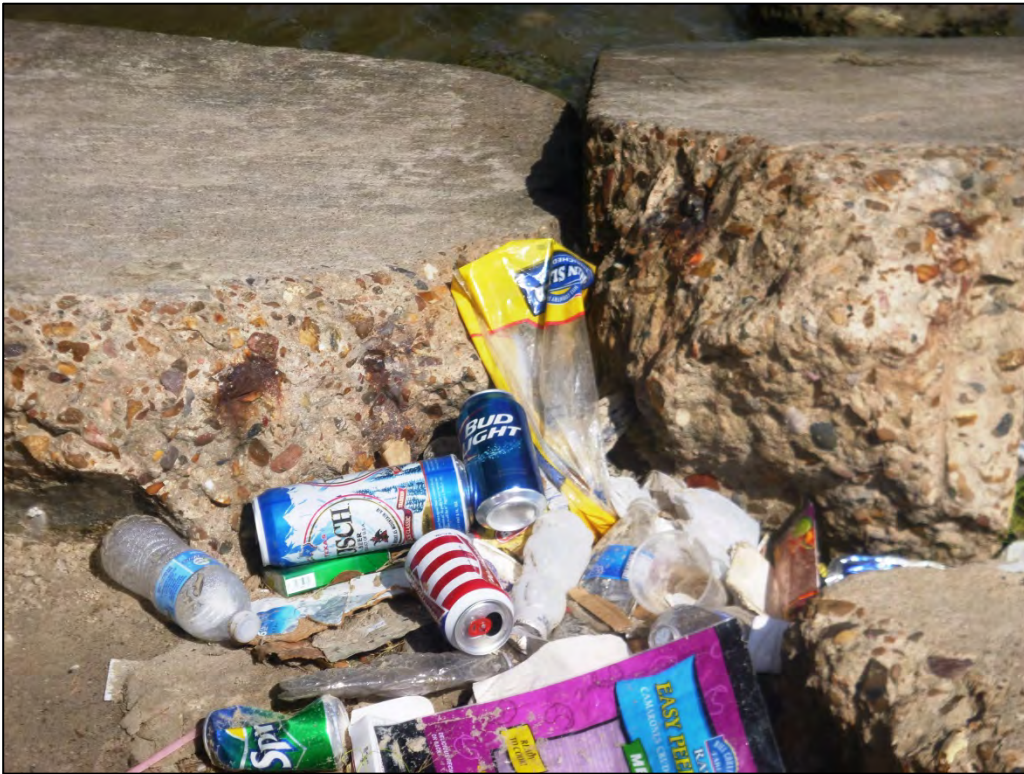
Figure 3.10. Station 13440 – Trash deposited among concrete riprap.

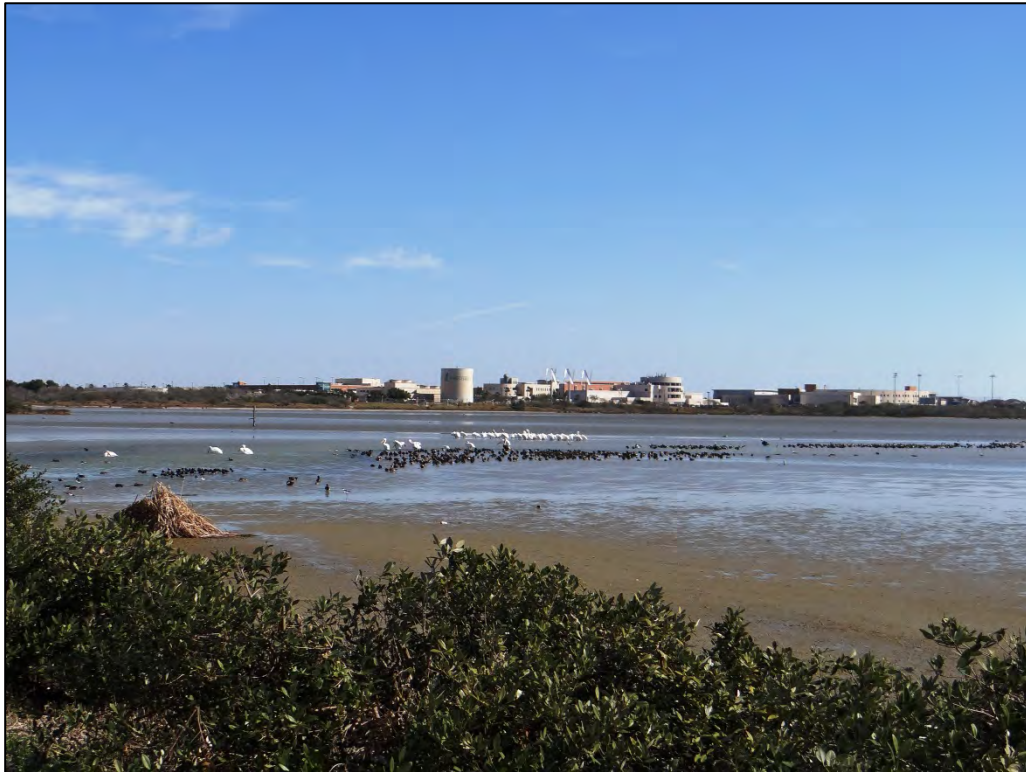
Figure 3.11. Station 13441 - Oso Bay at Hans Suter Park below OWWTP outfall.

Located west of Ward Island and the Texas A&M University-Corpus Christi campus (see Figure 3.1) this unique station is located at the Hans Suter Wildlife Refuge, which is adjacent to the OWWTP (Figure 3.11). Treated wastewater released from the OWWTP creates a freshwater wetland with such plant species as cattail. Transcending to the bay and adjacent areas, low, mid, and high marsh vegetation (i.e. *Borrichia frutescens*, *Avicennia germinans*) is along the banks (Figure 3.12). This station is located where the discharge channel enters Oso Bay; approximately 200 m from the OWWTP discharge pipe. Sampling takes place approximately 50 m from the end of the discharge channel adjacent to the viewing platform used by visitors to the refuge. Birds are observed feeding and resting at this location in high numbers year round.

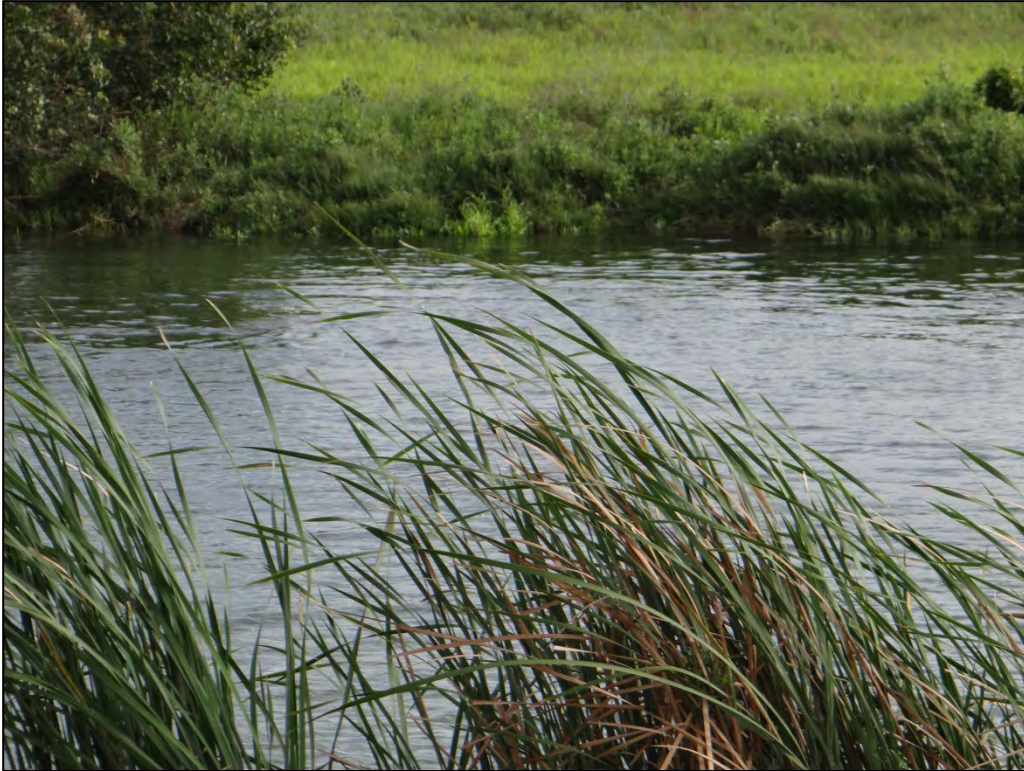
Figure 3.12. Station 13441 – Upper reach of discharge channel with freshwater wetland vegetation.

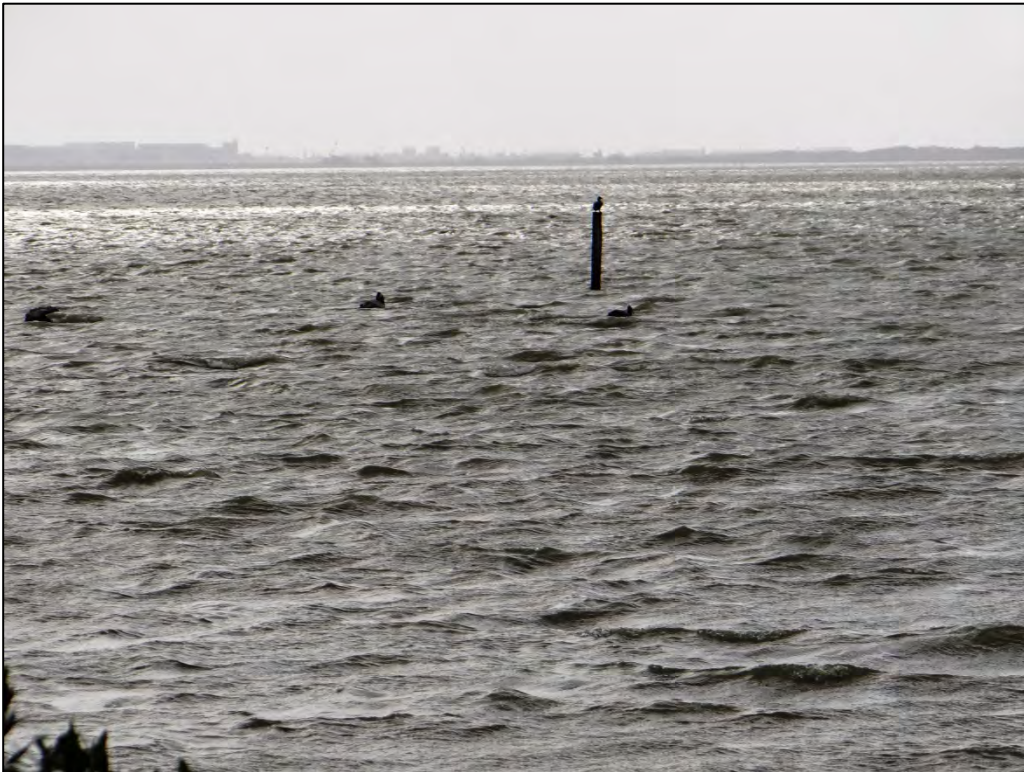
Figure 3.13. Station 13441 – High tide and strong winds covering tidal flats.

While considered a low energy environment, there is potential for considerable mixing from the prevailing southeasterly winds when water levels are high (Figure 3.13). While the permit defines the mixing zone as being within a 50-foot radius from the outflow pipe, typically the low water levels at this location result in a visible dominant plume of freshwater that flows out and mixes with the higher saline waters of Oso Bay. Due to low water levels resulting in extended periods of emergent tidal flats (see Figure 3.11), it is often necessary to walk extended distances to obtain enough water for representative samples. Bottom substrate is hard clay overlaid with silt and/or a layer of black pluffy organic material.

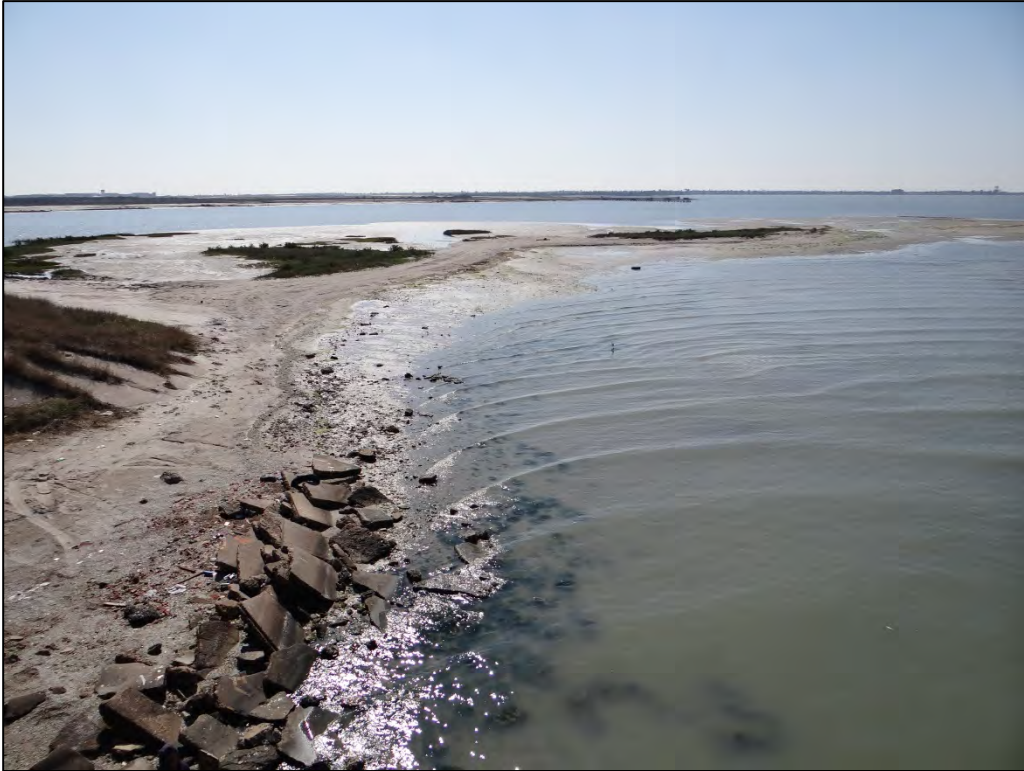
Figure 3.15. Station 13442 – Riprap along mostly bare shoreline.

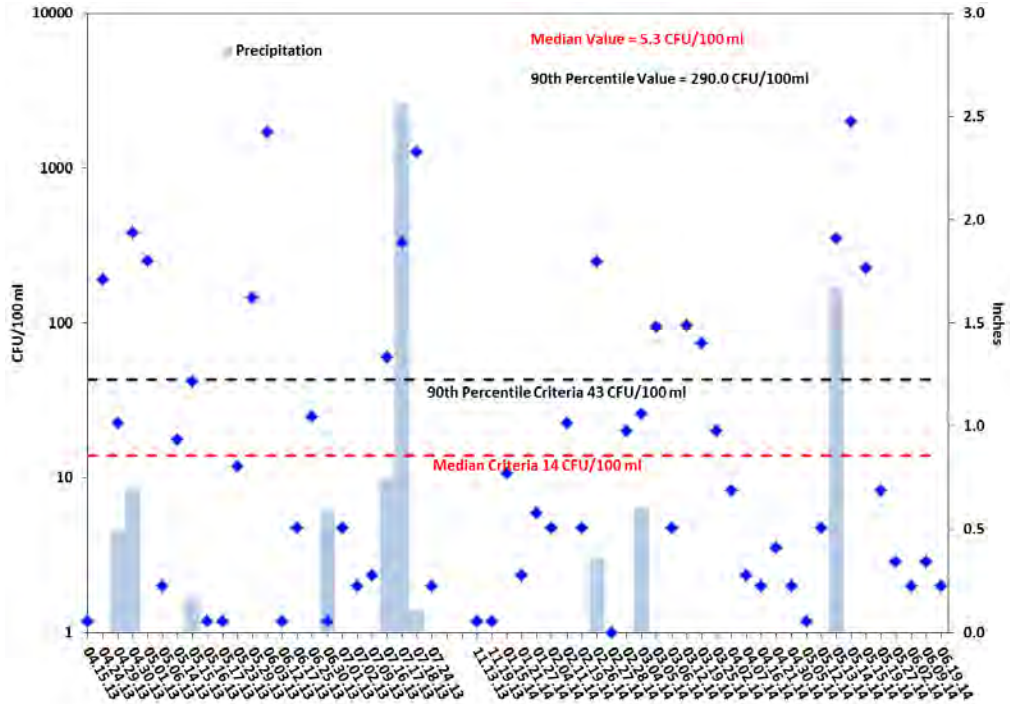
Figure 4.1. All fecal coliform concentrations at Station 13026 with precipitation amounts, median and 90th percentile criteria, and actual calculated median and 90th percentile values.

Regardless of rainfall, when all sampling events were combined the median criteria was exceeded at three stations and the 90th percentile was exceeded at all five stations, with both the median and 90th percentile exceeded for Oso Bay as a whole (Table 4.3). The largest source(s) of bacteria are likely carried in with stormwater, as exceedances were typically greater during rainfall events (see Table 4.2 and Figures 4.1 through 4.5). However, the 98.2% exceedance rate observed at Station 13441 at Hans Suter Park, adjacent to the OWWTP, indicates that additional investigation is needed to understand the source of the high bacteria concentrations being observed at this location (Figure 4.1)

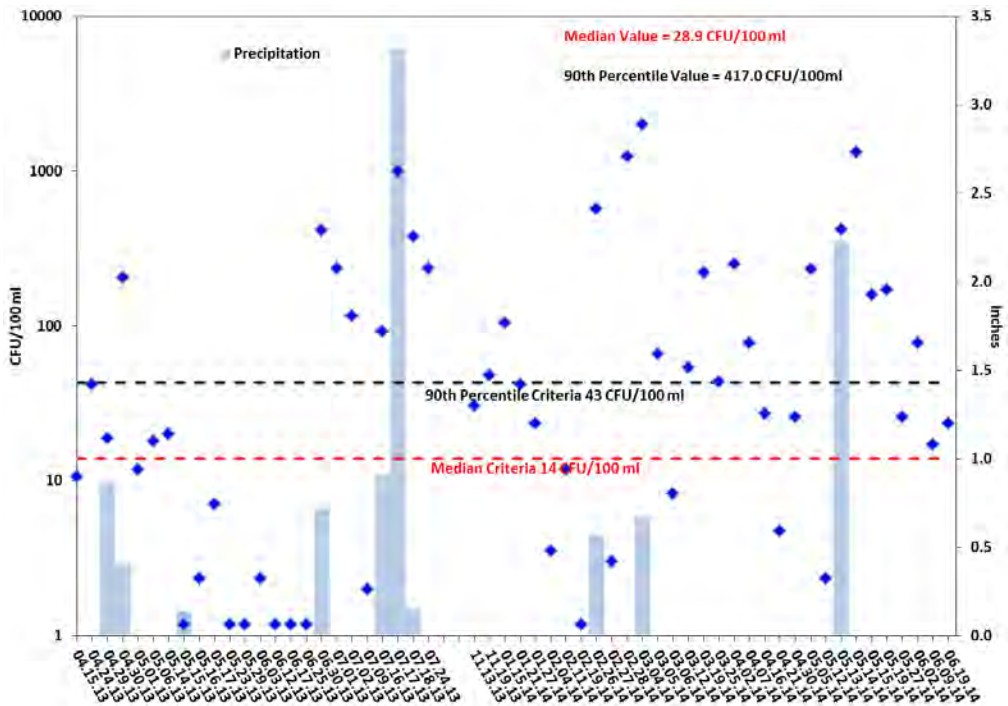
Figure 4.3. All fecal coliform concentrations at Station 13440 with precipitation amounts, median and 90th percentile criteria, and actual calculated median and 90th percentile values.

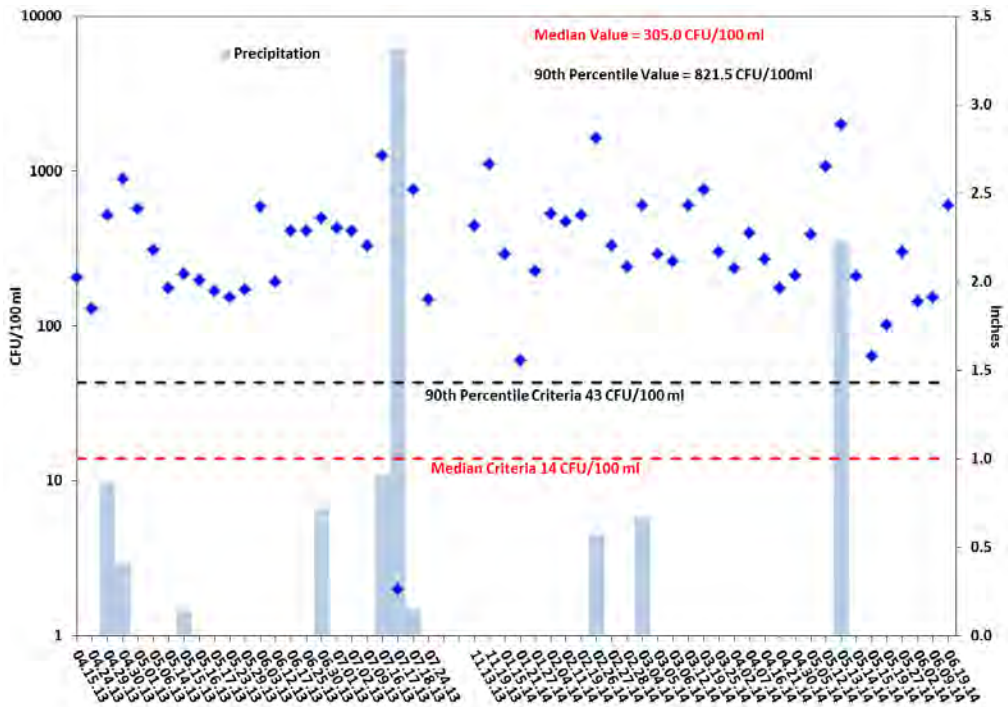
Figure 4.4. All fecal coliform concentrations at Station 13441 with precipitation amounts, median and 90th percentile criteria, and actual calculated median and 90th percentile values.

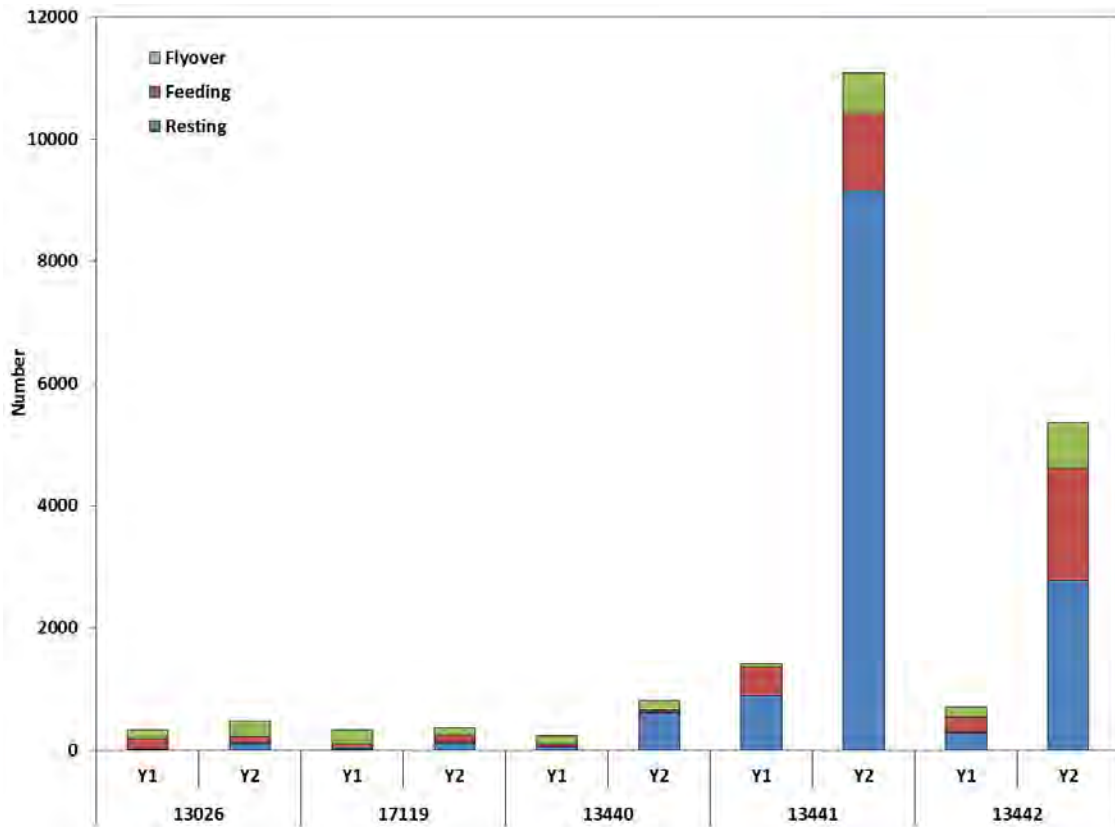
Figure 4.6. Total numbers of birds at each sampling location by activity observed for Year-one and Year-two.

Observations of avian activity during the 56 individual sampling events demonstrated the high use of Station 13441 in the Hans Suter Park area as a resting and feeding location for birds, especially during Year-two. As opposed to Year-one, higher numbers of birds observed in Year-two relate directly to sampling events that occurred during the winter months when wintering populations of birds populate this area. Station 13442 at Ocean Drive, while having approximate 50% less bird observations than Station 13441 in both years, was still a preferred habitat for bird species and regularly used for resting and feeding (Figure 4.6). Figures 4.7 through 4.11 provide pictures of bird use at each location.
