**Support for Total Maximum Daily Loads (TMDL) for Indicator Bacteria in Oso Bay  
Monitoring Report  
Fiscal Year 2013 (Year-one) and Fiscal Year 2014 (Year-two)**

**Texas Commission on Environmental Quality  
P.O. Box 13087  
Austin, Texas 78711-3087**

**Brien A. Nicolau and Erin M. Hill  
Center for Coastal Studies  
Texas A&M University-Corpus Christi  
6300 Ocean Drive, Suite 3200  
Corpus Christi, Texas 78412**

**November 2014**

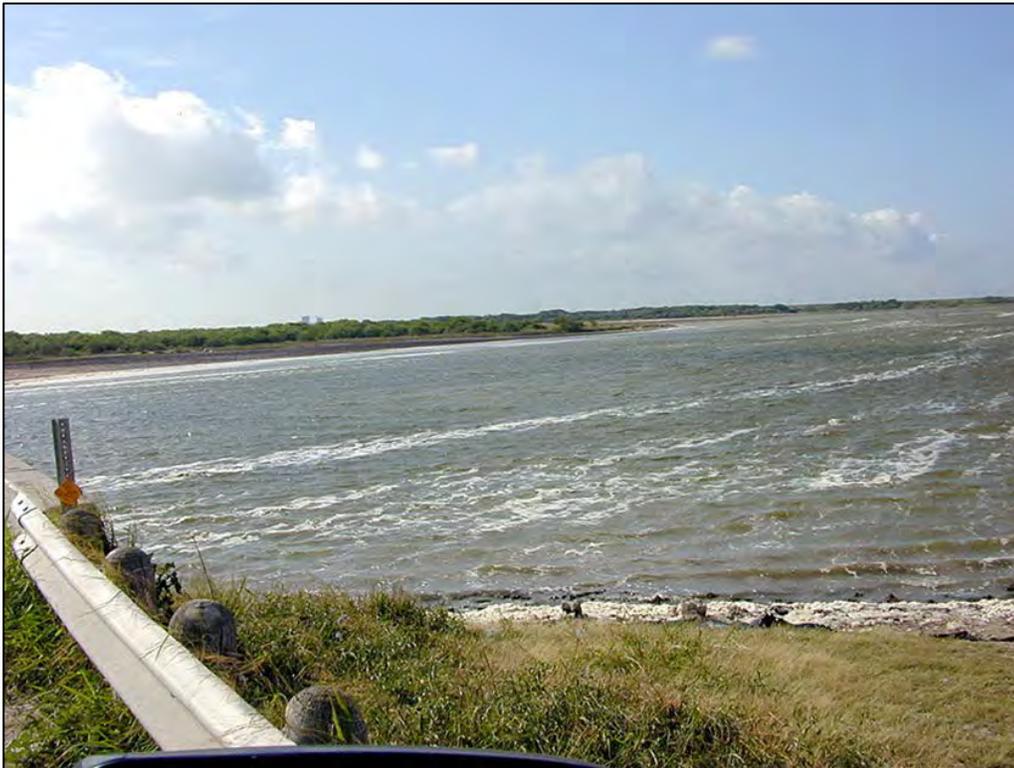
Figure 3.2. Station 13026 – Oso Bay at Yorktown Road.

Located where the Yorktown Road Bridge crosses Oso Bay (see Figure 3.1), this station is approximately 1000 m downstream of the Topaz Energy Group-Barney Davis Energy Center (formally the Central Power & Light Barney M. Davis Power Plant) cooling ponds outfall (Figure 3.2 and Figure 3.3). Clearing of vegetation for the construction of the adjacent bridge resulted in the shoreline being bare or covered in riprap to control erosion. Location of the outfall exerts a substantial influence on the substrate characteristics of the location. A scoured channel exists, with an approximate depth of 2.5 m, in the middle of the bay. This area is composed of a hard clay substrate but nearer the shore, the substrate transitions to a finer clay and silt composition mixed with patches of sand. Patches of the seagrass, *Halodule beaudettei* exists near the cooling pond discharge. The sampling area is adjacent and upstream (south side) of the bridge and water depth in the sample area ranges from 0.20 to 1.3 m. A large amount of tidal flat area exists and due to easy access to the water, anglers often use the bridge and surrounding area heavily, often driving vehicles around the protective barriers and across the tidal flats. This often results in a large amount of debris deposited on the shoreline or along the roadway near the bridge (Figure 3.4). Birds are observed in a limited number utilizing the flats.

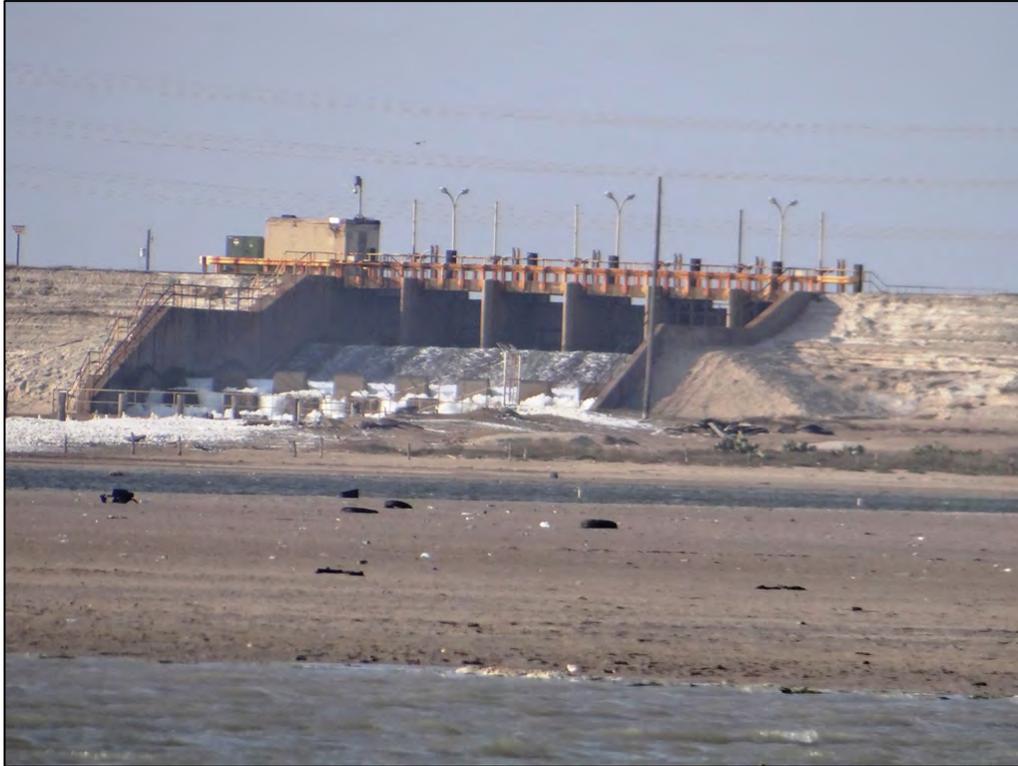
Figure 3.3. Cooling pond outfalls at the Topaz Energy Group-Barney Davis Energy Center.

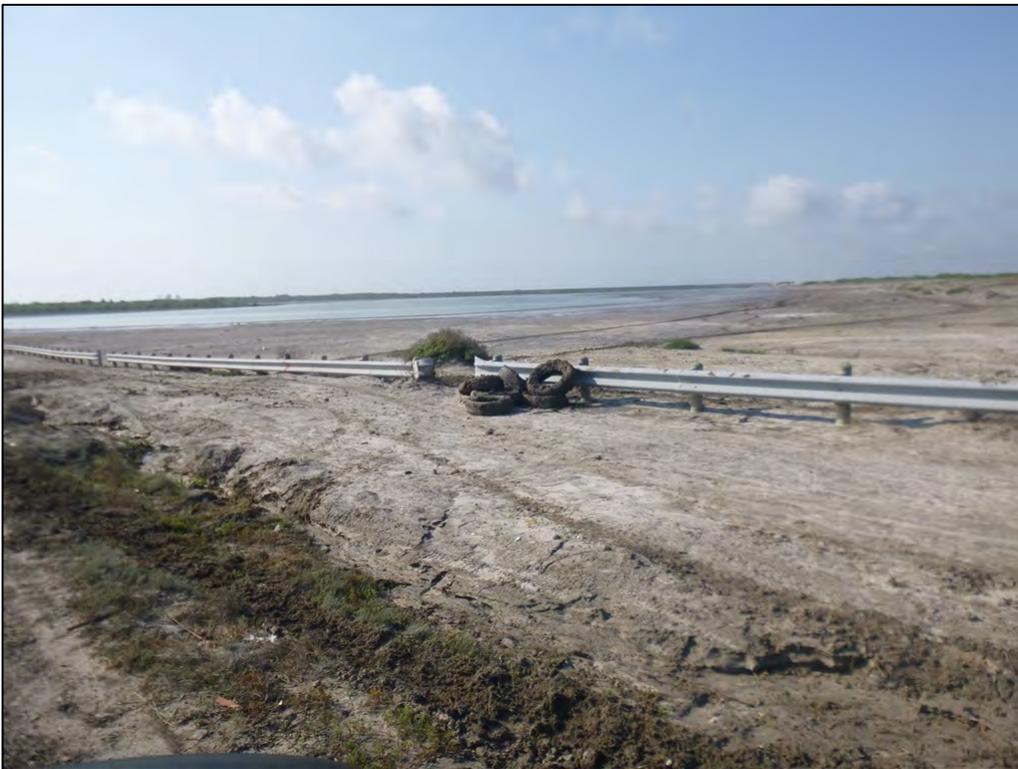
Figure 3.4. Abandoned tires at Station 13026.

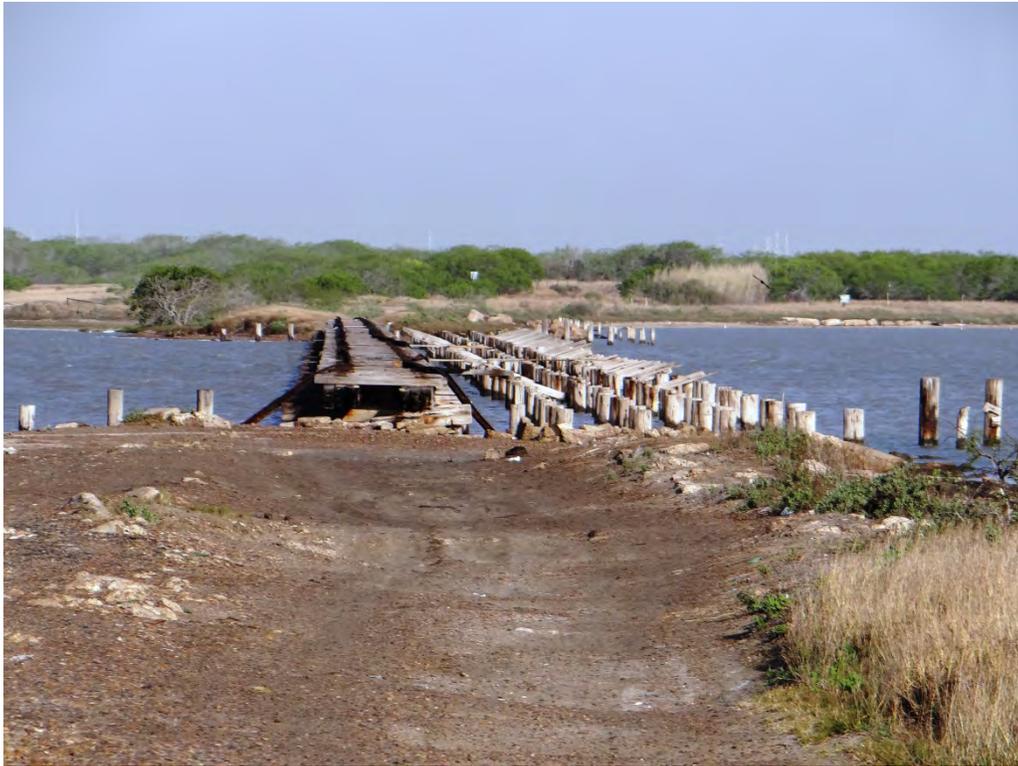
Figure 3.5. Station 17119 – Approach to station at the abandoned Holly Road Railroad tracks over Oso Bay.

Located where the abandoned Holly Road railroad tracks cross Oso Bay (see Figure 3.1), this station is located in the upper mid-bay reaches of the bay. Access to the station (Figure 3.5) is via the access road off Flour Bluff Drive, which ends at the old railway bridge. This station is used as a year-round illegal dumping ground for trash with the occasional animal carcass also deposited (Figure 3.6). The sampling site is from the railway bridge on the upstream (south) side. Bottom sediments at this station are primarily a soft clay/sand composition. Scour channels do exist under the bridge, as water velocity can be strong around the bridge supports during tidal exchange and storm events (Figure 3.7). Water depth within the sampling area typically ranged from 0.30 to 0.80 m. Anglers often use the bridge and will walk out on the bridge from either shoreline to fish. As this location has limited public exposure, it is often used for various illegal activities. Birds are observed in a limited number feeding on the adjacent mud flats or resting on the bridge itself.

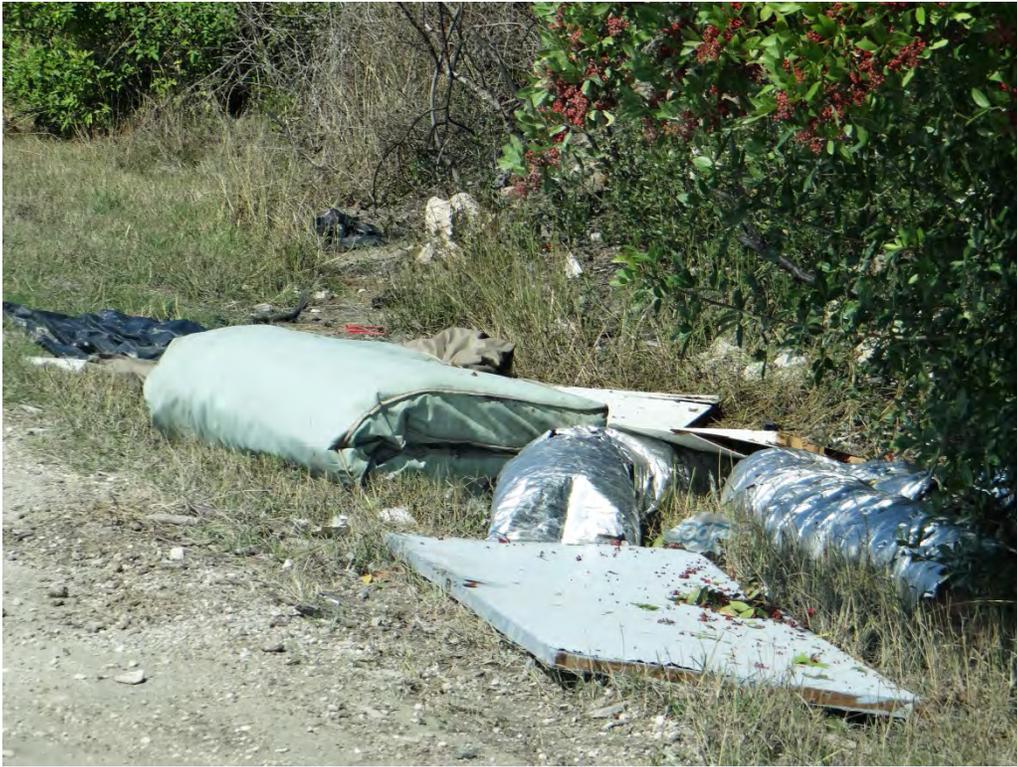
Figure 3.6. Trash deposited along access road to Station 17119.

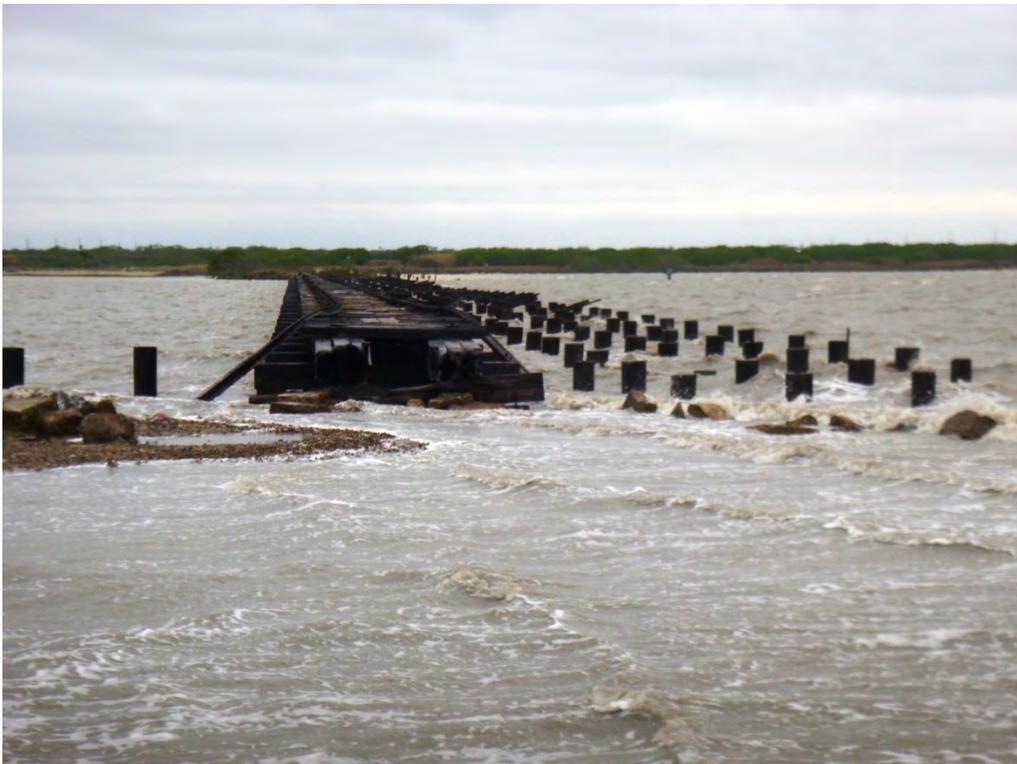
Figure 3.7. Access road submerged at Station 17119 during a storm at high tide.

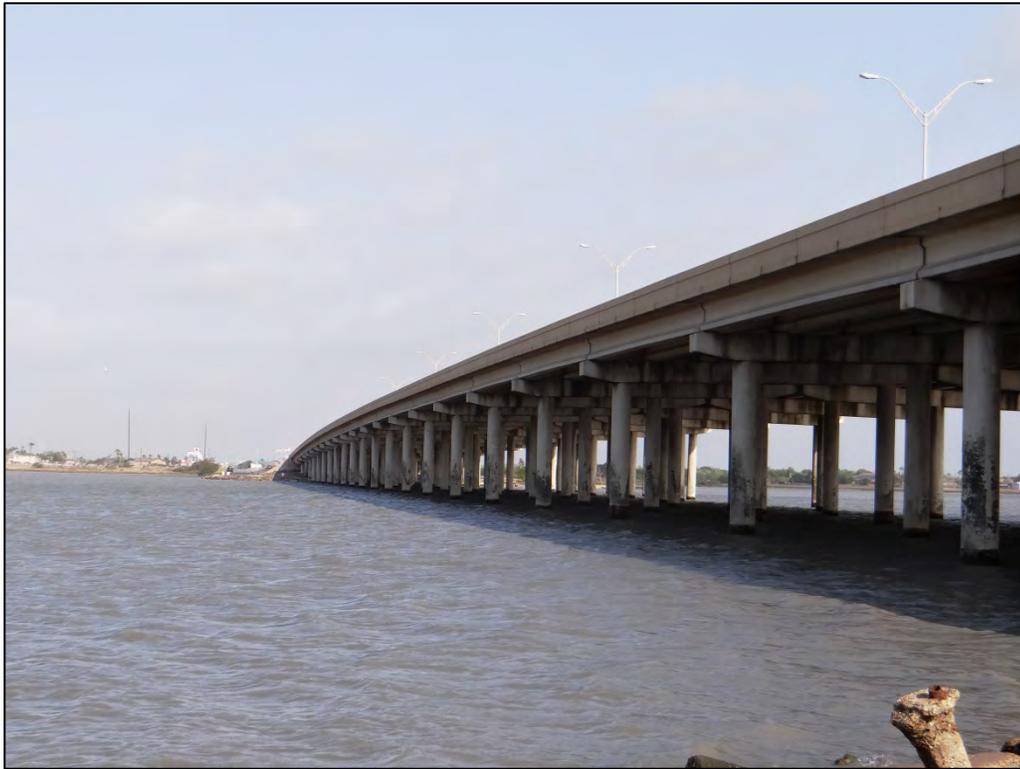
Figure 3.8. Station 13440 - Oso Bay at State Highway 358 (South Padre Island Drive).

Located where State Highway 358 (South Padre Island Drive) crosses Oso Bay (see Figure 3.1), this station is located at mid-bay (Figure 3.8). As with Station 13026, the clearing of vegetation during the construction of the adjacent bridge resulted in the shoreline being bare or covered in riprap to control erosion (Figure 3.9). The sampling area is adjacent to and on the southern side of the bridge. Bottom sediments are primarily a soft clay/sand composition. Water depth within the sampling area ranged from 0.30 to 0.80 m with some areas greater than 1.0 m. Small patches of seagrass composed of *Halodule beaudettei* exist on the northern portion of the location. Prevailing southeasterly winds provide for constant mixing of the water within this area of Oso Bay. Easy access to the water also makes this an attractive spot for anglers and despite trashcans provided by the City of Corpus Christi, there is still a considerable amount of trash and debris deposited on the shoreline in the immediate area (Figure 3.10). Bird use at this station is limited.

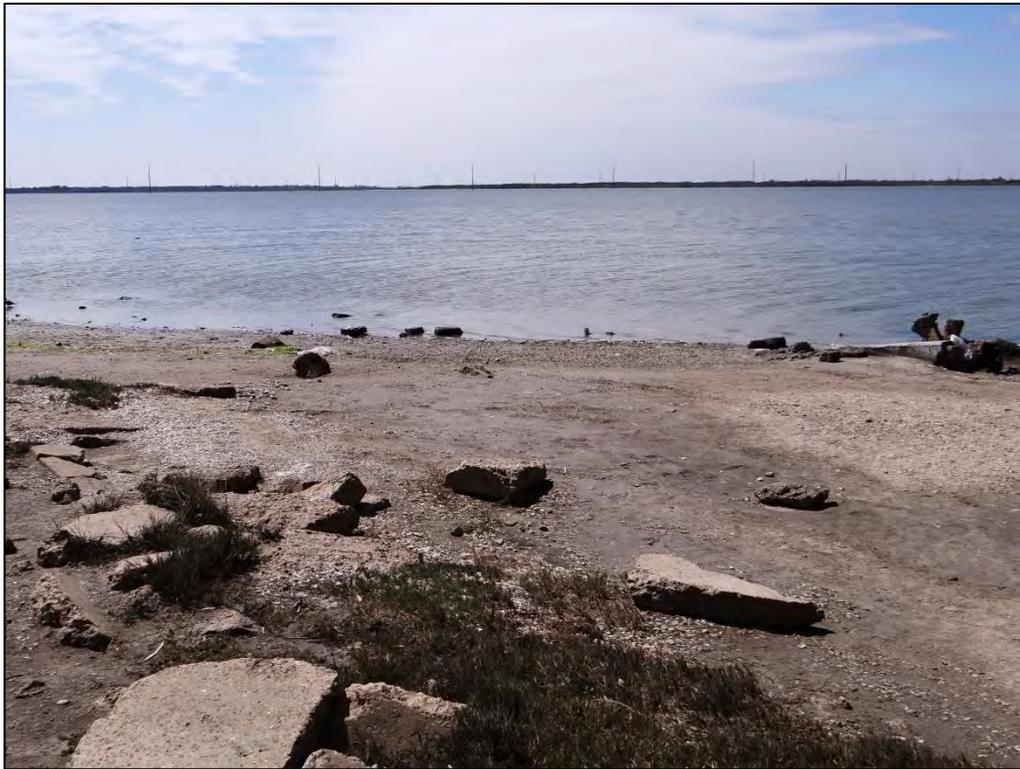
Figure 3.9. Station 13440 – Concrete blocks along shoreline.

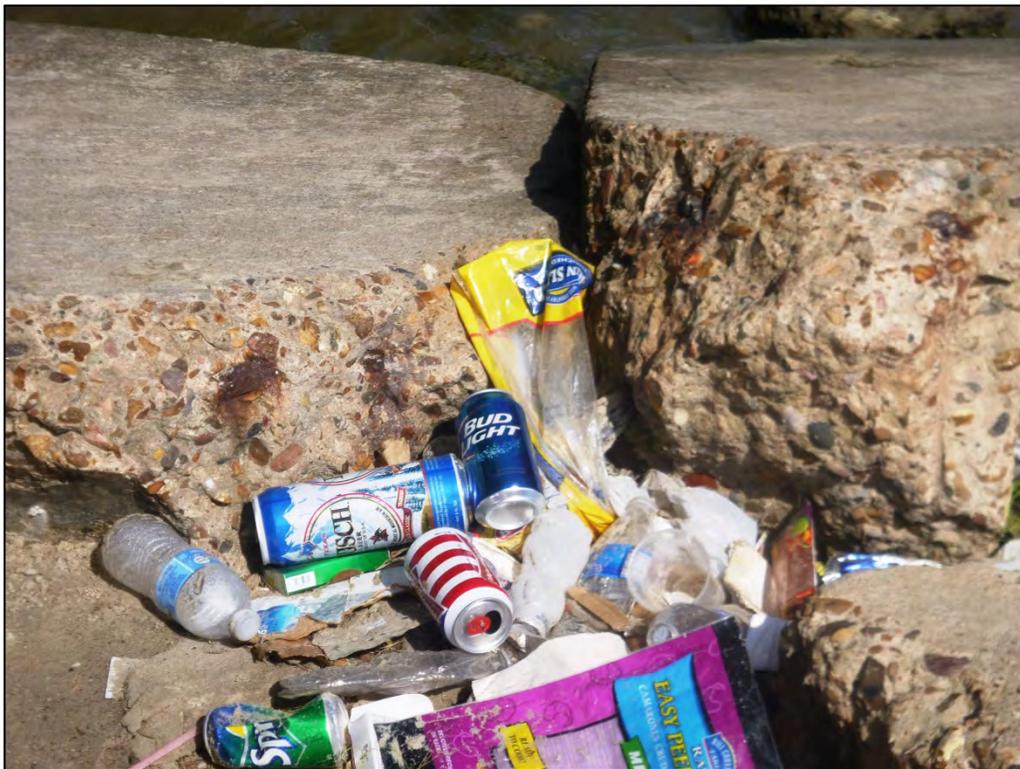
Figure 3.10. Station 13440 – Trash deposited among concrete riprap.

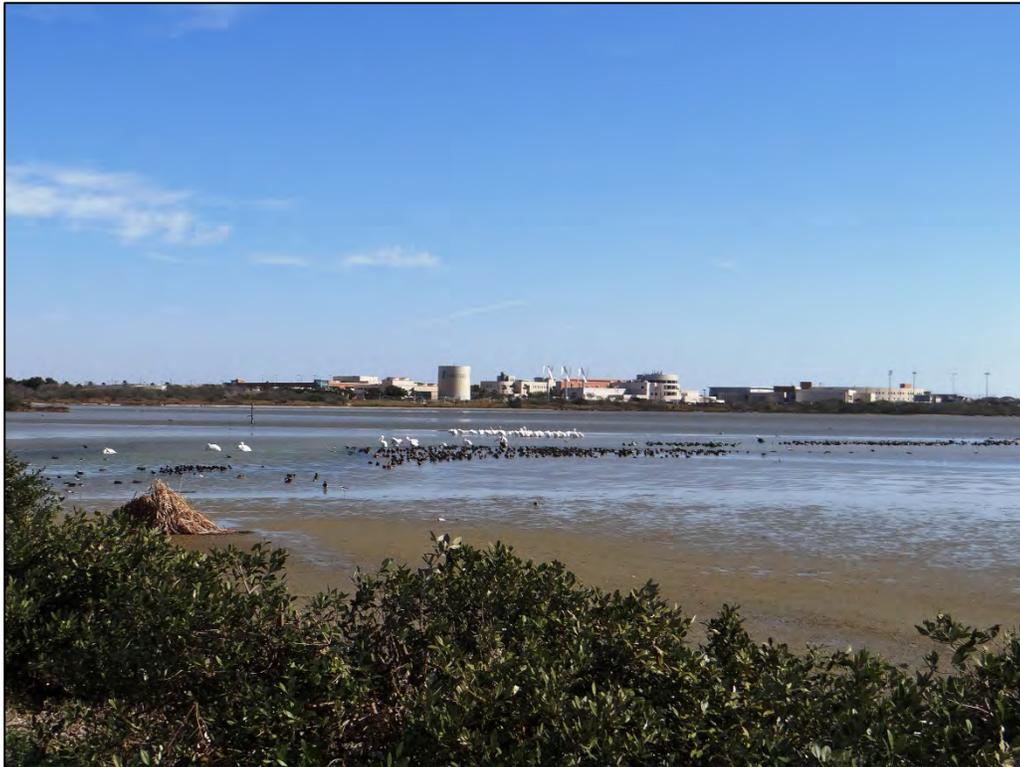
Figure 3.11. Station 13441 - Oso Bay at Hans Suter Park below OWWTP outfall.

Located west of Ward Island and the Texas A&M University-Corpus Christi campus (see Figure 3.1) this unique station is located at the Hans Suter Wildlife Refuge, which is adjacent to the OWWTP (Figure 3.11). Treated wastewater released from the OWWTP creates a freshwater wetland with such plant species as cattail. Transcending to the bay and adjacent areas, low, mid, and high marsh vegetation (i.e. *Borrichia frutescens*, *Avicennia germinans*) is along the banks (Figure 3.12). This station is located where the discharge channel enters Oso Bay; approximately 200 m from the OWWTP discharge pipe. Sampling takes place approximately 50 m from the end of the discharge channel adjacent to the viewing platform used by visitors to the refuge. Birds are observed feeding and resting at this location in high numbers year round.

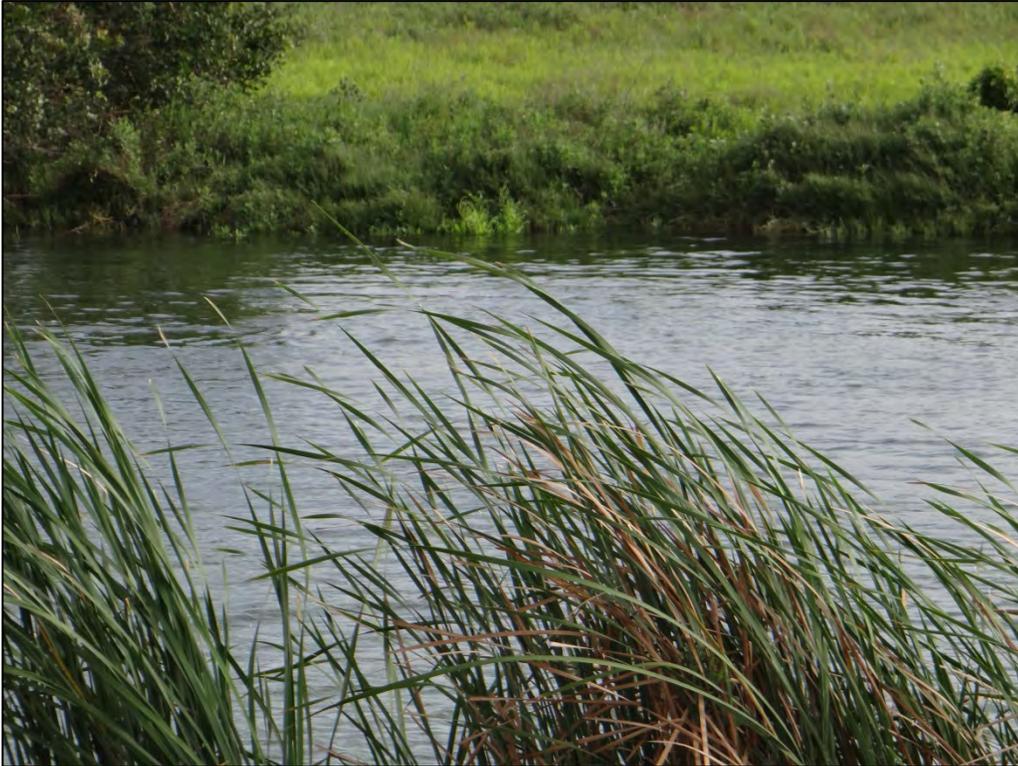
Figure 3.12. Station 13441 – Upper reach of discharge channel with freshwater wetland vegetation.

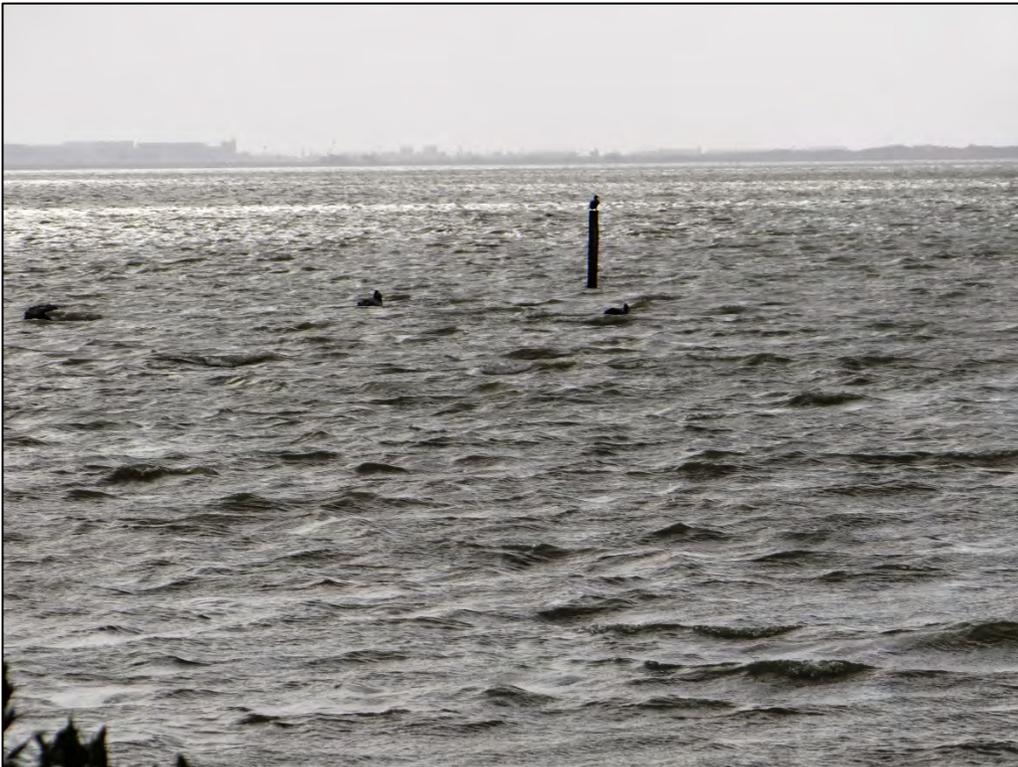
Figure 3.13. Station 13441 – High tide and strong winds covering tidal flats.

While considered a low energy environment, there is potential for considerable mixing from the prevailing southeasterly winds when water levels are high (Figure 3.13). While the permit defines the mixing zone as being within a 50-foot radius from the outflow pipe, typically the low water levels at this location result in a visible dominant plume of freshwater that flows out and mixes with the higher saline waters of Oso Bay. Due to low water levels resulting in extended periods of emergent tidal flats (see Figure 3.11), it is often necessary to walk extended distances to obtain enough water for representative samples. Bottom substrate is hard clay overlaid with silt and/or a layer of black pluffy organic material.

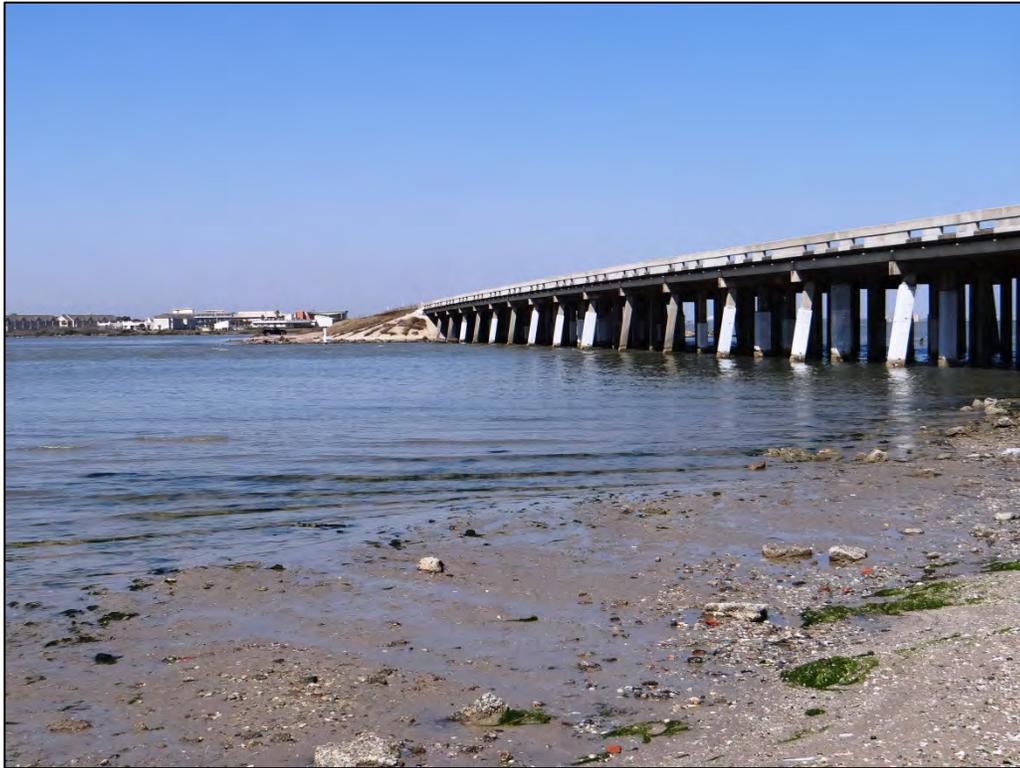
Figure 3.14. Station 13442 - Oso Bay at Ocean Drive.

This station is located east of Ward Island, where Oso Bay connects with Corpus Christi Bay (Segment 2484) and flows under Ocean Drive (see Figure 3.1). This area experiences significant wash and scour effects due to high rates of tidal exchange (Figure 3.14). Under usual conditions, all water exchange with Oso Bay and Corpus Christi Bay occurs through this area. The sampling area is adjacent to and south of the bridge. The bottom sediment at this station includes broken shell and sand atop clay substrate. Water depth within the sampling area ranged from 0.30 to 0.50 m with areas greater than 1.5 m located in the channel under the bridge. Seagrass beds composed of *Halodule beaudettei* exist on the southern portion of the sampling area. As with Station 13026 and 13440 the clearing of vegetation during the construction of the adjacent bridge resulted in the shoreline being bare or covered in riprap to control erosion (Figure 3.15). Easy access to the water also makes this an attractive spot for anglers and as seen at other stations this often results in debris deposited on the shoreline in the immediate area. Bird use is moderate at this location along shoreline and mudflats.

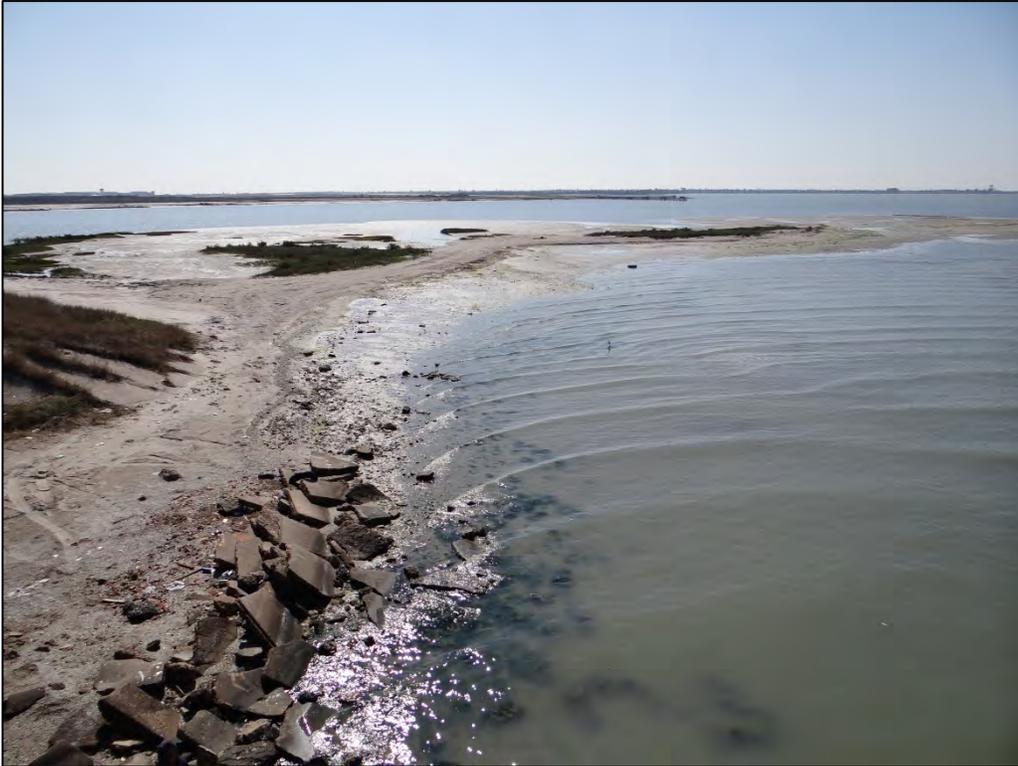
Figure 3.15. Station 13442 – Riprap along mostly bare shoreline.
