**Support for Total Maximum Daily Loads (TMDL) for Indicator Bacteria in Oso Bay
Interim Monitoring Report
Fiscal Year 2013 (Year-one)**

April 2014

TAMU-CC-1304-CCS

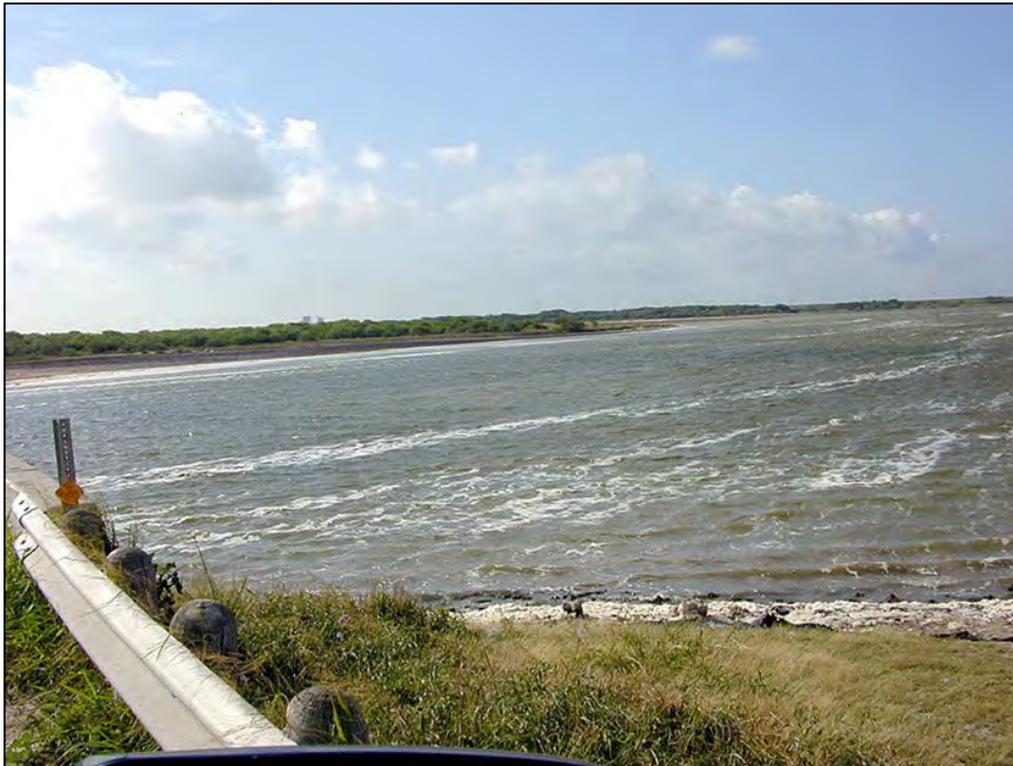
Figure 3.2. Station 13026 – Oso Bay at Yorktown Road.

Located where the Yorktown Road Bridge crosses Oso Bay (see Figure 3.1), this station is approximately 1000 m downstream of the Topaz Energy Group-Barney Davis Energy Center (formally the Central Power & Light Barney M. Davis Power Plant) cooling ponds outfall (Figure 3.2 and Figure 3.3). Clearing of vegetation for the construction of the adjacent bridge resulted in the shoreline being bare or covered in riprap to control erosion. Location of the outfall exerts a substantial influence on the substrate characteristics of the location. A scoured channel exists, with an approximate depth of 2.5 m, in the middle of the bay. This area is composed of a hard clay substrate but nearer the shore, the substrate transitions to a finer clay and silt composition mixed with patches of sand. Patches of the seagrass, *Halodule beaudettei* exists near the cooling pond discharge. The sampling area is adjacent and upstream (south side) of the bridge and water depth in the sample area ranges from 0.20 to 1.3 m. A large amount of tidal flat area exists and due to easy access to the water, anglers often use the bridge and surrounding area heavily, often driving vehicles around the protective barriers and across the tidal flats. This often results in a large amount of debris deposited on the shoreline or along the roadway near the bridge (Figure 3.4). Birds are observed in a limited number utilizing the flats.

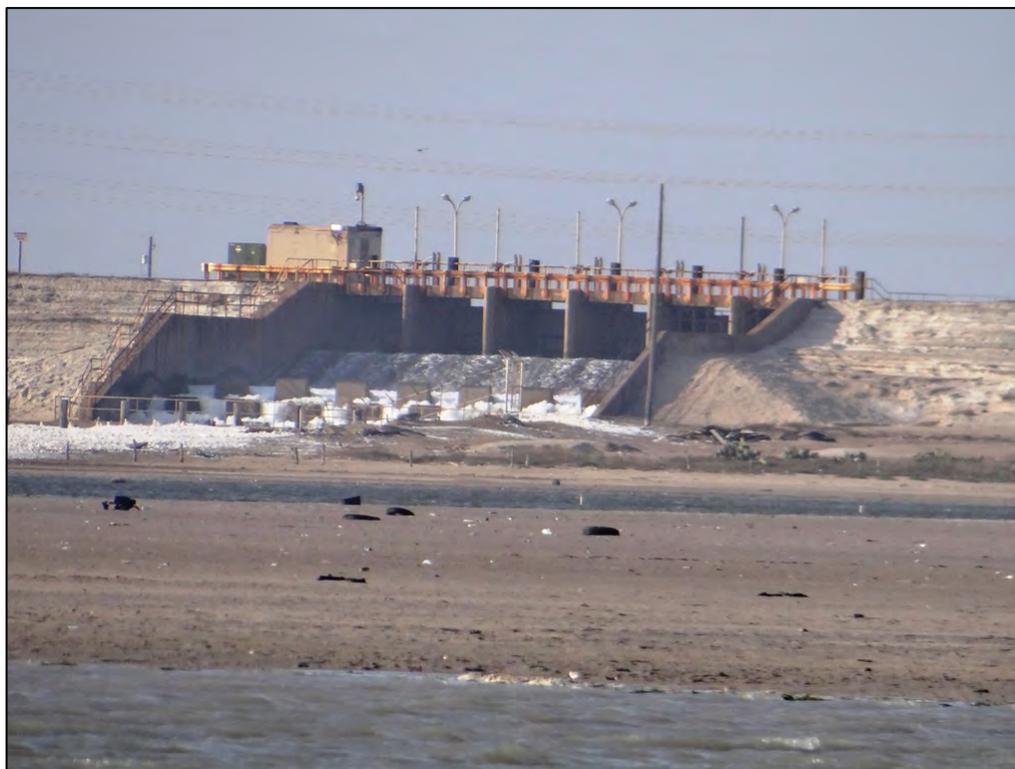
Figure 3.3. Cooling pond outfalls at the Topaz Energy Group-Barney Davis Energy Center.

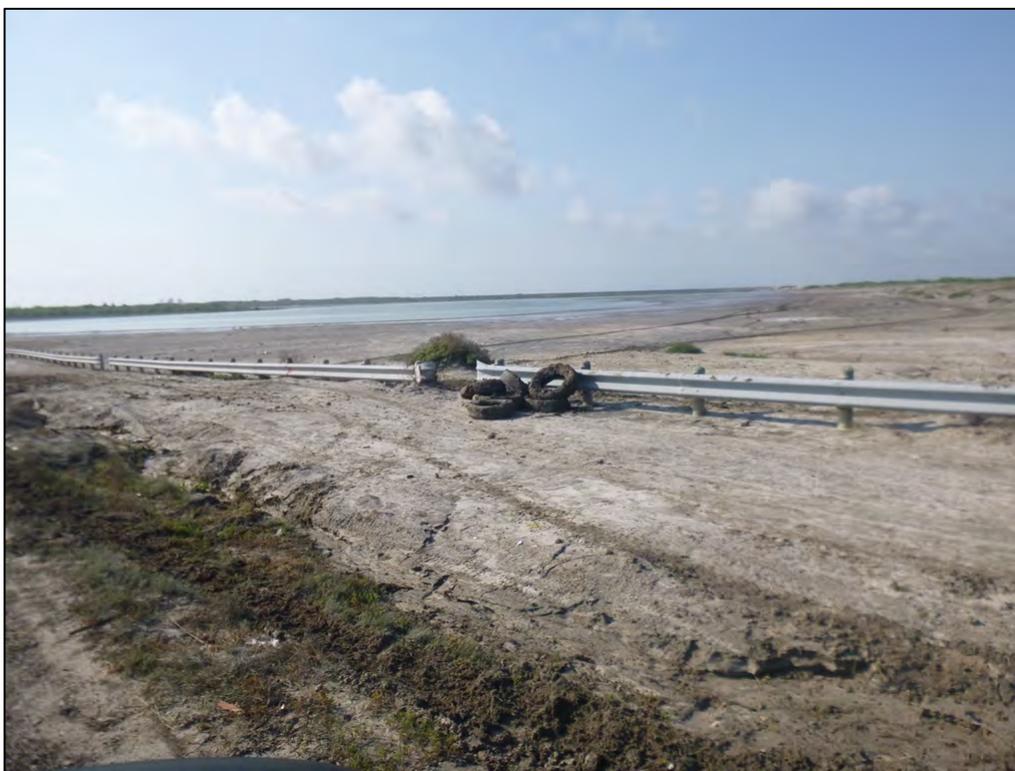
Figure 3.4. Abandoned tires at Station 13026.

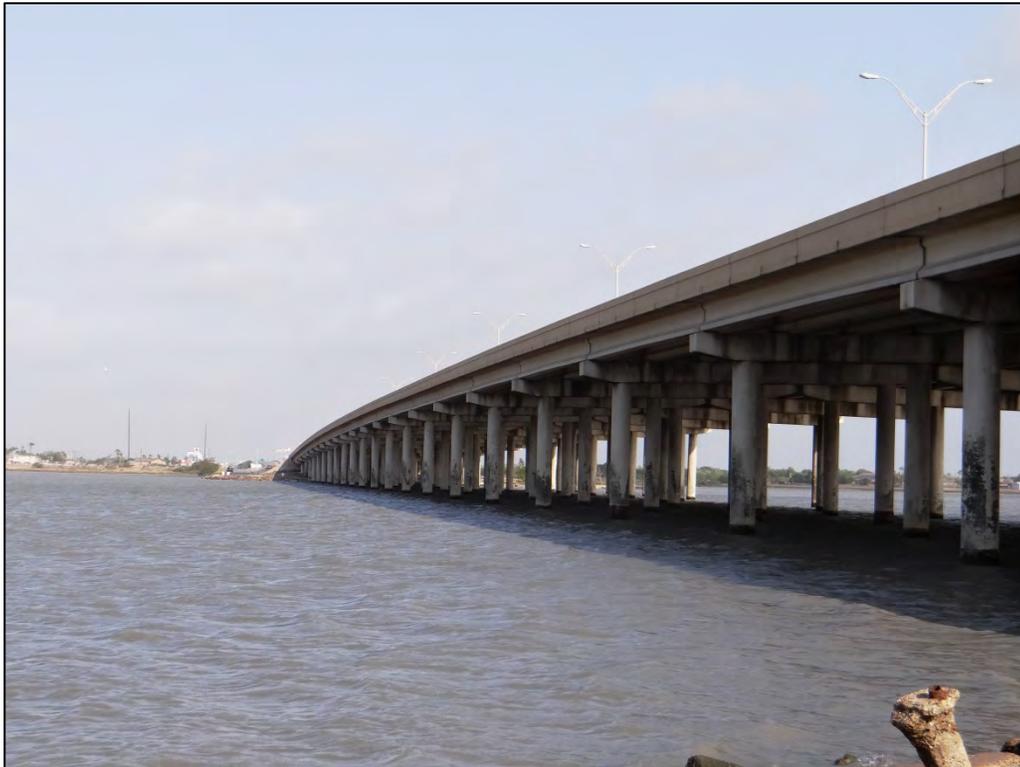
Figure 3.8. Station 13440 - Oso Bay at State Highway 358 (South Padre Island Drive).

Located where State Highway 358 (South Padre Island Drive) crosses Oso Bay (see Figure 3.1), this station is located at mid-bay (Figure 3.8). As with Station 13026, the clearing of vegetation during the construction of the adjacent bridge resulted in the shoreline being bare or covered in riprap to control erosion (Figure 3.9). The sampling area is adjacent to and on the southern side of the bridge. Bottom sediments are primarily a soft clay/sand composition. Water depth within the sampling area ranged from 0.30 to 0.80 m with some areas greater than 1.0 m. Small patches of seagrass composed of *Halodule beaudettei* exist on the northern portion of the location. Prevailing southeasterly winds provide for constant mixing of the water within this area of Oso Bay. Easy access to the water also makes this an attractive spot for anglers and despite trashcans provided by the City of Corpus Christi, there is still a considerable amount of trash and debris deposited on the shoreline in the immediate area (Figure 3.10). Bird use at this station is limited.

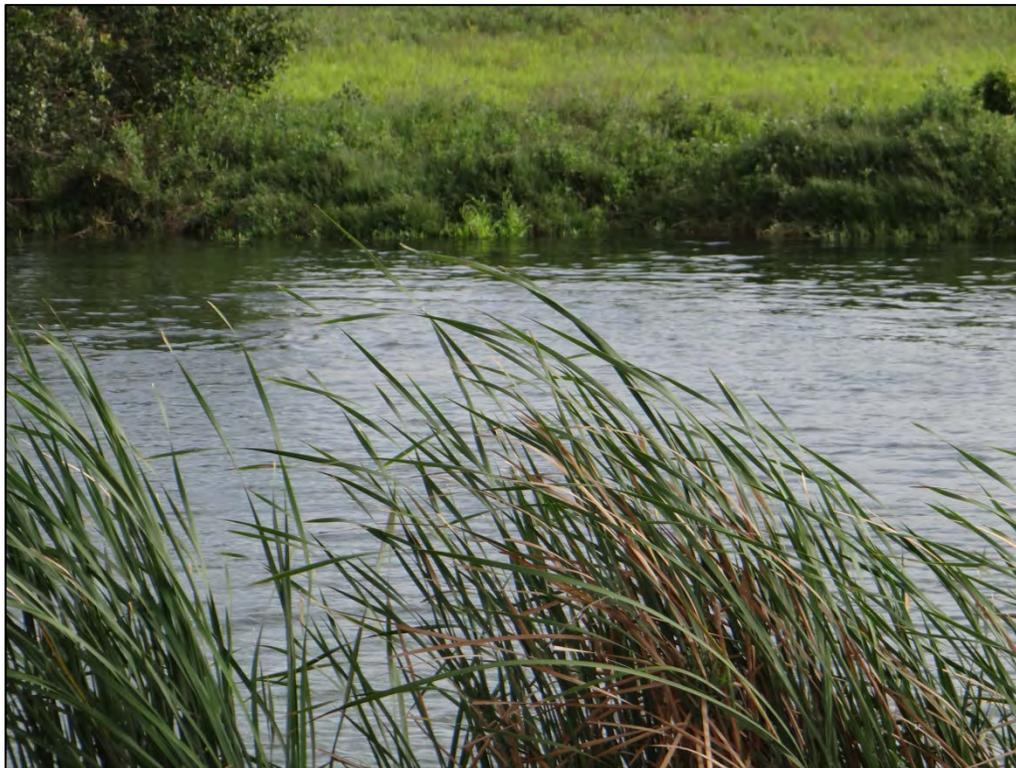
Figure 3.12. Station 13441 – Upper reach of discharge channel with freshwater wetland vegetation.

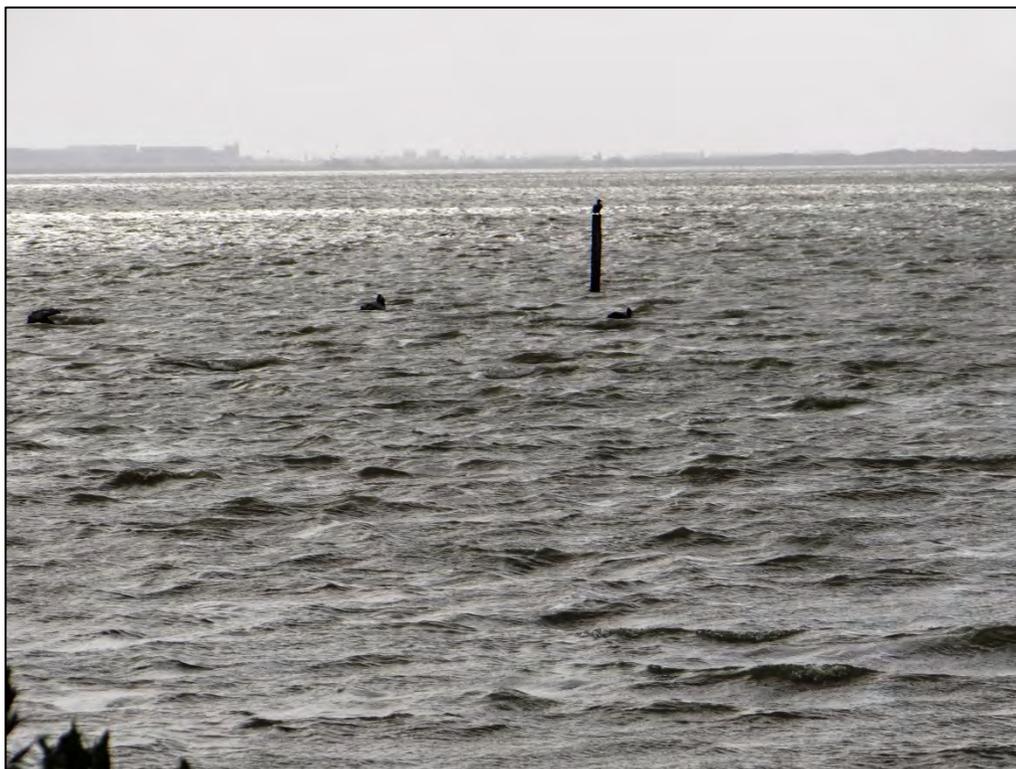
Figure 3.13. Station 13441 – High tide and strong winds covering tidal flats.

While considered a low energy environment, there is potential for considerable mixing from the prevailing southeasterly winds when water levels are high (Figure 3.13). While the permit defines the mixing zone as a being within a 50-foot radius from the outflow pipe, typically the low water levels at this location result in a visible dominant plume of freshwater that flows out and mixes with the higher saline waters of Oso Bay. Due to low water levels resulting in extended periods of emergent tidal flats (see Figure 3.11), it is often necessary to walk extended distances to obtain enough water for representative samples. Bottom substrate is hard clay overlaid with silt and/or a layer of black pluffy organic material.

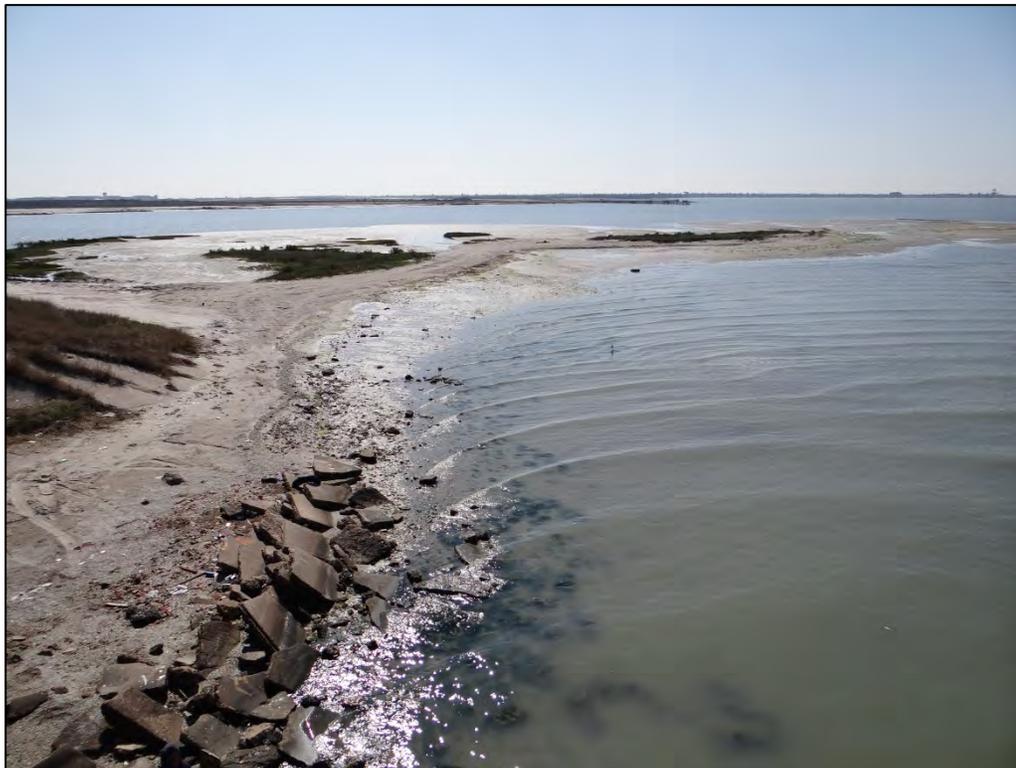
Figure 3.15. Station 13442 – Riprap along mostly bare shoreline.
