**Impairment Verification Monitoring-Volume 2: Biological and
Habitat Components
Segment 2104, Nueces River**

By:
Jeremy Walther and Victor Palma

Prepared for
Total Maximum Daily Load Program
Texas Commission on Environmental Quality
P.O. Box 13087, MC - 150
Austin, Texas 78711-3087

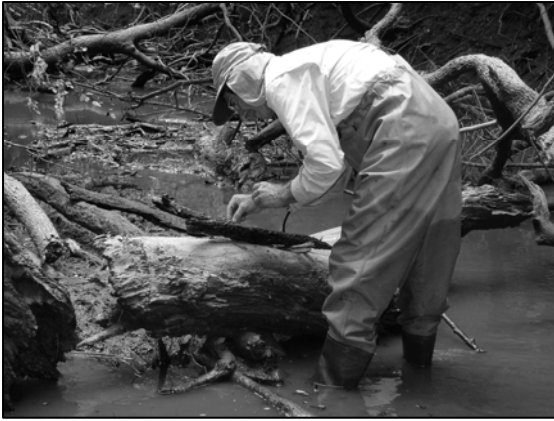
Figure 4. Macroinvertebrate Collection

Collection of benthic macroinvertebrates in the field was conducted using a 12-inch D-frame kicknet in riffle areas traveling a zigzag pattern across the bed in five-minute intervals. Intervals were repeated until the minimum sample size of 100 specimens was approached, met, or exceeded. All individuals collected within the net were transferred and stored in 70% ethanol for lab analysis and identification. The collection of all individuals within a sample assured that no biases were present for larger, more active, or otherwise more obvious species captured in the net. Most individuals were identified to genus, or as otherwise suggested by the RWA manual. Collections from sites were analyzed using the 12 metrics defined in the Rapid Bioassessment Protocol in Appendix B of the RWA manual. These metrics include parameters such as
