ARCADIS

Subject:
Asbestos Inspection Results
Encycle Facility
5500 Up River Road
Corpus Christi, Texas

Date
December 14, 2006

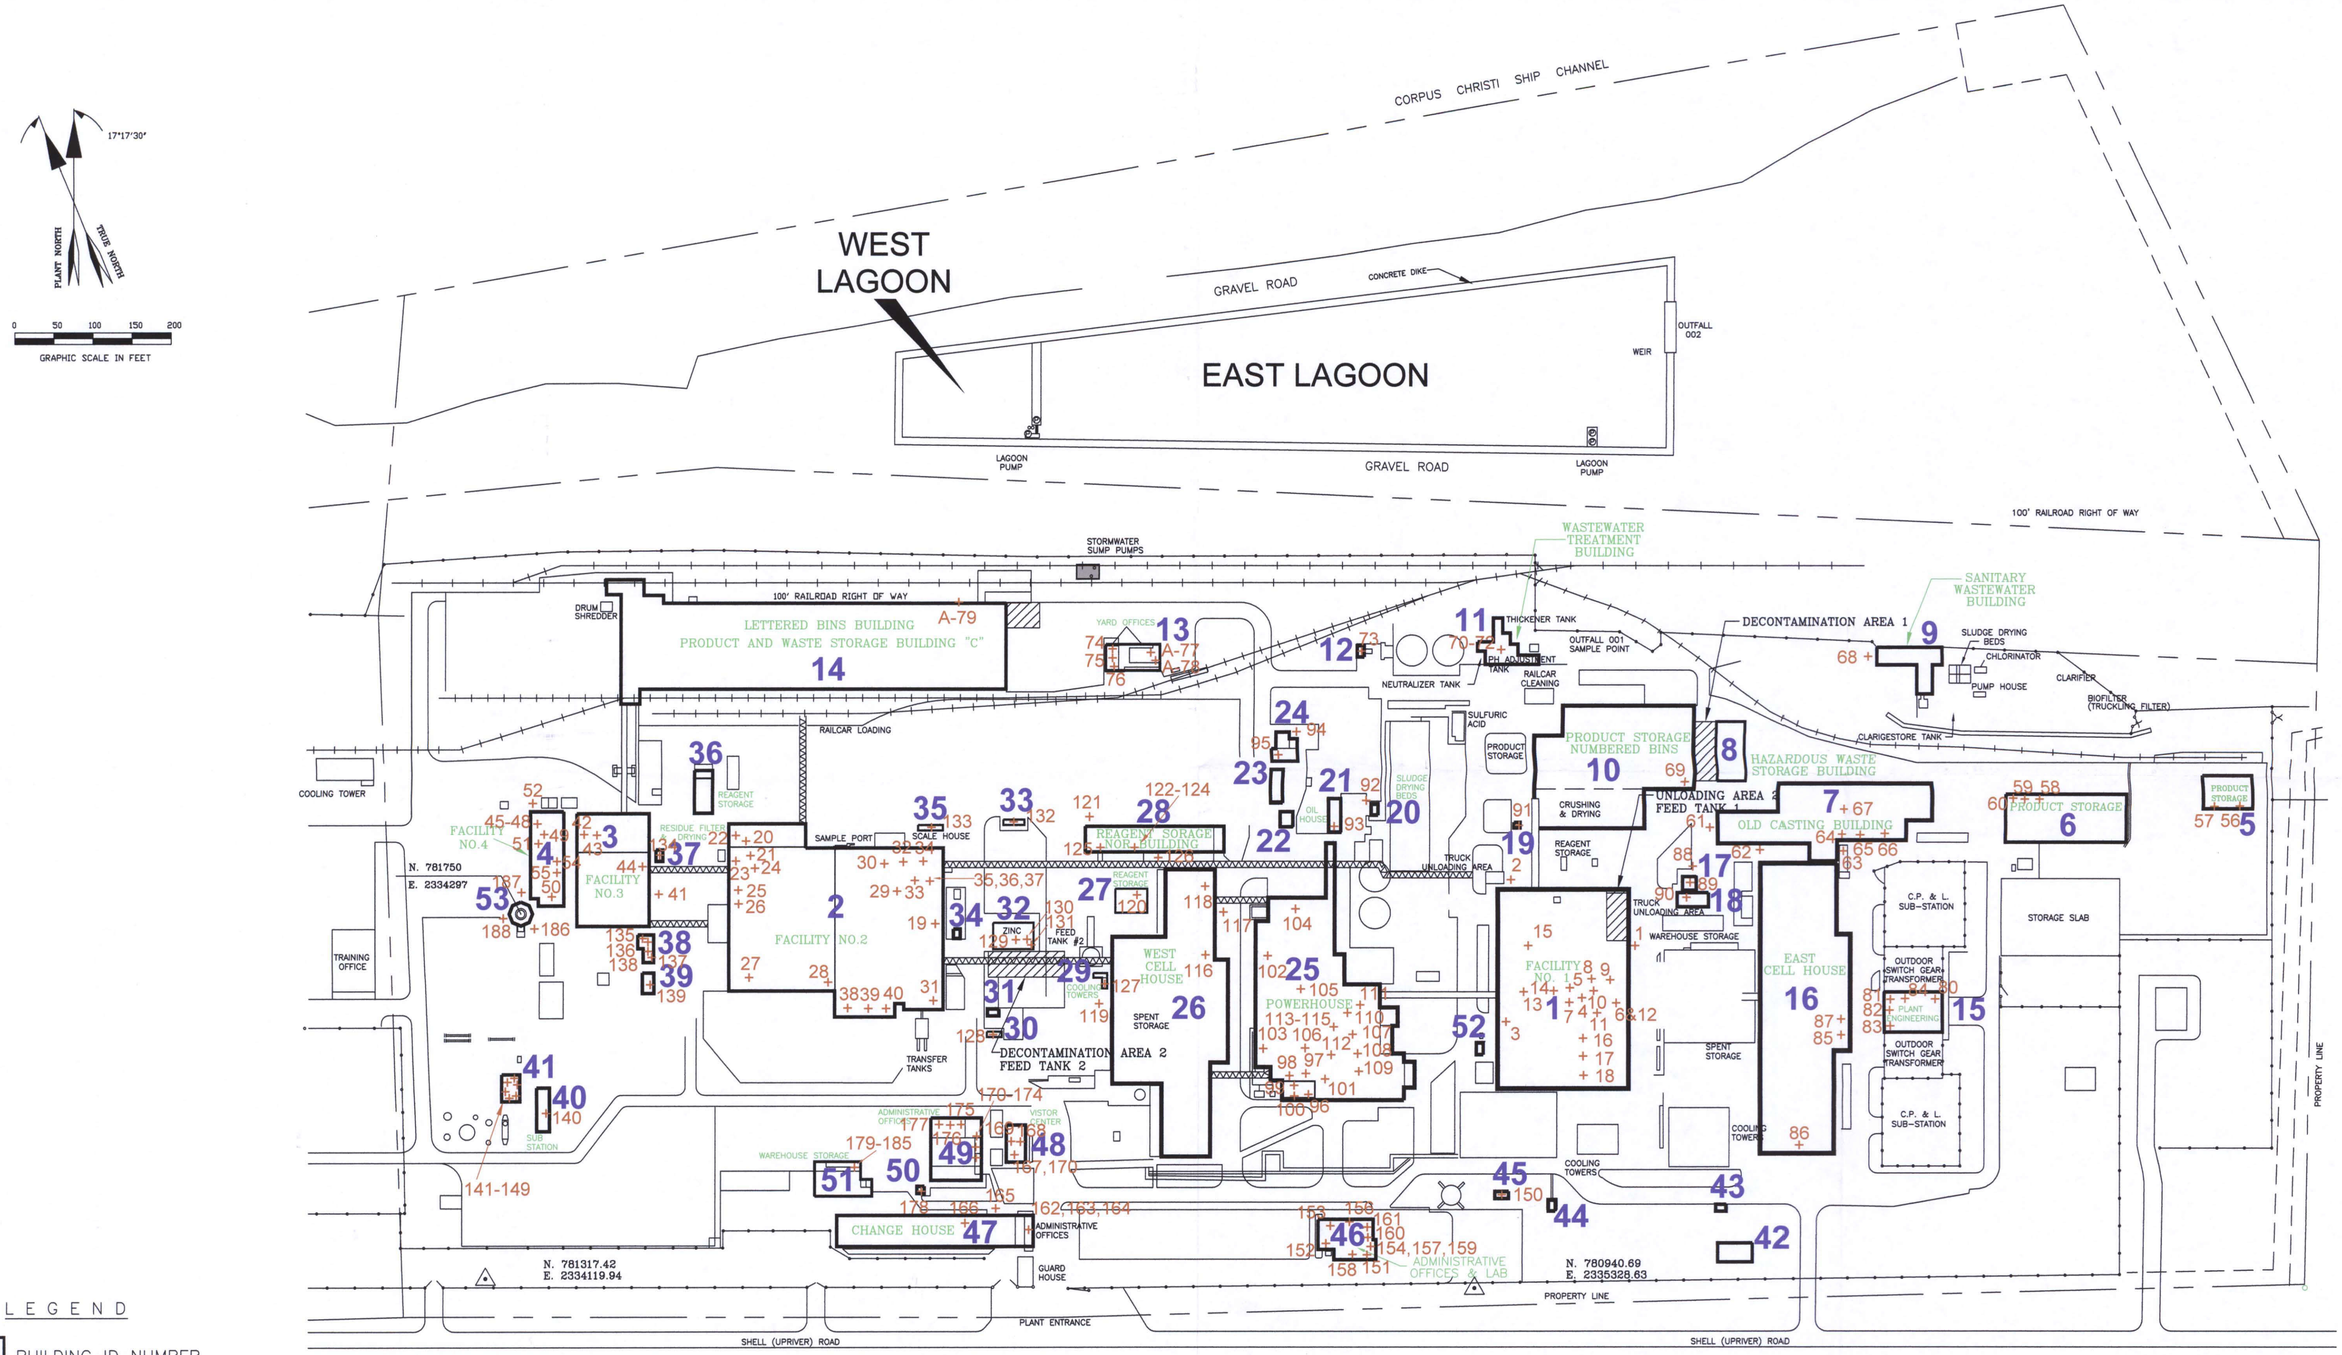
FIGURE 1

This letter report presents the results of an asbestos inspection conducted during November and December 2006 at the Encycle facility located at 5500 Up River Road in Corpus Christi, Texas. The asbestos inspection was conducted at the 51 buildings located at the facility. Building locations are shown on Figure 1.

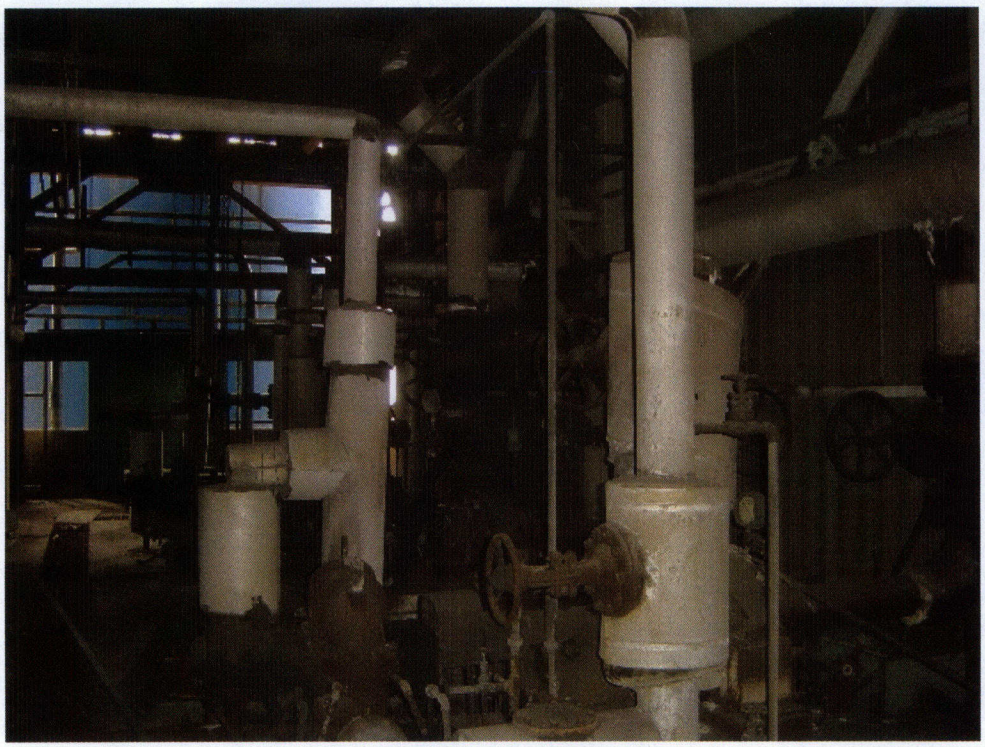
- Pipe wrap with white fibers and outer metal jacket (Homogenous Area 29 on Table 1): Pipe wrap with 1" to 2"-thick white fibers and an outer 1/16"-thick sheet metal jacket are present on pipes ranging in diameter from 2" to 8" on the 1st floor at the east end of Facility No. 4, and the 1st floor in the southeast portion of the Power House below the boilers (see Attachment 2, photographs 19 and 20). Five samples of the white pipe wrap with outer sheet metal jacket were collected for asbestos analysis (Sample IDs: A-54, A-55, A-110, A-111, and A-112), and three of the samples contained asbestos. The white pipe wrap is friable, and slightly damaged at Facility No. 4 (tears, deterioration).

- 12" x 12" white floor tile with light gray streaks (Homogenous Area 31 on Table 1): 12" x 12" white floor tile with light gray streaks (1/8"-thick) is present in the eastern portion of the Change House/Guard House (Building 47) (see Attachment 2, photograph 21). One sample of the floor tiles was collected for asbestos analysis (Sample ID: A-162), and asbestos was detected in the central layer (black vinyl layer) of the floor tile. This floor tile sample was also analyzed for asbestos using the point count method, and the presence of asbestos (1.75% asbestos) was confirmed. Materials containing more than 1% asbestos are considered asbestos-containing materials (40 CFR Part 763.83). The white floor tiles with light gray streaks were not friable and not damaged.

- 9" x 9" cream-white floor tile (Homogeneous Area 34 on Table 1): 9" x 9" cream-white floor tile (1/8"-thick) (approximately 400 square feet) is present in the office at the northeast end of Warehouse Storage Building 51 (see Attachment 2, photograph 22). Three samples of the 9" x 9" cream-white floor tile were collected for asbestos analysis (Sample IDs: A179, A-180, and A-181), and all of the samples contained asbestos. The floor tile was not friable and not damaged.

Photograph No. 19. White pipe wrap with outer sheet metal jacket on pipes on the 1st floor at the east end of Facility No. 4, view facing south. Photograph taken by K. Brandner, November 28, 2006.

Photograph No. 20. White pipe wrap with outer sheet metal jacket on pipes on the 1st floor at the southeast end of the Power House, view facing south. Photograph taken by K. Brandner, November 29, 2006.

Photograph No. 21. 12" x 12" white floor tile with light gray streaks in Change House/Guard House, view facing south. Photograph taken by K. Brandner, December 1, 2006.

Photograph No. 22. 9" x 9" cream-white floor tile in office at northeast end of Warehouse Storage Building 51, view facing east. Photograph taken by K. Brandner, December 1, 2006.

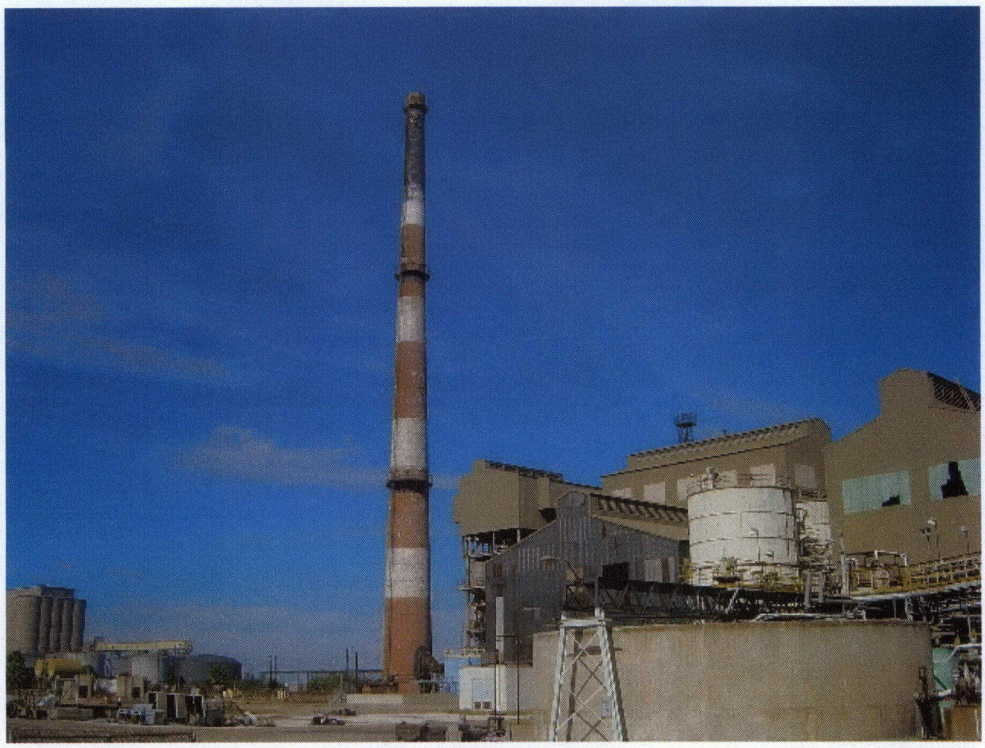
- 1/8"-inch-thick red coating on large brick/concrete smokestack southwest of Facility No. 4 (Homogenous Area 35 on Table 1): The large (estimated 250 feet high, 18'-diameter at base) brick and concrete smokestack directly southwest of Facility No. 4 has a 1/8"-thick red exterior coating (see Attachment 2, photograph 23). Three samples of the red exterior coating were collected for asbestos analysis (Sample IDs: A-186, A-187, and A-188), and all of the samples contained asbestos. The red exterior coating was non-friable, except along damaged areas (tears) where the materials was friable.

Photograph No. 23. Large red and white smokestack directly southwest of Facility No. 4, view facing northwest. Photograph taken by K. Brandner, December 1, 2006.
