# CHAPTER 11

## FISH CREEK (SEGMENT 0841J)

## North Fork Fish Creek (Segment 0841Q)

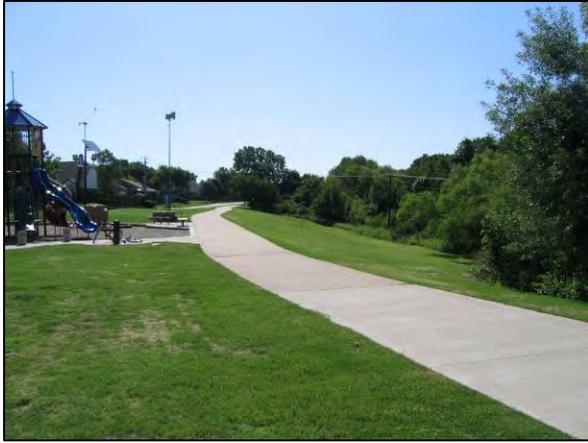
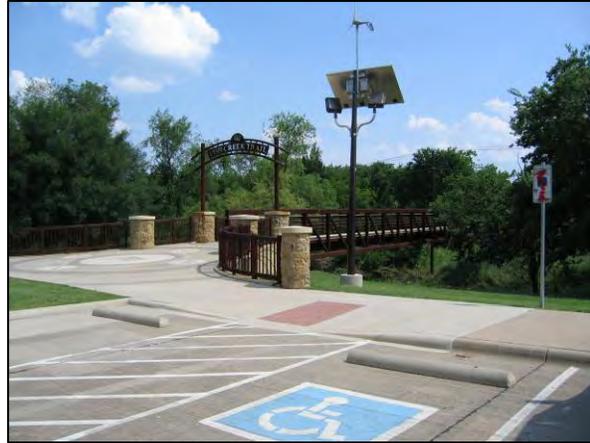
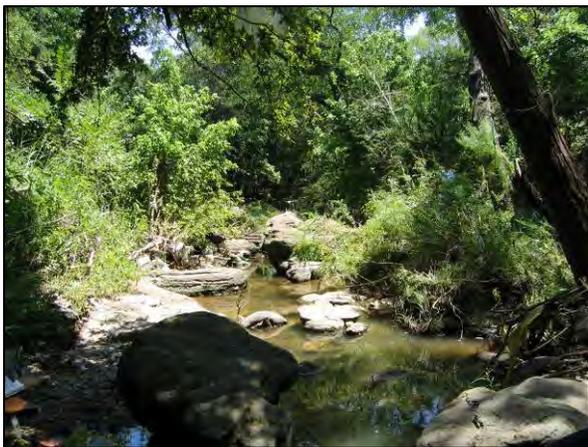
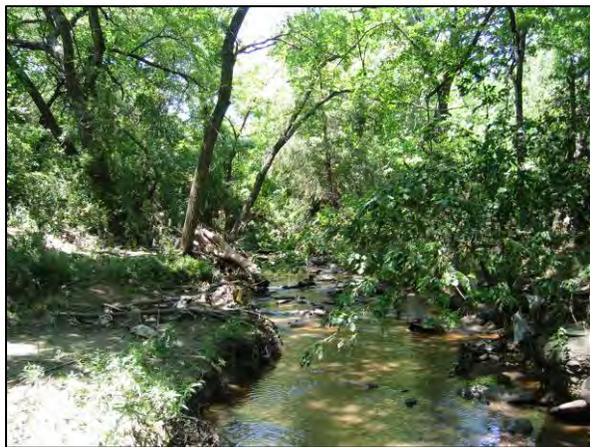
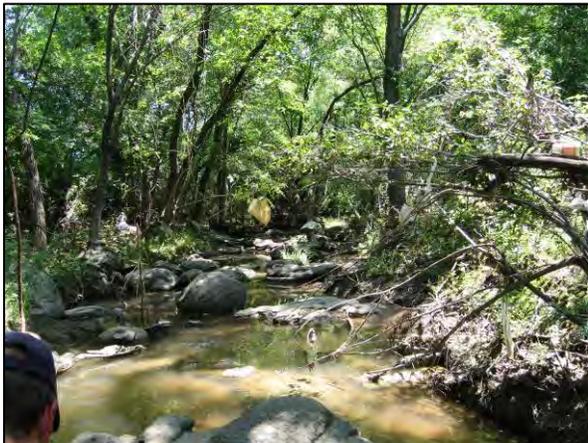
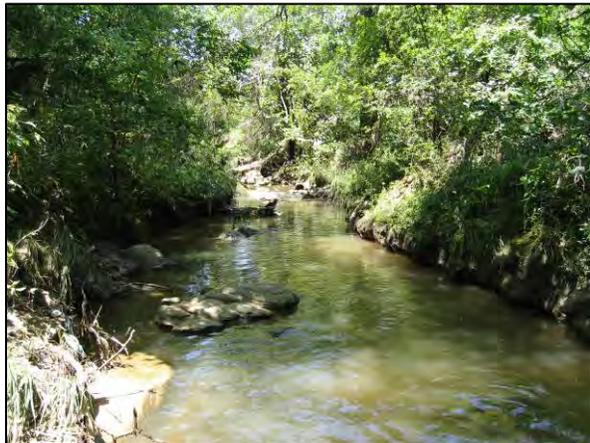
**Photogroup 11-9** Fish Creek Site FS104 showing adjacent hike/bike trail and play structure (upper left photograph; note wooded area to right contains the creek), parking near creek, and general characteristics of the creek. (Individual pictured is TIAER staff.) [\[Return to Text\]](#)

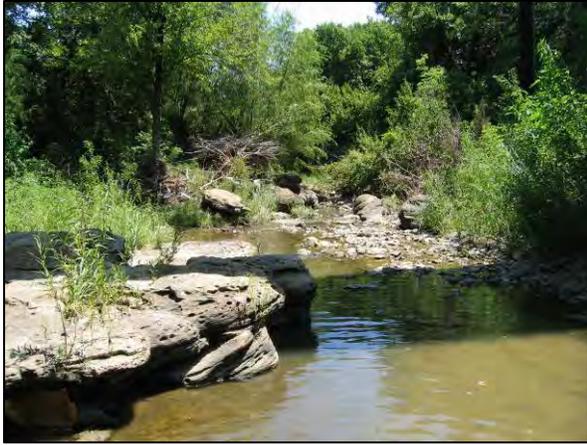
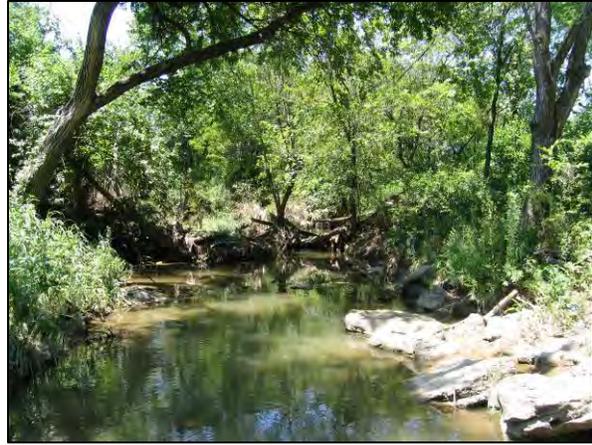
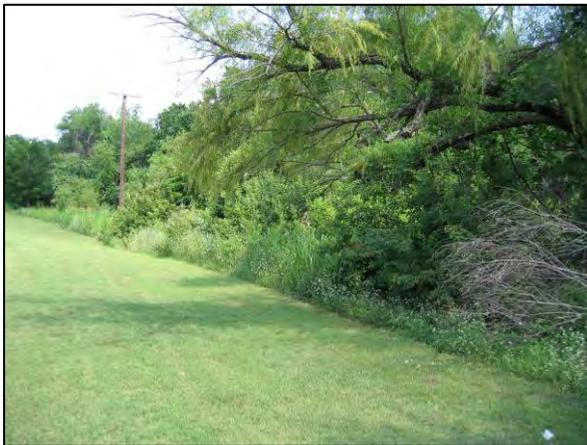
**Photogroup 11-10** Fish Creek Site FS104 showing typical stream characteristics and riparian zone with wooded/shrub area immediately adjacent to stream and mowed park area further from stream. [\[Return to Text\]](#)

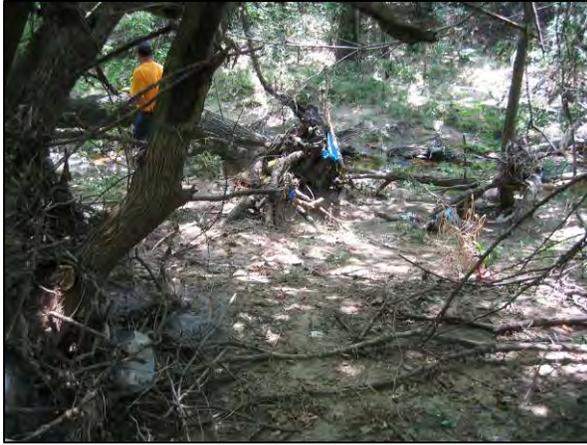
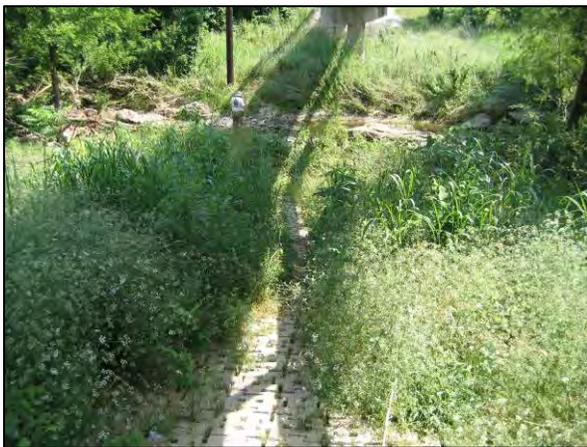
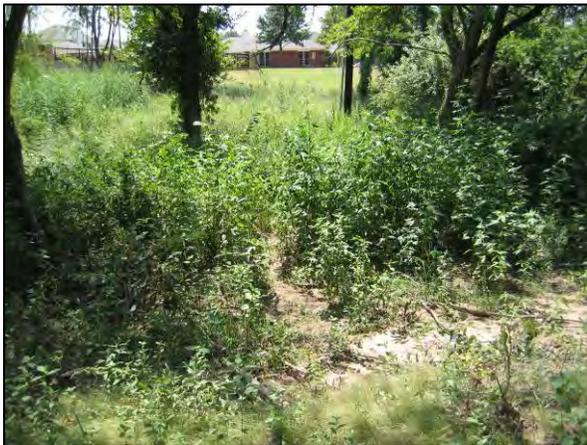
**Photogroup 11-11** Fish Creek Site FS104 showing footpaths to stream. (Individual pictured is TIAER staff.) [\[Return to Text\]](#)

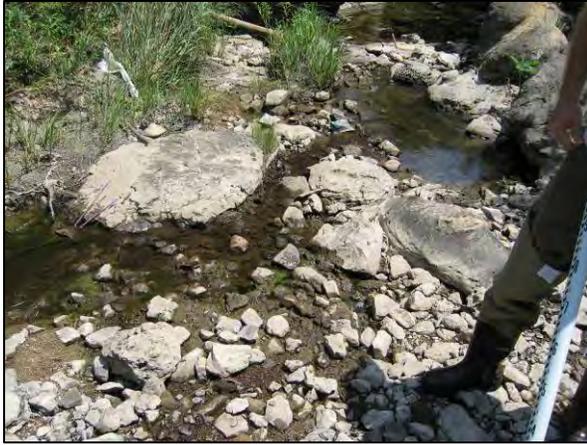
**Photogroup 11-12** Fish Creek Site FS 104 showing low flow encountered during second survey. (Individual pictured is TIAER staff.) [\[Return to Text\]](#)

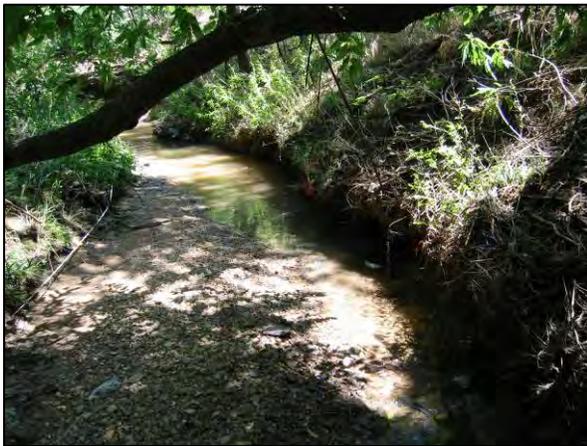
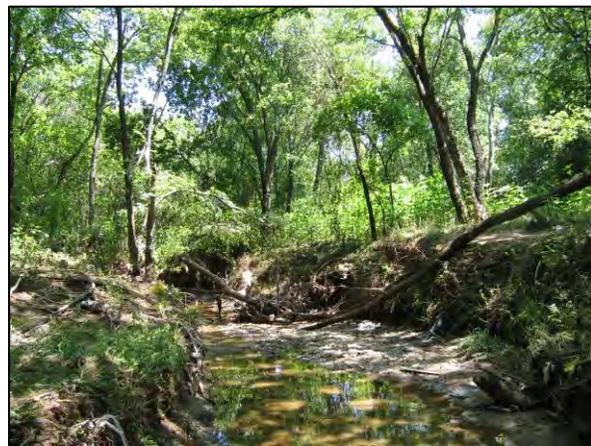
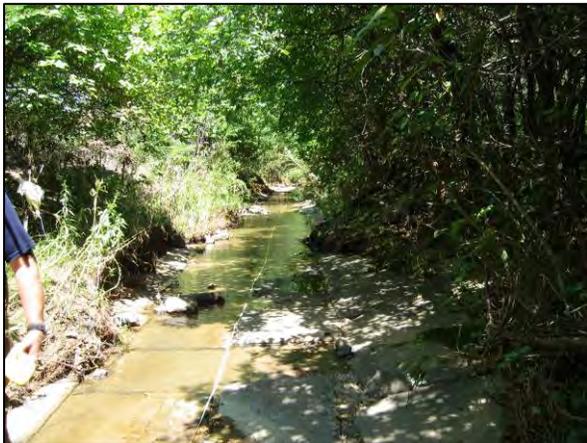
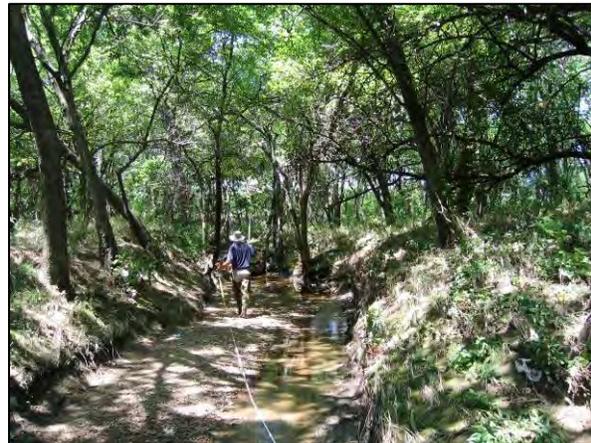
**Photogroup 11-13** Fish Creek Site FS105 showing general stream and bank characteristics. (Individuals pictured are TIAER staff.) [\[Return to Text\]](#)

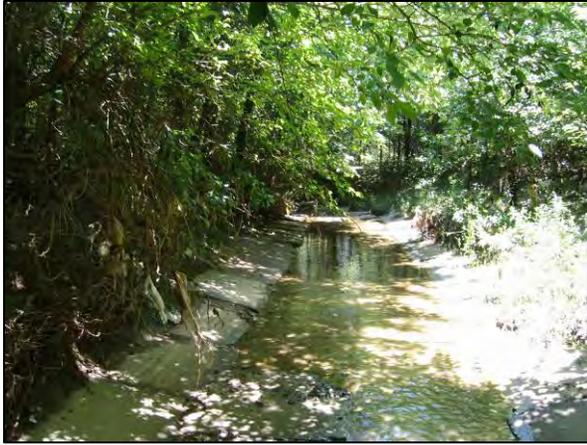
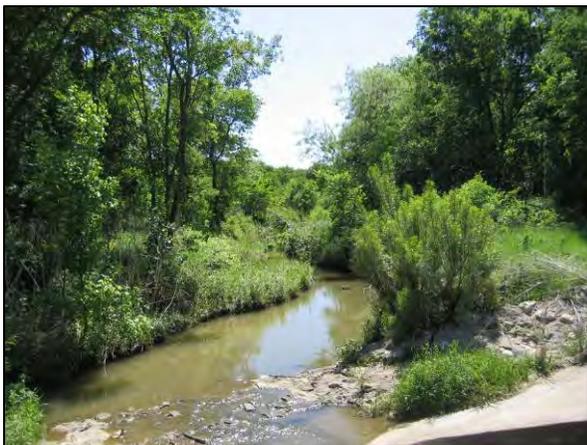
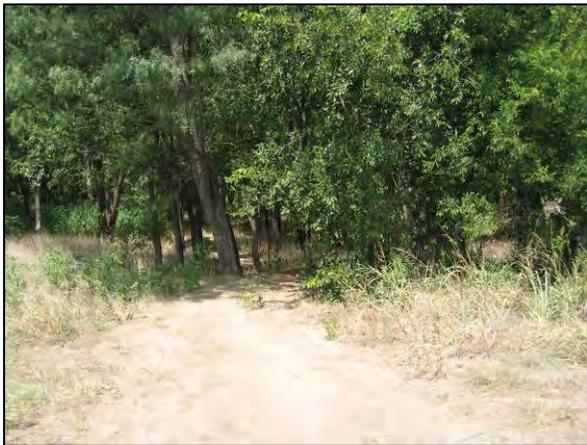
At Site FS105 two people indicated that the footpath leading to the stream is utilized by youths leaving school who jump across the stream on their way home. TIAER personnel did watch this occur during one of the surveys conducted in August of 2009, but interviews were not collected due to the age of the youths. (Note: the youths observed by staff were not young children, but youths in their early teens who were athletically developed. Although the site is directly behind an elementary school, there is a junior high school just a few blocks south on Cornwell Drive).

**Photogroup 11-14** Fish Creek Site FS105 showing stream and streambank characteristics (upper left photograph the concrete block streambed), stream tributary (upper right), access point (middle left), and surround area, including footpath leading to creek. [\[Return to Text\]](#)

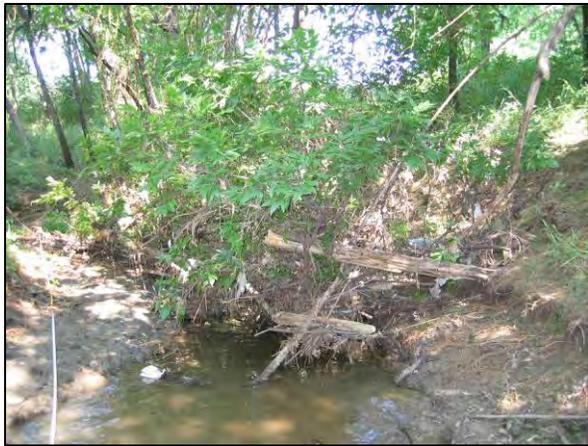
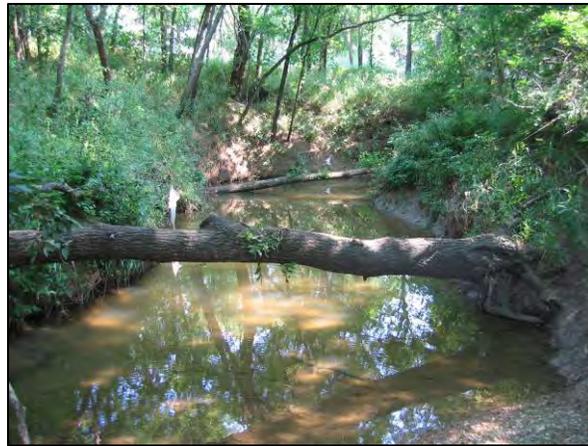
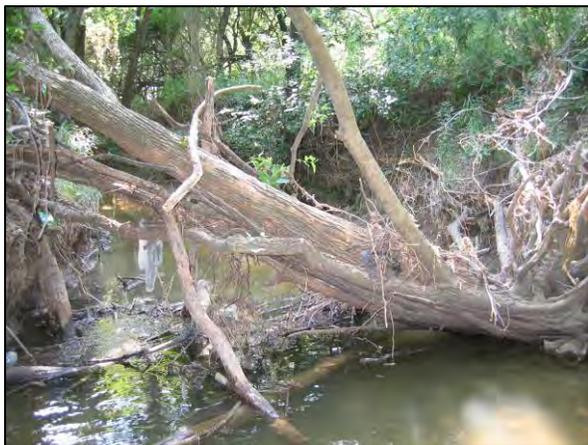
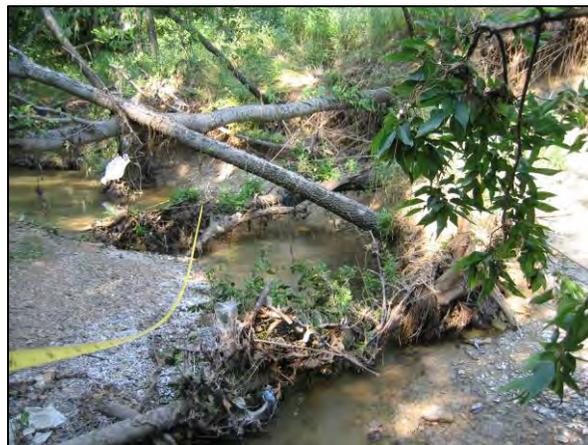
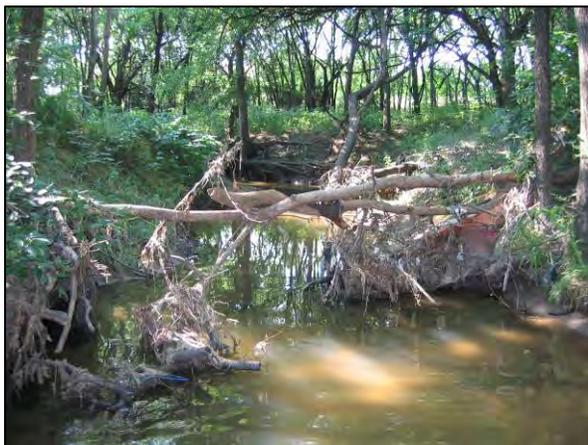
**Photogroup 11-15** Fish Creek Site FS105 showing debris and tree obstructions at and around the 60-m, 120-m, and 180-m transects. [[Return to Text](#)]

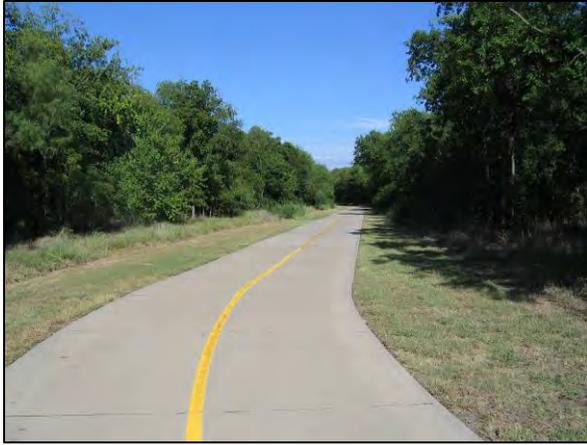
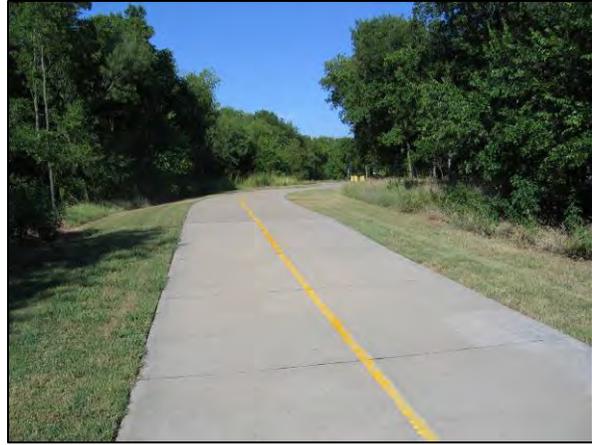
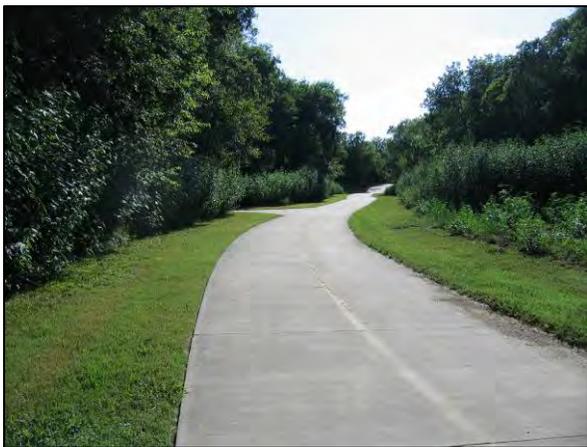
**Photogroup 11-16** Fish Creek Site FS105 showing hike/bike trail and mowed areas adjacent to trail. [\[Return to Text\]](#)

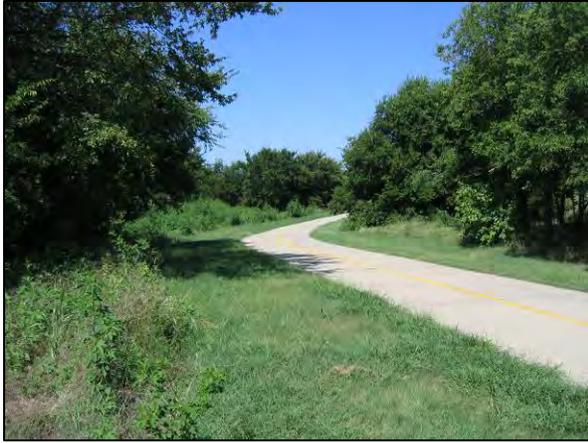
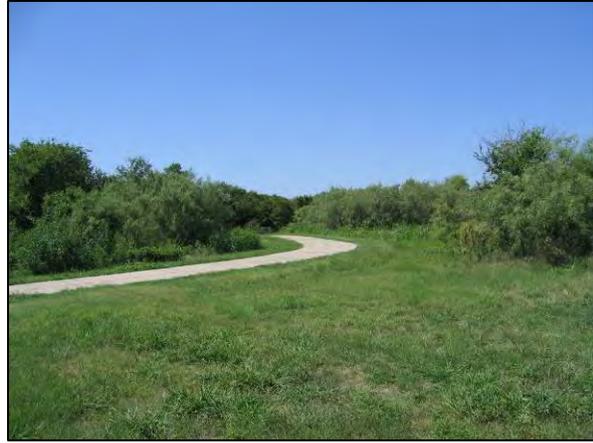
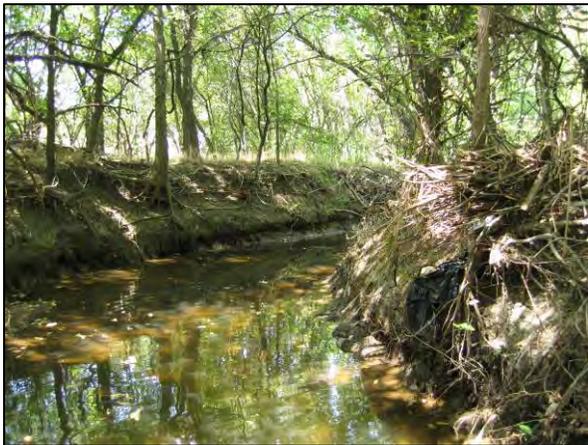
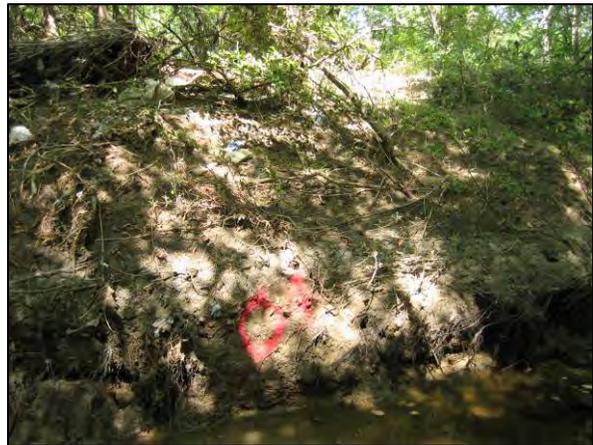
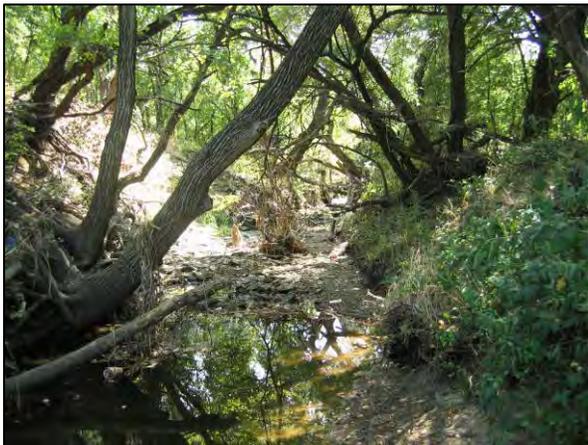
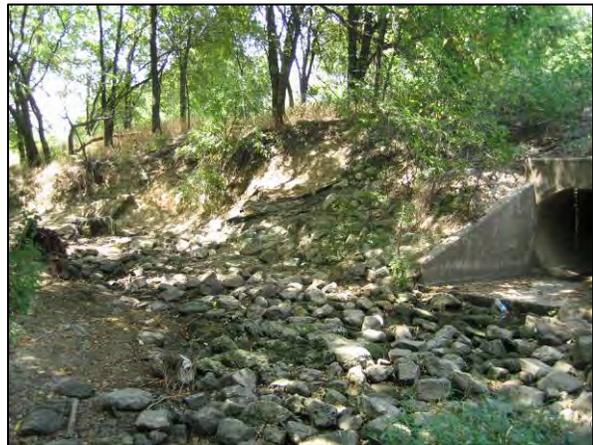
**Photogroup 11-17** Fish Creek Site FS106 showing hike/bike trail (upper row), typical stream and streambank characteristics, and storm drain entry (lower right). Note: Middle right photograph shows temporary markings from field crew used in surveying. [\[Return to Text\]](#)

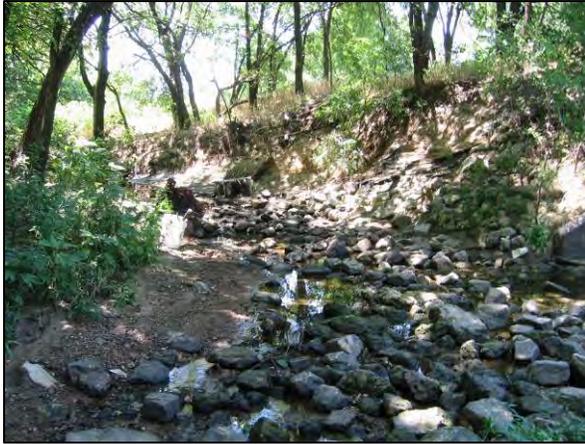
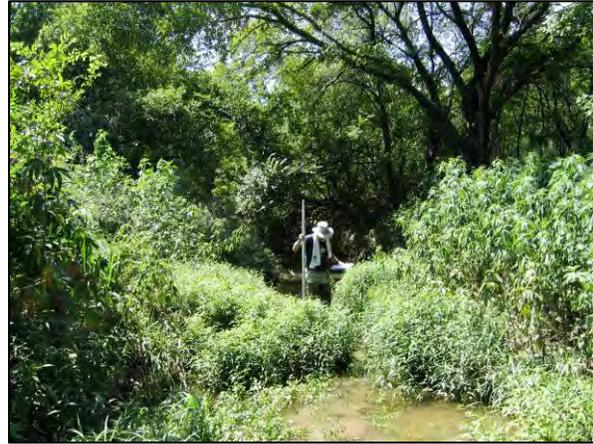
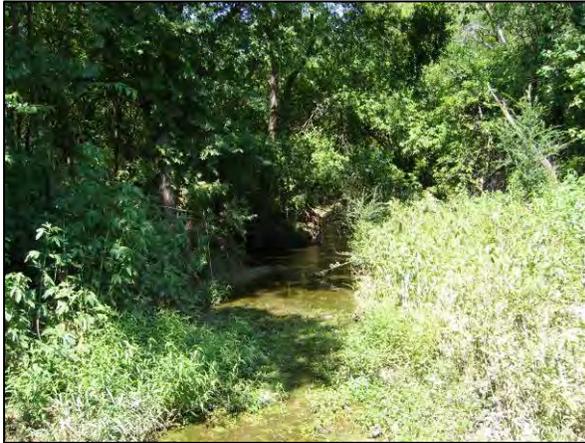
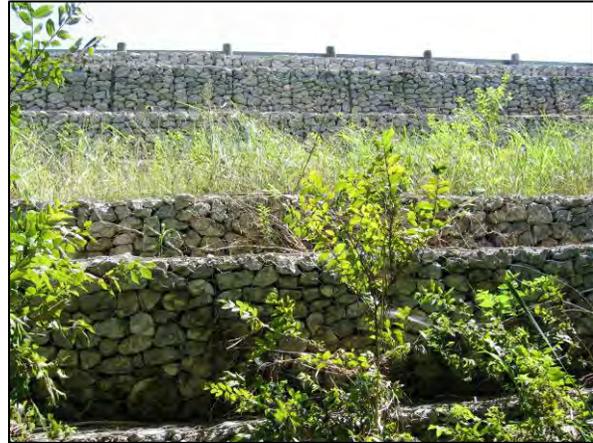
**Photogroup 11-18** Fish Creek Site FS106 showing area of cobble dominated substrate (upper left), area of abundant stream vegetation between 120-m and 210-m transects, and gabions along right bank in the areas of the 150-m transect. (Individual photographed is TIAER staff.) [\[Return to Text\]](#)

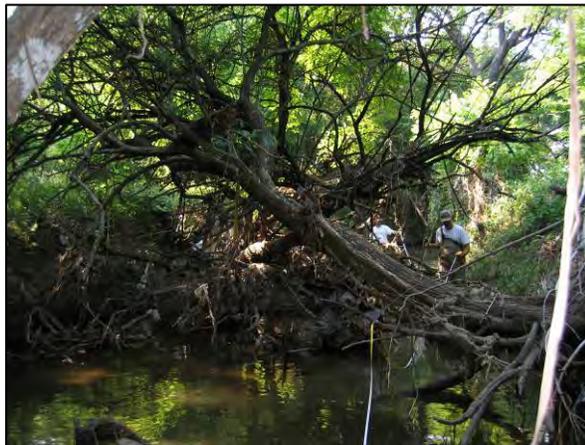
**Photogroup 11-19** Fish Creek Site FS106 showing obstacles from fallen trees and associated debris at the 180-m and 240-m transects. [Note field crew in both photographs] [\[Return to Text\]](#)

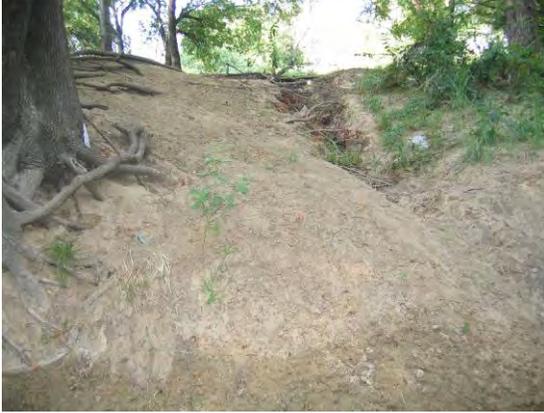
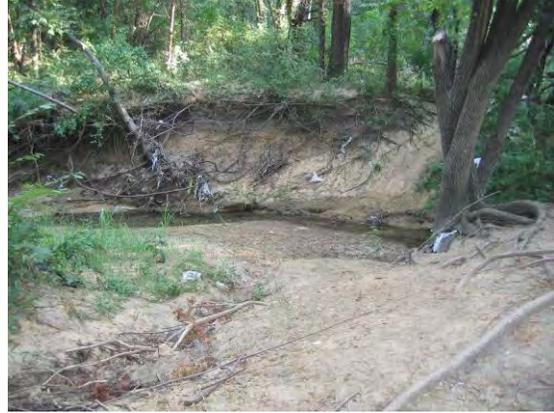
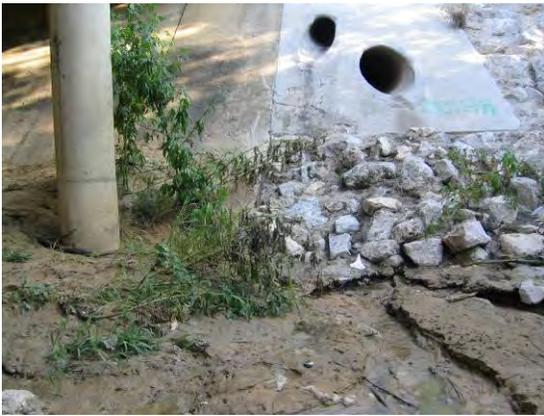
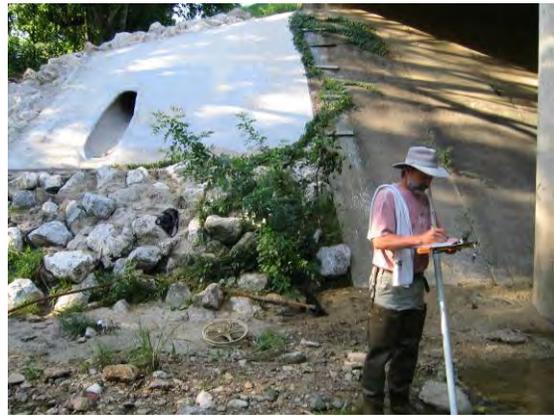
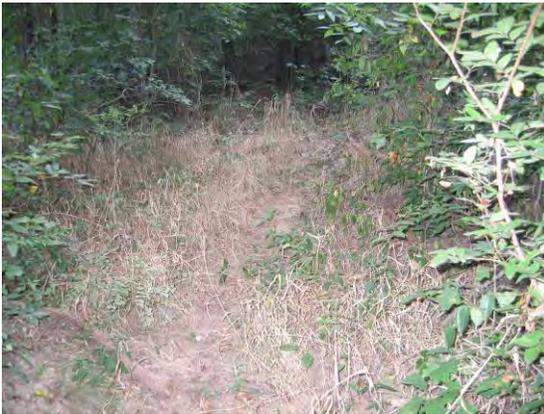
**Photogroup 12-2** Kirby Creek Site KC101 showing footpaths and easy access points to stream. (Individual photographed is TIAER staff.) [Return to Text](#)

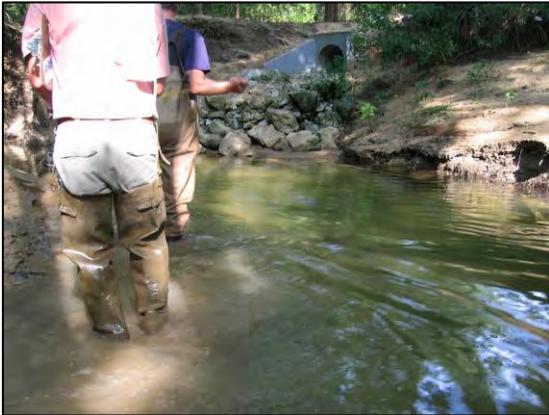
**Photogroup 12-5** Kirby Creek Site KC101 showing entry point of stormwater drain pipe at 240-m transect. (Individuals photographed are TIAER staff.) [\[Return to Text\]](#)

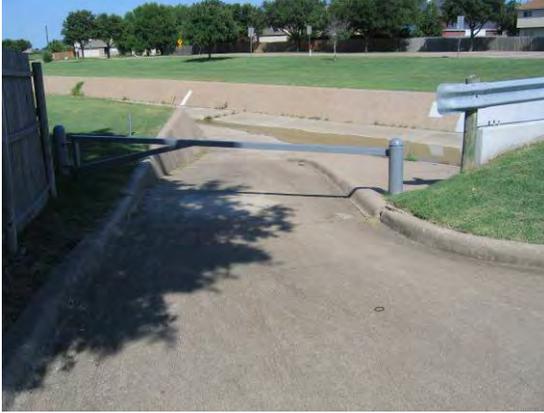
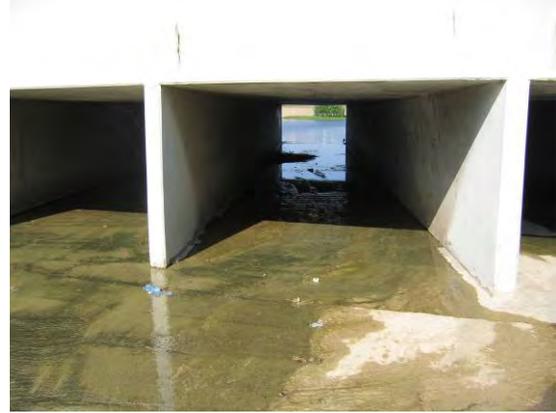
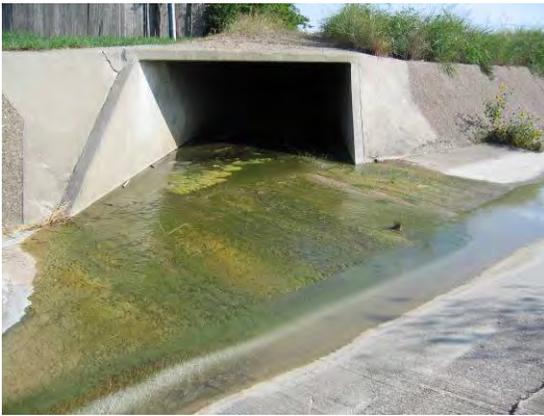
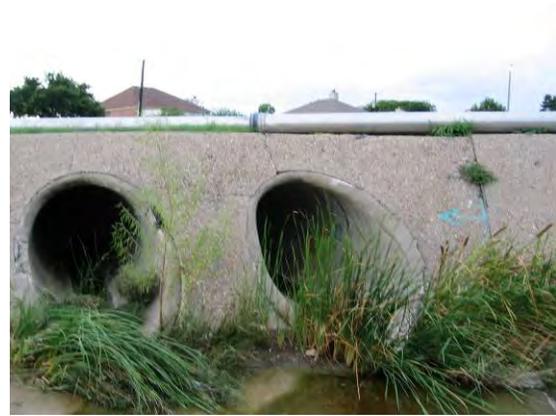
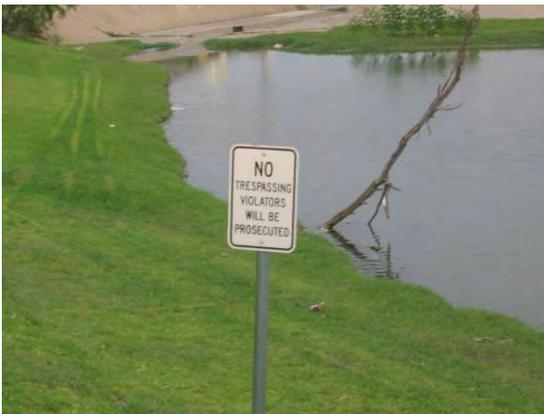
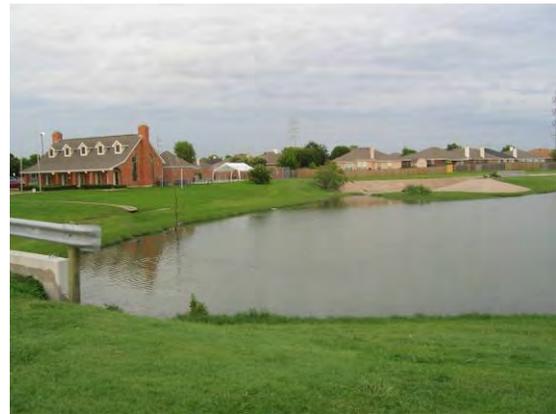
**Photogroup 12-6** Kirby Creek Site KC102 showing general characteristics of stream and adjacent area [\[Return to Text\]](#)

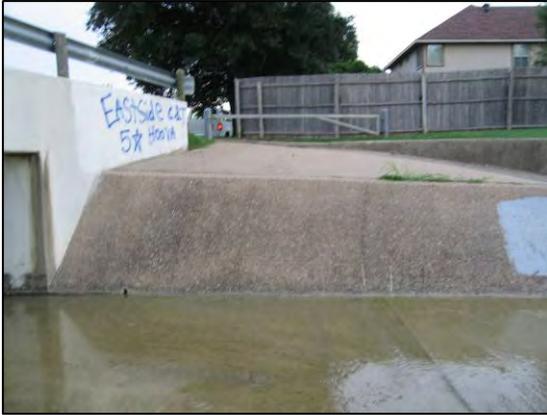
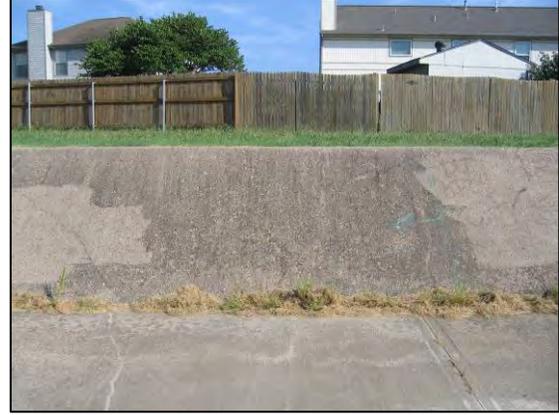
**Photogroup 12-7** Kirby Creek Site KC102 showing proximity of residential backyard fences adjacent to stream [[Return to Text](#)]

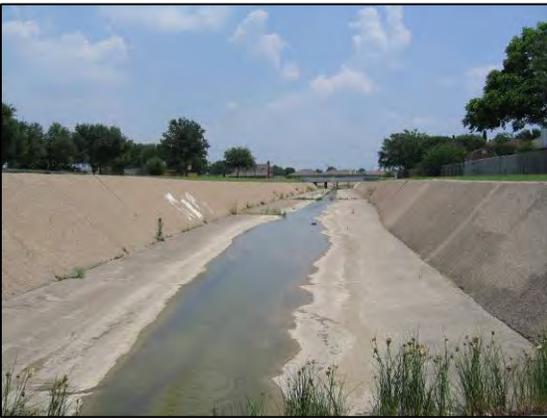
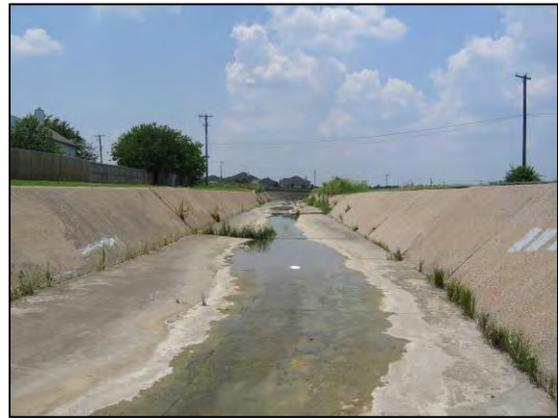
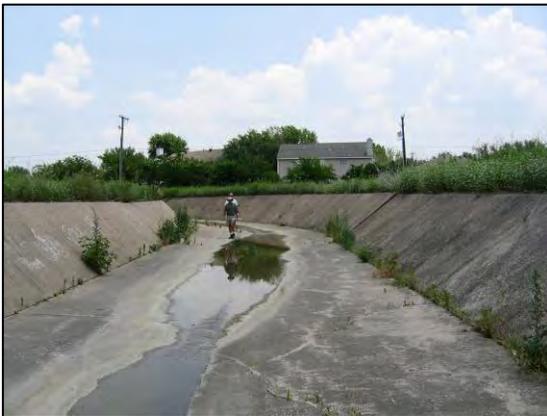
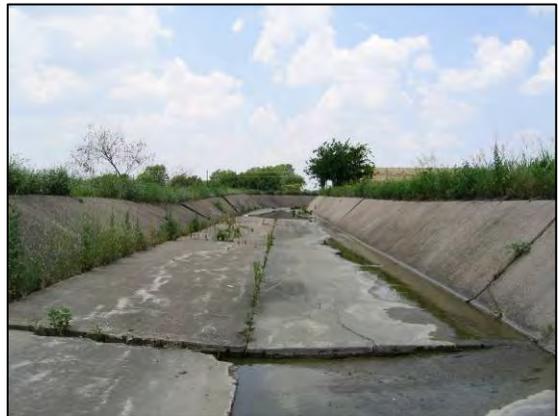
**Photogroup 12-8** Kirby Creek Site KC102 showing channelized stream channel and normal water levels (Upper photographs at 150-m transect and lower photographs at 300-m transect looking downstream and upstream; Field staff shown in photographs). (Individual photographed is TIAER staff.) [[Return to Text](#)]

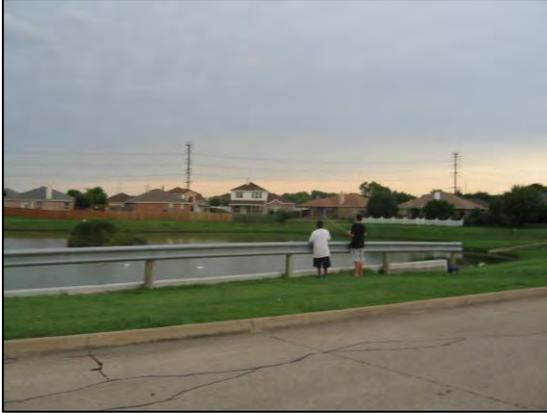
**Photogroup 12-9** Kirby Creek Site KC102 showing youths fishing in impounded pool  
[\[Return to Text\]](#)

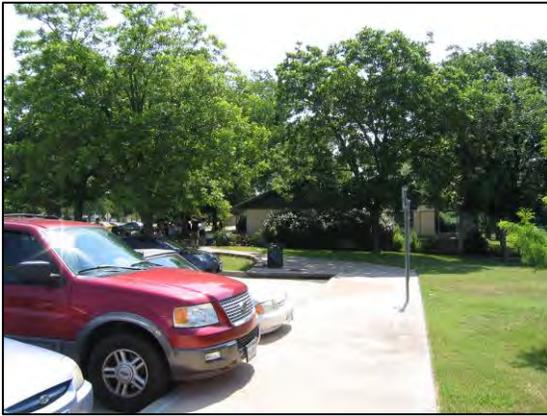
**Photogroup 12-10** Kirby Creek Site KC101 showing in distance, under the trees, some of the school-aged children at the end-of-school year party (because of age of persons involved, close up photographs were avoided) [\[Return to Text\]](#)

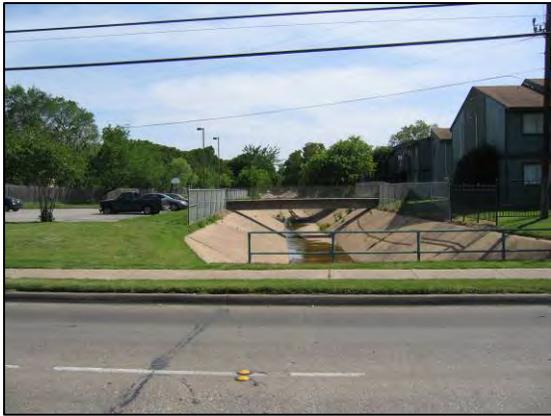
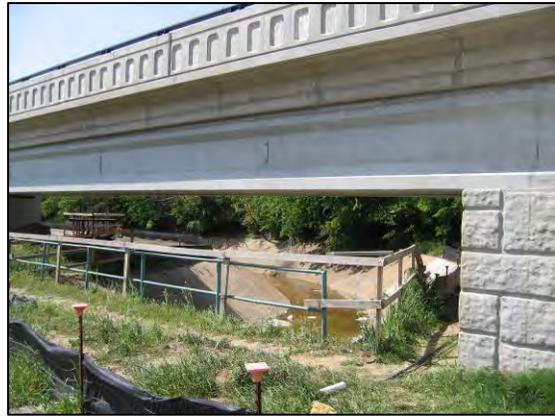
West Irving Creek at the Rock Island Road crossing is a concrete channel with little water observed ([Photogroup 13-1](#)). An apartment complex parking lot was located on the east side of the stream with a walkover to the complex that was situated on the left. Fences are located atop the culvert to make access to the stream difficult. Close to Rock Island Road, there is a portion which may offer public access; and this area appeared mowed and maintained. Upstream of the crossing, the road is under construction and access to the concrete lined channel is difficult.

**Photogroup 13-1** West Irving Creek at Rock Island Road looking upstream and downstream [\[Return to Text\]](#)

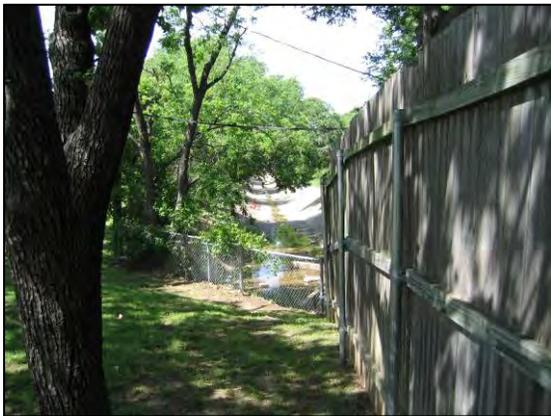
**Photogroup 13-2** West Irving Creek at 5<sup>th</sup> Street showing stream at this location [\[Return to Text\]](#)

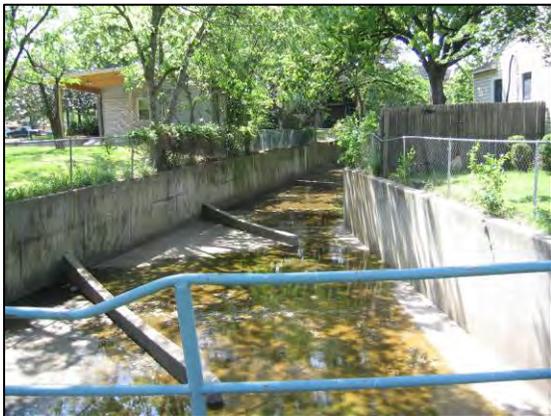
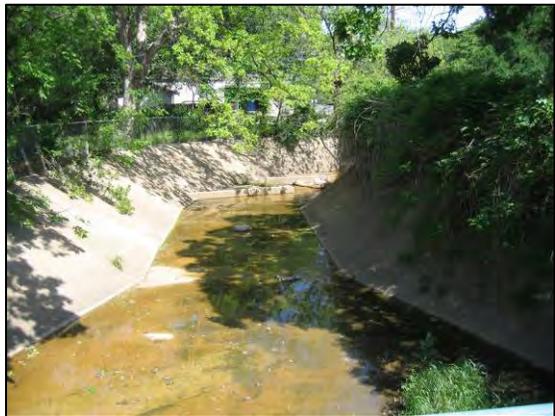
West Irving Creek at Wanda Drive is a concrete lined channel in a residential area ([Photogroup 13-3](#)). Chain link fences are located atop the concrete channel and the only access to the stream was at the road crossing. Access would be classified as moderately difficult and no evidence of recreational activity was observed at the site.

**Photogroup 13-3** West Irving Creek at Wanda Driver showing upstream and downstream views [\[Return to Text\]](#)

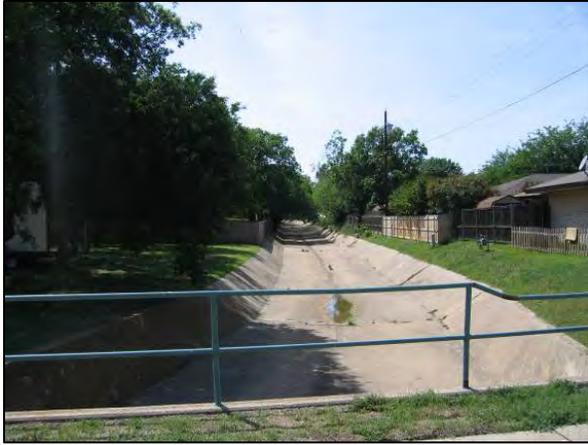
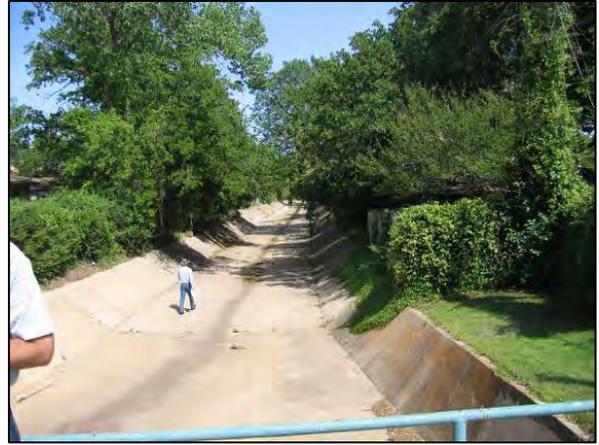
The creek crossing at Tipton Road is a concrete-lined tributary to West Irving Creek in a residential area ([Photogroup 13-4](#)). Backyard fences abut the stream channel making access from residences difficult. Access from the Tipton Road crossing is relatively easy. Very little water was observed in the stream and no evidence of water recreation was observed. The confluence with West Irving Creek at this location is slightly downstream. West Irving Creek is also concrete lined in this area and contained very little water at the time of the visit.

**Photogroup 13-4** A tributary West Irving Creek at Tipton Road showing upstream and downstream views (field crew in downstream view). [\[Return to Text\]](#)

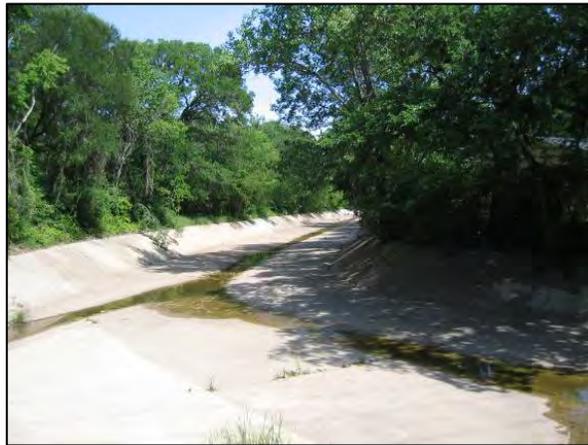
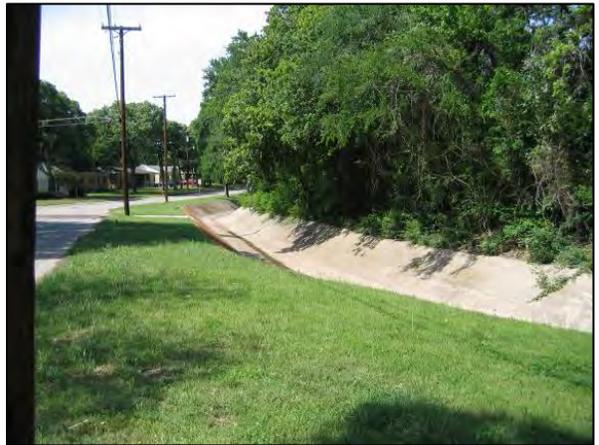
West Irving Creek at Bowman Street is a concrete lined channel in a residential area ([Photogroup 13-5](#)). The right bank is shrub/tree dominated atop the concrete channel and the left bank is a mowed and maintained grass corridor. Access to the stream appeared easy. No observed evidence of recreation was identified at this site.

**Photogroup 13-5** West Irving Creek at Bowman Street showing upstream and downstream views [\[Return to Text\]](#)

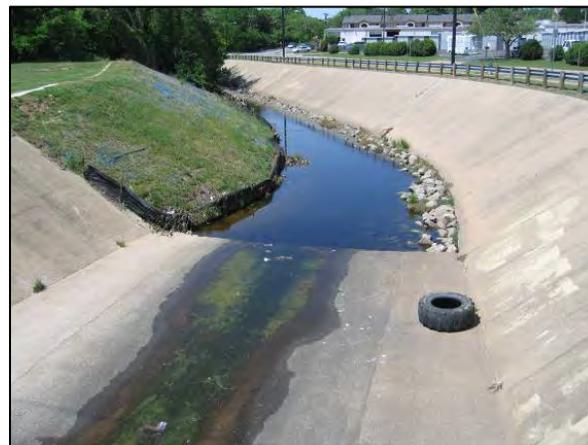
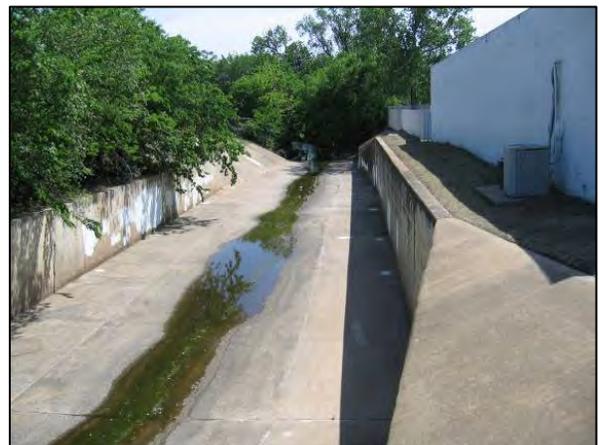
West Irving Creek at West Shady Grove Road appeared natural upstream of the road and as a concrete lined channel below ([Photogroup 13-6](#)). This potential site was located just to the north of Site WI101. Due to the similarities and proximity of Site WI101 and this location, the presence of the park at WI101 (no park was observed here) swayed the selection of Site WI101. Access to the stream from the Shady Grove location appeared to be moderately easy.

**Photogroup 13-6** West Irving Creek at Shady Grove Road showing upstream and downstream views [\[Return to Text\]](#)

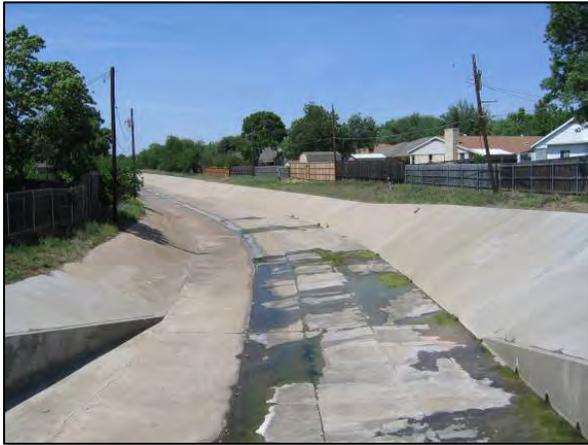
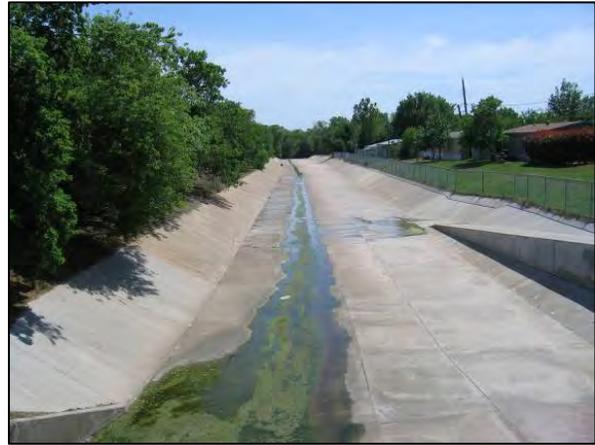
West Irving Creek at the West Oakdale Road crossing is a concrete lined channel in a residential neighborhood ([Photogroup 13-7](#)). A chain link fence is atop the upstream left bank of the channel and the upstream right bank has trees/shrubs to the edge of the stream. Residential backyard fences are located on the downstream sides of the channel. Access to the stream appeared moderately easy with very little water observed in the channel. No signs of recreation were observed.

**Photogroup 13-7** West Irving Creek at West Oakdale Read showing upstream and downstream views [\[Return to Text\]](#)
