Dallas-Fort Worth Metroplex Urban Creeks
Trinity River Bacteria TMDL Project
Recreational Use-Attainability Analysis Report

Report to TMDL Team
Texas Commission on Environmental Quality
Project and Work Order Number
582-5-70859-26

Jeff Stroebel
Tim Jones
Larry Hauck
Texas Institute for Applied Environmental Research
Tarleton State University
Stephenville, Texas

November 2010

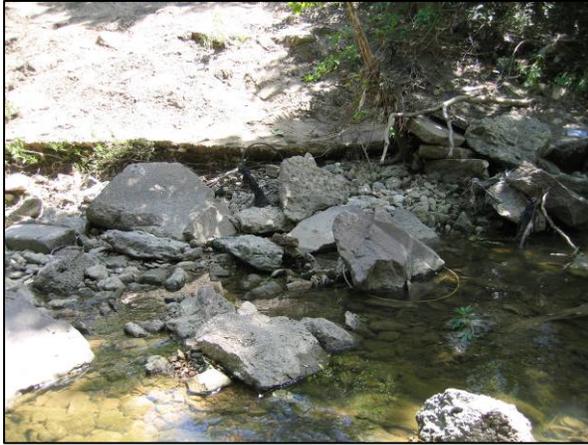
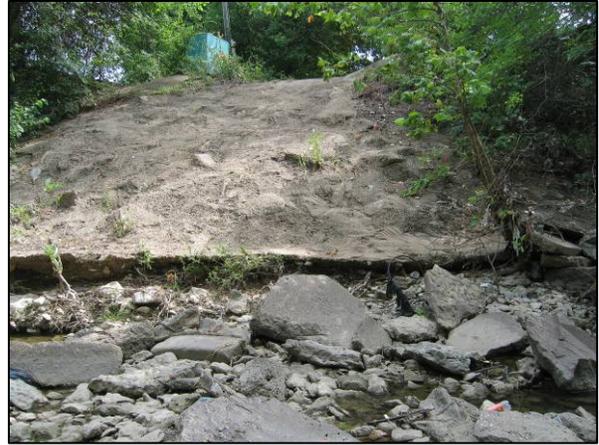
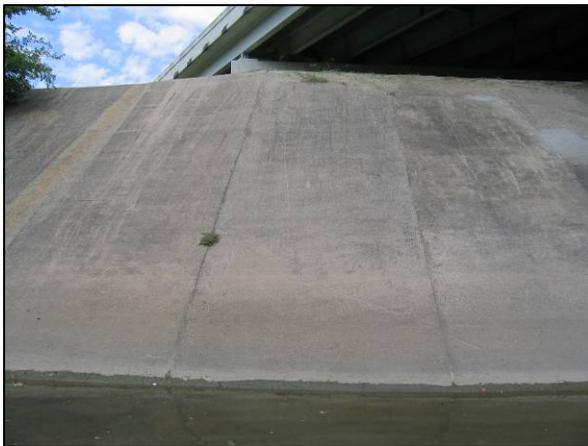
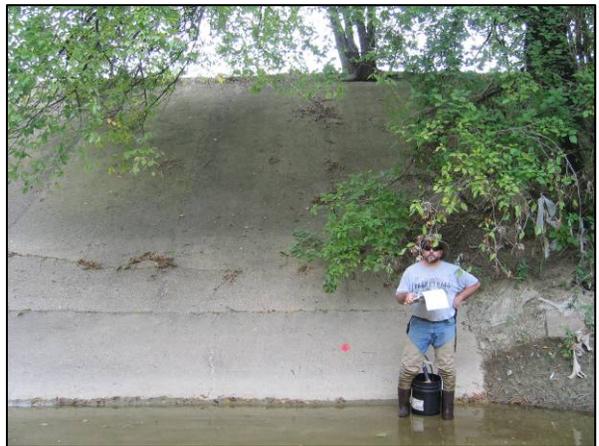
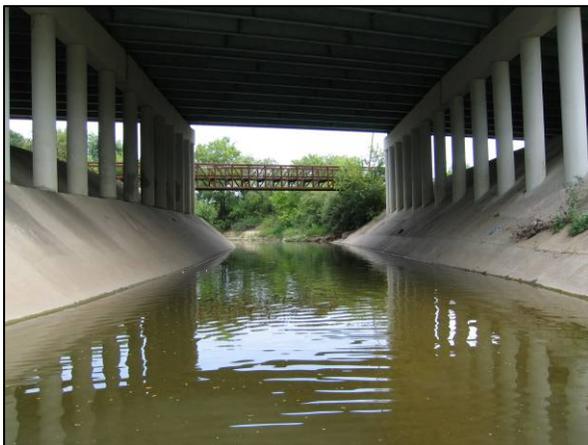
Photogroup 3-2

Sycamore Creek showing concrete pieces in stream and concrete apron leading to stream at the 150-m transect (upper row, note right photograph is looking up the apron) and stream and banks at the 0-m transect at IH-30 (middle and lower rows; note in lowermost photograph the pedestrian bridge in the background that is part of a hike/bike trail). (Individual pictured is TIAER staff.) [\[Return to Text\]](#)

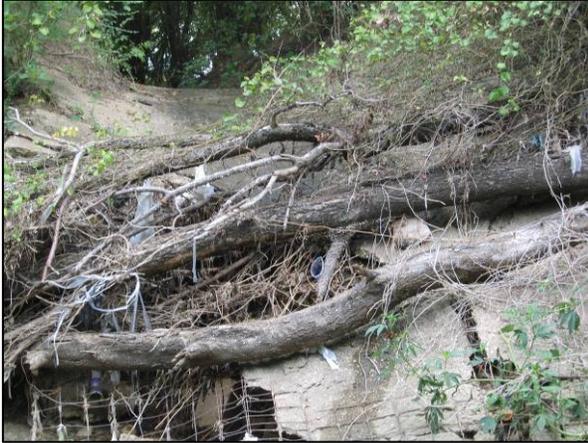
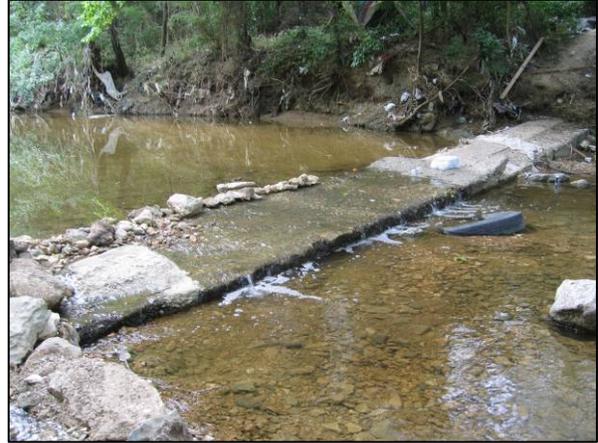
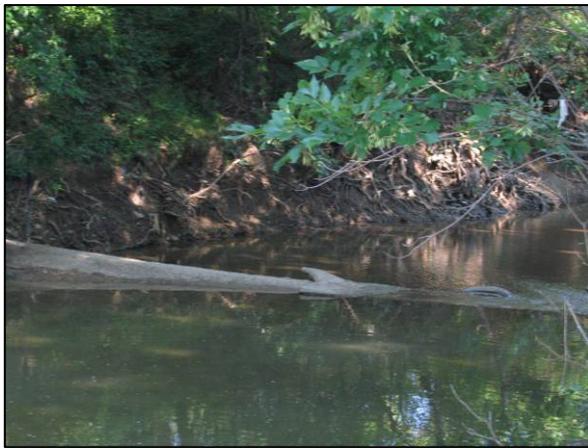
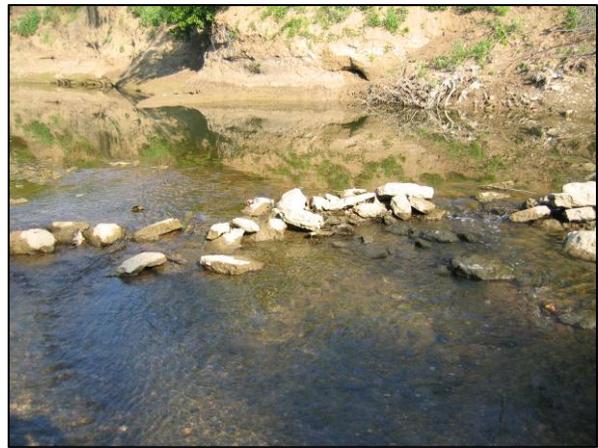
Photogroup 3-3 Sycamore Creek Site SC101 showing storm drain entering creek at 30-m transect (top portion of upper row, left side photograph); weir or low dam at 120-m transect (following two photographs); and temporary rock dam (lower row, right photograph). [\[Return to Text\]](#)

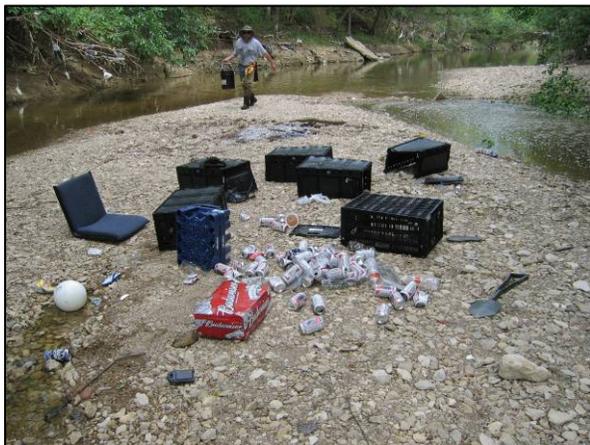
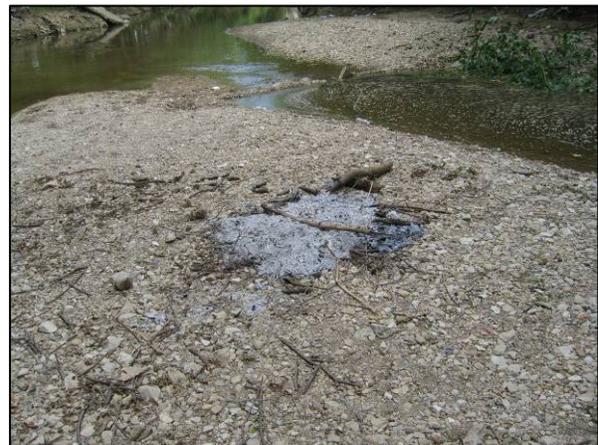
Photogroup 3-4 Sycamore Creek Site SC101 showing remnants of suspected party including camp fire. (Individual pictured is TIAER staff.) [\[Return to Text\]](#)

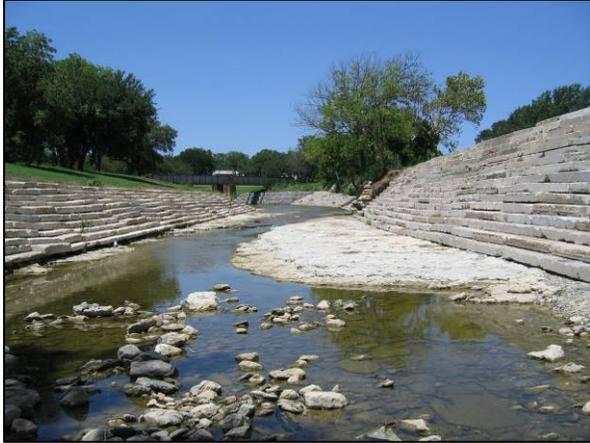
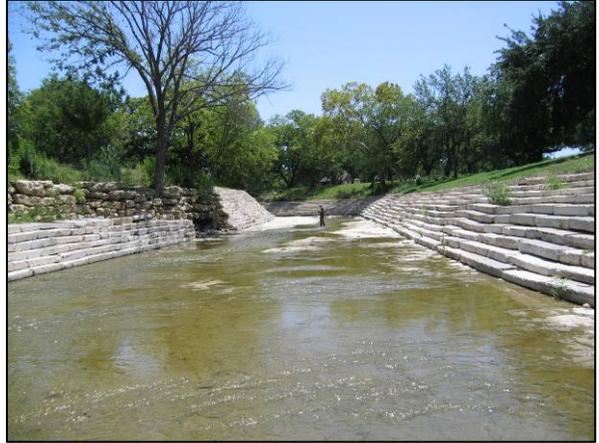
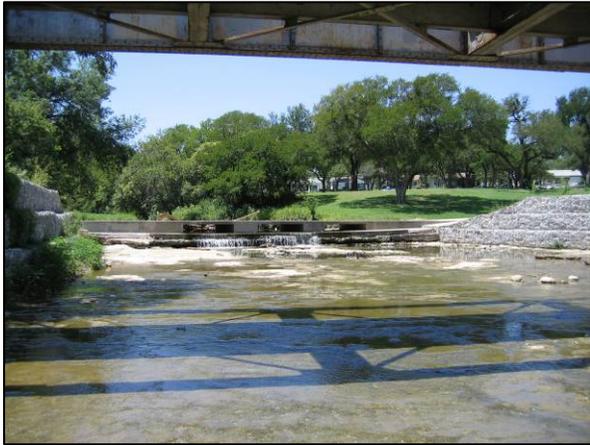
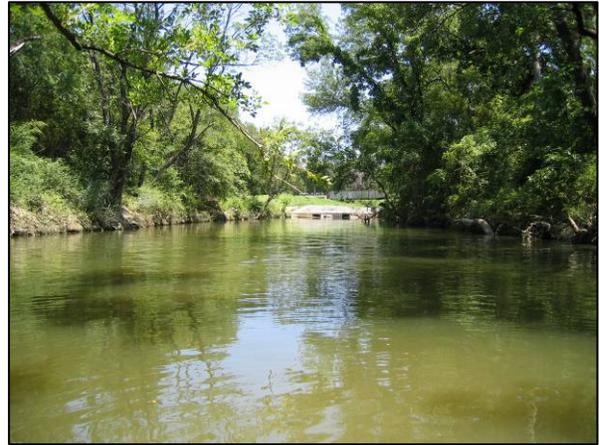
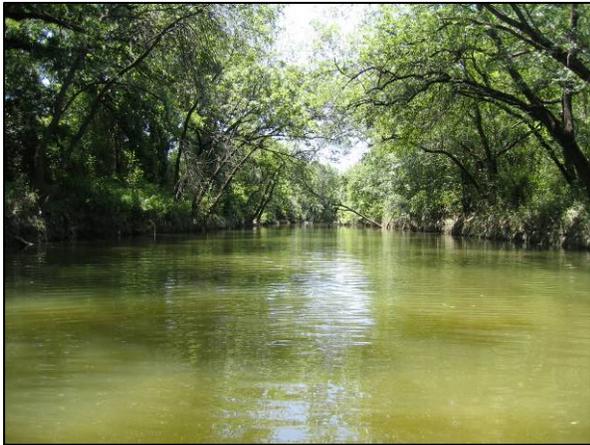
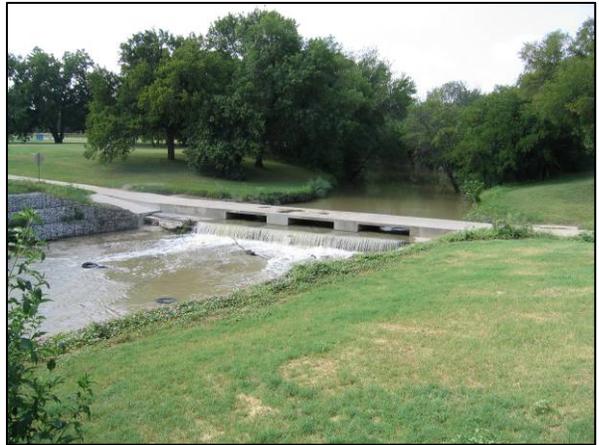
Photogroup 3-5

Sycamore Creek Site SC102 showing stream below low water dam at 210-m transect (upper row & middle row left) and large pool and dam (middle row right and lower row) above this transect. (Individual in upper right photograph is TIAER staff.) [\[Return to Text\]](#)

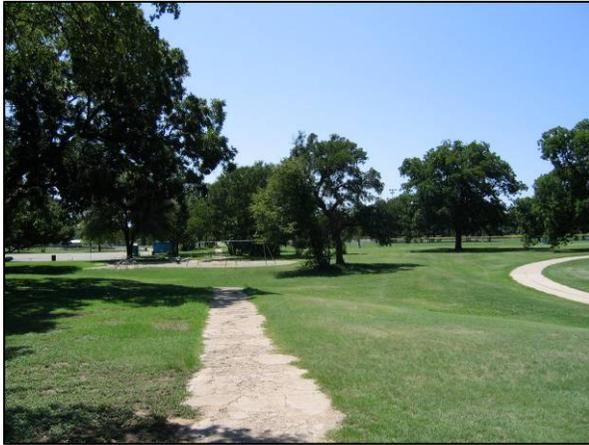
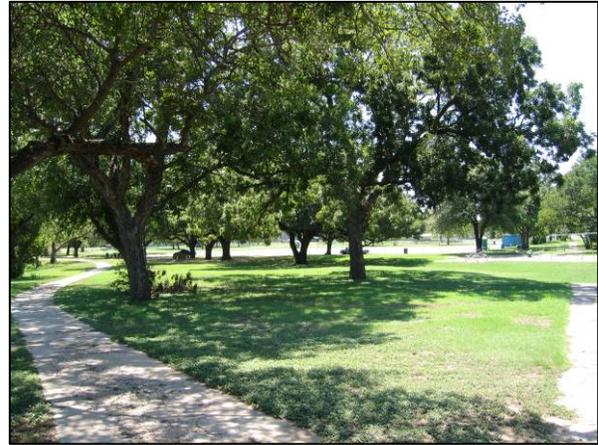
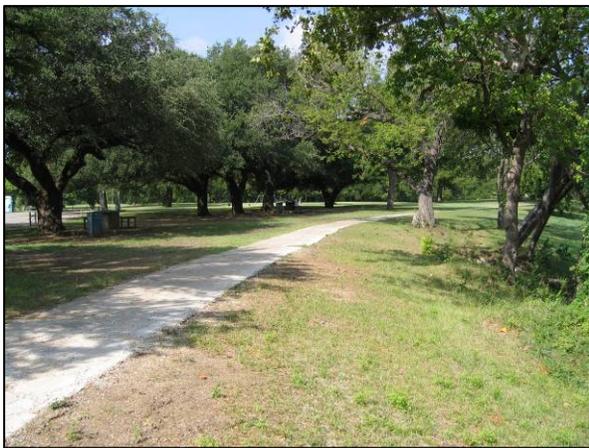
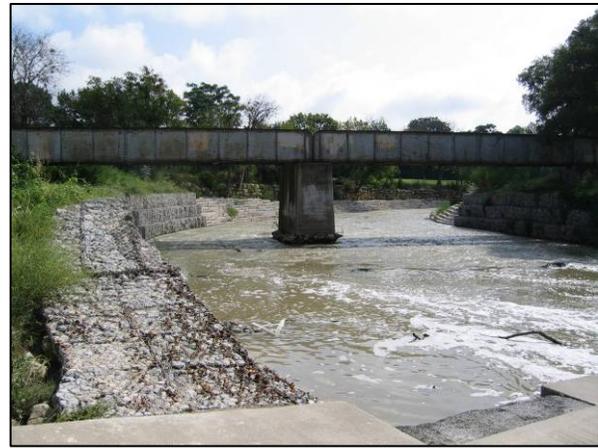
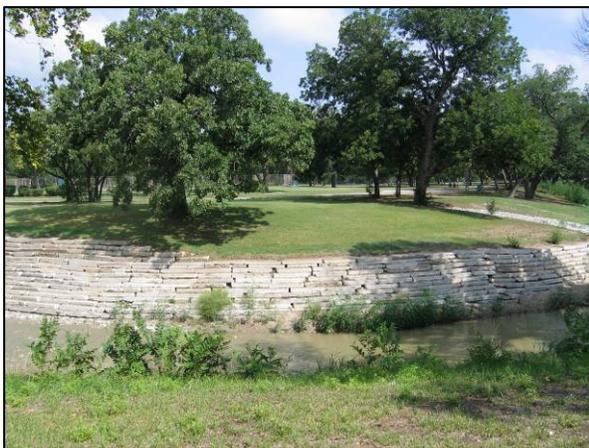
Photogroup 3-6 Sycamore Creek Site SC102 showing area within Sycamore Park and the bridge crossing the stream. [Return to Text](#)

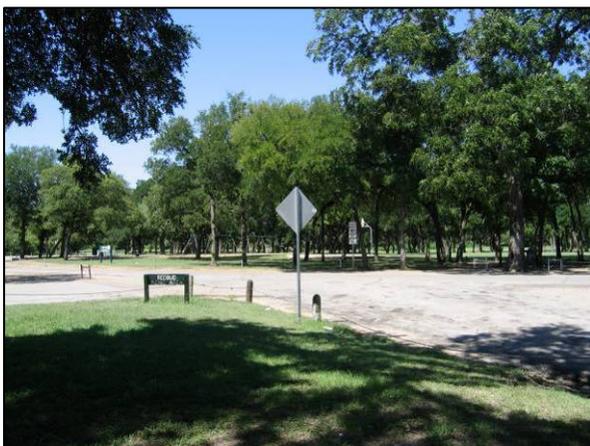
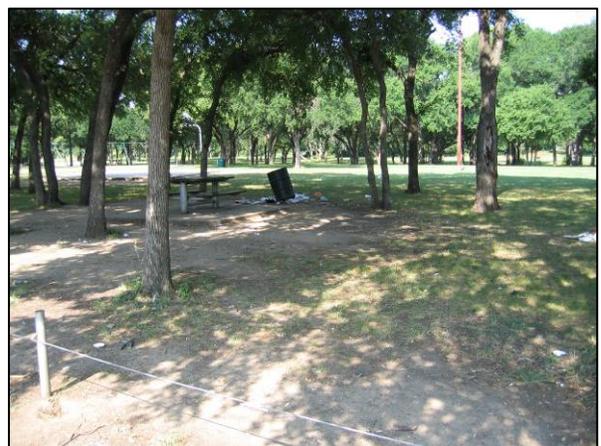
The effluent sewage smell in the area of Cobb Park was one of the reasons mentioned for not eating the fish caught or recreating in the stream. The amounts of garbage in the channel and on the banks at this location may also deter recreation.

Photogroup 3-9 Sycamore Creek Site SC103 showing Cobb Park. [\[Return to Text\]](#)

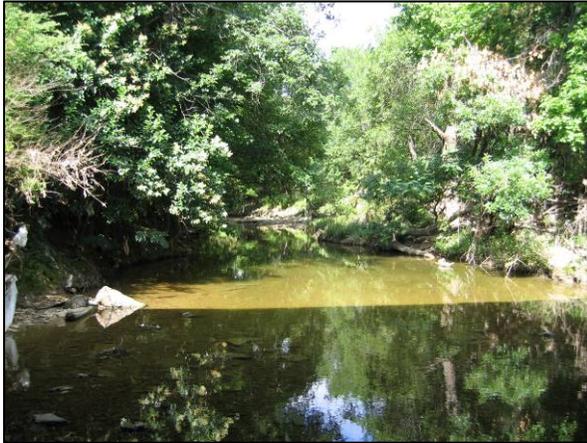
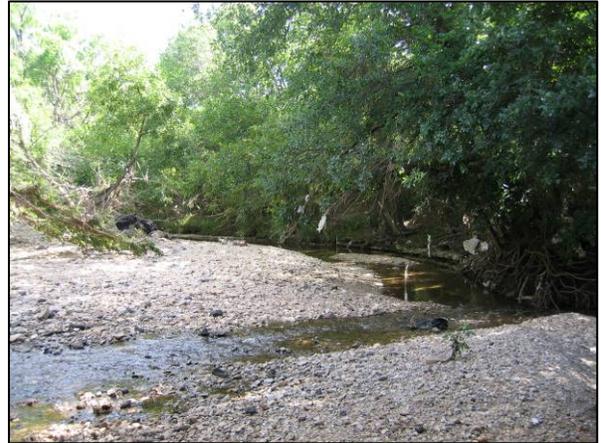
Photogroup 3-10 Sycamore Creek Site SC104 showing stream and riparian zone. [\[Return to Text\]](#)

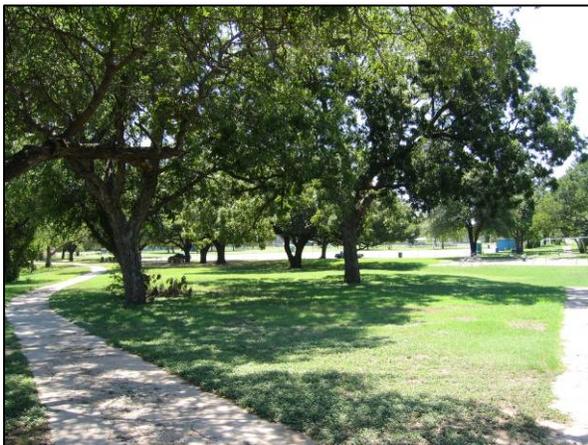
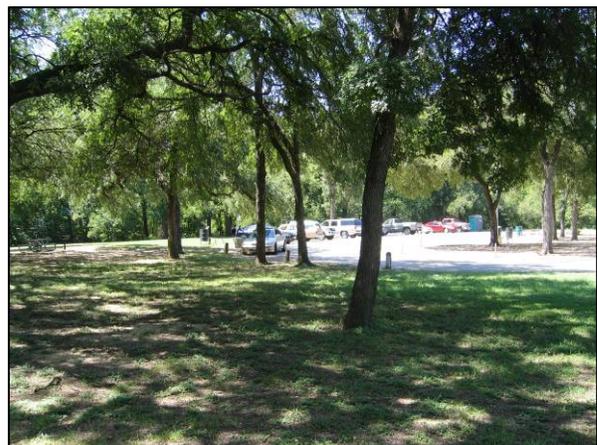
Photogroup 3-13 Sycamore Creek showing activities observed on parks along creek. [\[Return to Text\]](#)

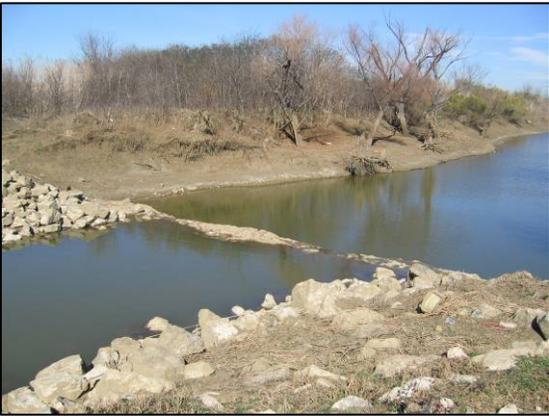
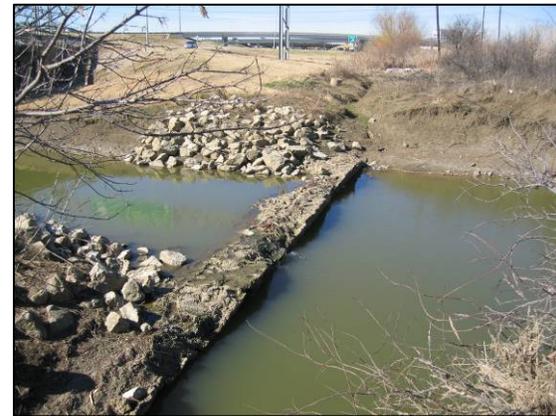
Photogroup 4-2 Cottonwood Branch Site CB101 showing small dam just downstream of 0-m transect. [\[Return to Text\]](#)

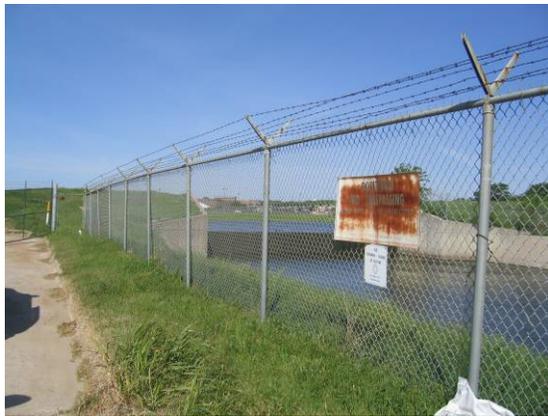
Photogroup 4-6 Cottonwood Branch Site CB102 showing DCRUD no trespassing sign on fence. [\[Return to Text\]](#)

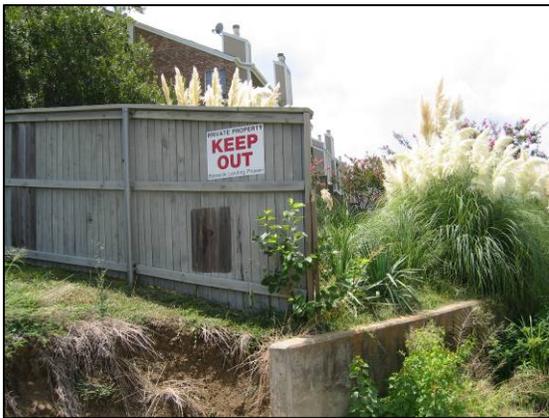
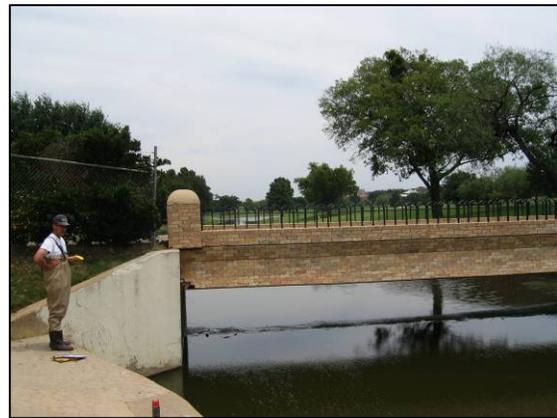
Photogroup 4-8 Cottonwood Branch Site CB103 showing access restrictions that limited reach length to 270-m. (Field crew shown in photographs) [\[Return to Text\]](#)

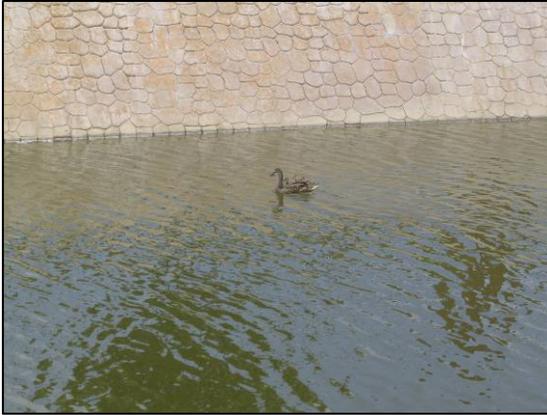
There was a slight to moderate presence of water dependent birds observed at the site ([Photogroup 4-11](#)). A snake was observed during one of the three trips with no other vertebrates observed. Fecal droppings were observed during all three surveys and tracks were observed during one trip. Aquatic vegetation and algae cover were rare to common. Garbage along the

Photogroup 4-11 Cottonwood Branch Site CB103 showing example of water fowl (duck). [\[Return to Text\]](#)

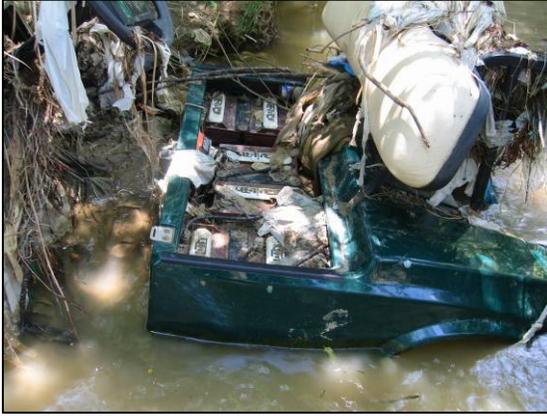
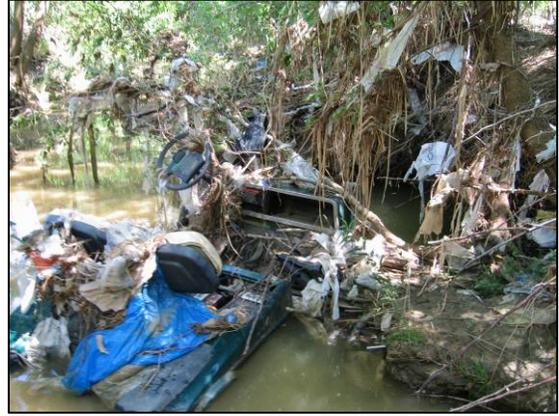
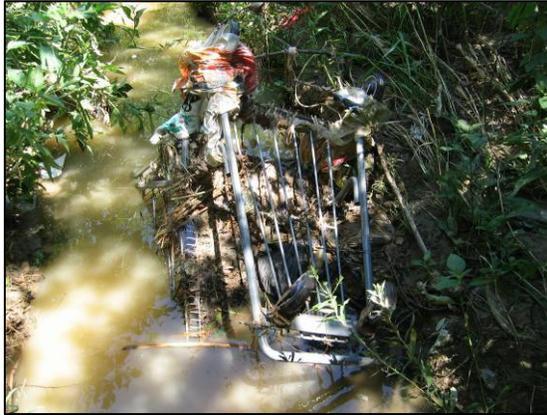
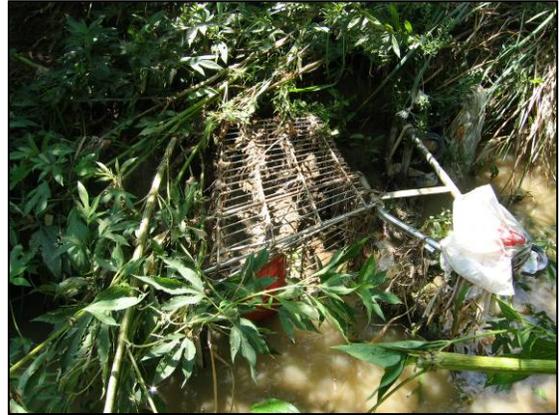
Garbage in the channel and on the banks was common for both large and small garbage. Two grocery carts and one golf cart were observed in the stream. Other garbage consisted of plastics, bags and bottles, and paper trash. [Photogroup 4-15](#) depicts the major objects found in the stream.

Photogroup 4-15 Cottonwood Branch Site CB104 showing debris and trash at 210-m, 240-m, and 270-m transects. [[Return to Text](#)]

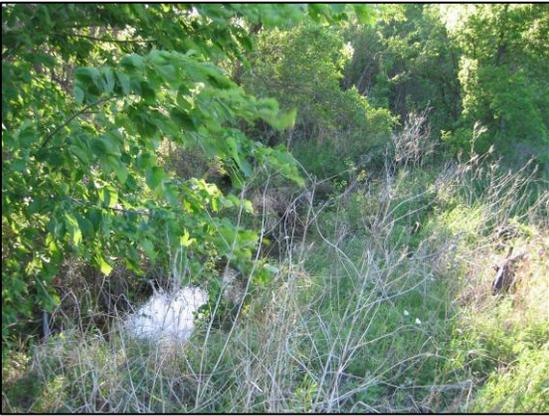
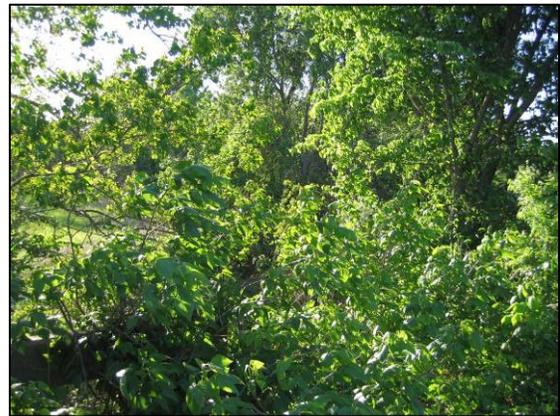
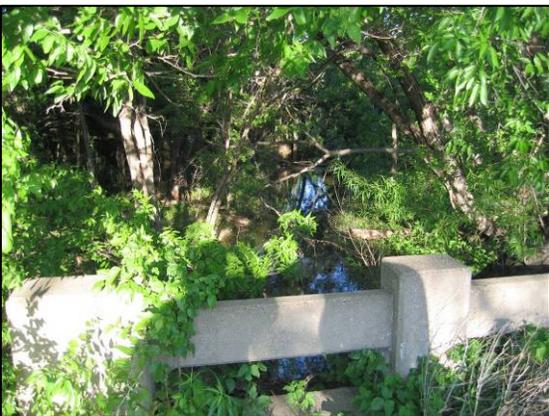
Photogroup 6-2 Copart Branch at Camden Drive showing dense vegetation along the stream at the road crossing. [Return to Text](#)

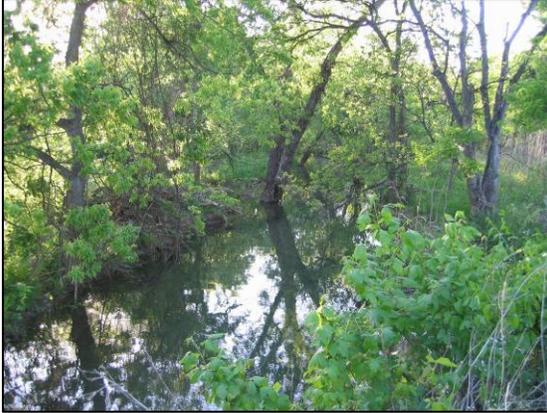
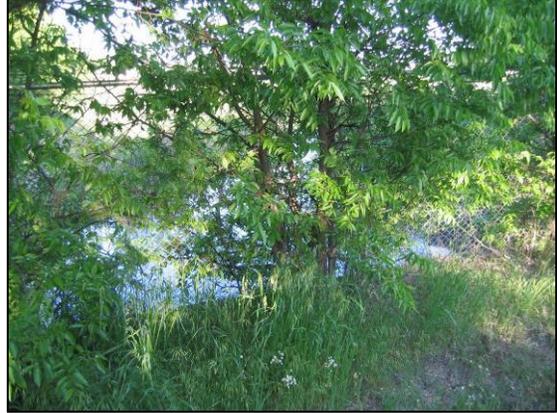
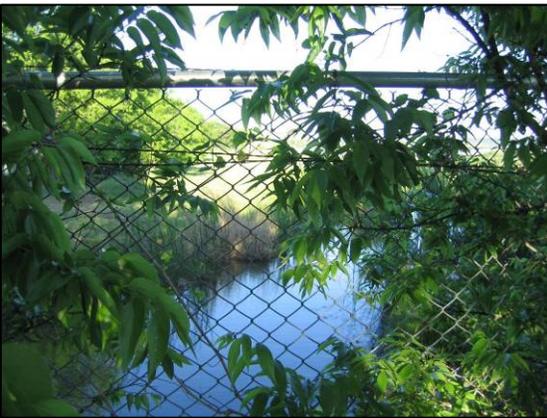
Photogroup 6-3 Copart Branch at Richardson Drive showing heavy bank vegetation on upstream side and fence along downstream side of the road. [\[Return to Text\]](#)

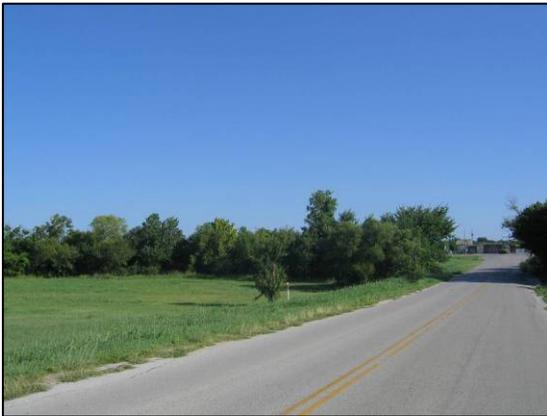
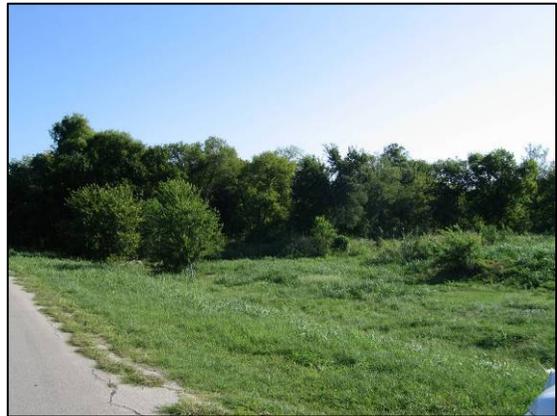
Photogroup 6-4 Copart Branch at Richardson Drive during August 8, 2010 survey showing absence of human activity in the vicinity of road crossing. [\[Return to Text\]](#)

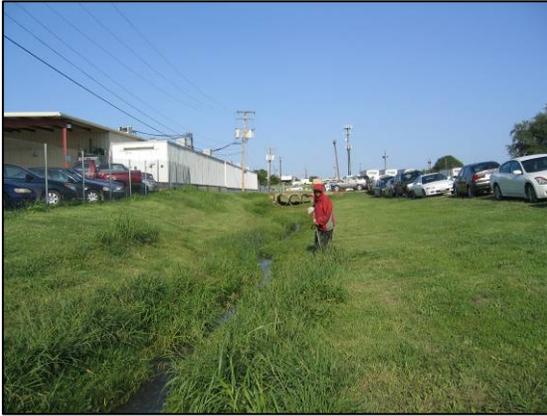
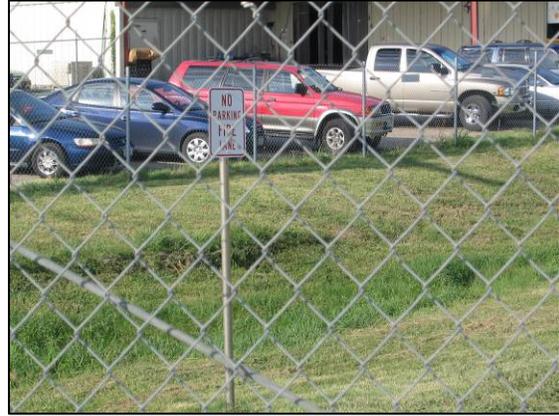
Photogroup 6-5 Copart Branch Site CM101 showing grass trimming on creek bank on August 5, 2009. [\[Return to Text\]](#)

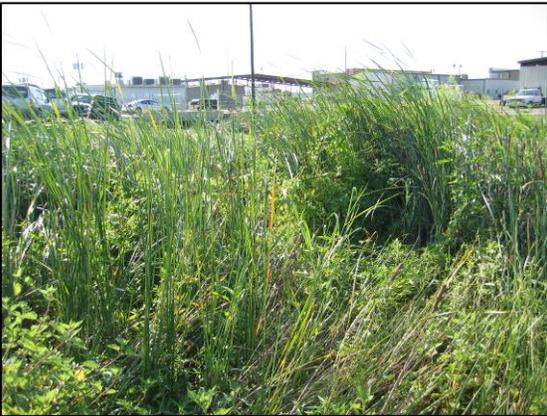
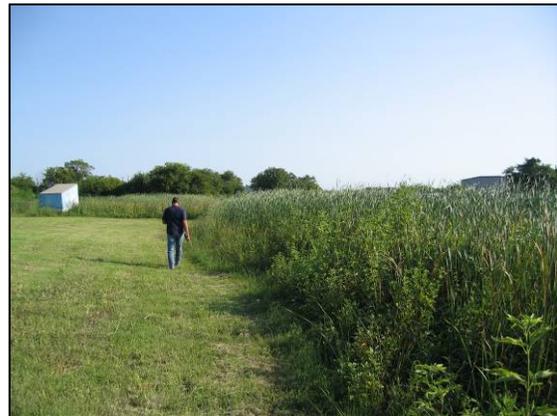
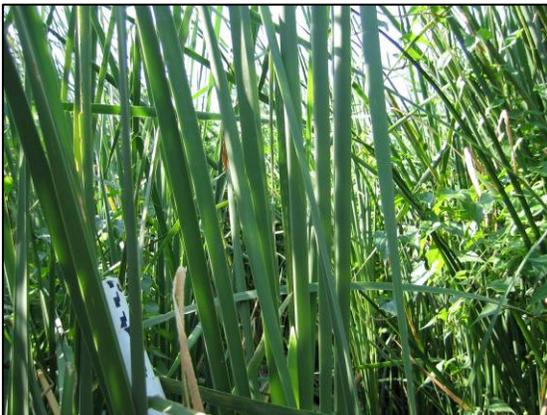
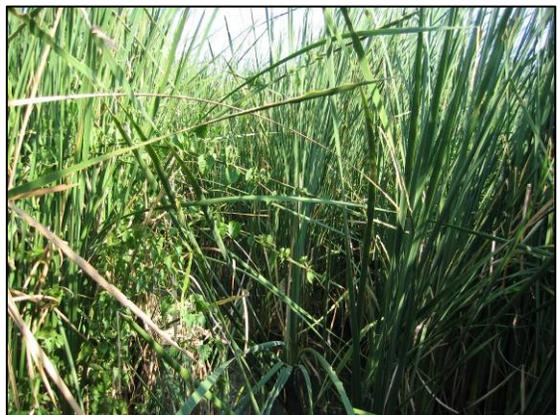
Photogroup 6-6 Copart Branch Site CM101 between the 210-m and 300-m transects showing emergent aquatic vegetation. (Individual pictured is TIAER staff.) [\[Return to Text\]](#)

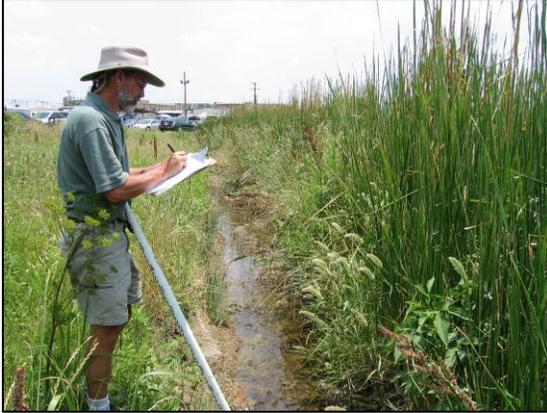
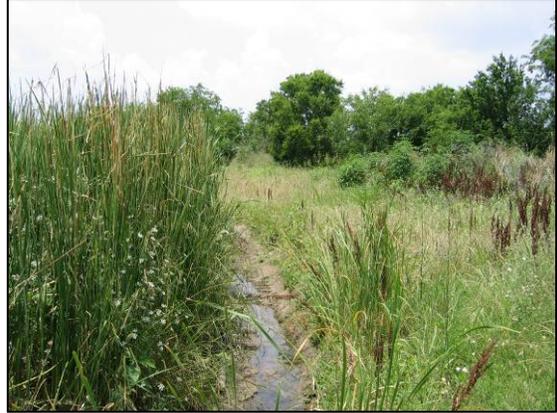
Photogroup 6-7 Copart Branch Site CM101 showing by-pass channel constructed around area of thick vegetation. (Individual pictured is TIAER staff.) [\[Return to Text\]](#)

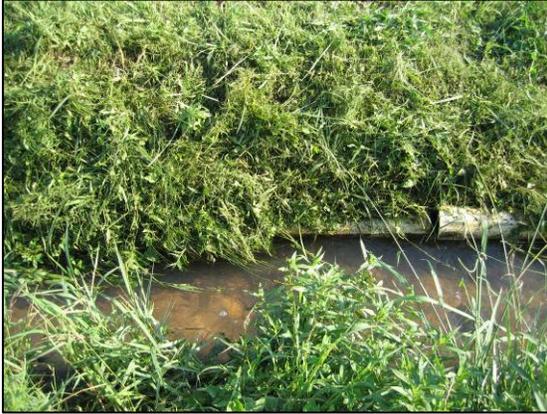
Photogroup 6-8 Copart Branch Site CM101 showing what is possibly a remnant section of the 4-in diameter pipe that contained the flow in past years. [\[Return to Text\]](#)

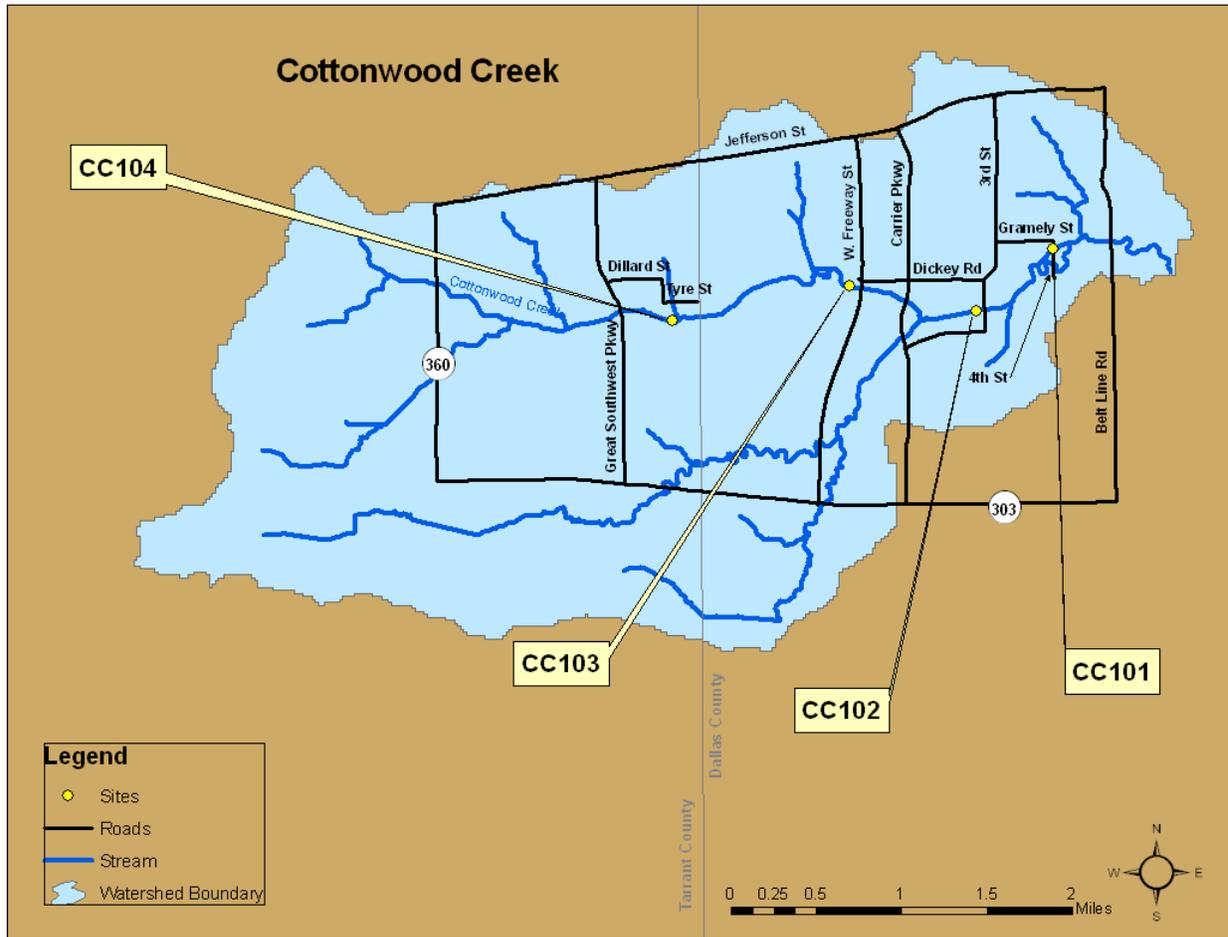
Figure 7-1 Cottonwood Creek (0841F) showing RUA survey sites

The survey sites selected for Cottonwood Creek (Segment 0841F) are provided in Figure 7-1. Four appropriate sites for the performance of a RUAA were identified in this stream. A brief description of each site follows.

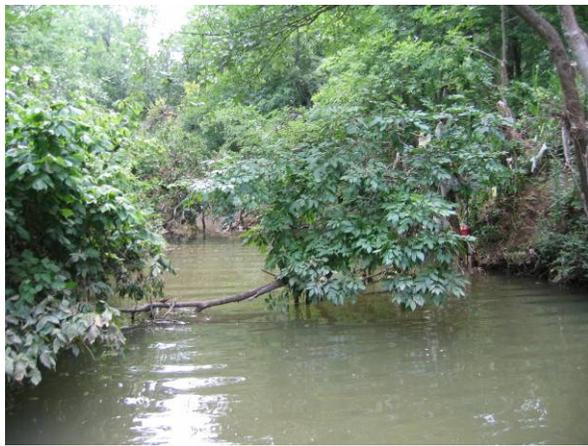
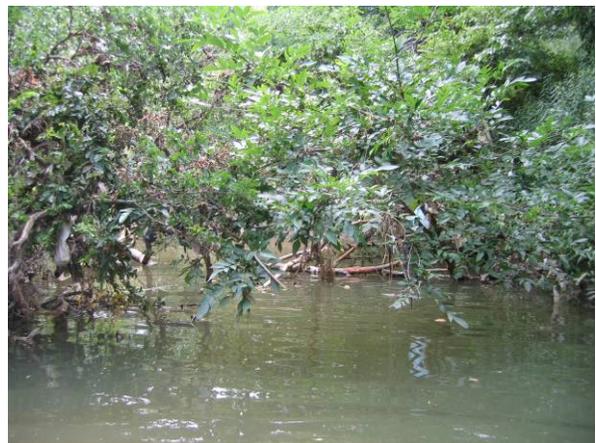
Photogroup 7-2 Cottonwood Creek Site CC101 showing obstructions from leaning trees at 180-m and 210-m transects. [\[Return to Text\]](#)

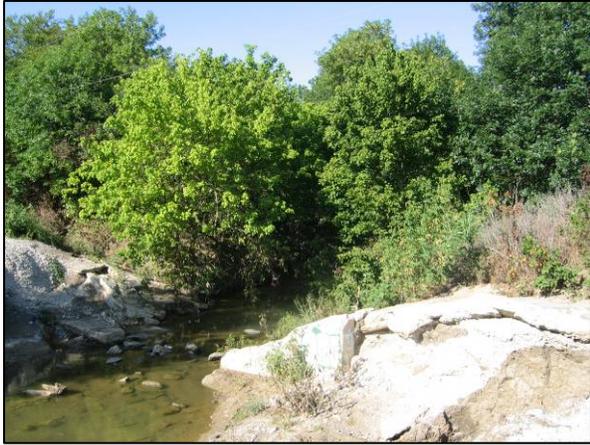
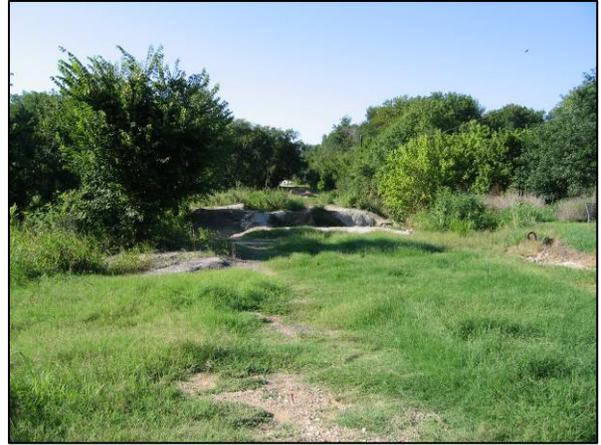
Photogroup 7-3 Cottonwood Creek Site CC101 showing abandoned road crossing providing access to stream. [\[Return to Text\]](#)

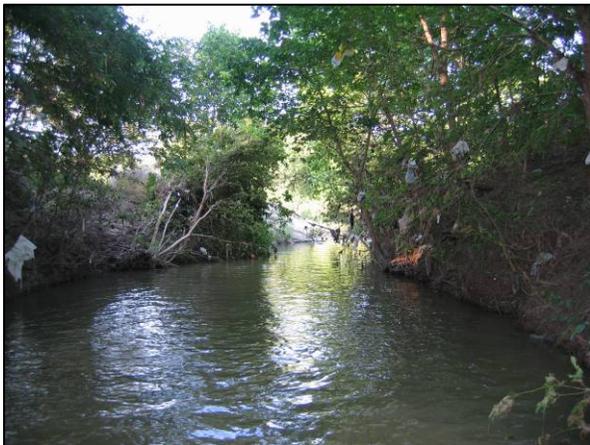
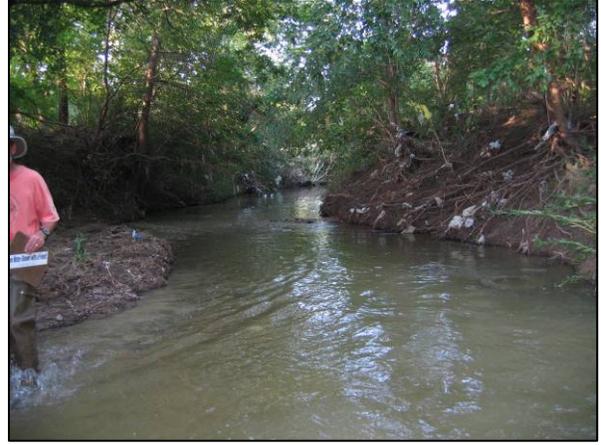
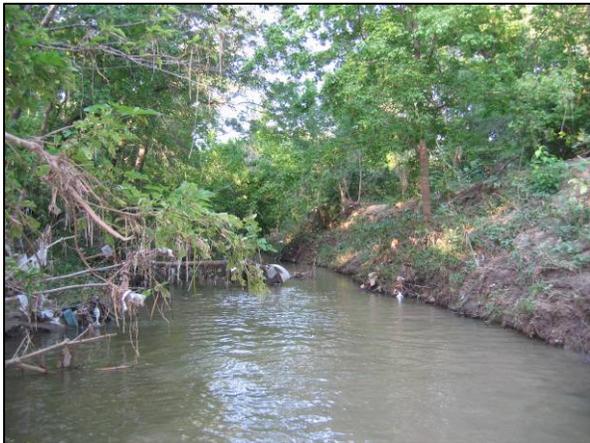
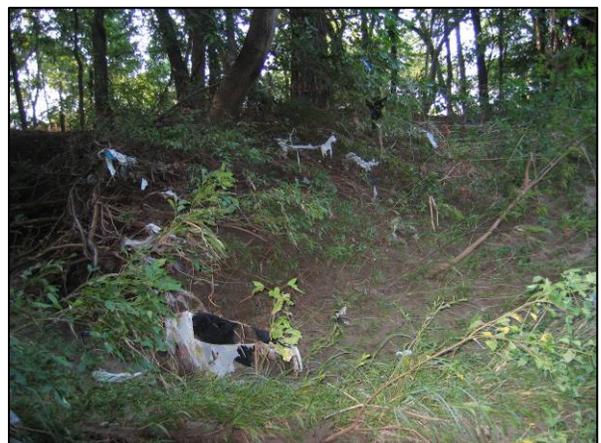
Aquatic vegetation at the site was absent and algae cover was absent to rare. A slight presence of water dependent birds and one snake was observed during one of the surveys. No other vertebrates were observed in the study reach, although fecal droppings and tracks were present. Unusual odors were rare and the surface of the stream was clear. Large garbage in the stream was common, while small garbage in the stream was rare. Large garbage consisted primarily of remnants from household appliances. Bank garbage consisting of plastic bottles and bags, paper was also abundant. The aesthetics of the stream were not pleasant due to the level of trash observed throughout the stream. [Photogroup 7-4](#) shows the garbage along the banks of the stream

Photogroup 7-4 Cottonwood Creek Site CC101 showing garbage along banks of creek at 120-m, 150-m, 210-m, and 270-m transects. (Individual pictured is TIAER staff.) [\[Return to Text\]](#)

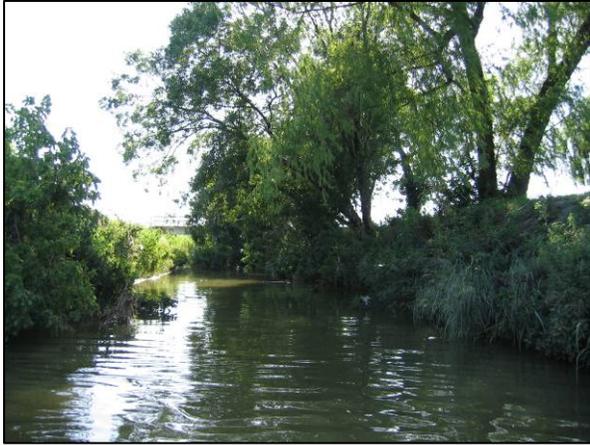
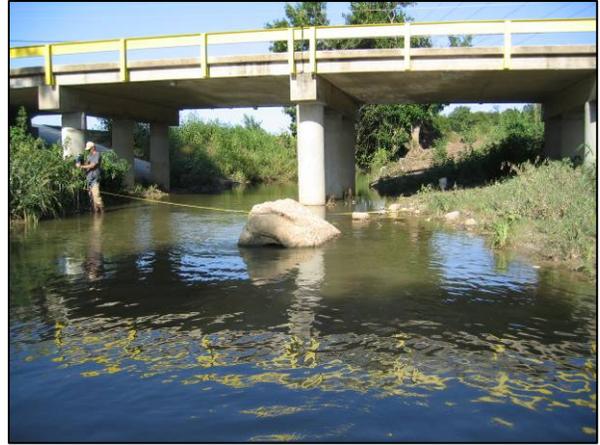
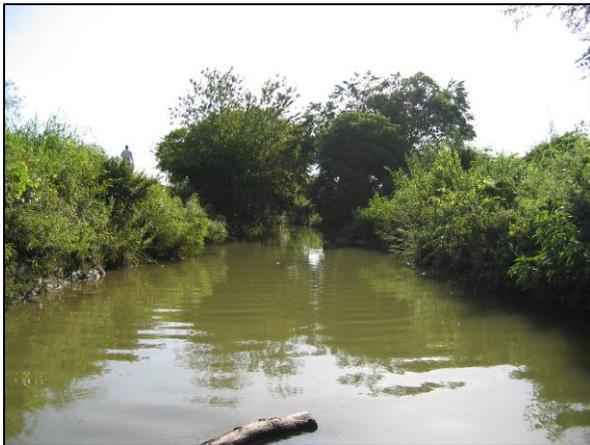
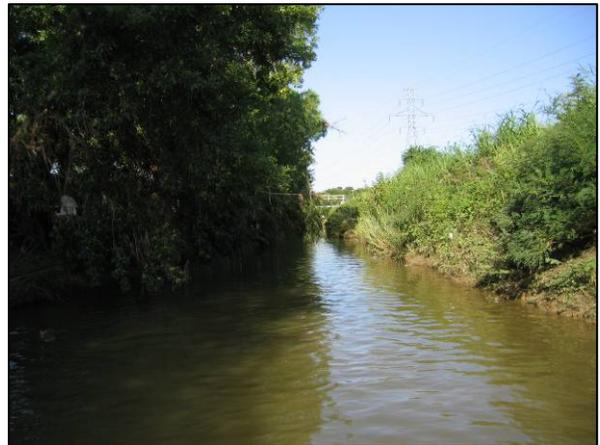
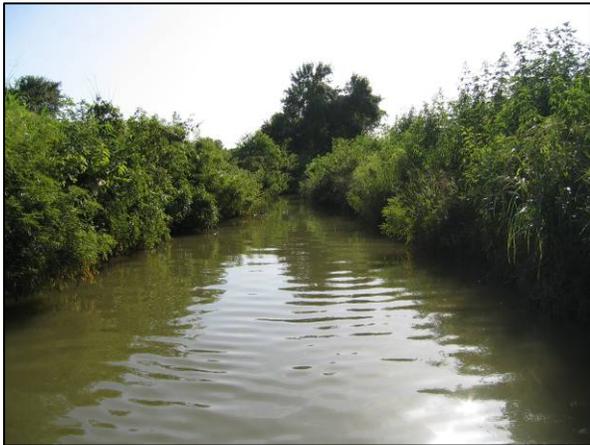
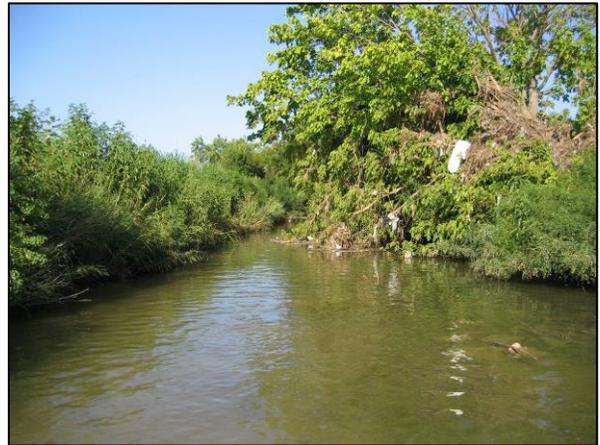
Photogroup 7-5

Cottonwood Creek Site CC102 showing stream views upstream and then downstream at the 0-m (upper row), 150-m (middle row), and 300-m (lower row) transects. (Individual pictured is TIAER staff.) [\[Return to Text\]](#)

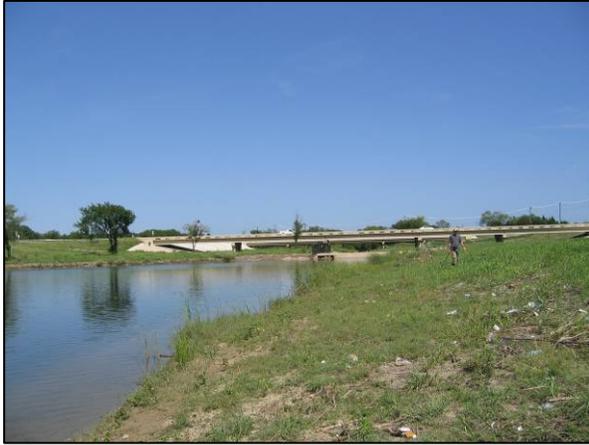
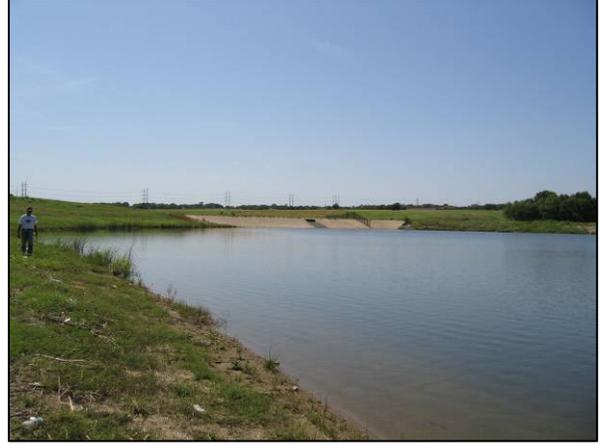
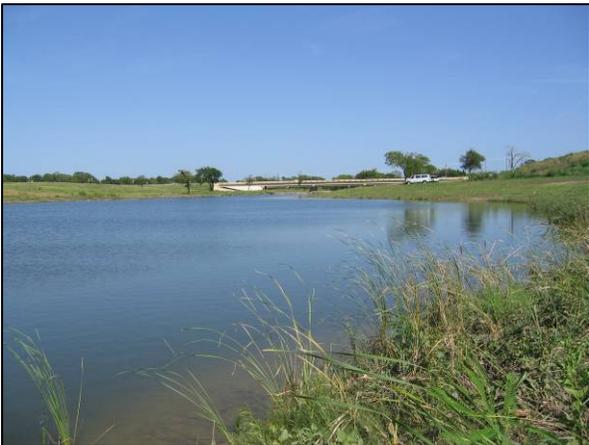
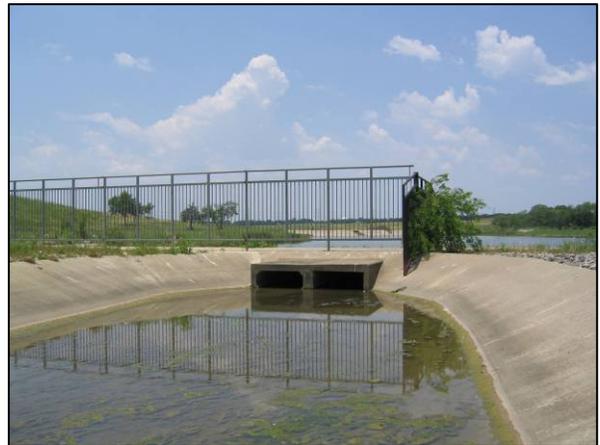
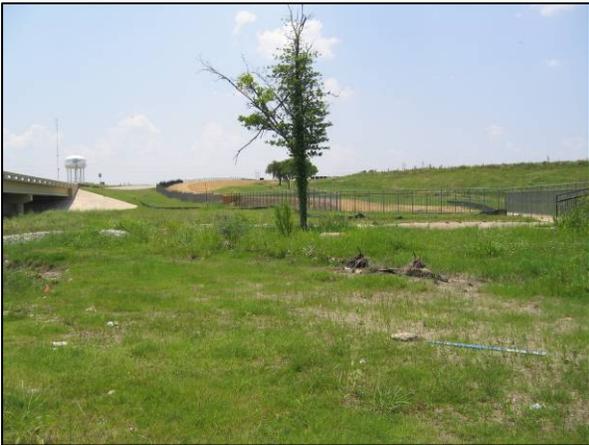
Photogroup 7-9 Cottonwood Creek Site CC103 showing impoundment. [\[Return to Text\]](#)

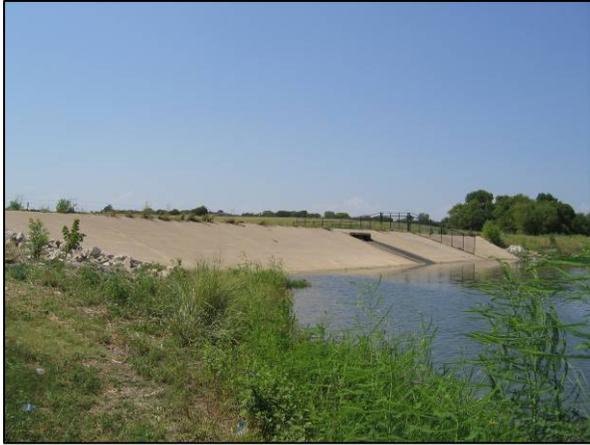
Photogroup 7-10 Cottonwood Creek Site CC103 showing impoundment and security fencing being constructed around private property including the impounded area. (Individuals pictured are TIAER staff.) [\[Return to Text\]](#)

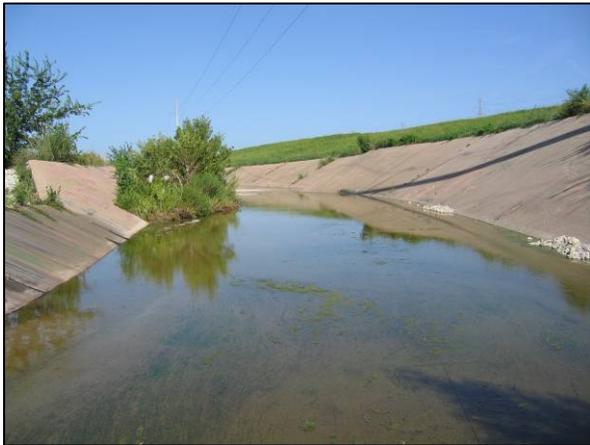
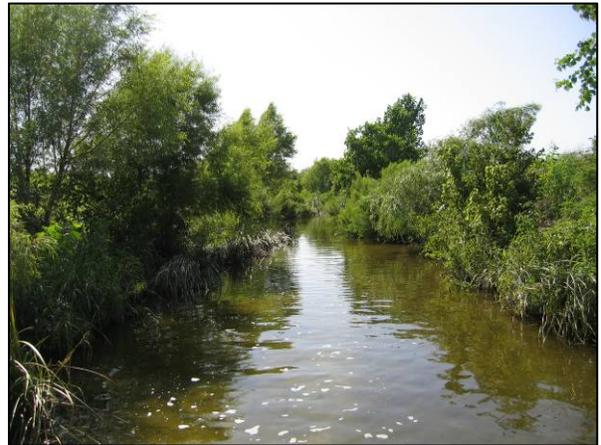
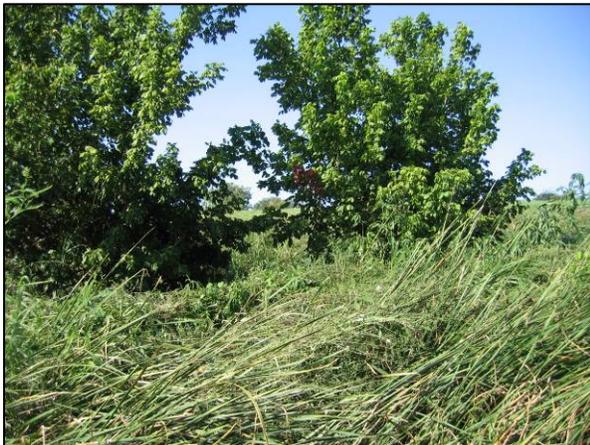
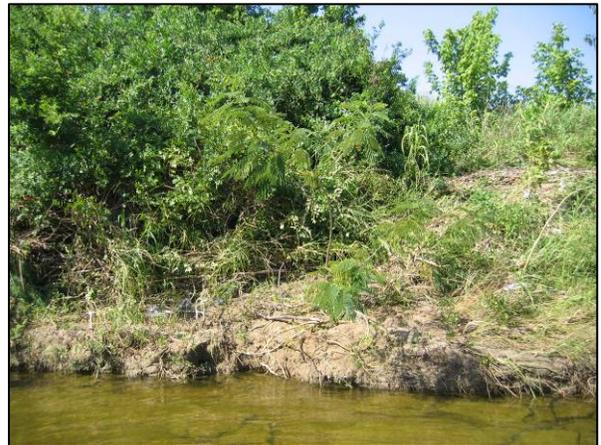
Photogroup 7-11 Cottonwood Creek Site CC103 showing another dam upstream of the 300-m transect. [\[Return to Text\]](#)
