Dallas-Fort Worth Metroplex Urban Creeks
Trinity River Bacteria TMDL Project
Recreational Use-Attainability Analysis Report

Report to TMDL Team
Texas Commission on Environmental Quality
Project and Work Order Number
582-5-70859-26

Jeff Stroebel
Tim Jones
Larry Hauck
Texas Institute for Applied Environmental Research
Tarleton State University
Stephenville, Texas

November 2010

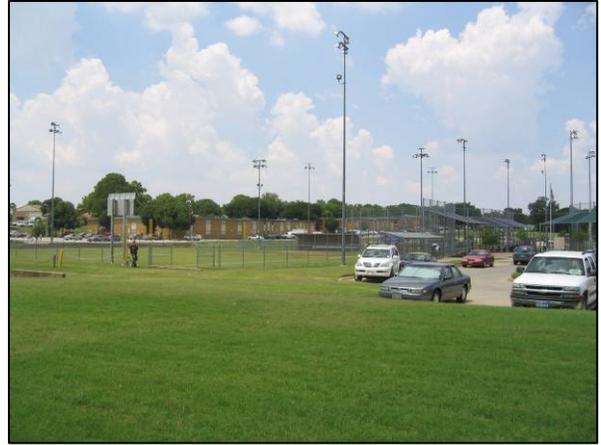
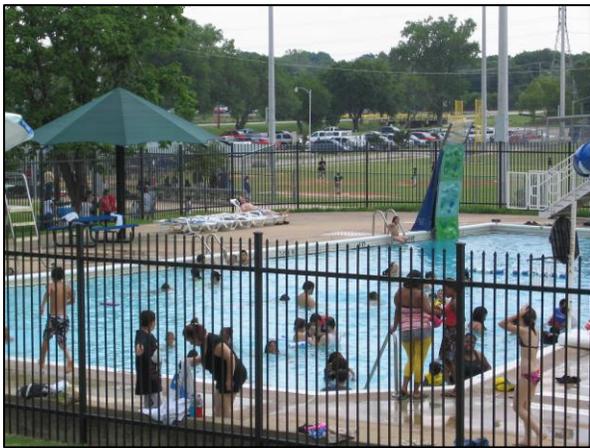
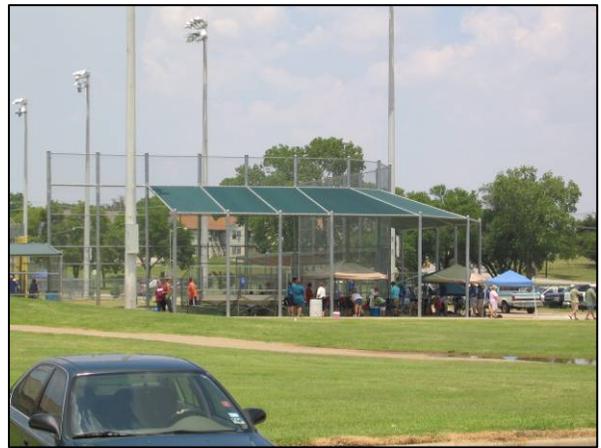
Photogroup 7-16 Cottonwood Creek Site CC102 showing some of the observed recreational activities in Cottonwood Park. [Return to Text](#)

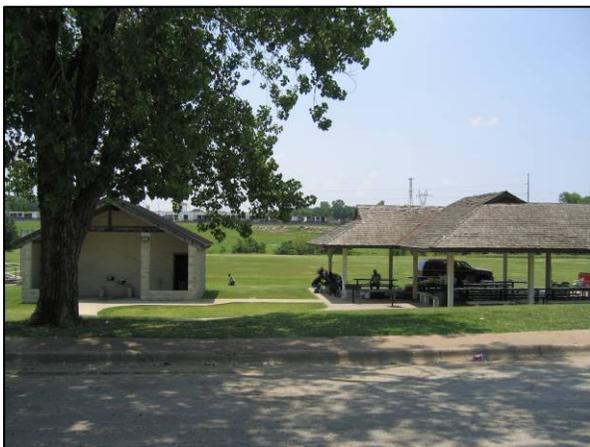
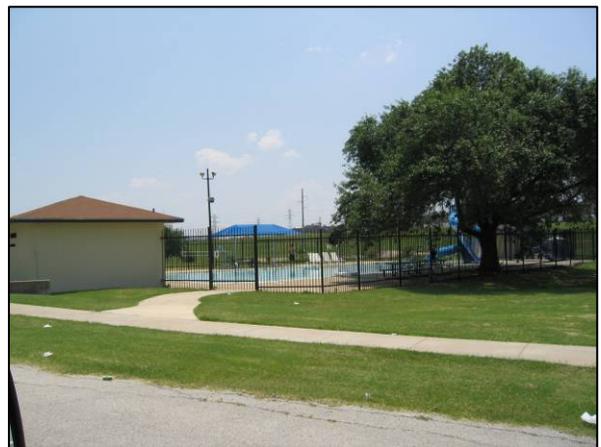
Photogroup 7-17 Cottonwood Creek Site CC104 showing some of observed activities at Tyre Park. [Return to Text](#)

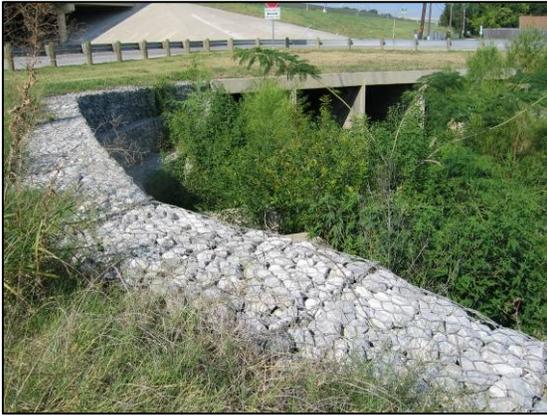
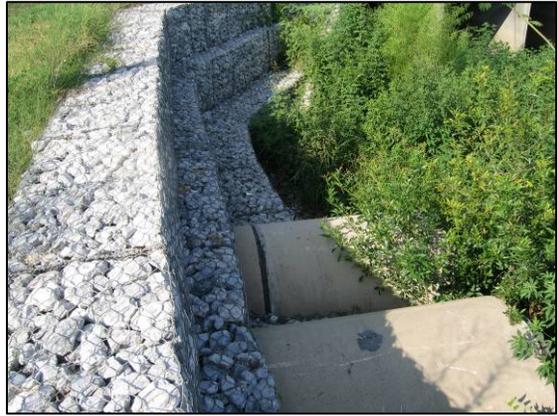
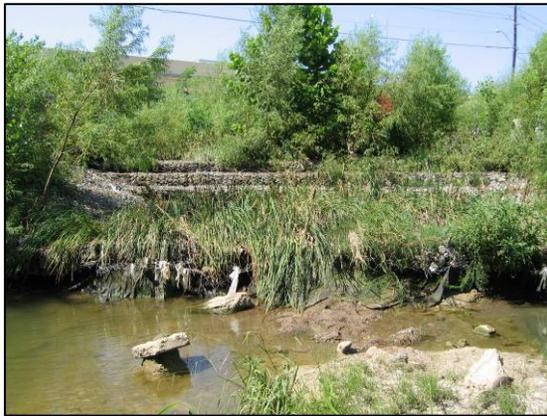
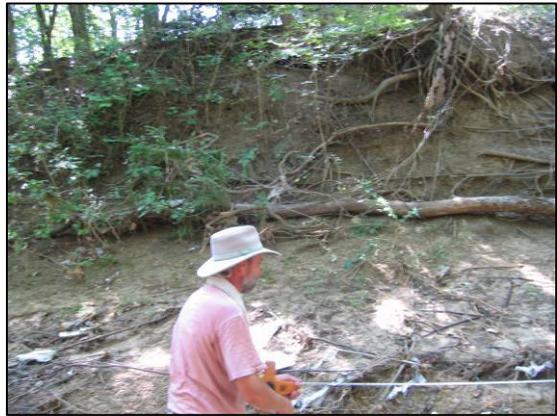
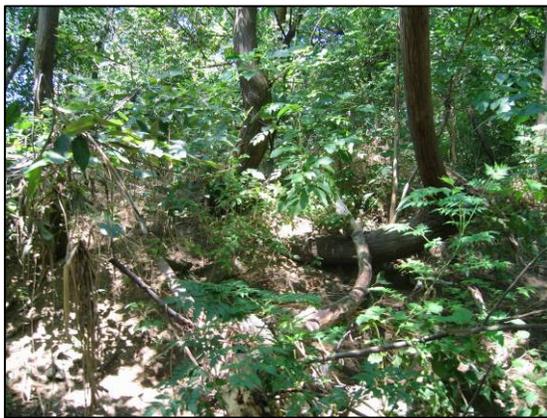
Photogroup 8-1 Dalworth Creek Site DW101 depicting steepness of bank and gabions. (Individual pictured is TIAER staff.) [\[Return to Text\]](#)

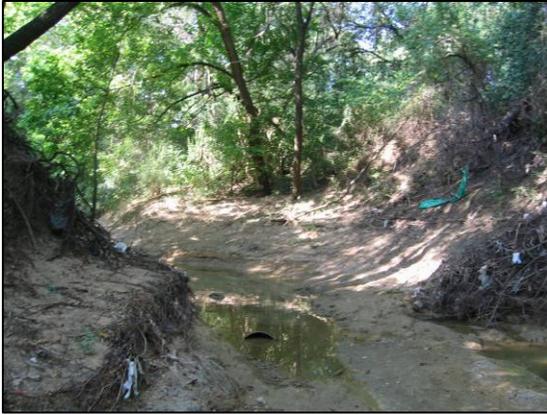
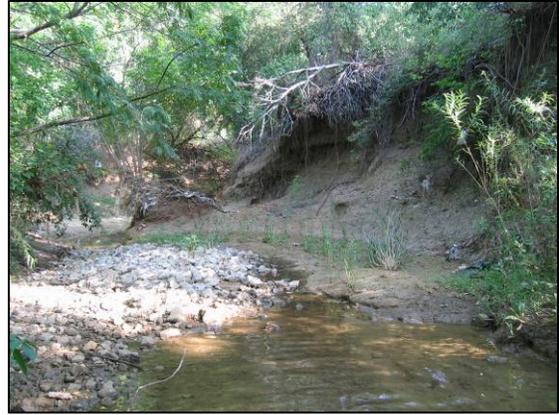
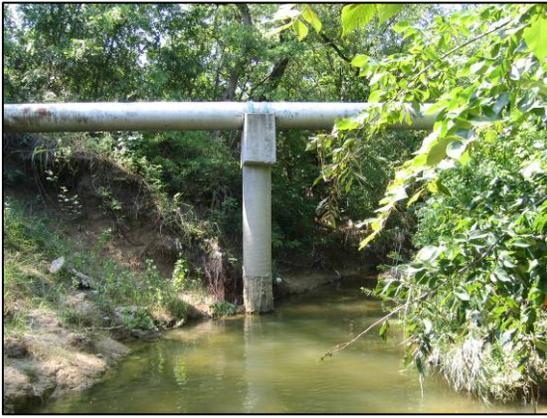
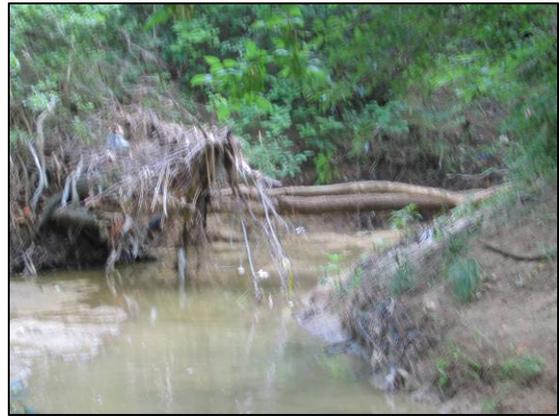
Photogroup 8-2 Dalworth Creek Site DW101 showing stream size, utility pipeline crossing and fallen tree obstruction. [\[Return to Text\]](#)

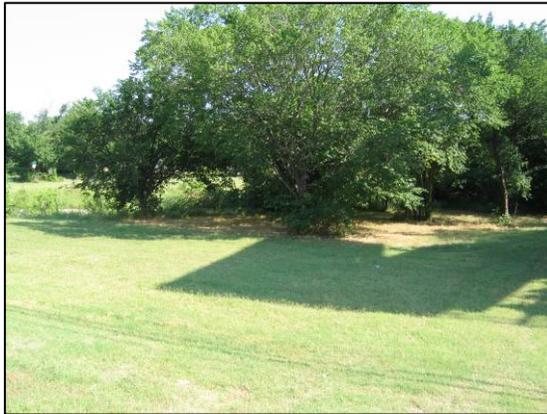
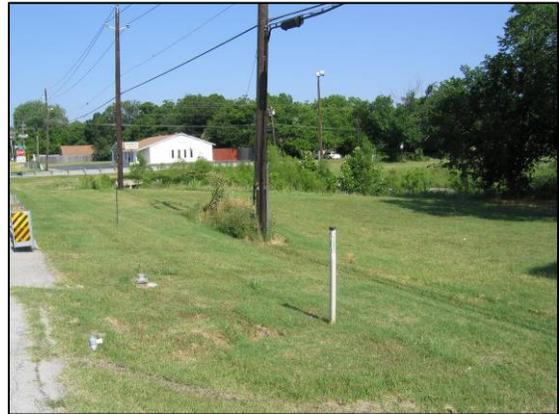
Photogroup 8-3 Dalworth Creek Site DW101 showing areas where vehicle parking could occur. [\[Return to Text\]](#)

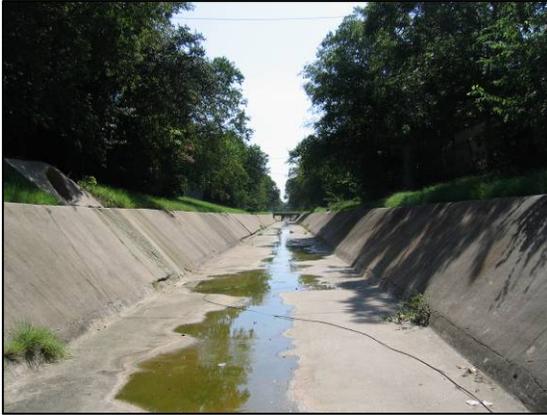
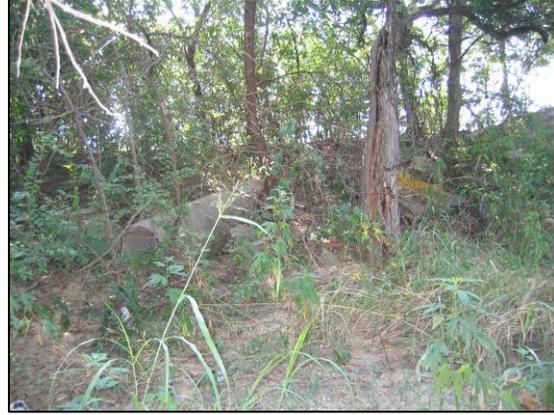
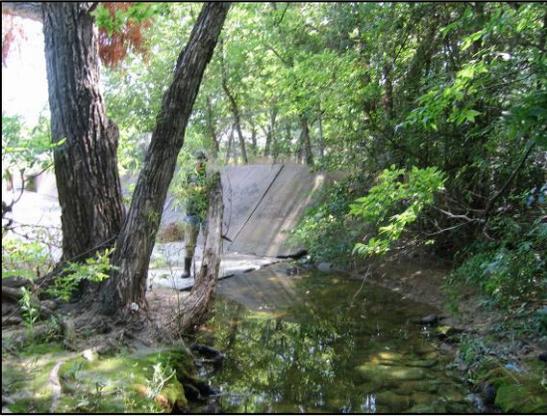
Photogroup 8-4 Dalworth Creek Site DW102 showing concrete lined channel, natural streambank, and transition between the two channel types. (Note: Person in bottom photograph is a member of the survey crew.) [\[Return to Text\]](#)

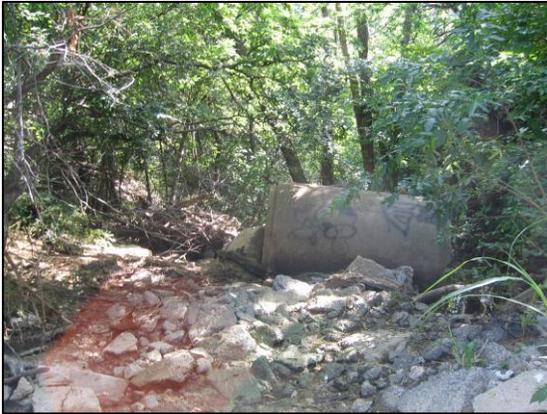
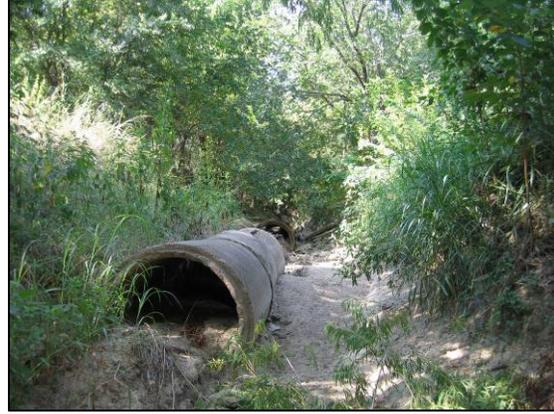
Photogroup 8-5 Dalworth Creek Site DW102 showing concrete pipes at 100-m and 200-m transects. [\[Return to Text\]](#)

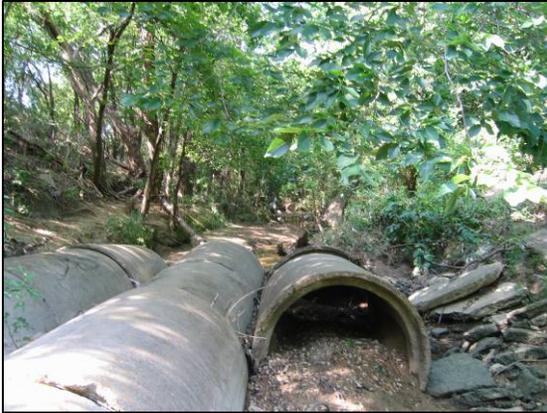
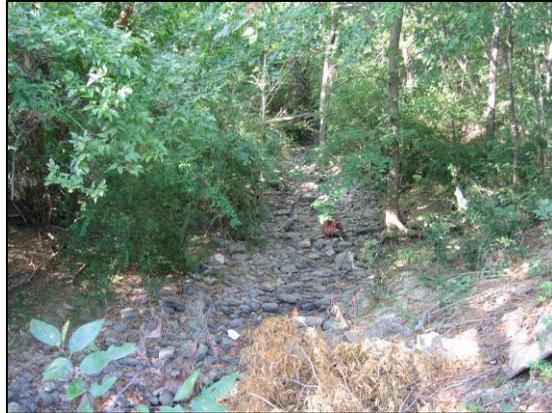
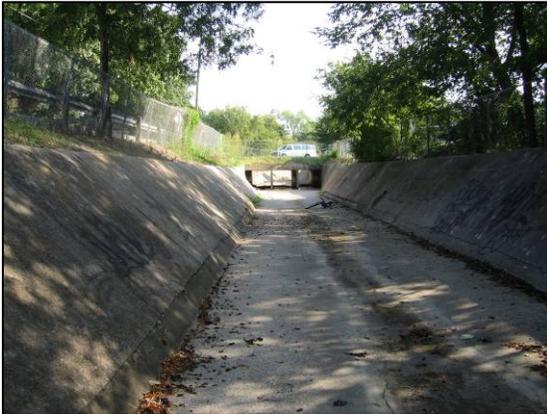
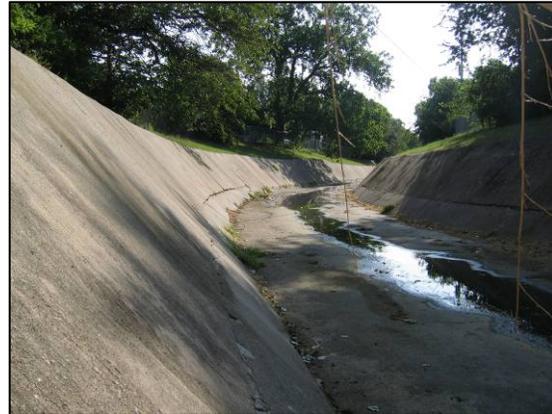
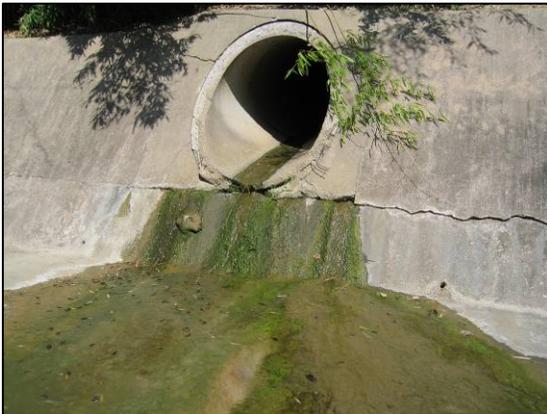
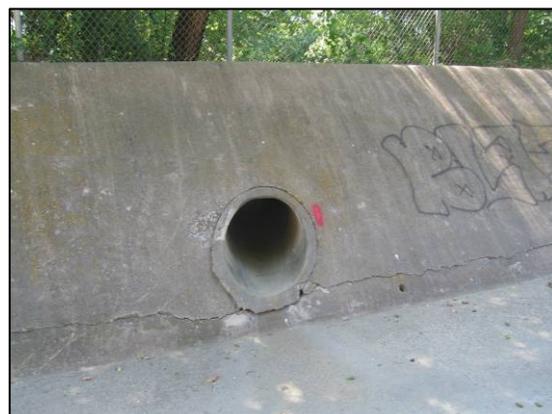
Photogroup 8-6 Dalworth Creek Site DW102 showing natural channel with concrete pipe, channelized portion, and storm drains entering stream. [[Return to Text](#)]

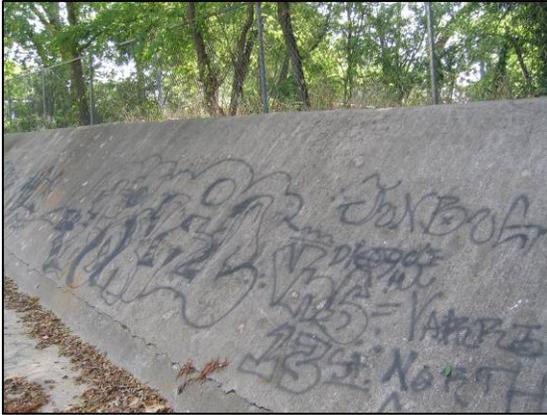
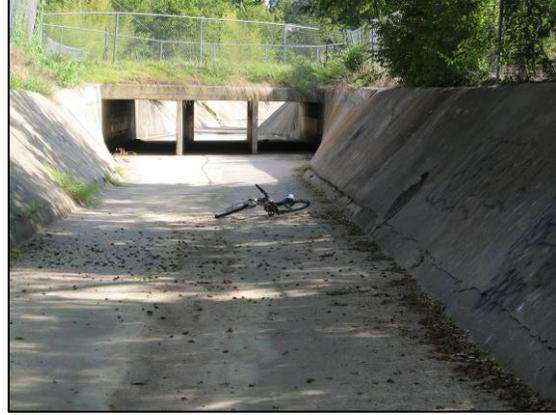
Photogroup 8-7 Dalworth Creek Site DW102 showing graffiti on channel walls and bicycle in bottom of channel. [\[Return to Text\]](#)

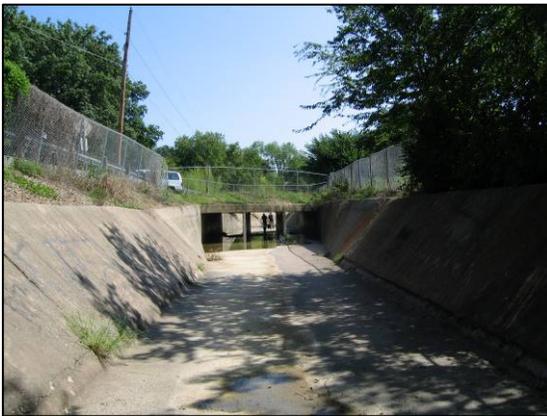
Photogroup 8-8 Dalworth Creek Site DW102 looking at Roman Road crossing showing box culvert and parking on Roman Road. (Note survey staff in stream at a distance.) [\[Return to Text\]](#)

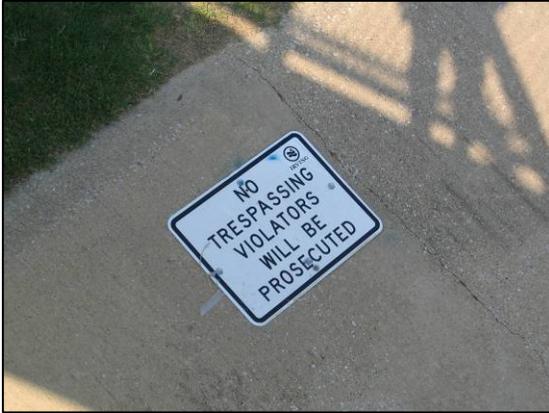
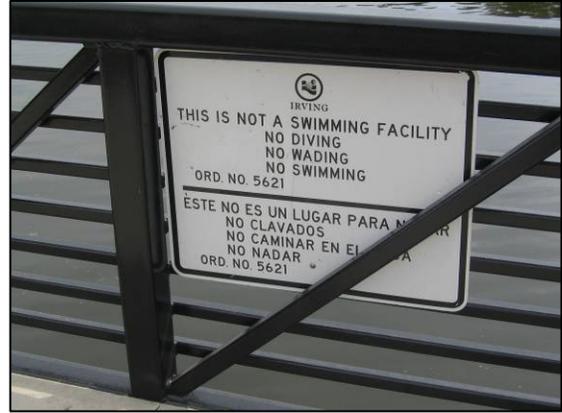
Photogroup 9-1 Typical no trespassing and no swimming signs posted in parks along Delaware Creek. [\[Return to Text\]](#)

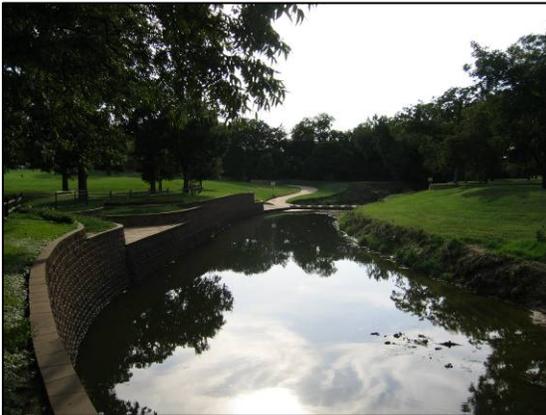
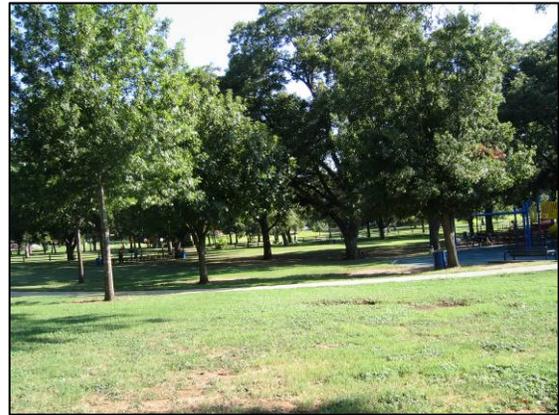
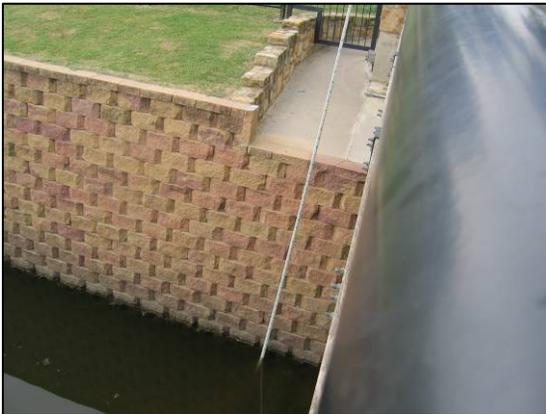
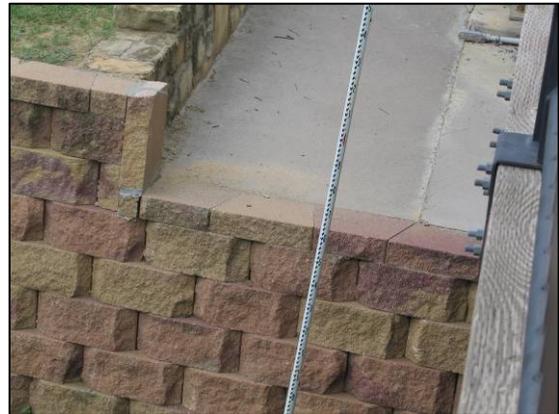
Site DC101 (TCEQ Station 15617) is located at Delaware Cr. and Fritz Park 756 meters upstream of E. Oakdale Rd. in Irving. The stream is accessible from the park though the stream is posted keep out until it reaches the downstream portion where the channel becomes more natural, where it is filled with large blocks of cement and rip rap.

Photogroup 9-2 Physical setting at Site DC101, Delaware Creek (Group 1 of 2). [\[Return to Text\]](#)

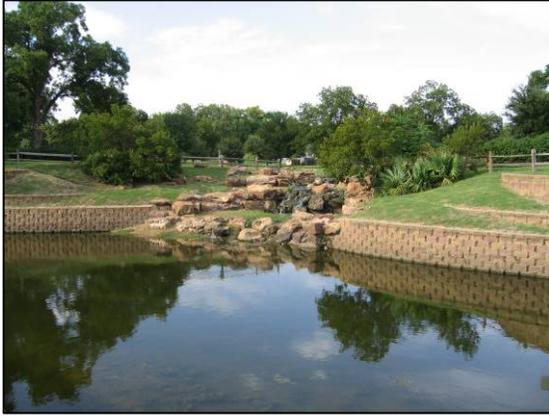
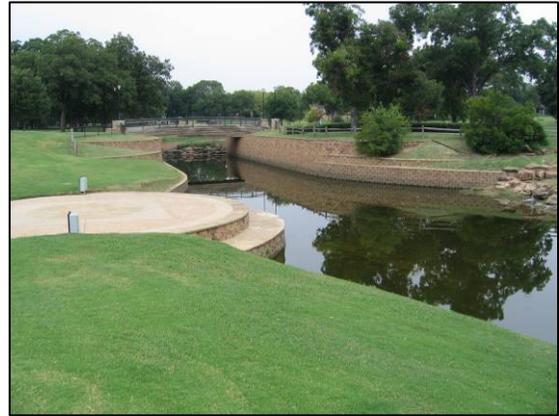
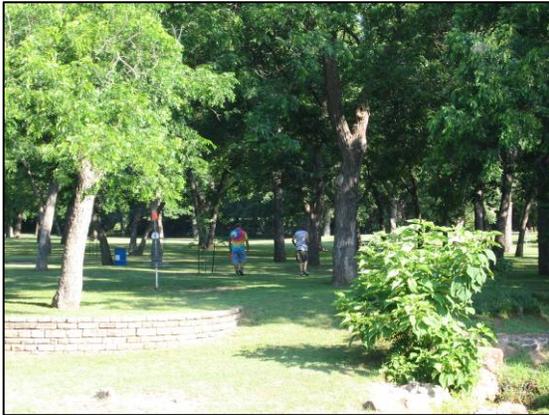
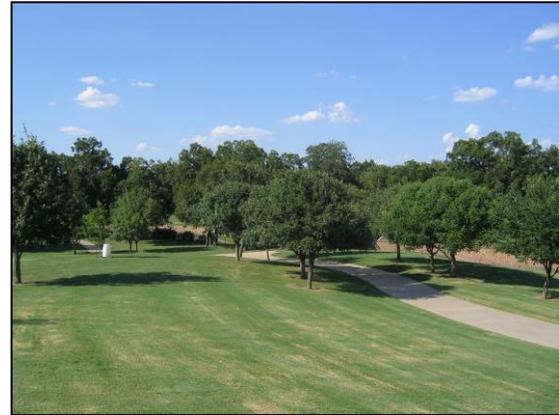
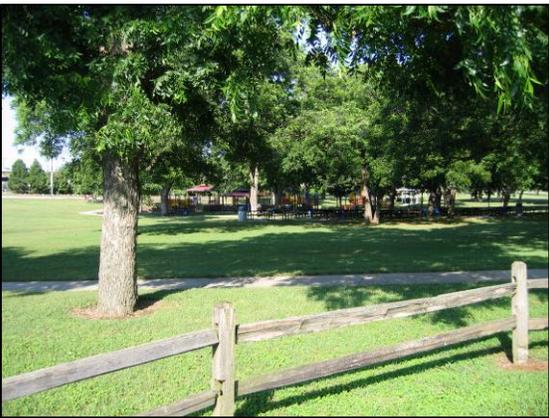
Photogroup 9-3 Physical setting at Site DC101, Delaware Creek (Group 2 of 2).
[\[Return to Text\]](#)

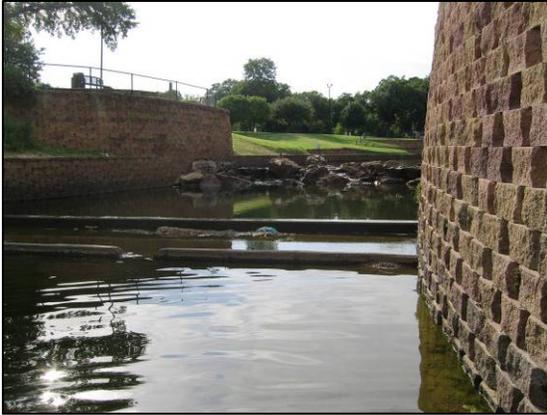
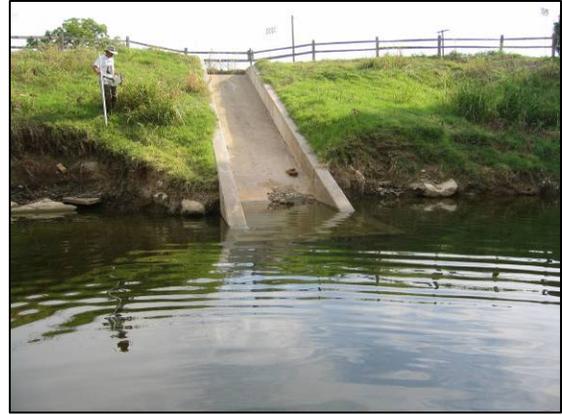
Photogroup 9-4 Delaware Creek Site DC101 near 60-m transect showing small dam and drainage culvert. (Individual pictured is TIAER staff.)
[\[Return to Text\]](#)

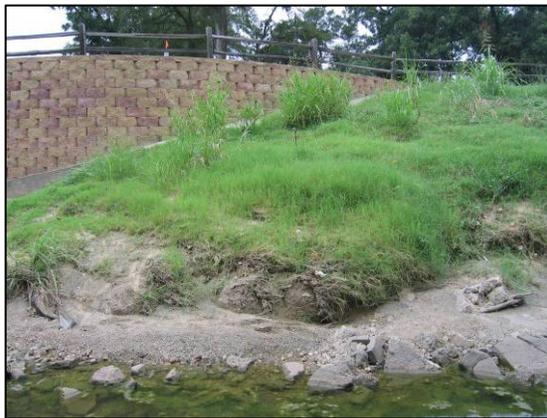
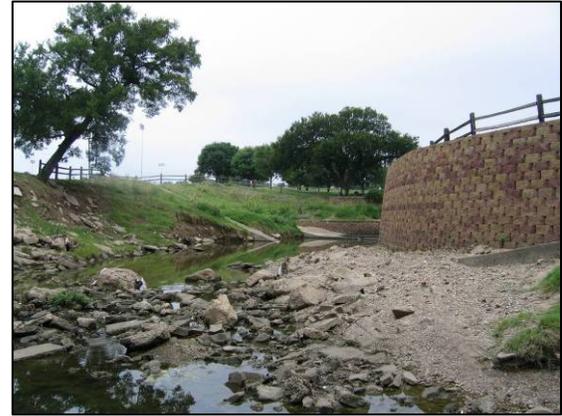
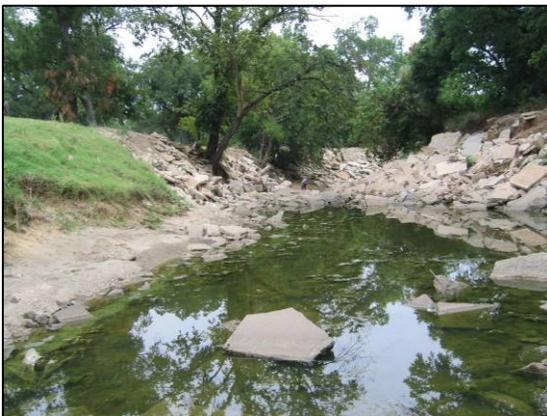
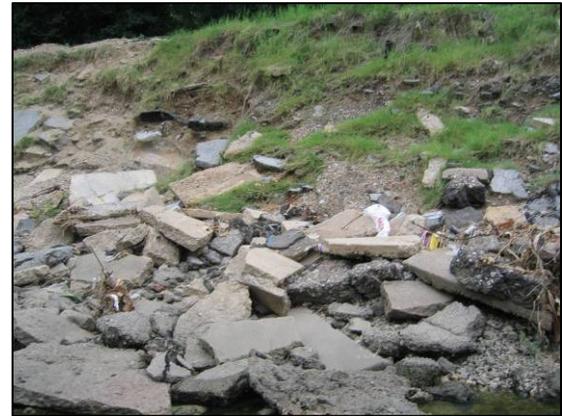
Photogroup 9-5 Delaware Creek Site DC101 below 60-m transect showing rocks and concrete debris [\[Return to Text\]](#)

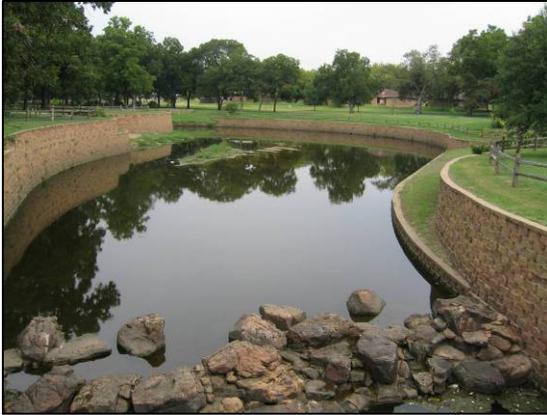
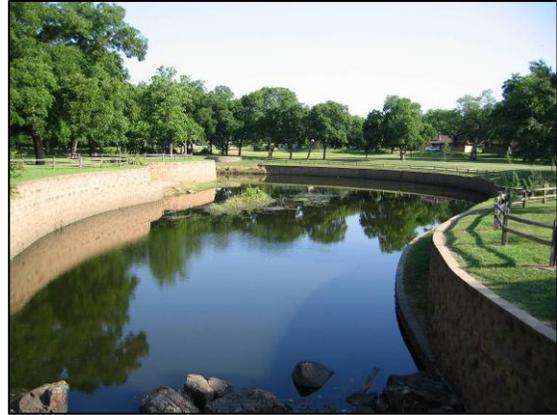
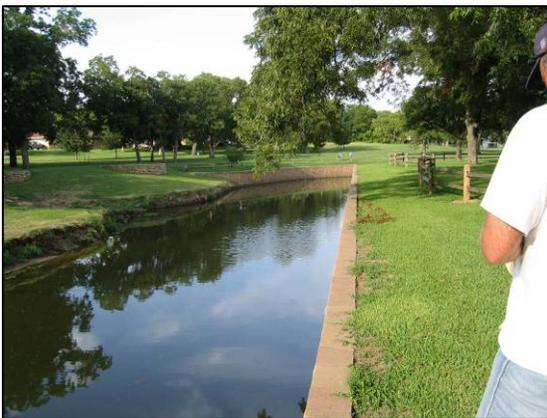
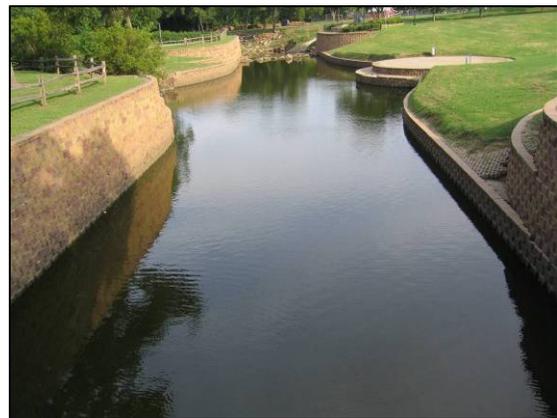
Photogroup 9-6 Delaware Creek Site DC101 showing pools in the 60-m to 150-m transect area. (Individual pictured is TIAER staff.) [[Return to Text](#)]

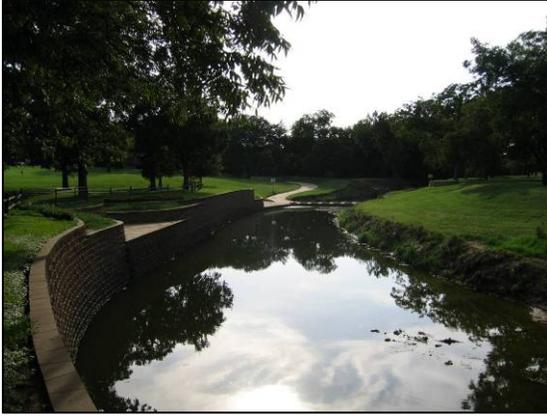
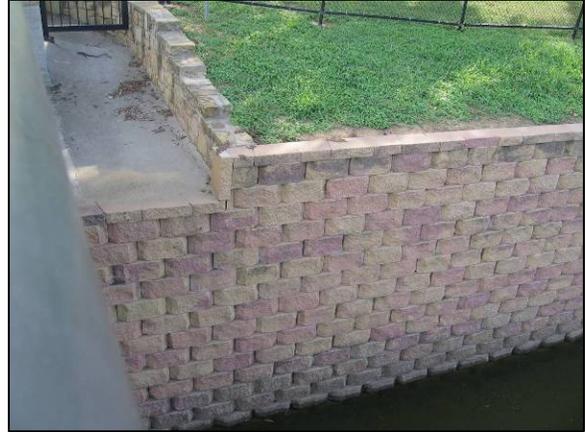
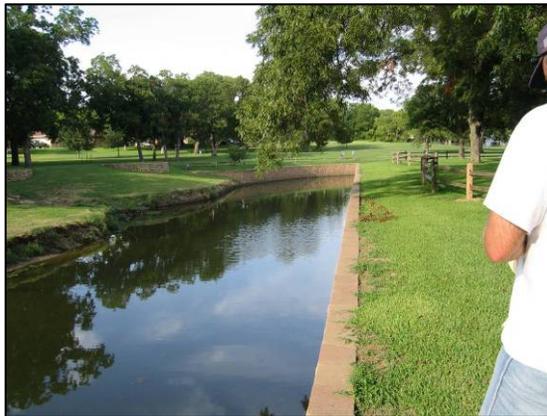
Photogroup 9-7 Delaware Creek Site DC101 showing streambanks along the 300-m reach. (Individual pictured is TIAER staff.) [\[Return to Text\]](#)

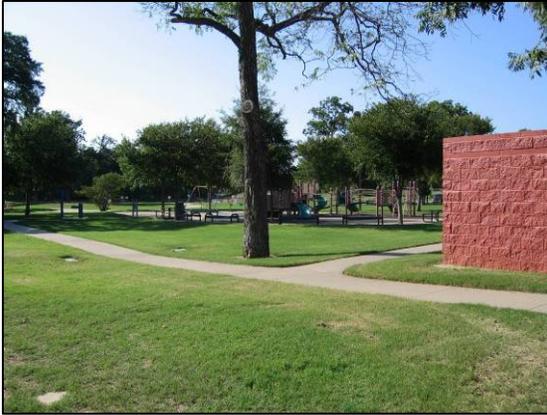
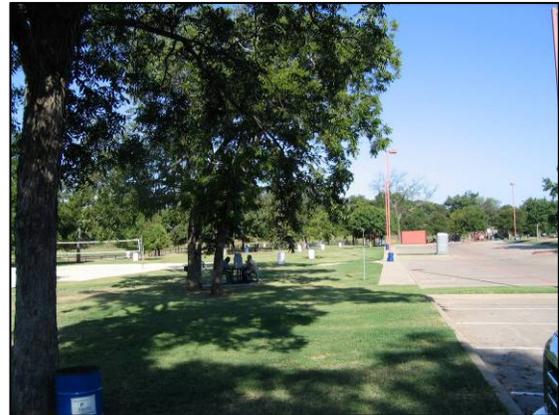
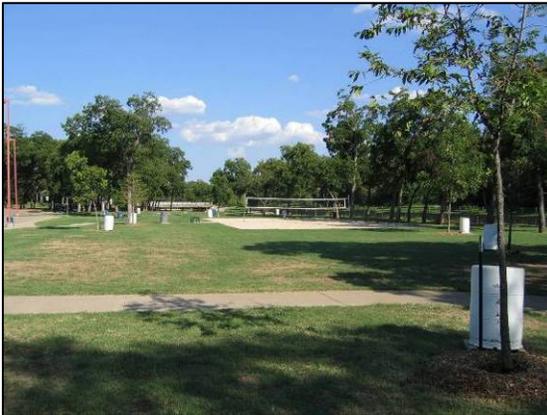
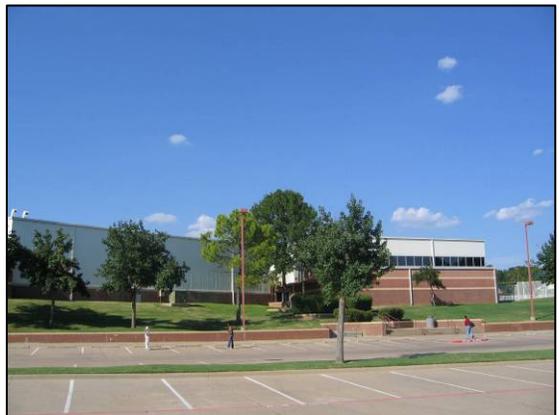
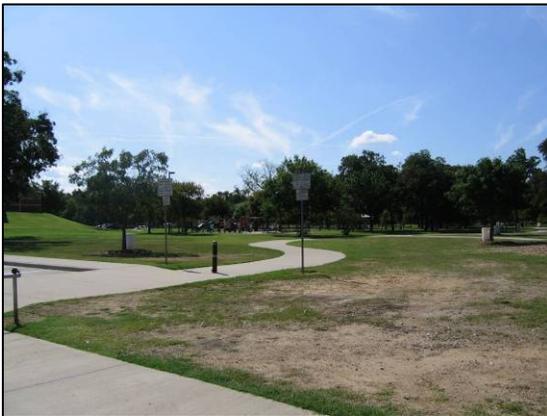
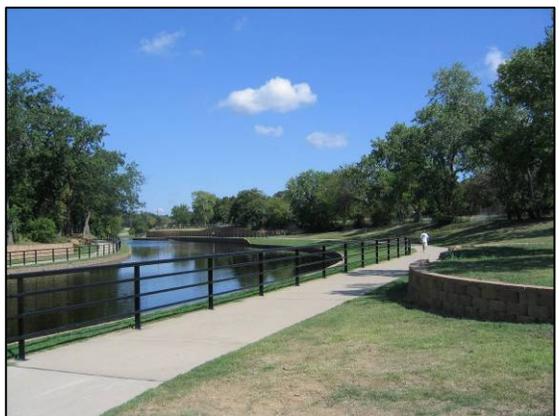
Photogroup 9-8 Delaware Creek Site DC102 showing amenities of Senter Park
[\[Return to Text\]](#)

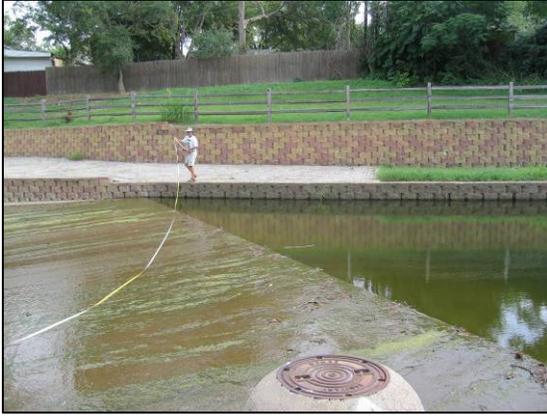
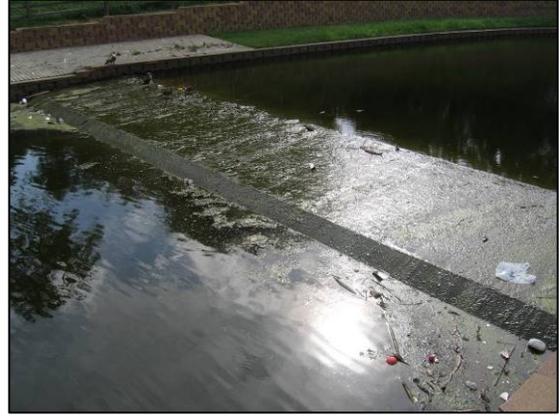
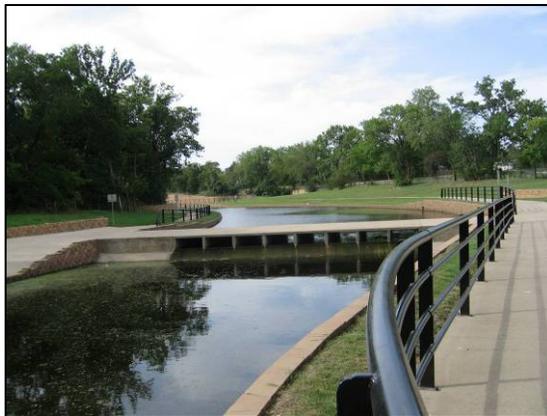
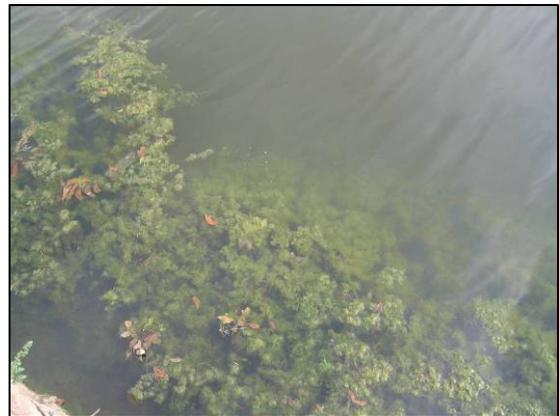
Photogroup 9-9 Delaware Creek Site DC102 depicting dams and macrophytic growth. (Individual pictured is TIAER staff.) [\[Return to Text\]](#)

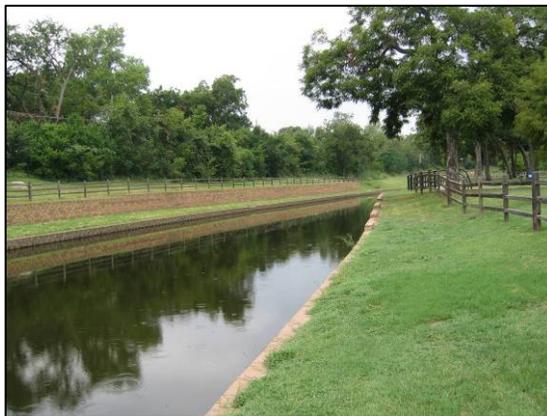
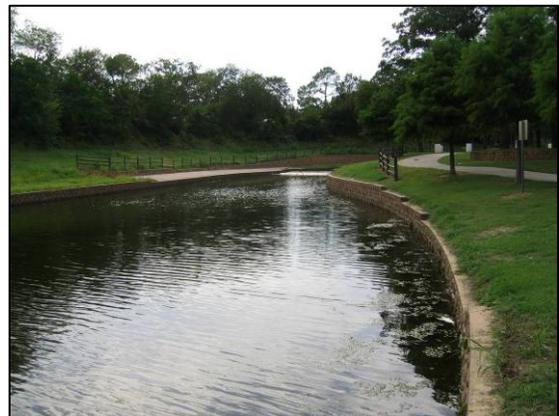
Photogroup 9-10 Delaware Creek Site DC102 showing pools behind dams. [\[Return to Text\]](#)

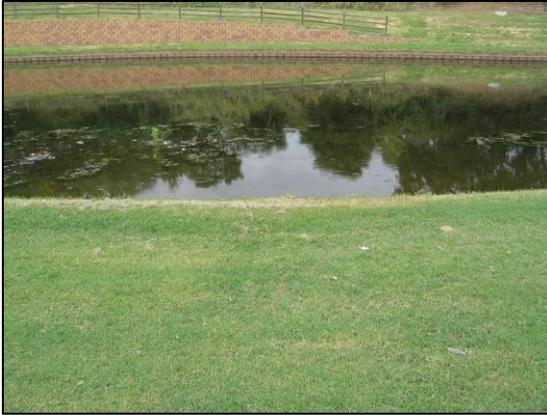
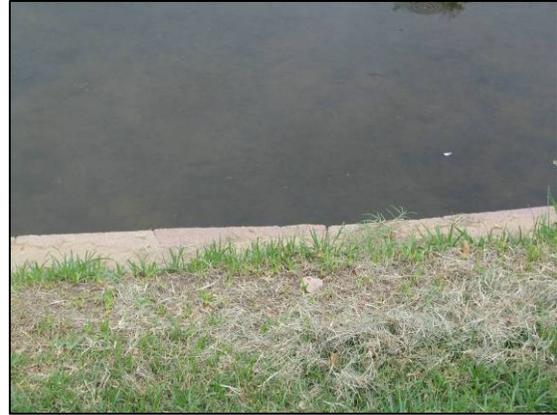
Photogroup 9-11 Delaware Creek Site DC102 showing ease of access to water
[\[Return to Text\]](#)

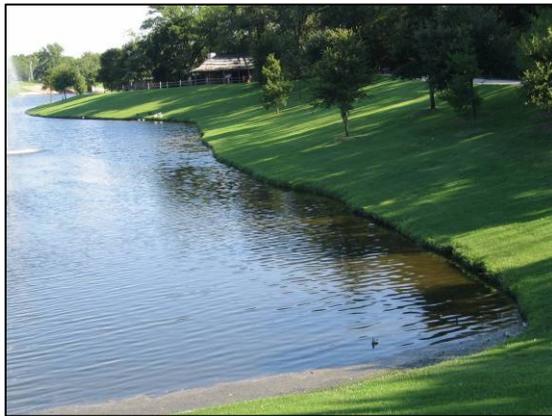
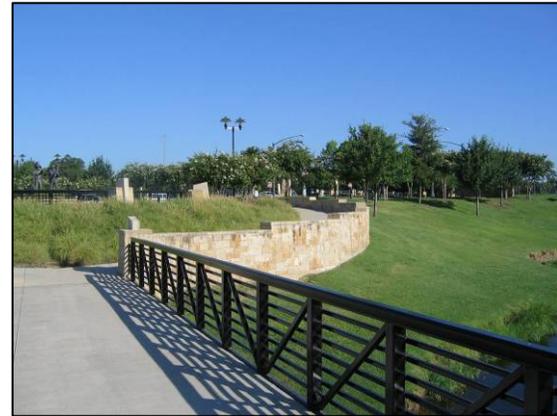
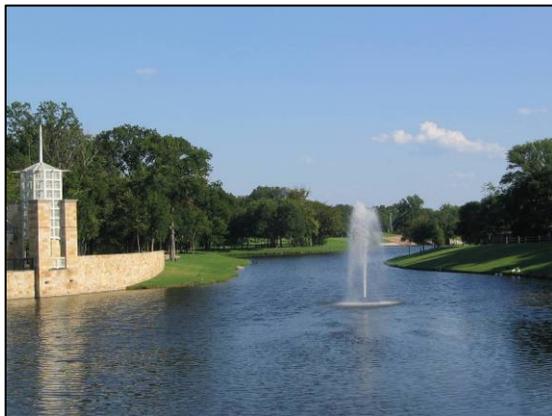
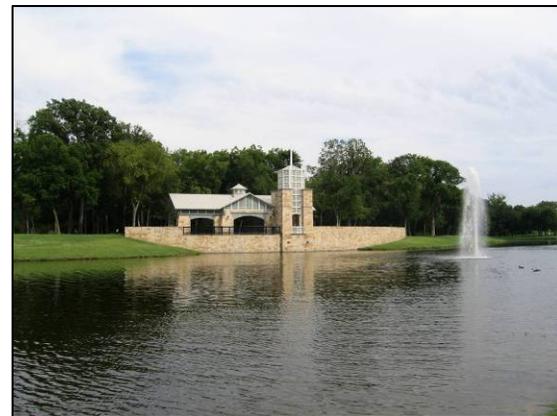
Photogroup 9-12 Delaware Creek Site DC103 showing features at Centennial Park
[\[Return to Text\]](#)

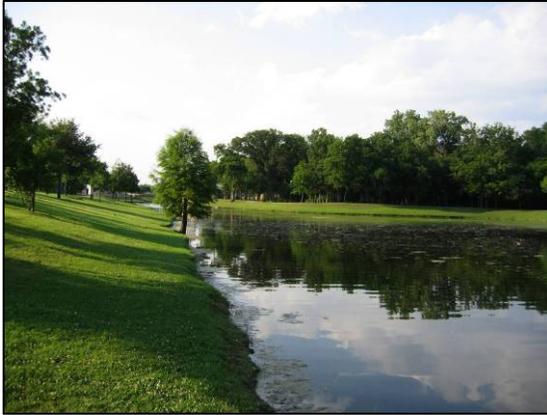
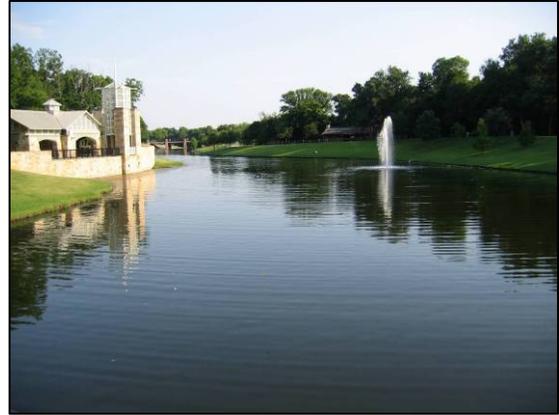
Photogroup 9-13 Delaware Creek Site DC201 showing access to stream. [Return to Text](#)

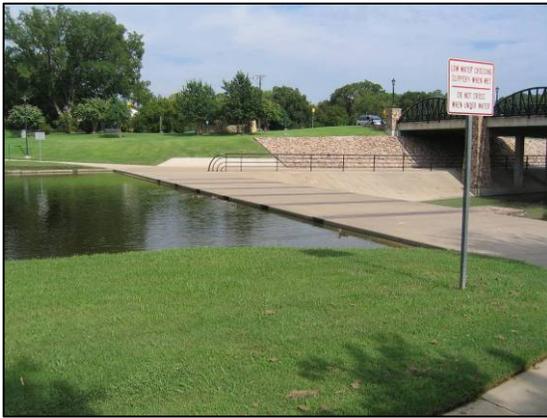
Photogroup 9-14 Delaware Creek Site DC103 showing stream below dam. [Return to Text](#)

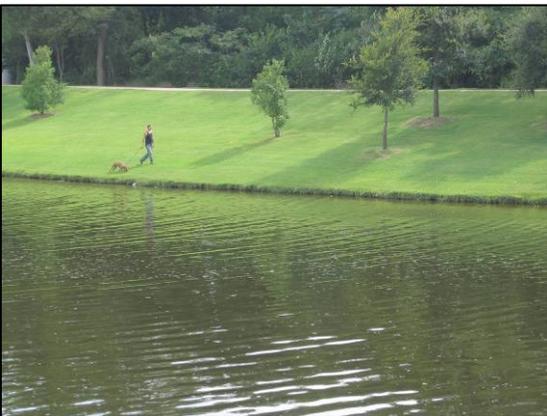
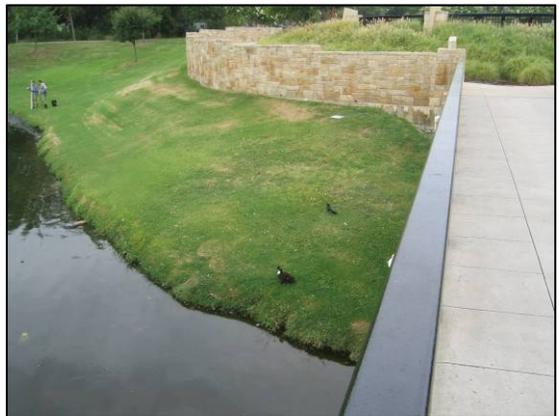
Photogroup 9-15 Delaware Creek Site DC103 showing dogs and ducks. (Individuals pictured in right photograph are TIAER staff.) [Return to Text](#)

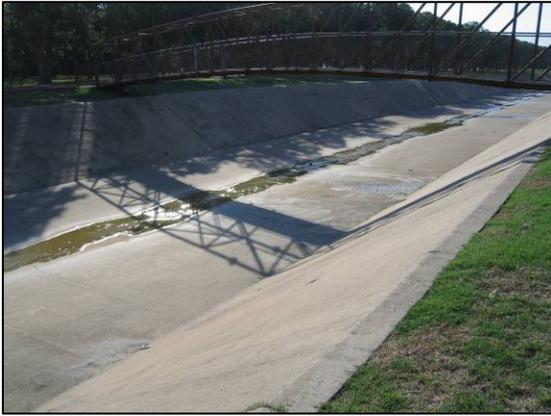
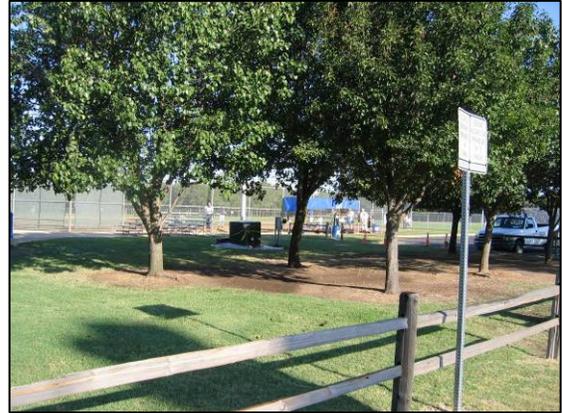
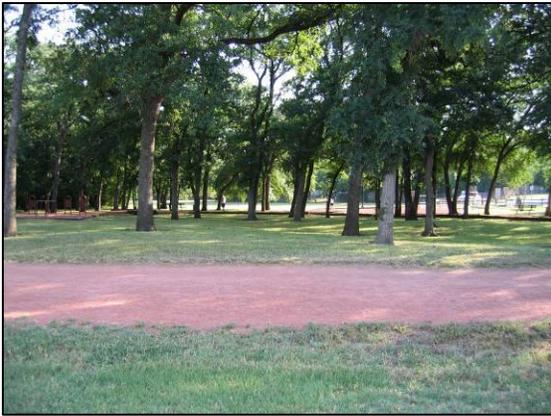
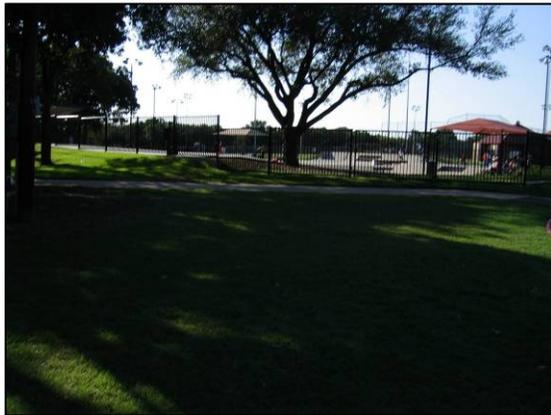
Photogroup 9-16 Delaware Creek Site DC104 showing amenities and conditions in Lively Park. [Return to Text](#)

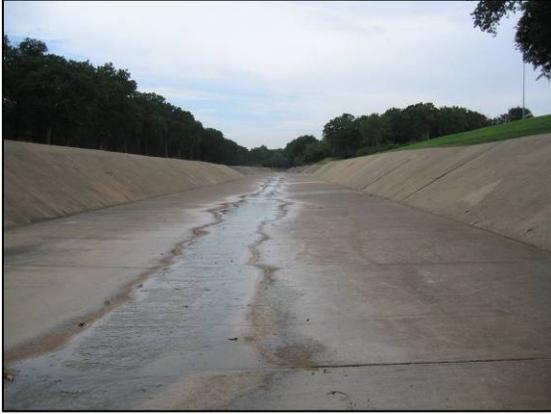
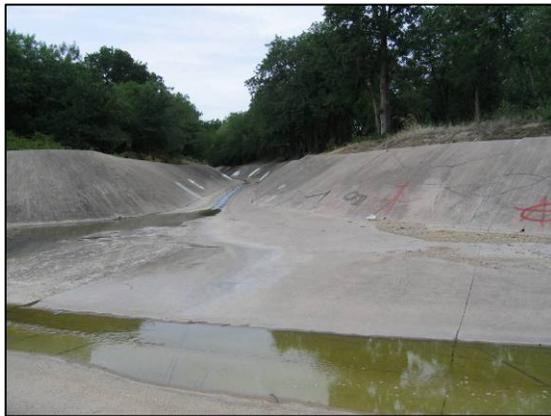
Photogroup 9-17 Delaware Creek Site DC104 at 0-m 300-m transects, and tributary entry at 180-m transect. Note: People in creek are TIAER survey crew. [\[Return to Text\]](#)

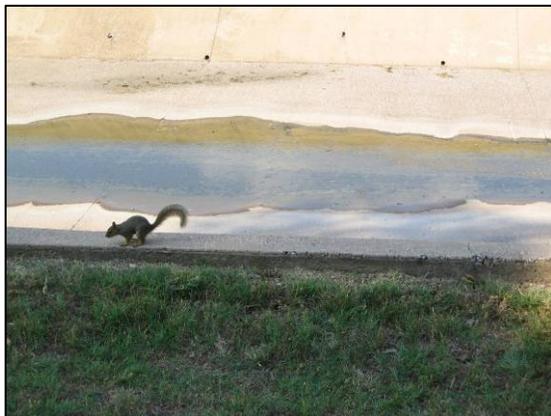
Photogroup 9-18 Delaware Creek Site DC104 showing limited urban wildlife encountered. [\[Return to Text\]](#)

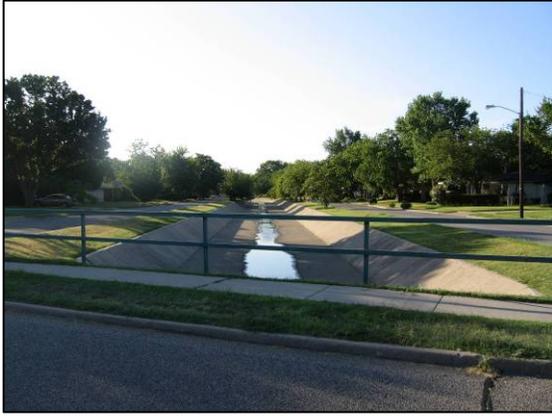
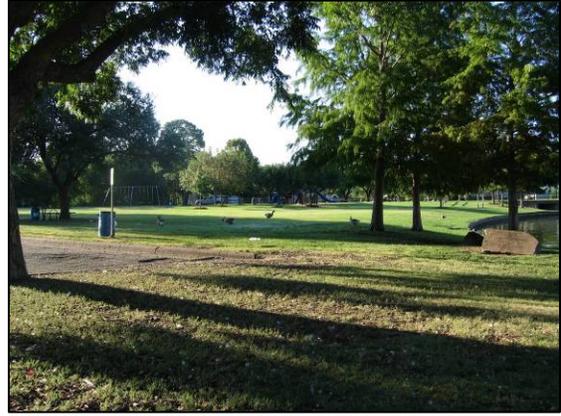
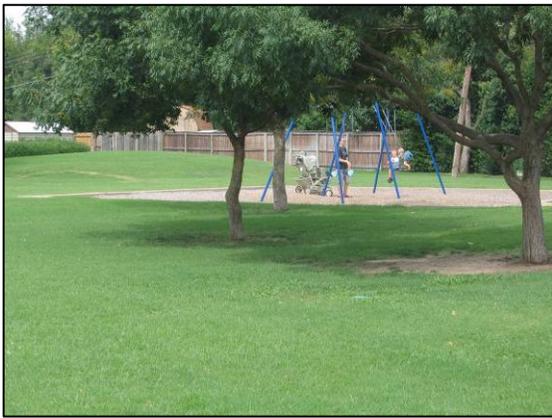
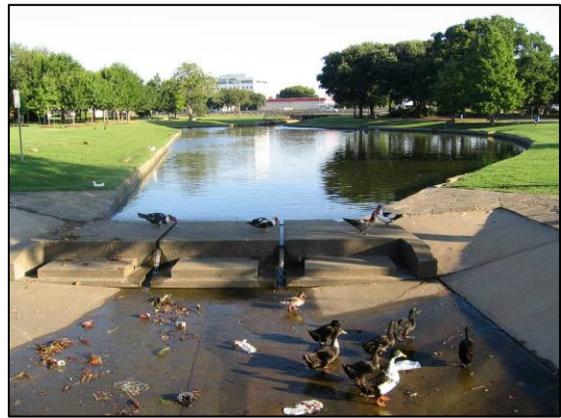
Photogroup 9-19 Delaware Creek Site DC105 showing creek and surrounding Jaycee Park [Return to Text](#)

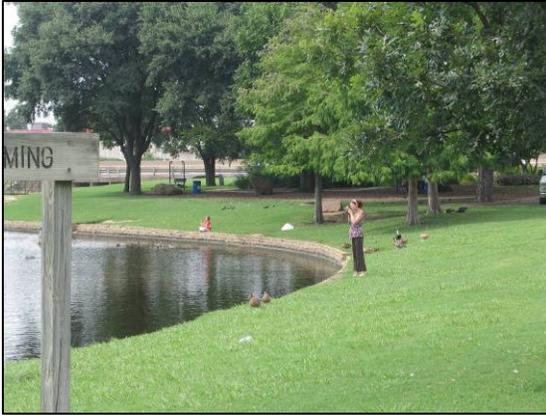
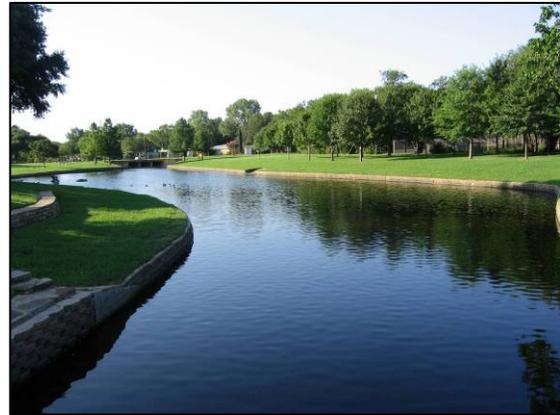
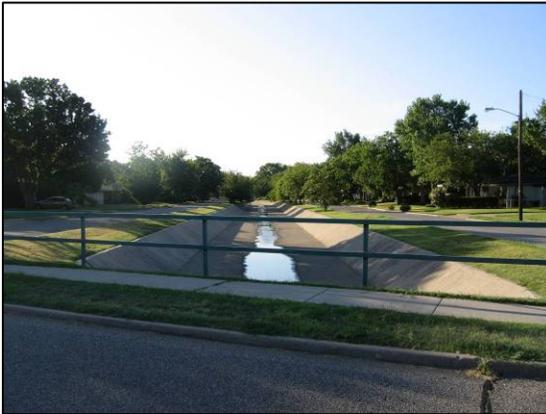
Photogroup 9-20 Delaware Creek Site DC105 showing stream accessibility and general conditions. [\[Return to Text\]](#)

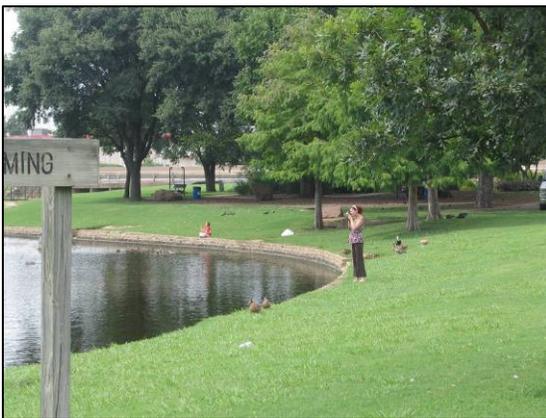
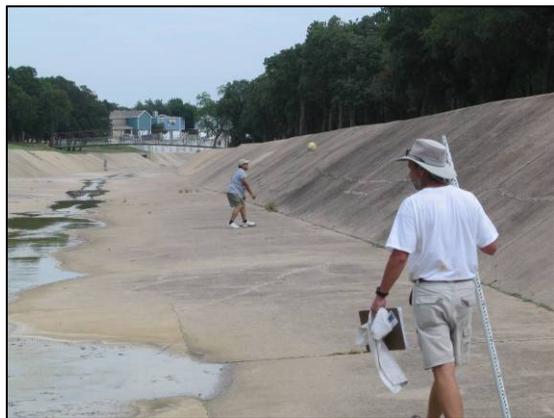
Photogroup 9-21 Delaware Creek Sites DC104 and DC105 depicting activities near water. [Person in foreground of right-hand photo is on survey crew.] [\[Return to Text\]](#)
