Dallas-Fort Worth Metroplex Urban Creeks
Trinity River Bacteria TMDL Project
Recreational Use-Attainability Analysis Report

Report to TMDL Team
Texas Commission on Environmental Quality
Project and Work Order Number
582-5-70859-26

Jeff Stroebel
Tim Jones
Larry Hauck
Texas Institute for Applied Environmental Research
Tarleton State University
Stephenville, Texas

November 2010

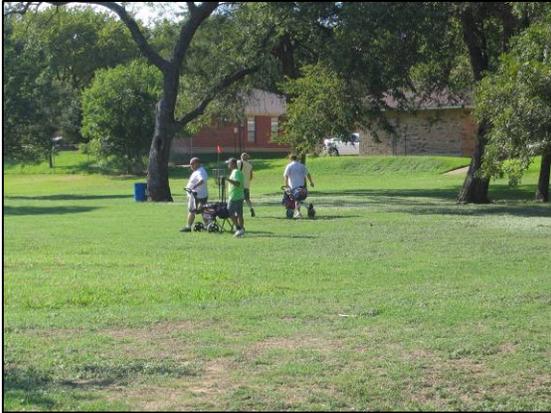
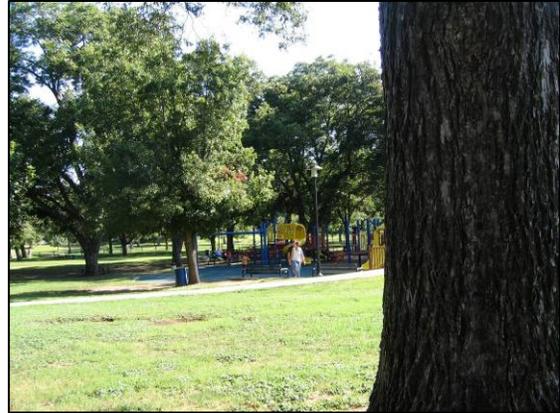
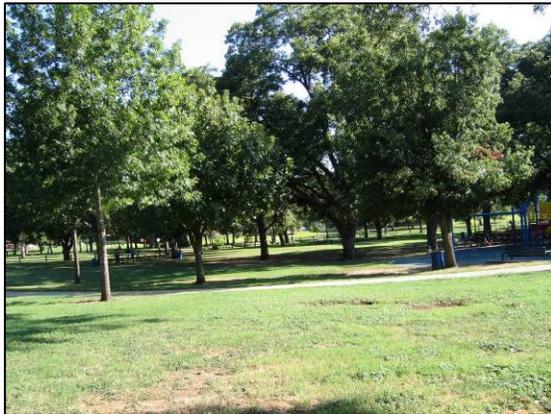
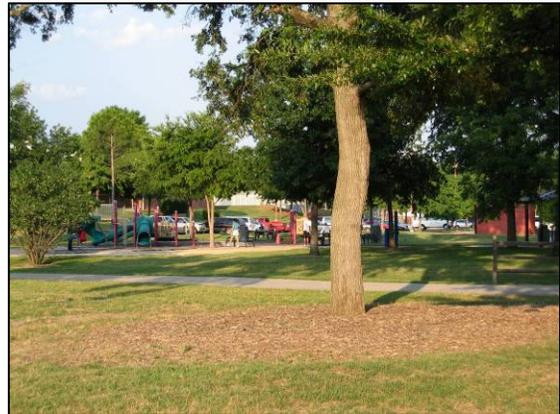
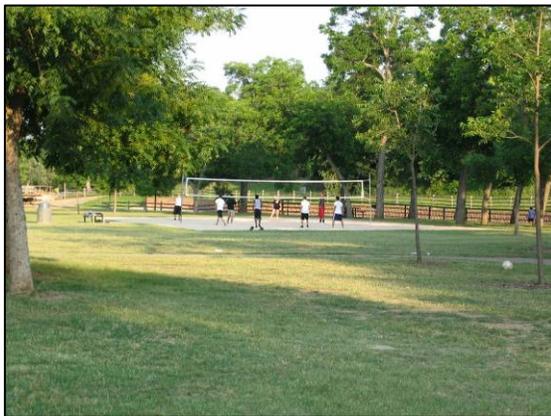
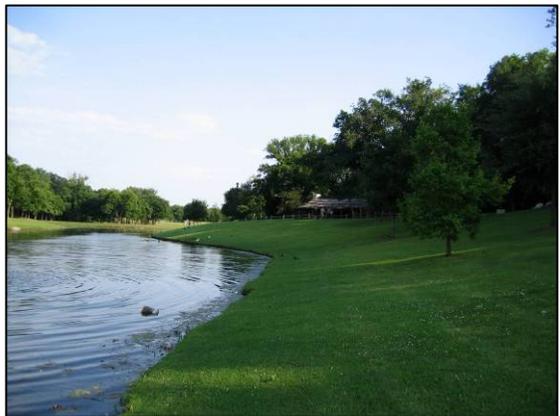
Photogroup 9-22 Activities observed at parks along Delaware Creek (Group 1 of 2).
[Return to Text](#)

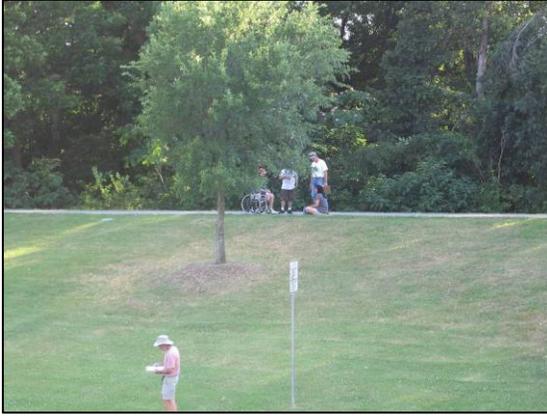
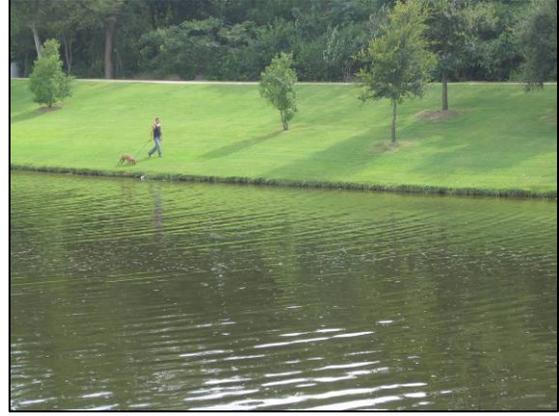
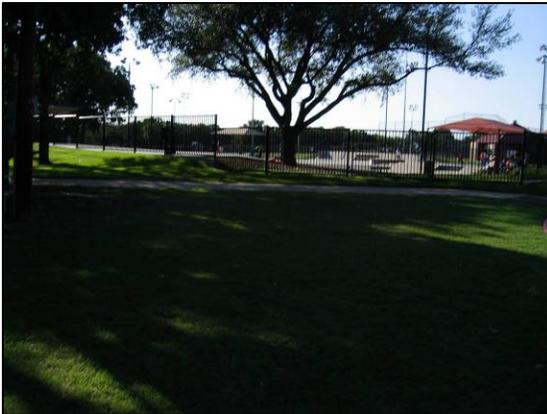
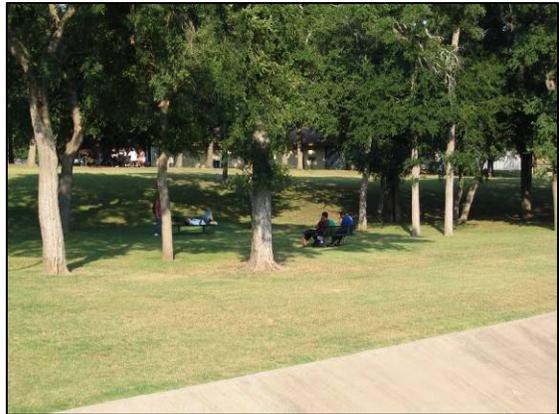
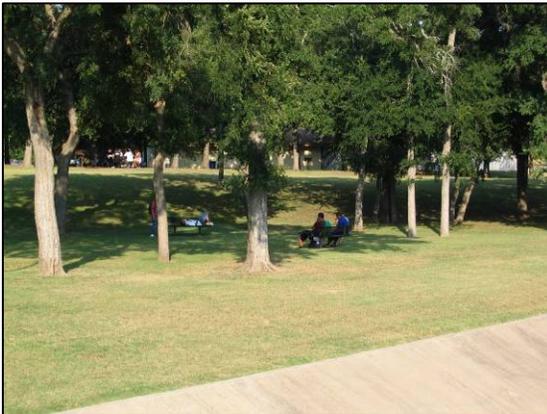
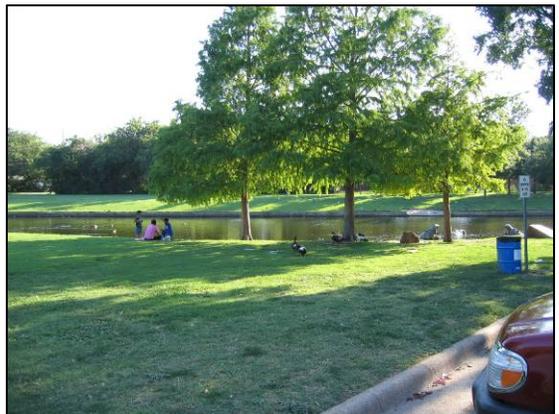
Photogroup 9-23 Activities observed at parks along Delaware Creek (Group 2 of 2).
[\[Return to Text\]](#)

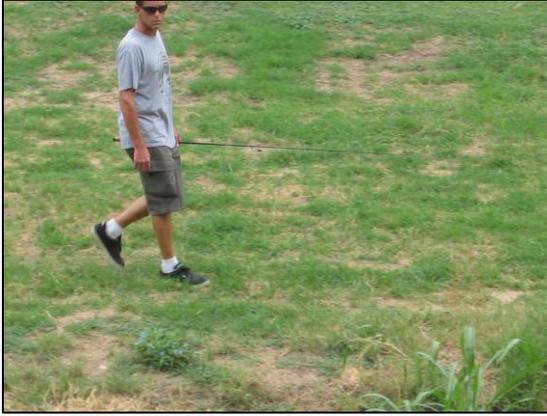
Photogroup 9-24 Delaware Creek Site DC101 showing young man with fishing pole
[\[Return to Text\]](#)

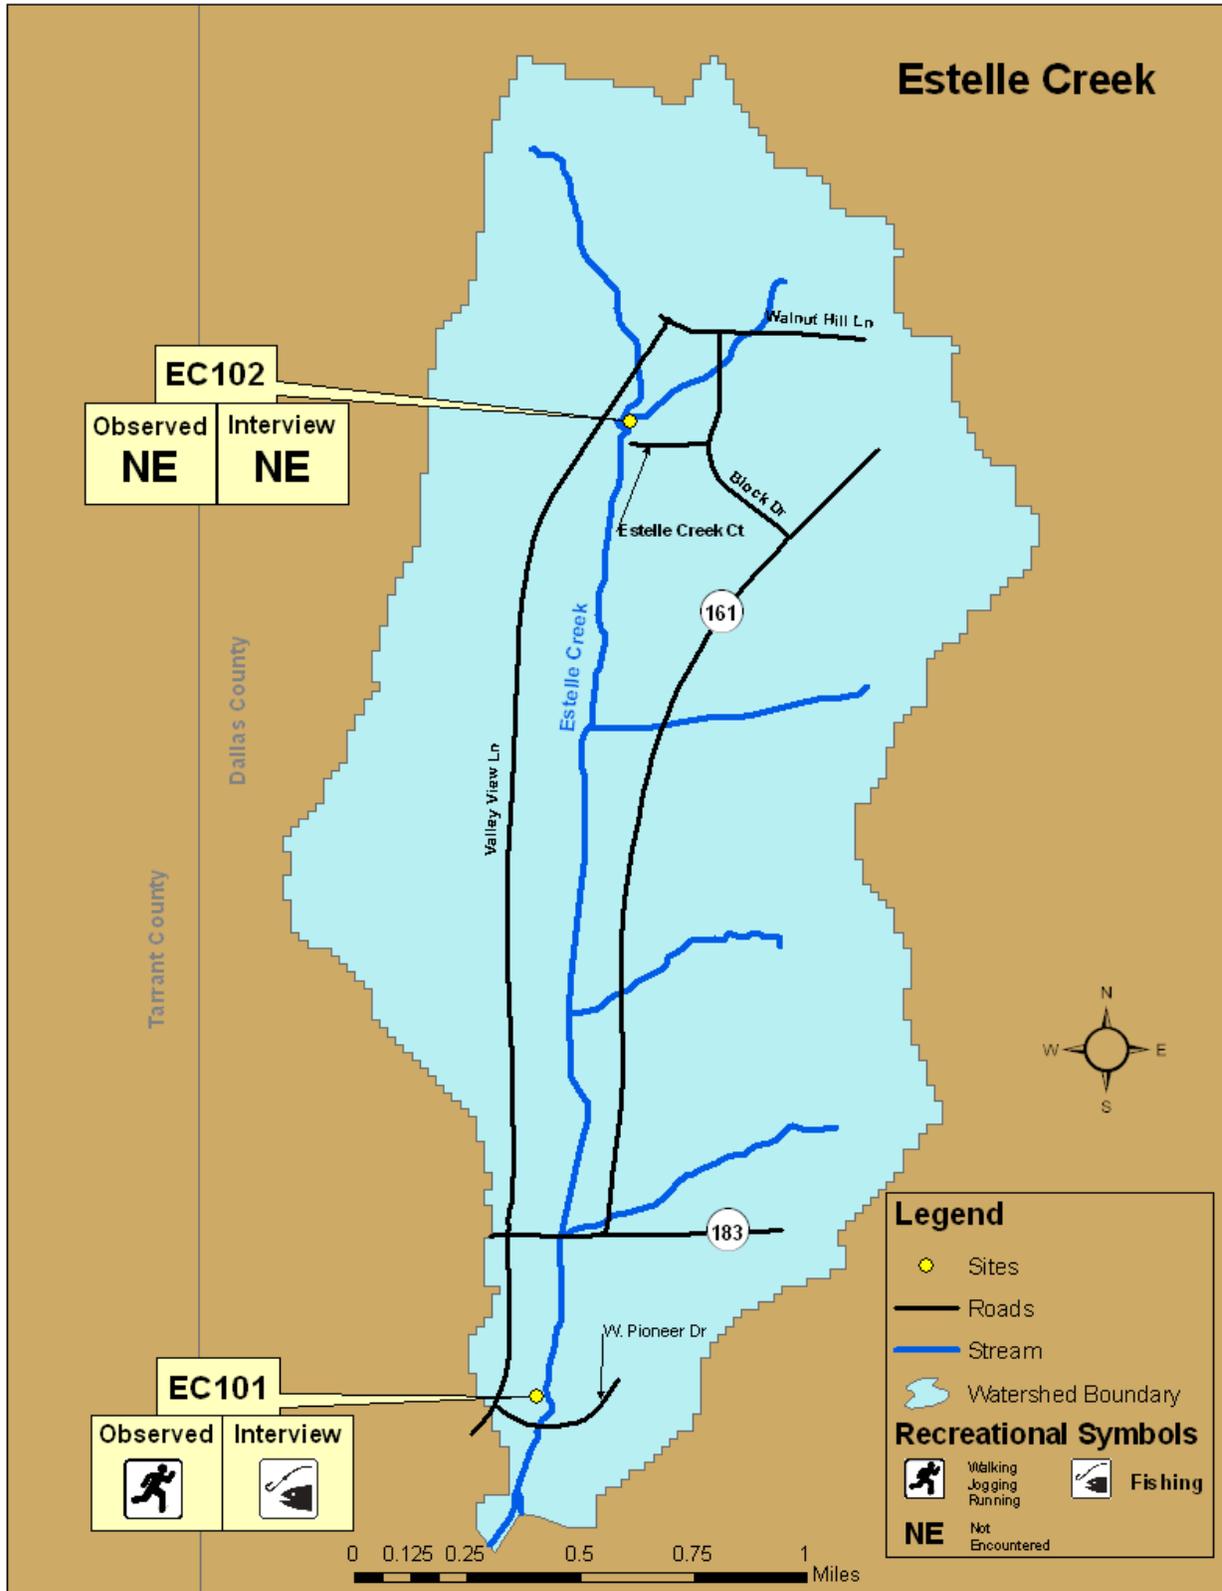
No contact recreation, either primary or secondary, was observed by TIAER field staff during the surveys. One interview reported individuals fishing in the impoundment at Site EC101. Figure 10-4 summarizes the observed and interview reported activities at the two sites.

Figure 10-4 Summary of activities observed and reported in interviews at sites along Estelle Creek

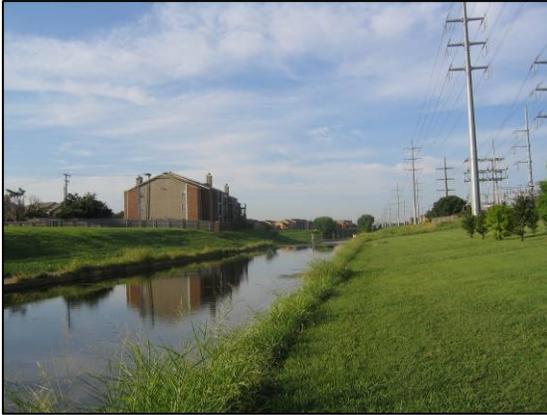
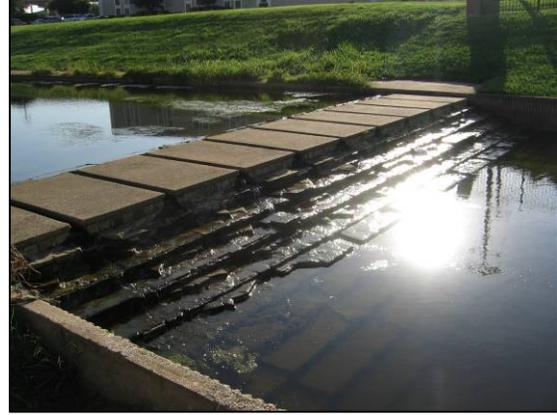
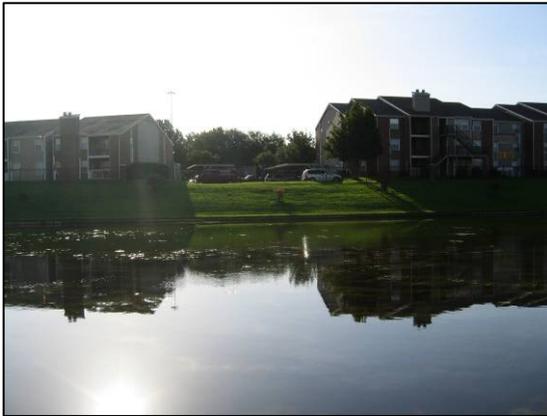
Photogroup 10-1 Estelle Creek Site EC101 showing features at site. (Individual barely visible in top left photograph is TIAER staff.) [\[Return to text\]](#).

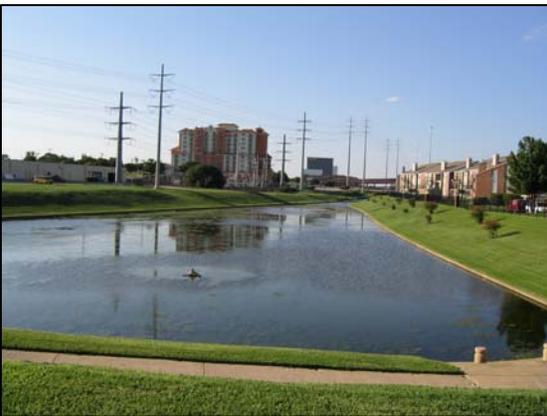
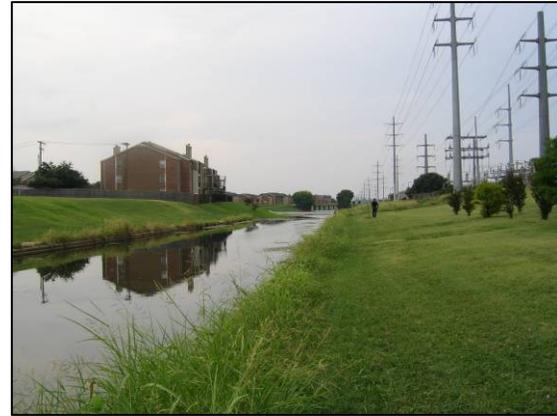
The riparian area around the large impoundment was mowed grass, from the edge of the stream to the top of the bank. There was an aerator located on the southern end of the pond. A security fence was present around the perimeter of the apartment complex but no other obstructions were observed that would impede a person from accessing the stream. The stream above a low-water dam at the 210-m transect was also manicured, except at the edges where vegetation appeared more natural. [Photogroup 10-2](#) depicts the conditions of the areas surrounding the stream.

Photogroup 10-2 Estelle Creek Site EC101 showing riparian area. (Right photograph includes member of field staff.) [\[Return to text\]](#)

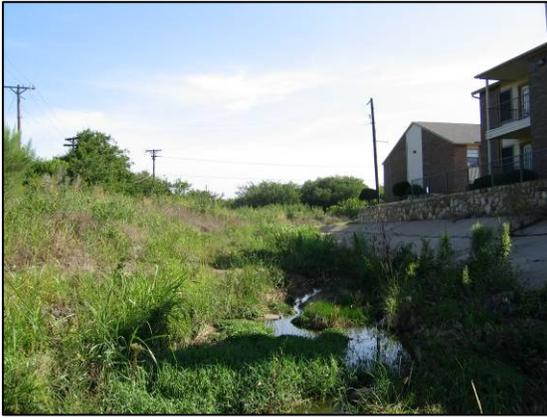
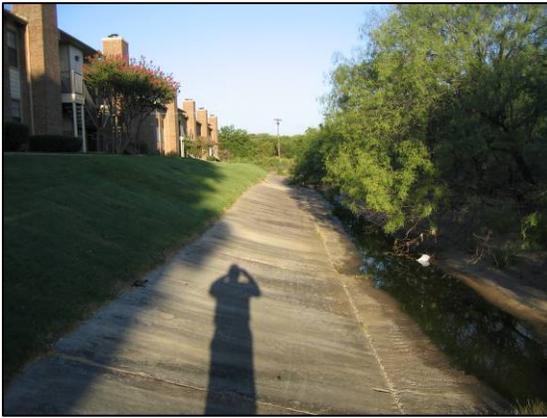
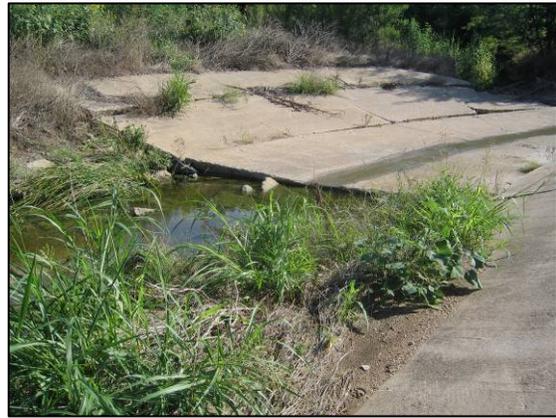
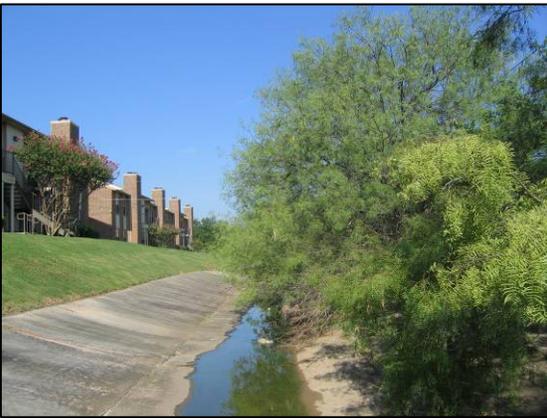
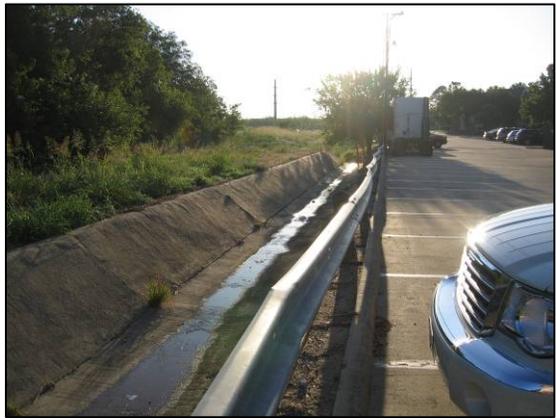
Photogroup 10-3 Estelle Creek Site EC102 showing stream conditions and proximity to apartment complex. [Return to text](#)

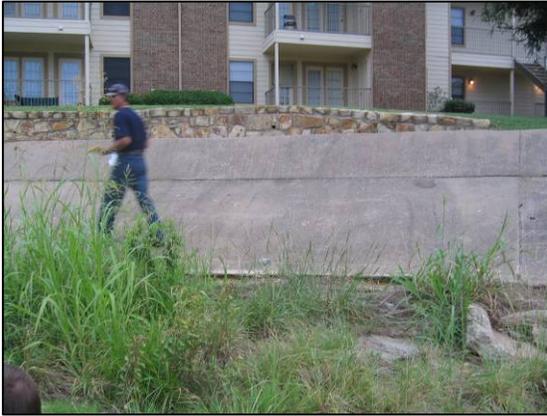
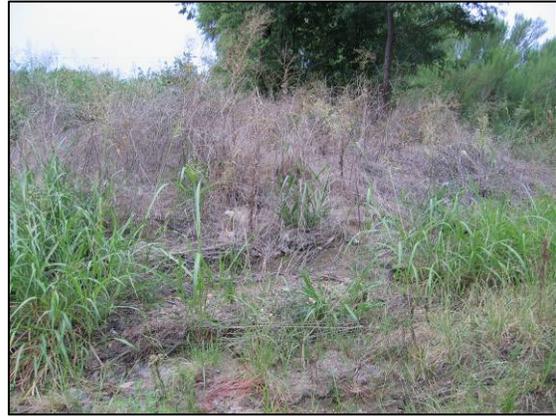
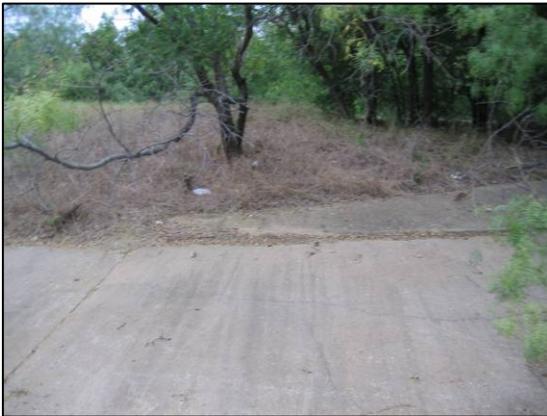
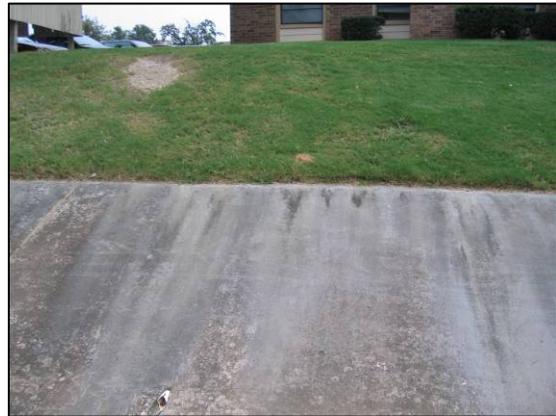
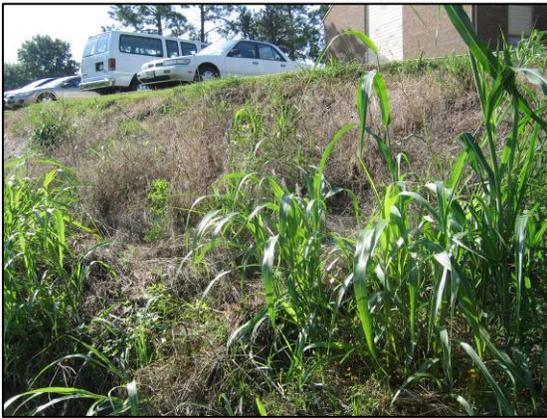
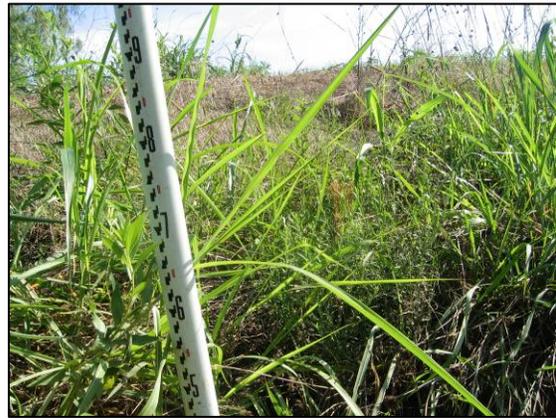
Photogroup 10-4 Estelle Creek Site EC102 showing riparian zone. (Upper left photograph shows member of field staff.) [\[Return to text\]](#)

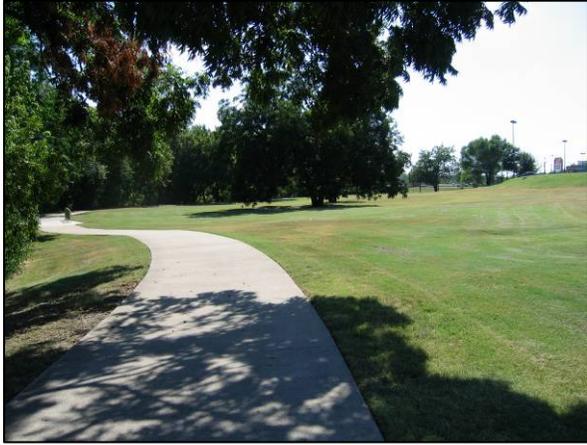
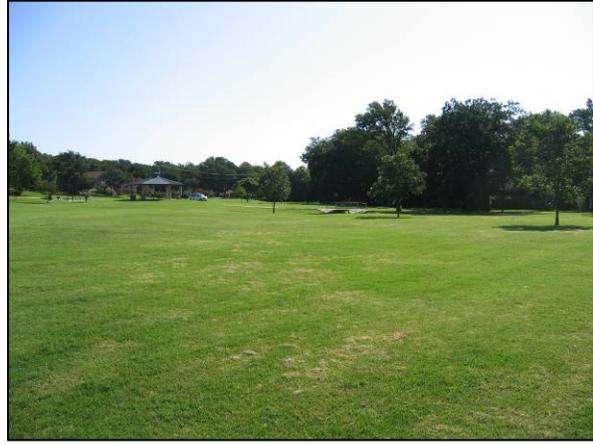
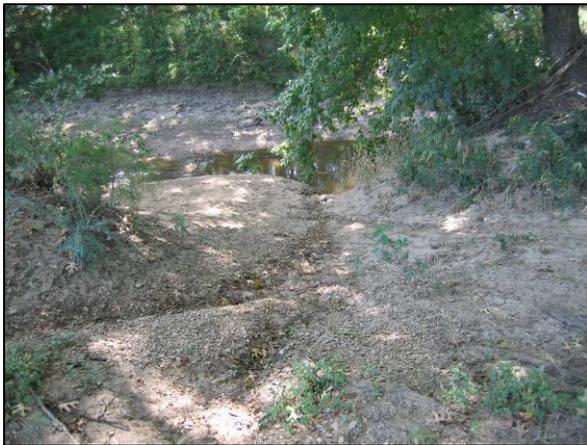
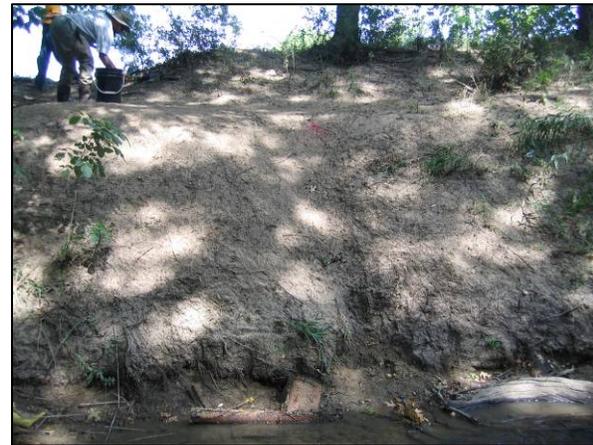
Photogroup 11-1 Fish Creek Site FS101 showing amenities along Fish Creek Linear Park (top row) and access point to stream used by field staff (lower row). (Individuals pictured are TIAER staff.) [\[Return to Text\]](#)

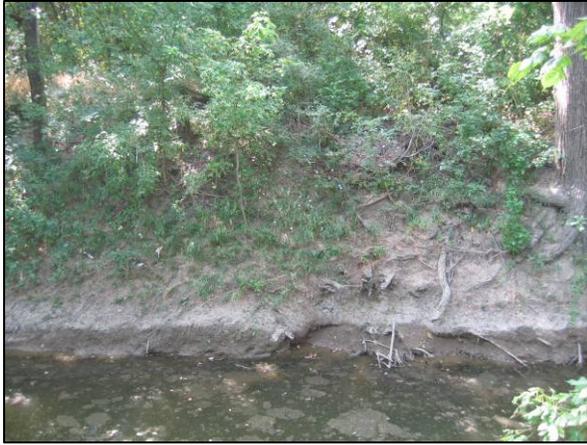
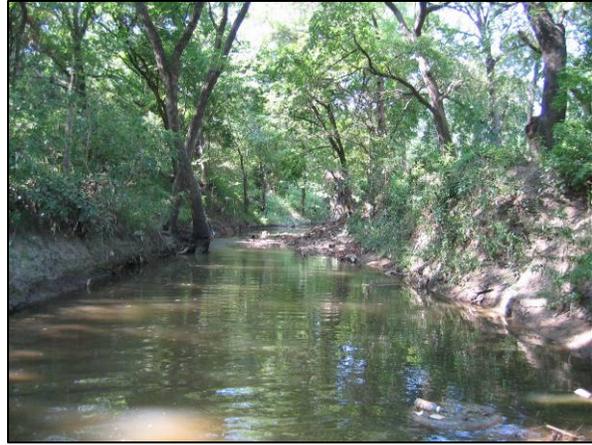
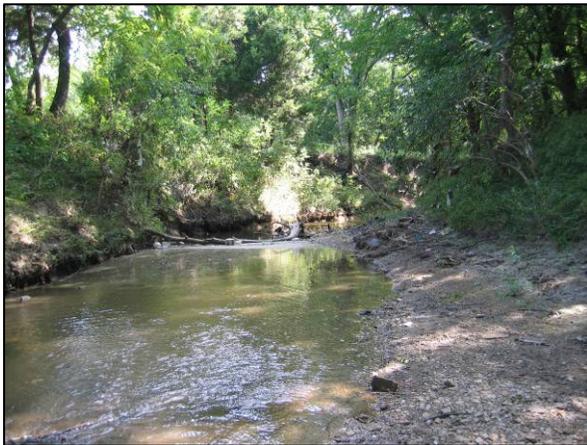
Photogroup 11-2 Fish Creek Site 103 showing streambanks and typical stream characteristics. [\[Return to Text\]](#)

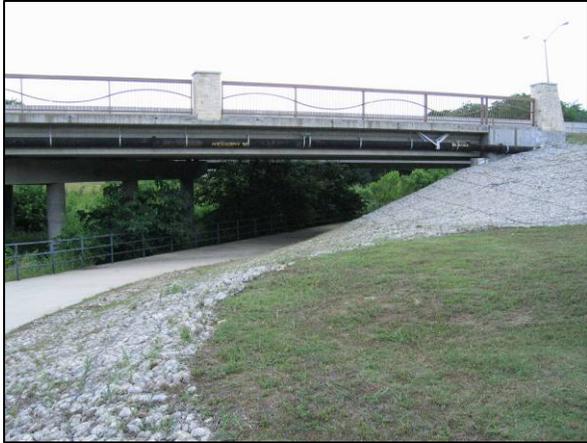
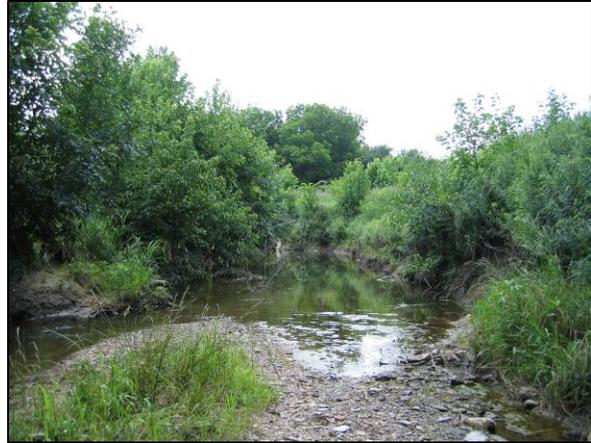
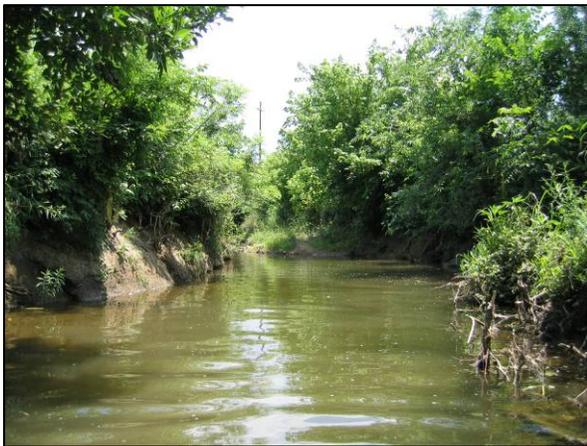
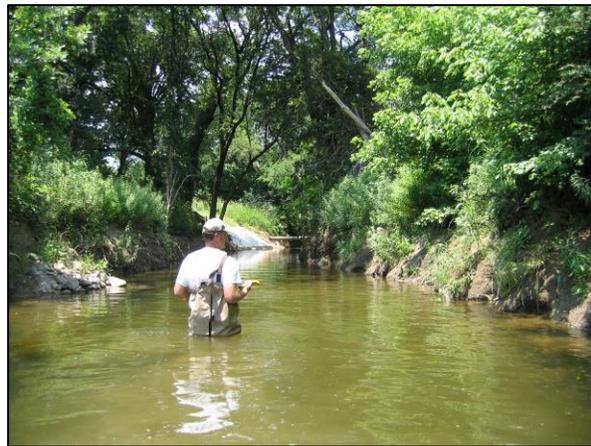
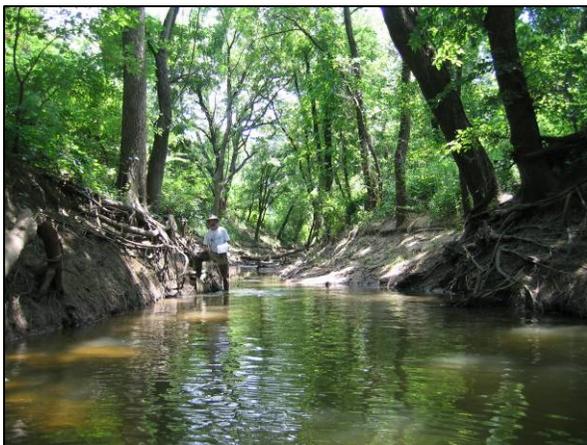
Photogroup 11-3 Fish Creek Site FS102 showing hike/bike path (upper left) and general stream and streambank characteristics. (Individuals pictured are TIAER staff.) [\[Return to Text\]](#)

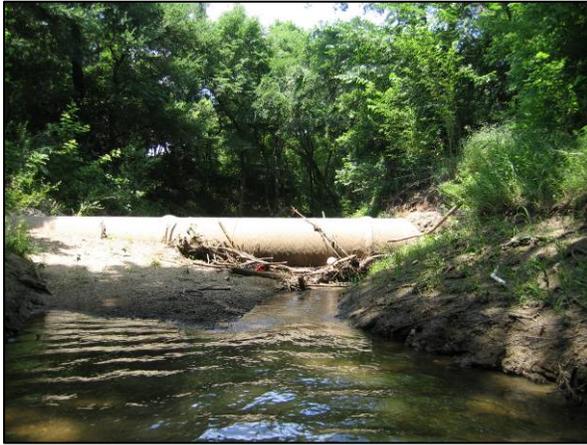
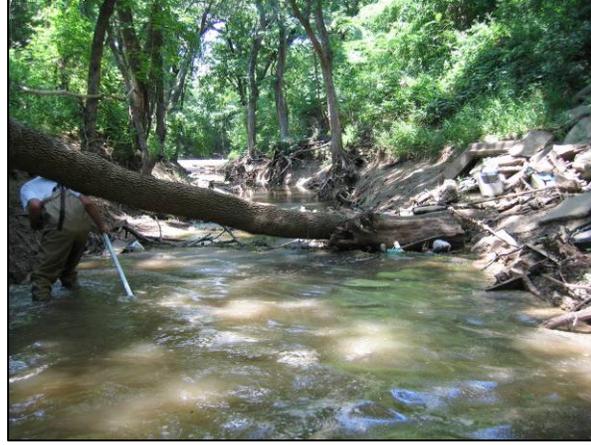
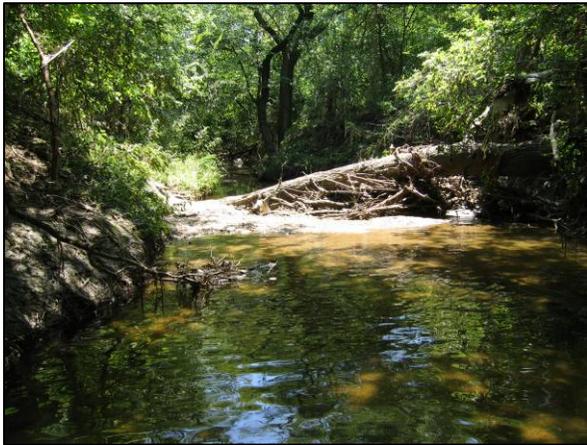
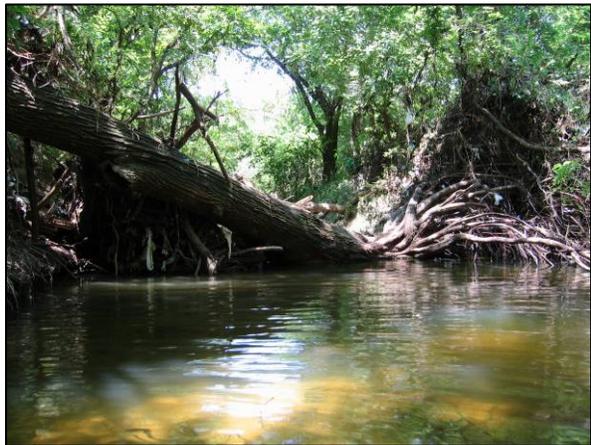
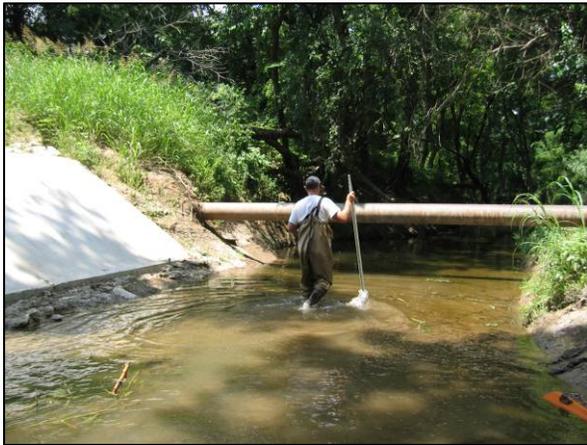
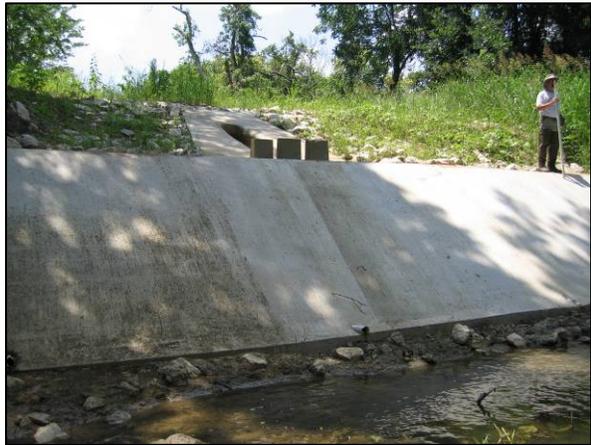
Photogroup 11-4 Fish Creek Site FS102 showing various obstructions in stream and storm drain entry (lower right). (Individuals pictured are TIAER staff.) [\[Return to Text\]](#)

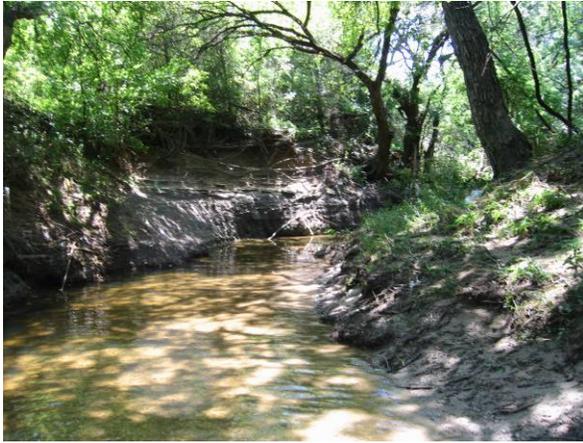
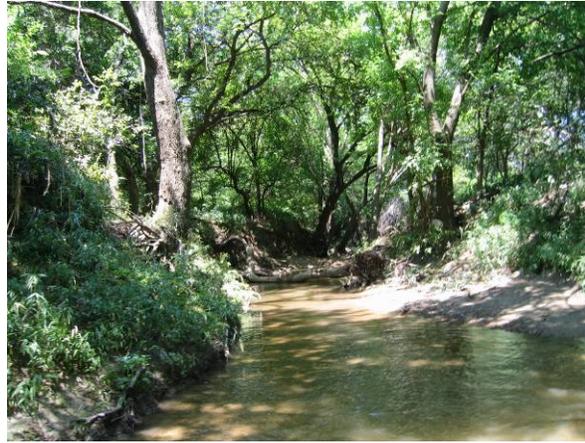
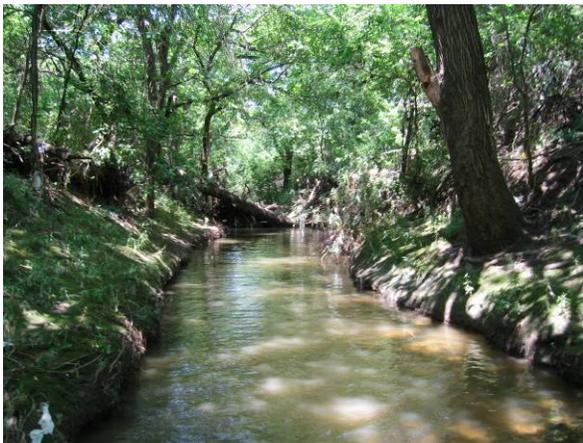
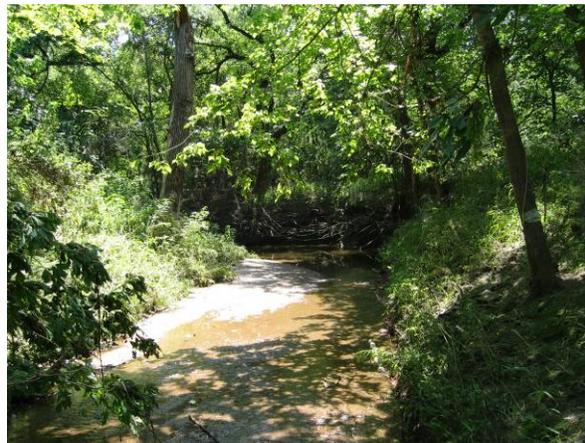
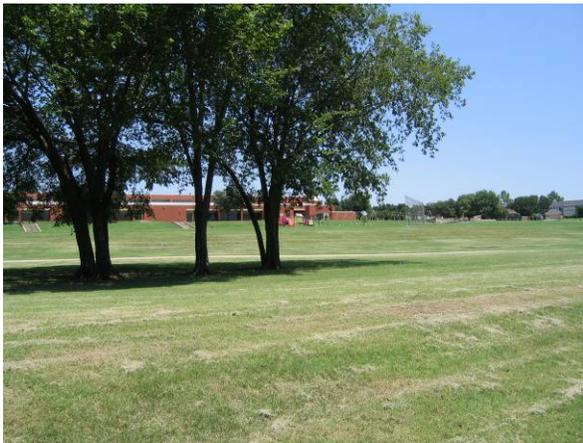
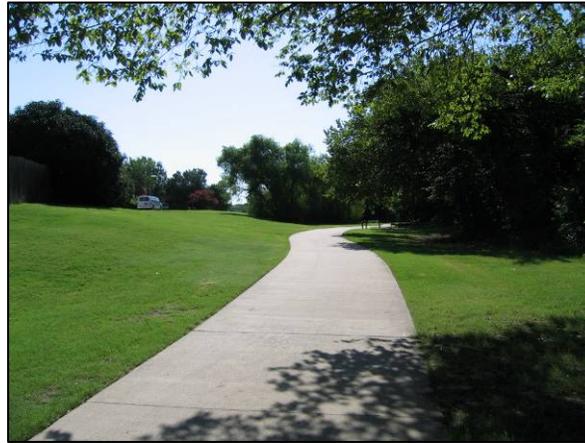
Photogroup 11-5 Fish Creek Site FS103 showing natural stream characteristics (upper and middle rows), elementary school (lower row, left) and hike/bike path.

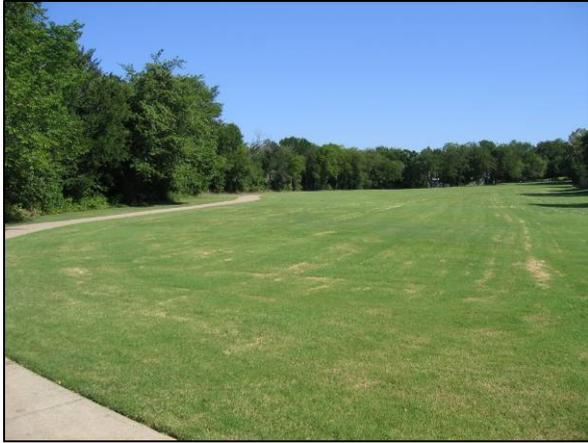
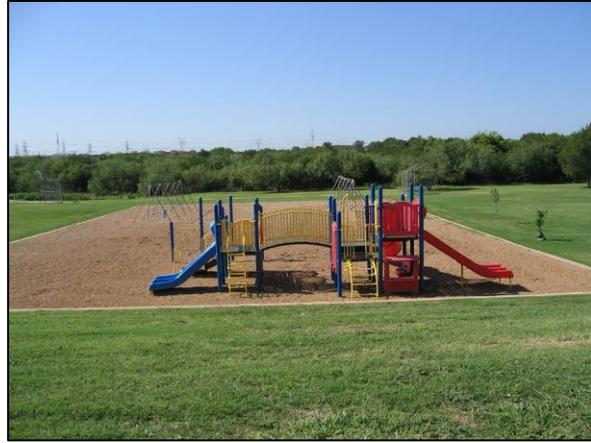
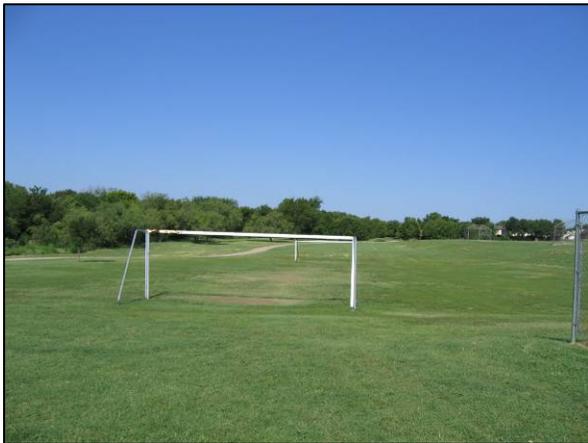
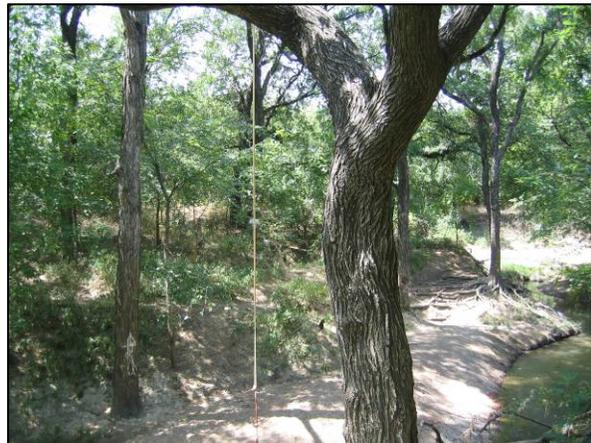
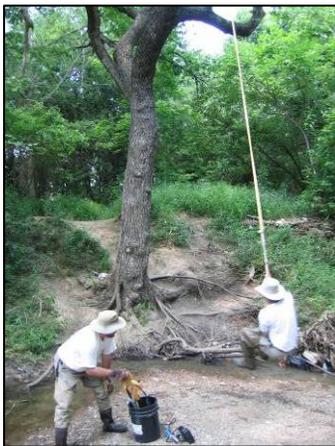
Two interviews of youths wading during elevated stream levels were reported for Sites FS103 and FS104. No other forms of primary contact recreation were identified. A rope swing was located at Site FS103, though the pool at this site is presently filled with gravel and sediment and no longer conducive to such activity. Infrequent fishing was reported at site FS106 by one interviewee. It should be noted that no footpaths to the stream were identified at Site FS106 by TIAER personnel.

Photogroup 11-6 Fish Creek Site FS103 showing play structure and soccer fields near stream and photographs of rope swing (field crew shown in photograph). [\[Return to Text\]](#)

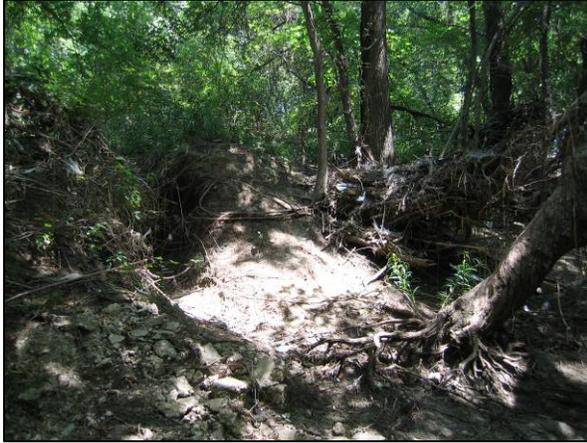
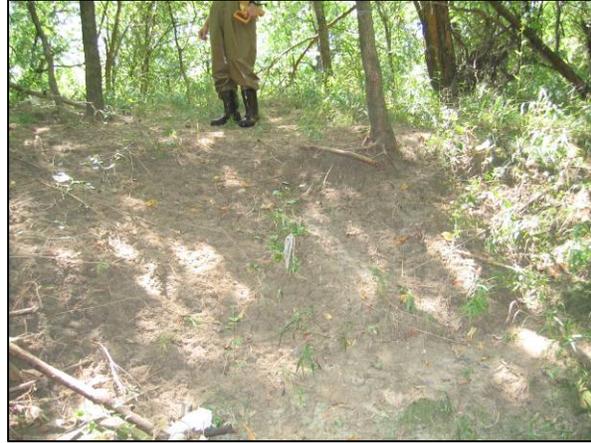
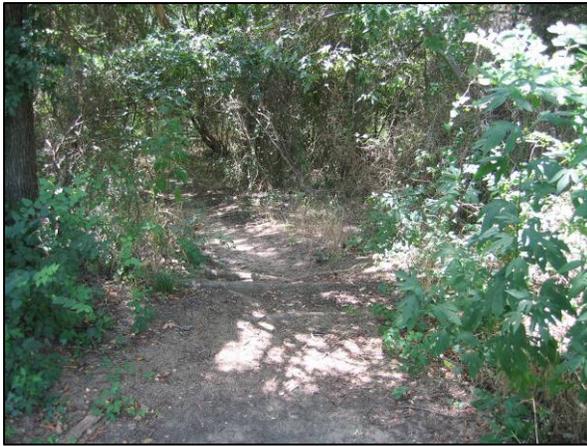
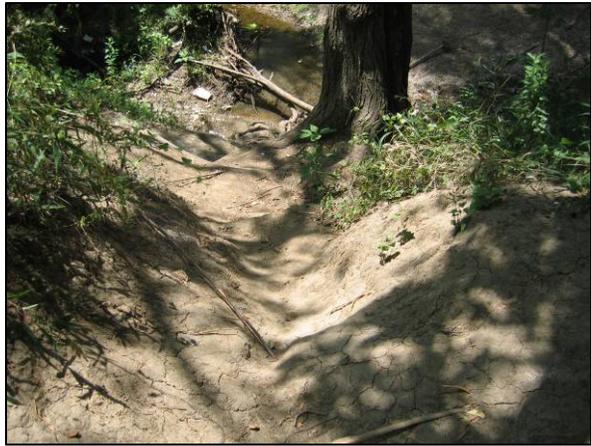
Photogroup 11-7 Fish Creek Site FS103 showing footpaths at 0-m and 300-m transects providing access to creek from both banks. (Individual pictured is TIAER staff.) [\[Return to Text\]](#)

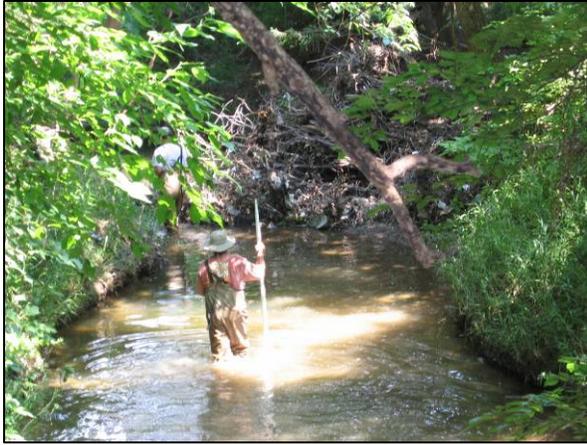
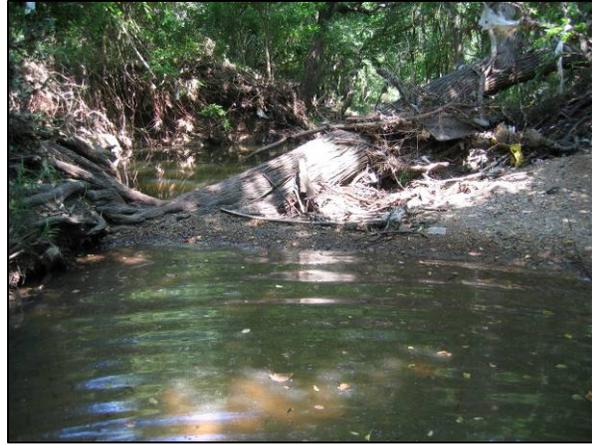
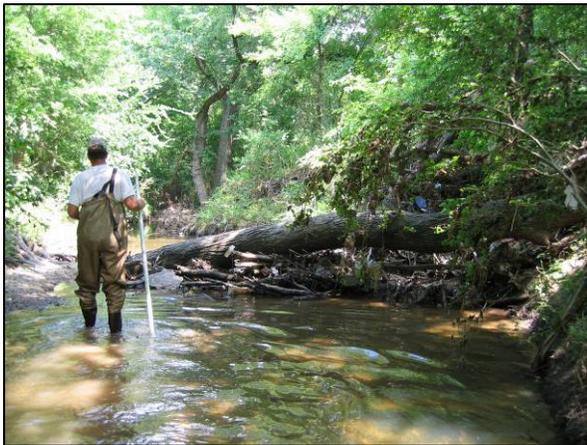
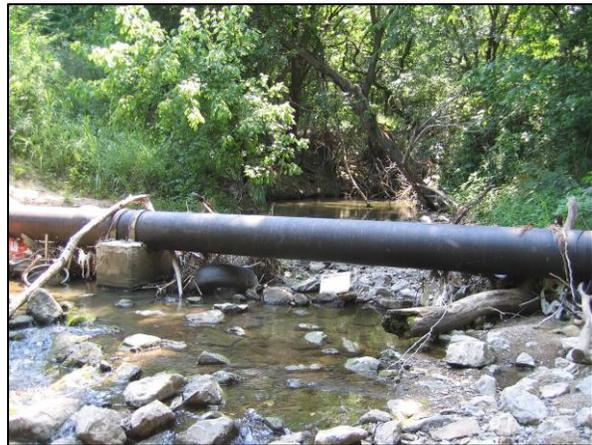
Photogroup 11-8 Fish Creek Site FS103 showing obstructions of trees at 120-m, 180-m, and 270-m transects and pipe crossing at 60-m transect. (Individuals pictured are TIAER staff.) [\[Return to Text\]](#)

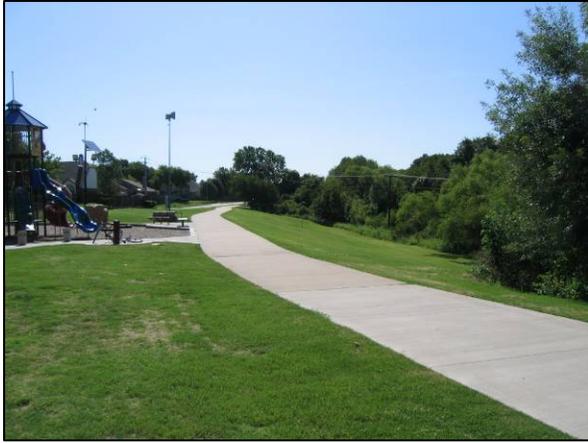
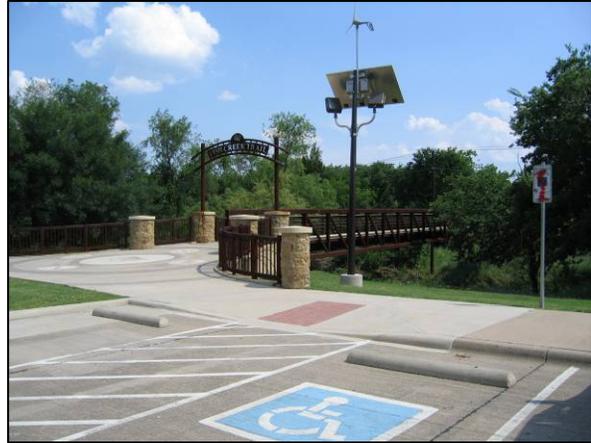
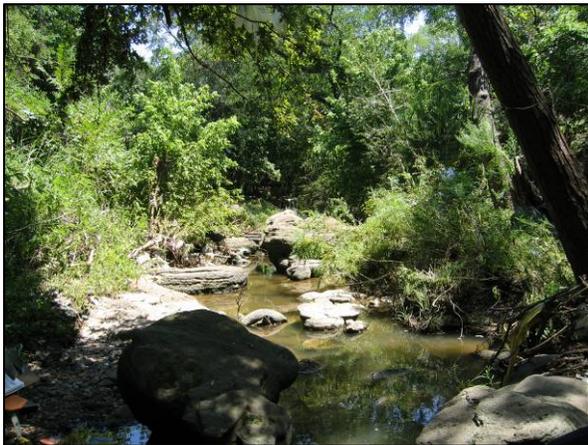
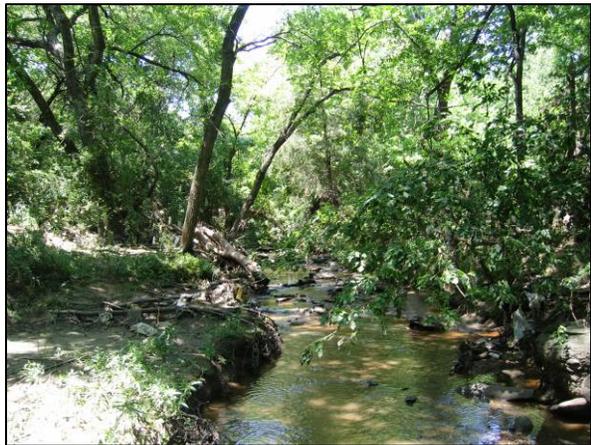
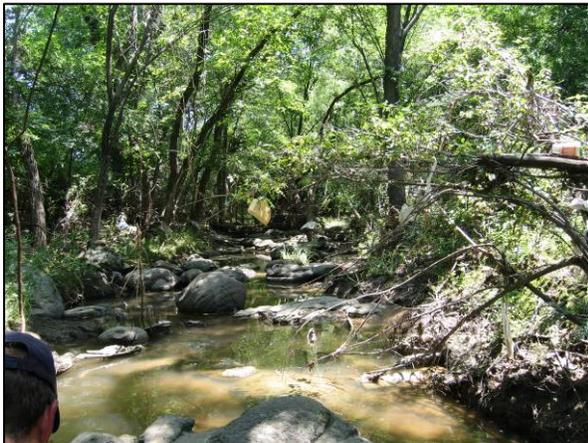
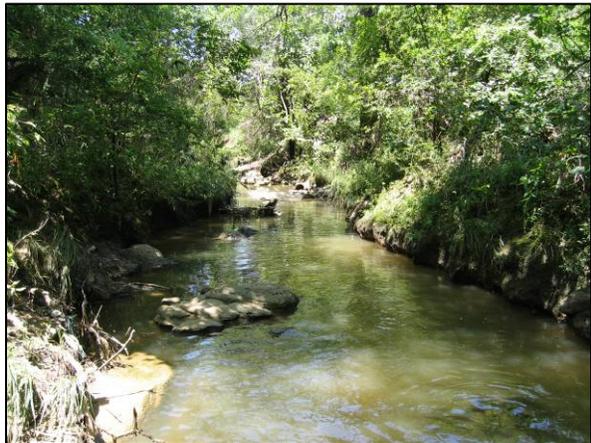
Photogroup 11-9 Fish Creek Site FS104 showing adjacent hike/bike trail and play structure (upper left photograph; note wooded area to right contains the creek), parking near creek, and general characteristics of the creek. (Individual pictured is TIAER staff.) [\[Return to Text\]](#)

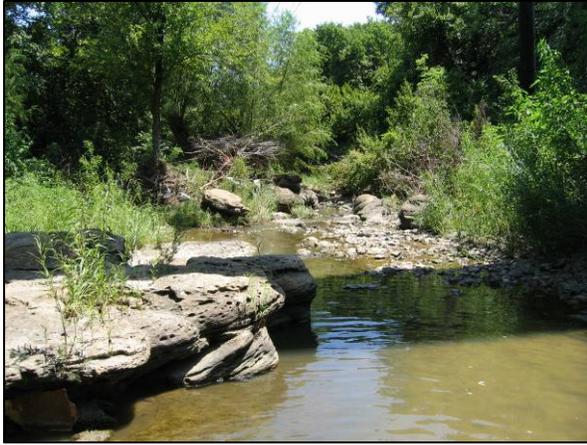
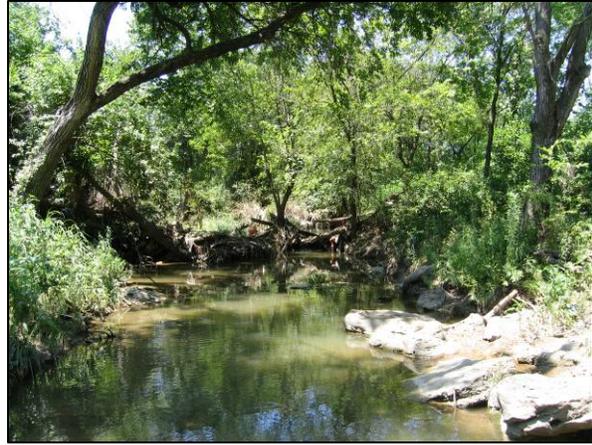
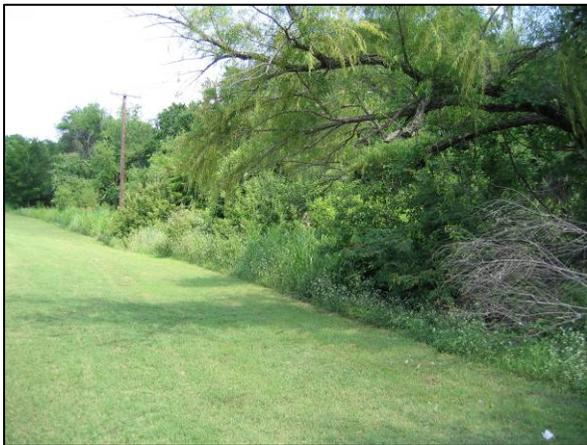
Photogroup 11-10 Fish Creek Site FS104 showing typical stream characteristics and riparian zone with wooded/shrub area immediately adjacent to stream and mowed park area further from stream. [\[Return to Text\]](#)

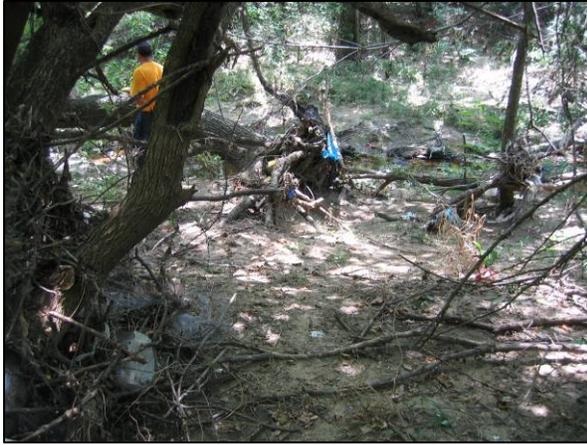
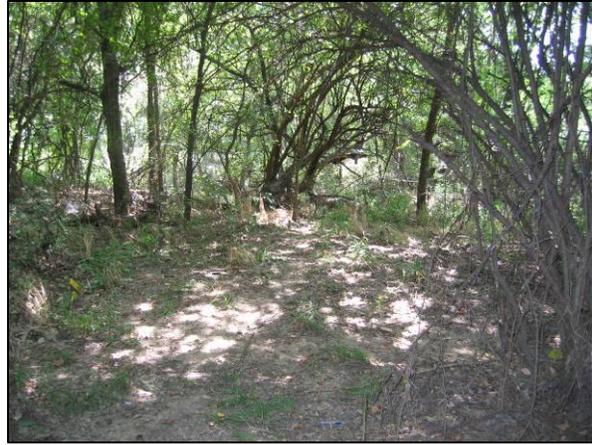
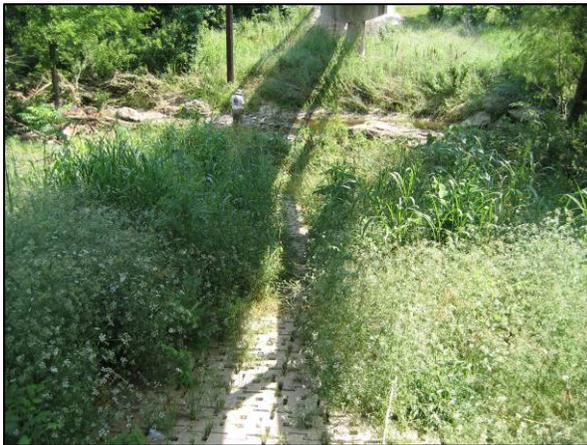
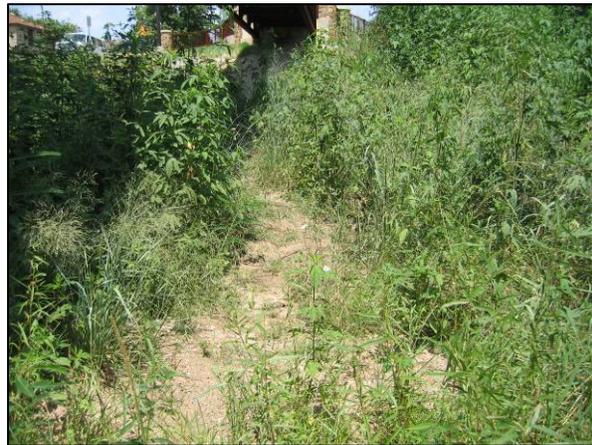
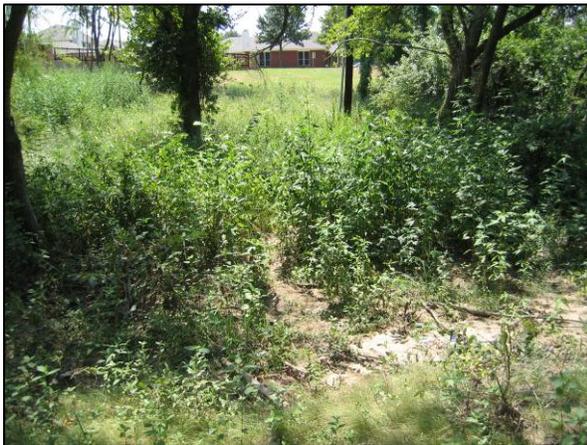
Photogroup 11-11 Fish Creek Site FS104 showing footpaths to stream. (Individual pictured is TIAER staff.) [\[Return to Text\]](#)
