Dallas-Fort Worth Metroplex Urban Creeks
Trinity River Bacteria TMDL Project
Recreational Use-Attainability Analysis Report

Report to TMDL Team
Texas Commission on Environmental Quality
Project and Work Order Number
582-5-70859-26

Jeff Stroebel
Tim Jones
Larry Hauck
Texas Institute for Applied Environmental Research
Tarleton State University
Stephenville, Texas

November 2010

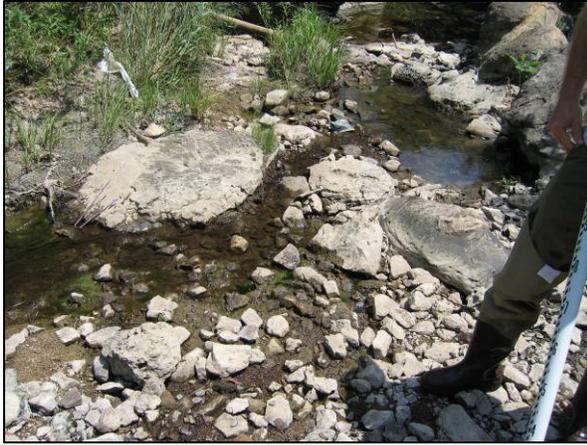
Photogroup 11-12 Fish Creek Site FS 104 showing low flow encountered during second survey. (Individual pictured is TIAER staff.) [\[Return to Text\]](#)

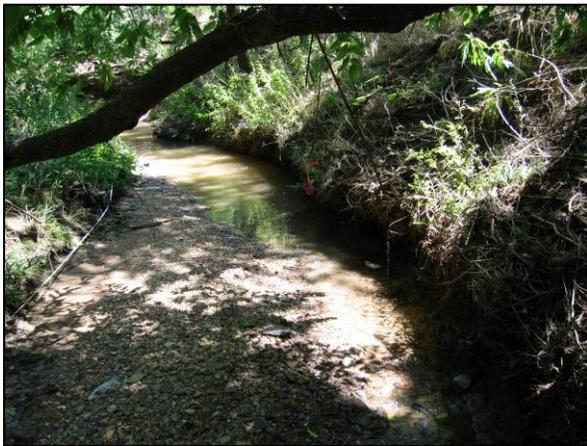
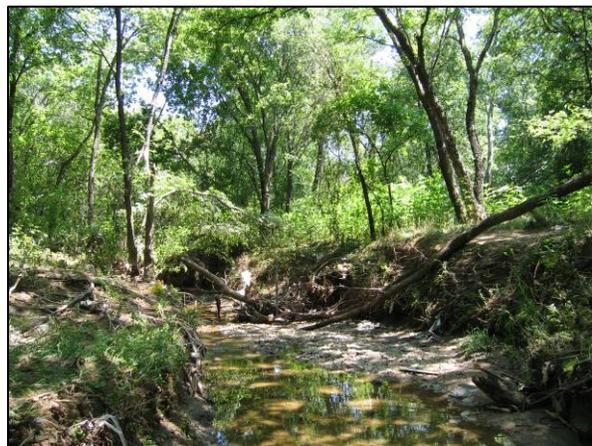
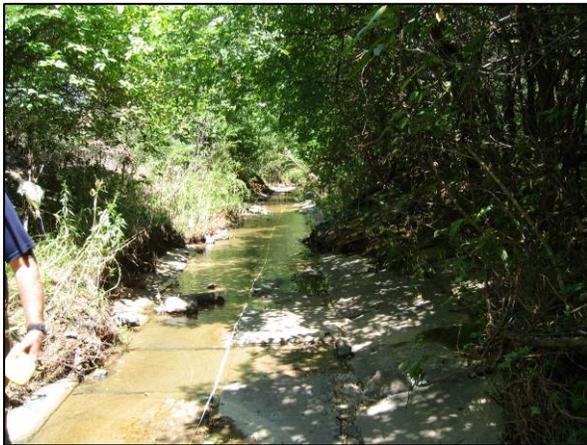
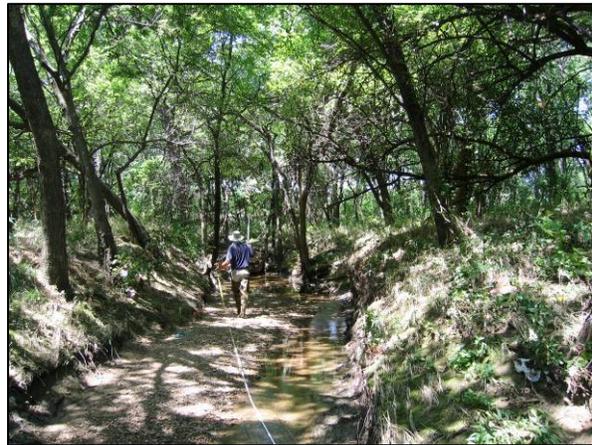
Photogroup 11-13 Fish Creek Site FS105 showing general stream and bank characteristics. (Individuals pictured are TIAER staff.) [\[Return to Text\]](#)

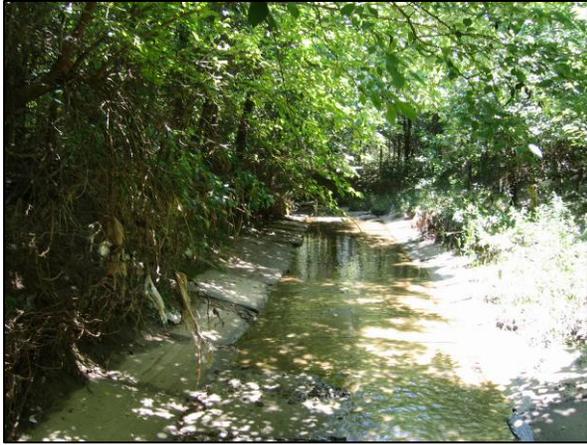
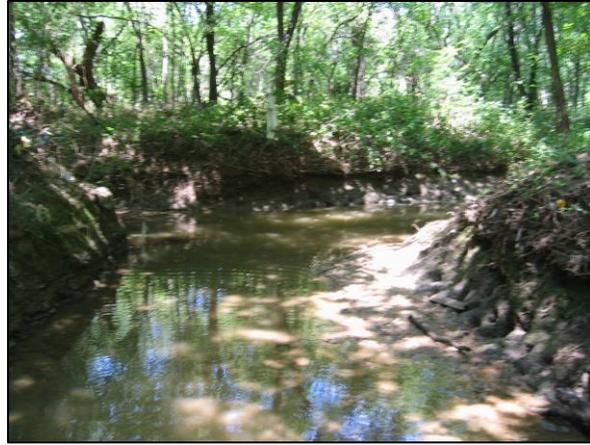
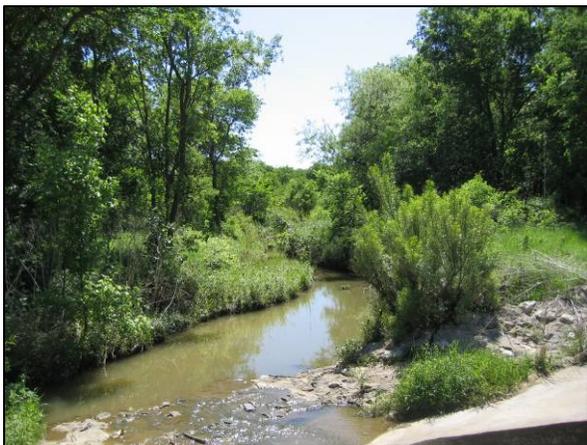
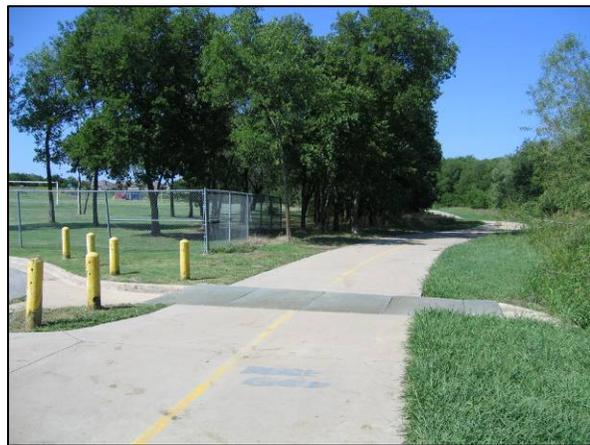
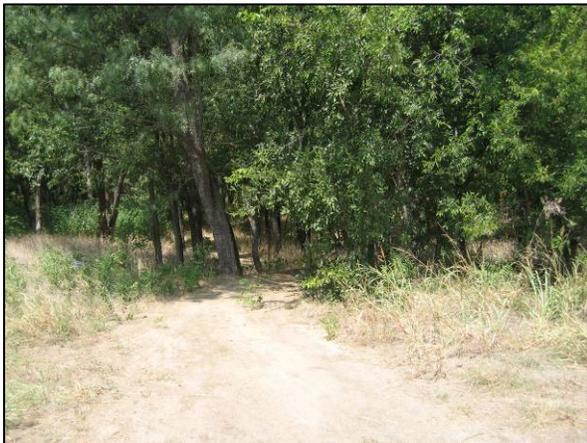
At Site FS105 two people indicated that the footpath leading to the stream is utilized by youths leaving school who jump across the stream on their way home. TIAER personnel did watch this occur during one of the surveys conducted in August of 2009, but interviews were not collected due to the age of the youths. (Note: the youths observed by staff were not young children, but youths in their early teens who were athletically developed. Although the site is directly behind an elementary school, there is a junior high school just a few blocks south on Cornwell Drive).

Photogroup 11-14 Fish Creek Site FS105 showing stream and streambank characteristics (upper left photograph the concrete block streambed), stream tributary (upper right), access point (middle left), and surround area, including footpath leading to creek. [\[Return to Text\]](#)

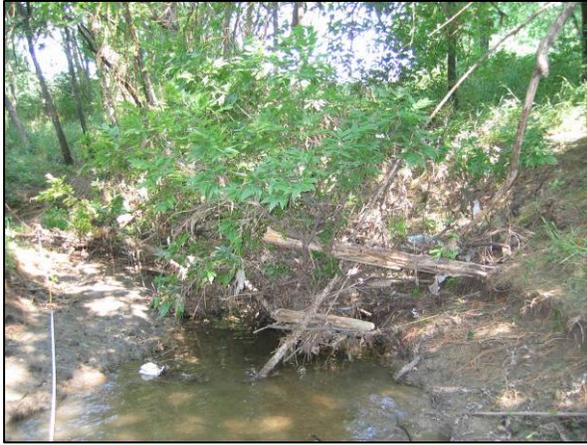
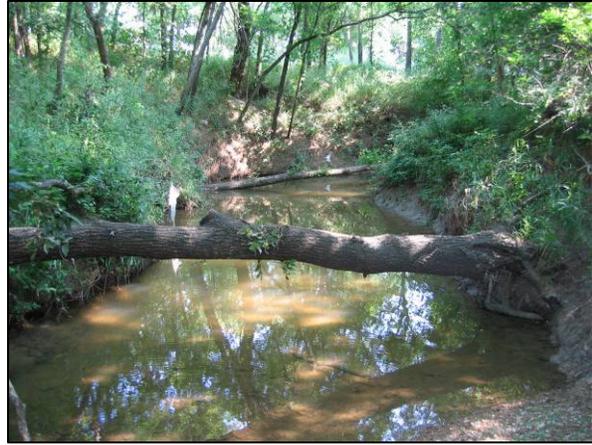
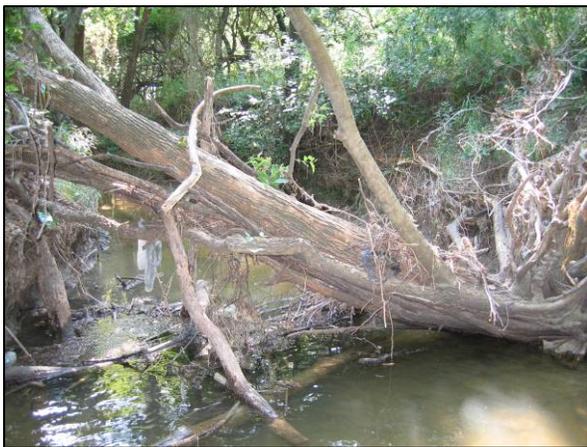
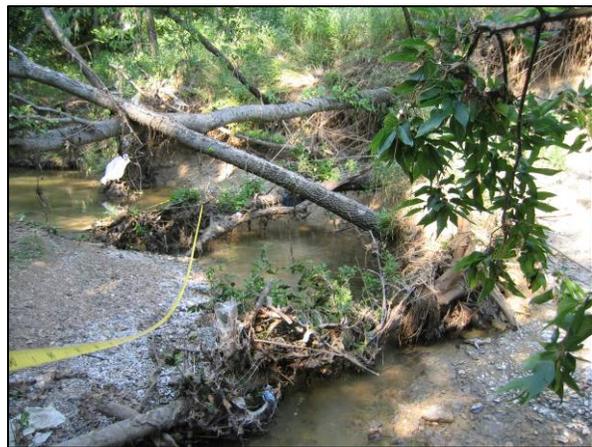
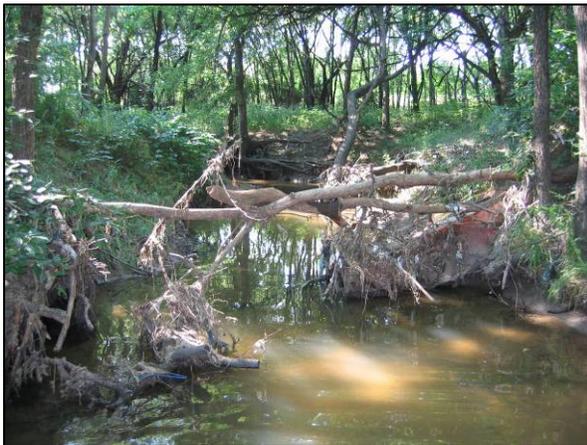
Photogroup 11-15 Fish Creek Site FS105 showing debris and tree obstructions at and around the 60-m, 120-m, and 180-m transects. [[Return to Text](#)]

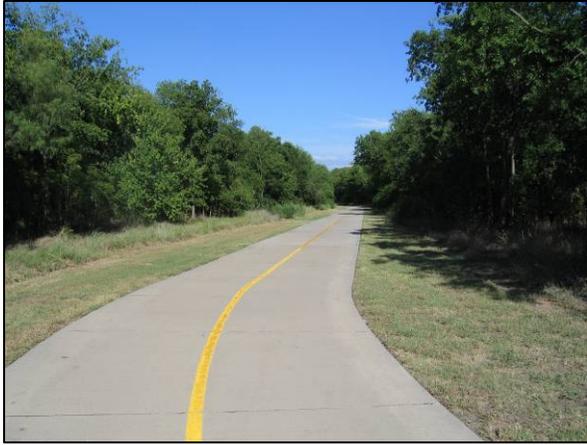
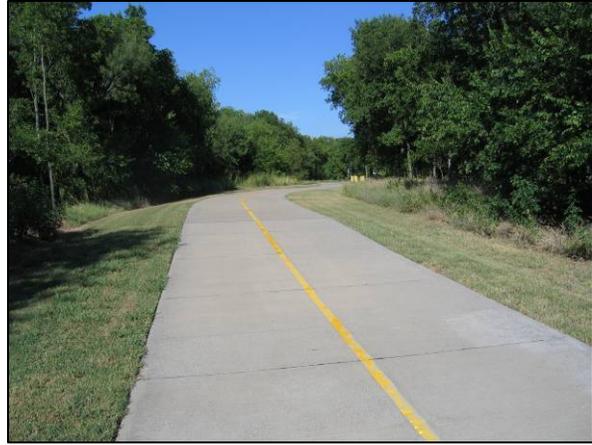
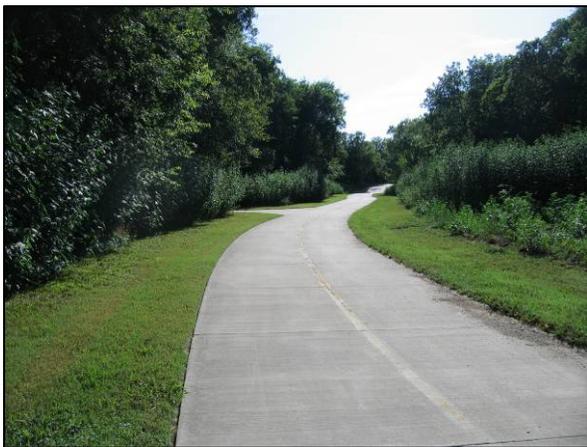
Photogroup 11-16 Fish Creek Site FS105 showing hike/bike trail and mowed areas adjacent to trail. [\[Return to Text\]](#)

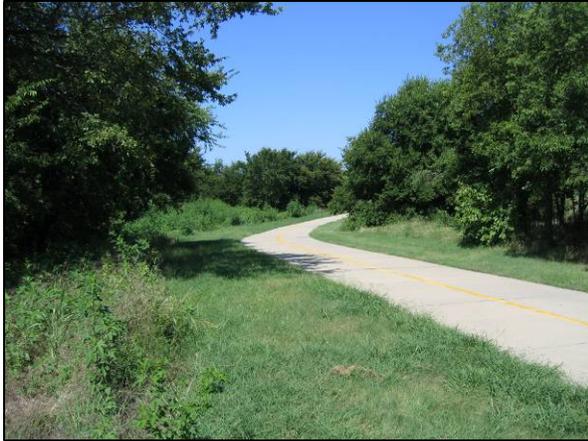
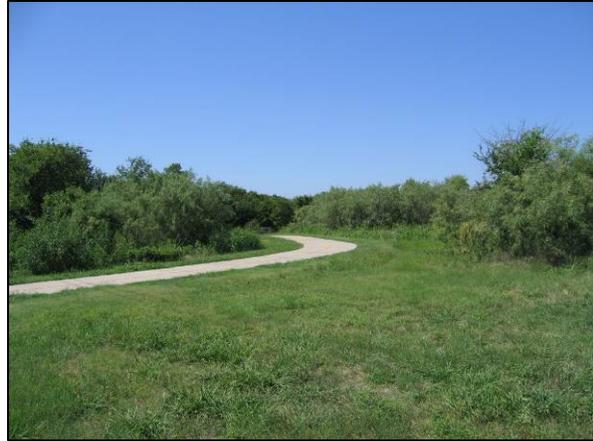
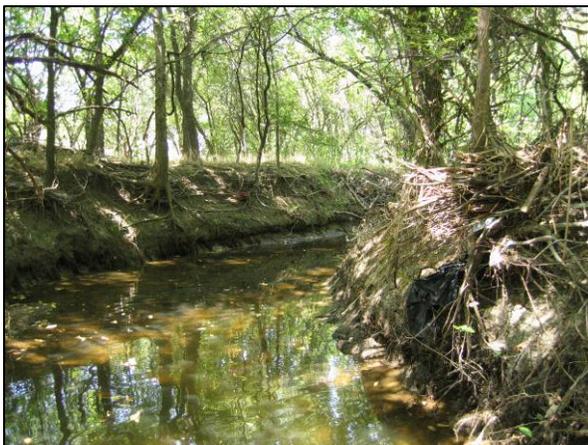
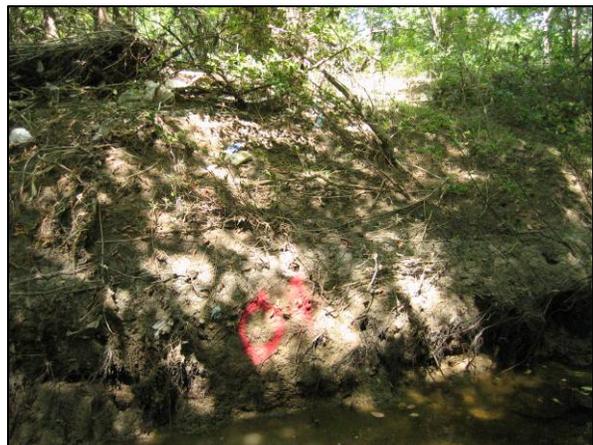
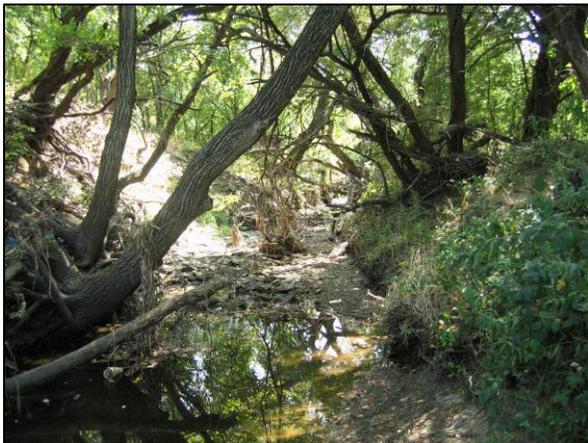
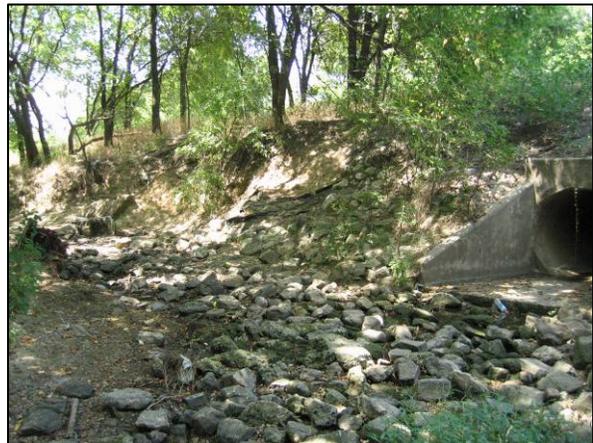
Photogroup 11-17 Fish Creek Site FS106 showing hike/bike trail (upper row), typical stream and streambank characteristics, and storm drain entry (lower right). Note: Middle right photograph shows temporary markings from field crew used in surveying. [\[Return to Text\]](#)

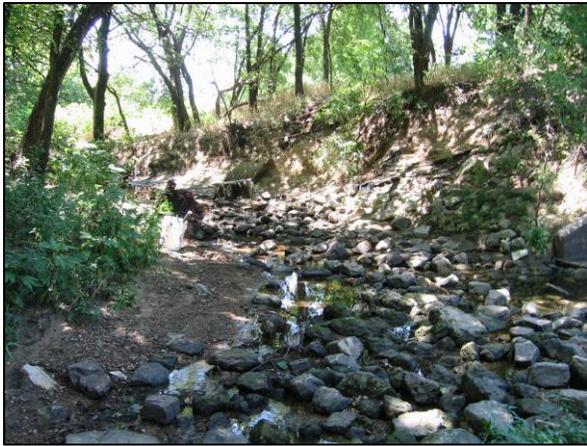
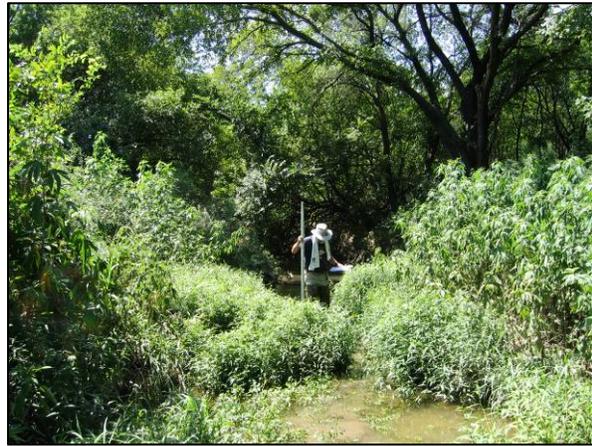
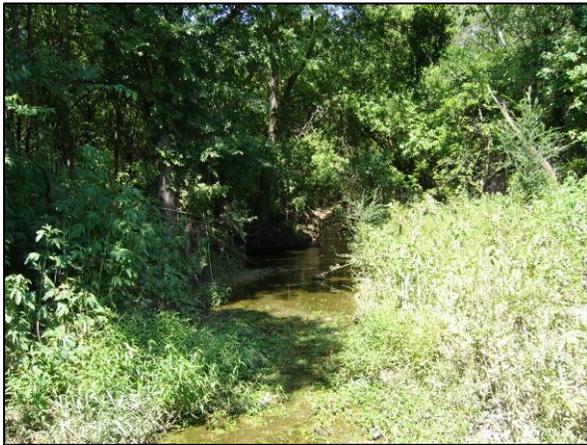
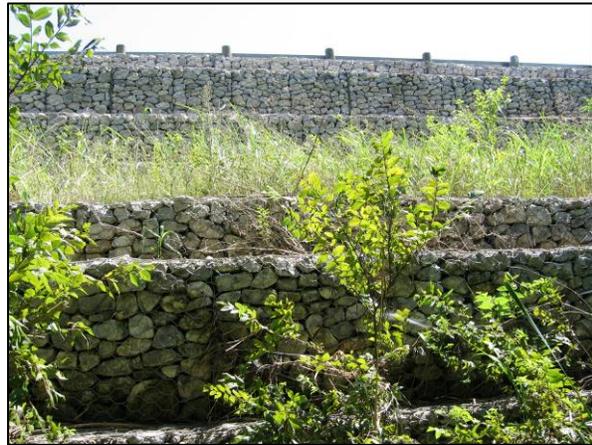
Photogroup 11-18 Fish Creek Site FS106 showing area of cobble dominated substrate (upper left), area of abundant stream vegetation between 120-m and 210-m transects, and gabions along right bank in the areas of the 150-m transect. (Individual photographed is TIAER staff.) [\[Return to Text\]](#)

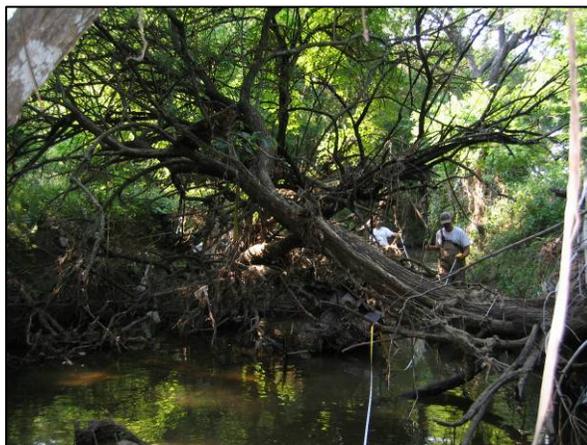
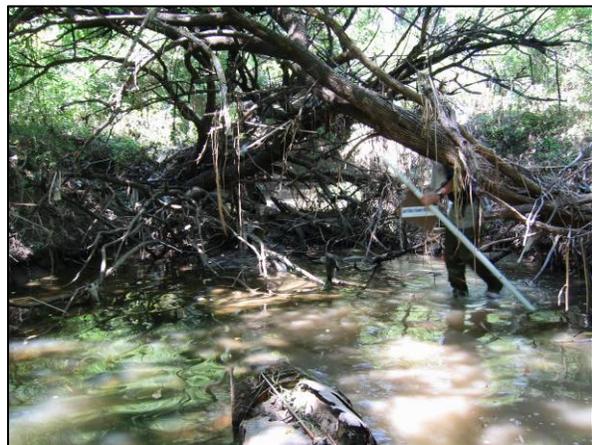
Photogroup 11-19 Fish Creek Site FS106 showing obstacles from fallen trees and associated debris at the 180-m and 240-m transects. [Note field crew in both photographs] [\[Return to Text\]](#)

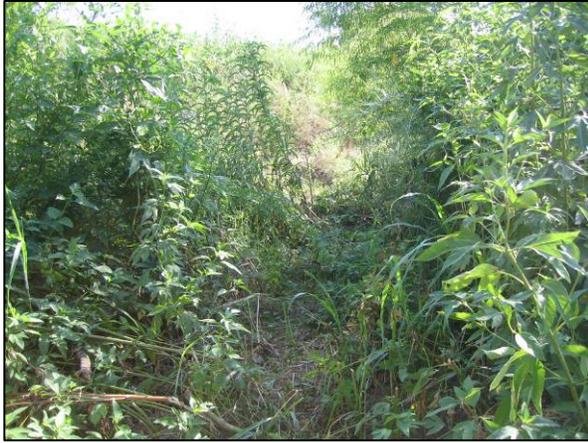
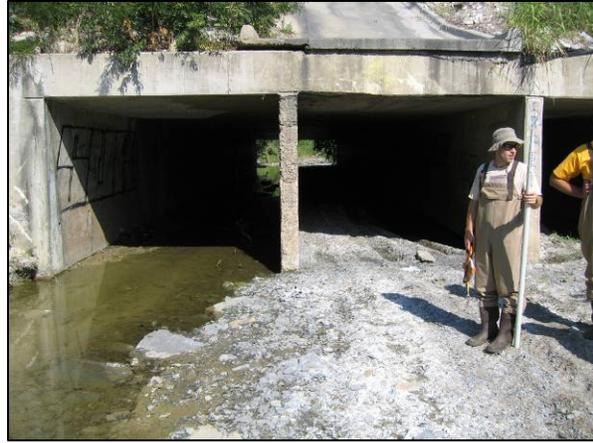
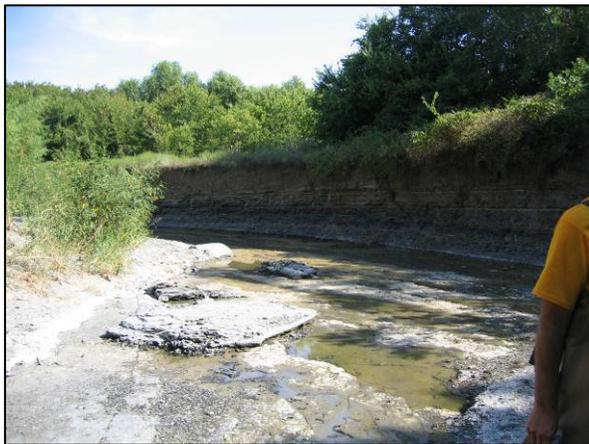
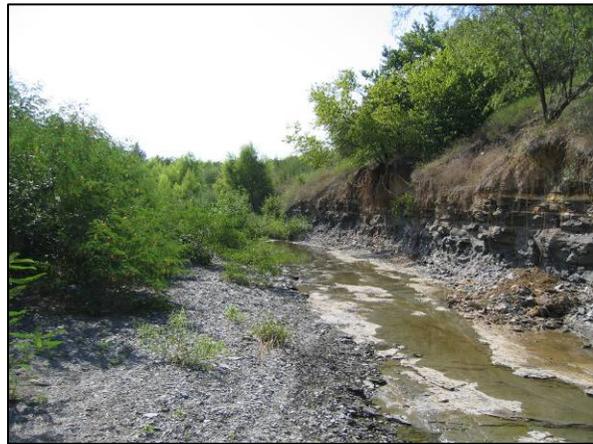
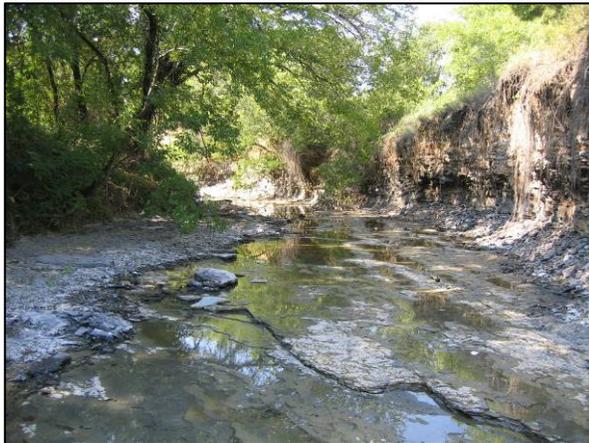
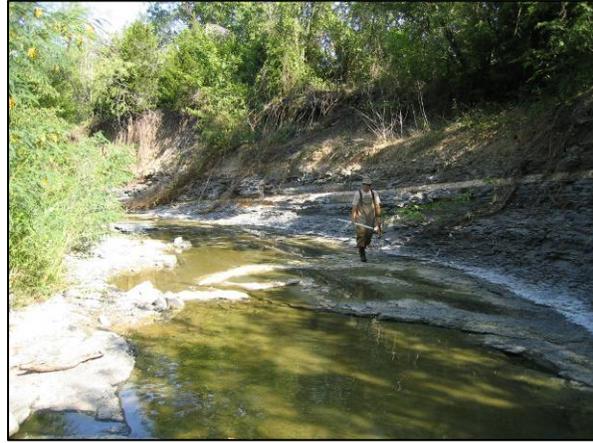
Photogroup 11-20 North Fork Fish Creek Site FN101 showing footpath to stream at 0-m transect (upper left), culvert at 0-m transect, and general stream and streambank characteristics at 0-m, 150-m, and 300-m transects. (Individuals photographed are TIAER staff.) [\[Return to Text\]](#)

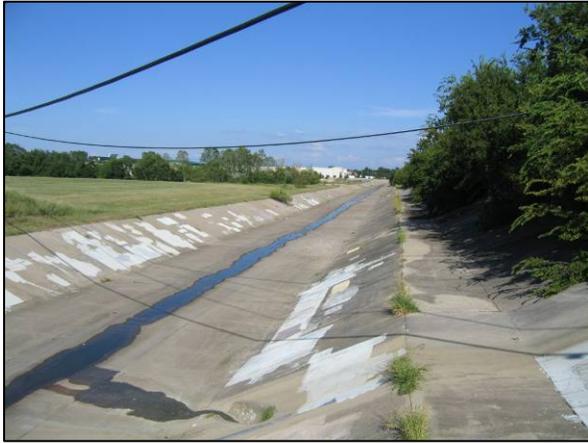
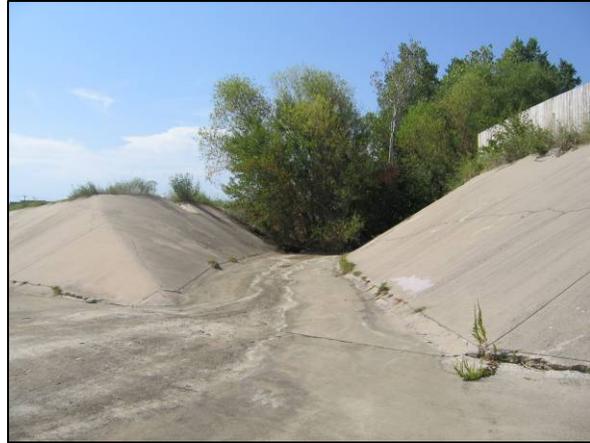
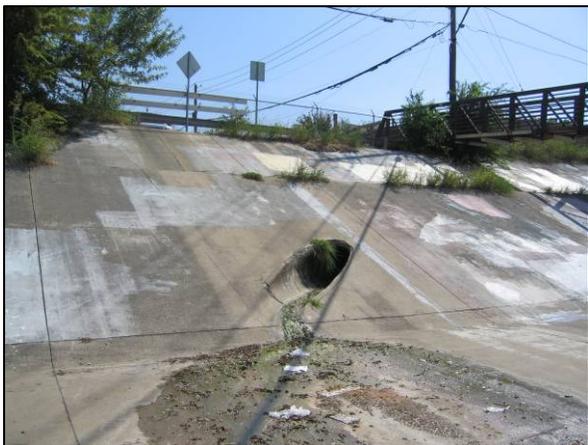
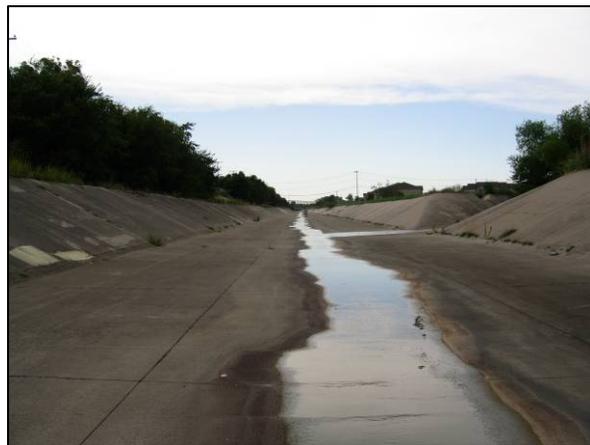
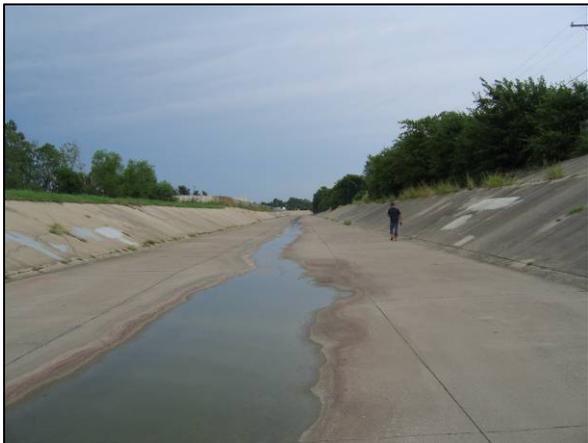
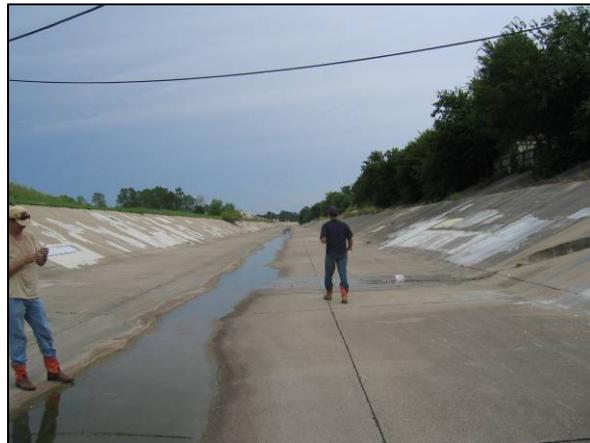
Photogroup 11-21 North Fork Fish Creek Site FN102 showing concrete lined channel along entire length of reach. (Individuals photographed are TIAER staff.)
[\[Return to Text\]](#)

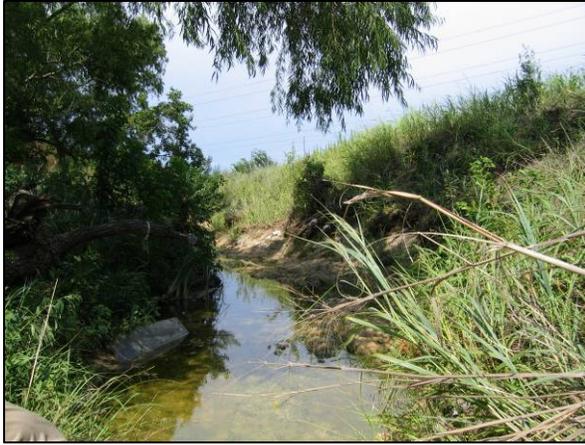
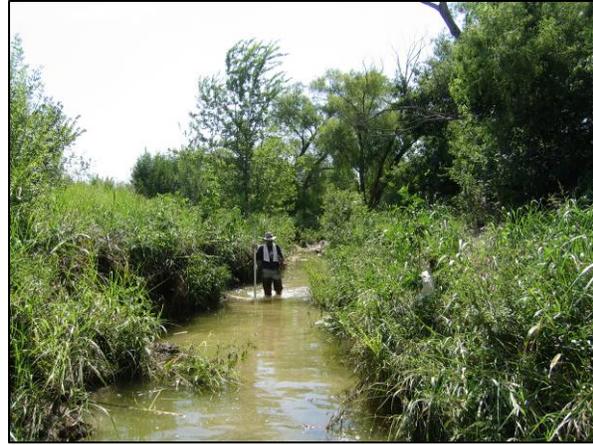
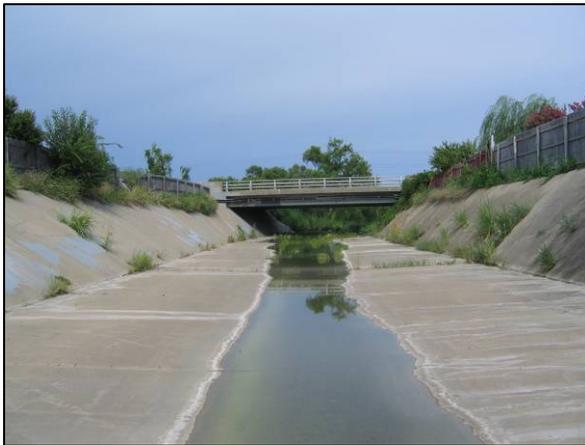
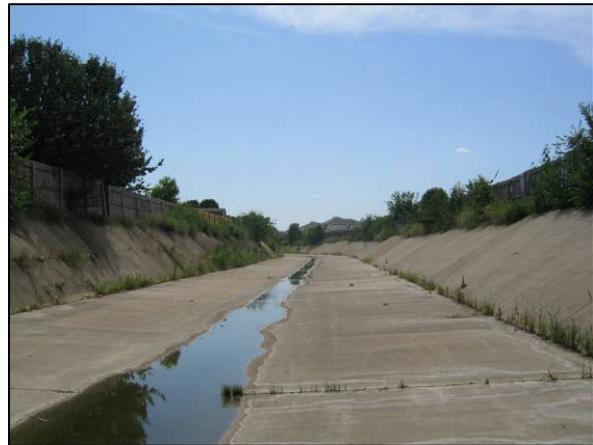
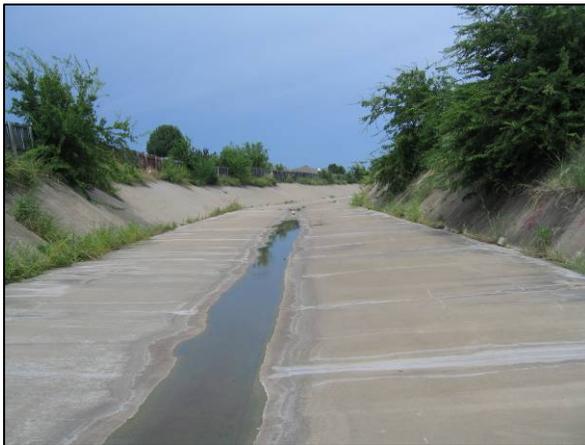
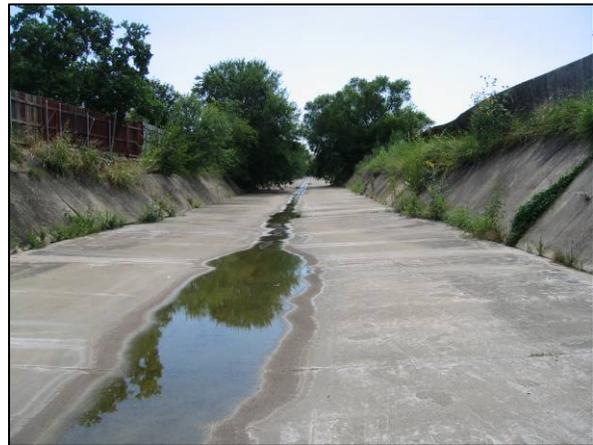
Photogroup 11-22 North Fork Fish Creek Site FN103 showing natural channel between 0-m and 60-m transects and concrete channel for remainder of reach. (Note backyard fences visible near concrete channel; Individual photographed is TIAER staff.) [\[Return to Text\]](#)

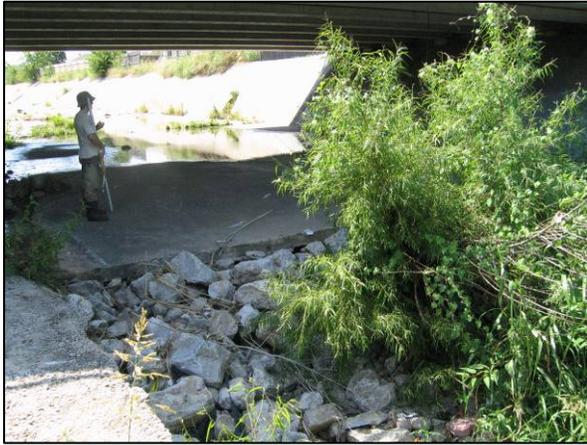
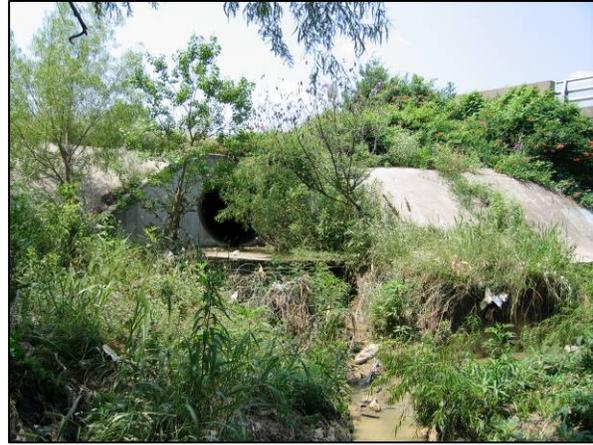
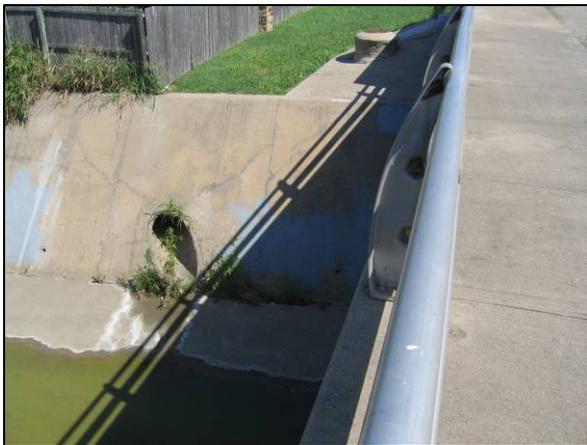
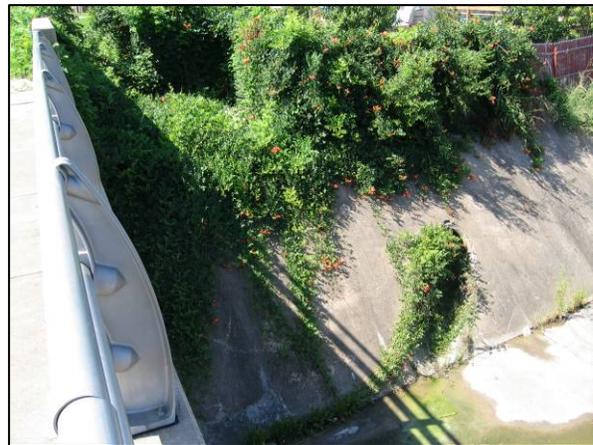
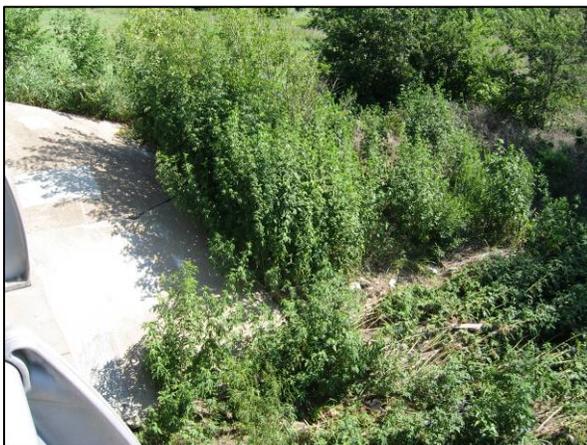
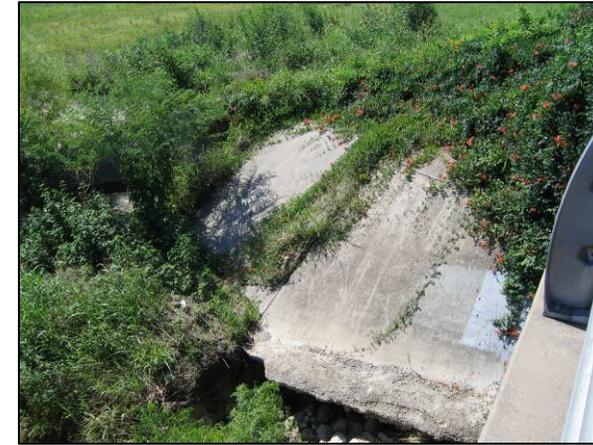
Photogroup 11-23 North Fork Fish Creek Site FN103 showing various access points (besides possible gates in backyard fences). ([Note that with the exception of one access point (middle left photograph) these access points were heavily vegetated; Individual pictured is TIAER staff.] [\[Return to Text\]](#)

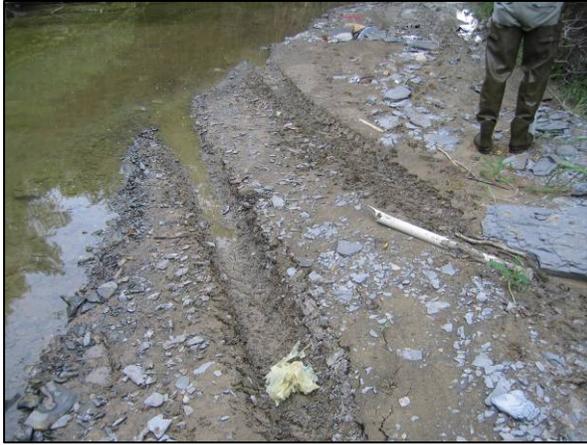
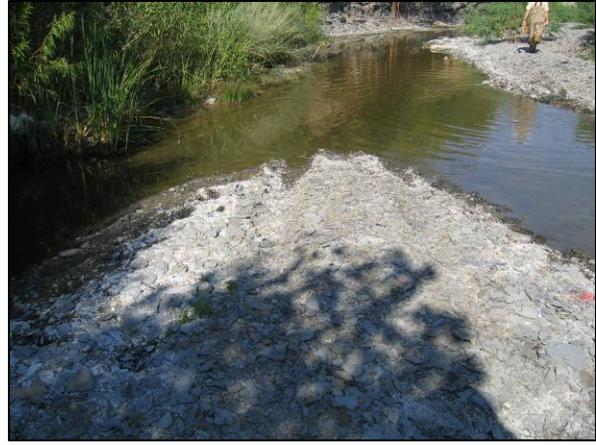
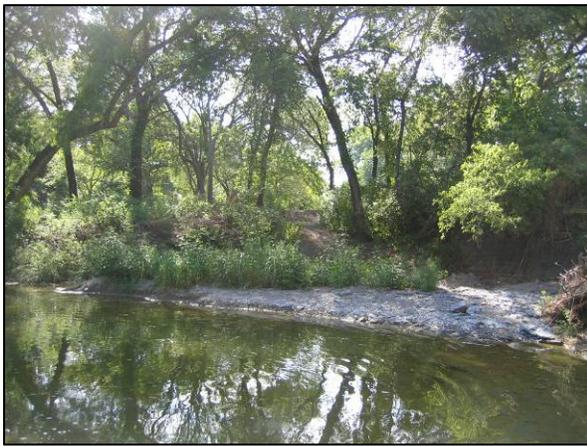
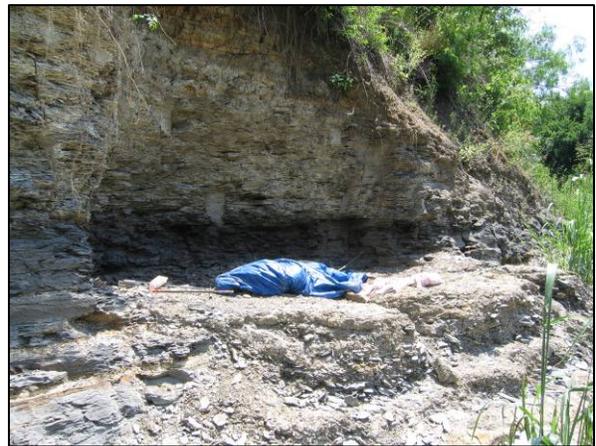
Although no activities, either primary or secondary contact or general, were observed or revealed through interviews at the North Fork Fish Creek sites, evidence was found to indicate some type of activity at FN101. ATV tracks were observed in the stream leading from off the bank of a backyard that abuts up to the creek through the culvert that flows under Great Southwest Parkway. In addition to the ATV tracks, a tarp and tent poles were discovered on a flat rock ledge on the left bank at Site FN101 during the May 2010 survey. [Photogroup 11-24](#) shows the ATV tracks and tarp and tent poles mentioned above.

Photogroup 11-24 North Fork Fish Creek showing ATV tracks and trail at Site FN101 (upper row and lower row left) and tent stakes and tarp for tent at Site FN101. (Individuals photographed are TIAER staff.) [\[Return to Text\]](#)

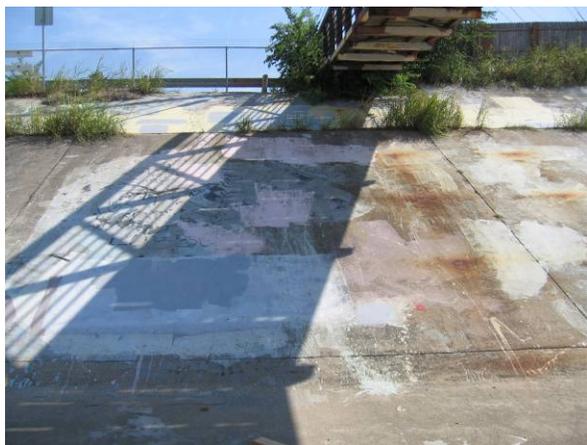
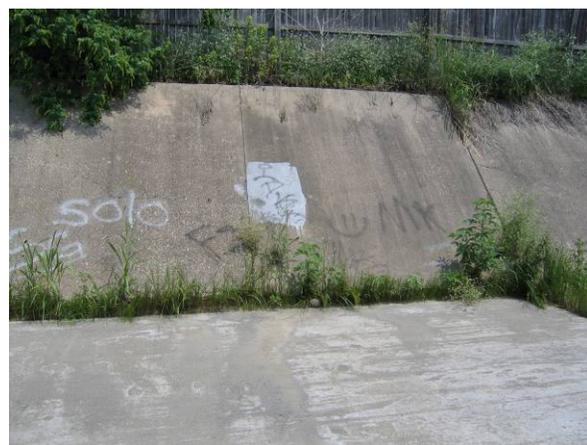
Photogroup 11-25 North Fork Fish Creek Sites FN102 and FN103 showing graffiti on concrete embankments. [\[Return to Text\]](#)

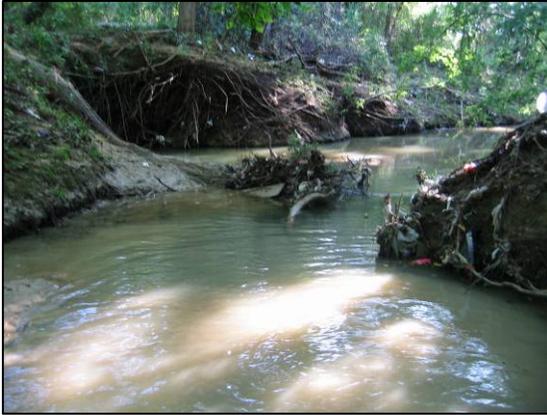
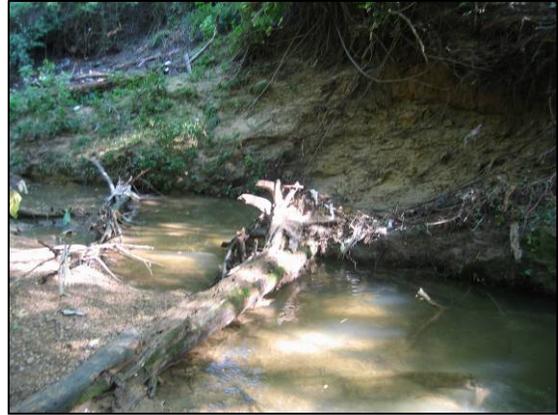
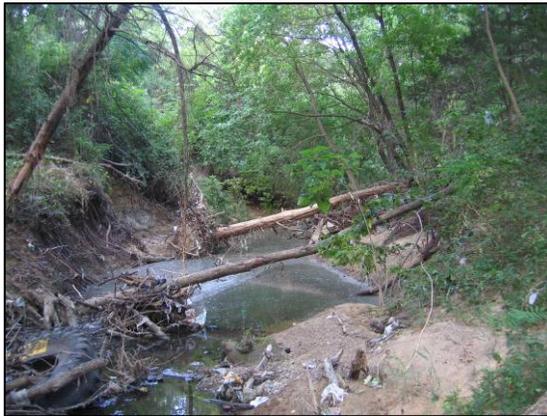
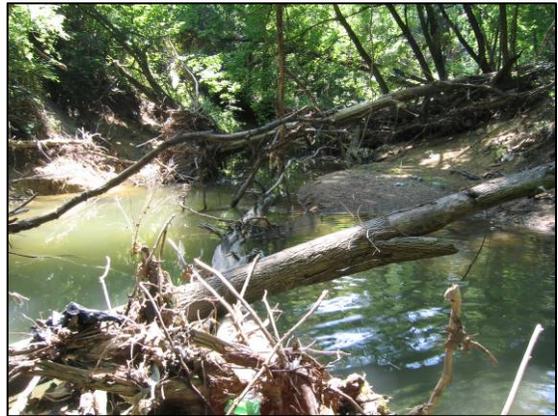
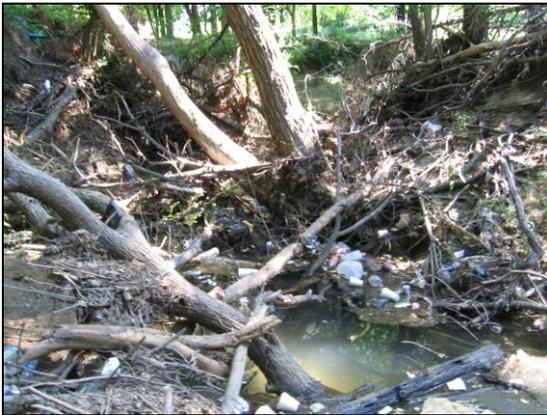
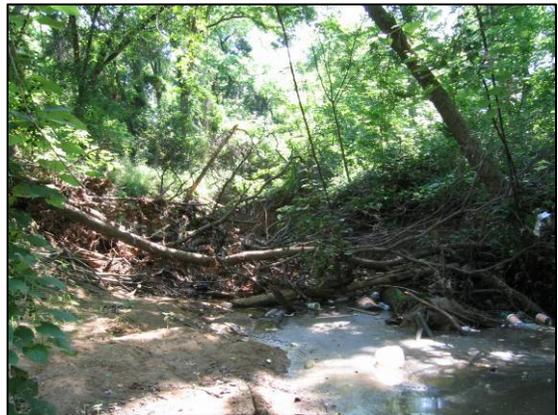
The number of channel obstructions observed varied with the three surveys. [Photogroup 12-3](#) and [Photogroup 12-4](#) depict obstructions located at the 90-m, 120-m, 130-m and 150-m transects. The obstructions consisted mainly of limbs, logs and trash. One large tractor tire was photographed in one of the obstructions. One storm water drainage pipe was also observed at the 240-m transect ([Photogroup 12-5](#)).

Photogroup 12-3 Kirby Creek Site KC101 showing obstructions observed at several transects during the surveys. [Return to Text](#)

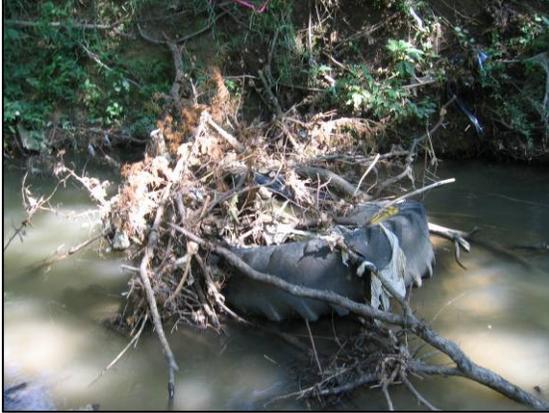
Photogroup 12-4 Kirby Creek Site KC101 showing obstruction containing large tire
[\[Return to Text\]](#)

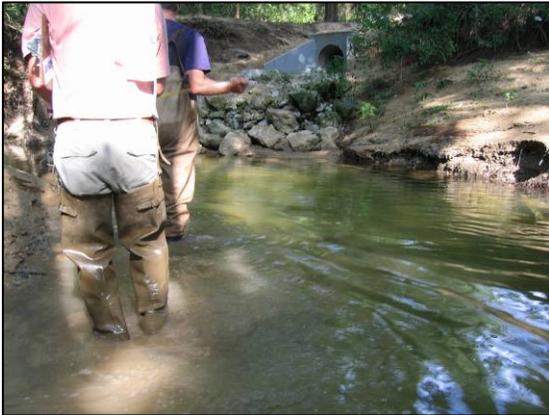
Photogroup 12-5 Kirby Creek Site KC101 showing entry point of stormwater drain pipe at 240-m transect. (Individuals photographed are TIAER staff.) [\[Return to Text\]](#)

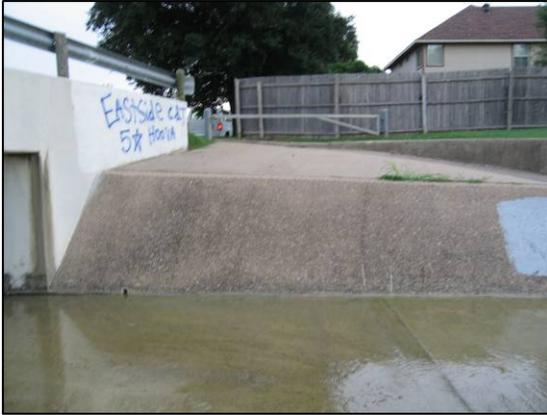
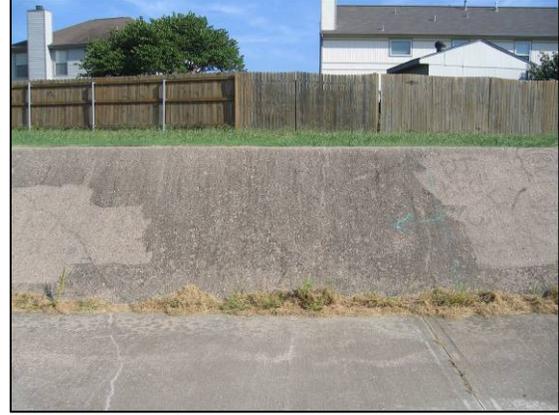
The surveyed reach at Site KC102 was a wadeable stream with depths not greater than 0.15 meters. The site is located in a highly residential area with yards of houses backing up to the stream ([Photogroup 12-7](#)). Graffiti on the banks of the concrete walls of the stream indicate that people do get into the stream. TIAER personnel observed several graffiti locations that were painted over from one survey to the next. The entire length of the stream was relatively shallow and narrow with not much water for contact recreation ([Photogroup 12-8](#)).

Photogroup 12-7 Kirby Creek Site KC102 showing proximity of residential backyard fences adjacent to stream [[Return to Text](#)]

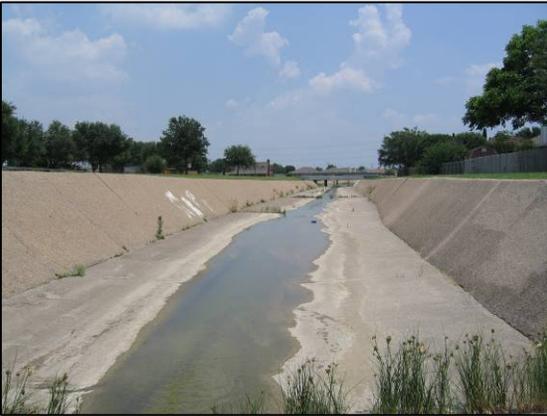
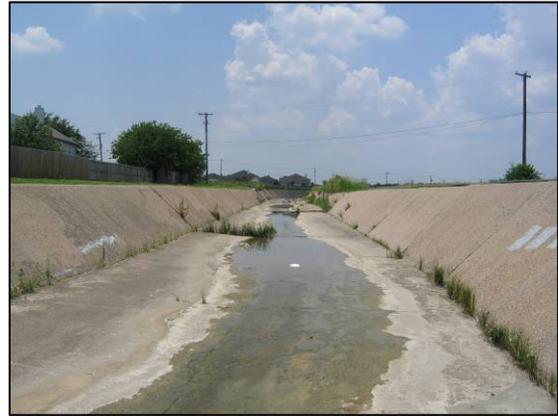
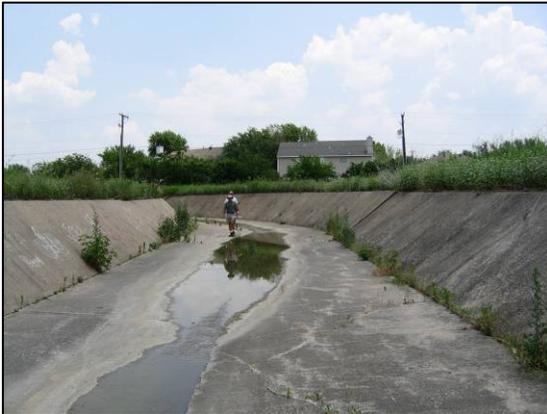
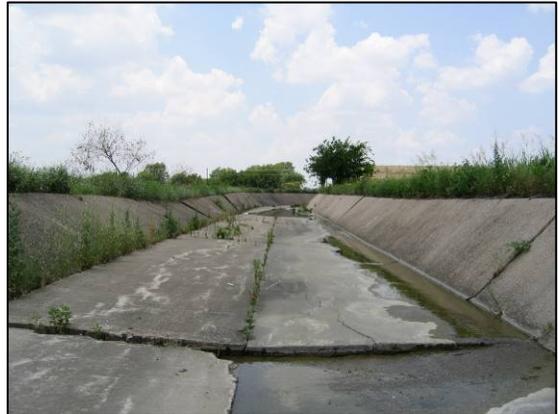
Photogroup 12-8 Kirby Creek Site KC102 showing channelized stream channel and normal water levels (Upper photographs at 150-m transect and lower photographs at 300-m transect looking downstream and upstream; Field staff shown in photographs). (Individual photographed is TIAER staff.) [[Return to Text](#)]

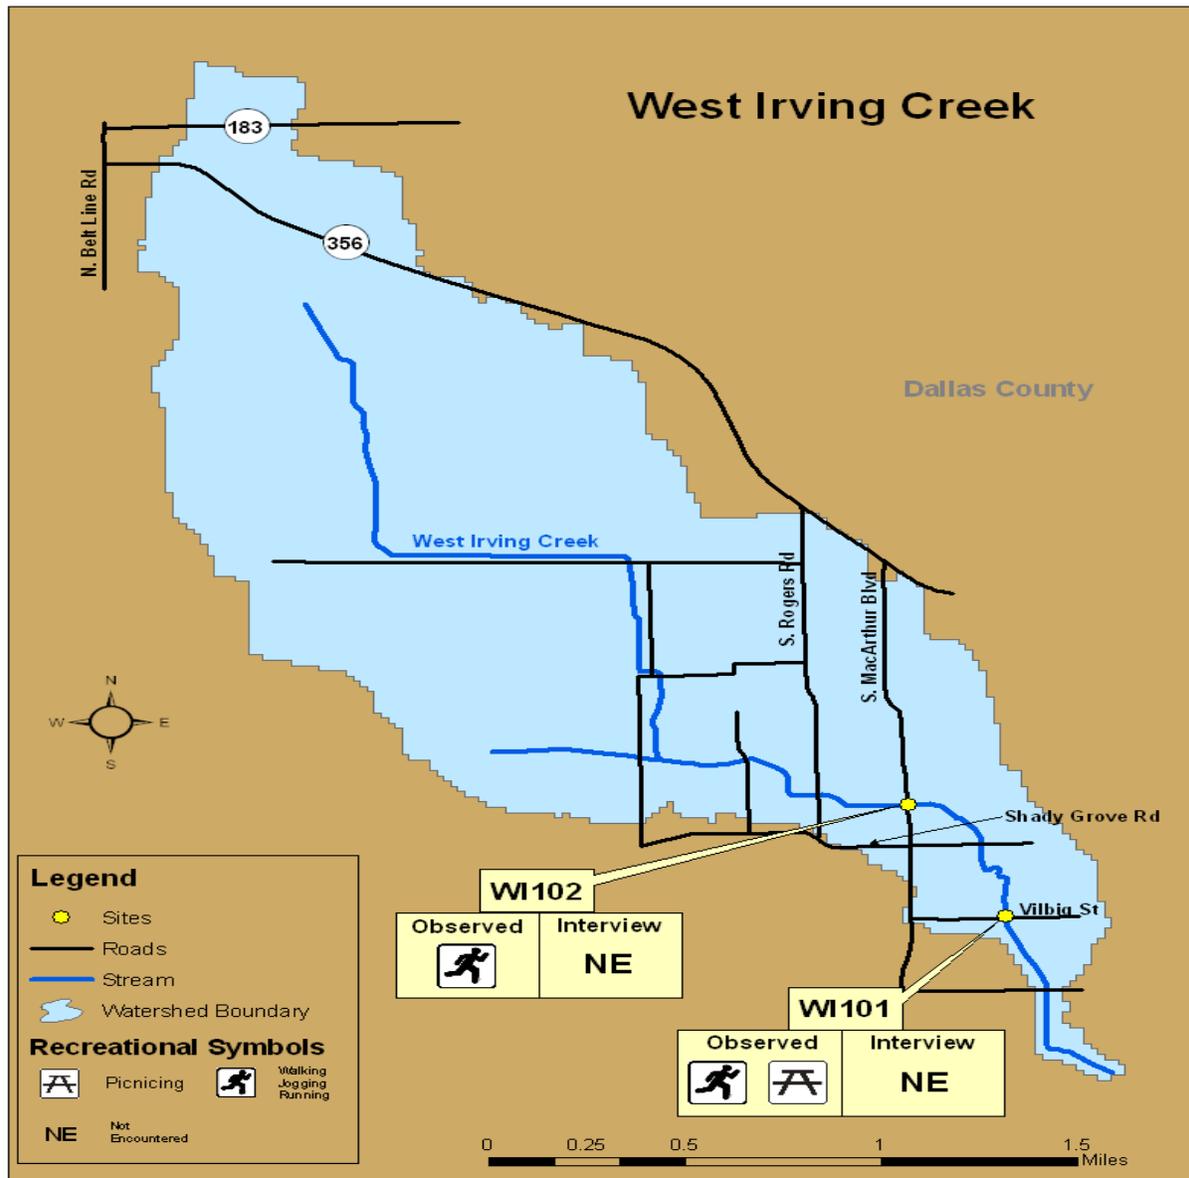
A minimal amount of activities were observed by TIAER field staff during the surveys and reported by interviewees, and these activities are summarized in Figure 13-4. The park facilities are well maintained by the City of Irving Parks and Recreation Department and are utilized by many people.

Figure 13-4 Summary of activities observed and reported in interviews at sites along West Irving Creek.

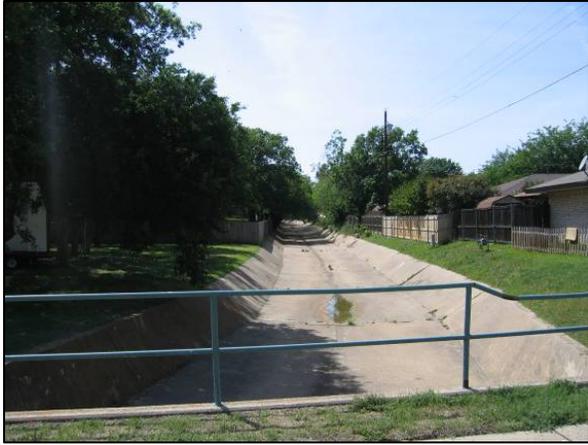
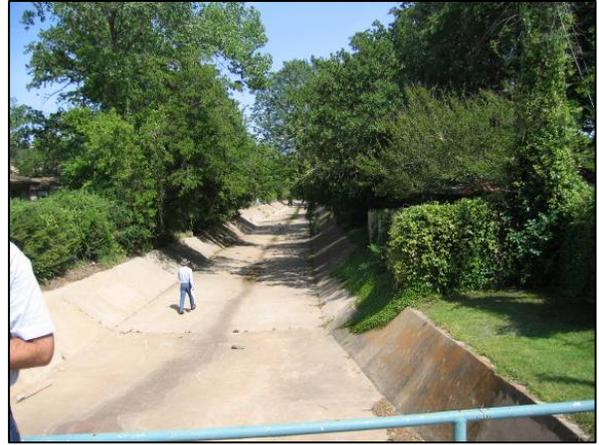
The creek crossing at Tipton Road is a concrete-lined tributary to West Irving Creek in a residential area ([Photogroup 13-4](#)). Backyard fences abut the stream channel making access from residences difficult. Access from the Tipton Road crossing is relatively easy. Very little water was observed in the stream and no evidence of water recreation was observed. The confluence with West Irving Creek at this location is slightly downstream. West Irving Creek is also concrete lined in this area and contained very little water at the time of the visit.

Photogroup 13-4 A tributary West Irving Creek at Tipton Road showing upstream and downstream views (field crew in downstream view). [\[Return to Text\]](#)
