Dallas-Fort Worth Metroplex Urban Creeks
Trinity River Bacteria TMDL Project
Recreational Use-Attainability Analysis Report

Report to TMDL Team
Texas Commission on Environmental Quality
Project and Work Order Number
582-5-70859-26

Jeff Stroebel
Tim Jones
Larry Hauck
Texas Institute for Applied Environmental Research
Tarleton State University
Stephenville, Texas

November 2010

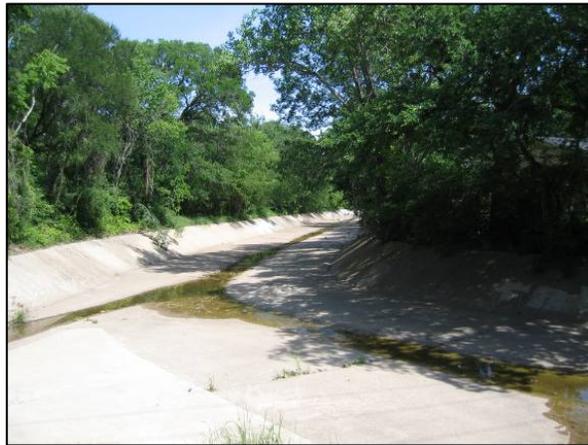
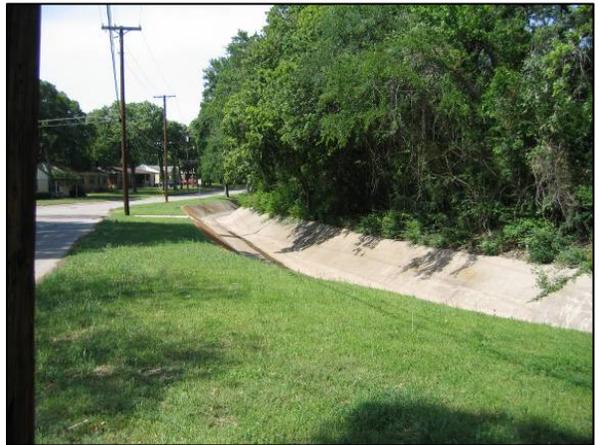
West Irving Creek at Bowman Street is a concrete lined channel in a residential area ([Photogroup 13-5](#)). The right bank is shrub/tree dominated atop the concrete channel and the left bank is a mowed and maintained grass corridor. Access to the stream appeared easy. No observed evidence of recreation was identified at this site.

Photogroup 13-5 West Irving Creek at Bowman Street showing upstream and downstream views [\[Return to Text\]](#)

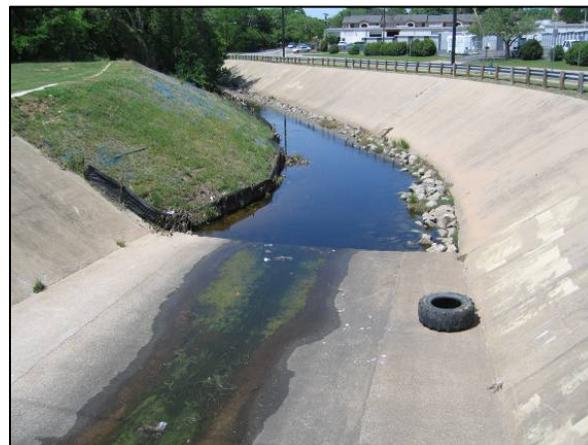
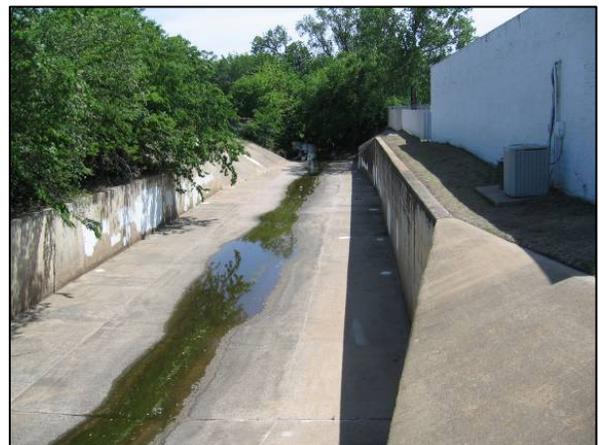
West Irving Creek at West Shady Grove Road appeared natural upstream of the road and as a concrete lined channel below ([Photogroup 13-6](#)). This potential site was located just to the north of Site WI101. Due to the similarities and proximity of Site WI101 and this location, the presence of the park at WI101 (no park was observed here) swayed the selection of Site WI101. Access to the stream from the Shady Grove location appeared to be moderately easy.

Photogroup 13-6 West Irving Creek at Shady Grove Road showing upstream and downstream views [\[Return to Text\]](#)

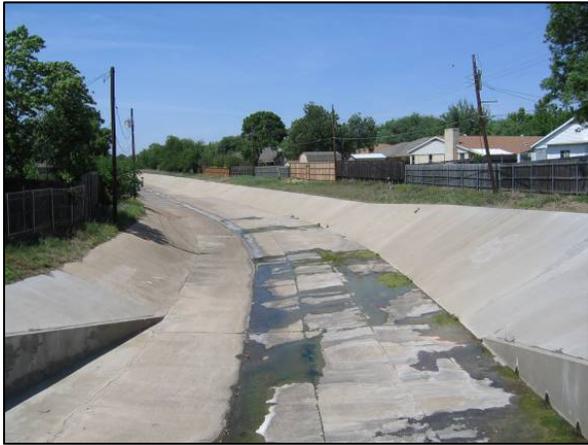
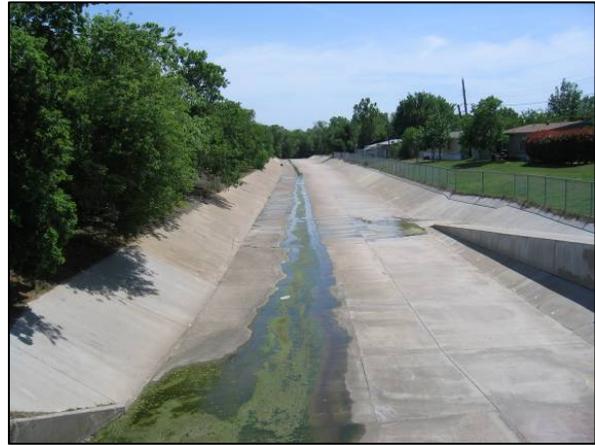
West Irving Creek at the West Oakdale Road crossing is a concrete lined channel in a residential neighborhood ([Photogroup 13-7](#)). A chain link fence is atop the upstream left bank of the channel and the upstream right bank has trees/shrubs to the edge of the stream. Residential backyard fences are located on the downstream sides of the channel. Access to the stream appeared moderately easy with very little water observed in the channel. No signs of recreation were observed.

Photogroup 13-7 West Irving Creek at West Oakdale Read showing upstream and downstream views [\[Return to Text\]](#)

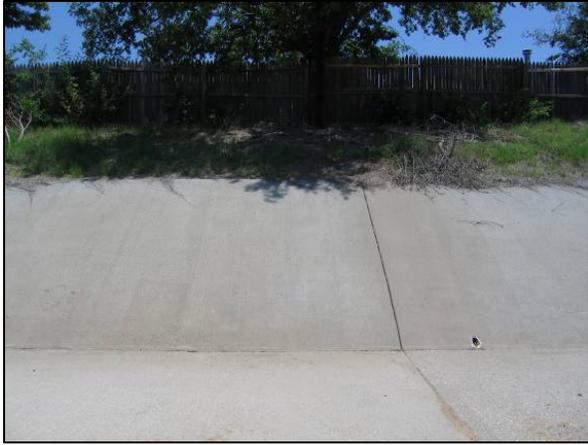
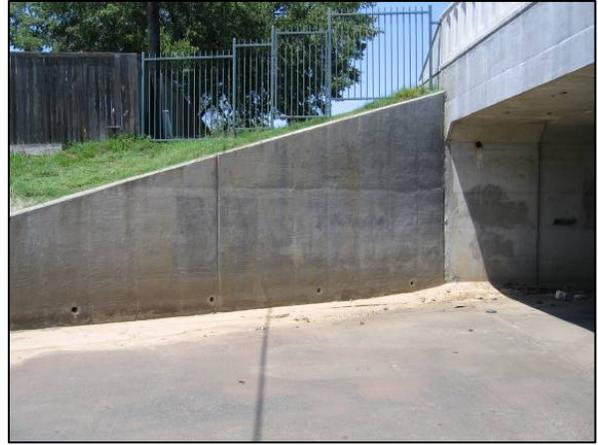
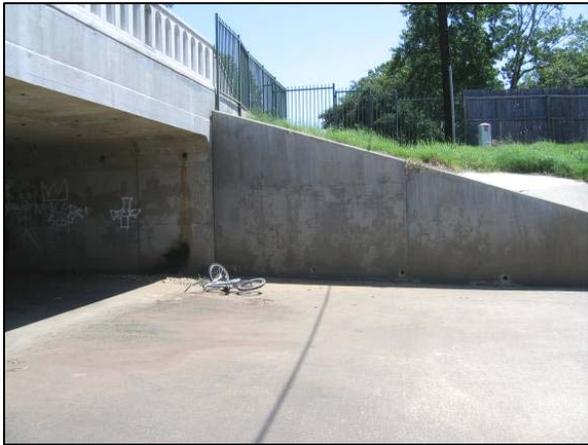
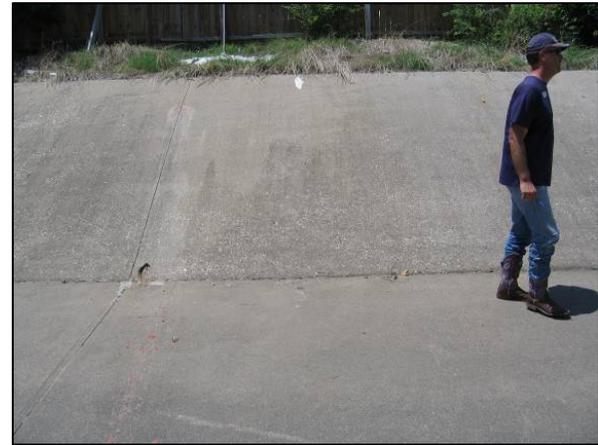
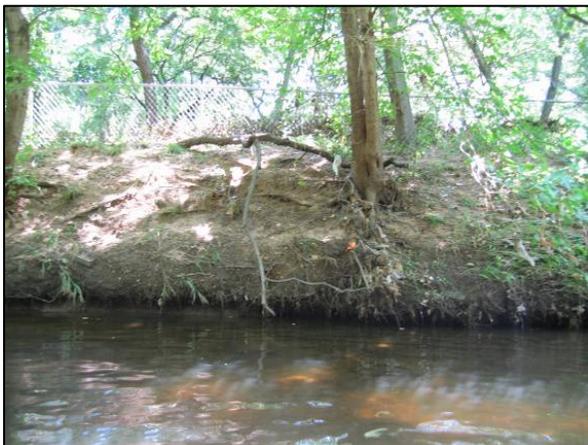
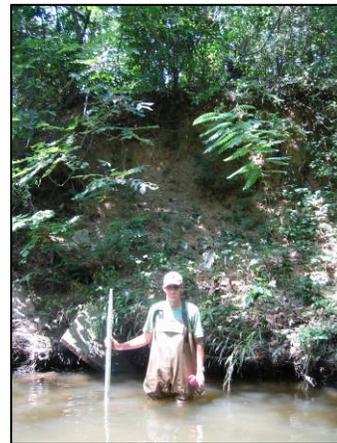
During the RUAA surveys, nobody was observed recreating in or near the stream at either site. There was a bicycle observed in the concrete channel of Site WI101 with graffiti also observed underneath the road culvert ([Photogroup 13-10](#); middle left photograph). There was an observation of sticks stuck into the mud at WI102 indicating someone may have been near the stream, possibly fishing or playing ([Photogroup 13-13](#)).

Photogroup 13-10 West Irving Creek Site WI101 showing areas adjacent to stream at 0-m, 150-m and 300-m transects (top, middle and bottom photographs). (Field crew only persons in photographs.) [\[Return to Text\]](#)

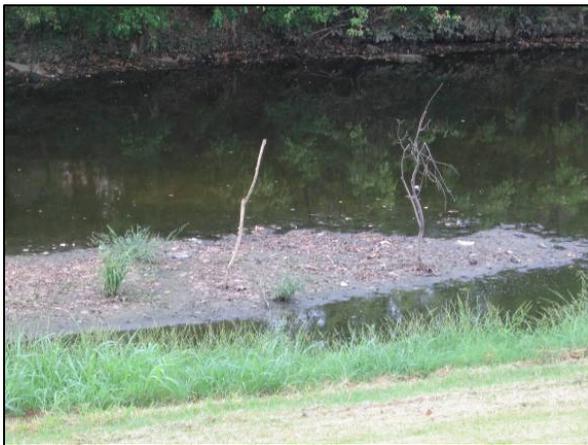
Photogroup 13-13 West Irving Creek Site WI102 showing sticks placed in mud by human activity [\[Return to Text\]](#)

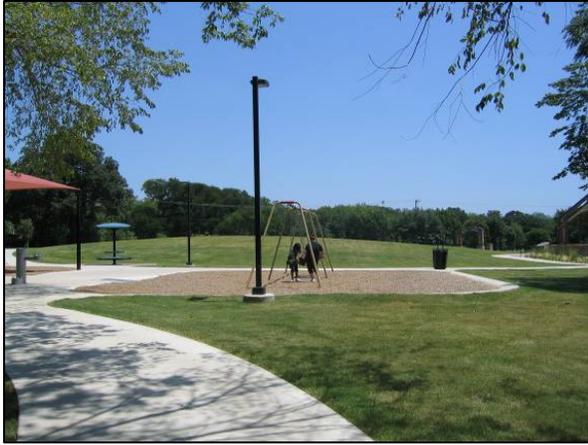
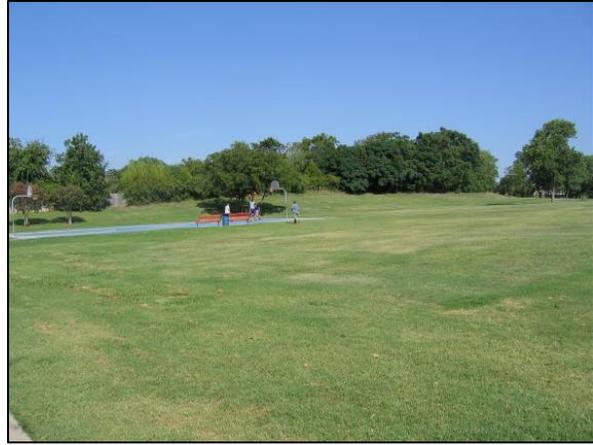
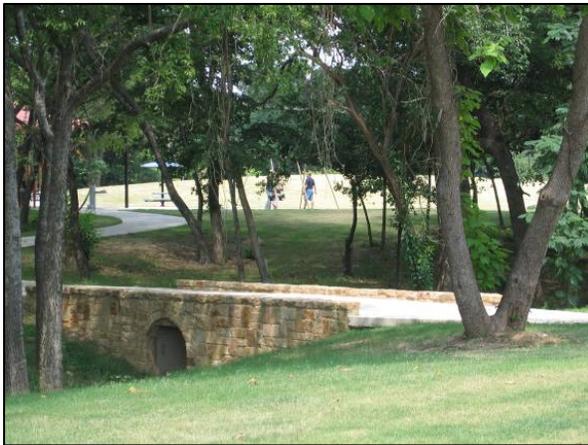
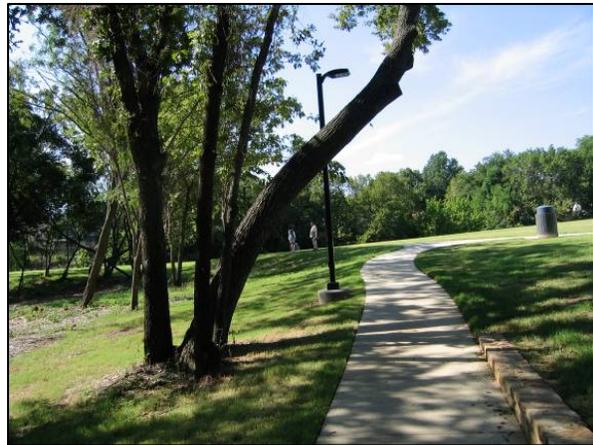
Activities observed at both sites occurred more than eight meters from the stream. Many people utilized the walking trails at the parks for exercise. A game of basketball was also observed on the basketball court at Site WI101, which was well over 100 m away from the stream. People with small children were observed utilizing the play structures at both of the parks and the picnic tables at Site WI101. [Photogroup 13-14](#) depicts some of the activities observed at the two locations along West Irving Creek.

Photogroup 13-14 West Irving Creek showing activities observed in parks associated with Sites WI101 and WI102 [Return to Text](#)
