# Attoyac Bayou Recreational Use Attainability Analysis

**Attoyac Bayou  
Recreational Use Attainability Analysis**

**Texas State Soil and Water Conservation Board  
Project # 09-10**

**October 2012**

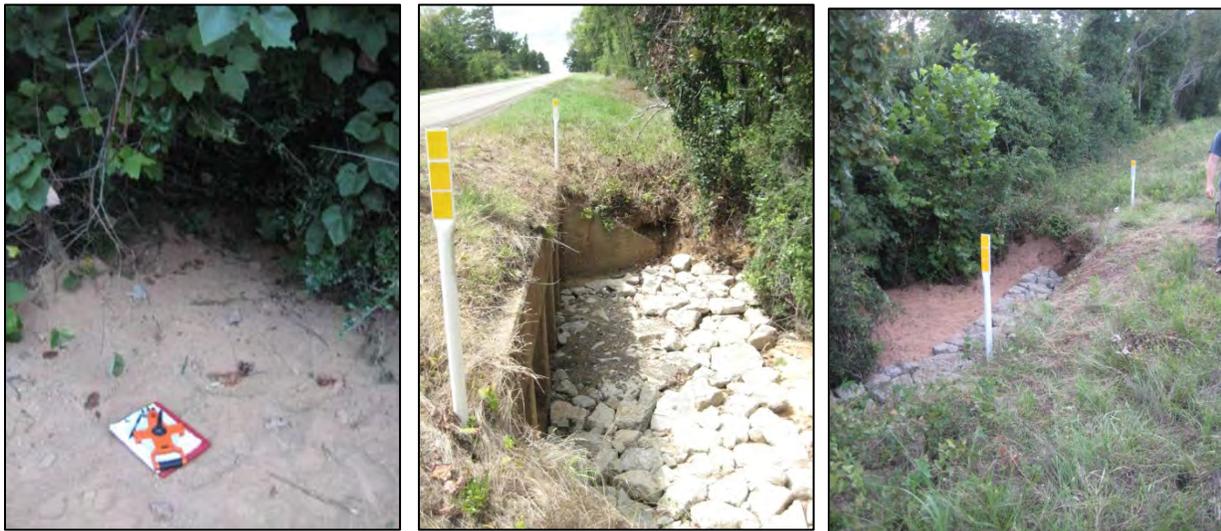
**Photogroup 4-1** Attoyac 1 depicting general appearance of the site from public access point, FM 95. Top left: 0-m transect, downstream view, stream channel with dense vegetation, July 2012; Top center: 0-m transect, downstream view, August 2012; Top right: 0-m transect, downstream view July 2012.

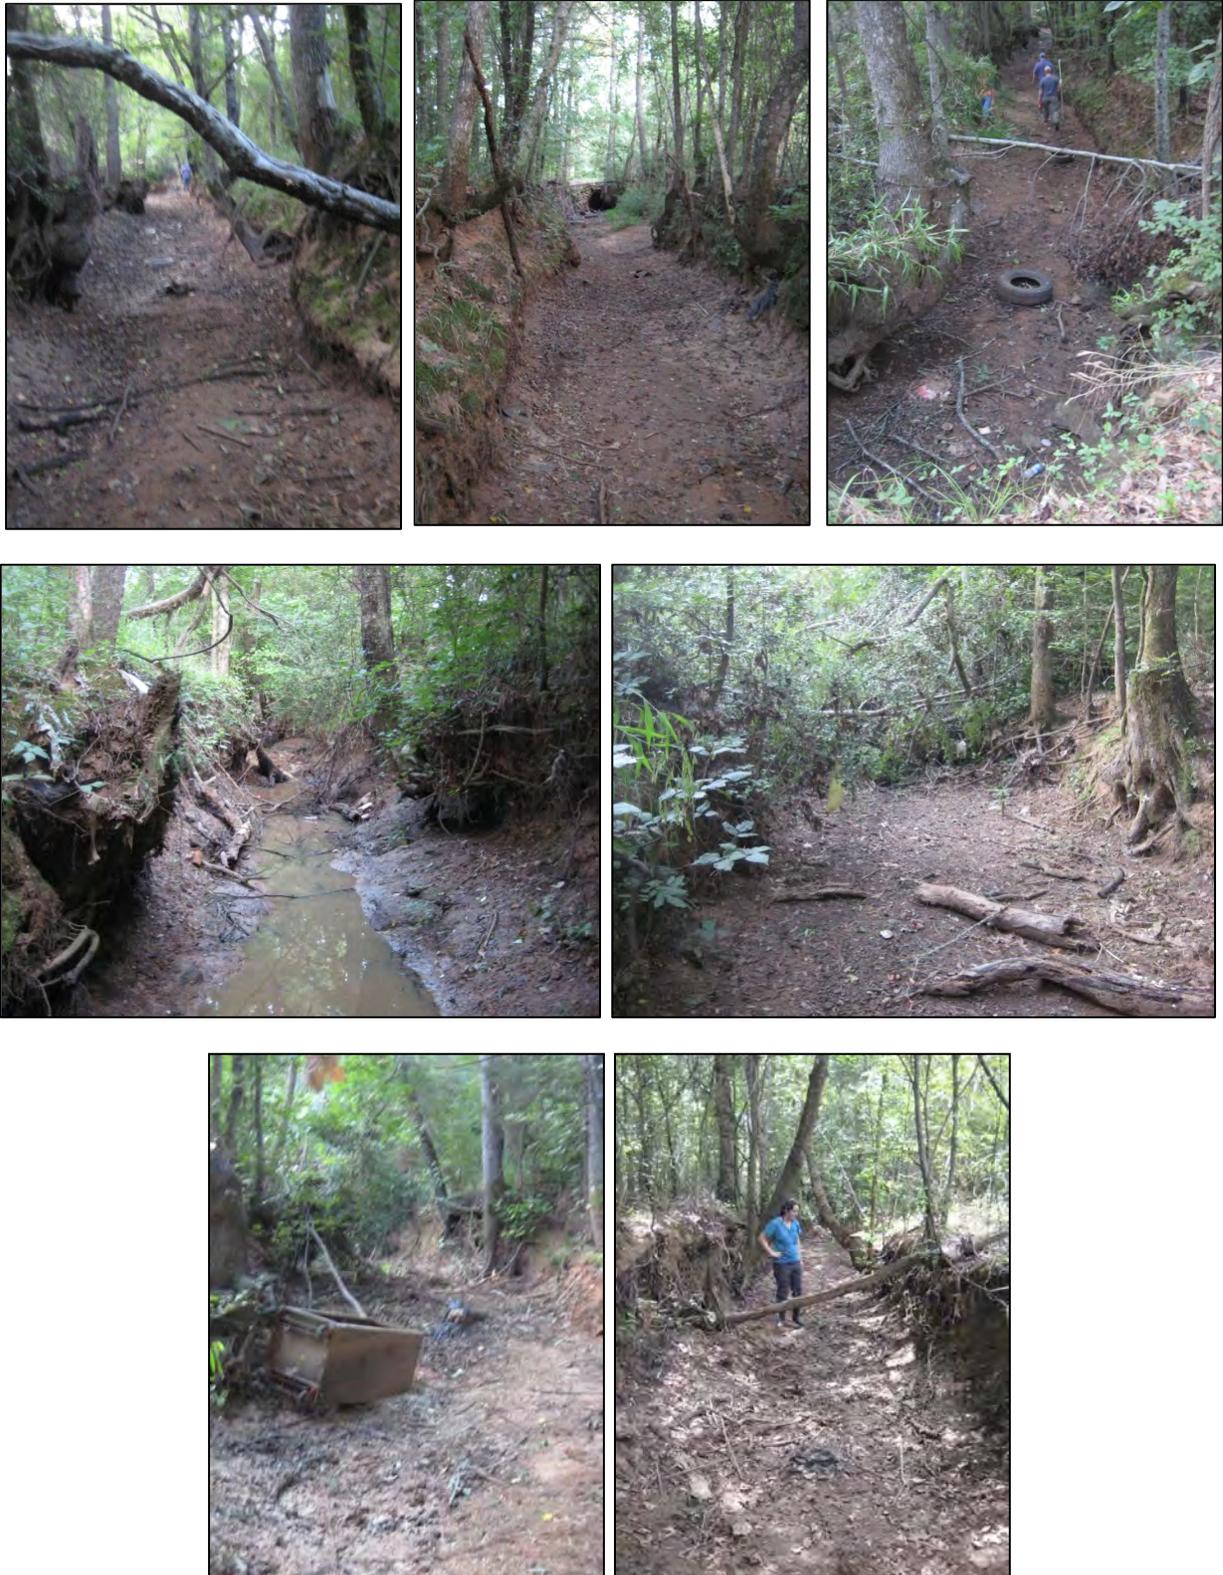
**Photogroup 4-2** Attoyac 2 depicting general appearance of the site. All individuals featured are SFASU and CES staff. Top left: 30-m transect, upstream, July 2012; Top center: 30-m downstream, July 2012; Top right: 90-m transect, downstream, July 2012; Middle left: 300-m transect, upstream, July 2012; Middle right: large woody debris, July 2012; Bottom left: large channel litter, July 2012; Bottom right: 300-m transect, upstream, August 2012.

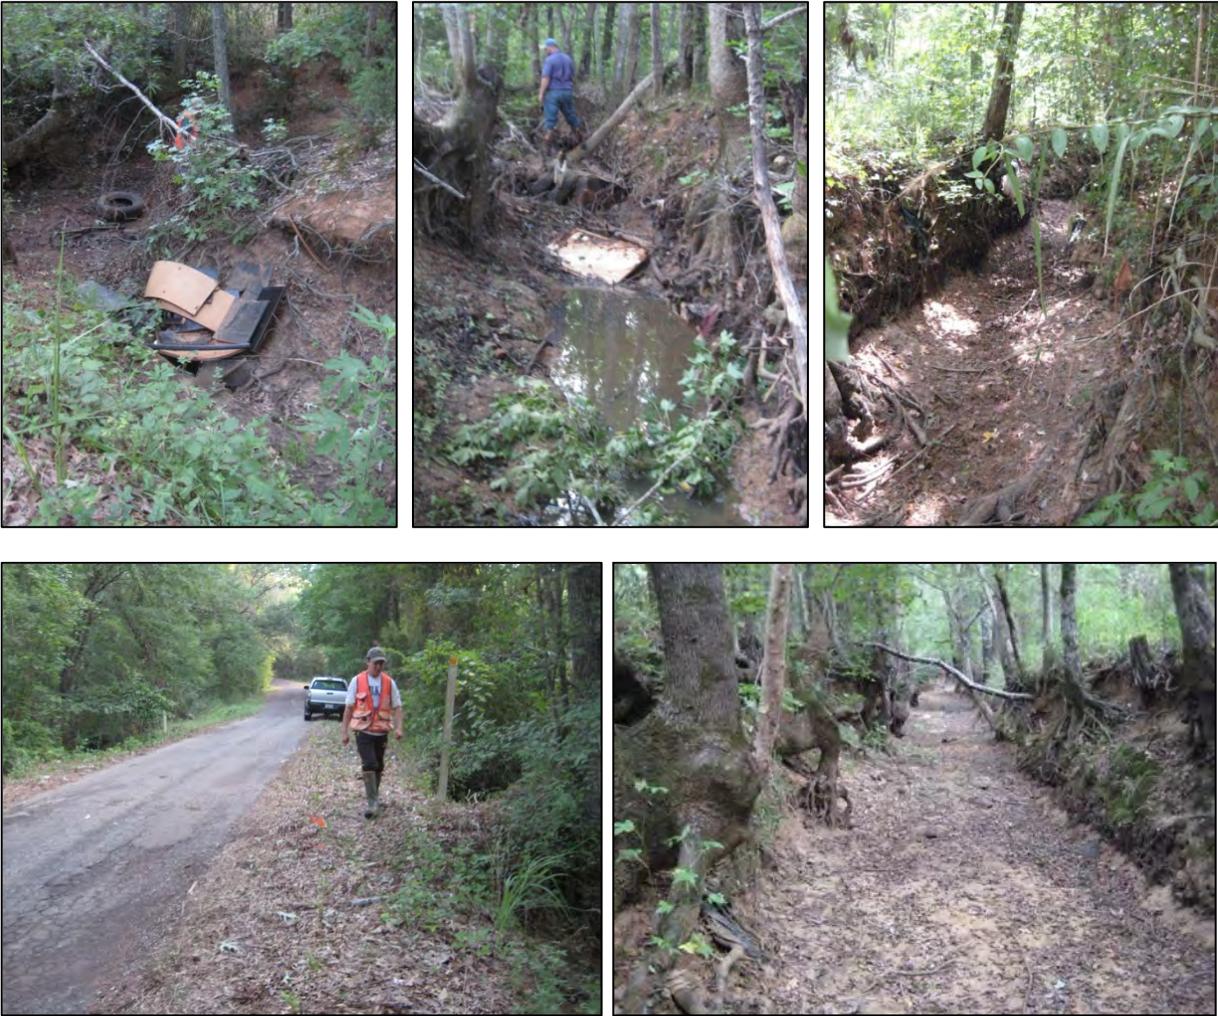
**Photogroup 4-2** Attoyac 2 depicting general bank appearance and stream access point. All individuals featured are SFASU and CES staff. Top left: 0-m transect, downstream bank, July 2012; Top center: 150-m transect, downstream, July 2012; Top right: 150-m transect, upstream, August 2012. Bottom left: Stream access point from CR 3122, July 2012; Bottom right: 30-m transect, downstream, August 2012.

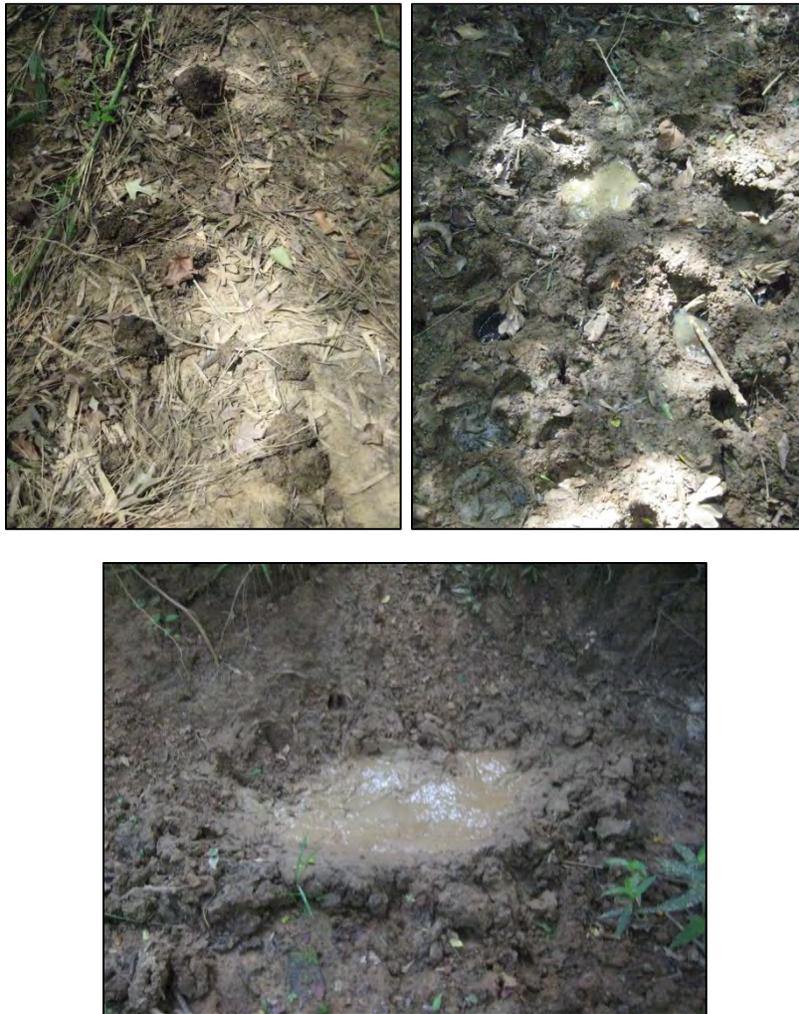
**Photogroup 4-2** Attoyac 2 depicting potential sources of contamination. Top left: Livestock fecal, August 2012. Top right: Livestock tracks in channel, August 2012; Bottom: Feral hog wallow, July 2012.

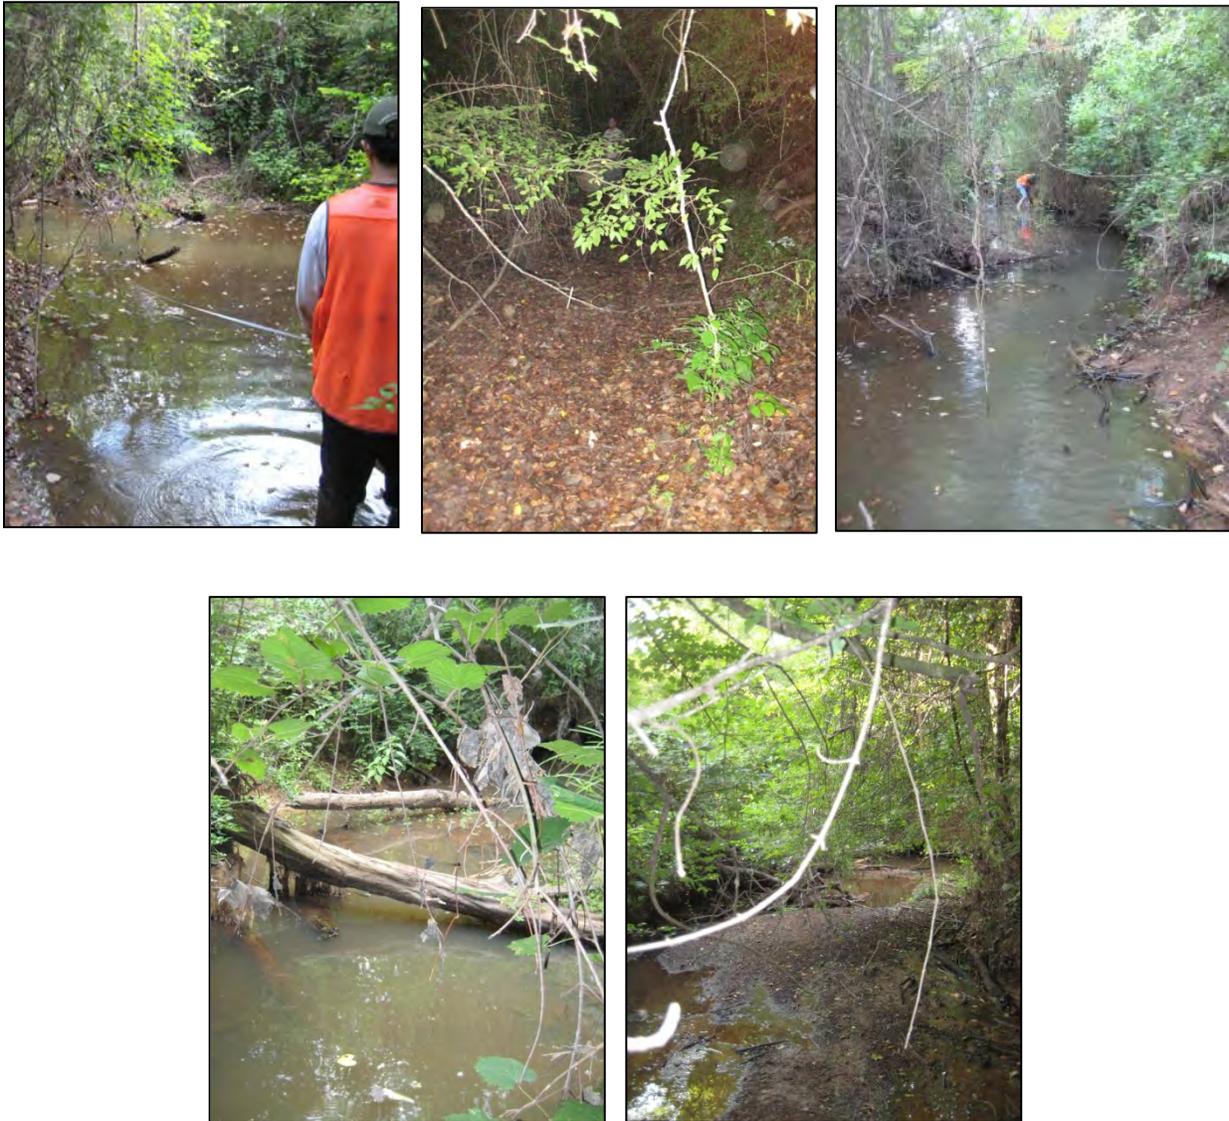
**Photogroup 4-3** Attoyac 3 depicting general stream appearance. All individuals featured are SFASU and CES staff. Top left: 30-m transect, downstream, July 2012; Top center: 150-m transect, upstream, August 2012; Top right: 30-m transect, July 2012; Bottom Left: 150-m transect, downstream, July 2012. Bottom right: 300-m transect, upstream, July 2012.

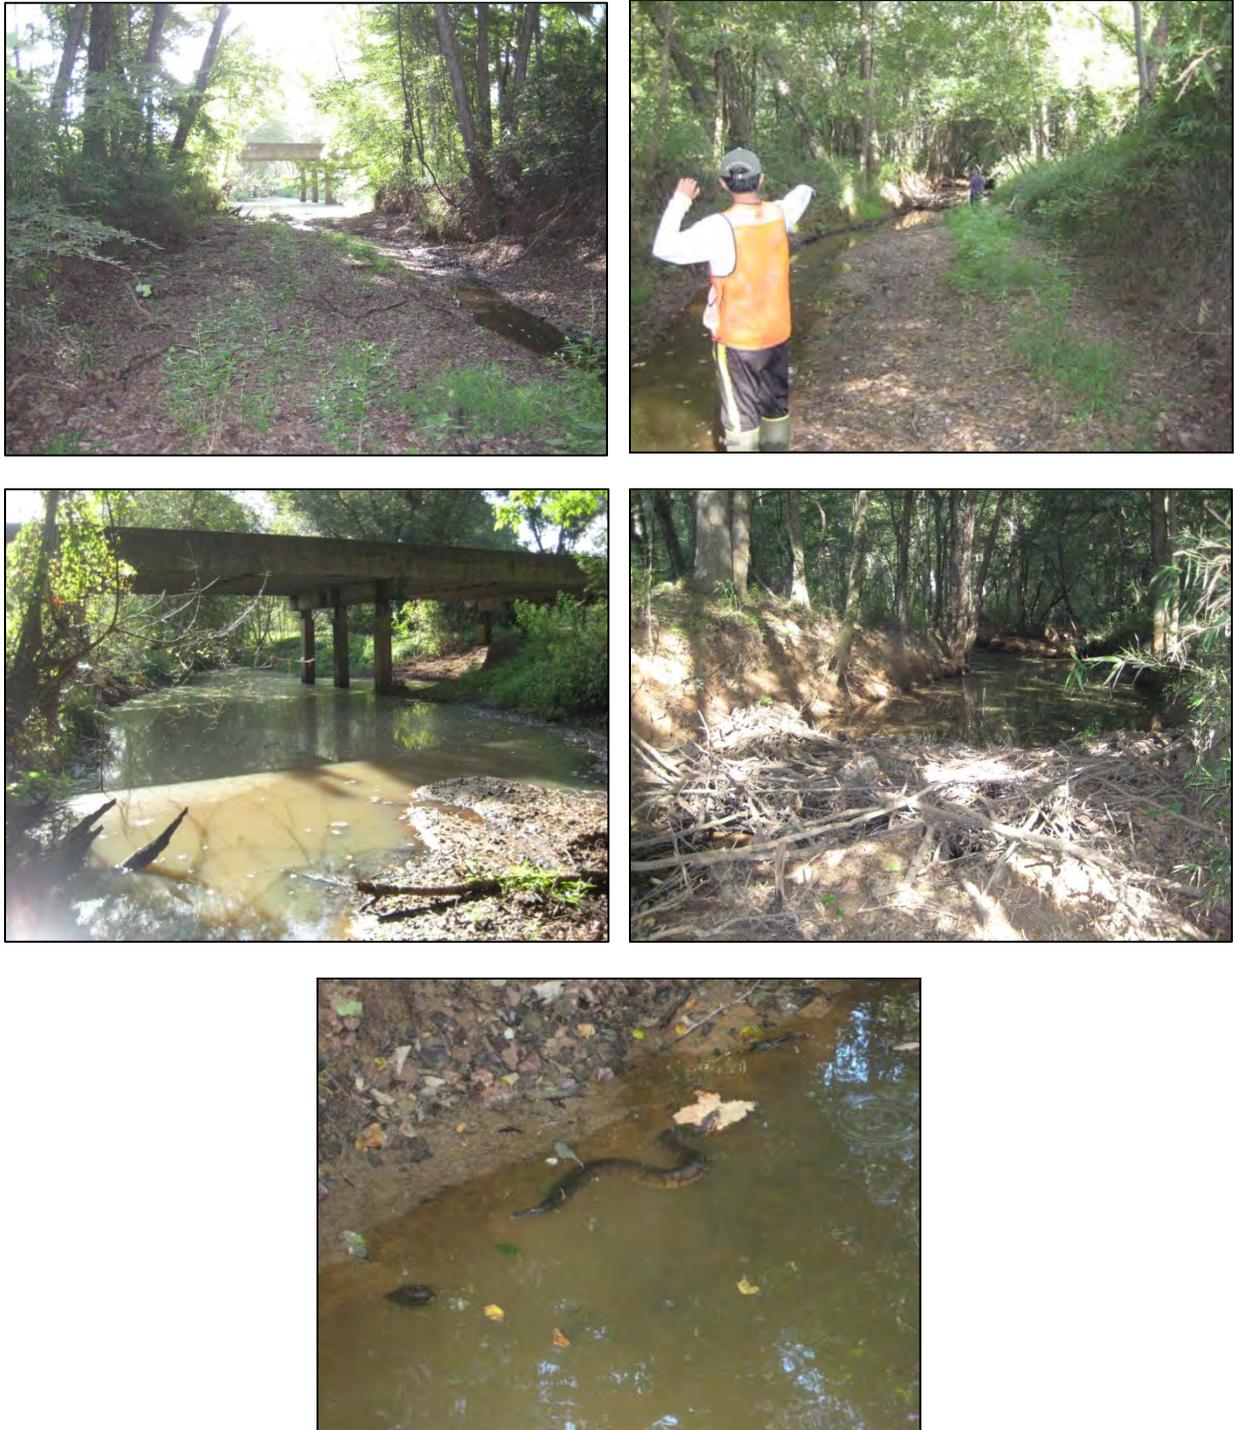
**Photogroup 4-4** Attoyac 4 depicting general stream characteristics. All individuals featured are SFASU and CES staff. Top left: 30-m transect, downstream, July 2012; Top right: 30-m transect, upstream, July 2012; Middle left: Pool at access point, July 2012; Middle right: Beaver dam, upstream, July 2012. Bottom: Water Moccasin in pool, July 2012.

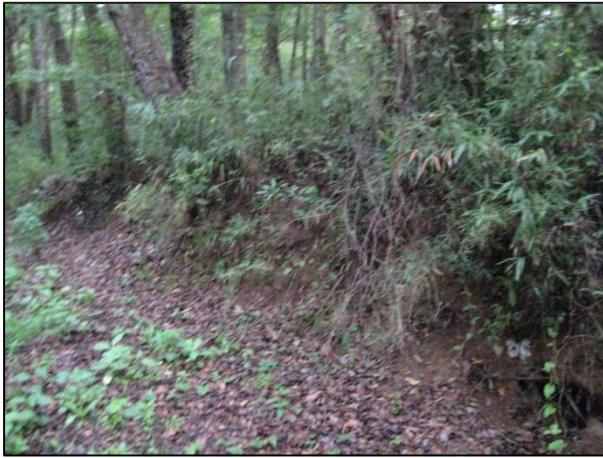
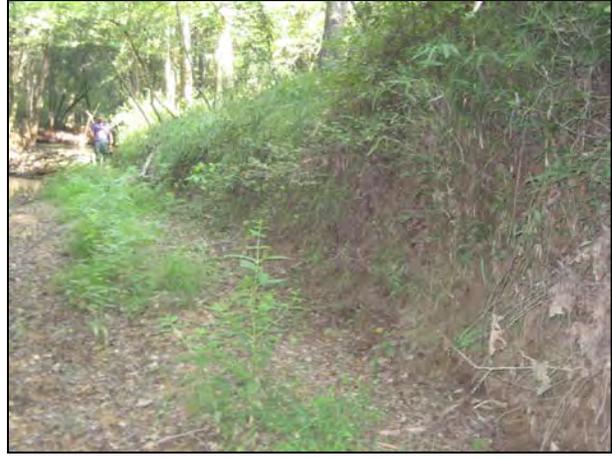
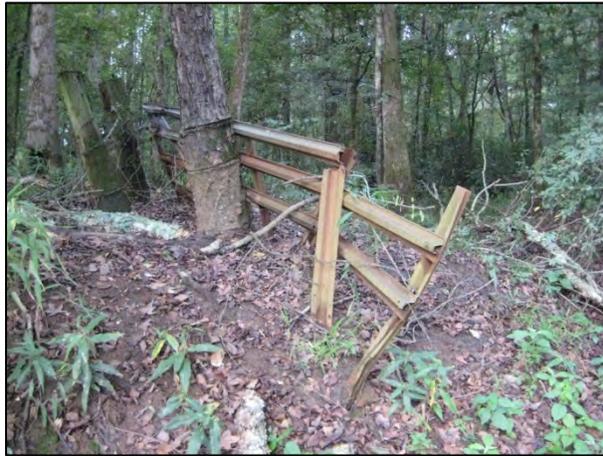
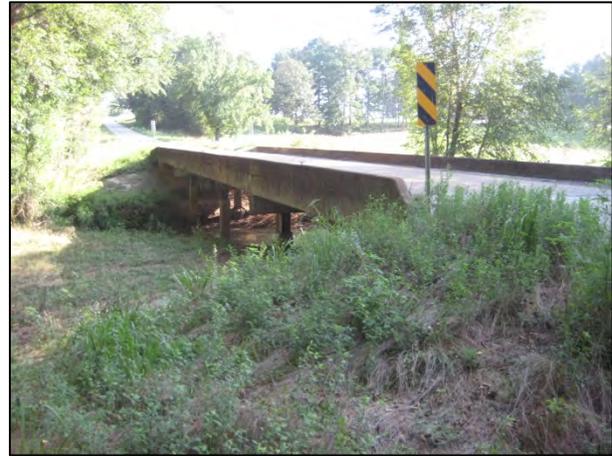
**Photogroup 4-4** Attoyac 4 depicting access point and general bank appearance. Top left: 0-m transect, left bank, July 2012; Top right: 30-m transect, right bank, August 2012; Bottom left: Fence on Right bank, August 2012; Bottom Right: Stream access point from FM 1971, July 2012.

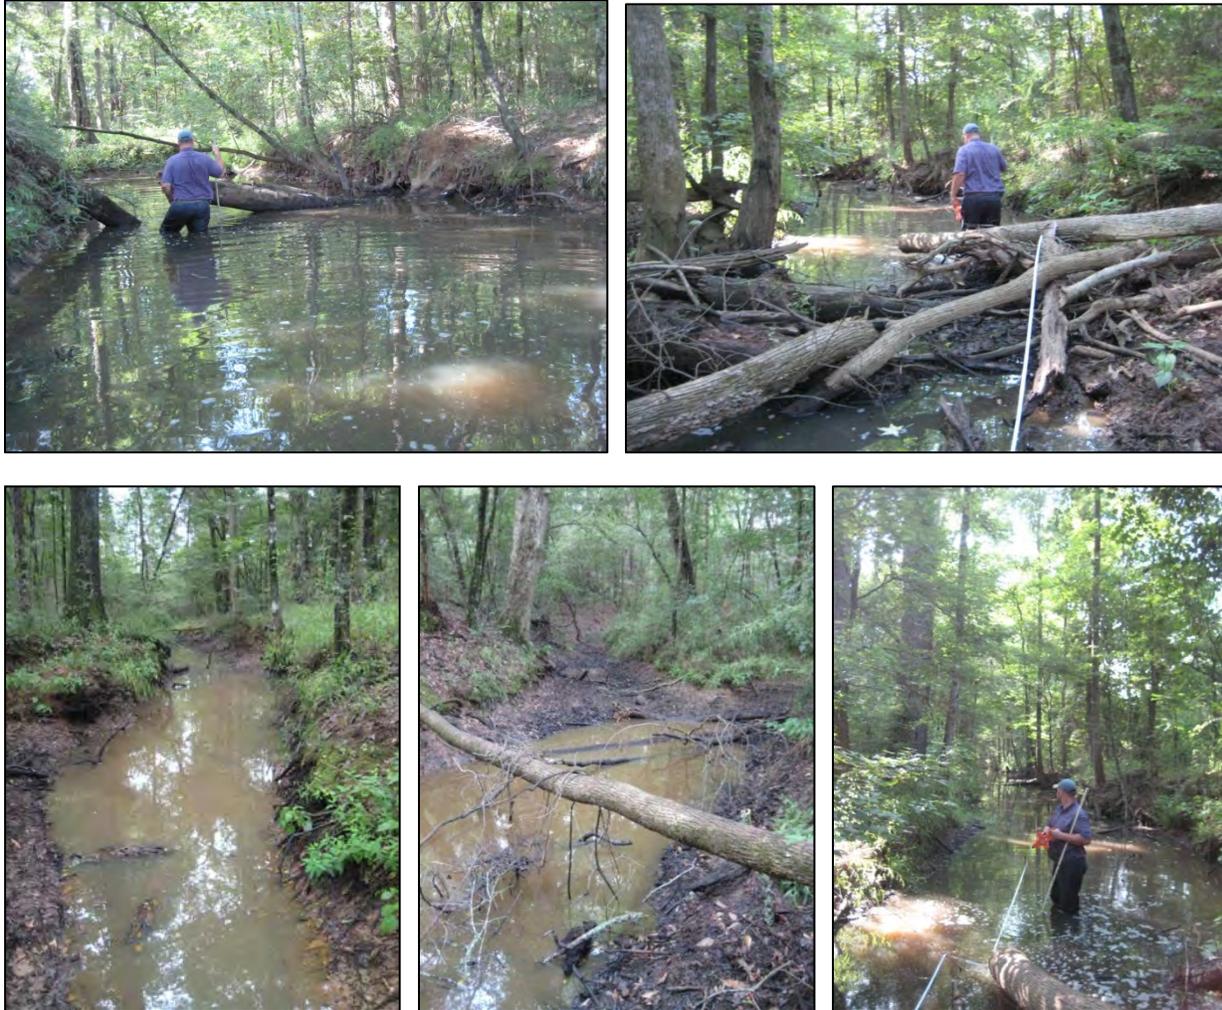
**Photogroup 4-5** Attoyac 5 (20842) depicting general stream characteristics. All individuals featured are SFASU and CES staff. Top left: 30-m transect, downstream, July 2012; Top right, Large woody debris, July 2012; Bottom left: 30-m transect, downstream, August 2012; Bottom center: 150-m transect, upstream, August 2012; Bottom right: 150-m transect, downstream, July 2012.

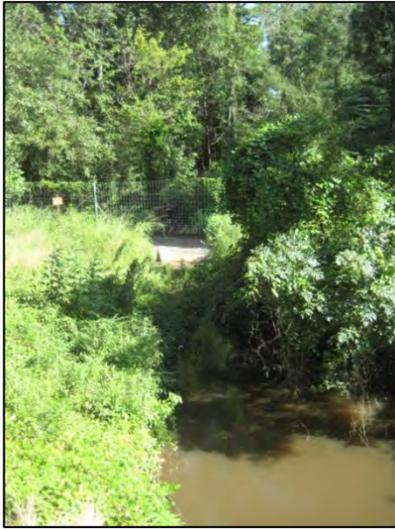
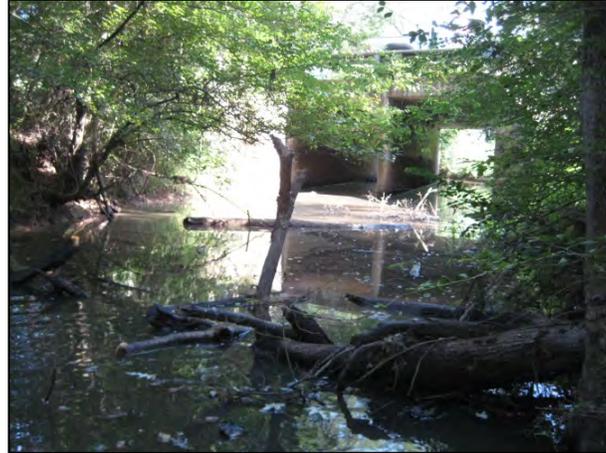
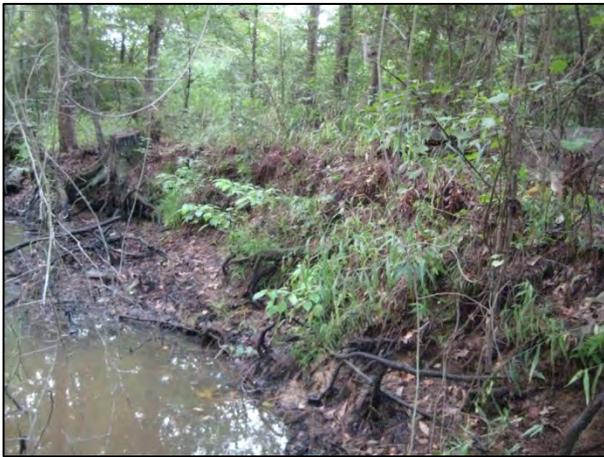
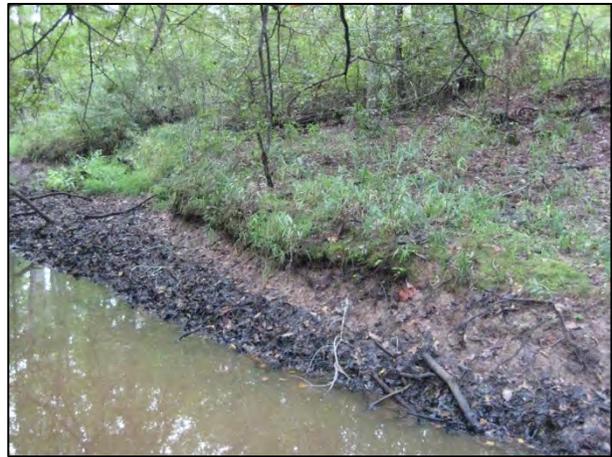
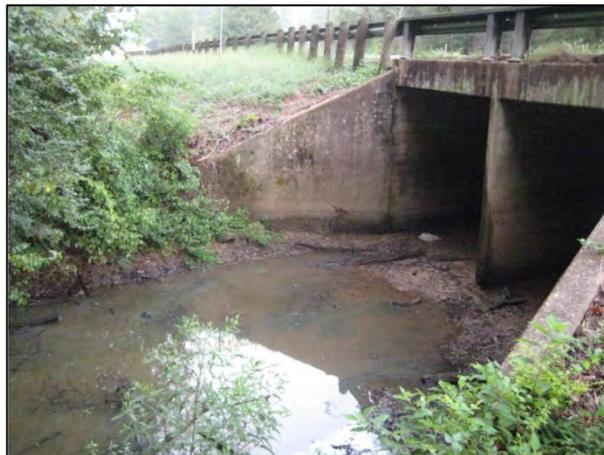
**Photogroup 4-5** Attoyac 5 (20842) depicting stream banka access and general bank appearance. Top left: Upstream channel fenced, July 2012; Top right: 30-m transect, upstream, July 2012; Middle left: 300-m transect, rightbank, August 2012; Middle right: 30-m transect, rightbank; Bottom: 0-m transect, stream access from Hwy 84; August 2012.

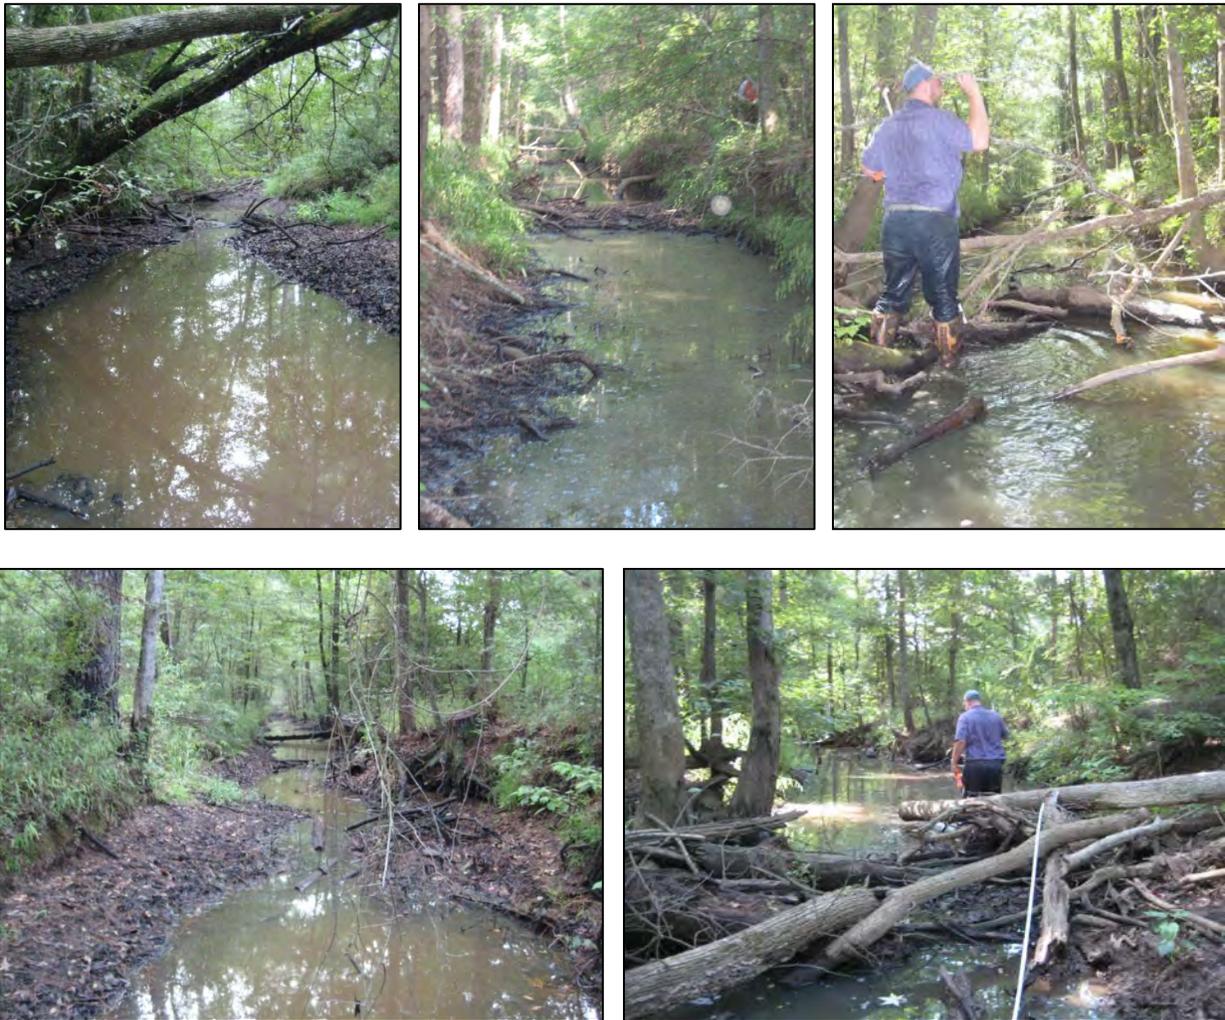
**Photogroup 4-5** Attoyac 5 (20842) depicting stream surface characteristics. All individuals featured are SFASU and CES staff. Top left: 150-m, downstream, August 2012; Top center: 300-m, upstream, July 2012; Top right: Large woody debris, July 2012; Bottom left: 300-m, downstream, August 2012; Bottom right: Large woody debris, July 2012.

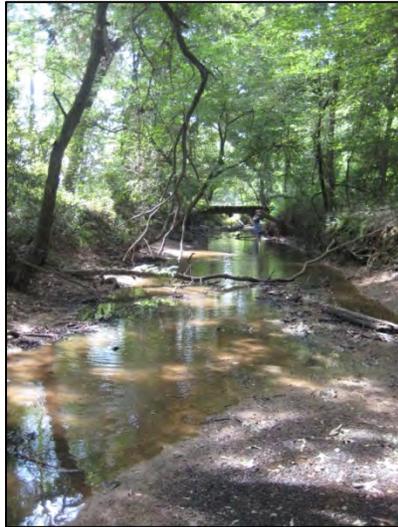
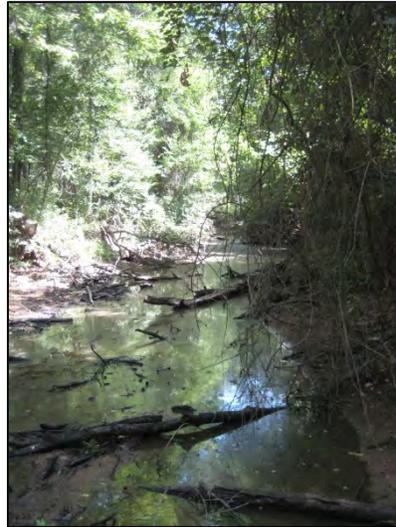
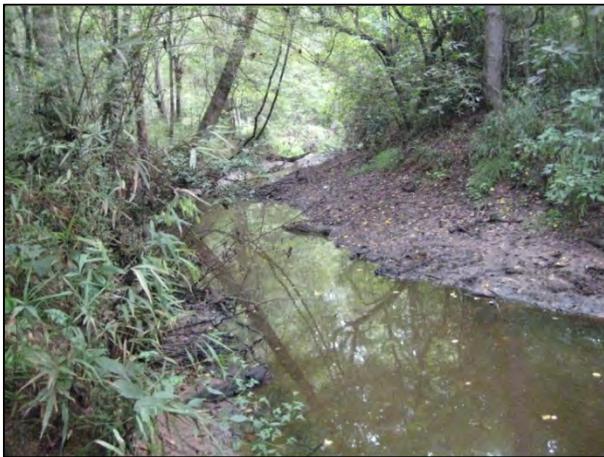
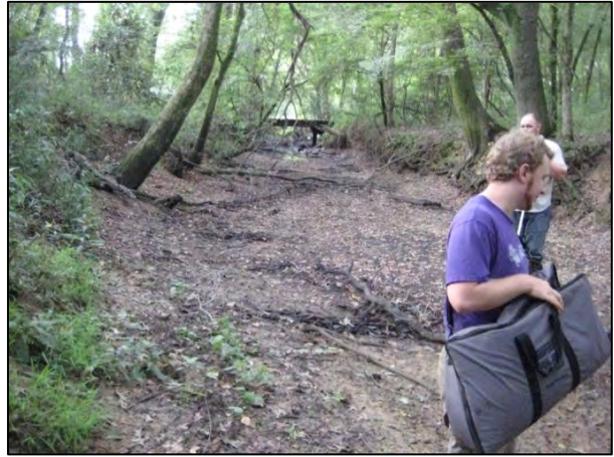
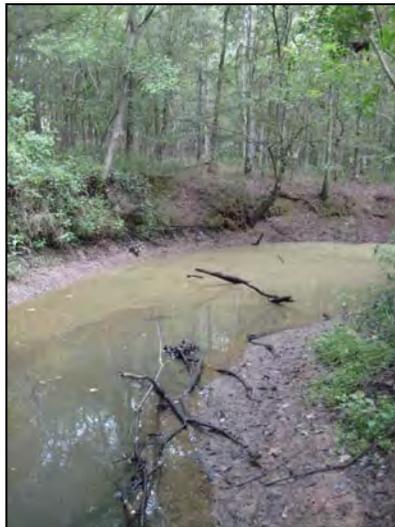
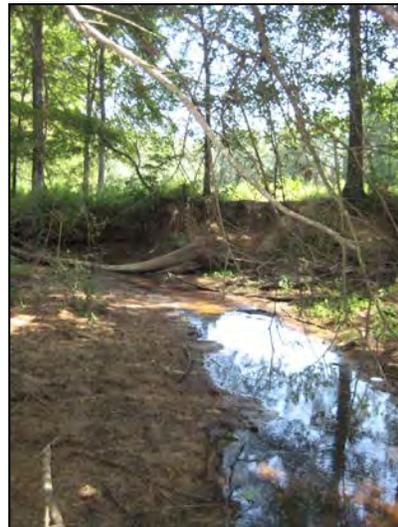
**Photogroup 4-6** Attoyac 6 depicting general stream characteristics. Top left: 30-m, downstream, July 2012; Top right: 150-m, upstream, July 2012; Middle left: 300-m, upstream, August 2012; Middle right: 30-m, downstream, August 2012; Bottom left: 30-m, upstream, August 2012; Bottom right: 300-m downstream, August 2012.

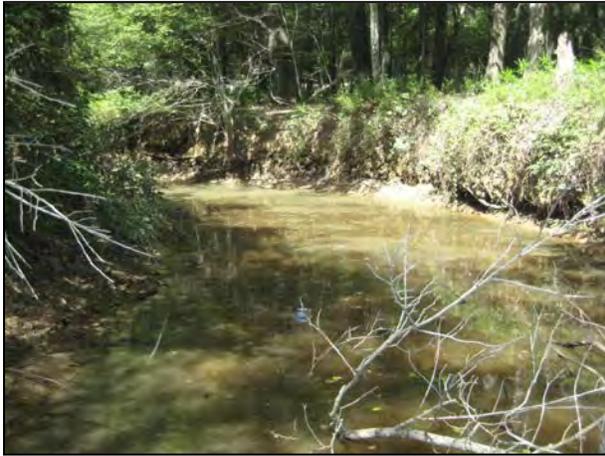
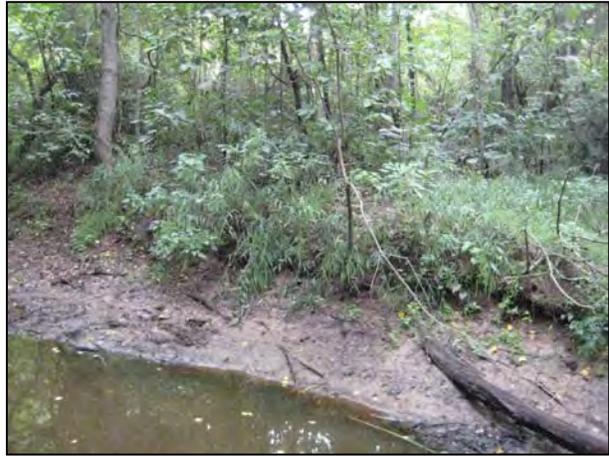
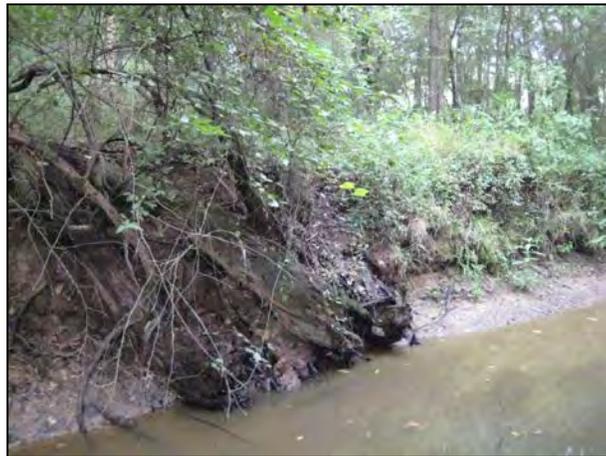
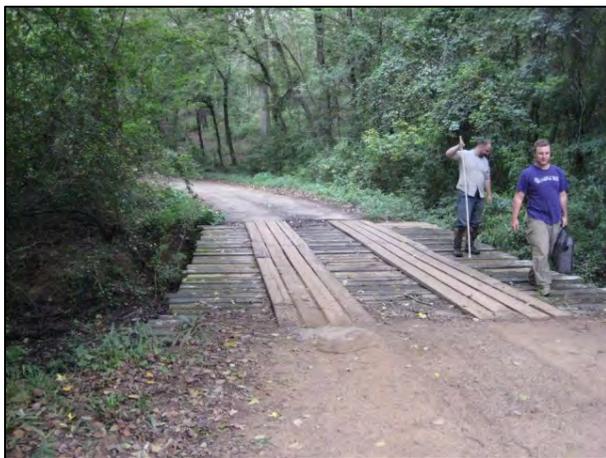
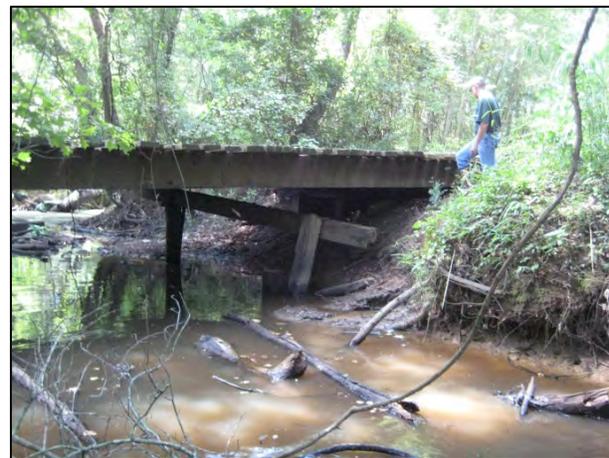
**Photogroup 4-6** Attoyac 6 depicting bank access and general bank appearance. All individuals featured are SFASU and CES staff. Top left: 150-m, downstream, July 2012; Top right: 300-m, right bank, August 2012; Middle: 30-m, left bank, August 2012; Bottom left: CR 4760 crossing, August 2012; Bottom right: 0-m, Bank access from CR 4760 crossing, July 2012.

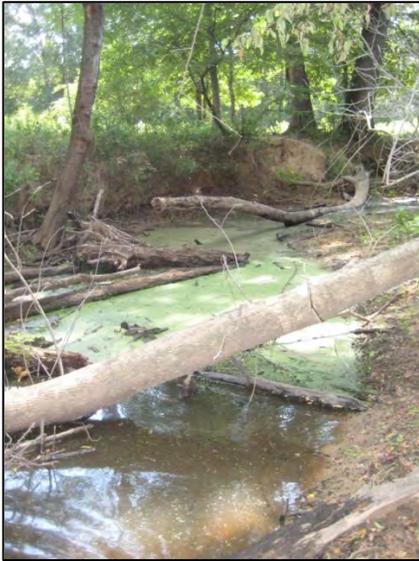
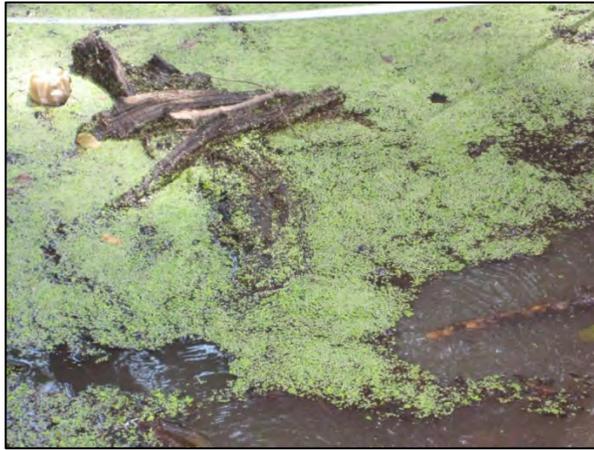
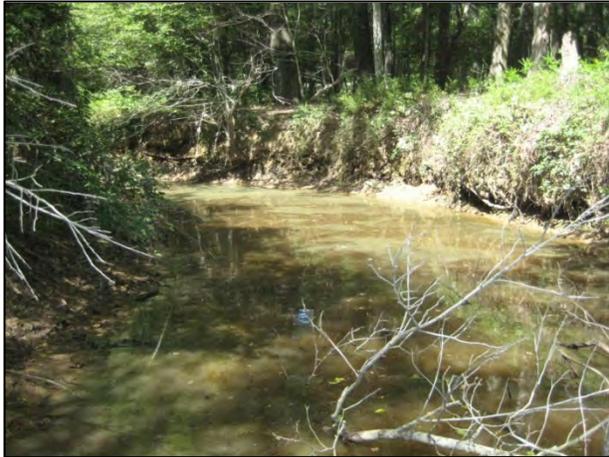
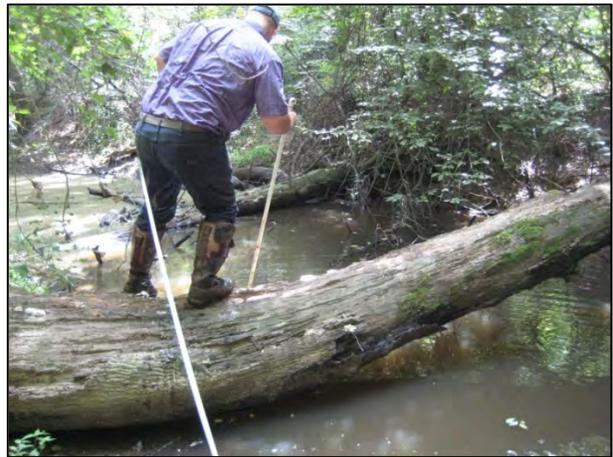
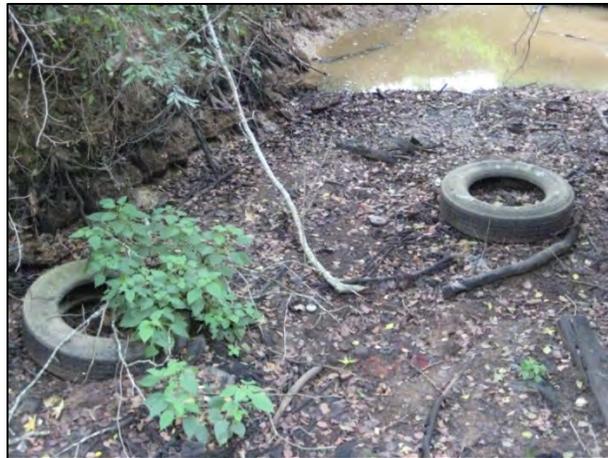
**Photogroup 4-6** Attoyac 6 depicting water surface characteristics. All individuals featured are SFASU and CES staff. Top left: Large woody debris in channel, July 2012; Top right: Woody debris and aquatic vegetation, July 2012; Middle left: 150-m transect, downstream, July 2012; Middle right: Large woody debris, July 2012; Bottom: Large channel litter (tires), July 2012.

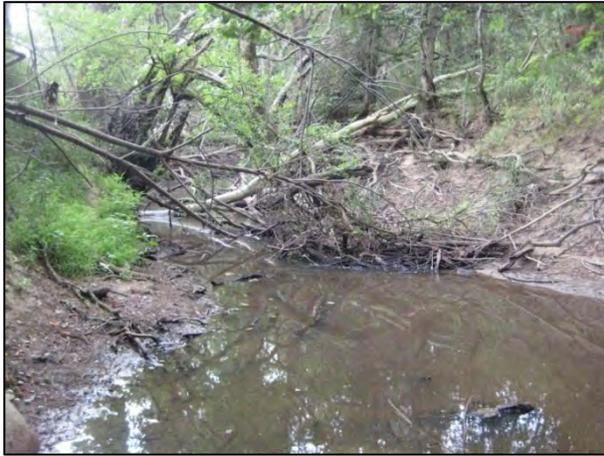
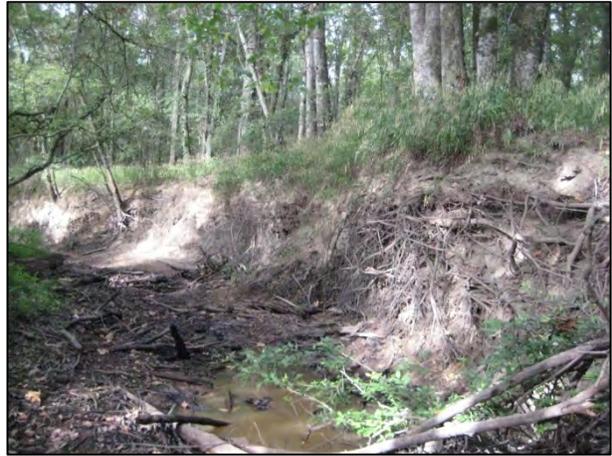
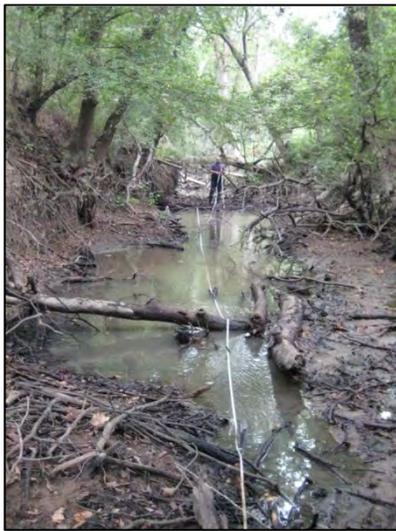
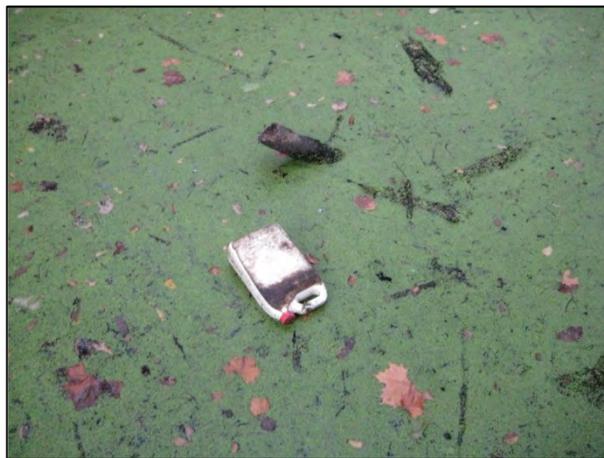
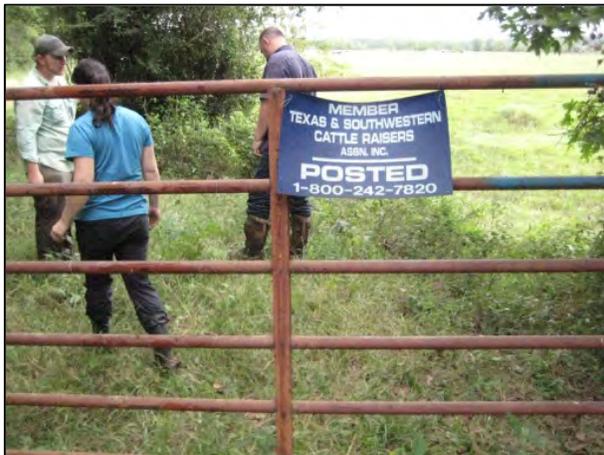
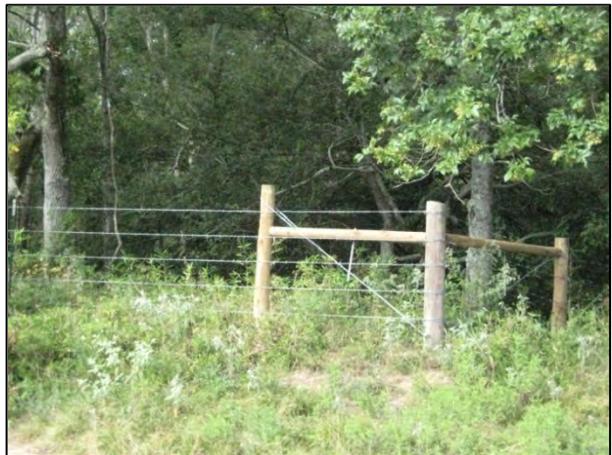
**Photogroup 4-10** Attoyac 11 depicting general bank access and water surface appearance. All individuals featured are SFASU and CES staff. Top left: Large woody debris, August 2012; Top right: 150-m, right bank, August 2012; Middle left: Woody debris in channel, August 2012; Middle right: Aquatic vegetation, August 2012; Bottom left: Gated site access, August 2012; Bottom right: Fenced stream bank, August 2012.

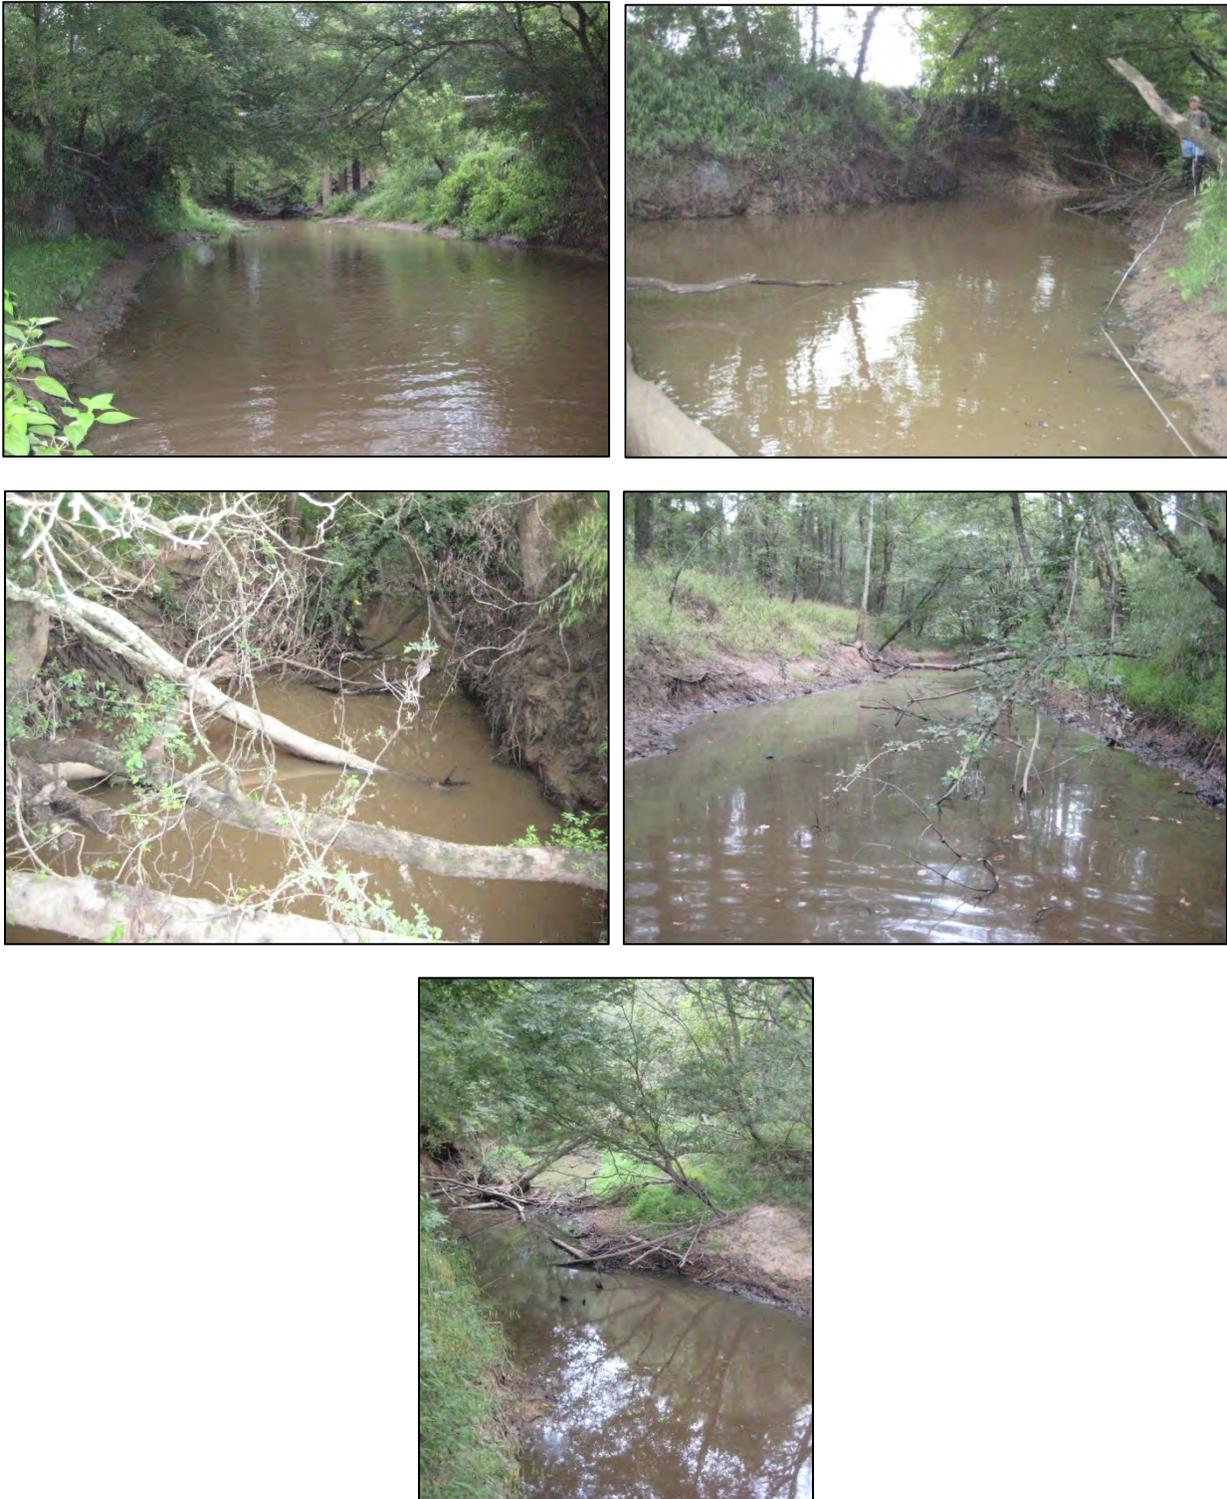
**Photogroup 4-11** Attoyac 12 depicting general stream characteristics. All individuals featured are SFASU and CES staff. Top left: 30-m, downstream, July 2012; Top right: 150-m, downstream, July 2012; Middle left: 300-m, upstream, July 2012; Middle right: 300-m, upstream, August 2012; Bottom: 30-m, downstream, August 2012.
