# Attoyac Bayou Recreational Use Attainability Analysis

**Attoyac Bayou  
Recreational Use Attainability Analysis**

**Texas State Soil and Water Conservation Board  
Project # 09-10**

**October 2012**

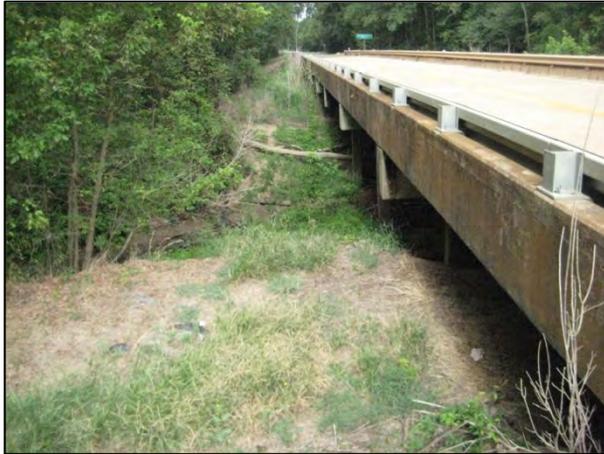
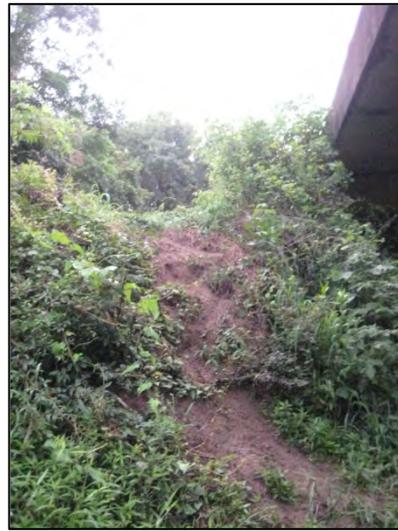
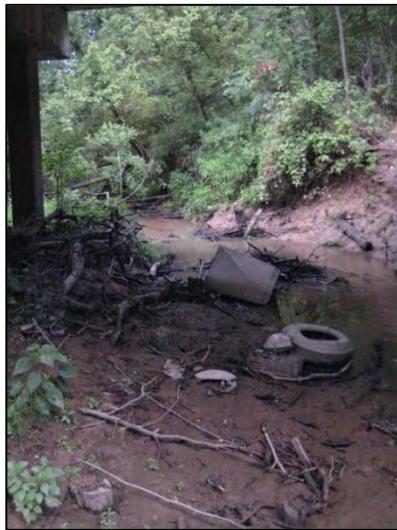
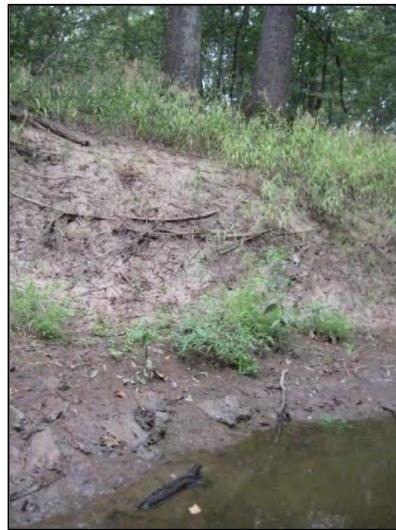
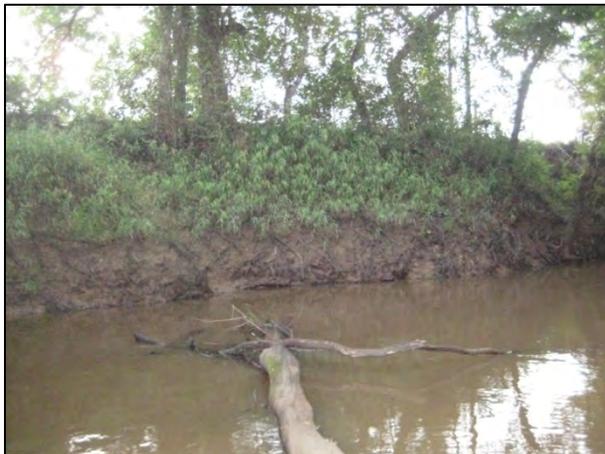
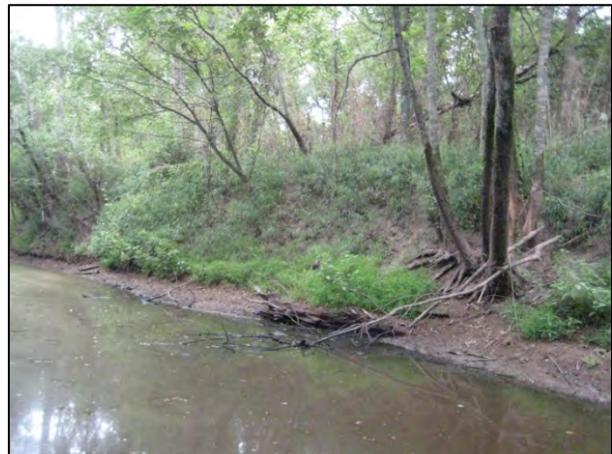
**Photogroup 4-11** Attoyac 12 depicting general bank access and bank appearance. Top left: FM 138 stream crossing, August 2012; Top right: Stream channel access with visible use, July 2012; Middle left: Large channel litter (tire and metal objects) under FM 138 crossing, July 2012; Middle right: 300-m, right bank, August 2012; Bottom left: 150-m, left bank, July 2012; Bottom right: 150-m, right bank, August 2012.

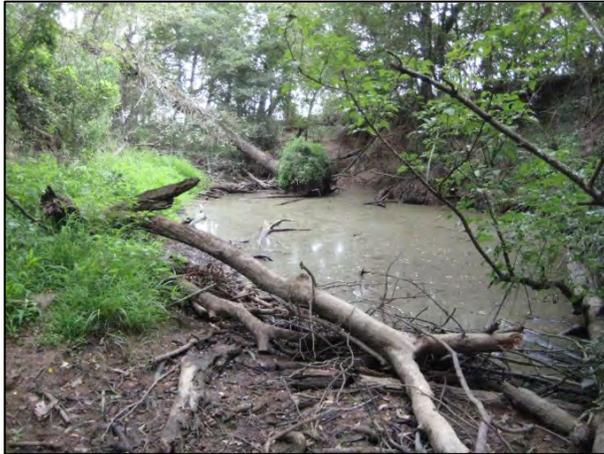
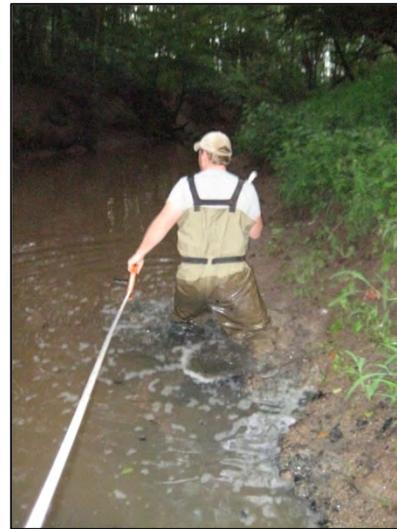
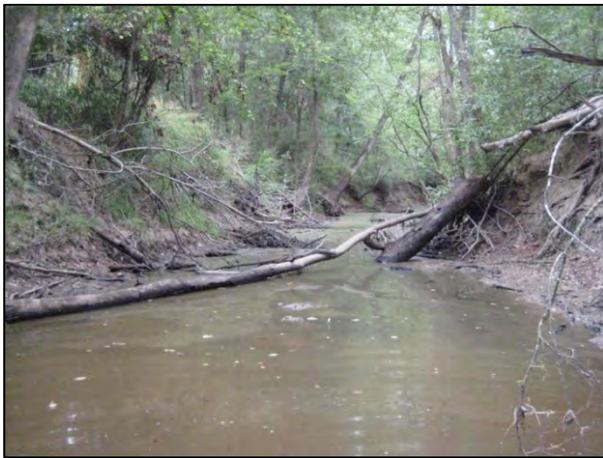
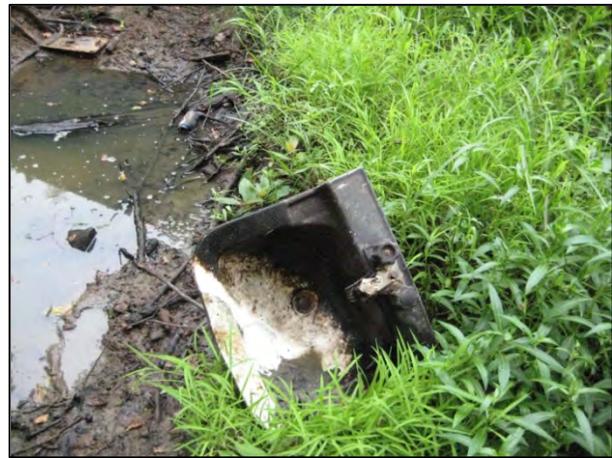
**Photogroup 4-11** Attoyac 12 depicting water surface characteristics. All individuals featured are SFASU and CES staff. Top left: Large woody debris, August 2012; Top right: Dense organic material as substrate, July 2012; Bottom left: 300-m downstream with scum, August 2012; Bottom right: Channel litter (bathroom sink), August 2012.

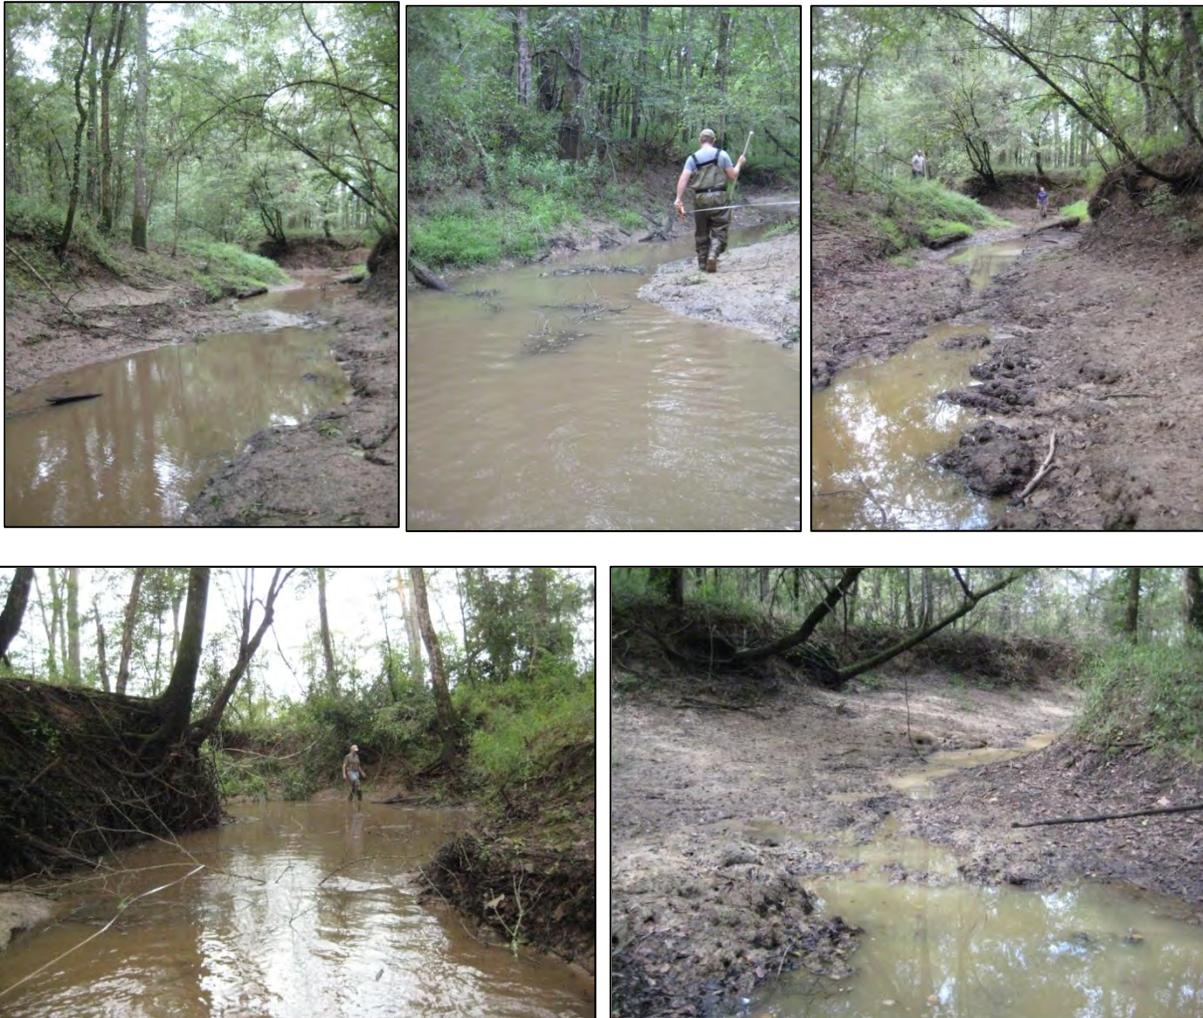
**Photogroup 4-12** Attoyac 13 depicting general stream characteristics. All individuals featured are SFASU and CES staff. Top left: 30-m, downstream, July 2012; Top middle: 150-m, upstream, July 2012; Top right: 30-m, downstream, August 2012; Bottom left: 300-m, downstream, July 2012; Bottom right: 300-m, downstream, August 2012.

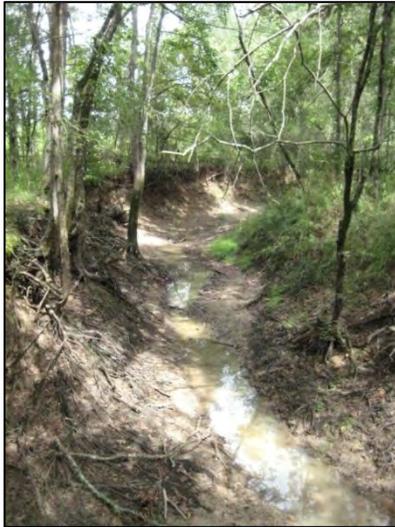
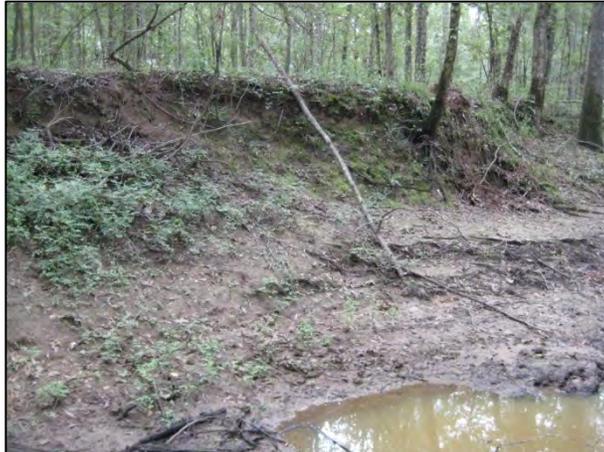
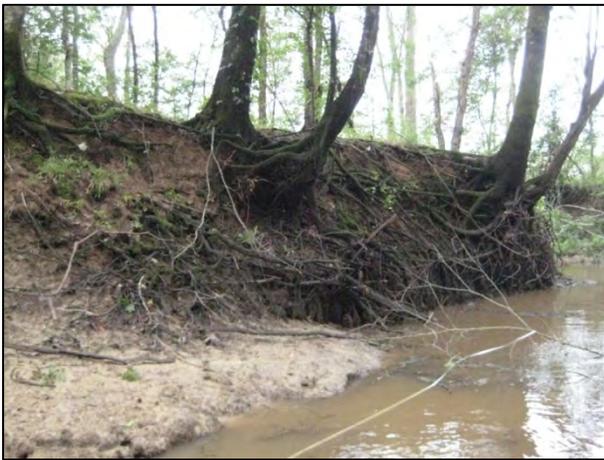
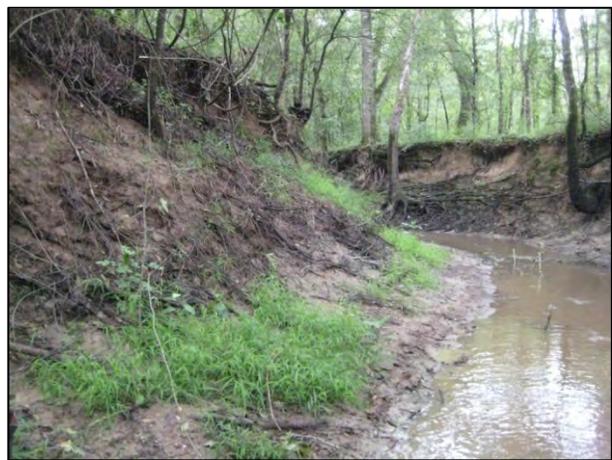
**Photogroup 4-12** Attoyac 13 depicting general bank appearance. Top left: 150-m, upstream, August 2012; Top right: 30-m, left bank, August 2012; Bottom left: 300-m, left bank, July 2012; Bottom right: 150-m, left bank, July 2012.

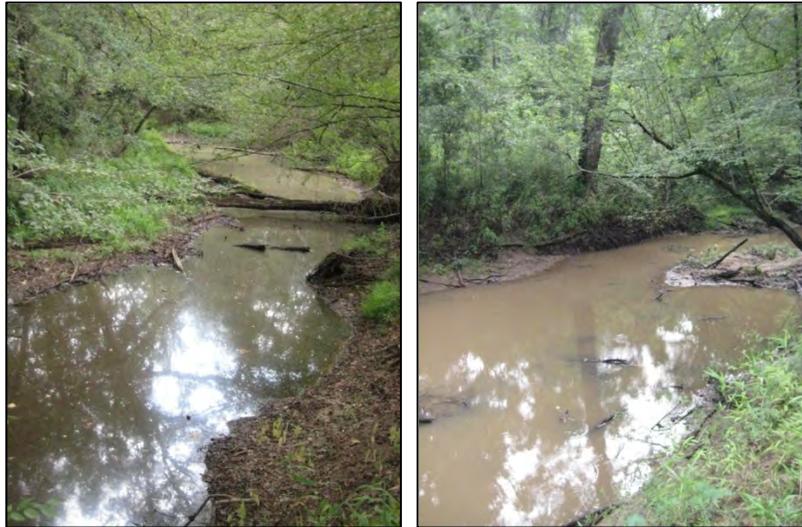
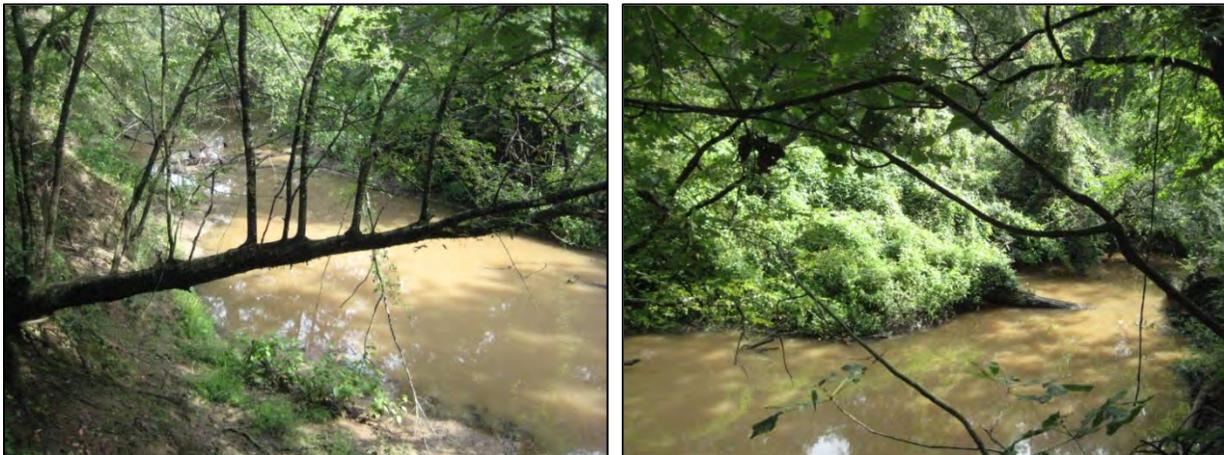
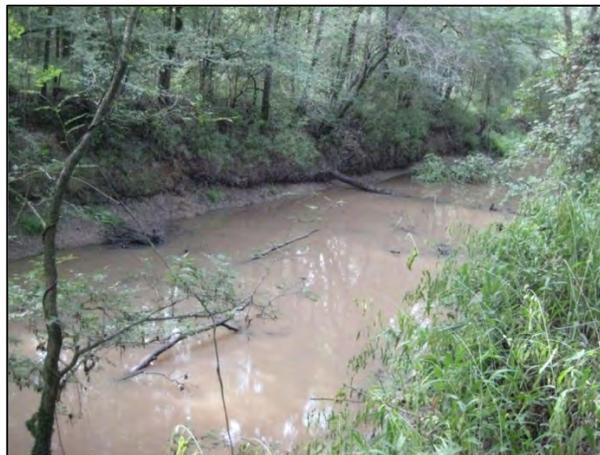
**Photogroup 4-13** Attoyac 14 depicting general stream characteristics. Top left: 30-m transect, downstream, August 2012; Top right: 300-m transect, downstream, August 2012; Middle left: 30-m transect, July 2012; Middle right: 30-m transect, downstream, July 2012; Bottom: 150-m transect, downstream, July 2012.

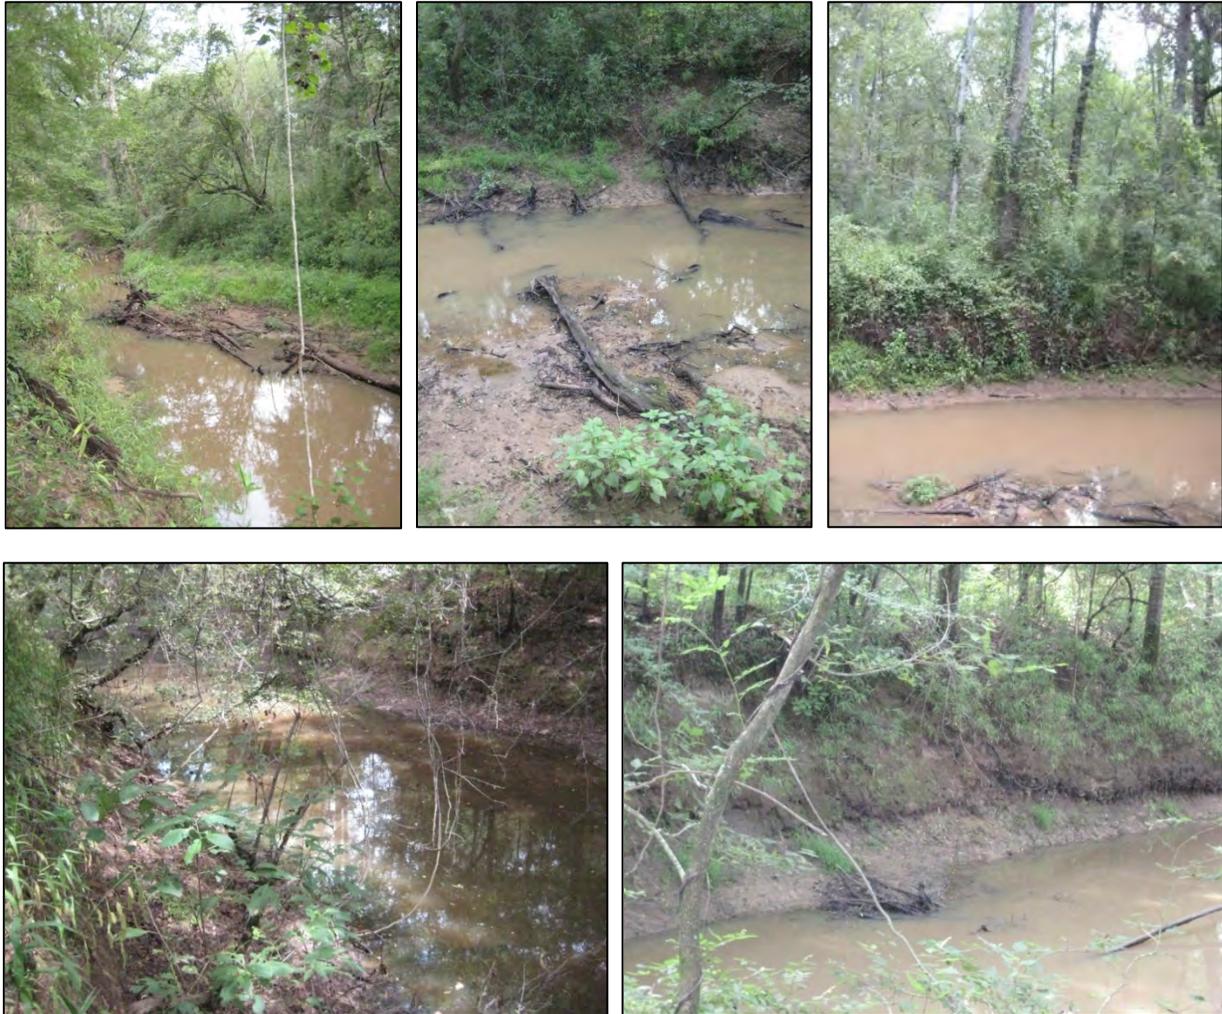
**Photogroup 4-13** Attoyac 14 depicting general bank appearance. Top left: 300-m transect; upstream, July 2012; Top center: Woody debris along banks; Top right: 300-m transect, left bank, July 2012; Bottom left: 150-m transect, upstream, August 2012; Bottom right: 150-m transect, left bank, August 2012.

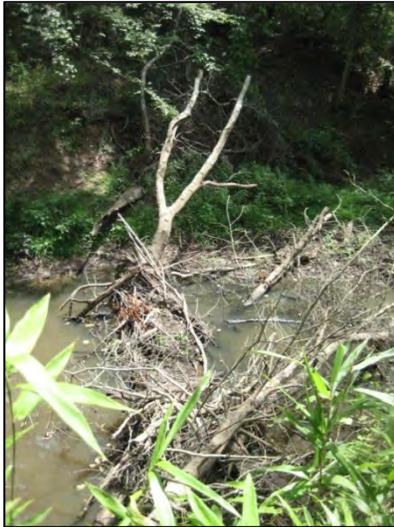
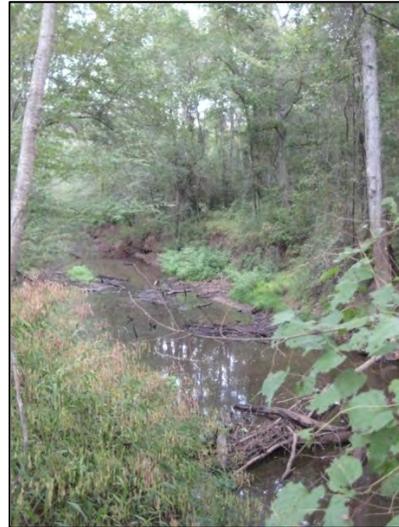
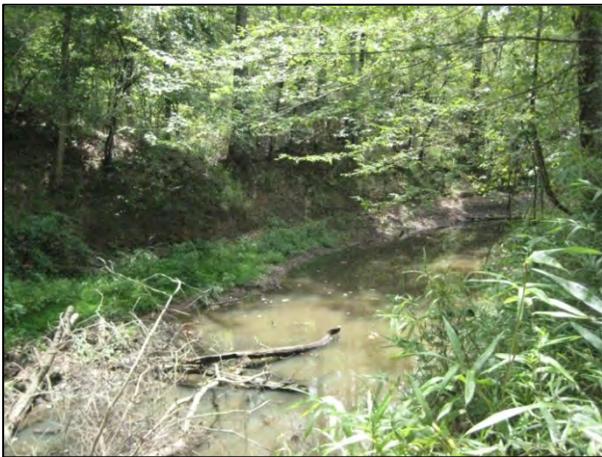
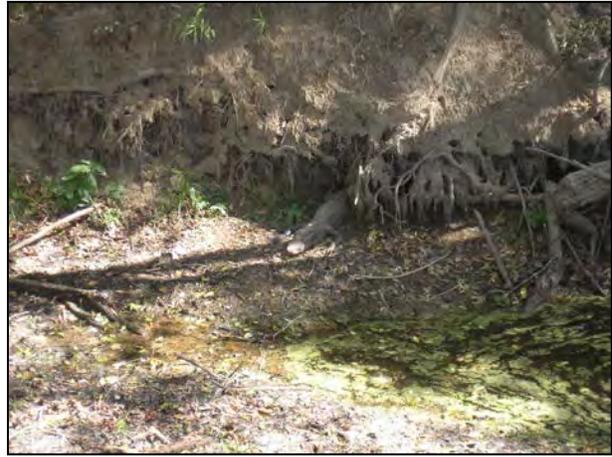
**Photogroup 4-13** Attoyac 14 depicting water surface characteristics. Top left: Log jam, August 2012; Top right: 30-m transect, upstream, July 2012; Bottom left: 300-m transect; downstream, August 2012, Bottom right: Photograph of alligator within survey area provided by landowner, taken 2011.

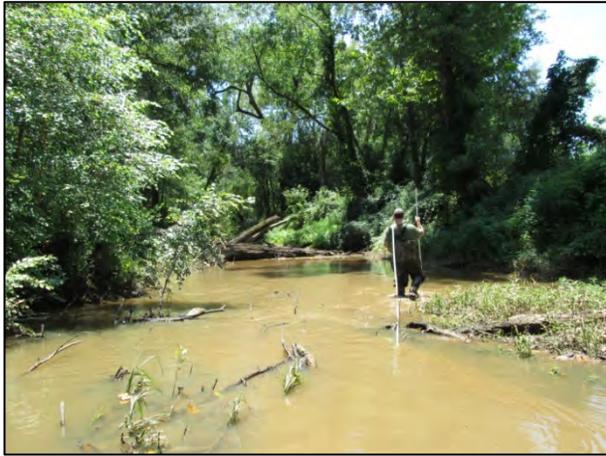
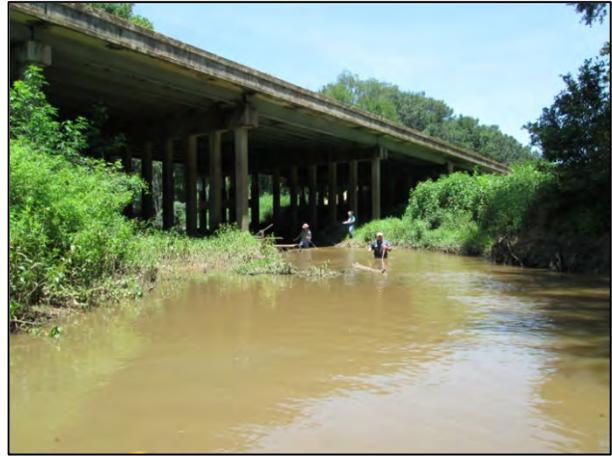
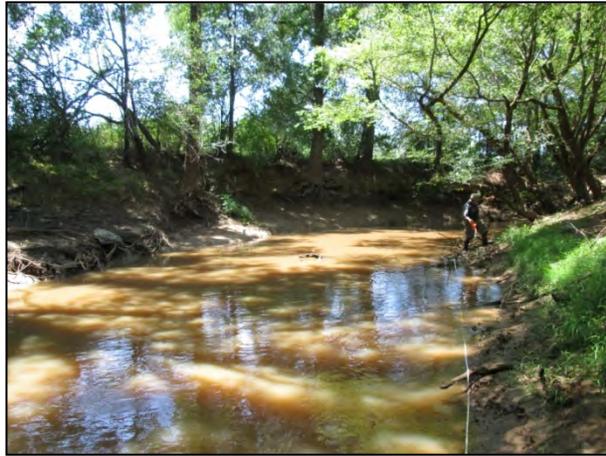
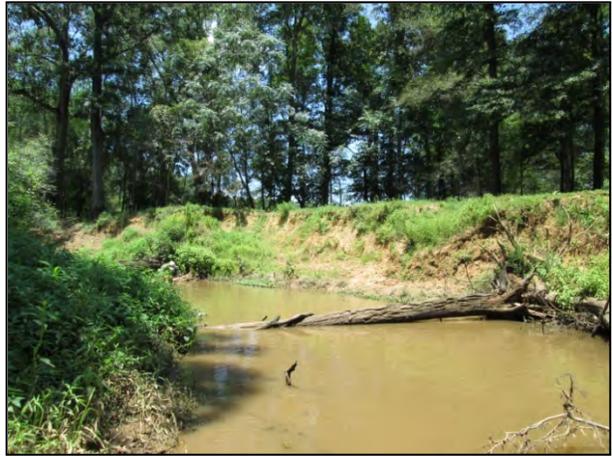
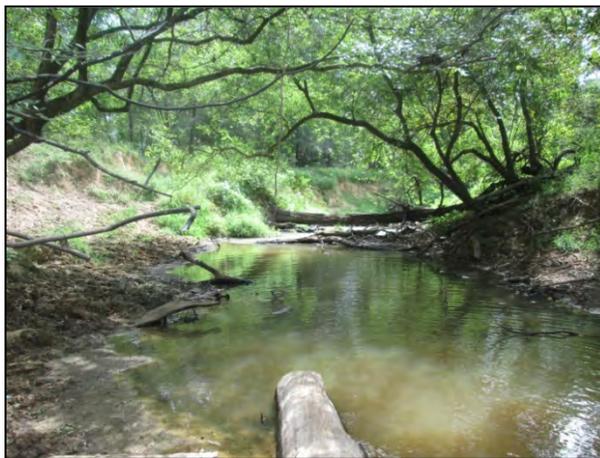
**Photogroup 4-14** Attoyac 15 depicting general stream characteristics. All individuals featured are SFASU and CES staff. Top left: 30-m transect, downstream, July 2012; Top right: 30-m transect, upstream, July 2012; Middle left: 150-m transect, downstream, July 2012; Middle right: 300-m transect, upstream, July 2012; Bottom: 150-m transect, downstream, August 2012.

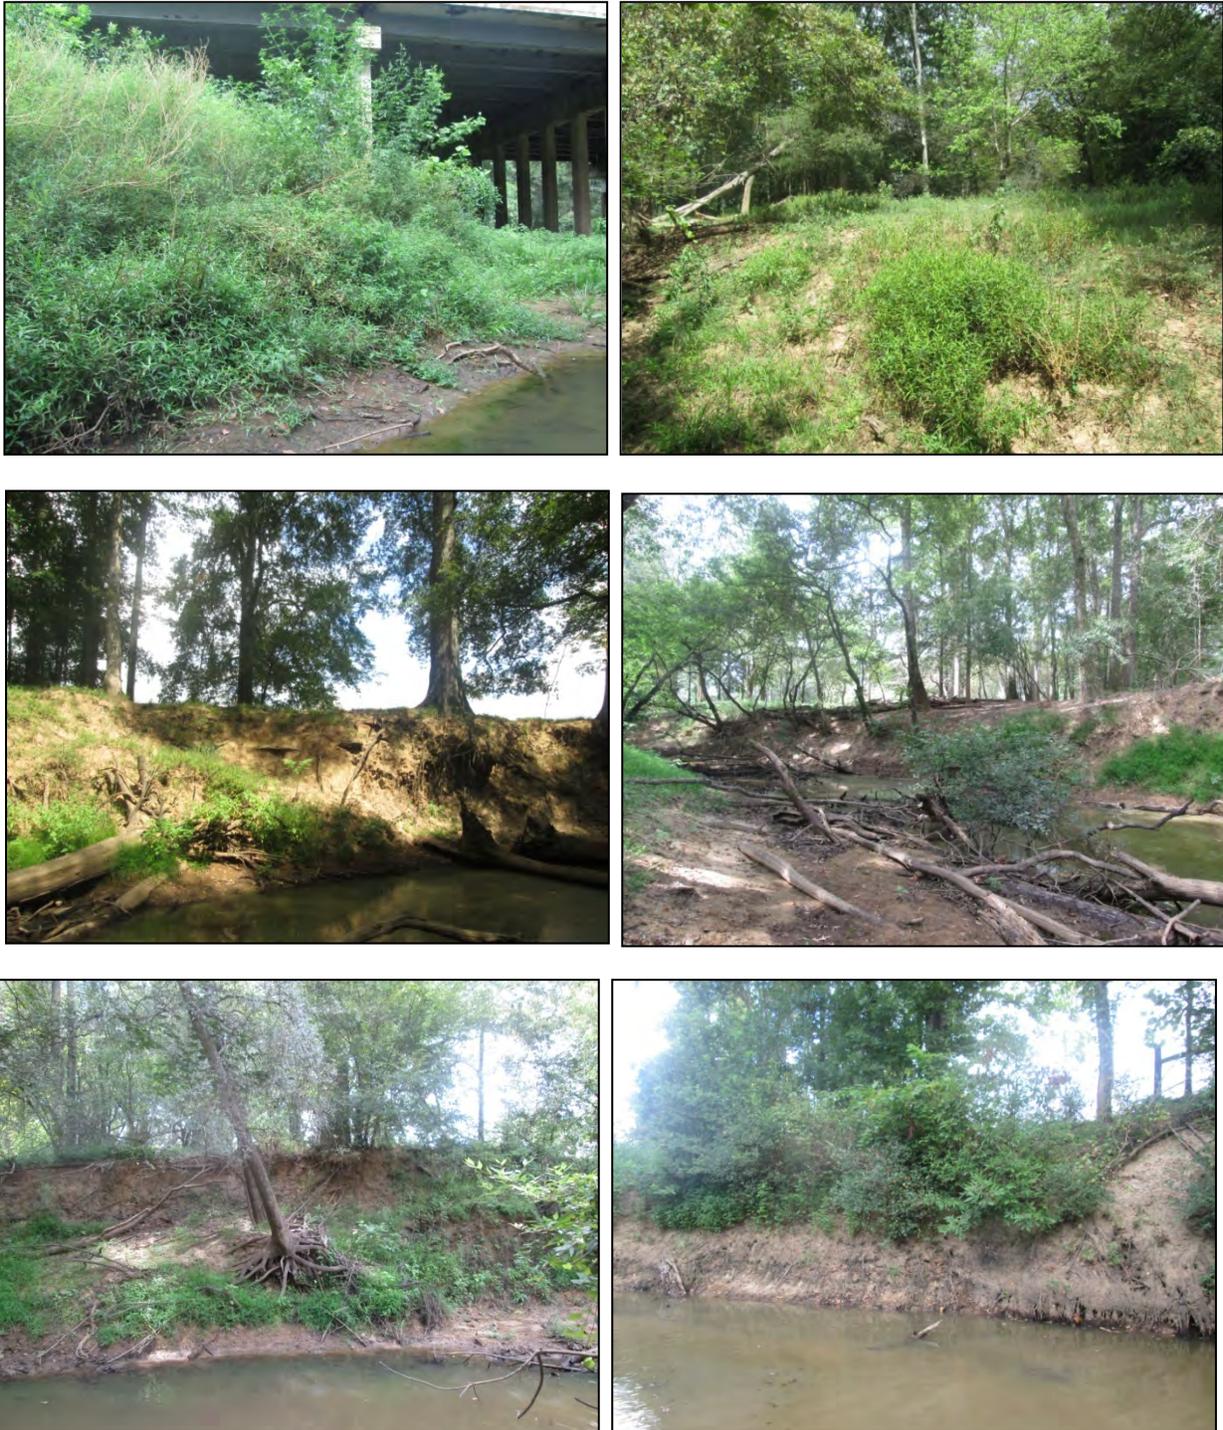
**Photogroup 4-14** Attoyac 15 depicting general bank appearance. Top left: 30-m transect, downstream, August 2012; Top right: 150-m transect, right bank, August 2012; Middle left: 300-m transect, left bank, August 2012; Middle right: 300-m, downstream, August 2012; Bottom left: 150-m transect, left bank, August 2012; Bottom right: 30-m transect, right bank, August 2012.

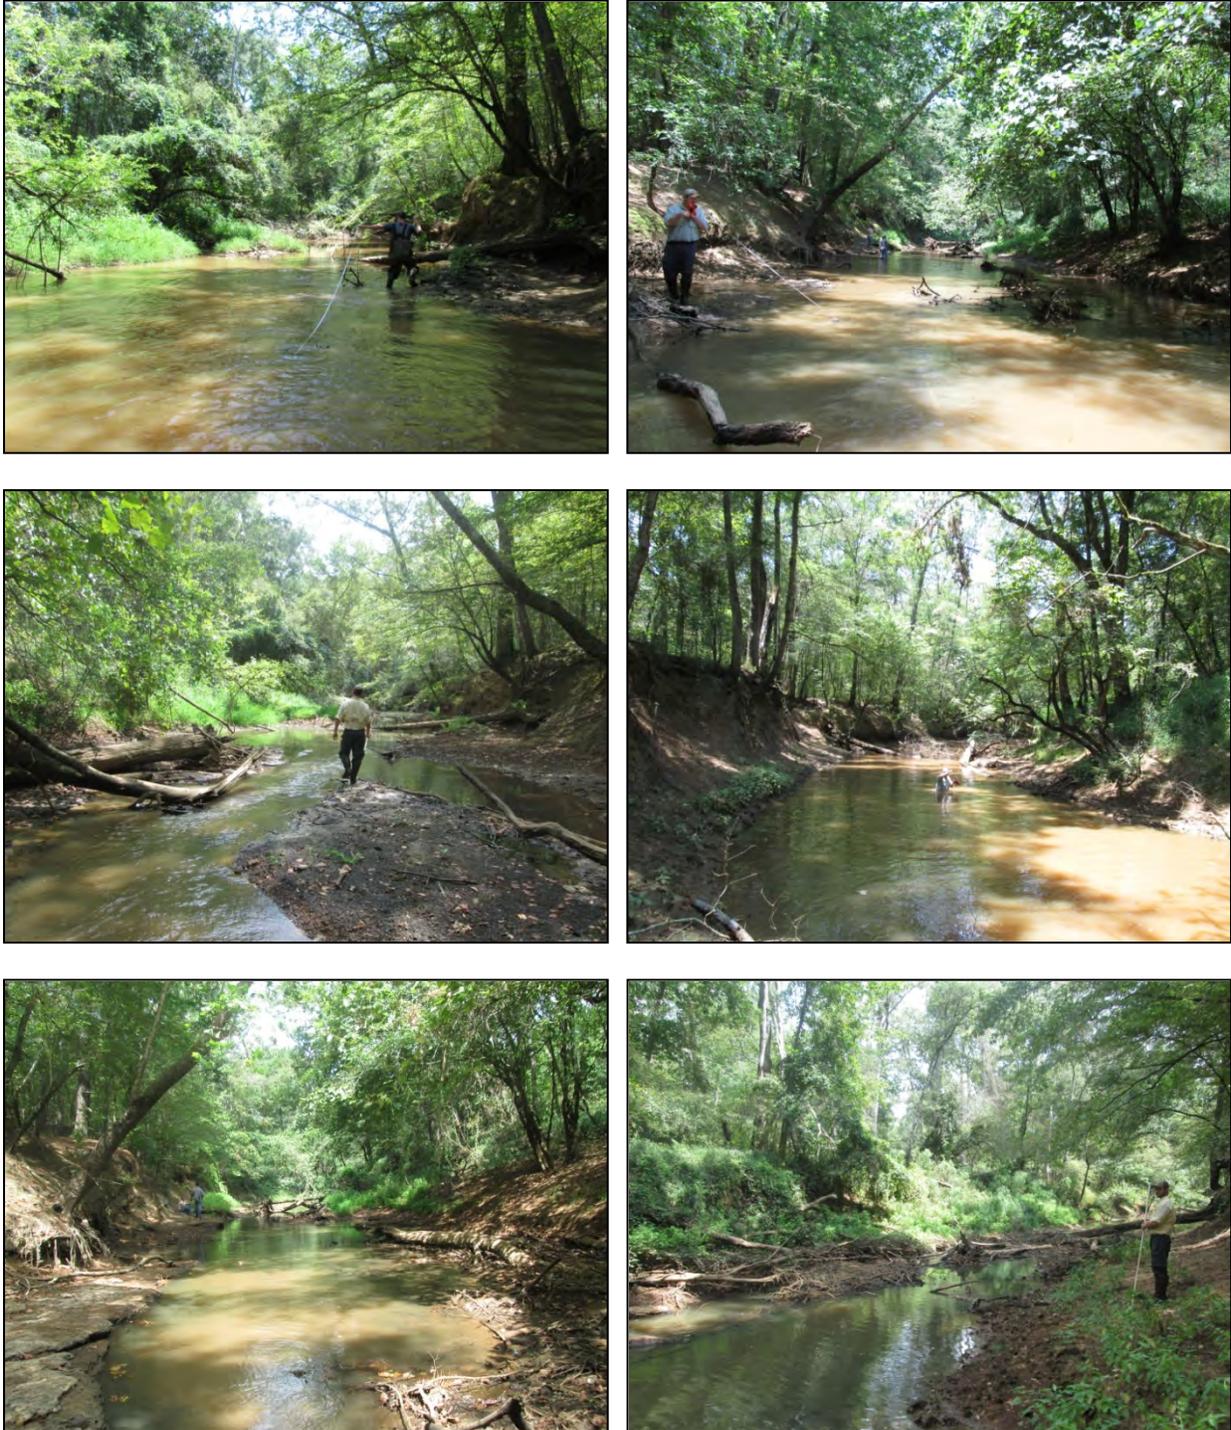
**Photogroup 4-15** Attoyac 16 depicting general stream characteristics. All individuals featured are SFASU and CES staff. Top left: 30-m transect, downstream, July 2012; Top right: 30-m transect, upstream, July 2012; Middle left: 30-m transect, downstream, August 2012; Middle right: 150-m transect, upstream, July 2012; Bottom left: 30-m transect, upstream, August 2012; Bottom right: 150-m transect, downstream, August 2012.

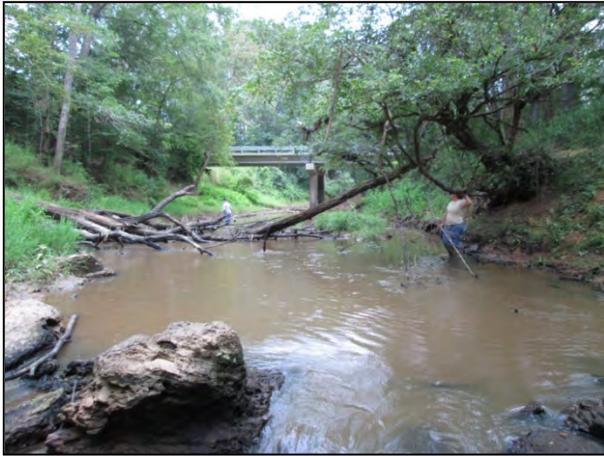
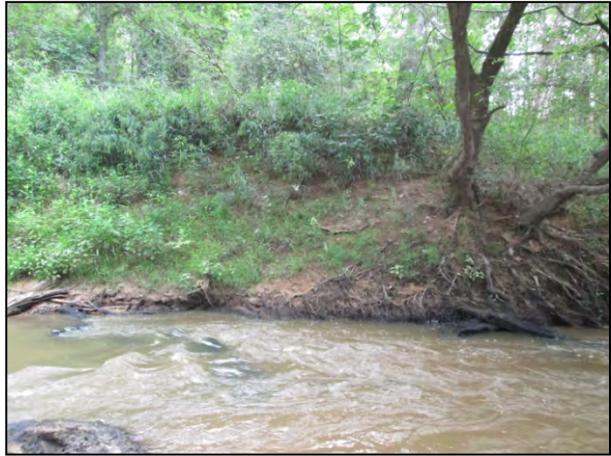
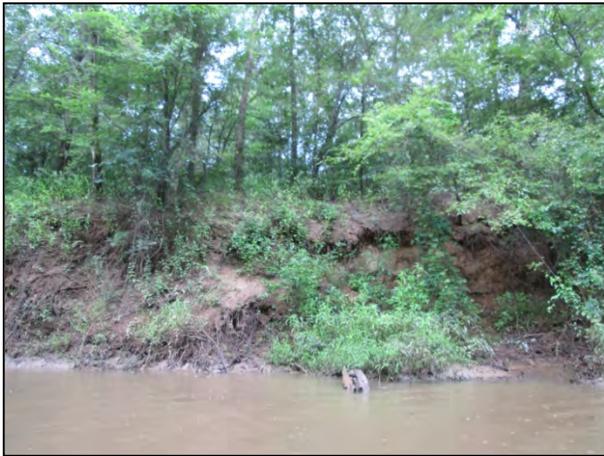
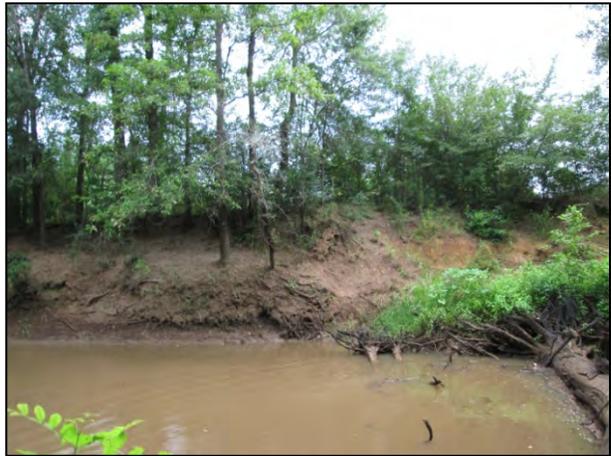
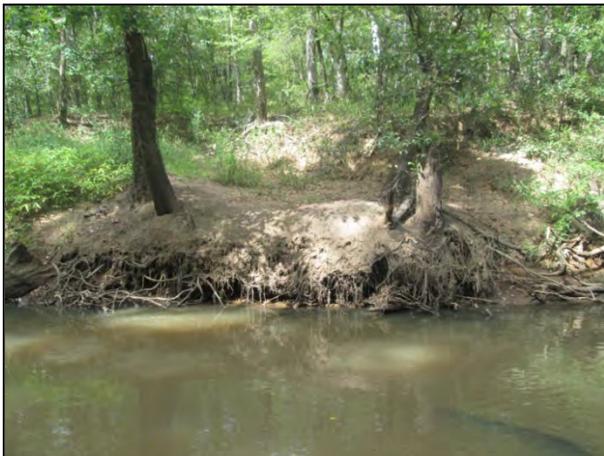
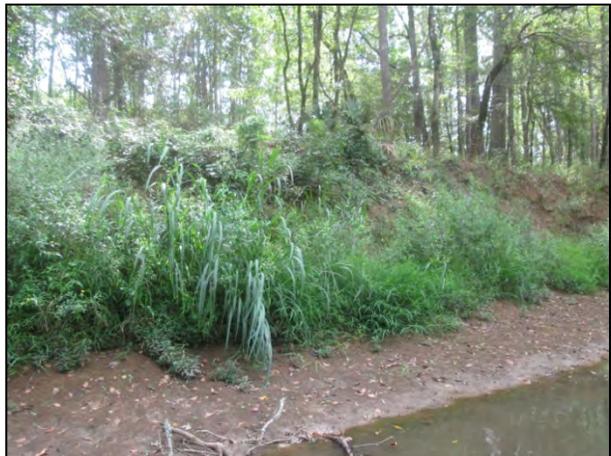
**Photogroup 4-16** Attoyac 17 depicting general stream characteristics. All individuals featured are SFASU and CES staff. Top left: 30-m transect, downstream, July 2012; Top right: 150-m transect, downstream, July 2012; Middle left: 150-m transect, upstream, July 2012; Middle right: 30-m transect, downstream, August 2012; Bottom left: 300-m transect, upstream, August 2012; Bottom right: 30-m transect, upstream, August 2012.

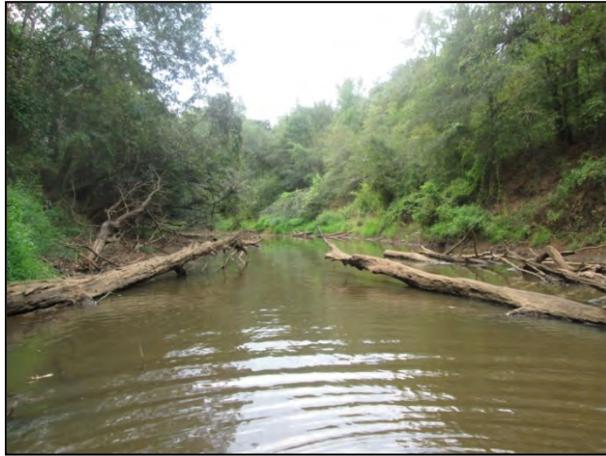
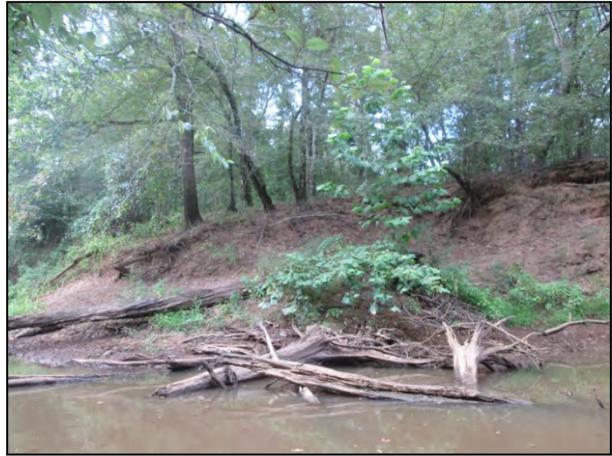
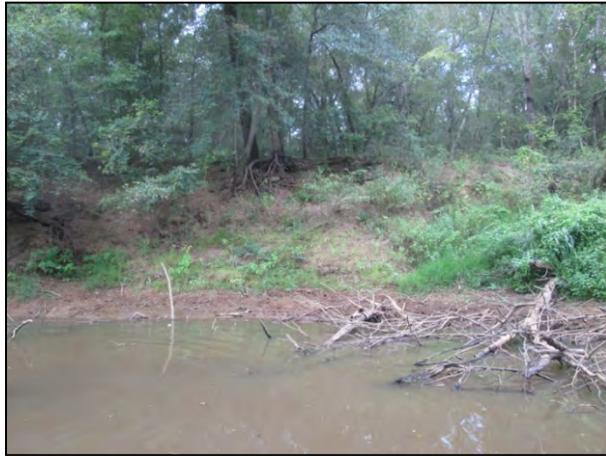
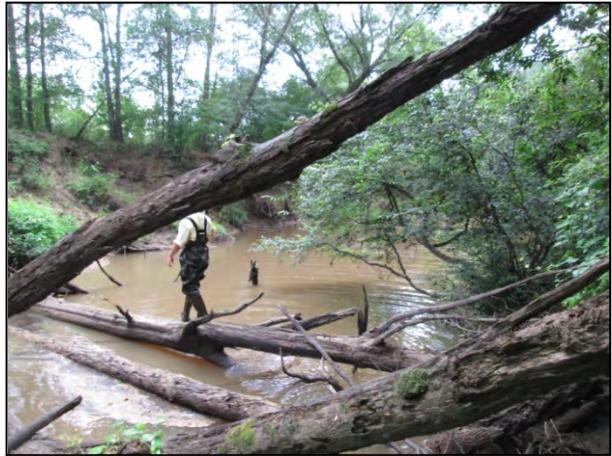
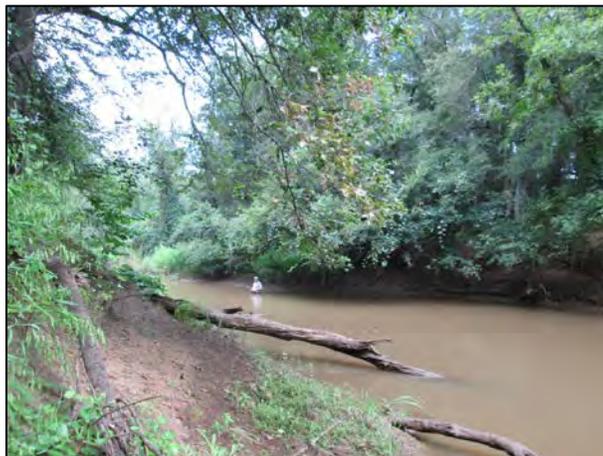
**Photogroup 4-16** Attoyac 17 depicting general bank appearance. All individuals featured are SFASU and CES staff. Top left: 30-m transect, upstream, July 2012; Top right: 30-m transect, left bank, July 2012; Middle left: 150-m transect, right bank, July 2012; Middle right: 300-m transect, left bank, July 2012; Bottom left: 30-m transect, right bank, August 2012; Bottom right: 30-m transect, left bank, August 2012.

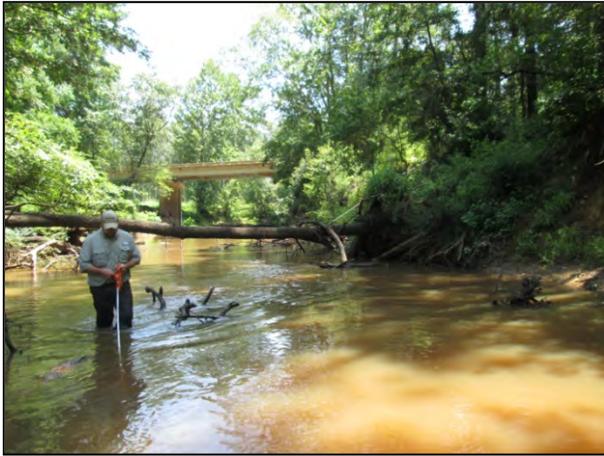
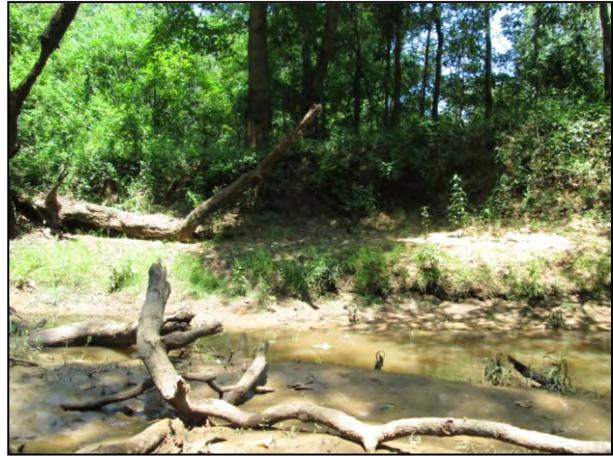
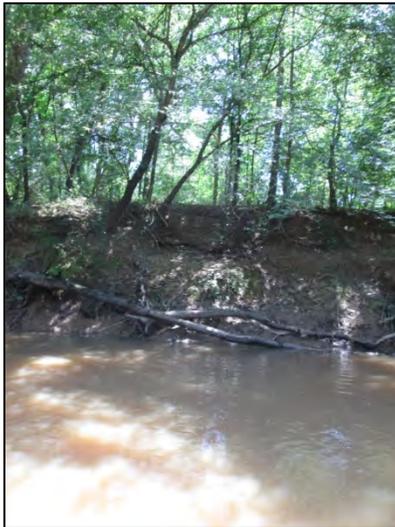
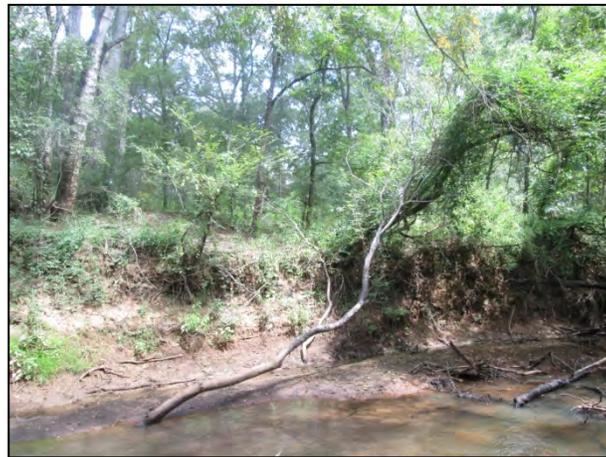
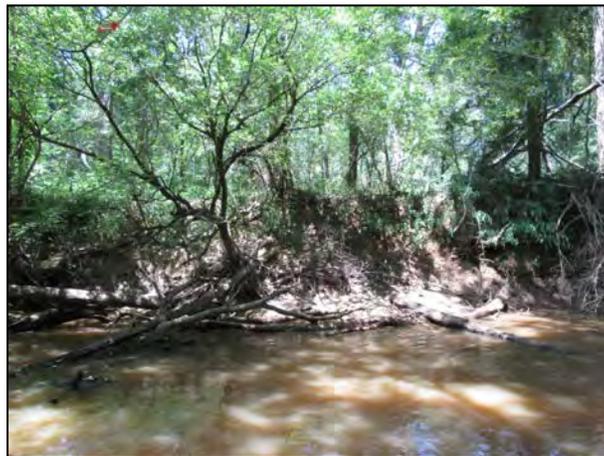
**Photogroup 4-17** Attoyac 18 depicting general stream appearance. All individuals featured are SFASU and CES staff. Top Left: 30-m transect, upstream, July 2012; Top right: 150-m transect, upstream, July 2012; Middle left: 300-m transect, upstream, July 2012; Middle right: 150-m transect, upstream, August 2012; Bottom left: 300-m transect, downstream, July 2012; Bottom right: 30-m transect, upstream, August 2012.

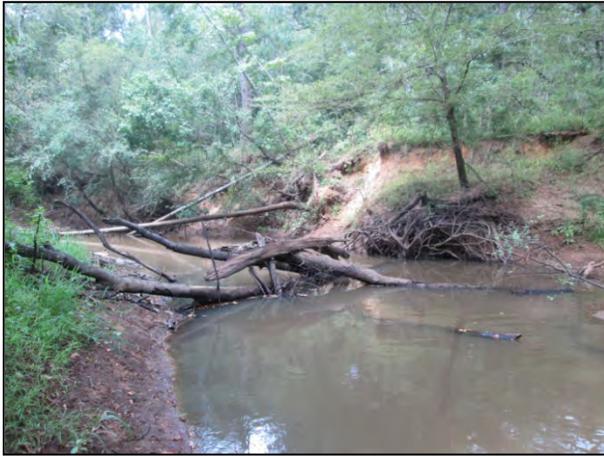
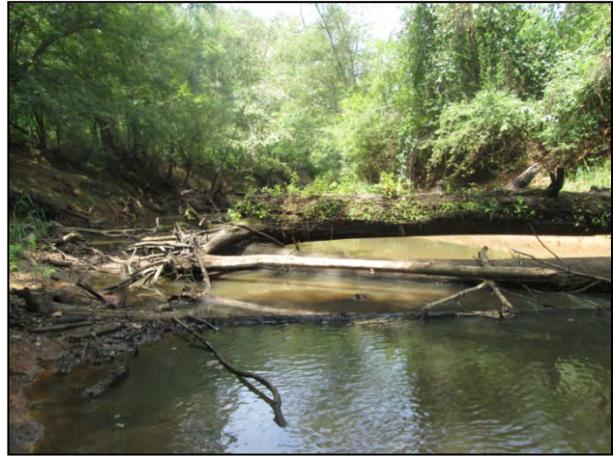
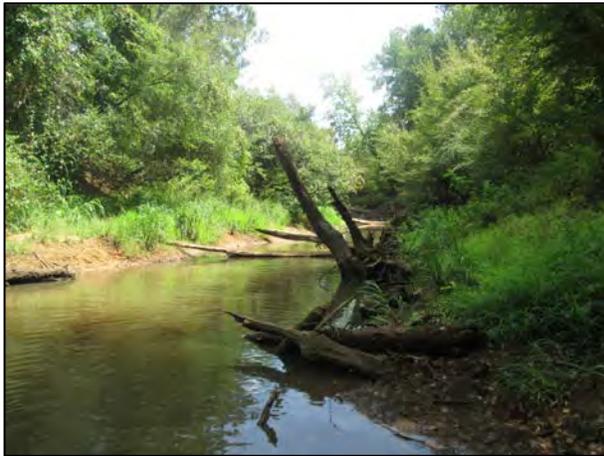
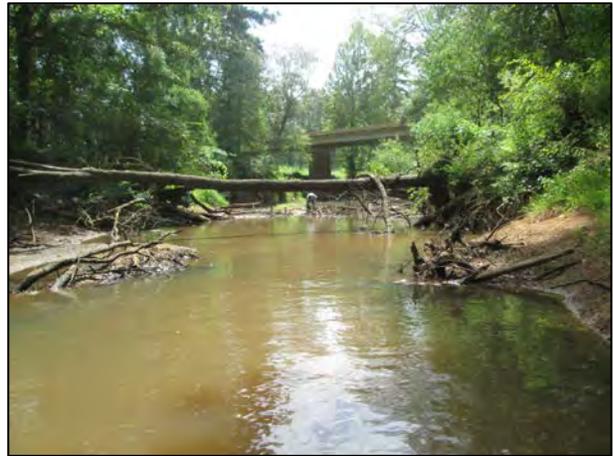
**Photogroup 4-17** Attoyac 18 depicting general bank appearance. All individuals featured are SFASU and CES staff. Top left: 30-m transect, downstream, July 2012; Top right: 30-m transect, left bank, July 2012; Middle left: 300-m transect, right bank, August 2012; Middle right: 150-m transect, left bank, August 2012; Bottom: 150-m transect, left bank, July 2012.

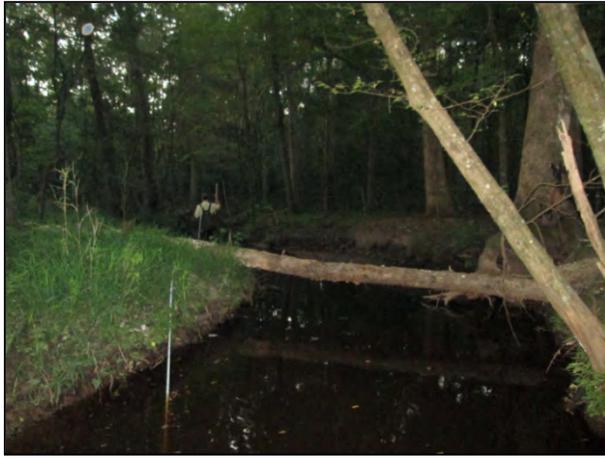
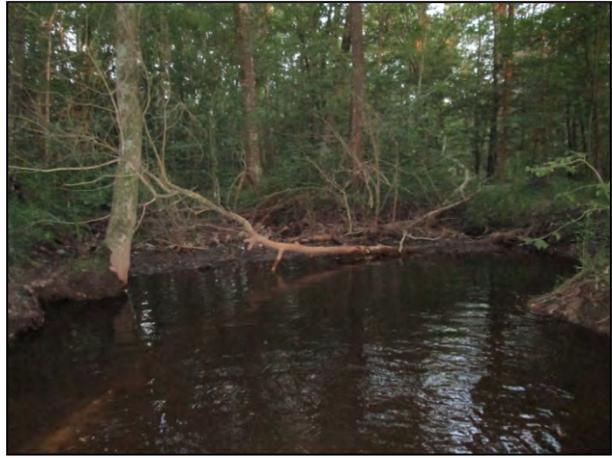
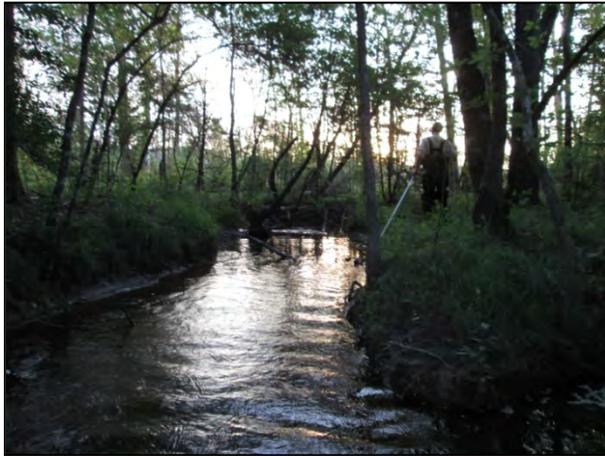
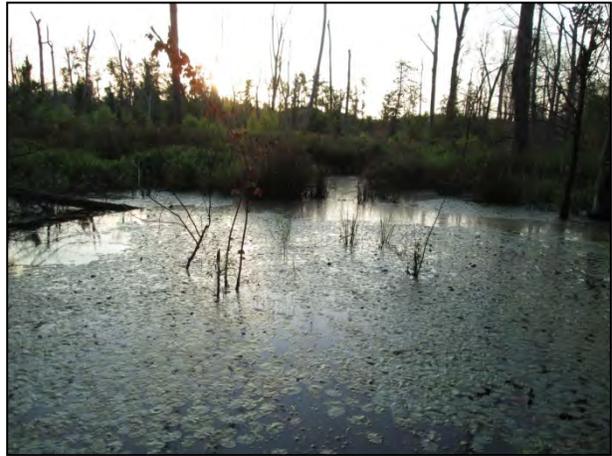
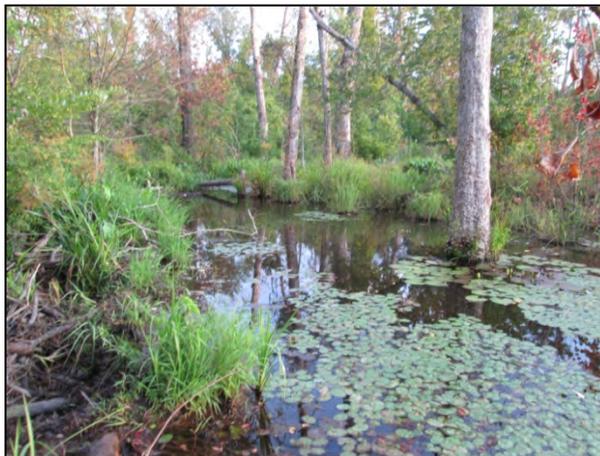
**Photogroup 4-18** Big Iron Ore 1 depicting general stream characteristics. All individuals featured are SFASU and CES staff. Top left: 30-m transect, upstream, July 2012; Top right: 150-m transect, downstream, July 2012; Middle left: 150-m transect, upstream, July 2012; Middle right: 300-m transect, upstream, July 2012; Bottom: 300-m transect, left bank, July 2012.
