# Attoyac Bayou Recreational Use Attainability Analysis

**Attoyac Bayou  
Recreational Use Attainability Analysis**

**Texas State Soil and Water Conservation Board  
Project # 09-10**

**October 2012**

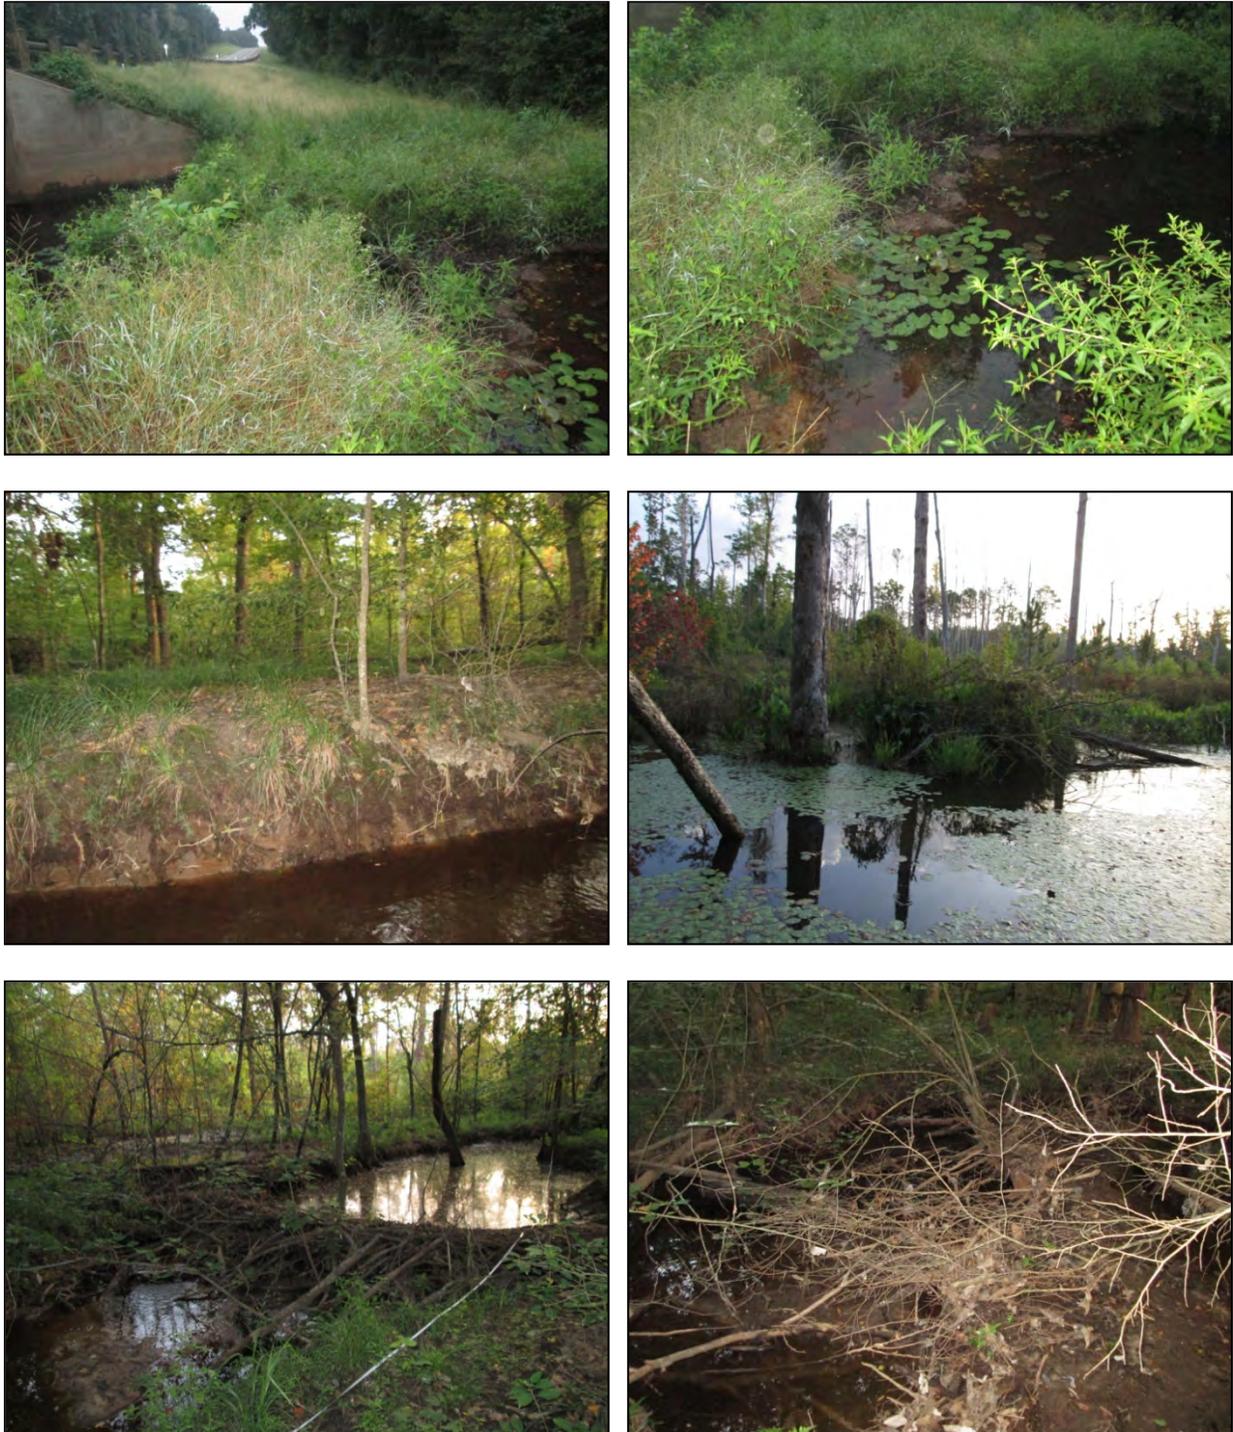
**Photogroup 4-18** Big Iron Ore 1 depicting general bank appearance and water surface characteristics. 0-m transect, Highway 96 access point; Top right: 0-m transect, left bank, August 2012; Middle left: 150-m transect, left bank, July 2012; Middle right: 300-m transect, right bank, July 2012; Bottom left: Beaver dam; Bottom right: Woody debris.

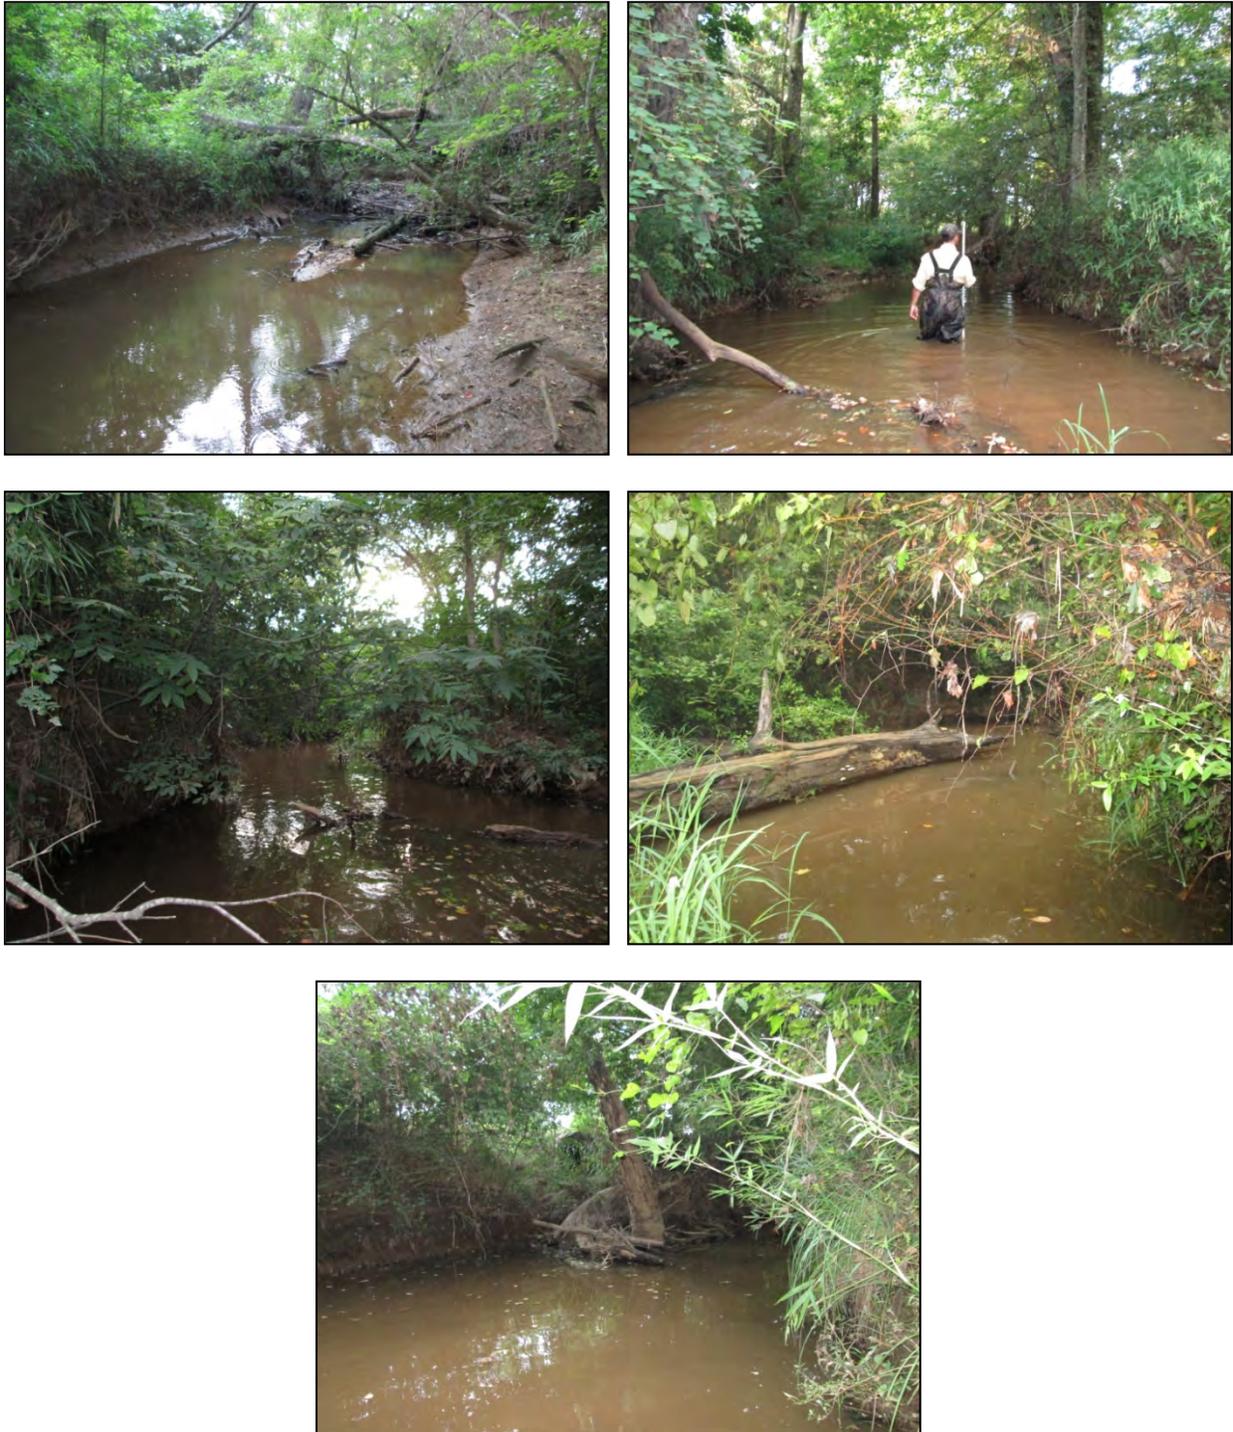
**Photogroup 4-19** Big Iron Ore 2 depicting general stream characteristics. All individuals featured are SFASU and CES staff. Top left: 30-m transect, upstream, July 2012; Top right: 150-m transect, upstream, July 2012; Middle left: 300-m, upstream, July 2012; Middle right: 150-m transect, downstream, August 2012; Bottom: 300-m transect, downstream, August 2012.

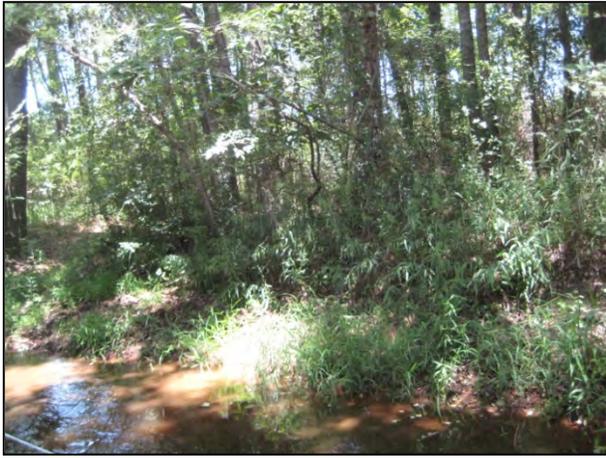
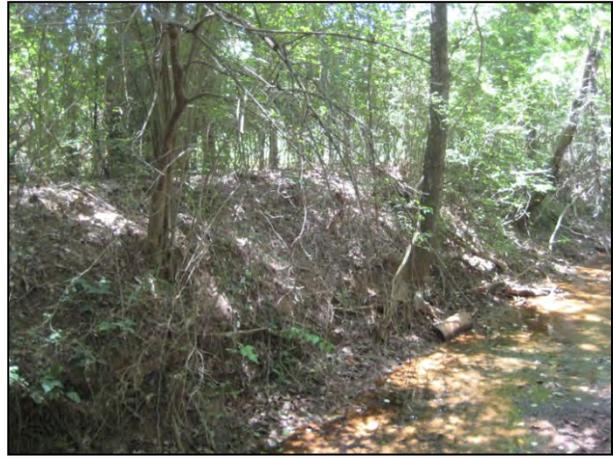
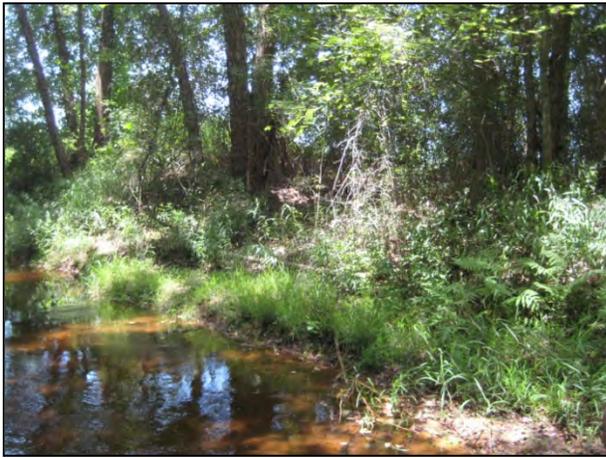
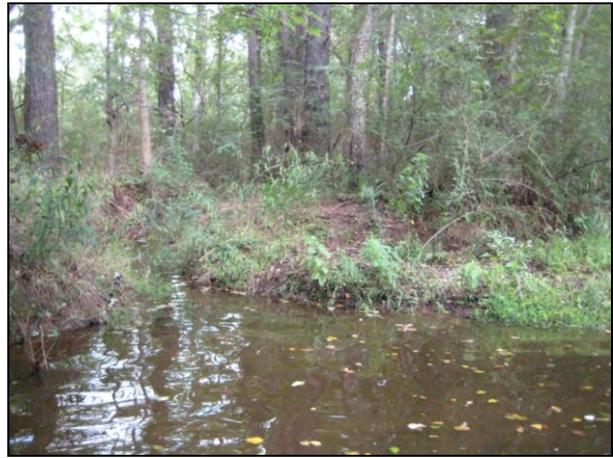
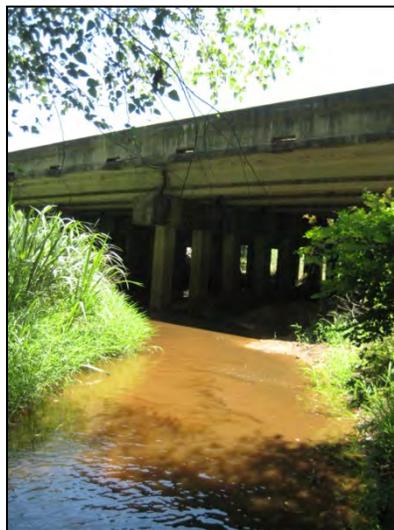
**Photogroup 4-25** Naconiche 6 depicting general stream characteristics. Top left: 300-m transect, upstream, July 2012; Top right: 150-m transect, upstream, July 2012; Middle left: 30-m transect, upstream, July 2012; Middle right: 150-m transect, downstream, July 2012; Bottom: CR 2435 crossing, upstream, July 2012.

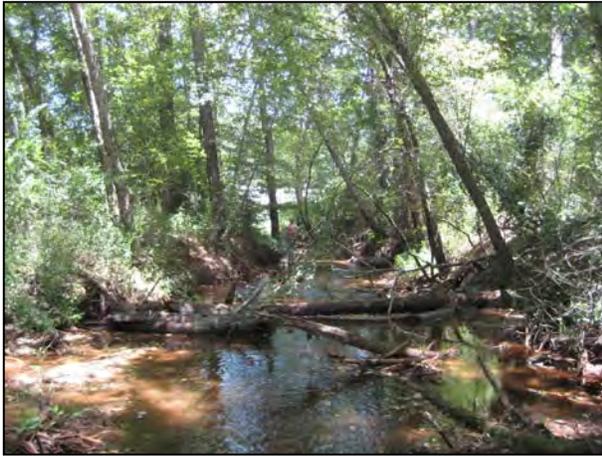
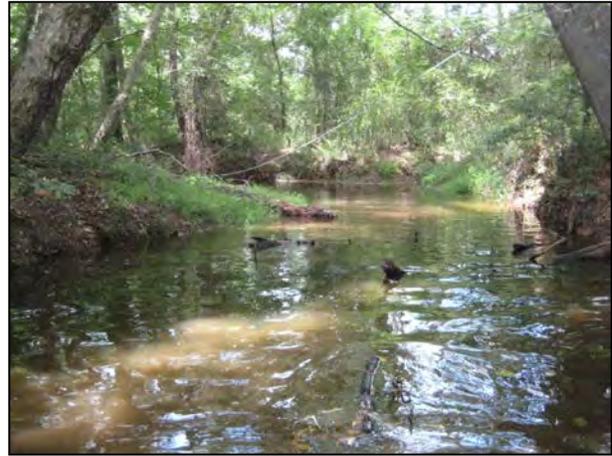
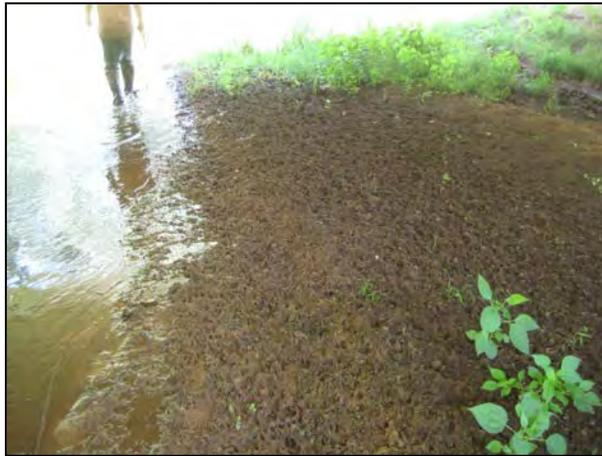
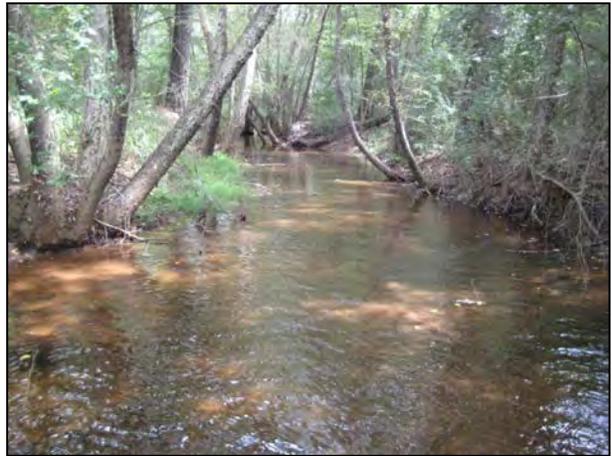
**Photogroup 4-25** Naconiche 6 depicting general bank appearance. Top left: 30-m transect, left bank, July 2012; Top right: 150-m transect, right bank, July 2012; Middle left: 300-m transect, right bank, July 2012; Middle right: 30-m transect, left bank, August 2012; Bottom: 30-m transect, downstream, July 2012.

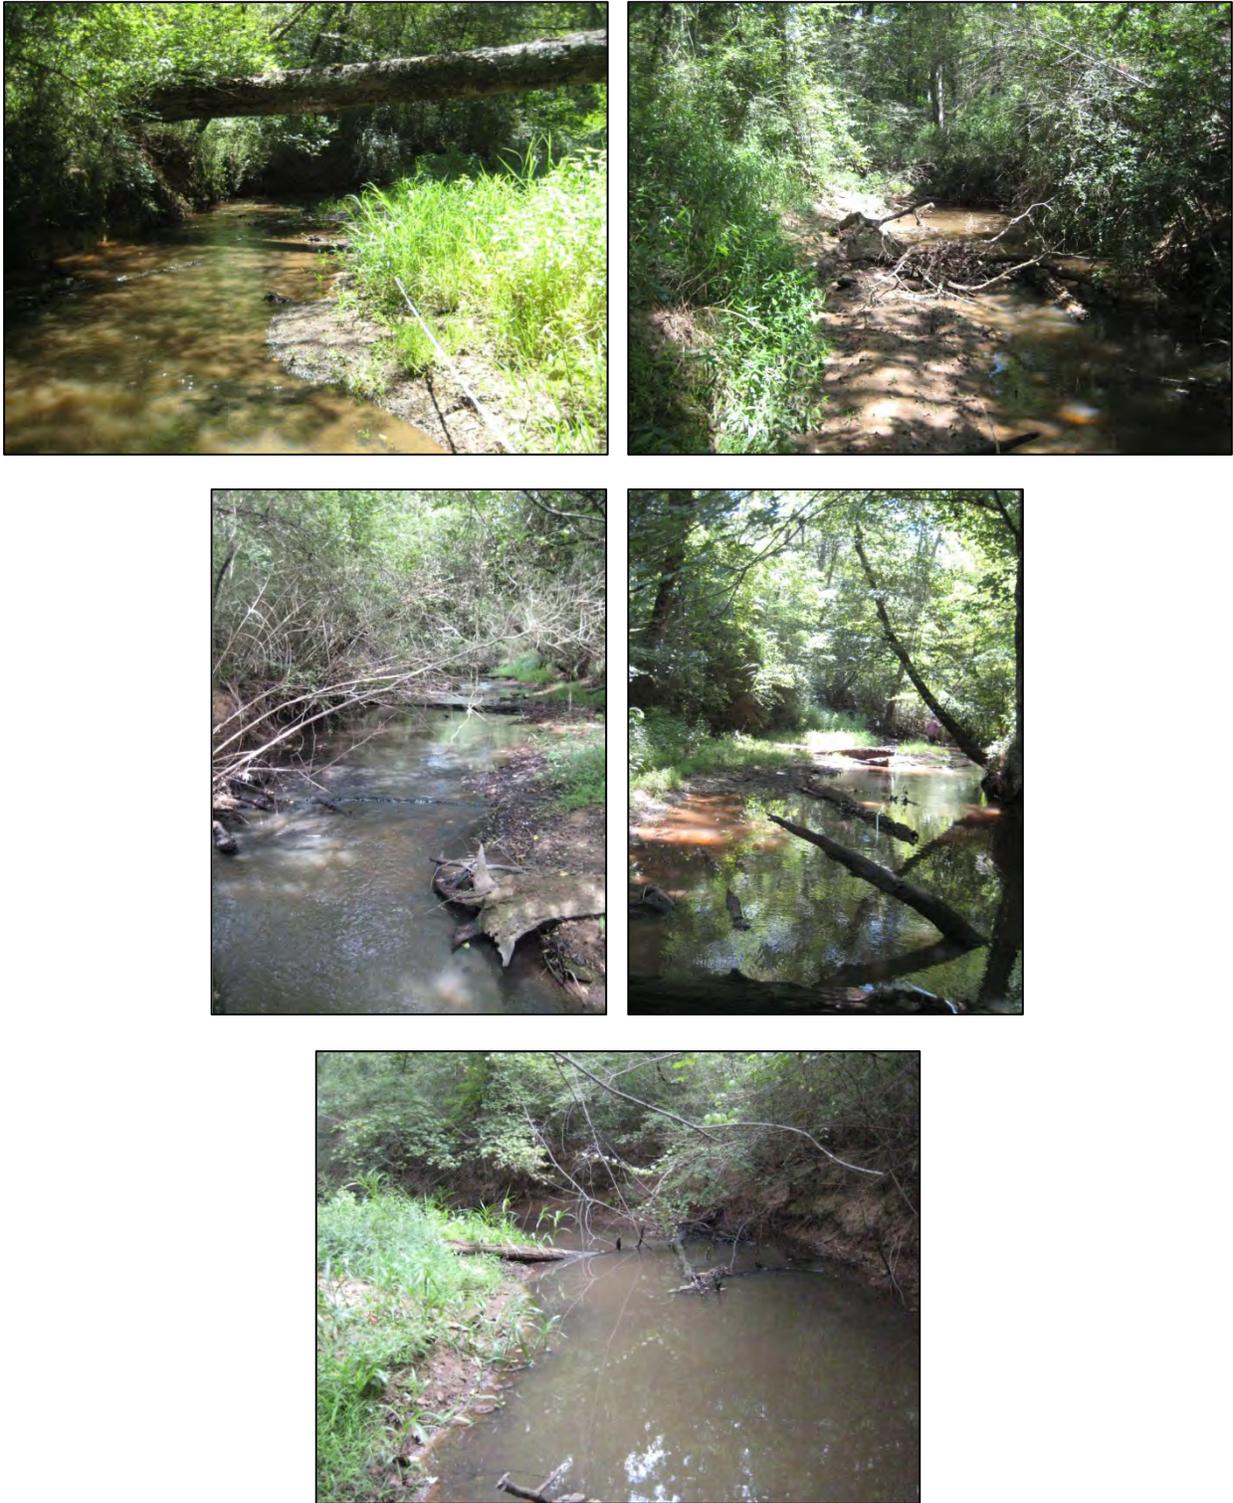
**Photogroup 4-25** Naconiche 6 depicting water surface characteristics and possible source of contamination. All individuals featured are SFASU and CES staff. Top left: 300-m transect, downstream, July 2012; Top right: 30-m transect, upstream, August 2012; Bottom left: Feral hog tracks/heavy use under CR 2435 crossing, July 2012; Bottom right: 150-m transect, downstream, August 2012.

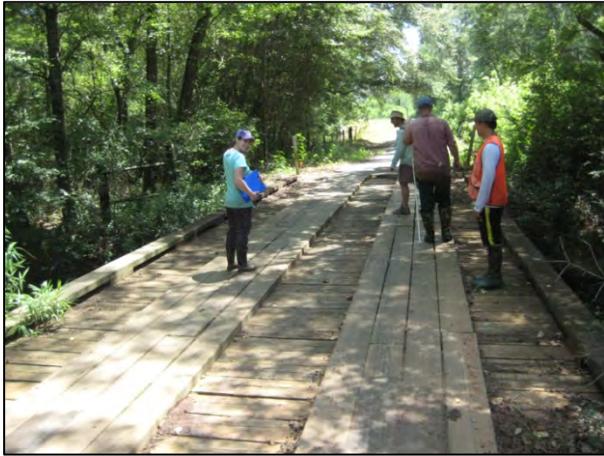
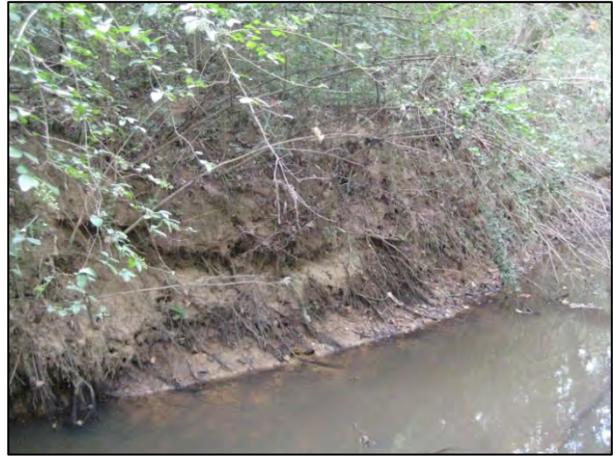
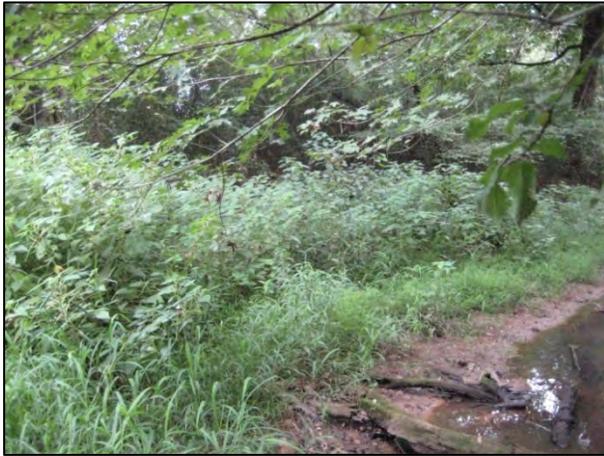
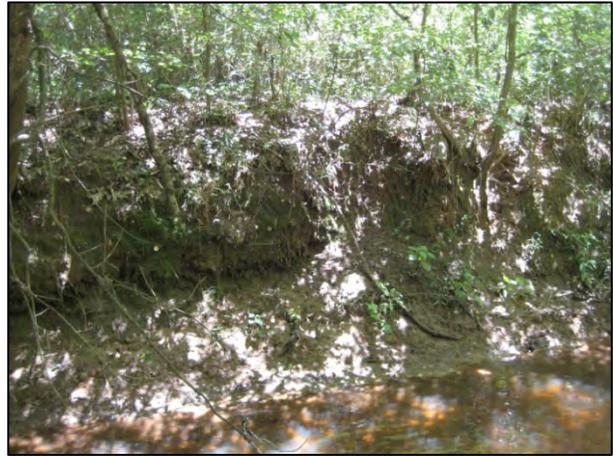
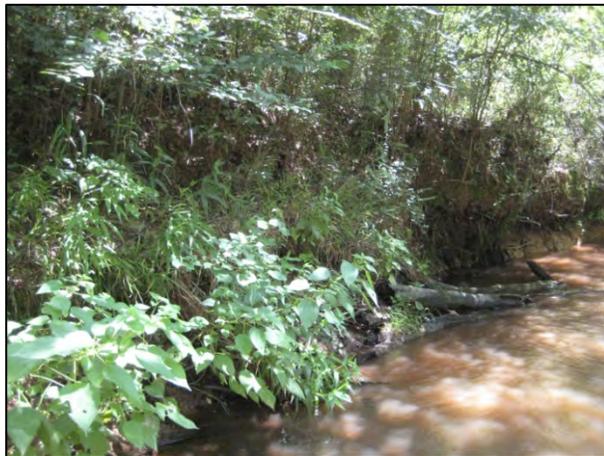
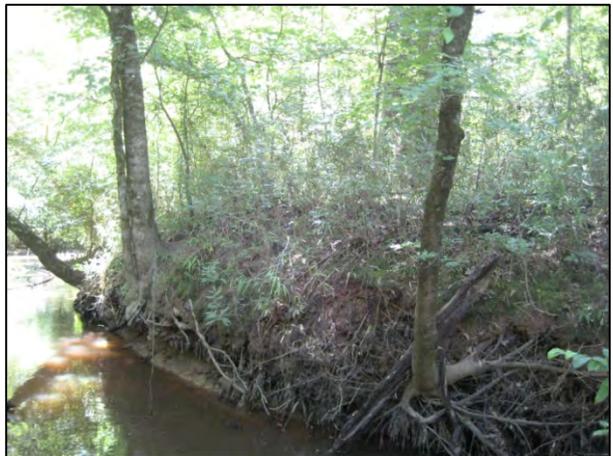
**Photogroup 4-26** Naconiche 7 depicting general stream characteristics. Top left: 150-m transect, downstream, July 2012; Top right: 300-m transect, upstream, July 2012; Middle left: 150-m transect, upstream, August 2012; Middle right: 30-m transect, downstream, July 2012; Bottom: 300-m transect, upstream, August 2012.

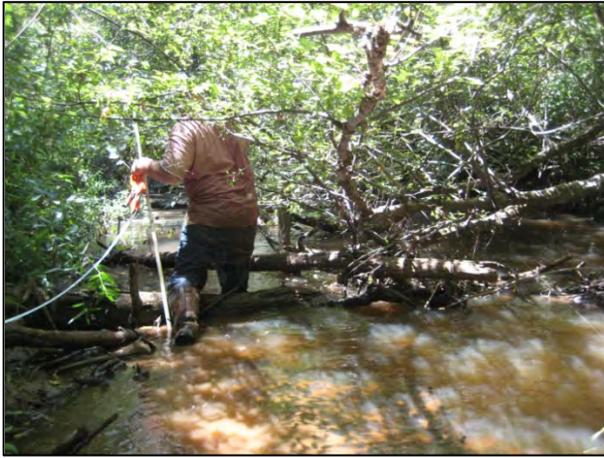
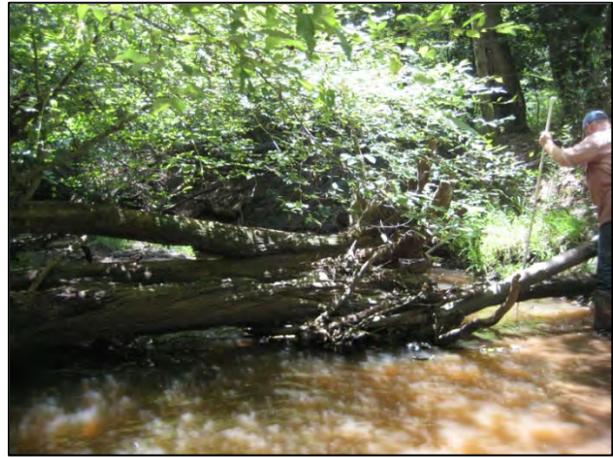
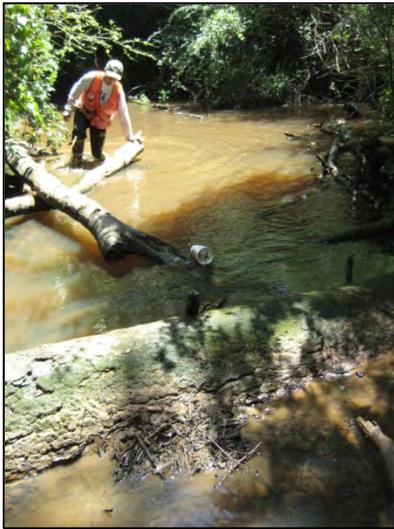
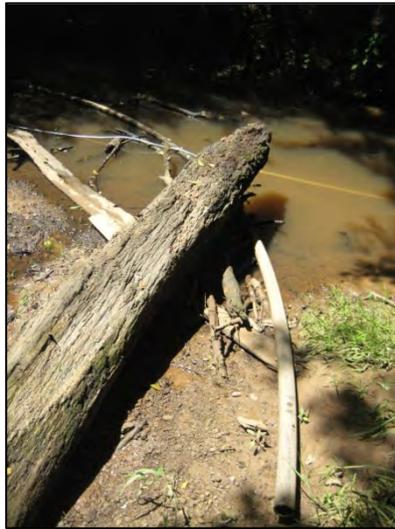
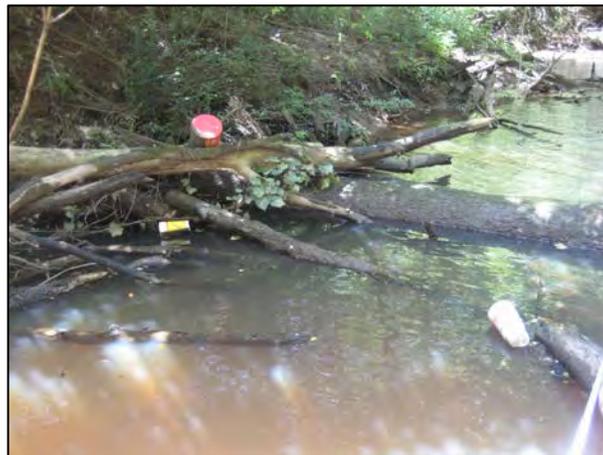
**Photogroup 4-26** Naconiche 7 depicting bank access and general bank appearance. All individuals featured SFASU and CES staff. Top left: CR 271 crossing/access point, July 2012; Top right: 300-m transect, left bank, August 2012; Middle left: 30-m transect, left bank, August 2012; Middle right: 300-m transect, right bank, July 2012; Bottom left: 150-m transect, right bank, July 2012; Bottom right: 30-m transect, right bank, July 2012.

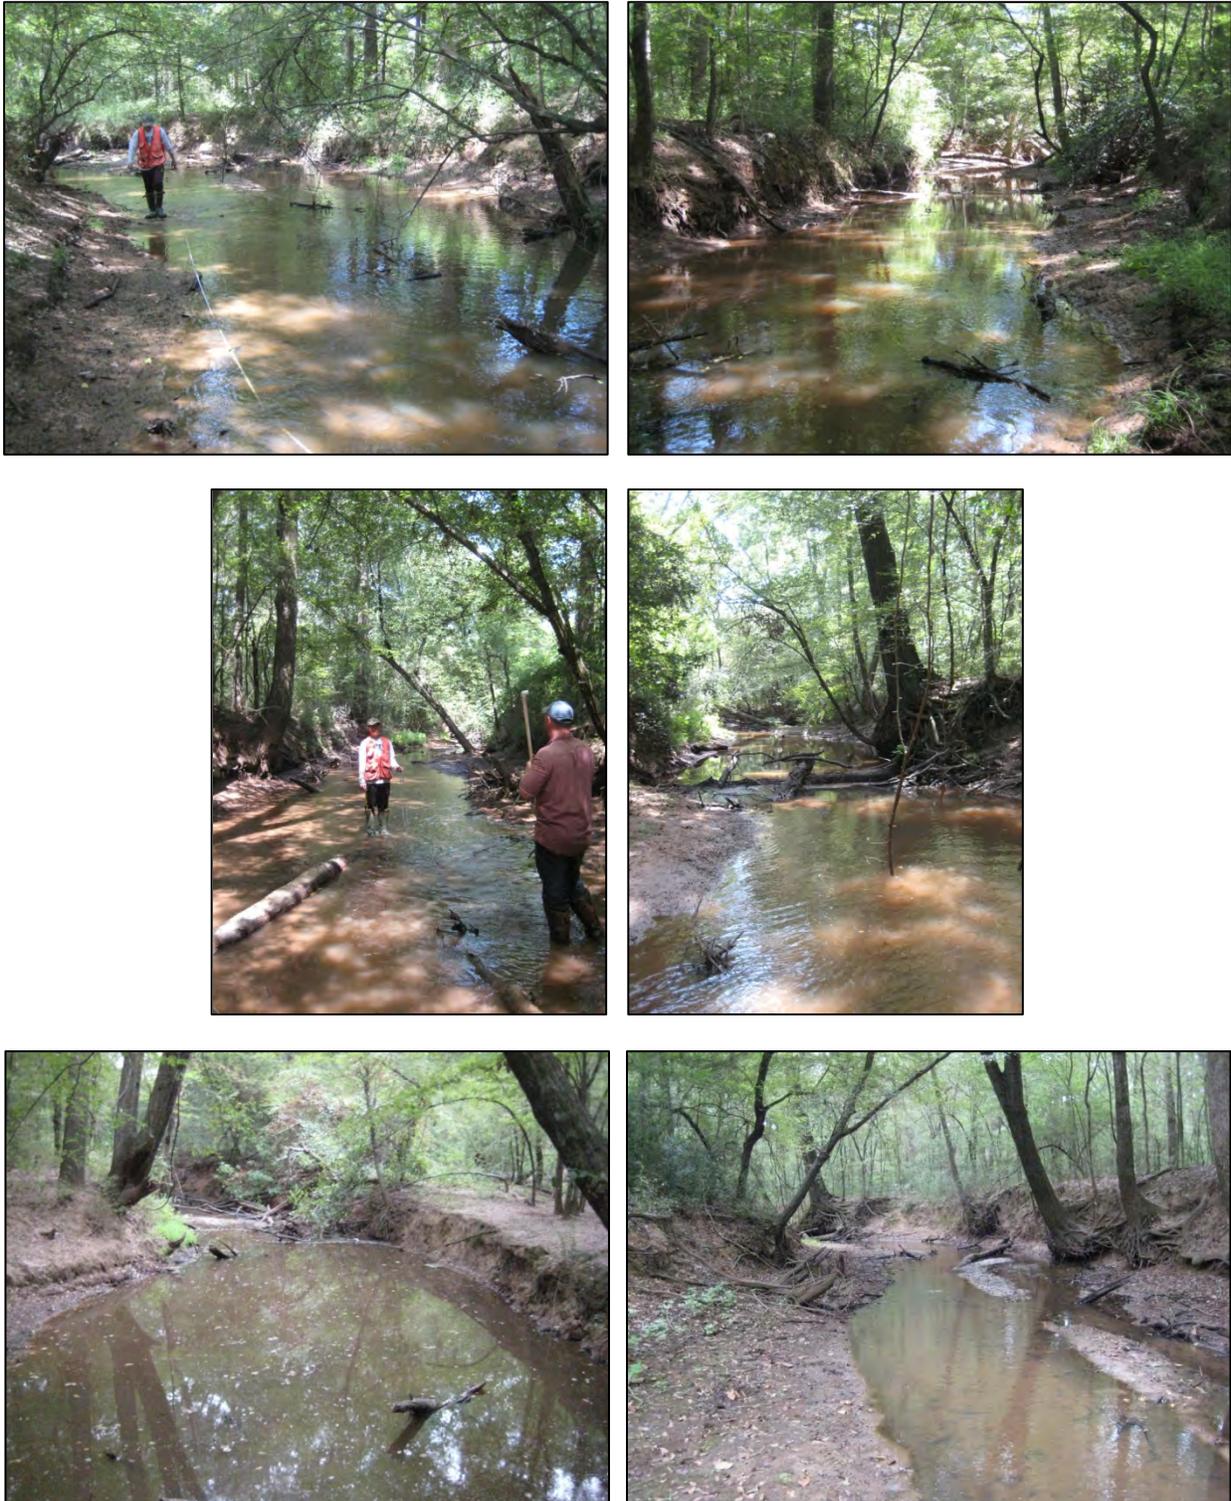
**Photogroup 4-26** Naconiche 7 depicting water surface characteristics. All individuals featured SFASU and CES staff. Top left: Large woody debris across/within channel, July 2012; Top right: Large woody debris across/within channel, July 2012; Middle left: Large woody debris in channel, July 2012; Middle right: Large woody debris and littler within channel, July 2012; Bottom: Large woody debris and small litter within channel, July 2012.

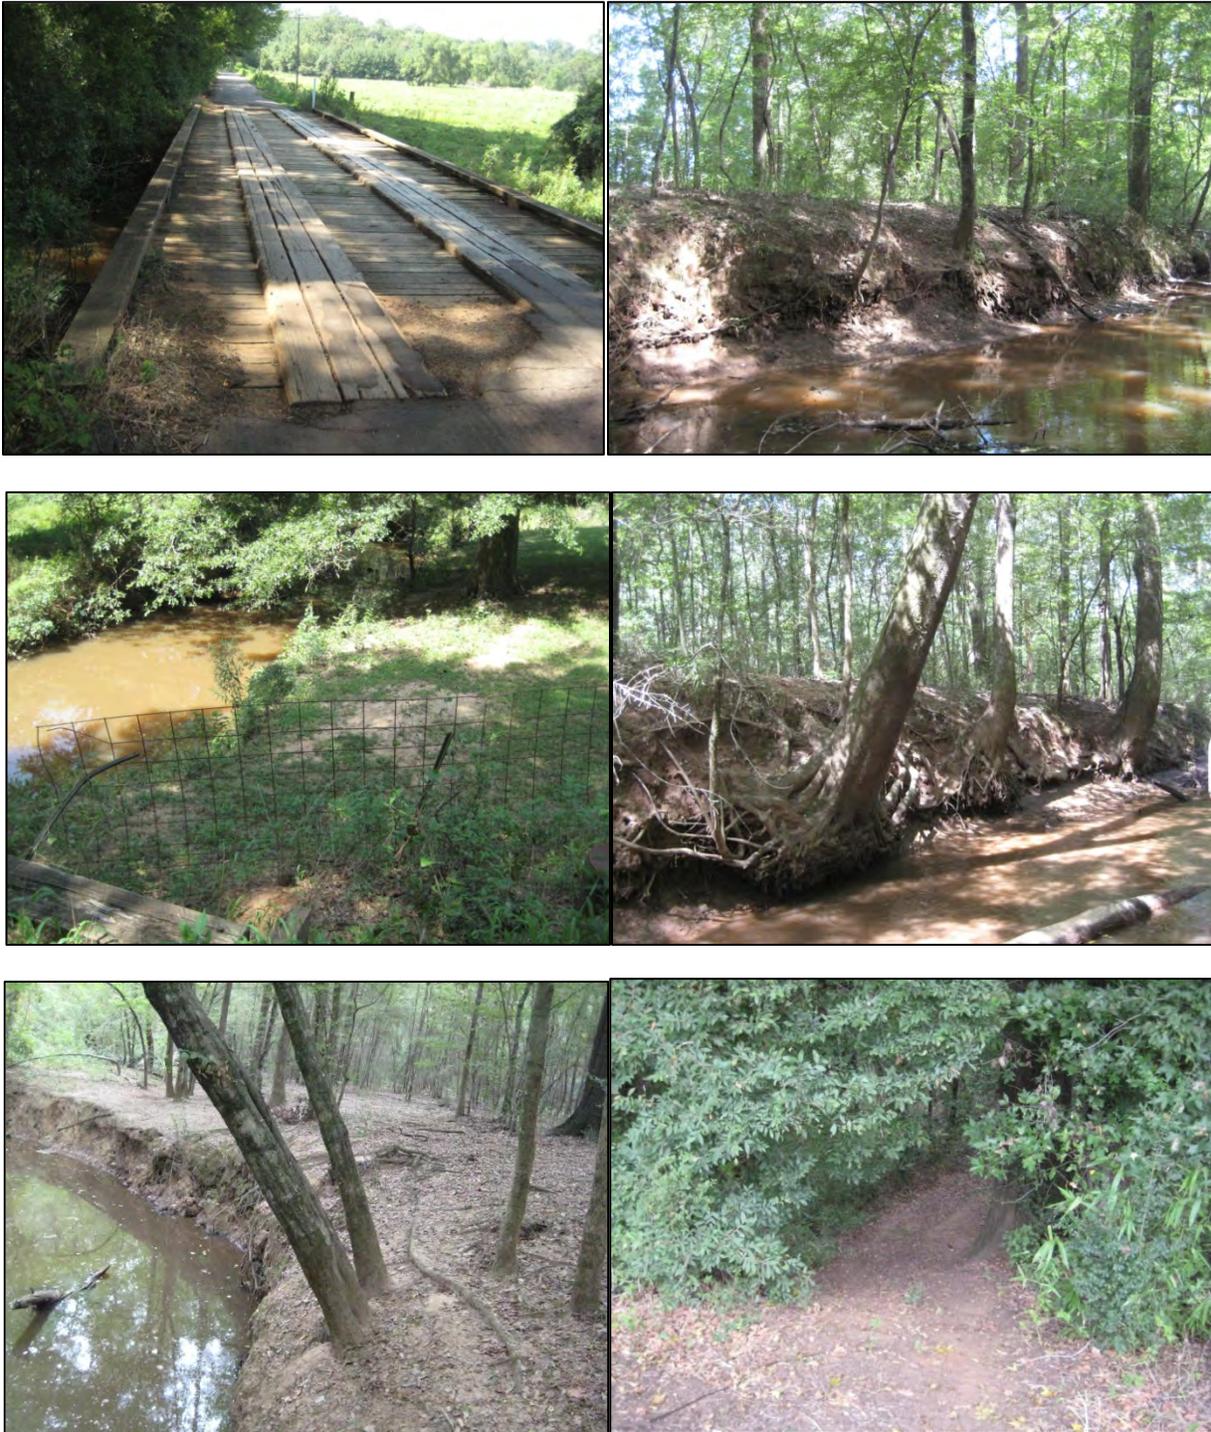
**Photogroup 4-27** Naconiche 8 depicting general stream characteristics. All individuals featured are SFASU and CES staff. Top left: 150-m transect, upstream, July 2012; Top right: 150-m transect, downstream, July 2012; Middle left: 300-m transect, upstream, July 2012; Middle right: 300-m transect, downstream, July 2012; Bottom left: 30-m transect, downstream, August 2012; Bottom right: 300-m transect, downstream, August 2012.

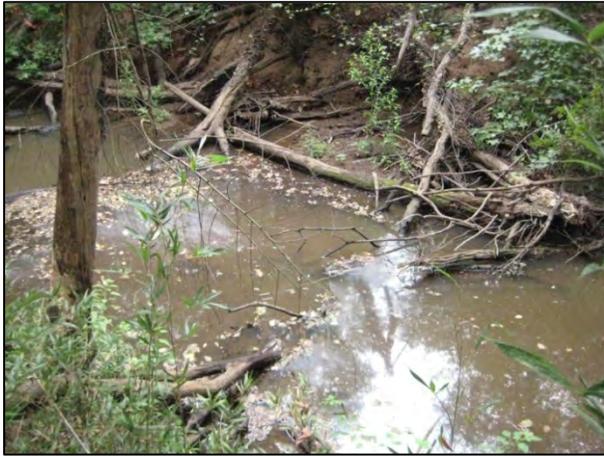
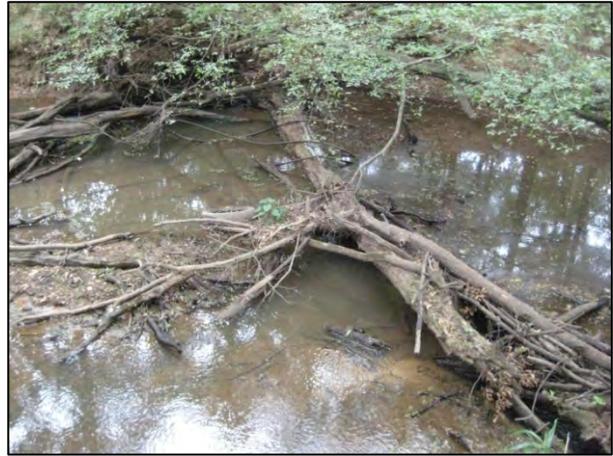
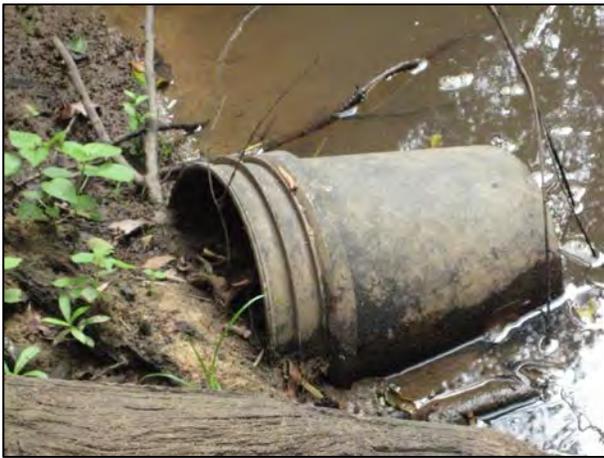
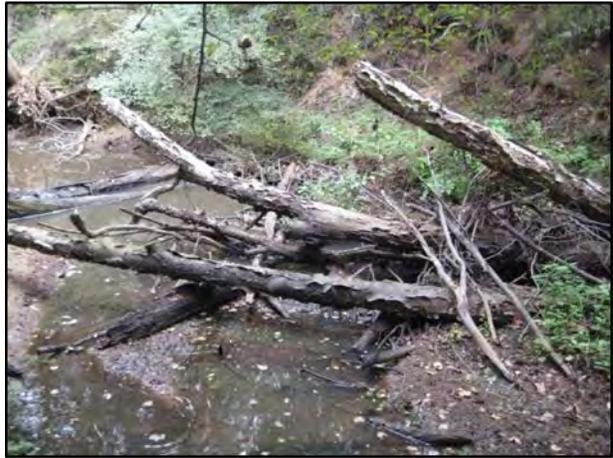
An ATV trail/access point was present on the right bank adjacent to the Cedar Bluff Road. No further signs of human access points were evident within the 300 meter reach of the survey. A portion of the upstream, left bank is fenced at the road crossing to prevent public access. Signs of recreation were also present in the form of a fish bait container. A portion of the container was found on the bank next to the road crossing while the bottom of the container was found in the stream channel. A tire, bucket, and old drink can were also present in the stream channel. Photogroup 5-14 documents these indications of recreational activity.

**Photogroup 4-27** Naconiche 8 depicting general bank appearance. All individuals featured are SFASU and CES staff. Top left: Cedar Bluff Road (CR 273) crossing, July 2012; Top right: 150-m transect, left bank, July 2012; Middle left: Fenced bank upstream adjacent to road crossing, July 2012; Middle right: 300-m transect, right bank, July 2012; Bottom left: 30-m transect, right bank, August 2012; Bottom right: Possible ATV trail entrance adjacent to stream crossing, August 2012.

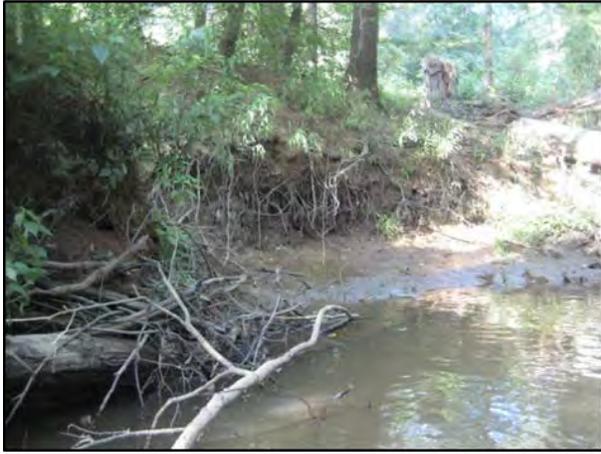
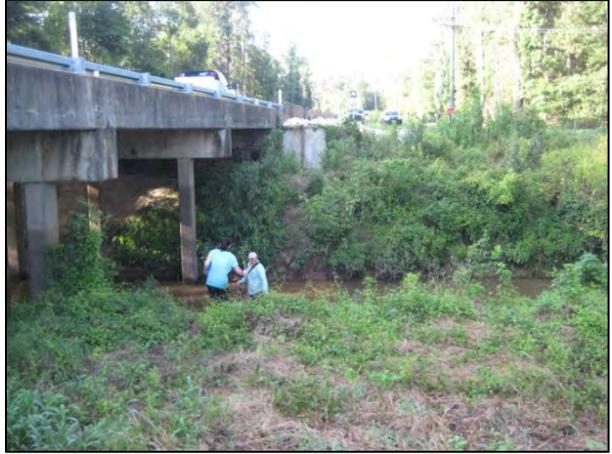
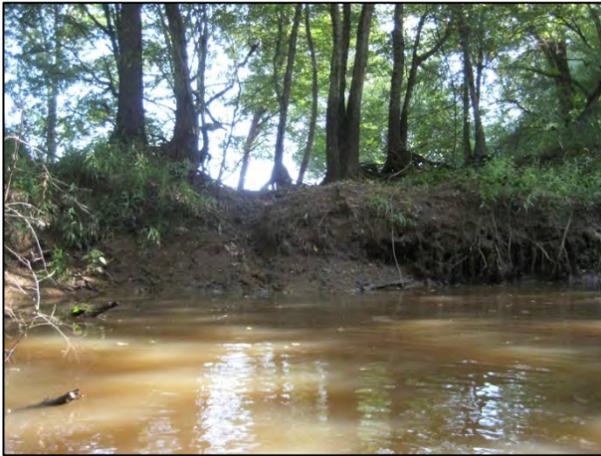
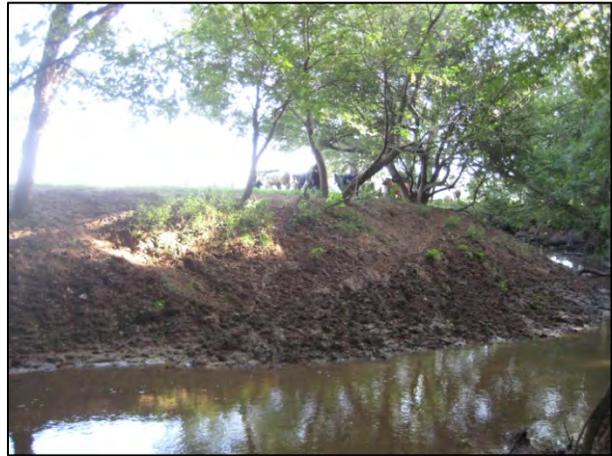
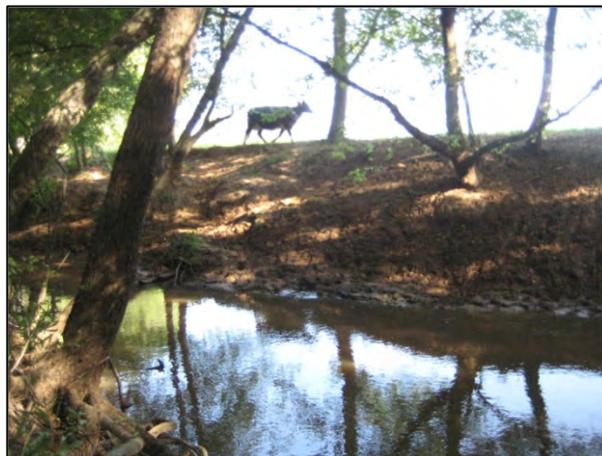
**Photogroup 4-30** Naconiche 11 depicting general stream characteristics. All individuals featured are SFASU and CES staff. Top left: 30-m transect, upstream, July 2012; Top right: 30-m transect, downstream, July 2012; Middle left: 300-m transect, upstream, July 2012; Middle right: 150-m transect, upstream, August 2012; Bottom: 300-m transect, upstream, August 2012.

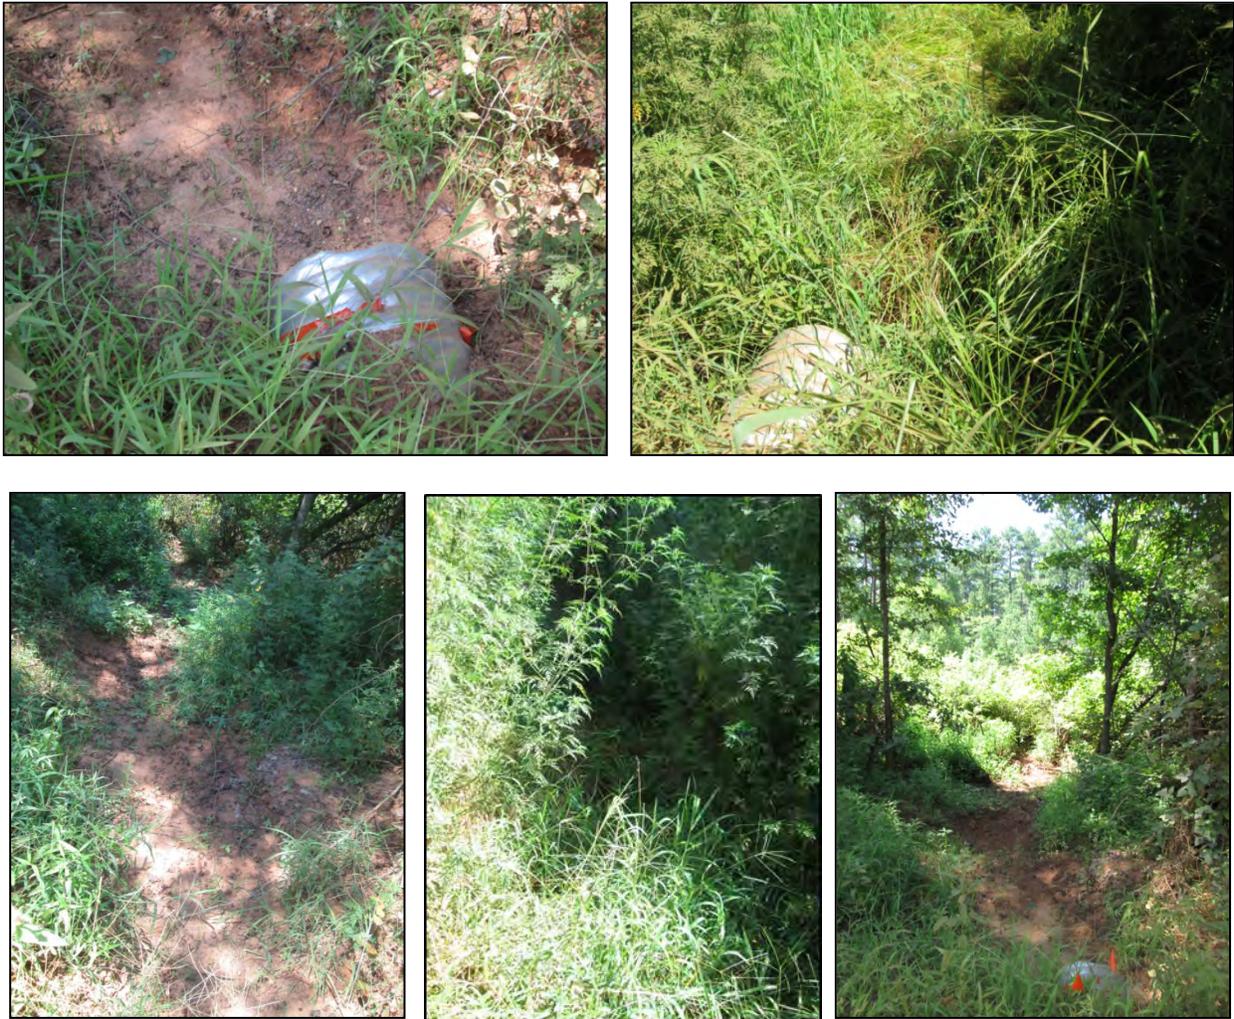
**Photogroup 4-31** Terrapin 1 depicting general stream characteristics. Top left: 0-m transect, downstream, July 2012; Top right: 0-m transect, upstream, July 2012; Bottom left: Downstream, dry stream channel, August 2012; Bottom center: Downstream, dense vegetation covering channel, August 2012; Bottom right: 0-m transect, downstream, view from CR 234 crossing, July 2012.

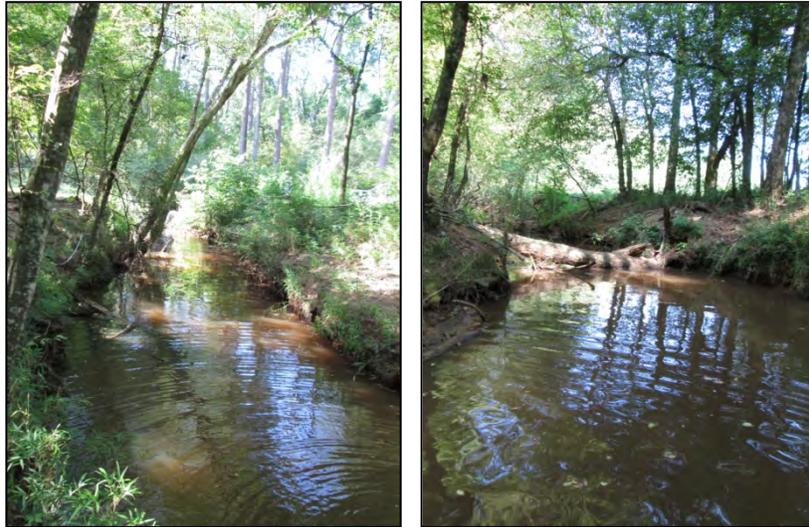
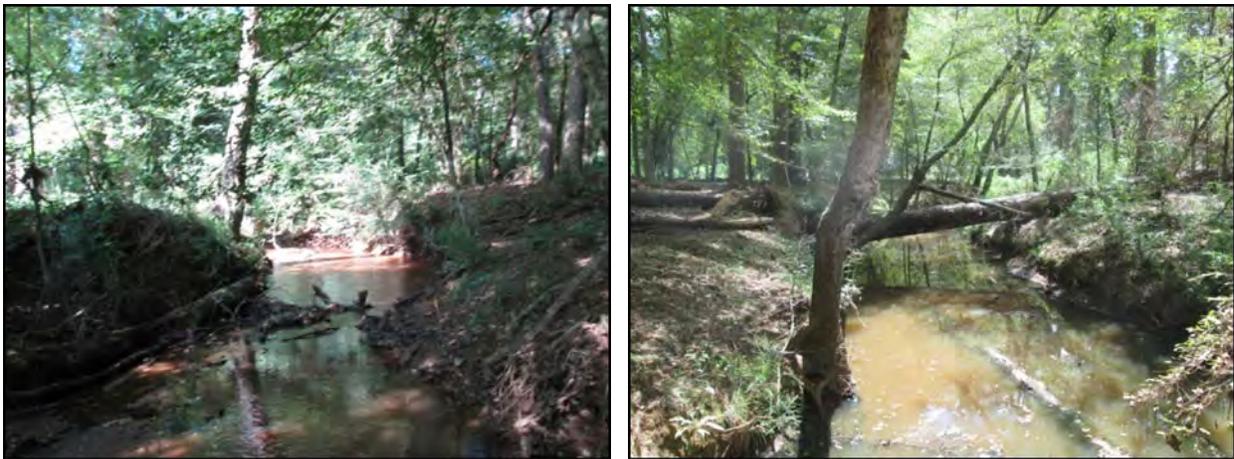
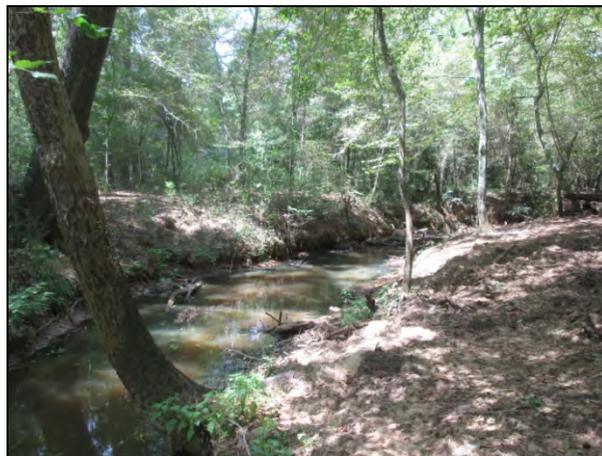
**Photogroup 4-32** Terrapin 2 depicting general stream characteristics. Top left: 30-m transect, downstream, July 2012; Top right: 150-m transect, upstream, July 2012; Middle left: 300-m transect, downstream, July 2012; Middle right: 30-m transect, downstream, August 2012; Bottom: 30-m transect, upstream, August 2012.

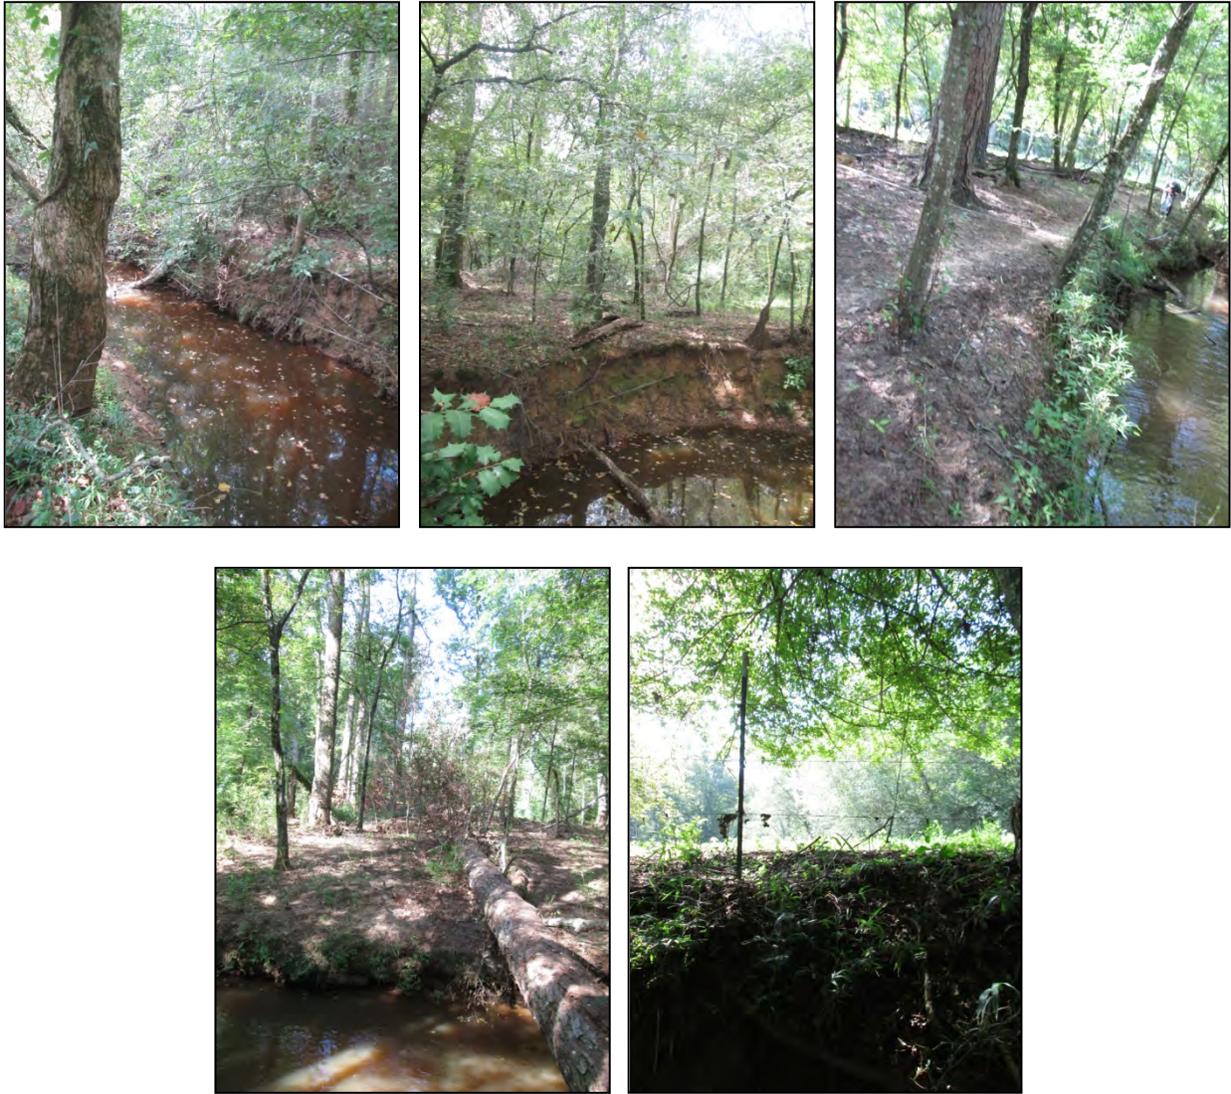
**Photogroup 4-32** Terrapin 2 depicting general bank appearance. Top left: 300-m transect, downstream, August 2012; Top center: 300-m transect, left bank, August 2012; Top right: 30-m transect, left bank, July 2012; Bottom left: 30-m transect, right bank, July 2012; Bottom right: Fenced pastureland, left bank, July 2012.
