# Attoyac Bayou Recreational Use Attainability Analysis

**Attoyac Bayou  
Recreational Use Attainability Analysis**

**Texas State Soil and Water Conservation Board  
Project # 09-10**

**October 2012**

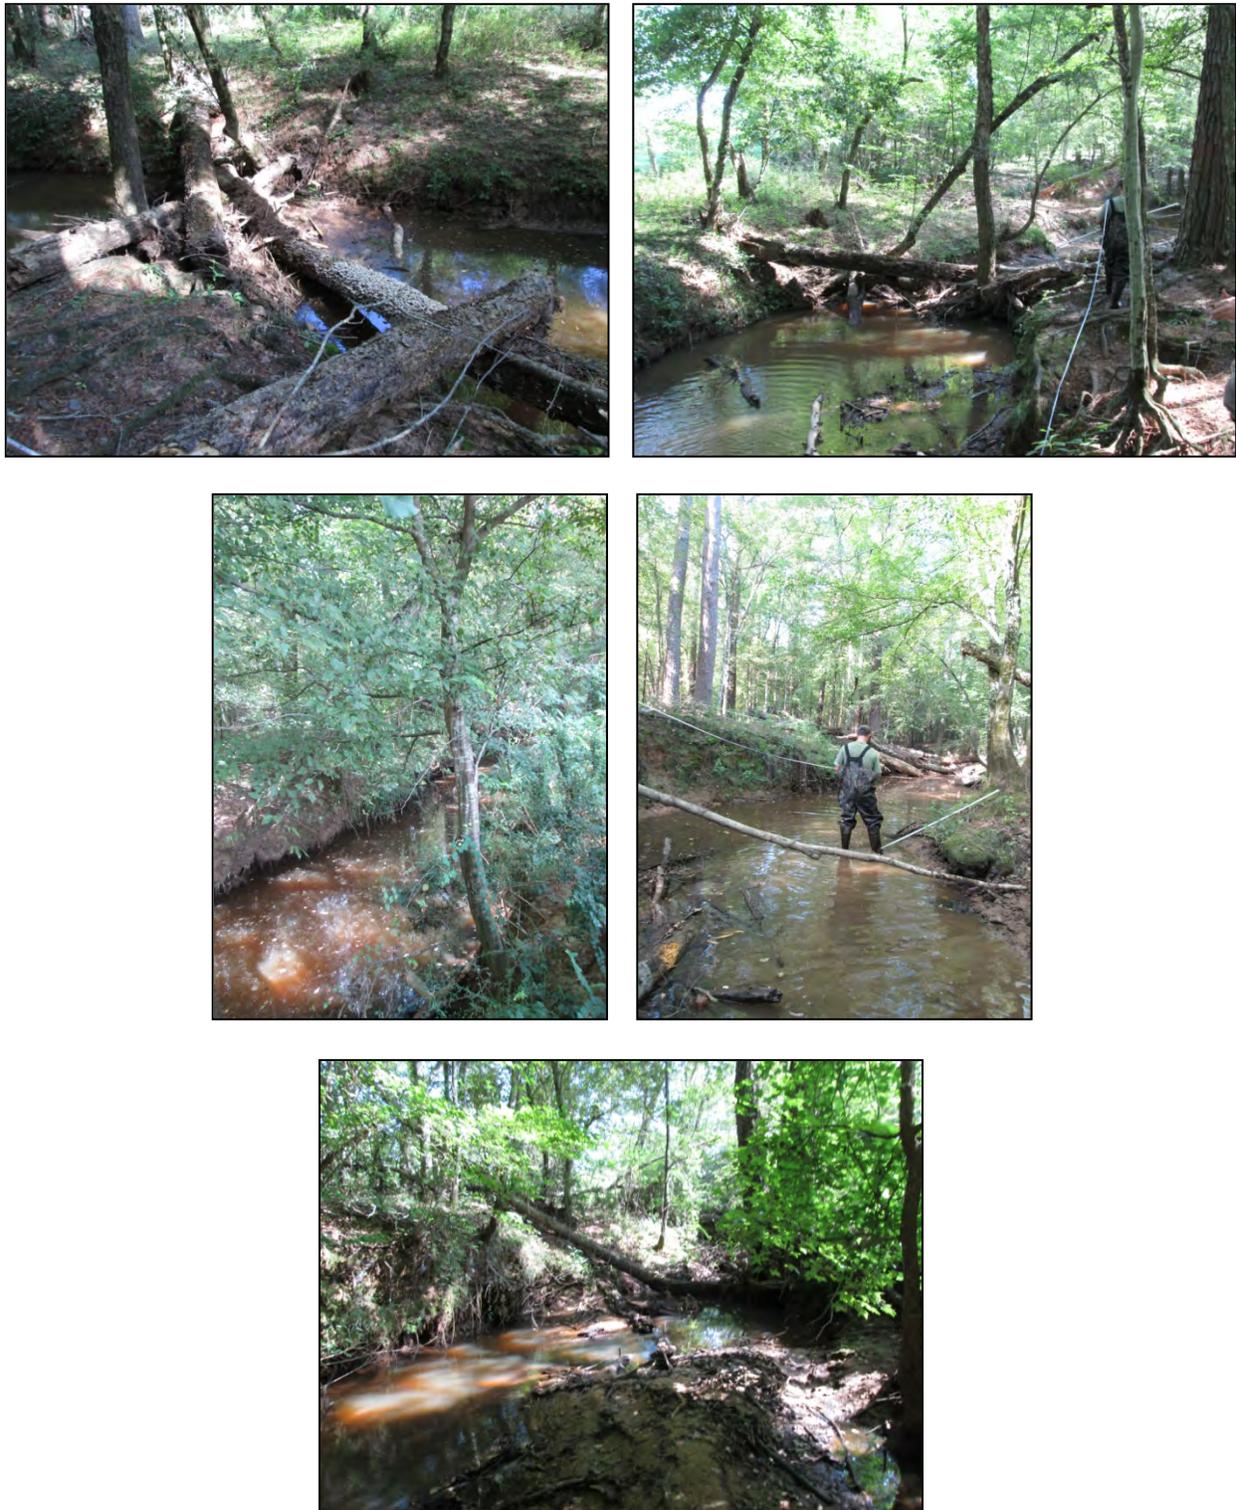
**Photogroup 4-32** Terrapin 2 depicting water surface characteristics. All individuals featured are SFASU and CES staff. Top left: Logjam with foam, July 2012; Top right: Logjam within channel, July 2012; Middle left: 150-m transect, upstream, August 2012; Middle right: 150-m transect, downstream, July 2012; Bottom: 300-m transect, upstream, July 2012.

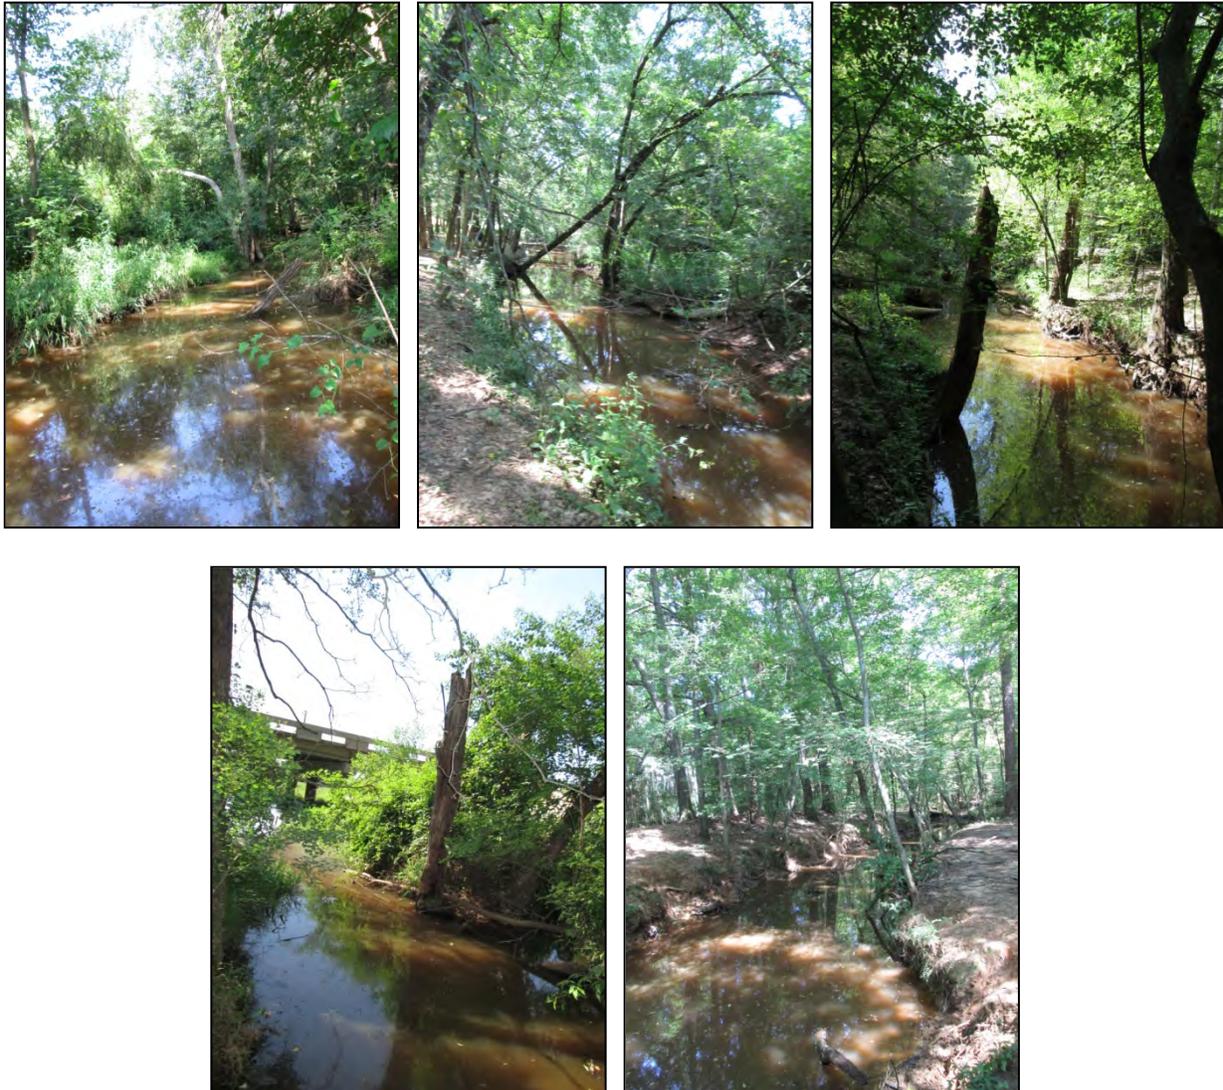
**Photogroup 4-33** Terrapin 3 depicting general stream characteristics. Top left: 30-m transect, upstream, July 2012; Top center: 150-m transect, downstream, July 2012; Top right: 300-m transect, downstream, July 2012; Bottom left: 30-m transect, downstream, July 2012; Bottom right: 300-m transect, upstream, July 2012.

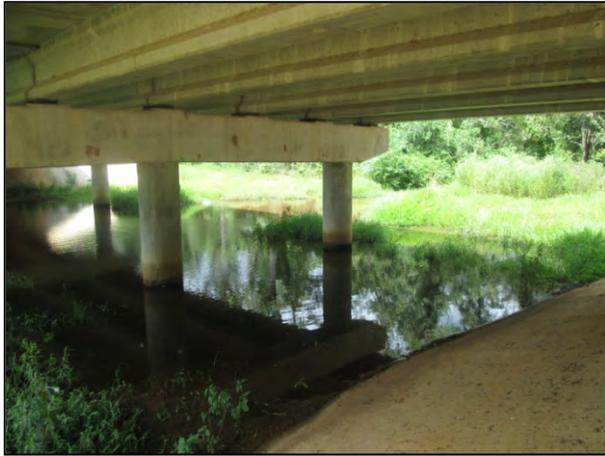
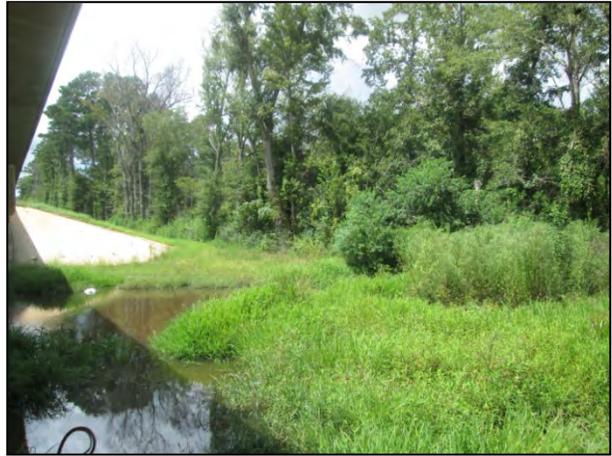
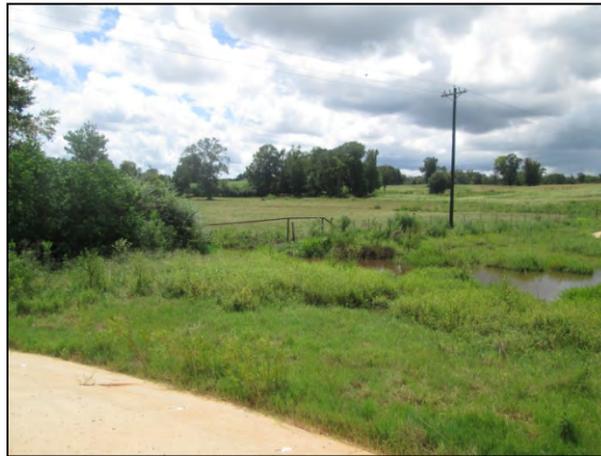
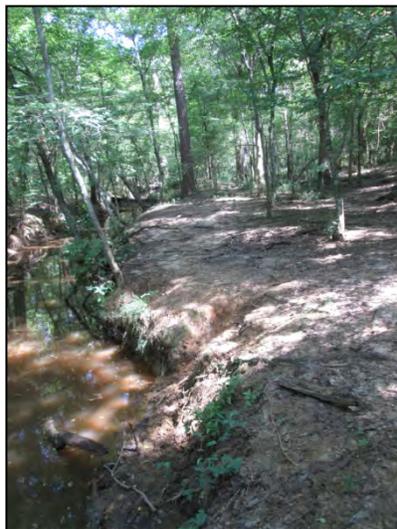
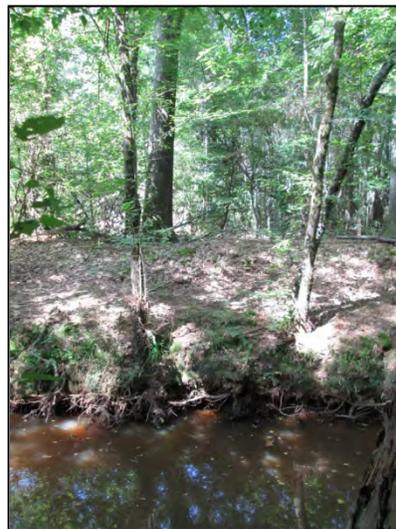
**Photogroup 4-33** Terrapin 3 depicting general bank appearance. Top left: 0-m transect, Highway 7 crossing, flooded banks, August 2012; Top right: 0-m transect, Bank access from Hwy 7, flooded banks, August 2012; Middle: Fenced channel, upstream, August 2012; Bottom left: 300-m transect, left bank, July 2012; Bottom right: 300-m transect, Right bank, July 2012.

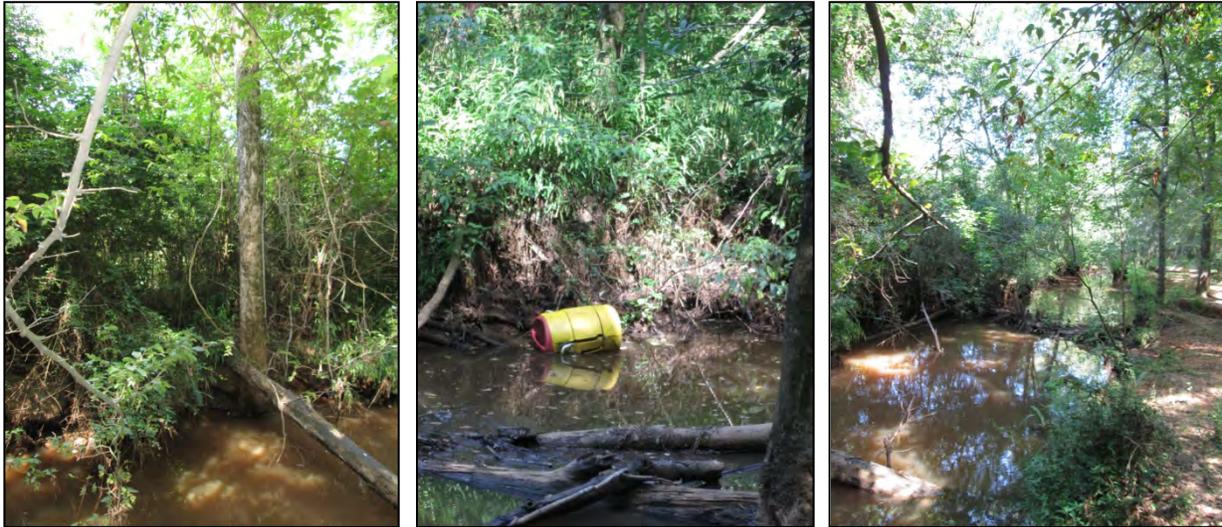
**Photogroup 4-33** Terrapin 3 depicting water surface characteristics. Left: 150-m transect, right bank, July 2012; Center: Large channel litter (cooler), July 2012; Right: 150-m transect, upstream, July 2012.

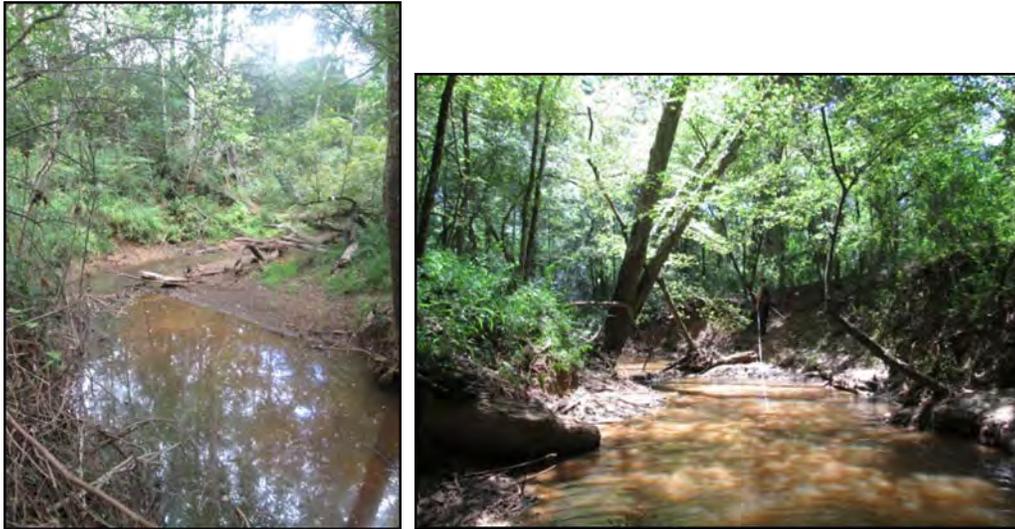
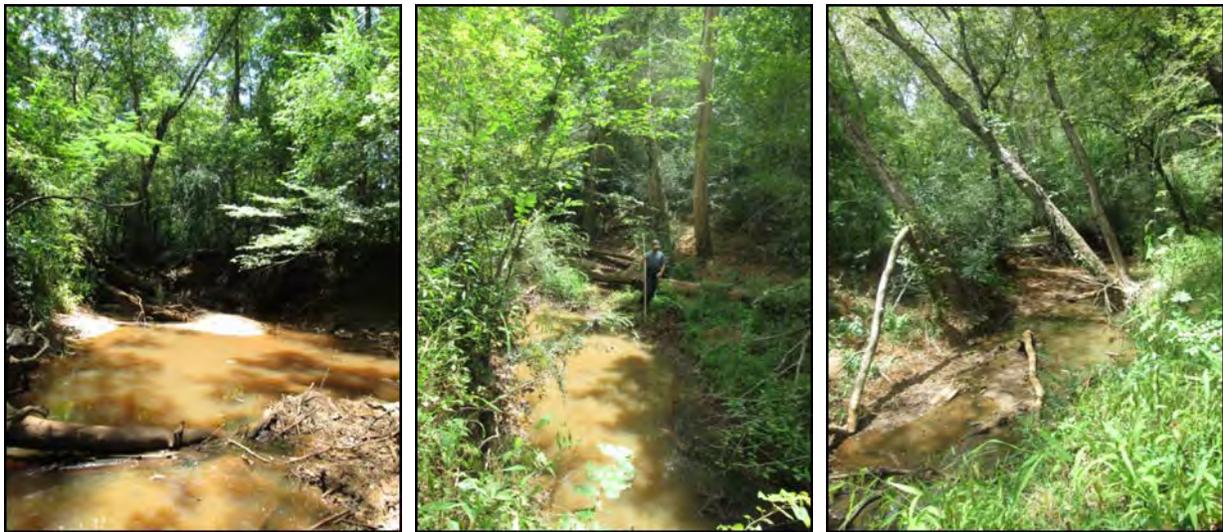
**Photogroup 4-34** Terrapin 4 depicting general stream characteristics. Top left: 300-m transect, downstream, August 2012; Top right: 150-m transect, downstream, July 2012; Bottom left: 300-m transect, downstream, July 2012; Bottom center: 150-m transect, downstream, August 2012; Bottom right: 150-m transect, upstream, August 2012.

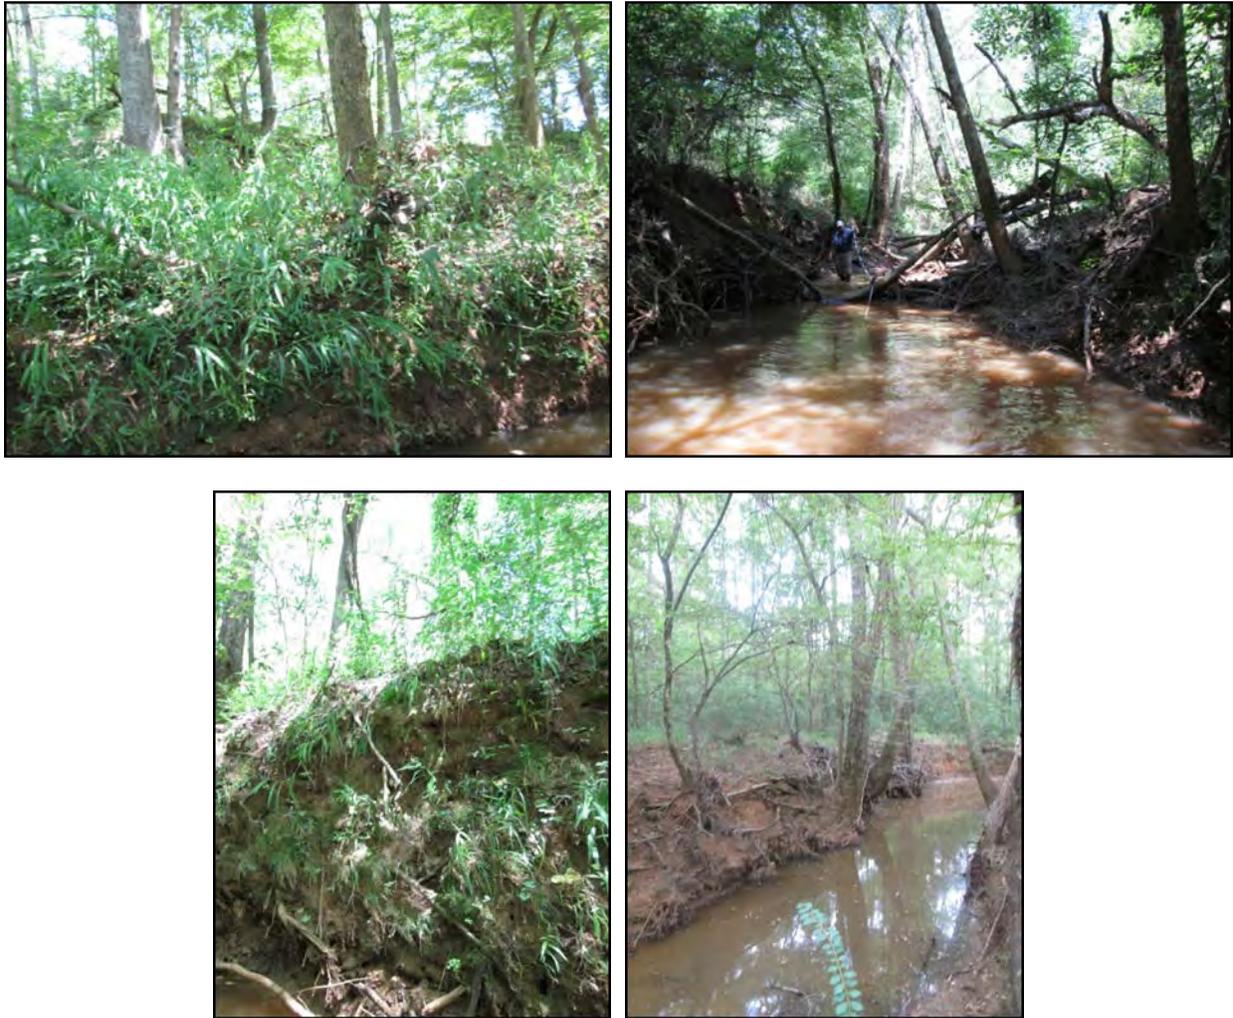
**Photogroup 4-34** Terrapin 4 depicting general bank appearance. Top left: 30-m transect, right bank, July 2012; Top right: 150-m transect, upstream, July 2012; Bottom left: 150-m transect, right bank, July 2012; Bottom right: 300-m transect, upstream, August 2012.

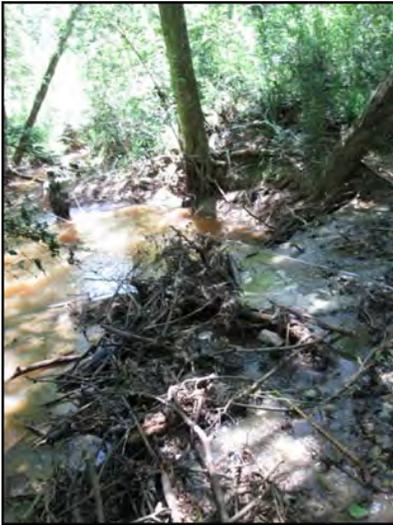
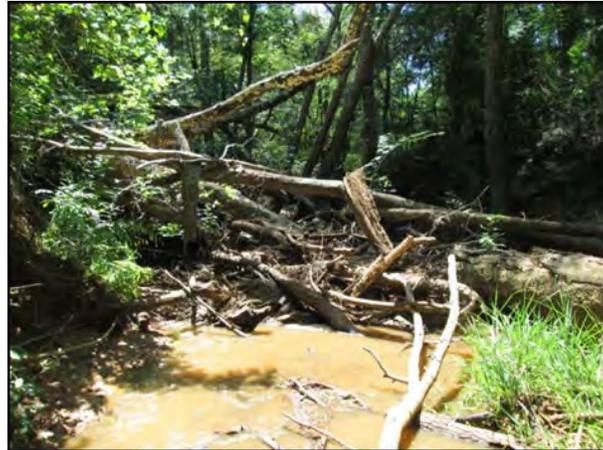
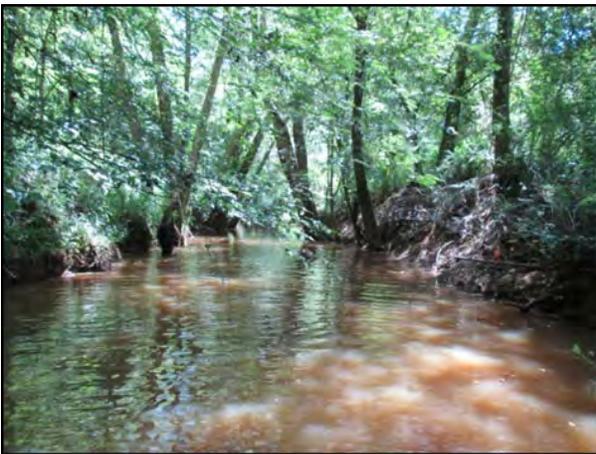
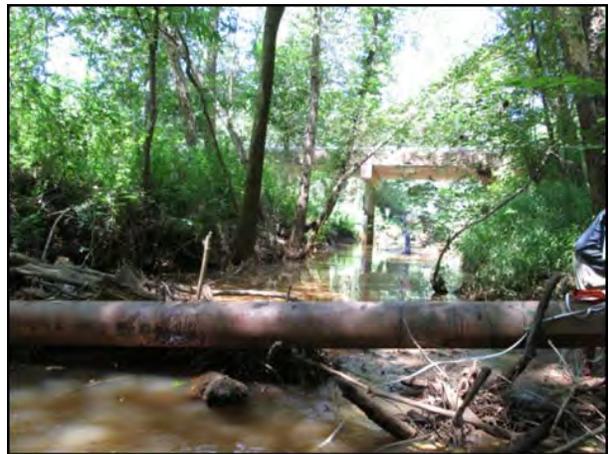
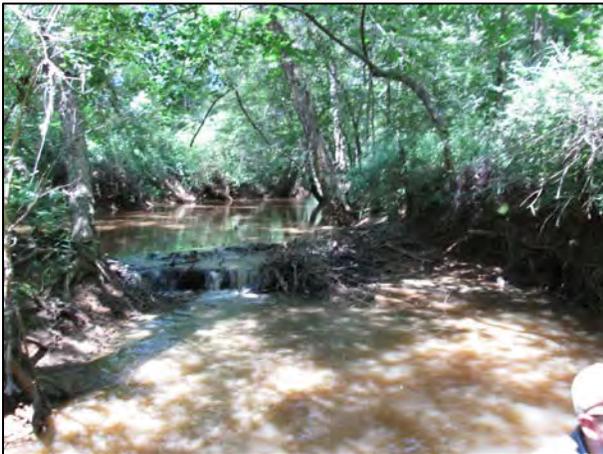
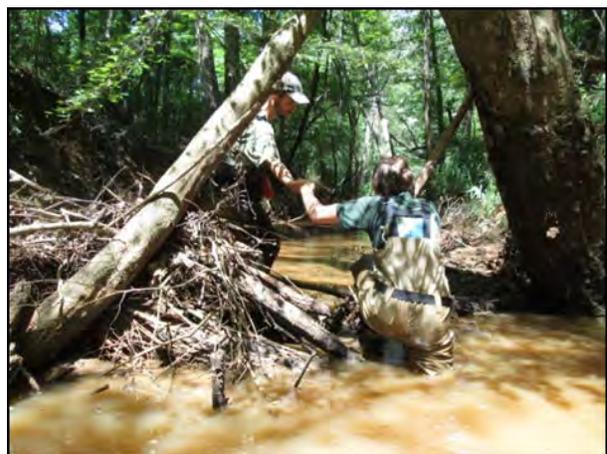
**Photogroup 4-34** Terrapin 4 depicting water surface characteristics. All individuals featured are SFASU and CES staff. Top left: Woody debris within channel, July 2012; Top right: Log jam, July 2012; Middle left: 30-m transect, downstream, July 2012; Middle right: 30-m transect, upstream, July 2012; Bottom left: Log under water surface with woody debris, July 2012; Bottom right: Large woody debris within channel (above and under water surface); July 2012.

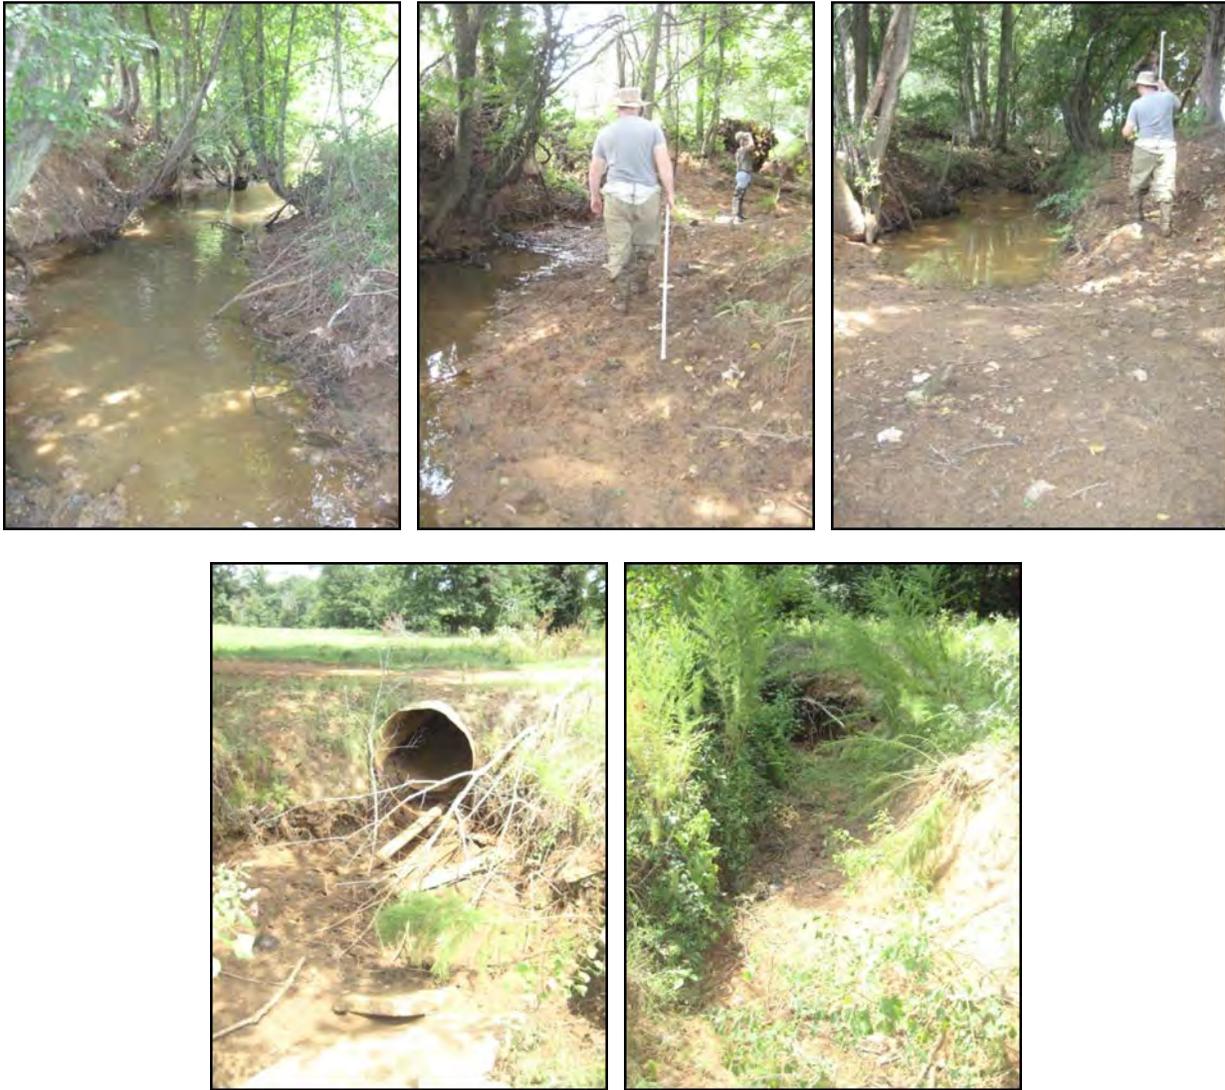
**Photogroup 4-35** Waffelow 1 depicting general stream characteristics. All individuals featured are SFASU and CES staff. Top left: 30-m transect, downstream, July 2012; Top center: 30-m transect, upstream, July 2012; Top right: 150-m transect, upstream, July 2012; Bottom left: 300-m transect, upstream, July 2012; Bottom right: 300-m transect, downstream, July 2012.

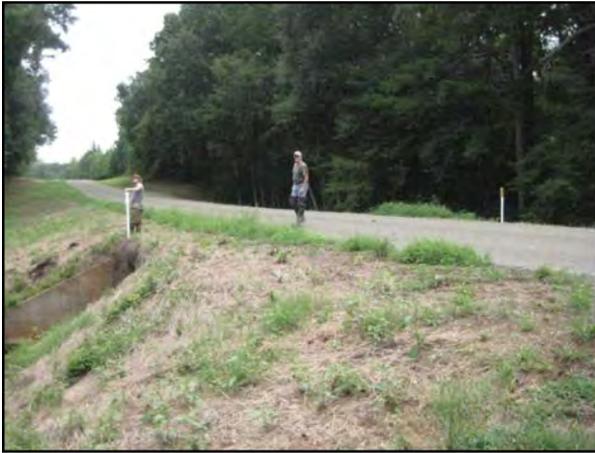
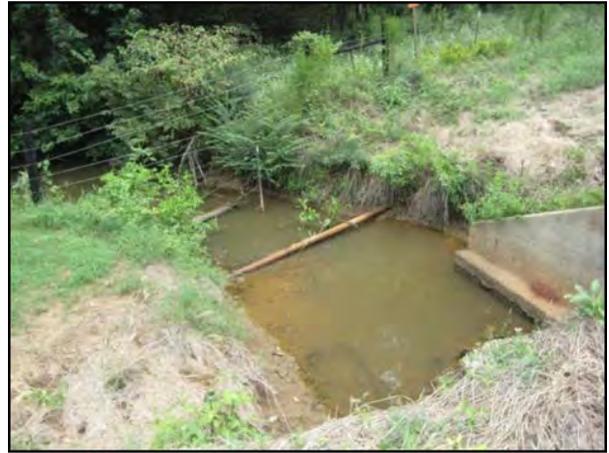
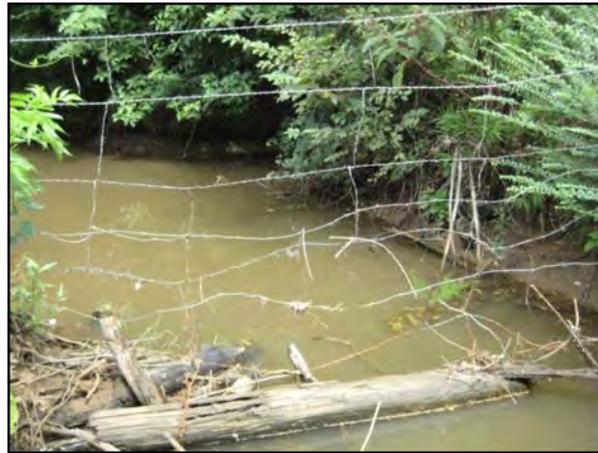
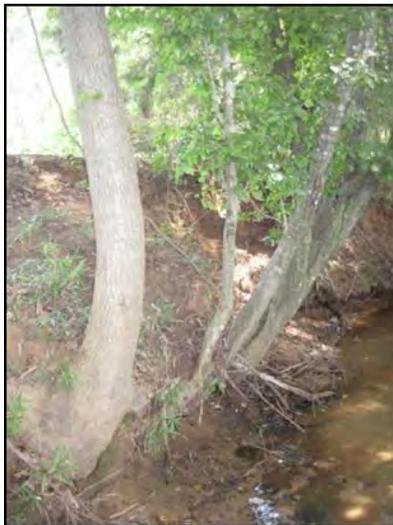
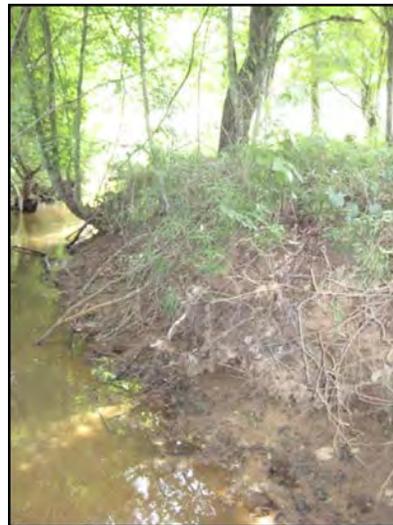
**Photogroup 4-35** Waffelow 1 depicting bank appearance. All individuals featured are SFASU and CES staff. Top left: FM 1878 crossing/access point, July 2012; Top right: 0-m transect, July 2012; Middle: 0-m transect, fenced stream channel, July 2012; Bottom left: 30-m transect, left bank, July 2012; Bottom right: 30-m transect, right bank, July 2012.

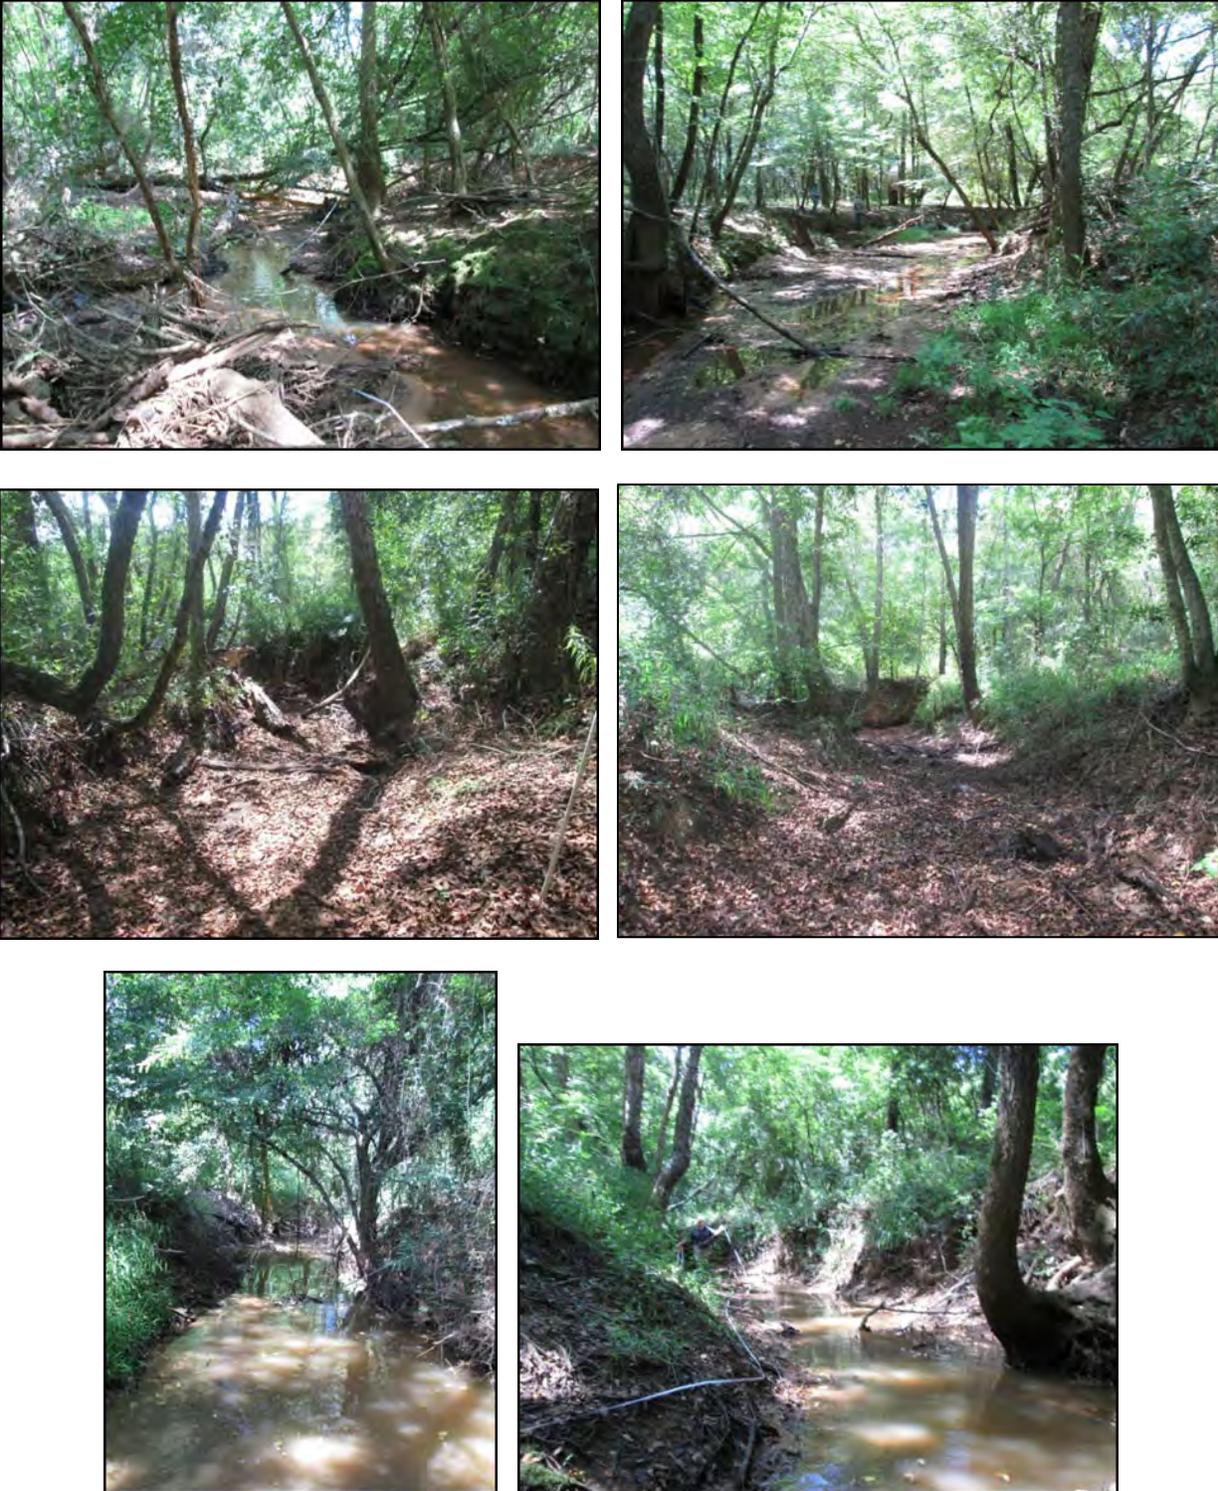
**Photogroup 4-36** Waffelow 2 depicting general stream characteristics. Top left: 30-m transect, upstream, July 2012; Top right: 30-m transect, downstream, July 2012; Middle left: 300-m transect, downstream, August 2012; Middle right: 150-m transect, downstream, August 2012. Bottom left: 300-m transect, upstream, July 2012; Bottom right: 150-m transect, downstream, July 2012.

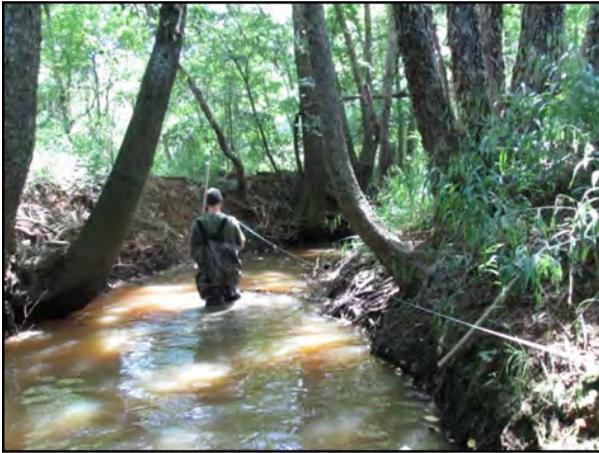
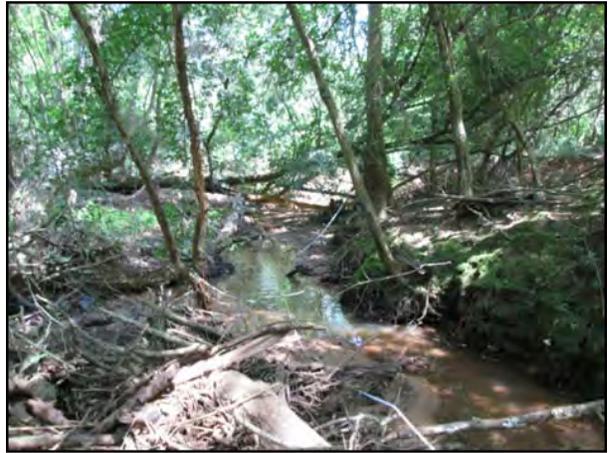
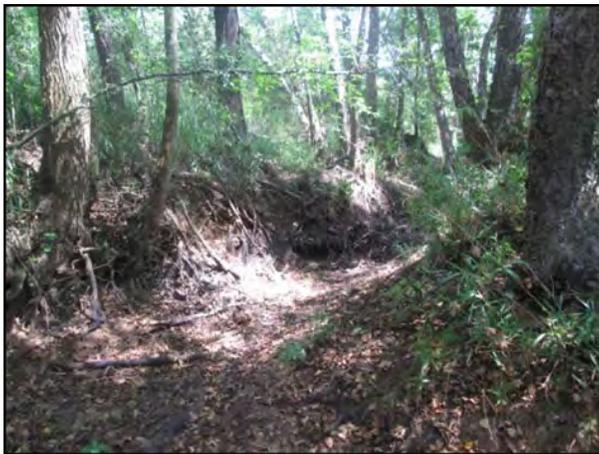
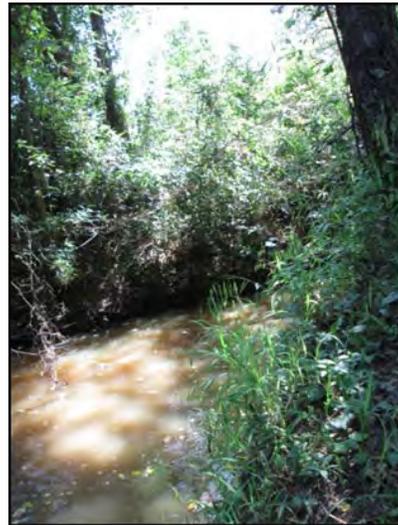
**Photogroup 4-36** Waffelow 2 depicting general bank appearance. All individuals featured are SFASU and CES staff. Top left: 150-m transect, upstream, July 2012; Top right: 30-m transect, upstream, July 2012; Bottom left: 300-m transect, upstream, August 2012; Bottom right: 300-m transect, downstream, July 2012.

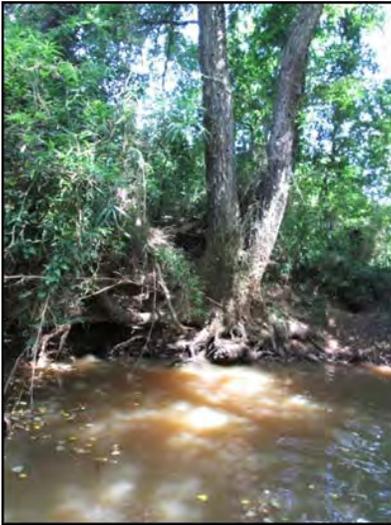
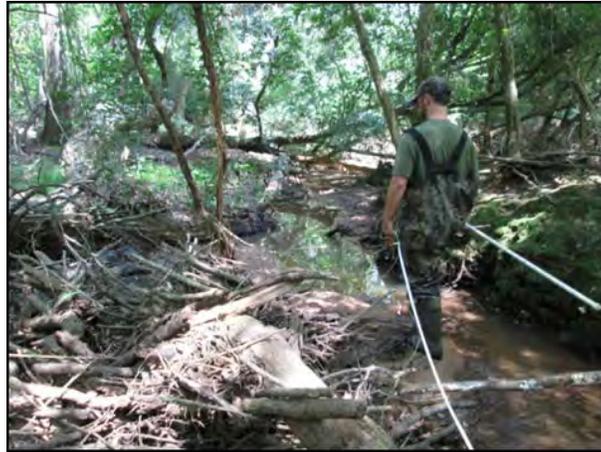
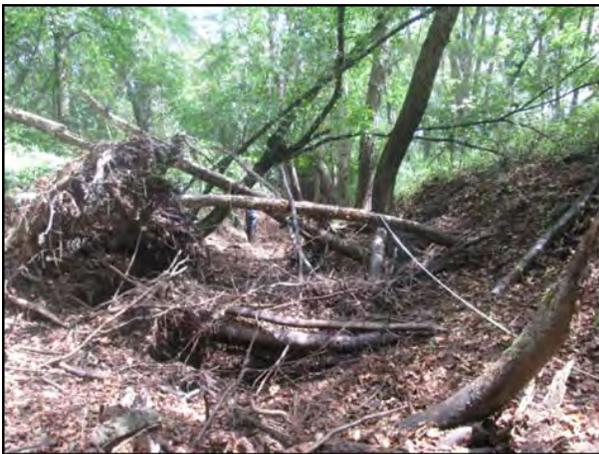
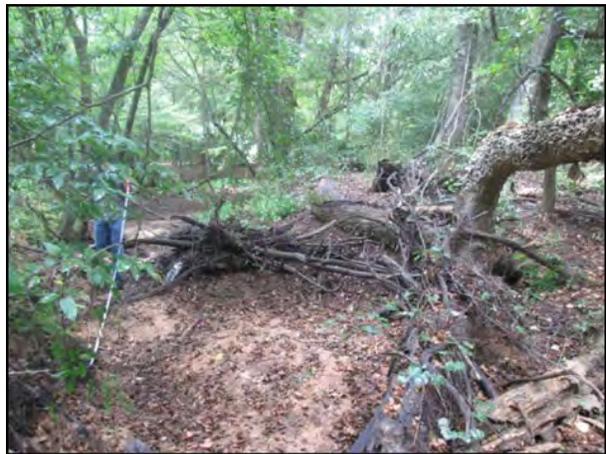
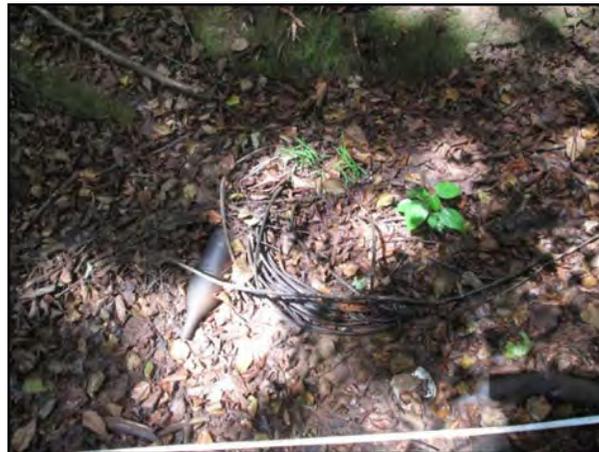
**Photogroup 4-36** Waffelow 2 depicting water surface characteristics. All individuals featured are SFASU and CES staff. Top left: 300-m transect, downstream, July 2012; Top right: Large woody debris along bank/within channel, July 2012; Middle left: 150-m transect, upstream, August 2012; Middle right: 30-m transect, upstream, August 2012; Bottom: Small channel litter (glass bottle and wire), August 2012.

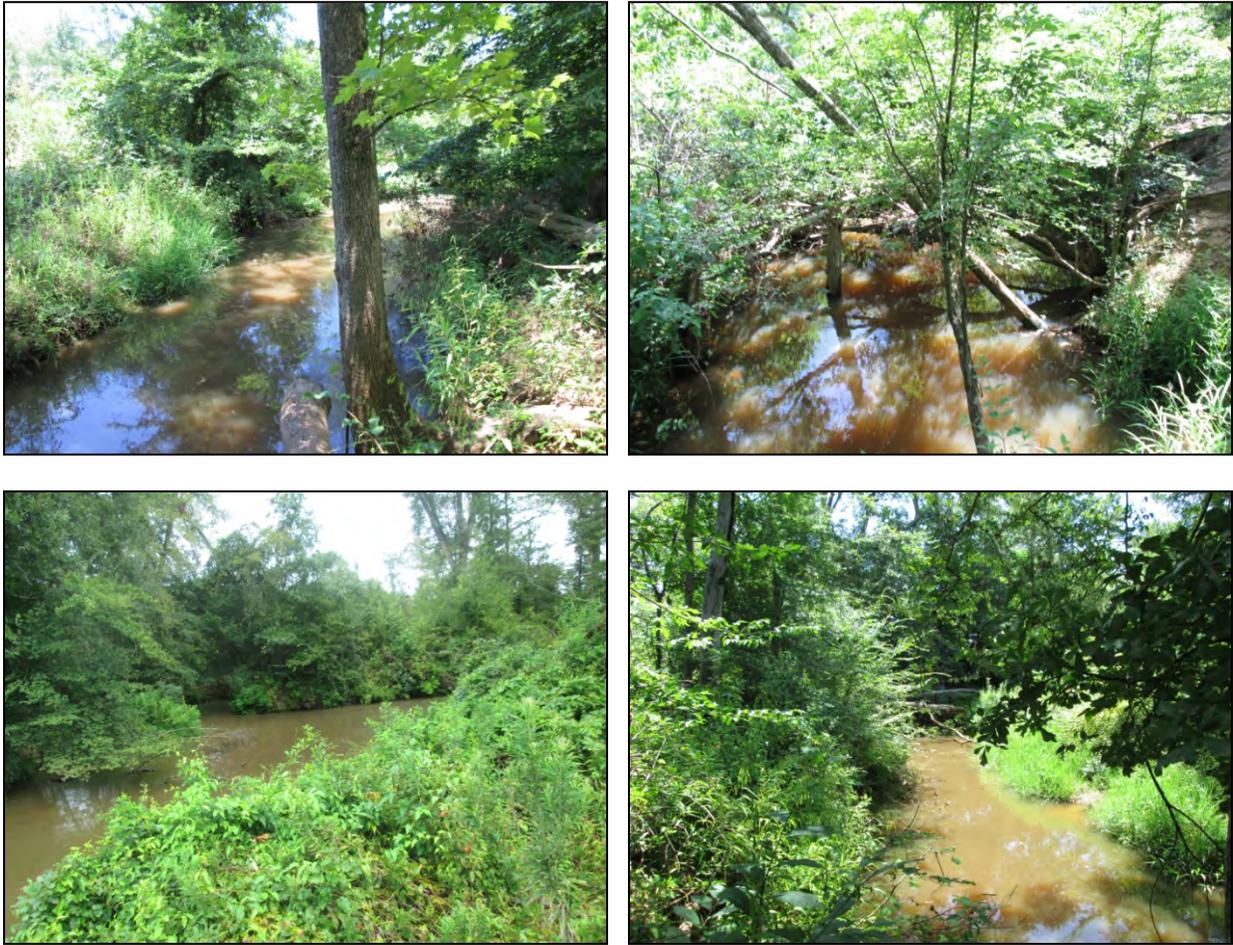
**Photogroup 4-37** Waffelow3 depicting general stream characteristics. Top left: 30-m transect, downstream, July 2012; Top right: 150-m transect, downstream, July 2012; Bottom left: 0-m transect, upstream, August 2012; Bottom right: 30-m transect, upstream, July 2012.

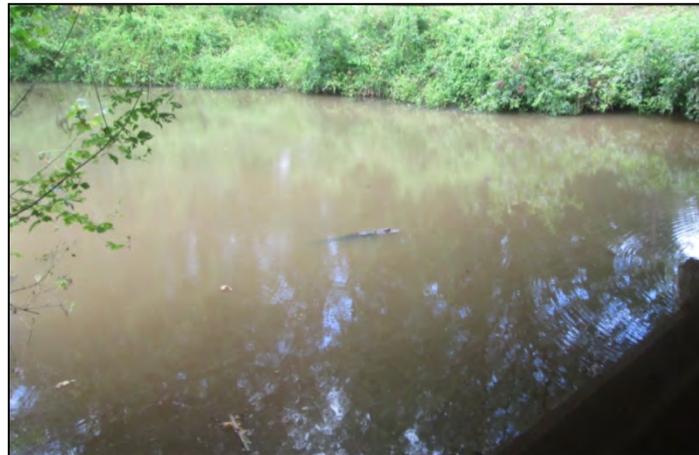
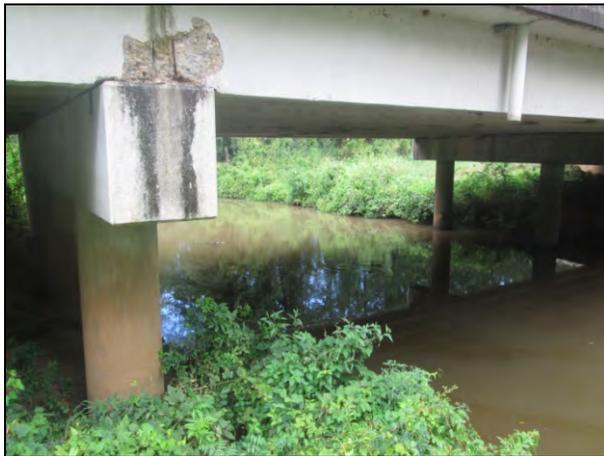
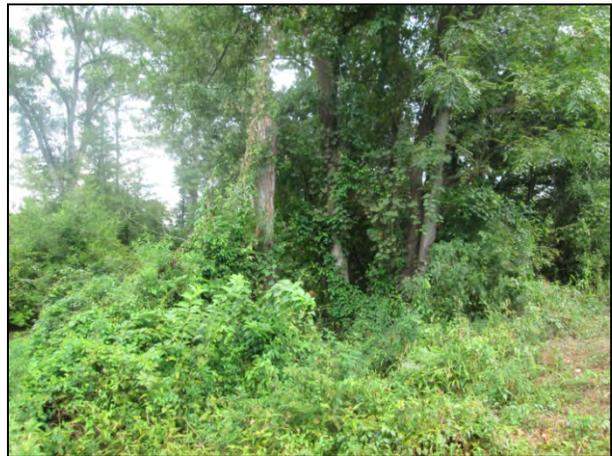
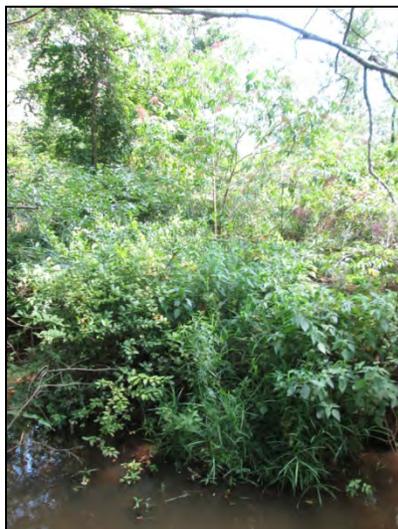
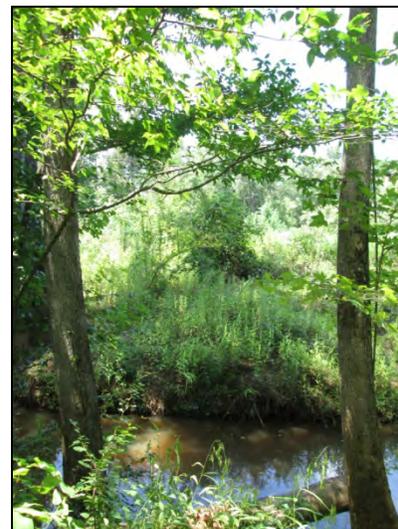
**Photogroup 4-37** Waffelow3 depicting general bank appearance. Top: 0-m transect, Juvenile alligator at FM 95 crossing access point, August 2012; Middle left: 0-m transect, FM 95 crossing, downstream, August 2012; Middle right: Dense bank vegetation; Bottom left: 150-m transect, right bank, July 2012; Bottom right: 30-m transect, left bank, July 2012.

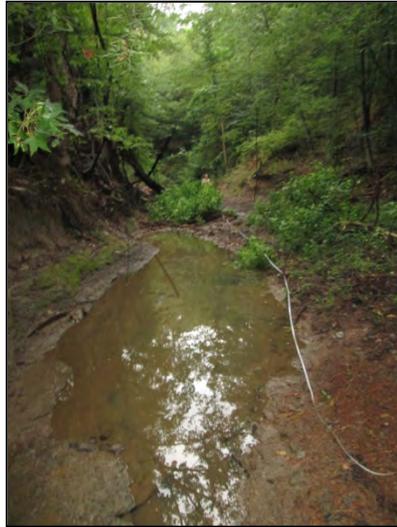
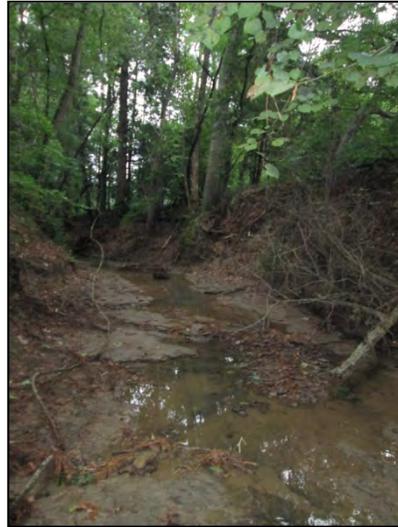
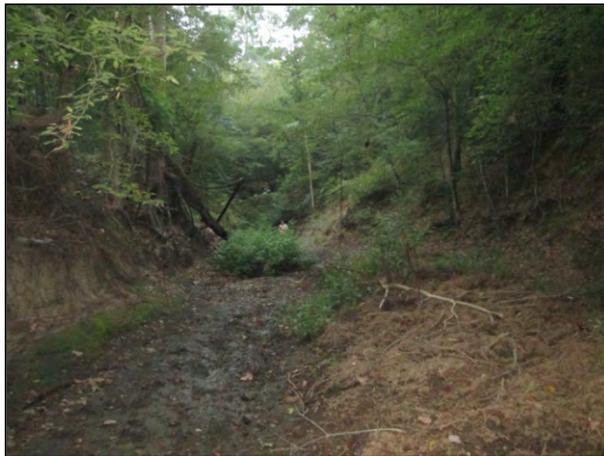
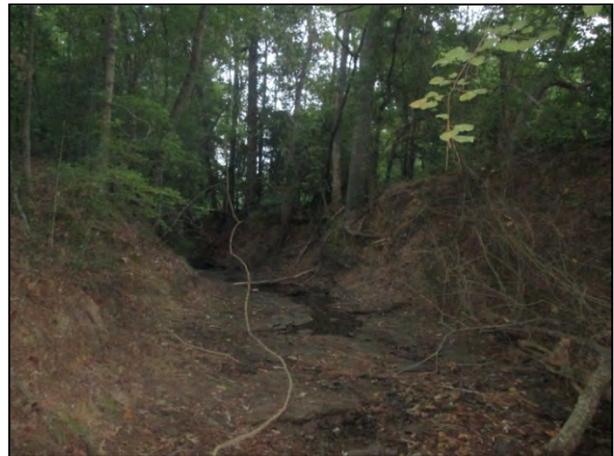
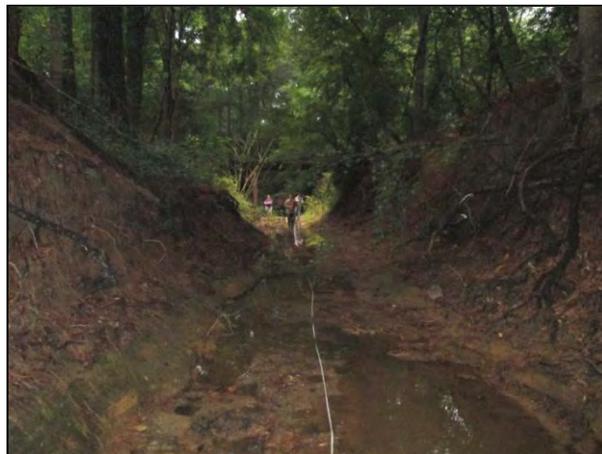
**Photogroup 4-38** West 1 depicting general stream characteristics. Top left: 300-m transect, downstream, July 2012; Top right: 300-m transect, upstream, July 2012; Middle left: 300-m transect, downstream, August 2012; Middle right: 300-m transect, upstream, August 2012; Bottom: 30-m transect, downstream, July 2012.

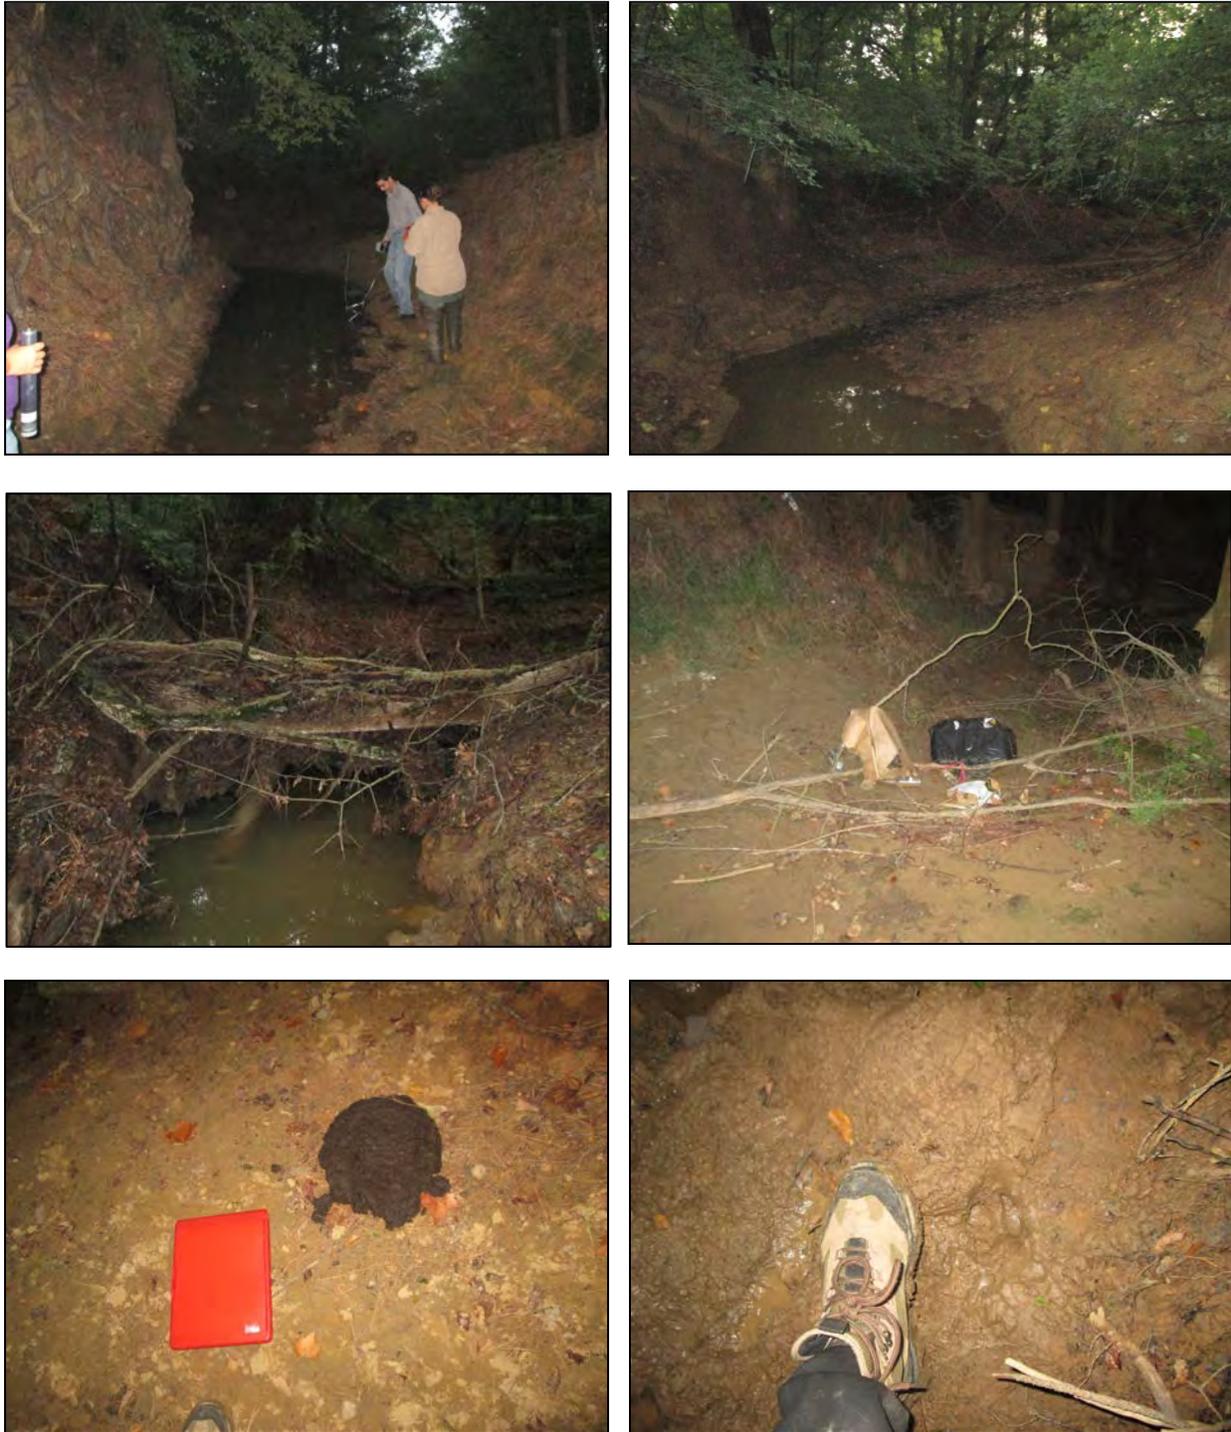
**Photogroup 4-38** West 1 depicting bank appearance, water surface characteristics and potential sources of contamination. All individuals featured are SFASU and CES staff. Top left: 30-m transect, upstream, August 2012; Top right: 30-m transect, upstream, July 2012; Middle left: Logjam, July 2012; Middle right: Channel litter (household garbage), August 2012; Bottom left: Livestock fecal, August 2012; Bottom right: Dog track or coyote track, August 2012.
