# Attoyac Bayou Recreational Use Attainability Analysis

**Attoyac Bayou  
Recreational Use Attainability Analysis**

**Texas State Soil and Water Conservation Board  
Project # 09-10**

**October 2012**

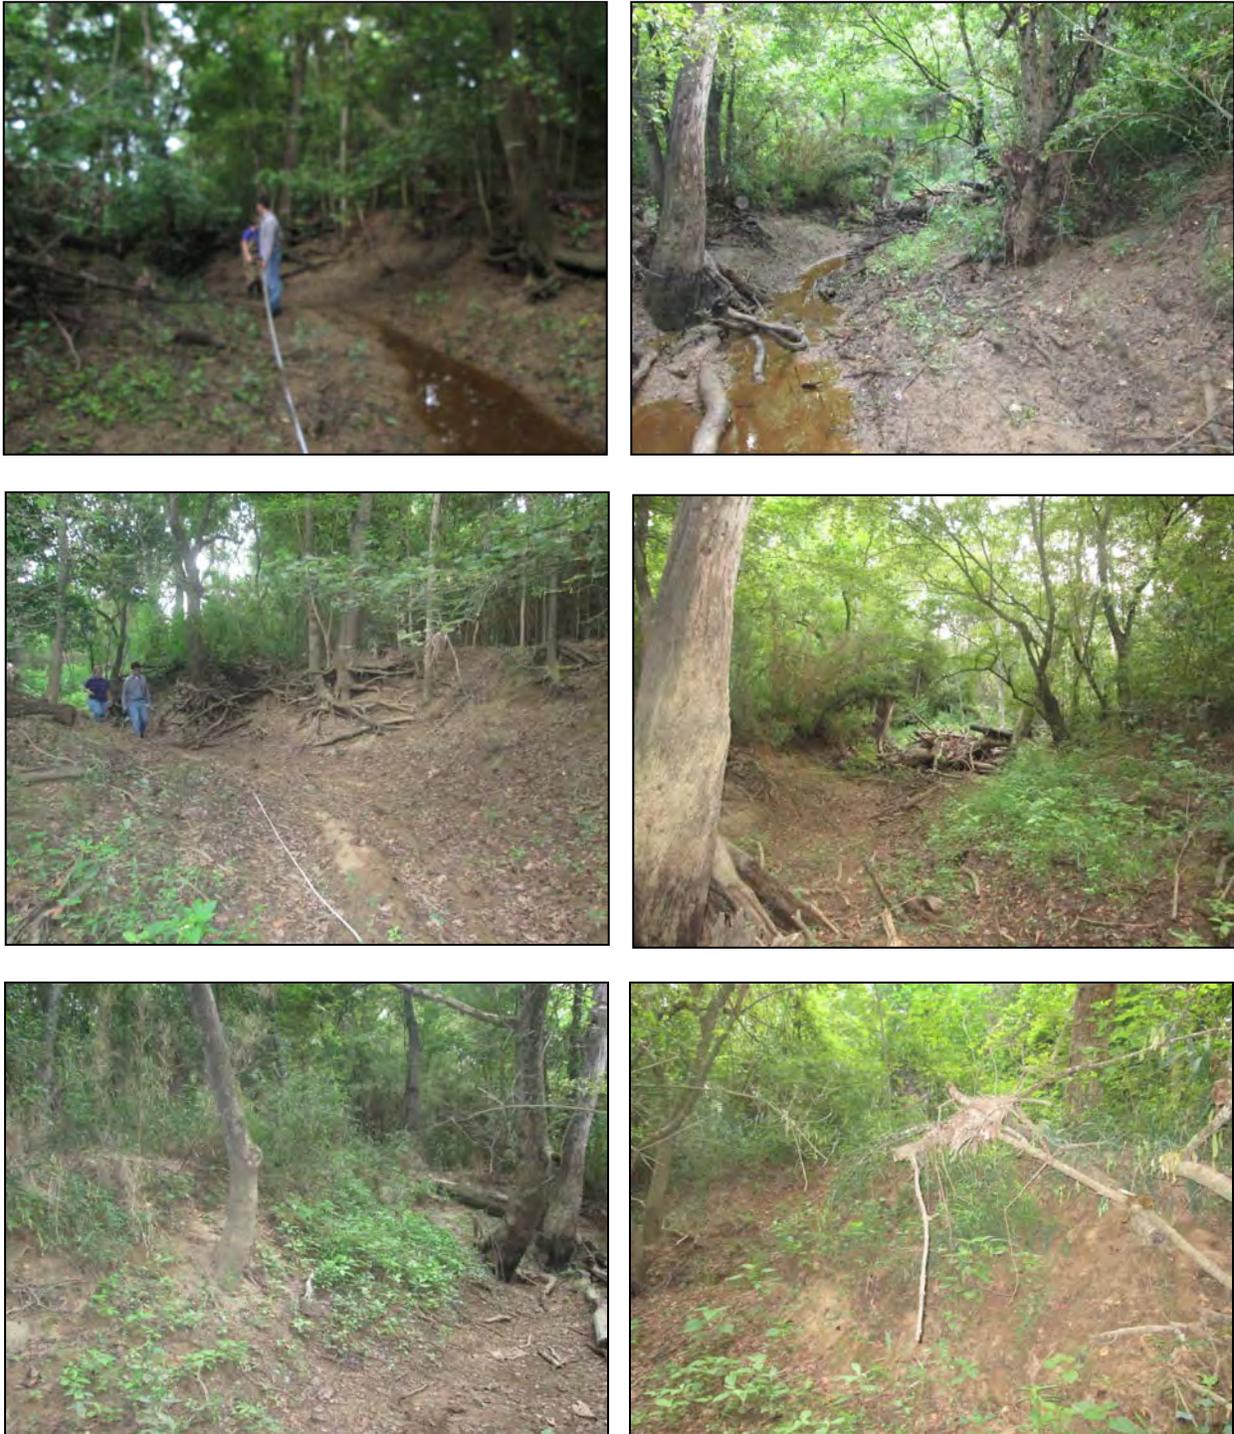
**Photogroup 4-39** West 2 depicting general stream characteristics and bank appearance. All individuals featured are SFASU and CES staff. Top left: 30-m transect, downstream, July 2012; Top right: 30-m transect, upstream, July 2012; Middle left: 30-m transect, downstream, August 2012; Middle right: 30-m transect, upstream, August 2012; Bottom left: 30-m transect, left bank, August 2012; Bottom right: 30-m transect, right bank, August 2012.

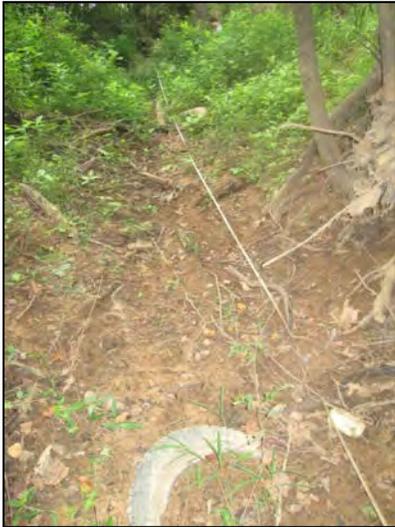
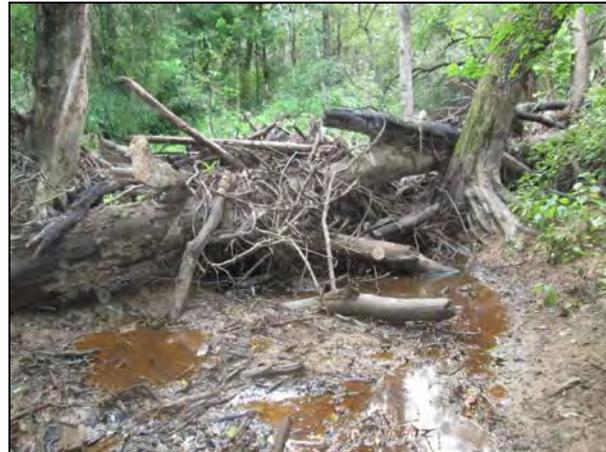
**Photogroup 4-39** West 2 depicting water surface characteristics. Top left: Channel litter (tire), August 2012; Top right: Logjam, July 2012.

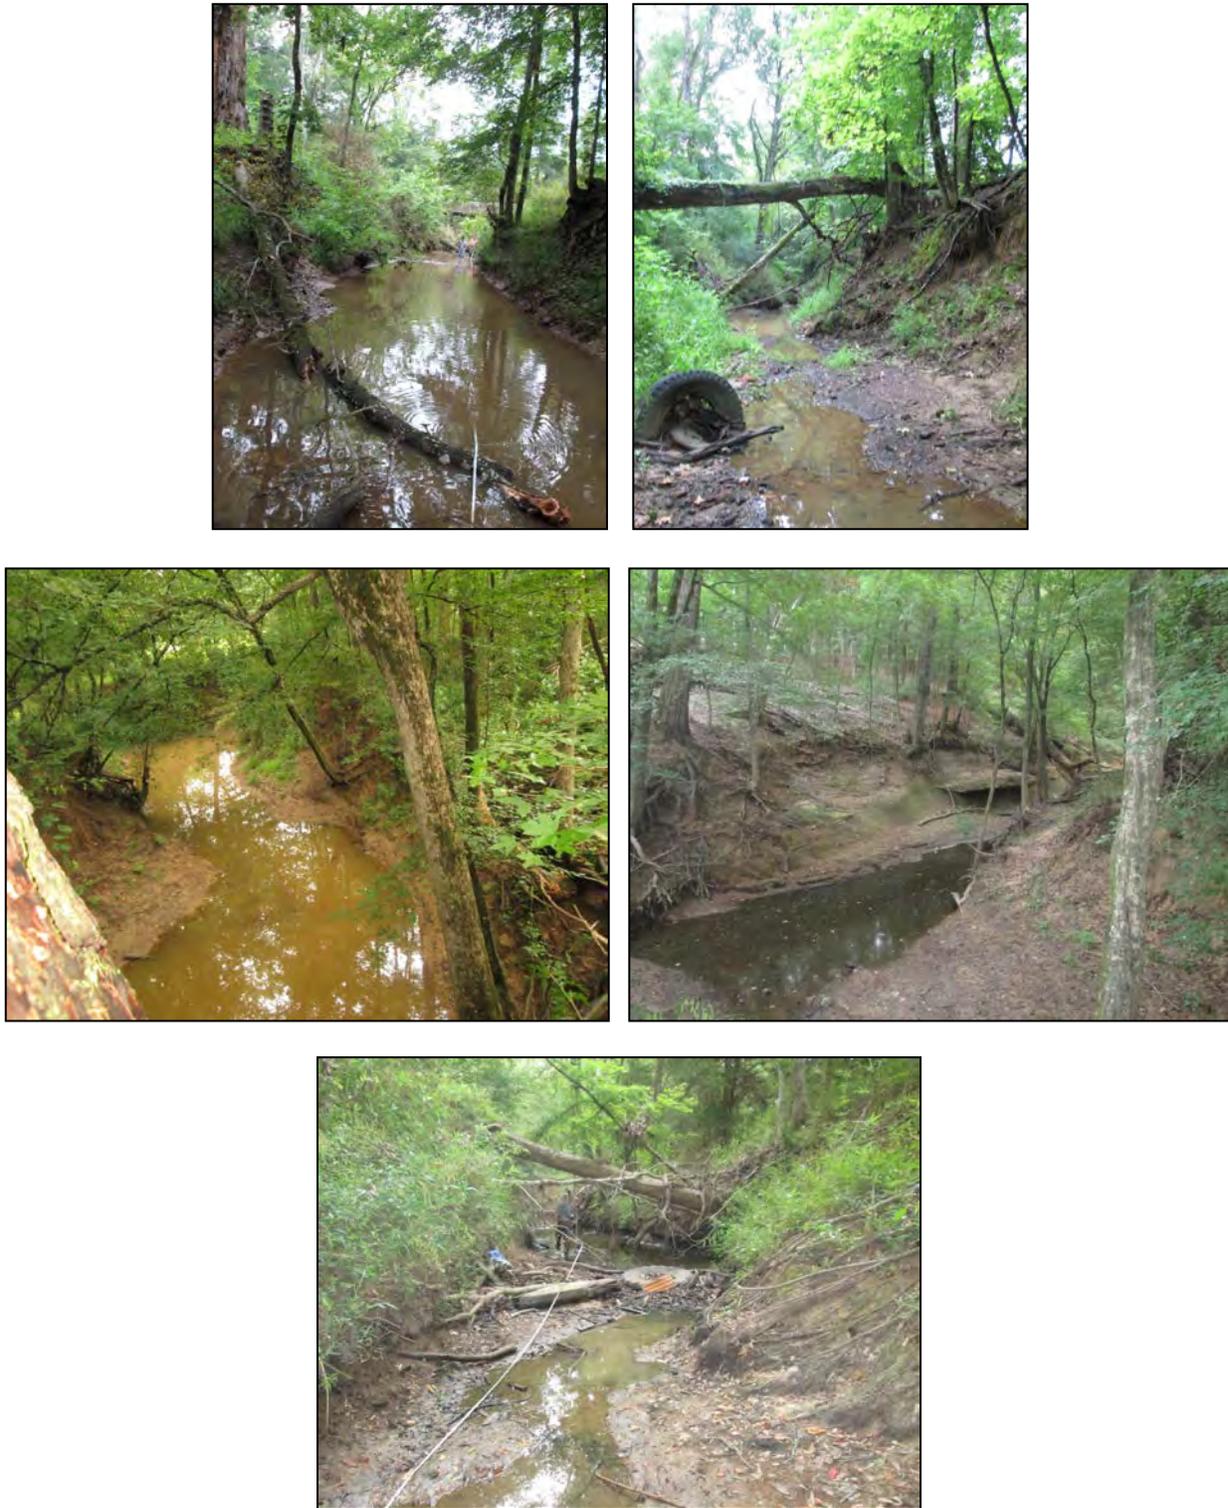
**Photogroup 4-40** West 3 depicting general stream characteristics. Top left: 30-m transect, downstream, July 2012; Top right: 30-m transect, upstream, July 2012; Middle left: 150-m transect, upstream, July 2012; Middle right: 150-m transect, upstream, August 2012; Bottom: Large channel litter (Tire), August 2012.

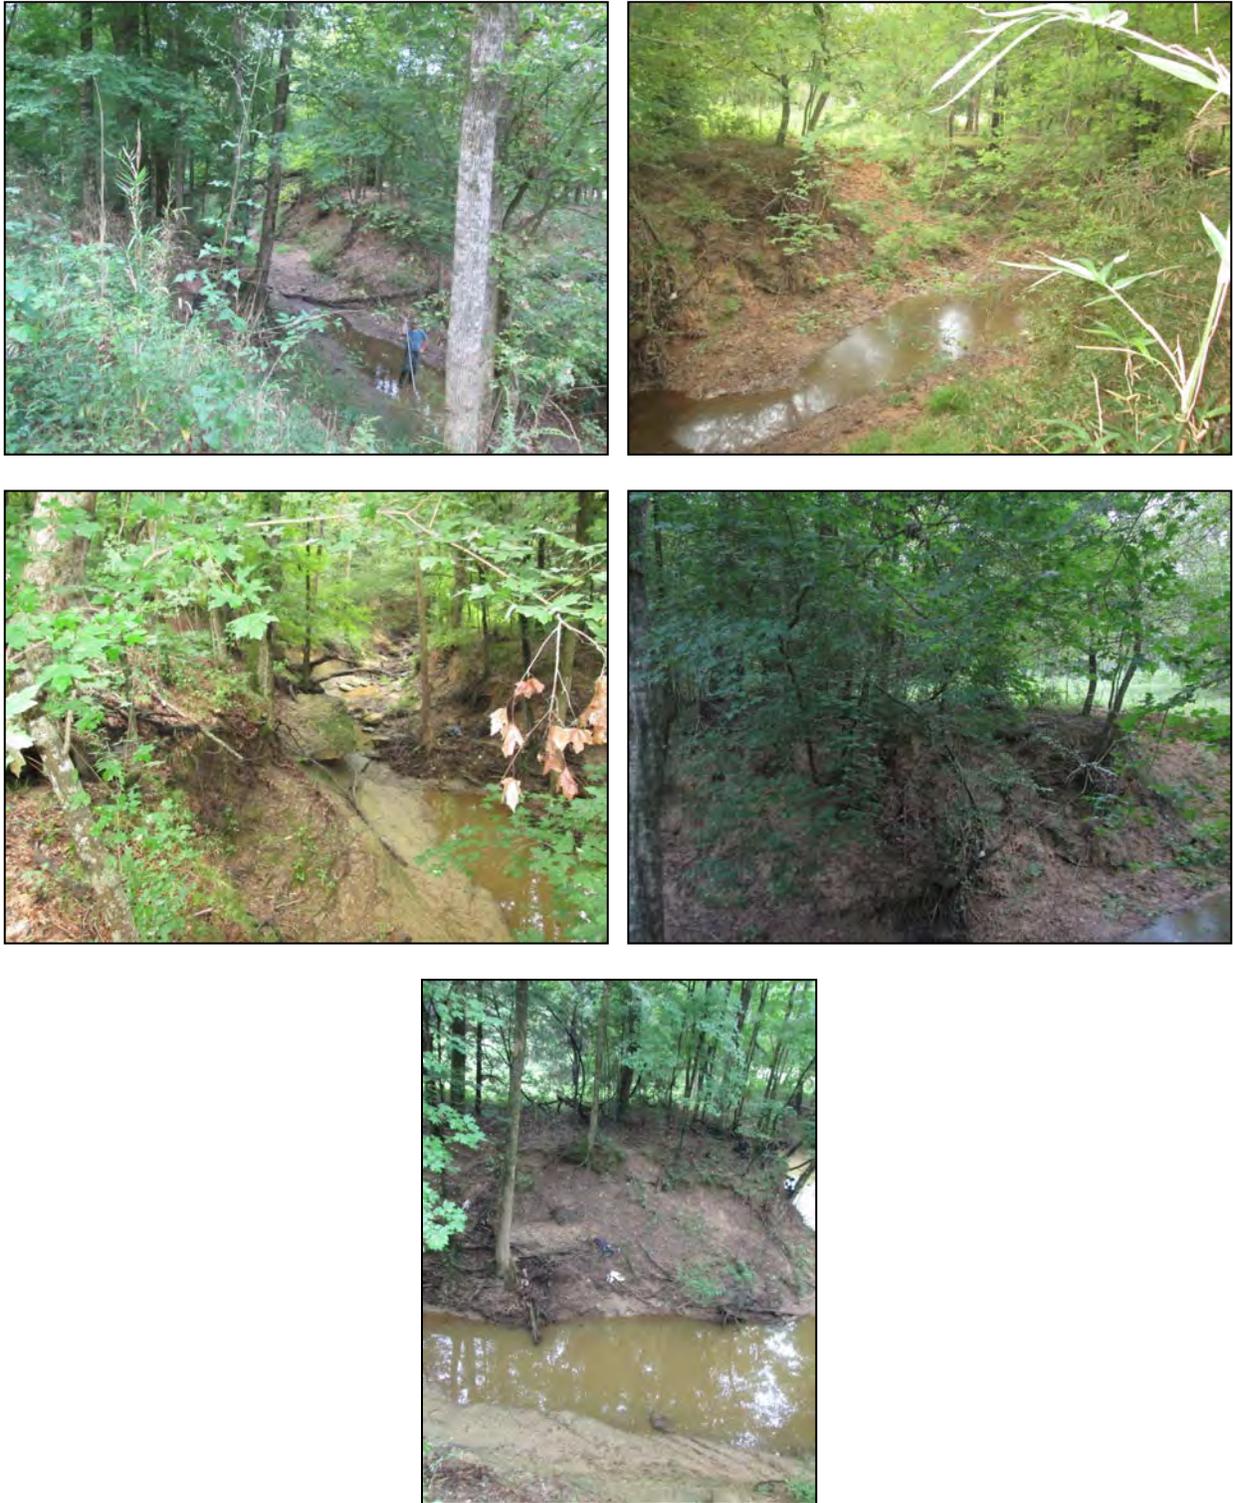
**Photogroup 4-40** West 3 depicting general bank appearance. Top left: 30-m transect, upstream, August 2012; Top right: 150-m transect, downstream, August 2012; Middle left: 150-m transect, downstream, July 2012; Middle right: 150-m transect, right bank, August 2012; Bottom: 300-m transect, left bank, July 2012.

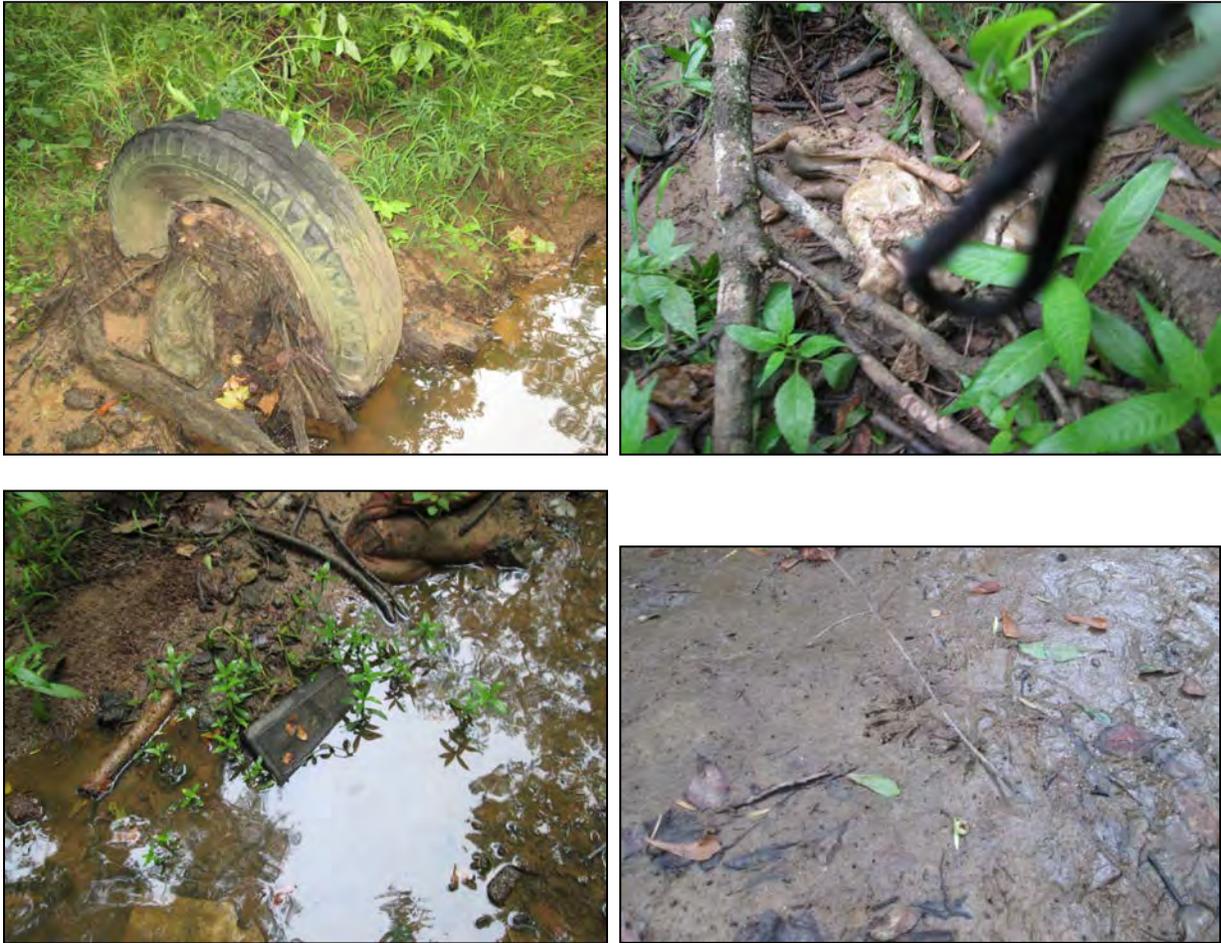
**Photogroup 4-40** West 3 depicting water surface characteristics. Top left: Large channel litter (tire), July 2012; Top right: Animal carcass within stream channel (photo strap also appears in photo), July 2012; Bottom left: Small channel litter (unidentified object), July 2012; Bottom right: Raccoon prints in channel, August 2012.

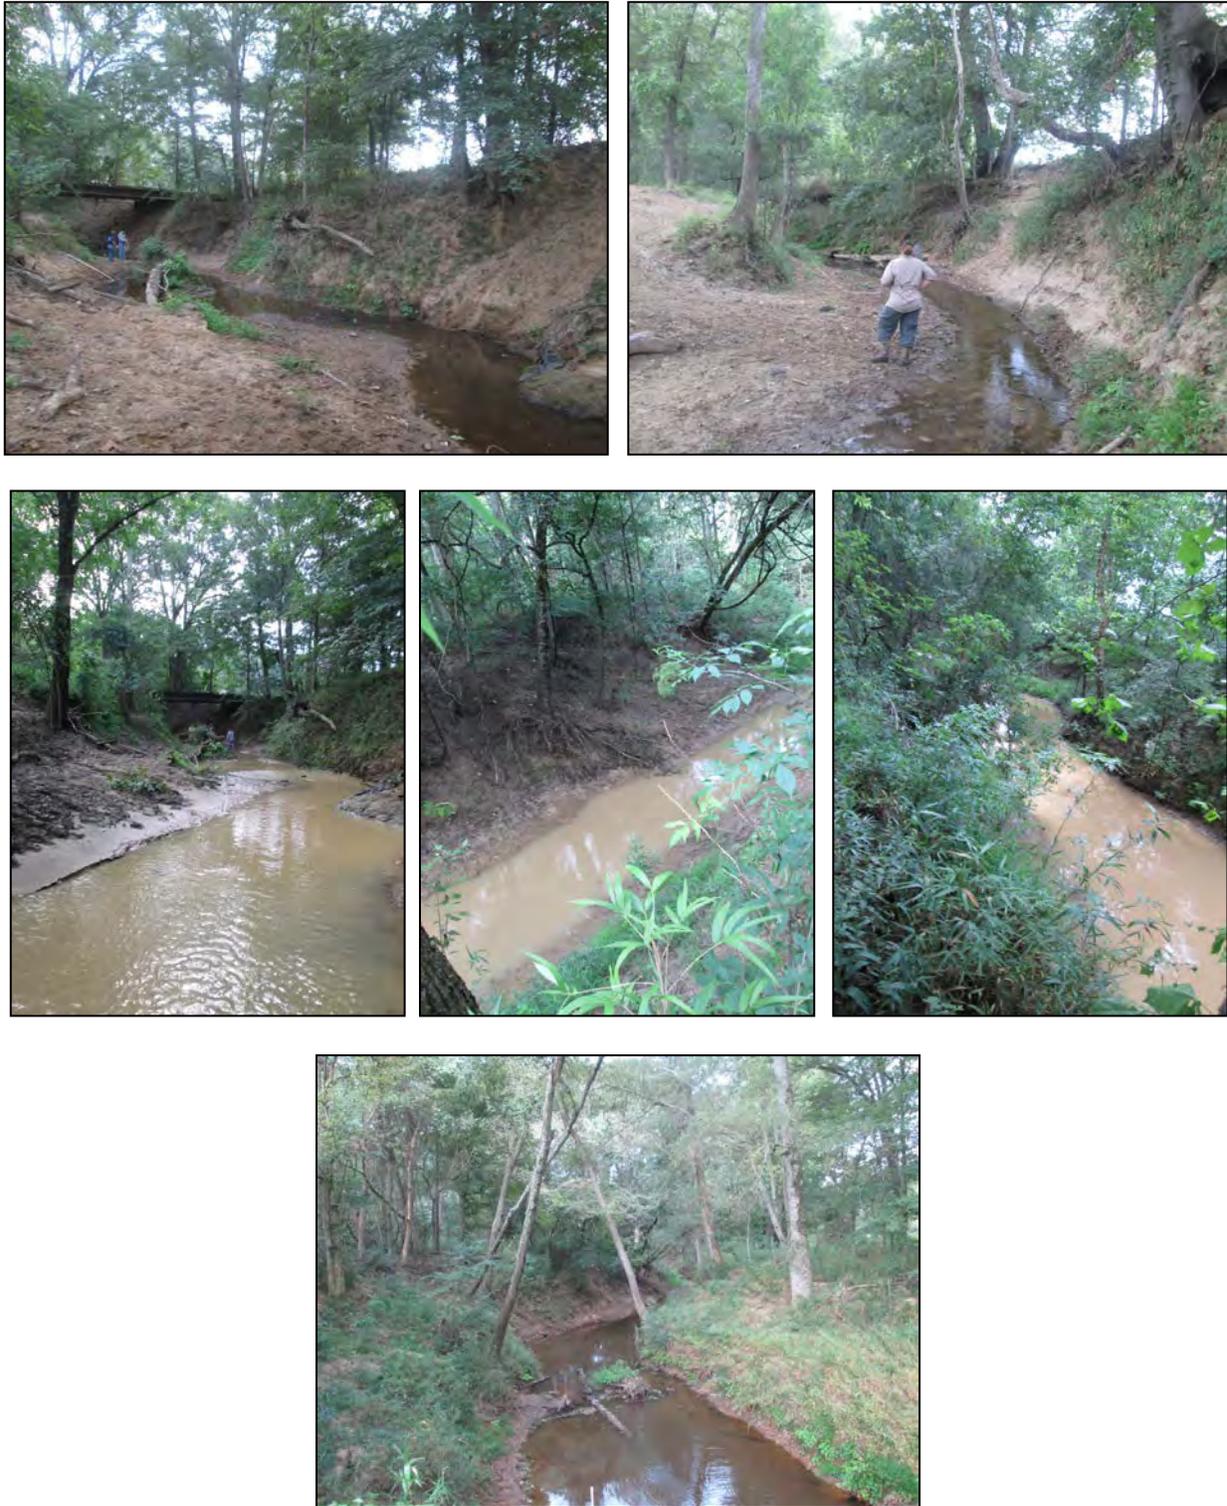
**Photogroup 4-41** West 4 depicting general stream characteristics and water surface appearance. All individuals featured are SFASU and CES staff. Top left: 30-m transect, upstream, August 2012; Top right: 30-m transect, downstream, August 2012; Middle left: 30-m transect, upstream, July 2012; Middle center: 150-m transect, downstream, July 2012; Middle right: 300-m transect, upstream, July 2012; Bottom: 150-m transect, downstream, August 2012.

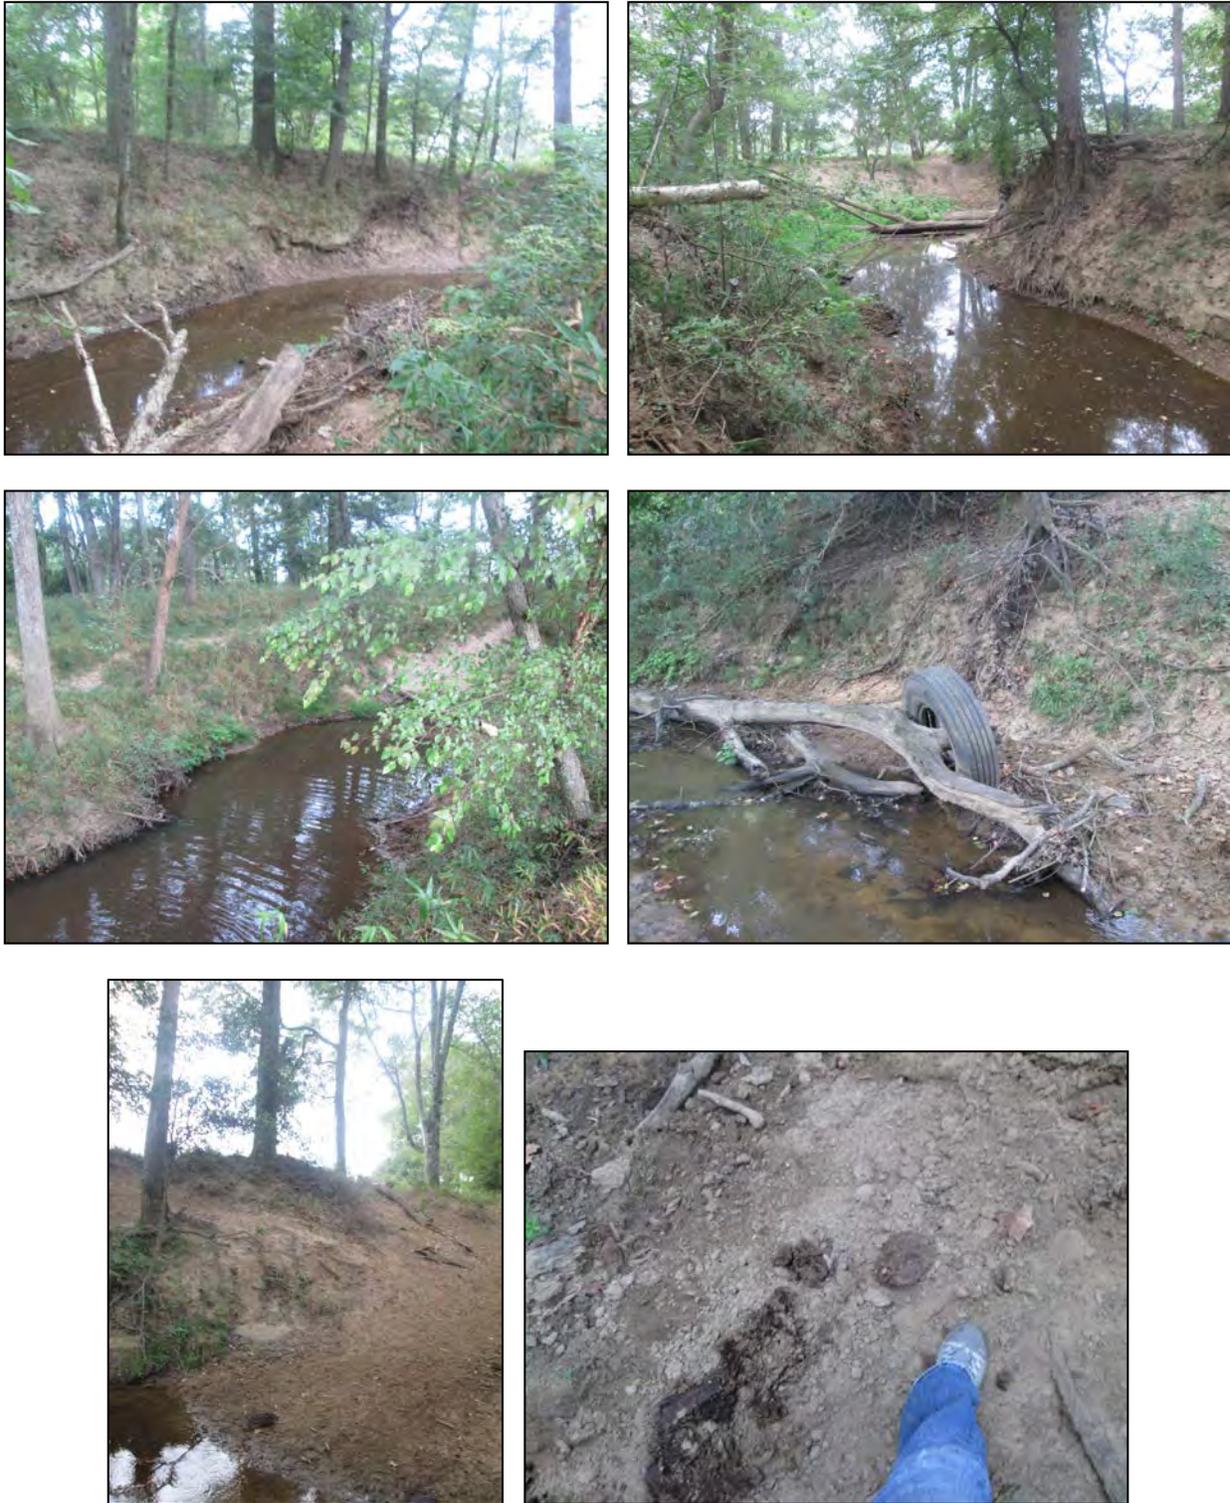
**Photogroup 4-41** West 4 depicting general bank appearance and potential sources of contamination. Top left: 300-m transect, upstream, August 2012; Top right: 300-m transect, downstream, August 2012; Middle left: 150-m transect, upstream, August 2012; Middle right: Large channel litter (tire), August 2012; Bottom left: 30-m transect, right bank, Cattle access point, August 2012; Bottom right: Livestock fecal, August 2012.

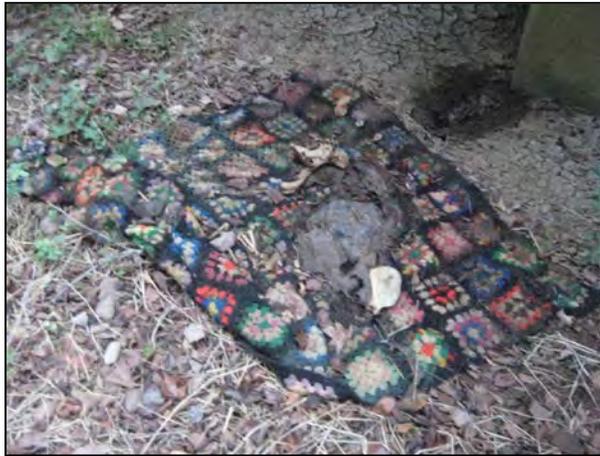
Evidence of intentional dumping was observed at site Attoyac 4 during Survey 2. A crocheted blanket which was not present during Survey 1 was spread out on the stream bank next to the County Road (CR) 1971 bridge crossing with an animal carcass lying on top of it during Survey 2 in August 2012. Photogroup 5-1 documents these indications of possible recreational activity.

**Photogroup 5-1** Attoyac 4 depicting crocheted afghan with unidentified animal carcass lying along the stream bank next to FM 1971 bridge crossing.

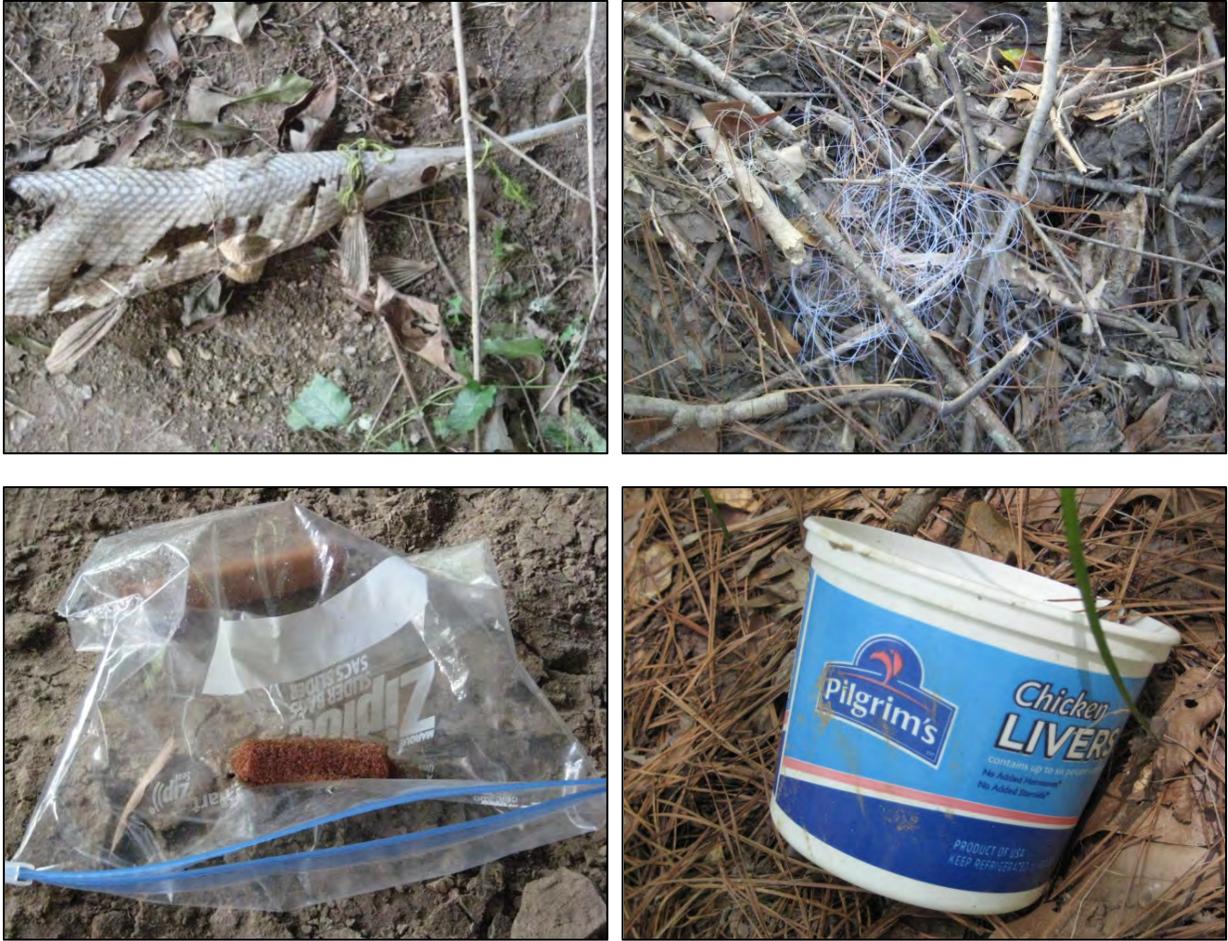
Evidence of fishing as well as general loitering was observed at site Attoyac 7 during both June and August 2012 surveys in the form of bait containers, discarded fishing line, beer bottles/cans, soda cans, and plastic bags full of refuse. Also observed on the bank during Survey 2 was the carcass of an alligator gar on a fish stringer as well as hot dog wieners in a zip-lock bag. Hot dog wieners are commonly used as fishing bait. Photogroup 5-2 documents these indications of recreational activity.

**Photogroup 5-2** Attoyac 7 depicting signs of recreational use along stream bank.

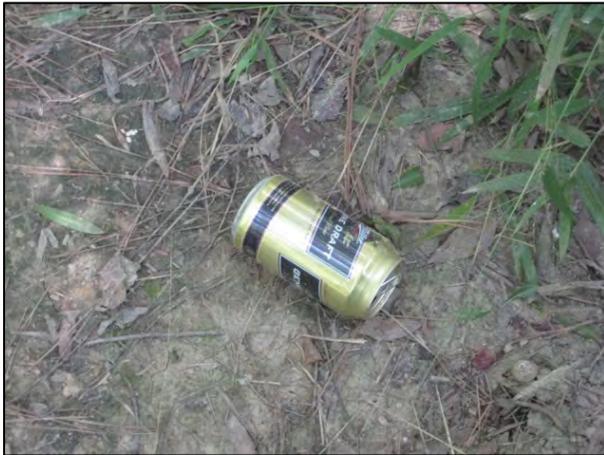
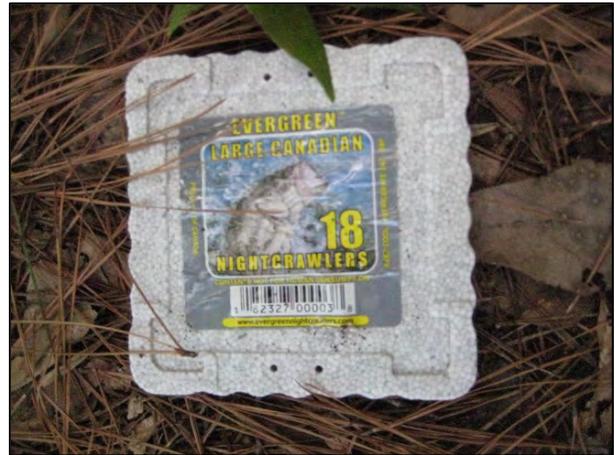
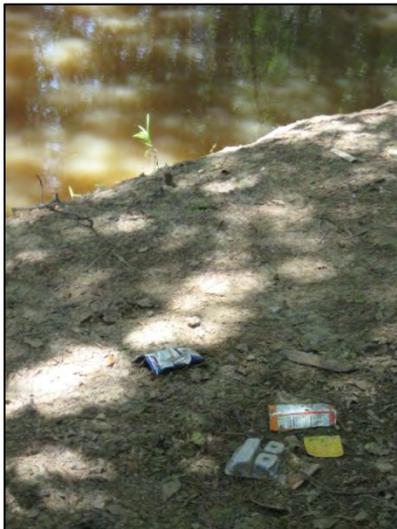
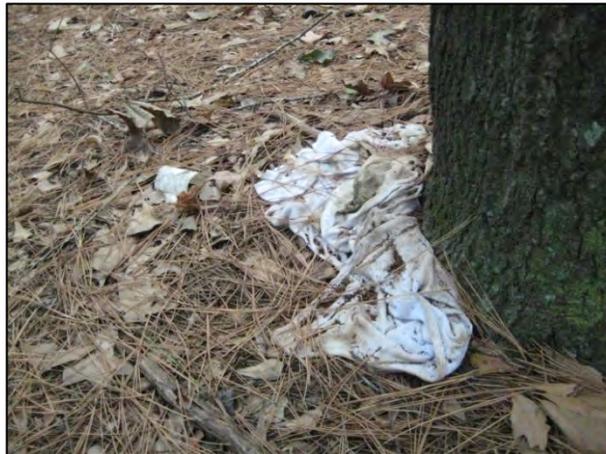
**Photogroup 5-2 cont.** Attoyac 7 depicting signs of recreational use along stream bank.

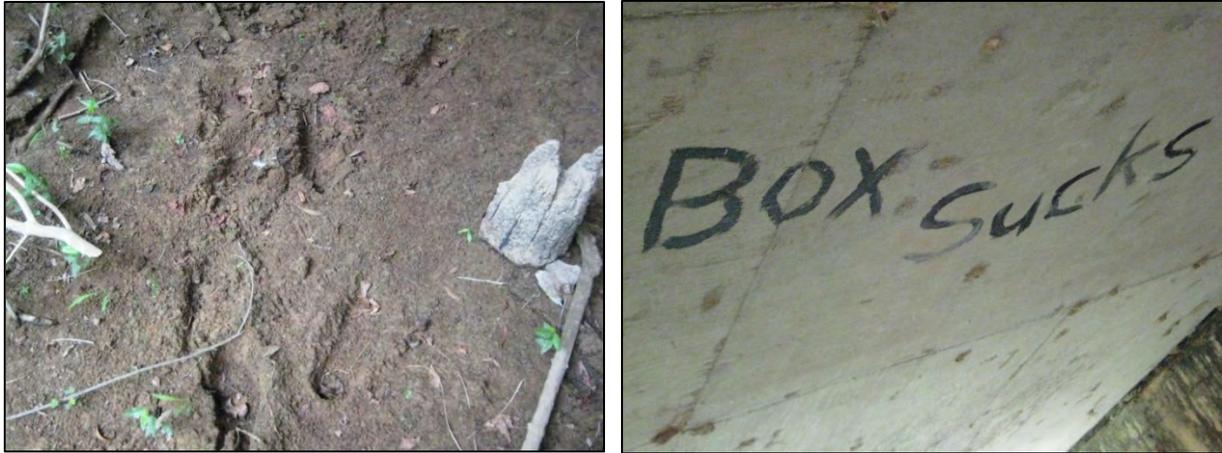
Evidence of possible recreation was observed at site Attoyac 12 during Survey 2. Human foot prints were observed along the stream bank underneath the highway bridge crossing. Also present under the highway bridge crossing was graffiti. Photogroup 5-3 documents these indications of recreational activity.

**Photogroup 5-3** Attoyac 12 depicting footprints along the stream bank as well as graffiti under the FM 138 bridge crossing.

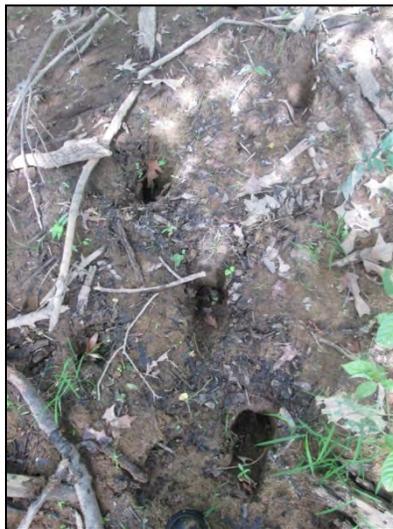
Evidence of possible recreation was observed at site Attoyac 15 during Survey 2. Human foot prints were observed along the bank underneath the highway bridge crossing. Photogroup 5-4 documents these indications of possible recreational activity.

**Photogroup 5-4** Attoyac 15 depicting footprints along the stream bank near the Hwy 7 bridge crossing.

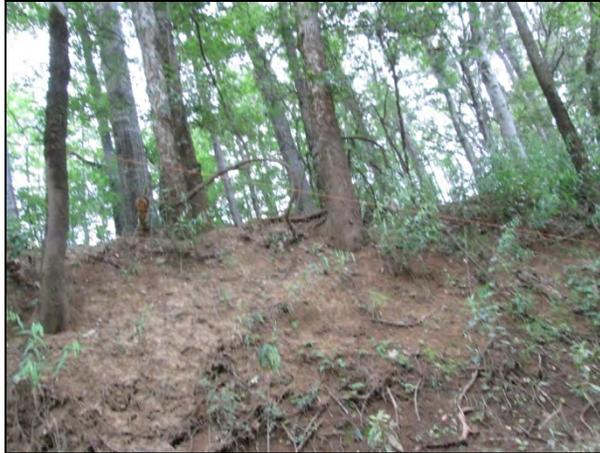
Evidence of possible recreation was observed at site Attoyac 17 during Survey 1. A trot line attached to a tree and stretched across the stream channel was present. Photogroup 5-5 documents these indications of recreational activity.

**Photogroup 5-5** Attoyac 17 depicting secondary contact recreation in the form of a trot line attached to a bank-side tree.

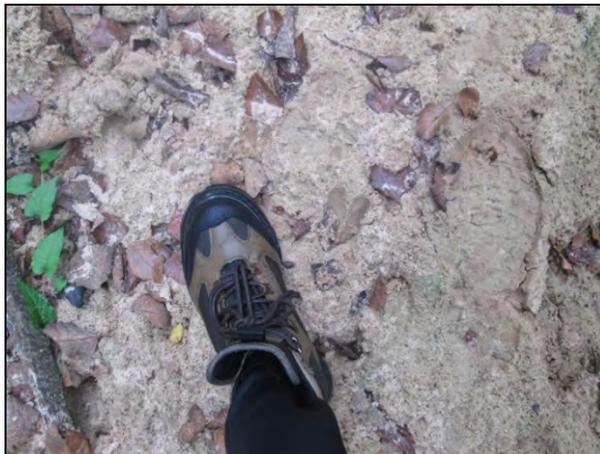
Evidence of possible recreation was observed at site Big Iron Ore 3 during Survey 2. Boot prints were observed along the stream bank. Photogroup 5-6 documents these indications of recreational activity.

**Photogroup 5-6** Big Iron Ore 3 depicting potential recreation with a boot print located along the stream bank. Print is located on the right side of photo; corresponding foot is used to establish scale.

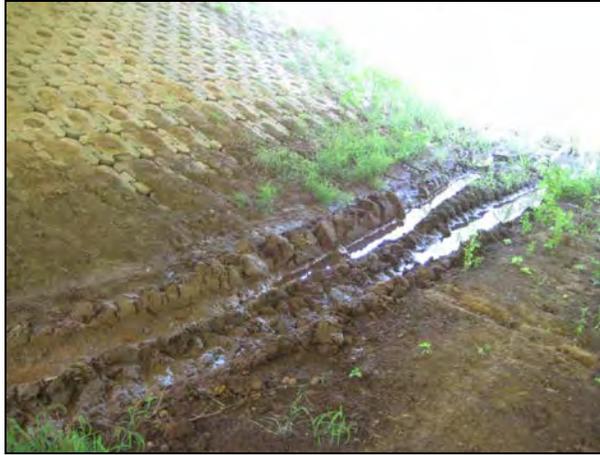
Evidence of recreation was observed at site Naconiche 6 during Survey 1 and 2. ATV tracks were present during both surveys underneath Farm to Market (FM) 2435 road crossing. Photogroup 5-7 documents these indications of recreational activity.

**Photogroup 5-7** Naconiche 6 depicting ATV use along stream bank.

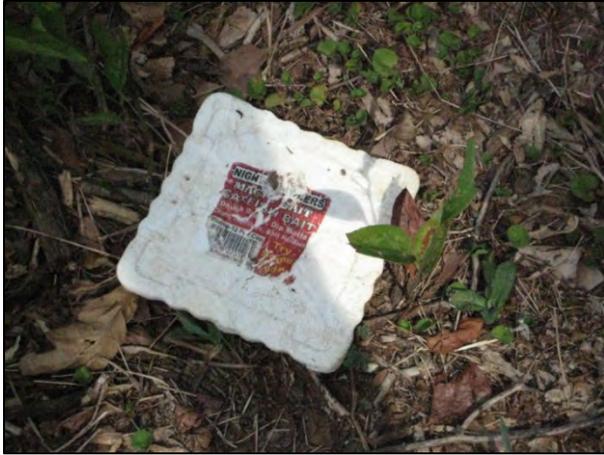
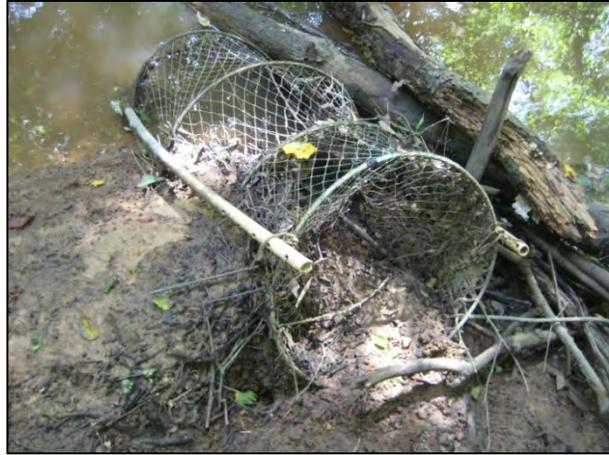
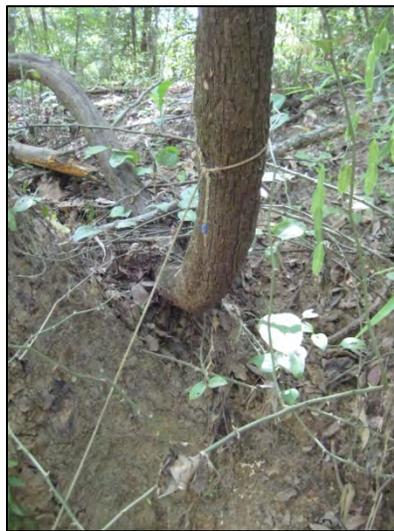
Evidence of possible recreation was observed at site Naconiche 8 during Survey 1 and Survey 2. During Survey 1, a bait net was present in the stream channel, and further downstream a defunct trotline/set hook was attached to a tree and hanging in the stream. A live bait container was present on the bank next to the public Cedar Bluff Road bridge crossing during Survey 2 in August. Photogroup 5-8 documents these indications of recreational activity.

**Photogroup 5-8** Naconiche 8 depicting the lid of a live bait container on the bank near stream access point, a fish trap located within the stream, and a set hook that is no longer used attached to a limb that overhangs the stream channel.

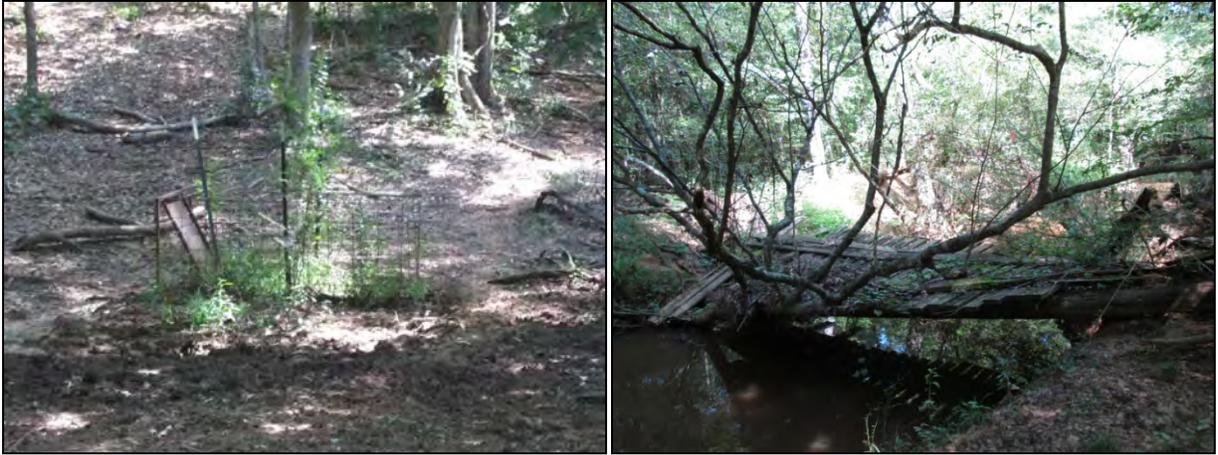
Evidence of possible recreation was observed at site Terrapin 3 during Survey 1. An animal trap was present on the left bank, and further downstream a defunct wooden bridge was found across the stream. Photogroup 5-9 documents these indications of recreational activity.

**Photogroup 5-9** Terrapin 3 depicting an animal trap located along the stream bank and a defunct bridge across the stream channel.

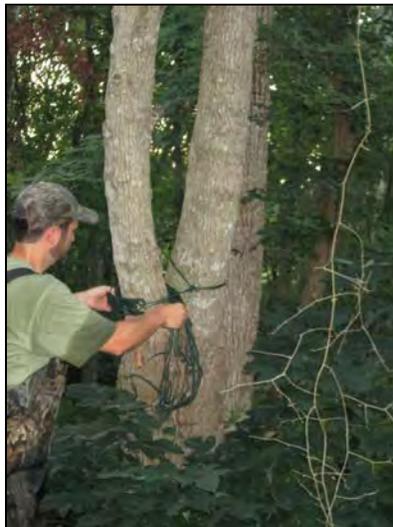
Evidence of recreation was observed at site West 6 during Survey 1 in July. A hammock was observed attached to a tree located along the stream bank. Photogroup 5-11 documents these indications of recreational activity.

**Photogroup 5-10** West 6 depicting a hammock attached to a stream-side tree.

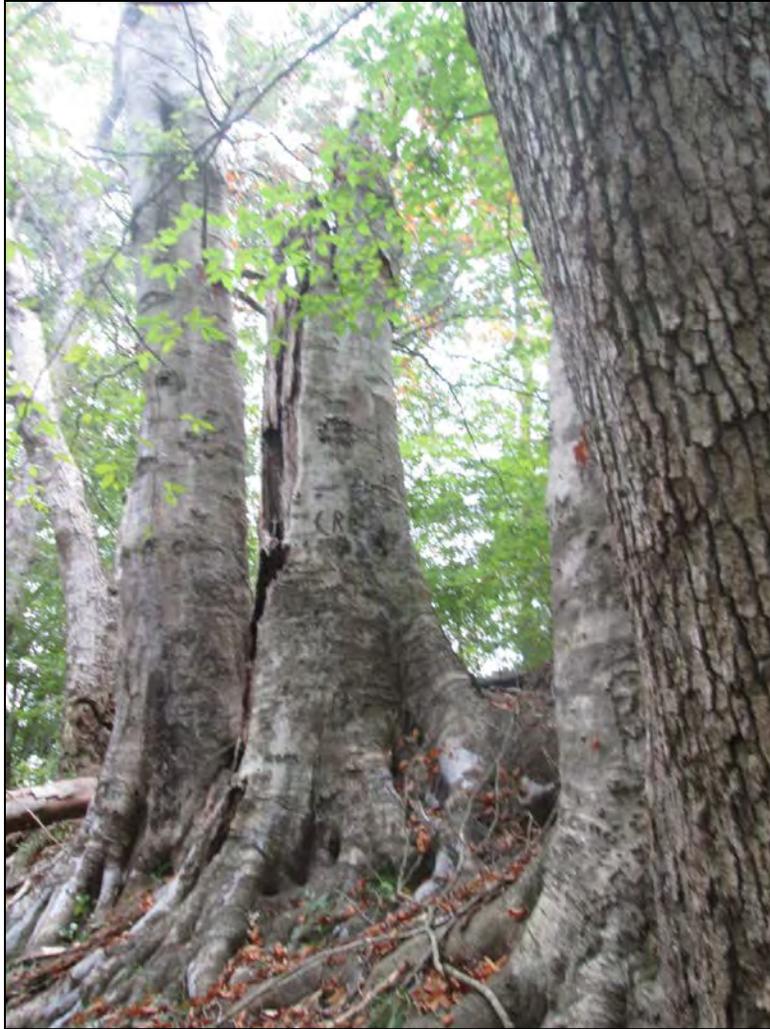
Evidence of possible recreation was observed at site Terrapin 4 during Survey 2. Along the right stream bank, approximately 5m downstream, field staff observed a beech tree in which initials had been carved into the bark. Photogroup 5-10 documents these indications of bank-side recreational activity.

**Photogroup 5-11** Terrapin 4 depicting initials appearing to read “CR” carved into a beech tree located along stream bank. Photo enlarged to show detail.
