Recreational Use Attainability Analysis for Buffalo Creek (0214B), Paradise Creek (0230A), and Sweetwater Creek (0299A) in the Red River Basin

Prepared for:
Texas State Soil and Water Conservation Board
Project 12-52

Texas Institute for Applied Environmental Research
Tarleton State University
Stephenville, Texas

TR 1308

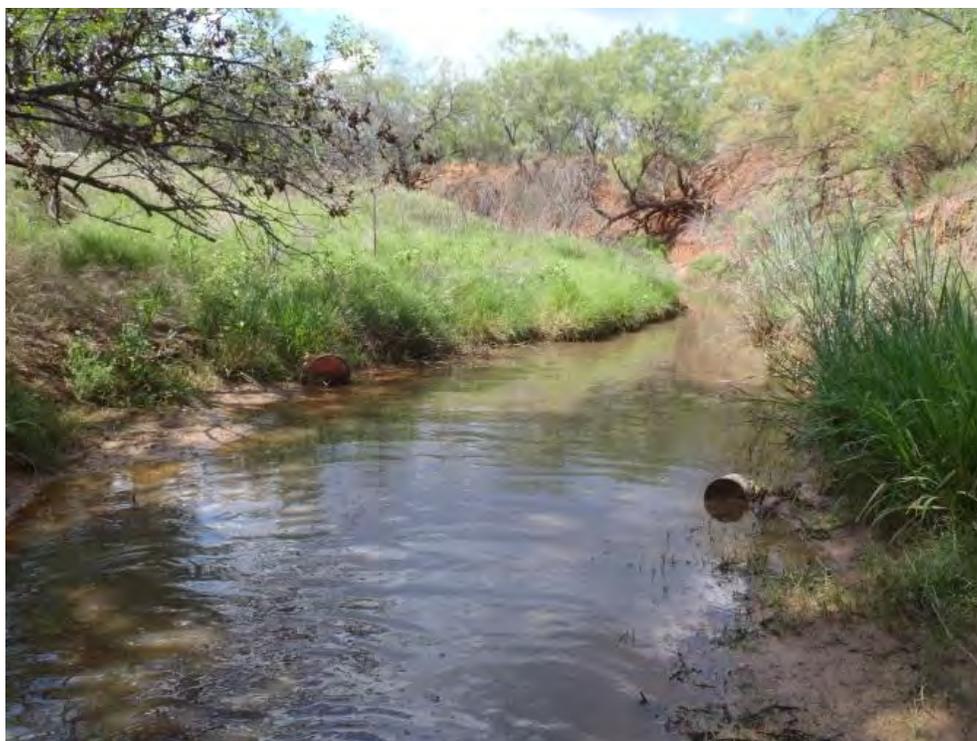
Figure 3.3 Photograph of Buffalo Creek at Site BF001. Downstream view of the 150-m transect on July 7, 2013.

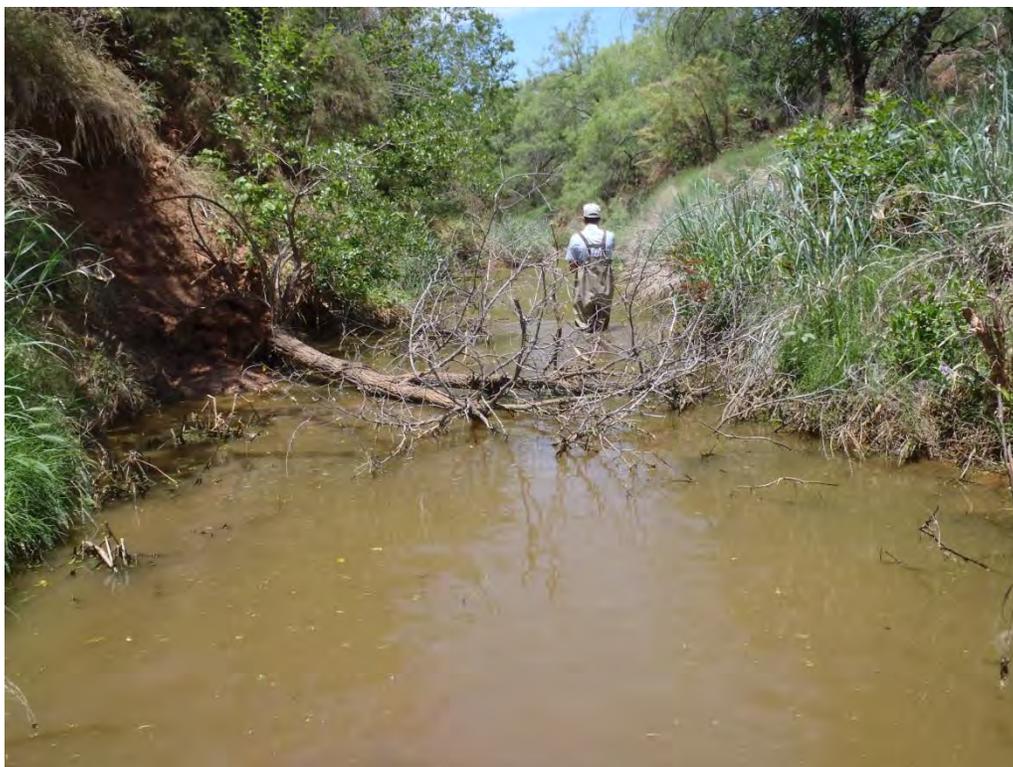
Figure 3.4 Photograph of Buffalo Creek at Site BF001 taken June 8, 2013, downstream view at 40-m. Note log obstruction, dense vegetation and steep banks. TIAER personnel in photograph.

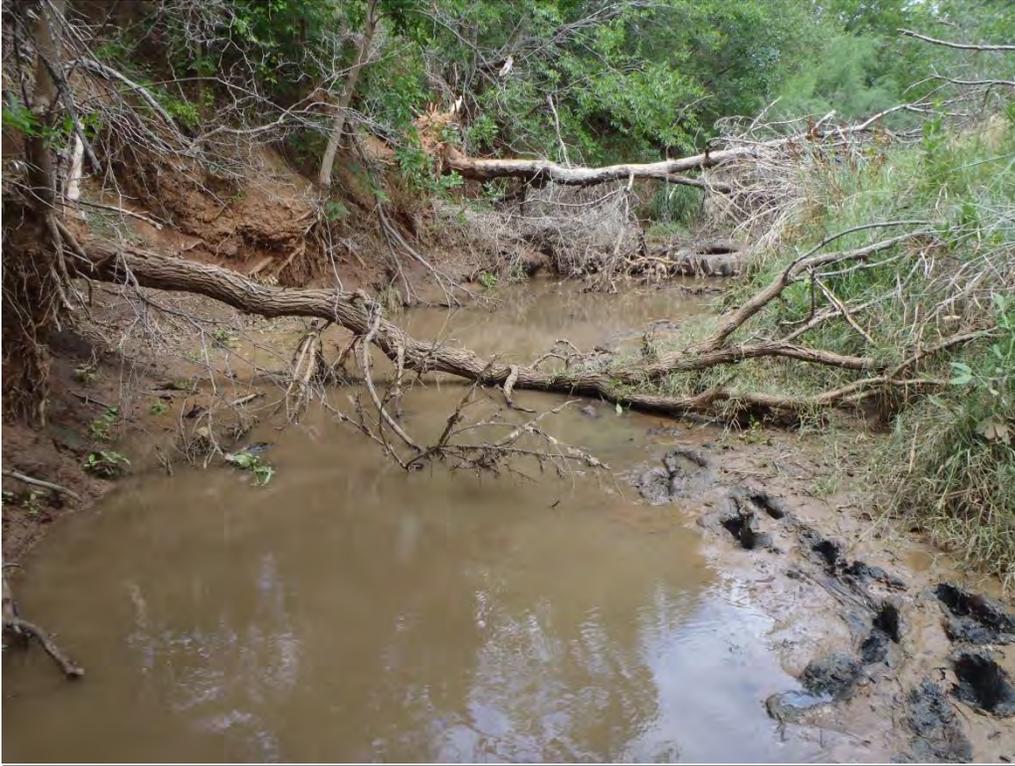
Figure 3.5 Photograph of Site BF002 taken on June 8, 2013, upstream view at 30-m transect.

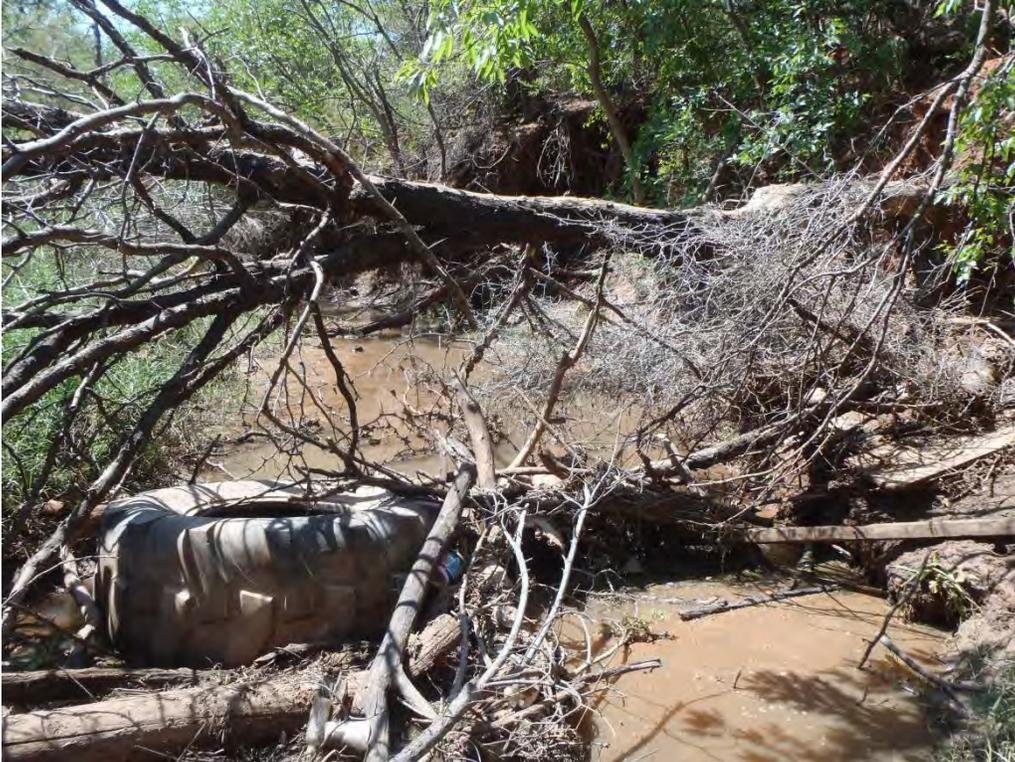
Figure 3.6 Photograph of site BF002 taken July 20, 2013. Downstream view at 30-m transect. Note log and large garbage obstructions.

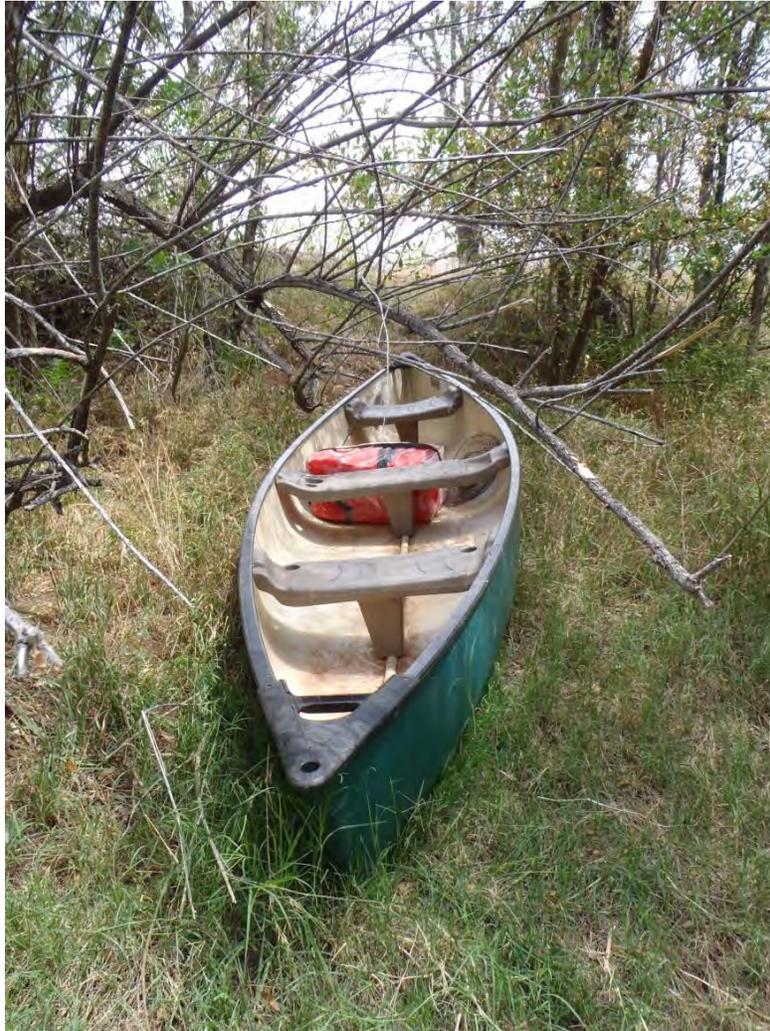
Figure 3.7 Photograph of Site BF002 taken June 8, 2013 of canoe on left bank approximately 150-m from bridge.

No contact (primary or secondary) or noncontact recreational activities were observed by TIAER employees at any of the sites during the field surveys. The only evidence field personnel found of any possible recreation occurring was at Site BF002. A canoe and a pack with unknown contents were found on the bank of the stream (Figure 3.7). No evidence of recreation was found at any of the other sites.

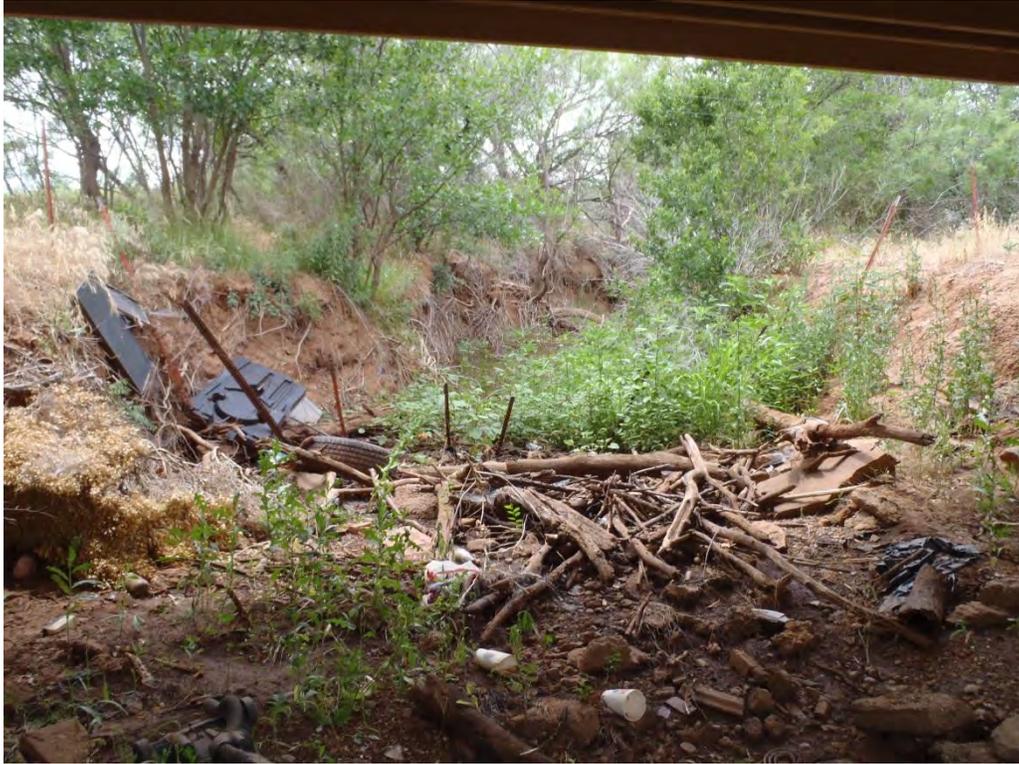
Figure 3.8 Photograph of Site BF003, taken on June 14, 2013, upstream view at 300-m transect under the bridge.

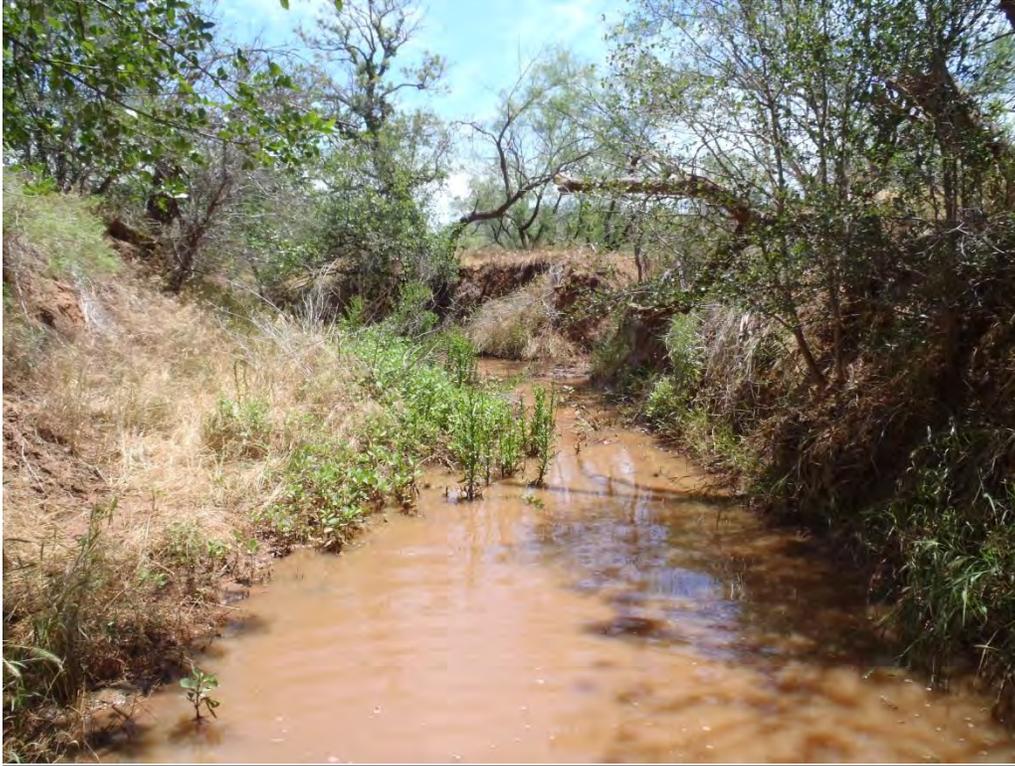
BF004 was surveyed on June 8, and July 20, 2013. No public access to this site was available and only possible with landowner permission and escort to the site which was approximately 1 mile from a public road, down a private dirt road. Once at the site, access into and through the stream was moderately easy except for some steep banks in some places (Table 3.5 and Figure 3.11).

Figure 3.11 Photograph of Site BF004, downstream view at 30-m transect. Note steep banks on right side and more gradual bank on left.

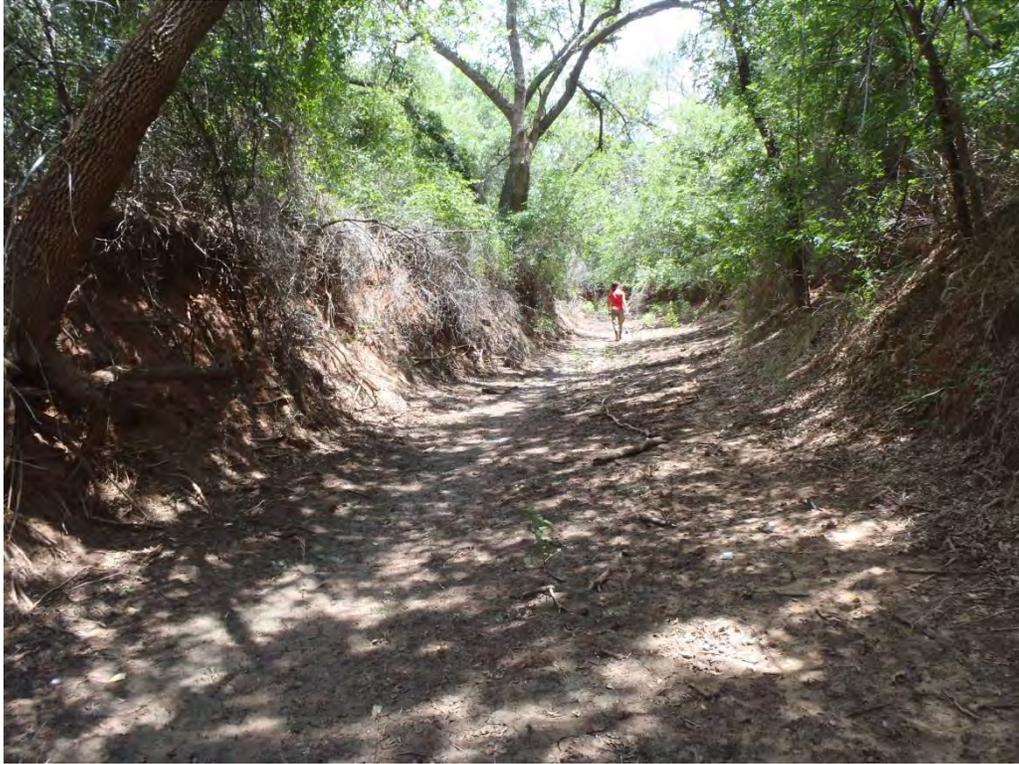
Figure 3.13 Photograph of BF005 taken on July 20, 2013, downstream view at 30-m transect. TIAER personnel in photograph.

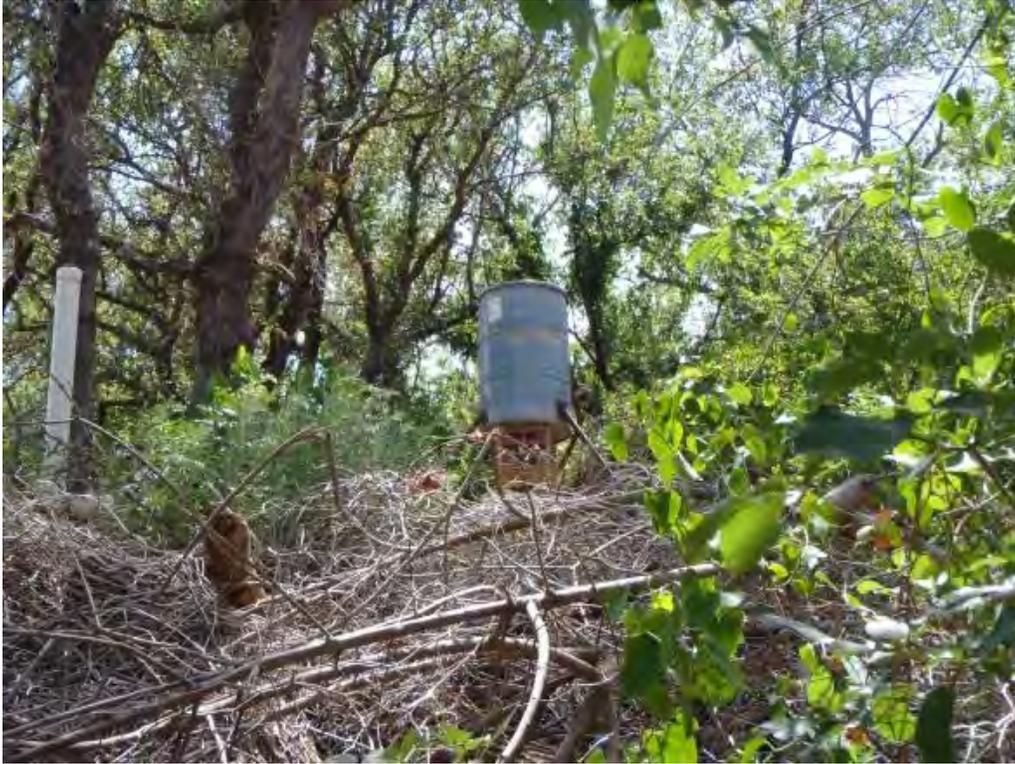
Figure 3.16 Photograph of BF005, taken on June 8, 2013, deer feeder at 210-m.

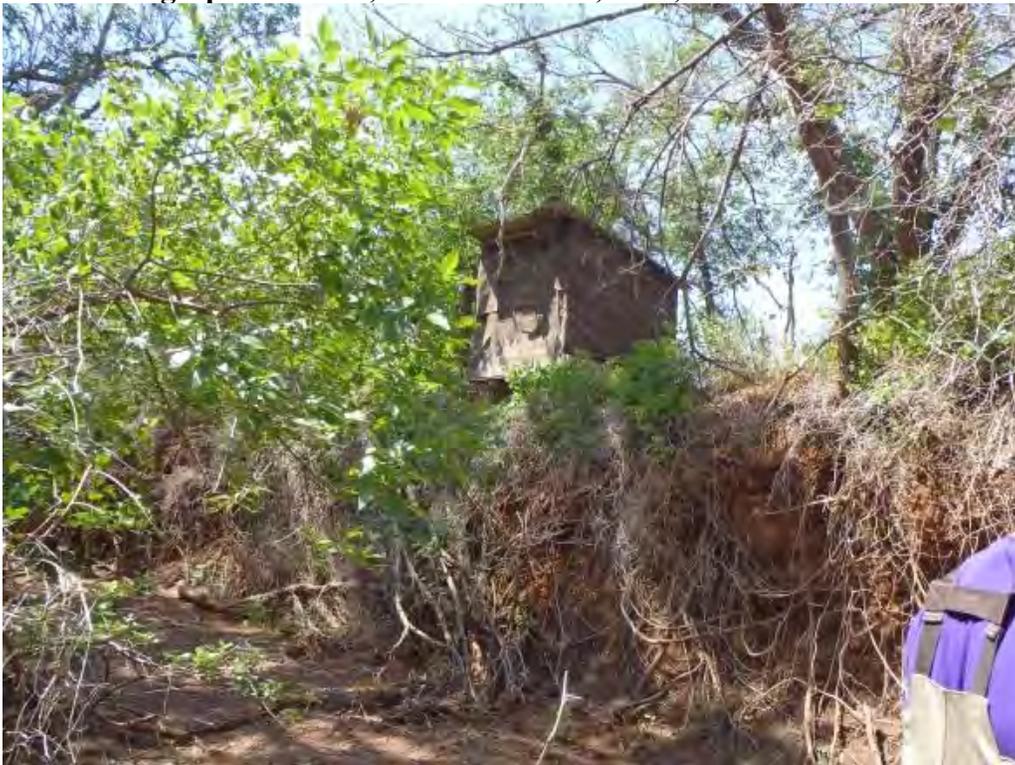
Figure 3.17 Photograph of BF005, taken on June 8, 2013, hunting blind at 210 m. TIAER personnel in photograph.

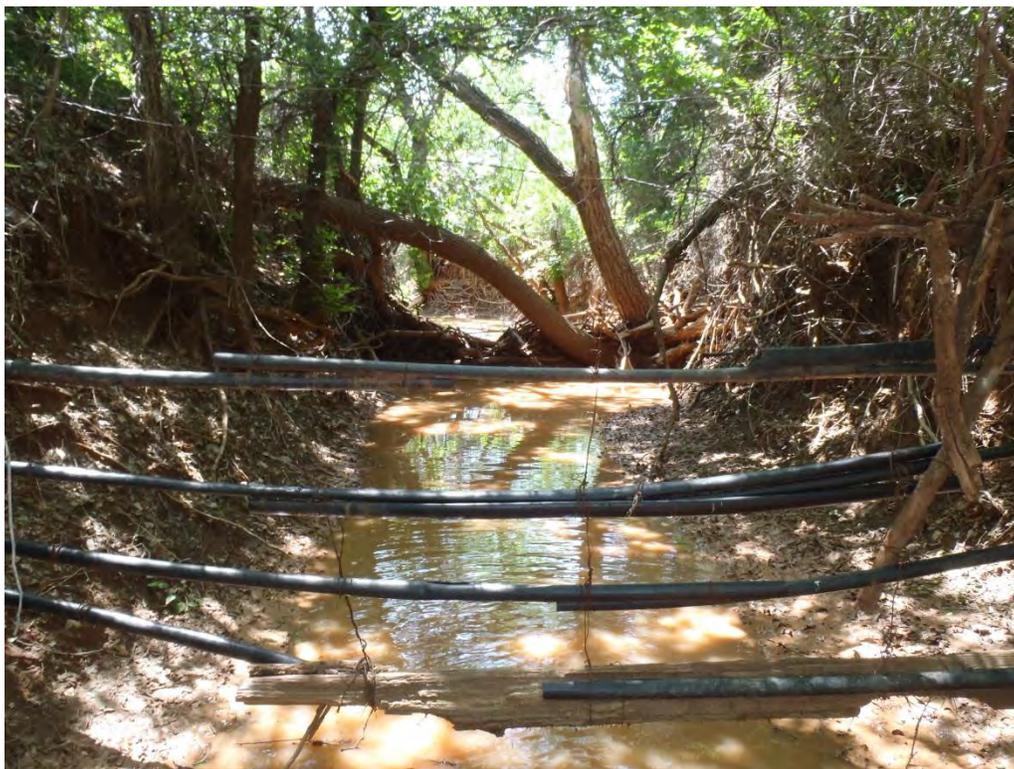
Figure 3.18 Photograph of Site BF006 taken June 8, 2013, upstream view at 300-m transect with a fence intersecting the stream.

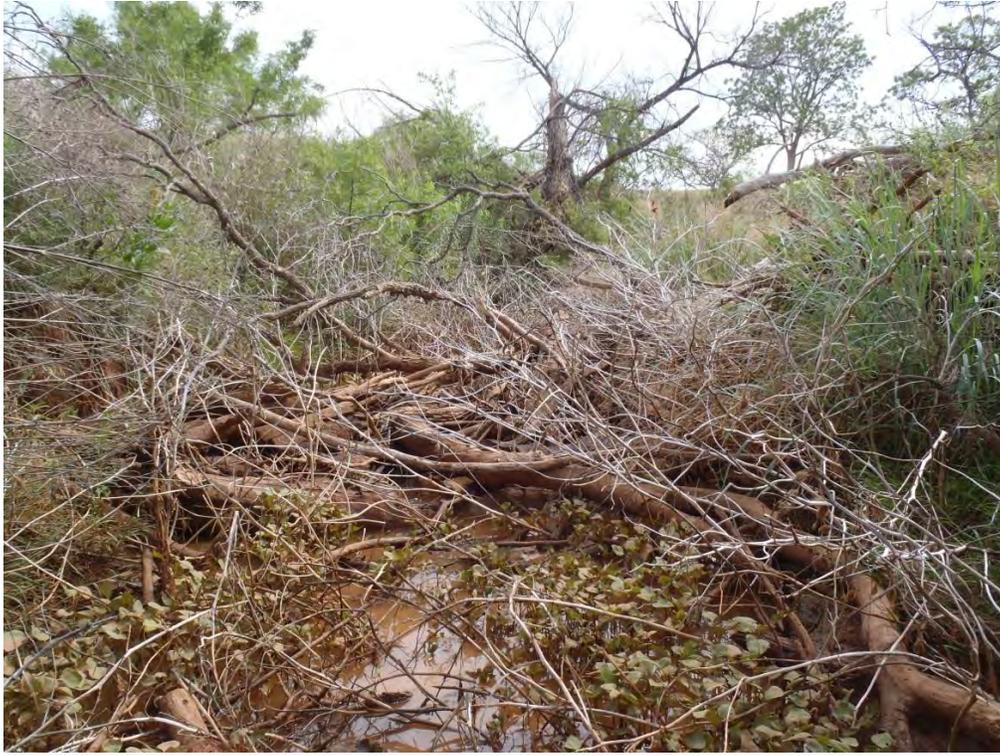
Figure 3.20 Photograph of Site BF007 taken on June 8, 2013, downstream view at a large debris accumulation in the stream at the 150-m transect.

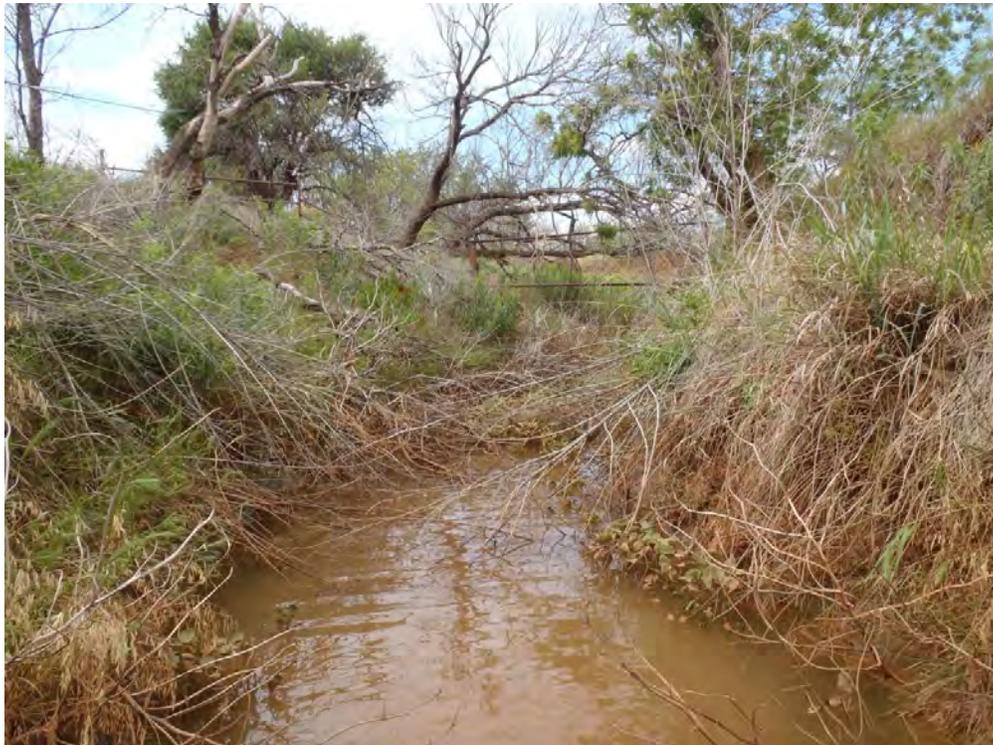
Figure 3.21 Photograph of BF007 taken on June 8, 2013, upstream view at 300-m transect. Note steep vegetated banks and cross fence with welded wire water gap.

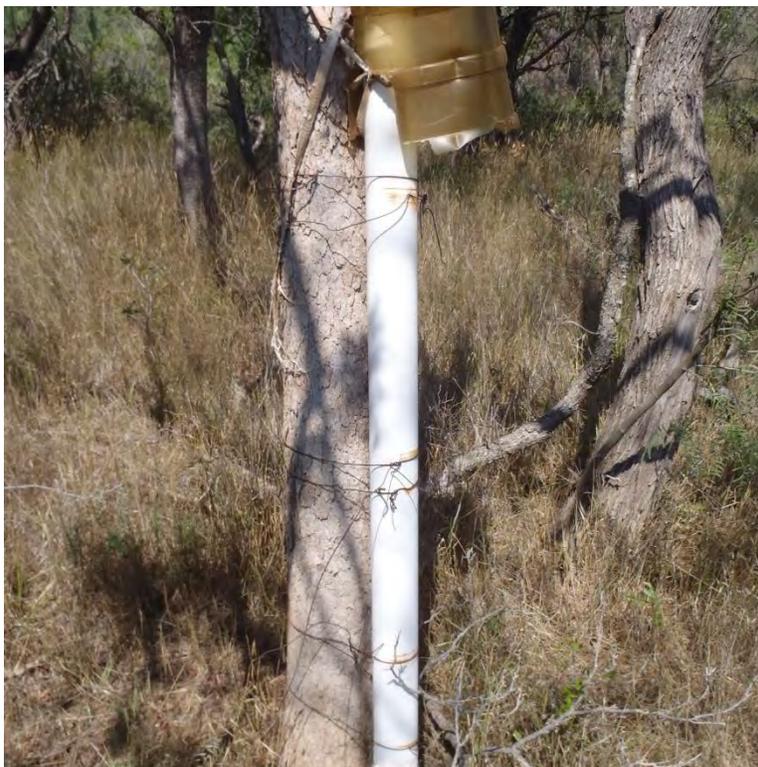
Figure 3.22 Photograph of BF007 taken on July 20, 2013, PVC gravity corn feeder wired to a tree.

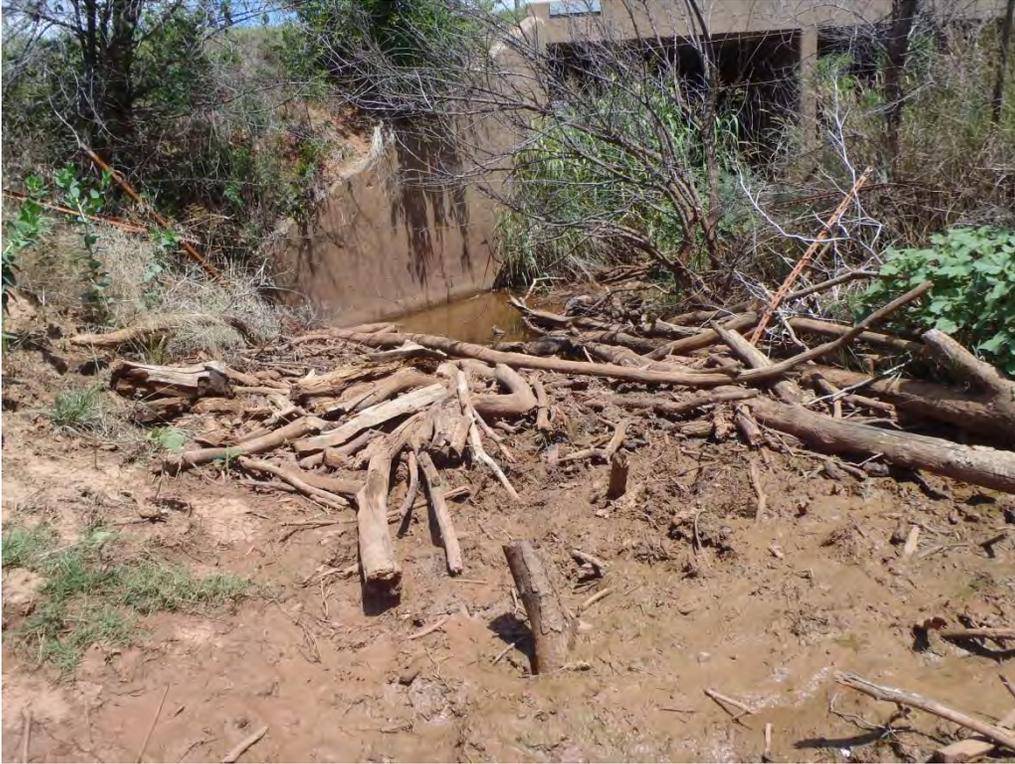
Figure 3.23 Photograph of BF008 taken on July 20, 2013 downstream view at 30-m transect. Note private barbed wire fence line and log jam.

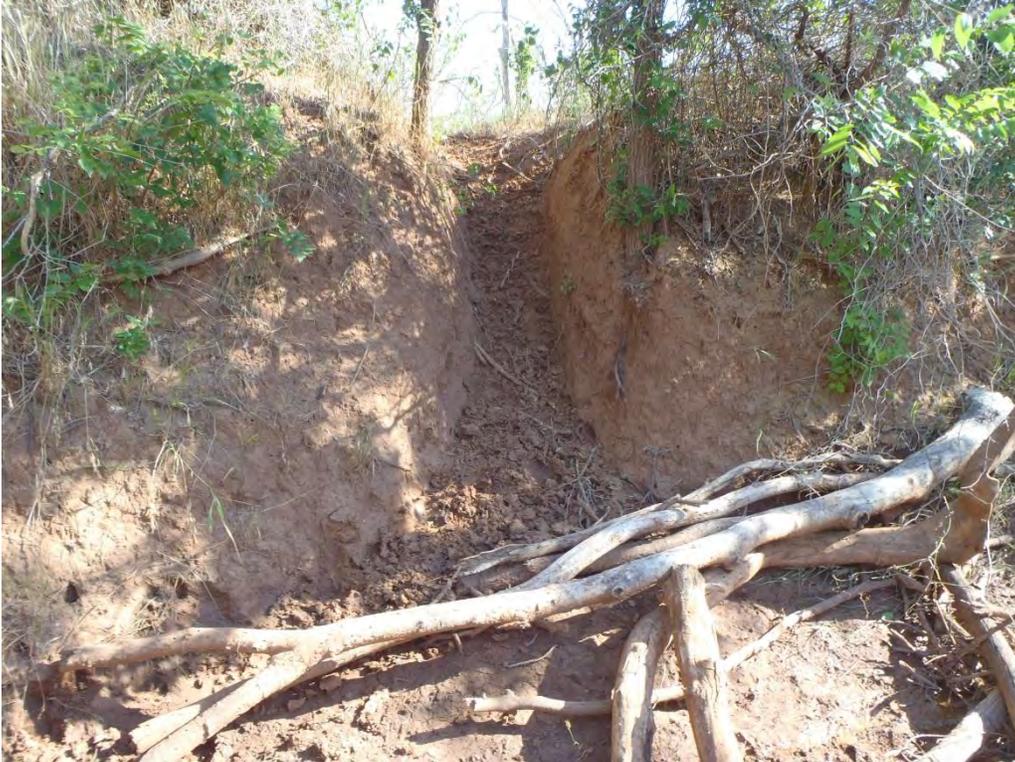
Figure 3.25 Photograph of BF008 taken on June 8, 2013 of wildlife and livestock travel corridor leading into creek.

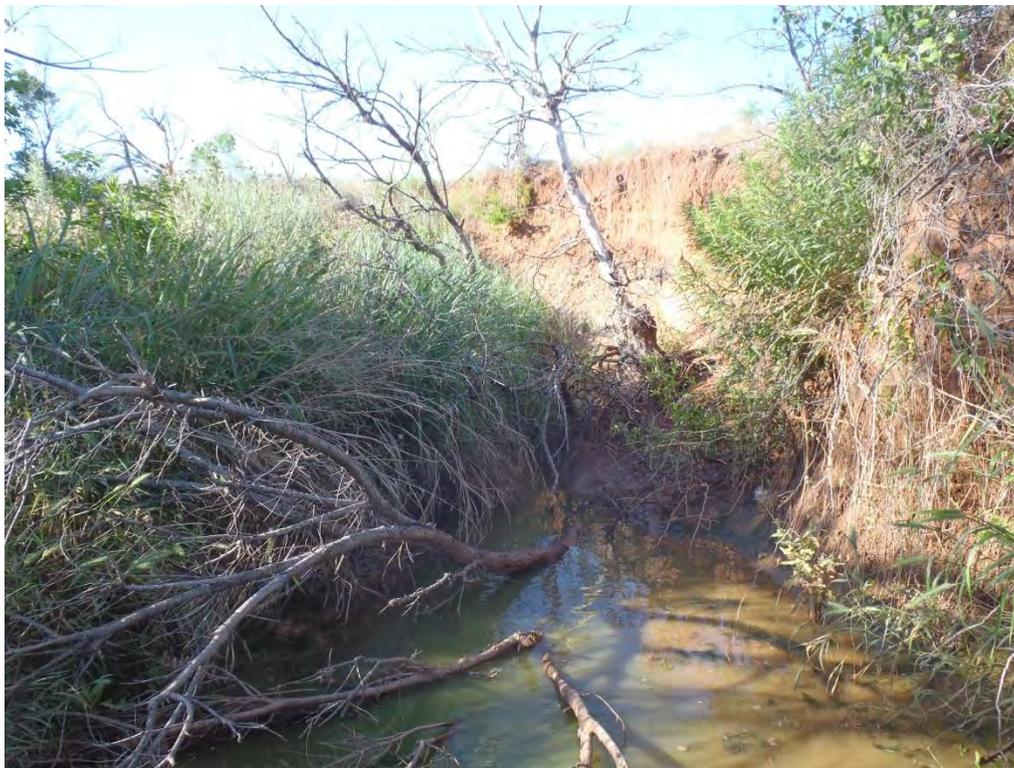
Figure 3.26 Photograph of site BF009 taken on June 8, 2013, upstream view at 30-m transect. Note the steep banks, water levels and debris.

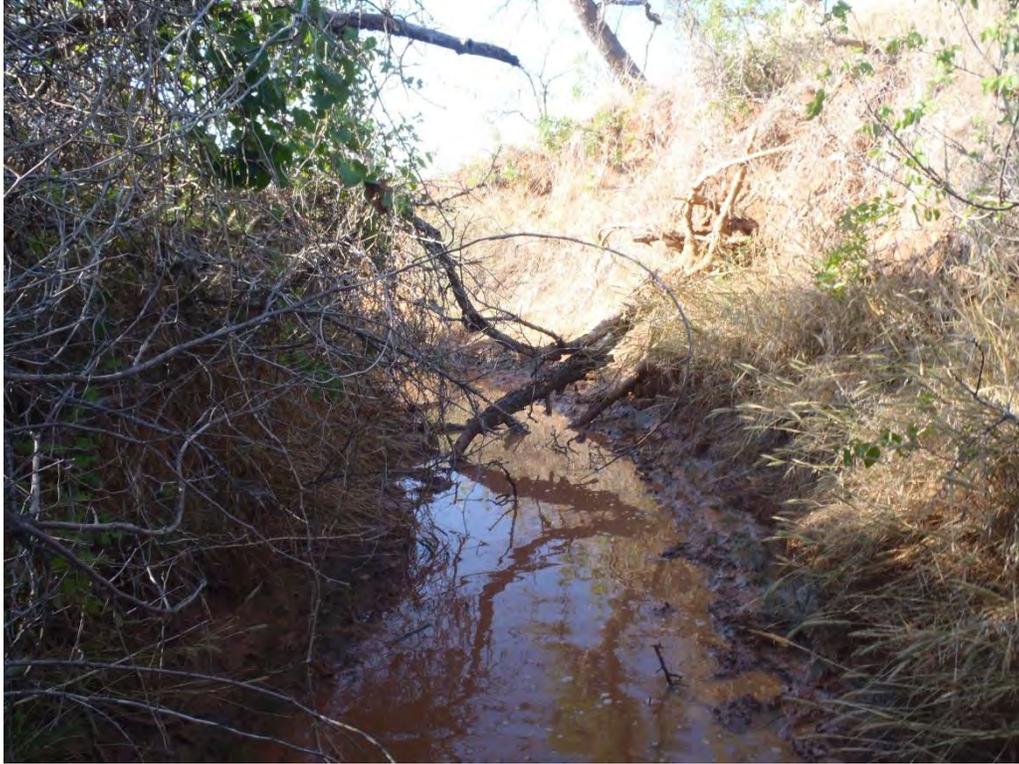
Figure 3.27 Photograph of site BF009 taken on July 20, 2013, downstream view at 150-m transect. Note narrow channel, steep banks and dense vegetation on the left.

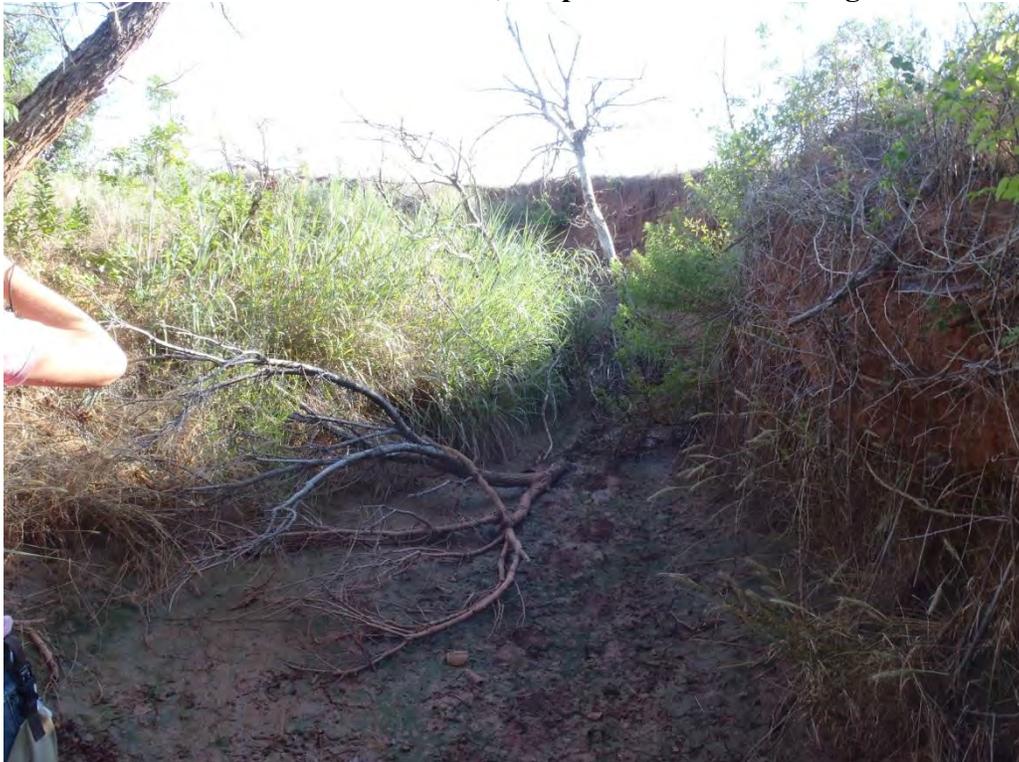
Figure 3.28 Photograph of site BF009 taken on July 20, 2013, upstream view at 30-m transect. Note absence of water and debris. TIAER personnel in photograph.

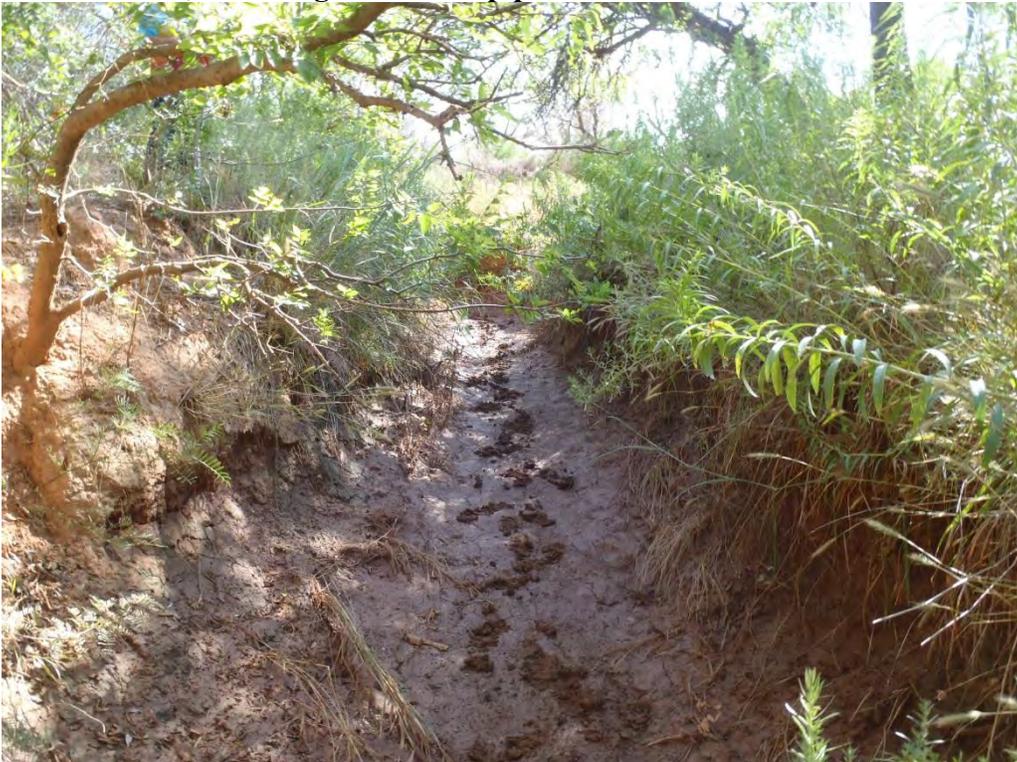
Figure 3.30 Photograph of BF010 taken on July 20, 2013, upstream view at 30-m transect. Note lack of water, muddy substrate, dense vegetation and steep banks.

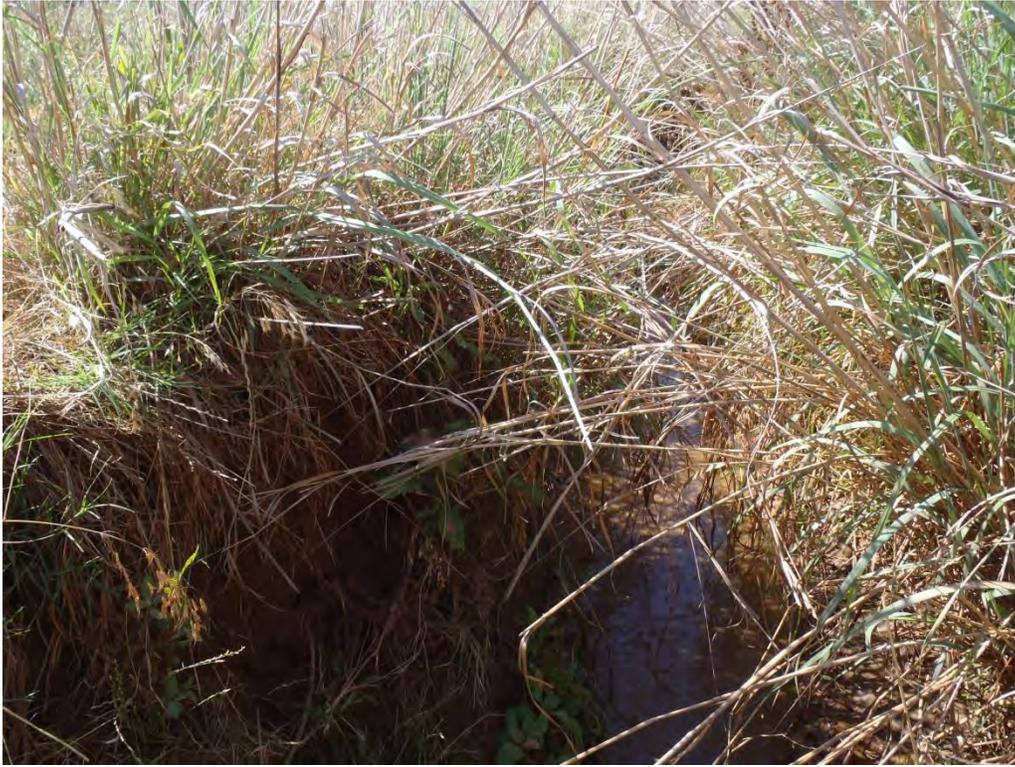
Figure 3.31 Photograph of site BF011, upstream view at 150-m transect. Note narrow channel and thick vegetation.

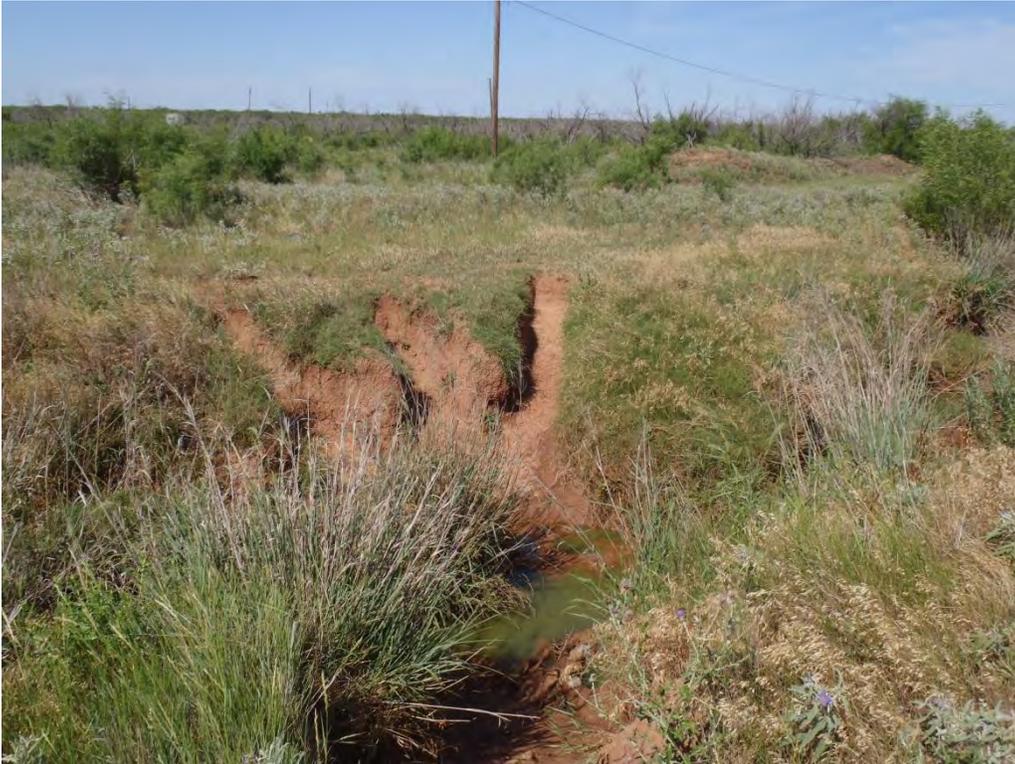
Indications of wildlife presence included tracks of raccoon, canine, bird, deer and turtle. Fecal material of bird, cattle, and some of unknown origin was documented. Bones of a deceased cow were seen and the call of a bobwhite quail was heard. At the 110-m transect a livestock trail was observed crossing through the creek (Figure 3.32) and evidence of a depredated turtle nest was observed. Although garbage was rarely seen at this site, a plastic oil can and styrofoam were

Figure 3.32 Photograph of BF011 taken on June 8, 2013, of a livestock crossing at 110-m transect.

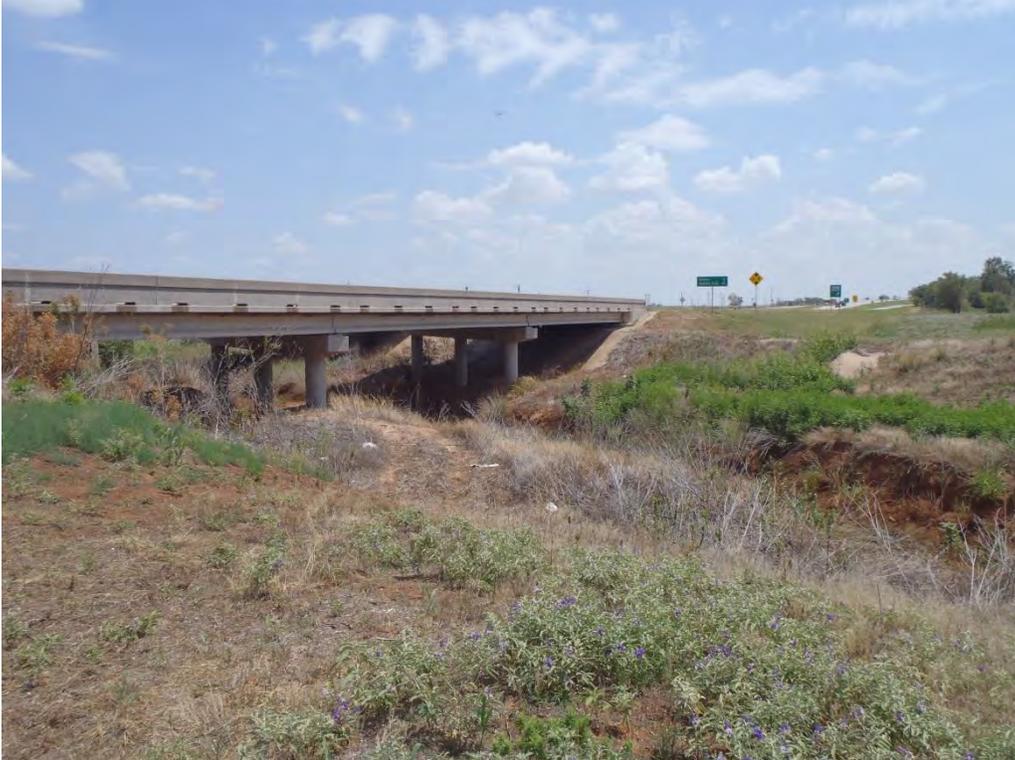
Figure 4.3 Photograph of PD001 taken on August 11, 2013 of public access point at the creek and Hwy 287.

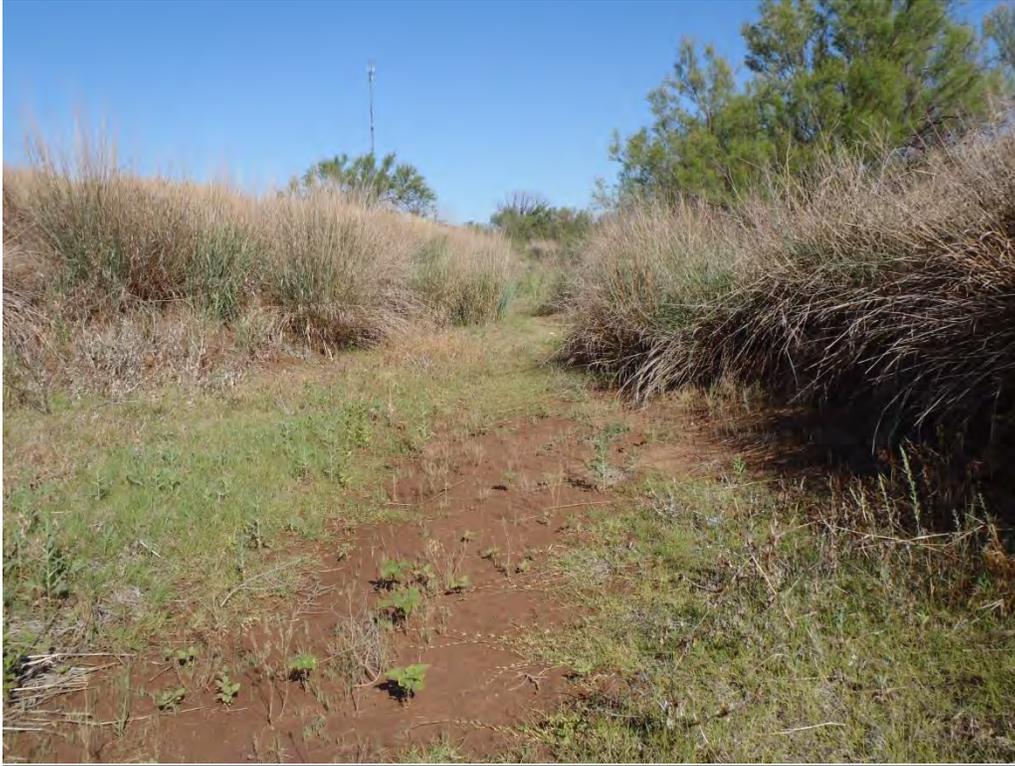
The stream channel was well defined and naturally vegetated. Banks were steep and vegetated with switchgrass on the right bank, some trees on the left with pasture out away from the stream (Figure 4.4). The fine sediment substrate was slick when wet and caused sinking when wading in places. During the first survey, where water was present, the surface was clear of algae, clear in color with an occasionally detectable odor (Table 4.9). During the second survey, there was more water in the form of small pools. The surfaces of these pools were clear and brown in color with some algae, foam and scum. An oily sheen was observed in small amounts in a few places where water was present (Table 4.10).

Figure 4.4 Photograph of site PD001 taken June 9, 2013, upstream view at 300-m transect. Note steep banks dominated by dense switchgrass.

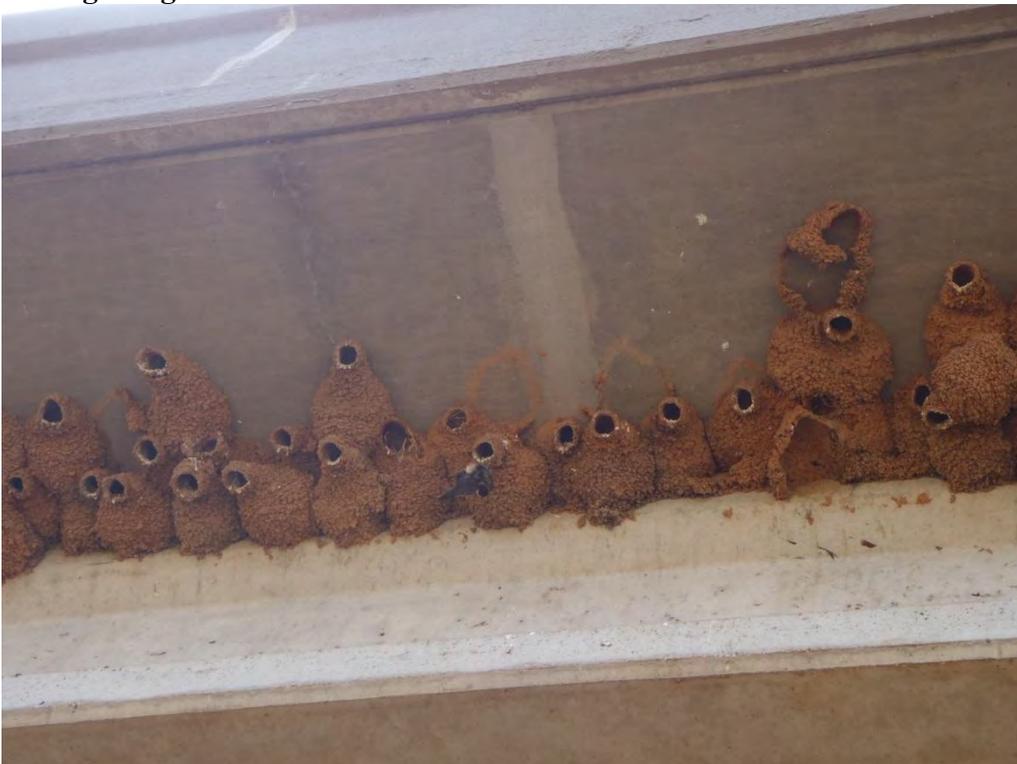
Figure 4.6 Photograph of PD001 taken on August 11, 2013 of cliff swallow nests under Hwy 287 bridge.

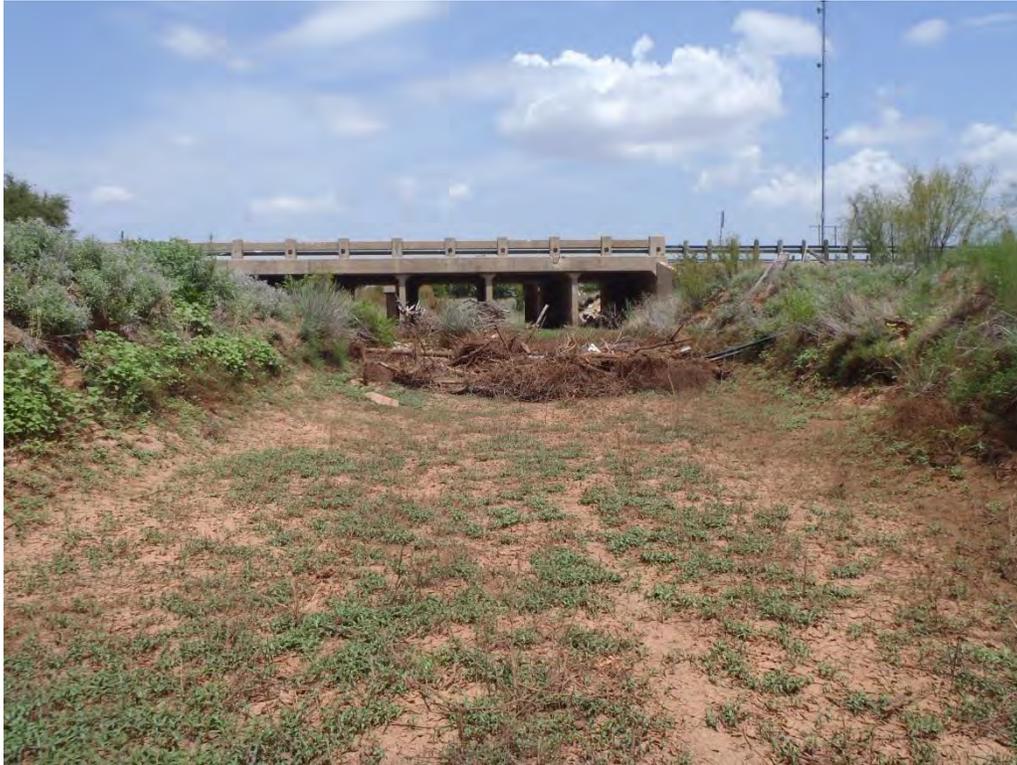
This site was surveyed on June 9 and August 11, 2013. Public access at the bridge made entering the stream moderately easy (Table 4.6). However, crossing a private fence through a large accumulation of debris in the stream bed within the first 30 m created an initial challenge to complete the 300-m survey (Figure 4.7). Average thalweg depths of the reach were 0.00 m during the first survey and 0.00 m during the second survey (Table 4.6).

Figure 4.7 Photograph of PD002 taken on June 9, 2013. Downstream view at the 30-m transect. Note the public access point at the bridge and debris piled up at the private fence line.

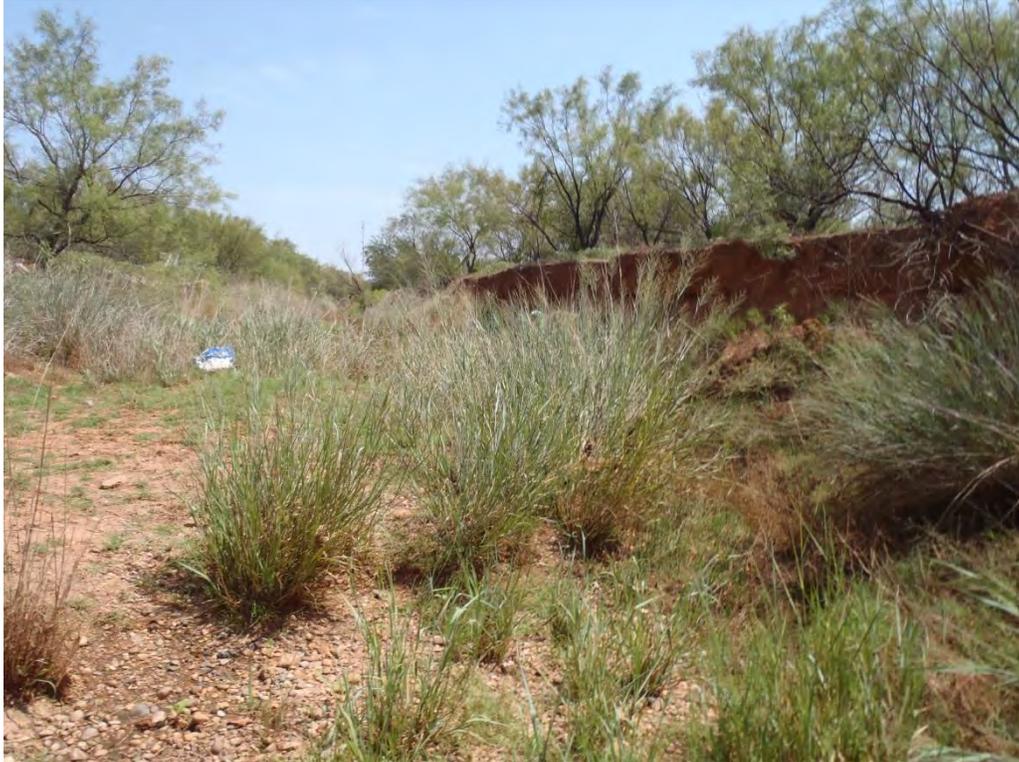
The banks were steep in some places and vegetated with switchgrass, willow trees and some cottonwoods opening up to pastureland past the edges of the riparian area (Figure 4.10). Some stretches of the stream bottom were vegetated with grasses as well. Evidence of beaver was observed in the form of gnaw marks on trees. A dead snake and shells of bivalves were seen. Horse and bird manure as well as tracks of raccoon, deer, and dog were observed in the stream bed. Garbage was rare at this site and included a tractor tire (Figure 4.11), some aluminum cans, and bottles (Tables 4.9 and 4.10). No evidence of human recreation was observed at this site.

Figure 4.10 Photograph taken of PD003 on August 11, 2013. Downstream view at the 30-m transect. Note vegetated streambed, steep right bank.
