Recreational Use Attainability Analysis for Buffalo Creek (0214B), Paradise Creek (0230A), and Sweetwater Creek (0299A) in the Red River Basin

Prepared for:
Texas State Soil and Water Conservation Board
Project 12-52

Texas Institute for Applied Environmental Research
Tarleton State University
Stephenville, Texas

TR 1308

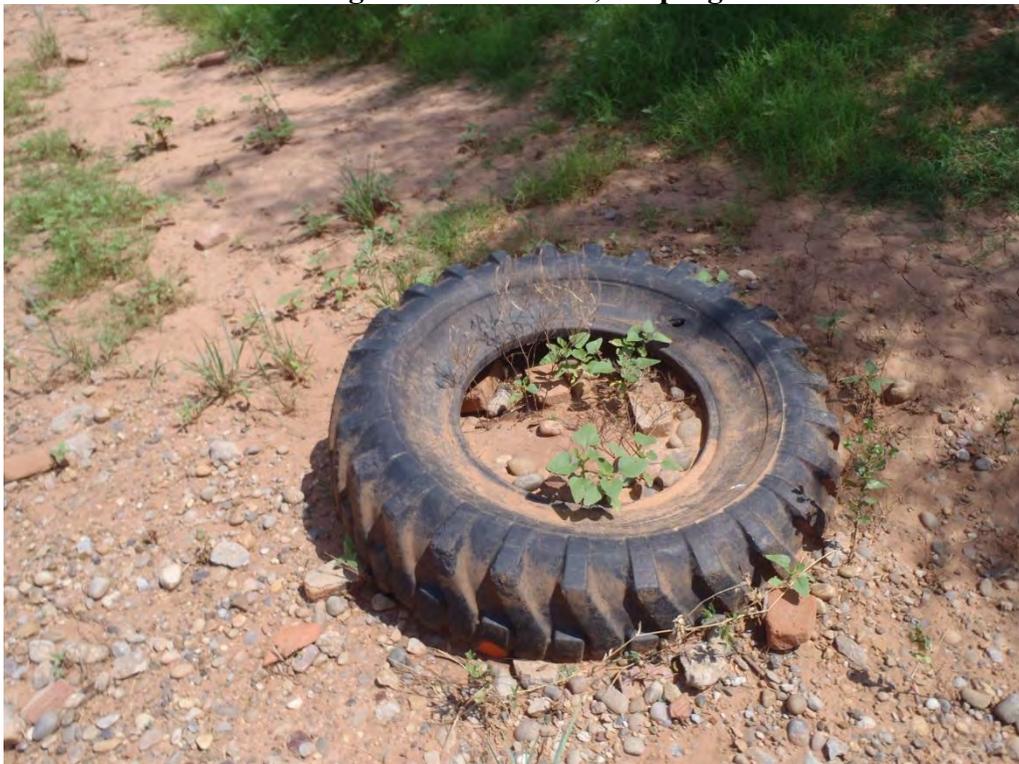
Figure 4.11 Photograph take of PD003 on August 11, 2013. Note tractor tire and brick debris.

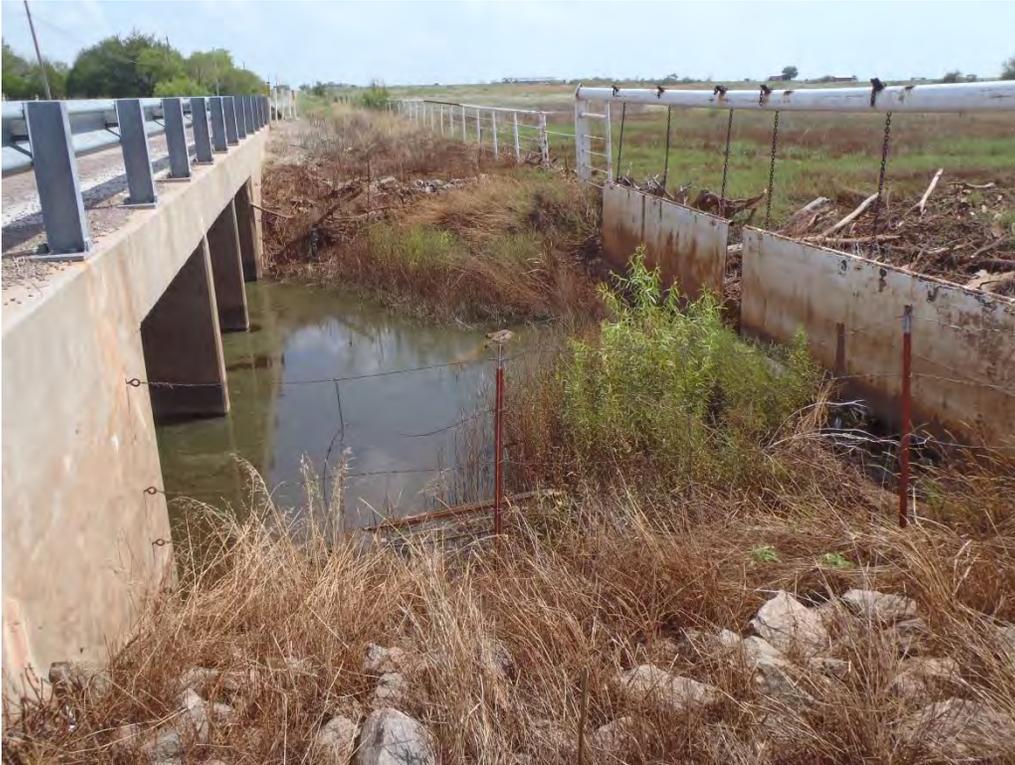
PD004 was surveyed on June 9 and August 11, 2013. Access to this site was only public from the Eagle Street bridge. Getting down to the creek bed was moderately difficult because of riprap on banks, barbed wire fence, unstable log jam accumulations and a substantial steel and pipe water gap which hindered travel through the corridor (Table 4.6 and Figure 4.12). Additionally, once in the stream bed, extremely dense vegetation made traversing the entire 300-m stretch challenging.

Figure 4.12 Photograph taken on June 9, 2013. Public access of the Eagle Street bridge. Note the rip-rap, barbed wire fence, heavy steel and pipe water gap and unstable log jams.

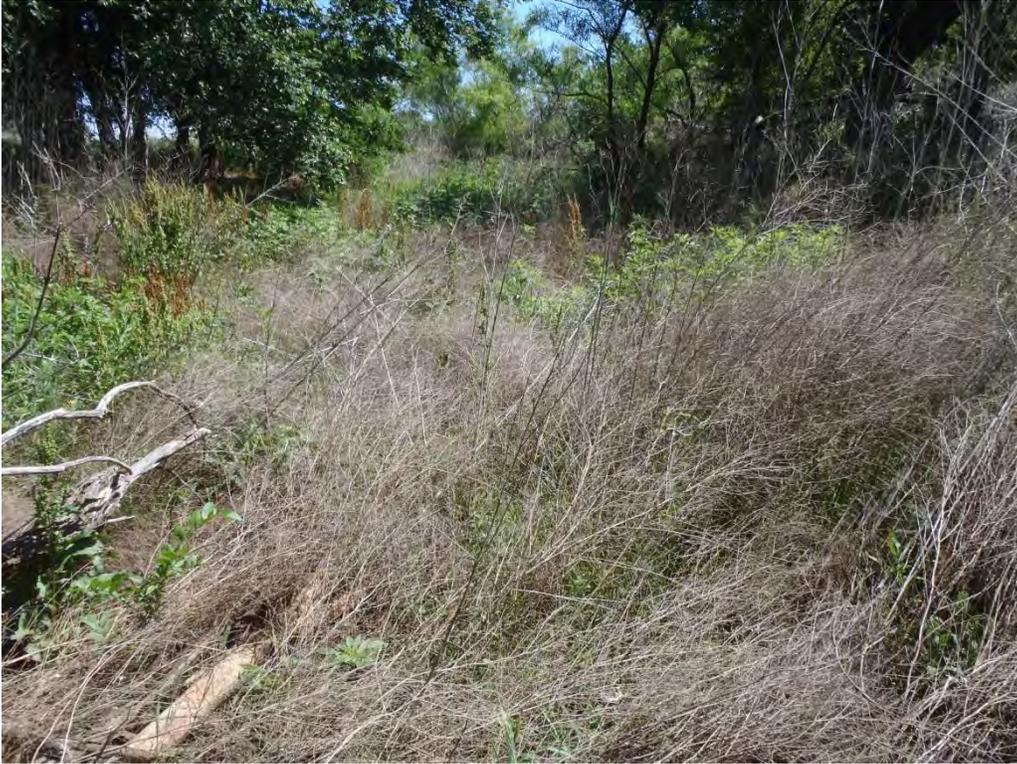
Figure 4.13 Photograph of PD004 taken on June 9, 2013. Downstream view at 150-m transect. Note dense vegetation throughout corridor.

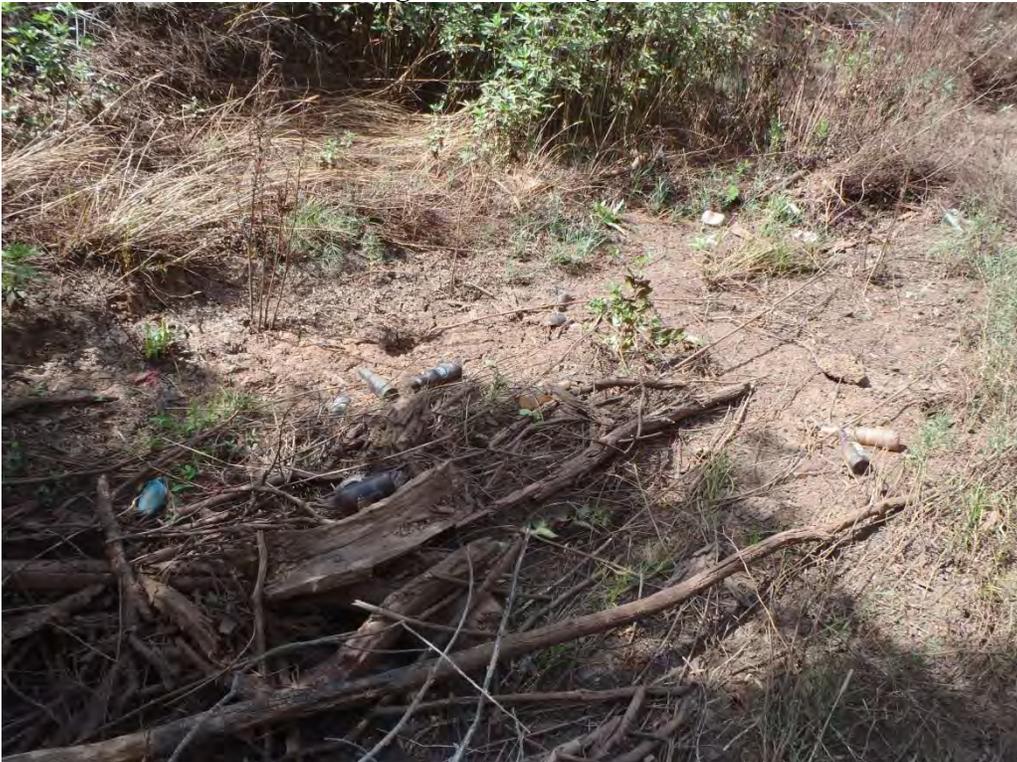
Figure 4.14 Photograph of PD004 taken on August 11, 2013. Note concentration of garbage in streambed and log jam debris.

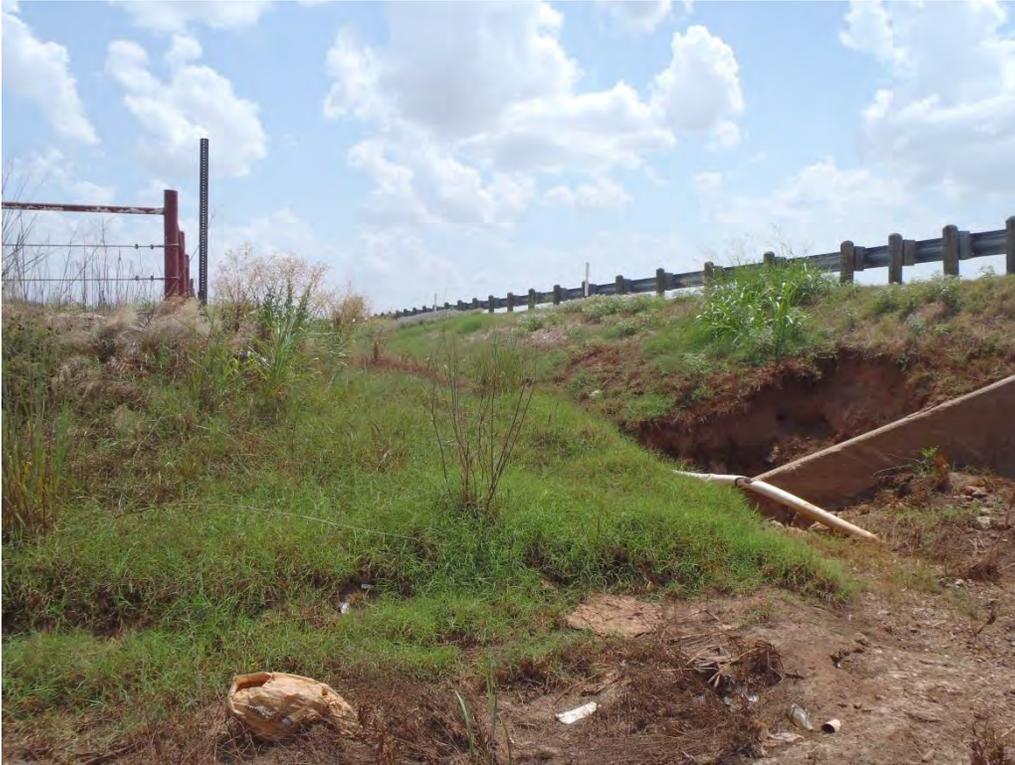
Figure 4.15 Photograph of PD005 taken August 11, 2013 of public access point at the Hwy 183 bridge.

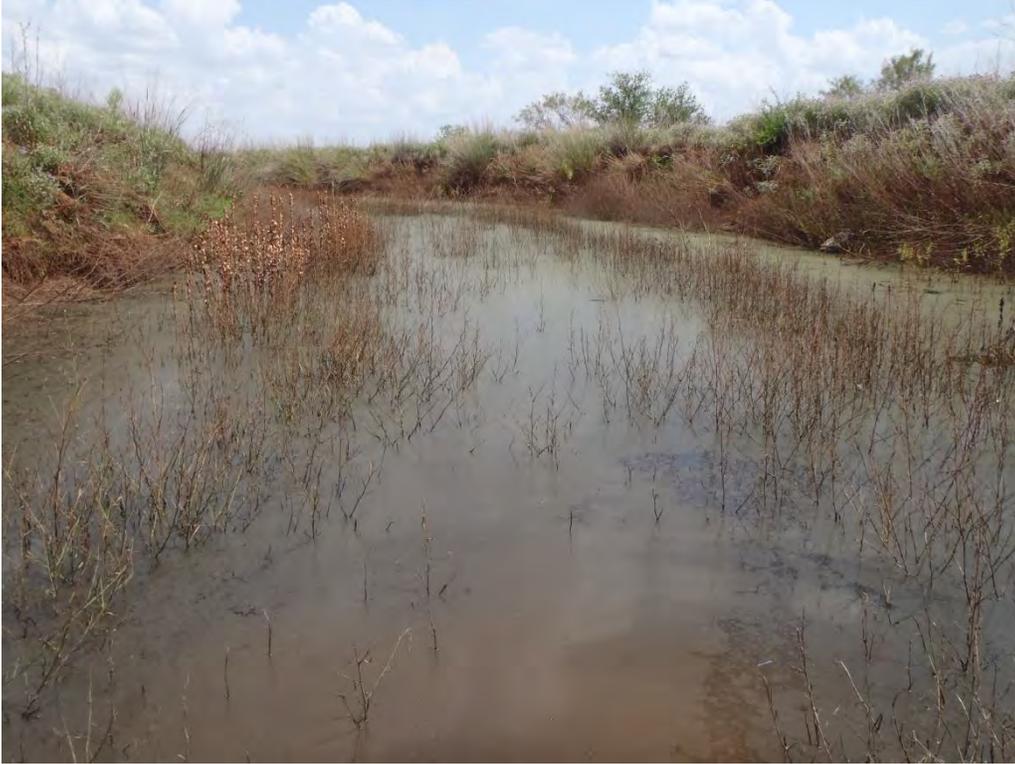
The dominant substrate at this site was fine sediment. The water encountered during the second survey had a scum on the surface and was a brown color (Figure 4.16). Algae cover was also present during the second survey. The banks were vegetated with pasture beyond the riparian area on both the right and left sides of the stream (Table 4.5 and Figure 4.17). Vegetation at the bridge was slightly more dense and dominated by salt cedars (Figure 4.18).

Figure 4.16 Photograph of PD005 taken on August 11, 2013. Downstream 300-m transect. Note the surface scum.

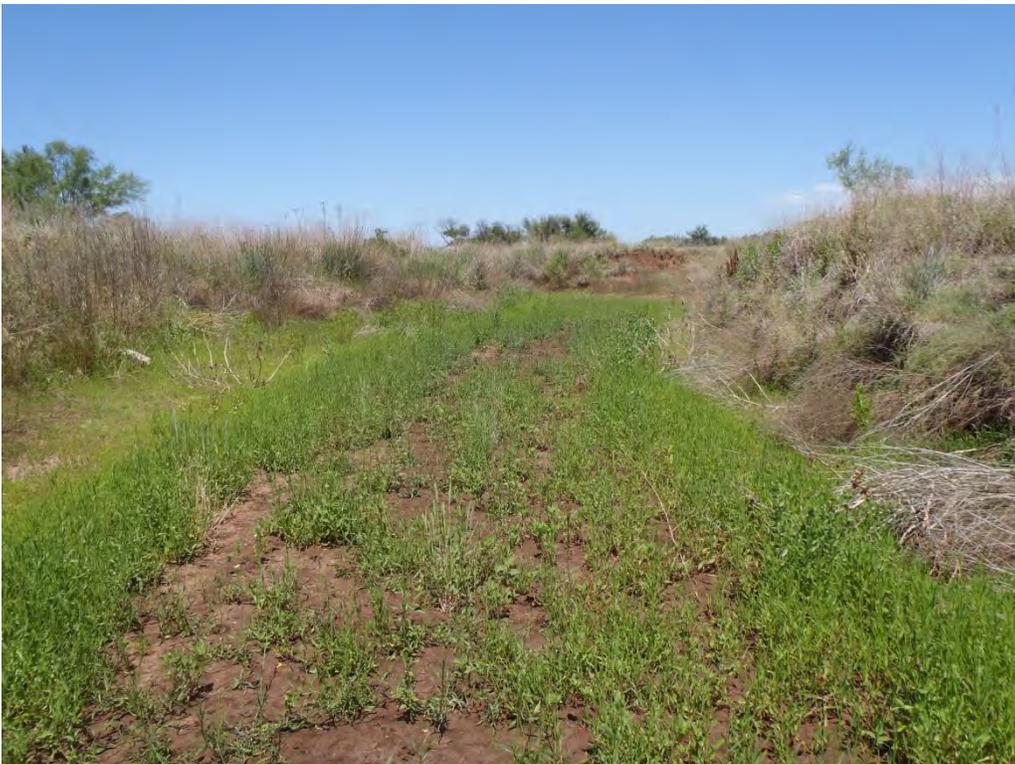
Figure 4.17 Photograph of PD005 taken on June 9, 2013. Upstream view of the 30-m transect.

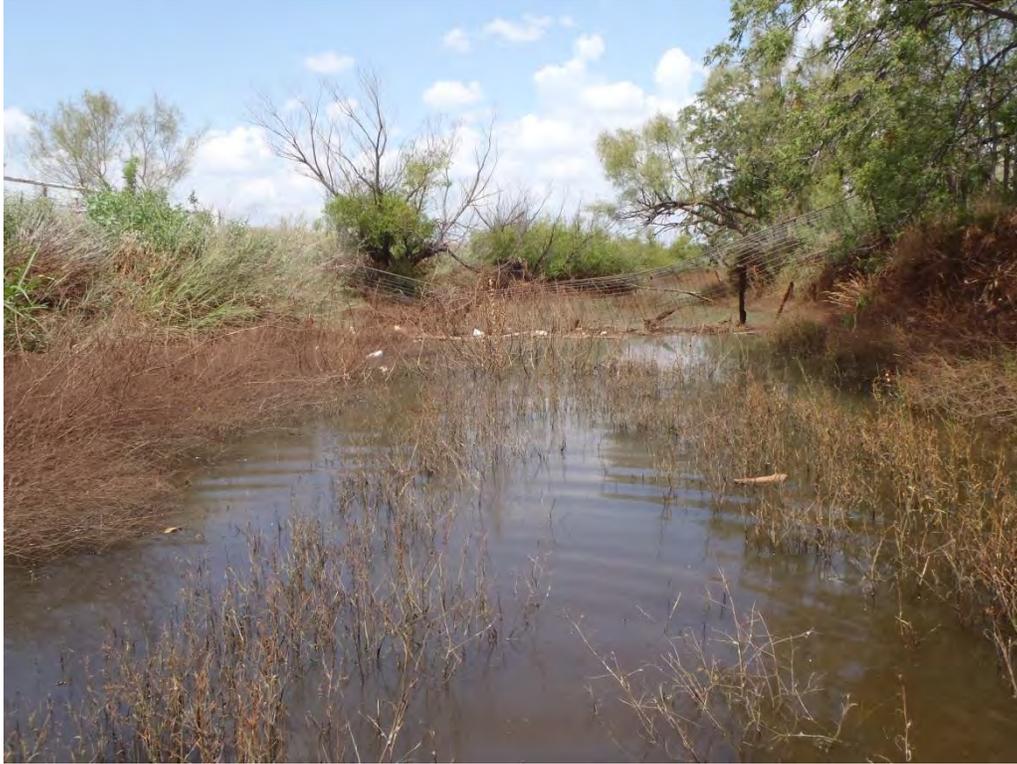
Figure 4.18 Photograph of PD005 taken on August 11, 2013. Downstream view at the 150-m transect. Note the steep, vegetated banks, water gap and presence of water.

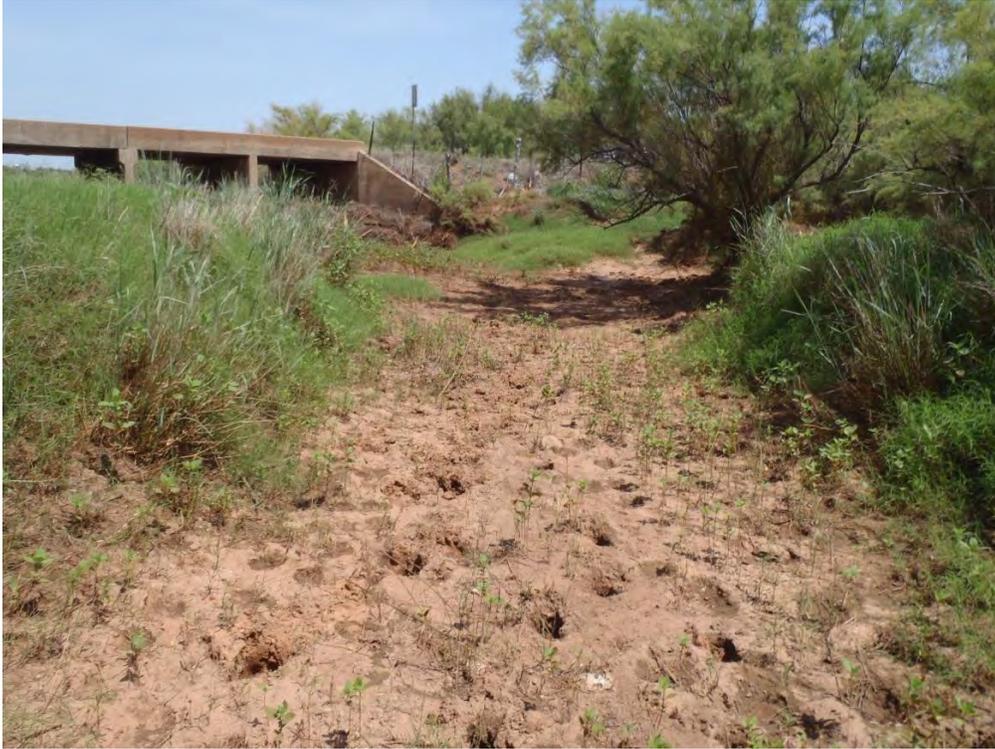
Figure 4.19 Photograph of PD006 taken on August 11, 2013. Downstream view of the 30-m transect. Note private fence connecting with the bridge, hindering public access.

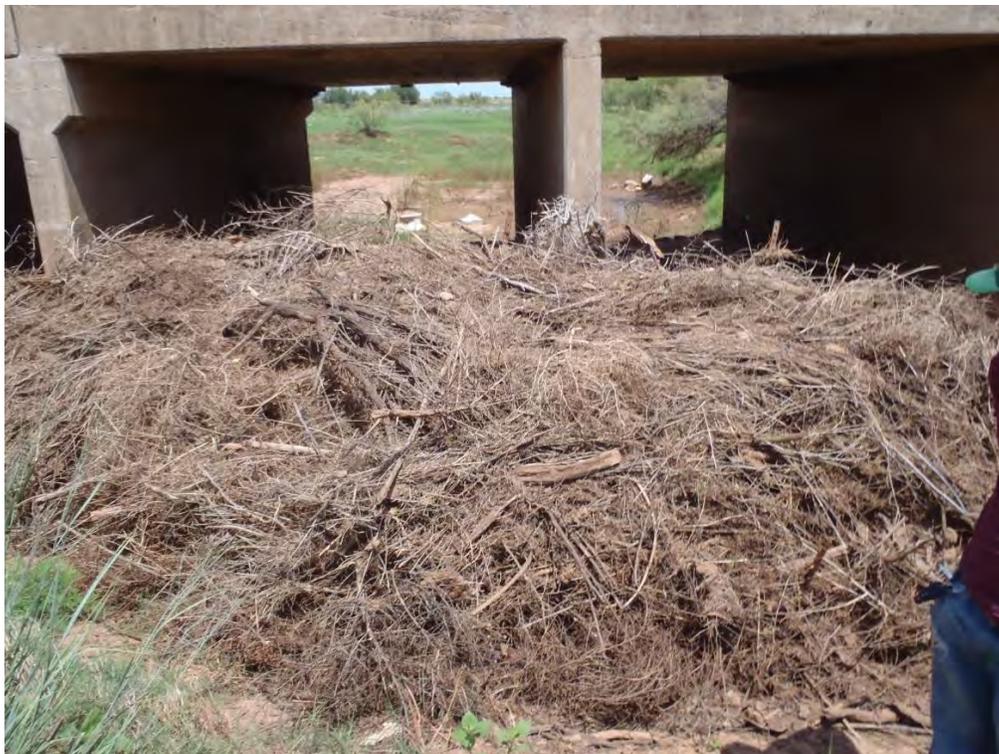
PD006 was surveyed on June 9 and August 13, 2013. Access to this site was moderately easy as it was located at the County Road 128 bridge. However, entering the stream at this site is only publically accessible from the bridge itself. A private property fence comes up and meets the bridge then restricts further stream access as it bisects the creek as well (Table 4.6 and Figure 4.19). Traveling the creek was also moderately easy as it had little to no water and was relatively free of dense vegetation or debris. A large debris pile had accumulated at the bridge between surveys but did not cause a hindrance for the second survey (Figure 4.20).

Figure 4.20 Photograph of PD006 taken on August 11, 2013 of the debris accumulation at the bridge. TIAER personnel in photograph.

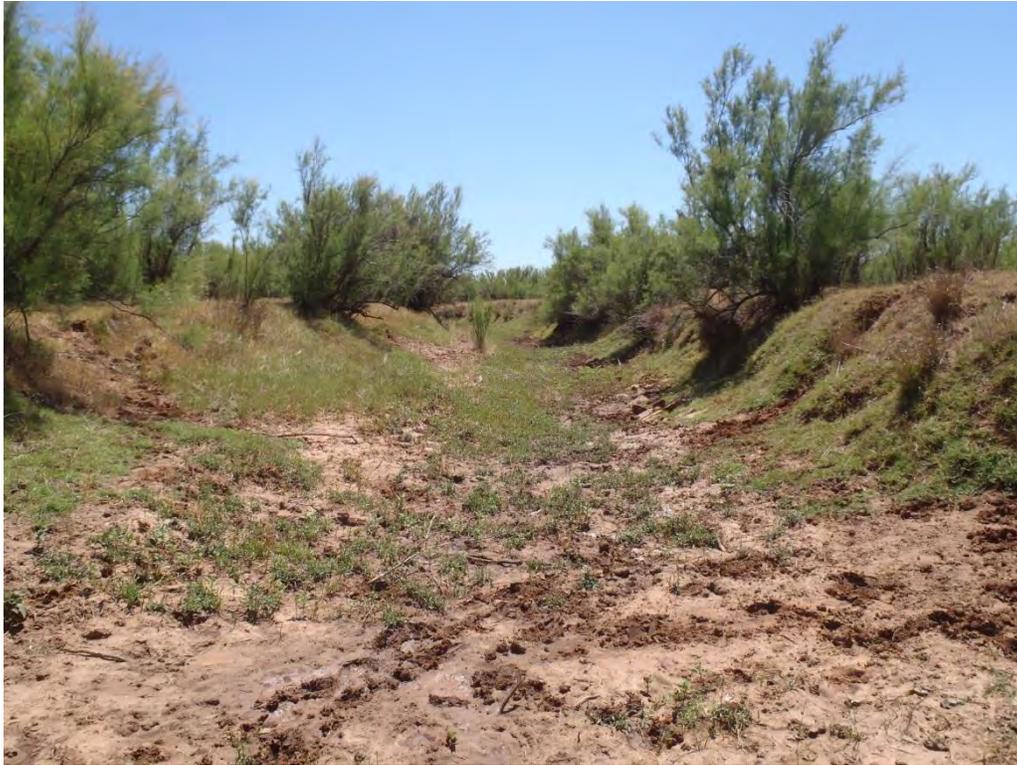
Primary substrate was fine sediment that turned to mud/clay when wet (Table 4.5). During the second survey when water was present, the water surface was clear with a brown color (Tables 4.9 and 4.10). The banks were gently sloping with some livestock trails leading out and the dominant vegetation type in the corridor was salt cedar shrub land (Figure 4.21).

Figure 4.21 Photograph of PD006 taken on June 9, 2013. Upstream view of the 300-m transect. Note gentle sloping banks, lack of water and shrub dominated corridor.

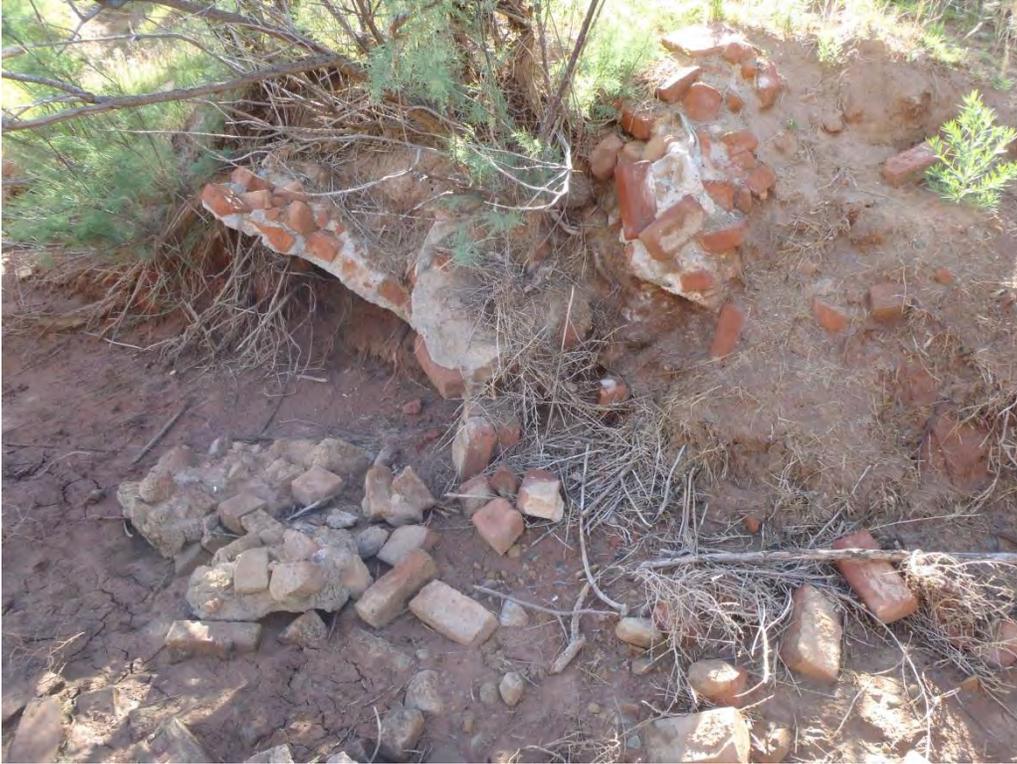
Garbage was rare at this site. Concrete debris, rebar and some irrigation pipe was seen at the washed out bridge transect (Figure 4.23). Along the stretch a few glass bottles were noted. Approximately half way through the 300-m stretch, debris of bricks fused with concrete and rebar were observed on the bank and down the bank into the channel (Figure 4.24). At the 300-m transect, plastic duck decoys were observed floating in the water (Figure 4.25). No other evidence of human recreation was observed.

Figure 4.24 Photograph of PD007 taken June 10, 2013 of brick and concrete on the bank and in the stream.

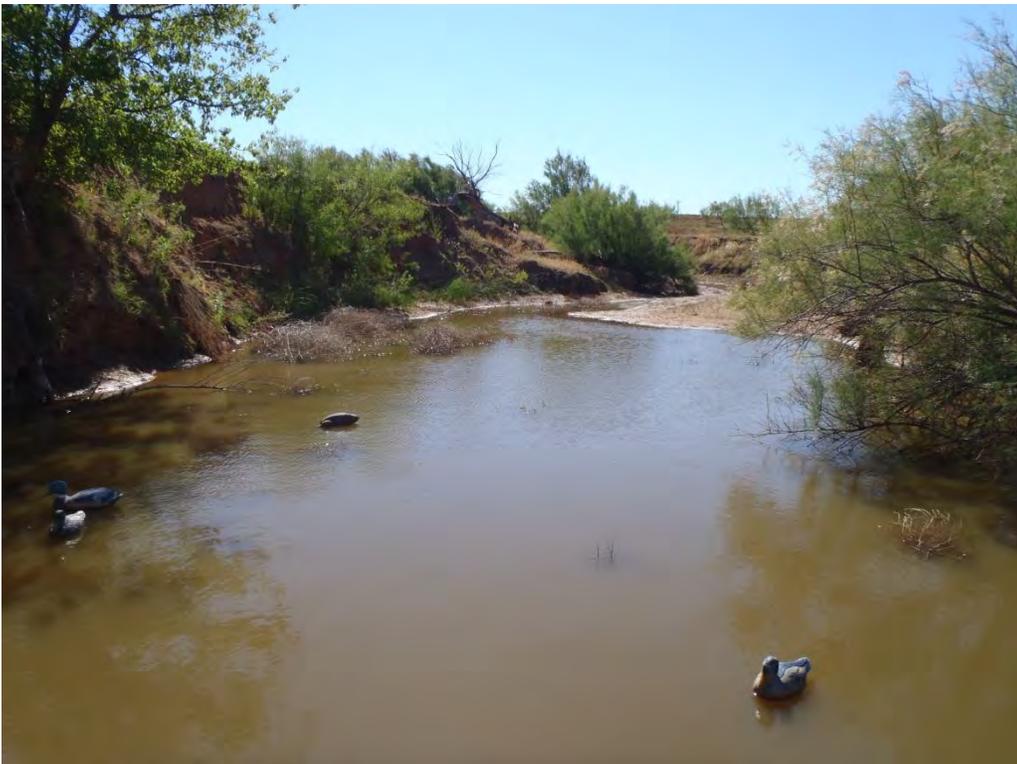
Figure 4.25 Photograph of PD007 taken June 10, 2013. Downstream view at the 300-m transect. Note the pool, duck decoys and steep, shrubby banks.

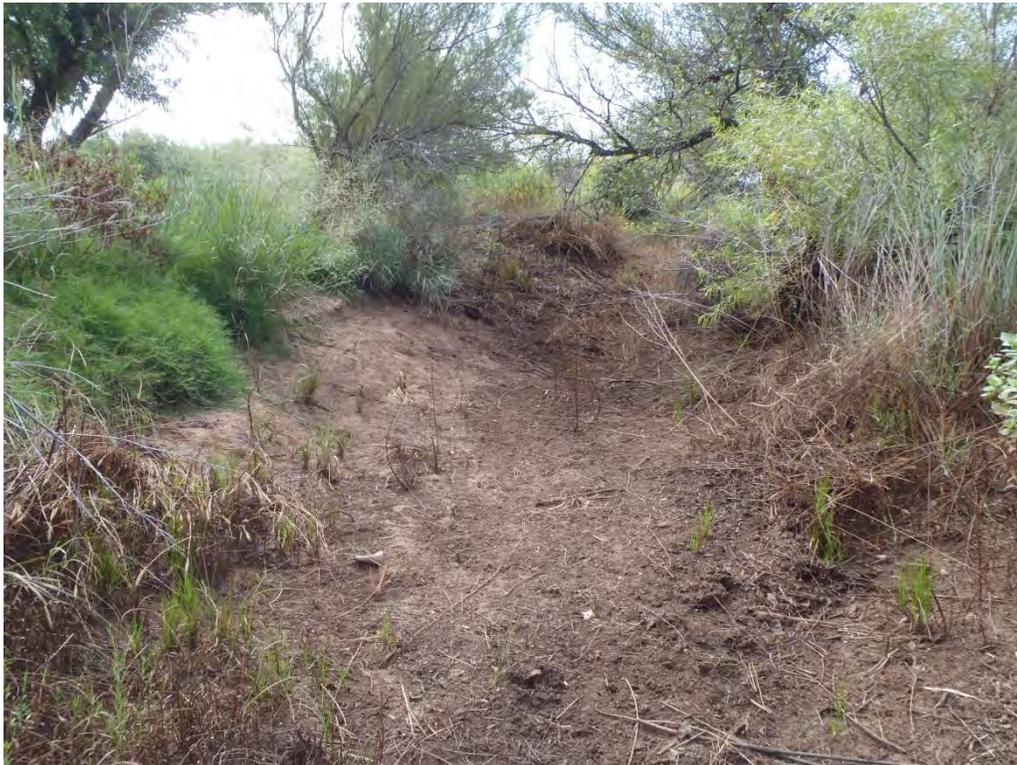
Figure 4.26 Photograph of PD008 taken August 12, 2013. Upstream view at the 30-m transect. Note the open pastureland beyond riparian area and relative ease of access.

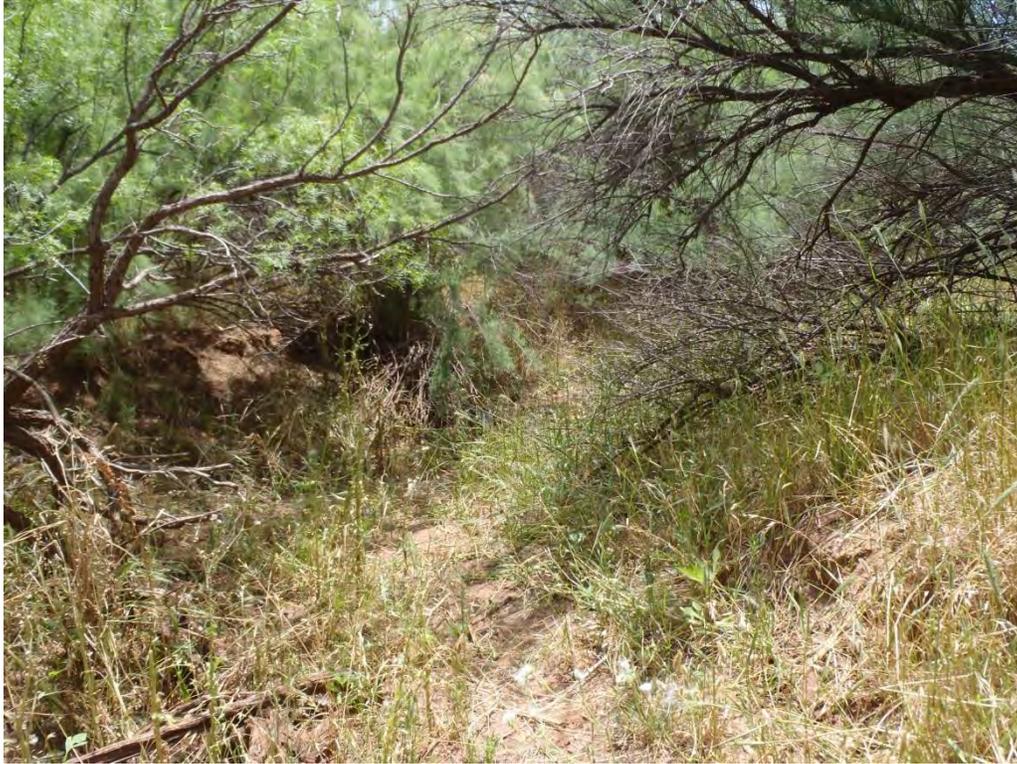
Figure 4.27 Photograph of PD008 taken June 14, 2013. Upstream view of the 150-m transect. Note the dense vegetation.

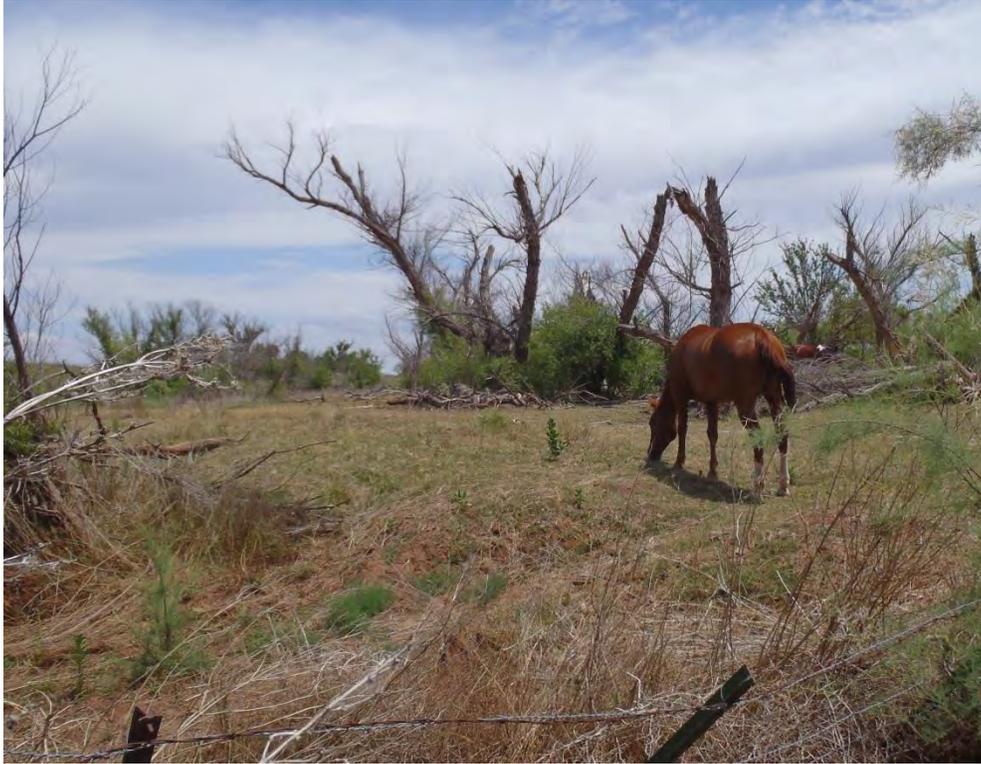
Figure 4.28 Photograph of PD008 taken on June 14, 2013 of a horse observed downstream from site.

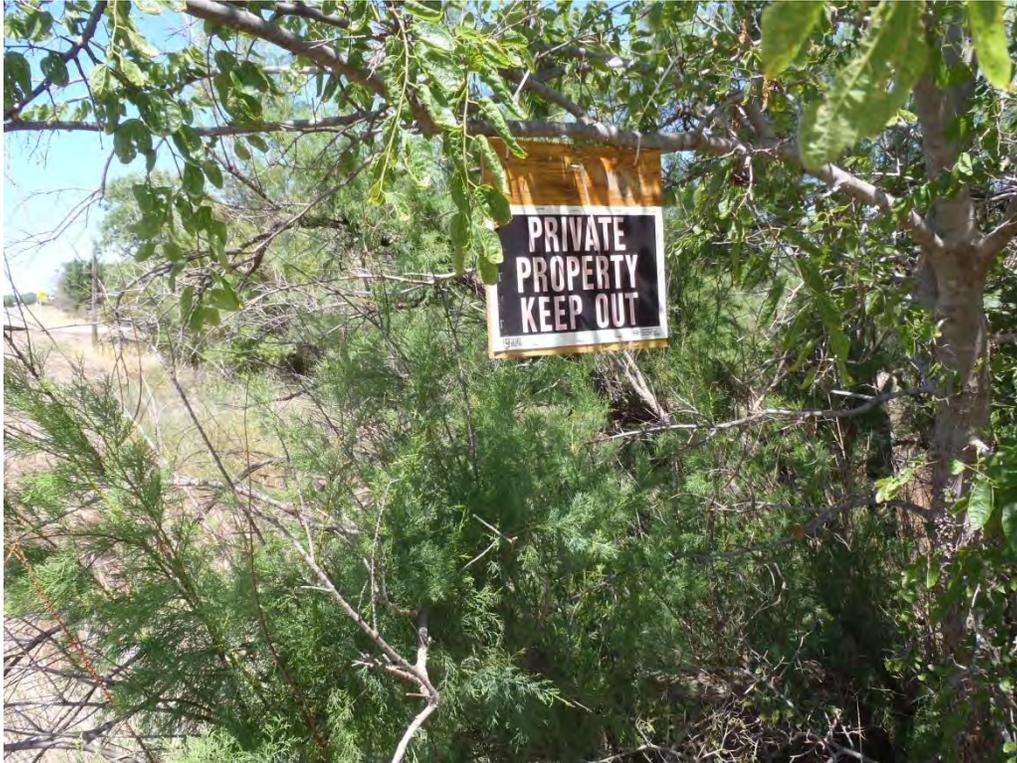
Figure 4.30 Photograph of PD009 taken on June 6, 2013 of private property sign posted on property line at county road 433 and the creek.

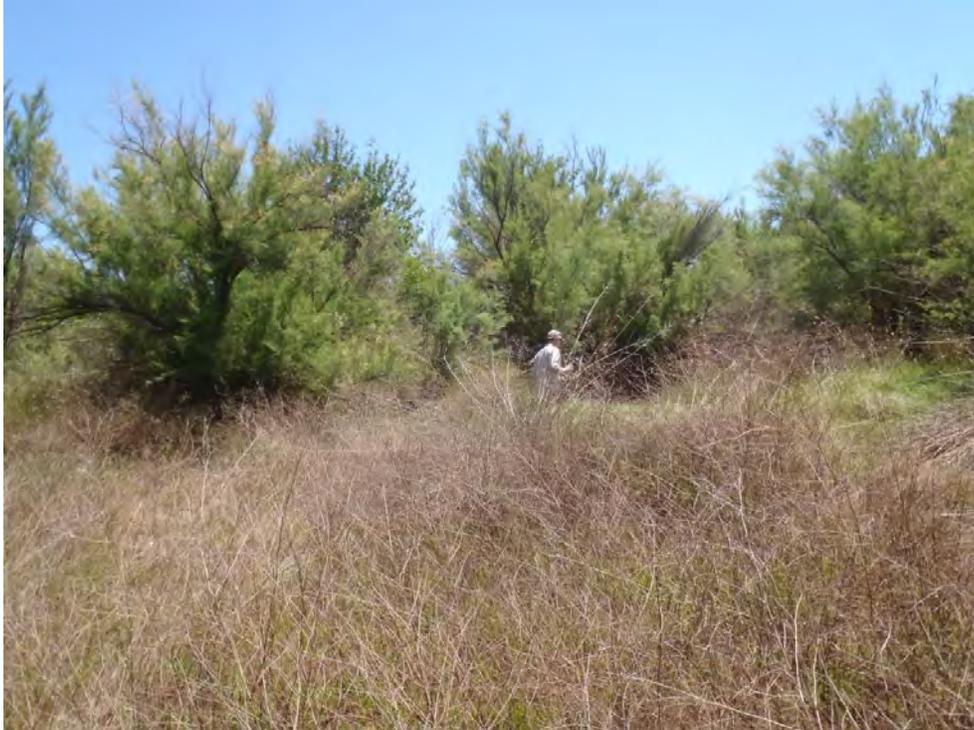
Figure 4.31 Photograph of PD009 taken on June 6, 2013. Downstream view at the 30-m transect. Note thick vegetation and brush on the banks. TIAER personnel in photograph.

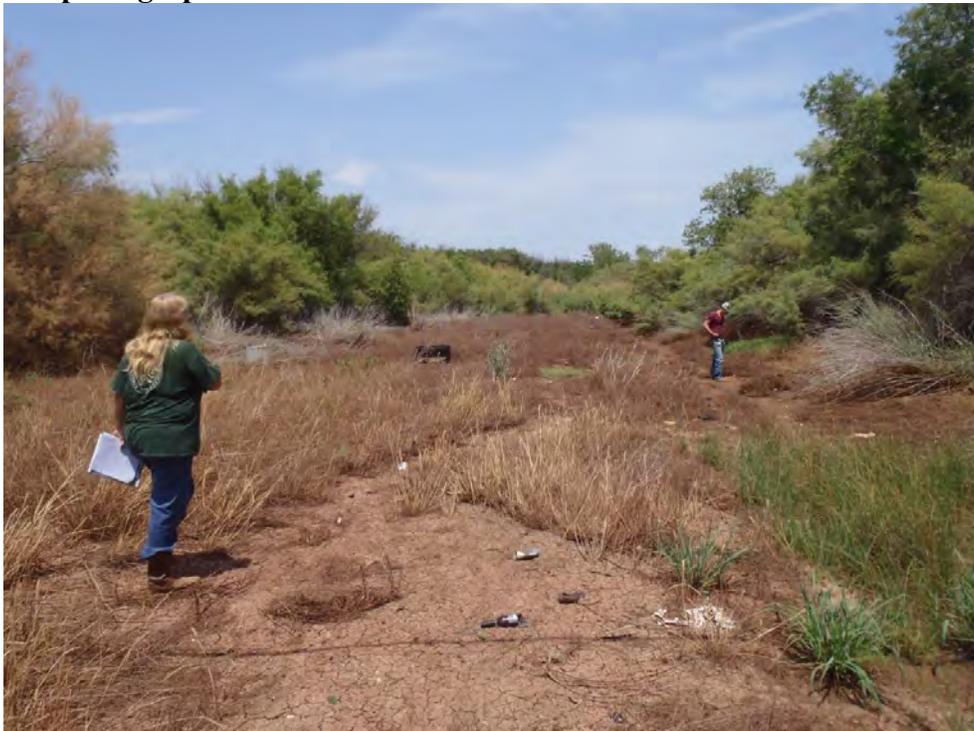
Figure 4.32 Downstream view of the 300-m transect at Site PD009 taken August 11, 2013. Note lack of water and scattered garbage in the channel. TIAER personnel in photograph.

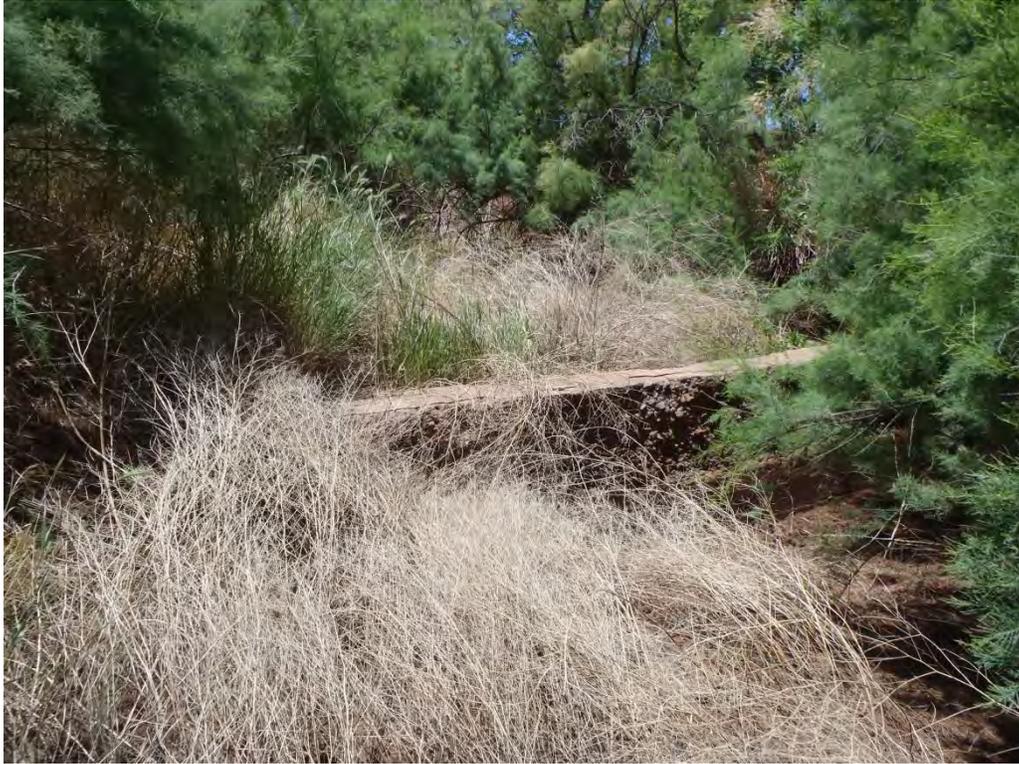
This segment of the Paradise Creek was dry with an average thalweg of 0.00 m during both surveys (Tables 4.6, 4.7 and 4.8). No water was observed in the stream nor measured. A man-made stone dam was observed at approximately at the 45-m transect (Figure 4.35).

Figure 4.35 Photograph of PD011 taken June 9, 2013. Upstream view of the 30-m transect. Note the dense vegetation and the stone dam.

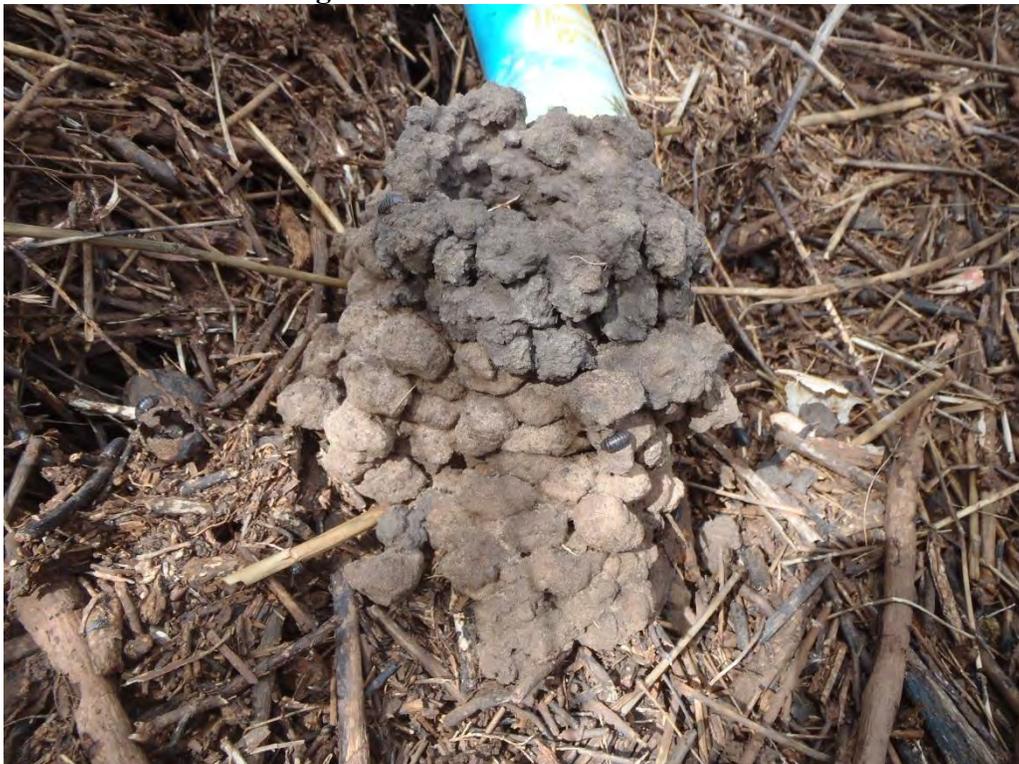
Figure 4.36 Photograph of PD011 taken August 12, 2013 of a crawfish burrow.

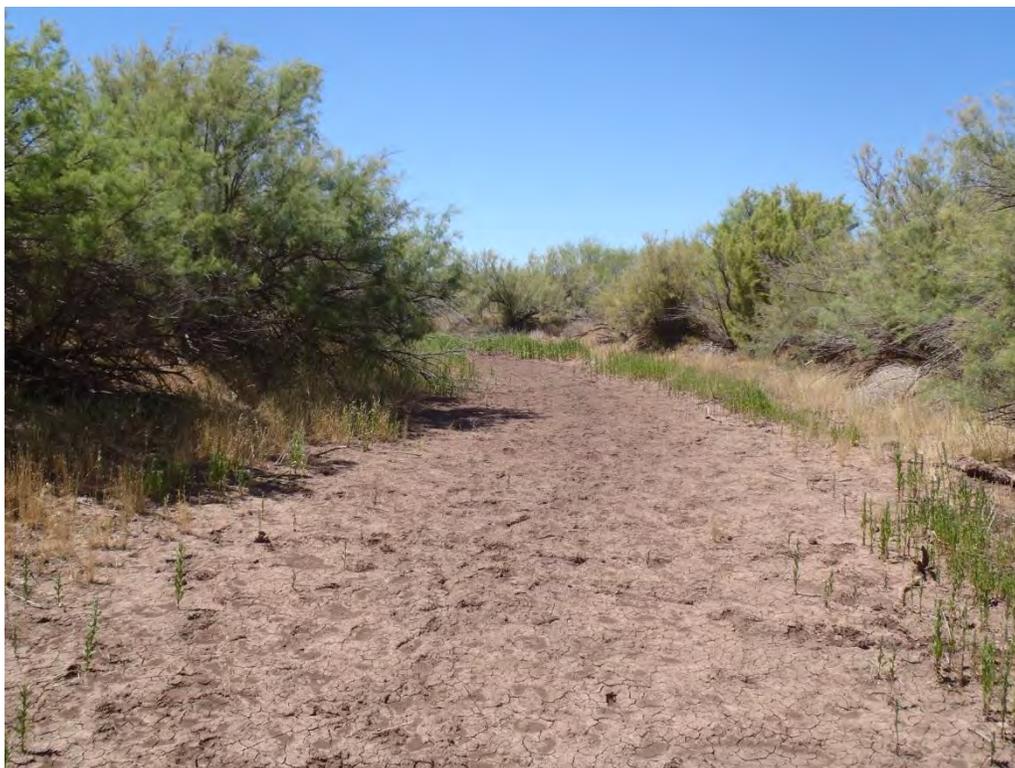
Figure 4.37 Photograph of PD012 taken June 10, 2013. Downstream view of the 150-m transect. Note the lack of water, shrub dominated banks and animal tracks in the creek bed.

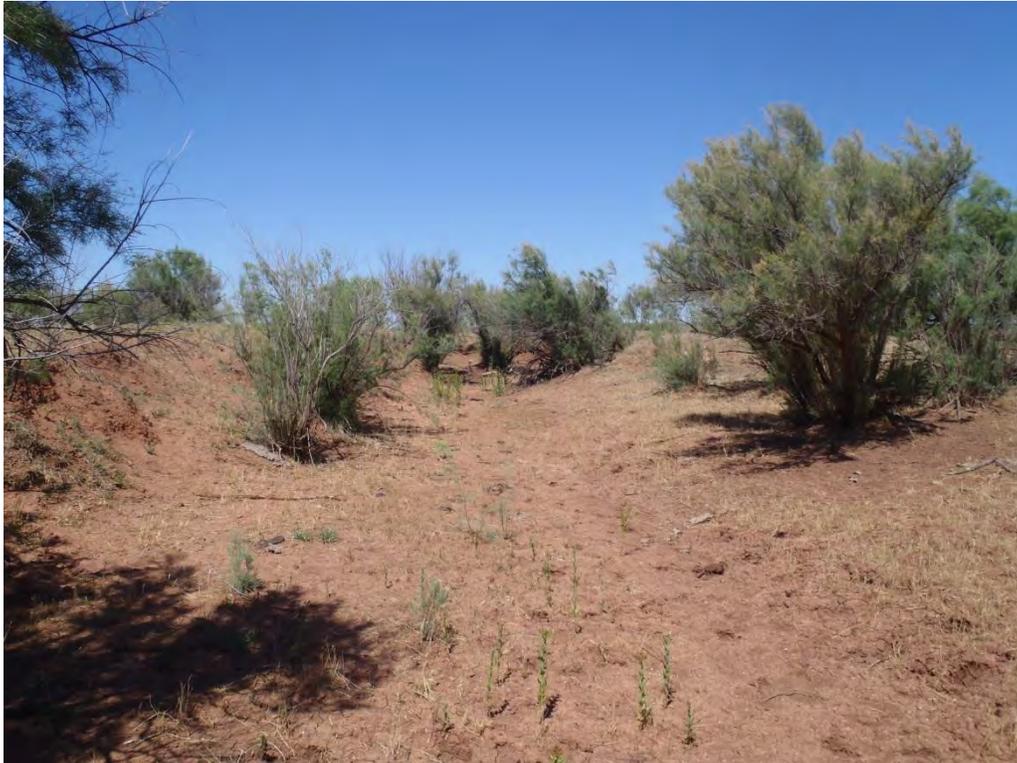
Figure 4.38 Photograph of PD013 taken June 10, 2013. Upstream view at the 150-m transect. Note the minimal brush, livestock tracks and lack of water.

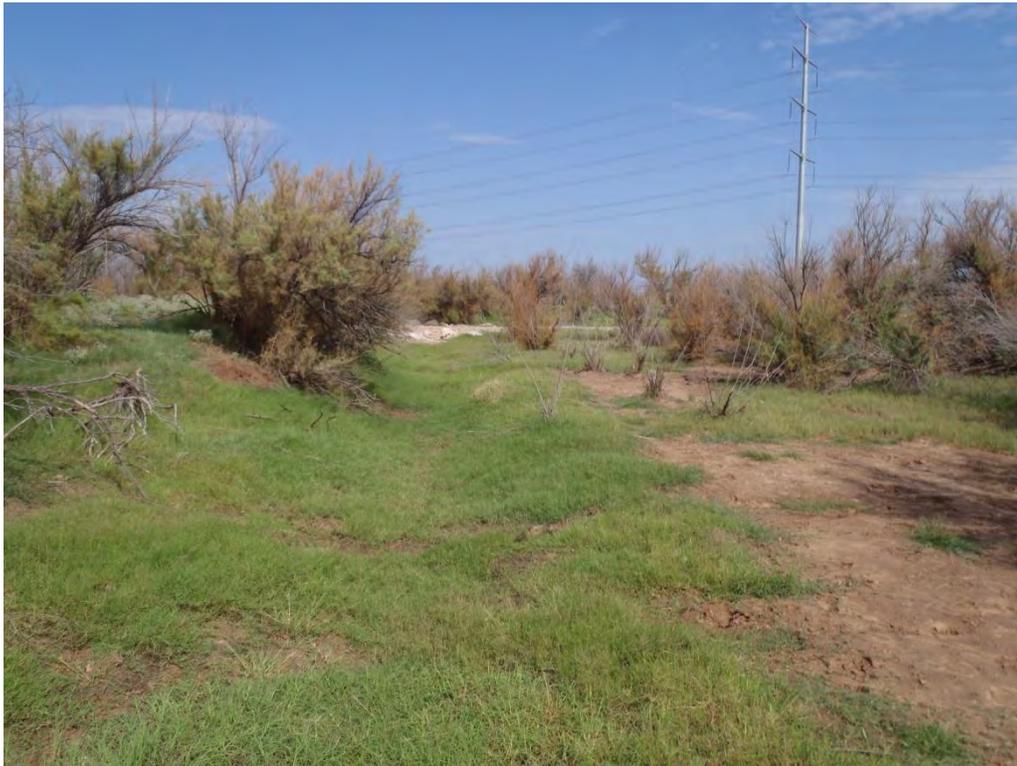
Figure 4.40 Photograph of PD014 taken August 12, 2013. Upstream view of the 150-m transect. Note open corridor with minimal brush and transmission line right of way bisecting the creek

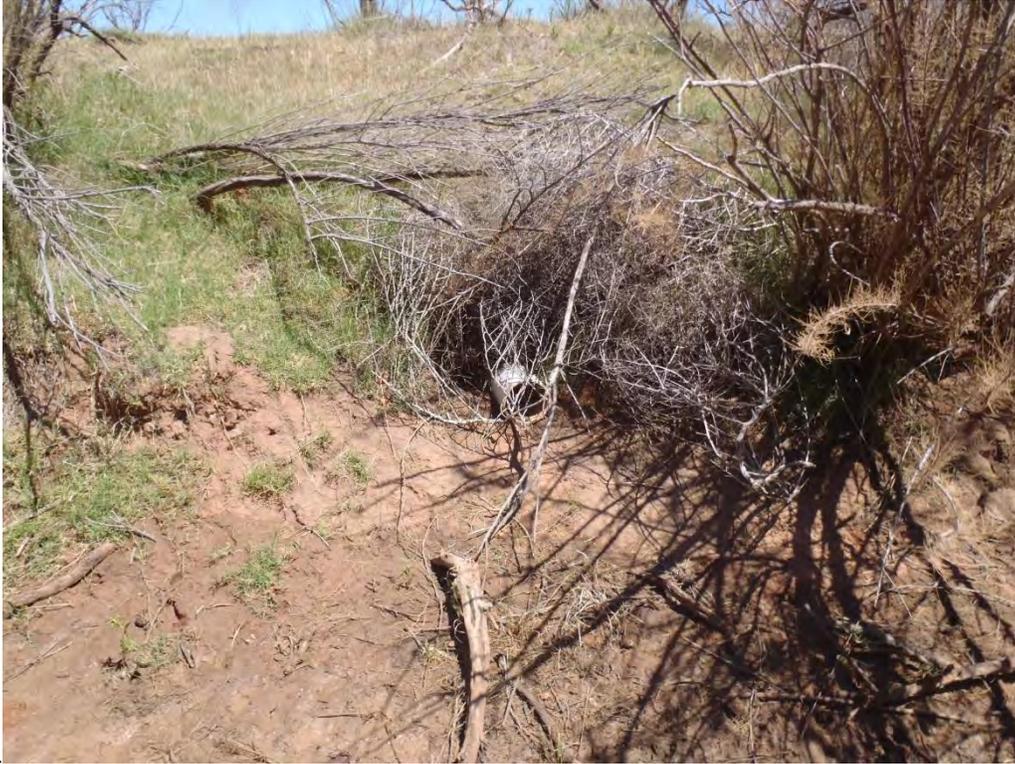
Figure 4.41 Photograph of PD014 taken June 10, 2013 of a tile drain at the 120-m transect.

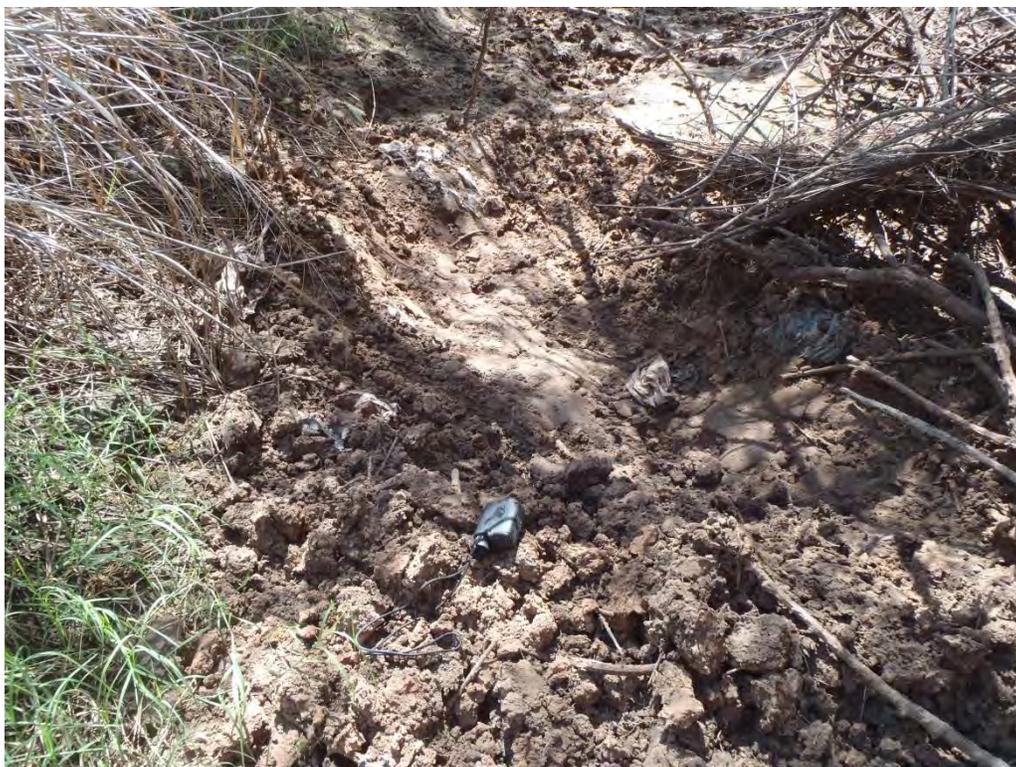
Wildlife evidence included tracks of deer, raccoon, hog and bobcat. Hog wallows were also observed (Figure 4.43). Fecal material of deer and birds were observed in the creek. Some dead crayfish were seen along with bleached cow bones. Garbage was abundant in the creek, especially during the second survey. This included tires, bricks, pipe, a bucket, cardboard, discarded tarp, glass bottles, aluminum cans, and various plastics (Tables 4.9 and 4.10). A working pump jack and petroleum storage tanks existed within approximately 50m of the stream at this site. Also, during the time the surveys were taking place, construction of new transmission lines was in progress in the immediate area. Construction traffic was noticeable on County Road 138. No evidence of human recreation was observed at this site.

Figure 4.43 Photograph of PD015 taken August 12, 2013 of hog wallow at 180-m transect with range finder placed for scale. Note garbage in the dried mud.

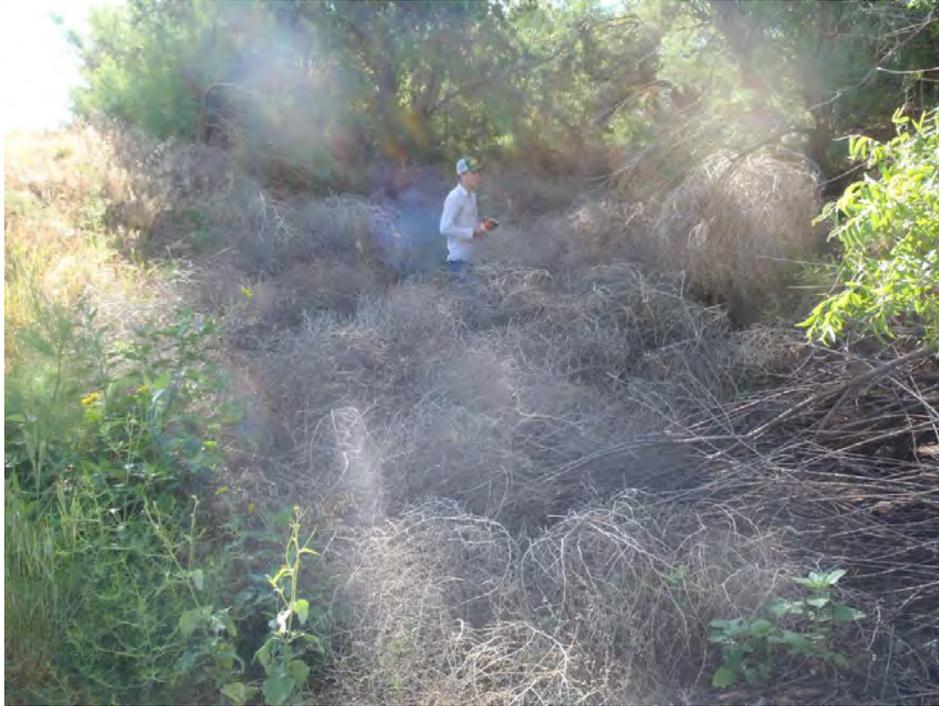
Figure 4.44 Photograph of PD016 taken June 10, 2013 of accumulation of tumbleweeds in the channel. TIAER personnel in photograph.
