Recreational Use Attainability Analysis for Buffalo Creek (0214B), Paradise Creek (0230A), and Sweetwater Creek (0299A) in the Red River Basin

Prepared for:
Texas State Soil and Water Conservation Board
Project 12-52

Texas Institute for Applied Environmental Research
Tarleton State University
Stephenville, Texas

TR 1308

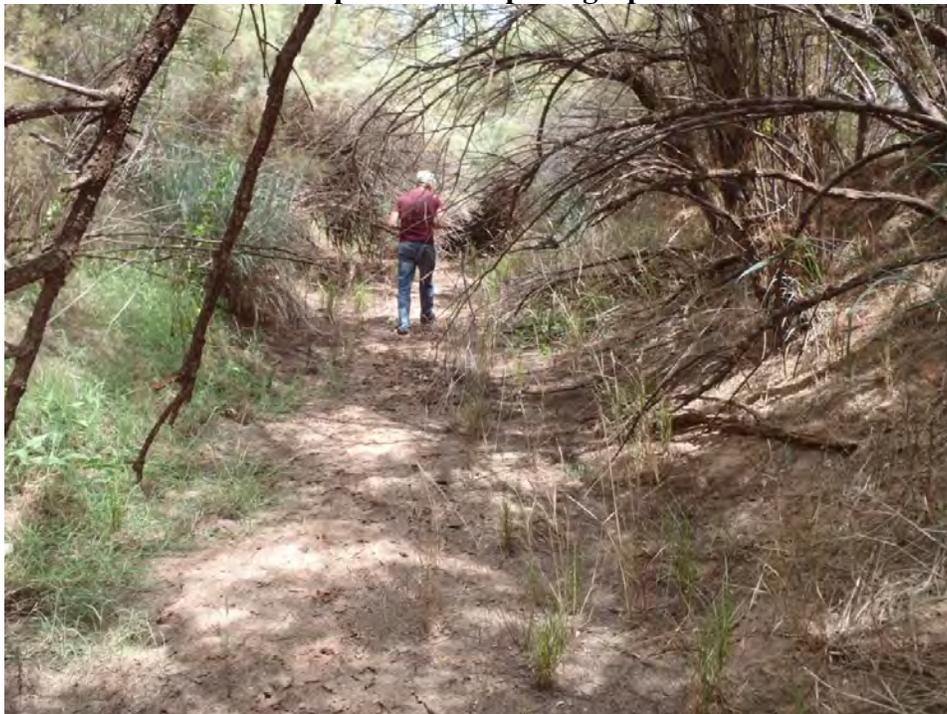
Figure 4.45 Photograph of PD016 taken August 11, 2013. Downstream view at the 150-m transect. Note densely vegetated banks, lack of water and grass in the channel. TIAER personnel in photograph.

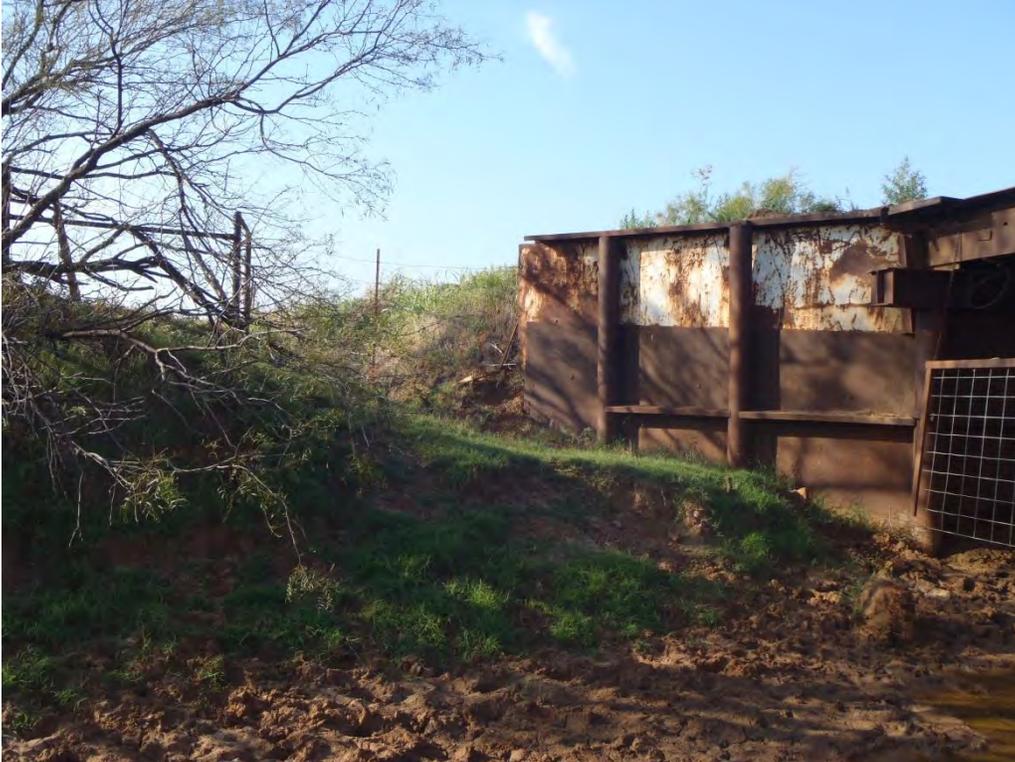
This site was surveyed on June 9 and August 13, 2013. Although access to this site is considered public, private fencing was built up to the bridge on both sides (Figure 4.46). Therefore, this site has significantly limited public access availability (Table 4.6). Permission from the landowner was granted to enter the stream. Barbed wire fencing and steep banks at the bridge initially made access moderately difficult. The channel was deep, however the banks were grassy and gently sloping with frequent livestock trails leading into the creek. All other travel through the creek at this site was easy and no obstacles were encountered.

Figure 4.46 Photograph of PD017 taken August 13, 2013 of limited access at bridge. Note the private fencing connecting to bridge.

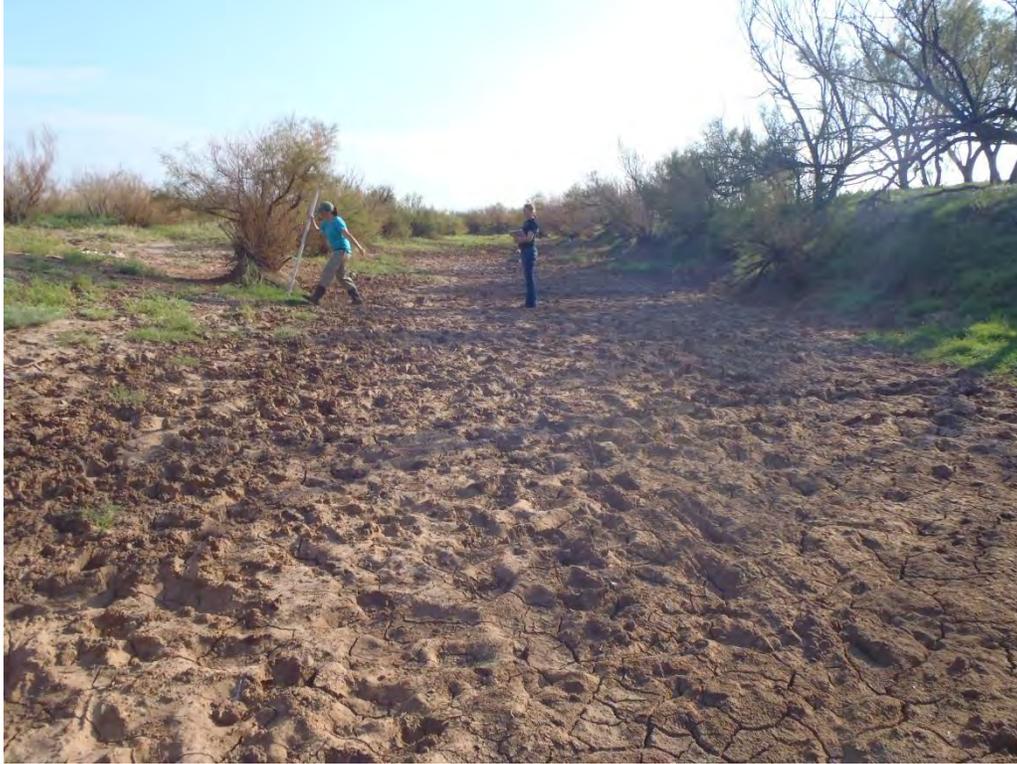
Figure 4.47 Photograph of PD017 taken August 13, 2013. Downstream view at the 300-m transect. Note lack of water, pasture at the top of the banks with some shrubs on the bank and in the channel. TIAER personnel in photograph.

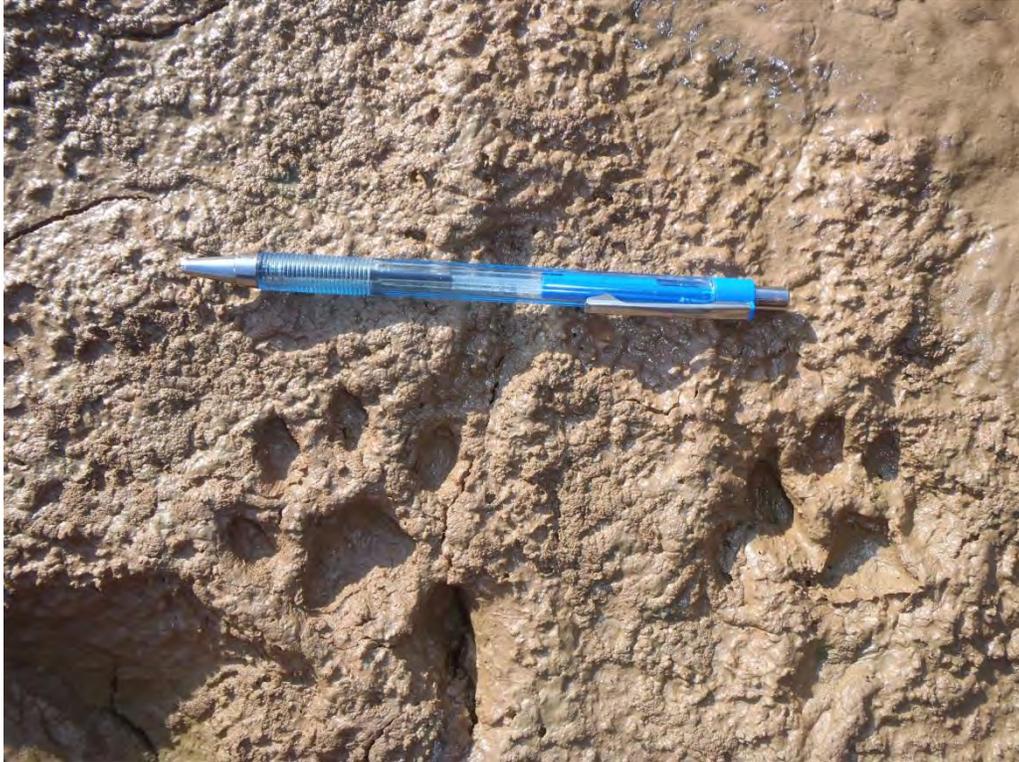
Figure 4.48 Photograph of PD017 taken August 13, 2013 of bobcat tracks.

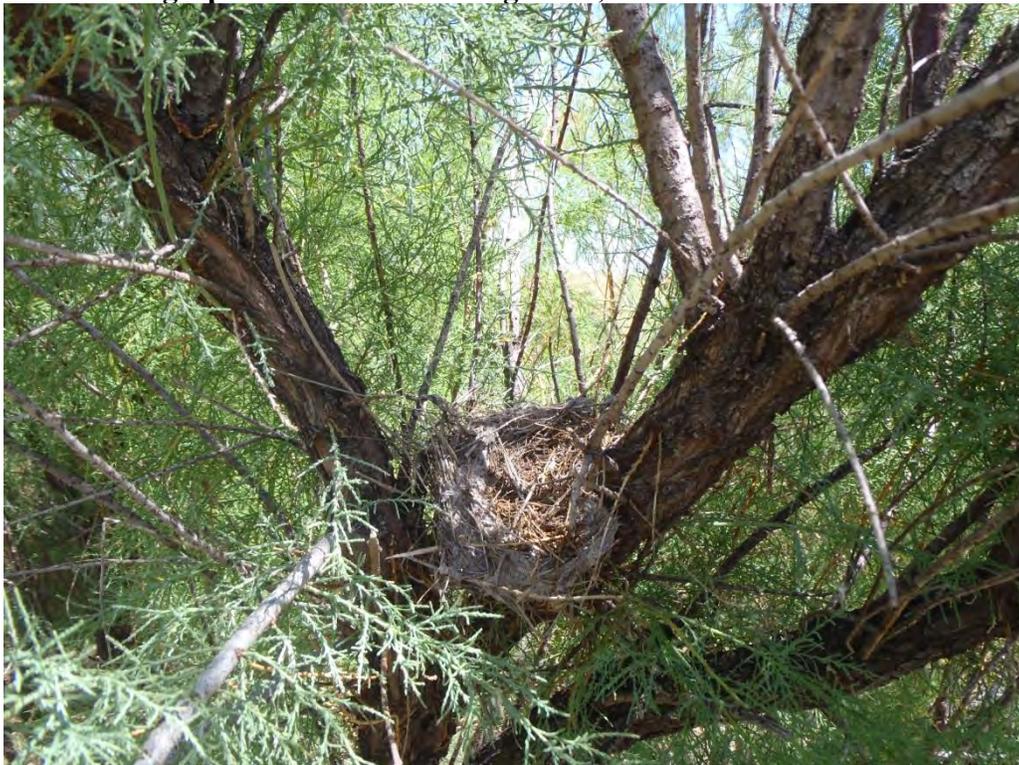
Figure 4.49 Photograph of PD017 taken June 9, 2013 of a bird nest.

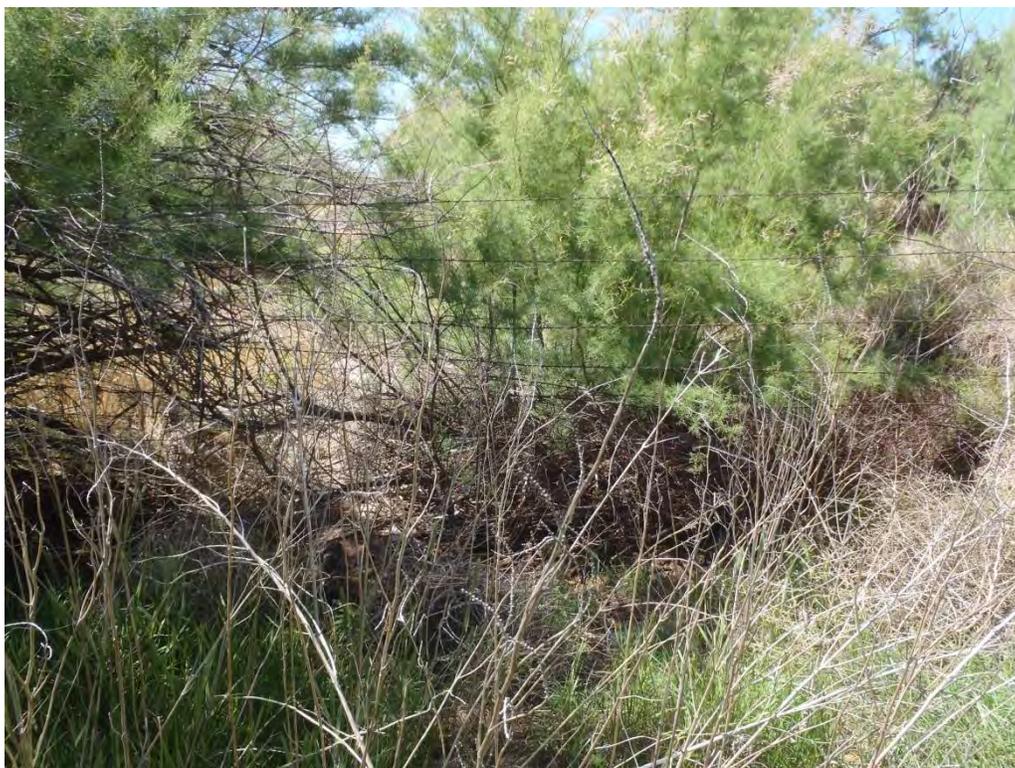
Figure 4.50 Photograph of PD018 taken June 9, 2013. Downstream view at the 300-m transect taken from the county road crossing. Note the private property barbed wire fence limiting public access.

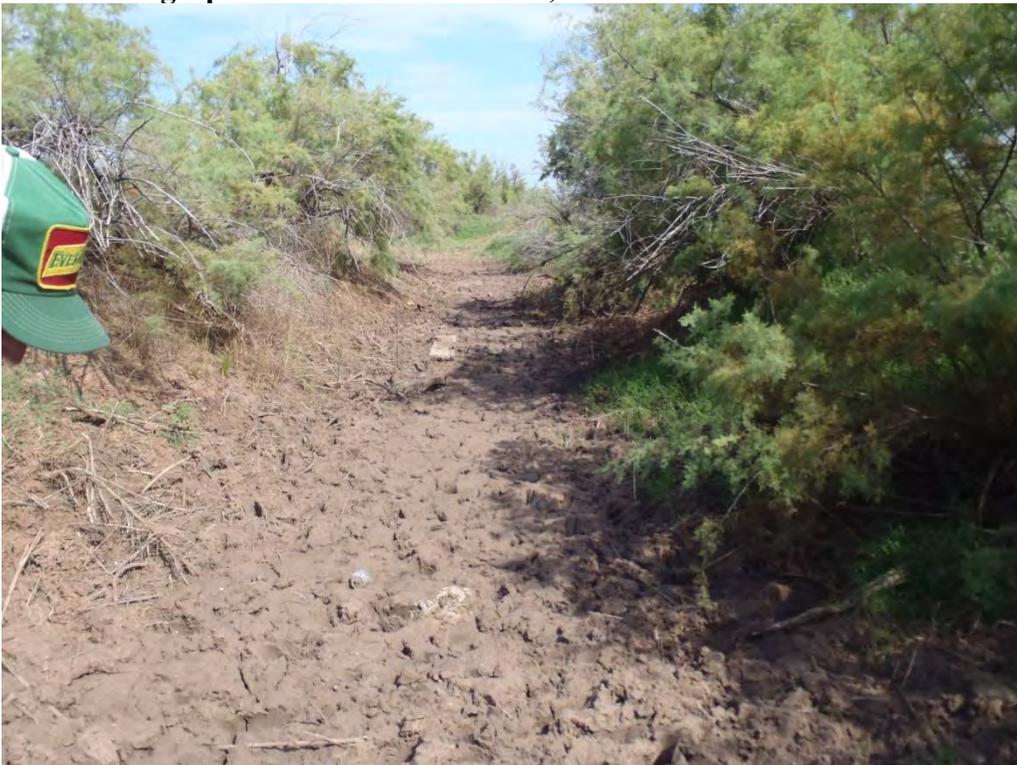
Figure 4.52 Photograph of PD018 taken August 12, 2013. Downstream view at the 300-m transect. Note lack of water, garbage in the stream and shrub dominated corridor. TIAER personnel in photograph.

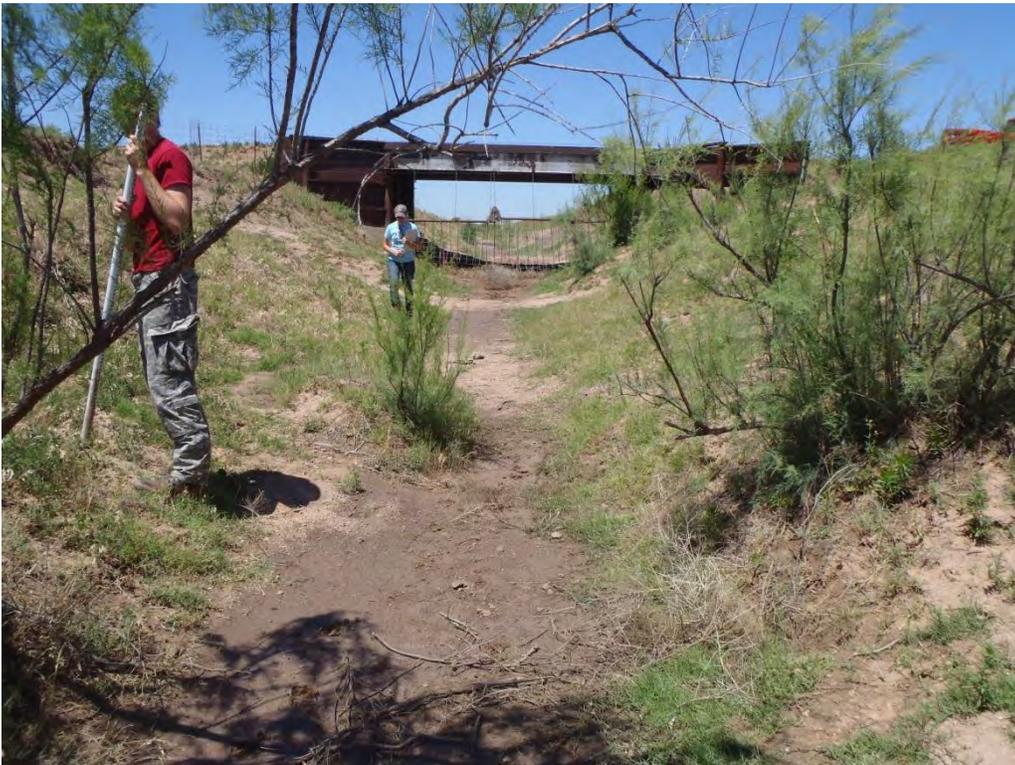
Figure 4.53 Photograph of PD020 taken June 10, 2013. Upstream view at 300-m transect. Note limited public access point. TIAER personnel in photograph.

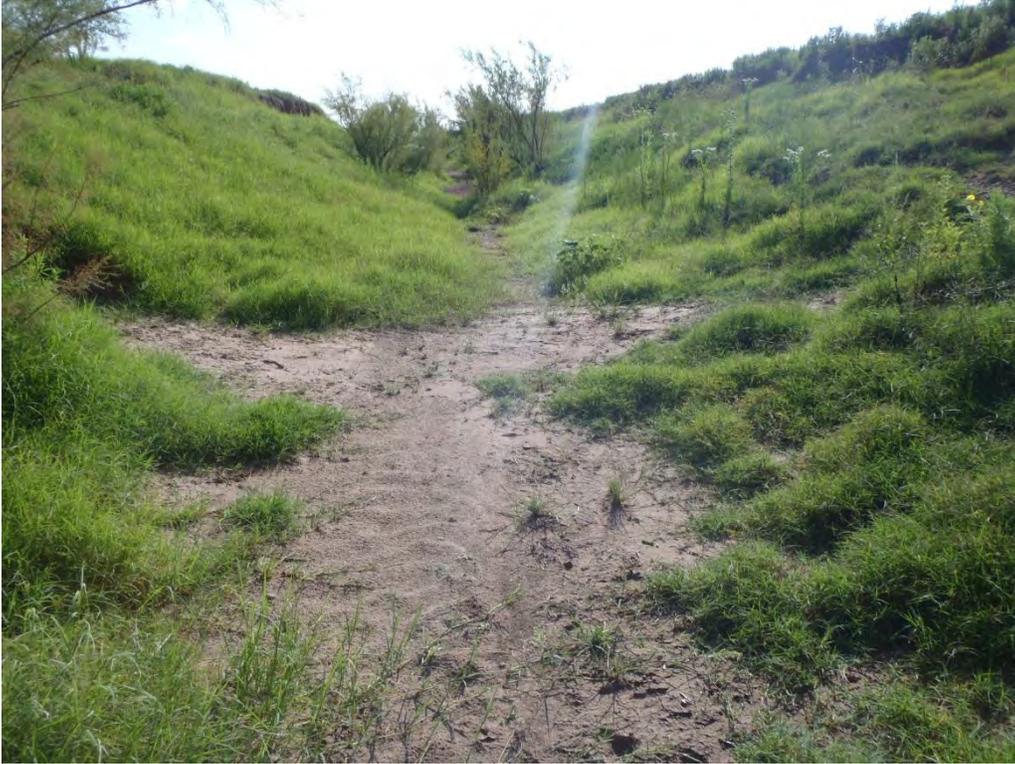
Figure 4.54 Photograph of PD020 taken August 13, 2013. Downstream view at the 300-m transect. Note lack of water, gentle slopes with improved grass and some shrubs.

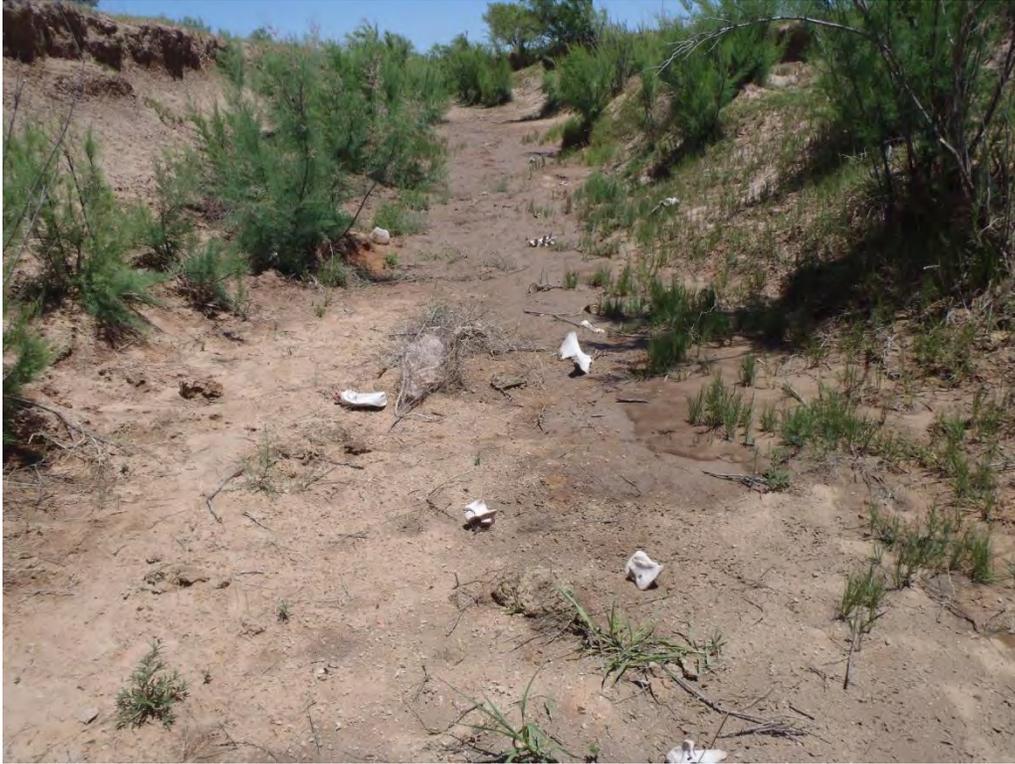
This segment of Paradise Creek was dry with an average thalweg of 0.00 m during both surveys (Tables 4.6, 4.7 and 4.8). No water was observed or measured at this site. The primary substrate was clay/mud (Table 4.5). The corridor was dominated by improved pasture on the right bank and cultivated field on the left bank. However, some brush existed in the stream bed.

Figure 4.55 Photograph of PD021 taken on June 10, 2013. Downstream view of the 150-m transect. Note the sloping banks, brush along stream and scattered cow bones.

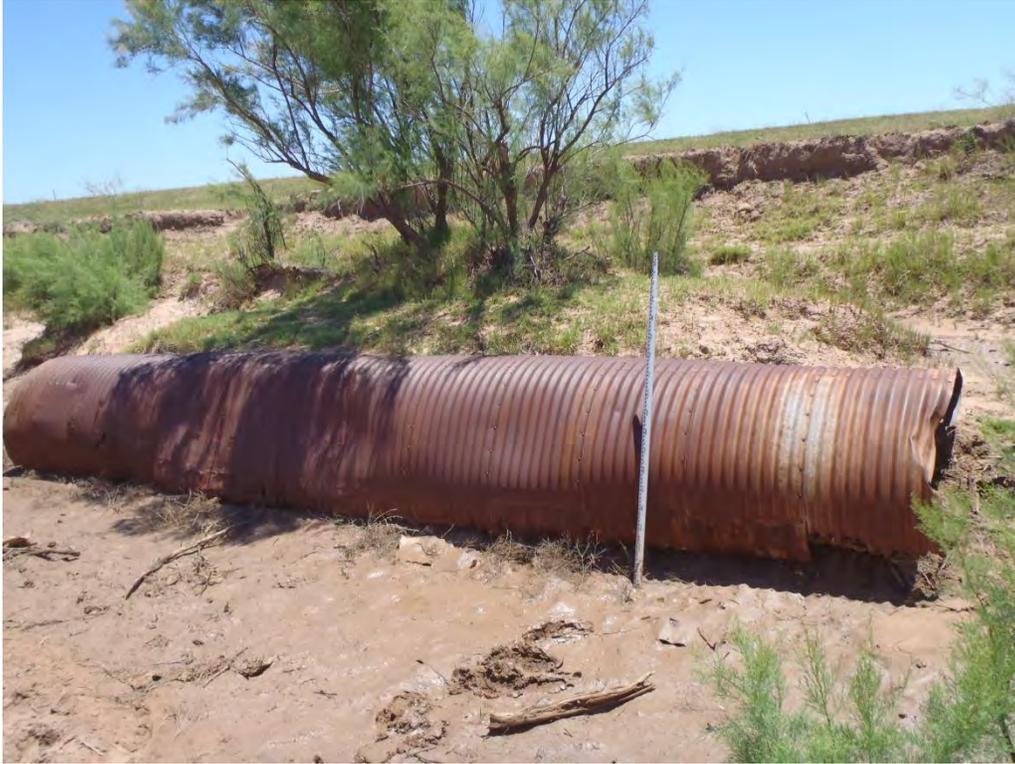
Evidence of wildlife observed included tracks of deer, hog, canine, rabbit, kangaroo rat and armadillo. Bird droppings and cow manure were seen as were the bleached bones of a cow. At the 0-m transect brick and concrete debris were observed in the creek. Between the 150-m and 300-m transects a large steel pipe, approximately 3-ft diameter was observed lying in the creek parallel with the banks (Figure 4.56). Garbage at this site was rare but did include baling twine, tire, scrap metal, a spent shotgun shell, discarded outdoor tablecloth, trash bag, tarp, glass bottles and aluminum cans (Tables 4.9 and 4.10). No evidence of human recreation was observed at this site.

Figure 4.56 Photograph of PD021 taken June 10, 2013 of steel pipe in stream. Note wading rod leaning against it for scale.

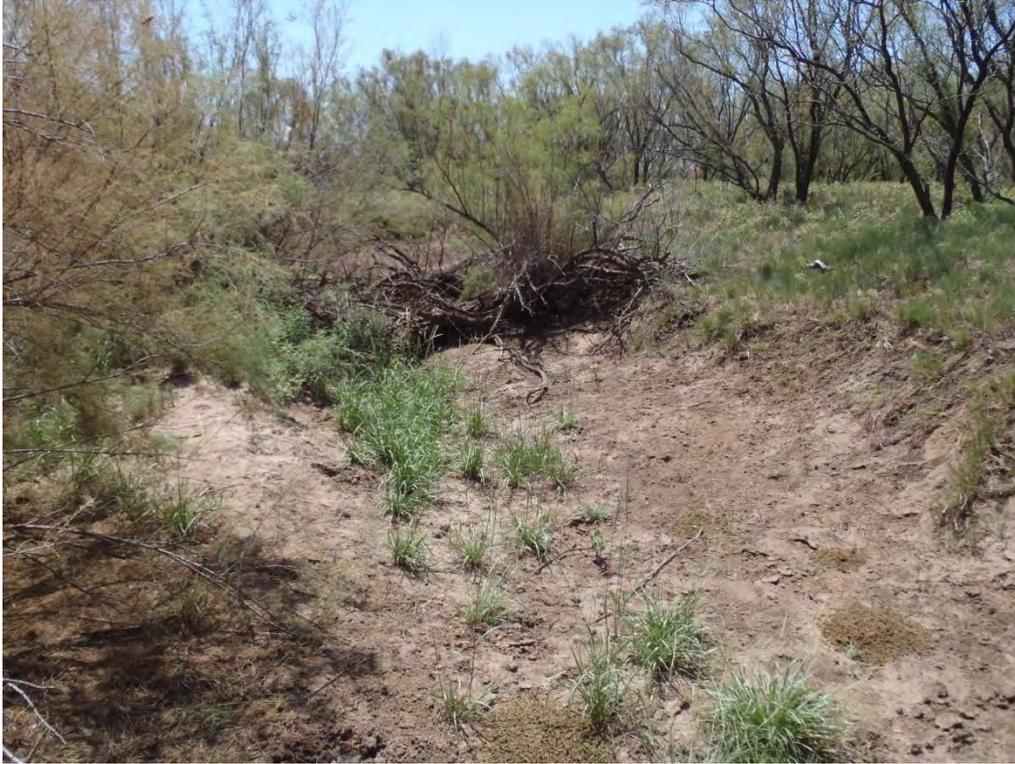
Figure 4.57 Photograph of PD022 taken August 12, 2013. Upstream view of the 300-m transect. Note lack of water, log obstruction, shrub and grass dominated corridor.

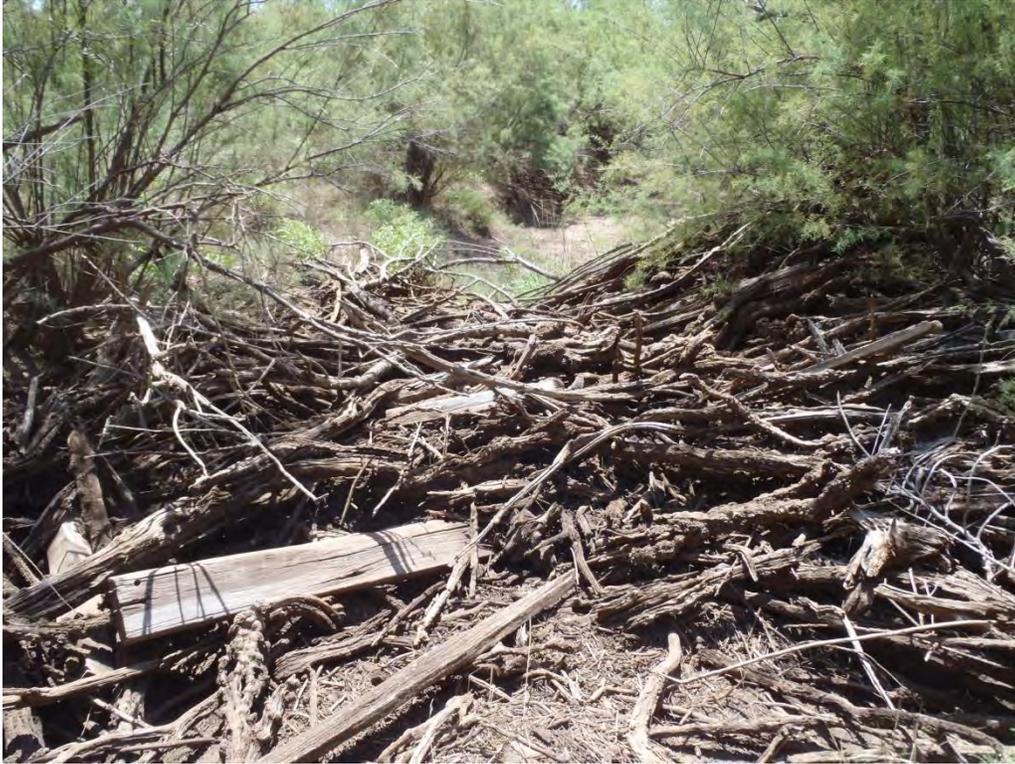
This site was surveyed June 10 and August 12, 2013. Access to this site was through a private gate only with landowner permission. Once at the site, access to the stream channel was moderately easy (Table 4.6). It lacked water, the bottom was dry and firm with gently sloping banks and a few log obstructions (Figure 4.58). Heavy vegetation added some difficulty to conducting the survey at this site.

Figure 4.58 Photograph of PD023 taken June 10, 2013 of a log obstruction.

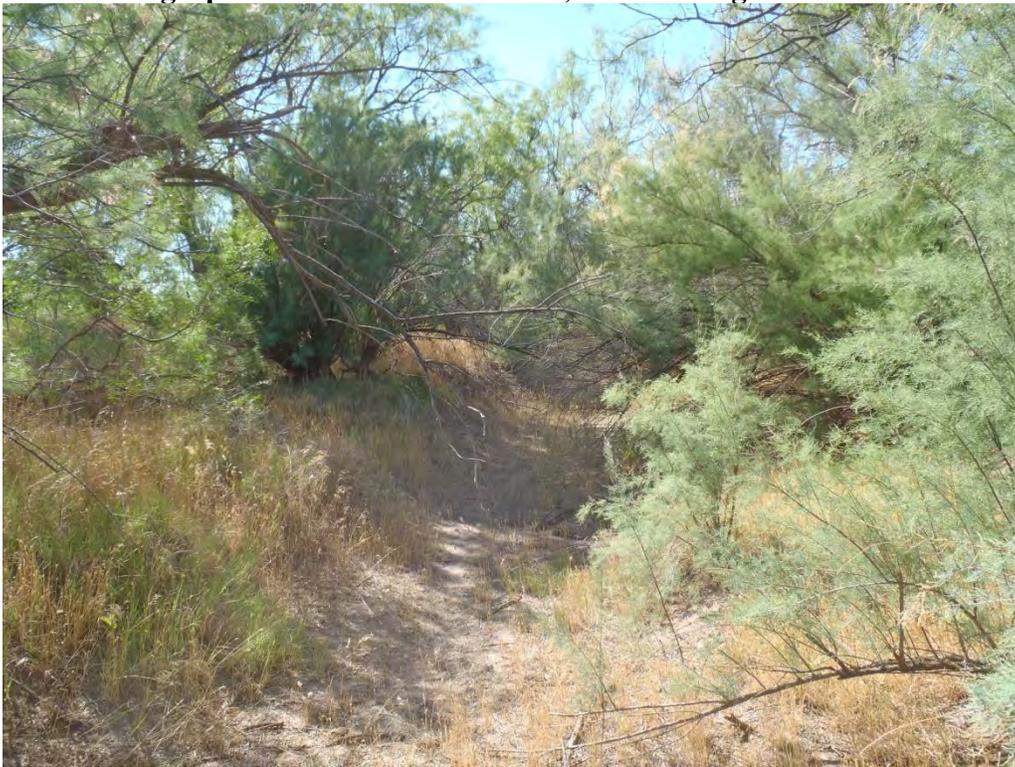
Figure 4.59 Photograph of PD023 taken August 12, 2013. Upstream view at the 150-m transect. Note shrub and grass vegetation on the banks and lack of water.

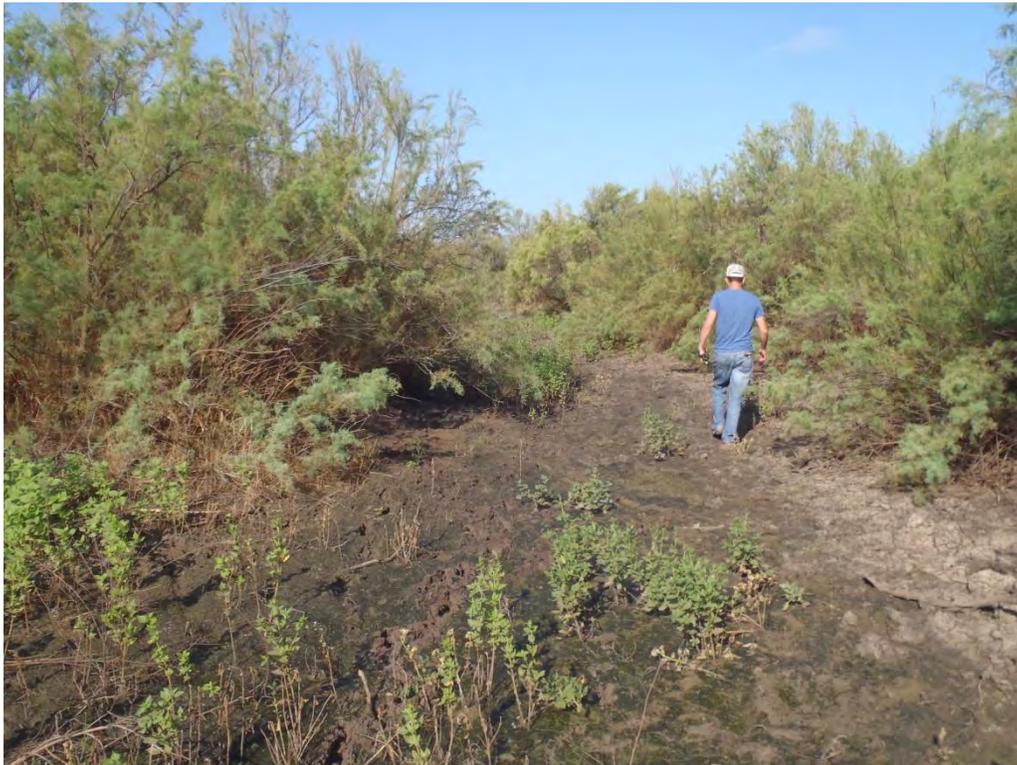
The primary substrate was a mud/clay. The corridor was primarily shrubland (Table 4.5 and Figure 4.60). Banks were gently sloping. Evidence of wildlife presence was rare, however hog tracks were observed (Tables 4.9 and 4.10). Tracks and manure of cattle were noted as well. The only garbage observed was during the first survey of a small compressed-helium tank. No evidence of human recreation was observed at this site (Figure 4.61).

Figure 4.60 Photograph of PD 024 taken August 13, 2013. Upstream view of the 150-m transect. Note lack of water and dense bank vegetation. TIAER personnel in photograph.

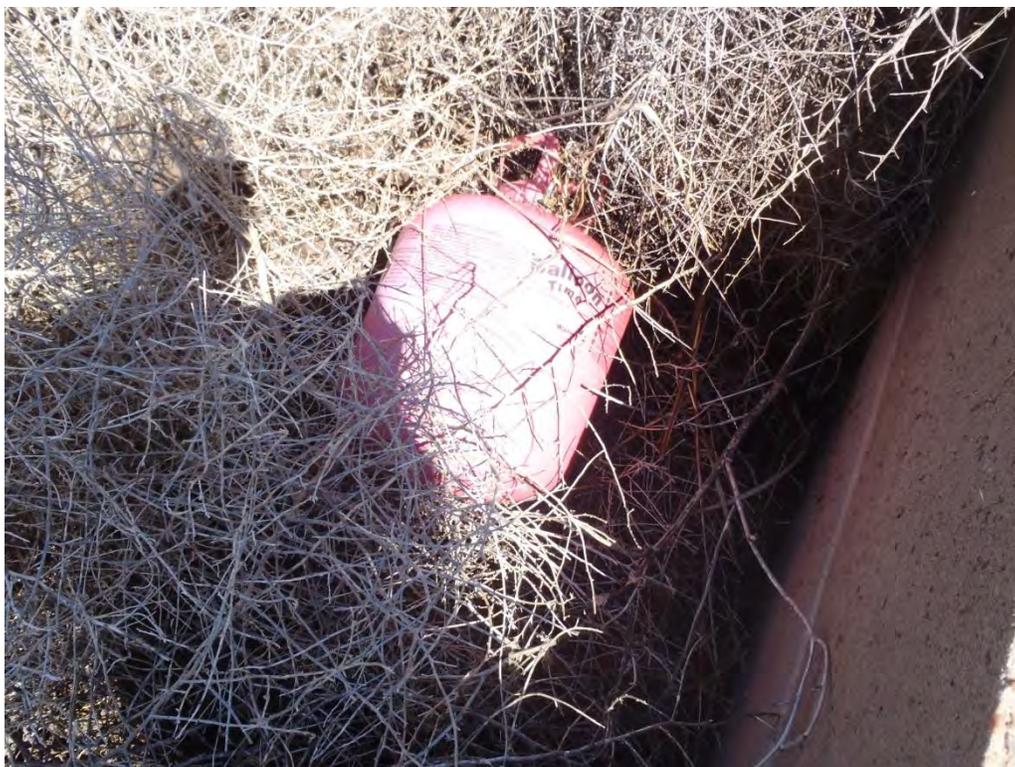
Figure 4.61 Photograph of PD024 taken June 9, 2013 of a compressed-helium tank.

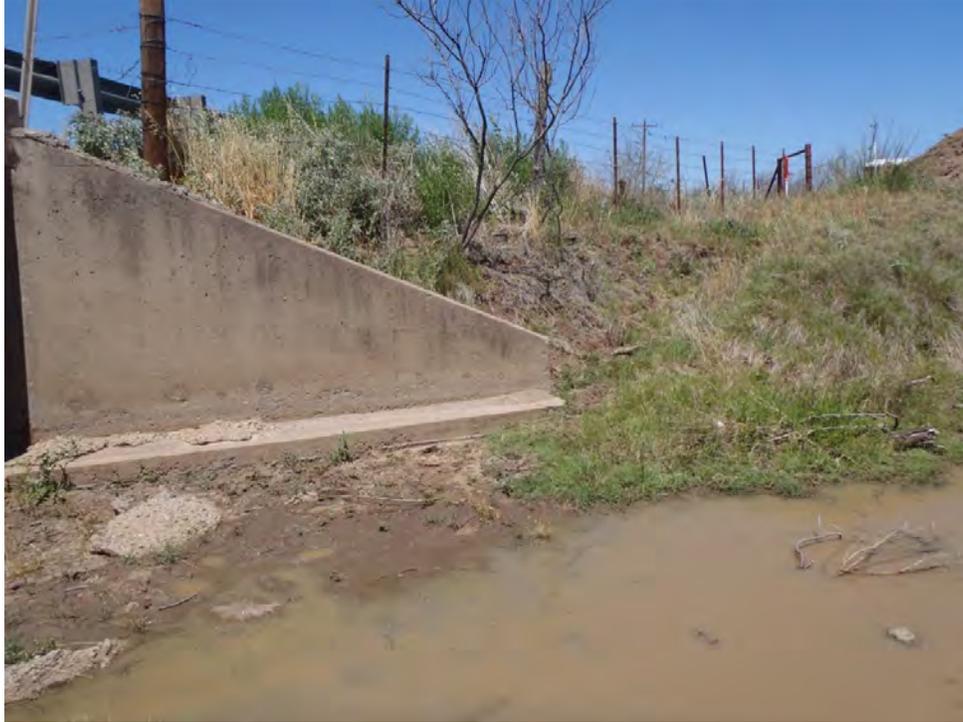
This site was surveyed June 10 and August 12, 2013. Access to the stream at this site is only possible from the bridge crossing. Private fencing was built up to the sides of the bridge (Figure 4.62), and landowner permission was required to access the site through a closed gate in order to conduct the survey (Table 4.6). Once at the site, travel through the stream was easy, except for a few pockets of water where wading through the mud was difficult.

Figure 4.62 Photograph of PD025 taken June 10, 2013. Left bank view at the 300-m transect. Note fence line built up to edge of bridge limiting public access and presence of water.

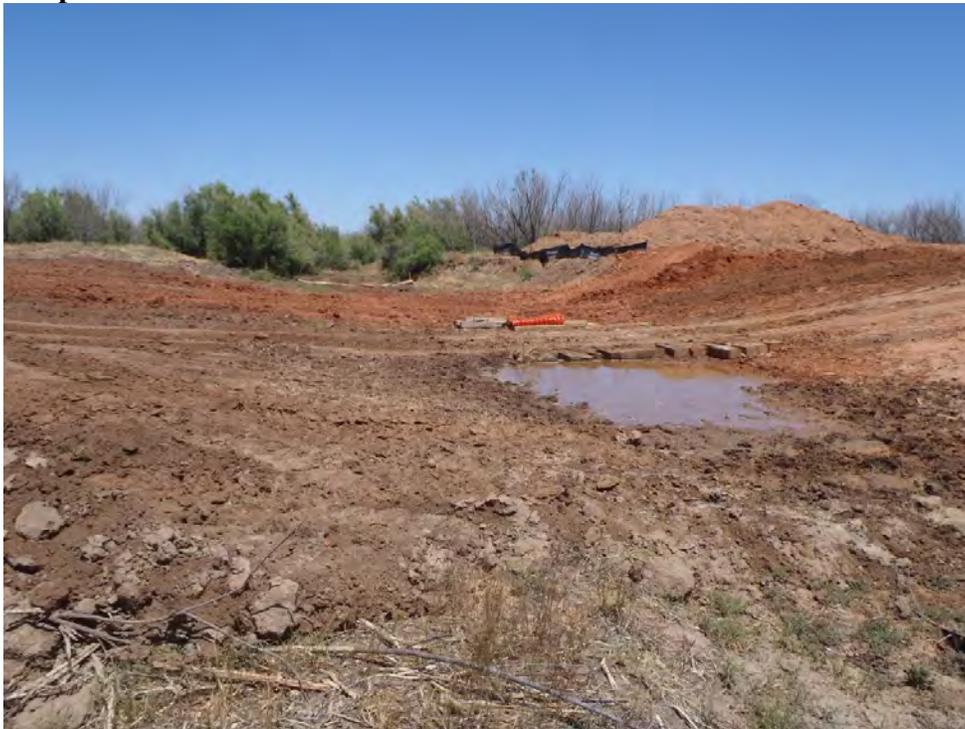
Primary substrate consisted of a clay/mud mix. The corridor at this site was dominated by shrubs on both banks. Current construction of a power line right of way bisected the creek between the 150-m and 300-m transects, which formed a break in the bank vegetation (Table 4.5). This section of the creek had been excavated to develop a low crossing across the creek for vehicles. Additionally, erosion control structures and related materials were present in the channel and along the banks within the vicinity of the construction activity (Figure 4.63). During the first survey water surfaces had foam and scum and the color of the water was green. During the second survey water surfaces had only scum and the color had become brown (Figure 4.64).

Figure 4.63 Photograph of PD025 taken June 10, 2013 of power line construction right of way crossing the stream between 300-m and 150-m transects. Note excavated earth, pocket of water and erosion control structures.

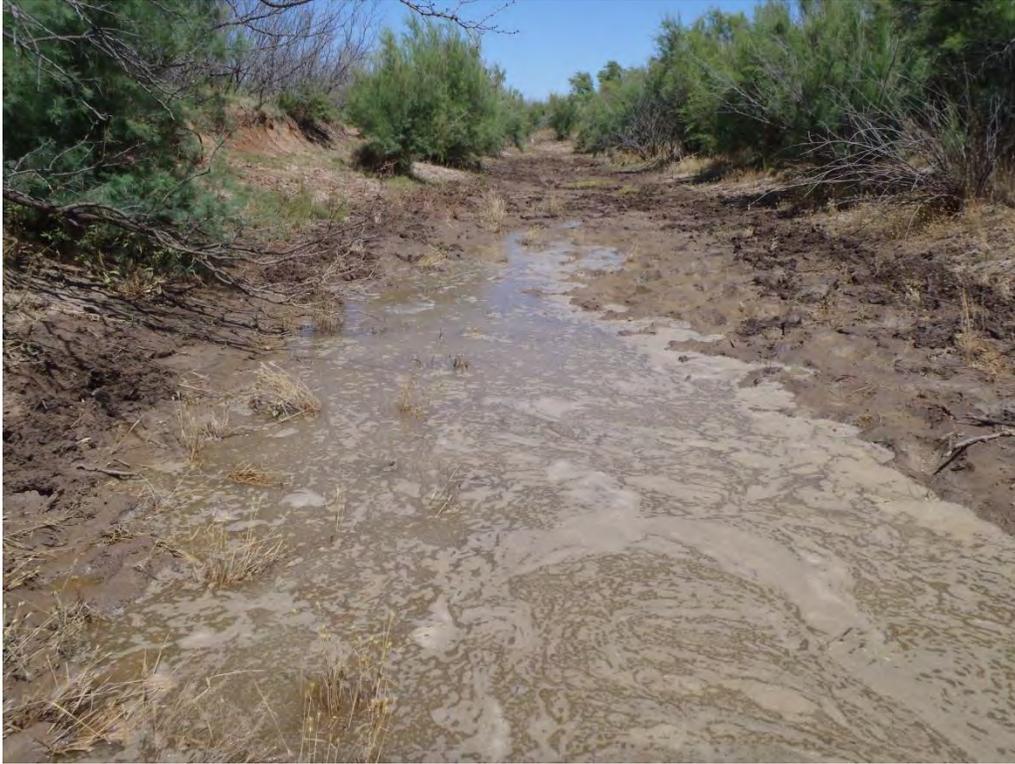
Figure 4.64 Photograph of PD025 taken June 10, 2013. Downstream view at the 150-m transect. Note foam/scum on water and shrub dominated banks.

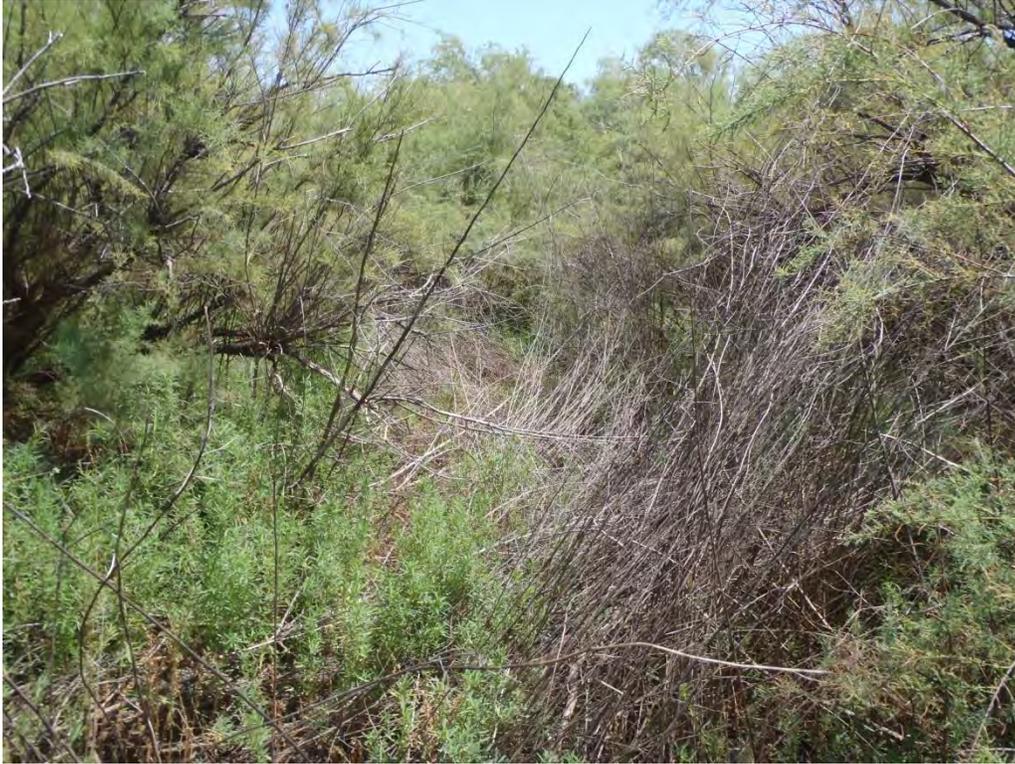
This site was surveyed June 9 and August 12, 2013. This site is publically accessible at the bridge on CR 288 and at a transmission line road. Nevertheless, landowner permission was obtained prior to conducting the surveys. Accessing this site for the survey was moderately difficult primarily because of dense vegetation (Table 4.6 and Figure 4.65).

Figure 4.65 Photograph of PD026 taken August 12, 2013. Downstream view at the 300-m transect. Note the dense vegetation.

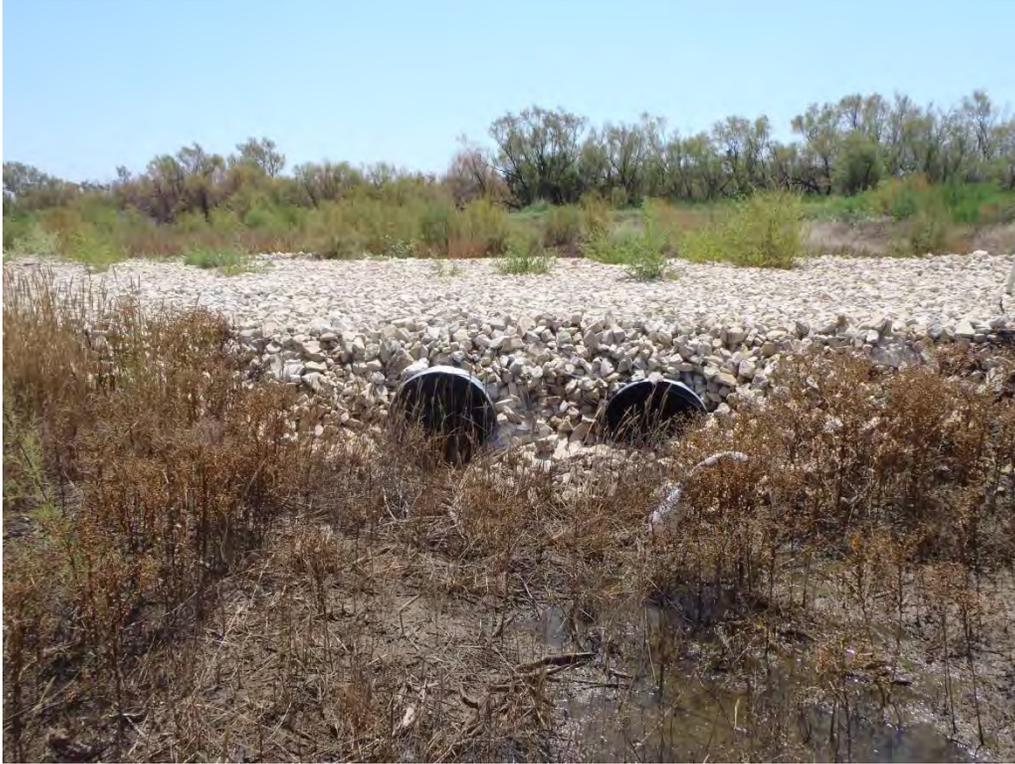
Similarly to PD025, new transmission line construction and a right of way bisected the creek between the 30m and 150m transects. However a more substantial crossing had been built including a culvert and rip-rap (Figure 4.66). A flatbed trailer loaded with transmission line components was observed near the riparian area (Figure 4.67).

Figure 4.66 Photograph of PD026 taken August 12, 2013 of the transmission line right of way located between the 30-m and 150-m transects.

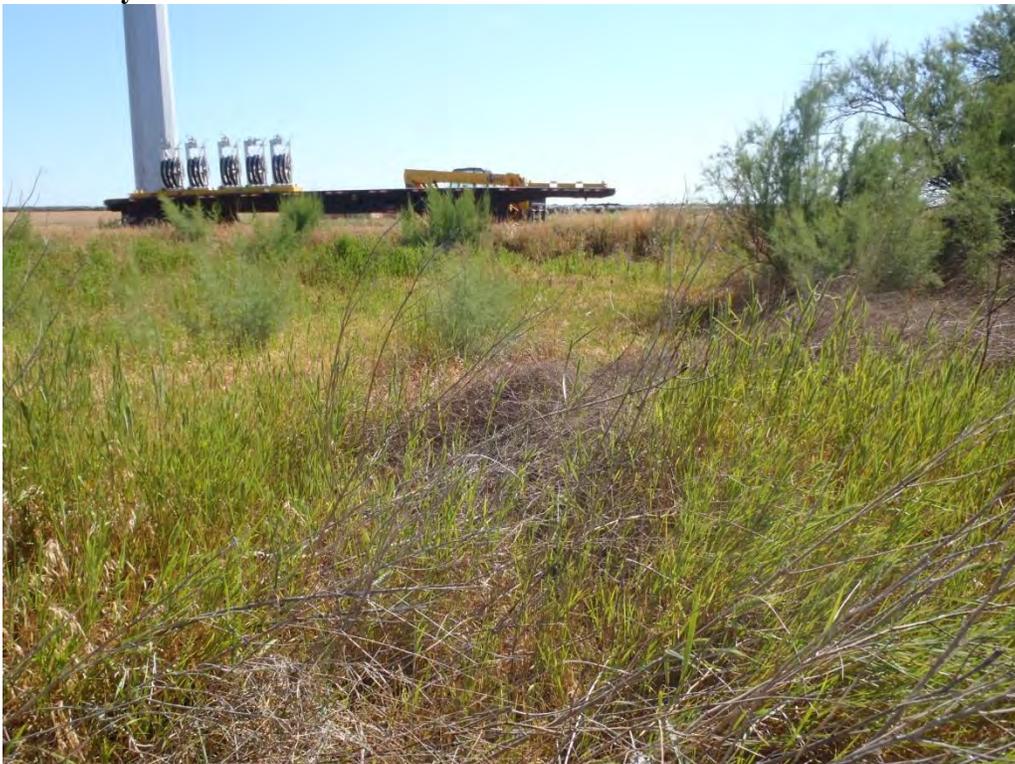
Figure 4.67 Photograph of PD026 taken June 9, 2013. Left bank view at the 30-m transect. Note the flatbed trailer loaded with transmission line components.

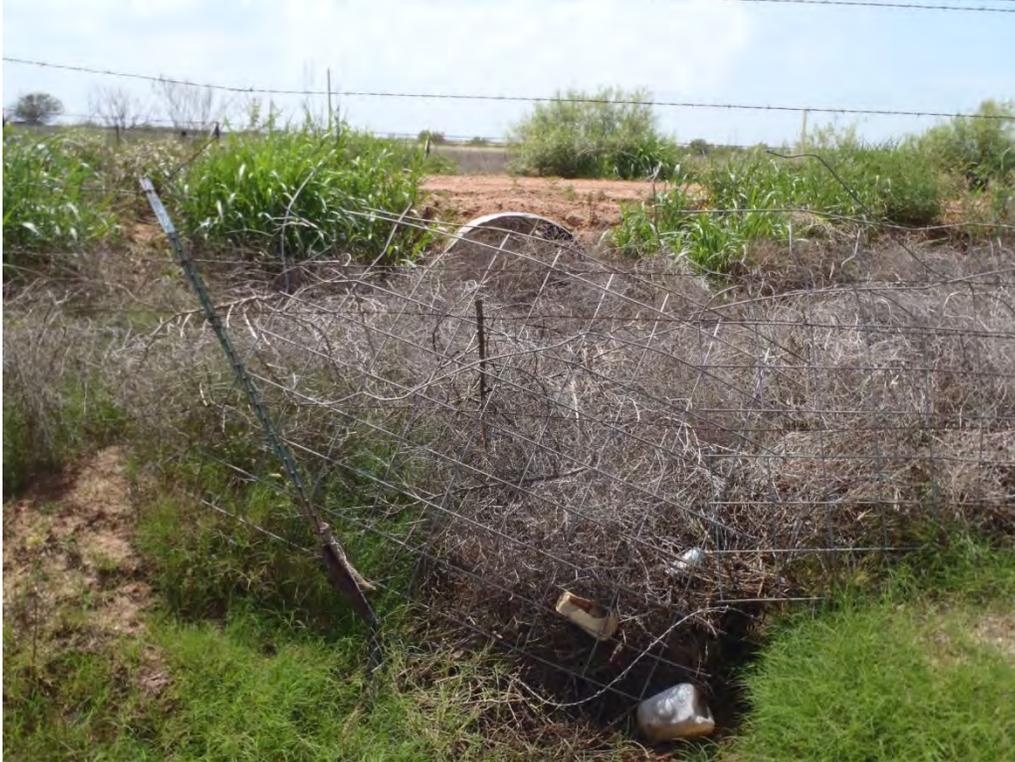
This site was surveyed June 9 and August 11, 2013. It was accessible from the county road bridge, however, landowner permission to cross a private fence was required to conduct the entire survey (Figure 4.68). Traversing the stream was easy as it had no water in it, the bottom was dry and firm with gently sloping banks and only a few log obstructions (Table 4.6).

Figure 4.68 Photograph of PD027 taken August 11, 2013. Upstream view at the 300-m transect. Note limited public access at the county road, private fence and garbage.

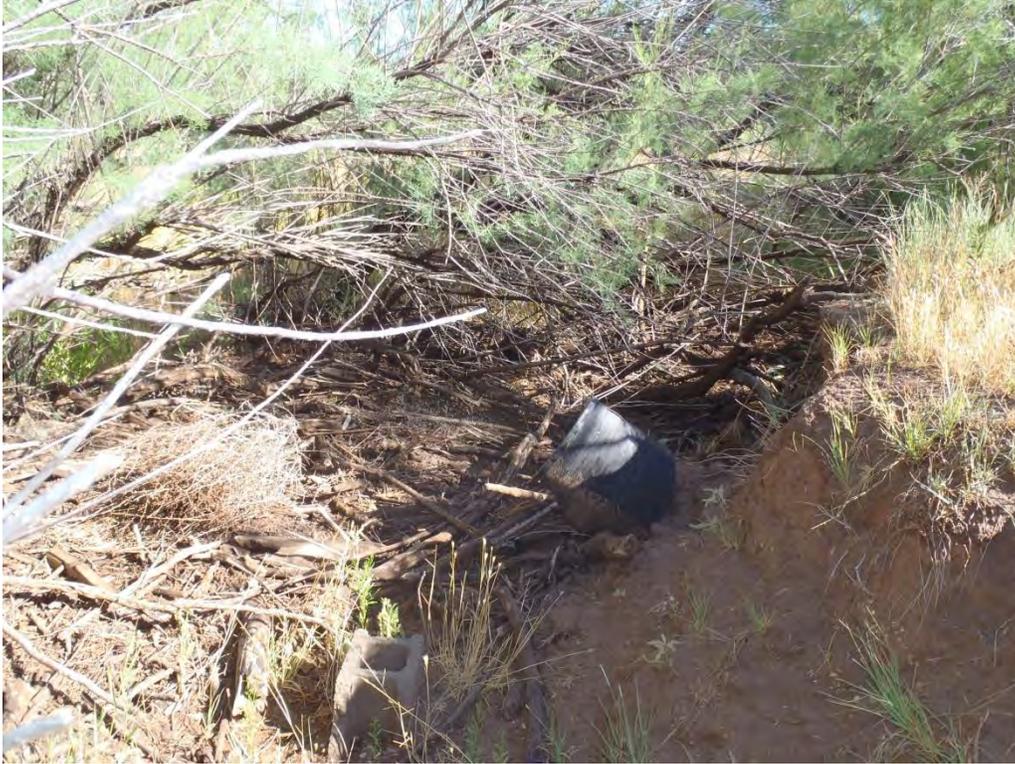
Evidence of wildlife presence was rare, however, tracks of hog, raccoon, and deer were observed in addition to bird droppings (Tables 4.9 and 4.10). Field crews reported seeing a rabbit in the stream bed as well as a deer carcass. Tracks and manure of cattle were seen in the creek and four bulls were encountered in the pasture. Small amounts of garbage were only detected in the channel. Glass bottles, aluminum cans, tires, concrete block, discarded lumber, and livestock mineral tubs were the only garbage observed at this site (Figure 4.69). No evidence of human recreation was observed at this site.

Figure 4.69 Photograph of PD027 taken June 9, 2013. Note log obstruction, livestock mineral bucket and concrete block.

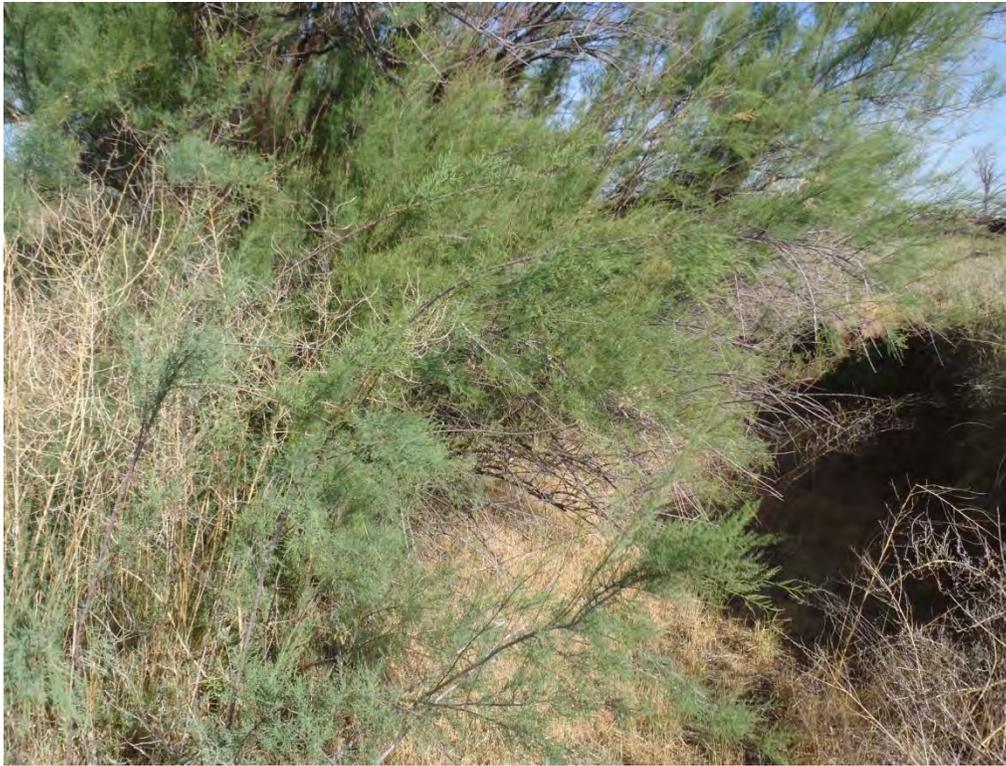
This site was surveyed June 11 and August 13, 2013. Access to this site was through a private gate only with landowner permission. Once at the site, access to the stream channel was moderately easy (Table 4.6). It lacked water, the bottom was dry and firm with gently sloping banks and a few log obstructions. Heavy vegetation added some difficulty to conducting the survey at this site (Figure 4.70).

Figure 4.70 Photograph of PD028 taken June 11, 2013. Log obstruction and dense vegetation at 200-m transect.

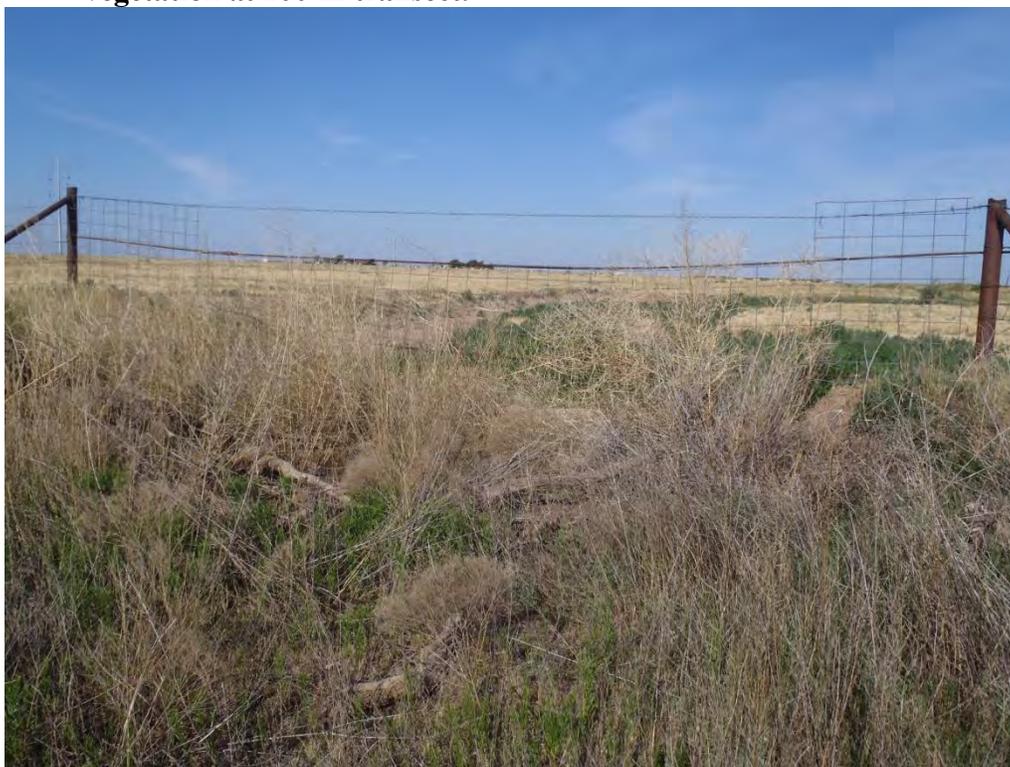
The primary substrate was a mud/clay but the creek was dry therefore mud was not encountered. The area immediately at the edge of the creek has some shrubby vegetation but is primarily native pasture up to the edge of the creek (Table 4.5 and Figure 4.71).

Figure 4.71 Photograph of PD028 on June 11, 2013. Upstream view of the 300-m transect. Note private fence bisecting the creek and pasture dominated corridor.
