Recreational Use Attainability Analysis for Buffalo Creek (0214B), Paradise Creek (0230A), and Sweetwater Creek (0299A) in the Red River Basin

Prepared for:
Texas State Soil and Water Conservation Board
Project 12-52

Texas Institute for Applied Environmental Research
Tarleton State University
Stephenville, Texas

TR 1308

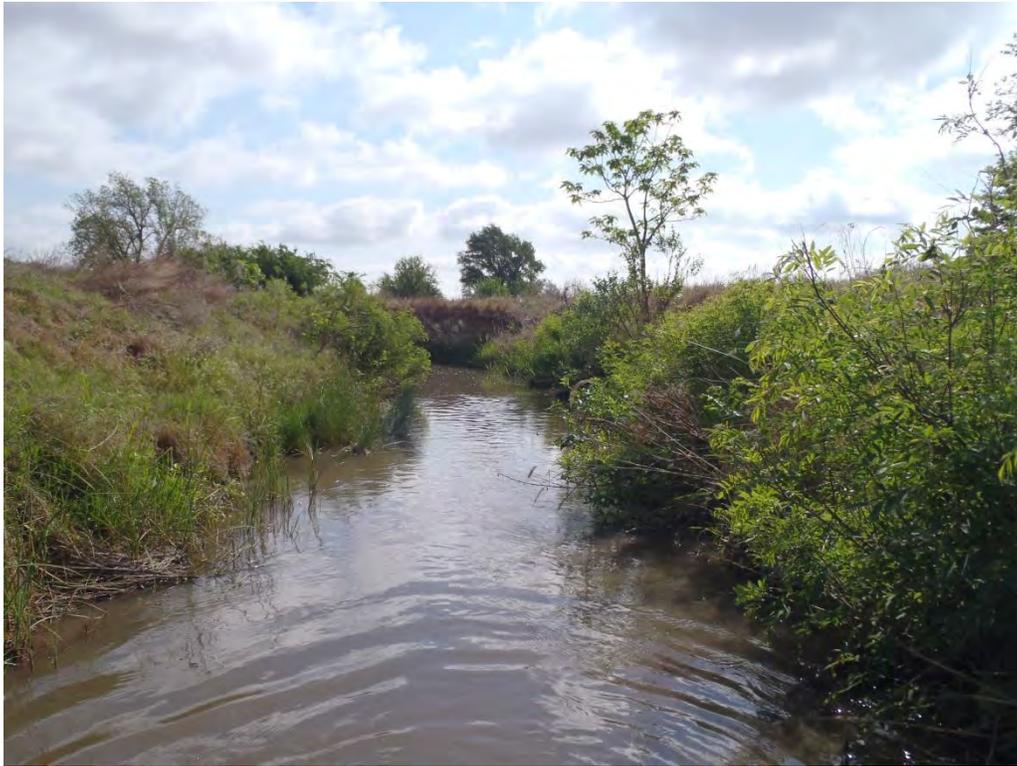
Figure 5.3 Photograph of Sweetwater Creek Site SW001 taken on May 26, 2013. The downstream view of the 300-m transect.

Site SW001 was wadeable for the entire 300-m reach length. During the first survey in May, the shallow water, average thalweg of 0.31 meters, and the sandy substrate made for easy wading. During the second survey in July, the lack of any water made walking in the streambed easy. Figures 5.3 and 5.4 represent the site with and without the presence of water. Stream widths ranged from 5.5 m to 2.6 m during the first survey and 0 m during the second survey (Tables 5.7 and 5.8).

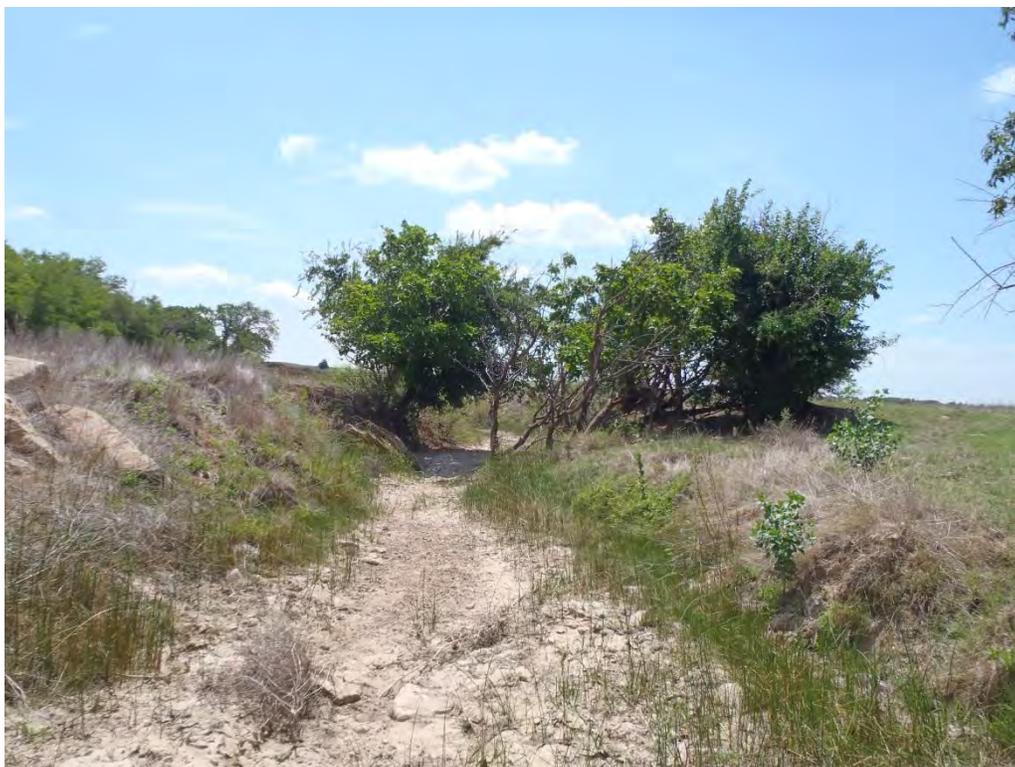
Figure 5.4 Photograph of Sweetwater Creek Site SW001 taken on July 29, 2013. The upstream view of the 300-m transect.

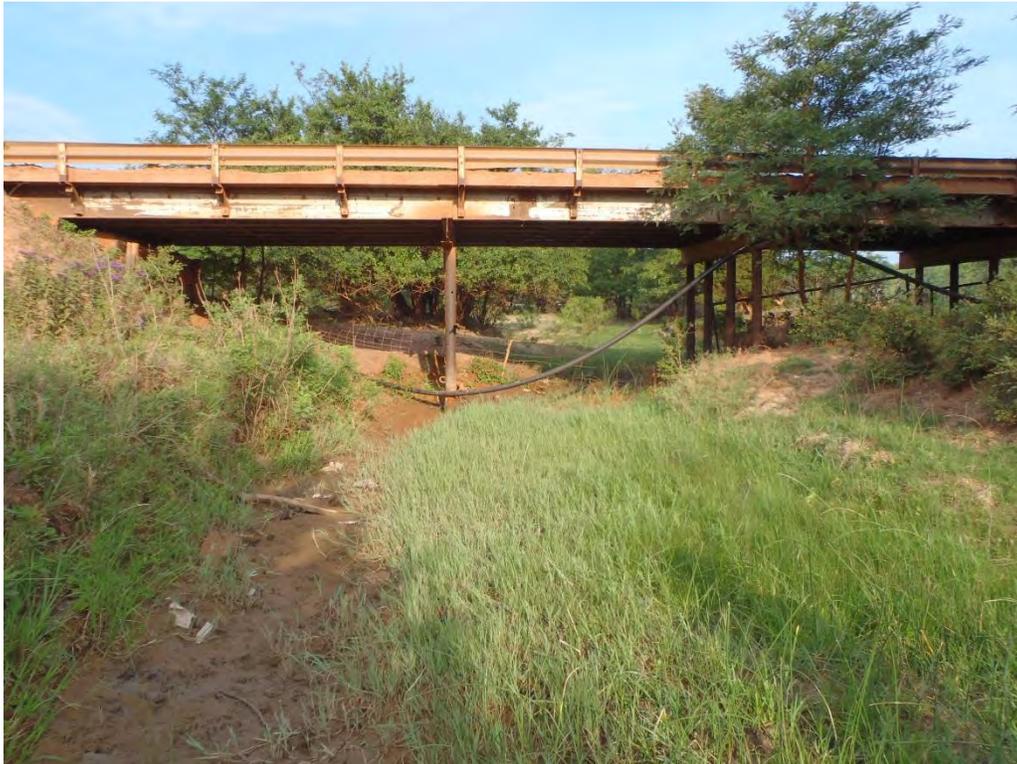
Sweetwater Creek at site SW002 was visited on May 26 and July 29, 2013. This site, located east of Wheeler, Texas in Wheeler County, was accessible through private lands that were fenced with a cattle guard and potentially locked gate. Although the site is listed as being publically accessible, access is very limited due to the property fences attaching to the bridge (Figure 5.5). With

Figure 5.5 Photograph of Sweetwater Creek Site SW002 taken on July 29, 2013. The upstream view of the 150-m transect.

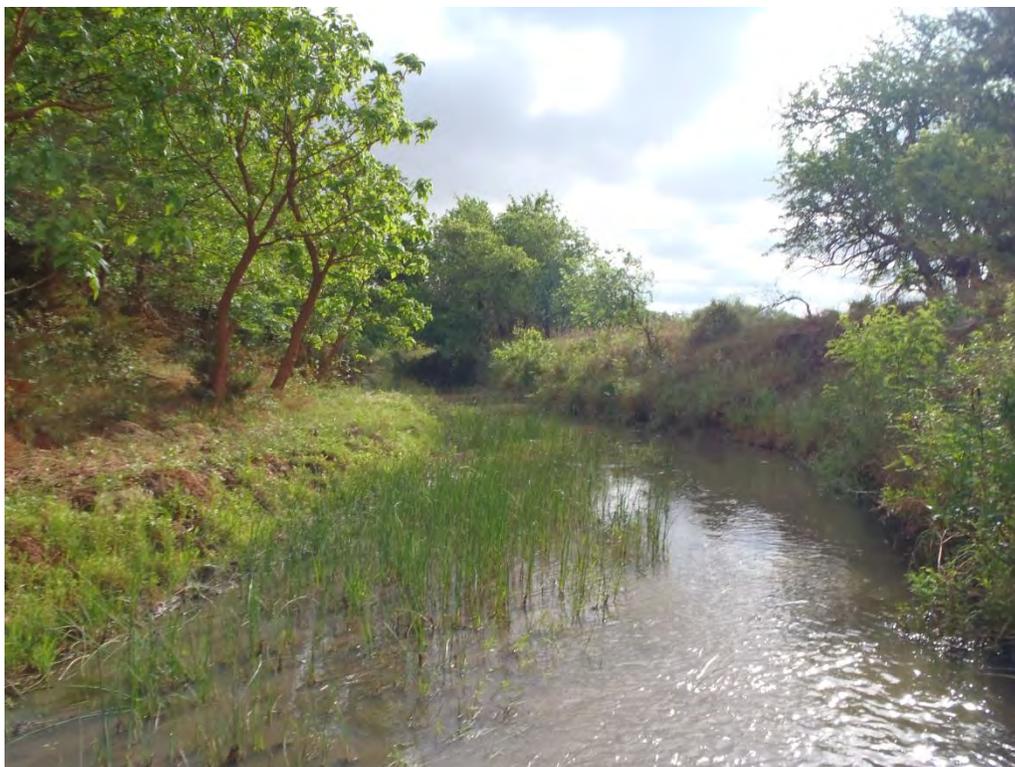
Figure 5.6 Photograph of Sweetwater Creek Site SW002 taken on May 26, 2013. The downstream view of the 150-m transect.

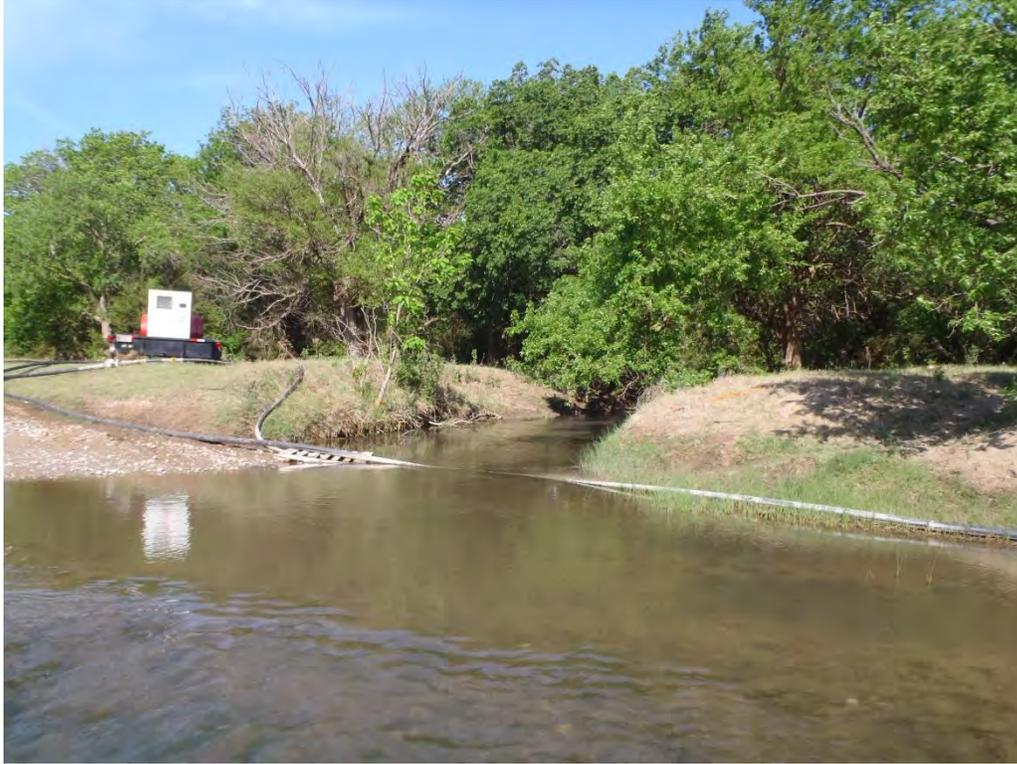
Figure 5.7 Photograph of Sweetwater Creek Site SW003 taken on May 26, 2013, the upstream view of the 150-m transect.

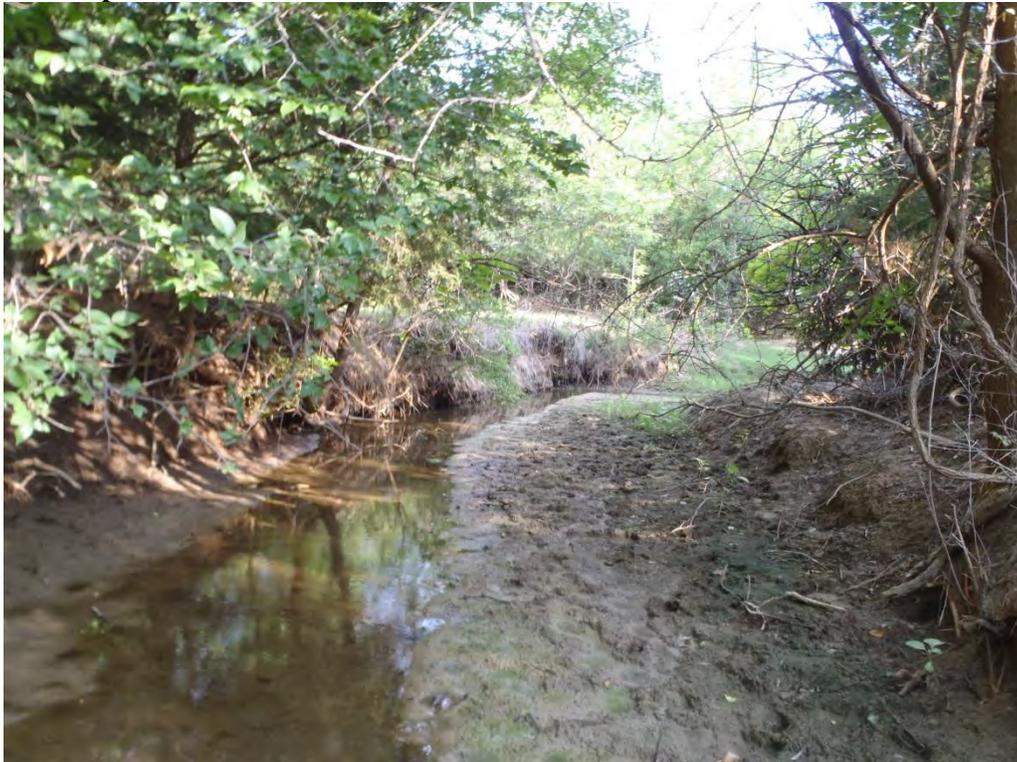
Figure 5.8 Photograph of Sweetwater Creek Site SW003 taken on July 29, 2013, the upstream view of the 300-m transect.

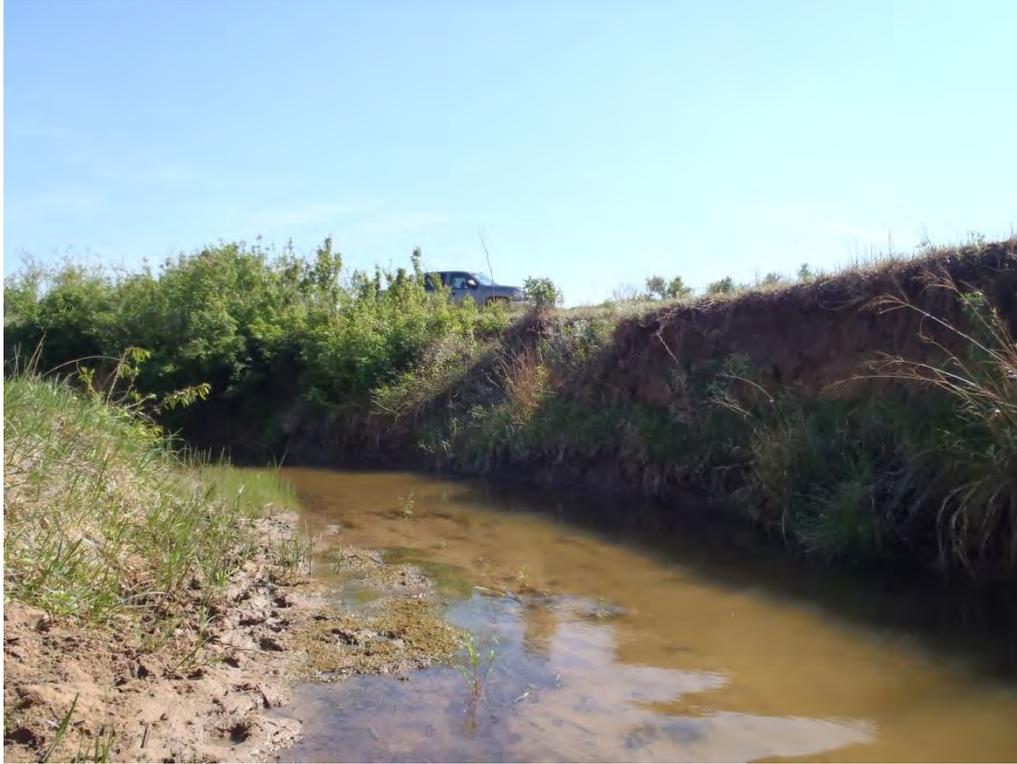
Figure 5.9 Photograph of Sweetwater Creek Site SW004 taken on May 26, 2013, the upstream view of the 30-m transect. TIAER vehicle shown in the background.

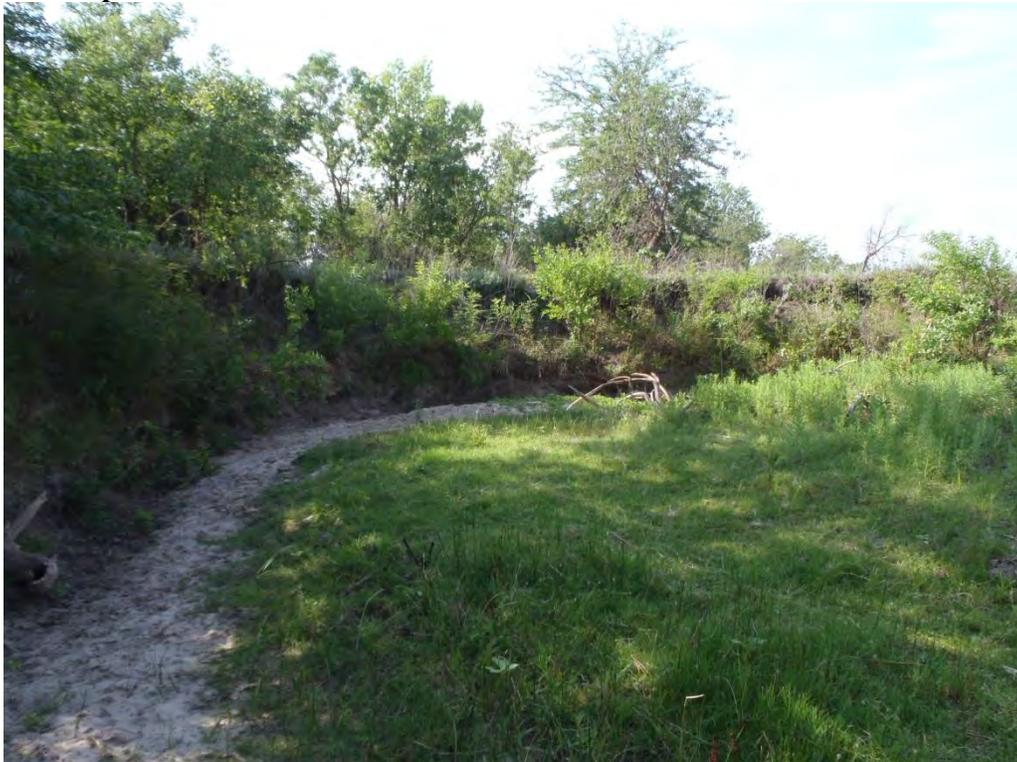
Figure 5.10 Photograph of Sweetwater Creek Site SW004 taken on July 29, 2013, the upstream view of the 300-m transect.

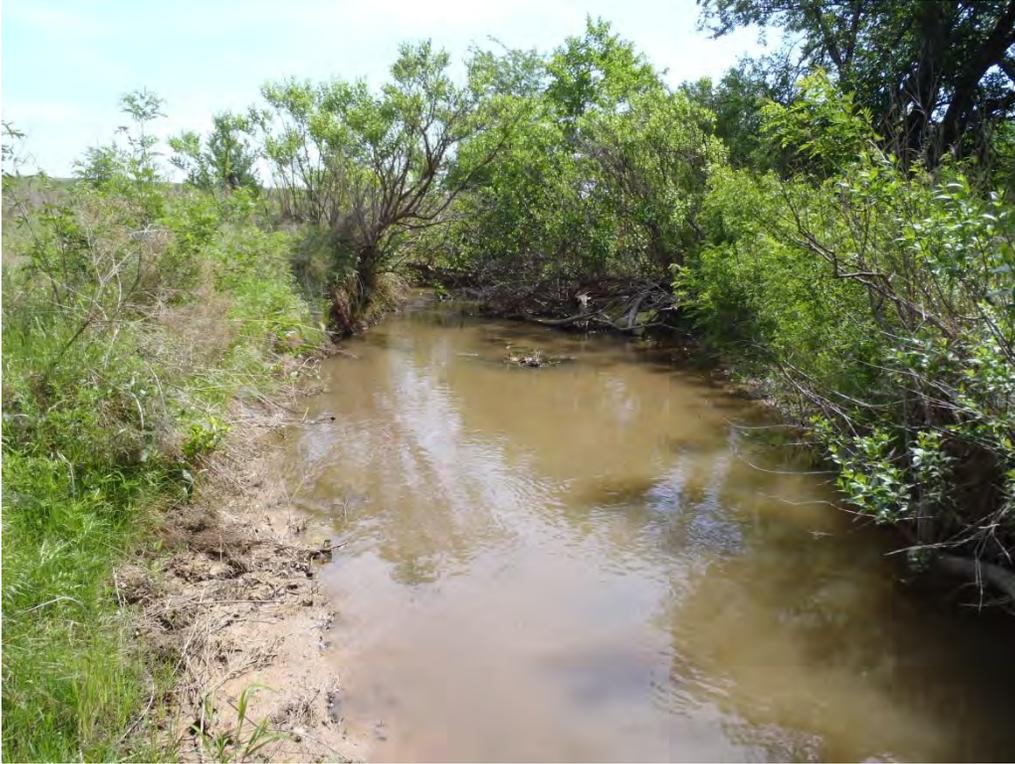
Figure 5.11 Photograph of Sweetwater Creek Site SW005 taken on May 26, 2013, the downstream view of the 300-m transect.

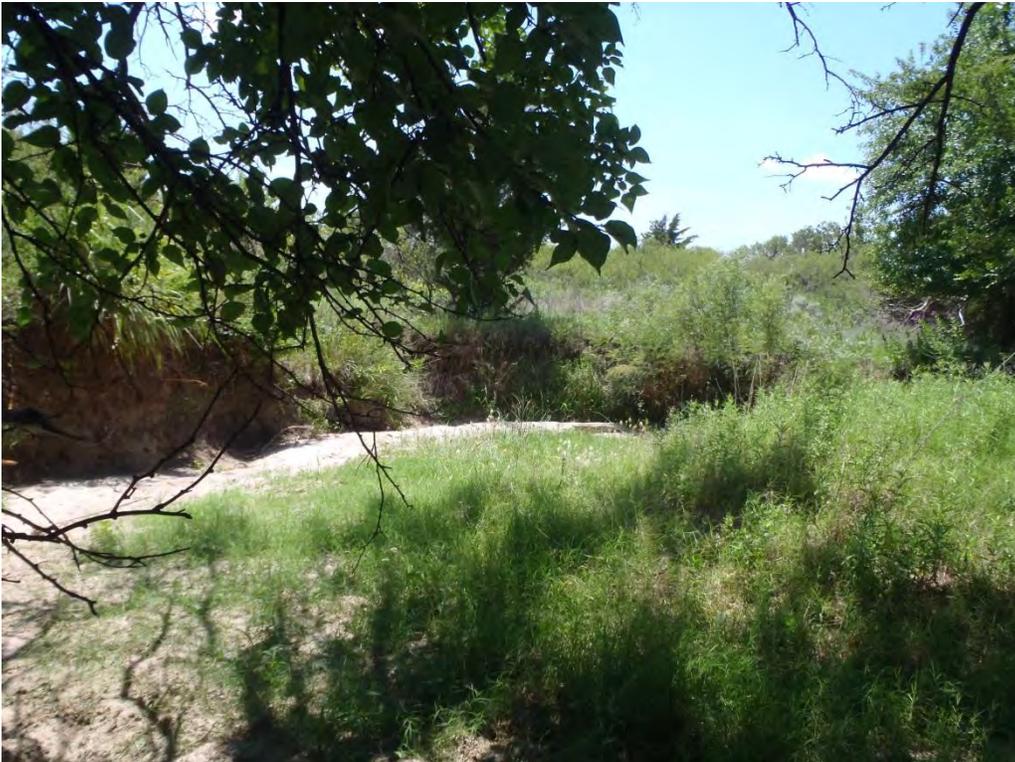
Figure 5.12 Photograph of Sweetwater Creek Site SW005 taken on July 29, 2013, the upstream view of the 150-m transect.

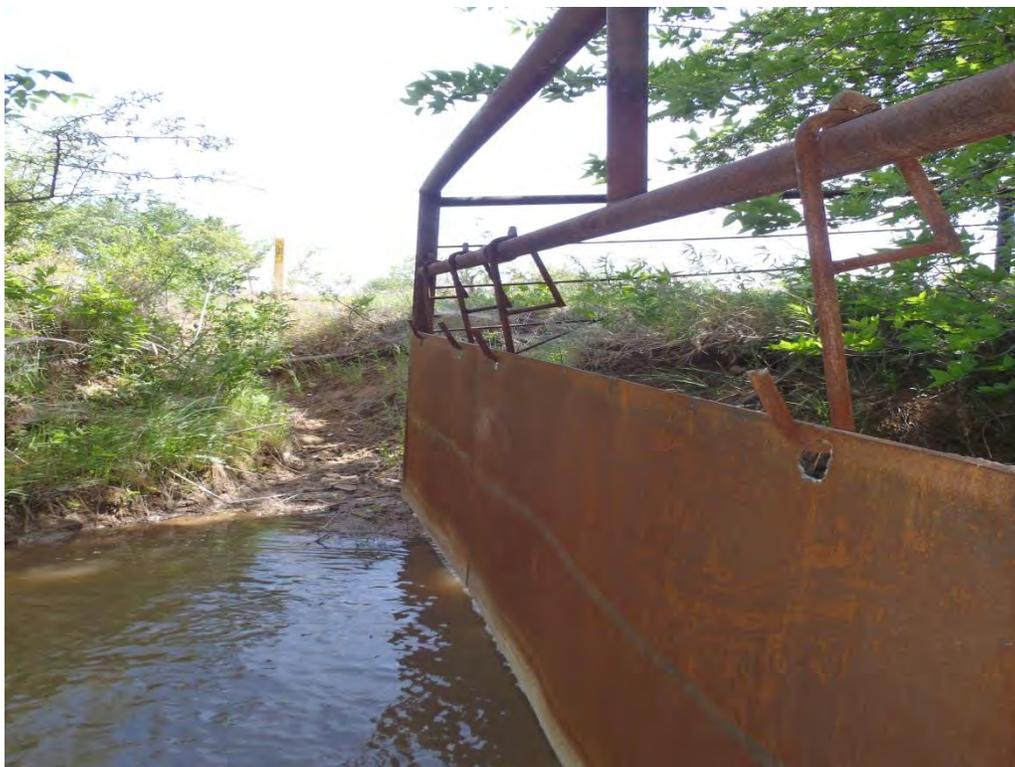
Site SW005 was wadeable for the entire 300-m reach length. Average thalweg ranged from 0.31 m during the first survey to 0.0 m during the second survey when the stream was dry (Table 5.6). During both surveys, the shallow water depths or lack of water with the sandy substrate made wading in the stream channel easy. Widths of the stream ranged from 2.5 m to 10 m during the first survey when water was present (Tables 5.7 and 5.8). There were a couple of log obstructions and one metal water gap located in the lower half of the reach (Figure 5.13).

Figure 5.13 Photograph of Sweetwater Creek Site SW005 taken on May 26, 2013, the water gap obstruction.

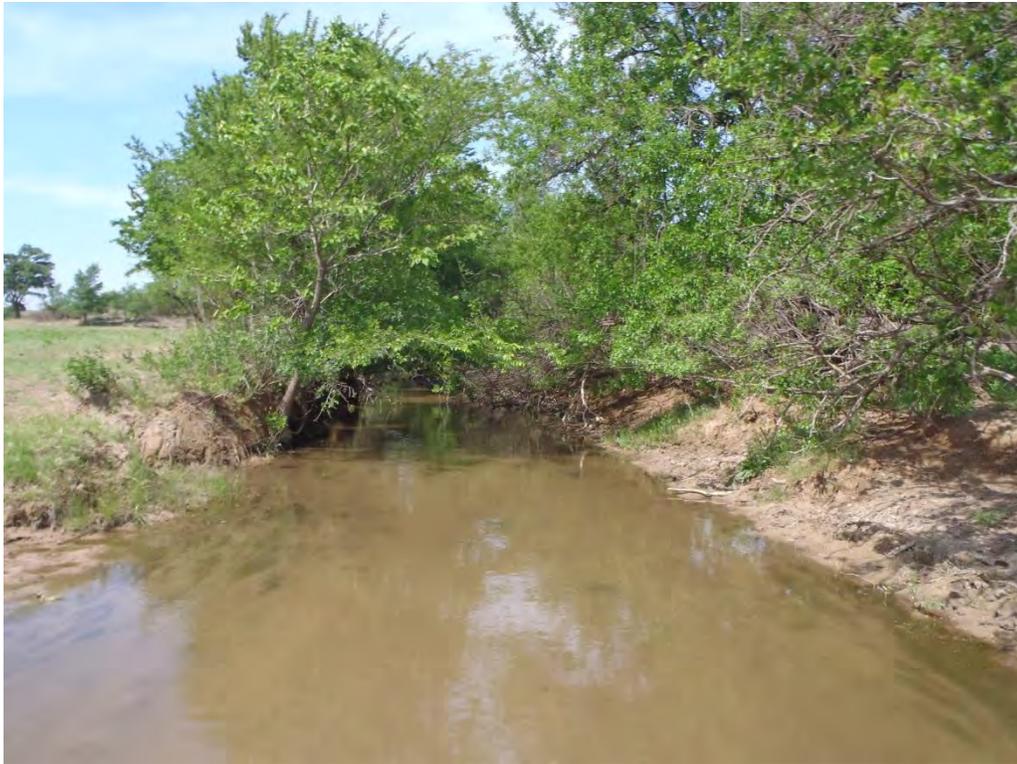
Figure 5.14 Photograph of Sweetwater Creek Site SW006 taken on May 26, 2013, the upstream view of the 150-m transect.

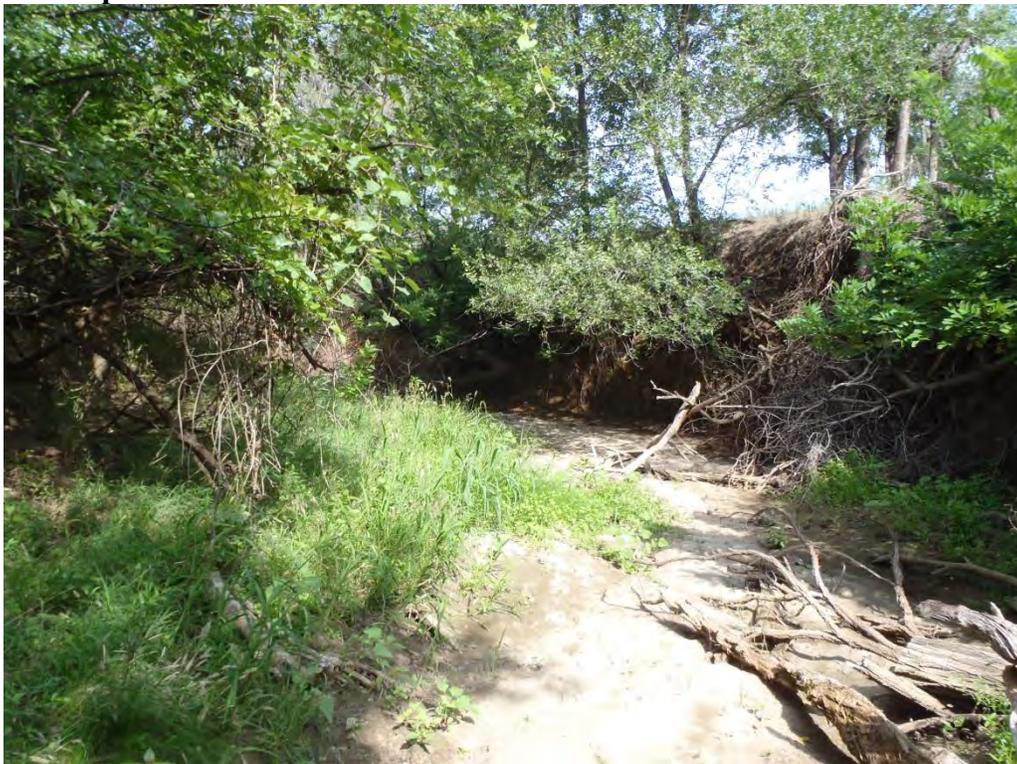
Figure 5.15 Photograph of Sweetwater Creek Site SW006 taken on July 29, 2013, the upstream view of the 30-m transect.

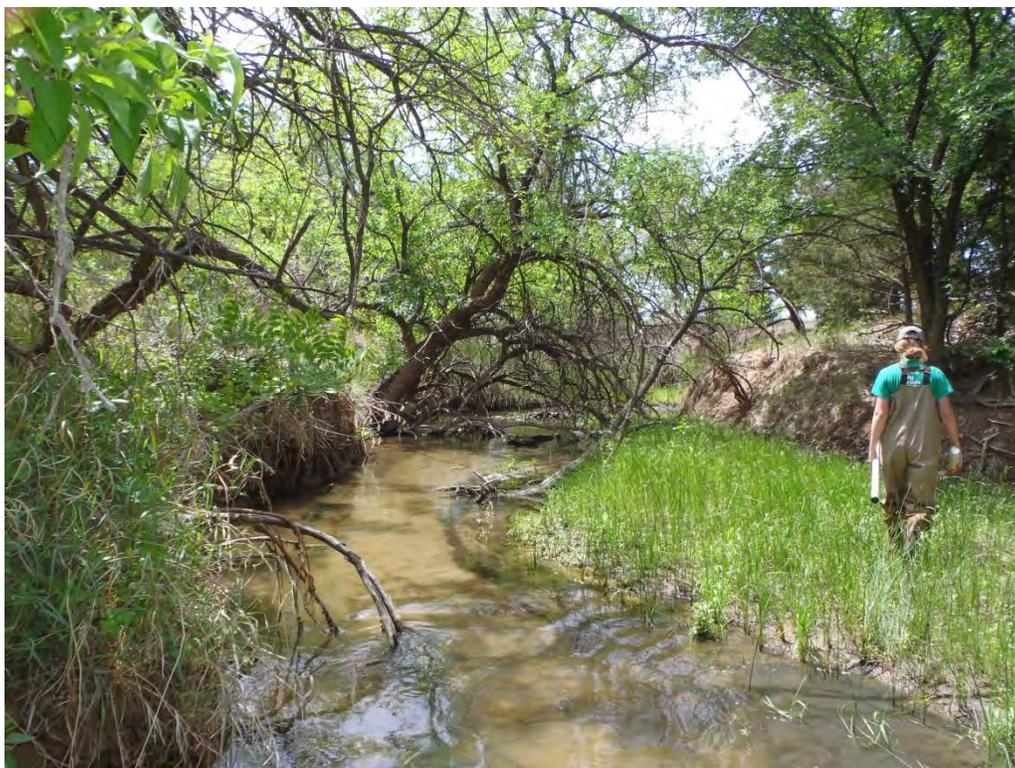
Figure 5.16 Photograph of Sweetwater Creek Site SW007 taken on May 26, 2013, the upstream view of the 300-m transect. TIAER personnel in photograph.

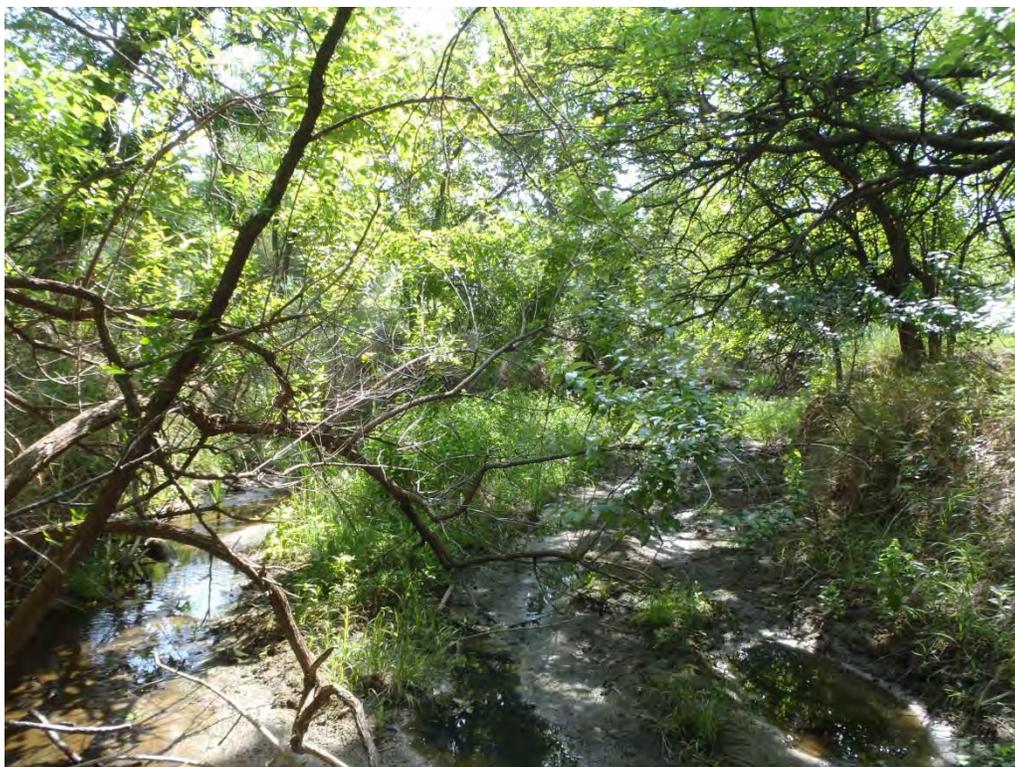
Figure 5.17 Photograph of Sweetwater Creek Site SW007 taken on July 29, 2013, the upstream view of the 30-m transect.

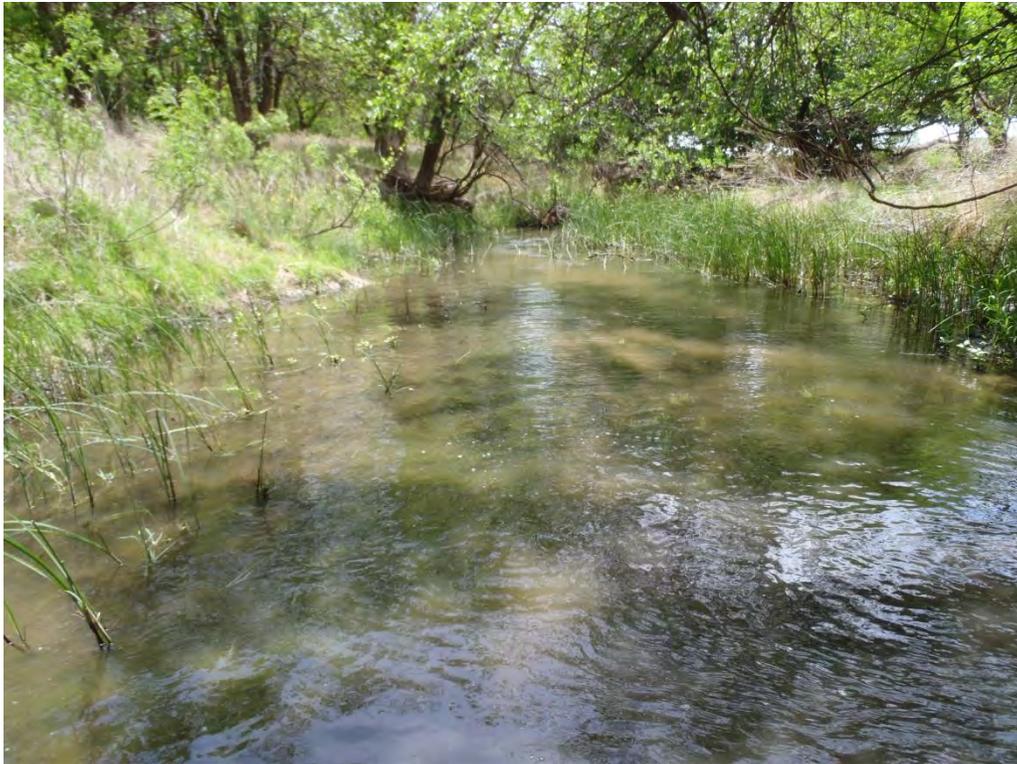
Figure 5.19 Photograph of Sweetwater Creek Site SW008 taken on May 26, 2013, the downstream view of the 300-m transect.

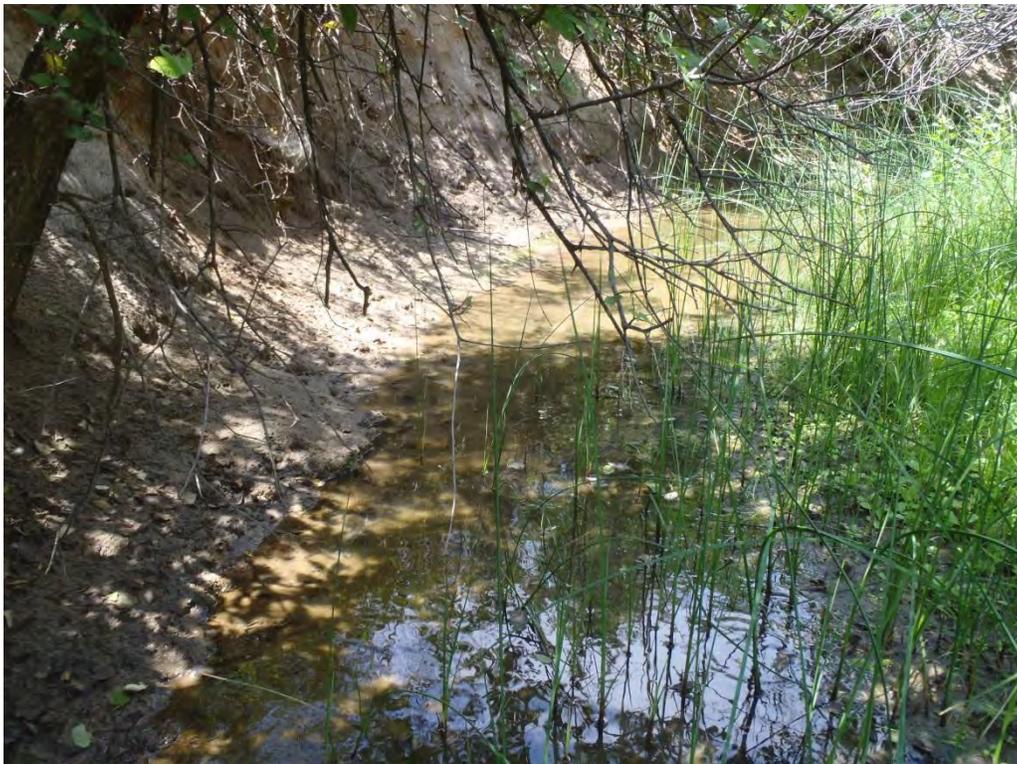
Figure 5.20 Photograph of Sweetwater Creek Site SW008 taken on July 29, 2013, the upstream view of the 150-m transect.

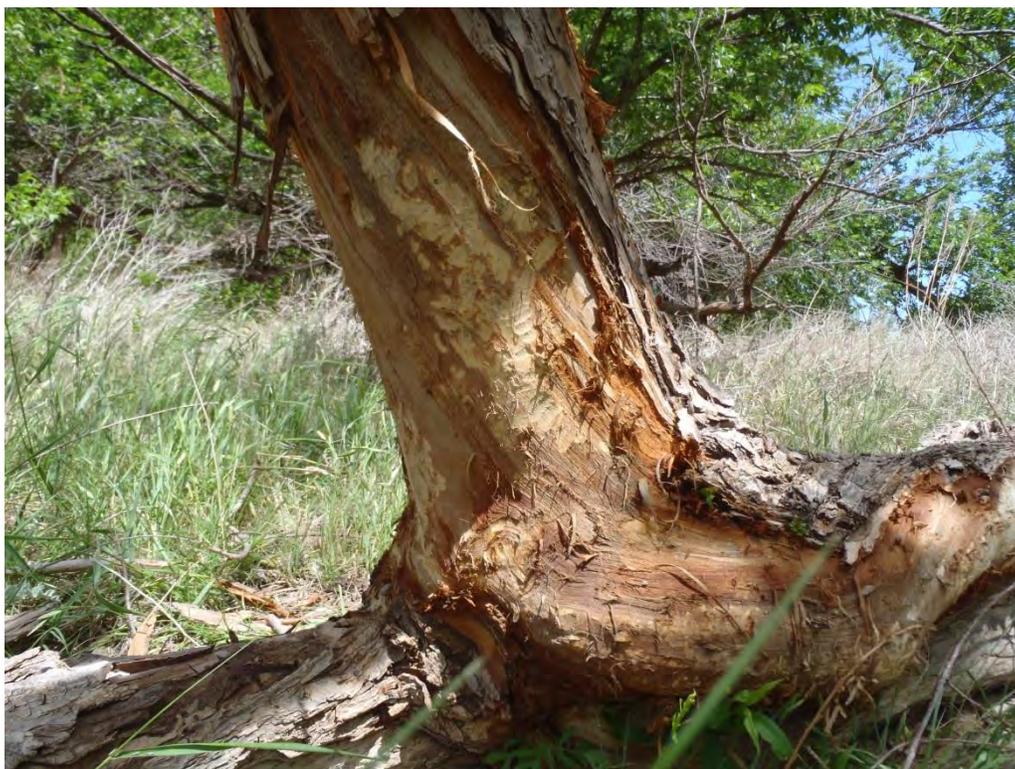
Figure 5.21 Photograph of Sweetwater Creek Site SW008 taken on July 29, 2013 showing typical gnaw marks observed on several trees within the survey reach.

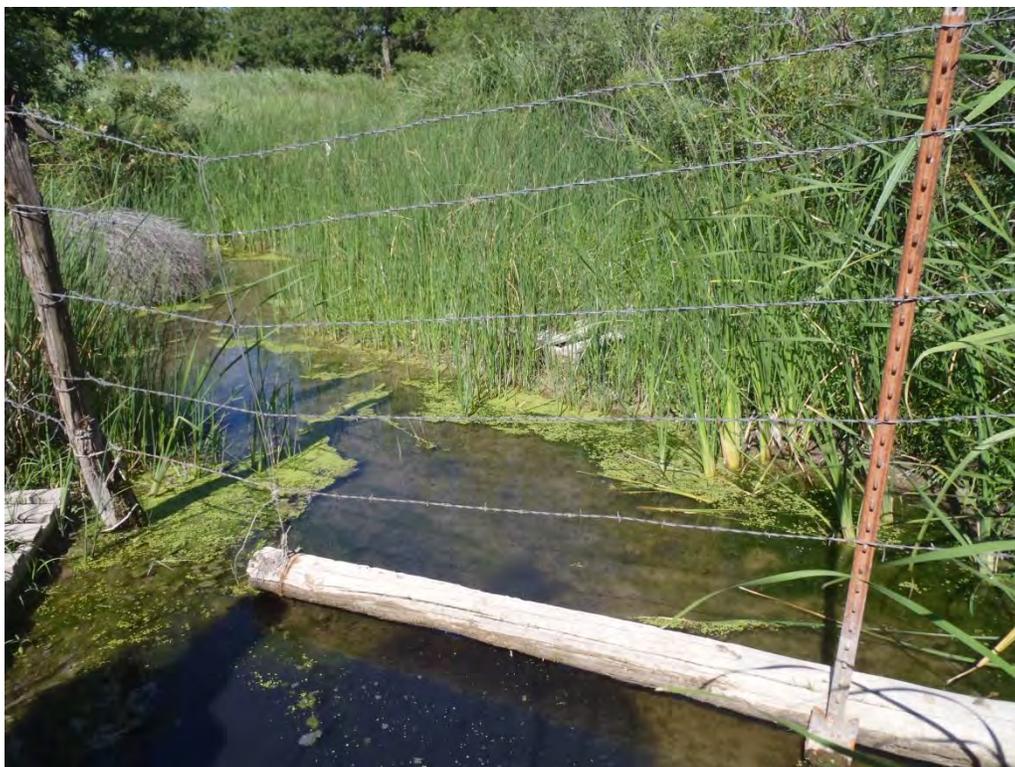
Sweetwater Creek at site SW009 was visited on May 26 and July 28, 2013. This site, located east of Wheeler, Texas in Wheeler County, was accessible only through private lands that were fenced and required landowner cooperation to enter the property. With landowner permission, TIAER personnel drove underneath the Ranch Road 592 bridge crossing and crossed a private property fence to conduct the entire 300 meter length of the reach. Although this site is listed as being publicly accessible, it is only accessible to the public for approximately 20 meter upstream and downstream of the bridge. Water gaps cross the stream impeding persons from traversing the stream in both directions (Figure 5.22).

Figure 5.22 Photograph of Sweetwater Creek Site SW009 taken on July 28, 2013 showing the water gap downstream of the bridge.

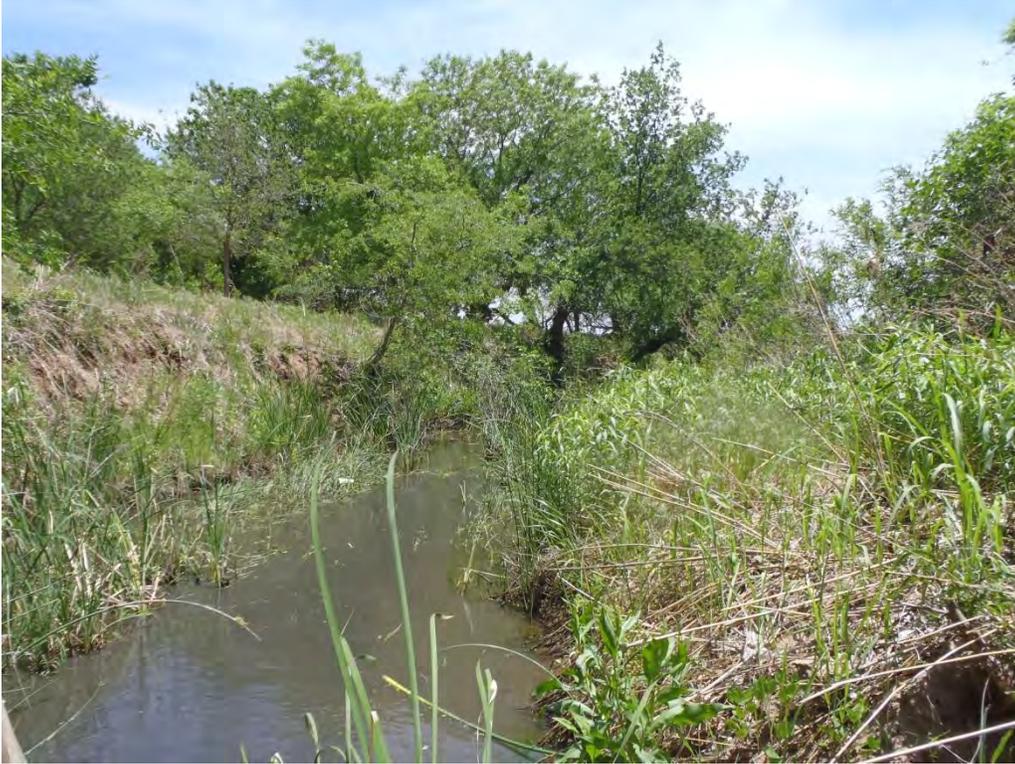
Figure 5.23 Photograph of Sweetwater Creek Site SW009 taken on May 26, 2013, the downstream view of the 30-m transect.

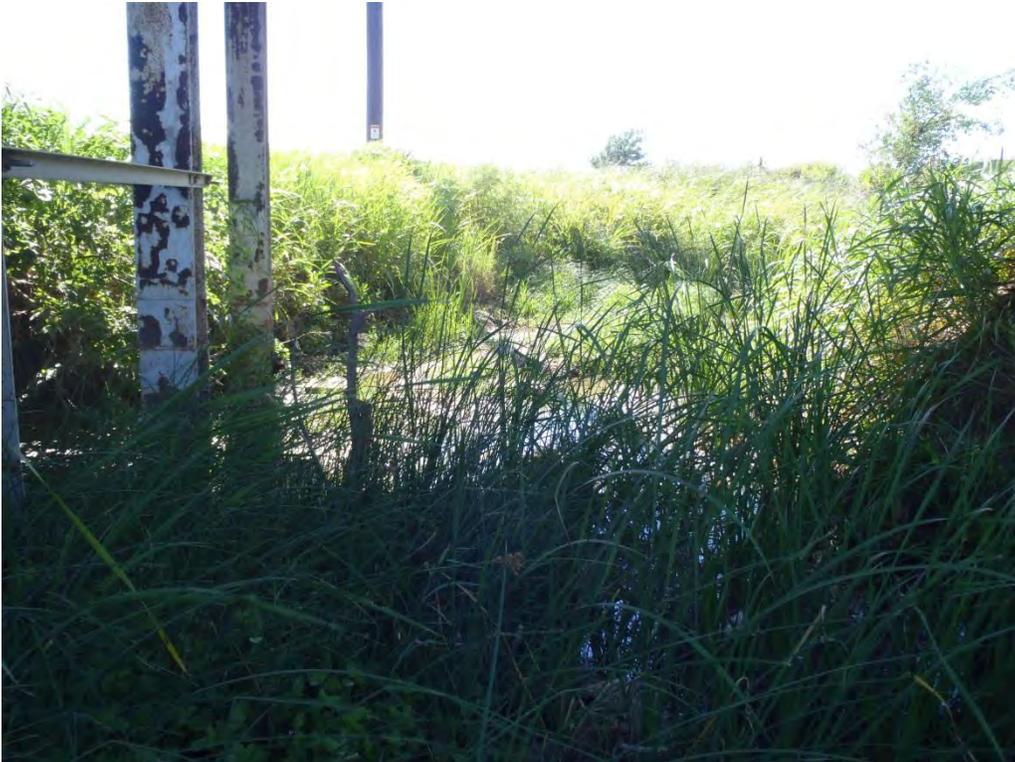
Figure 5.24 Photograph of Sweetwater Creek Site SW009 taken on July 28, 2013, the upstream view of the 300-m transect.

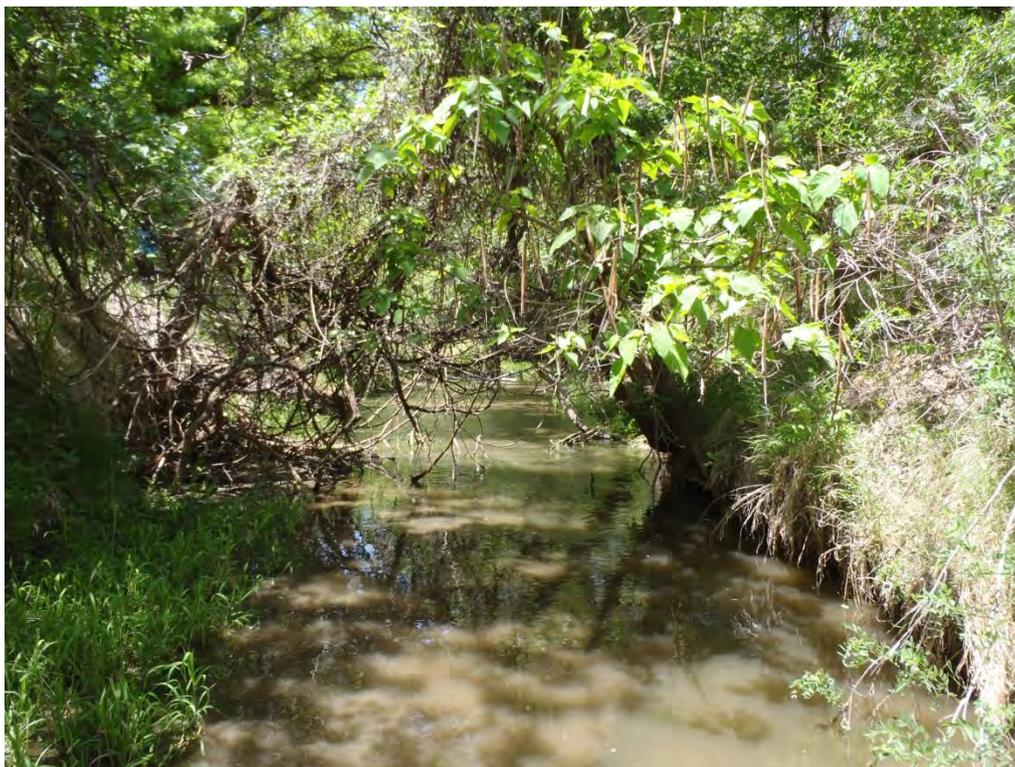
Figure 5.25 Photograph of Sweetwater Creek Site SW010 taken on May 27, 2013, the upstream view of the 30-m transect.

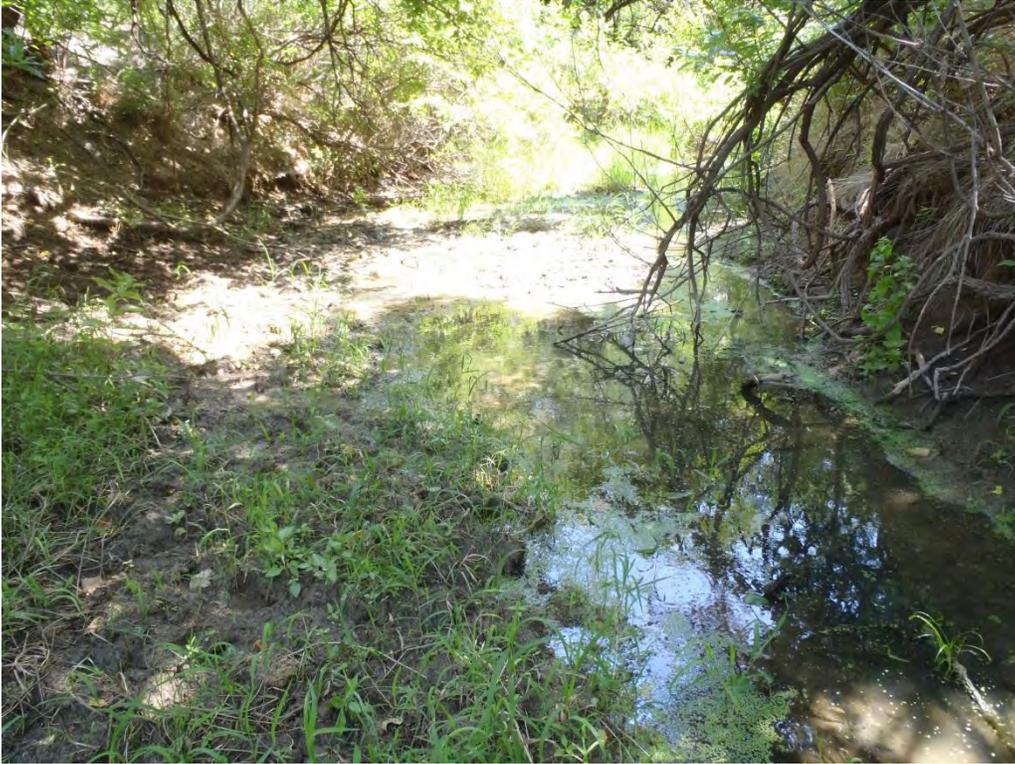
Figure 5.26 Photograph of Sweetwater Creek Site SW010 taken on July 29, 2013, the downstream view of the 150-m transect.

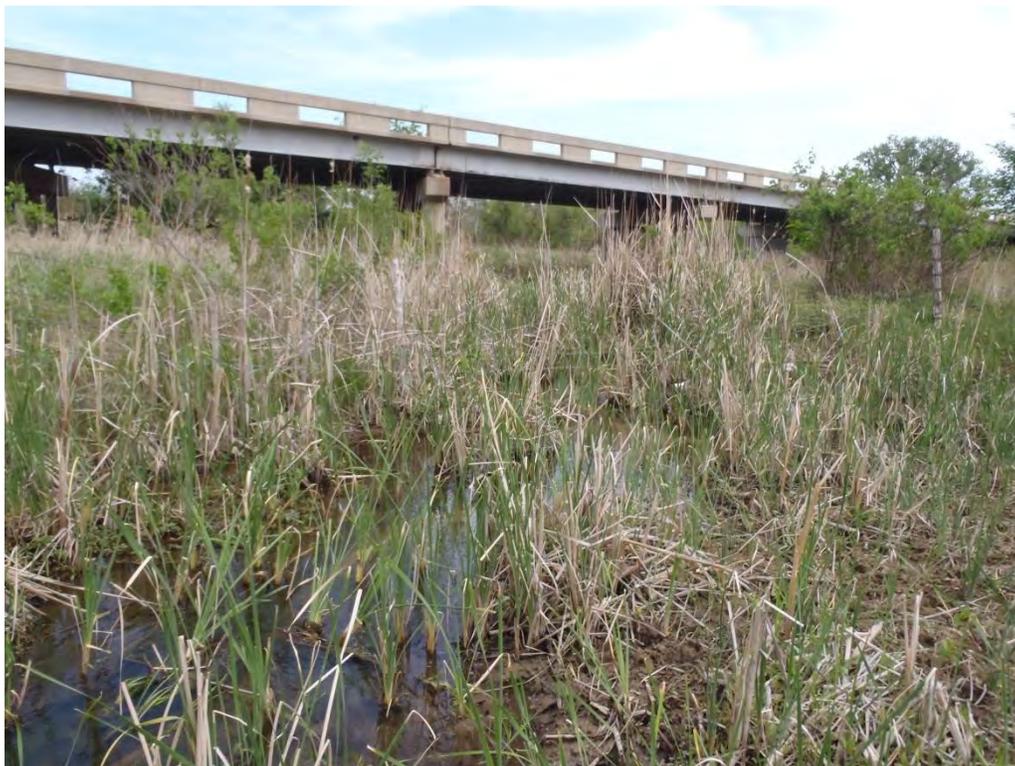
Sweetwater Creek at site SW020 was visited on May 27 and July 29, 2013. This site, located north of Wheeler, Texas in Wheeler County, was accessible through private land that was fenced and required landowner permission to access. Although the site is listed as being publicly accessible, access is limited to approximately 20 meters upstream and downstream of the bridge crossing on State Highway 83 due to a barbed wire fence (Figure 5.49). With permission from the landowner,

Figure 5.49 Photograph of Sweetwater Creek Site SW020 taken on May 27, 2013, the downstream view of the 30-m transect showing the barbed wire property fence.

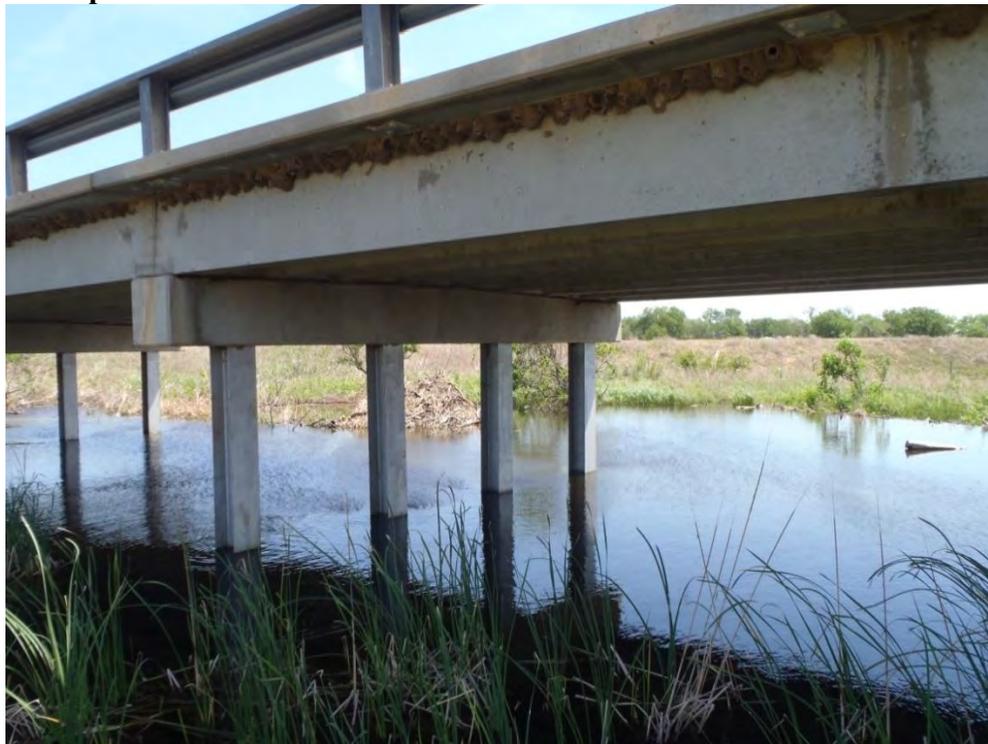
Site SW024 was wadeable for the entire 300-m reach length, although it was challenging. There was a beaver dam with a hut on the downstream side of the bridge crossing Ranch Road 3182 and water was backed up for a large distance upstream (Figure 5.59). The study reach was determined to be one large pool greater than 300 meters long with a maximum depth greater than 1.4 meters and a maximum width of 14 meters during the first survey. During the second survey, the maximum width was 13 meters with a maximum depth of 1.1 meters. Average thalweg was >1.0 m during the first survey and 0.70 m during the second survey (Table 5.6).

Figure 5.59 Photograph of Sweetwater Creek Site SW024 taken on May 26, 2013 showing the beaver hut located on the downstream side of the bridge crossing Ranch Road 3182.

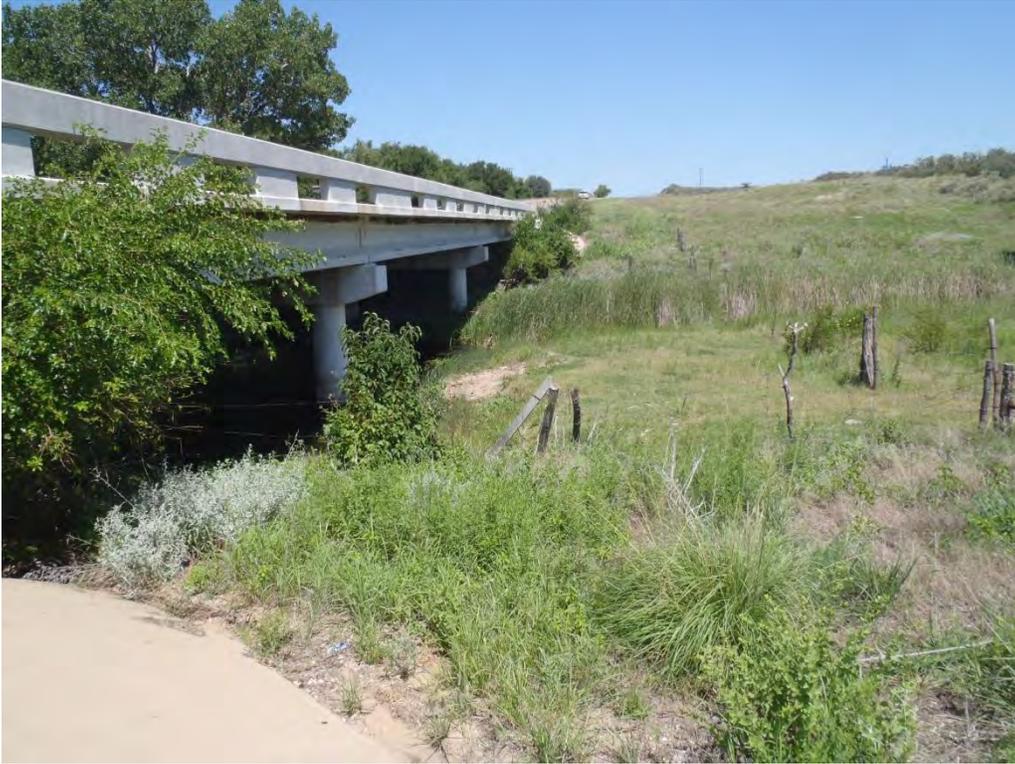
Sweetwater Creek at site SW026 was visited on May 27 and July 28, 2013. This site, located southeast of Mobeetie, Texas in Wheeler County, was accessible through private land that was fenced. The site is listed as being publicly accessible but property fences underneath the bridge crossing State Highway 152 limit public access (Figure 5.62). With landowner permission, TIAER personnel stepped over the fence and established the 0-m transect at the bridge crossing and worked upstream. The site is located in a grass and forb dominated corridor with a few shrubs along the bank and pastureland beyond (Table 5.5). At the site, access to the stream was moderately easy due to thick vegetation throughout the reach and occasional steep banks. The vegetation and sometimes dense shrubs made efforts to gain access to the stream challenging except for a few locations (Table 5.6). Figures 5.63 and 5.64 depict the appearance of the site during each of the surveys.

Figure 5.62 Photograph of Sweetwater Creek Site SW026 taken on July 28, 2013 showing the property fences underneath the bridge crossing State Highway 152.
