Recreational Use Attainability Analysis for Buffalo Creek (0214B), Paradise Creek (0230A), and Sweetwater Creek (0299A) in the Red River Basin

Prepared for:
Texas State Soil and Water Conservation Board
Project 12-52

Texas Institute for Applied Environmental Research
Tarleton State University
Stephenville, Texas

TR 1308

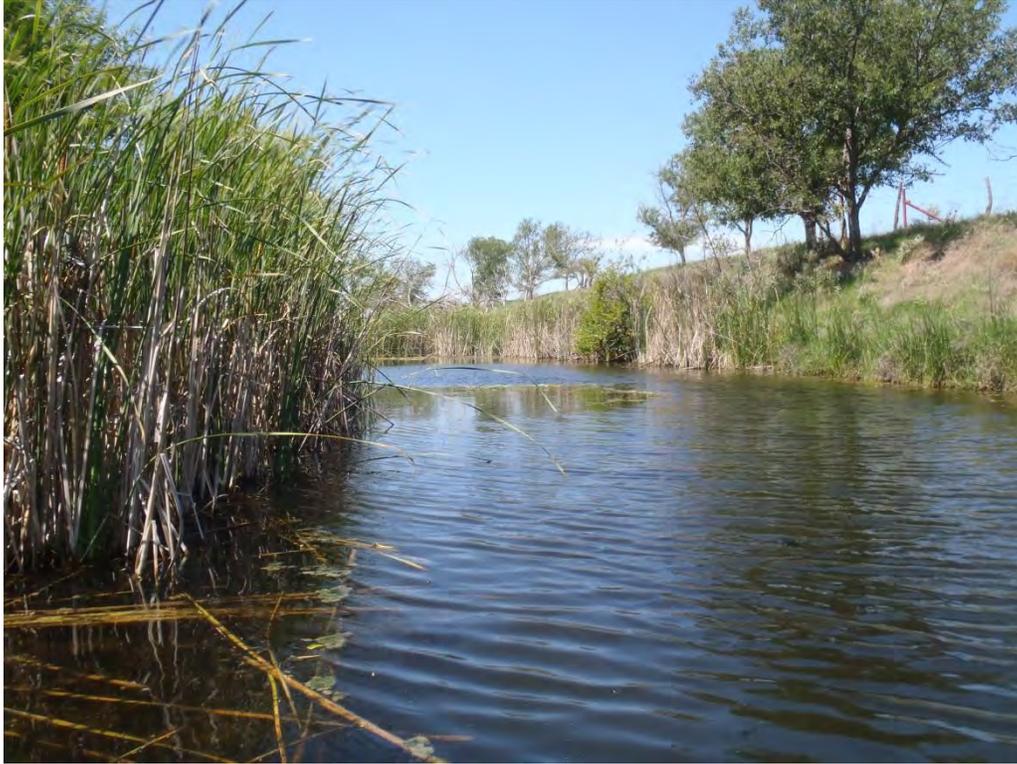
Site SW026 was wadeable for the entire 300-m reach length, although it was challenging due to some deep pools created by beaver dams (Figure 5.64). TIAER personnel carefully waded the edges of the pools to avoid filling their waders. The two pools were observed during both of the surveys in the same locations, between the 180-m and 210-m transects for the first pool and from the 280-m transect to beyond the 300-m transect. The length of the first pool ranged from 25 to 30 meters, with widths of approximately 10 meters and depths over 1.5 meters. The second pool was greater than 50 meters long, as it went well beyond the 300-m transect. Widths of the second pool ranged from 7.5 to 9.0 meters wide with depths also over 1.5 meters. Average thalweg was >0.56 m during the first survey and >0.54 m during the second survey (Table 5.6).

Figure 5.64 Photograph of Sweetwater Creek Site SW026 taken on July 28, 2013, the upstream view of the 300-m transect.

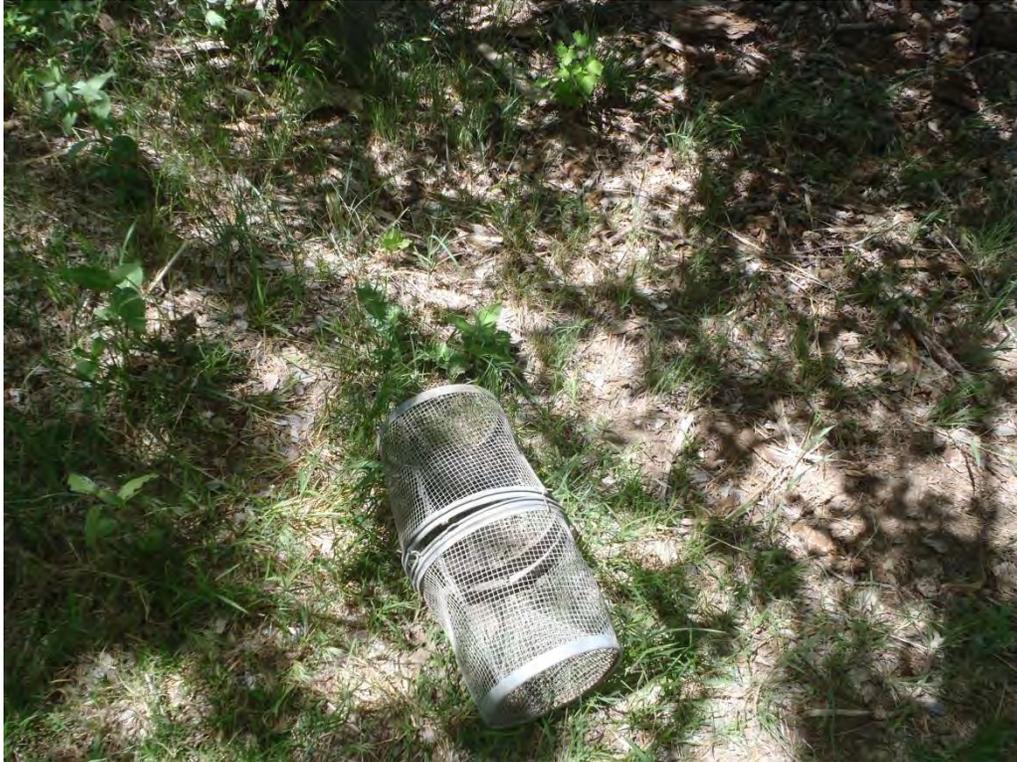
Aesthetic appearance of the water and wildlife observations for the site during each survey have been previously provided in Tables 5.9 and 5.10, respectively. There was a slight presence of snakes during the first survey with no other mammals or vertebrates observed. No animals or vertebrates were encountered during the second survey. Tracks found during both surveys were identified as cattle, raccoon, canine, and deer. Bird and cattle feces were found throughout the reach during both surveys. Aquatic vegetation was abundant during both surveys while algae was common during the first survey and rare during the second survey. Water color was clear with no surface scum and foam observed during either survey. During the second survey, there was an odor to the water, which may have been caused by TIAER personnel disturbing the sludge deposits on the bottom of the stream. Trash, rarely observed during the both surveys, consisted of typical plastics and aluminum cans. The only evidence of human activity within the reach was a minnow trap and a fishing lure, both found on the bank of the stream (Figures 5.65 and 5.66).

Figure 5.65 Photograph of minnow trap at Site SW026 taken on May 27, 2013.

One minnow trap and fishing lure were found at Site SW026. They were found at the large pool near the 300-m transect.

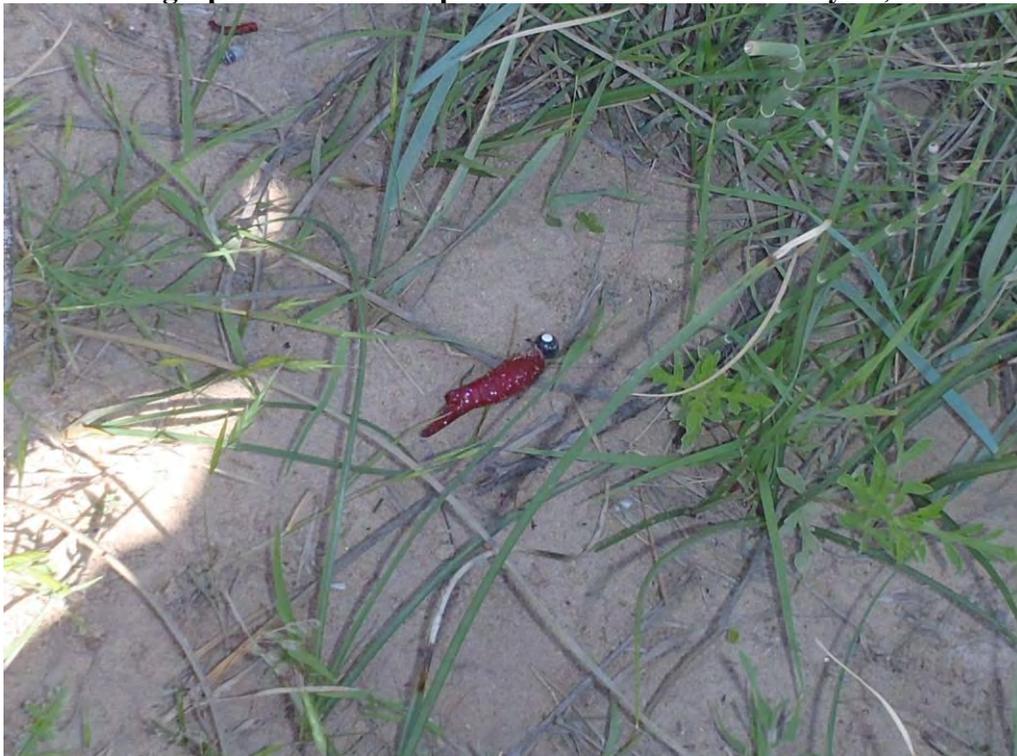
Figure 5.66 Photograph of fishing lure at Site SW026 taken on May 27, 2013.

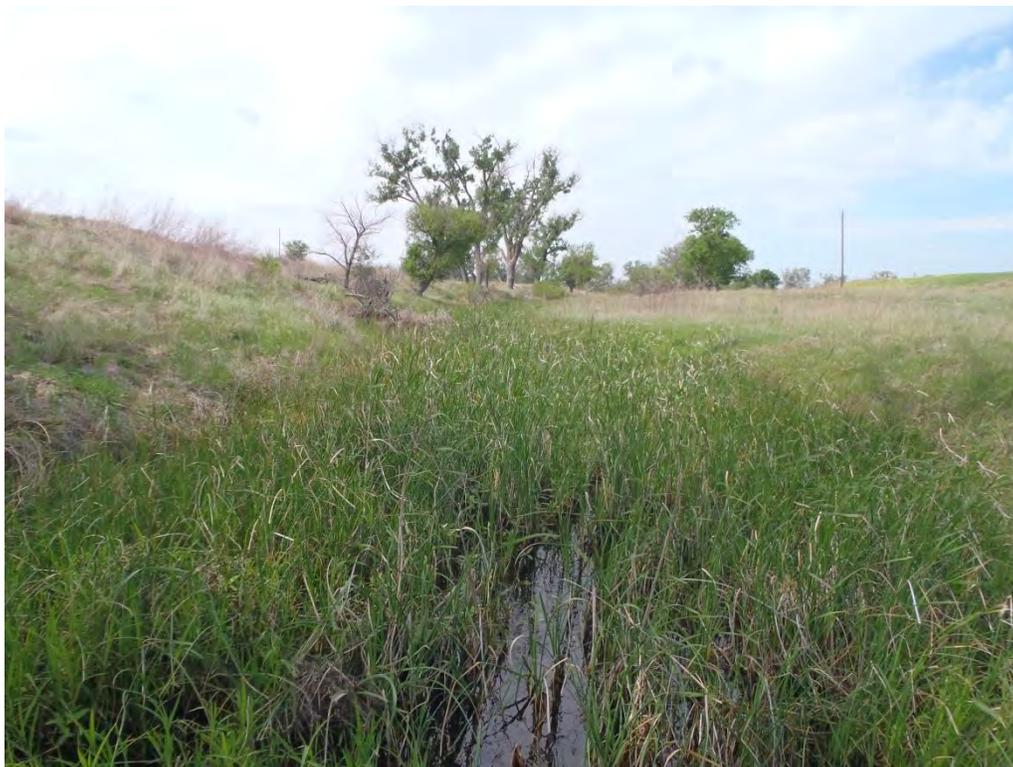
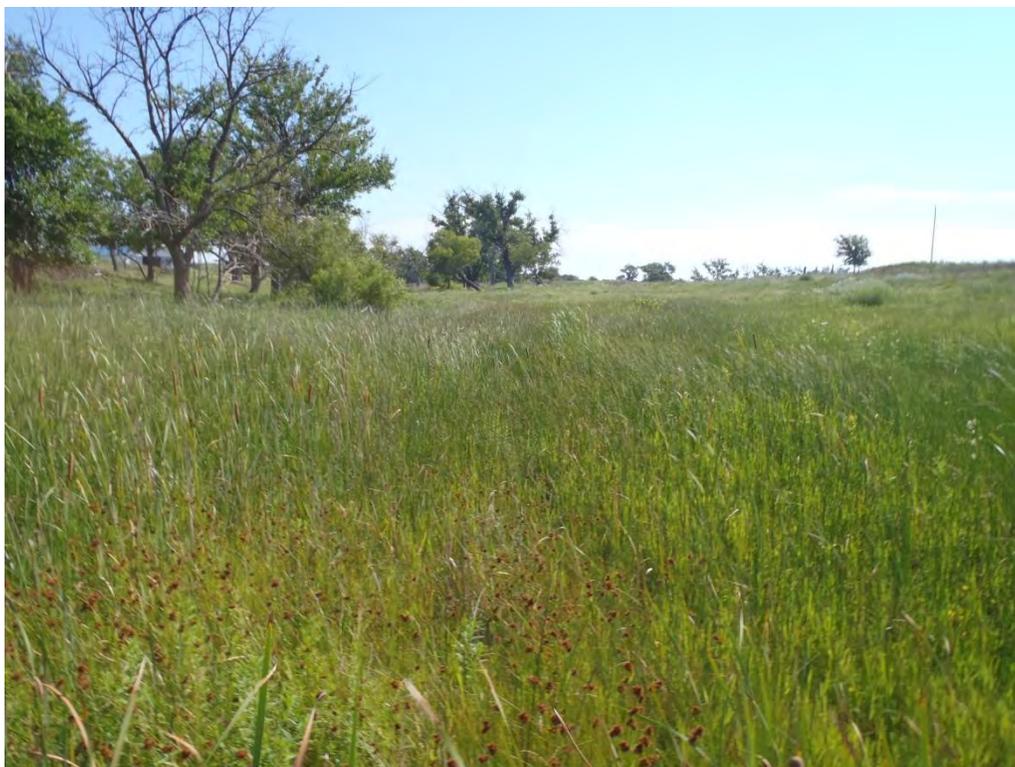
Figure 5.67 Photograph of Sweetwater Creek Site SW027 taken on May 28, 2013, the upstream view of the 30-m transect.

Site SW027 was wadeable for the entire 300-m reach length, although thick vegetation made traversing the stream channel challenging (Figures 5.67 and 5.68). One pool was identified during the first survey that was 30 meters long, 11 meters wide and had a maximum depth of 1.6 meters. Average thalweg was 0.18 m during the first survey and 0.08 m during the second survey (Table 5.6). During both surveys, the vegetation and sludge bottom deposits made walking in the stream channel challenging despite the sand dominant substrate. TIAER personnel would typically walk along the bank and forge a path through the vegetation at each transect to obtain depth measurements and photographic documentation of conditions. Widths of the stream ranged from a maximum of 20 m to a minimum of 1.4 m both encountered during the second survey (Tables 5.7 and 5.8). Thick vegetation and one log jam were the only obstructions encountered throughout the reach during both surveys.

Figure 5.68 Photograph of Sweetwater Creek Site SW027 taken on July 28, 2013, the downstream view of the 300-m transect.

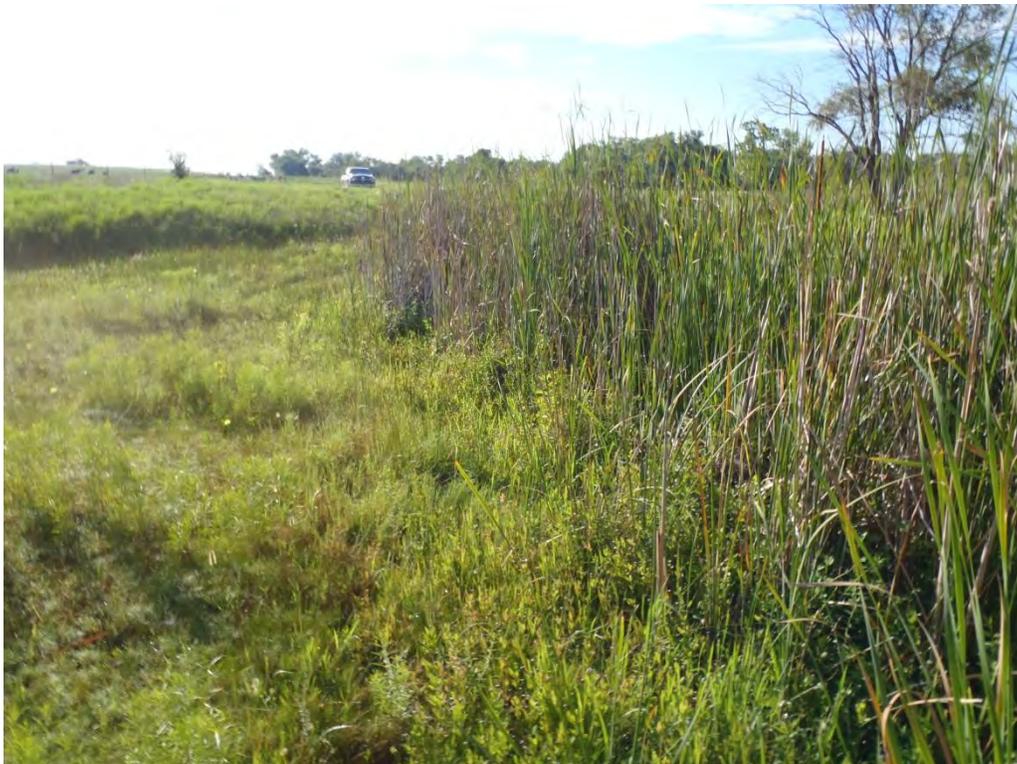
Figure 5.70 Photograph of Sweetwater Creek Site SW028 taken on July 28, 2013, the downstream view of the 30-m transect. TIAER truck in photograph.

Site SW028 was wadeable for the entire 300-m reach length, although thick vegetation made traversing the stream channel challenging (Figure 5.99 and 5.70). No pools were identified during either survey. Average thalweg was 0.33 m during the first survey and 0.19 m during the second survey (Table 5.6). During both surveys, the vegetation and sludge bottom deposits made walking in the stream channel challenging despite the sand dominant substrate. TIAER personnel would typically walk along the bank and forge a path through the vegetation at each transect to obtain depth measurements and photographic documentation of the conditions. Widths of the stream ranged from a maximum of 14 m during the first survey to a minimum of 0.0 m during the second survey when the stream was not flowing (Tables 5.7 and 5.8). Thick vegetation was the only obstruction encountered throughout the reach during both surveys.

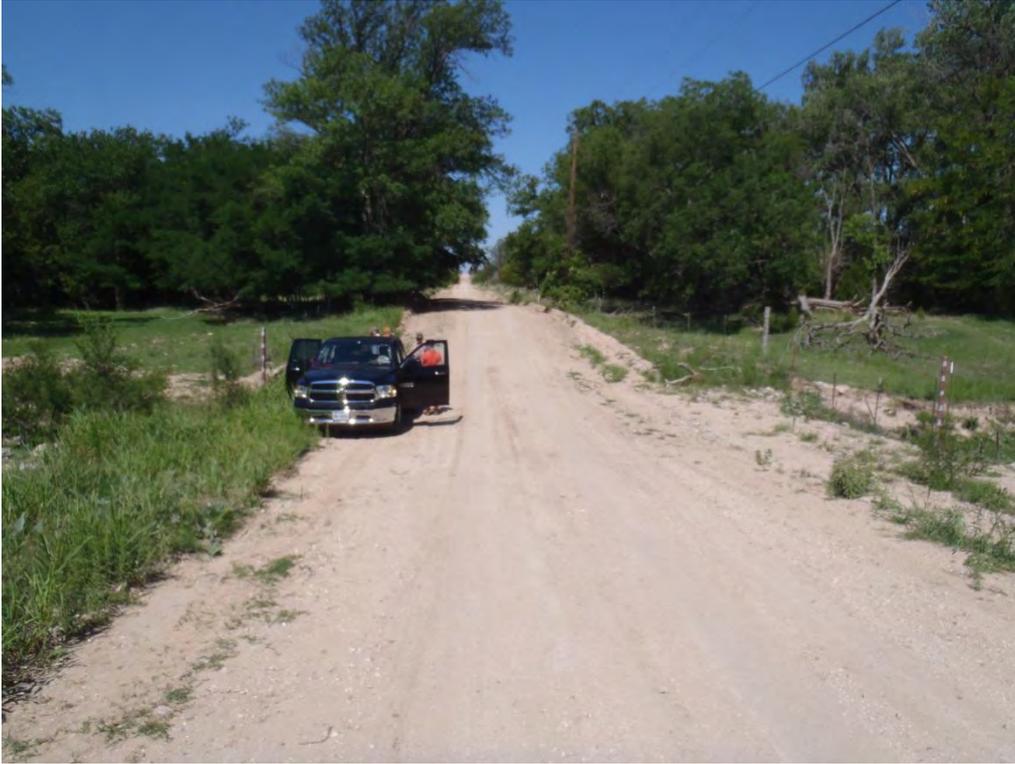
Figure 5.71 Photograph of Sweetwater Creek Site SW029 taken on July 28, 2013 showing public accessibility at the road. TIAER truck and personnel in photograph.

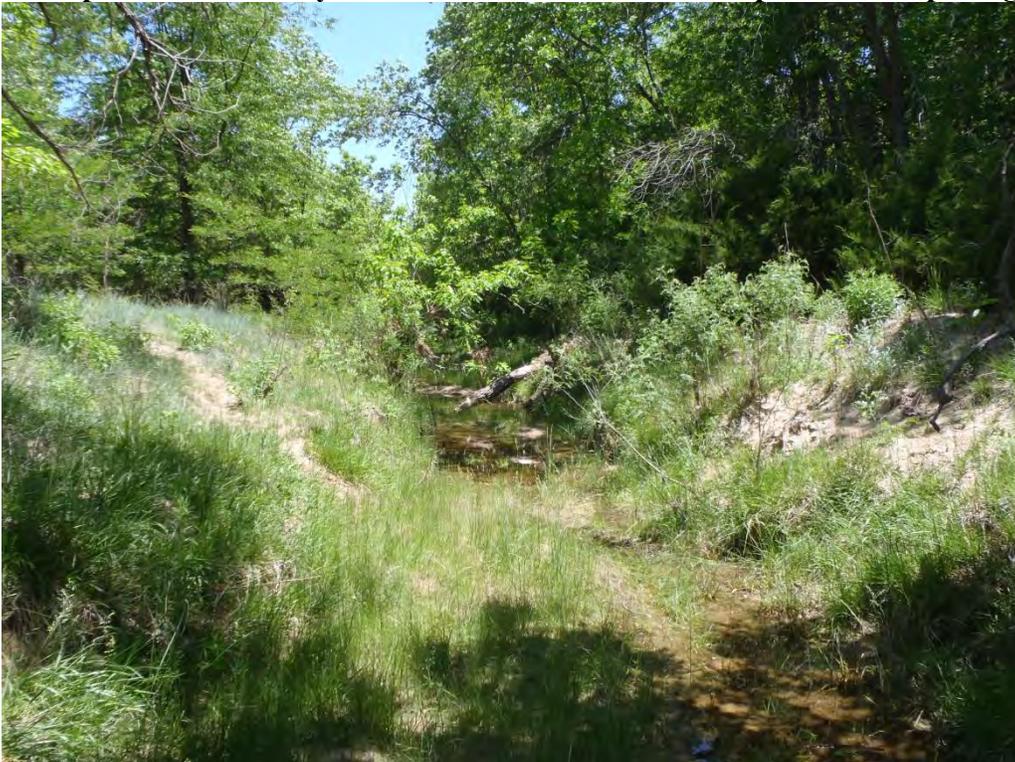
Figure 5.72 Photograph of Sweetwater Creek Site SW029 taken on May 27, 2013, the upstream view of the 150-m transect.

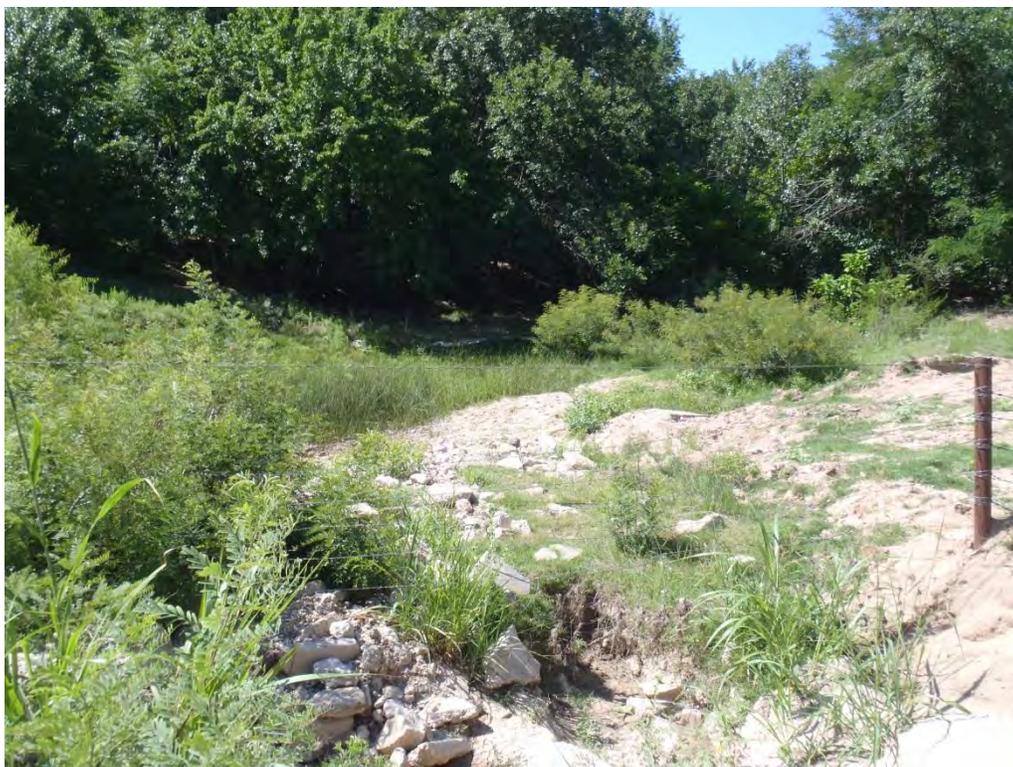
Figure 5.73 Photograph of Sweetwater Creek Site SW029 taken on July 28, 2013, the downstream view of the 300-m transect.

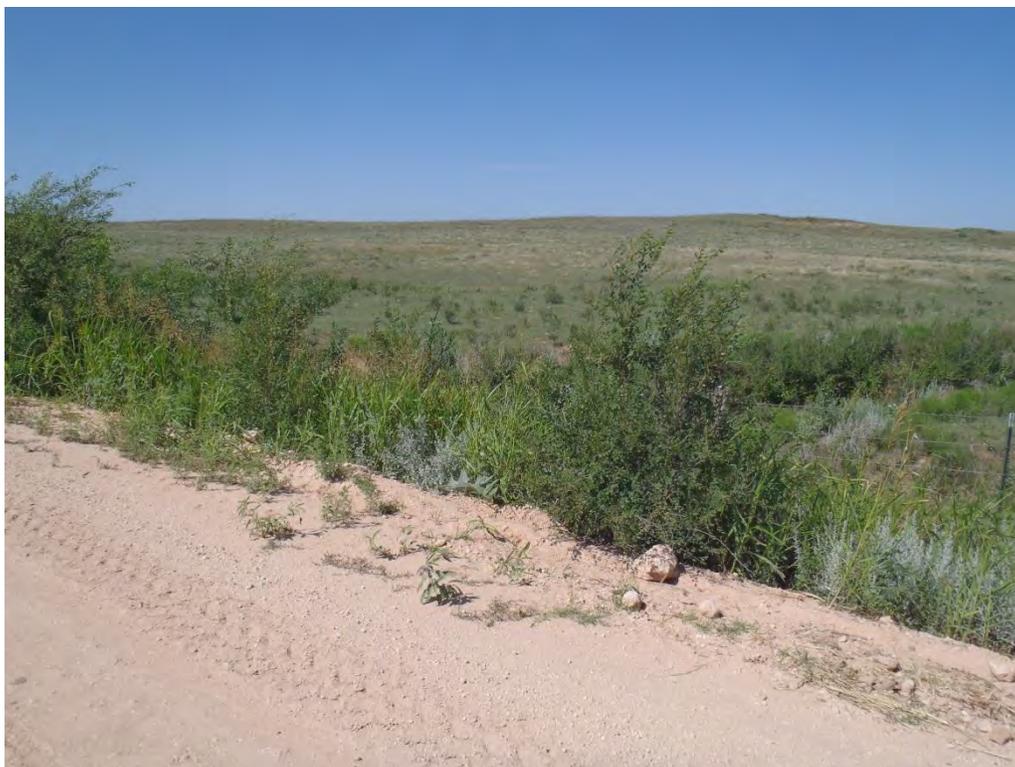
Sweetwater Creek at site SW030 was visited on May 27 and July 28, 2013. This site, located northwest of Mobeetie, Texas in Wheeler County, was accessible through private land that was fenced. With landowner permission, TIAER personnel parked along the county road and stepped through the property fence to conduct the survey. The road crossing served as the 0-m transect and TIAER personnel worked upstream from the road. Although the site is listed as being publicly accessible, public access is limited to an area approximately eight feet up and downstream of the culvert crossing to the property fence (Figure 5.74).

Figure 5.74 Photograph of Sweetwater Creek Site SW030 taken on July 28, 2013 showing public accessibility at the road.

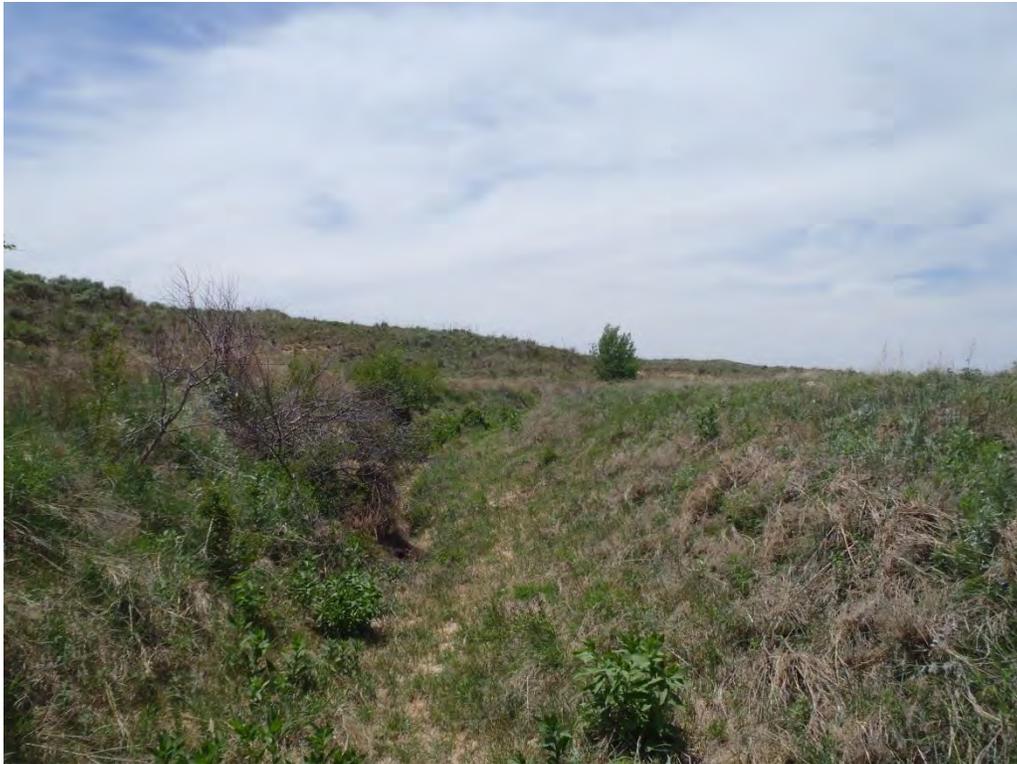
Figure 5.75 Photograph of Sweetwater Creek Site SW030 taken on May 27, 2013, the upstream view of the 300-m transect.

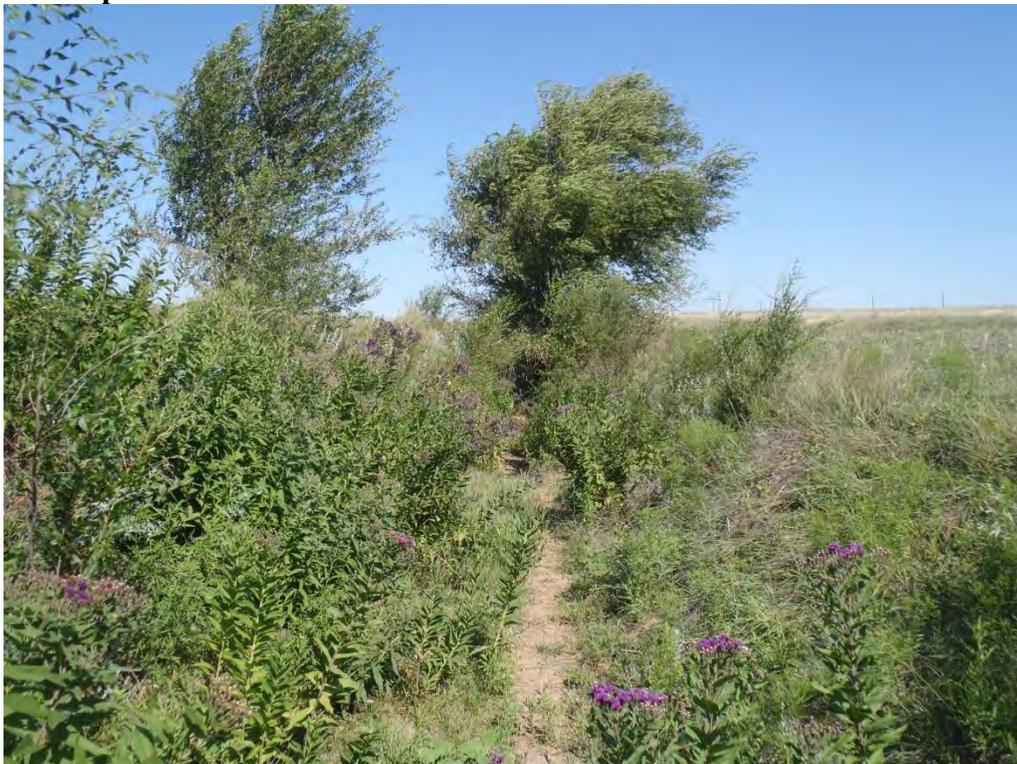
Figure 5.76 Photograph of Sweetwater Creek Site SW030 taken on July 28, 2013, the upstream view of the 150-m transect.

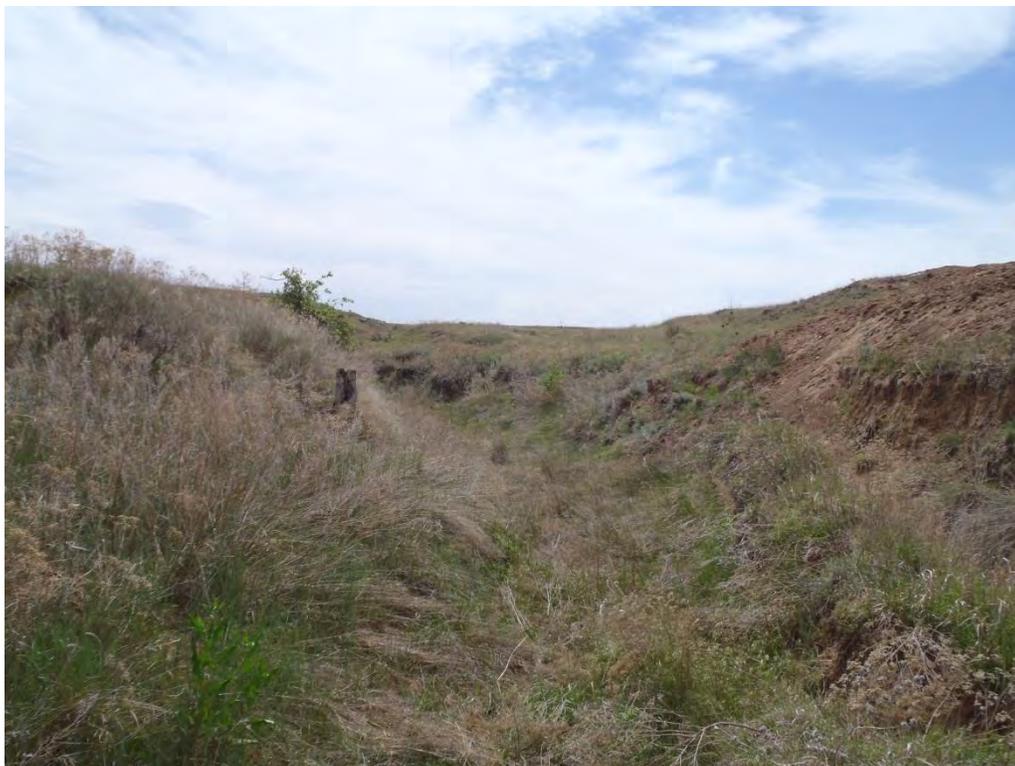
Figure 5.77 Photograph of Sweetwater Creek Site SW031 taken on May 27, 2013, the upstream view of the 300-m transect.

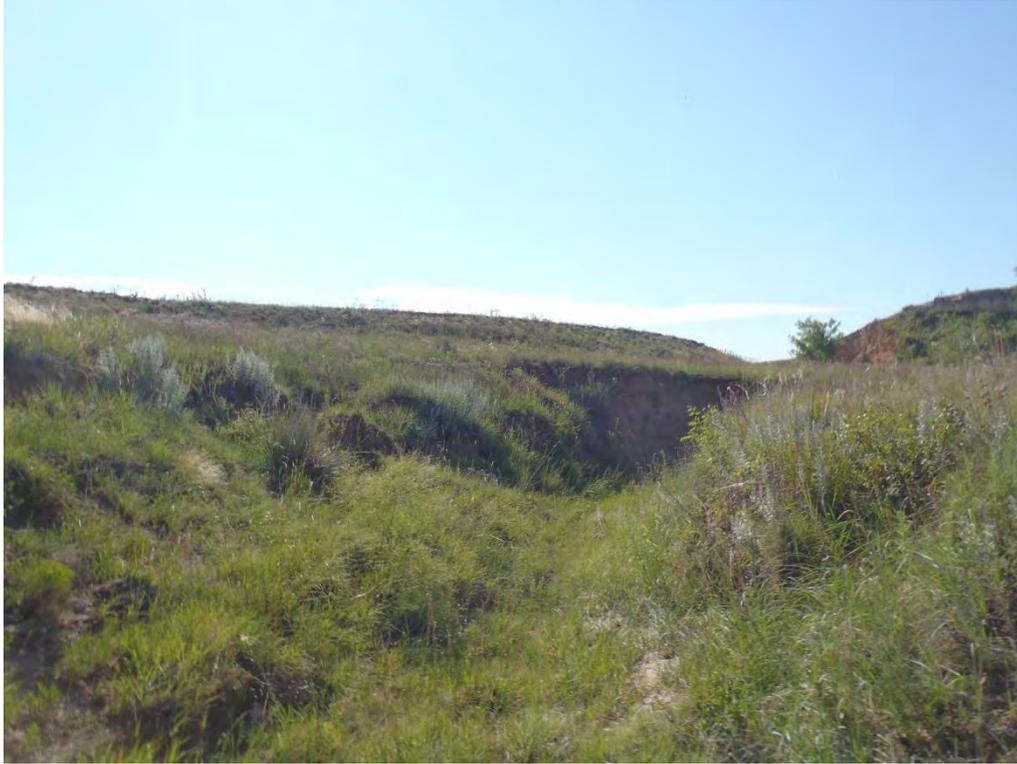
Figure 5.78 Photograph of Sweetwater Creek Site SW031 taken on July 28, 2013, the upstream view of the 30-m transect.

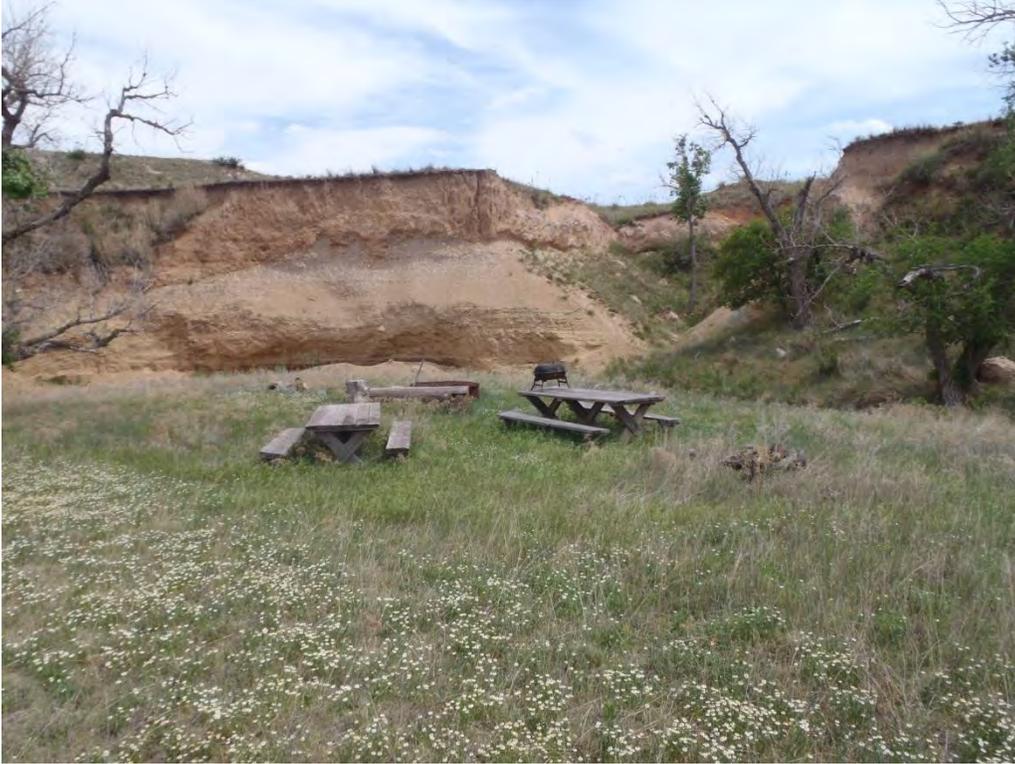
Figure 5.79 Photograph of picnic area between Sites SW031 and SW032 taken on July 28, 2013.

Aesthetic appearance of the water and wildlife observations for the site during each survey have been previously provided in Tables 5.9 and 5.10, respectively. There was a slight presence of turkeys during the first survey. There were no other mammals or vertebrates encountered during either survey. Tracks found during both surveys were identified as canine, cattle, and deer. Bird, canine, and deer feces were found throughout the reach during both surveys. Trash, which was rare, consisted of one metal drum. There was no evidence of human activity was found within the study reach. As previously mentioned, a picnic area was observed on the property between Sites SW031 and SW032.

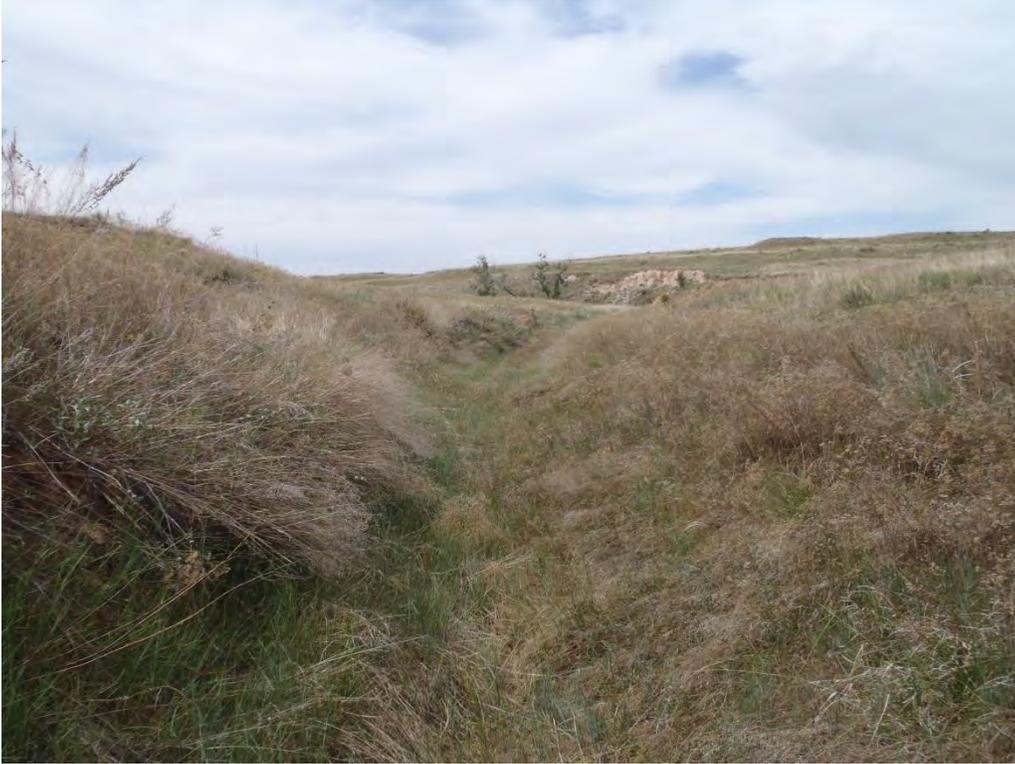
Figure 5.80 Photograph of Sweetwater Creek Site SW032 taken on May 27, 2013, the upstream view of the 300-m transect.

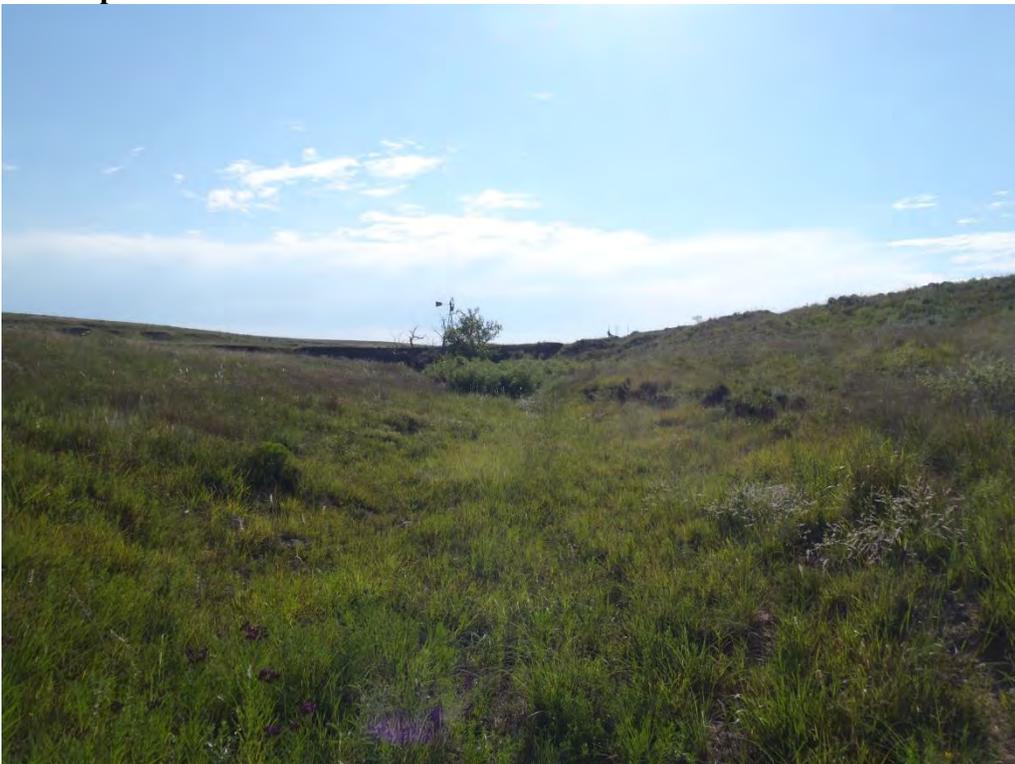
Figure 5.81 Photograph of Sweetwater Creek Site SW032 taken on July 28, 2013, the downstream view of the 150-m transect.

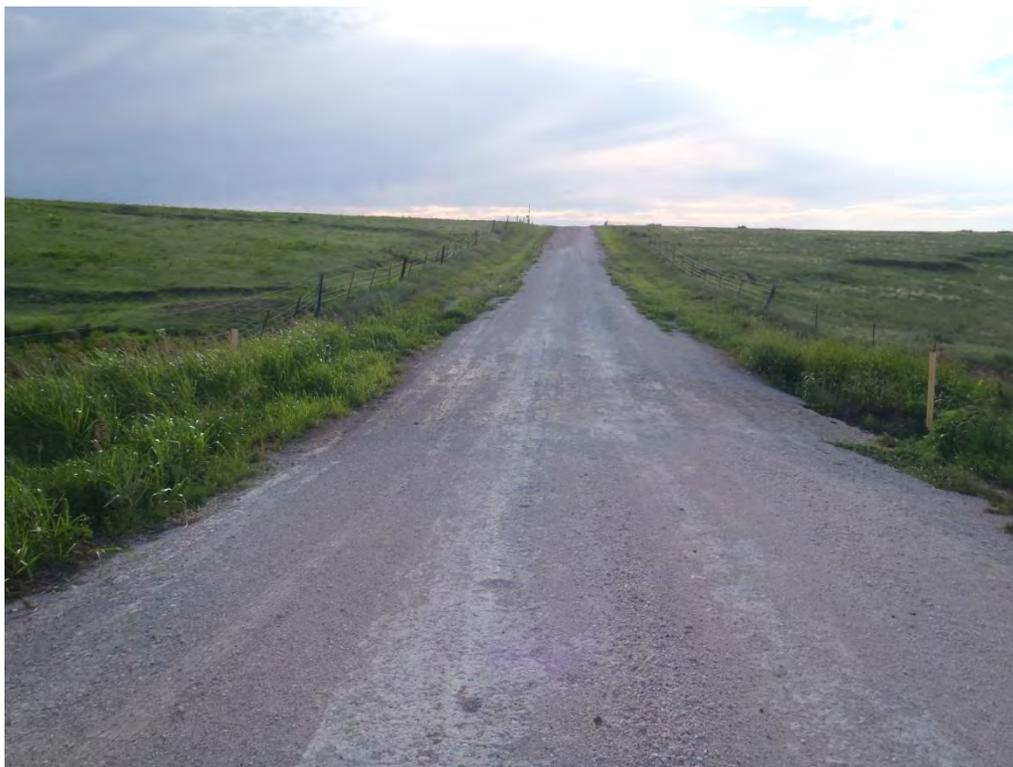
Figure 5.82 Photograph of the road crossing on County Road B (Hoffer Road) at Site SW033 taken on July 28, 2013 showing limited public accessibility.

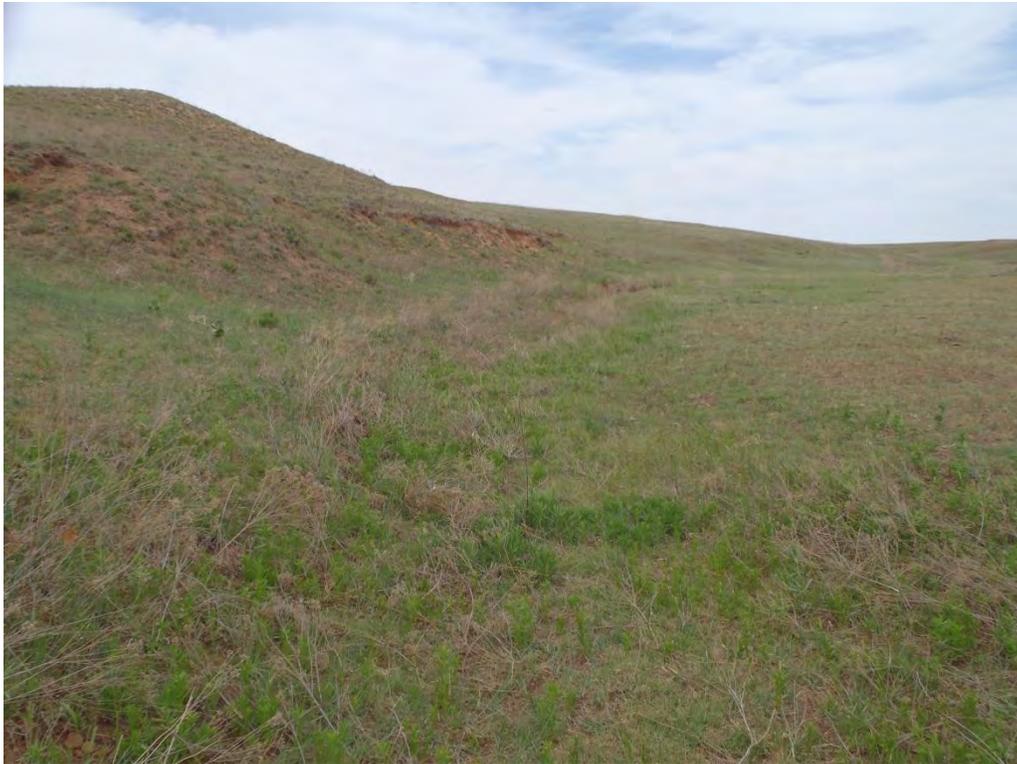
Figure 5.83 Photograph of Sweetwater Creek Site SW033 taken on May 27, 2013, the upstream view of the 150-m transect.

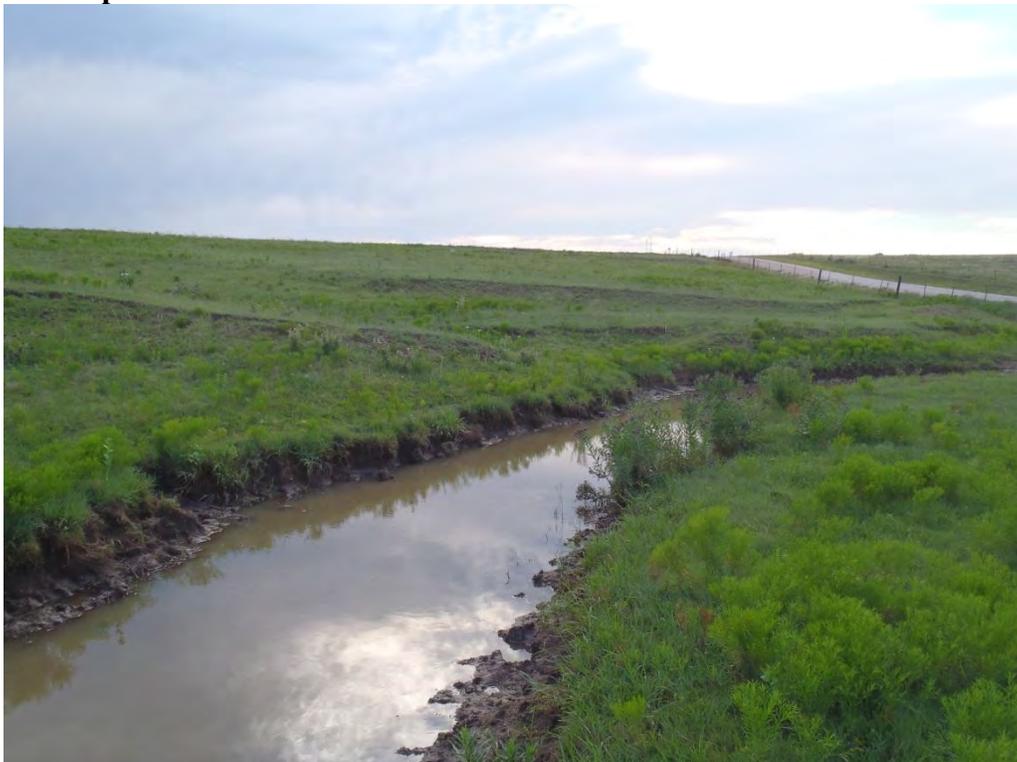
Figure 5.84 Photograph of Sweetwater Creek Site SW033 taken on July 28, 2013, the downstream view of the 30-m transect.

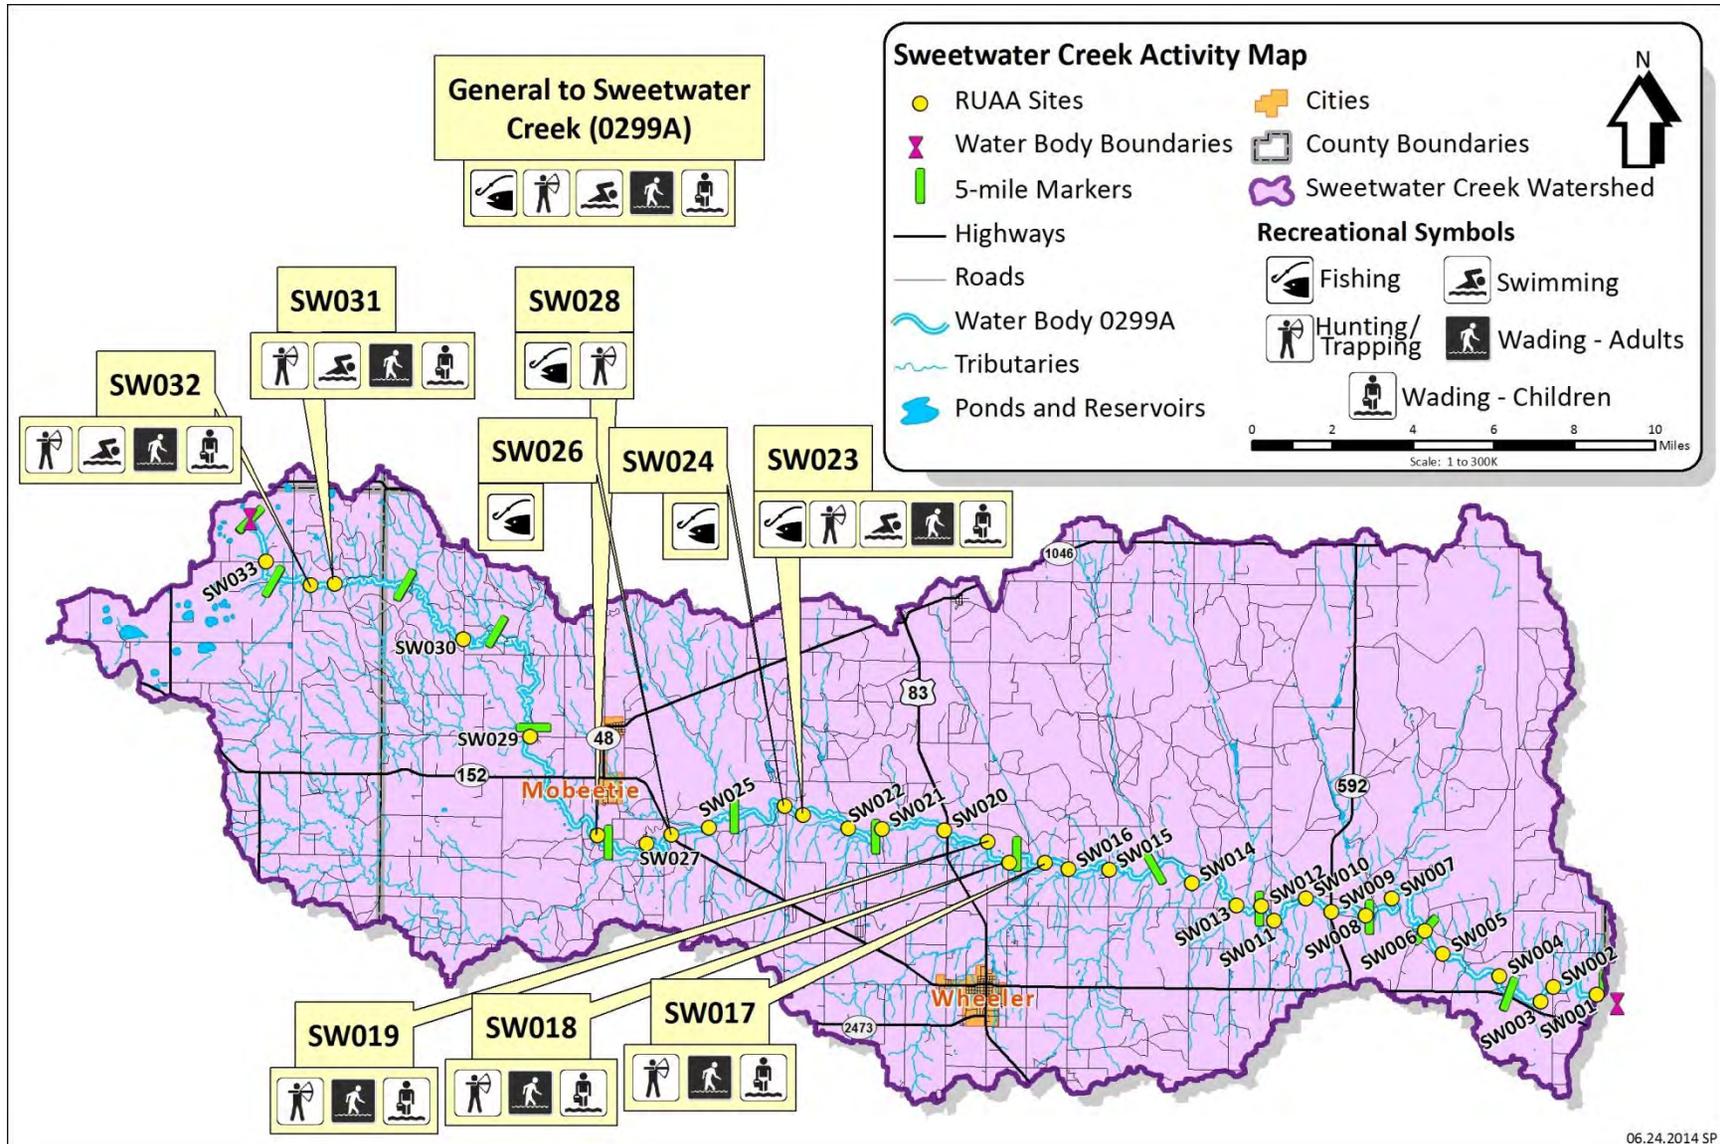
During the two surveys, there were no contact recreational activities observed by TIAER field staff. Additionally, there were no non-contact recreational activities observed during either survey. Interviews revealed that swimming, adult wading, children wading, hunting and fishing has occurred at various sites throughout the reach, although not frequently. Areas of the stream open to the public are limited to the right-of-ways immediately underneath bridge crossings or areas immediately up and down stream of culvert crossings, typically ranging from 5 to 20 meters. Recreational activities reported by interviewees are summarized in Figure 5.85. Overall RUAA findings are summarized in the form below.

Figure 5.85 Summary of observed and interviewed human activities on Sweetwater Creek.
