Storage Tank Fire at Intercontinental Terminals Company, LLC (ITC) Terminal

Deer Park, Texas | Incident Date: March 17, 2019 | No. 2019-01-I-TX

Investigation Report

Published: July 6, 2023

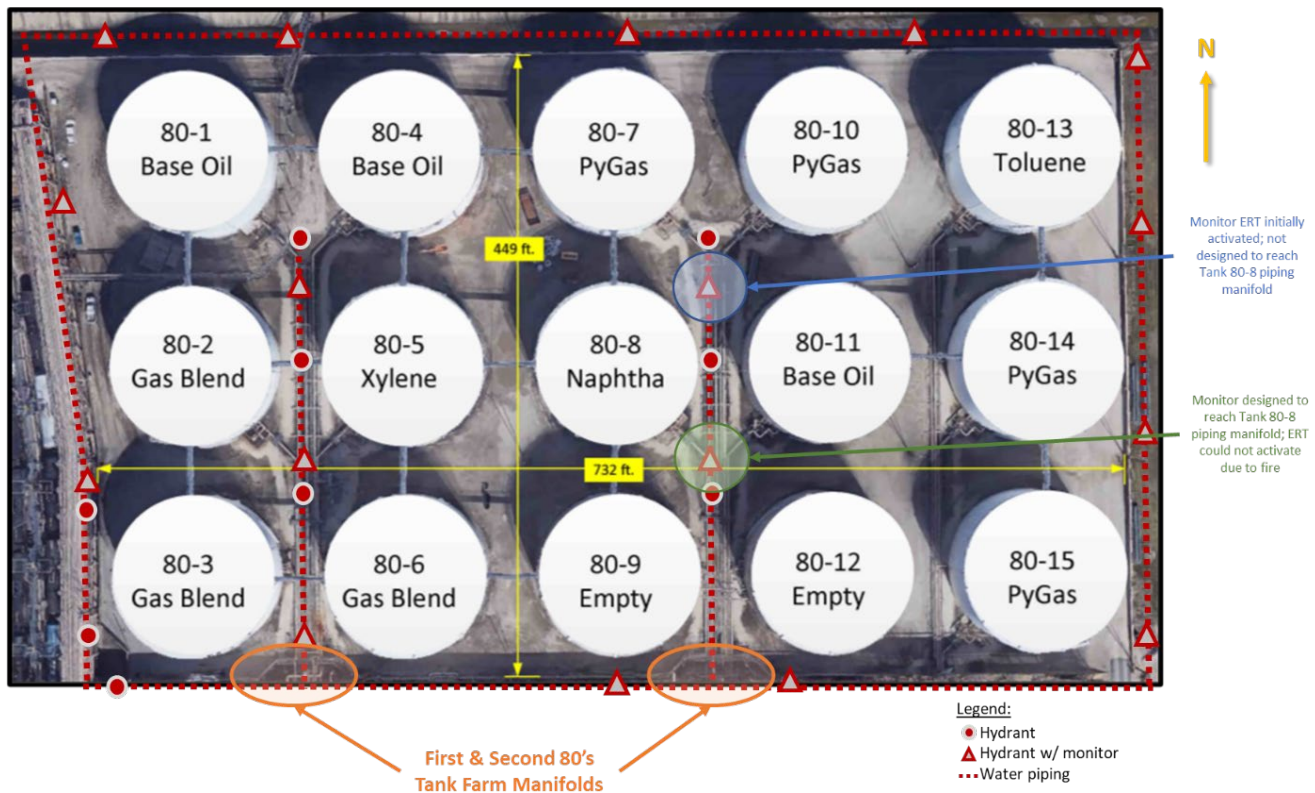
Figure 10. First & Second 80's tank farm layout, including products contained in the tanks at the time of the incident and positions of fire water equipment. (Credit: ITC, annotations by CSB)

^f These five additional tanks included Tanks 80-2, 80-3, 80-6, 80-9, and 80-11, which contained gasoline blendstock and base oil. Flammable vapors ignited along the rooflines of Tanks 80-2, 80-3, 80-6, and 80-9, causing fire to expel from the vents located near the top of the tanks. At this time, the fire involving Tank 80-11 burned at ground level in the area of the piping manifold. Sometime before 5:30 a.m., an additional tank containing toluene, Tank 80-13, became involved in the fire at ground level but was quickly extinguished (Figure 10).

^g For example, Tanks 80-14 and 80-15, which caught fire in the early hours of March 19, were located in the southeast corner of the tank farm (Figure 10) and contained Pygas, a highly flammable liquid.

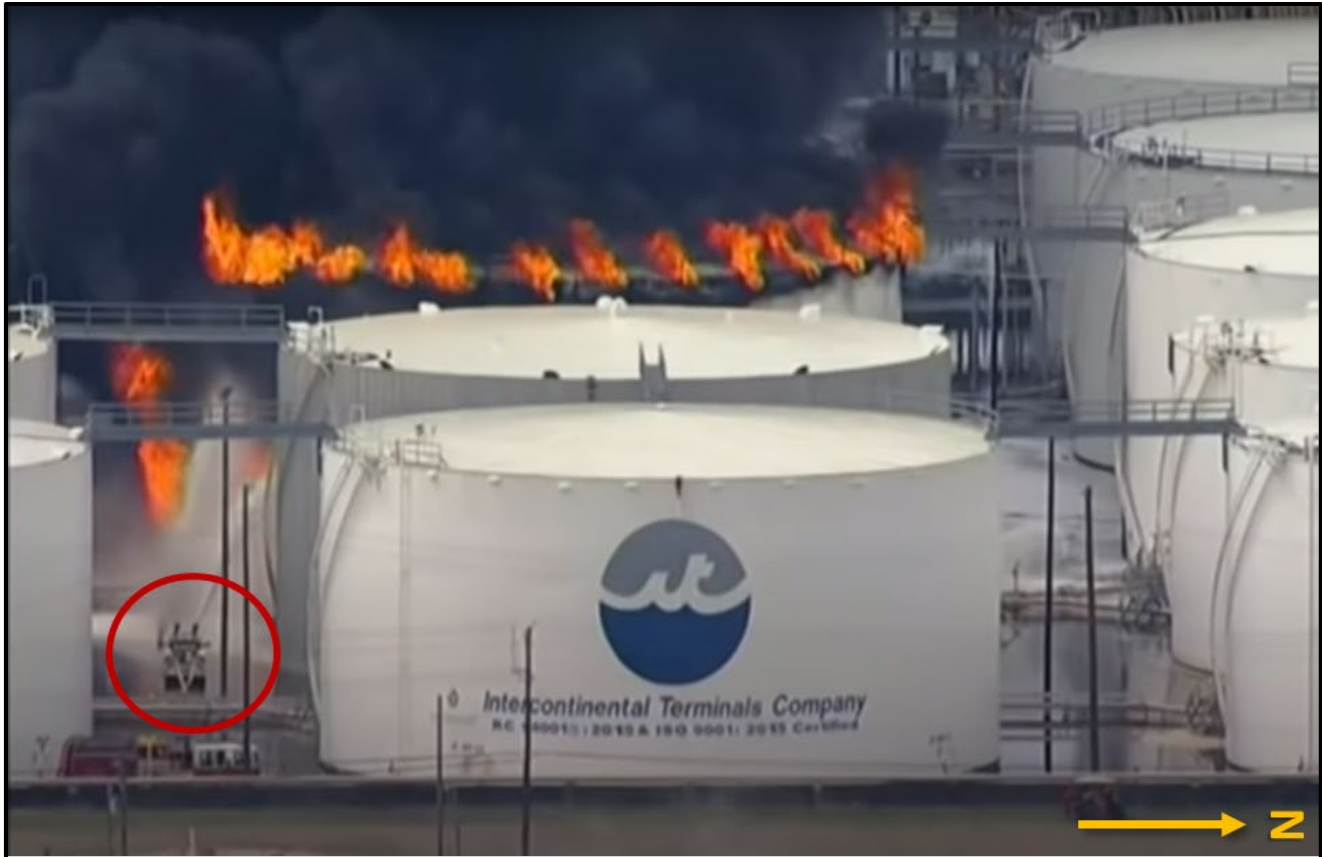
Early response efforts focused on life safety^a and directing water sources at Tank 80-8 and the ground-level fire that engulfed its piping manifold (**Figure 13**). As the fire grew, additional water supply was needed; so, efforts were also underway to establish water supply from neighboring facilities and the Houston Ship Channel via fire boats. Emergency responders continued to work to control the fire; however, it was "growing faster than [they] could do anything."

Figure 13. The quick attack truck (circled in red) staged between Tanks 80-11 and 80-12 on March 17, 2019. (Credit: Associated Press, annotations by CSB.)

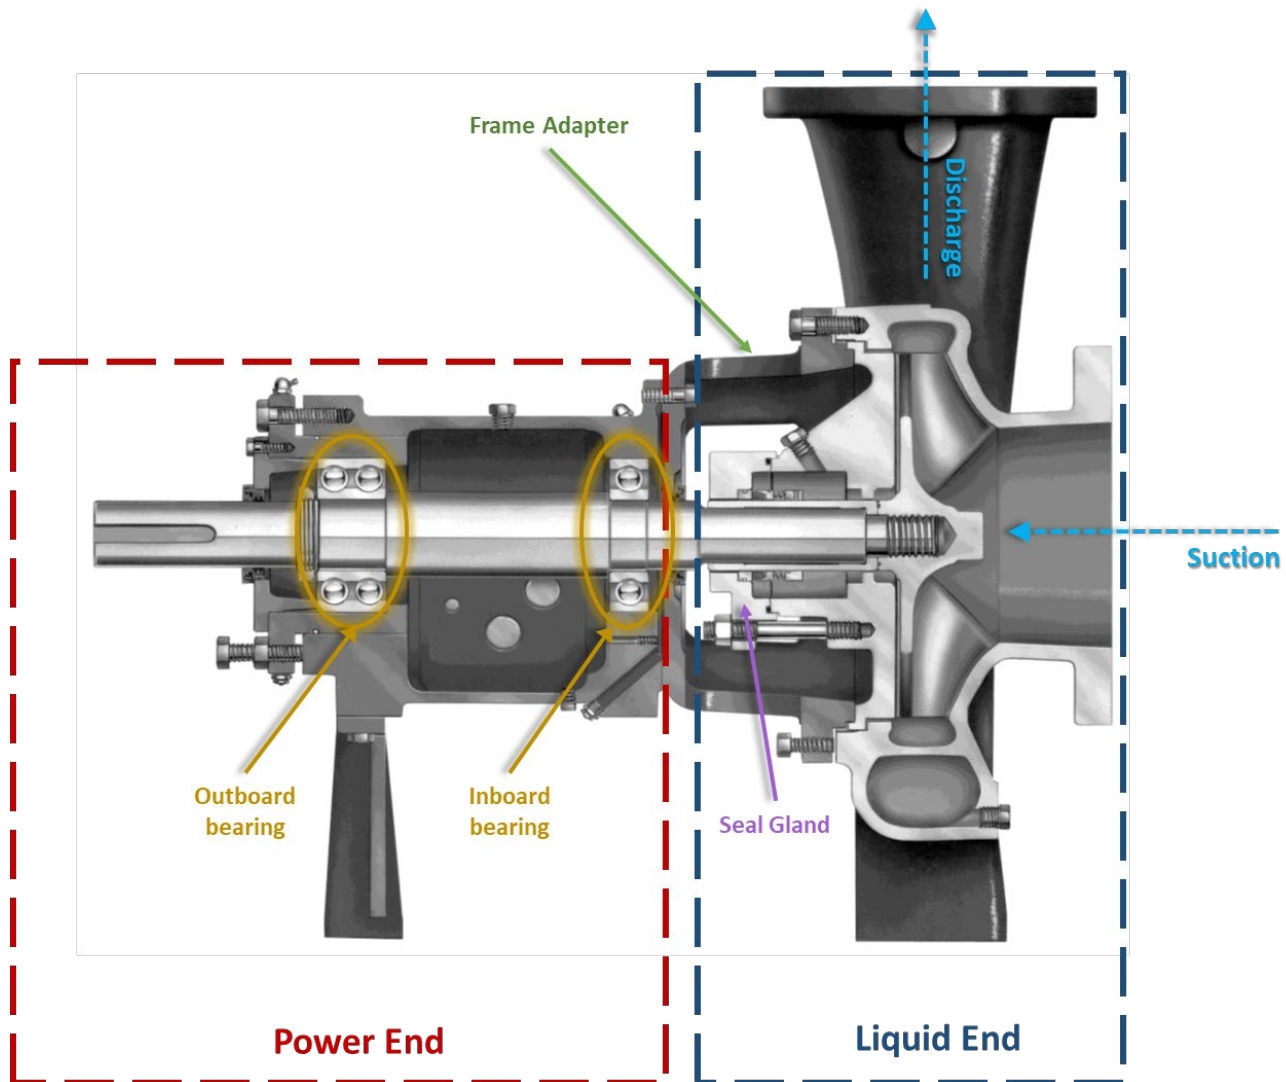
Figure 21. Sectional view of *Goulds Model 3196 XLT-X* chemical process pump. This view identifies the pump's liquid end, power end, and rigid frame adapter. (Credit: *Goulds*, annotations by CSB)

(**Figure 21**). The liquid end was comprised of the casing, impeller, seal chamber, and mechanical seal gland.^a The mechanical seal was designed to contain the butane-enriched naphtha product inside the seal chamber as it flowed through the pump. The seal gland mounted flush to the seal chamber cover and was secured by four gland nuts threaded onto the seal chamber studs that extended through designated slots on the seal gland. The power end was comprised of the bearing frame, pump shaft, two sets of ball bearings, and oil seals. The purpose of the two sets of ball bearings was to support the pump shaft. The inboard bearing was responsible for carrying radial loads,^b and the outboard bearing was responsible for carrying both radial and thrust (axial) loads. The pump shaft extended from the impeller through the seal chamber and bearing frame to the motor coupling.

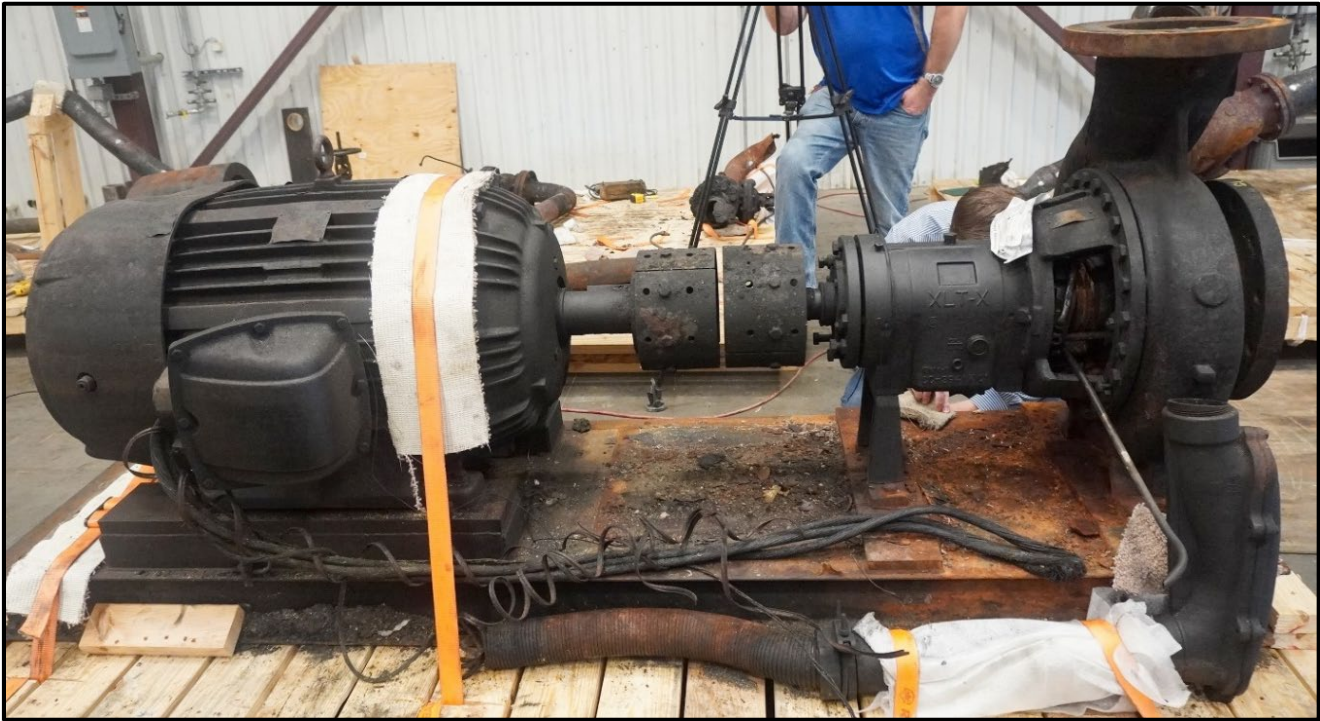
Figure 22. Tank 80-8 pump removed from ITC Deer Park terminal. Pictured is the pump kit on a pallet, as removed from the incident site. (Credit: CSB)

Following the incident, the Tank 80-8 circulation pump skid was transported to a third-party facility for inspection and teardown (**Figure 22**). The pump was fully disassembled to allow for visual examination of its individual components and documentation of their condition. Severe degradation and wear damage were observed on the pump shaft, seal, and outboard bearing. Substantial abrasive wear was visible on the pump shaft adjacent to the seal on the inboard side of the bearing housing (**Figure 23**). Extensive contact wear was also visible on the seal gland (**Figure 24**).

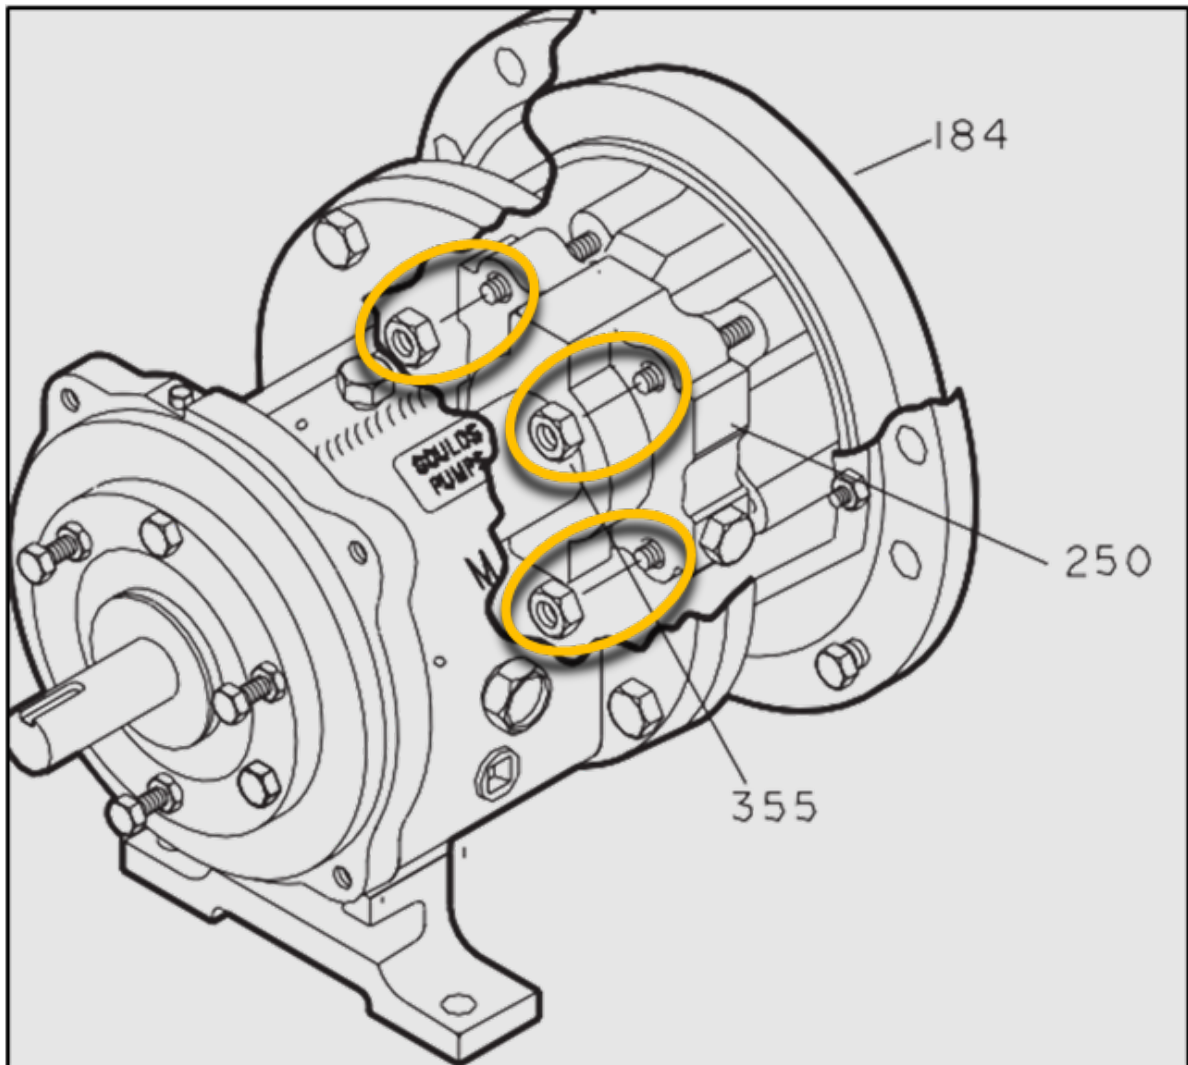
Figure 25. Cutaway drawing of *Goulds* chemical process pump showing the locations of three of the four gland nuts that held the seal gland in place against the seal chamber cover. *Note: fourth gland nut is not visible in drawing.* [Credit: *Goulds*, annotations by CSB]

Four gland nuts secured the seal gland to the seal chamber cover to prevent the butane-enriched naphtha product from leaking from the pump, as shown in **Figure 25**. Post-incident inspection of the Tank 80-8 circulation pump revealed that none of the four gland nuts remained in place and that the seal gland was completely separated from the seal chamber cover (**Figure 26**). Additionally, the barrier fluid steel tubing used to provide lubrication

to the mechanical seal via the seal gland was found severed from the nearby external seal pot and wrapped around the pump shaft.

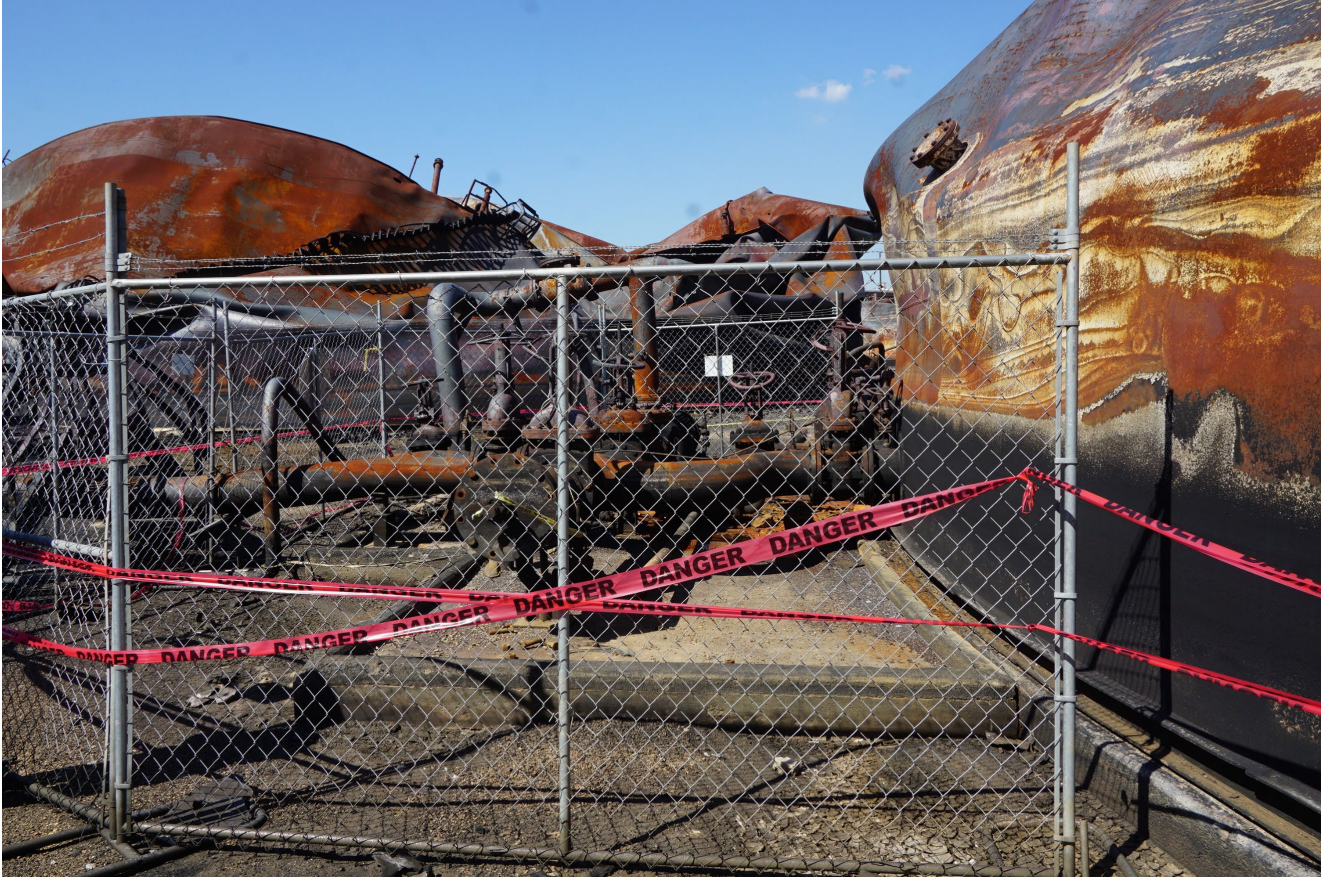
Figure 30. Small concrete containment area around the Tank 80-8 circulation pump. (Credit: CSB)

ITC had “small concrete containment area[s]” immediately adjacent to the majority of the tanks at its facility, including Tank 80-8 (**Figure 30**). ITC’s Spill Prevention Control and Countermeasure Plan (SPCC) stated that these concrete containment areas were designed to provide local containment and drainage capabilities for pumps and valves associated with the tanks: “Leaks, drips, etc. that originate at the pumps/valves are contained and immediately drained to the wastewater treatment system via the chemical drain system.” This was the only containment area that separated Tank 80-8 spills from adjacent tanks. On the day of the incident, the butane-enriched naphtha product released from Tank 80-8 overflowed this small containment area and entered the common containment area of the tank farm.

The CSB concludes that ITC's First & Second 80's tank farm was not subdivided as was required by NFPA 30. Although the subdivisions of the diking required by NFPA 30 likely would have been insufficient to hold the full contents of Tank 80-8, additional subdivisions could have slowed the spread of the butane-enriched naphtha product and allowed responders the opportunity to access and activate the fixed fire monitors located within the containment area to fight the fire surrounding the Tank 80-8 piping manifold before it spread to adjacent tanks.

The First & Second 80's tank farm was not the only tank farm at the ITC Deer Park terminal that contained this type of arrangement. Among others at the terminal, the Third 80's tank farm, located adjacent to the First & Second 80's tank farm (see **Figure 3**), contained 12 large-capacity atmospheric storage tanks and their associated piping manifolds/equipment, spaced similarly, within a common containment area. As a result, the CSB recommends that ITC conduct an evaluation of the design of all new and existing tank farms at the ITC Deer Park terminal. The evaluation should identify additional engineering controls needed to address subdivisions between tanks (**2019-01-I-TX-R5**).

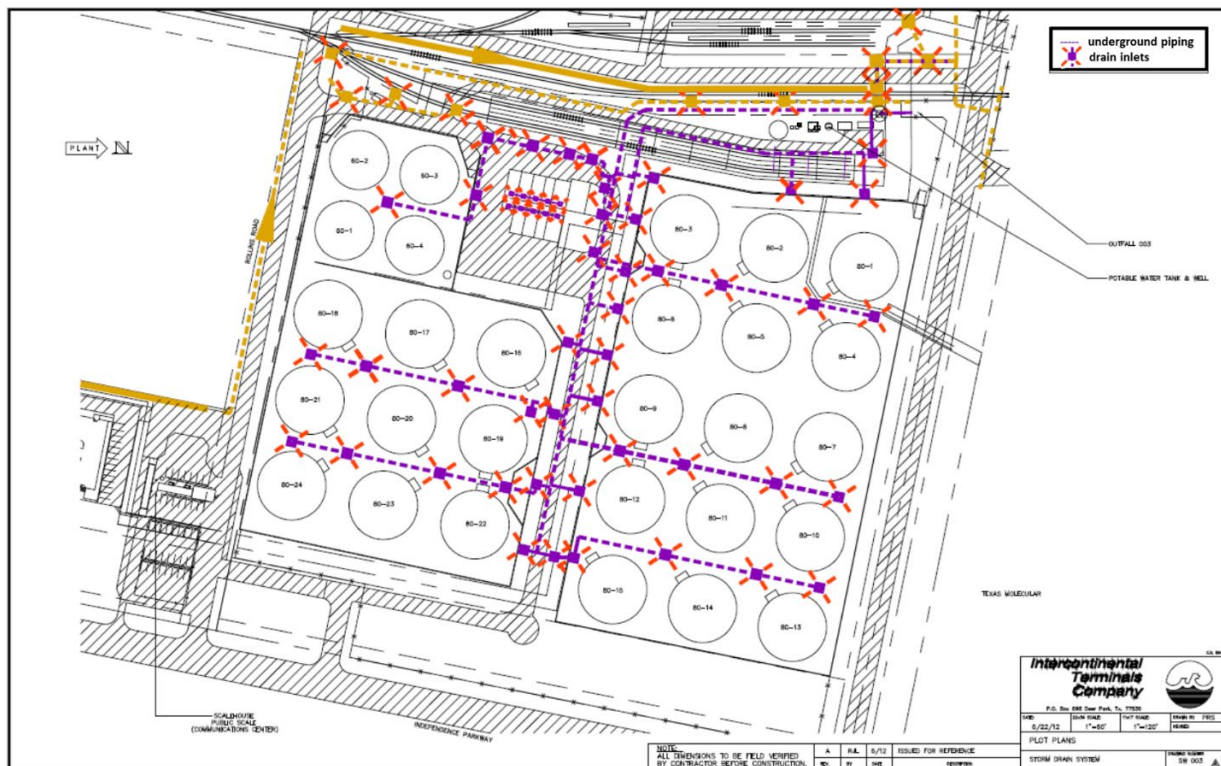
Figure 31. Plot plan of First & Second 80's tank farm stormwater drain system. (Credit: ITC)

- The stormwater drains were generally positioned along the same pathway as the transverse piping that ran north to south in between the tanks;
- The tank farm was graded to facilitate drainage to stormwater catch basins on the south side of the tank farm; and
- The containment wall failed, allowing the mixture of hydrocarbon products, firefighting foam, and contaminated water to eventually enter the Houston Ship Channel.

The stormwater drain system allowed the water, released materials, and firefighting foam to accumulate in the containment area while emergency responders were fighting the fire. The tank farm grading also provided a means for the fire to spread across the tank farm. The water and released materials flowed toward the transverse piping and piping manifolds and then south, which would have caused a “running fire” (i.e., one that tracked with the spill) that exposed other tanks and their respective piping manifolds prior to entering the drainage system. Since both naphtha and xylene are lighter than water,^a the initially released flammable products floated on top of the water in the containment area, ignited, and caused several small fires to burn on the water surface where gaps in the foam existed. The movement of the fire toward the south prevented emergency responders from accessing the firewater system valves and foam connections located along the containment wall on the south side of the tank farm. It also prevented emergency responders from being able to position personnel at the monitor nozzles or employ other fire apparatus or equipment in this area.

Burning liquid on the ground or floating on the water during the initial and subsequent releases likely contributed to thermal exposure to the tanks as the burning liquid moved toward and then passed the tanks on its way toward drains. This movement continued as the stormwater drainage system became overwhelmed by the volume of materials, which partially explains the fire spread. This also helps explain why fire damage on the south side of the tank farm was more severe than on the north side.

The CSB concludes that the accumulation of hydrocarbon products, firefighting foam, and contaminated water within the First & Second 80's tank farm containment area contributed to the fire spreading to additional tanks in the common containment area. The accumulation likely also contributed to the containment wall failure, which allowed a mixture of hydrocarbon products, firefighting foam, and contaminated water to be released into the local waterways.

API STD 2610 was not published until 1994, and thus did not exist at the time that the First & Second 80's tank farm was constructed; however, the recommendations contained in API STD 2610 can be considered while evaluating future recommendations related to the design of ITC's tank farms' drainage systems. The CSB recommends that ITC conduct an evaluation of the design of all new and existing tank farms at the ITC Deer Park terminal. The evaluation should assess the adequacy of the containment wall and drainage system designs, accounting for the impact of firefighting activities, including the application of firewater and foam on these systems (**2019-01-I-TX-R5**).
