Riparian Evaluation of Oso Creek and Tributaries

Funding Entity: Texas Commission on Environmental Quality (TCEQ)

Contractor and Performing Party: Nueces River Authority (NRA)

Report Date: August 31, 2016

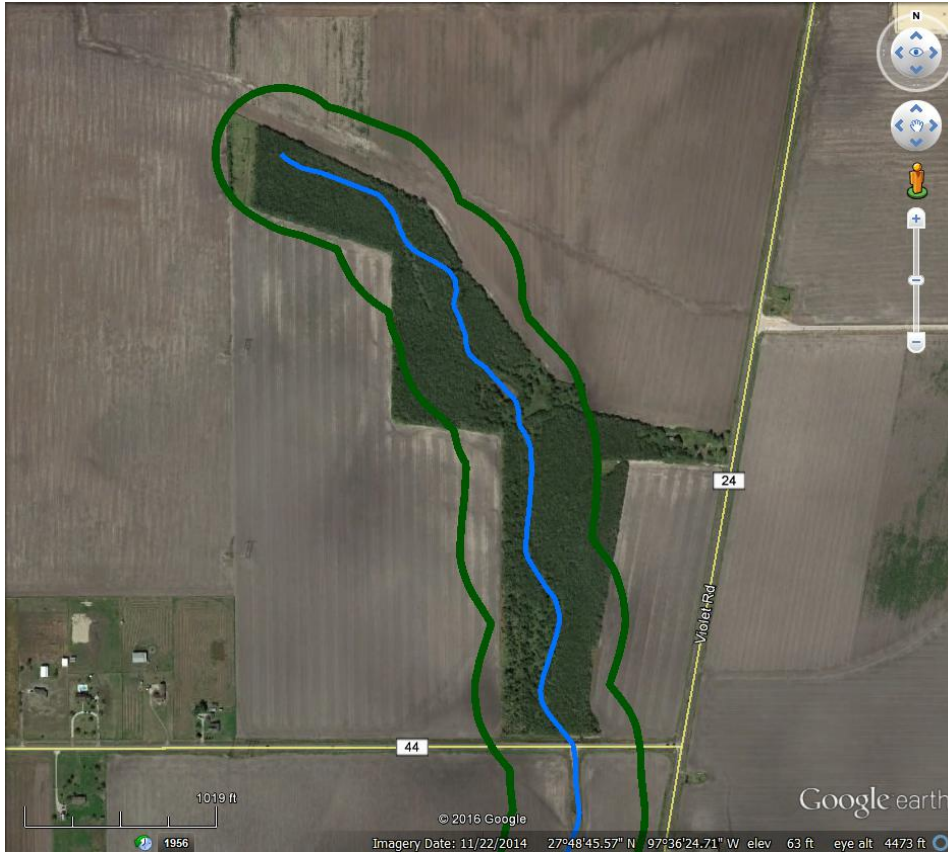
Oso Creek Segment 1

This short segment forms what appears to be the beginning of Oso Creek. It is a heavily wooded water saturated area, located at 27°49.030 N and 97°36.663 W, extending about ½ mile in length to CR 44. Most of the riparian area appears highly functional, with one large pool of water and many smaller ones visible through the canopy. A 300 foot buffer on each side amounts to about 36 acres of potential riparian function of which most appears to be functioning.

Saturated soils and standing water

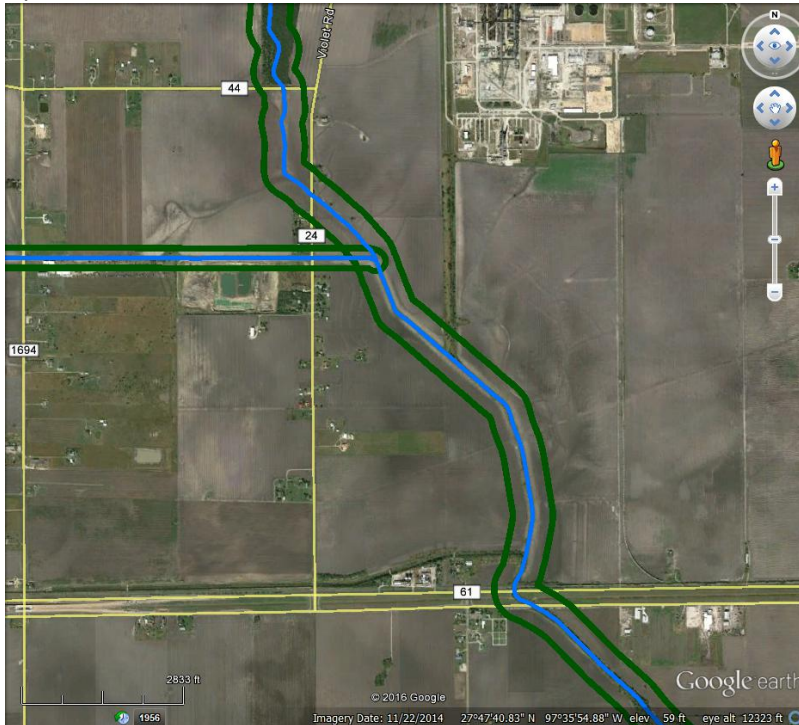
Oso Creek Segment 2

This segment runs from CR 44 across Violet Road (CR 24) to SH 44 (Agnes St.)/CR 61 and it is about 2 miles in length containing about 145 potential riparian acres. The riparian area is non-functional in the first 0.67 miles where the creek is disturbed. Below this point, a classified tributary (2485C), which carries the Robstown Wastewater Treatment Plant (WWTP) effluent, enters from the west contributing a strong flow of clear water. A small band of vegetation, averaging about 30 feet in width, can be seen on each side of the creek. Another drain enters from the north at 1.08 miles and the riparian area widens, gaining function. At 1.85 miles, a larger well vegetated drain joins from the west and the riparian area widens to about 70 feet on each side, is wooded and appears functional.

Non Functional

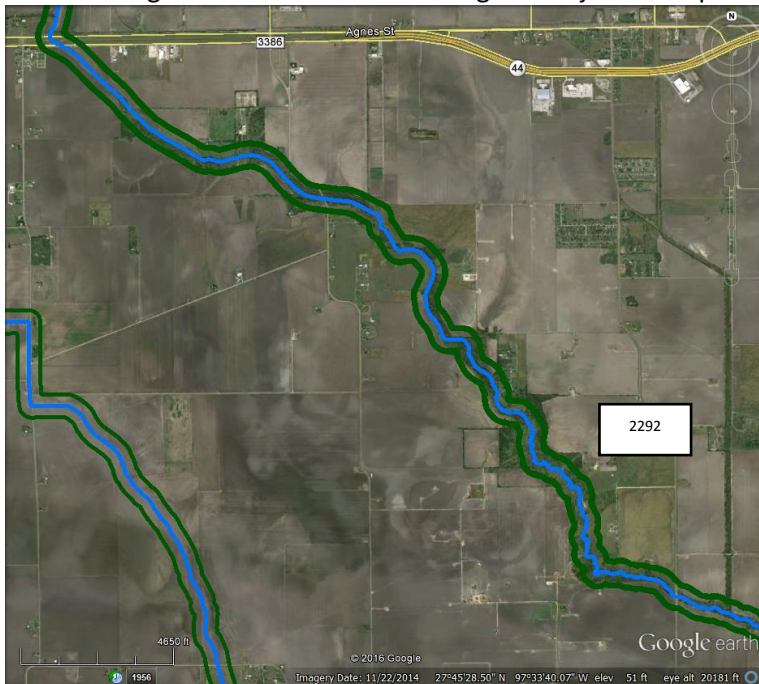
Oso Creek Segment 3

The riparian area is marginally functional for the first 0.44 miles, where the vegetated banks average about 40 feet on each side and the channel appears overly straight. From 0.44 miles to 5.4 miles, with another 0.5 mile exception, the creek is highly sinuous and the riparian area is wide, heavily wooded, and highly functional. In places, the riparian area is vegetated with plant groups that are indicative of riparian water storage (plants with wetland statuses of FACW and OBL). In places, this vegetation is present over 300 feet from the channel. The 0.5 mile exception is an area where woody vegetation has been cleared and replaced with improved pasture (non-riparian) grasses and off-channel ponds have been developed. Toward the bottom of this segment, the channel appears to be down-cut or slightly incised and gullies have formed reaching into adjacent crop land.

Functional riparian area

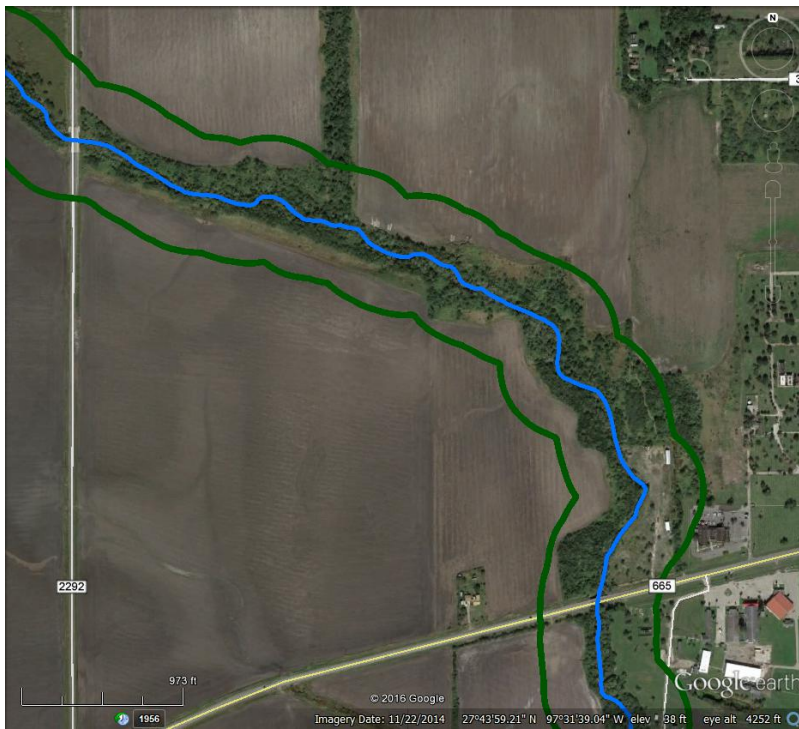
Oso Creek Segment 4

This segment of the creek runs from FM 2292 to FM 665 (Old Brownsville Road) and is about 1 mile in length. In this segment, the creek's channel appears to become consistently incised. The band of riparian vegetation is about 100-150 feet wide on each side of the creek and includes mostly upland woody species and non-riparian grasses. Several active gullies are visible across the adjacent farm lands and enter the creek in this section. Some are old and covered with upland grasses and some are actively degrading and barren. Within the first quarter mile of the segment, a well vegetated, but unnaturally straight, drain enters from the north and was delivering a small steady flow of water. The channel of this drain also appears to be incised and capable of delivering large volumes of higher energy runoff. This segment is marginally functional but tending toward the non-functional condition.

Numerous gullies enter the channel

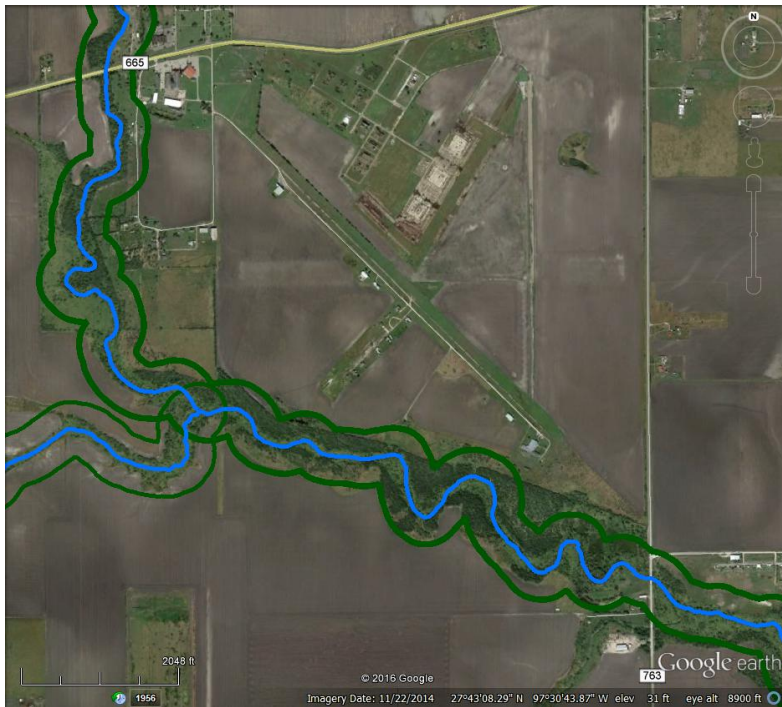
Oso Creek Segment 5

Except near its beginning, at FM 665, this segment is sinuous and bordered by a wide, heavily wooded, riparian area. The vegetated area is, on average, 200-300 feet wide on each side of the creek, but the channel appears cut-down and the creek does not appear to regularly access the wider floodplain. The channel is braided in a few spots and at least one oxbow can be seen in this segment. This segment can be considered marginally functional, but tending toward the non-functional condition.

Wooded sinuous channel

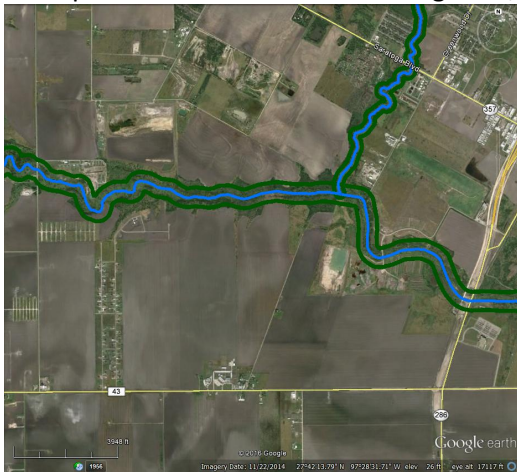
Oso Creek Segment 6

This segment of Oso Creek, from FM 763 to SH 286 (Crosstown Expressway), is about 3.9 miles in length. In this segment, the creek leaves mostly rural lands and enters a mostly urban area. The band of vegetation bordering the creek becomes more irregular; sometimes wide on one side and absent on another. The prevalent vegetation, while better than bare ground, is mostly not of the type indicative of functioning riparian areas. The highly invasive *Arundo donax* (Giant cane) is present in this segment. Even where a broad band of vegetation exists, the riparian area does not appear very functional. The creek channel may have been dredged or artificially deepened in the past. Deep gullies can be seen entering the creek from adjacent lands.

Gulf cordgrass, a strong riparian native

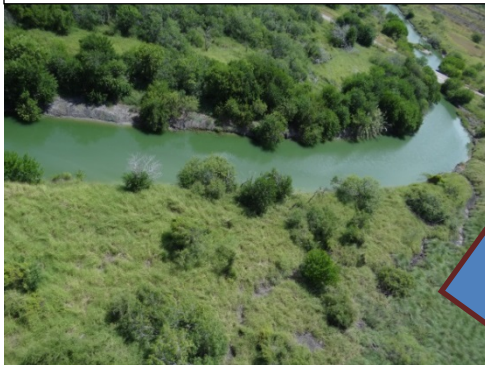
Gulf cordgrass
FACW SR9

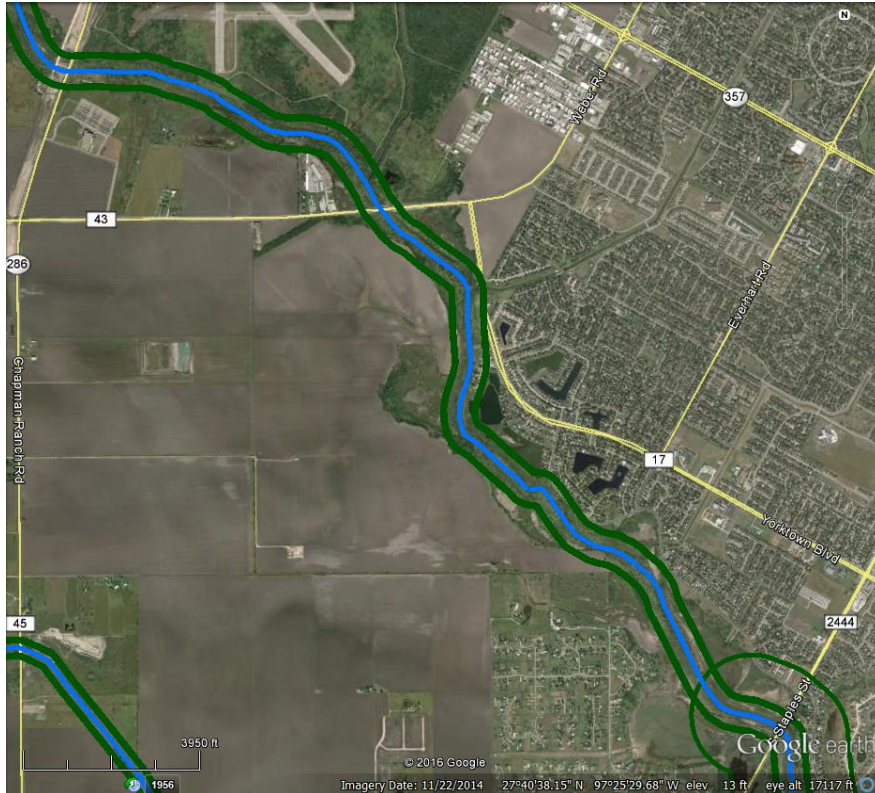
Oso Creek Segment 7

This segment of Oso Creek, from SH 286 (Crosstown Expressway) to FM 2444 (Staples Street), appears to be channelized with limited riparian function. Two urban drains enter the creek in this segment. Both were flowing on the day of this survey. Fresh water of this magnitude is a sign of opportunity, but without floodplain access and a wide, well vegetated floodplain, riparian recovery and riparian water cleaning capability is hindered. This section, like the previous one, has limited riparian function.

Example of urban riparian opportunity for enhanced function.

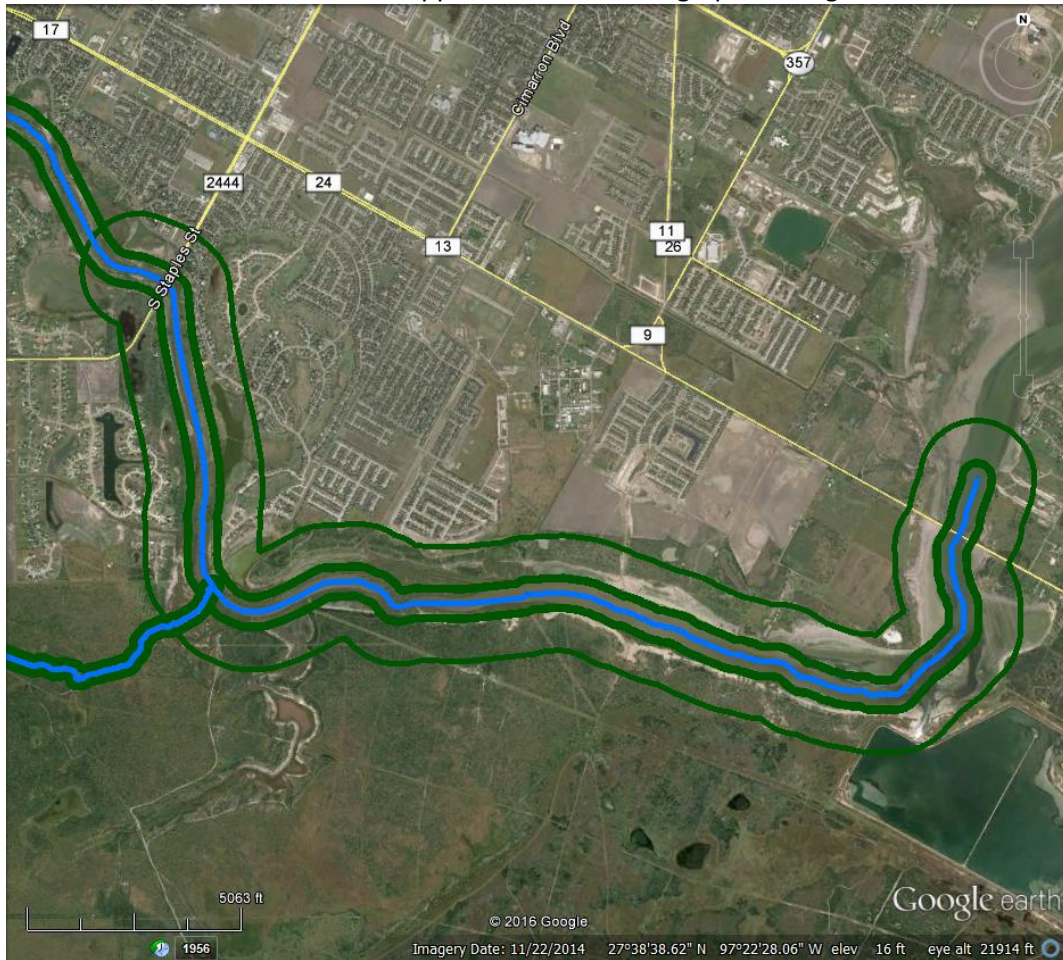
Oso Creek Segment 8

This section, from FM 2444 to Oso Bay, is about 8 miles long. After the first mile of urban development along its banks, looking downstream, Oso Creek is bordered on its right bank by undeveloped lands and on its right bank by the King Ranch. Through most of this segment, the creek is virtually untouched and functional. At the lower end of this reach, near the crossing of Yorktown Blvd., below the Barney Davis Power Plant, off-road vehicle use appears to be hindering riparian vegetation.

Undisturbed banks and highly functional riparian areas

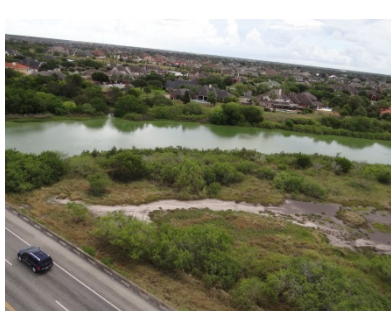
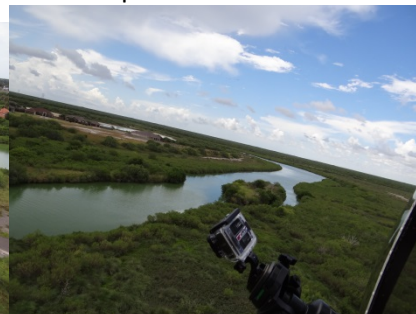
Off-road vehicle use

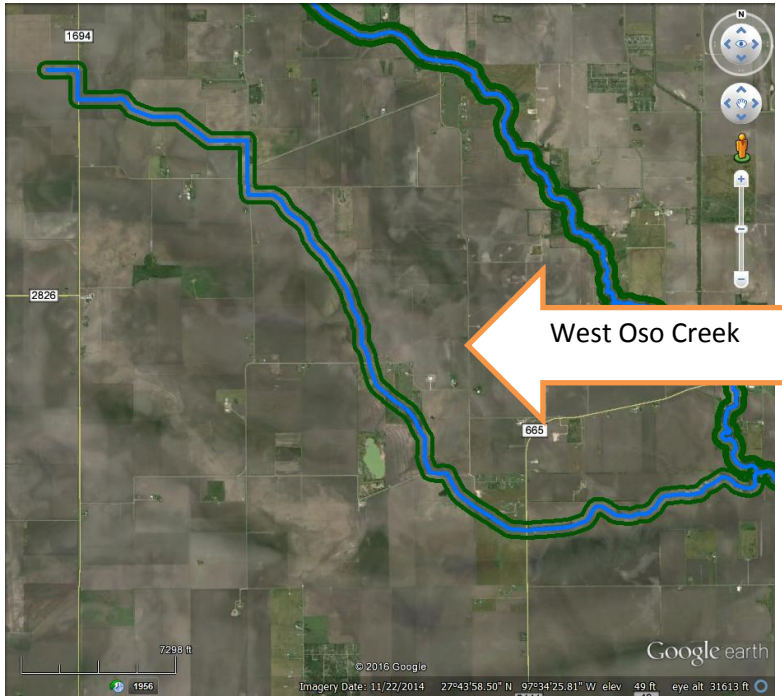
West Oso Creek 2485D

West Oso Creek’s current riparian condition is functional in some areas where vegetation has been allowed to grow and non-functional in other areas where it is disturbed. Overall, it is estimated that about 15% of the creek is bordered by marginally functional riparian areas of varying width and about 85% is in non-functional condition.

Near its origin
at FM 1694

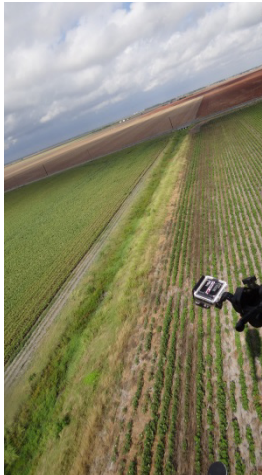
Field drains
to West Oso Creek

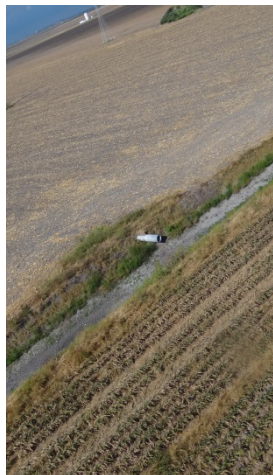
Thin band
of riparian vegetation

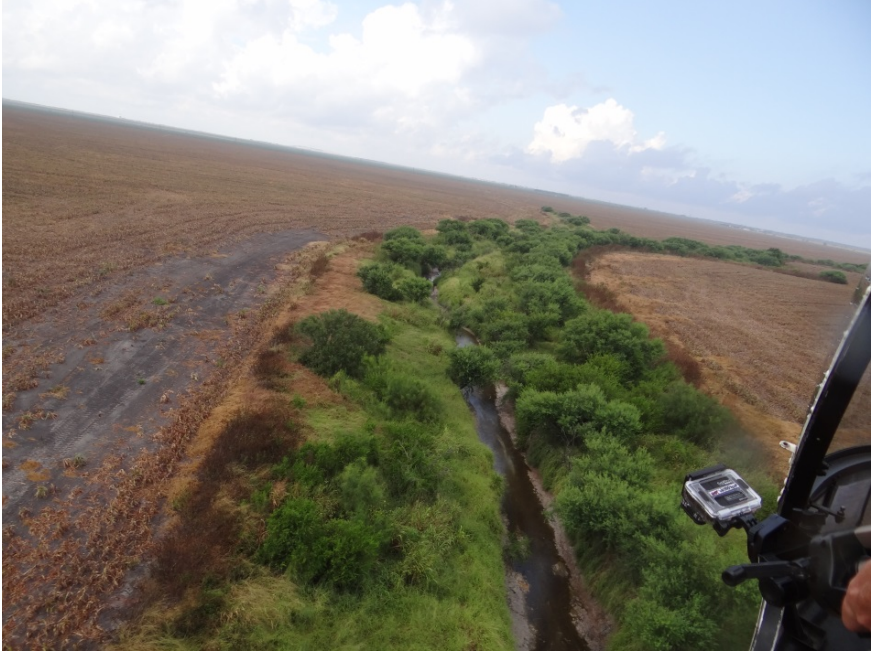
Example of non-functional riparian areas along West Oso Creek.

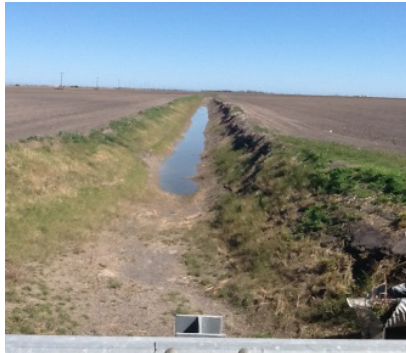
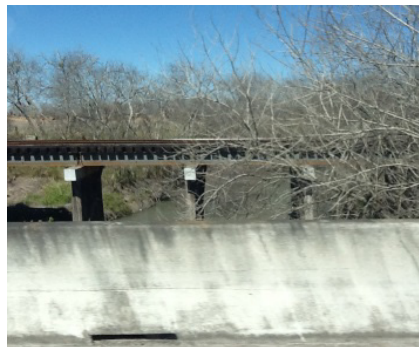
Ditch cleaning project on 2485C

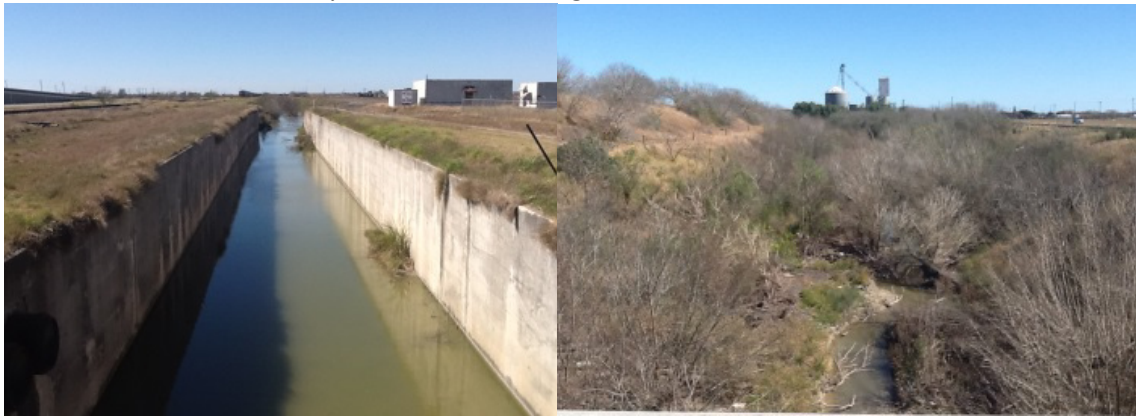
Another water rich tributary observed in this segment

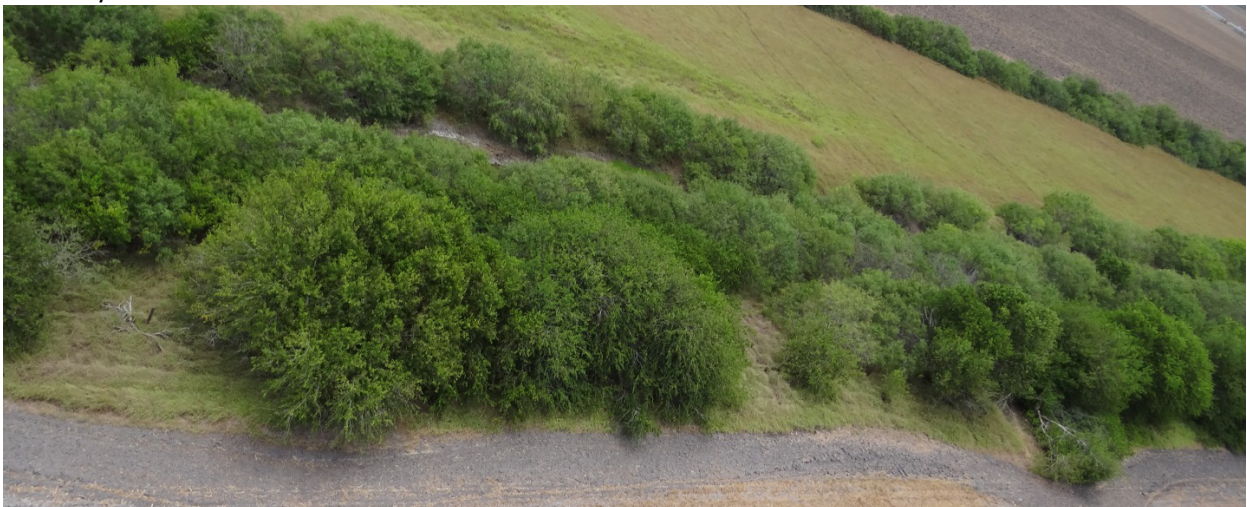
As the tributary enters the King Ranch, the riparian area becomes very functional. The image on the left shows the visual contrast approaching the ranch fence line.

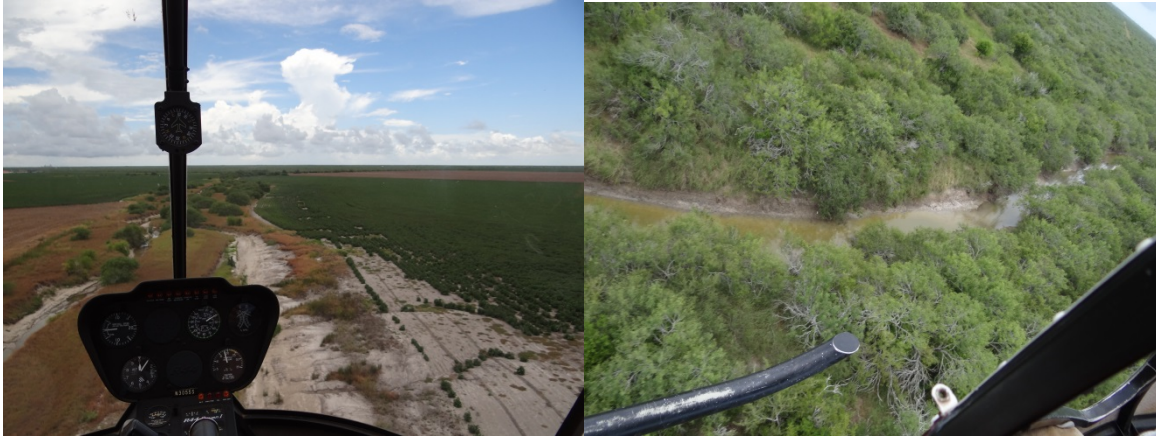
In the King Ranch the landscape becomes dotted with wet spots and undisturbed vegetation, providing a visual benchmark of riparian/wetland function.

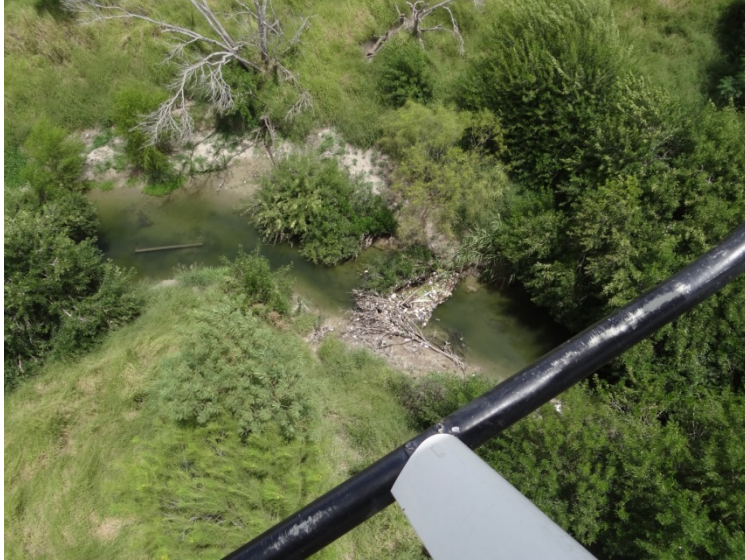
La Volla Creek near the Greenwood wastewater discharge. Water is very clear at this location.

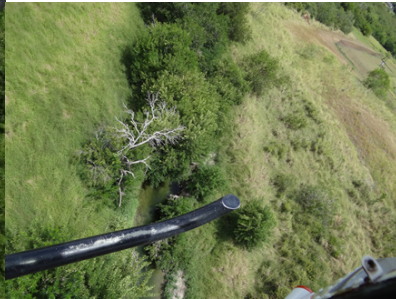
La Volla Creek channel clearing project at FM 357 (Saratoga Blvd.).

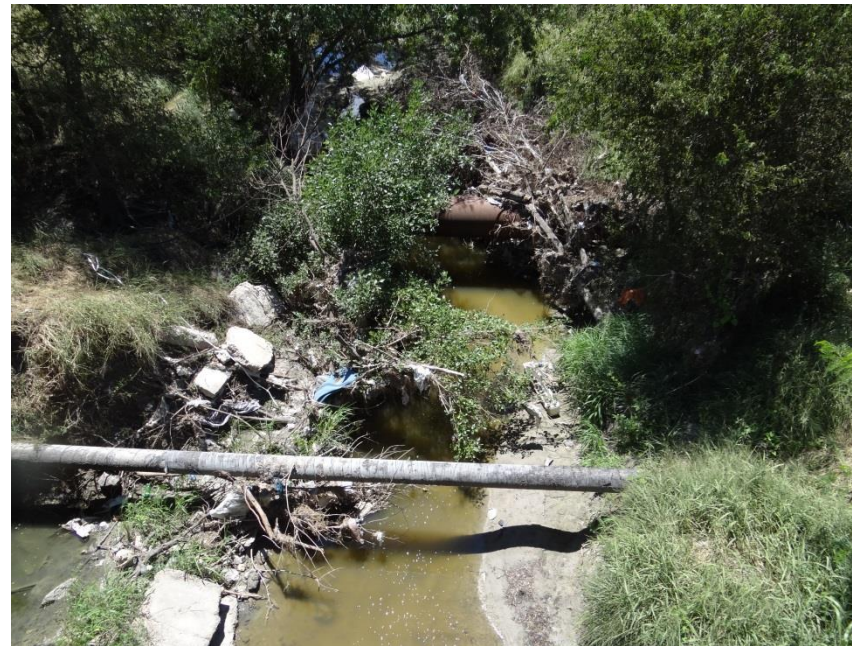
A large scale stream bank and channel clearing project was observed upstream of evaluation site. Subsequent evaluations of this site may identify downstream riparian impacts. A photo point of the disturbed riparian site was established. Its recovery may be visually documented by taking subsequent photos over time.
