**Texas Commission on Environmental Quality
New Technology Research & Development (NTRD) Program
Monthly Project Status Report**

Grantee: Transportation Power, Inc. (TransPower)

Report for the Monthly period: 09/08/12 – 10/05/12 **Date Submitted:** 10/10/12

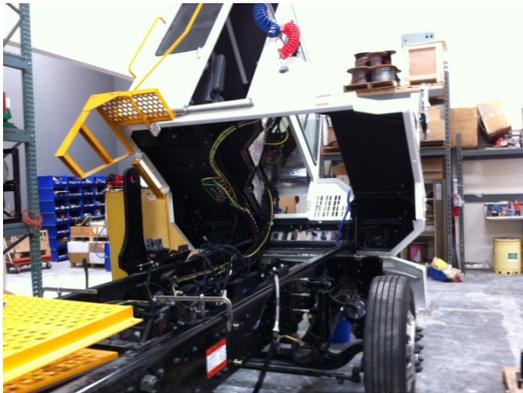
- Tractor #1 was drive tested during the period. While initial drive testing validated the basic functionality of the tractor, including driving during a highly successful “roll-out” event held near the Port of Los Angeles in early September 2012. However, several issues did emerge during drive testing, which are detailed in the Problems/Solutions sections below. Drive testing on Tractor #1 is not yet complete and delivery of the tractor to H-E-B in San Antonio, Texas, is being delayed by about a month to enable us to fully resolve these issues before the tractor is delivered.
- The specifications for electrical infrastructure to support charging were approved by H-E-B. H-E-B expects to complete installation during the next reporting period.
- Tractor #2 has been disassembled with all legacy diesel equipment removed

Figure 1: Disassembled tractor

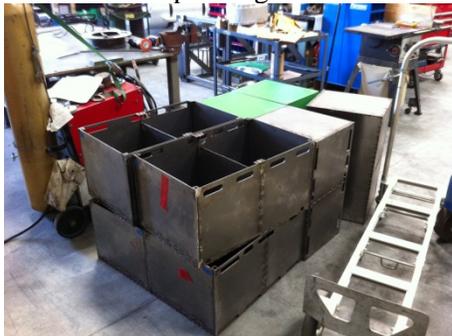
- The mechanical components of Tractor #2’s energy storage system have largely been fabricated and are out for painting. This includes the mile max module enclosures and mile max module mounts.

Figure 2: Mile Max module enclosures

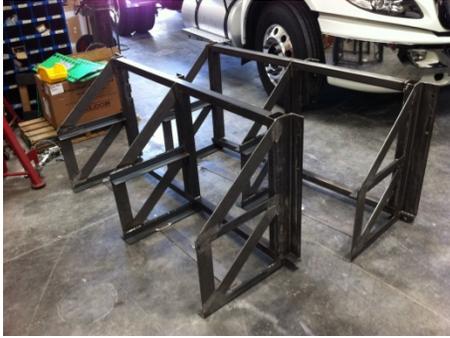
Figure 3: Mile Max module mounts

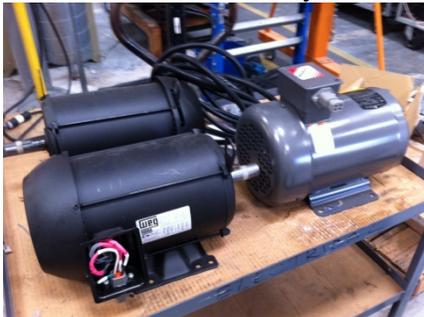
- The electric accessory motors for Tractor #2 have passed component level testing.

Figure 4: Electric motors after testing
