CHAPTER 3

SYCAMORE CREEK (SEGMENT 0806E)

Watershed Characterization

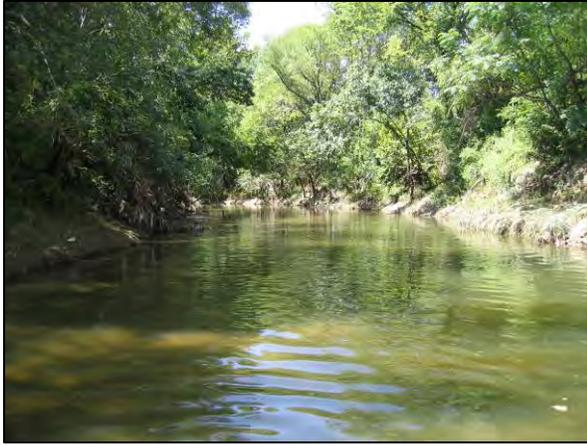
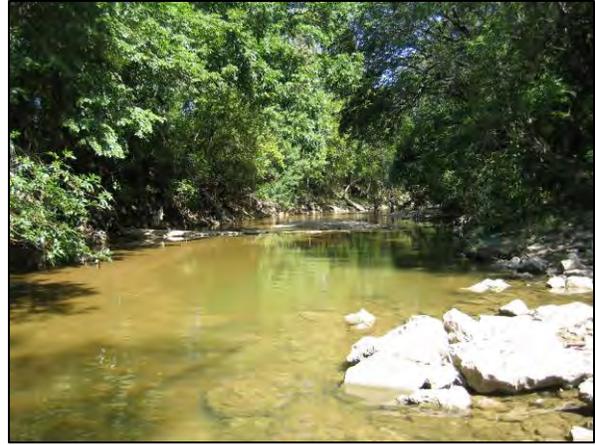
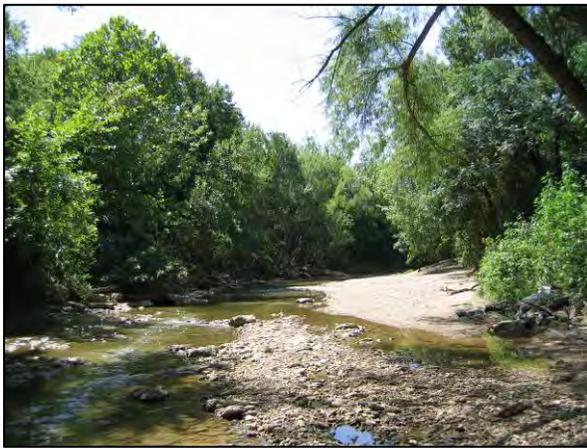
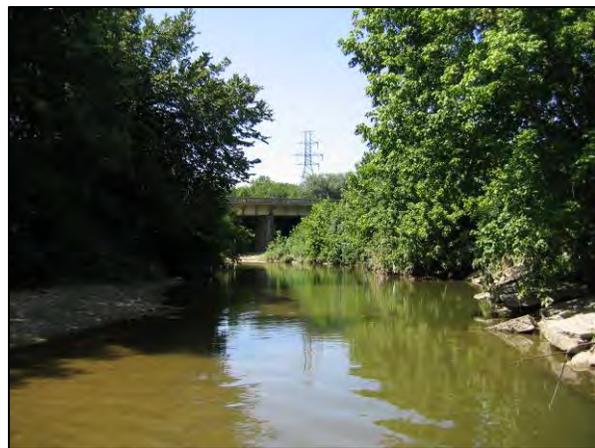
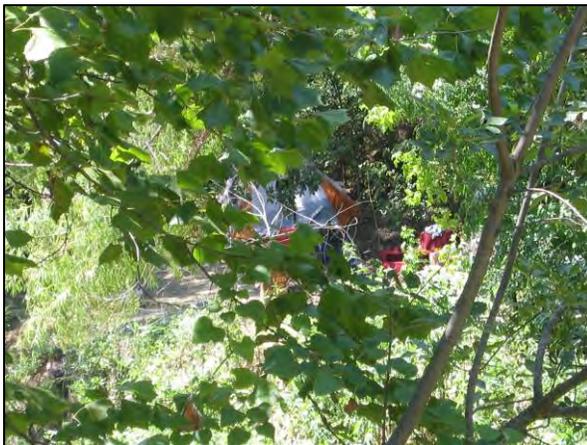
Photogroup 3-1 Sycamore Creek Site SC101 depicting stream and tree/shrub dominated riparian zone and on the lower row a distant photograph through the trees of a tent at the homeless camp near the creek. [\[Return to Text\]](#)

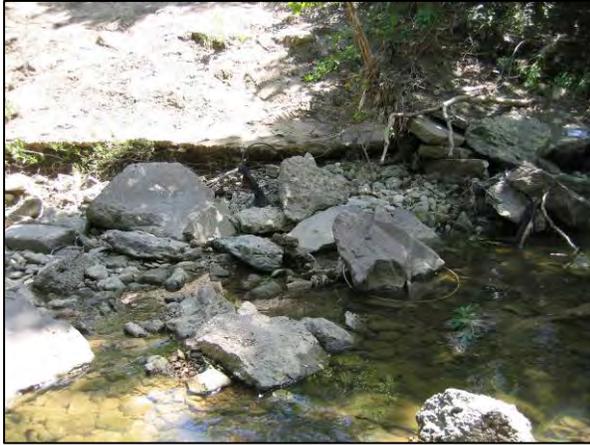
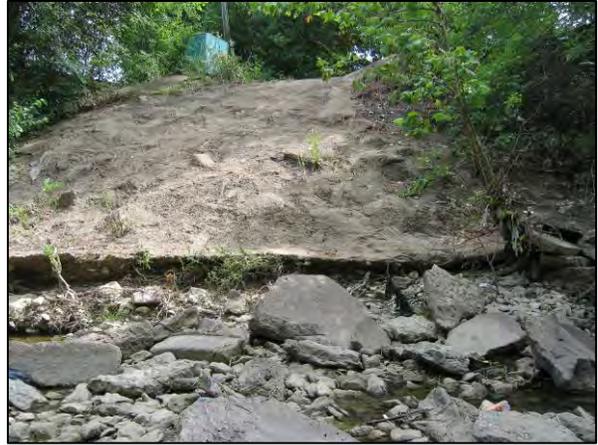
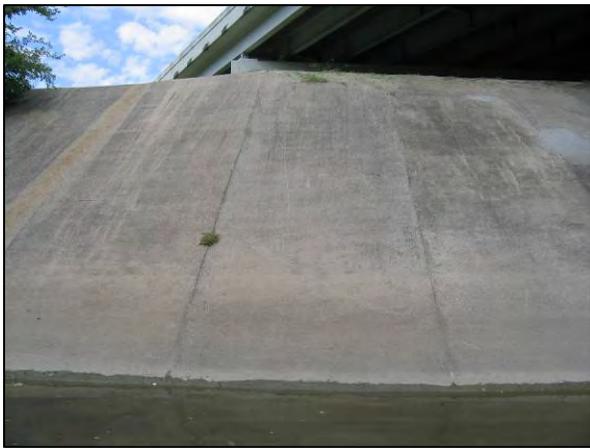
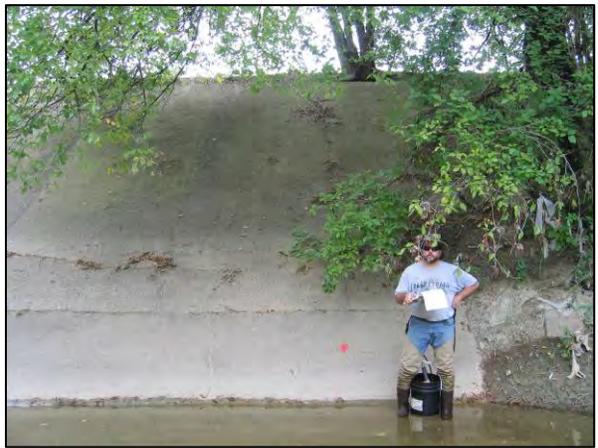
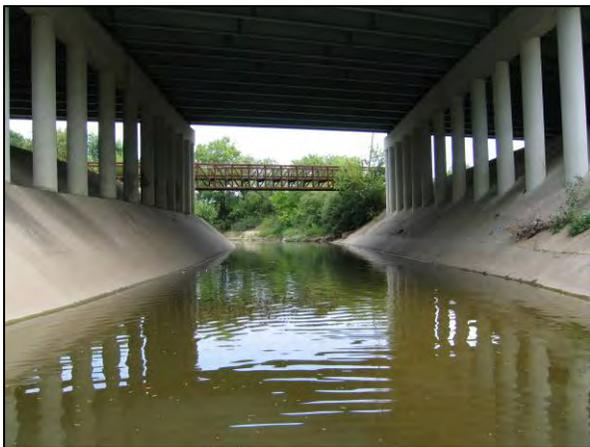
Photogroup 3-2

Sycamore Creek showing concrete pieces in stream and concrete apron leading to stream at the 150-m transect (upper row, note right photograph is looking up the apron) and stream and banks at the 0-m transect at IH-30 (middle and lower rows; note in lowermost photograph the pedestrian bridge in the background that is part of a hike/bike trail). (Individual pictured is TIAER staff.) [\[Return to Text\]](#)

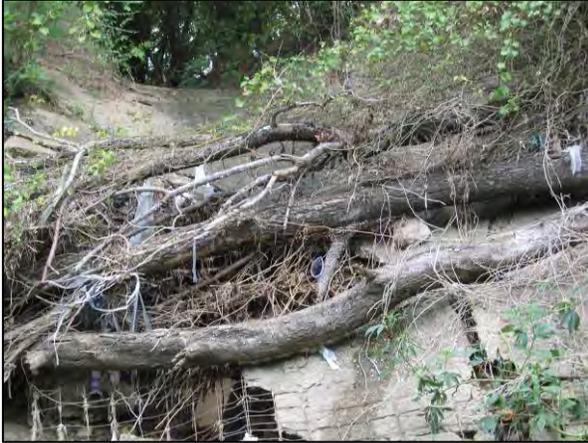
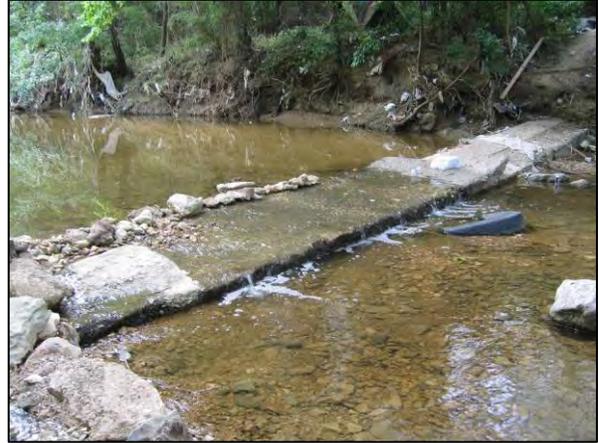
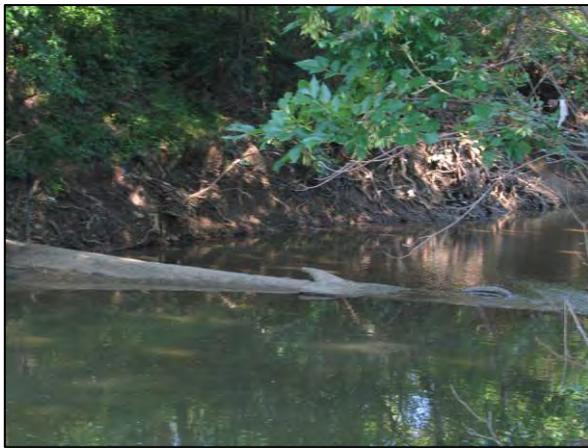
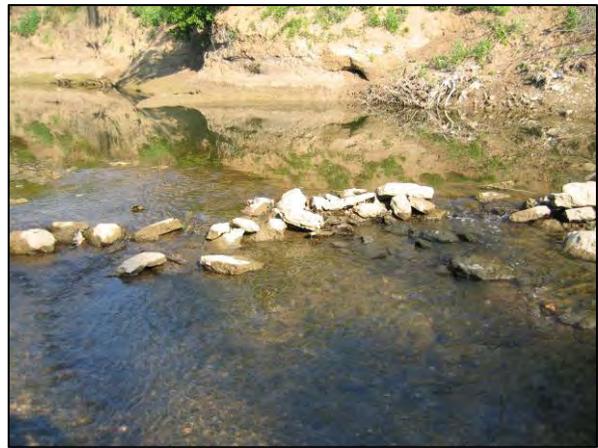
**Photogroup 3-3**

Sycamore Creek Site SC101 showing storm drain entering creek at 30-m transect (top portion of upper row, left side photograph); weir or low dam at 120-m transect (following two photographs); and temporary rock dam (lower row, right photograph). [\[Return to Text\]](#)

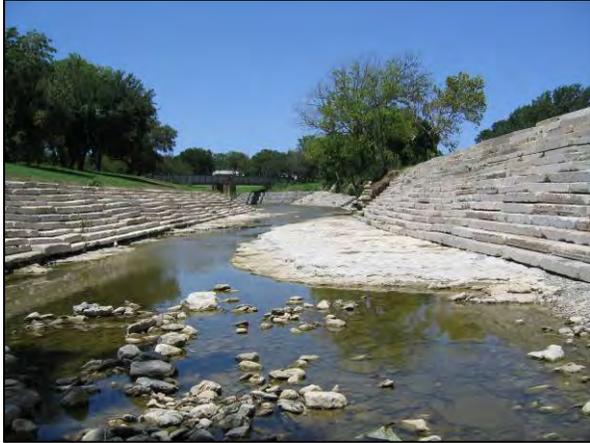
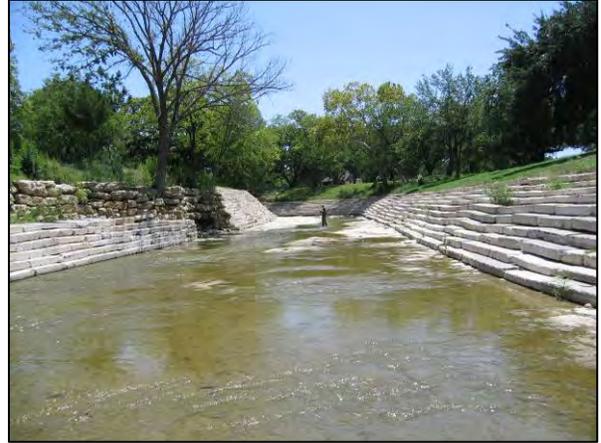
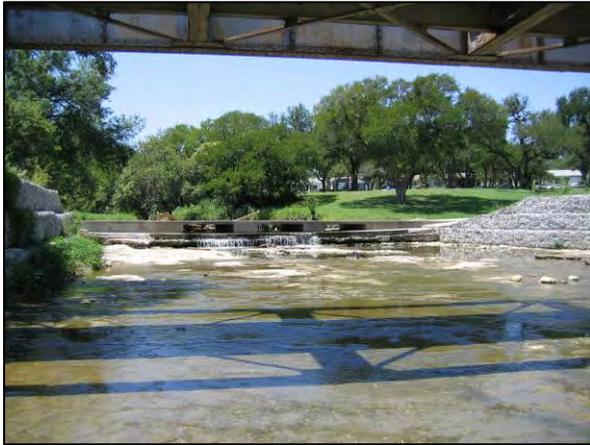
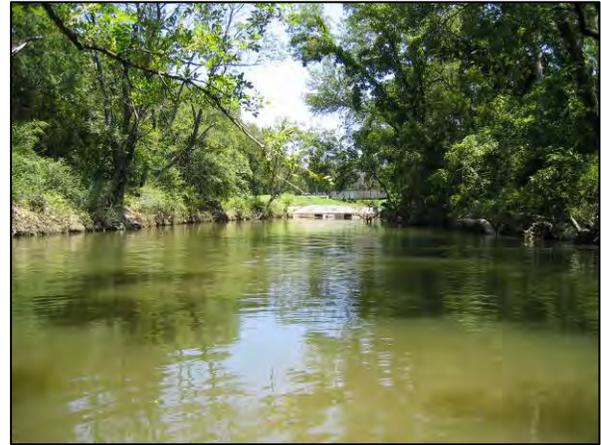
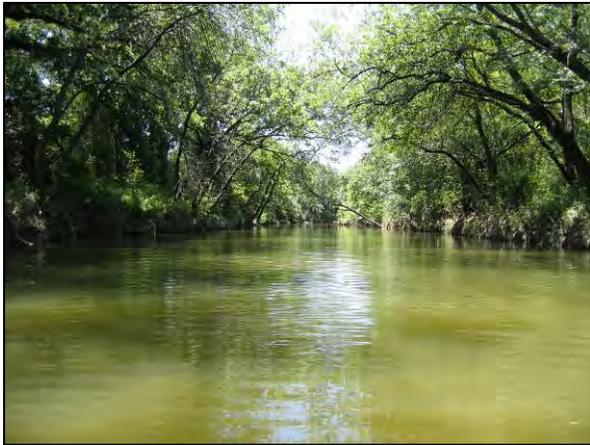
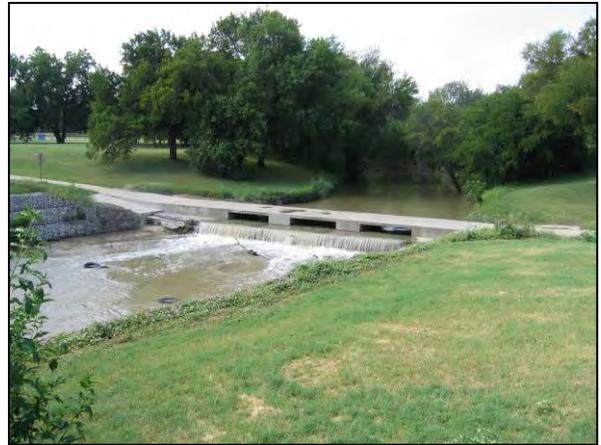
**Photogroup 3-5**

Sycamore Creek Site SC102 showing stream below low water dam at 210-m transect (upper row & middle row left) and large pool and dam (middle row right and lower row) above this transect. (Individual in upper right photograph is TIAER staff.) [\[Return to Text\]](#)

The surveyed reach at Site SC102 was a wadeable stream. Upstream of the dam the banks were natural in appearance with trees/shrubs being the dominant riparian vegetation. Thalweg depths above the dam were typically over 1.0 m during all three of the surveys. Stream depths below the dam were typically less than 0.2 meters during each survey. Table 3-3 shows the average thalweg depths collected at Site SC102. The thalweg depths are reported in three categories (average overall depth, below dam depth, and above dam depth) to show the change in stream conditions along the 300-m reach.

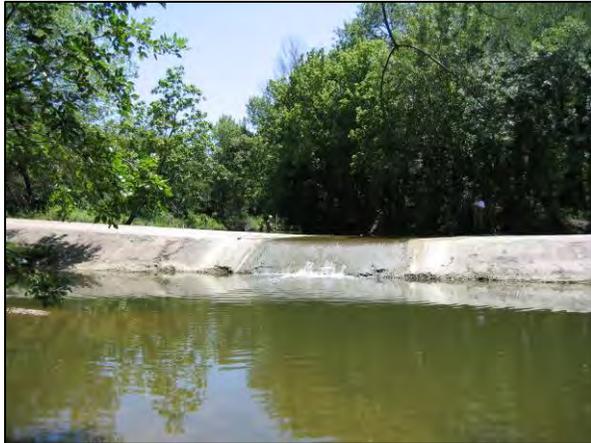
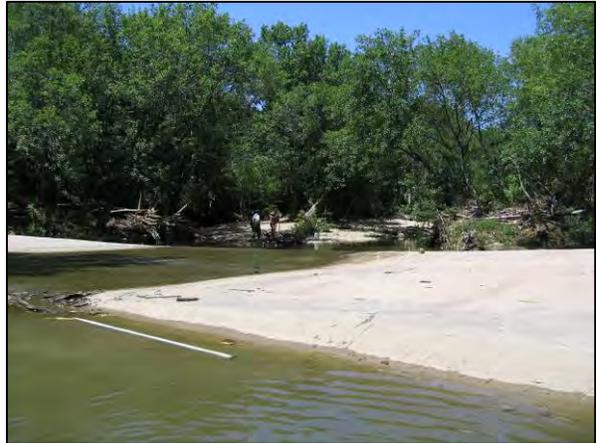
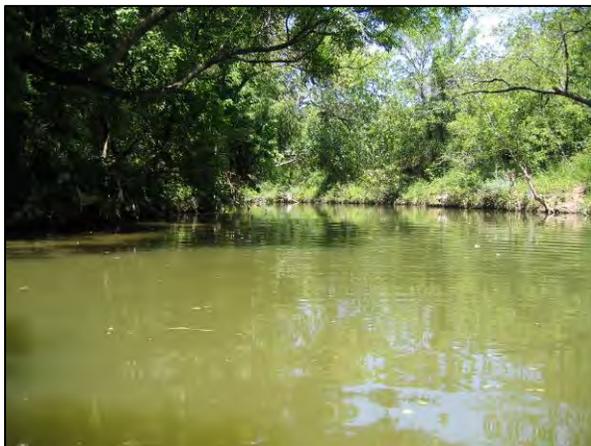
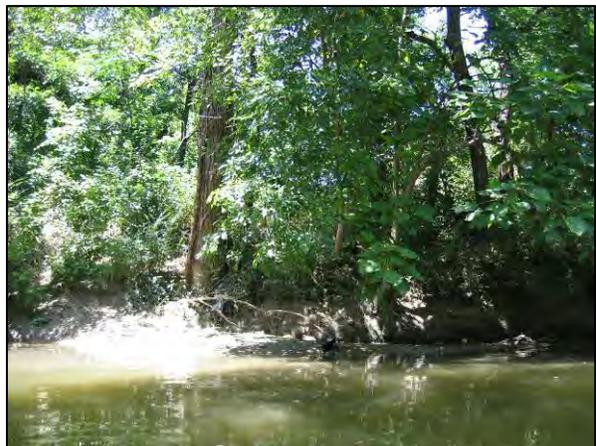
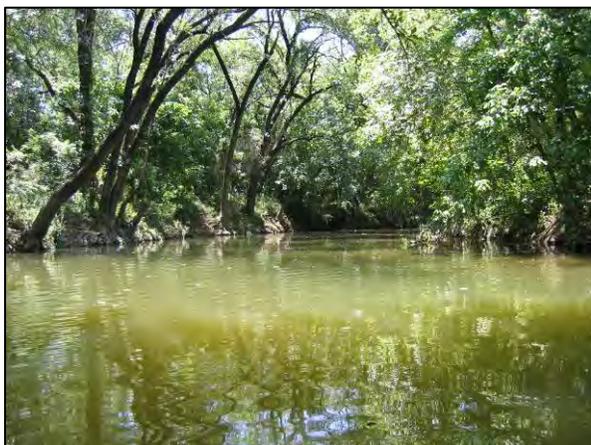
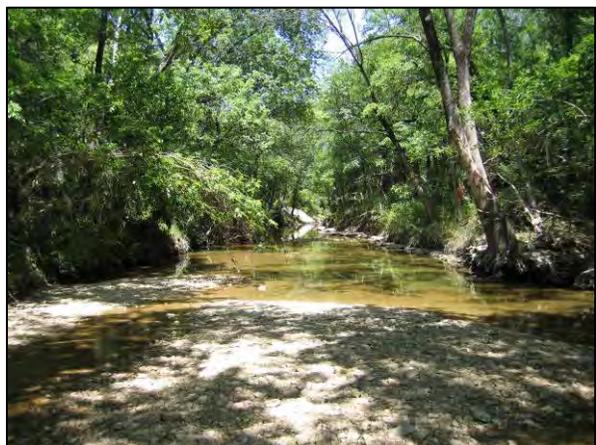
Photogroup 3-7 Sycamore Creek Site SC103 showing stream channel, pooled conditions, and riparian vegetation. [\[Return to Text\]](#)

Two pools were identified in the study reach during each site survey. One pool was immediately below the low-water crossing. The second pool was upstream of the low-water crossing and extended beyond the 300-m transect. Dimensions of the pools are found in Table 3-6.

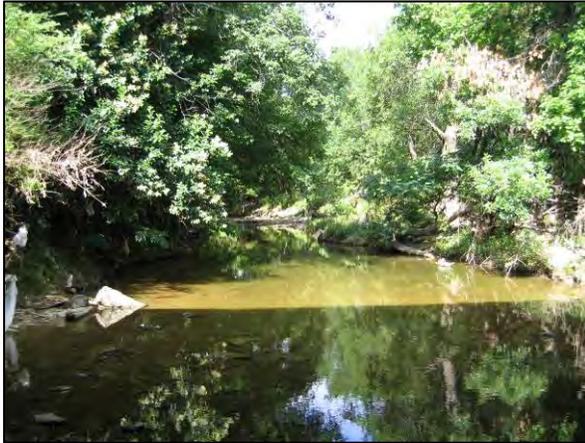
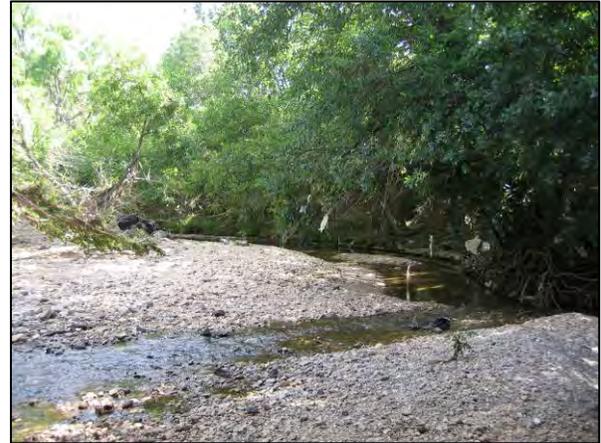
Photogroup 3-10 Sycamore Creek Site SC104 showing stream and riparian zone. [\[Return to Text\]](#)

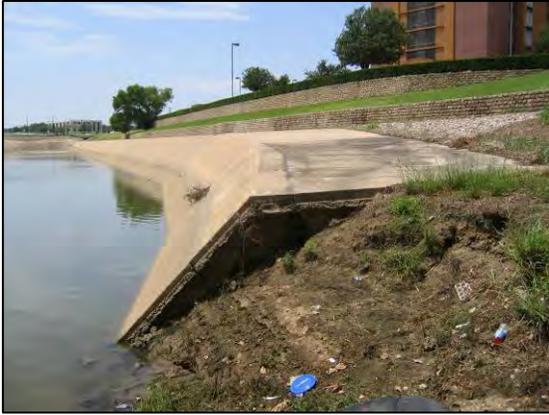
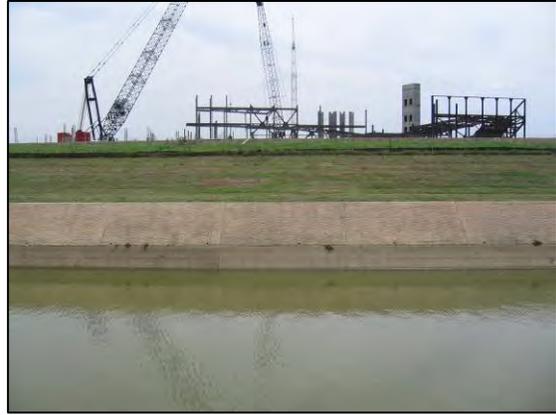
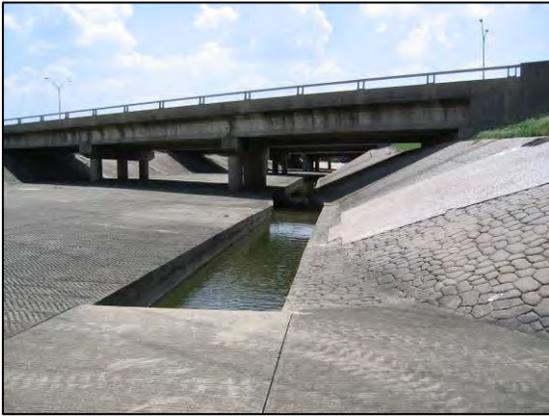
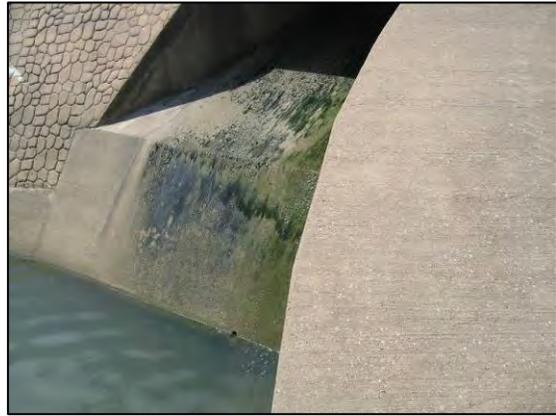
Photogroup 4-1 Cottonwood Branch Site CB101 showing streambanks and in bottom right photograph the drop structure for Cottonwood Creek at the golf course. [\[Return to Text\]](#)

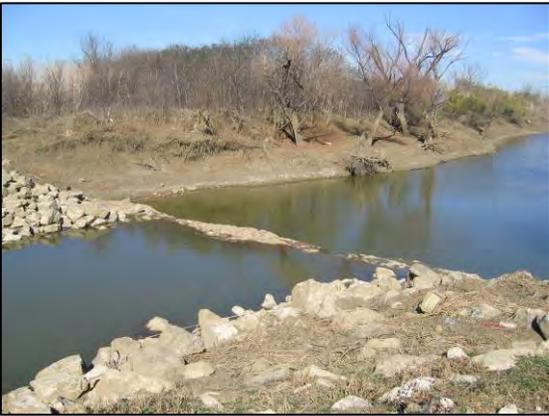
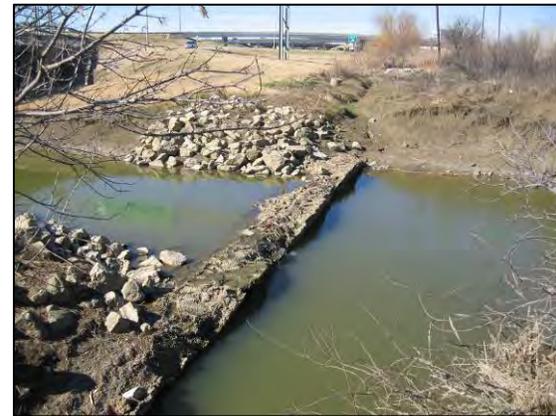
Photogroup 4-2 Cottonwood Branch Site CB101 showing small dam just downstream of 0-m transect. [\[Return to Text\]](#)

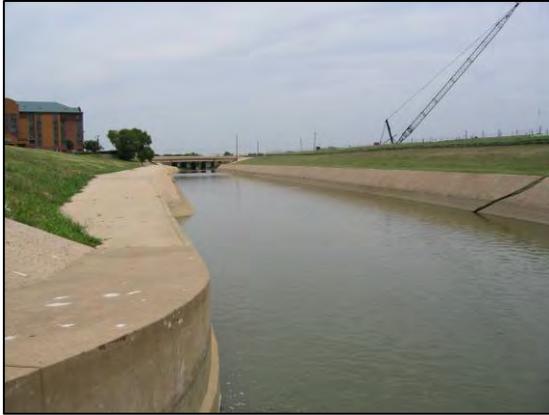
Photogroup 4-3 Cottonwood Branch Site CB101 showing consistency of channel dimensions. [\[Return to Text\]](#)

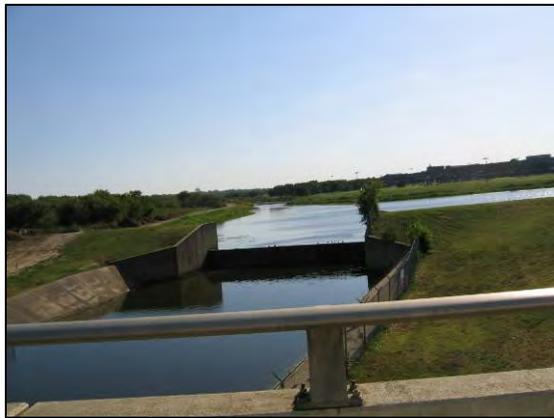
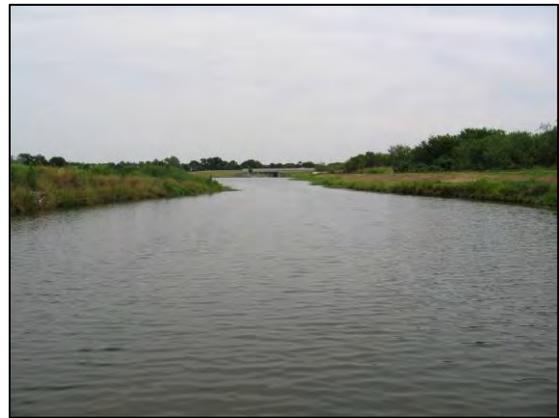
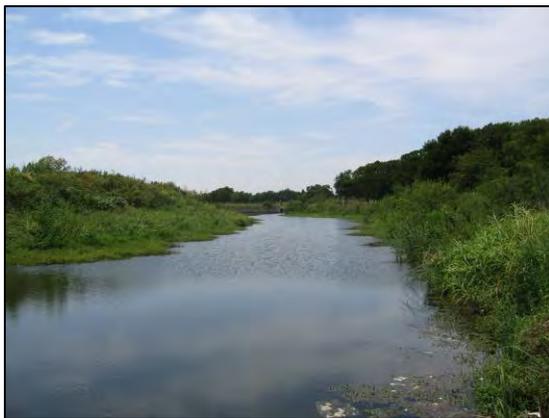
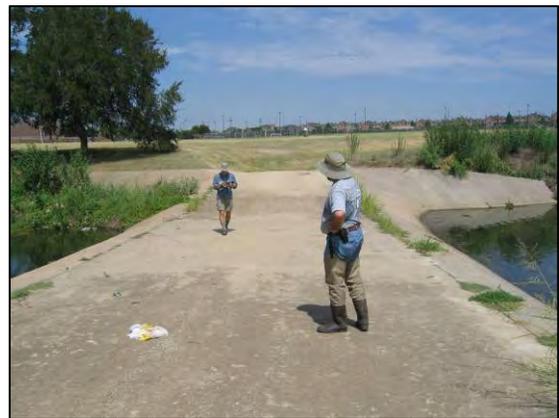
Photogroup 4-4 Cottonwood Branch Site CB102 showing general stream characteristics and concrete stream crossing. (Individuals pictured are TIAER staff.) [\[Return to Text\]](#)

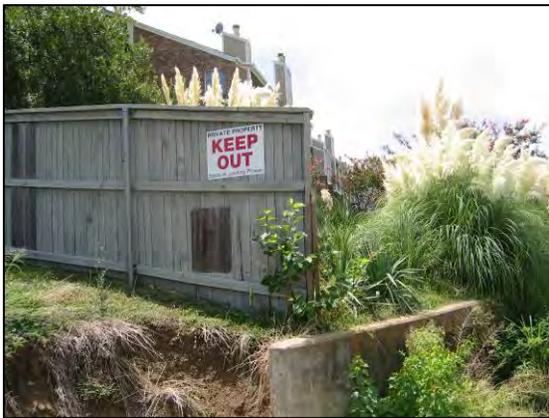
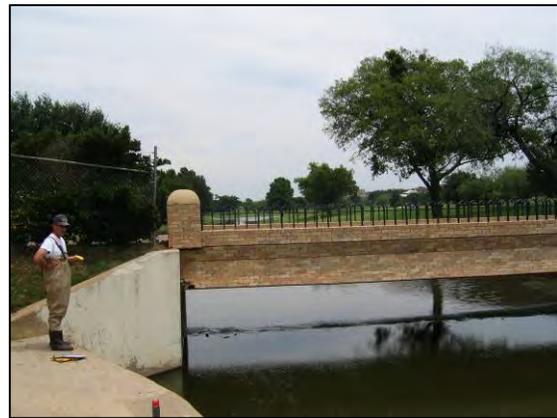
Photogroup 4-8 Cottonwood Branch Site CB103 showing access restrictions that limited reach length to 270-m. (Field crew shown in photographs) [\[Return to Text\]](#)

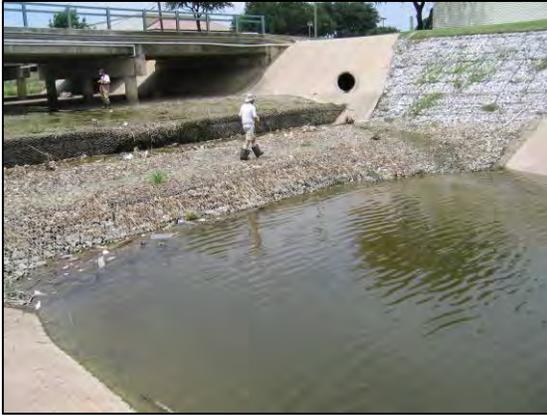
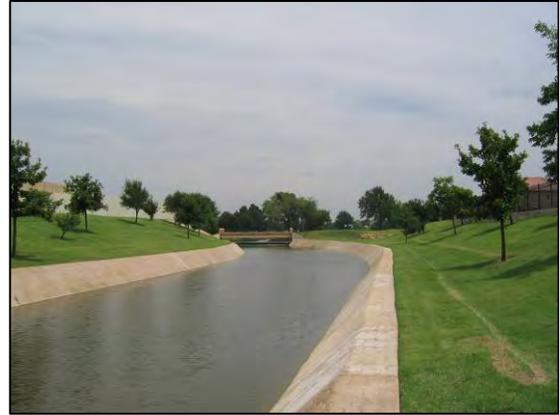
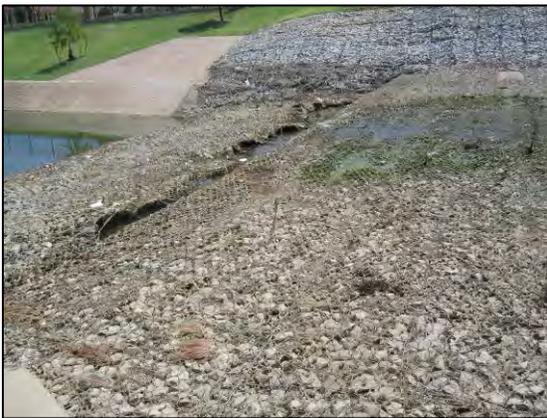
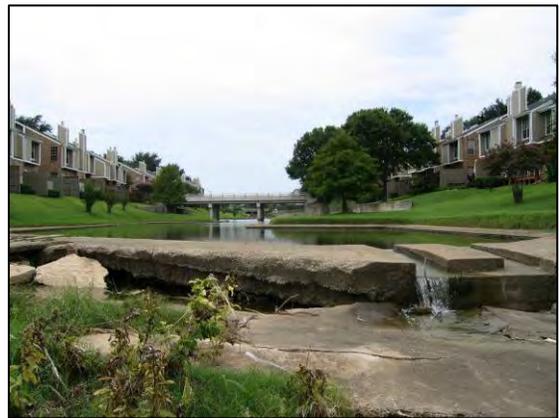
Photogroup 4-9 Cottonwood Branch Site CB103 showing dam above 270-m transect (lower right photograph) and the gabions and concrete channel in the vicinity of the 240-m transect. (Individuals pictured are TIAER staff.) [\[Return to Text\]](#)

At Site CB103, the lower 120 meters is a non-wadeable, wide, deep stream with depths greater than 1.0 meter. A depth measurement of 1.45 meters was collected off of a pipe crossing the stream at the 0-m transect. The width of the lower portion of the stream was 14 meters. The dominant substrate in this portion of the stream is concrete. From the 120-m transect to just below the 150-m transect, the stream is flowing through the gabions and sometimes was not observed on the surface as it filtered through the rock structure. From just below the 150-m transect to the 180-m transect, the stream is narrow and shallow as it is flowing on the concrete bottom of the bridge crossing ([Photogroup 4-10](#), right side photograph). At the 180-m transect, the stream becomes a wadeable, more natural channel that is wide with some deep pools that continues up to the 270-m transect. The primary substrate in the natural portion of the stream is mud/clay. Table 4-3 shows the average thalweg at this site for the entire study reach using an estimated depth for the non-wadeable portion, and then the wadeable portion, from the 150-m transect to the 270-m transect. The estimated depth for the non-wadeable portion was based on the measured depth from a pipe crossing the stream at the 0-m transect. Field personnel walked out on the pipe to collect a depth measurement and assumed that the remainder was the same depth, thus unwadeable.

Access to the stream edge was moderately easy, as was access to the stream. There is a small concrete path to walk along the top of the concrete lined channel of the lower portions of the study reach. Footpaths were observed along the top of the right streambank in the upper portions of the stream. A golf course is located on the south east side of the stream, a shopping strip mall is located to the northwest, and a large parking lot is located north east of the stream. A large fenced in field is located southwest of the stream.

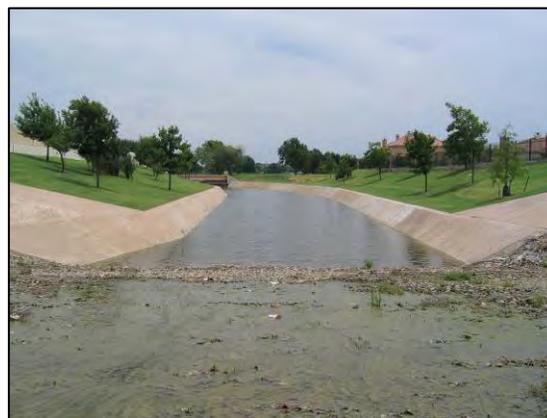
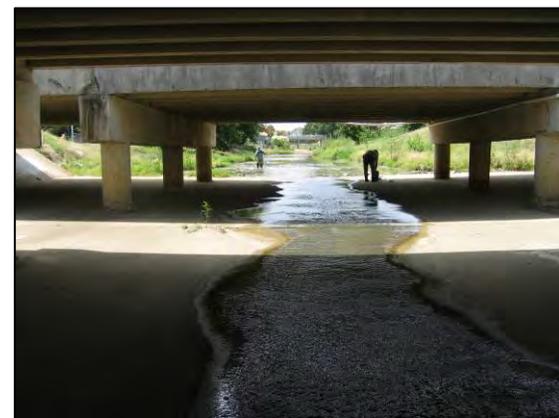
Photogroup 4-10 Cottonwood Branch Site CB103 showing riparian zone. (Field staff shown on photograph on right) [\[Return to Text\]](#)

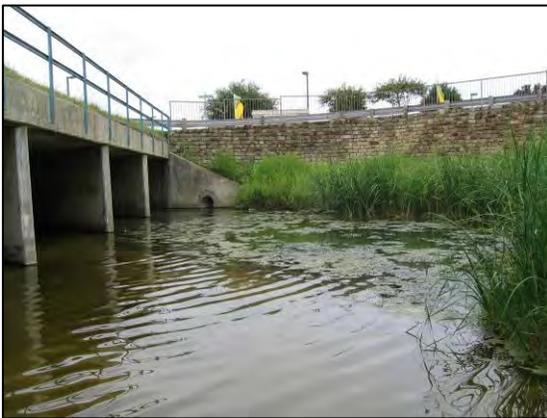
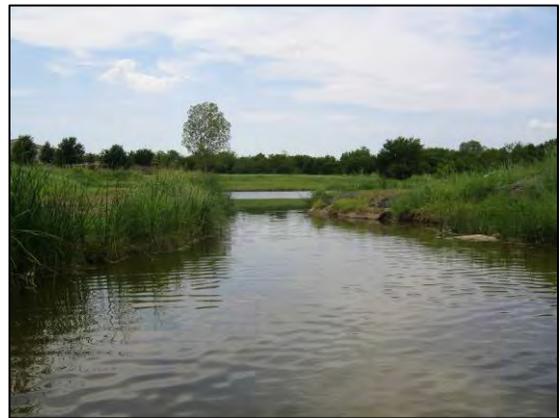
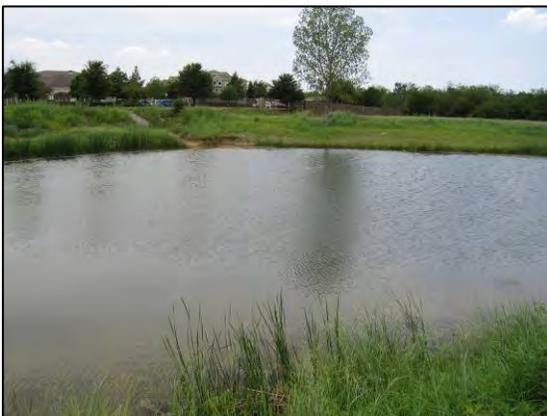
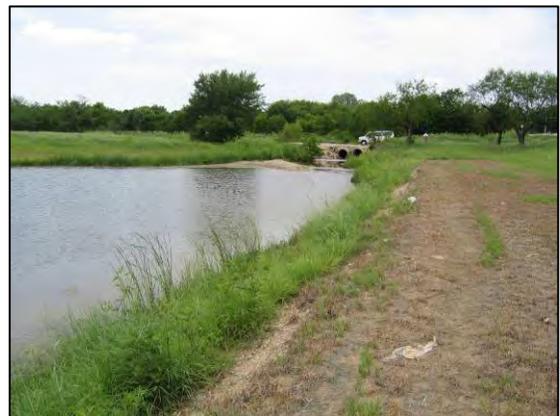
Photogroup 4-12 Cottonwood Branch Site CB104 showing stream and surrounding riparian zone at 0-m transect (upper row of photographs) and impoundment at 60-m transect (lower row of photographs). [\[Return to Text\]](#)

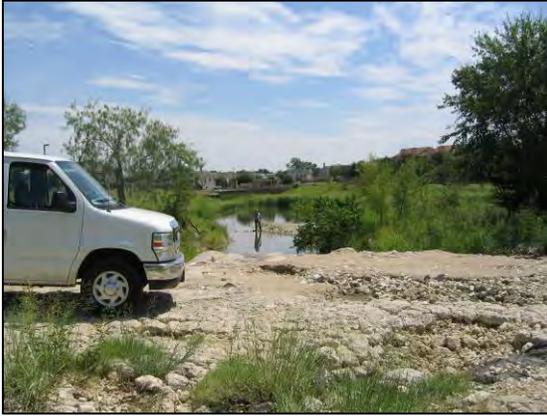
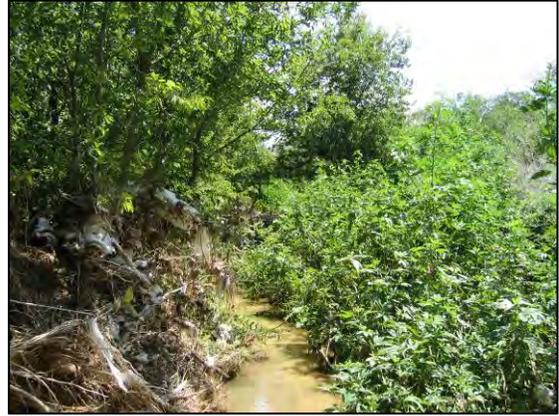
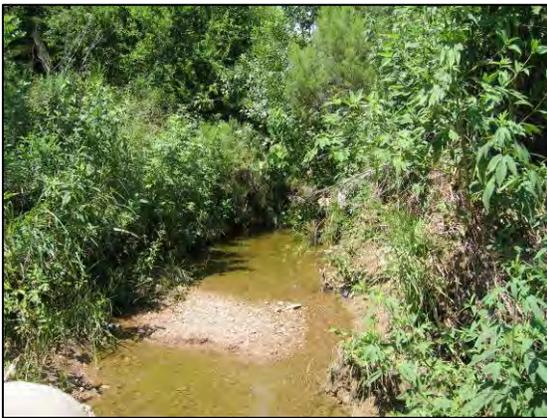
Photogroup 4-13 Cottonwood Branch Site CB103 showing impoundment at 150-m transect (upper left) and natural channel at 300-m transect (other two photographs). (Individual in upper left picture is TIAER staff.) [\[Return to Text\]](#)

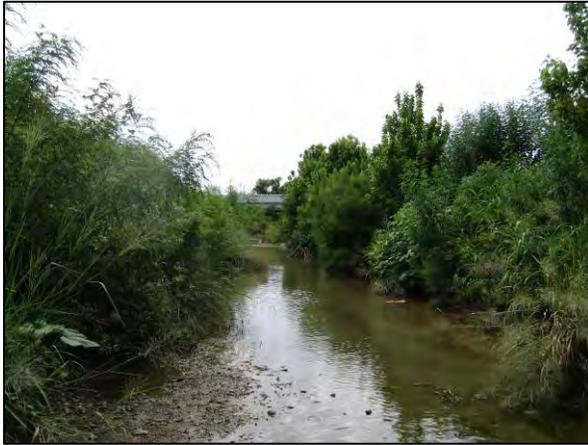
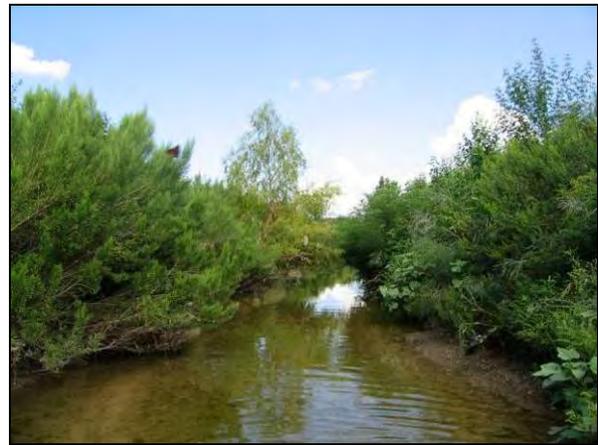
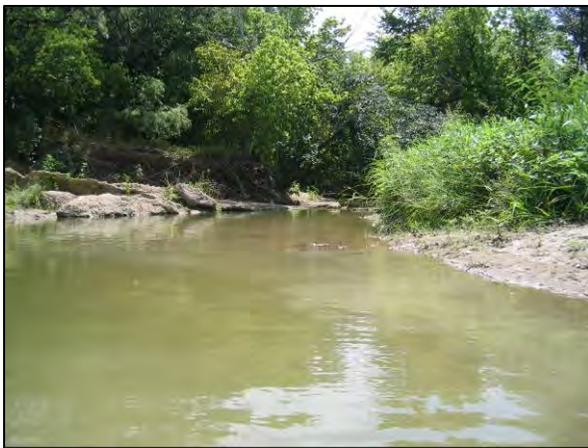
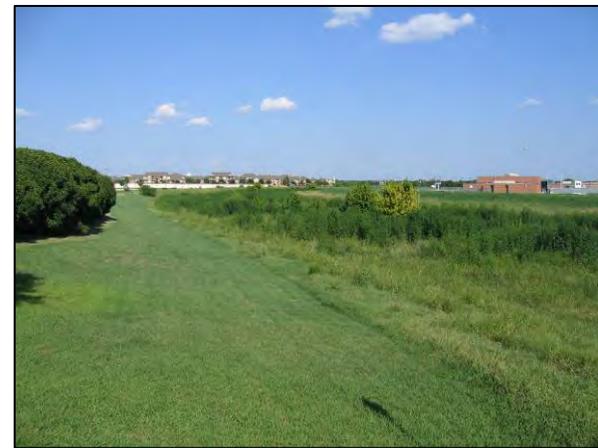
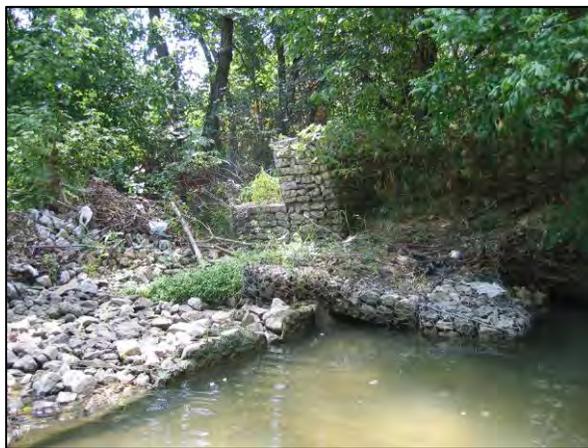
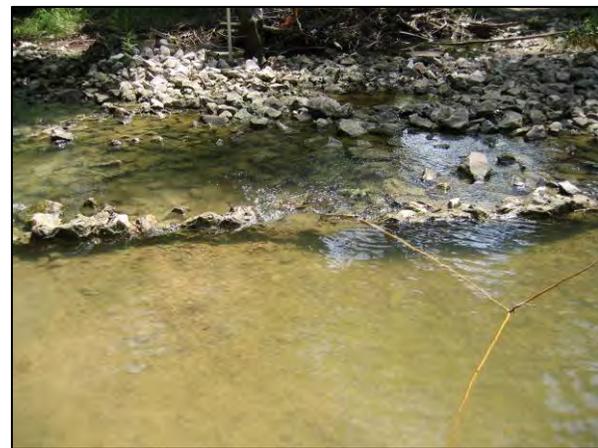
**Photogroup 5-1**

Grapevine Creek Site GC101 showing creek upstream and downstream at 0-m transect (upper row), downstream at 300-m transect (middle row left), and riparian zone on lower half of reach (middle row right) and at 210-m transect (lower row). [\[Return to Text\]](#)

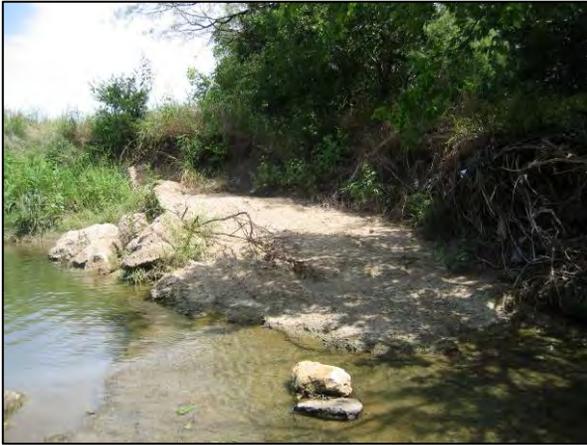
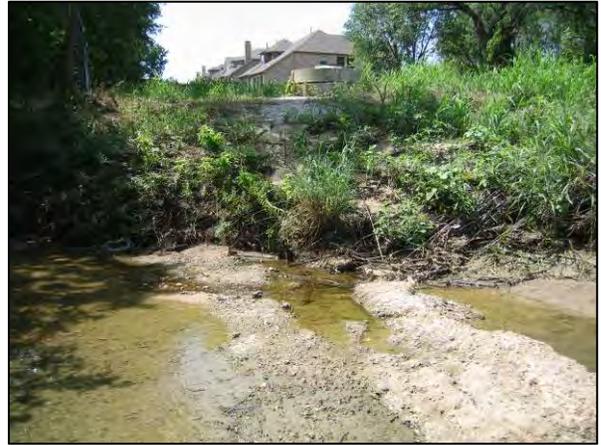
Photogroup 5-2 Grapevine Creek Site GC101 showing low water crossing at 270-m transect. [\[Return to Text\]](#)

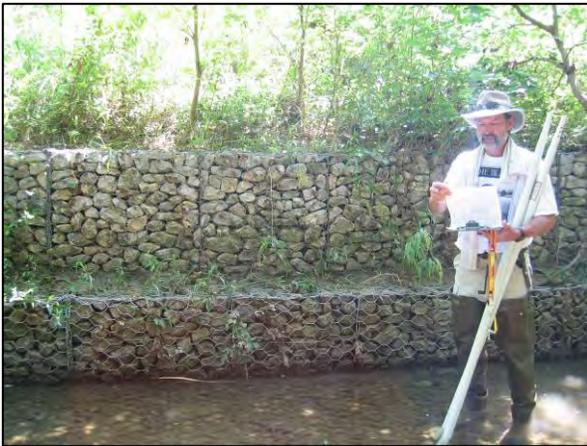
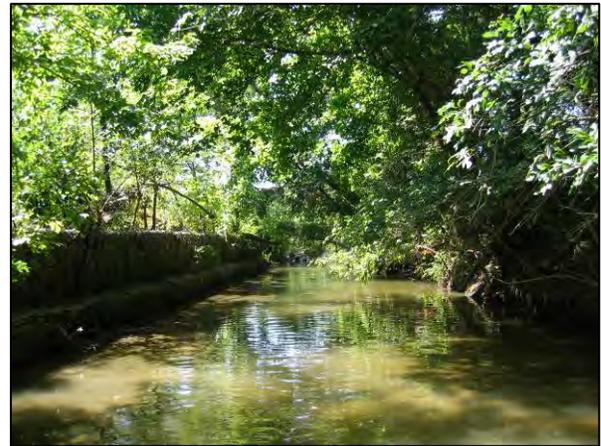
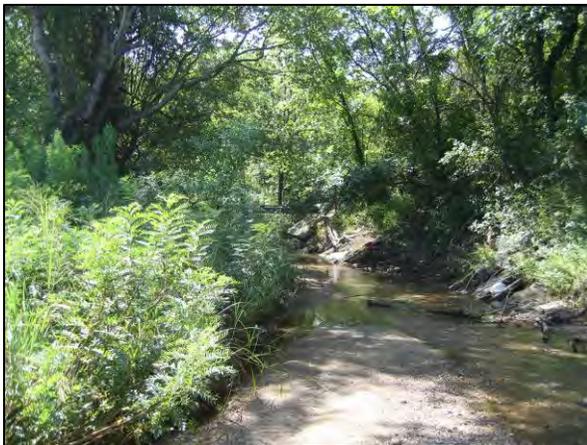
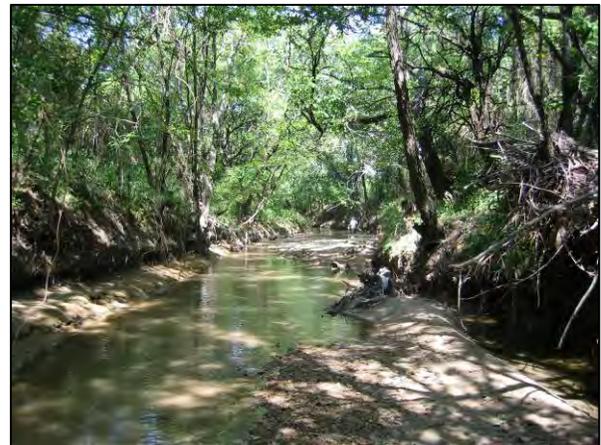
Photogroup 5-3 Grapevine Creek Site GC102 showing upper half of stream with gabions at 300-m transect (upper row) and natural channel of lower half at 150-m and 0-m transects (lower row). (Individual pictured is TIAER staff.) [\[Return to Text\]](#).

Grapevine Creek at Site GC102 is a mostly natural wadeable stream located at East Belt Line Road and Grapevine Creek in a largely suburban area. The upper half of the stream is partially channelized with gabions located along the left bank. The right side of the upper half, and both sides of the lower half, are natural in appearance. The concrete apron of the bridge provides moderately easy access to the stream, although no immediate parking is available. The only observed potential parking was on the right-of-way, next to East Belt Line Road. A railroad trestle crosses the creek at the 240-m transect and a pipeline crosses the stream at the 120-m transect. Table 5-2 describes the stream channel and riparian zone appearance at this site. [Photogroup 5-3](#) and [Photogroup 5-4](#) depict the stream appearance and pipeline and railroad crossings.

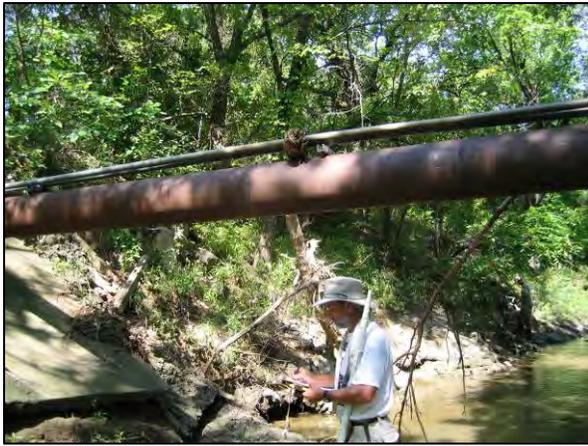
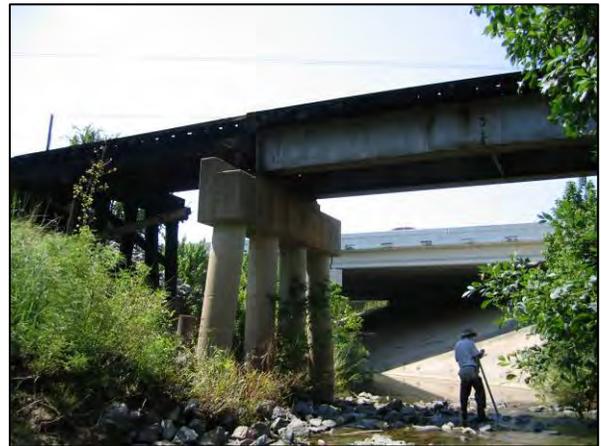
Photogroup 5-4 Grapevine Creek Site GC102 showing pipeline and railroad crossings. (Individuals pictured are TIAER staff.) [Return to Text](#)

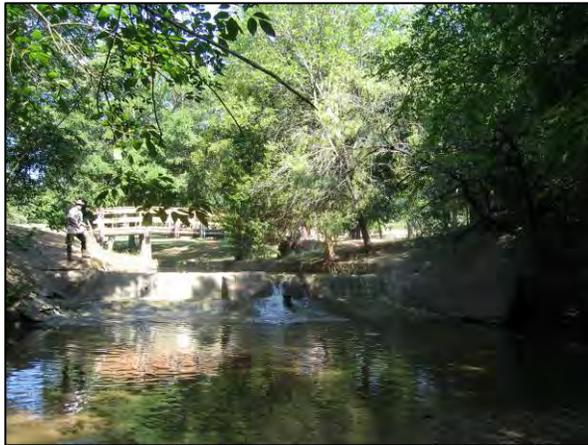
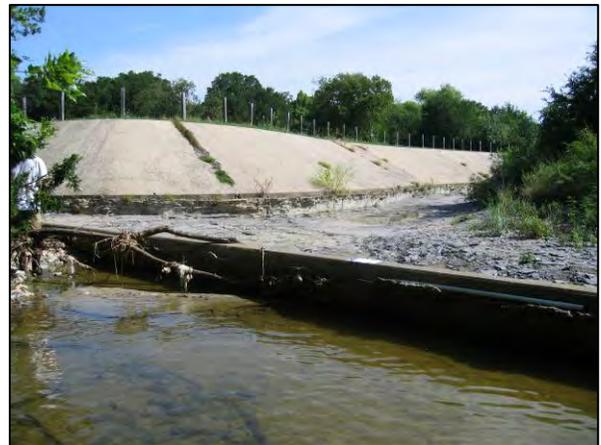
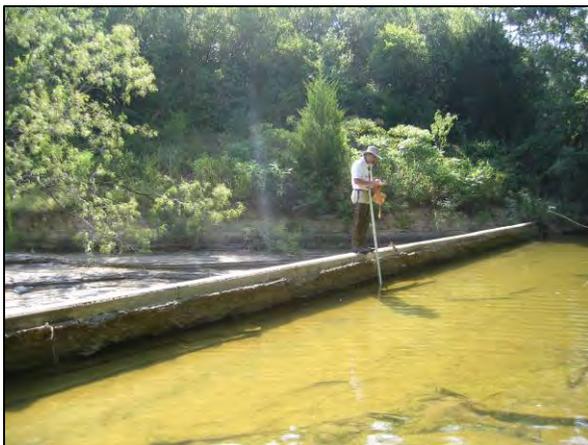
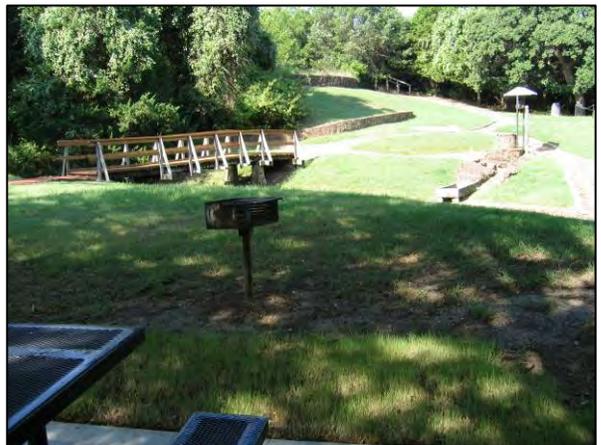
Photogroup 5-5 Grapevine Creek Site GC103 showing streambanks and bridges in Grapevine Spring Park. (Individuals pictured are TIAER staff.) [Return to Text](#)

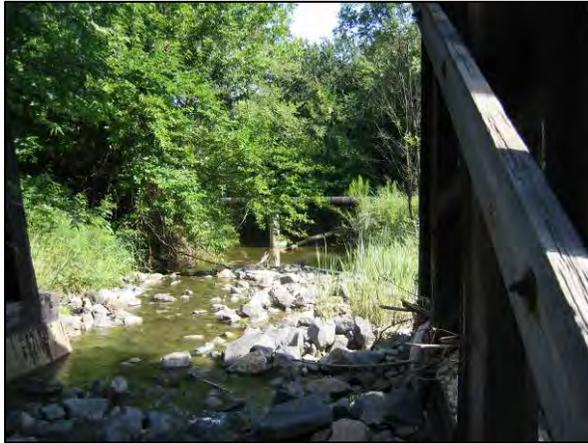
Photogroup 5-6 Grapevine Creek Site GC103 at 300-m transect looking downstream.
[\[Return to Text\]](#)

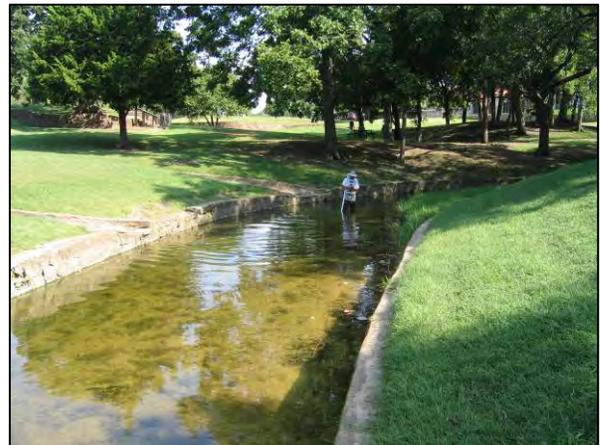
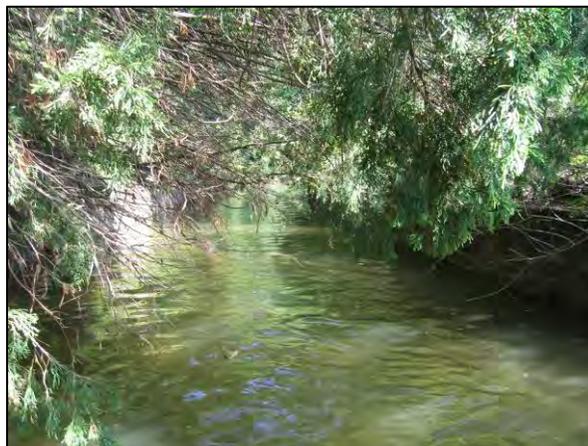
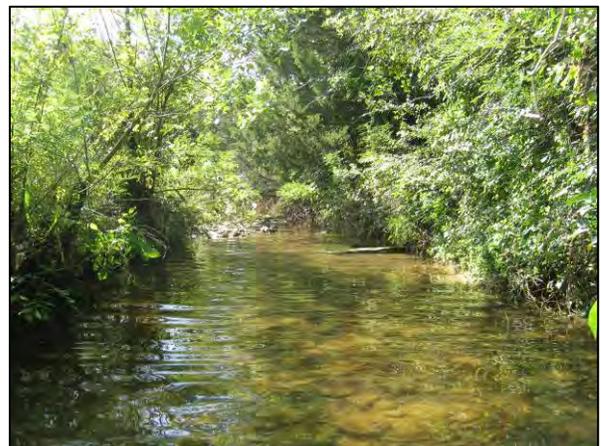
Photogroup 5-7 Grapevine Creek Site GC103 showing banks of stream at and below the 120-m transect (upper row) and above the 120-m transect (lower row). (Individuals pictured are TIAER staff.) [\[Return to Text\]](#)

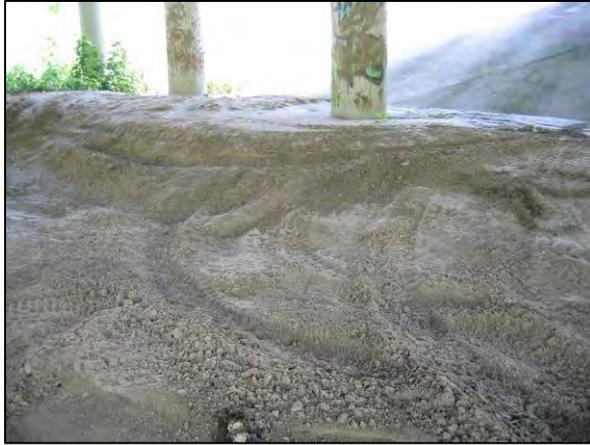
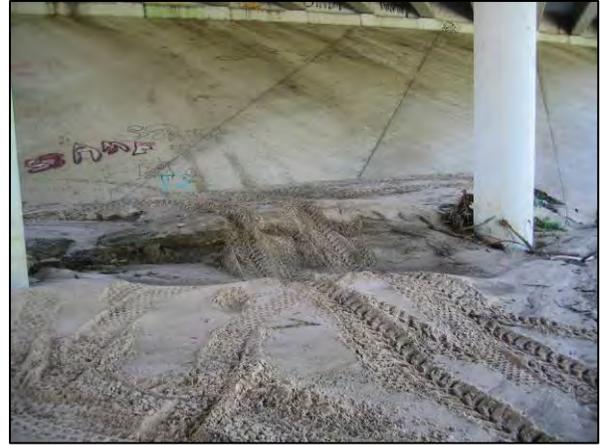
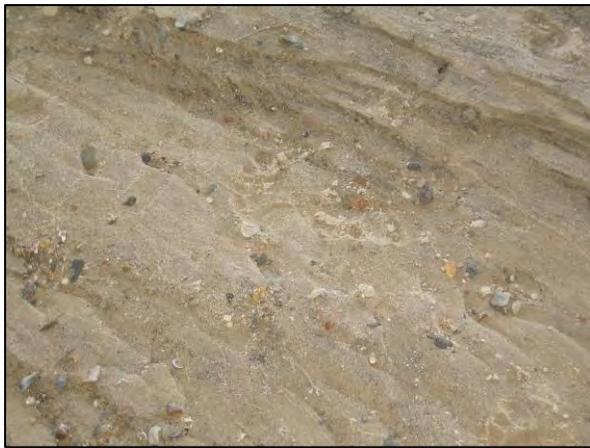
Photogroup 5-10 Grapevine Creek Site GC102 showing ATV tracks, graffiti on bridge apron, and barefoot tracks. [\[Return to Text\]](#)

No primary contact recreation was identified at Site GC102. ATV tracks and bare-foot prints were observed beneath the bridge crossing in the sand. Graffiti was also located on the apron of the bridge. [Photogroup 5-10](#) depicts the aforementioned tracks and graffiti. During the third survey, a jogger was observed running beneath the bridge. The jogger came down the north side of the bridge, ran beneath the bridge, and ran back up the south side of the bridge. No other activities were identified at Site GC102 which would involve water recreation, primary or secondary contact. In an interview with a City of Irving employee, ATV tracks are often seen
