CHAPTER 3

SYCAMORE CREEK (SEGMENT 0806E)

Watershed Characterization

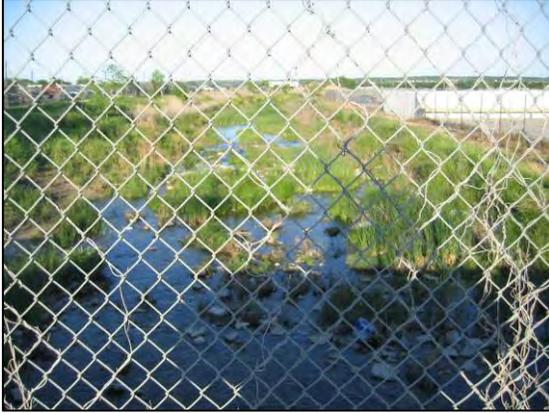
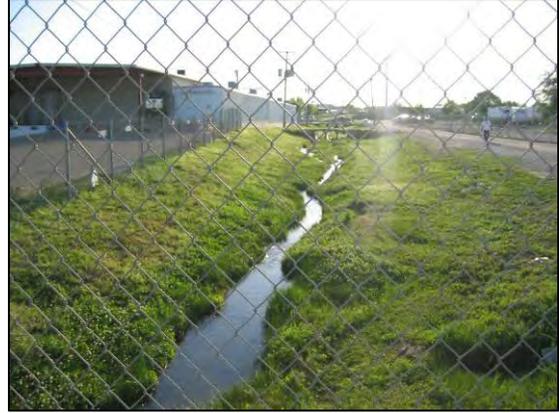
Photogroup 6-1 Copart Branch Site CM101 (Idlewild Rd.) looking downstream (left) and upstream (right). [Return to Text](#)

Site CM101 (TCEQ Station 17672) is located at Copart Branch downstream of Idlewild Rd. west of Mountain Creek, in Grand Prairie, Texas. The area is heavy commercial with no residential development near the stream. Access is limited by chain link fences that line the stream at the road crossing ([Photogroup 6-1](#)) and down both sides past numerous wrecking yards used for stockpiling old cars. The stream below this station appears channelized and the banks appeared to be levied. Access to the stream at this location was obtained through contacting the owner of the business upstream of Idlewild Rd. The property owners downstream of Idlewild were contacted for access permission but this request was denied.

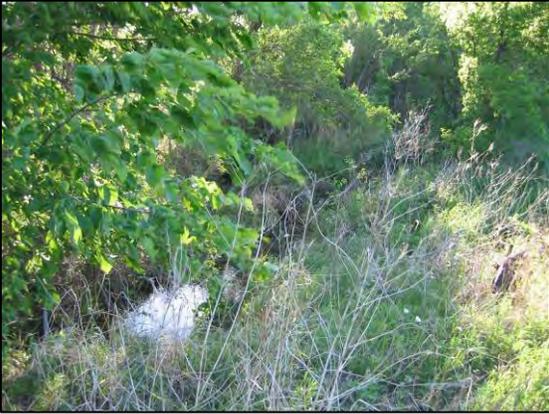
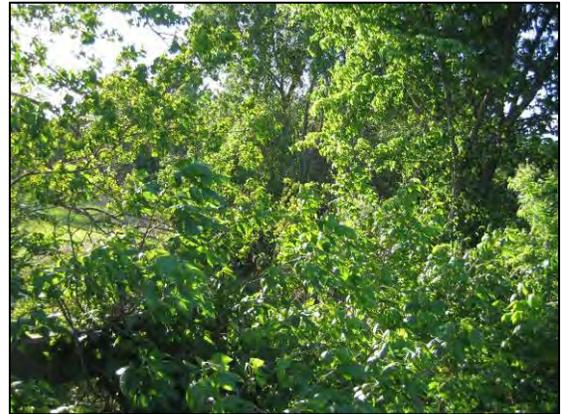
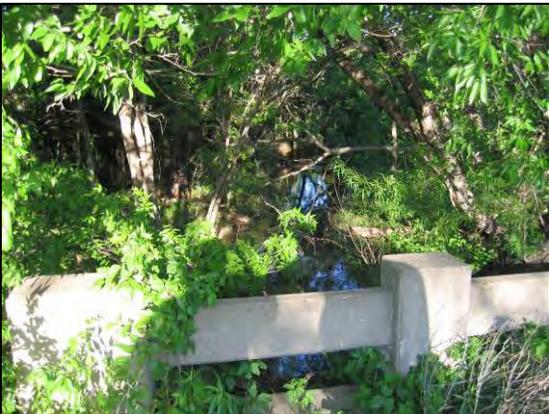
Photogroup 6-2 Copart Branch at Camden Drive showing dense vegetation along the stream at the road crossing. [Return to Text](#)

A potential site was identified at the Camden Drive road crossing of Copart Branch Mountain Creek (Figure 6-1; [Photogroup 6-2](#)). The adjacent area upstream consisted of trees and dense vegetation, much of which was poison ivy. There were no footpaths or walkways observed leading to the stream. The area downstream was much the same with more trees and vegetation, including poison ivy. A concrete guardrail was located on the downstream side of the crossing. There were no visual signs of recreation, primary or secondary, identified at this site. The site was located in a highly commercial land use area with no residential areas identified in the immediate area. The density of the poison ivy at this location was instrumental in the decision not to use this location due to the health risk to personnel.

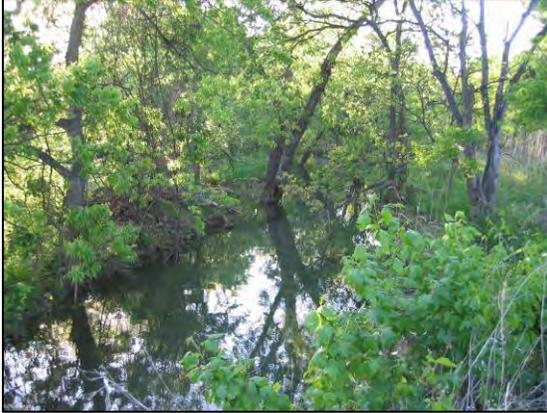
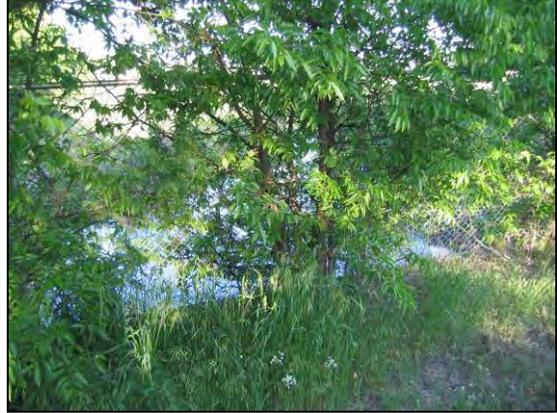
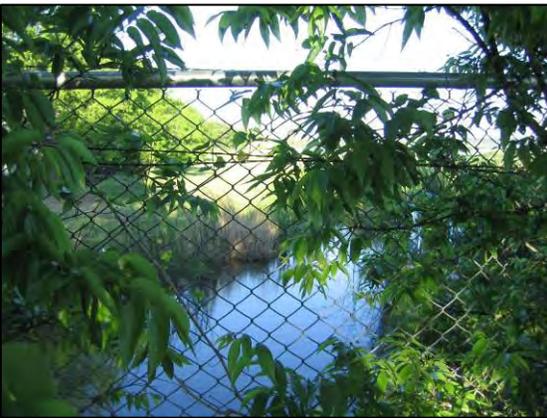
Photogroup 6-3 Copart Branch at Richardson Drive showing heavy bank vegetation on upstream side and fence along downstream side of the road. [\[Return to Text\]](#)

A second potential site was identified at the Richardson Drive crossing of Copart Branch Mountain Creek (Figure 6-1; [Photogroup 6-3](#)). The area upstream consisted of trees and vegetation along the banks of the stream, most of which was poison ivy and beggar's lice. The downstream area contained a chain link fence at the road which prevented anyone from entering the stream or banks. No visual signs such as footpaths, trails, or fishing gear were observed in

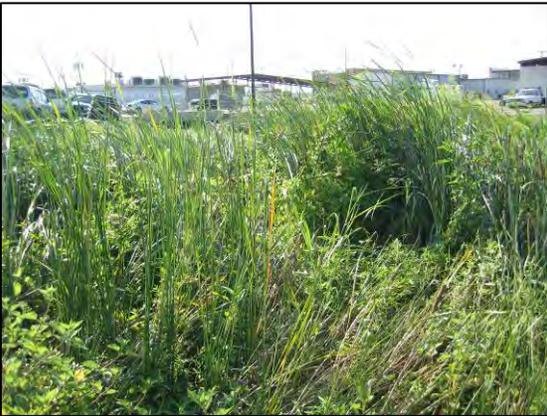
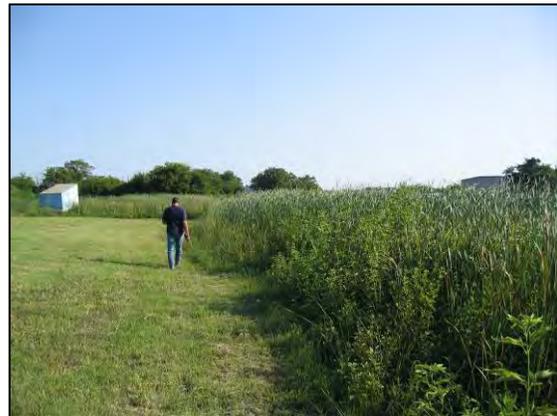
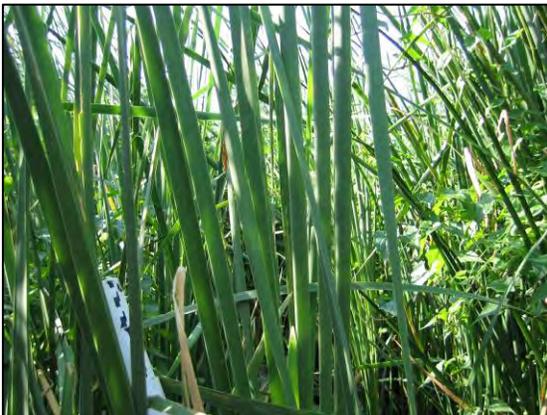
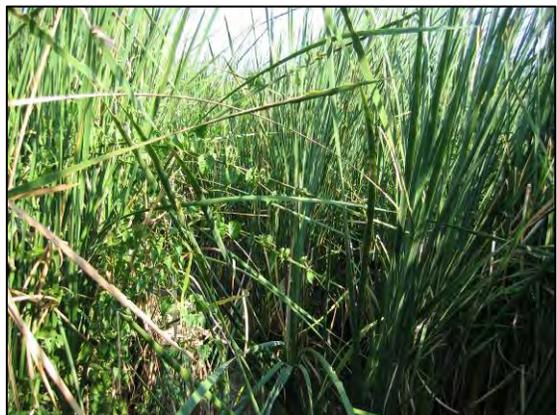
Photogroup 6-6 Copart Branch Site CM101 between the 210-m and 300-m transects showing emergent aquatic vegetation. (Individual pictured is TIAER staff.) [\[Return to Text\]](#)

At CM101 the stream was generally narrow and shallow with depths typically less than 1.0 meter. The stream had a mud/clay dominated substrate. Little to no algae was observed; however, aquatic vegetation was abundant, especially from the 210-m to the 300-m transect ([Photogroup 6-6](#)). No odors were detected on any trip. Depth measurements were collected in this densely vegetated area during the first survey, but based on the difficulty in obtaining the measurements, they were not attempted on the second survey. During the May 2010, it was observed that a diversion channel had been constructed to bypass the thick vegetation, so the depths were collected in that channel on that visit ([Photogroup 6-7](#)).

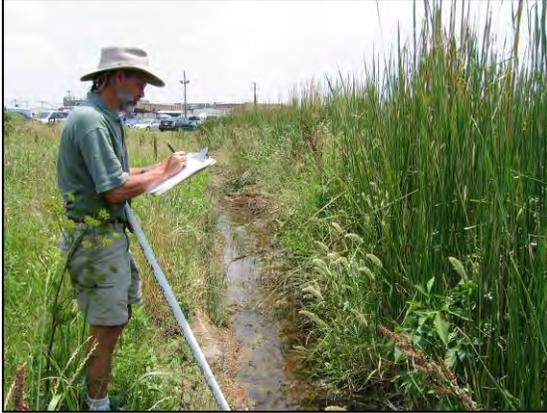
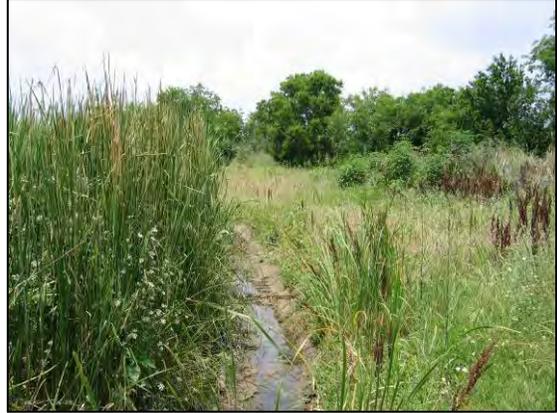
Photogroup 6-7 Copart Branch Site CM101 showing by-pass channel constructed around area of thick vegetation. (Individual pictured is TIAER staff.) [\[Return to Text\]](#)

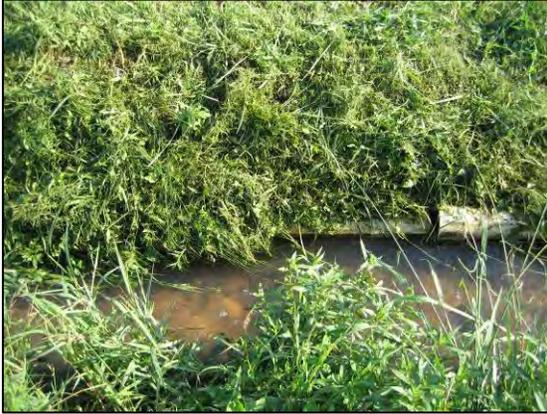
Photogroup 6-8 Copart Branch Site CM101 showing what is possibly a remnant section of the 4-in diameter pipe that contained the flow in past years. [\[Return to Text\]](#)

An interview of the mobile catering service owner was conducted. He related that he has been in the area 30 to 40 years and has never observed anyone recreating in the area. He further stated that years ago the streamflow was contained in a four-inch pipe, but when the Naval Air Station was built, the flow rate increased to an amount greater than what the pipe could handle and the stream was created. Evidence of the PVC pipe was observed at the 30-m transect as depicted in [Photogroup 6-8](#). He further stated that following our visits to the facility in 2009 the flow rate decreased to what it measured in May. Finally, he stated that the diversion channel was constructed due to beavers building dams creating the marsh type environment observed above the 210-m transect. They were attempting to drain the marsh area but the beavers just built dams farther upstream. A copy of the interview sheet is located in Appendix D-4.
