Figure 1. Percent composition of debris items found in the shoreline, nearshore, submerged and floating environments of the Galveston Bay Estuary.

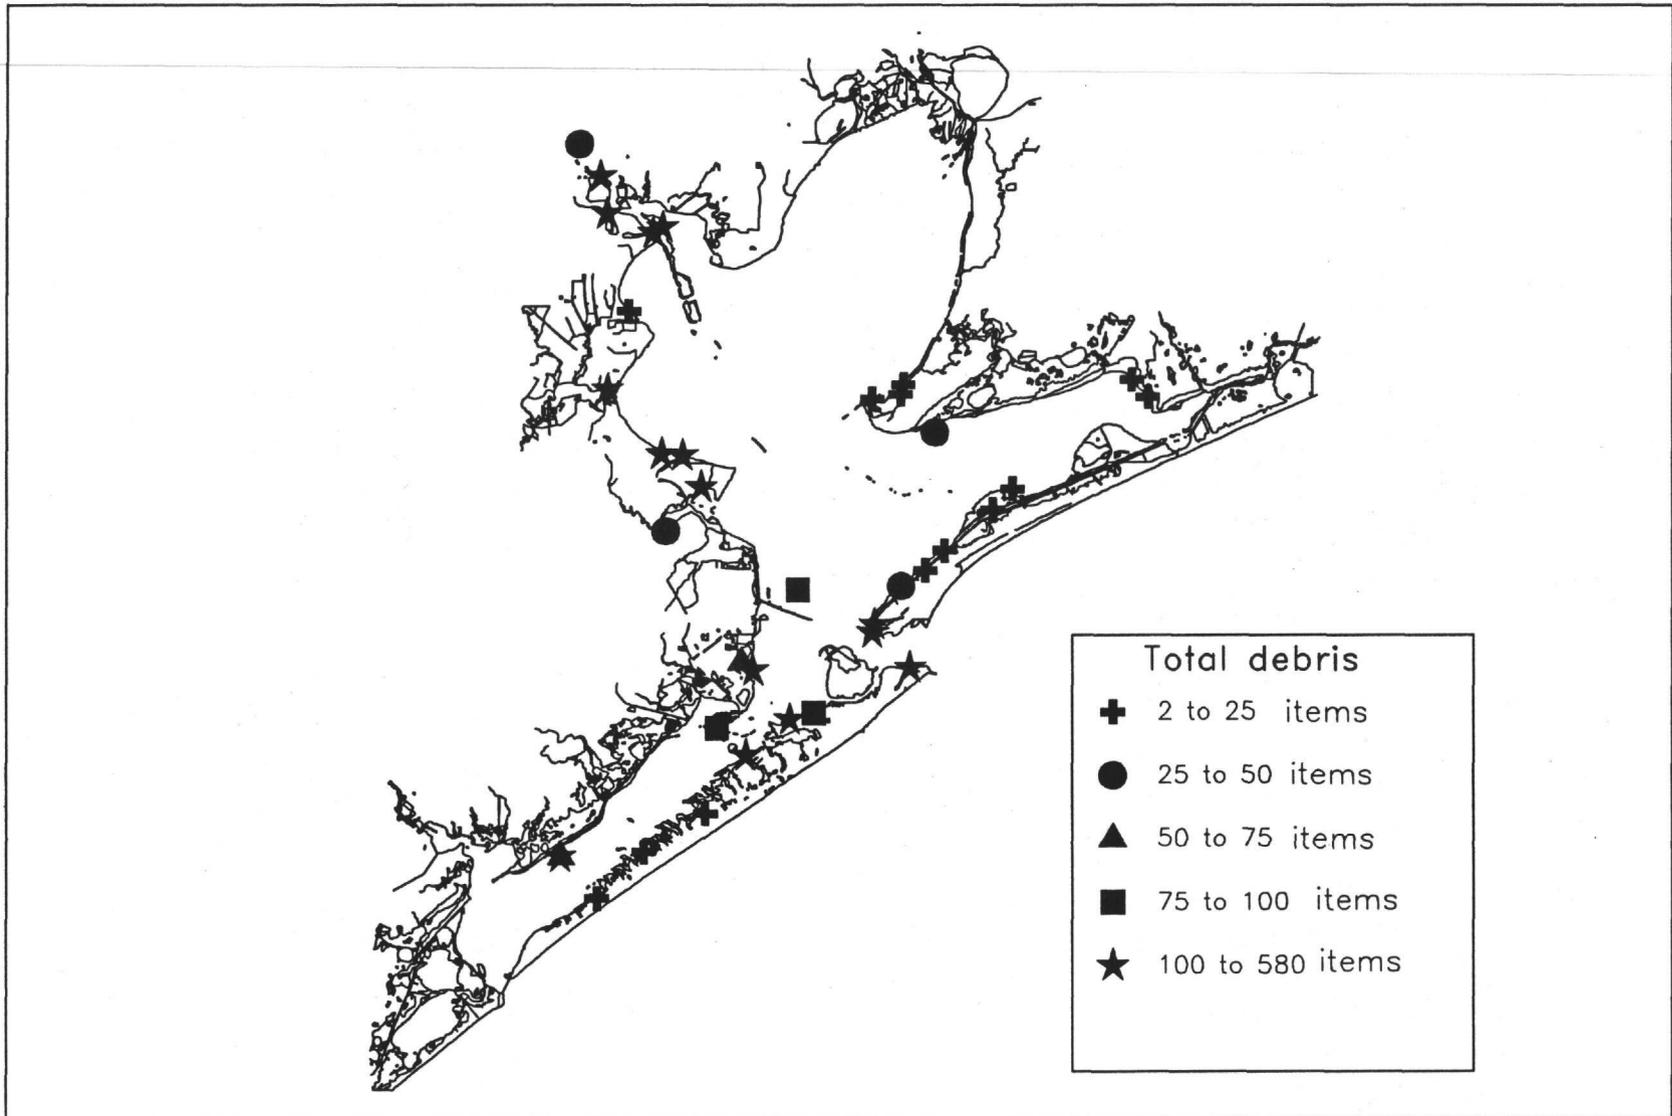
Figure 2. Spatial distribution of debris items in the shoreline environment of the Galveston Bay Estuary.

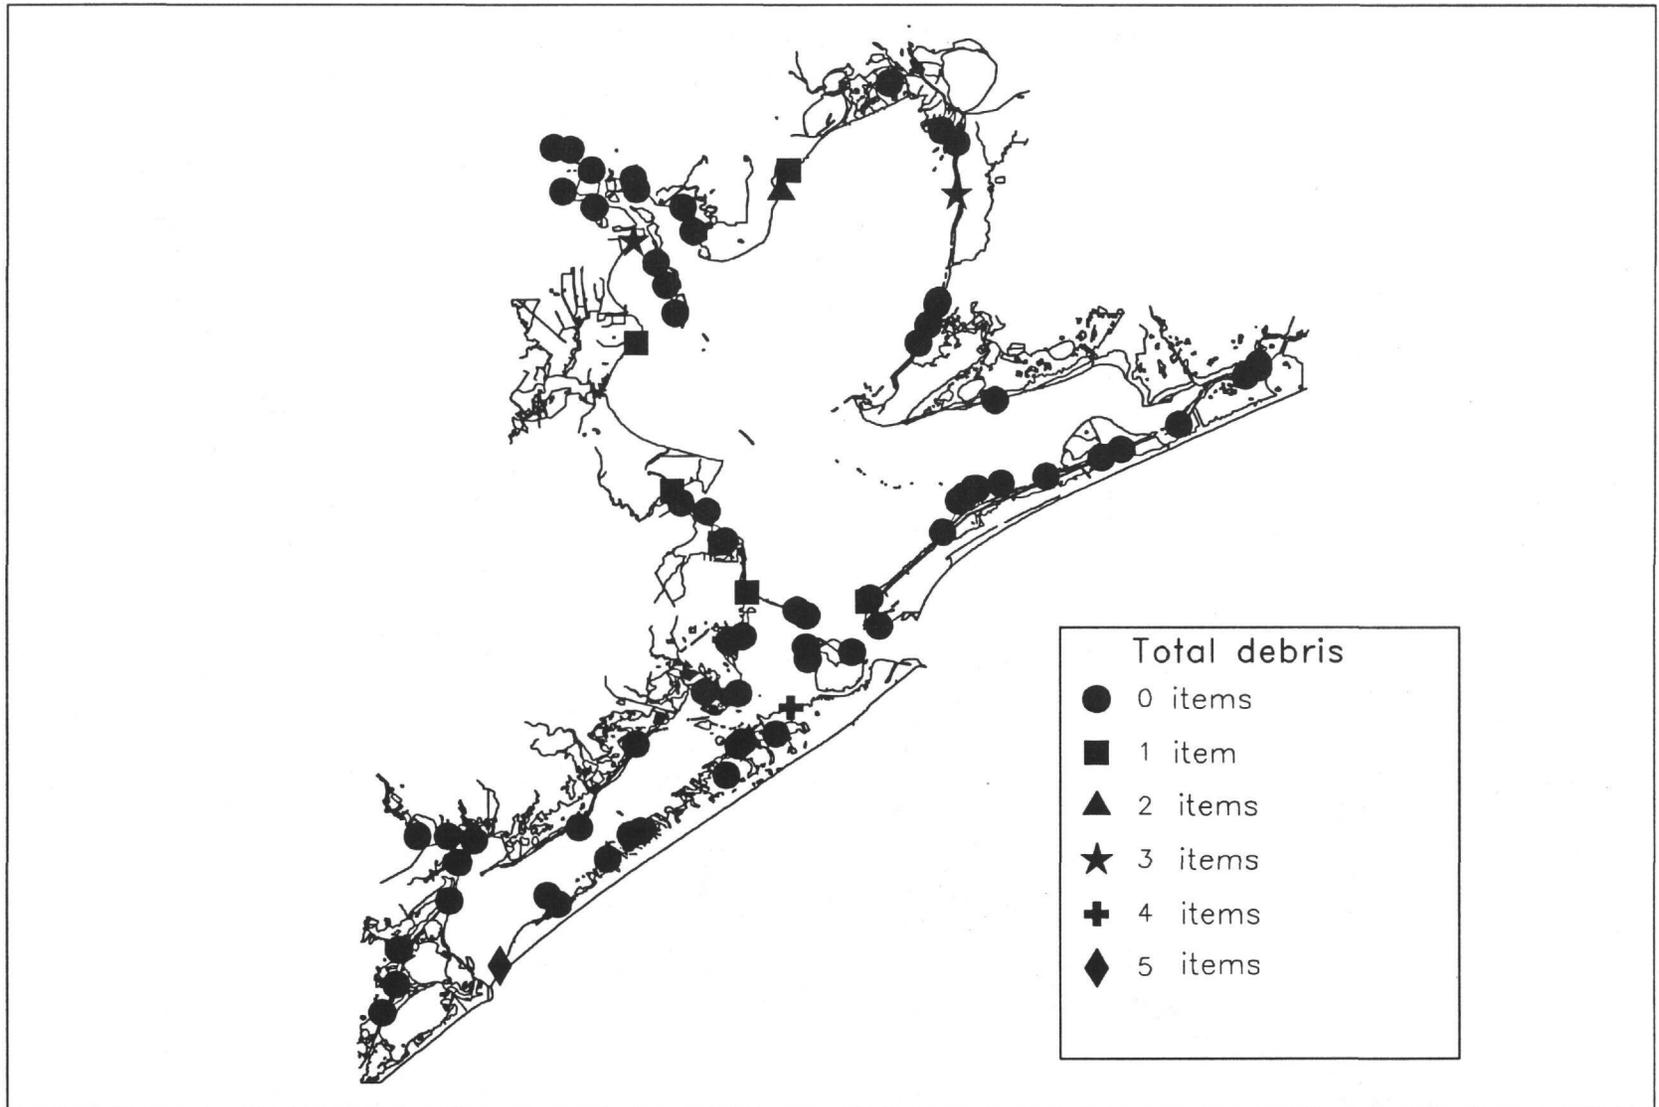
Figure 3. Spatial distribution of debris items in the nearshore environment of the Galveston Bay Estuary.

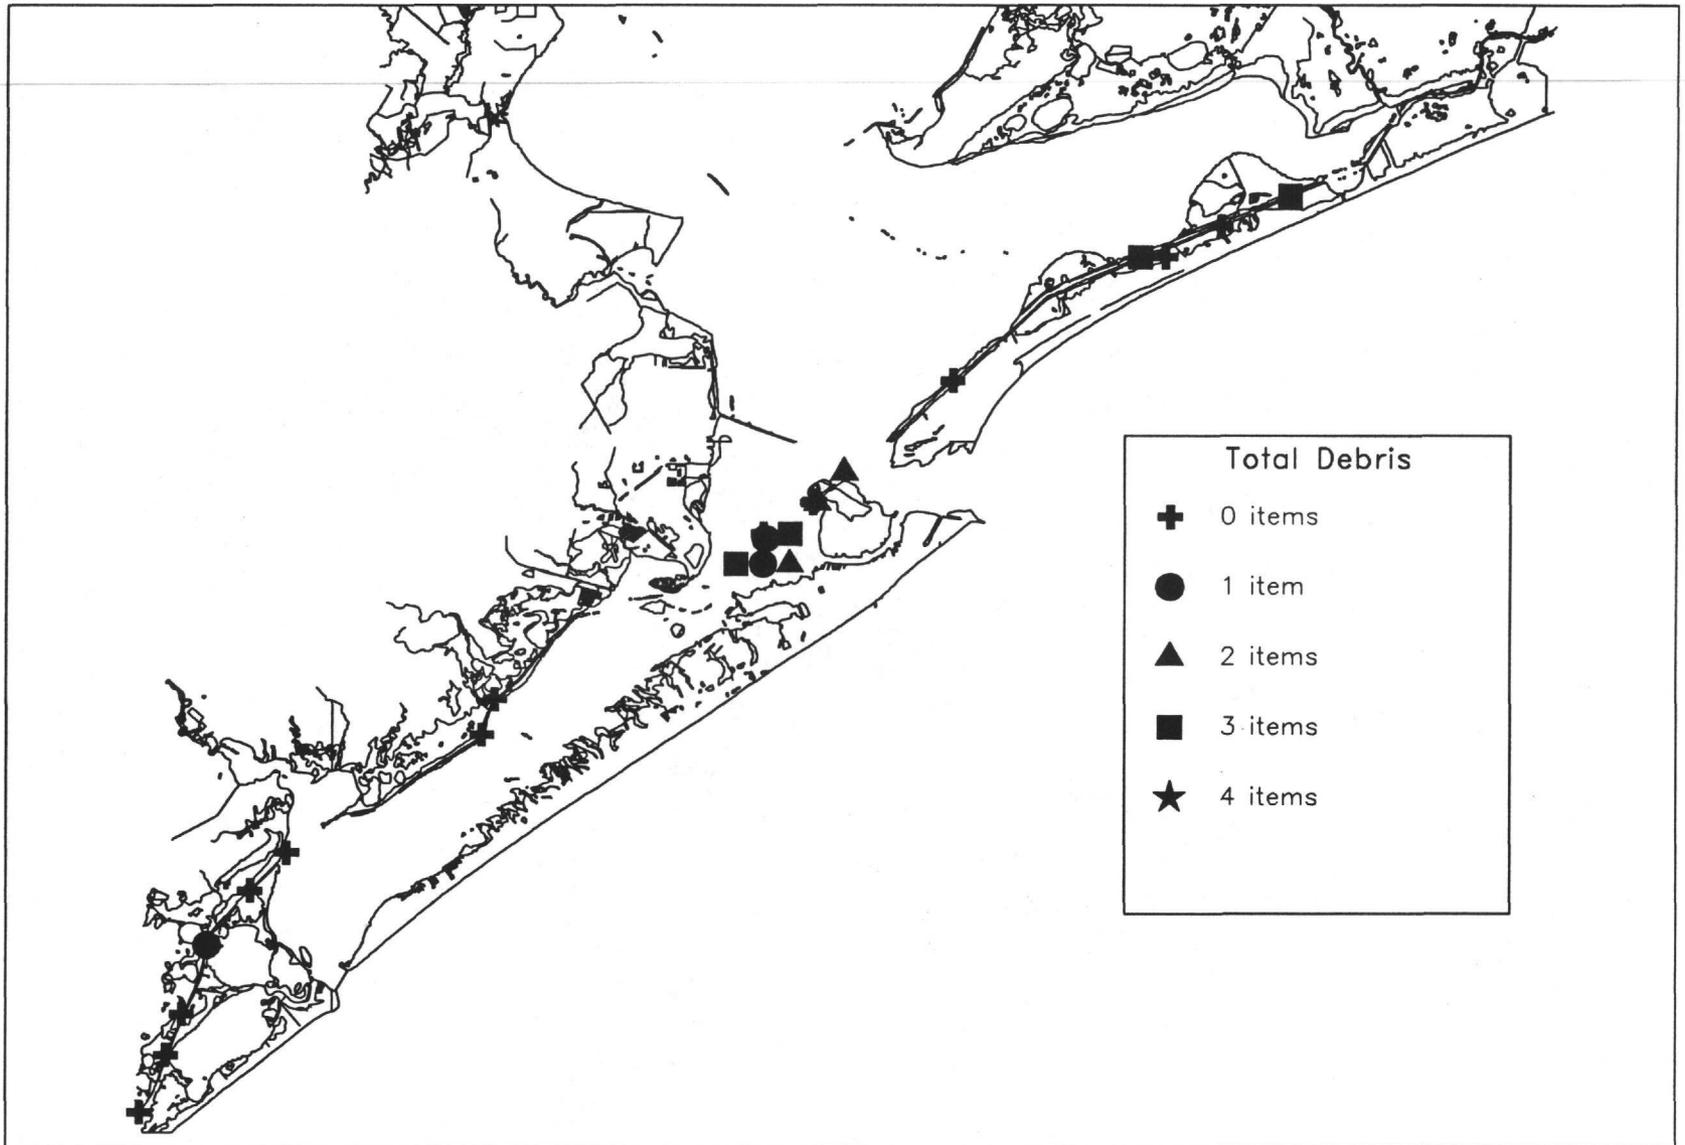
Figure 4. Spatial distribution of debris items in the submerged environment of the intracoastal waterway in the Galveston Bay Estuary.

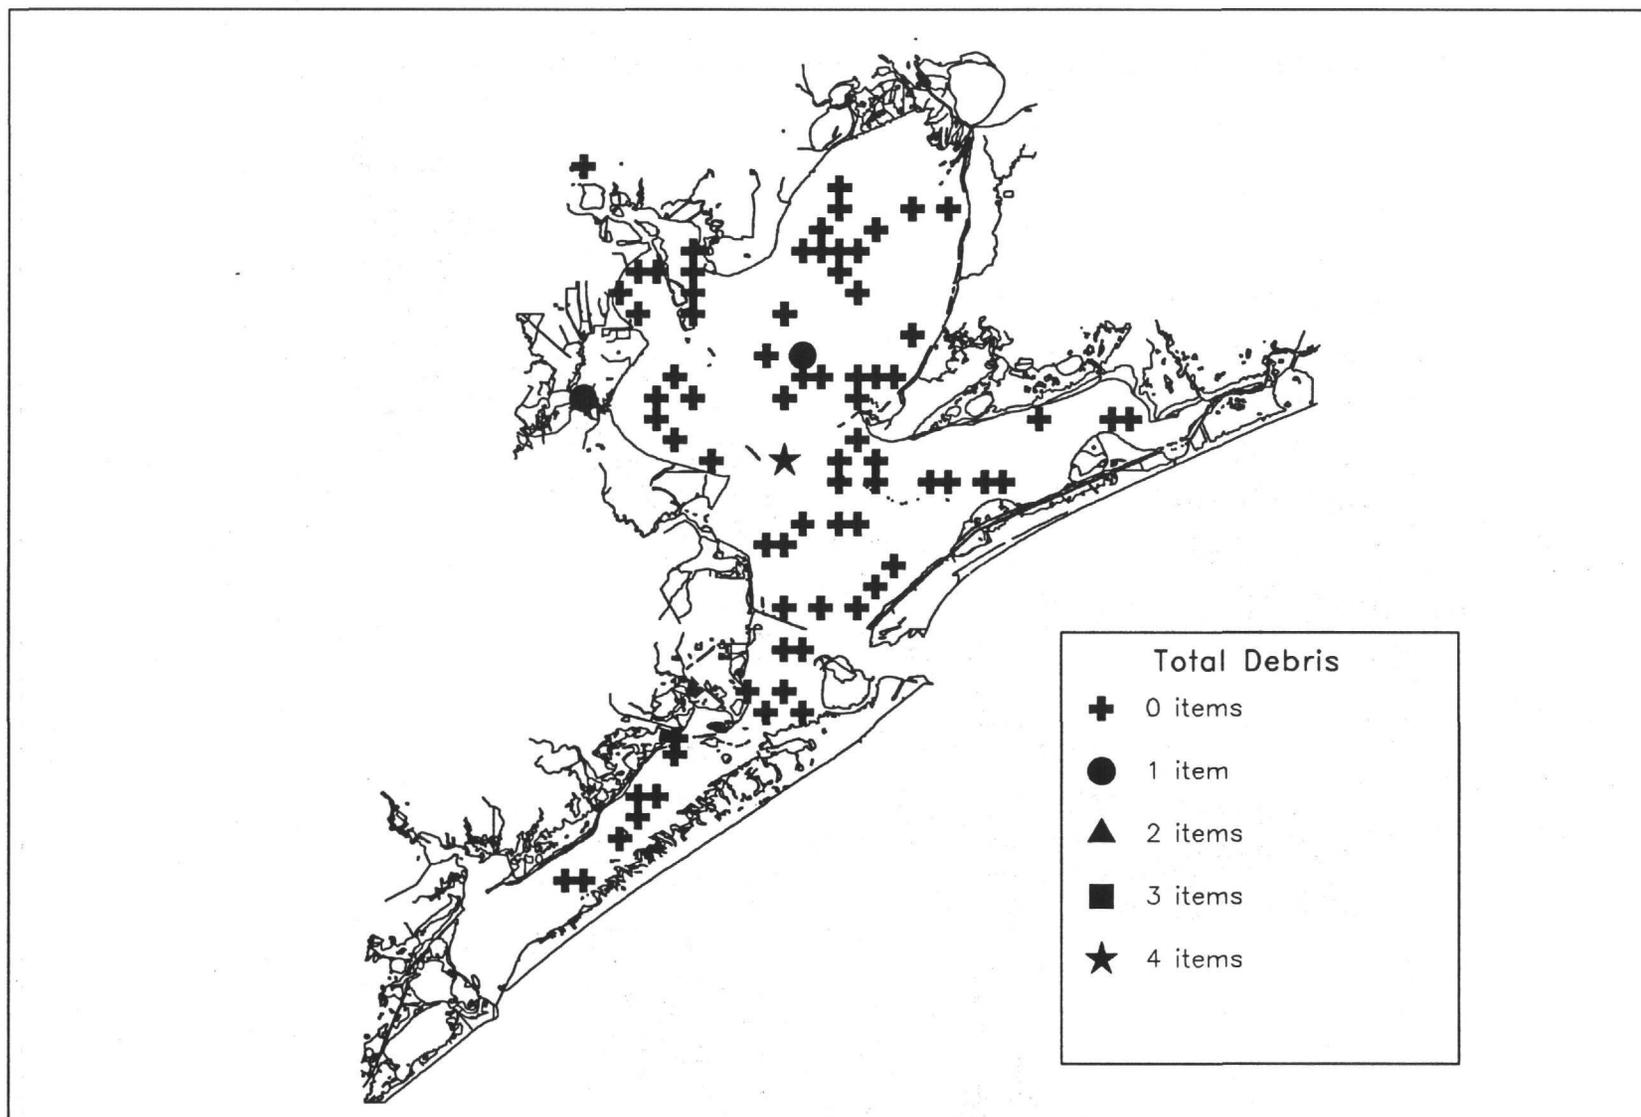
Figure 5. Spatial distribution of debris items in the submerged environment of the Galveston Bay Estuary, exclusive of intracoastal samples.

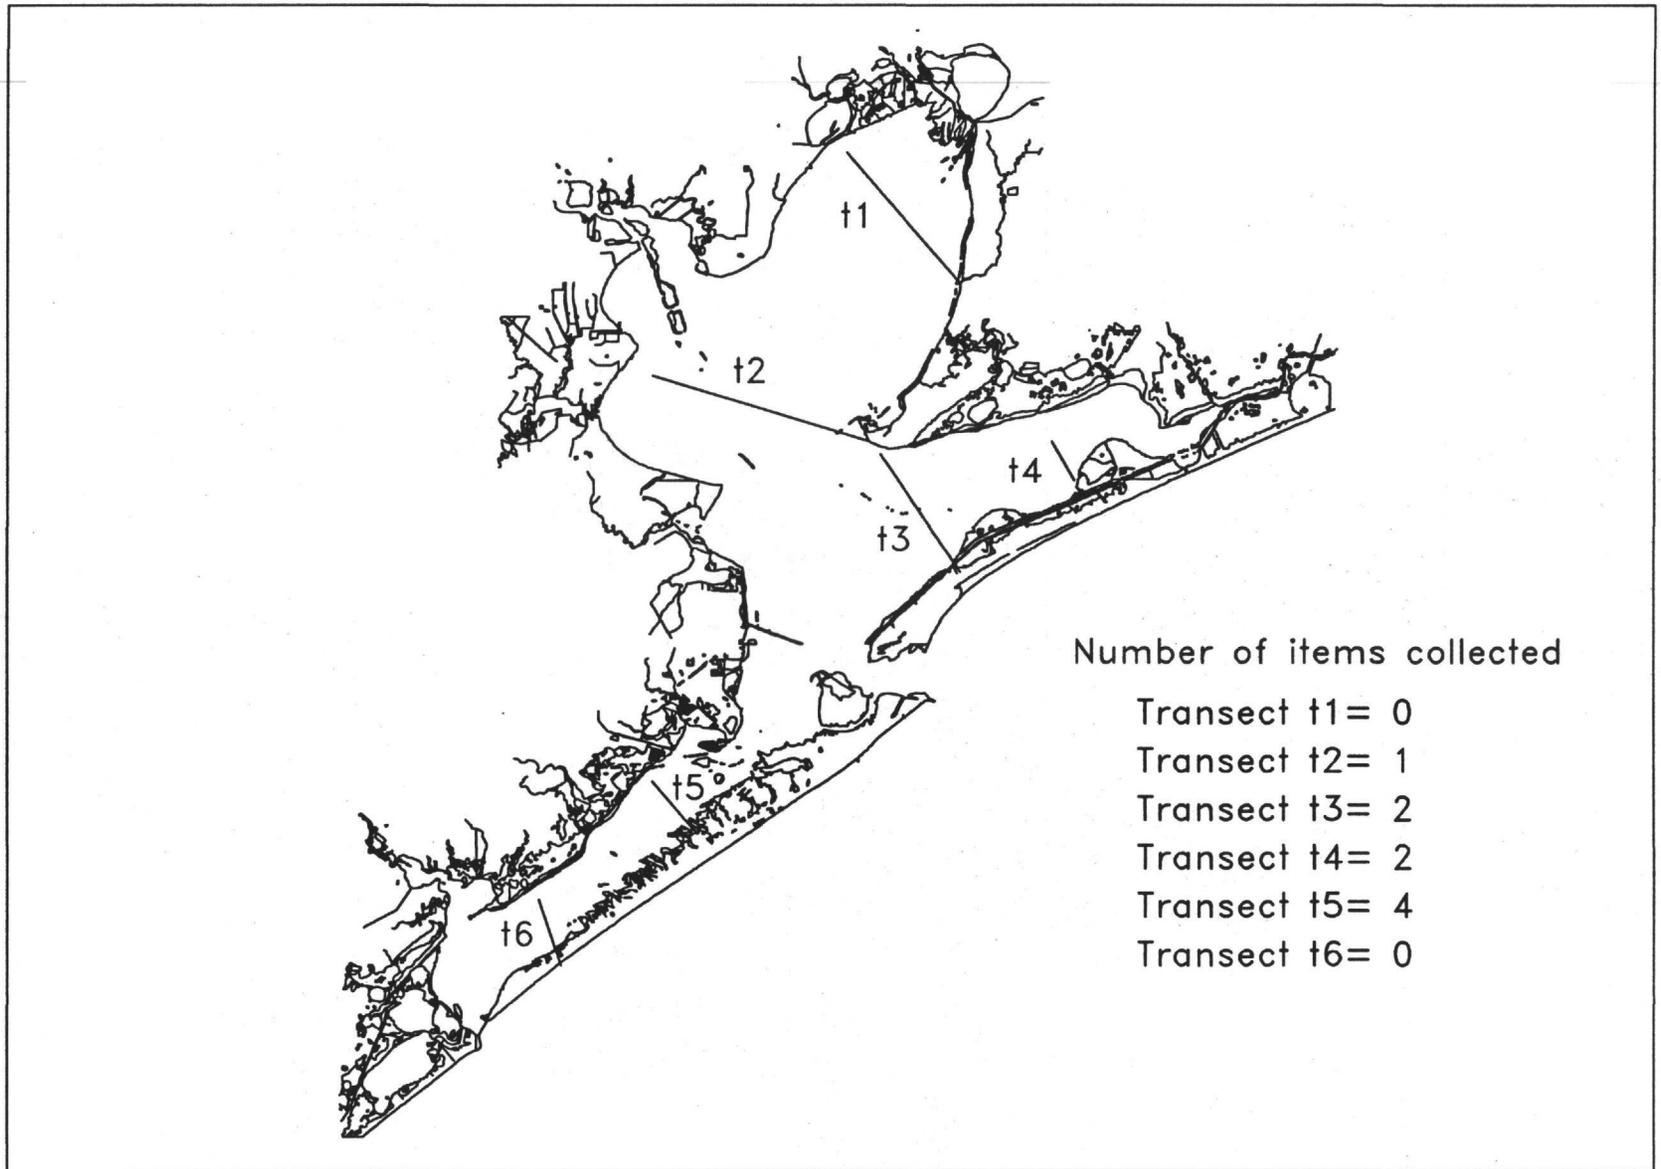
Figure 6. Location of floating debris transects in the Galveston Bay Estuary.
