RECONNAISSANCE GEOPHYSICAL INVESTIGATIONS OF SALINIZATION  
ALONG THE UPPER COLORADO RIVER (TMDL SEGMENT 1426),  
COKE AND RUNNELS COUNTIES, TEXAS

Jeffrey G. Paine and Edward W. Collins  
Bureau of Economic Geology  
John A. and Katherine G. Jackson School of Geosciences  
The University of Texas at Austin

Texas Commission on Environmental Quality  
P.O. Box 13087  
MC 150  
Austin, Texas 78711-3087

September 2004

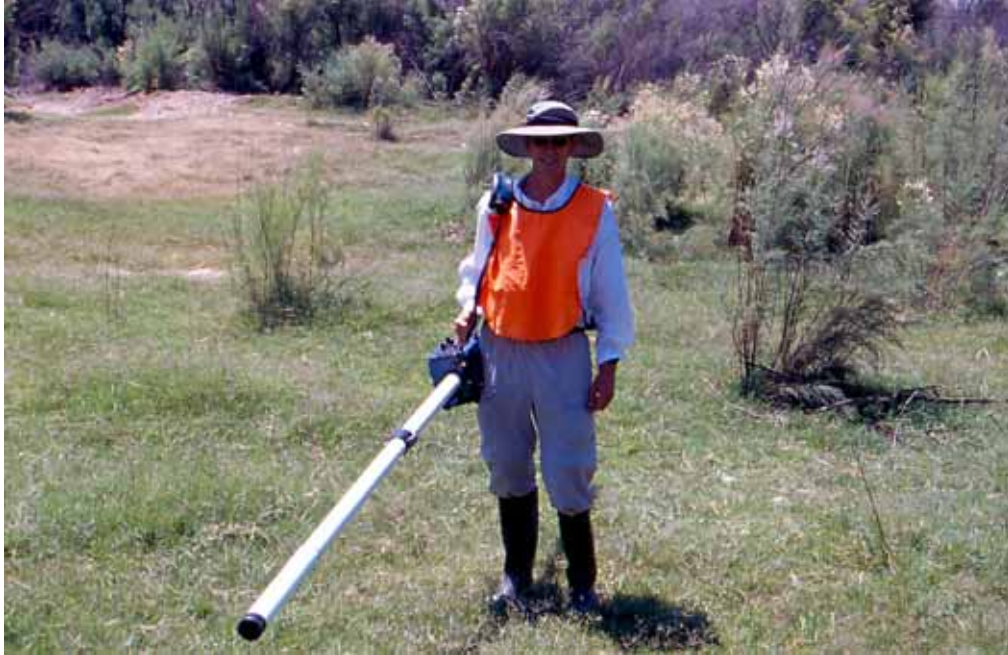
Figure 3. Geonics EM31 ground conductivity meter.

We used a Geonics EM31 ground conductivity meter (fig. 3) to measure the apparent conductivity of the ground. This instrument operates at a primary EM frequency of 9.8 kHz, measuring apparent conductivity to a depth of about 3 m (horizontal dipole [HD] orientation) and 6 m (vertical dipole [VD] orientation) using transmitter and receiver coils that are separated by 3.7 m. The instrument has a useful conductivity range of less than 1 millisiemens/m (mS/m) to 1,000 mS/m.

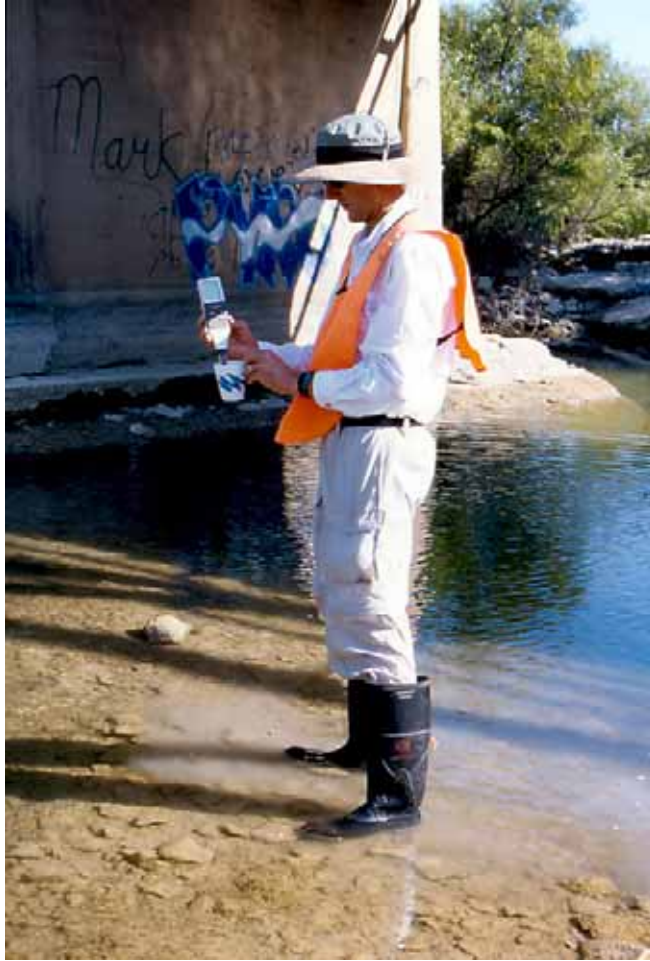
Figure 4. Measuring water temperature, conductivity, and total dissolved solids (TDS) concentration on Mustang Creek using a Corning Checkmate 90 probe.

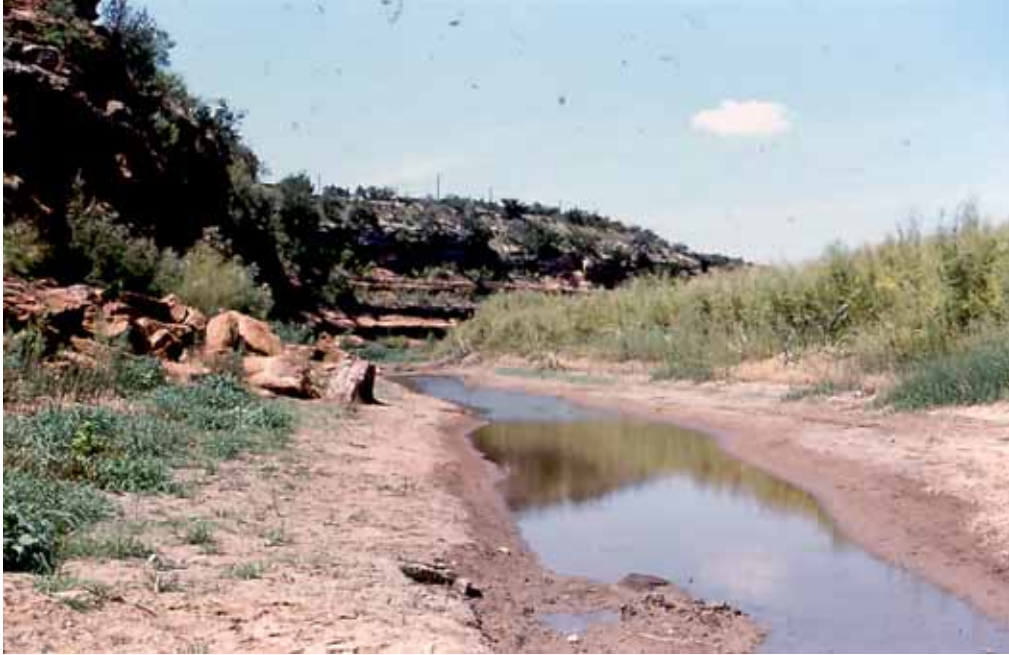
Figure 8. Photograph looking upstream along Salt Creek at Lake Spence.

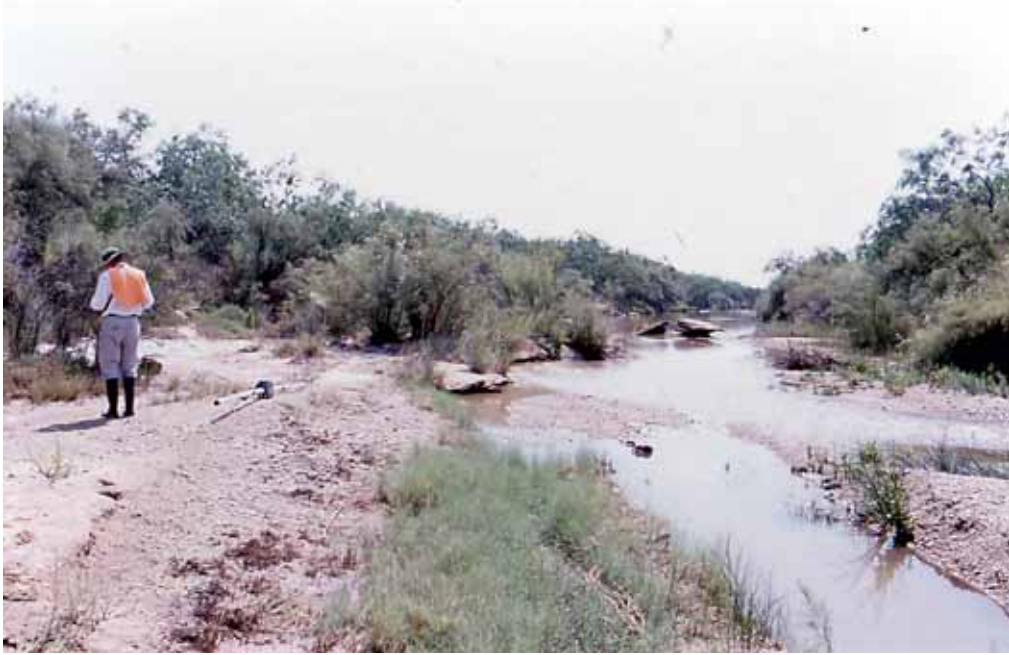
Figure 10. Photograph of efflorescence on the bank of the Colorado River in a saltwater seep area near Machae Creek.
