**Texas Commission on Environmental Quality
New Technology Research & Development (NTRD) Program
Monthly Project Status Report**

Contract Number: 582-11-13472-2019

Grantee: Transportation Power, Inc.

**Report for the
Monthly period:** 10/08/11 – 11/11/11

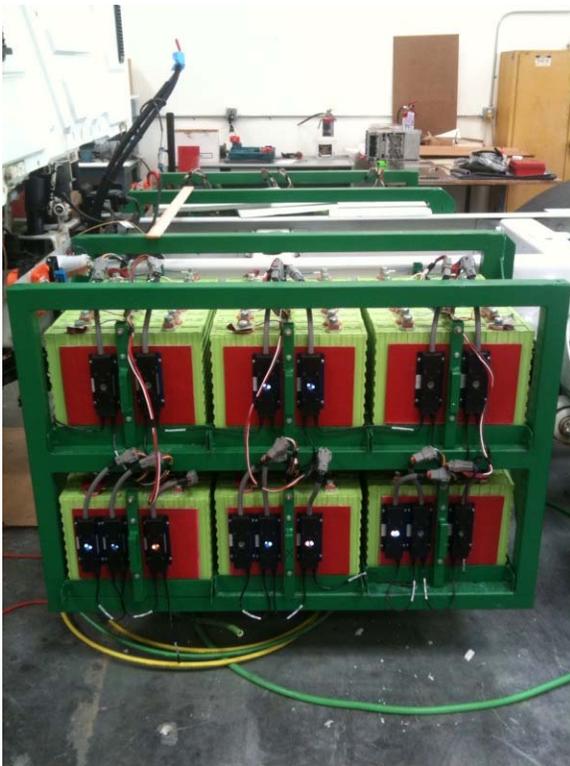
- Completed testing and calibration of the battery management system (BMS) installed on our first test battery pack. A ground fault protection unit was also selected and integrated with the pack to provide added safety. This is important to the project because, while the test battery pack is presently installed on a Navistar truck, it is electrically nearly identical to the packs to be installed on the electric terminal tractors. It consists of 120 large lithium-ion cells with a total energy storage capacity of 100 kilowatt-hours (kWh). The electric tractor battery pack will consist of 120 lithium-ion cells which will be the same size as those in the test pack, but will have about 15% more energy capacity.

Figure 1. Test battery pack with BMS and ground fault hardware fully integrated.

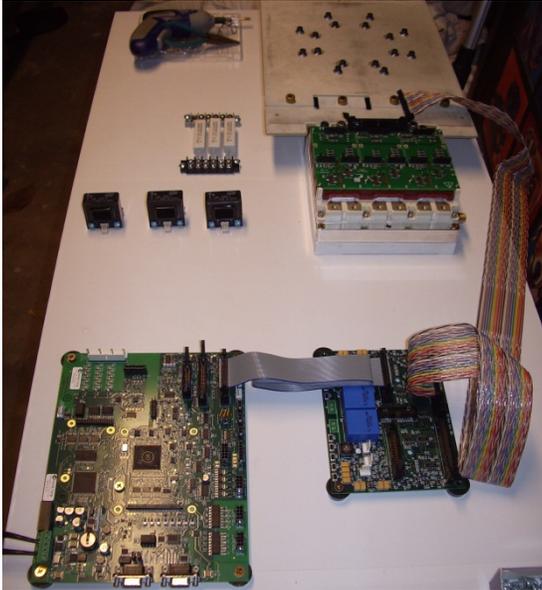
- Initiated bench testing of our advanced onboard inverter-charger, which is important because this begins the process of validating one of the major components required for electrification of the terminal tractors. Testing will continue for approximately three months, after which any needed design changes will be made and the units to be used on the electric tractors will be assembled.

Figure 2. Inverter-charger hardware configured for bench testing.

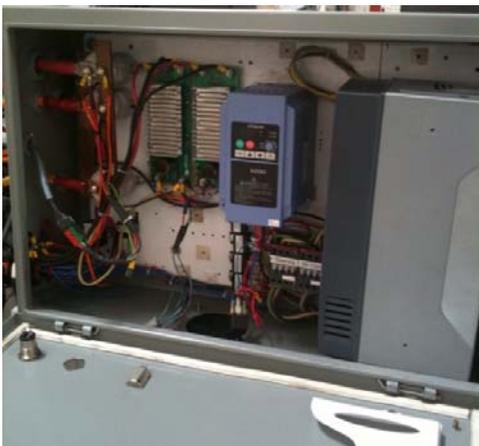
- Completed assembly of a test version of our High Voltage Distribution Center (HVDC), which routes high-voltage power from the battery pack to the inverters that control the electric motors and the electrically-driven accessory subsystem. Control code was created and underwent initial calibration to govern accessory start up and vehicle starting safety. High voltage pre-charge and contactor control was verified. DC-DC production of 12 volt system power was verified and connected to the 12 volt supply on our Navistar test truck. As with the battery subsystem, the HVDC subsystem is also installed on our Navistar test truck, but its design will be replicated for the electric terminal tractors. The Navistar truck in these cases is being used in lieu of a bench test setup to provide a more accurate platform for testing and evaluation of all of our prototype subsystems and components.

Figure 3. High Voltage Distribution System.
