Preliminary Hand- Held Air Monitoring Locations | ITC Deer Park Tank Fire

Reading Date
3/26/2019 11:00:00 PM to 3/27/2019 12:00:00 AM

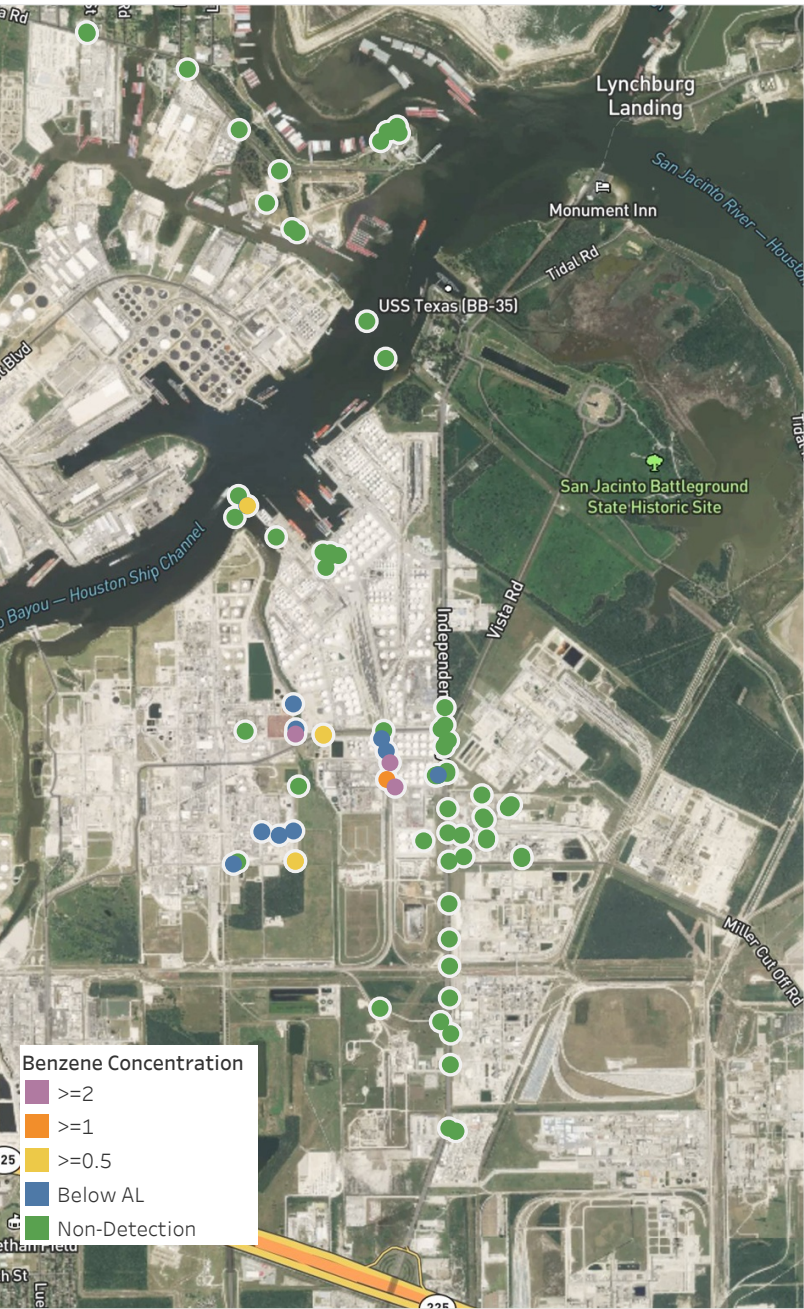
Recent Benzene Detections

Location Category	Reading Date	Concentration
Division B	3/26/2019 23:29:51	0.750 ppm
	3/26/2019 23:21:45	0.120 ppm
Division E	3/26/2019 23:15:14	1.300 ppm
	3/26/2019 23:21:16	0.100 ppm
	3/26/2019 23:17:50	3.300 ppm
	3/26/2019 23:12:29	2.150 ppm
	3/26/2019 23:26:21	0.125 ppm
	3/26/2019 23:55:25	0.600 ppm
	3/26/2019 23:50:50	0.950 ppm
Impacted Tank Farm	3/26/2019 23:00:11	0.125 ppm
Industrial Area	3/26/2019 23:02:22	0.260 ppm
	3/26/2019 23:13:31	0.420 ppm
	3/26/2019 23:36:55	0.110 ppm
	3/26/2019 23:29:22	2.950 ppm
	3/26/2019 23:26:35	0.250 ppm
	3/26/2019 23:22:27	0.150 ppm
	3/26/2019 23:43:48	0.500 ppm
	3/26/2019 23:50:12	0.710 ppm
	3/26/2019 23:57:15	0.170 ppm

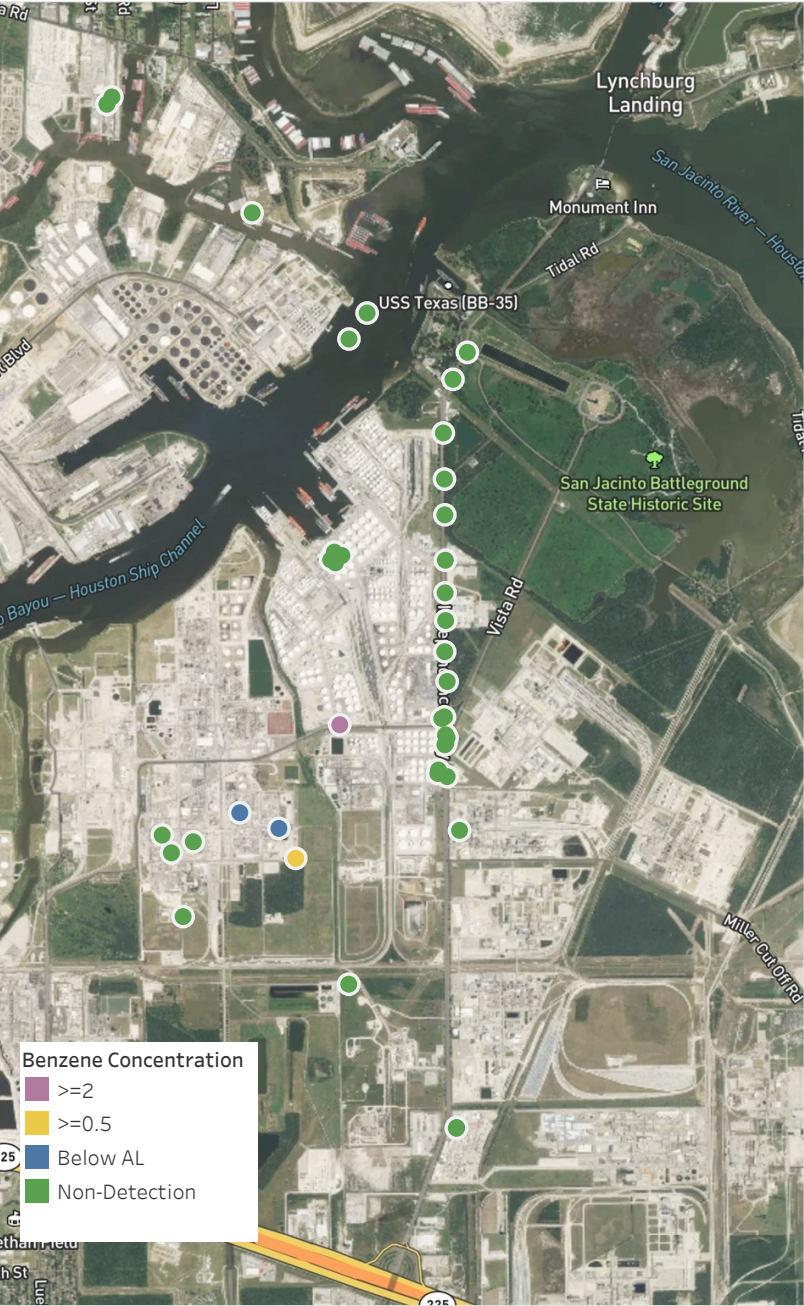
Reading Date
3/27/2019 12:00:00 AM to 3/27/2019 1:00:00 AM

Recent Benzene Detections

Location Category	Reading Date	Concentration
Division E	3/27/2019 00:01:48	2.800 ppm
	3/27/2019 00:03:17	0.350 ppm
Industrial Area	3/27/2019 00:28:23	0.600 ppm
	3/27/2019 00:21:29	0.350 ppm

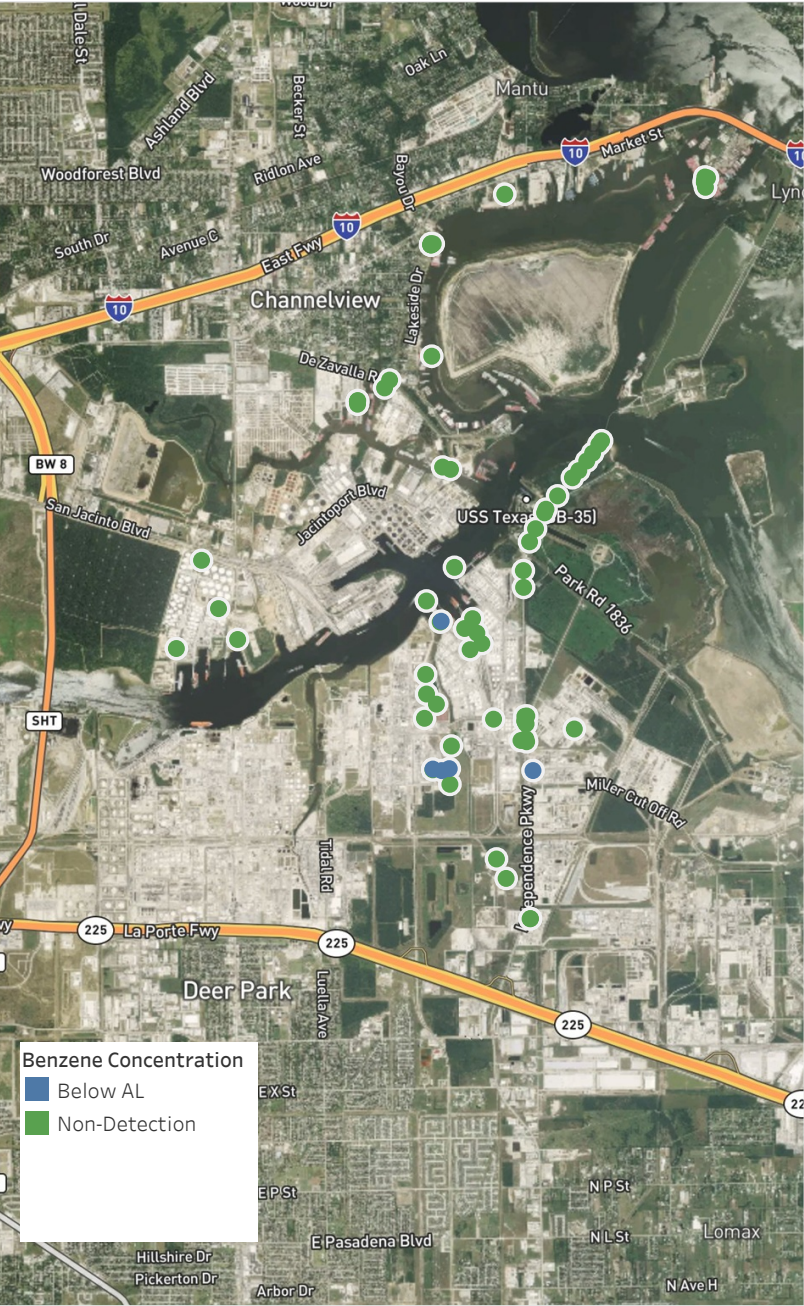
Reading Date
3/27/2019 1:00:00 AM to 3/27/2019 2:00:00 AM

Recent Benzene Detections

Location Category	Reading Date	Concentration
Division B	3/27/2019 01:45:06	0.420 ppm
Industrial Area	3/27/2019 01:31:44	0.110 ppm
	3/27/2019 01:33:44	0.360 ppm
	3/27/2019 01:43:25	0.350 ppm
	3/27/2019 01:37:14	0.410 ppm

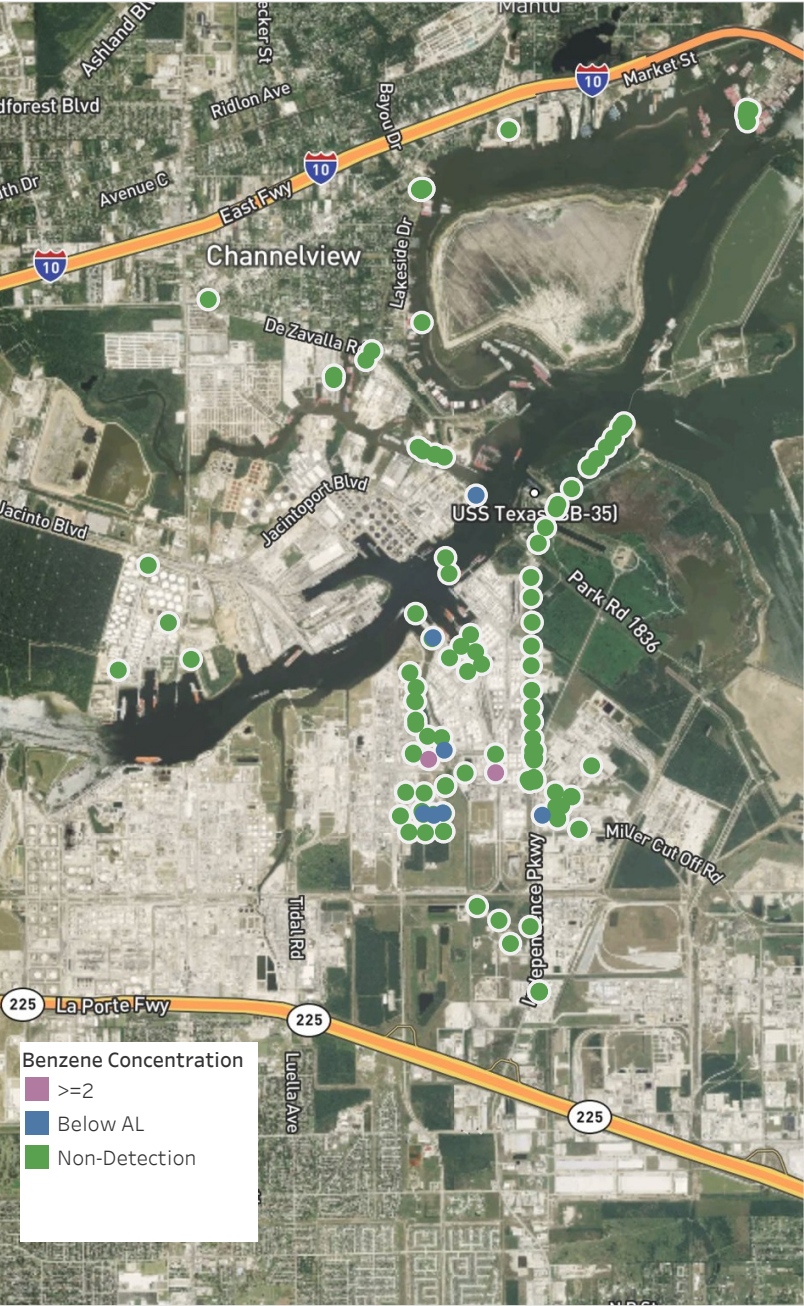
Reading Date
3/27/2019 1:00:00 AM to 3/27/2019 3:00:00 AM

Recent Benzene Detections

Location Category	Reading Date	Concentration
Division B	3/27/2019 01:45:06	0.420 ppm
Division C	3/27/2019 02:18:55	0.175 ppm
Division E	3/27/2019 02:37:31	3.730 ppm
Industrial Area	3/27/2019 01:31:44	0.110 ppm
	3/27/2019 01:33:44	0.360 ppm
	3/27/2019 01:43:25	0.350 ppm
	3/27/2019 01:37:14	0.410 ppm
	3/27/2019 02:03:49	0.175 ppm
	3/27/2019 02:08:45	4.050 ppm

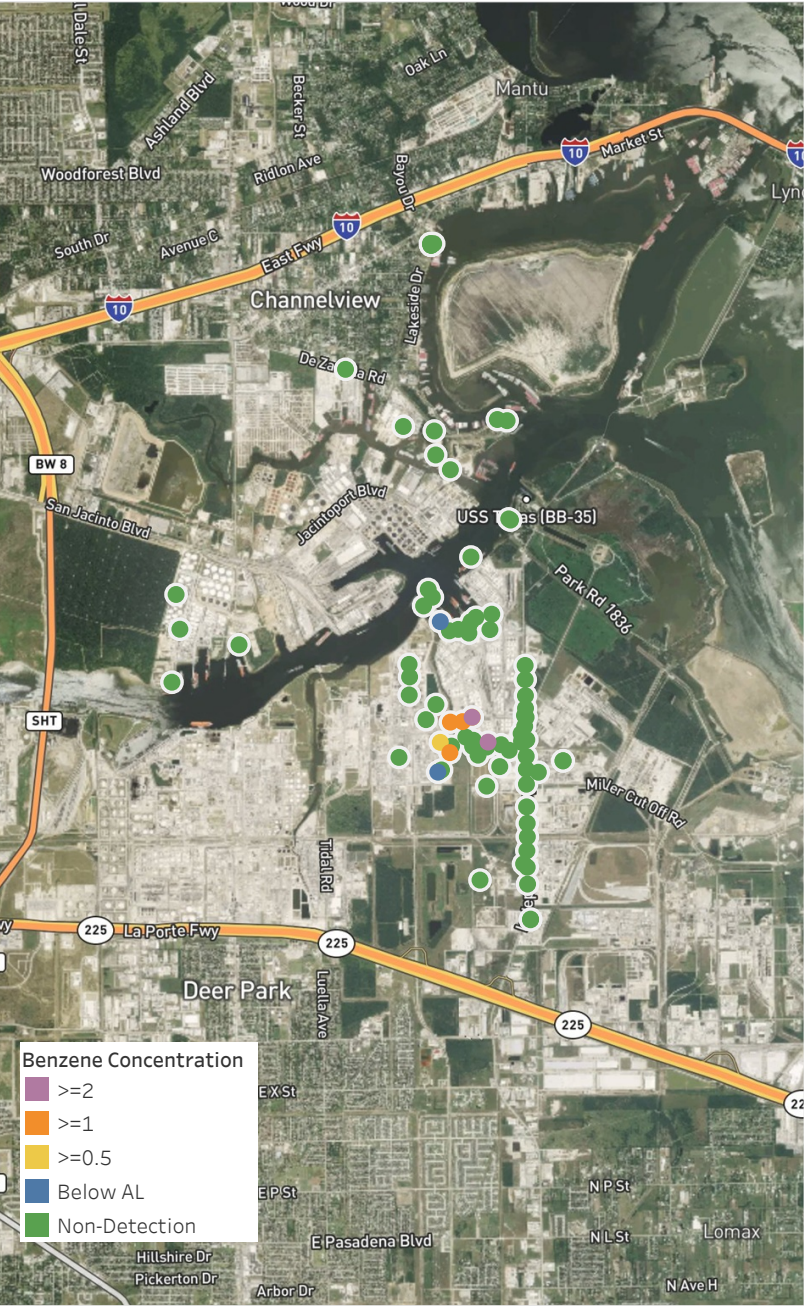
Reading Date
3/27/2019 3:00:00 AM to 3/27/2019 4:00:00 AM

Recent Benzene Detections

Location Category	Reading Date	Concentration
Division B	3/27/2019 03:30:41	0.200 ppm
Division E	3/27/2019 03:04:16	2.400 ppm
	3/27/2019 03:33:23	2.000 ppm
	3/27/2019 03:17:03	1.275 ppm
	3/27/2019 03:37:04	0.525 ppm
	3/27/2019 03:21:14	0.875 ppm
Industrial Area	3/27/2019 03:00:25	1.250 ppm
	3/27/2019 03:25:23	0.180 ppm
	3/27/2019 03:18:13	1.975 ppm

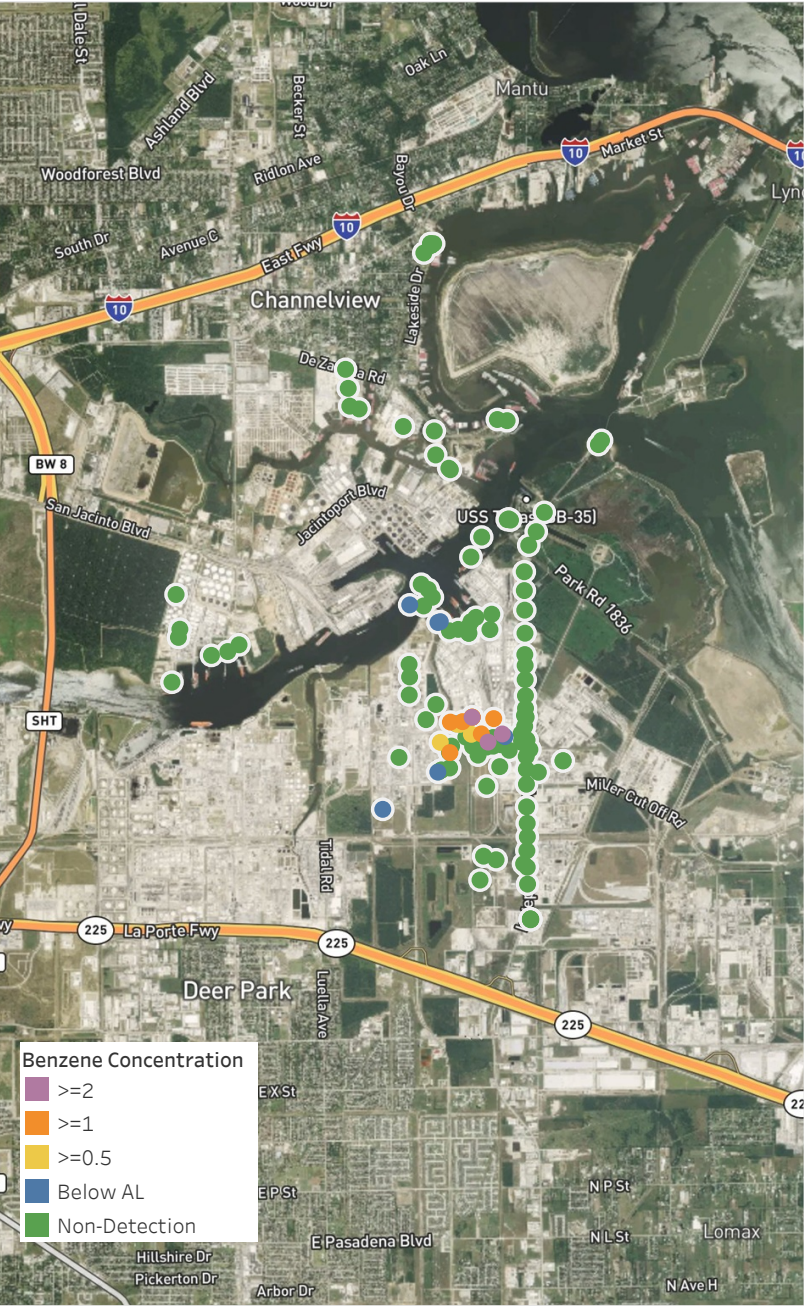
Reading Date
3/27/2019 3:00:00 AM to 3/27/2019 5:00:00 AM

Recent Benzene Detections

Location Category	Reading Date	Concentration
Division B	3/27/2019 03:30:41	0.200 ppm
	3/27/2019 04:06:10	0.310 ppm
	3/27/2019 04:33:34	0.350 ppm
Division E	3/27/2019 03:04:16	2.400 ppm
	3/27/2019 04:04:56	1.100 ppm
	3/27/2019 03:33:23	2.000 ppm
	3/27/2019 04:08:37	0.425 ppm
	3/27/2019 03:17:03	1.275 ppm
	3/27/2019 03:37:04	0.525 ppm
	3/27/2019 04:12:56	0.350 ppm
	3/27/2019 03:21:14	0.875 ppm
	3/27/2019 04:00:10	0.540 ppm
	3/27/2019 04:46:15	0.625 ppm
	3/27/2019 04:40:48	0.825 ppm
	3/27/2019 04:47:08	1.080 ppm
	3/27/2019 04:56:12	1.200 ppm
	3/27/2019 04:52:47	1.325 ppm
Impacted Tank Farm	3/27/2019 04:03:38	0.360 ppm
	3/27/2019 04:22:07	2.850 ppm
Industrial Area	3/27/2019 03:00:25	1.250 ppm
	3/27/2019 03:25:23	0.180 ppm
	3/27/2019 03:18:13	1.975 ppm

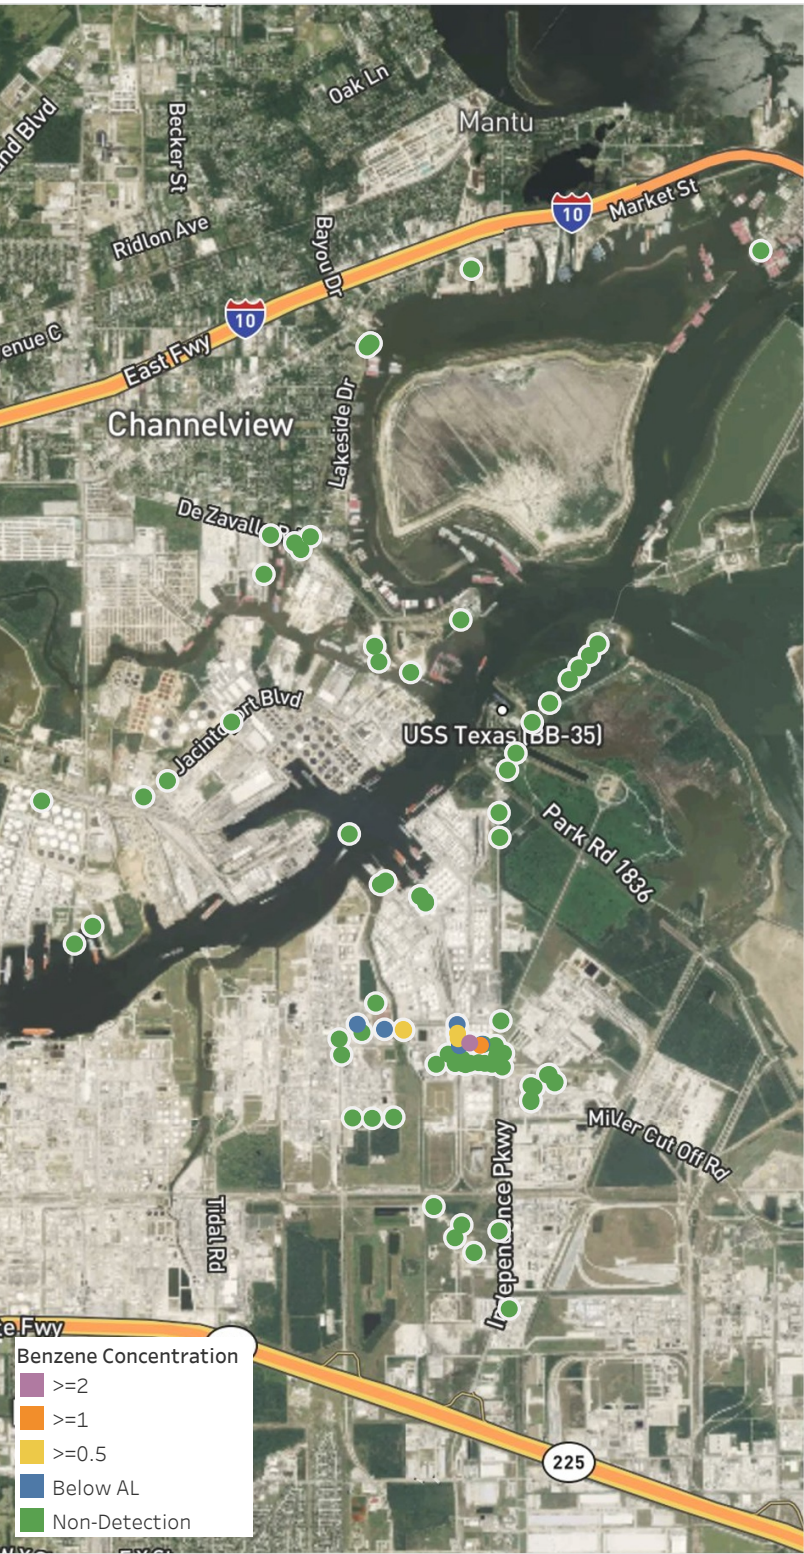
Reading Date
3/27/2019 5:00:00 AM to 3/27/2019 6:00:00 AM

Recent Benzene Detections

Location Category	Reading Date	Concentration
Division E	3/27/2019 05:57:06	0.975 ppm
	3/27/2019 05:54:45	0.300 ppm
	3/27/2019 05:51:03	0.225 ppm
	3/27/2019 05:46:24	0.975 ppm
	3/27/2019 05:44:07	0.650 ppm
	3/27/2019 05:43:25	0.450 ppm
	3/27/2019 05:35:56	0.900 ppm
Impacted Tank Farm	3/27/2019 05:59:28	1.640 ppm
	3/27/2019 05:56:18	2.270 ppm
	3/27/2019 05:14:55	0.400 ppm
Industrial Area	3/27/2019 05:57:52	0.290 ppm
	3/27/2019 05:36:56	0.225 ppm

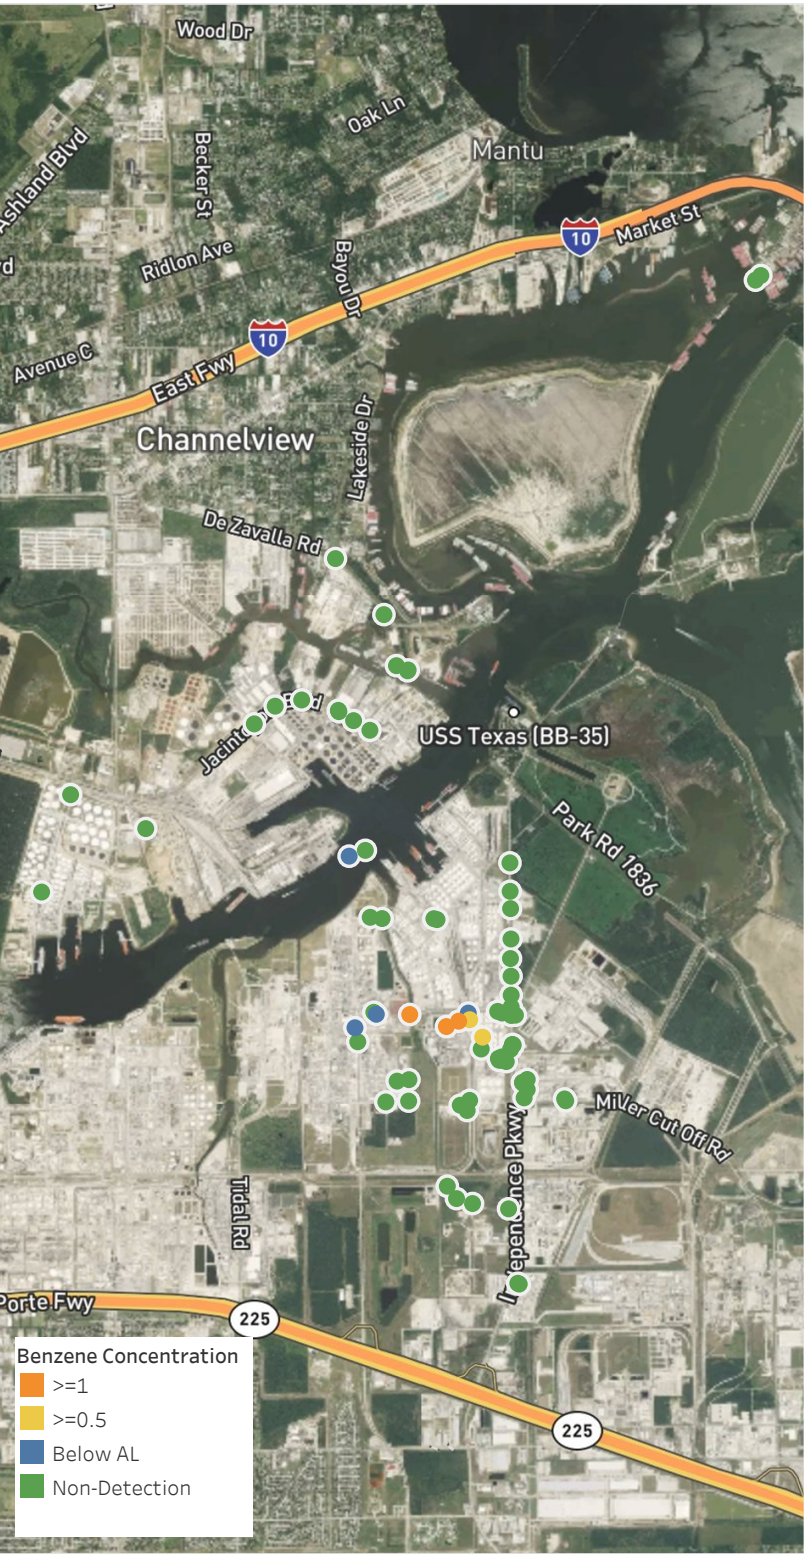
Reading Date
3/27/2019 6:00:00 AM to 3/27/2019 7:00:00 AM

Recent Benzene Detections

Location Category	Reading Date	Concentration
Division B	3/27/2019 06:20:02	0.250 ppm
Division E	3/27/2019 06:51:51	1.800 ppm
	3/27/2019 06:40:40	1.600 ppm
	3/27/2019 06:03:26	0.125 ppm
	3/27/2019 06:00:25	0.525 ppm
Impacted Tank Farm	3/27/2019 06:02:32	0.510 ppm
Industrial Area	3/27/2019 06:34:23	0.410 ppm
	3/27/2019 06:27:23	1.500 ppm
	3/27/2019 06:01:44	0.225 ppm

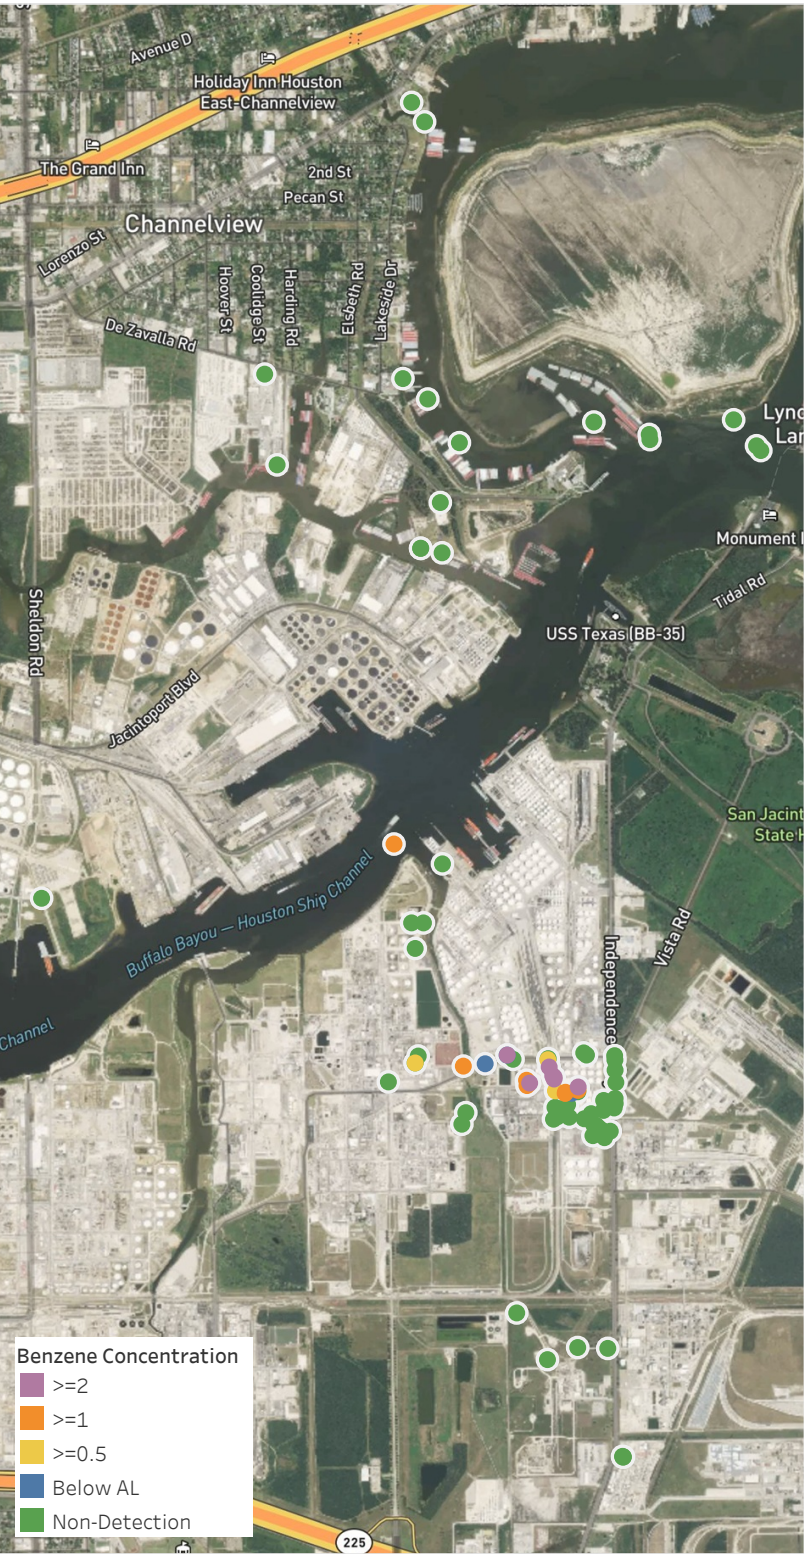
Reading Date
3/27/2019 7:00:00 AM to 3/27/2019 8:00:00 AM

Recent Benzene Detections

Location Category	Reading Date	Concentration
Division B	3/27/2019 07:15:00	1.250 ppm
Division E	3/27/2019 07:56:48	1.560 ppm
	3/27/2019 07:45:40	0.400 ppm
	3/27/2019 07:44:14	2.175 ppm
	3/27/2019 07:41:45	4.350 ppm
	3/27/2019 07:39:22	0.900 ppm
	3/27/2019 07:34:44	0.250 ppm
	3/27/2019 07:29:47	3.500 ppm
	3/27/2019 07:21:54	3.100 ppm
	3/27/2019 07:20:54	3.100 ppm
	3/27/2019 07:19:17	0.675 ppm
	3/27/2019 07:04:13	1.875 ppm
	3/27/2019 07:01:03	2.075 ppm
Impacted Tank Farm	3/27/2019 07:50:07	1.580 ppm
	3/27/2019 07:50:00	4.500 ppm
	3/27/2019 07:42:28	0.125 ppm
	3/27/2019 07:34:13	1.910 ppm
	3/27/2019 07:30:32	1.450 ppm
Industrial Area	3/27/2019 07:50:40	0.775 ppm
	3/27/2019 07:06:34	1.450 ppm

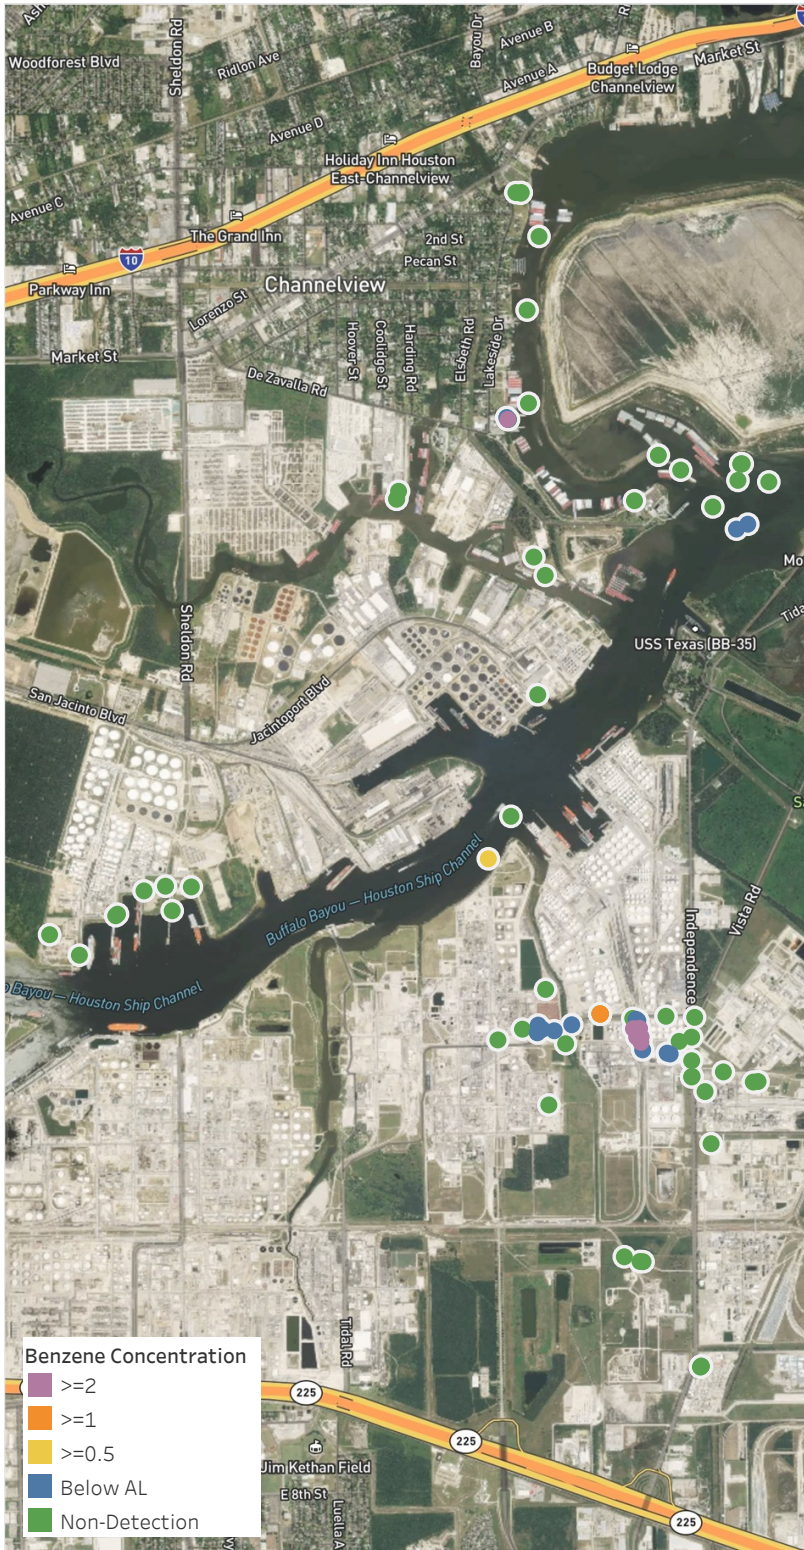
3/27/2019 8:00:00 AM to 3/27/2019 9:00:00 AM

Recent Benzene Detections

Location Category	Reading Date	Concentration
Division B	3/27/2019 08:56:10	0.970 ppm
	3/27/2019 08:48:56	0.100 ppm
	3/27/2019 08:47:55	0.050 ppm
	3/27/2019 08:20:18	0.100 ppm
	3/27/2019 08:18:43	2.500 ppm
Division E	3/27/2019 08:09:35	0.250 ppm
	3/27/2019 08:51:15	2.180 ppm
	3/27/2019 08:48:03	1.570 ppm
	3/27/2019 08:42:37	0.070 ppm
	3/27/2019 08:42:18	0.610 ppm
	3/27/2019 08:40:56	2.460 ppm
	3/27/2019 08:33:14	0.300 ppm
	3/27/2019 08:32:36	0.290 ppm
	3/27/2019 08:29:54	3.290 ppm
	3/27/2019 08:27:56	0.460 ppm
	3/27/2019 08:26:58	1.350 ppm
	3/27/2019 08:21:32	0.920 ppm
	3/27/2019 08:18:17	0.710 ppm
	3/27/2019 08:17:49	0.130 ppm
	3/27/2019 08:15:05	0.150 ppm
	3/27/2019 08:13:48	0.410 ppm
	3/27/2019 08:09:47	2.750 ppm
	3/27/2019 08:09:30	0.880 ppm
	3/27/2019 08:01:46	0.170 ppm
	3/27/2019 08:00:46	0.760 ppm
	3/27/2019 08:00:42	0.020 ppm
Impacted Tank Farm	3/27/2019 08:23:39	2.900 ppm
Industrial Area	3/27/2019 08:22:03	0.300 ppm

3/27/2019 08:14:48	0.150 ppm
	3/27/2019 08:06:25	0.175 ppm

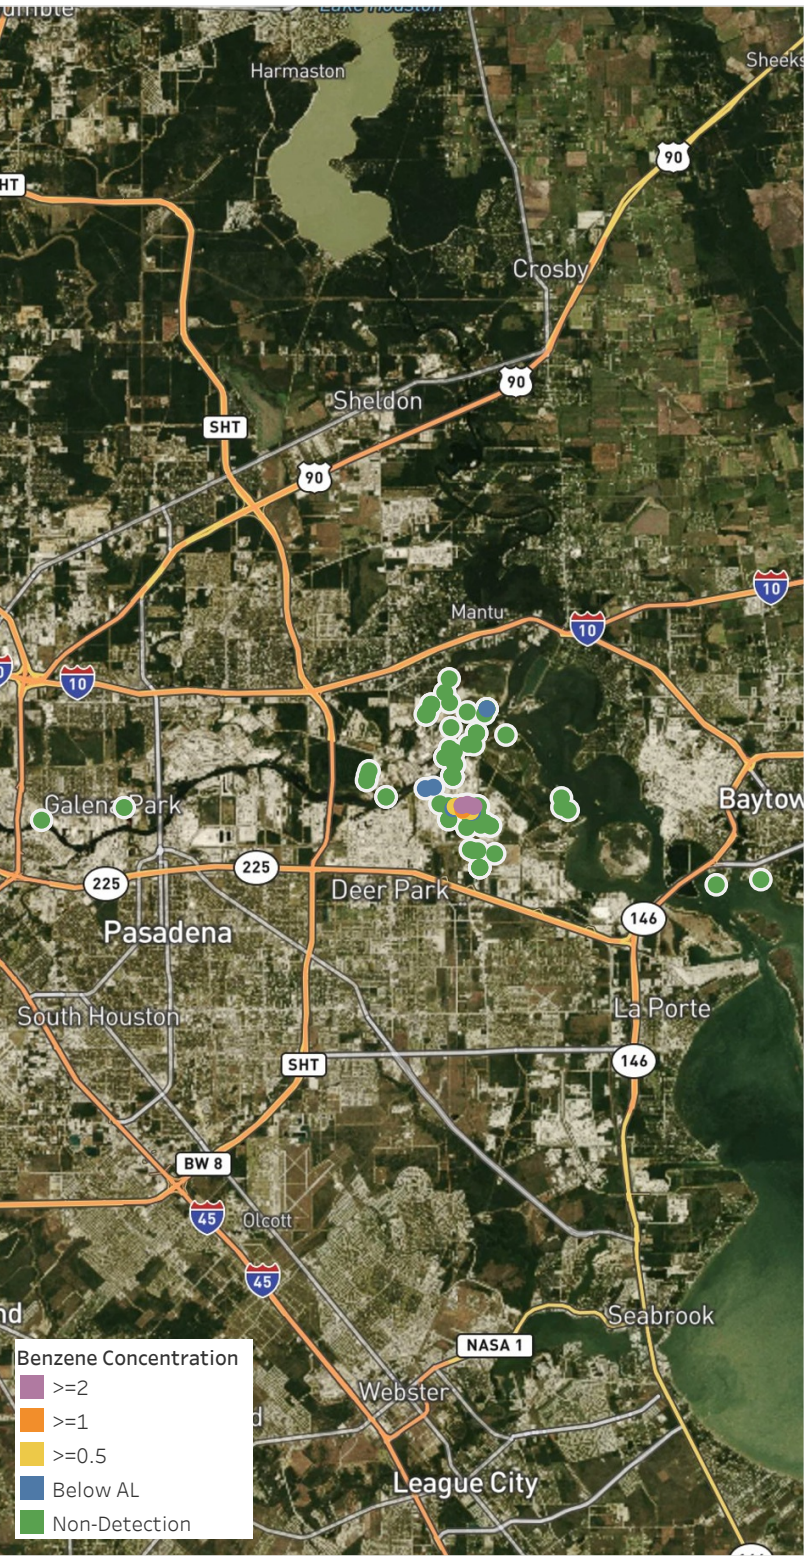
Reading Date
3/27/2019 9:00:00 AM to 3/27/2019 10:00:00 AM

Recent Benzene Detections

Location Category	Reading Date	Concentration
Division B	3/27/2019 09:59:43	0.13 ppm
	3/27/2019 09:27:09	0.09 ppm
Division C	3/27/2019 09:22:39	0.18 ppm
Division E	3/27/2019 09:58:50	2.04 ppm
	3/27/2019 09:55:44	2.60 ppm
	3/27/2019 09:50:55	12.25 ppm
	3/27/2019 09:47:04	4.73 ppm
	3/27/2019 09:46:55	0.57 ppm
	3/27/2019 09:41:30	0.26 ppm
	3/27/2019 09:41:08	0.04 ppm
	3/27/2019 09:39:39	0.15 ppm
	3/27/2019 09:33:17	0.02 ppm
	3/27/2019 09:32:37	0.82 ppm
	3/27/2019 09:25:33	1.16 ppm
	3/27/2019 09:18:31	0.94 ppm
	3/27/2019 09:15:28	0.68 ppm
	3/27/2019 09:13:46	0.24 ppm
	3/27/2019 09:12:21	0.13 ppm
	3/27/2019 09:09:50	0.77 ppm
	3/27/2019 09:06:07	1.03 ppm
Impacted Tank Farm	3/27/2019 09:29:36	0.60 ppm
	3/27/2019 09:19:07	0.20 ppm
Industrial Area	3/27/2019 09:52:59	0.30 ppm
	3/27/2019 09:46:38	0.65 ppm
	3/27/2019 09:39:52	ppm
	3/27/2019 09:24:55	0.84 ppm
	3/27/2019 09:19:32	0.11 ppm

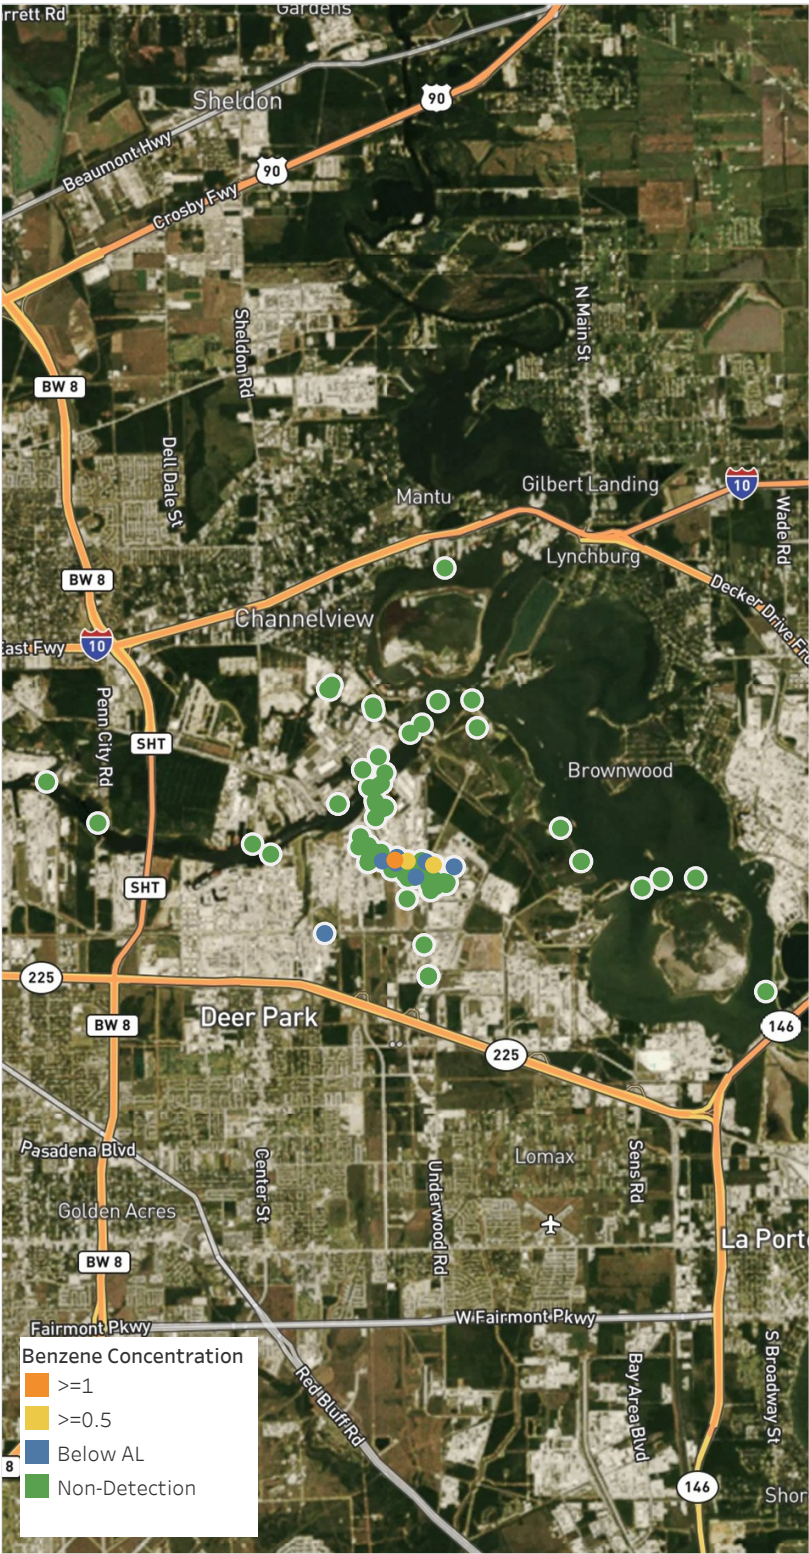
Reading Date
3/27/2019 10:00:00 AM to 3/27/2019 11:00:00 AM

Recent Benzene Detections

Location Category	Reading Date	Concentration
Division E	3/27/2019 10:54:13	0.030 ppm
	3/27/2019 10:51:57	0.200 ppm
	3/27/2019 10:37:32	0.570 ppm
	3/27/2019 10:29:09	1.250 ppm
	3/27/2019 10:26:22	0.200 ppm
	3/27/2019 10:24:24	0.110 ppm
	3/27/2019 10:15:47	0.410 ppm
	3/27/2019 10:10:59	0.760 ppm
	3/27/2019 10:01:00	0.175 ppm
	3/27/2019 10:23:03	0.160 ppm
Industrial Area	3/27/2019 10:23:03	0.160 ppm

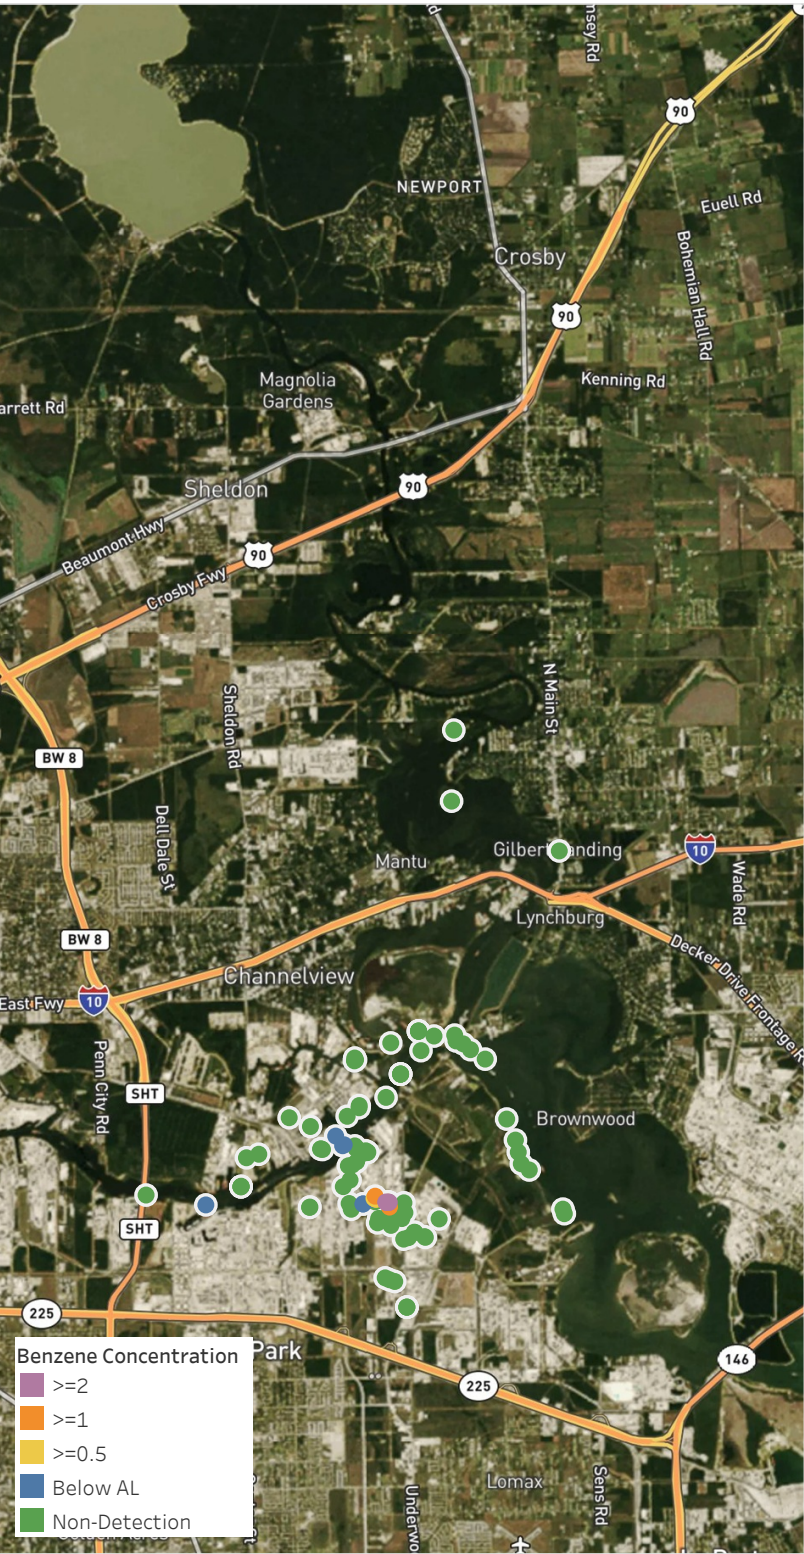
Reading Date
3/27/2019 11:00:00 AM to 3/27/2019 12:00:00 PM
and Null values

Recent Benzene Detections

Location Category	Reading Date	Concentration
Division B	3/27/2019 11:58:37	0.120 ppm
	3/27/2019 11:53:24	0.030 ppm
	3/27/2019 11:31:22	0.380 ppm
Division E	3/27/2019 11:59:16	6.740 ppm
	3/27/2019 11:58:28	5.230 ppm
	3/27/2019 11:47:50	6.560 ppm
	3/27/2019 11:43:10	8.880 ppm
	3/27/2019 11:39:17	0.330 ppm
	3/27/2019 11:34:38	0.700 ppm
	3/27/2019 11:30:45	0.360 ppm
	3/27/2019 11:22:20	4.440 ppm
	3/27/2019 11:21:41	3.760 ppm
	3/27/2019 11:18:20	0.710 ppm
	3/27/2019 11:17:20	2.630 ppm
	3/27/2019 11:10:34	5.500 ppm
	3/27/2019 11:08:43	1.070 ppm
	3/27/2019 11:05:32	3.170 ppm
	3/27/2019 11:04:45	0.820 ppm
Impacted Tank Farm	3/27/2019 11:36:56	1.650 ppm
Industrial Area	3/27/2019 11:37:37	0.125 ppm
	3/27/2019 11:27:02	0.225 ppm
Over Water (No Division)	3/27/2019 11:29:14	0.075 ppm

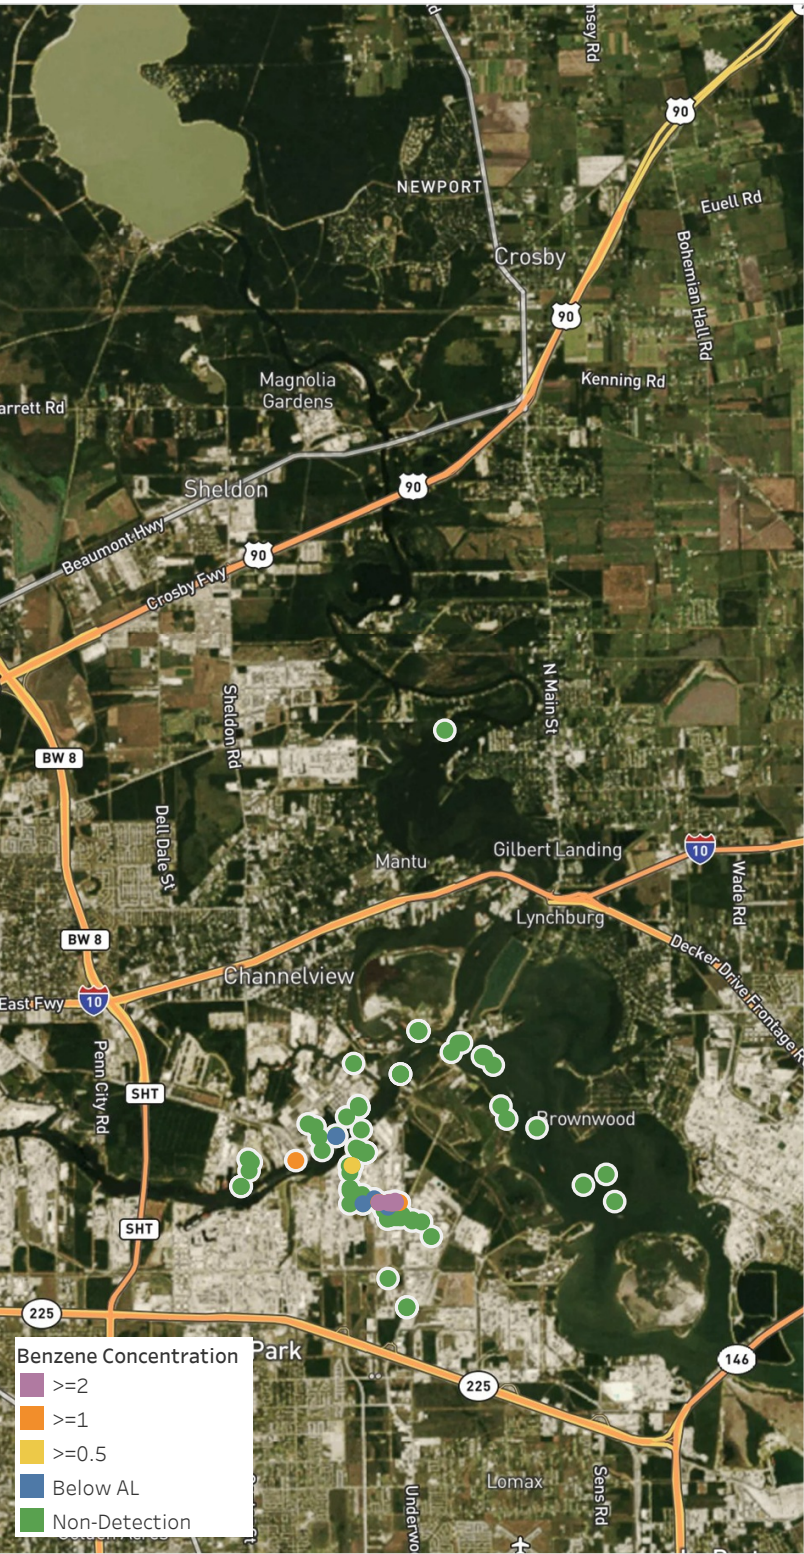
Reading Date
3/27/2019 12:00:00 PM to 3/27/2019 1:00:00 PM
and Null values

Recent Benzene Detections

Location Category	Reading Date	Concentration
Division A	3/27/2019 12:37:59	1.30 ppm
Division B	3/27/2019 12:35:58	0.03 ppm
Division C	3/27/2019 12:50:21	0.11 ppm
Division E	3/27/2019 12:59:49	4.47 ppm
	3/27/2019 12:45:56	15.05 ppm
	3/27/2019 12:42:03	8.95 ppm
	3/27/2019 12:36:18	2.71 ppm
	3/27/2019 12:34:41	0.29 ppm
	3/27/2019 12:32:27	1.75 ppm
	3/27/2019 12:29:21	0.05 ppm
	3/27/2019 12:29:13	1.28 ppm
	3/27/2019 12:23:49	1.10 ppm
	3/27/2019 12:21:08	4.20 ppm
Impacted Tank Farm	3/27/2019 12:16:56	6.83 ppm
	3/27/2019 12:14:28	1.85 ppm
	3/27/2019 12:11:25	1.98 ppm
Industrial Area	3/27/2019 12:10:38	0.30 ppm
Industrial Area	3/27/2019 12:45:25	0.23 ppm
	3/27/2019 12:27:34	0.56 ppm

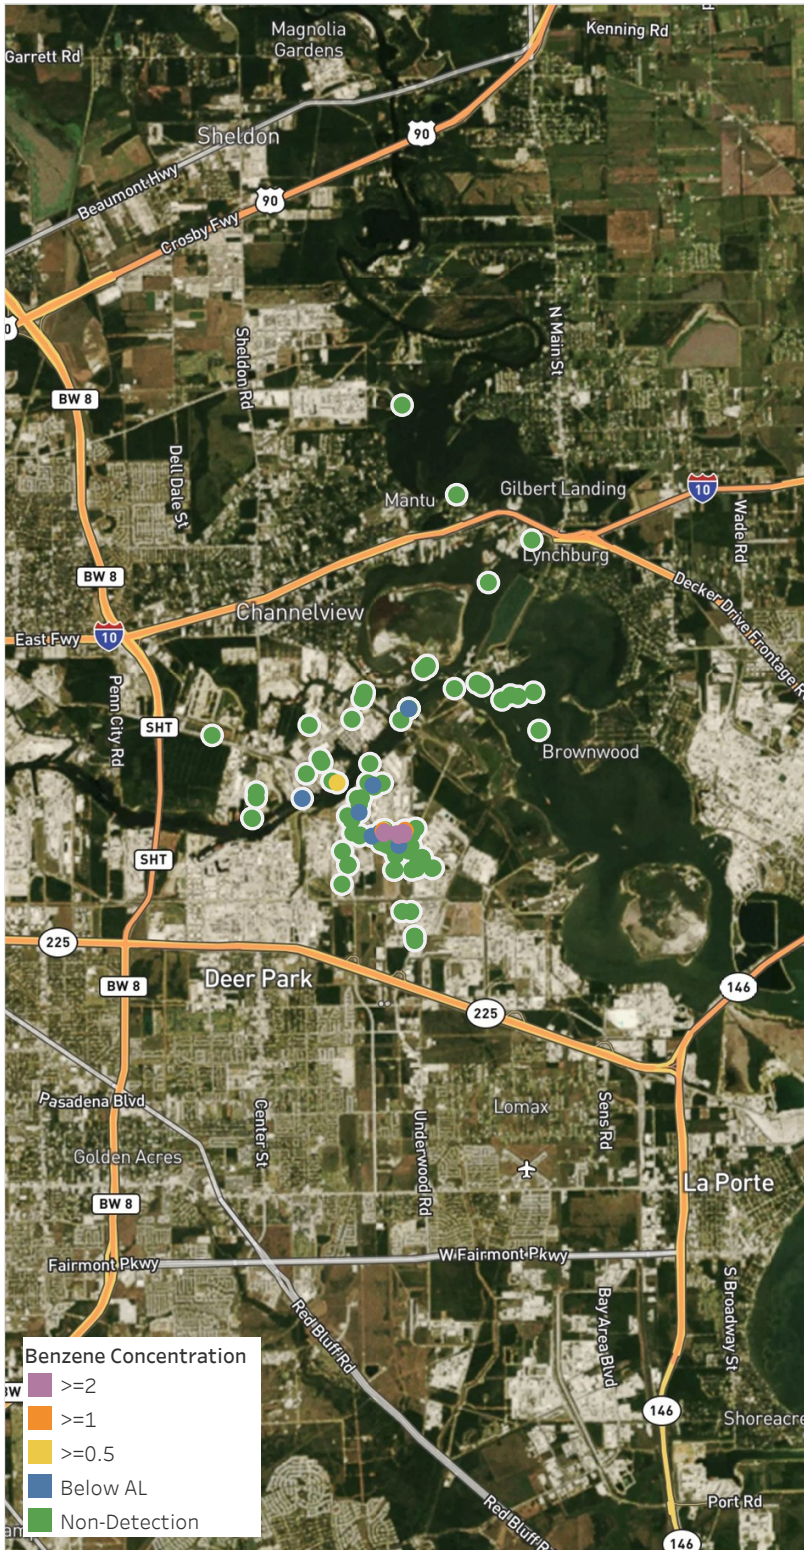
3/27/2019 1:00:00 PM to 3/27/2019 2:00:00 PM
and Null values

Recent Benzene Detections

Location Category	Reading Date	Concentration
Division A	3/27/2019 13:08:22	0.850 ppm
Division B	3/27/2019 13:20:16	0.000 ppm
Division E	3/27/2019 13:57:45	4.900 ppm
	3/27/2019 13:55:45	0.010 ppm
	3/27/2019 13:55:35	7.540 ppm
	3/27/2019 13:53:27	0.760 ppm
	3/27/2019 13:50:17	1.000 ppm
	3/27/2019 13:40:51	3.220 ppm
	3/27/2019 13:39:52	6.700 ppm
	3/27/2019 13:36:29	3.360 ppm
	3/27/2019 13:36:11	4.175 ppm
	3/27/2019 13:21:06	0.140 ppm
	3/27/2019 13:19:53	0.150 ppm
	3/27/2019 13:08:32	1.250 ppm
	3/27/2019 13:05:05	4.825 ppm
	3/27/2019 13:03:54	0.600 ppm
Industrial Area	3/27/2019 13:40:04	0.130 ppm
	3/27/2019 13:28:44	0.180 ppm
	3/27/2019 13:26:29	0.040 ppm
Over Water (No Division)	3/27/2019 13:27:37	0.150 ppm

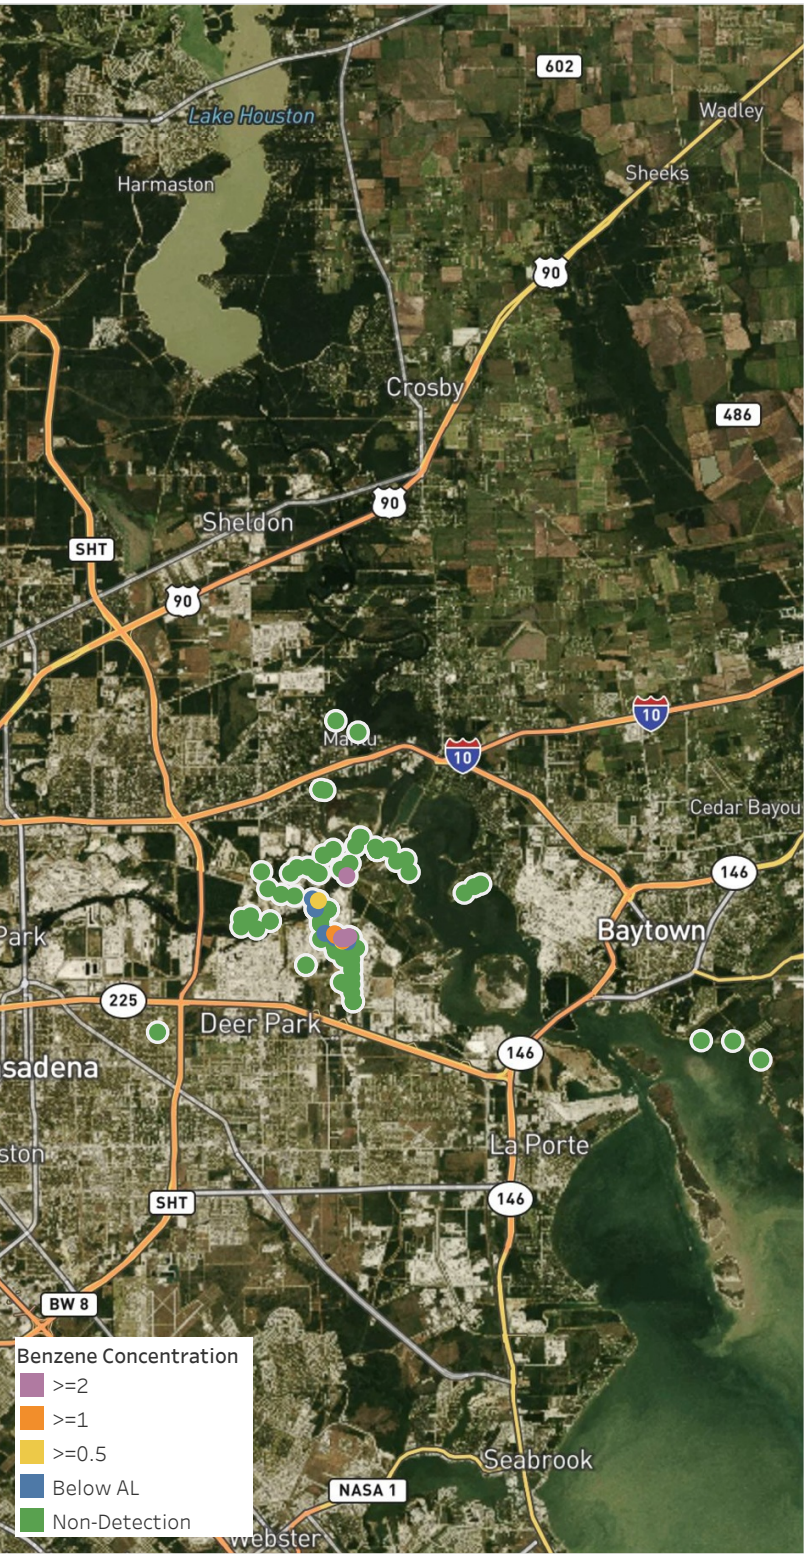
Reading Date
3/27/2019 2:00:00 PM to 3/27/2019 3:00:00 PM
and Null values

Recent Benzene Detections

Location Category	Reading Date	Concentration
Division A	3/27/2019 14:17:30	0.28 ppm
	3/27/2019 14:16:32	0.35 ppm
Division B	3/27/2019 14:59:40	0.80 ppm
	3/27/2019 14:58:46	0.13 ppm
	3/27/2019 14:38:53	0.15 ppm
	3/27/2019 14:14:19	2.40 ppm
Division E	3/27/2019 14:57:01	7.10 ppm
	3/27/2019 14:55:40	0.05 ppm
	3/27/2019 14:46:53	0.20 ppm
	3/27/2019 14:39:15	4.45 ppm
	3/27/2019 14:39:02	0.19 ppm
	3/27/2019 14:35:13	18.15 ppm
	3/27/2019 14:31:53	16.25 ppm
	3/27/2019 14:26:40	6.89 ppm
	3/27/2019 14:23:11	12.20 ppm
	3/27/2019 14:22:21	19.80 ppm
	3/27/2019 14:09:32	1.71 ppm
	3/27/2019 14:08:23	3.75 ppm
	3/27/2019 14:05:57	1.29 ppm
	3/27/2019 14:03:18	0.25 ppm
Impacted Tank Farm	3/27/2019 14:00:35	1.81 ppm
	3/27/2019 14:31:04	0.66 ppm
	3/27/2019 14:00:46	1.62 ppm
Industrial Area	3/27/2019 14:28:14	0.30 ppm
