Preliminary Hand- Held Air Monitoring Locations | ITC Deer Park Tank Fire

Reading Date
3/26/2019 11:00:00 PM to 3/27/2019 12:00:00 AM

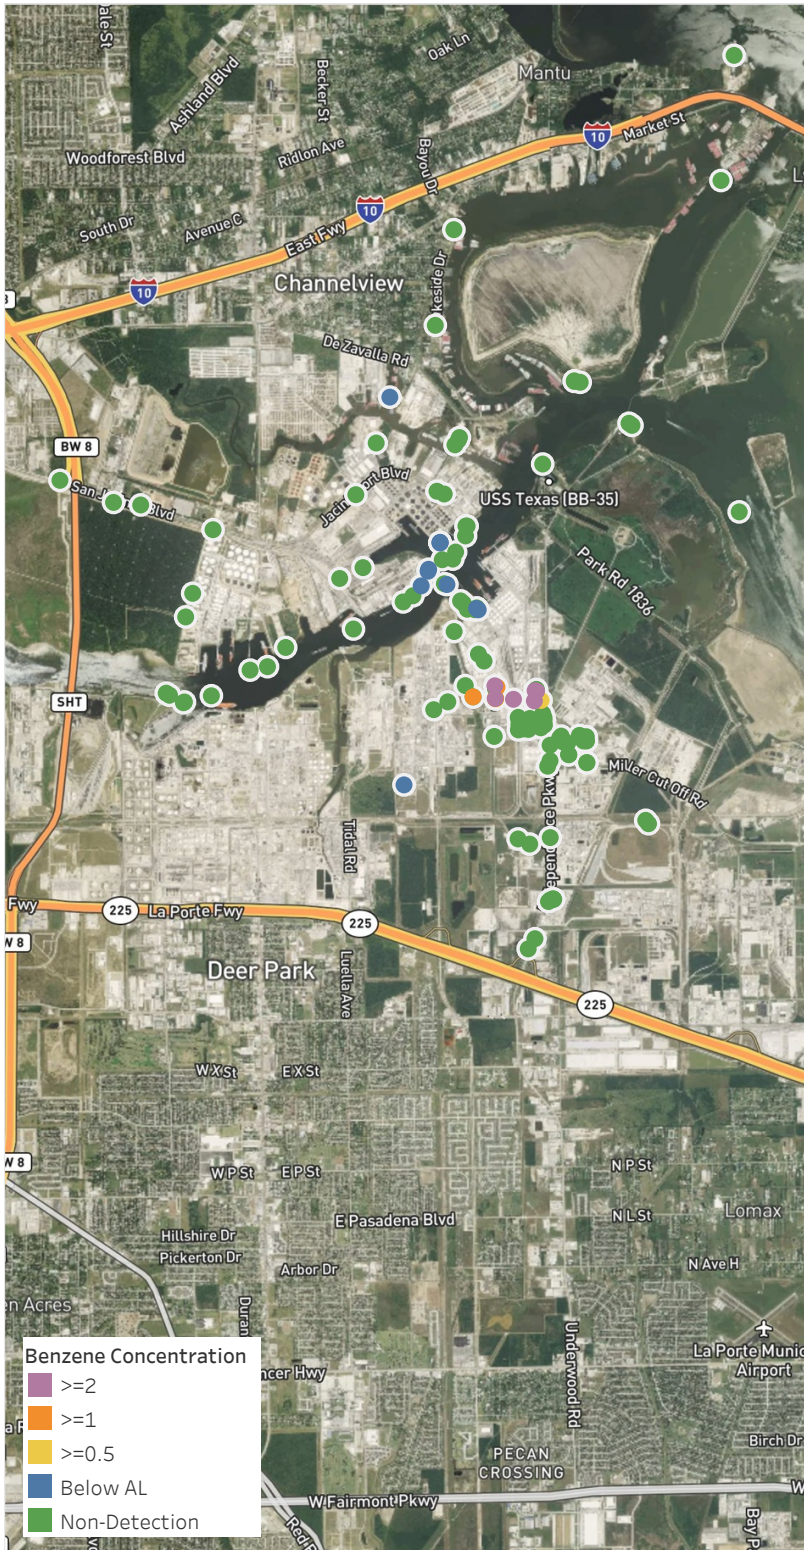
3/27/2019 3:00:00 PM to 3/27/2019 4:00:00 PM

Recent Benzene Detections

Location Category	Reading Date	Concentration
Division A	3/27/2019 15:33:45	0.25 ppm
	3/27/2019 15:37:11	0.10 ppm
	3/27/2019 15:36:32	0.36 ppm
Division B	3/27/2019 15:16:11	0.24 ppm
	3/27/2019 15:00:34	0.23 ppm
	3/27/2019 15:51:39	2.95 ppm
Division C	3/27/2019 15:49:39	22.95 ppm
	3/27/2019 15:45:35	0.02 ppm
	3/27/2019 15:38:46	1.77 ppm
	3/27/2019 15:37:08	0.60 ppm
	3/27/2019 15:36:49	0.01 ppm
	3/27/2019 15:33:28	0.45 ppm
	3/27/2019 15:31:17	0.95 ppm
	3/27/2019 15:30:30	12.75 ppm
	3/27/2019 15:25:37	0.96 ppm
	3/27/2019 15:25:00	22.45 ppm
	3/27/2019 15:21:17	1.20 ppm
	3/27/2019 15:12:31	0.90 ppm
Division E	3/27/2019 15:04:48	9.35 ppm
	3/27/2019 15:31:06	1.77 ppm
Industrial Area	3/27/2019 15:36:20	0.05 ppm
	3/27/2019 15:25:05	0.02 ppm
	3/27/2019 15:15:41	0.02 ppm

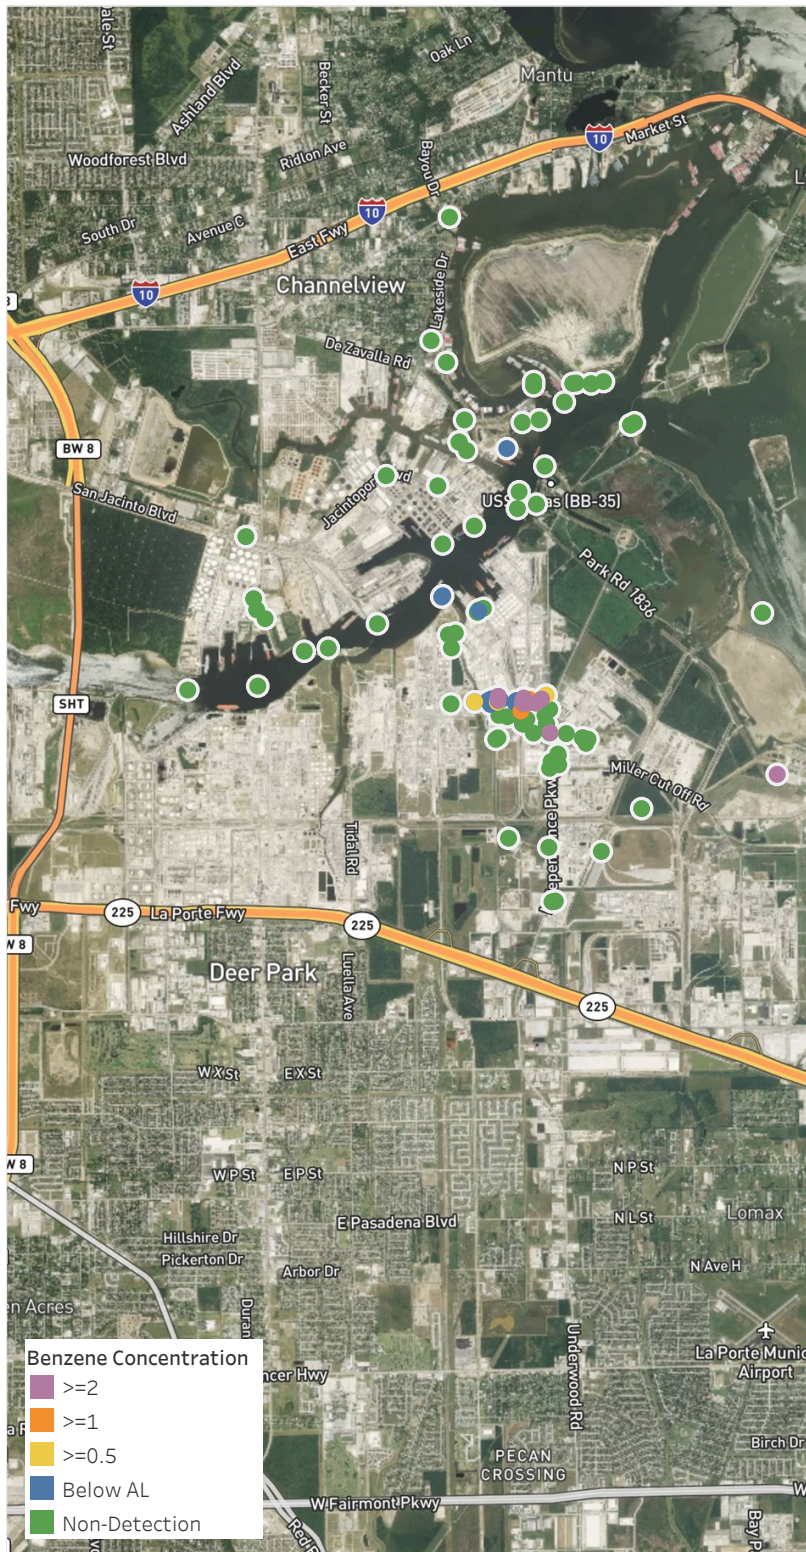
3/27/2019 4:00:00 PM to 3/27/2019 5:00:00 PM

Recent Benzene Detections

Location Category	Reading Date	Concentration
Division B	3/27/2019 16:38:12	0.28 ppm
	3/27/2019 16:32:47	0.14 ppm
	3/27/2019 16:09:15	0.28 ppm
Division E	3/27/2019 16:59:53	0.07 ppm
	3/27/2019 16:59:21	42.50 ppm
	3/27/2019 16:53:44	0.11 ppm
	3/27/2019 16:49:17	0.19 ppm
	3/27/2019 16:47:23	4.00 ppm
	3/27/2019 16:44:53	0.61 ppm
	3/27/2019 16:43:31	1.27 ppm
	3/27/2019 16:42:46	0.09 ppm
	3/27/2019 16:40:04	0.04 ppm
	3/27/2019 16:37:26	31.45 ppm
	3/27/2019 16:35:32	16.95 ppm
	3/27/2019 16:34:54	0.15 ppm
	3/27/2019 16:31:04	28.95 ppm
	3/27/2019 16:29:08	15.40 ppm
	3/27/2019 16:28:39	5.42 ppm
	3/27/2019 16:28:26	16.00 ppm
	3/27/2019 16:27:58	17.85 ppm
	3/27/2019 16:23:37	0.04 ppm
	3/27/2019 16:22:18	0.13 ppm
	3/27/2019 16:20:56	0.70 ppm
	3/27/2019 16:18:23	7.65 ppm
	3/27/2019 16:18:05	0.24 ppm
	3/27/2019 16:15:38	0.10 ppm
	3/27/2019 16:15:23	0.79 ppm
	3/27/2019 16:11:32	0.16 ppm
	3/27/2019 16:10:52	0.33 ppm
	3/27/2019 16:08:31	15.60 ppm

3/27/2019 16:04:19	13.60 ppm
Impacted Tank Farm	3/27/2019 16:27:09	1.45 ppm
Industrial Area	3/27/2019 16:56:09	0.63 ppm
	3/27/2019 16:55:09	0.10 ppm

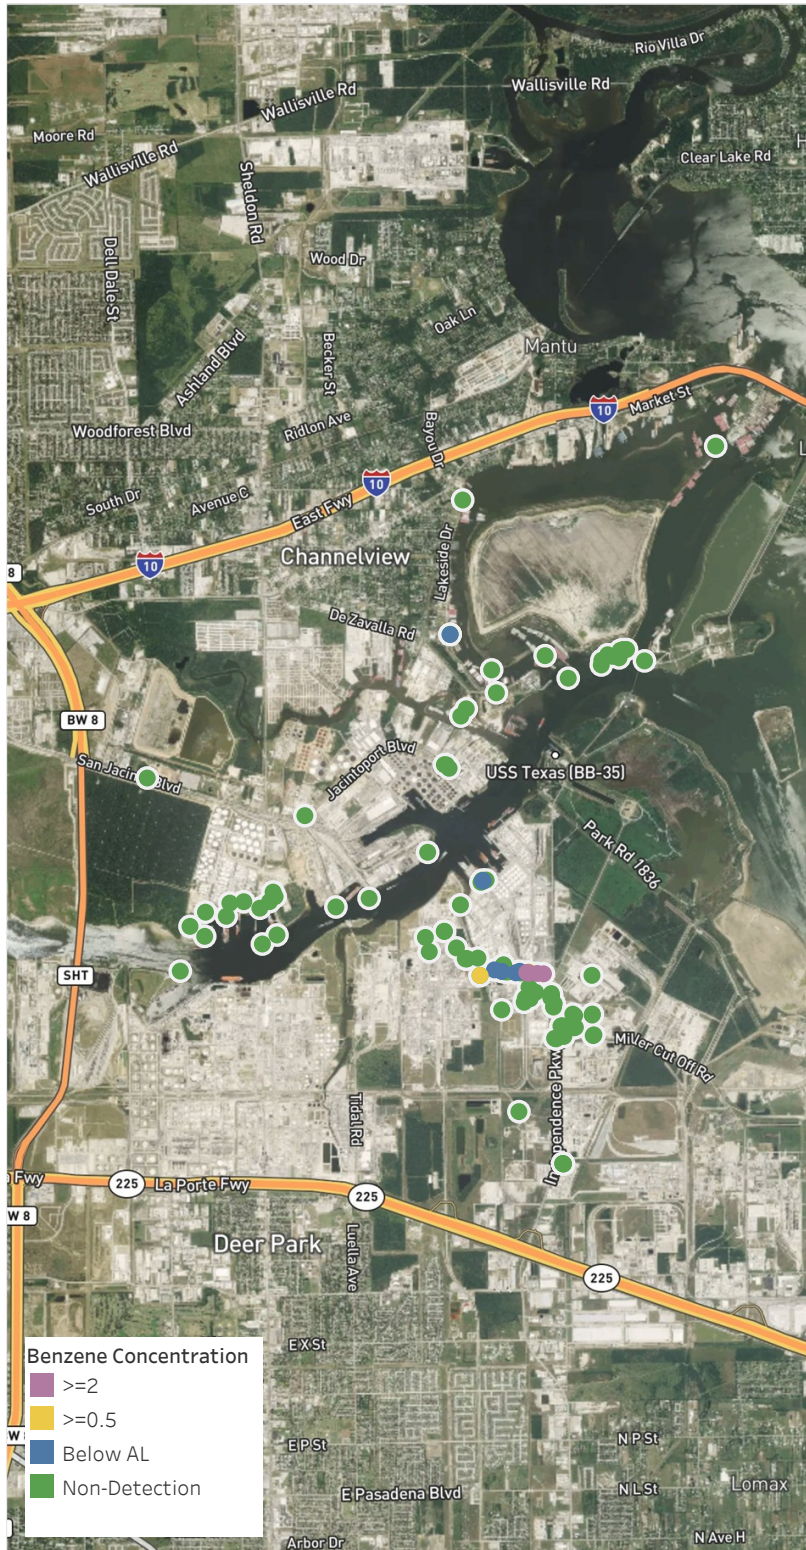
3/27/2019 5:00:00 PM to 3/27/2019 6:00:00 PM

Recent Benzene Detections

Location Category	Reading Date	Concentration
Division C	3/27/2019 17:15:48	0.13 ppm
	3/27/2019 17:58:53	2.51 ppm
	3/27/2019 17:56:11	0.56 ppm
	3/27/2019 17:51:29	0.04 ppm
	3/27/2019 17:45:57	2.02 ppm
	3/27/2019 17:40:09	0.06 ppm
	3/27/2019 17:35:56	0.14 ppm
	3/27/2019 17:31:46	0.20 ppm
	3/27/2019 17:31:07	4.05 ppm
	3/27/2019 17:30:52	0.33 ppm
	3/27/2019 17:29:55	15.15 ppm
	3/27/2019 17:29:26	0.11 ppm
	3/27/2019 17:24:00	20.65 ppm
	3/27/2019 17:15:01	0.48 ppm
	3/27/2019 17:13:20	2.28 ppm
	3/27/2019 17:12:00	3.27 ppm
	3/27/2019 17:06:38	0.01 ppm
Industrial Area	3/27/2019 17:32:32	0.53 ppm

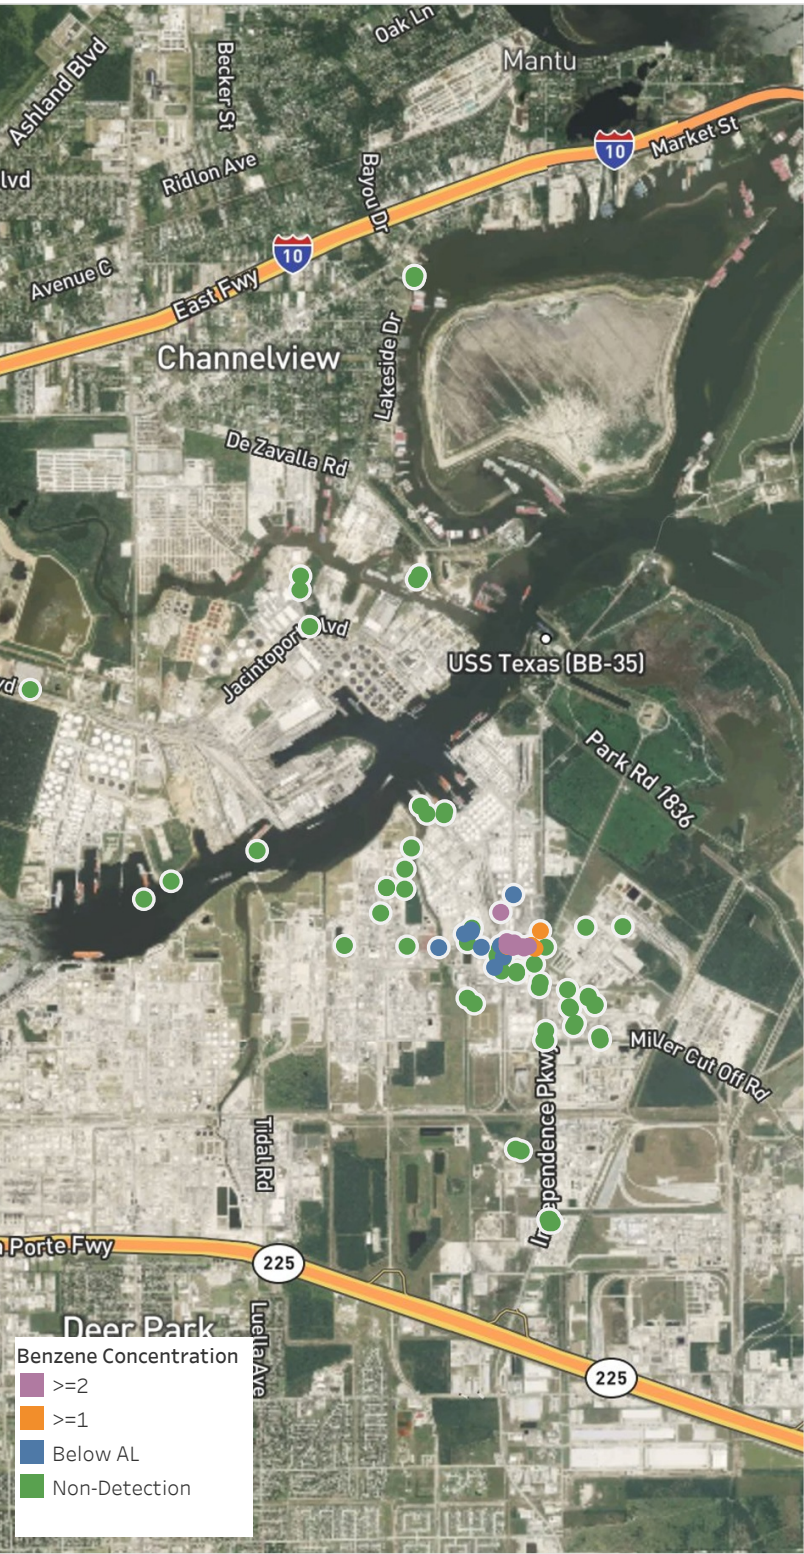
Reading Date
3/27/2019 6:00:00 PM to 3/27/2019 7:00:00 PM

Recent Benzene Detections

Location Category	Reading Date	Concentration
Division E	3/27/2019 18:59:13	5.88 ppm
	3/27/2019 18:56:04	8.62 ppm
	3/27/2019 18:54:28	20.35 ppm
	3/27/2019 18:51:01	1.58 ppm
	3/27/2019 18:48:44	5.76 ppm
	3/27/2019 18:42:28	0.03 ppm
	3/27/2019 18:41:23	3.04 ppm
	3/27/2019 18:38:12	0.43 ppm
	3/27/2019 18:37:55	0.03 ppm
	3/27/2019 18:29:00	1.35 ppm
	3/27/2019 18:25:01	1.08 ppm
	3/27/2019 18:23:30	10.35 ppm
	3/27/2019 18:23:09	0.03 ppm
	3/27/2019 18:18:47	7.83 ppm
	3/27/2019 18:15:55	7.83 ppm
	3/27/2019 18:13:07	1.38 ppm
	3/27/2019 18:11:40	0.08 ppm
	3/27/2019 18:11:16	1.89 ppm
	3/27/2019 18:09:07	0.20 ppm
	3/27/2019 18:06:07	0.05 ppm
	3/27/2019 18:01:54	6.19 ppm
	3/27/2019 18:00:19	0.03 ppm
Industrial Area	3/27/2019 18:47:37	0.35 ppm

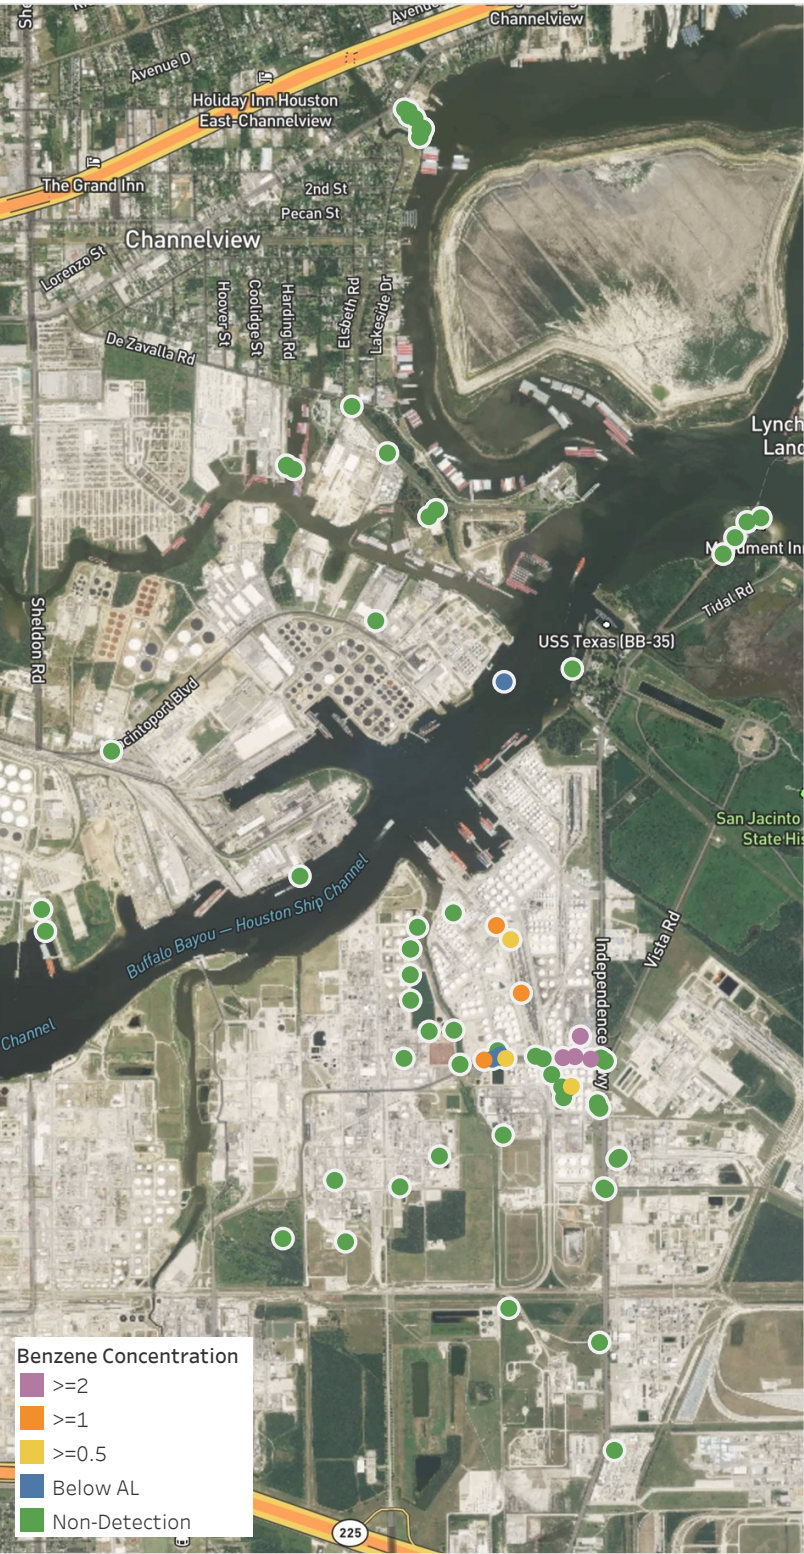
Reading Date
3/27/2019 7:00:00 PM to 3/27/2019 8:00:00 PM

Recent Benzene Detections

Location Category	Reading Date	Concentration
Division B	3/27/2019 19:33:25	0.33 ppm
Division E	3/27/2019 19:43:29	2.90 ppm
	3/27/2019 19:39:57	11.95 ppm
	3/27/2019 19:37:26	4.43 ppm
	3/27/2019 19:28:01	1.12 ppm
	3/27/2019 19:25:04	0.60 ppm
	3/27/2019 19:22:19	0.91 ppm
	3/27/2019 19:21:22	0.05 ppm
	3/27/2019 19:19:10	1.10 ppm
	3/27/2019 19:14:55	1.49 ppm
	3/27/2019 19:12:50	0.43 ppm
	3/27/2019 19:12:15	16.70 ppm
	3/27/2019 19:07:48	0.24 ppm
Impacted Tank Farm	3/27/2019 19:50:05	0.73 ppm

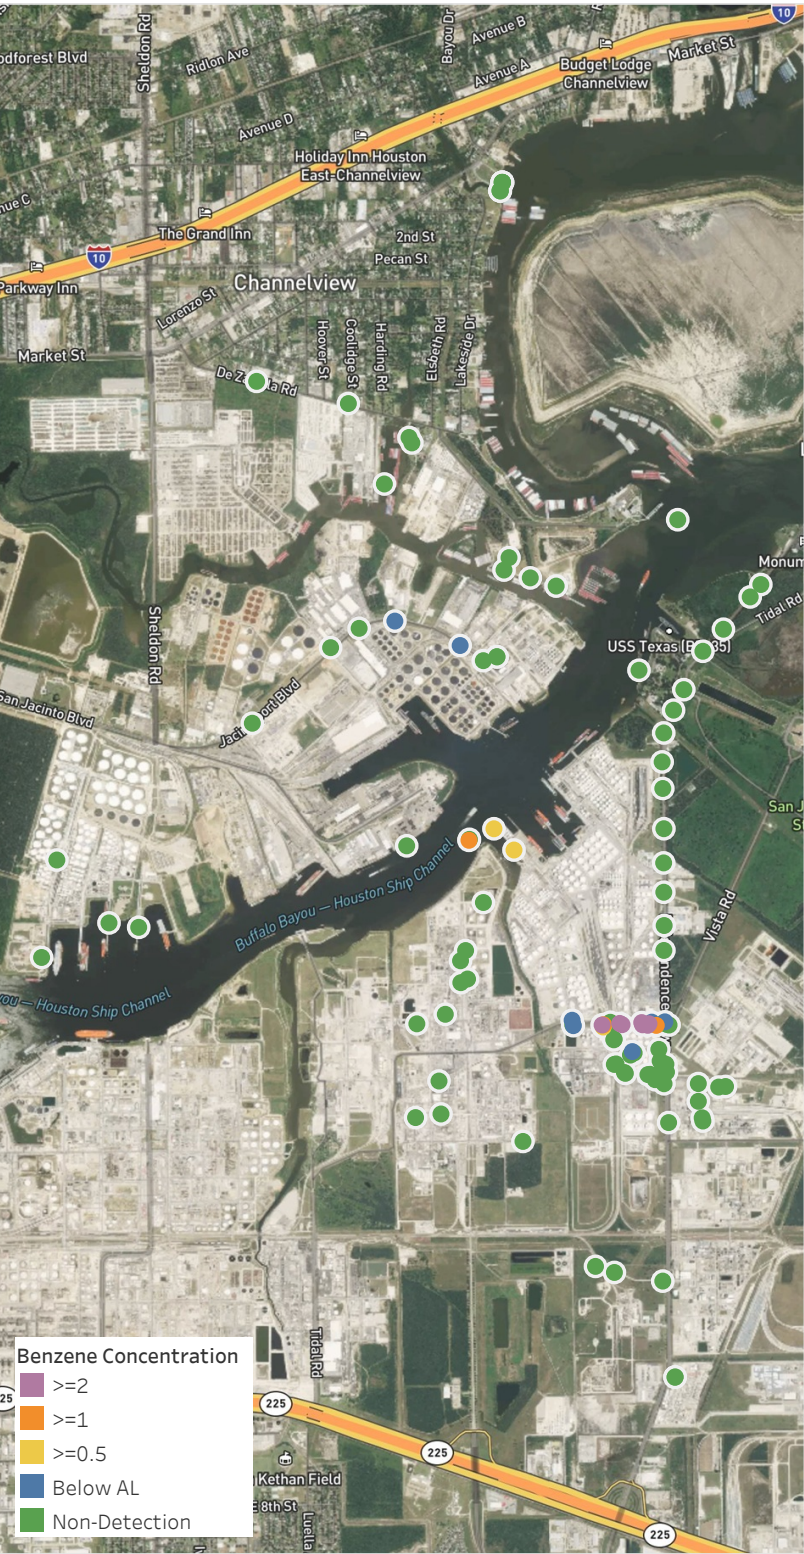
Reading Date
3/27/2019 8:00:00 PM to 3/27/2019 9:00:00 PM

Recent Benzene Detections

Location Category	Reading Date	Concentration
Division B	3/27/2019 20:32:05	0.53 ppm
	3/27/2019 20:28:43	0.57 ppm
	3/27/2019 20:21:20	1.00 ppm
Division E	3/27/2019 20:59:46	0.67 ppm
	3/27/2019 20:51:53	9.82 ppm
	3/27/2019 20:47:18	0.15 ppm
	3/27/2019 20:46:24	1.53 ppm
	3/27/2019 20:41:37	3.58 ppm
	3/27/2019 20:38:13	3.53 ppm
	3/27/2019 20:34:18	19.40 ppm
	3/27/2019 20:32:01	8.20 ppm
	3/27/2019 20:30:15	2.78 ppm
	3/27/2019 20:29:10	0.30 ppm
	3/27/2019 20:27:59	4.25 ppm
	3/27/2019 20:25:08	1.30 ppm
	3/27/2019 20:24:39	0.23 ppm
	3/27/2019 20:24:31	0.09 ppm
Impacted Tank Farm	3/27/2019 20:00:35	0.19 ppm
Industrial Area	3/27/2019 20:50:08	0.45 ppm
	3/27/2019 20:12:13	0.20 ppm

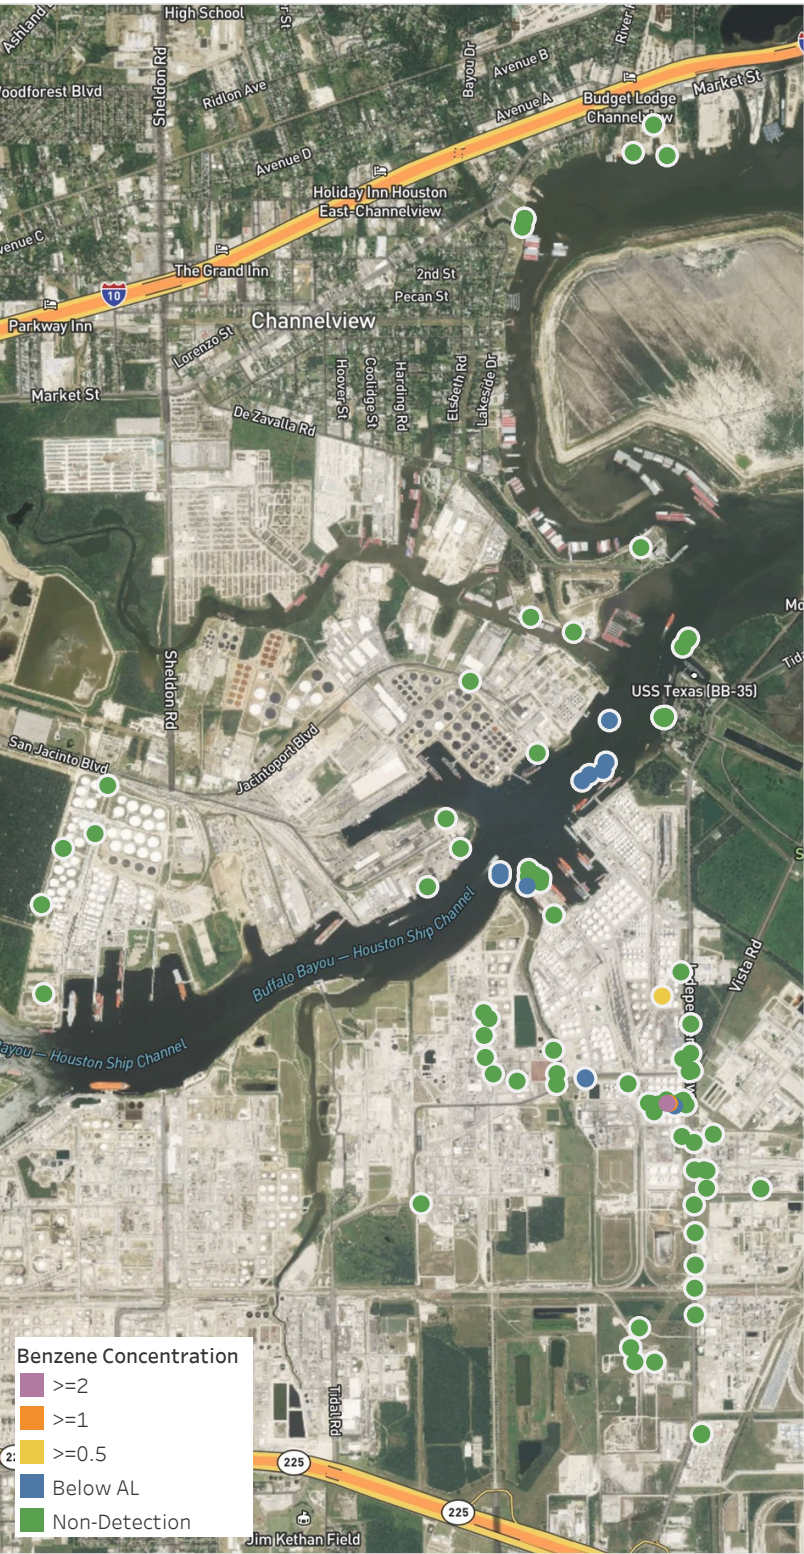
Reading Date
3/27/2019 9:00:00 PM to 3/27/2019 10:00:00 PM

Recent Benzene Detections

Location Category	Reading Date	Concentration
Division B	3/27/2019 21:58:29	0.125 ppm
	3/27/2019 21:39:25	0.110 ppm
	3/27/2019 21:34:06	0.150 ppm
	3/27/2019 21:27:01	0.225 ppm
	3/27/2019 21:18:07	0.175 ppm
	3/27/2019 21:13:12	0.250 ppm
	3/27/2019 21:06:24	0.090 ppm
Division E	3/27/2019 21:53:32	0.100 ppm
	3/27/2019 21:48:57	0.400 ppm
	3/27/2019 21:43:58	0.300 ppm
Impacted Tank Farm	3/27/2019 21:59:53	1.900 ppm
	3/27/2019 21:54:56	0.200 ppm
	3/27/2019 21:51:51	8.590 ppm

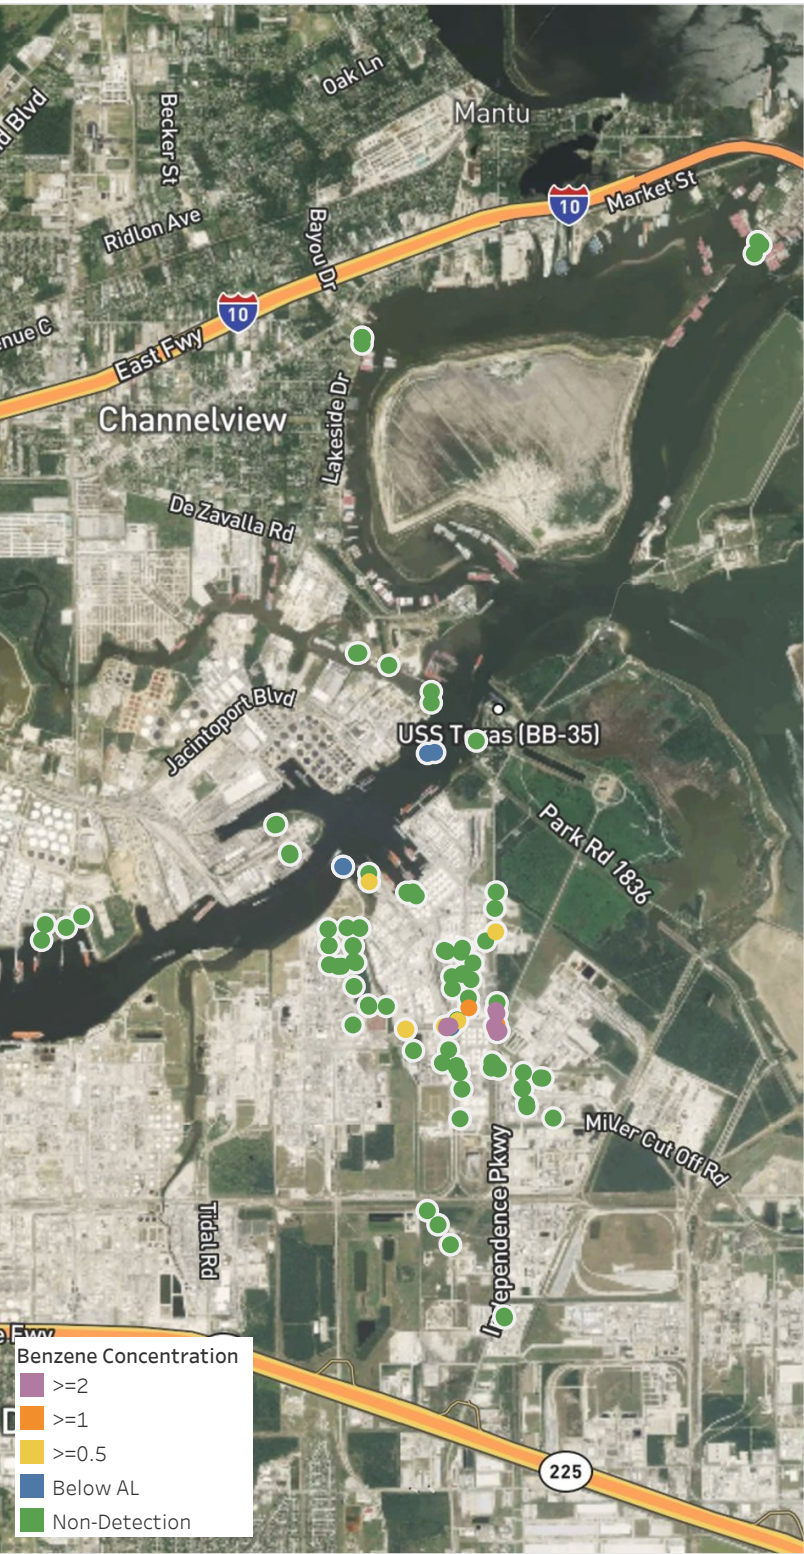
Reading Date
3/27/2019 10:00:00 PM to 3/27/2019 11:00:00 PM

Recent Benzene Detections

Location Category	Reading Date	Concentration
Division B	3/27/2019 22:57:00	0.125 ppm
	3/27/2019 22:53:11	0.075 ppm
	3/27/2019 22:49:21	0.260 ppm
	3/27/2019 22:33:09	0.600 ppm
	3/27/2019 22:25:24	0.110 ppm
	3/27/2019 22:07:16	0.100 ppm
Division E	3/27/2019 22:59:36	2.620 ppm
	3/27/2019 22:58:11	4.600 ppm
	3/27/2019 22:55:07	4.500 ppm
	3/27/2019 22:55:06	2.750 ppm
	3/27/2019 22:53:12	7.530 ppm
	3/27/2019 22:52:38	0.270 ppm
	3/27/2019 22:41:34	0.290 ppm
	3/27/2019 22:37:18	0.150 ppm
	3/27/2019 22:36:21	5.480 ppm
	3/27/2019 22:32:15	0.500 ppm
	3/27/2019 22:29:20	0.625 ppm
	3/27/2019 22:29:04	0.540 ppm
	3/27/2019 22:21:39	4.075 ppm
	3/27/2019 22:17:36	0.100 ppm
	3/27/2019 22:15:40	0.530 ppm
	3/27/2019 22:13:52	0.870 ppm
	3/27/2019 22:11:56	1.600 ppm
	3/27/2019 22:07:45	3.250 ppm
Industrial Area	3/27/2019 22:04:21	1.425 ppm
	3/27/2019 22:24:36	1.100 ppm
	3/27/2019 22:13:17	6.770 ppm
