Preliminary Hand- Held Air Monitoring Locations | ITC Deer Park Tank Fire

Reading Date
6/8/2019 11:00:00 PM to 6/9/2019 12:00:00 AM

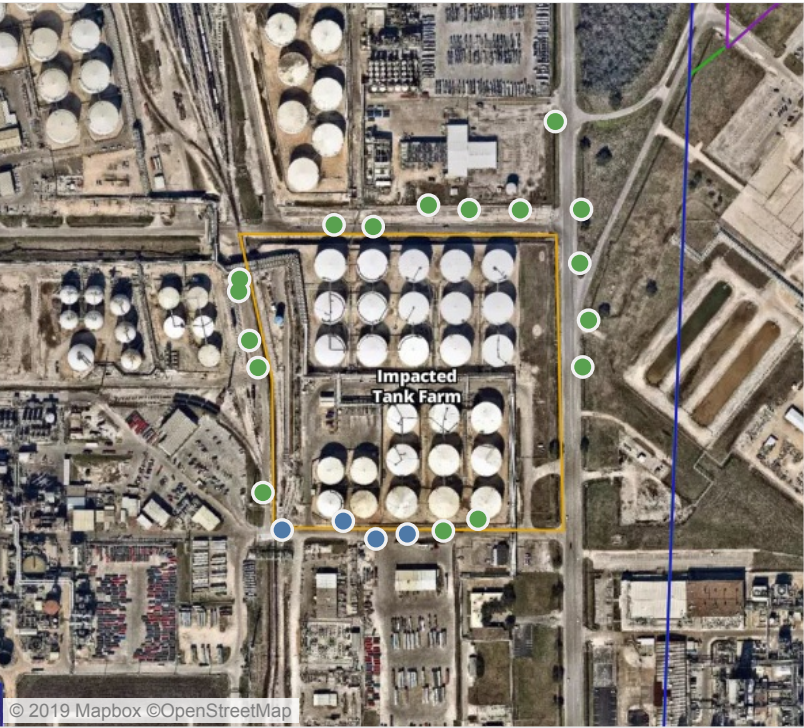
Recent Benzene Detections

Location Category	Reading Date	Range of Detections
Division E	6/8/2019 23:16:16	0.1200 ppm
	6/8/2019 23:18:02	0.1700 ppm
	6/8/2019 23:22:22	0.2000 ppm
	6/8/2019 23:19:51	0.0700 ppm

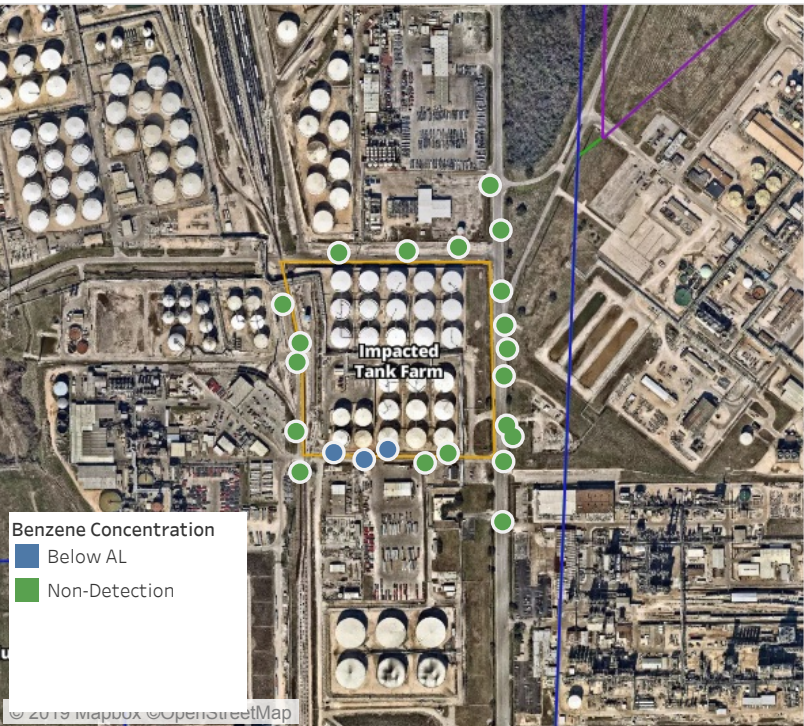
Reading Date
6/9/2019 12:00:00 AM to 6/9/2019 1:00:00 AM

Recent Benzene Detections

Location Category	Reading Date	Range of Detections
Division E	6/9/2019 00:42:22	0.0400 ppm
	6/9/2019 00:43:58	0.1600 ppm
	6/9/2019 00:46:06	0.0800 ppm

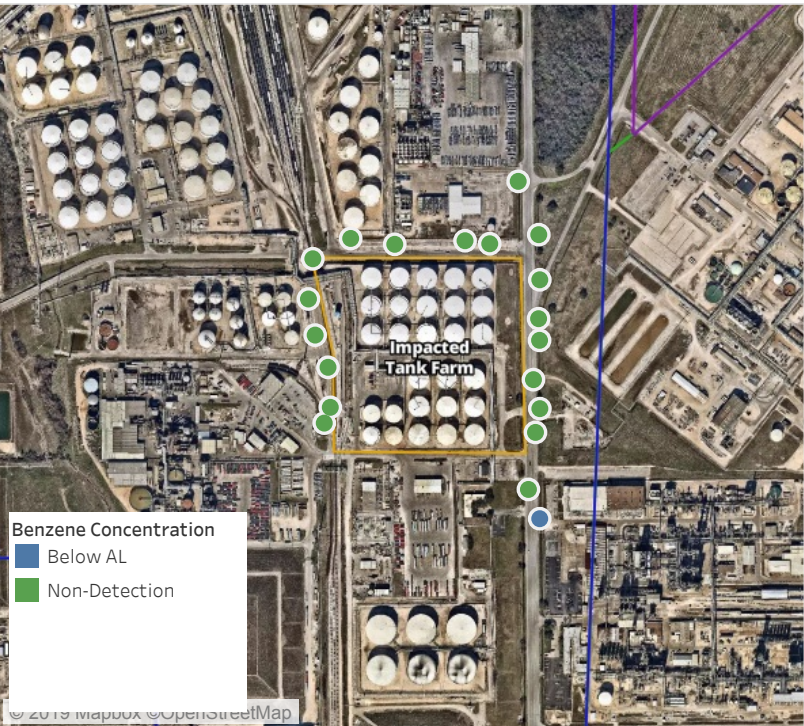
Reading Date
6/9/2019 2:00:00 AM to 6/9/2019 3:00:00 AM

Recent Benzene Detections

Location Category	Reading Date	Range of Detections
Division E	6/9/2019 02:37:10	0.02000 ppm

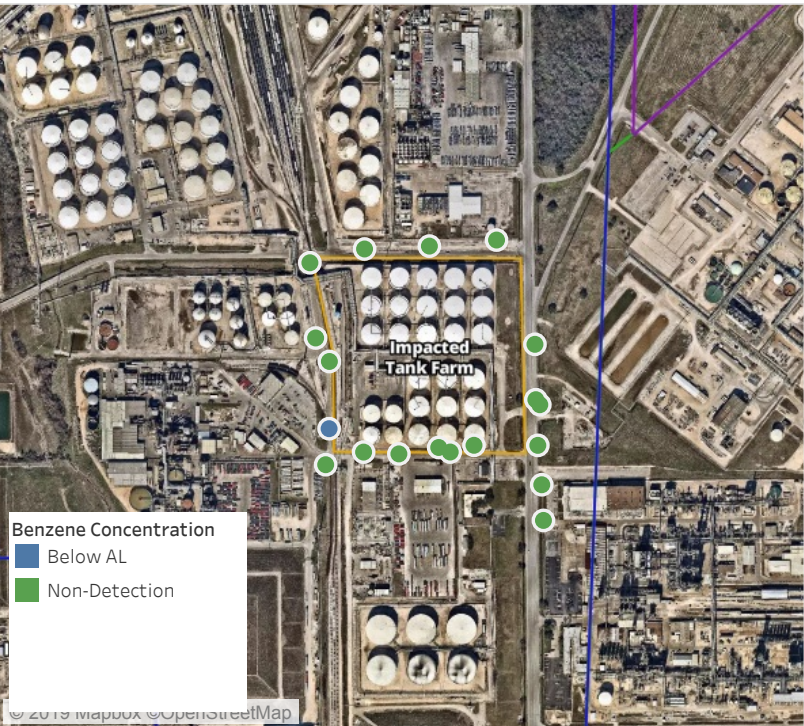
Reading Date
6/9/2019 3:00:00 AM to 6/9/2019 4:00:00 AM

Recent Benzene Detections

Location Category	Reading Date	Range of Detections
Division E	6/9/2019 03:12:36	0.06000 ppm

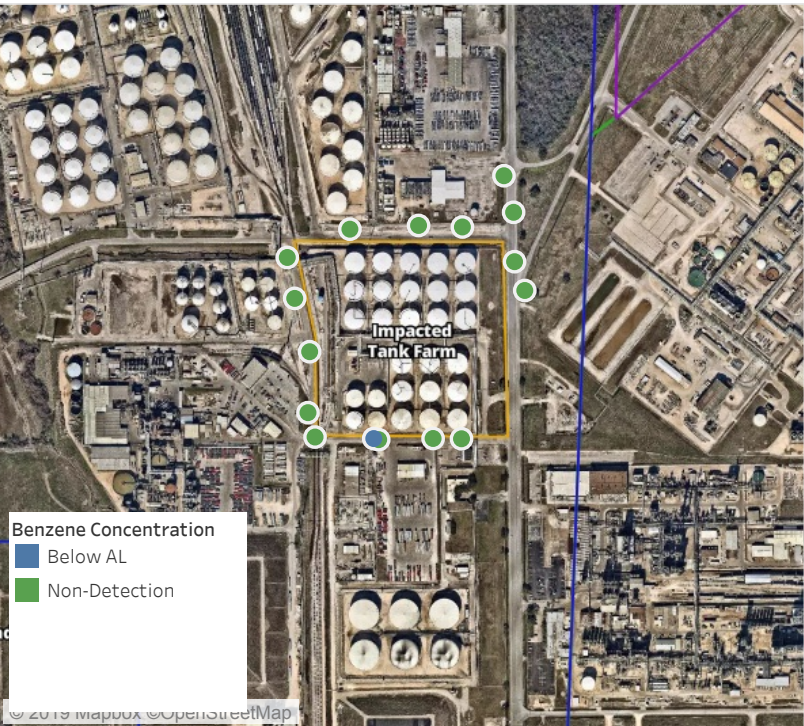
Reading Date
6/9/2019 4:00:00 AM to 6/9/2019 5:00:00 AM

Recent Benzene Detections

Location Category	Reading Date	Range of Detections
Division E	6/9/2019 04:33:12	0.03000 ppm

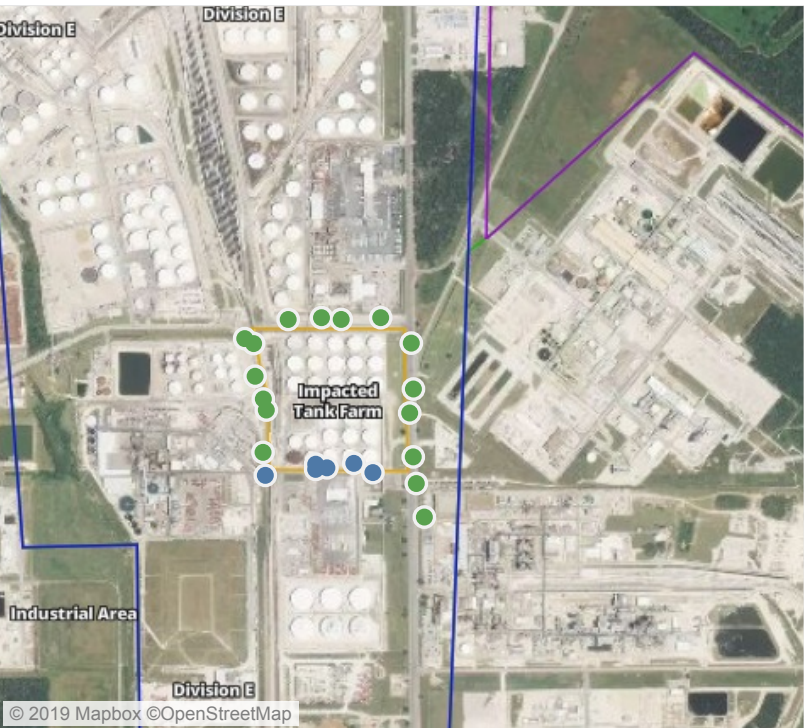
Reading Date
6/9/2019 6:00:00 AM to 6/9/2019 7:00:00 AM

Recent Benzene Detections

Location Category	Reading Date	Range of Detections
Division E	6/9/2019 06:03:13	0.0500 ppm
	6/9/2019 06:05:55	0.0200 ppm
	6/9/2019 06:09:23	0.3200 ppm
	6/9/2019 06:15:31	0.0400 ppm
	6/9/2019 06:18:11	0.0500 ppm
	6/9/2019 06:25:24	0.0200 ppm

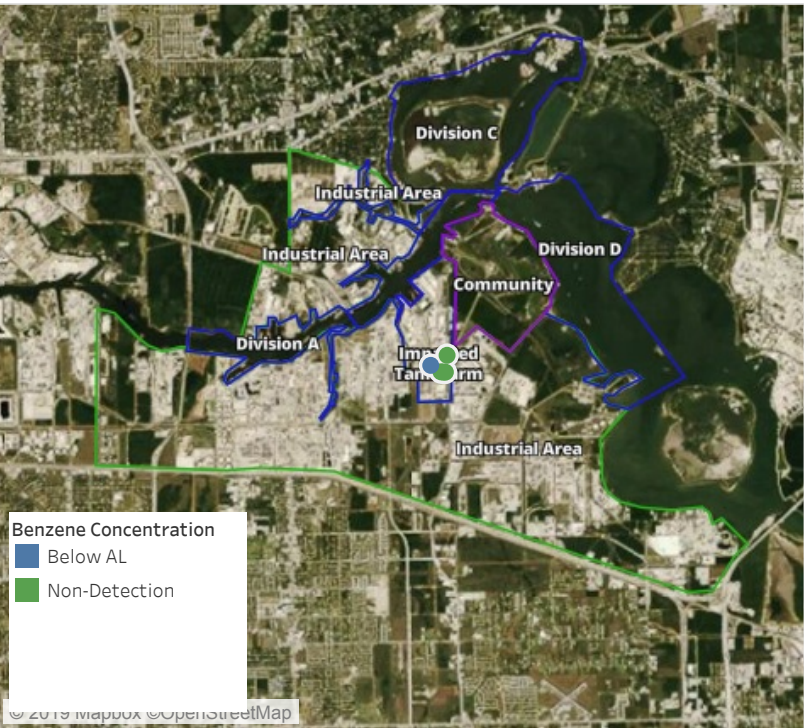
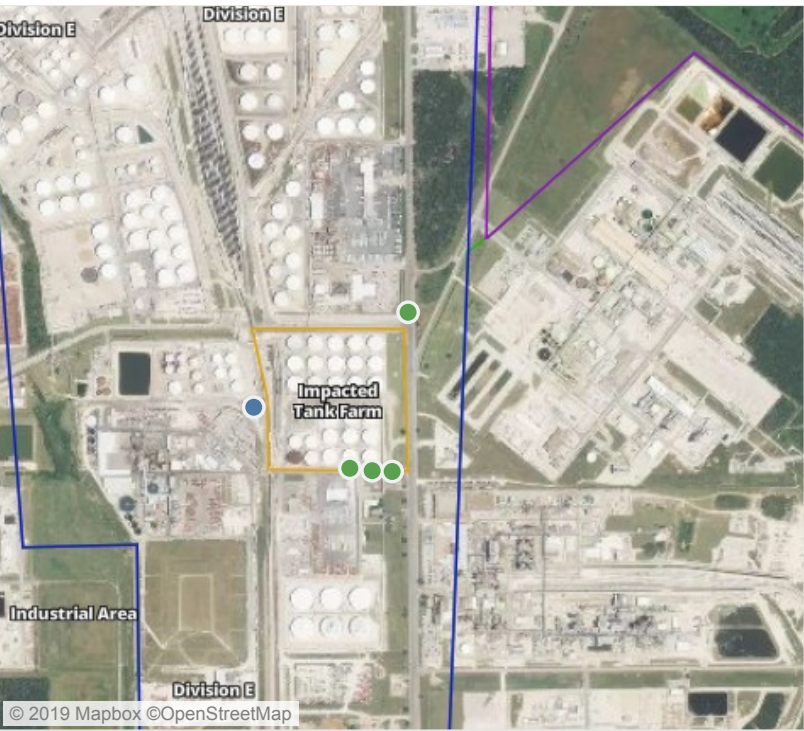
Reading Date
6/9/2019 7:00:00 AM to 6/9/2019 8:00:00 AM

Recent Benzene Detections

Location Category	Reading Date	Range of Detections
Division E	6/9/2019 07:54:45	0.08000 ppm

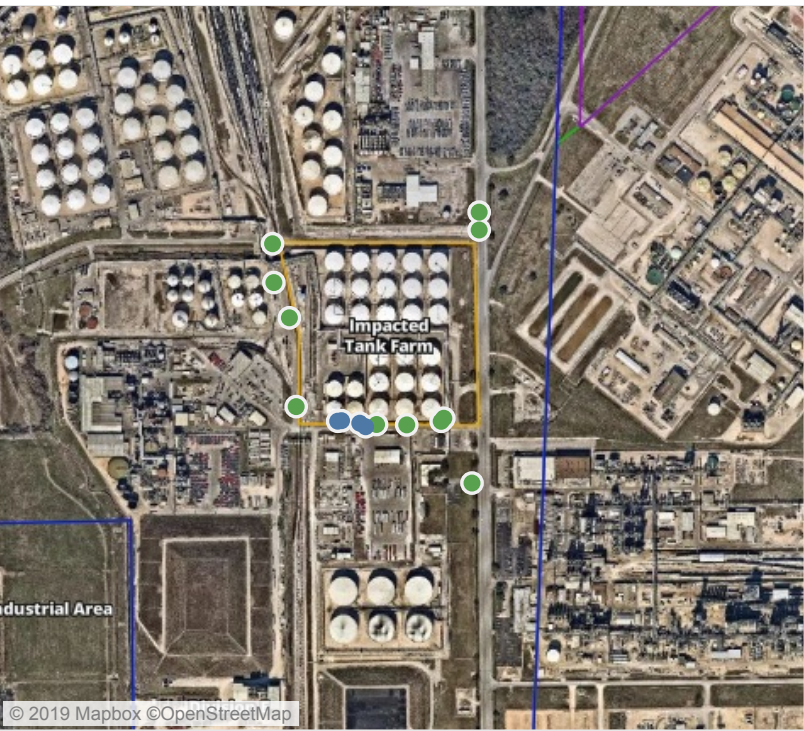
Reading Date
6/9/2019 2:00:00 PM to 6/9/2019 3:00:00 PM

Recent Benzene Detections

Location Category	Reading Date	Range of Detections
Division E	6/9/2019 14:29:47	0.0800 ppm
	6/9/2019 14:28:16	0.1000 ppm
	6/9/2019 14:35:42	0.1900 ppm
	6/9/2019 14:34:18	0.1700 ppm

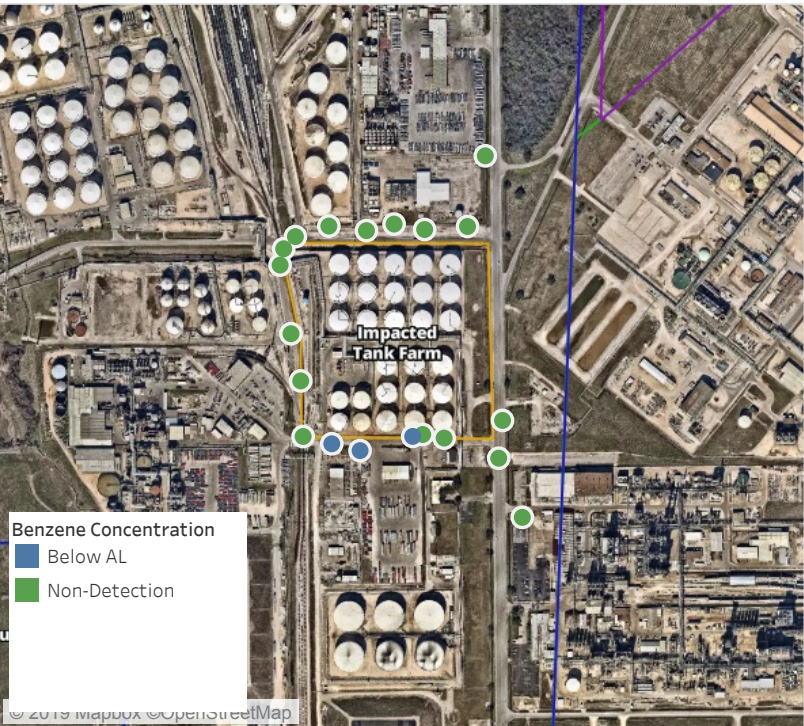
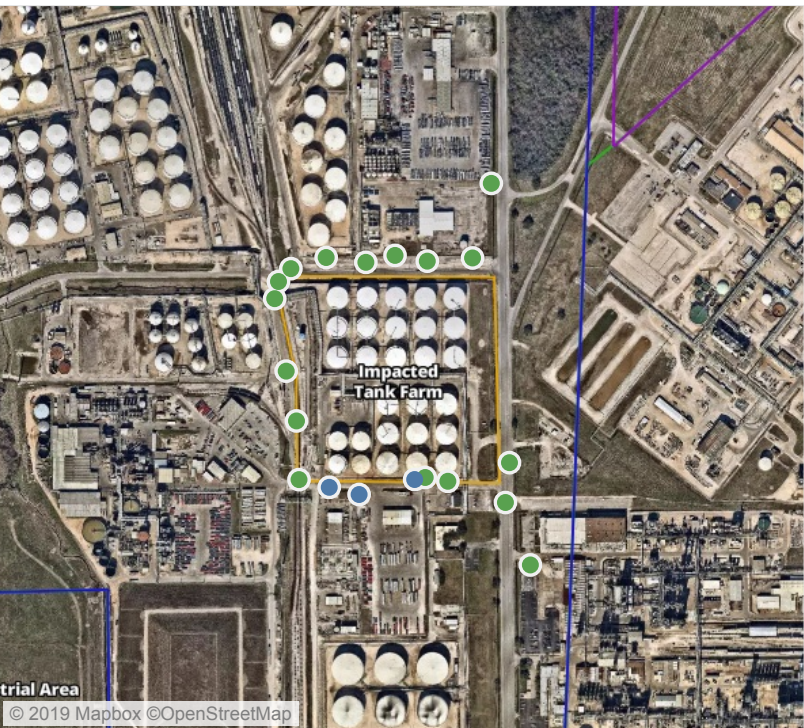
Reading Date
6/9/2019 8:00:00 PM to 6/9/2019 9:00:00 PM

Recent Benzene Detections

Location Category	Reading Date	Range of Detections
Division E	6/9/2019 20:12:36	0.1800 ppm
	6/9/2019 20:18:06	0.2100 ppm
	6/9/2019 20:20:03	0.0900 ppm

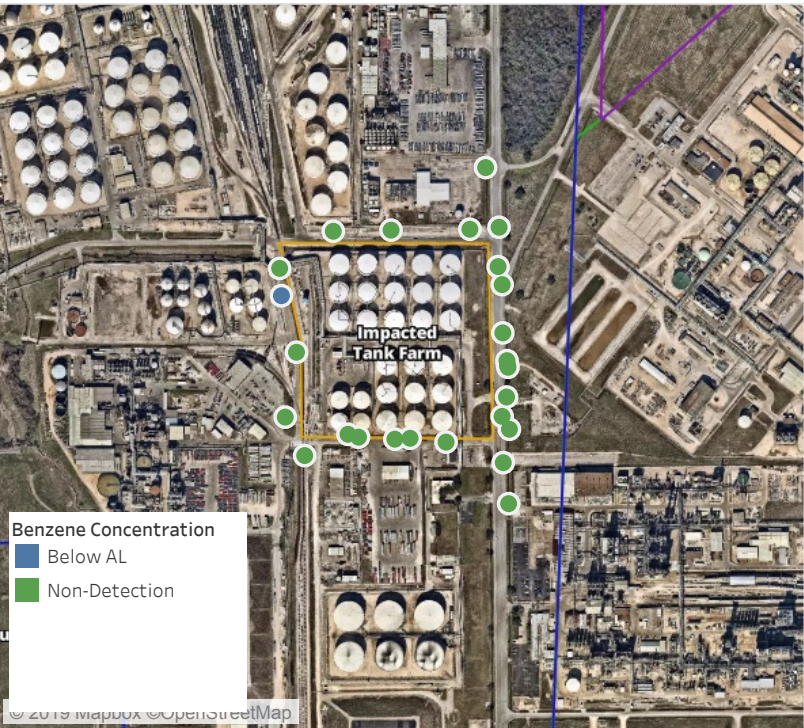
Reading Date
6/9/2019 9:00:00 PM to 6/9/2019 10:00:00 PM

Recent Benzene Detections

Location Category	Reading Date	Range of Detections
Division E	6/9/2019 21:22:51	0.02000 ppm
