Preliminary Hand- Held Air Monitoring Locations | ITC Deer Park Tank Fire

Reading Date
6/10/2019 11:00:00 PM to 6/11/2019 12:00:00 AM

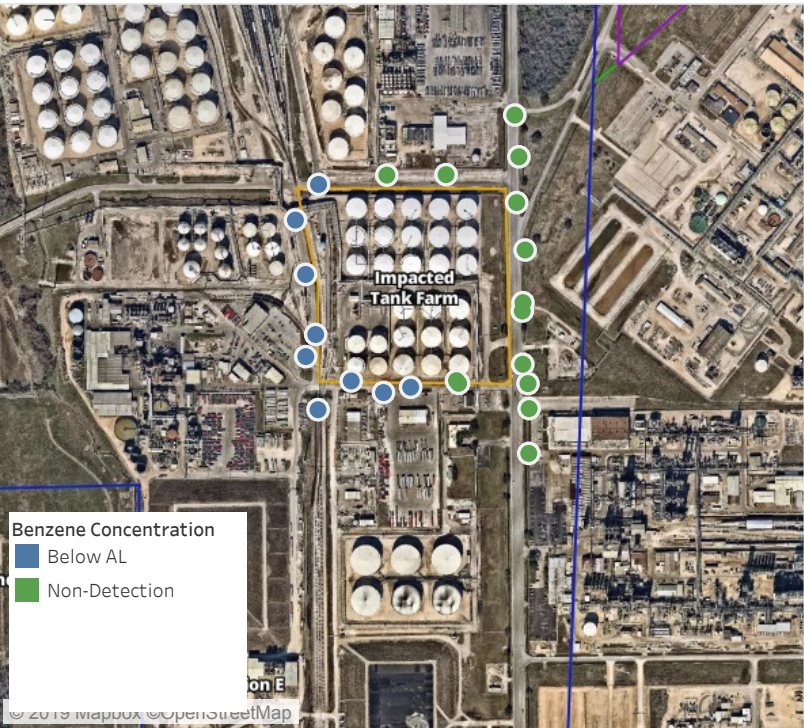
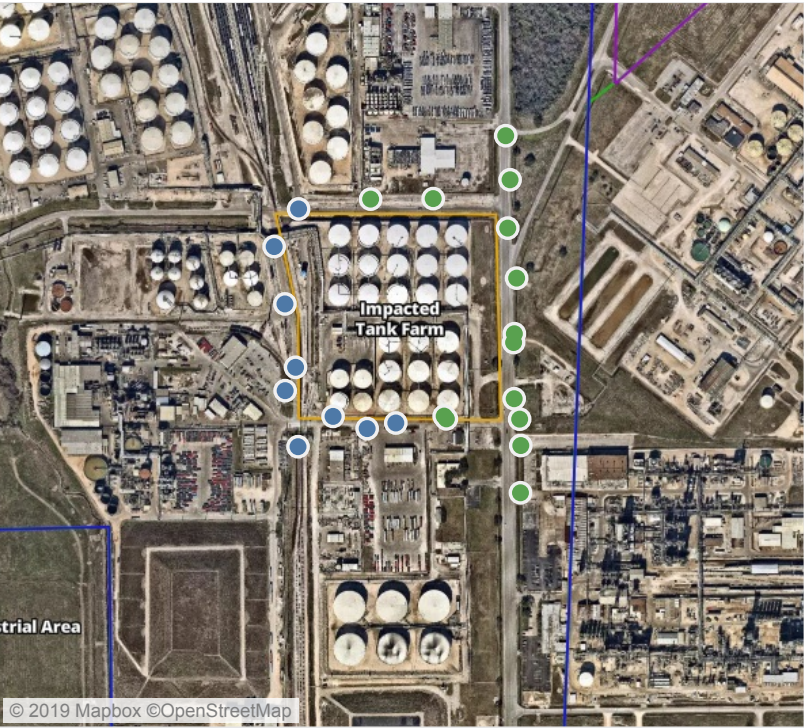
Location Category	Reading Date	Range of Detections
Division E	6/10/2019 23:35:25	0.2800 ppm
	6/10/2019 23:39:46	0.0500 ppm
	6/10/2019 23:38:02	0.1200 ppm
	6/10/2019 23:42:14	0.0500 ppm
	6/10/2019 23:15:27	0.0800 ppm
	6/10/2019 23:40:00	0.0800 ppm
	6/10/2019 23:27:10	0.0600 ppm
	6/10/2019 23:33:32	0.0900 ppm
	6/10/2019 23:18:24	0.0500 ppm

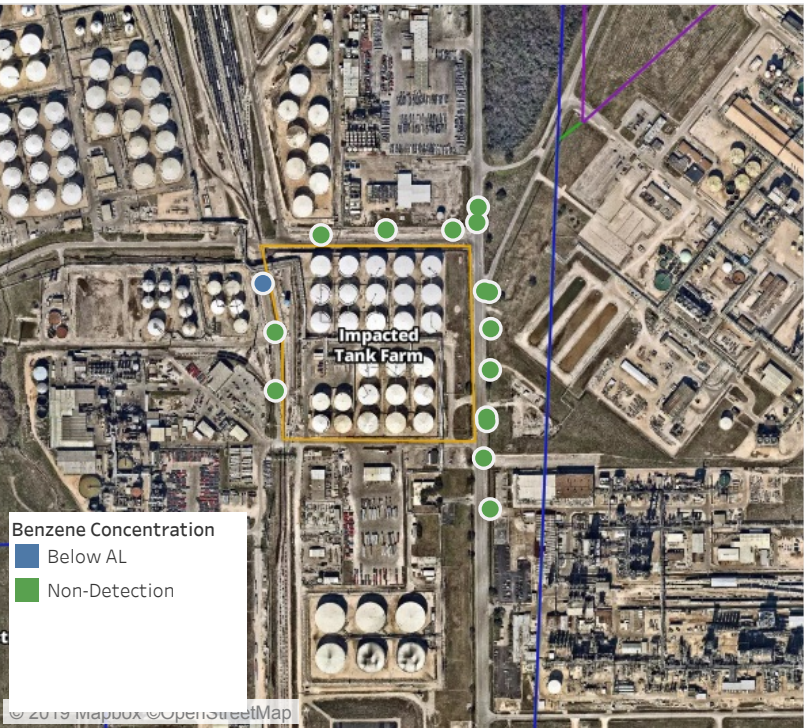
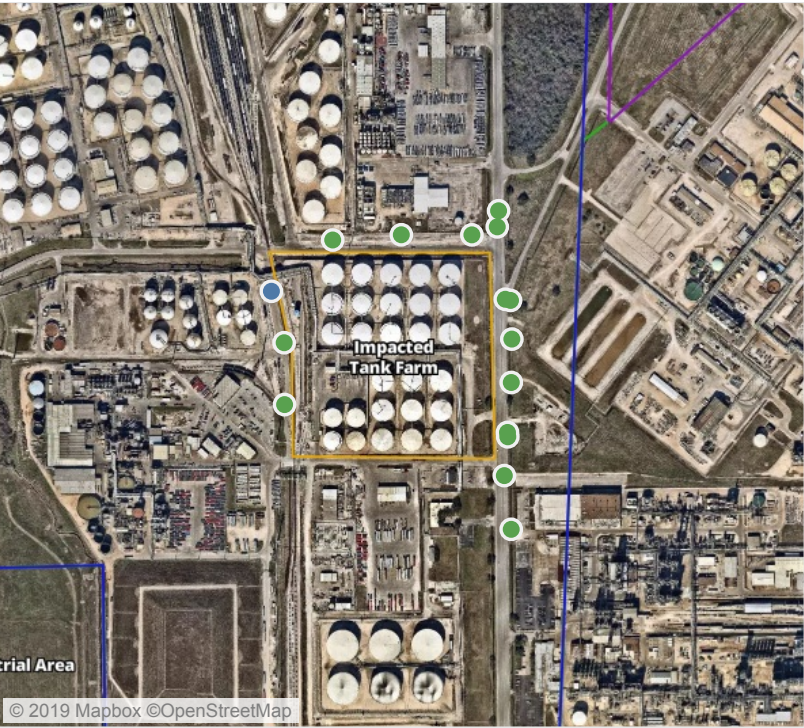
Reading Date
6/11/2019 12:00:00 AM to 6/11/2019 1:00:00 AM

Location Category	Reading Date	Range of Detections
Division E	6/11/2019 00:28:58	0.06000 ppm
	6/11/2019 00:34:40	0.05000 ppm

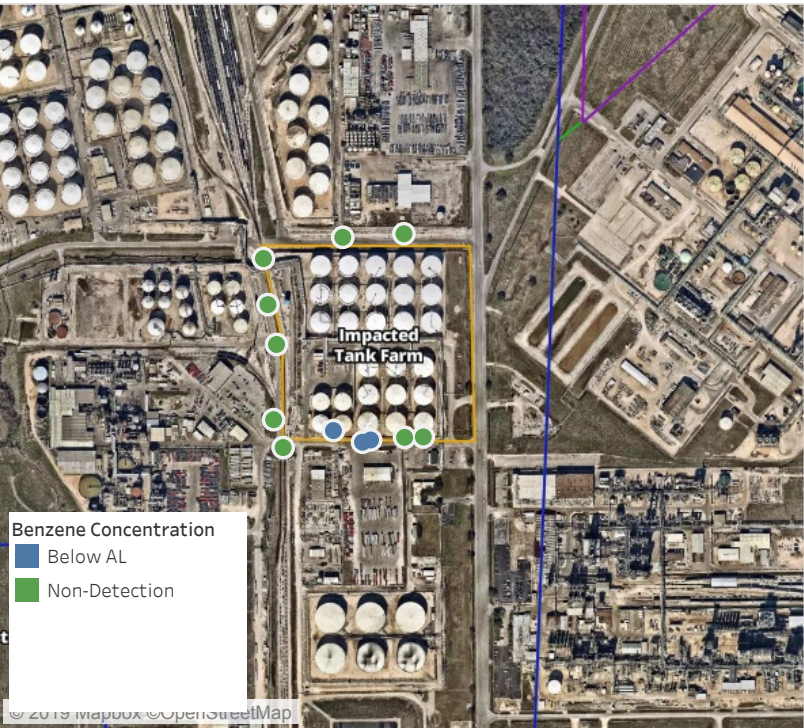
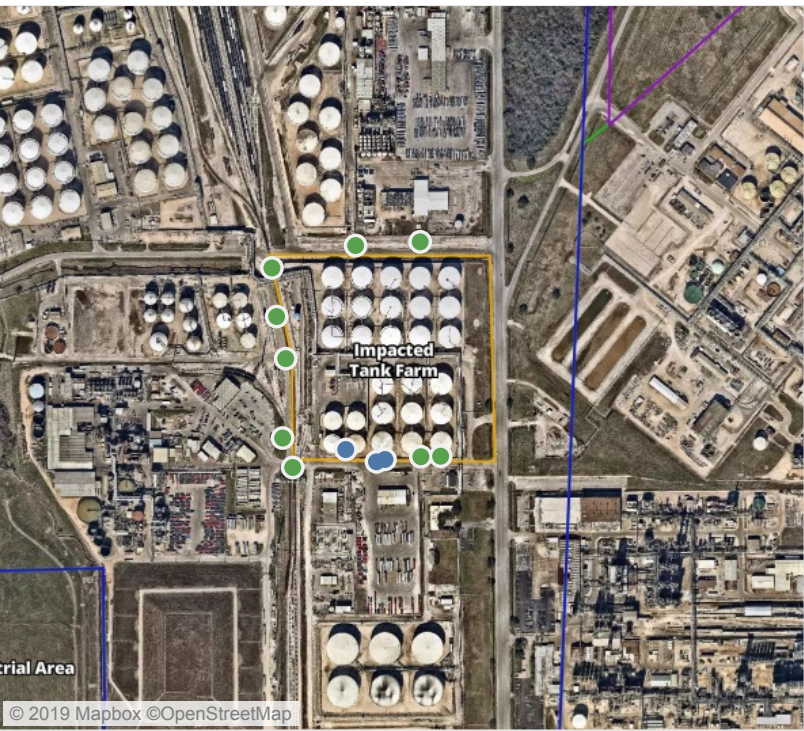
Reading Date
6/11/2019 1:00:00 AM to 6/11/2019 2:00:00 AM

Location Category	Reading Date	Range of Detections
Division E	6/11/2019 01:10:26	0.3400 ppm
	6/11/2019 01:08:21	0.1200 ppm
	6/11/2019 01:12:42	0.1100 ppm

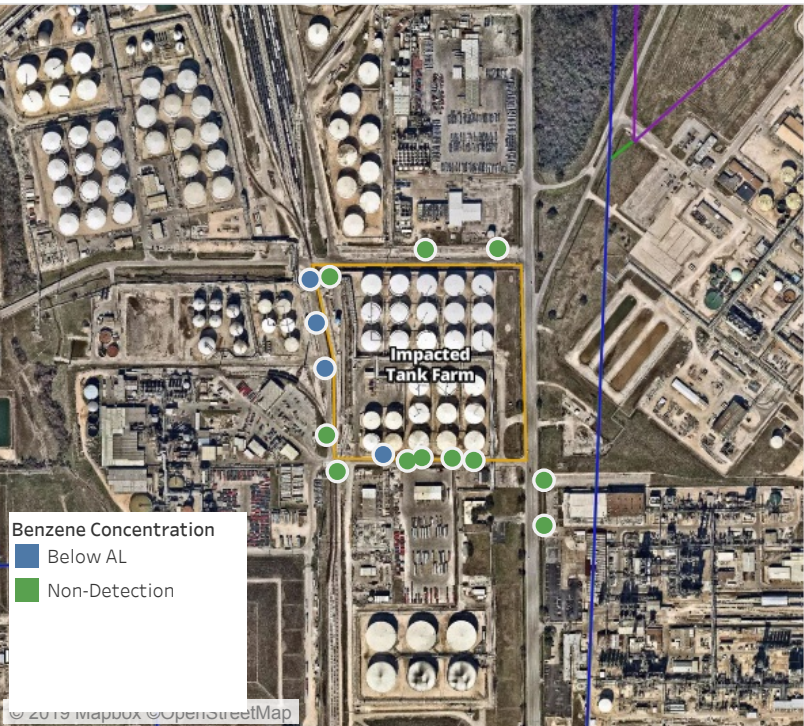
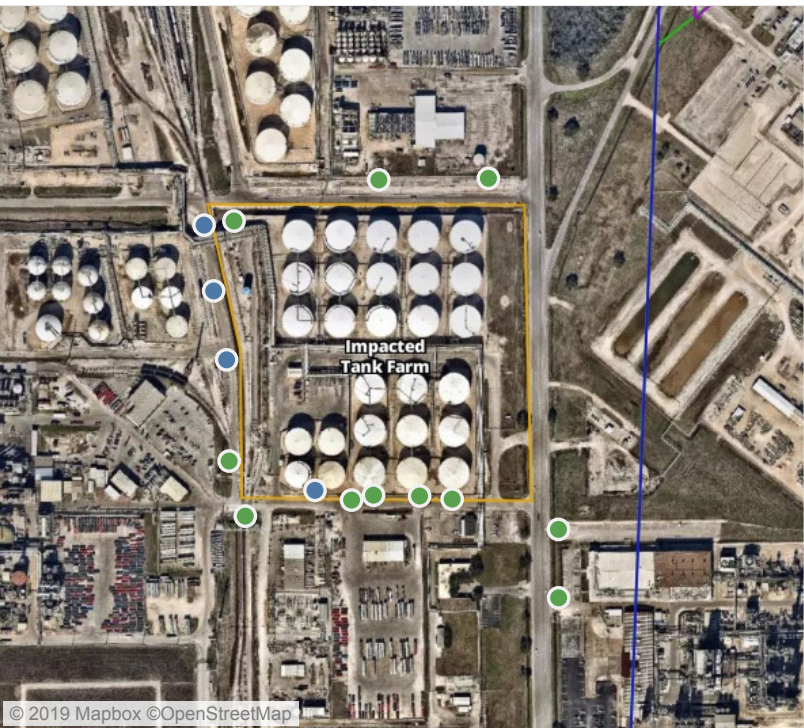
Reading Date
6/11/2019 3:00:00 AM to 6/11/2019 4:00:00 AM

Location Category	Reading Date	Range of Detections
Division E	6/11/2019 03:15:40	0.02000 ppm
	6/11/2019 03:16:15	0.07000 ppm
	6/11/2019 03:22:44	0.06000 ppm
	6/11/2019 03:27:45	0.06000 ppm

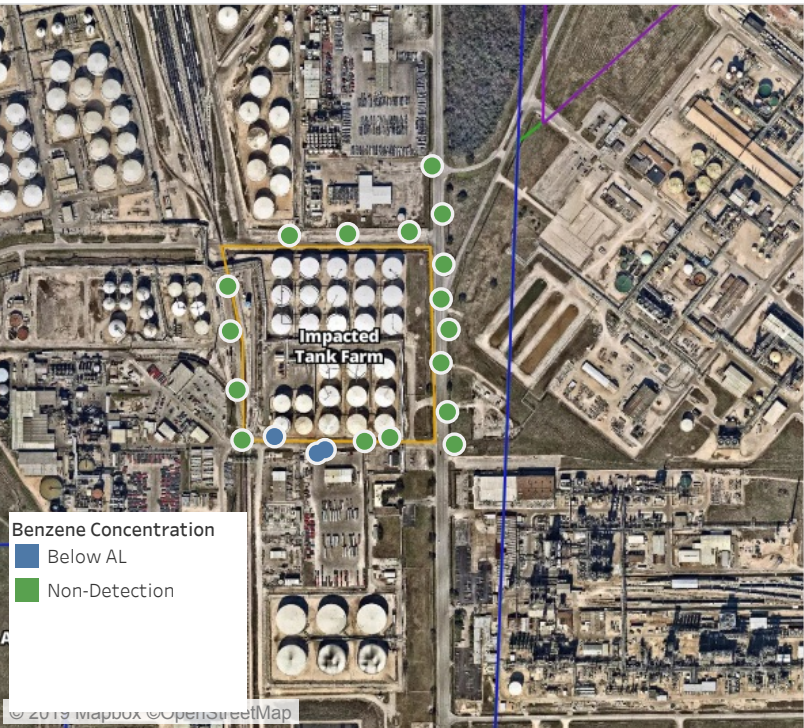
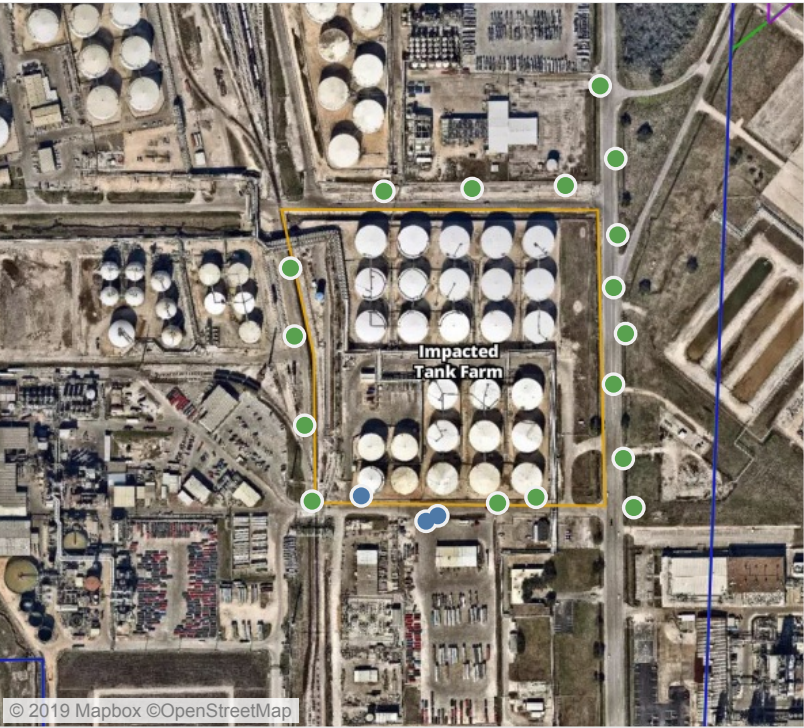
Reading Date
6/11/2019 4:00:00 AM to 6/11/2019 5:00:00 AM

Location Category	Reading Date	Range of Detections
Division E	6/11/2019 04:46:12	0.04000 ppm
	6/11/2019 04:49:02	0.13000 ppm
	6/11/2019 04:51:57	0.08000 ppm

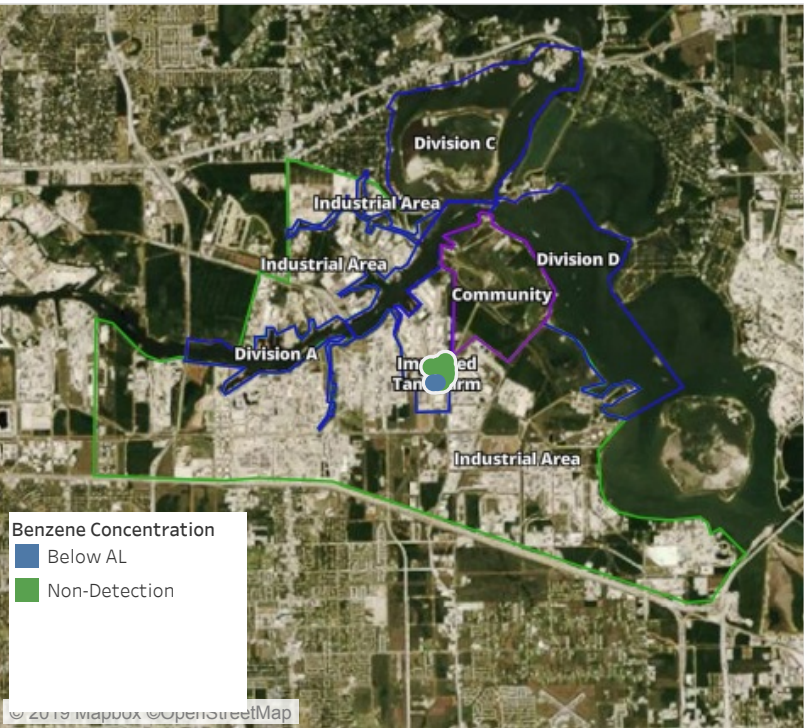
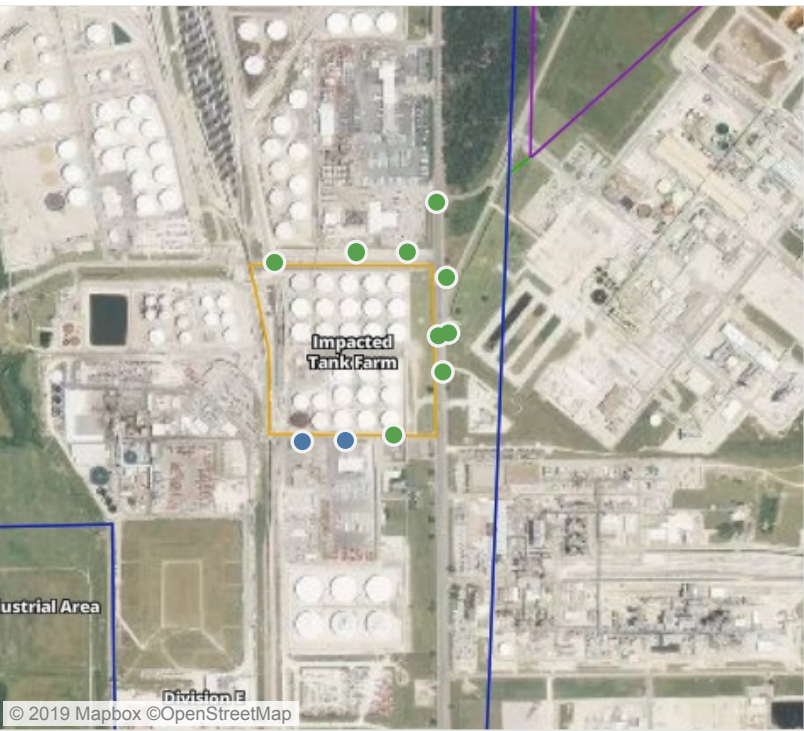
Reading Date
6/11/2019 6:00:00 AM to 6/11/2019 7:00:00 AM

Location Category	Reading Date	Range of Detections
Division E	6/11/2019 06:51:49	0.22000 ppm
	6/11/2019 06:57:23	0.17000 ppm

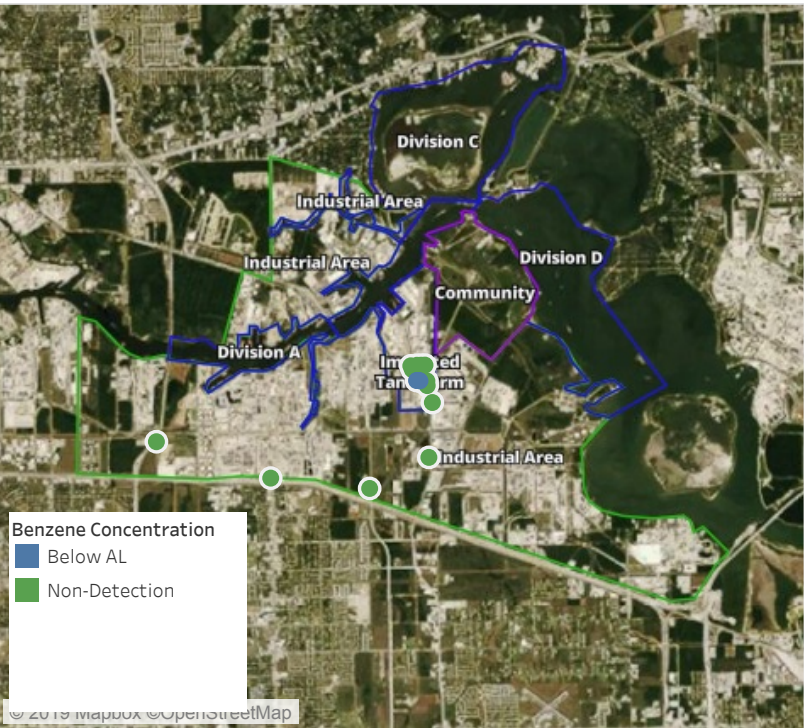
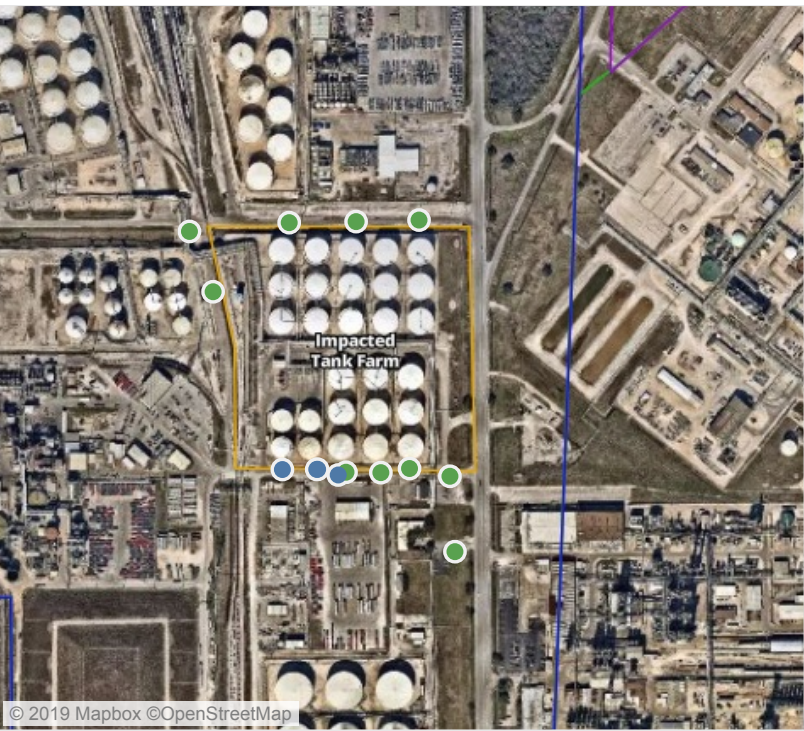
Reading Date
6/11/2019 8:00:00 AM to 6/11/2019 9:00:00 AM

Location Category	Reading Date	Range of Detections
Division E	6/11/2019 08:18:02	0.3400 ppm
	6/11/2019 08:24:09	0.1100 ppm
	6/11/2019 08:32:04	0.0900 ppm
	6/11/2019 08:25:11	0.1100 ppm

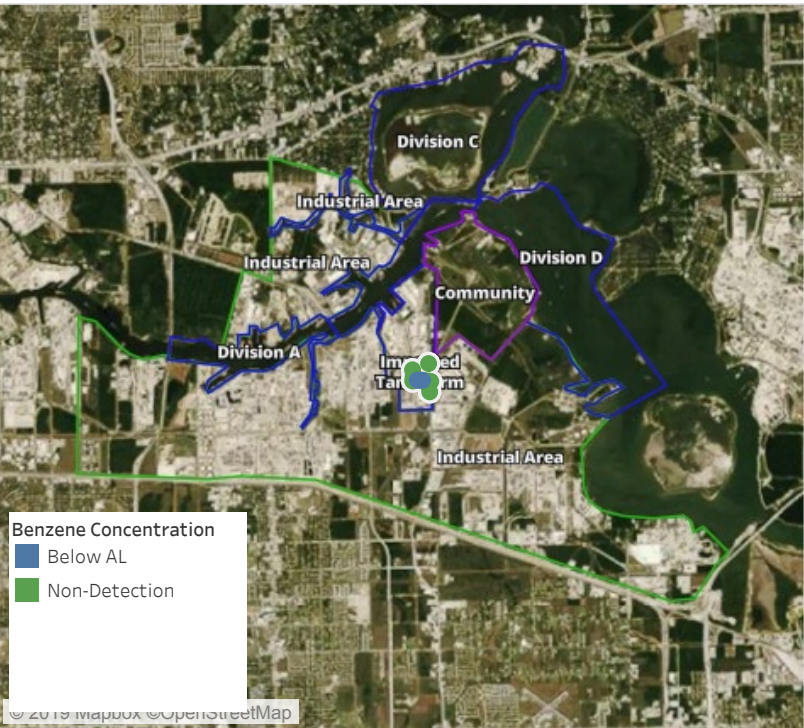
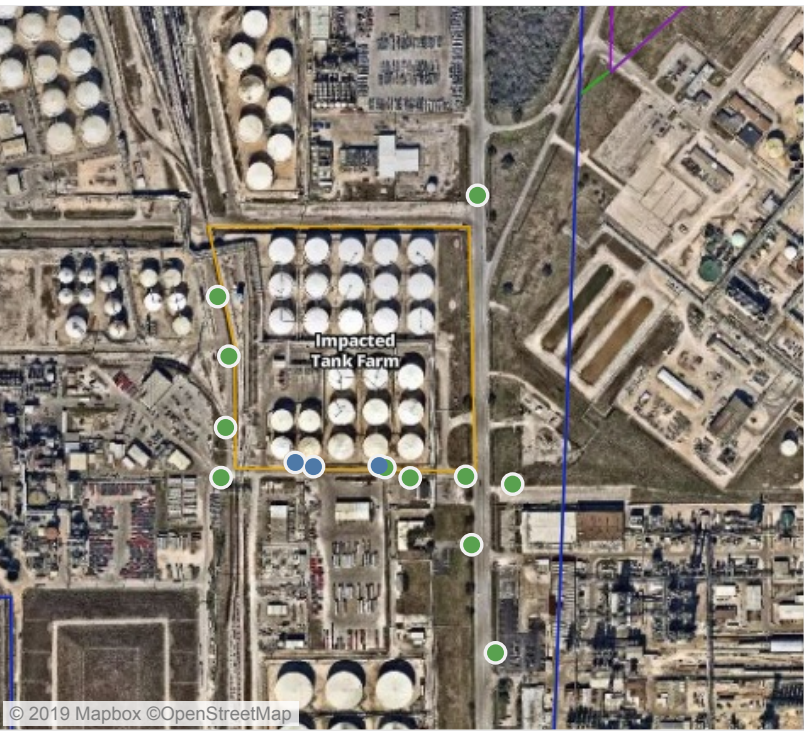
Reading Date
6/11/2019 9:00:00 AM to 6/11/2019 10:00:00 AM

Location Category	Reading Date	Range of Detections
Division E	6/11/2019 09:41:40	0.06000 ppm
	6/11/2019 09:45:27	0.07000 ppm
Impacted Tank Farm	6/11/2019 09:43:19	0.12000 ppm

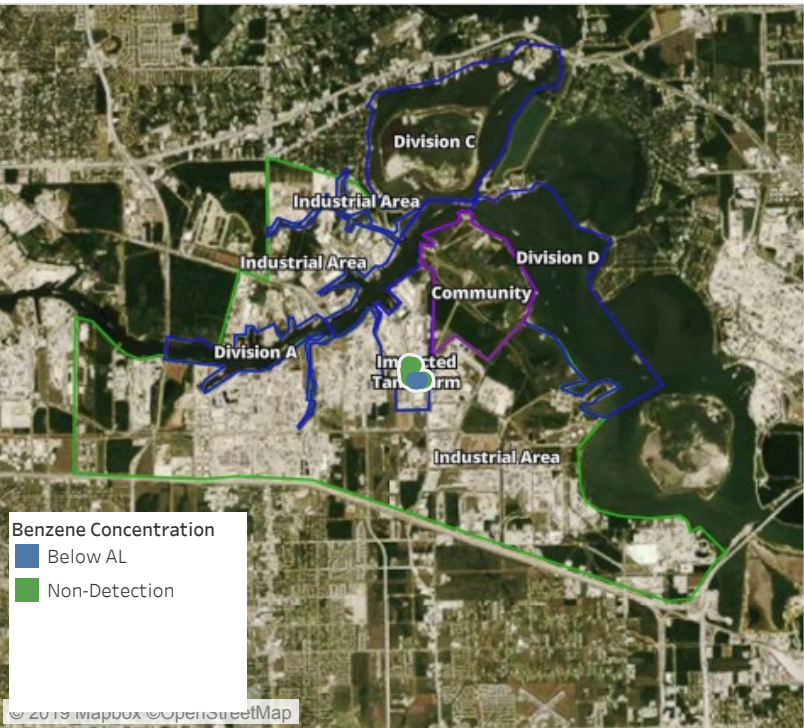
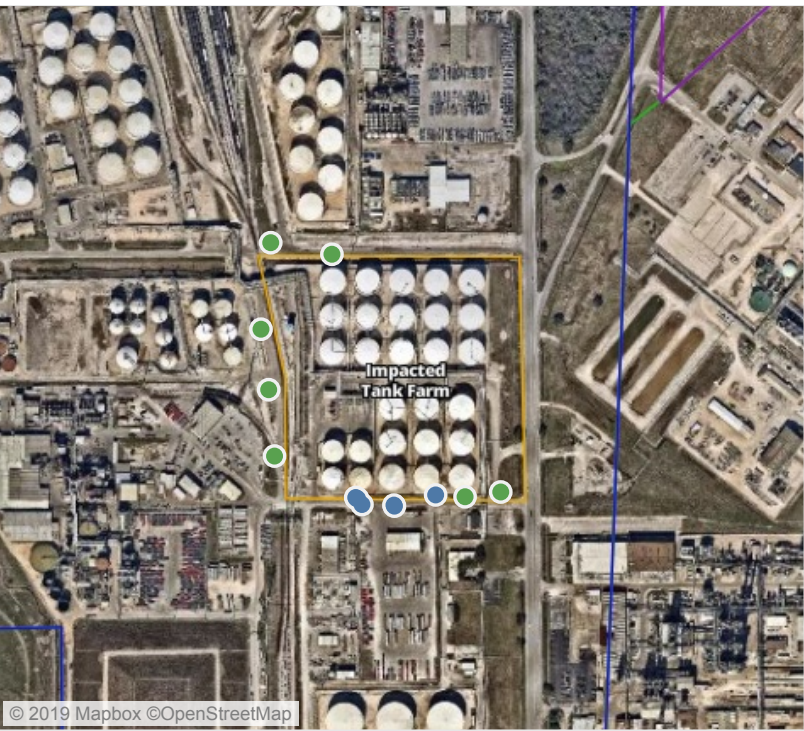
Reading Date
6/11/2019 11:00:00 AM to 6/11/2019 12:00:00 PM

Location Category	Reading Date	Range of Detections
Division E	6/11/2019 11:32:30	0.0900 ppm
	6/11/2019 11:31:51	0.1100 ppm
	6/11/2019 11:23:07	0.0300 ppm
	6/11/2019 11:25:50	0.1200 ppm
	6/11/2019 11:30:27	0.2100 ppm
	6/11/2019 11:27:55	0.1200 ppm
	6/11/2019 11:25:15	0.1600 ppm

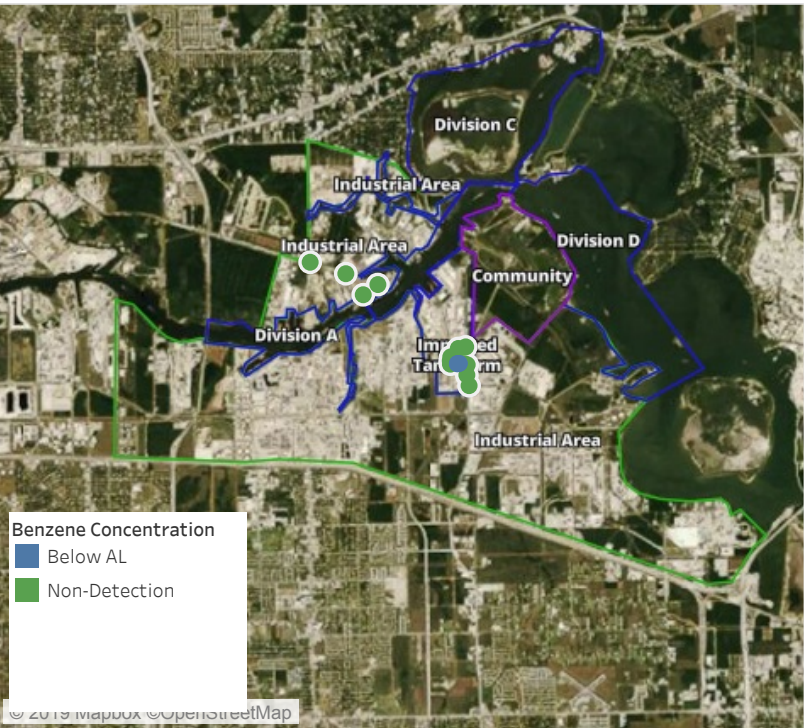
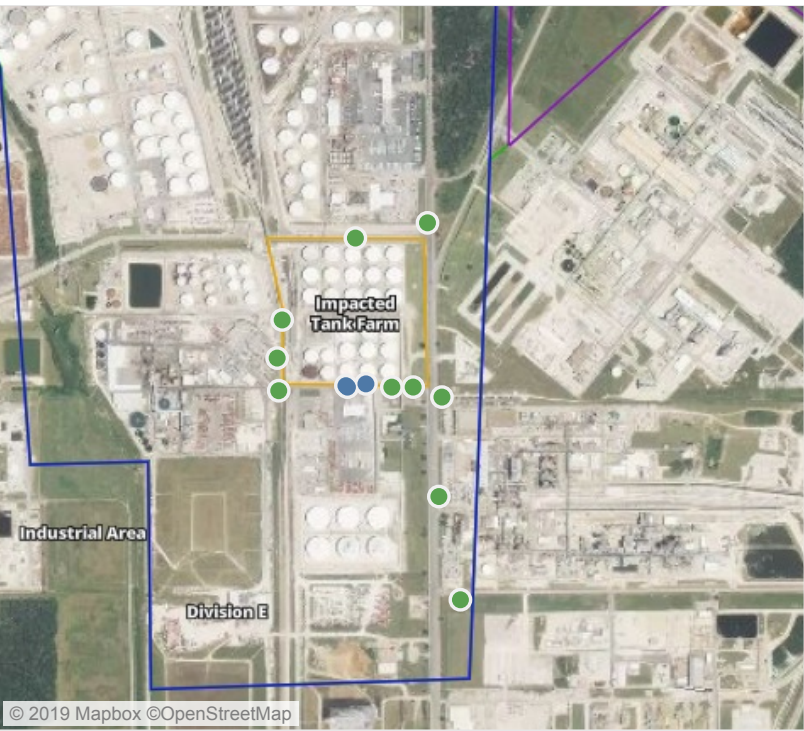
Reading Date
6/11/2019 12:00:00 PM to 6/11/2019 1:00:00 PM

Location Category	Reading Date	Range of Detections
Division E	6/11/2019 12:53:49	0.17000 ppm
	6/11/2019 12:56:37	0.19000 ppm
Impacted Tank Farm	6/11/2019 12:49:17	0.17000 ppm

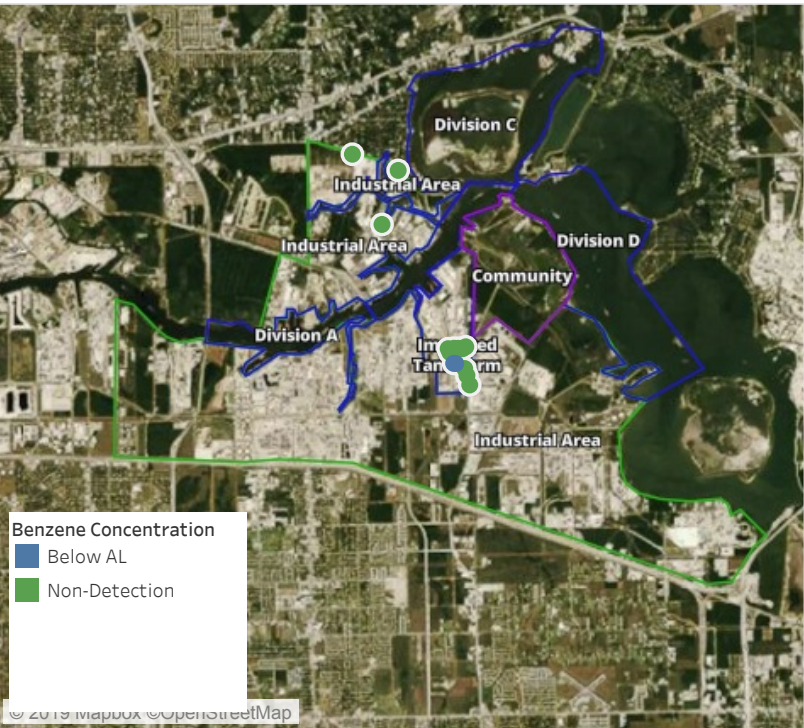
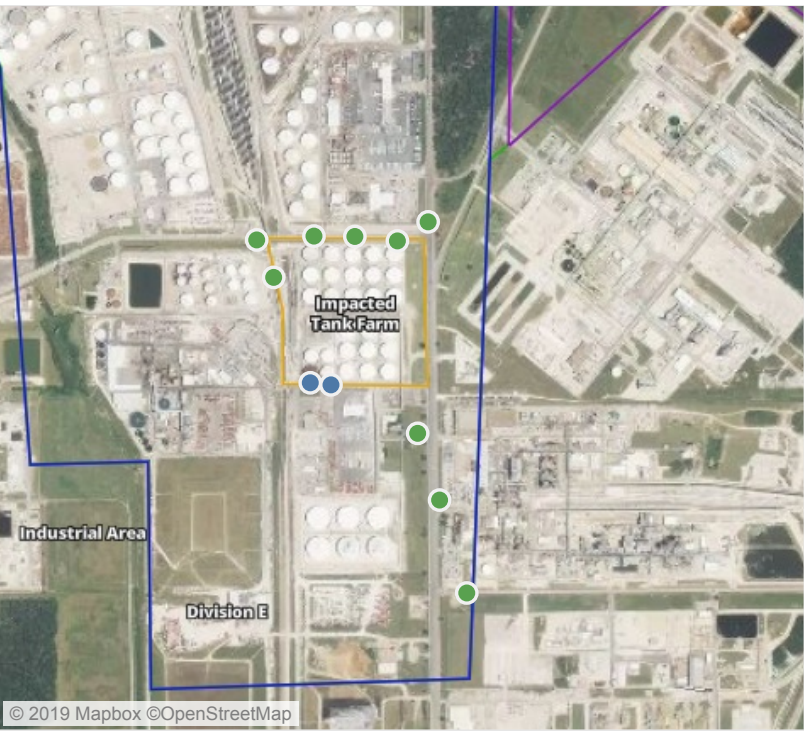
Reading Date
6/11/2019 1:00:00 PM to 6/11/2019 2:00:00 PM

Location Category	Reading Date	Range of Detections
Impacted Tank Farm	6/11/2019 13:00:38	0.11000 ppm
	6/11/2019 13:02:15	0.09000 ppm

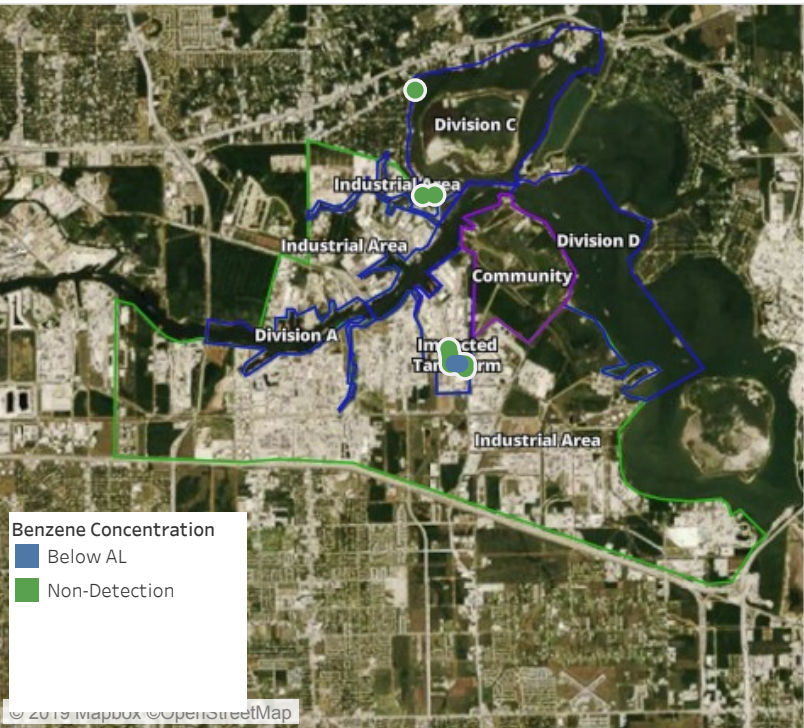
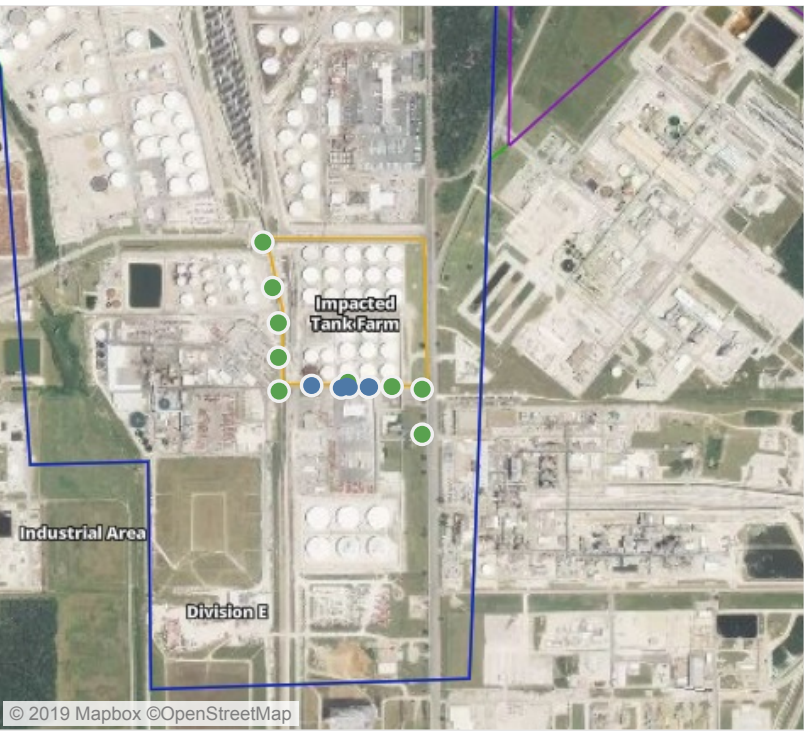
Reading Date
6/11/2019 2:00:00 PM to 6/11/2019 3:00:00 PM

Location Category	Reading Date	Range of Detections
Division E	6/11/2019 14:30:16	0.1500 ppm
	6/11/2019 14:25:03	0.4000 ppm
	6/11/2019 14:27:28	0.1800 ppm
	6/11/2019 14:42:01	0.2400 ppm
	6/11/2019 14:44:58	0.0800 ppm
	6/11/2019 14:48:55	0.1900 ppm
	6/11/2019 14:41:23	0.1200 ppm

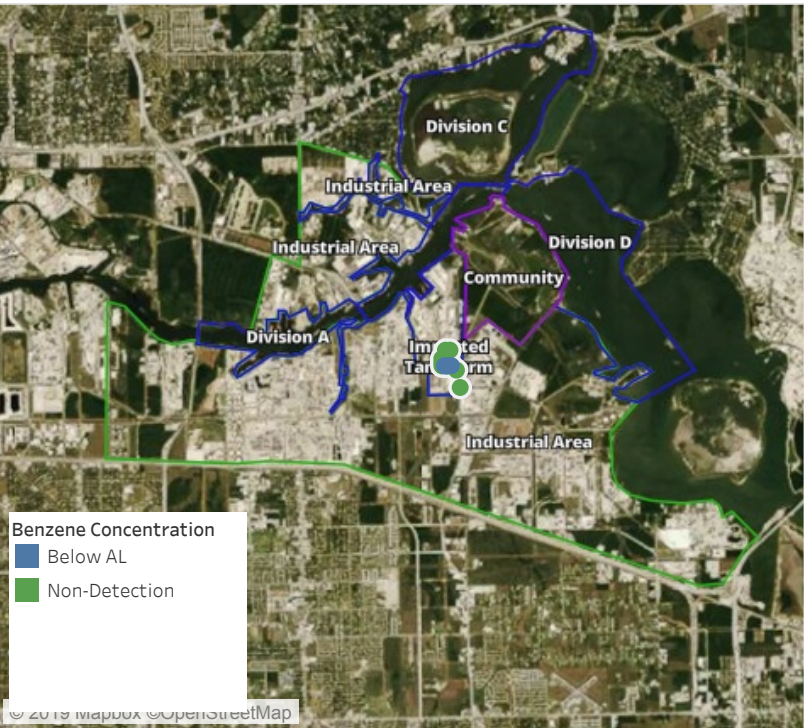
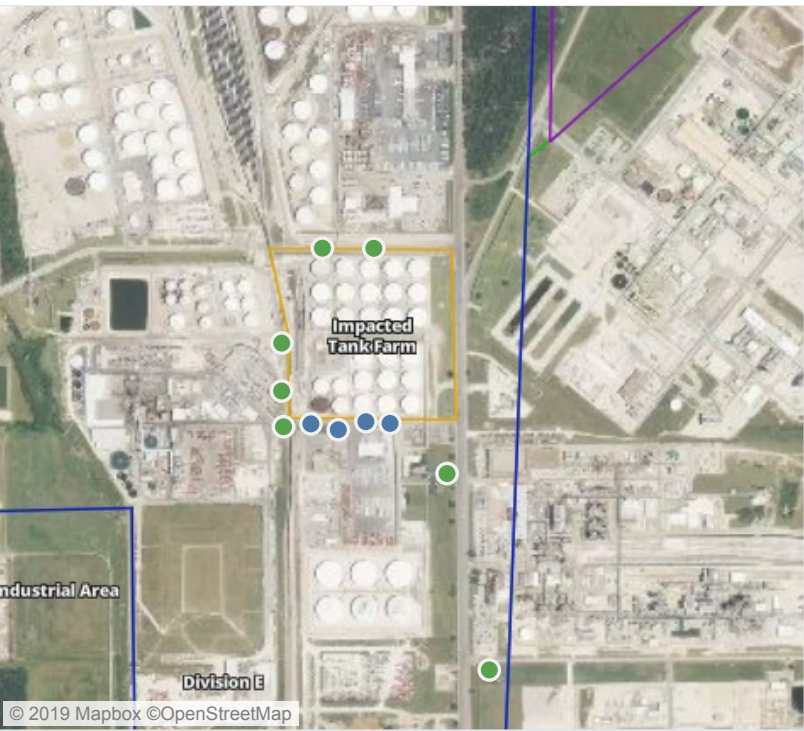
Reading Date
6/11/2019 4:00:00 PM to 6/11/2019 5:00:00 PM

Location Category	Reading Date	Range of Detections
Division E	6/11/2019 16:06:36	0.07000 ppm
	6/11/2019 16:04:14	0.14000 ppm
	6/11/2019 16:11:35	0.08000 ppm
	6/11/2019 16:09:44	0.16000 ppm

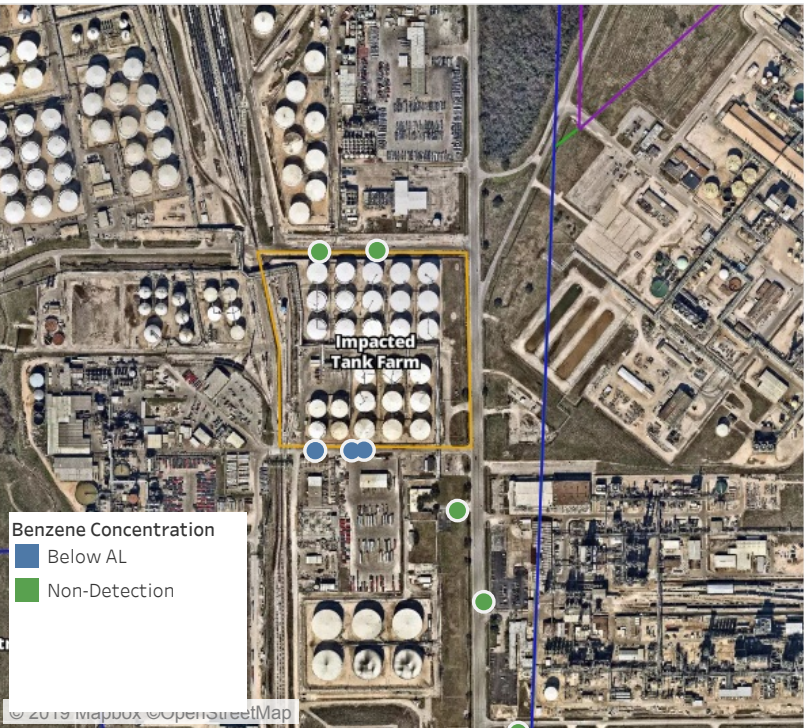
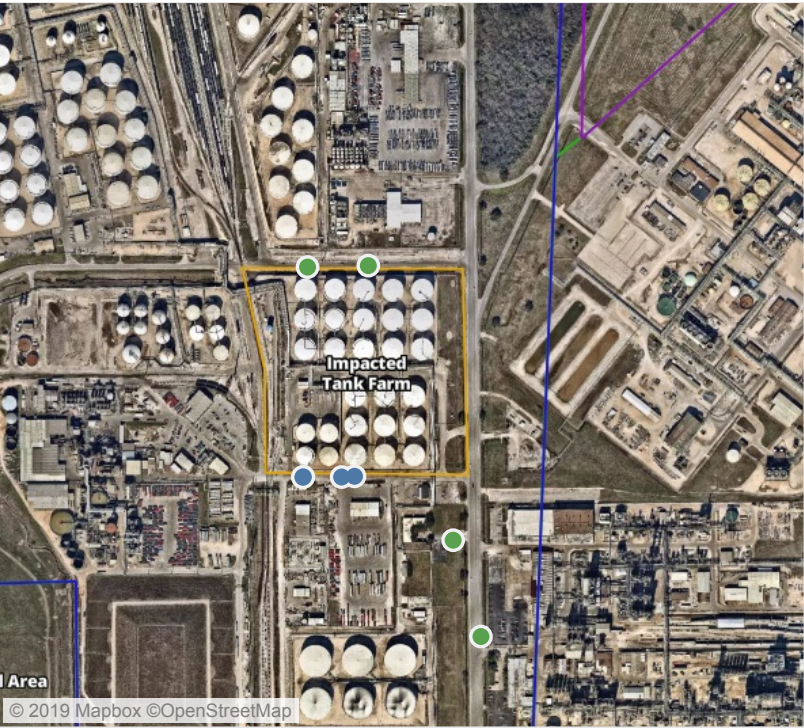
Reading Date
6/11/2019 6:00:00 PM to 6/11/2019 7:00:00 PM

Location Category	Reading Date	Range of Detections
Division E	6/11/2019 18:00:44	0.3600 ppm
	6/11/2019 18:05:52	0.1900 ppm
	6/11/2019 18:01:46	0.1400 ppm
	6/11/2019 18:06:35	0.0600 ppm

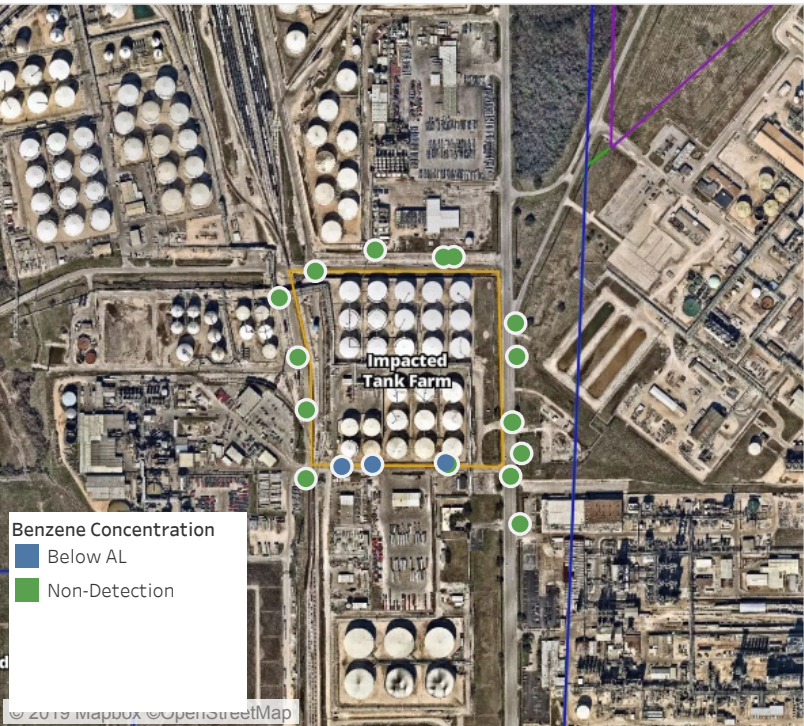
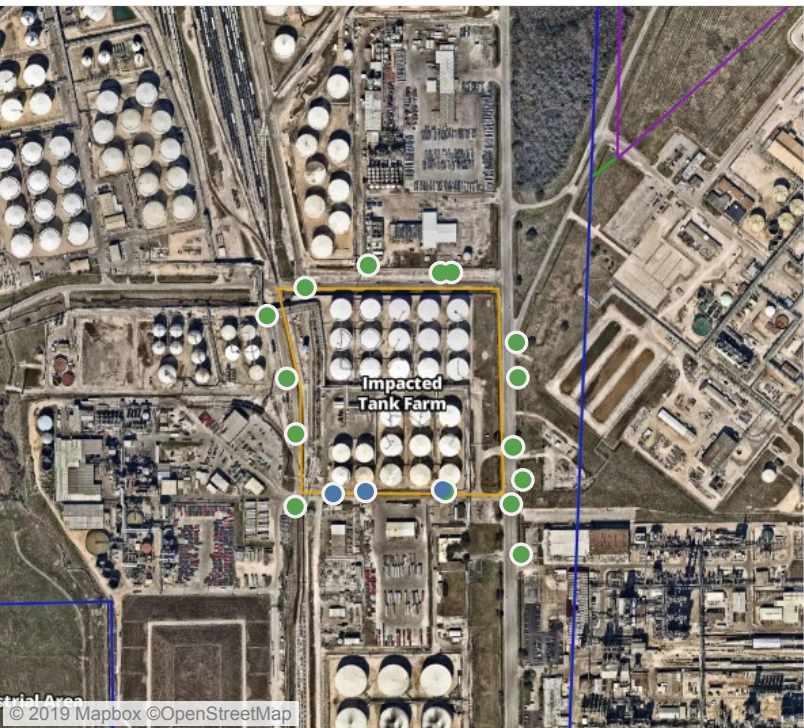
Reading Date
6/11/2019 8:00:00 PM to 6/11/2019 9:00:00 PM

Location Category	Reading Date	Range of Detections
Division E	6/11/2019 20:05:12	0.0200 ppm
	6/11/2019 20:09:58	0.1100 ppm
	6/11/2019 20:07:59	0.3500 ppm

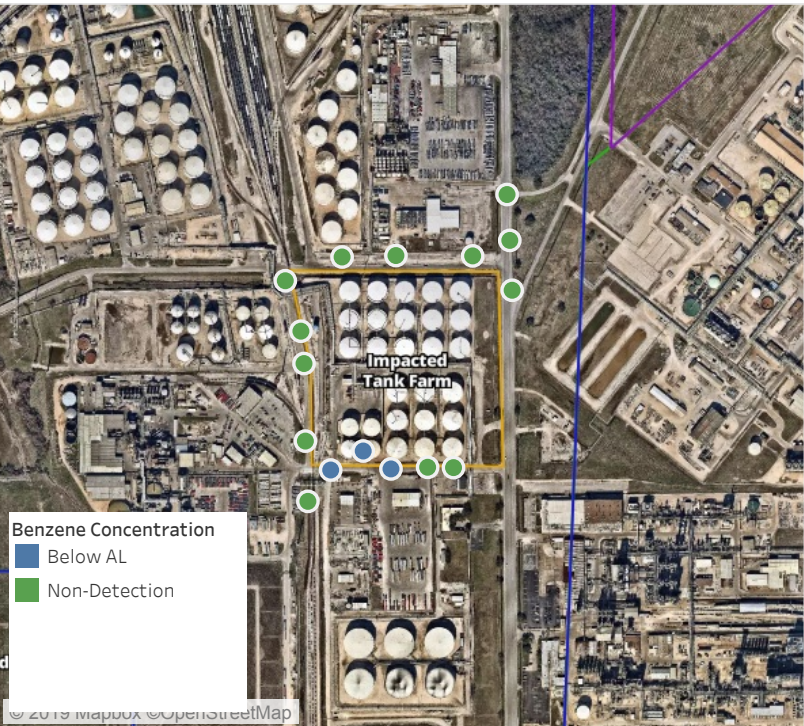
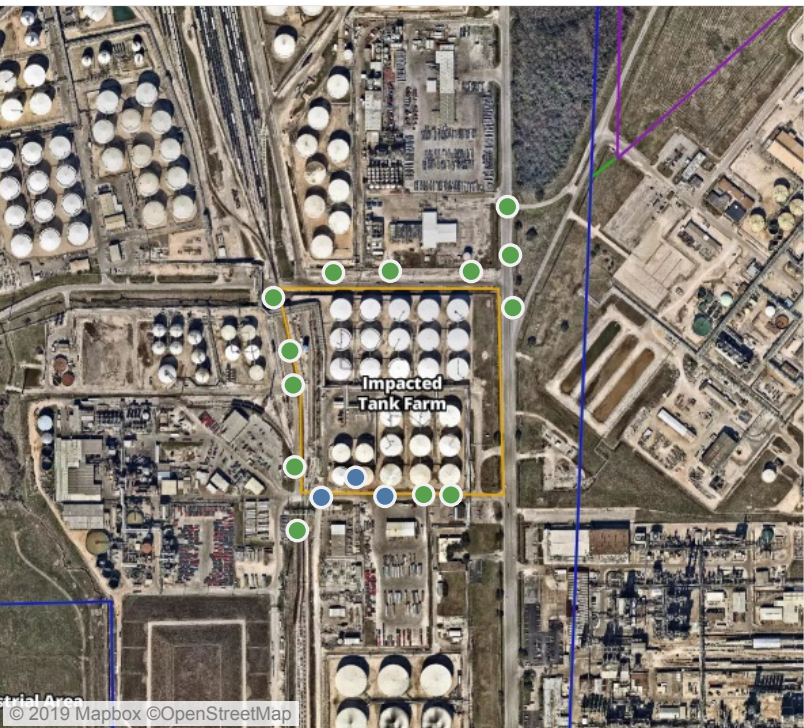
Reading Date
6/11/2019 9:00:00 PM to 6/11/2019 10:00:00 PM

Location Category	Reading Date	Range of Detections
Division E	6/11/2019 21:15:30	0.2000 ppm
	6/11/2019 21:19:29	0.2200 ppm
	6/11/2019 21:22:56	0.0800 ppm

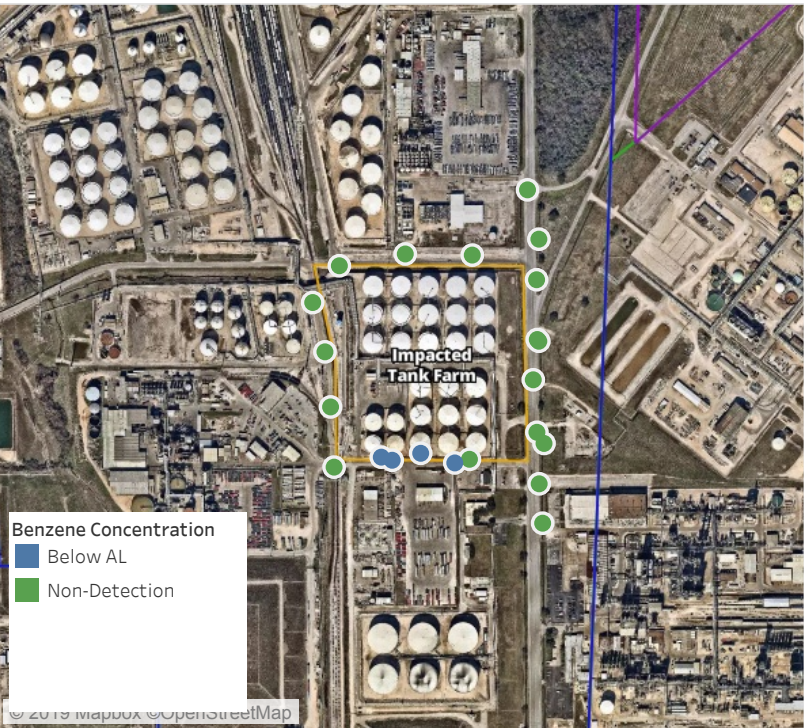
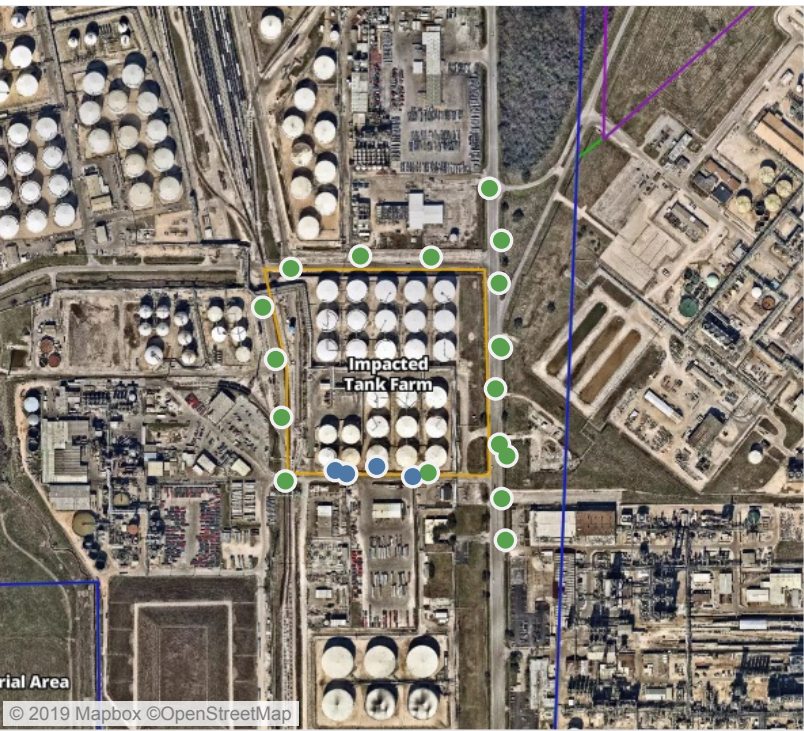
Reading Date
6/11/2019 10:00:00 PM to 6/11/2019 11:00:00 PM

Location Category	Reading Date	Range of Detections
Division E	6/11/2019 22:36:08	0.0200 ppm
	6/11/2019 22:38:50	0.2000 ppm
	6/11/2019 22:41:09	0.2600 ppm
	6/11/2019 22:43:36	0.1500 ppm
