Preliminary Hand- Held Air Monitoring Locations | ITC Deer Park Tank Fire

Reading Date
6/13/2019 11:00:00 PM to 6/14/2019 12:00:00 AM

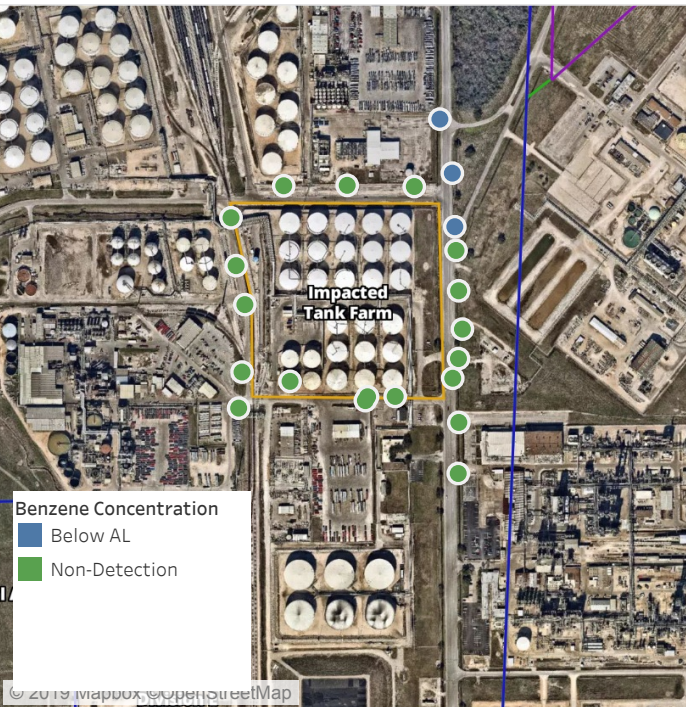
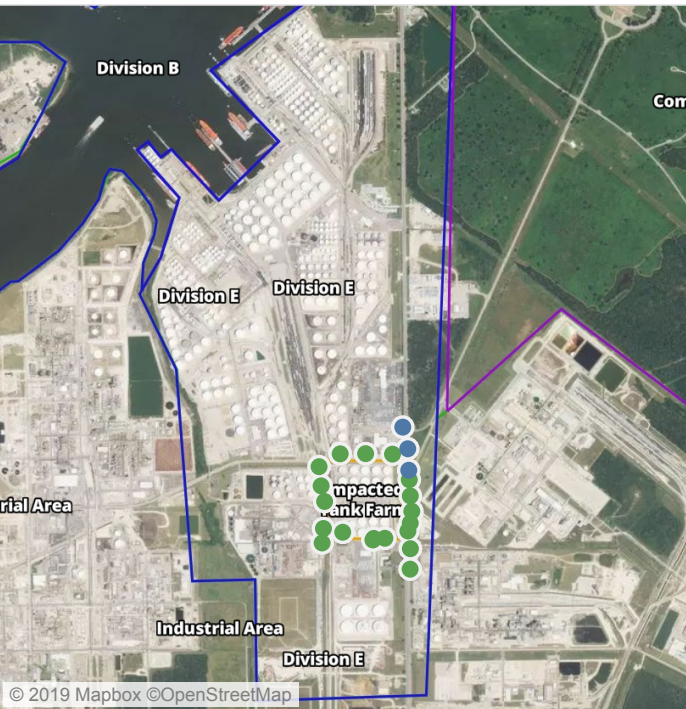
Recent Benzene Detections

Location Category	Reading Date	Range of Detections
Division E	6/13/2019 23:30:37	0.08000 ppm
	6/13/2019 23:32:57	0.10000 ppm
	6/13/2019 23:36:28	0.05000 ppm

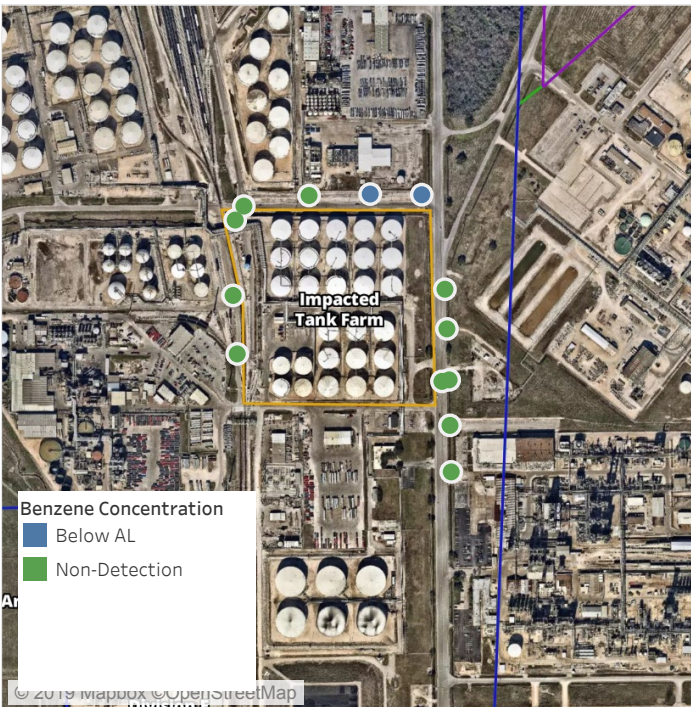
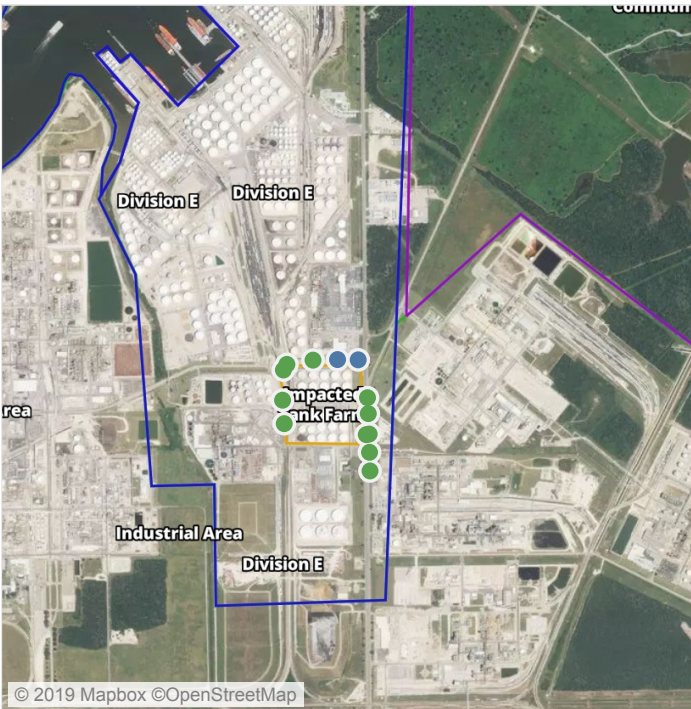
Reading Date
6/14/2019 12:00:00 AM to 6/14/2019 1:00:00 AM

Recent Benzene Detections

Location Category	Reading Date	Range of Detections
Division E	6/14/2019 00:21:35	0.07000 ppm
	6/14/2019 00:26:13	0.06000 ppm

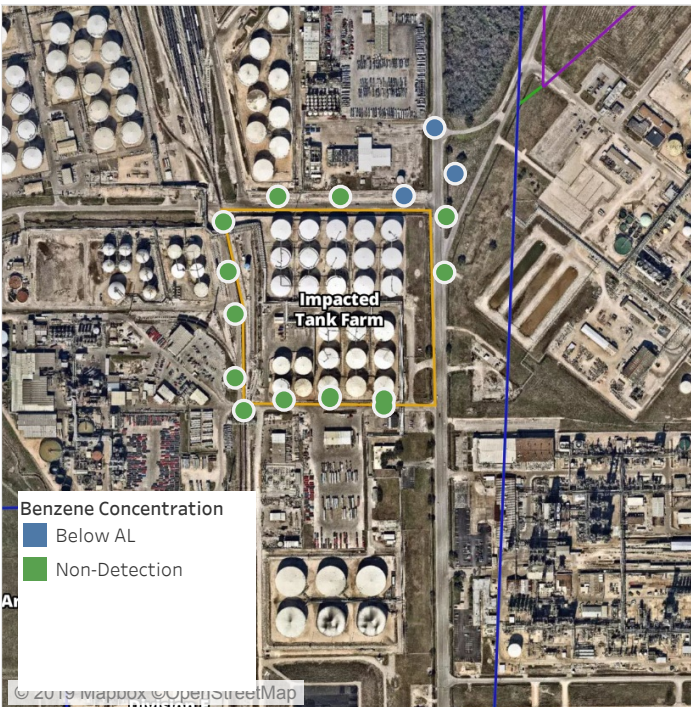
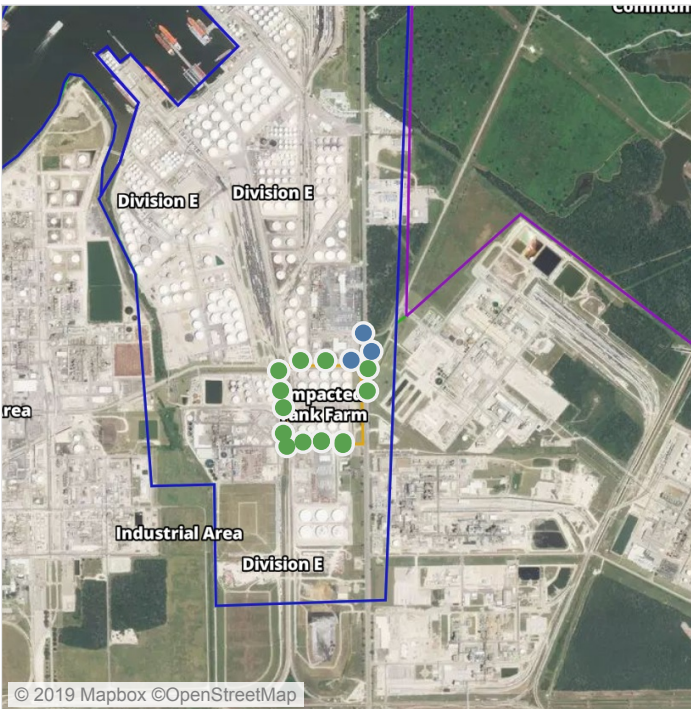
Reading Date
6/14/2019 1:00:00 AM to 6/14/2019 2:00:00 AM

Recent Benzene Detections

Location Category	Reading Date	Range of Detections
Division E	6/14/2019 01:06:46	0.08000 ppm
	6/14/2019 01:09:33	0.04000 ppm
	6/14/2019 01:40:41	0.07000 ppm

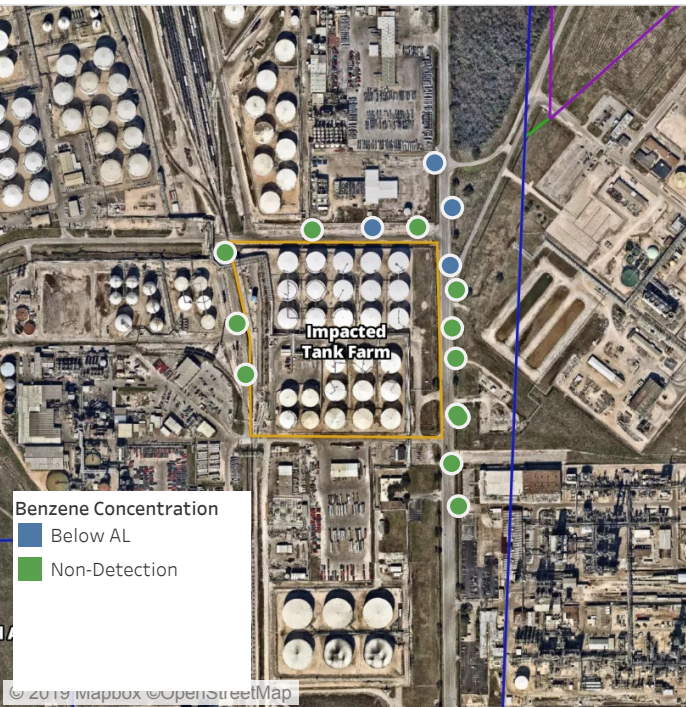
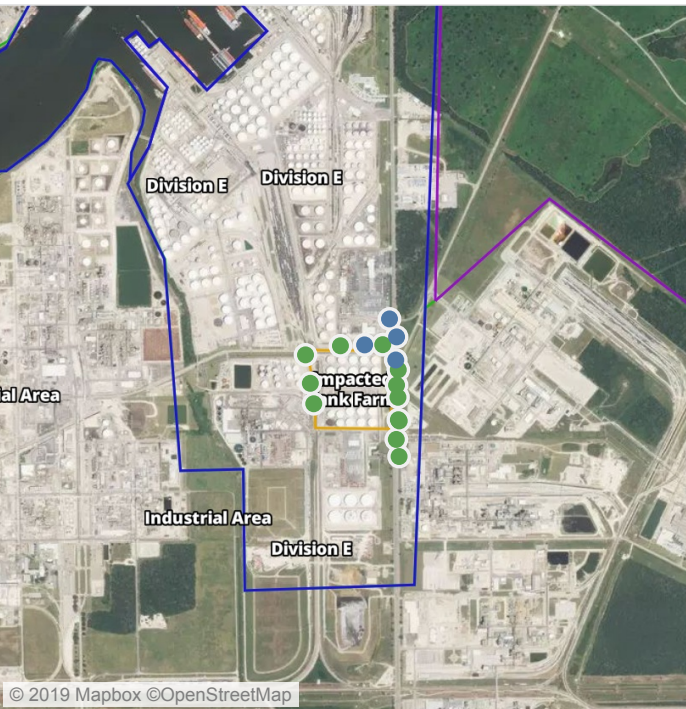
Reading Date
6/14/2019 2:00:00 AM to 6/14/2019 3:00:00 AM

Recent Benzene Detections

Location Category	Reading Date	Range of Detections
Division E	6/14/2019 02:45:45	0.03000 ppm
	6/14/2019 02:49:35	0.06000 ppm
	6/14/2019 02:43:28	0.05000 ppm
	6/14/2019 02:54:30	0.03000 ppm

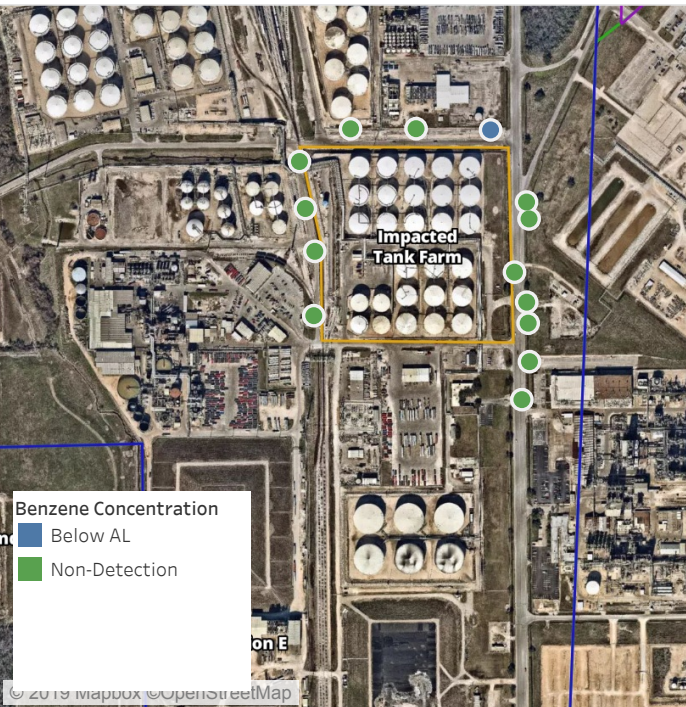
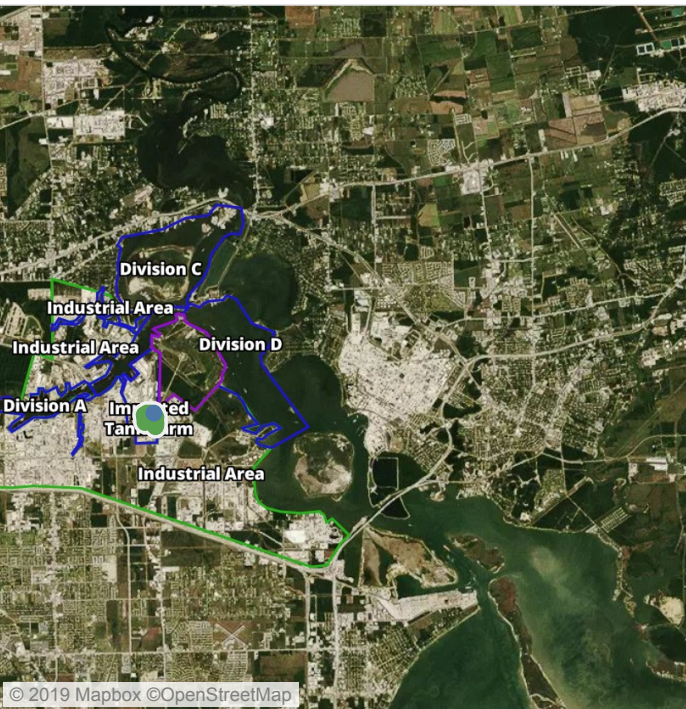
Reading Date
6/14/2019 4:00:00 AM to 6/14/2019 5:00:00 AM

Recent Benzene Detections

Location Category	Reading Date	Range of Detections
Division E	6/14/2019 04:50:06	0.07000 ppm

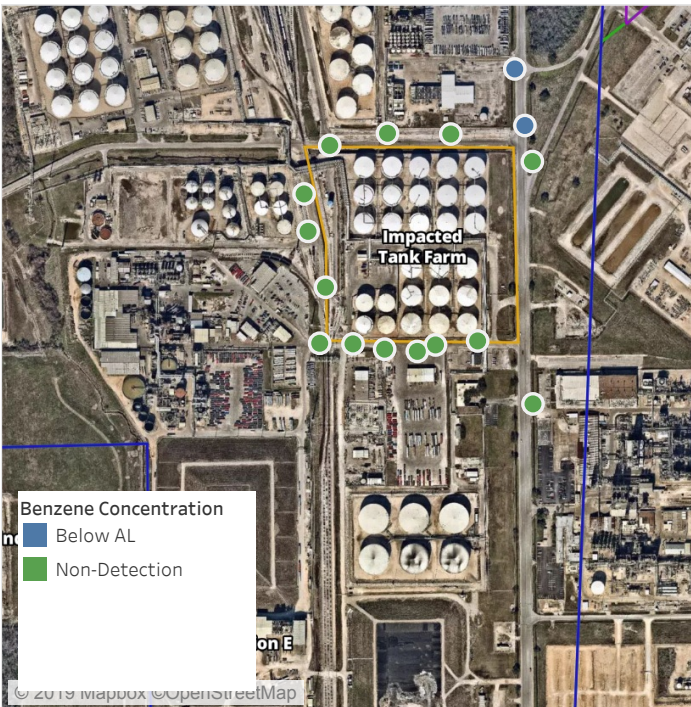
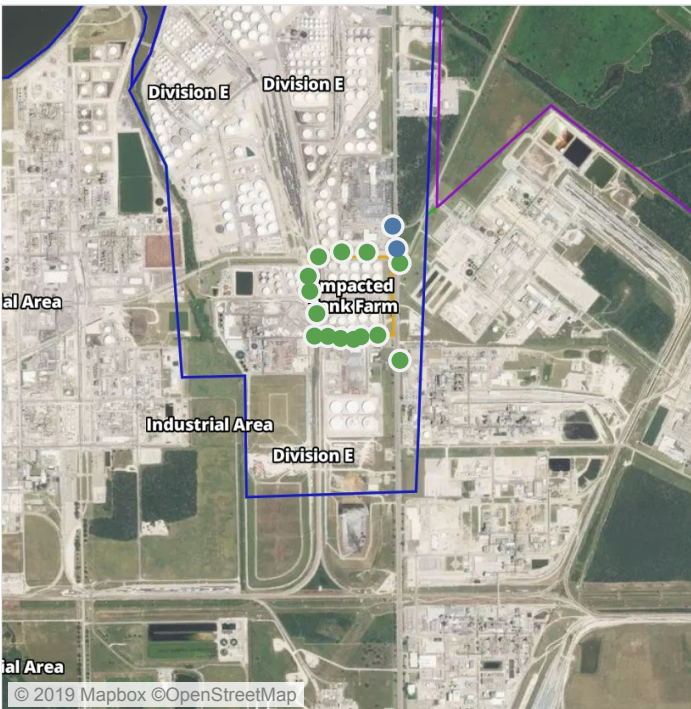
Reading Date
6/14/2019 5:00:00 AM to 6/14/2019 6:00:00 AM

Recent Benzene Detections

Location Category	Reading Date	Range of Detections
Division E	6/14/2019 05:04:34	0.09000 ppm
	6/14/2019 05:07:04	0.09000 ppm

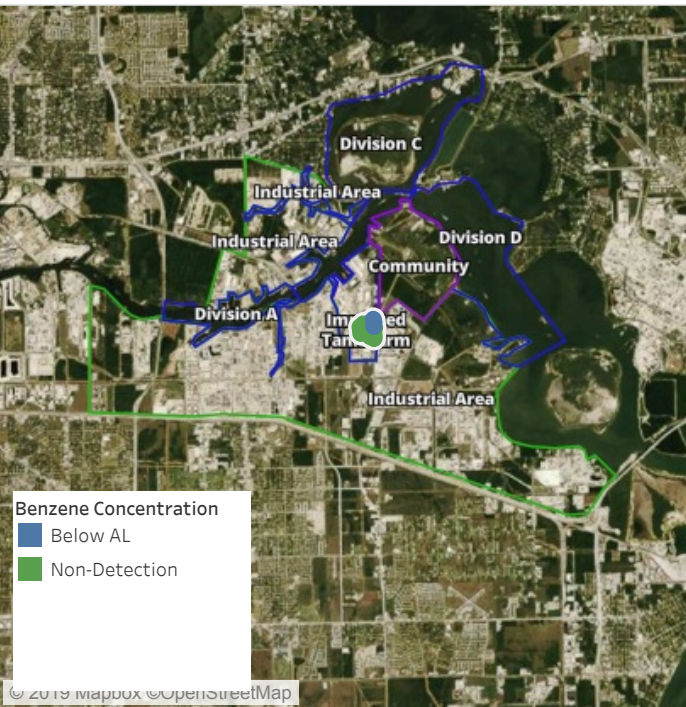
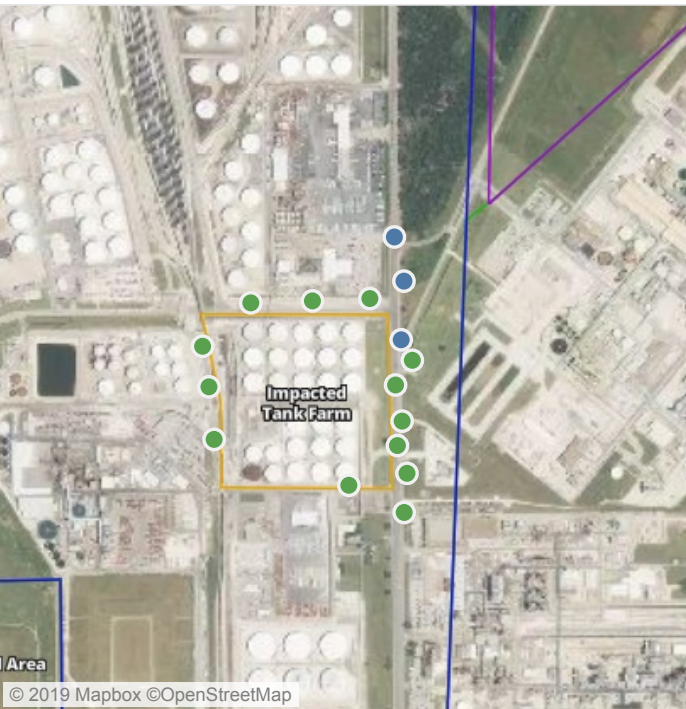
Reading Date
6/14/2019 6:00:00 AM to 6/14/2019 7:00:00 AM

Recent Benzene Detections

Location Category	Reading Date	Range of Detections
Division E	6/14/2019 06:34:31	0.06000 ppm
	6/14/2019 06:36:32	0.05000 ppm
	6/14/2019 06:39:05	0.05000 ppm

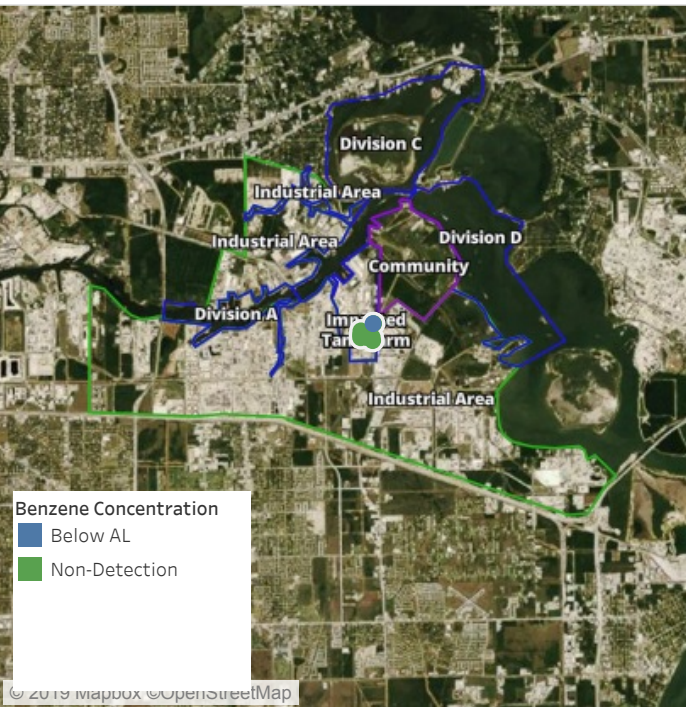
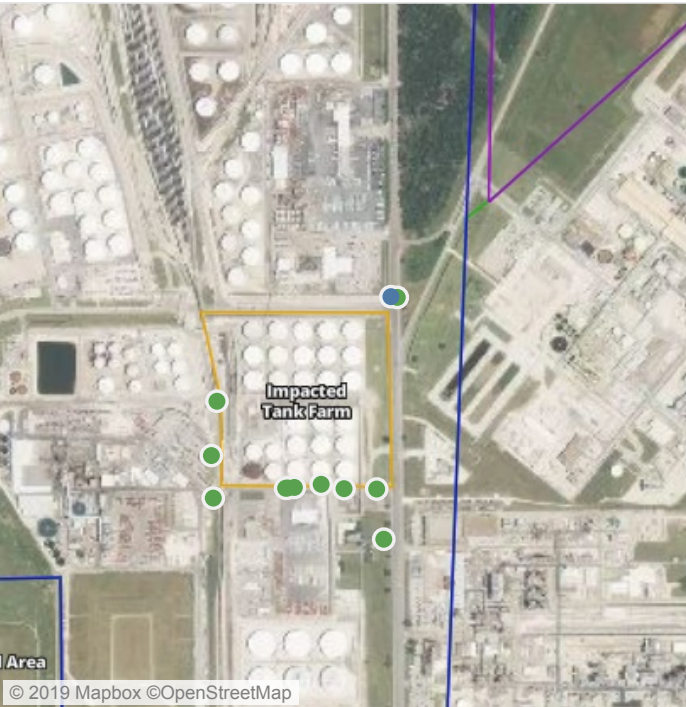
Reading Date
6/14/2019 7:00:00 AM to 6/14/2019 8:00:00 AM

Recent Benzene Detections

Location Category	Reading Date	Range of Detections
Division E	6/14/2019 07:29:52	0.03000 ppm

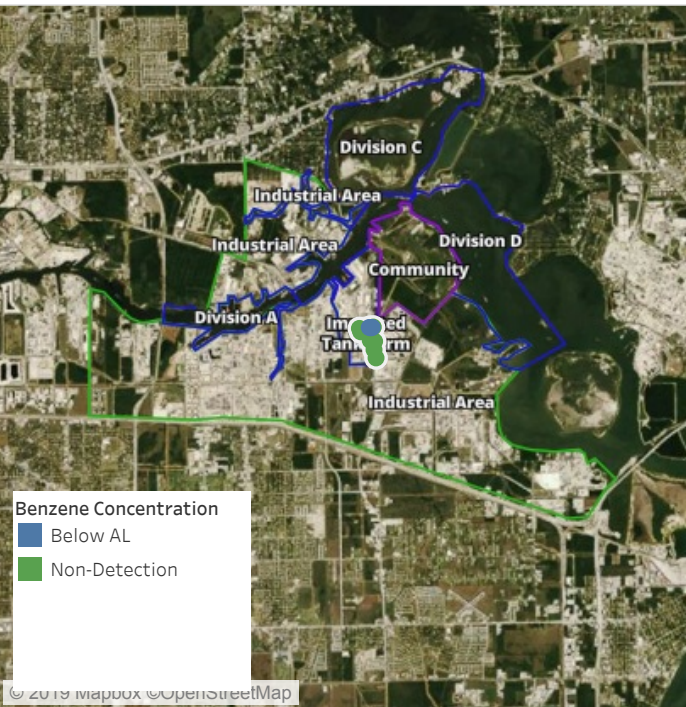
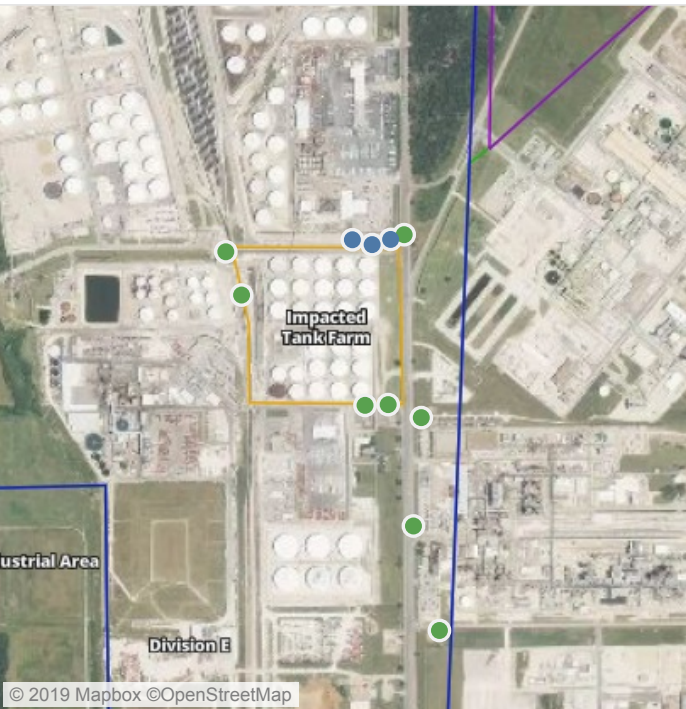
Reading Date
6/14/2019 8:00:00 AM to 6/14/2019 9:00:00 AM

Recent Benzene Detections

Location Category	Reading Date	Range of Detections
Division E	6/14/2019 08:24:21	0.05000 ppm
	6/14/2019 08:36:39	0.07000 ppm
	6/14/2019 08:47:26	0.04000 ppm
