# Preliminary Hand- Held Air Monitoring Locations | ITC Deer Park Tank Fire

Reading Date  
6/20/2019 11:00:00 PM to 6/21/2019 12:00:00 AM

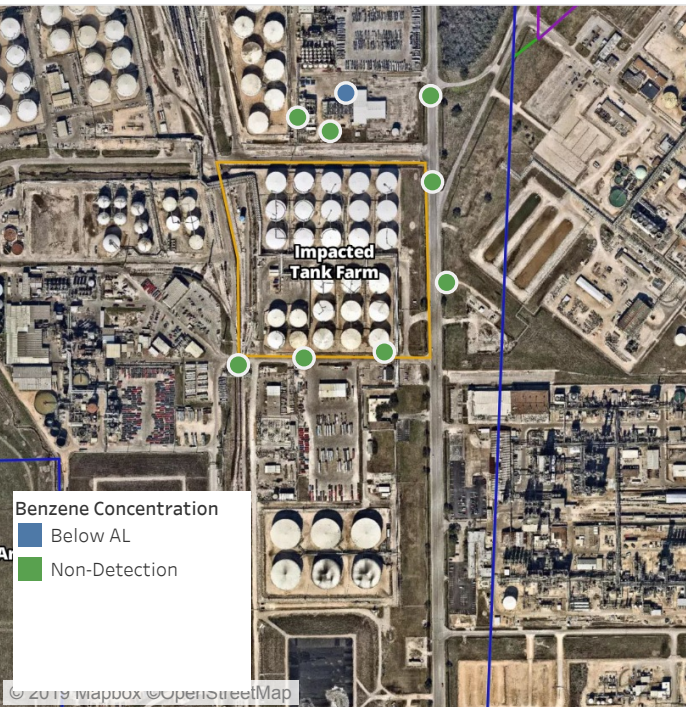
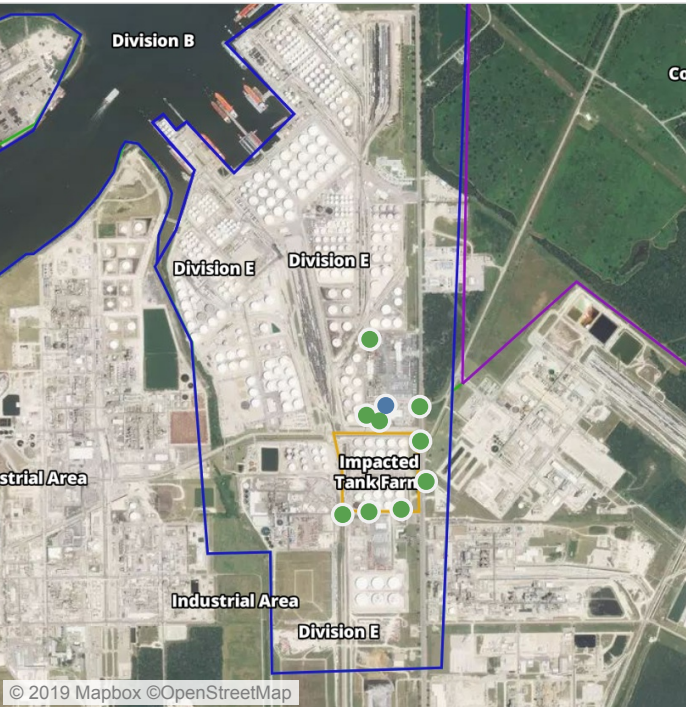
Location Category	Reading Date	Range of Detections
Division E	6/20/2019 23:11:17	0.03000 ppm

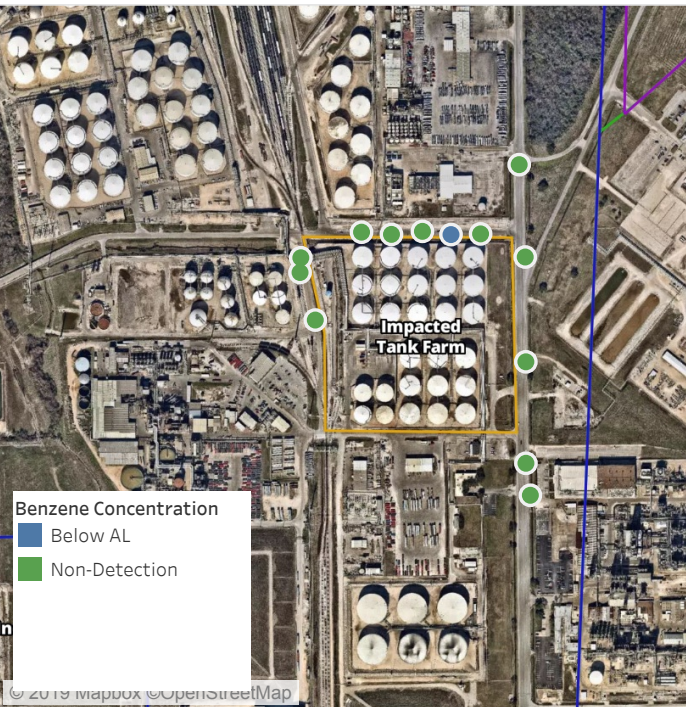
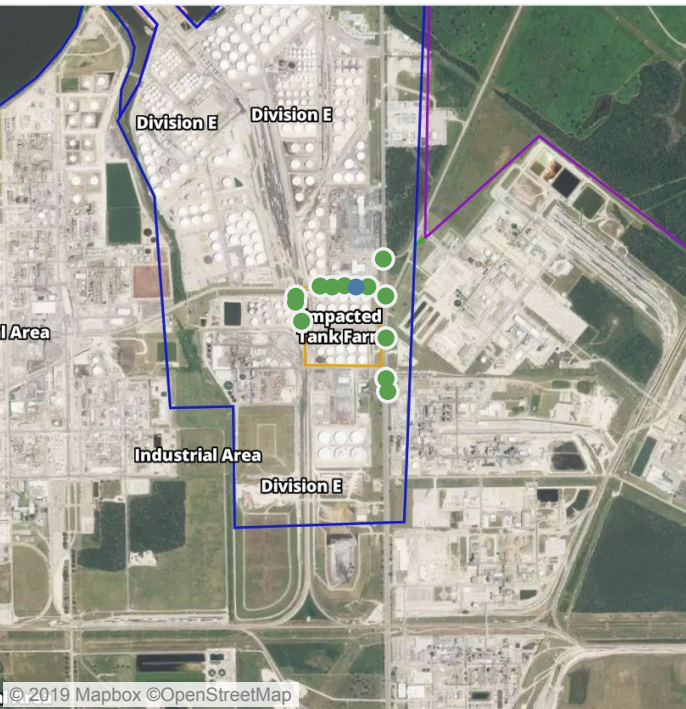
Location Category	Reading Date	Range of Detections
Division E	6/21/2019 02:39:53	0.09000 ppm

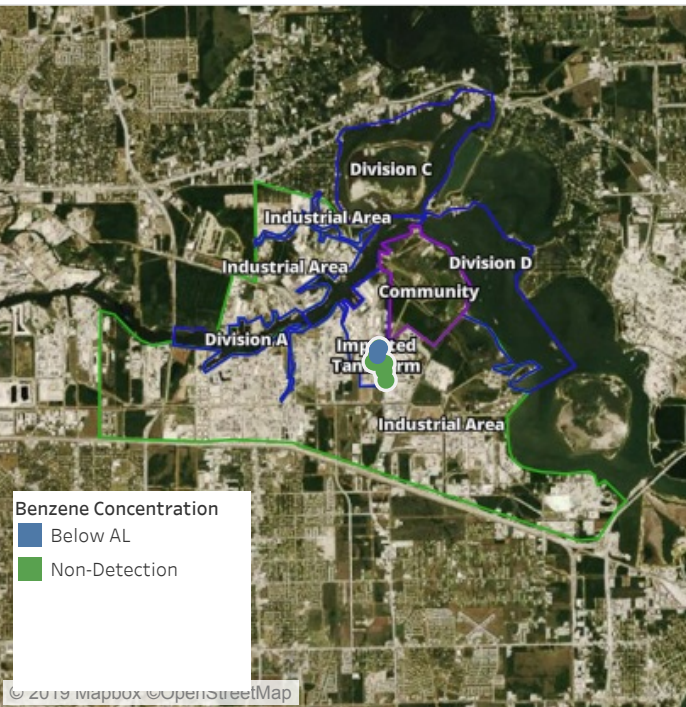
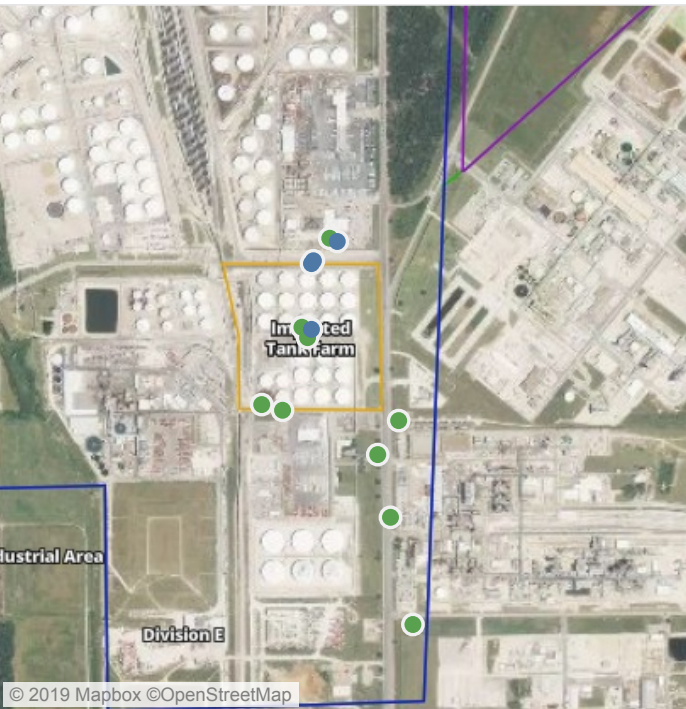
Location Category	Reading Date	Range of Detections
Division E	6/21/2019 08:45:40	0.06000 ppm
	6/21/2019 08:46:27	0.08000 ppm
	6/21/2019 08:56:13	0.05000 ppm
Impacted Tank Farm	6/21/2019 08:03:46	0.02000 ppm

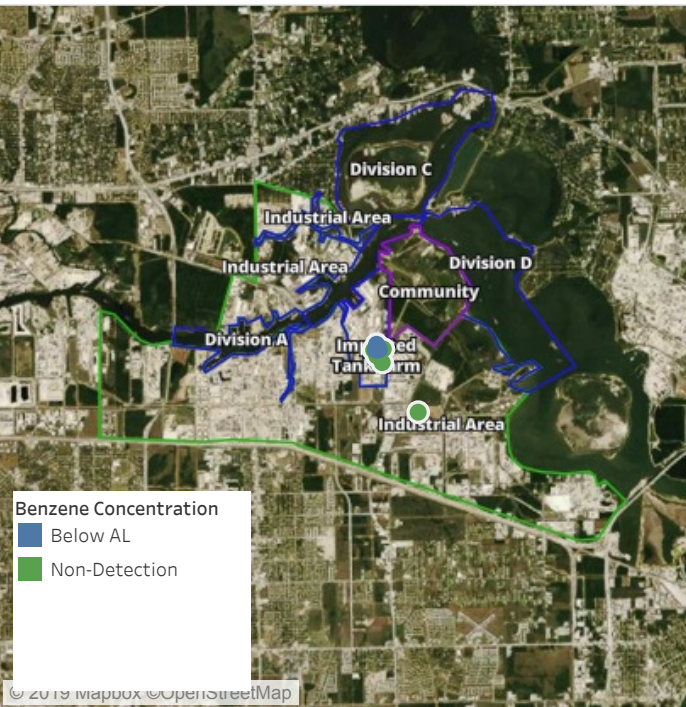
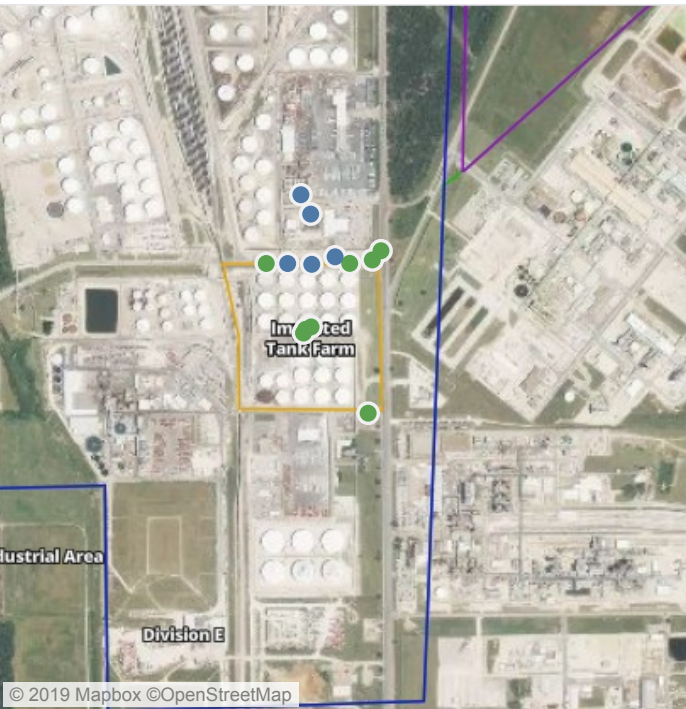
Location Category	Reading Date	Range of Detections
Division E	6/21/2019 09:10:51	0.04000 ppm
	6/21/2019 09:12:03	0.07000 ppm
	6/21/2019 09:23:44	0.04000 ppm
	6/21/2019 09:33:47	0.02000 ppm
	6/21/2019 09:45:09	0.02000 ppm

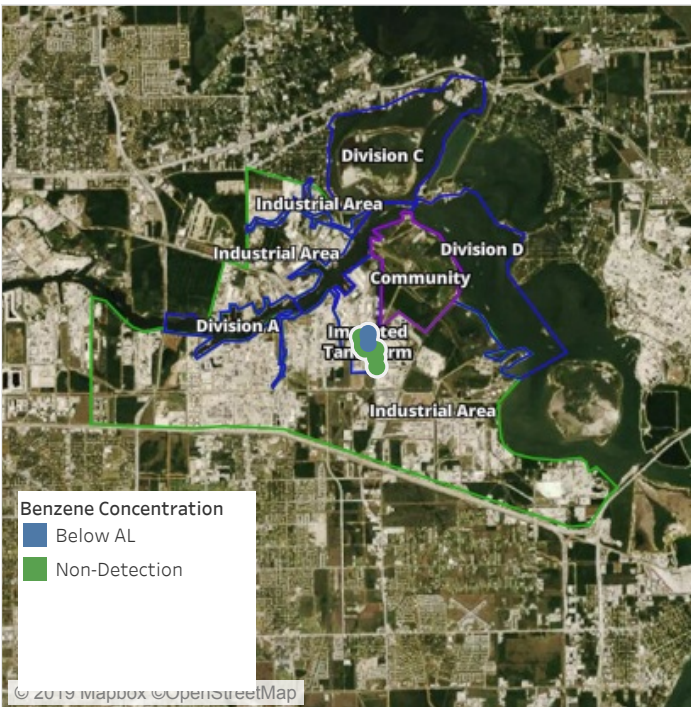
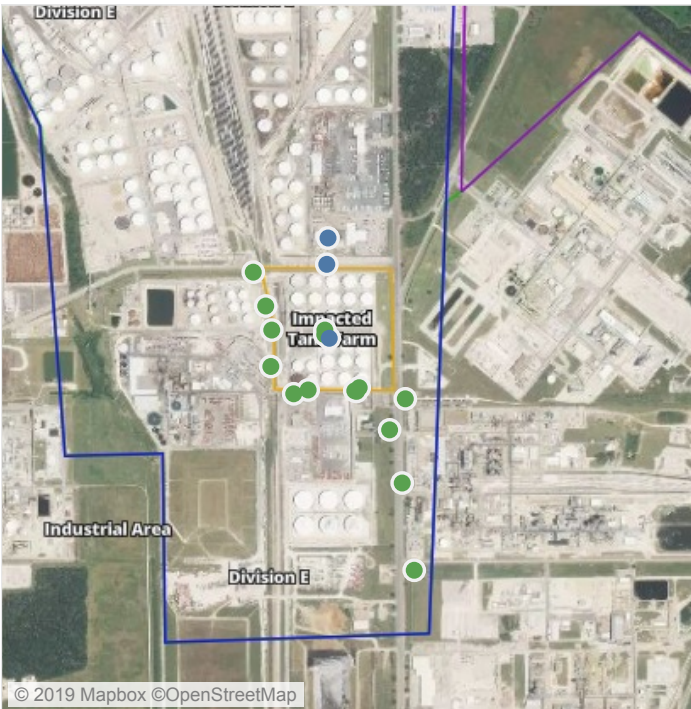
Location Category	Reading Date	Range of Detections
Division E	6/21/2019 10:52:19	0.04000 ppm
	6/21/2019 10:51:28	0.04000 ppm
Impacted Tank Farm	6/21/2019 10:58:06	0.06000 ppm

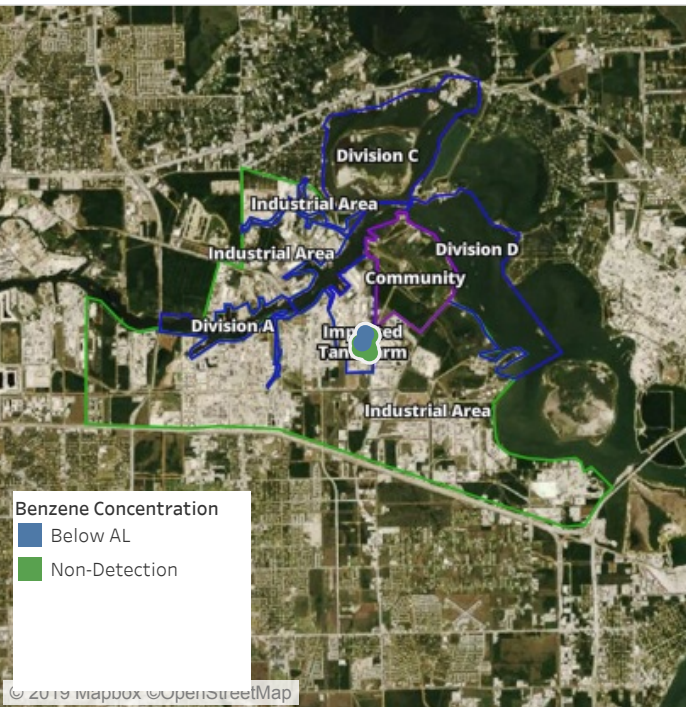
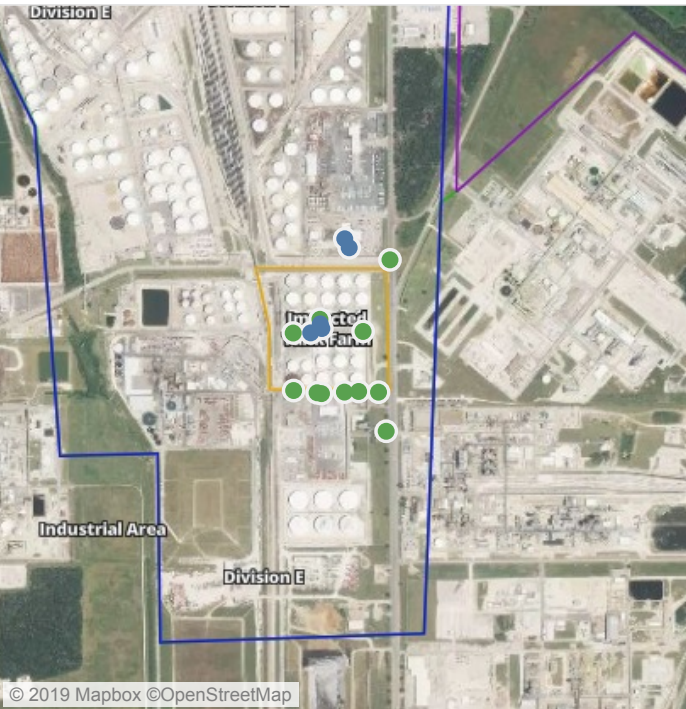
Location Category	Reading Date	Range of Detections
Division E	6/21/2019 11:01:10	0.09000 ppm
	6/21/2019 11:03:31	0.03000 ppm
Impacted Tank Farm	6/21/2019 11:18:34	0.03000 ppm
	6/21/2019 11:25:38	0.05000 ppm
	6/21/2019 11:51:38	0.09000 ppm

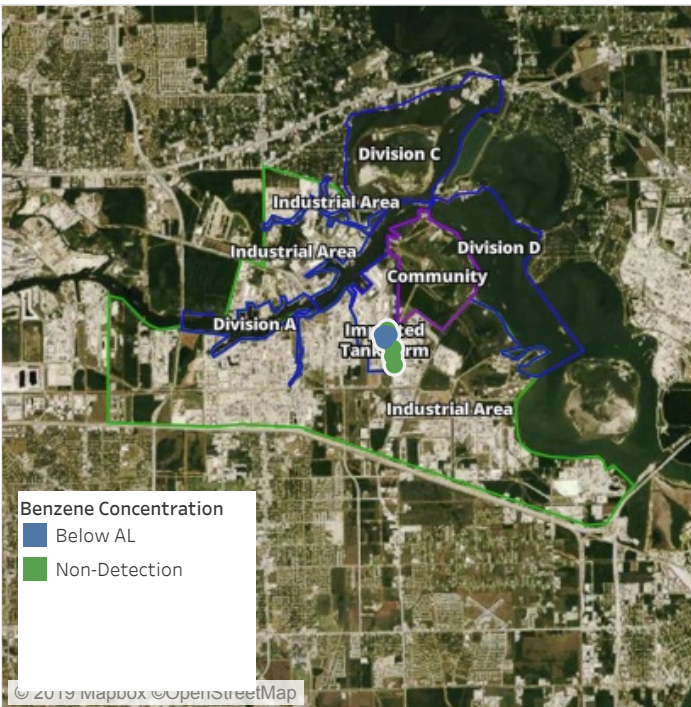
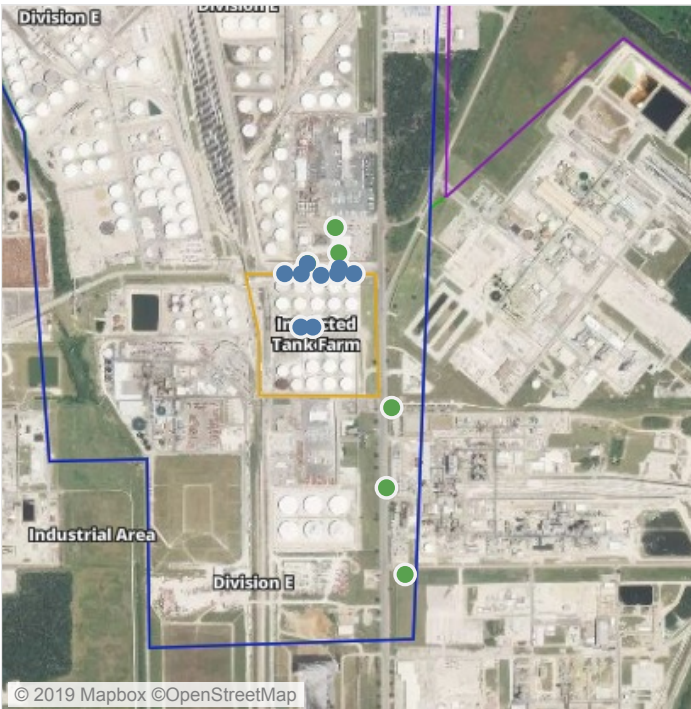
Location Category	Reading Date	Range of Detections
Division E	6/21/2019 12:17:43	0.04000 ppm
	6/21/2019 12:26:32	0.02000 ppm
	6/21/2019 12:34:26	0.02000 ppm
	6/21/2019 12:43:17	0.06000 ppm
	6/21/2019 12:53:34	0.03000 ppm
	6/21/2019 12:59:50	0.04000 ppm
	6/21/2019 12:43:49	0.05000 ppm
Impacted Tank Farm	6/21/2019 12:10:22	0.10000 ppm
	6/21/2019 12:40:04	0.06000 ppm

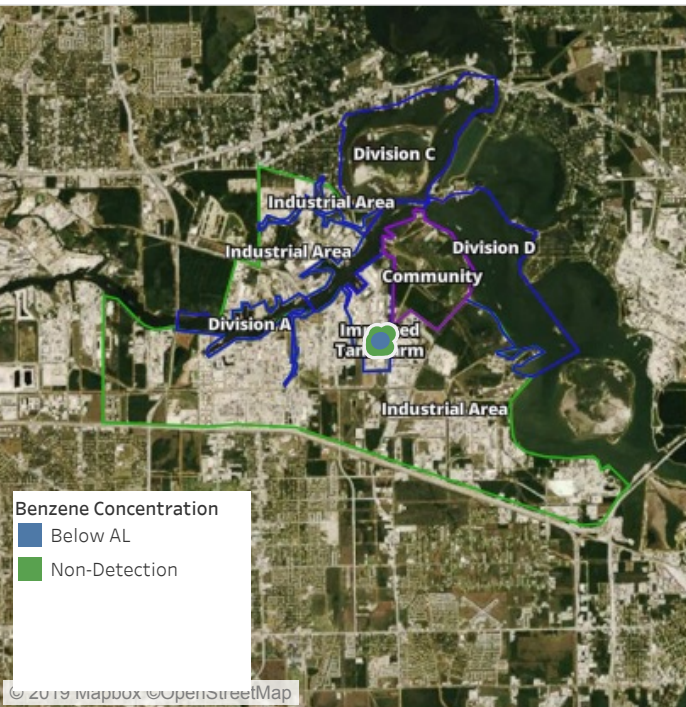
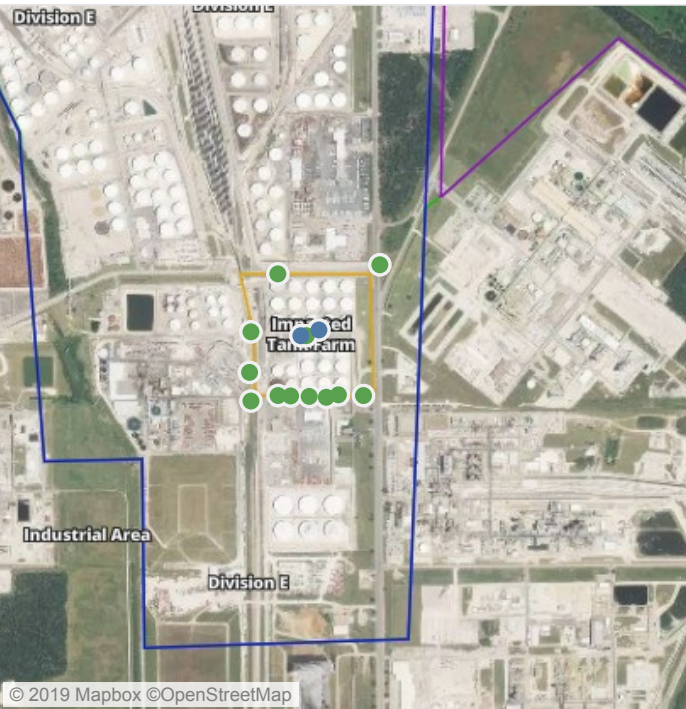
Location Category	Reading Date	Range of Detections
Impacted Tank Farm	6/21/2019 13:01:13	0.07000 ppm
	6/21/2019 13:47:20	0.03000 ppm

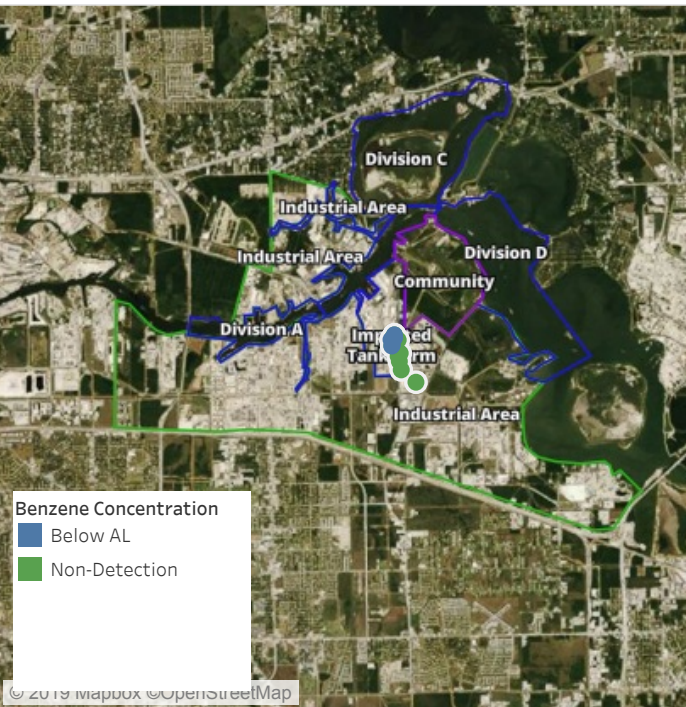
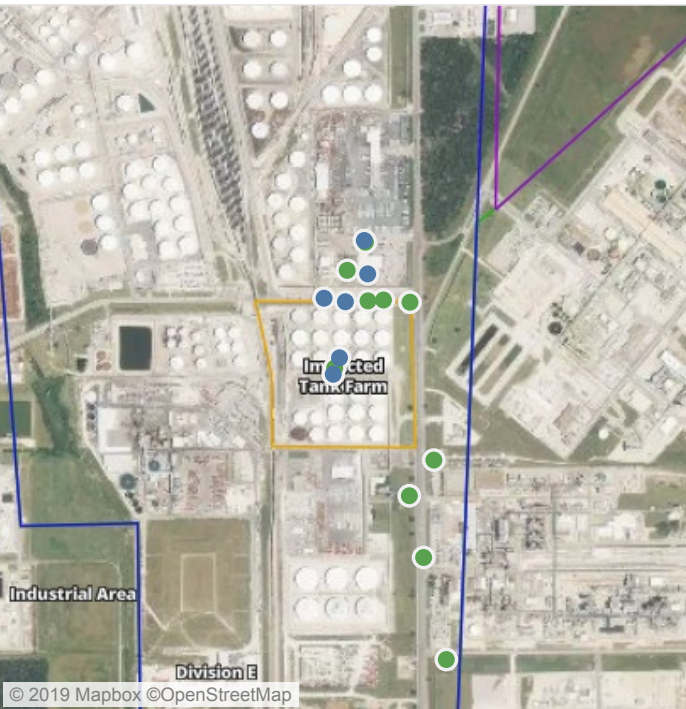
Location Category	Reading Date	Range of Detections
Division E	6/21/2019 14:26:45	0.05000 ppm
	6/21/2019 14:36:24	0.05000 ppm
	6/21/2019 14:57:45	0.03000 ppm
	6/21/2019 14:51:36	0.03000 ppm
Impacted Tank Farm	6/21/2019 14:07:31	0.11000 ppm
	6/21/2019 14:47:24	0.05000 ppm

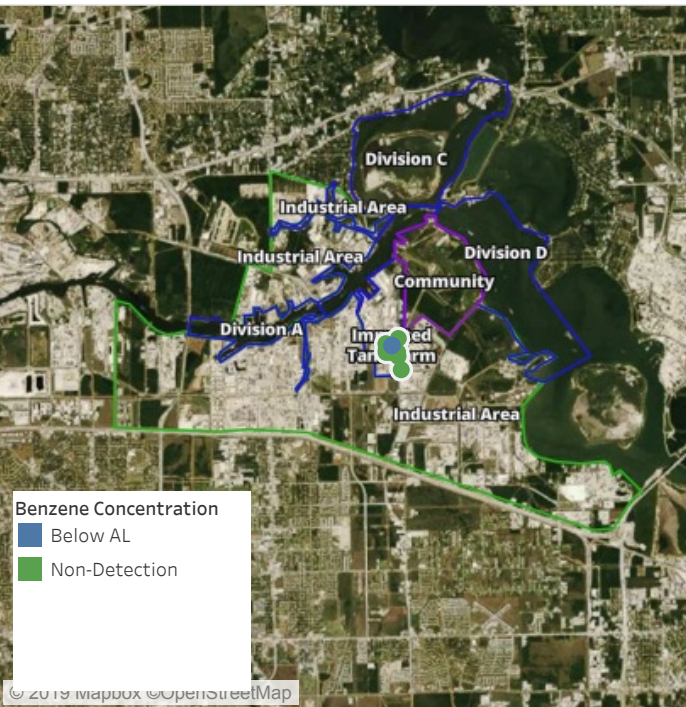
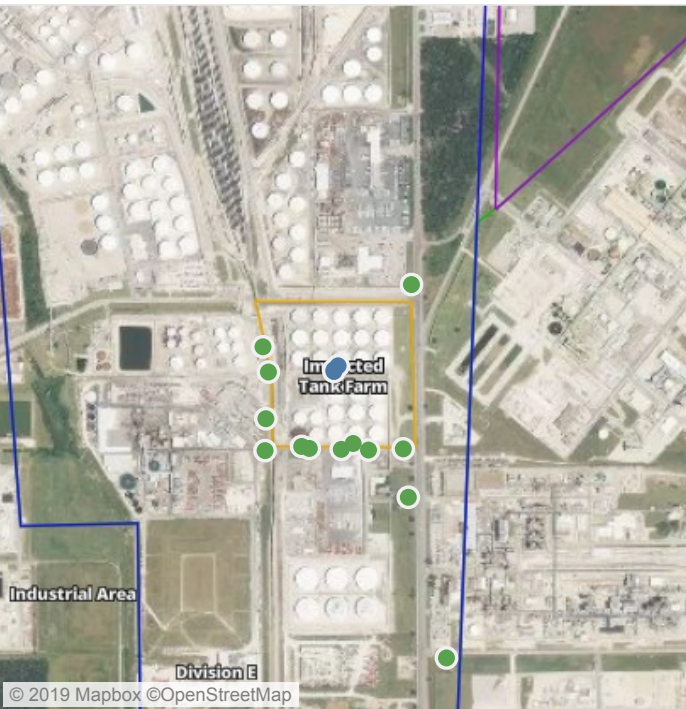
Location Category	Reading Date	Range of Detections
Impacted Tank Farm	6/21/2019 15:15:55	0.05000 ppm
	6/21/2019 15:54:20	0.05000 ppm
	6/21/2019 15:34:32	0.02000 ppm

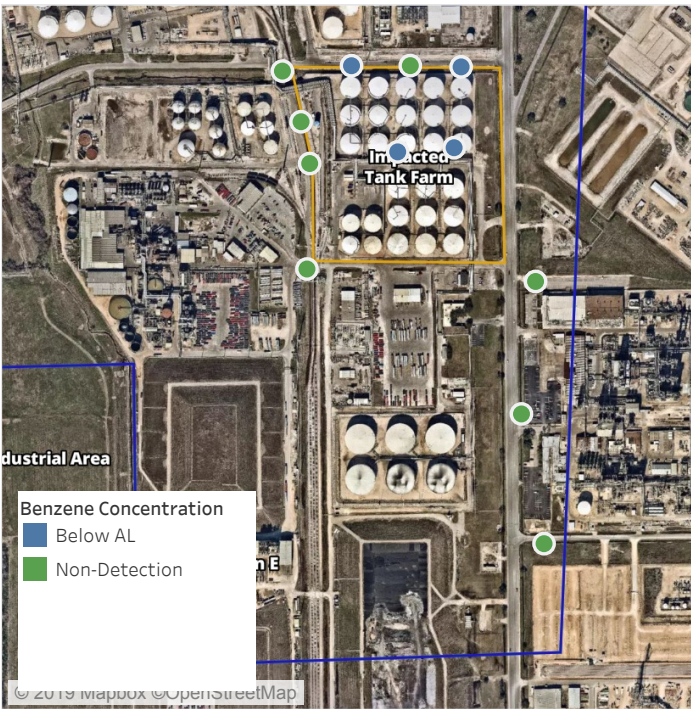
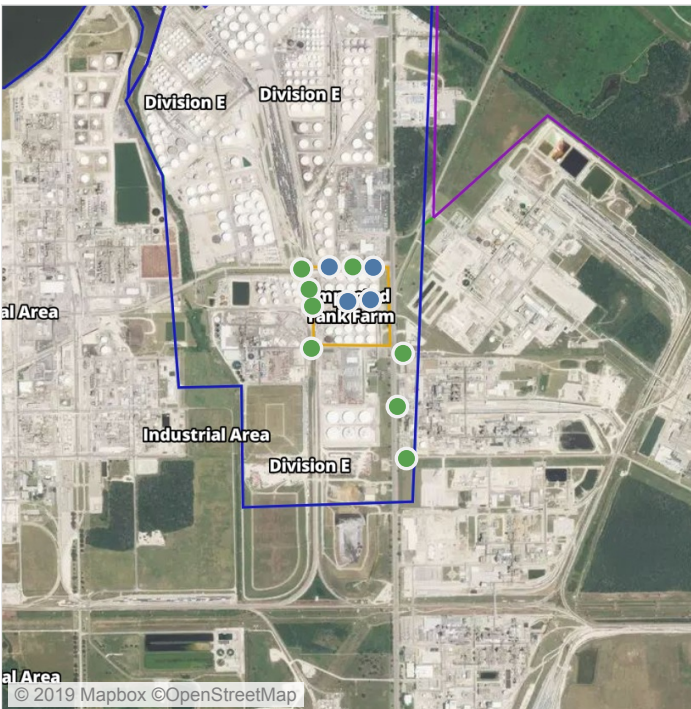
Location Category	Reading Date	Range of Detections
Division E	6/21/2019 18:15:23	0.08000 ppm
	6/21/2019 18:26:06	0.03000 ppm
Impacted Tank Farm	6/21/2019 18:15:18	0.03000 ppm
	6/21/2019 18:34:56	0.08000 ppm
	6/21/2019 18:55:39	0.03000 ppm

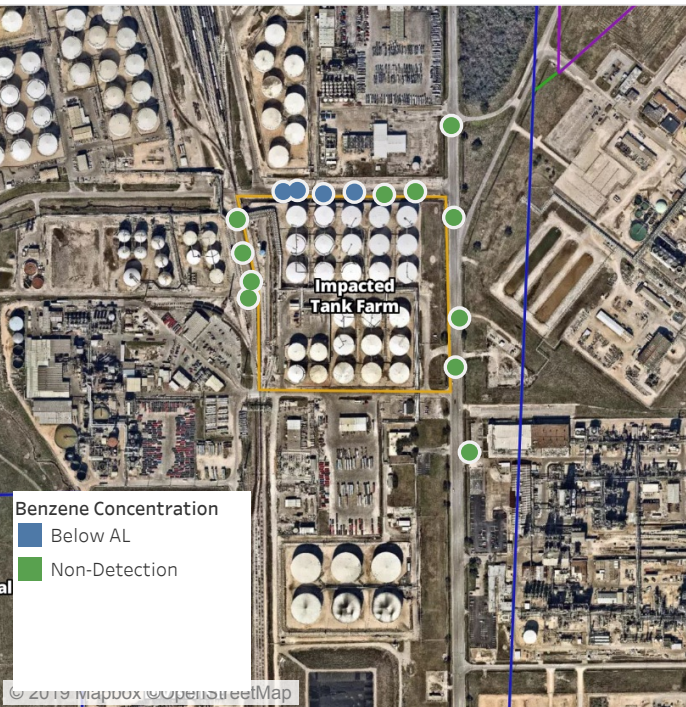
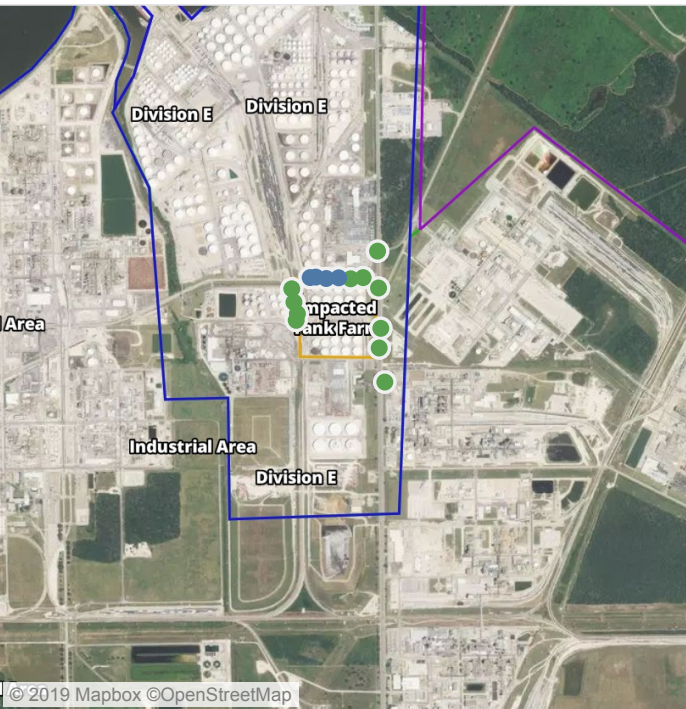
Location Category	Reading Date	Range of Detections
Division E	6/21/2019 20:22:53	0.05000 ppm
	6/21/2019 20:18:14	0.05000 ppm
	6/21/2019 20:42:13	0.06000 ppm
	6/21/2019 20:47:12	0.03000 ppm

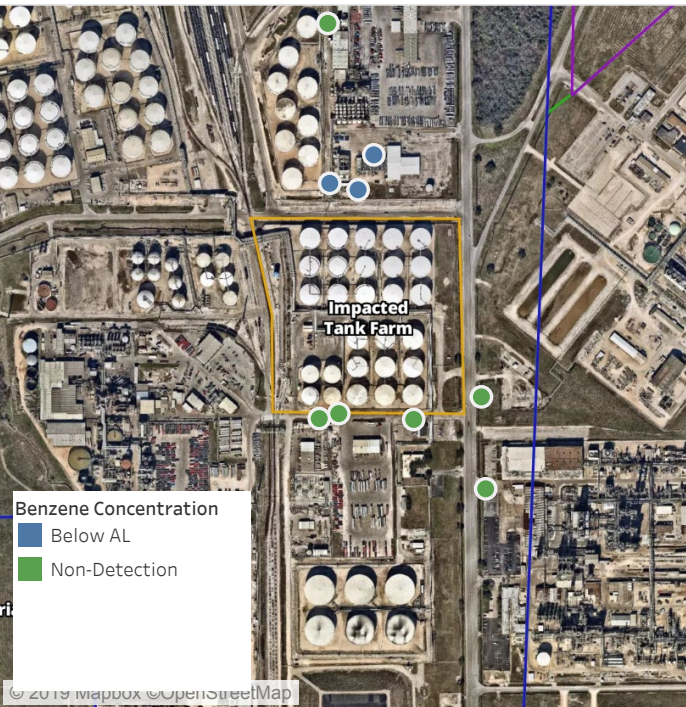
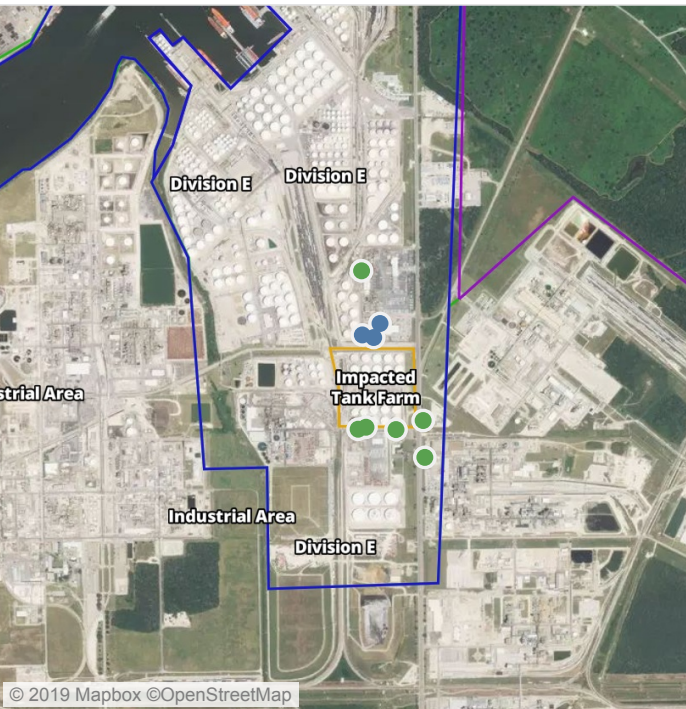
Location Category	Reading Date	Range of Detections
Division E	6/21/2019 21:18:12	0.0400 ppm
	6/21/2019 21:14:00	0.0400 ppm
	6/21/2019 21:23:01	0.3000 ppm

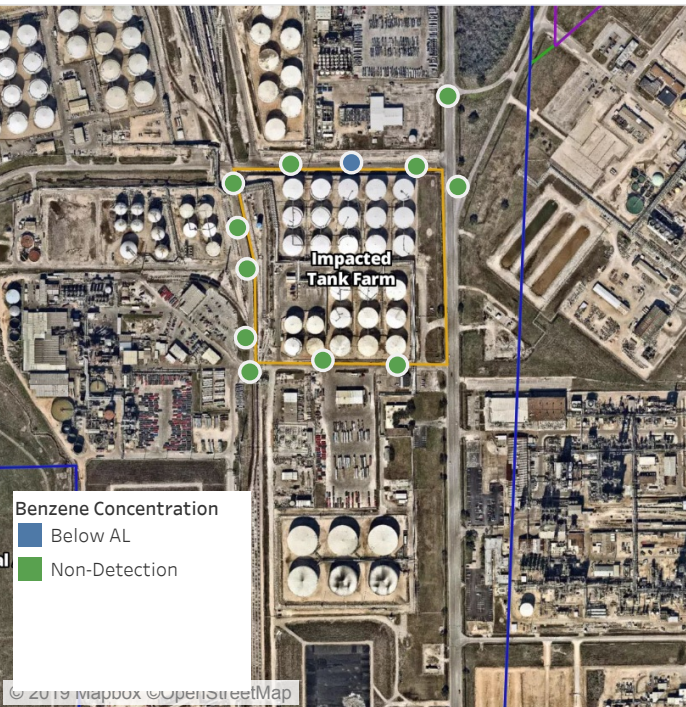
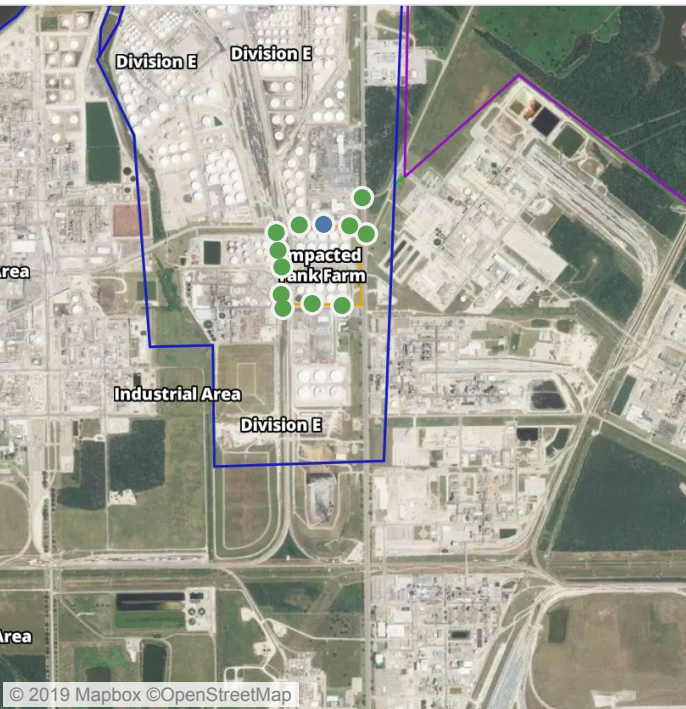
Location Category	Reading Date	Range of Detections
Division E	6/21/2019 22:46:56	0.3000 ppm
