Preliminary Hand- Held Air Monitoring Locations | ITC Deer Park Tank Fire

Reading Date
6/21/2019 11:00:00 PM to 6/22/2019 12:00:00 AM

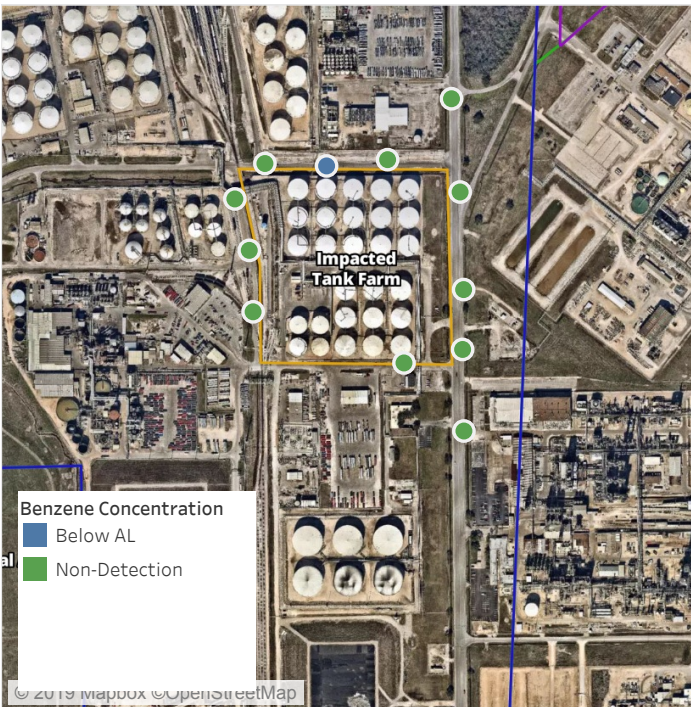
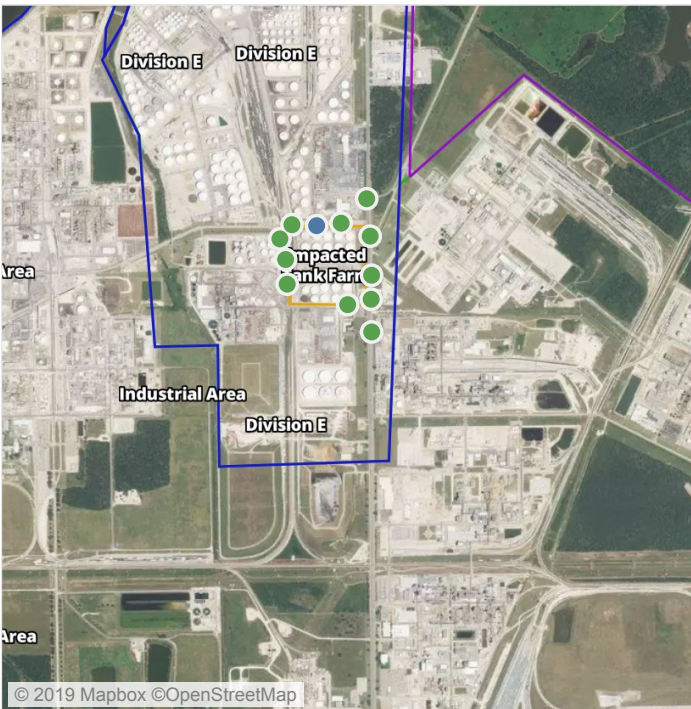
Location Category	Reading Date	Range of Detections
Division E	6/21/2019 23:11:03	0.07000 ppm

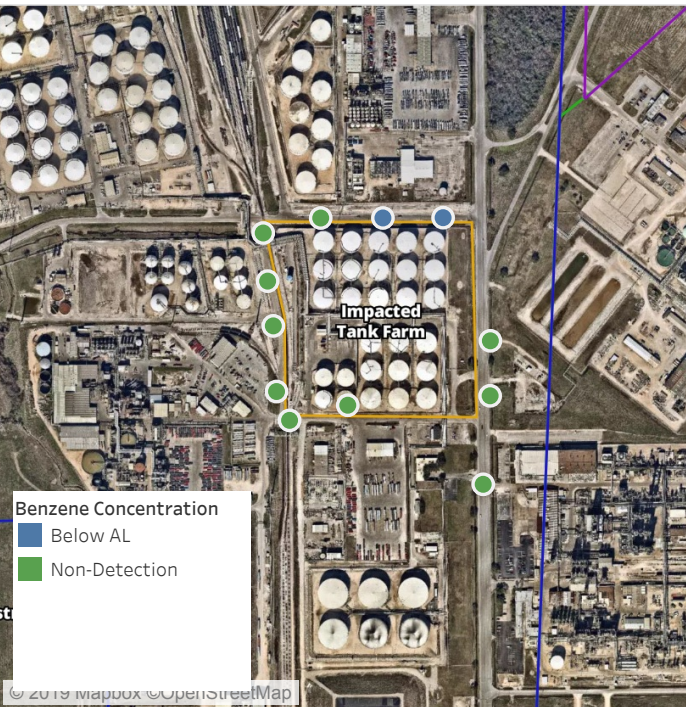
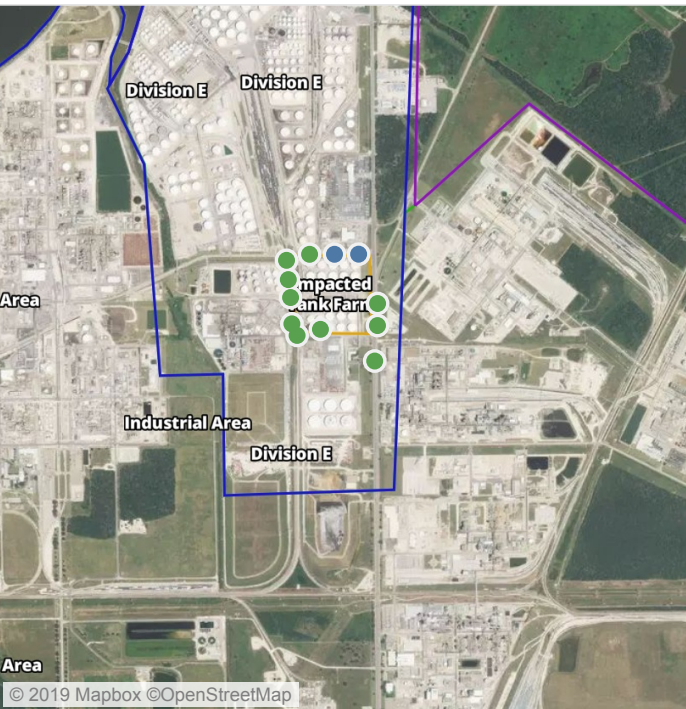
Reading Date
6/22/2019 12:00:00 AM to 6/22/2019 1:00:00 AM

Location Category	Reading Date	Range of Detections
Division E	6/22/2019 00:43:52	0.03000 ppm
	6/22/2019 00:51:25	0.03000 ppm

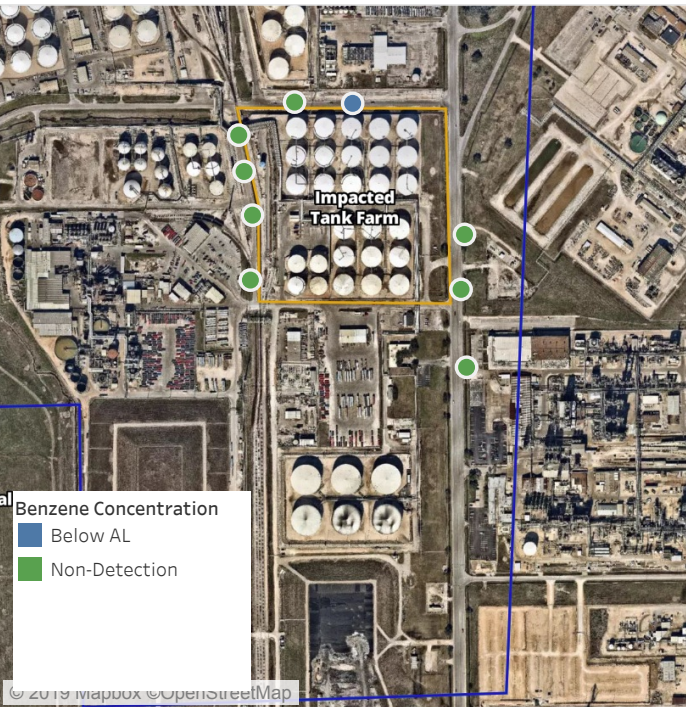
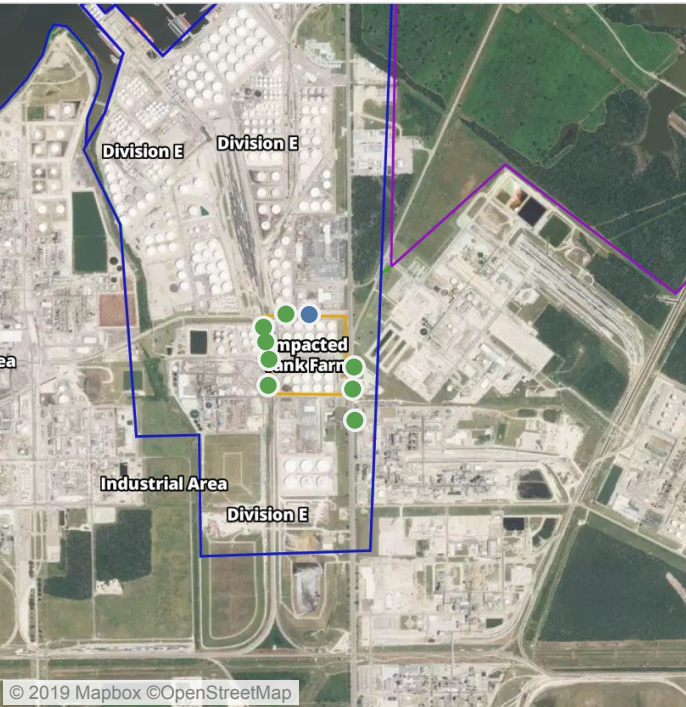
Reading Date
6/22/2019 2:00:00 AM to 6/22/2019 3:00:00 AM

Location Category	Reading Date	Range of Detections
Division E	6/22/2019 02:56:24	0.03000 ppm

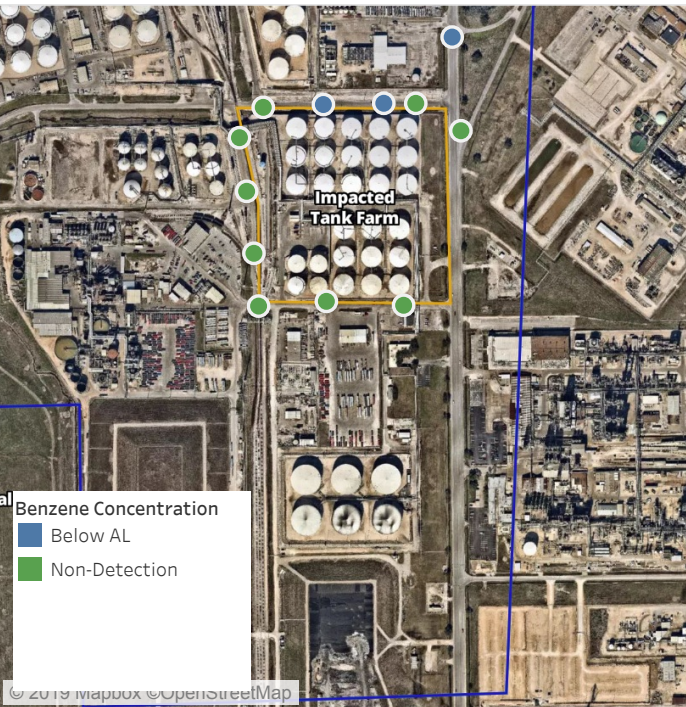
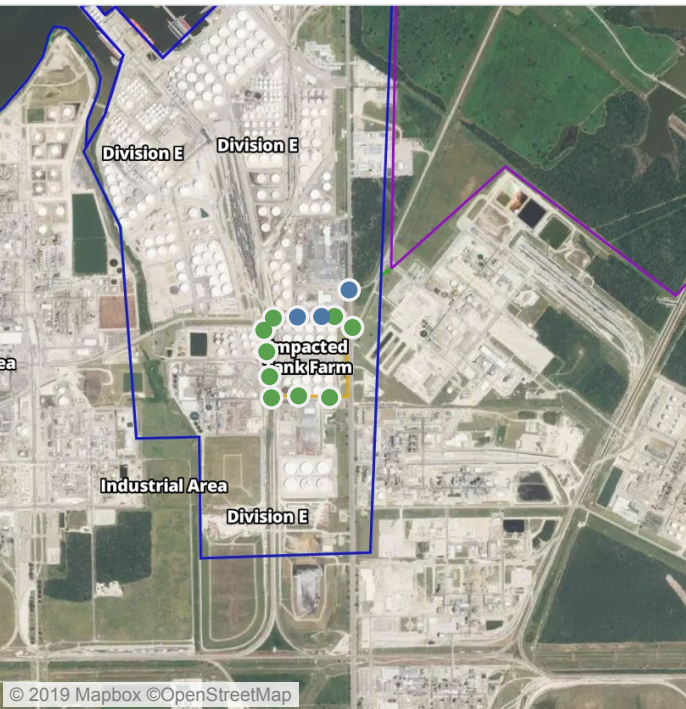
Reading Date
6/22/2019 3:00:00 AM to 6/22/2019 4:00:00 AM

Location Category	Reading Date	Range of Detections
Division E	6/22/2019 03:16:24	0.0500 ppm
	6/22/2019 03:21:33	0.4000 ppm
	6/22/2019 03:23:00	0.0300 ppm

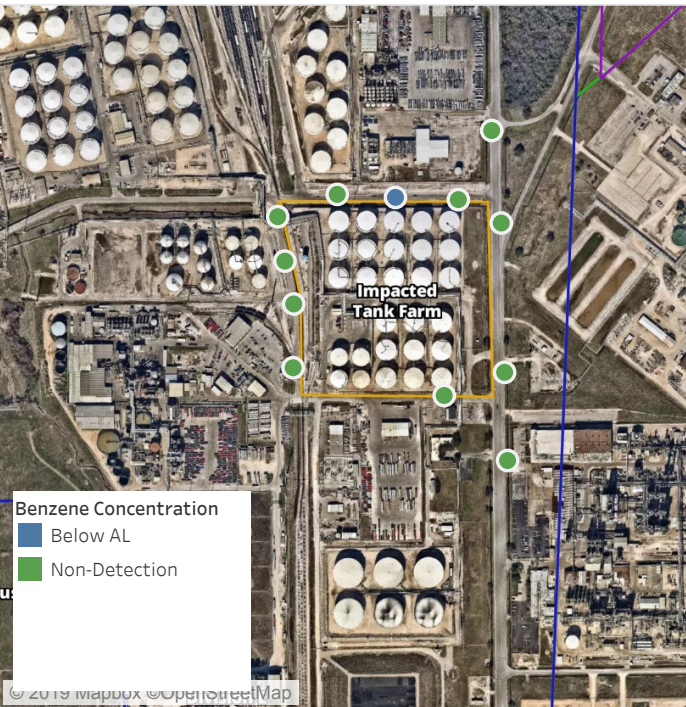
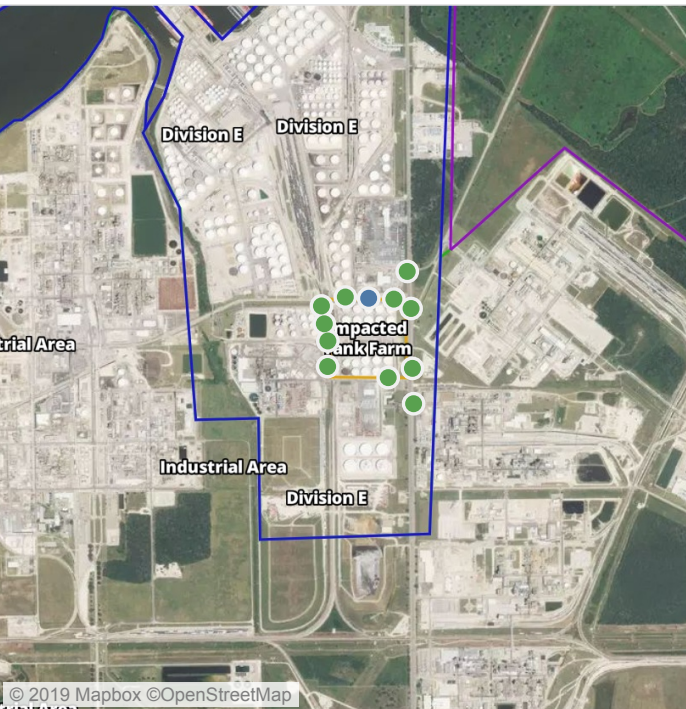
Reading Date
6/22/2019 4:00:00 AM to 6/22/2019 5:00:00 AM

Location Category	Reading Date	Range of Detections
Division E	6/22/2019 04:49:43	0.03000 ppm

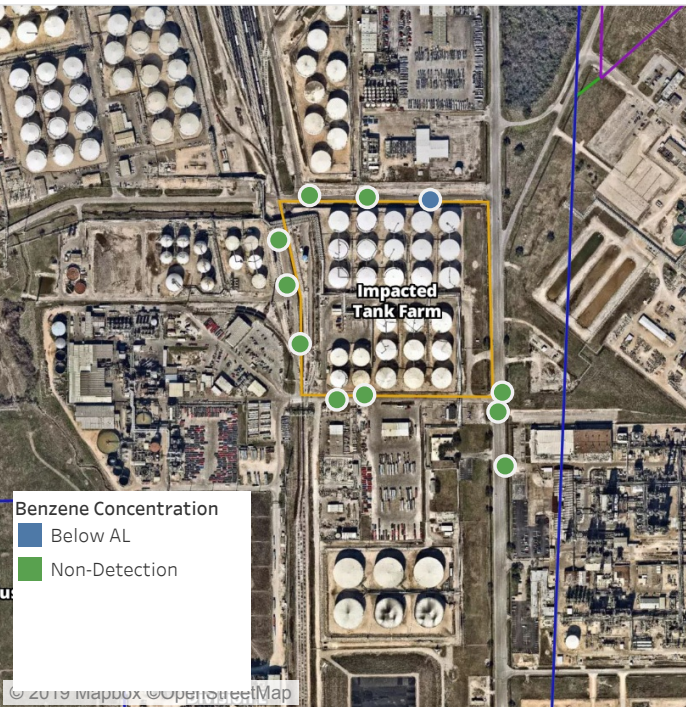
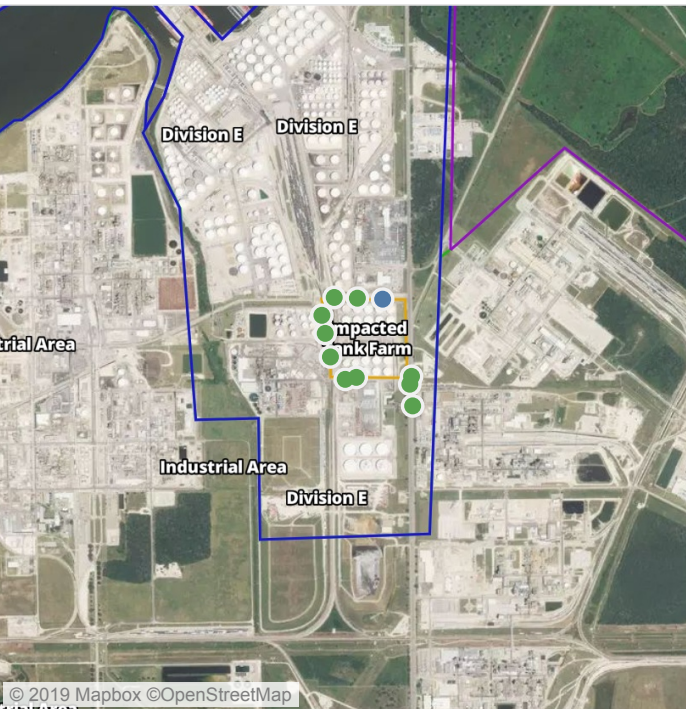
Reading Date
6/22/2019 5:00:00 AM to 6/22/2019 6:00:00 AM

Location Category	Reading Date	Range of Detections
Division E	6/22/2019 05:08:11	0.05000 ppm

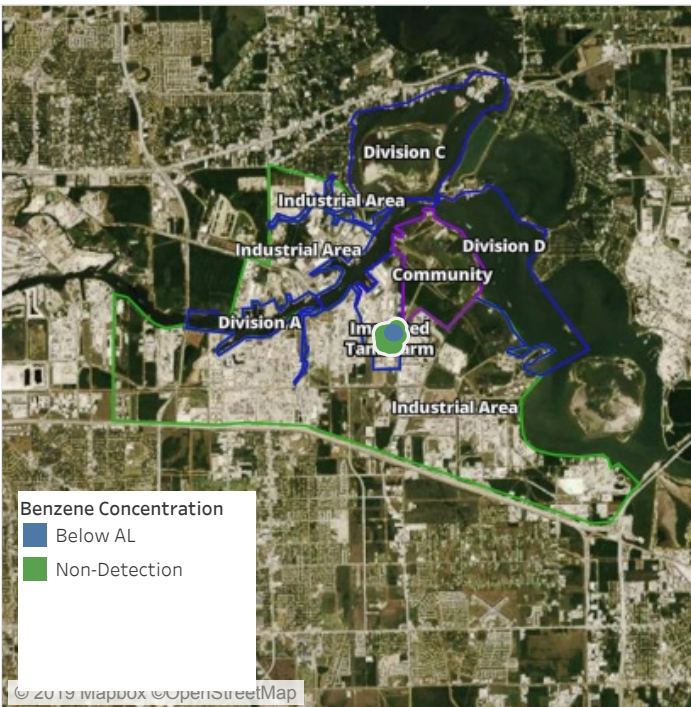
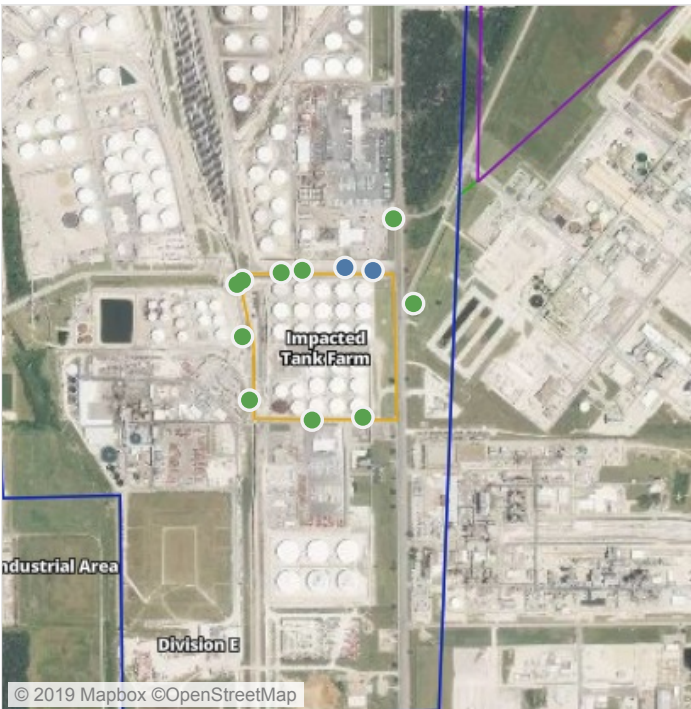
Reading Date
6/22/2019 6:00:00 AM to 6/22/2019 7:00:00 AM

Location Category	Reading Date	Range of Detections
Division E	6/22/2019 06:37:27	0.3000 ppm
	6/22/2019 06:41:41	0.0400 ppm

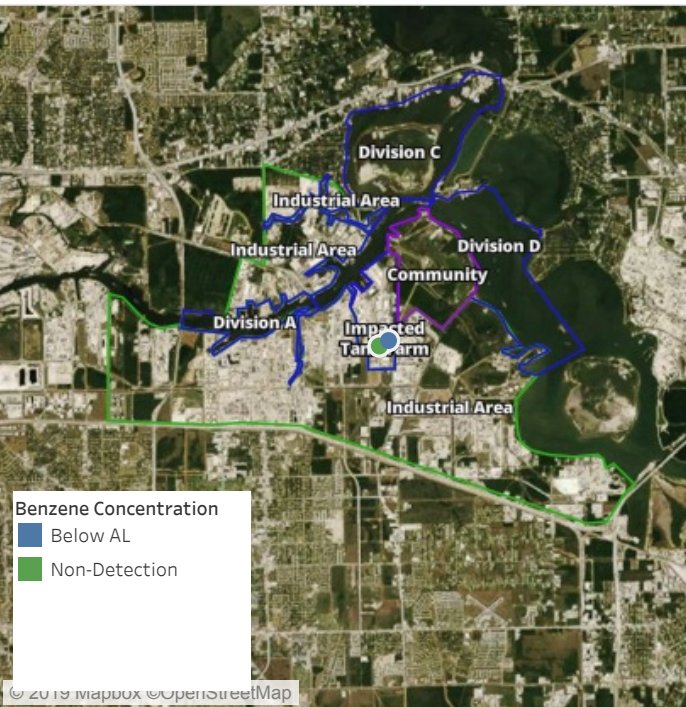
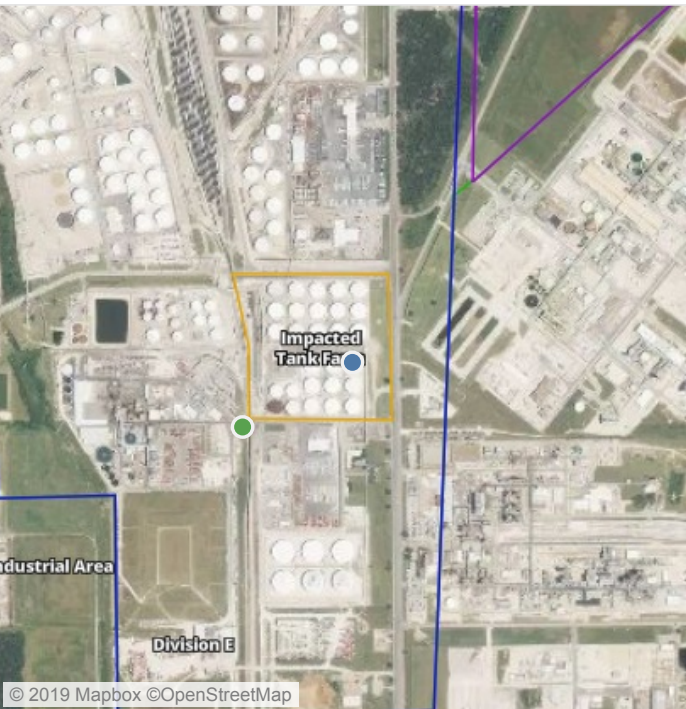
Reading Date
6/22/2019 7:00:00 AM to 6/22/2019 8:00:00 AM

Location Category	Reading Date	Range of Detections
Impacted Tank Farm	6/22/2019 07:53:30	0.04000 ppm

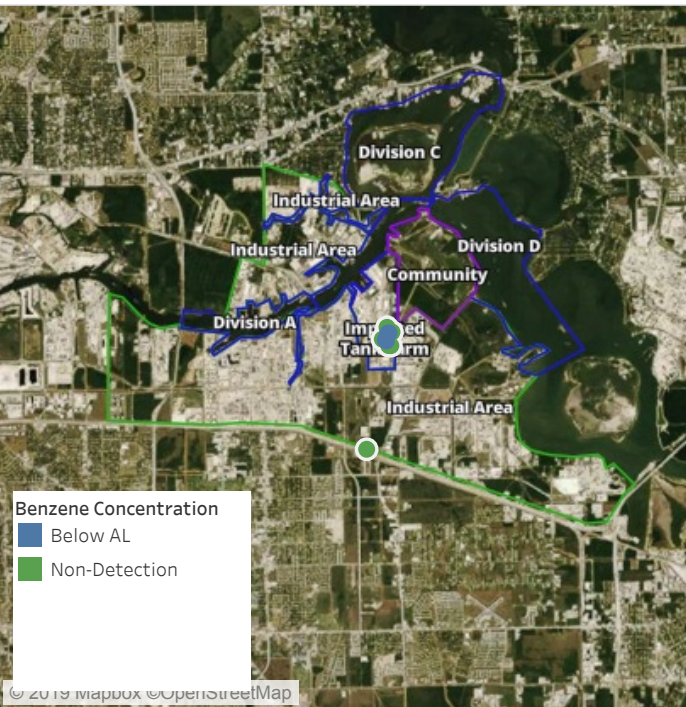
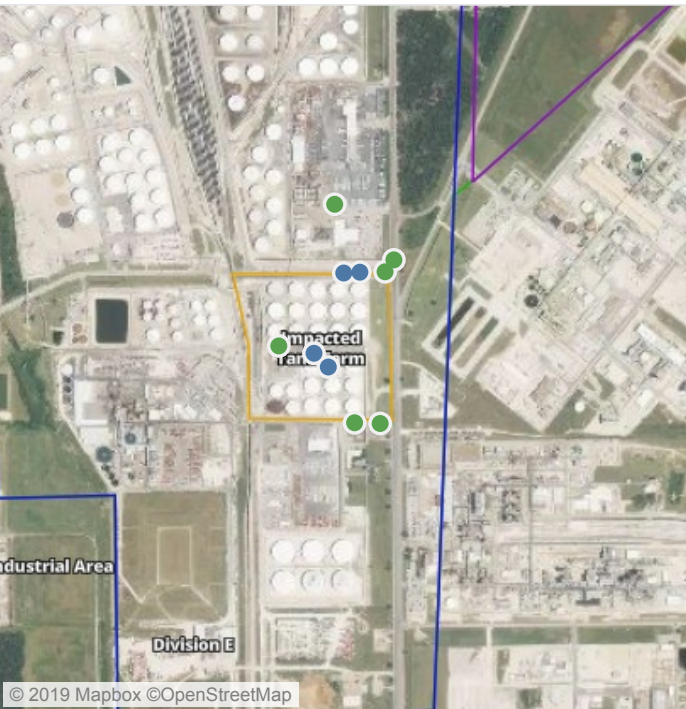
Reading Date
6/22/2019 9:00:00 AM to 6/22/2019 10:00:00 AM

Location Category	Reading Date	Range of Detections
Division E	6/22/2019 09:13:41	0.0500 ppm
	6/22/2019 09:21:41	0.0700 ppm
Impacted Tank Farm	6/22/2019 09:15:20	0.1300 ppm
	6/22/2019 09:49:25	0.2700 ppm

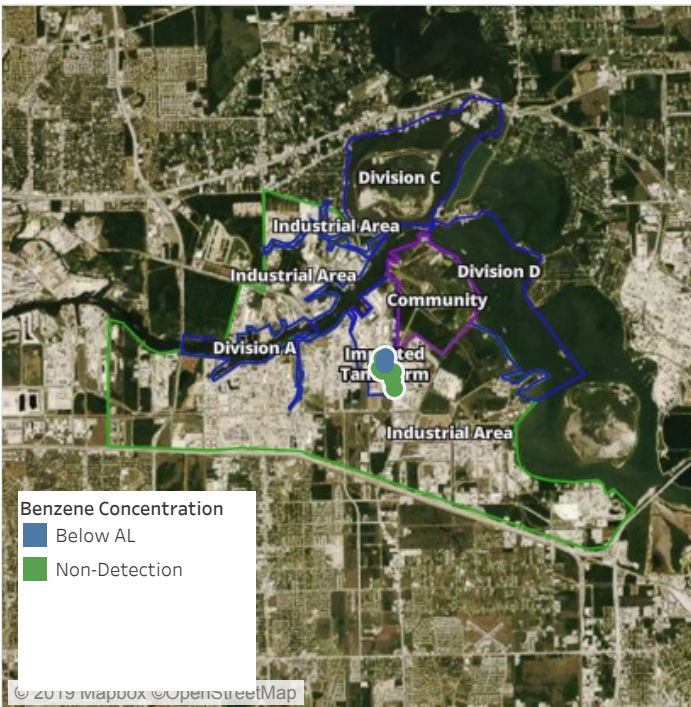
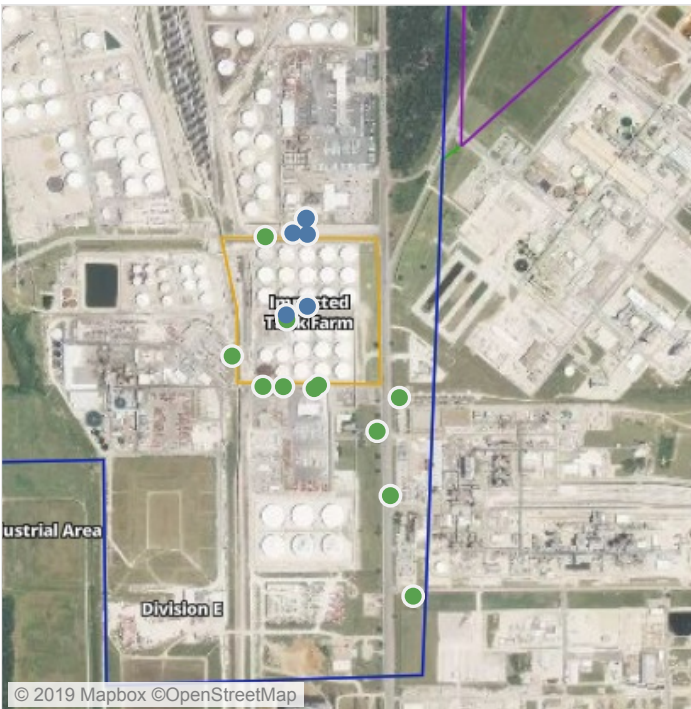
Reading Date
6/22/2019 10:00:00 AM to 6/22/2019 11:00:00 AM

Location Category	Reading Date	Range of Detections
Division E	6/22/2019 10:19:26	0.0700 ppm
	6/22/2019 10:30:37	0.0400 ppm
	6/22/2019 10:53:45	0.0300 ppm
	6/22/2019 10:52:56	0.0500 ppm
Impacted Tank Farm	6/22/2019 10:19:52	0.0400 ppm
	6/22/2019 10:44:50	0.1300 ppm

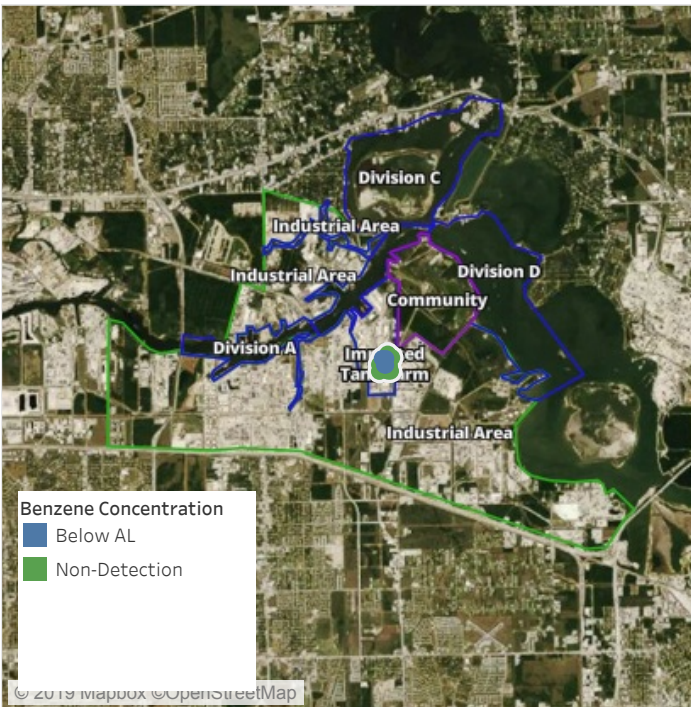
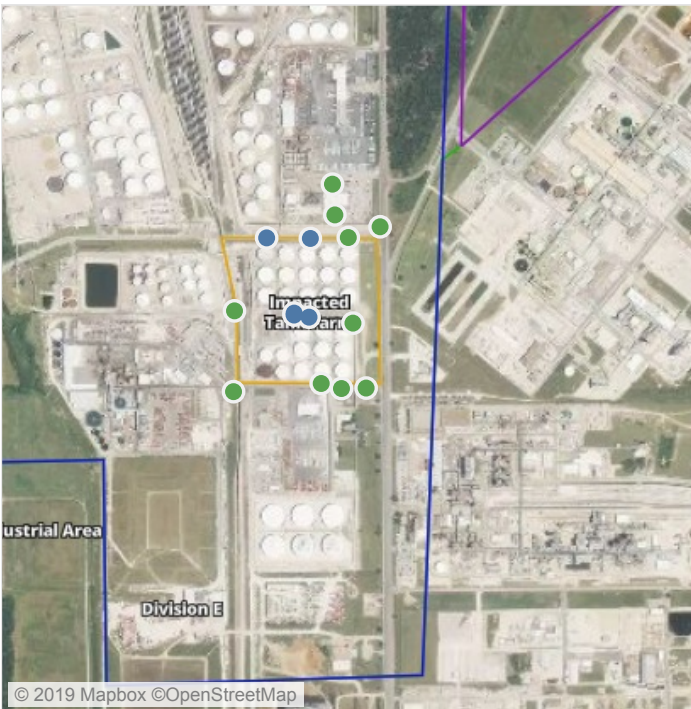
Reading Date
6/22/2019 11:00:00 AM to 6/22/2019 12:00:00 PM

Location Category	Reading Date	Range of Detections
Division E	6/22/2019 11:47:24	0.04000 ppm
	6/22/2019 11:55:17	0.03000 ppm
Impacted Tank Farm	6/22/2019 11:02:01	0.07000 ppm
	6/22/2019 11:22:48	0.04000 ppm
	6/22/2019 11:45:52	0.02000 ppm

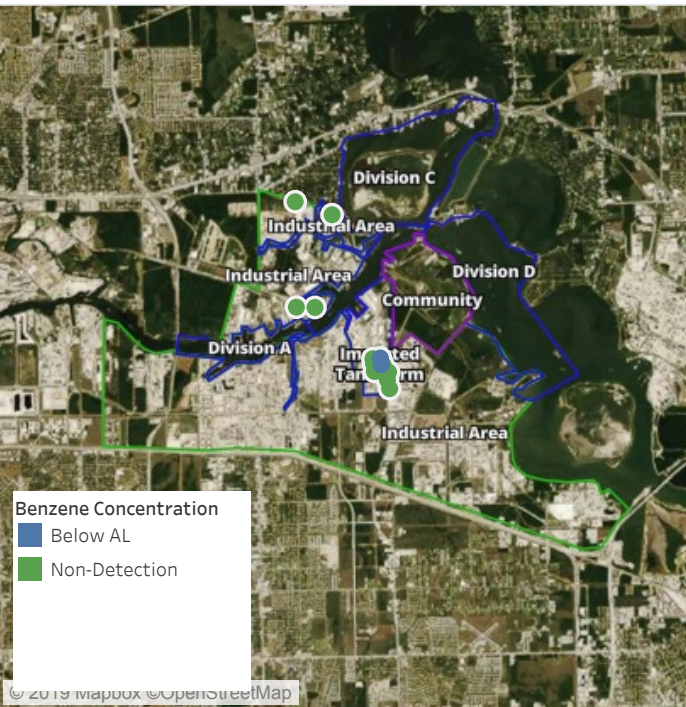
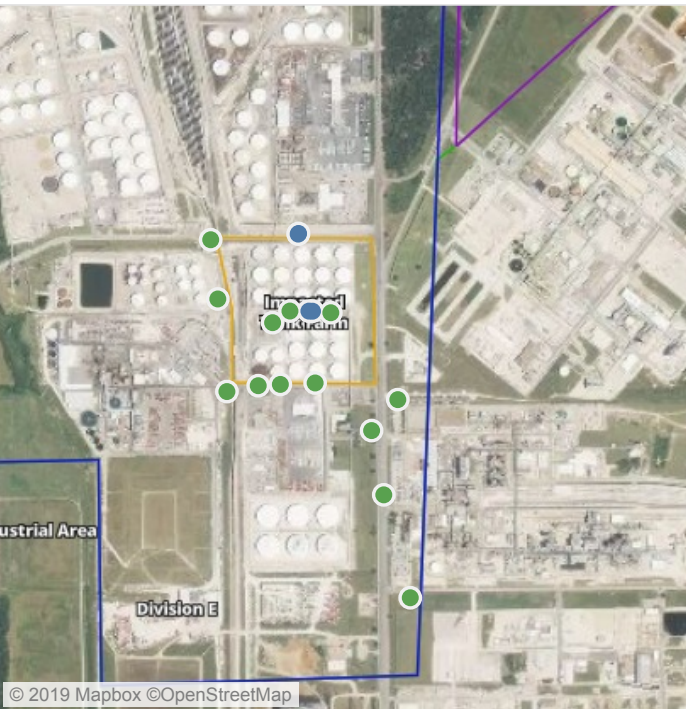
Reading Date
6/22/2019 12:00:00 PM to 6/22/2019 1:00:00 PM

Location Category	Reading Date	Range of Detections
Division E	6/22/2019 12:57:54	0.03000 ppm
	6/22/2019 12:58:38	0.06000 ppm
Impacted Tank Farm	6/22/2019 12:45:59	0.07000 ppm
	6/22/2019 12:52:27	0.10000 ppm

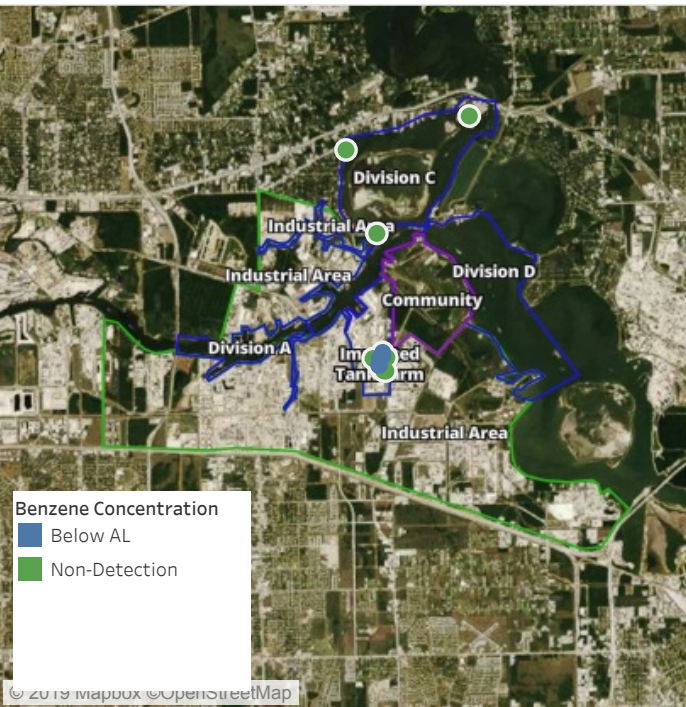
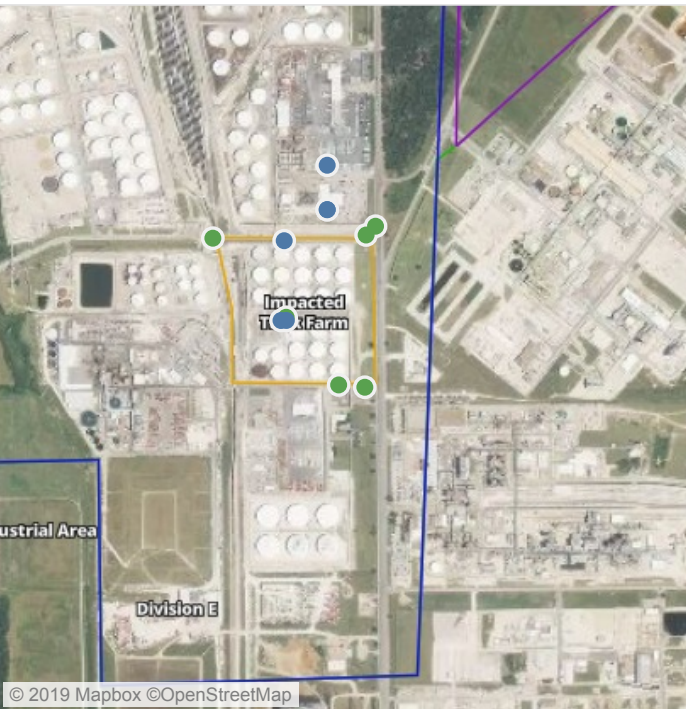
Reading Date
6/22/2019 1:00:00 PM to 6/22/2019 2:00:00 PM

Location Category	Reading Date	Range of Detections
Division E	6/22/2019 13:10:05	0.04000 ppm
	6/22/2019 13:10:59	0.05000 ppm
	6/22/2019 13:23:54	0.04000 ppm
	6/22/2019 13:35:22	0.08000 ppm
Impacted Tank Farm	6/22/2019 13:05:00	0.04000 ppm
	6/22/2019 13:32:10	0.04000 ppm

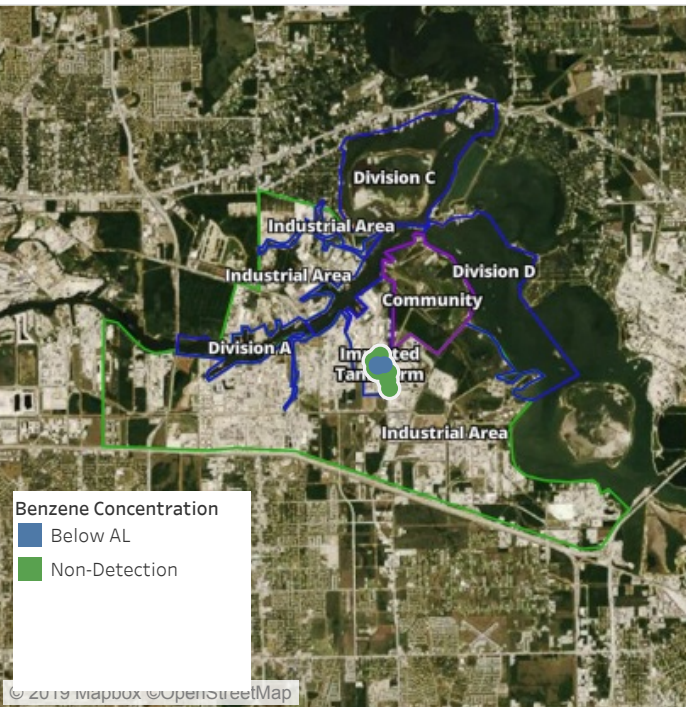
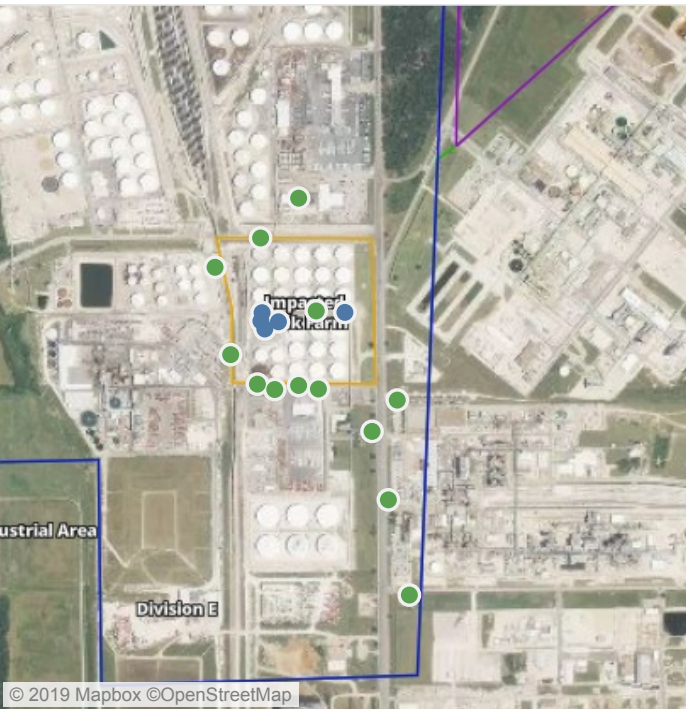
Reading Date
6/22/2019 2:00:00 PM to 6/22/2019 3:00:00 PM

Location Category	Reading Date	Range of Detections
Impacted Tank Farm	6/22/2019 14:06:36	0.0500 ppm
	6/22/2019 14:10:15	0.1700 ppm
	6/22/2019 14:20:56	0.0400 ppm
	6/22/2019 14:37:51	0.0400 ppm
	6/22/2019 14:43:08	0.0300 ppm

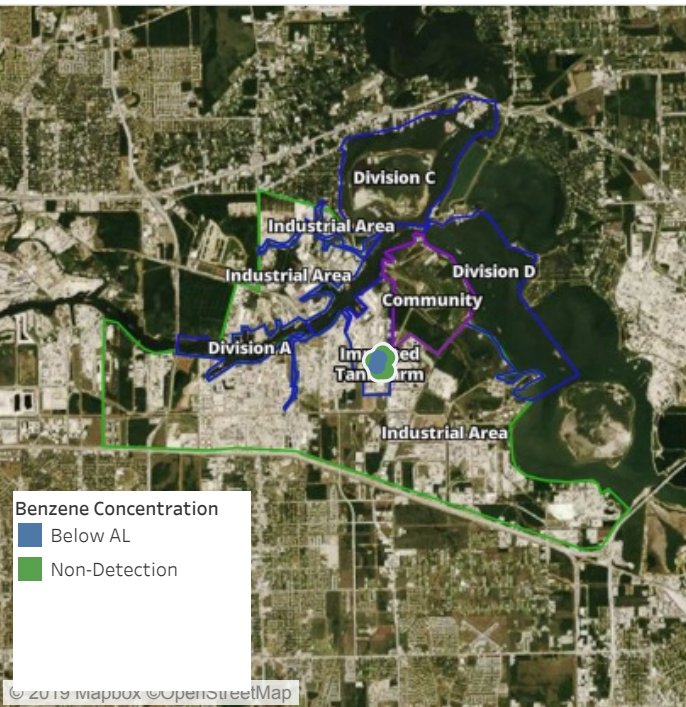
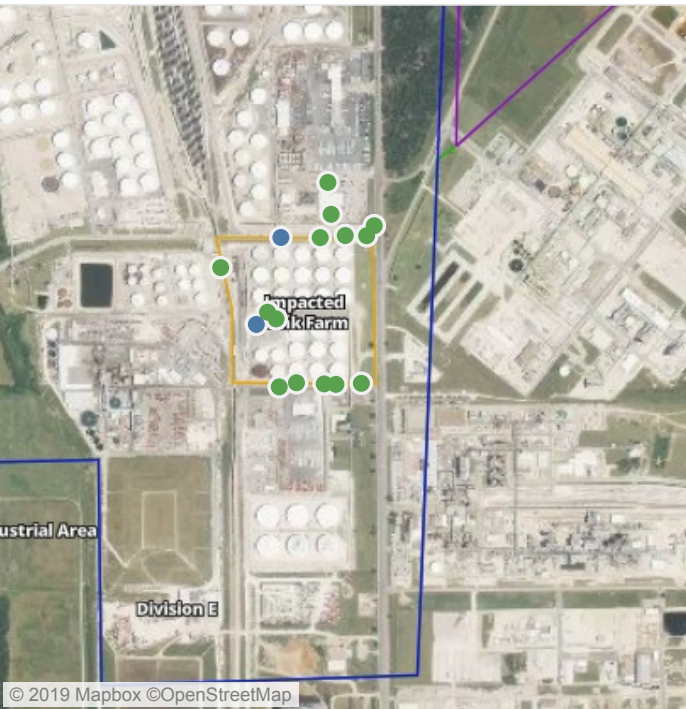
Reading Date
6/22/2019 3:00:00 PM to 6/22/2019 4:00:00 PM

Location Category	Reading Date	Range of Detections
Division E	6/22/2019 15:35:28	0.06000 ppm
Impacted Tank Farm	6/22/2019 15:05:42	0.11000 ppm

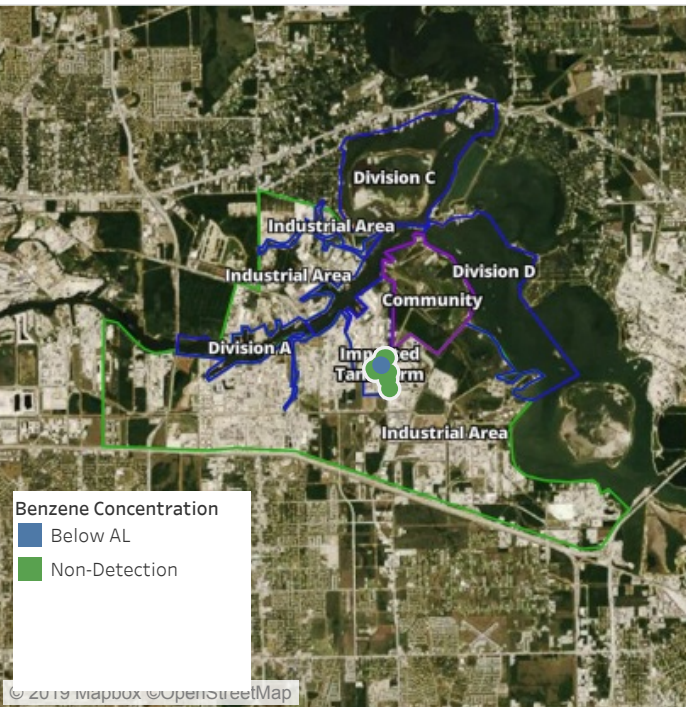
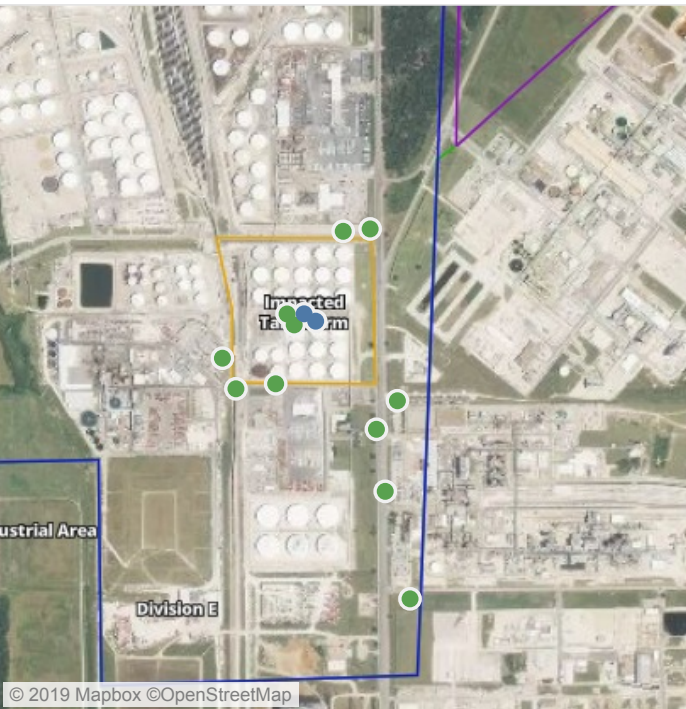
Reading Date
6/22/2019 4:00:00 PM to 6/22/2019 5:00:00 PM

Location Category	Reading Date	Range of Detections
Impacted Tank Farm	6/22/2019 16:13:01	0.1800 ppm
	6/22/2019 16:27:37	0.0500 ppm

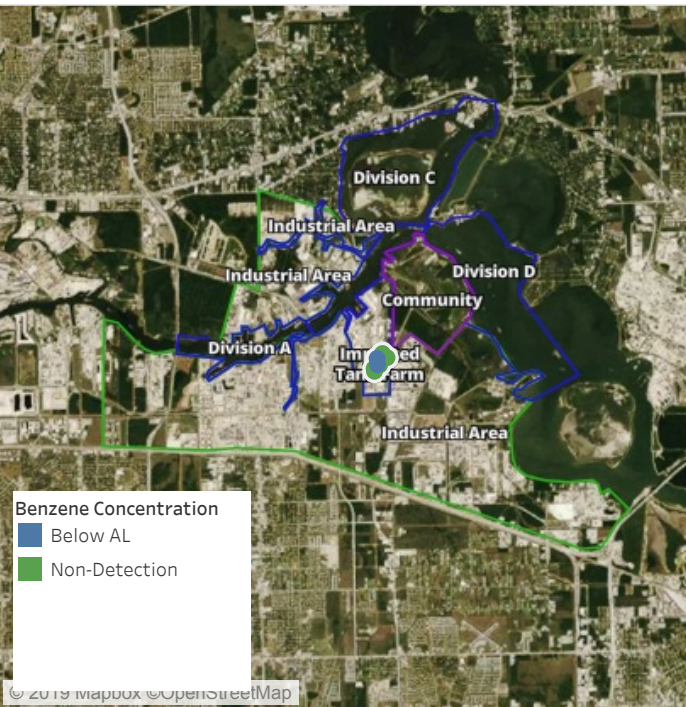
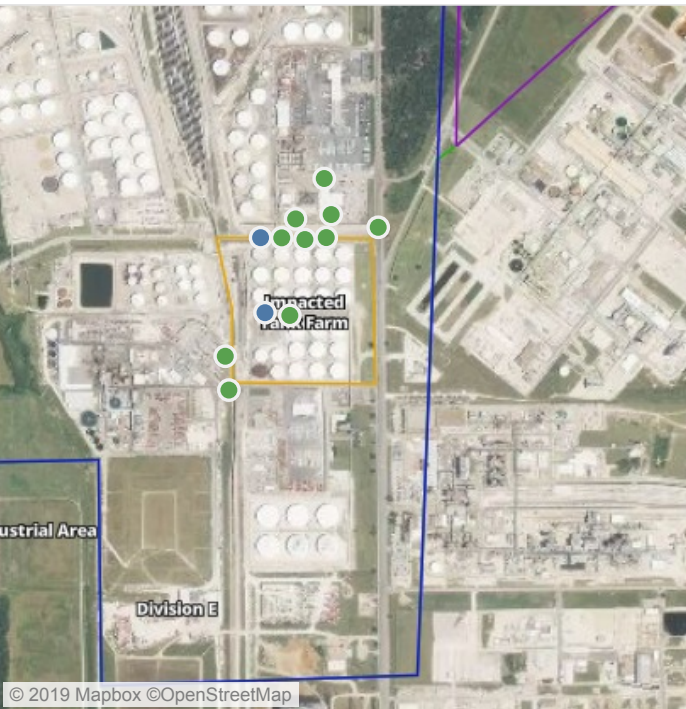
Reading Date
6/22/2019 5:00:00 PM to 6/22/2019 6:00:00 PM

Location Category	Reading Date	Range of Detections
Division E	6/22/2019 17:24:56	0.02000 ppm
Impacted Tank Farm	6/22/2019 17:52:00	0.06000 ppm

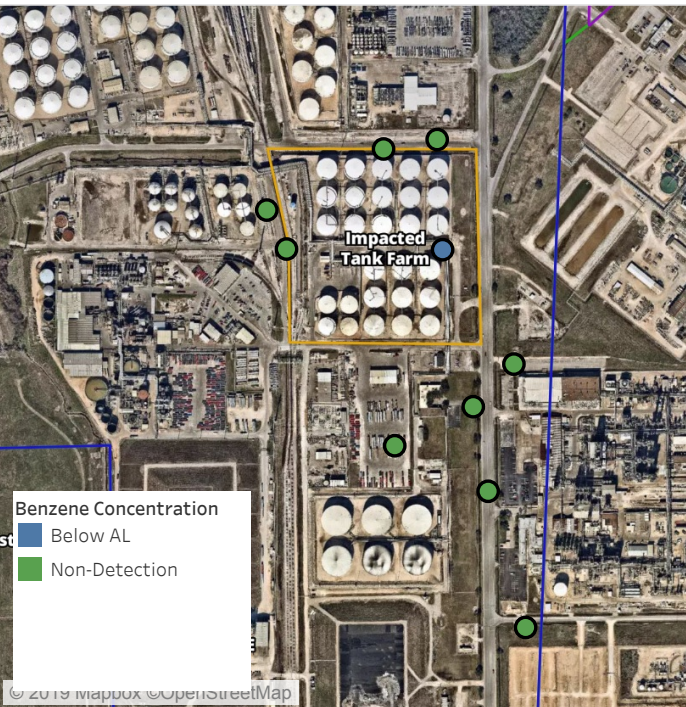
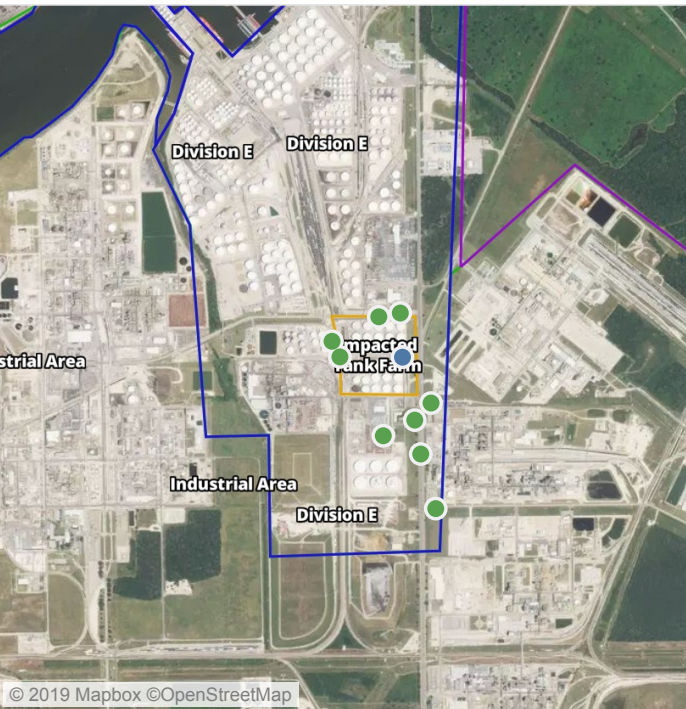
Reading Date
6/22/2019 6:00:00 PM to 6/22/2019 7:00:00 PM

Location Category	Reading Date	Range of Detections
Impacted Tank Farm	6/22/2019 18:31:49	0.04000 ppm

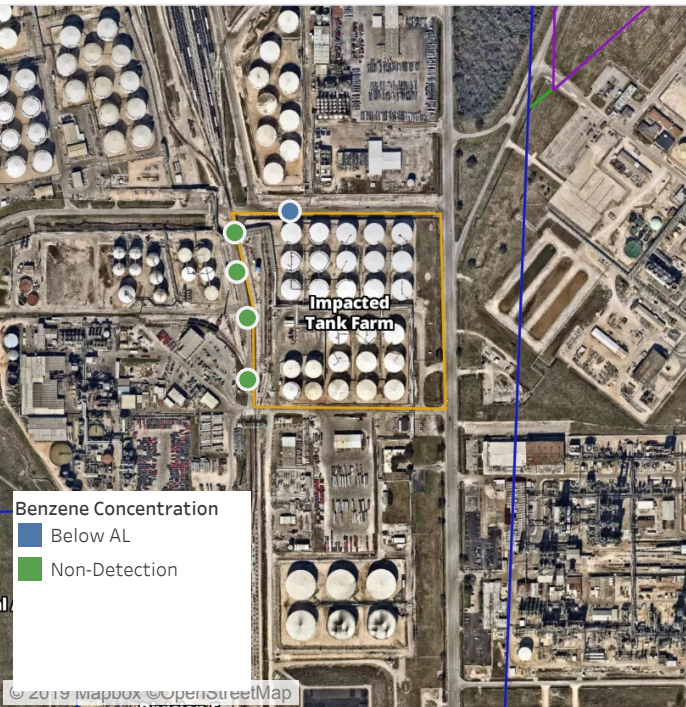
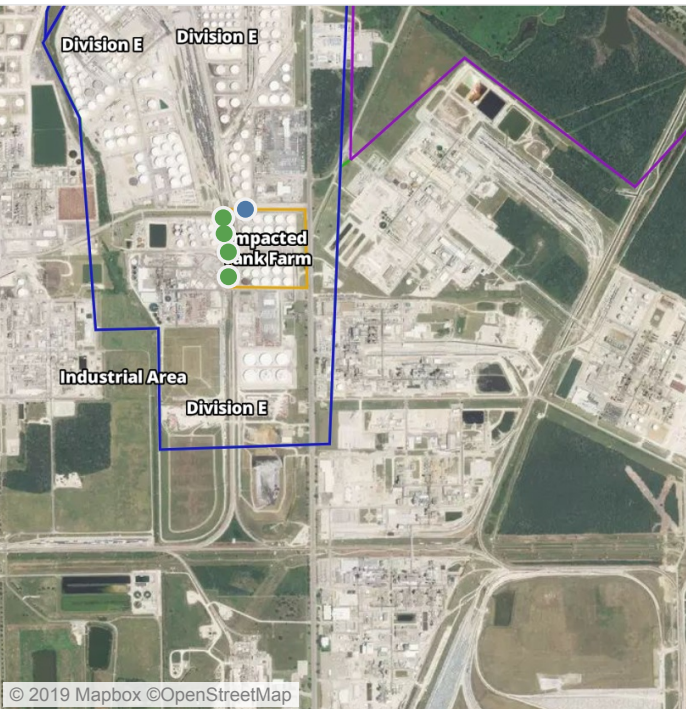
Reading Date
6/22/2019 7:00:00 PM to 6/22/2019 8:00:00 PM

Location Category	Reading Date	Range of Detections
Division E	6/22/2019 19:56:52	0.03000 ppm

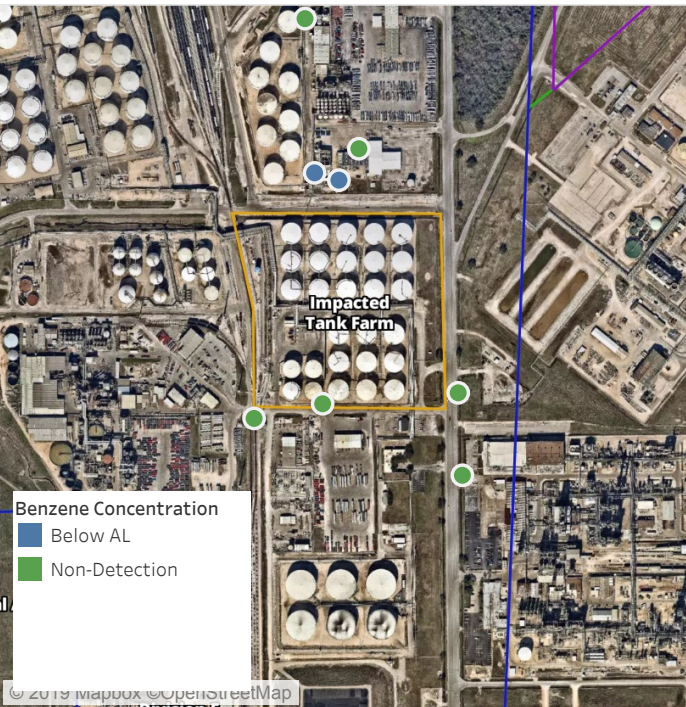
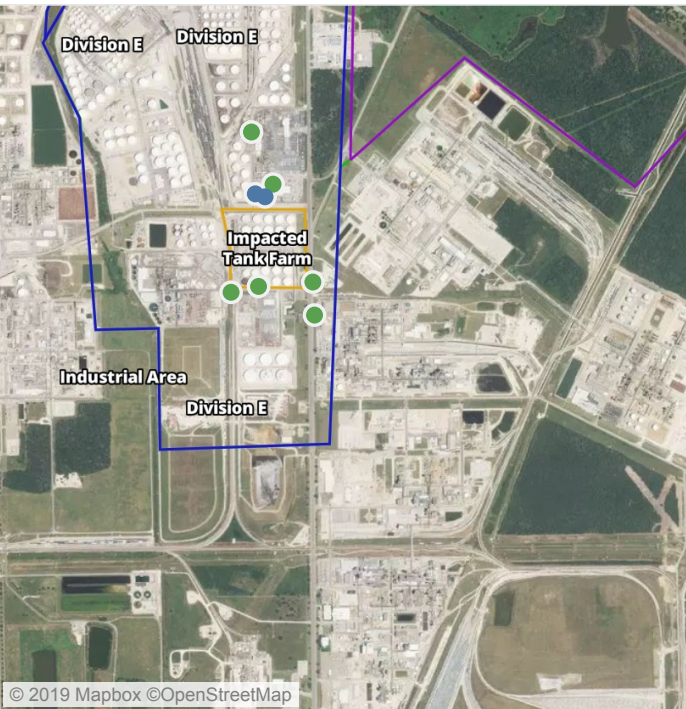
Reading Date
6/22/2019 9:00:00 PM to 6/22/2019 10:00:00 PM

Location Category	Reading Date	Range of Detections
Division E	6/22/2019 21:47:10	0.03000 ppm
	6/22/2019 21:32:44	0.04000 ppm

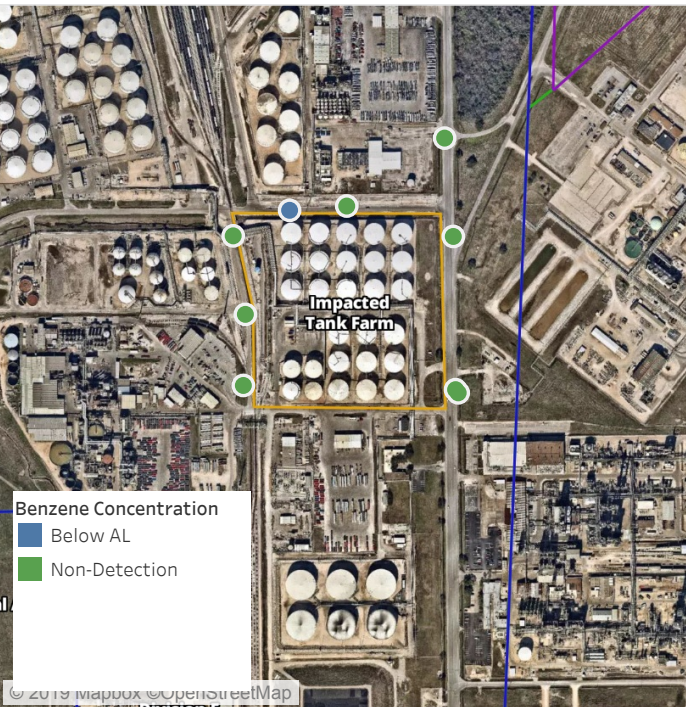
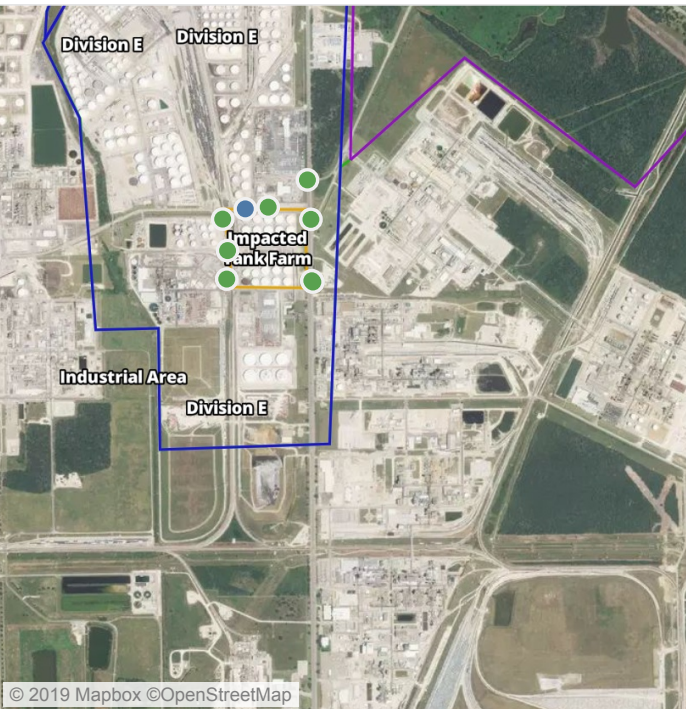
Reading Date
6/22/2019 10:00:00 PM to 6/22/2019 11:00:00 PM

Location Category	Reading Date	Range of Detections
Division E	6/22/2019 22:47:54	0.03000 ppm
