Preliminary Hand- Held Air Monitoring Locations | ITC Deer Park Tank Fire

Reading Date
6/30/2019 11:00:00 PM to 7/1/2019 12:00:00 AM

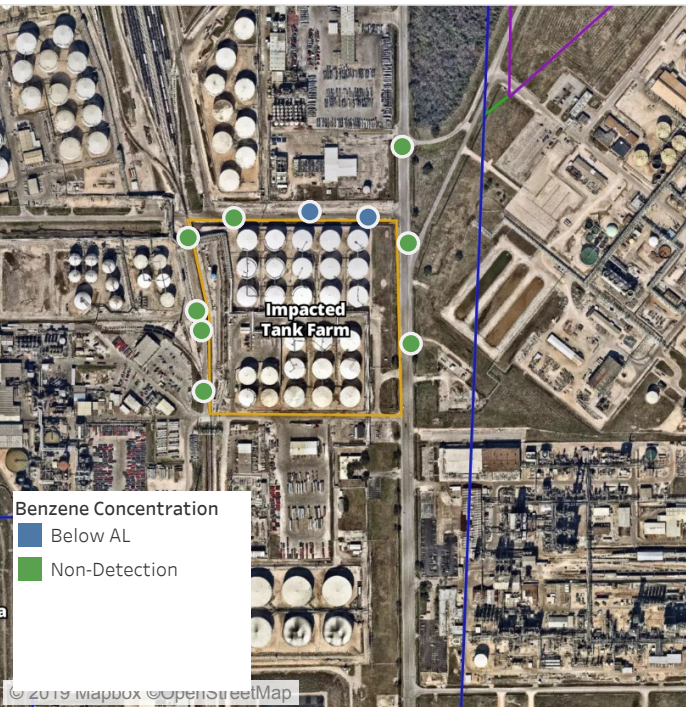
Reading Date
7/1/2019 12:00:00 AM to 7/1/2019 1:00:00 AM

Location Category	Reading Date	Range of Detections
Division E	7/1/2019 00:44:01	0.07000 ppm
	7/1/2019 00:50:04	0.09000 ppm

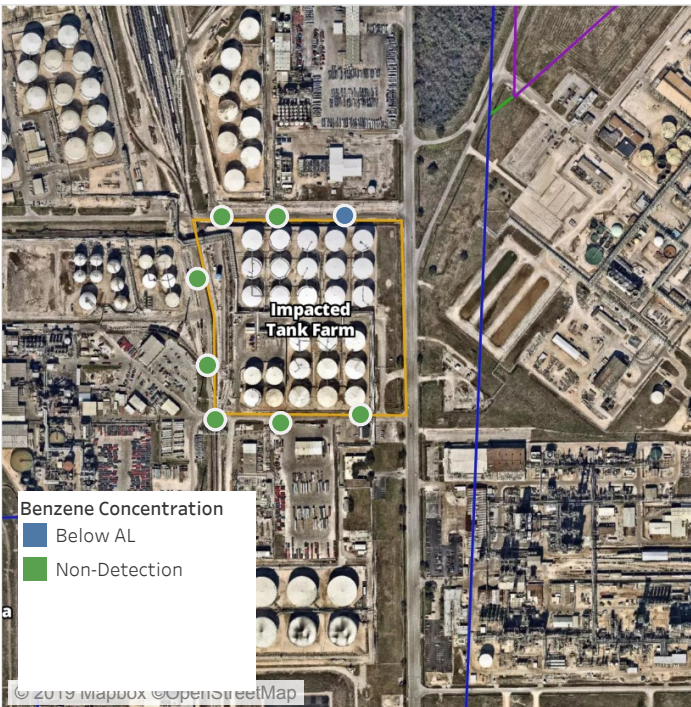
Reading Date
7/1/2019 1:00:00 AM to 7/1/2019 2:00:00 AM

Location Category	Reading Date	Range of Detections
Division E	7/1/2019 01:07:54	0.04000 ppm

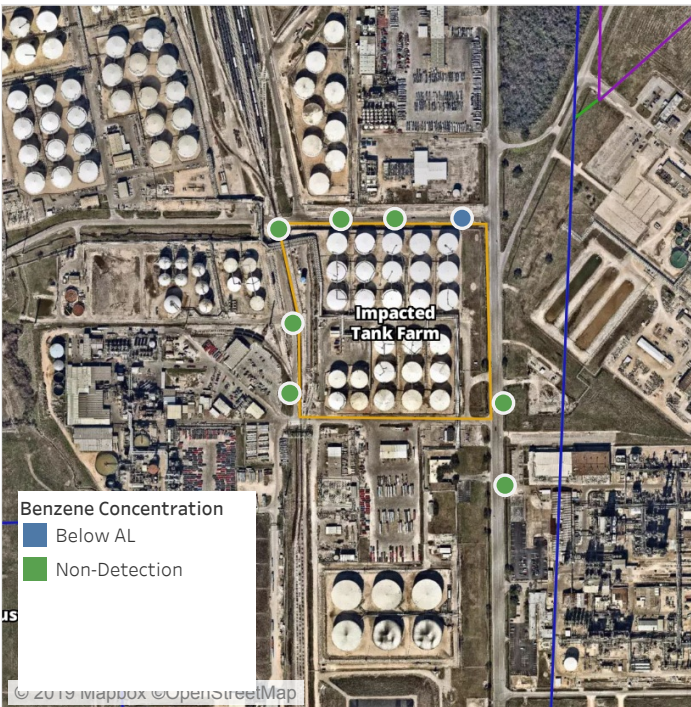
Reading Date
7/1/2019 2:00:00 AM to 7/1/2019 3:00:00 AM

Location Category	Reading Date	Range of Detections
Division E	7/1/2019 02:56:55	0.05000 ppm

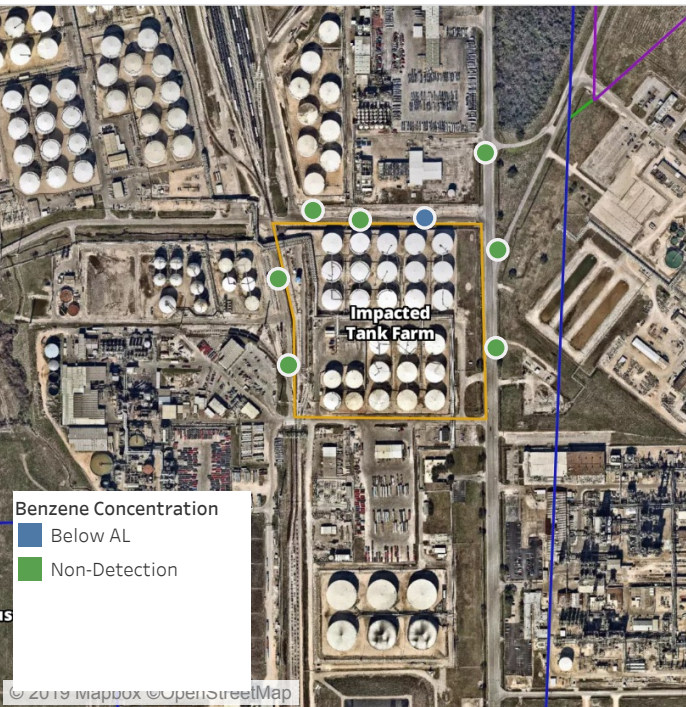
Reading Date
7/1/2019 3:00:00 AM to 7/1/2019 4:00:00 AM

Location Category	Reading Date	Range of Detections
Division E	7/1/2019 03:11:33	0.03000 ppm

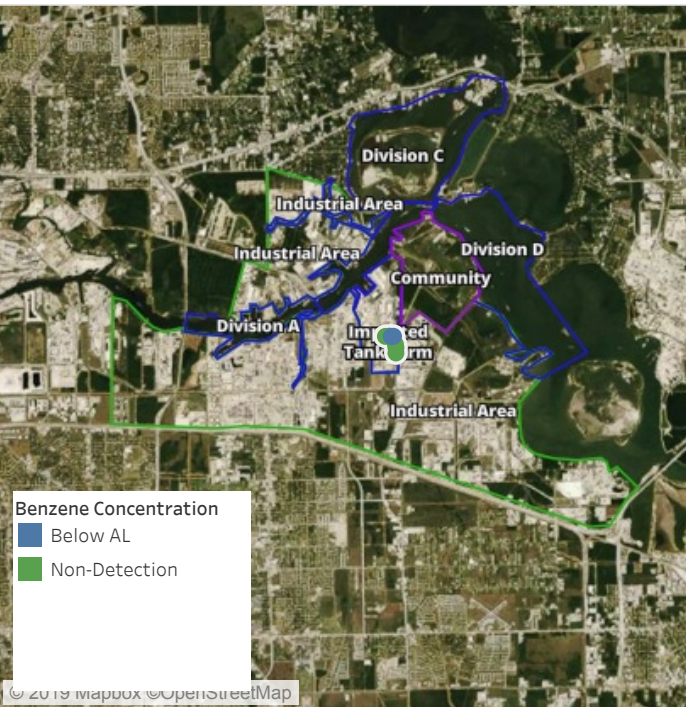
Reading Date
7/1/2019 5:00:00 AM to 7/1/2019 6:00:00 AM

Location Category	Reading Date	Range of Detections
Division E	7/1/2019 05:39:14	0.05000 ppm
	7/1/2019 05:28:23	0.04000 ppm

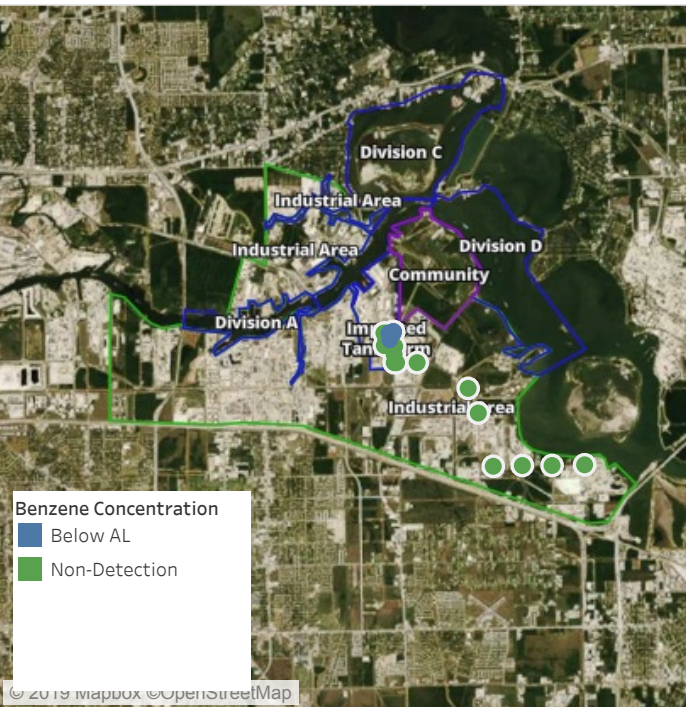
Reading Date
7/1/2019 8:00:00 AM to 7/1/2019 9:00:00 AM

Location Category	Reading Date	Range of Detections
Division E	7/1/2019 08:02:07	0.10000 ppm
	7/1/2019 08:02:44	0.08000 ppm
	7/1/2019 08:22:06	0.06000 ppm
	7/1/2019 08:39:30	0.05000 ppm
	7/1/2019 08:44:07	0.02000 ppm
	7/1/2019 08:45:29	0.07000 ppm
Impacted Tank Farm	7/1/2019 08:38:03	0.04000 ppm

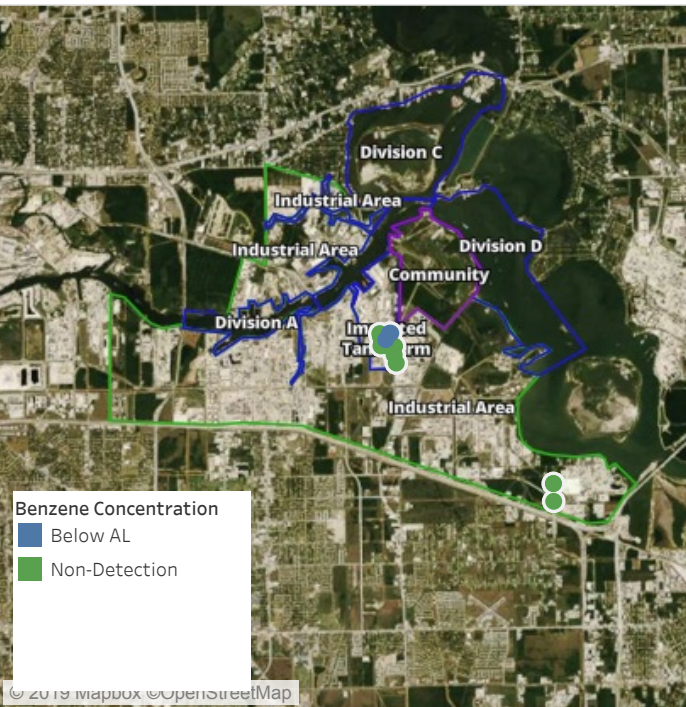
Reading Date
7/1/2019 9:00:00 AM to 7/1/2019 10:00:00 AM

Location Category	Reading Date	Range of Detections
Division E	7/1/2019 09:54:49	0.05000 ppm
	7/1/2019 09:58:01	0.02000 ppm
Impacted Tank Farm	7/1/2019 09:35:11	0.02000 ppm

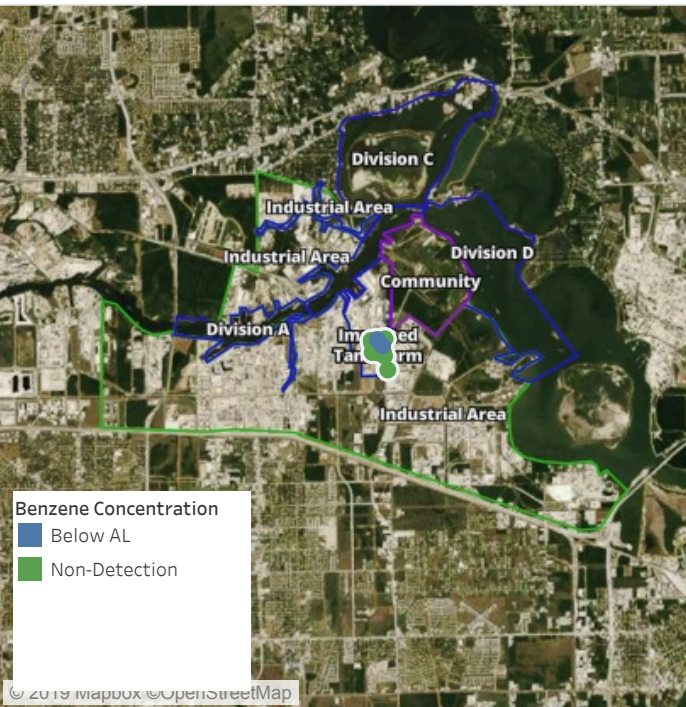
Reading Date
7/1/2019 10:00:00 AM to 7/1/2019 11:00:00 AM

Location Category	Reading Date	Range of Detections
Division E	7/1/2019 10:08:46	0.03000 ppm
Impacted Tank Farm	7/1/2019 10:39:35	0.03000 ppm

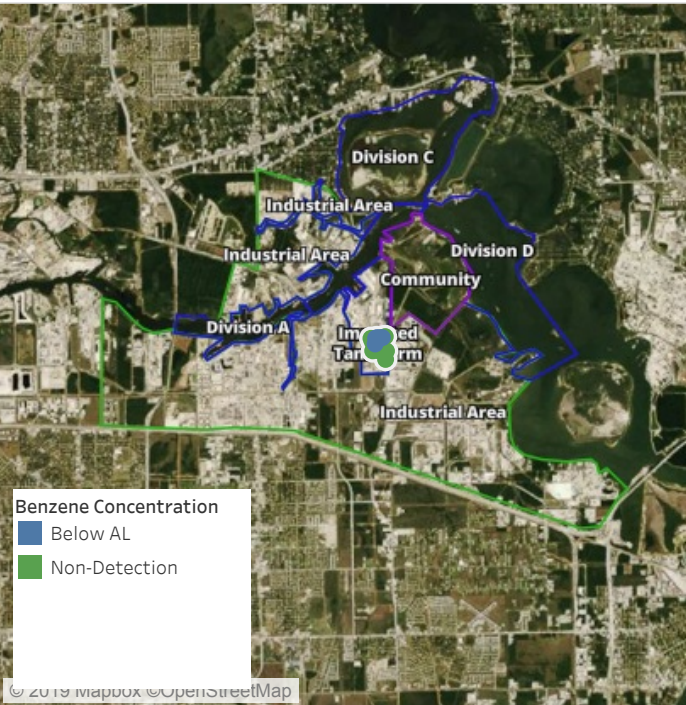
Reading Date
7/1/2019 11:00:00 AM to 7/1/2019 12:00:00 PM

Location Category	Reading Date	Range of Detections
Division E	7/1/2019 11:04:07	0.07000 ppm
	7/1/2019 11:12:01	0.02000 ppm
	7/1/2019 11:16:49	0.06000 ppm
	7/1/2019 11:20:11	0.05000 ppm
Impacted Tank Farm	7/1/2019 11:55:40	0.03000 ppm

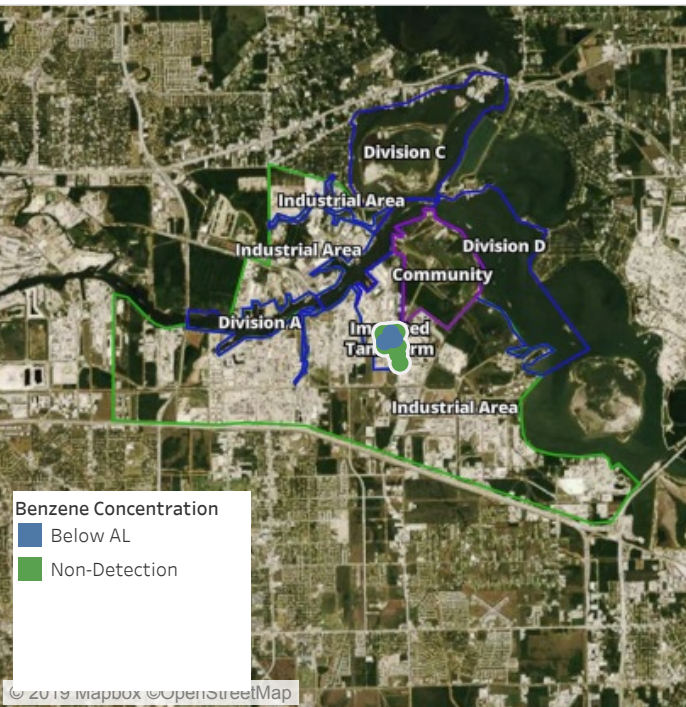
Reading Date
7/1/2019 12:00:00 PM to 7/1/2019 1:00:00 PM

Location Category	Reading Date	Range of Detections
Division E	7/1/2019 12:27:34	0.05000 ppm
	7/1/2019 12:52:15	0.04000 ppm
Impacted Tank Farm	7/1/2019 12:02:57	0.04000 ppm
	7/1/2019 12:06:38	0.09000 ppm

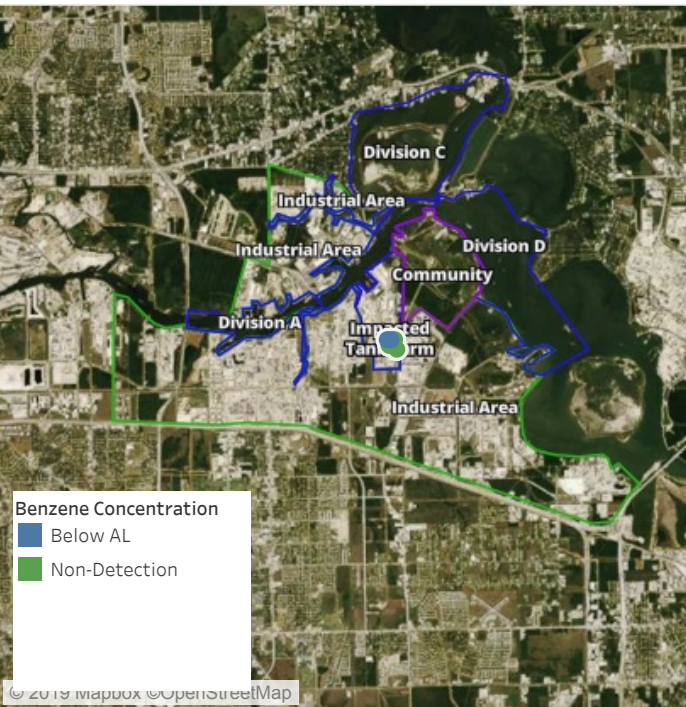
Reading Date
7/1/2019 1:00:00 PM to 7/1/2019 2:00:00 PM

Location Category	Reading Date	Range of Detections
Impacted Tank Farm	7/1/2019 13:02:16	0.08000 ppm
	7/1/2019 13:06:35	0.02000 ppm
	7/1/2019 13:09:24	0.04000 ppm

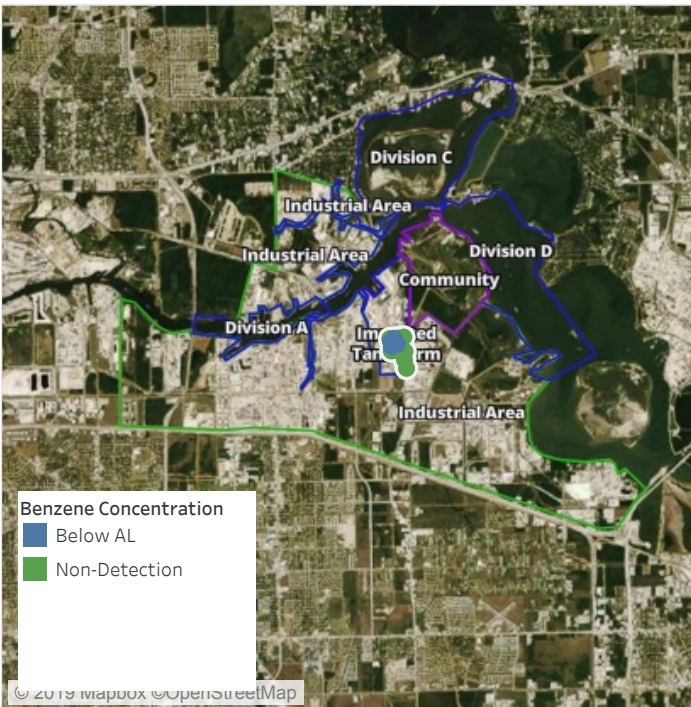
Reading Date
7/1/2019 2:00:00 PM to 7/1/2019 3:00:00 PM

Location Category	Reading Date	Range of Detections
Division E	7/1/2019 14:19:49	0.02000 ppm
	7/1/2019 14:36:46	0.03000 ppm
	7/1/2019 14:38:31	0.02000 ppm
Impacted Tank Farm	7/1/2019 14:51:30	0.02000 ppm
	7/1/2019 14:55:15	0.03000 ppm
	7/1/2019 14:57:30	0.05000 ppm

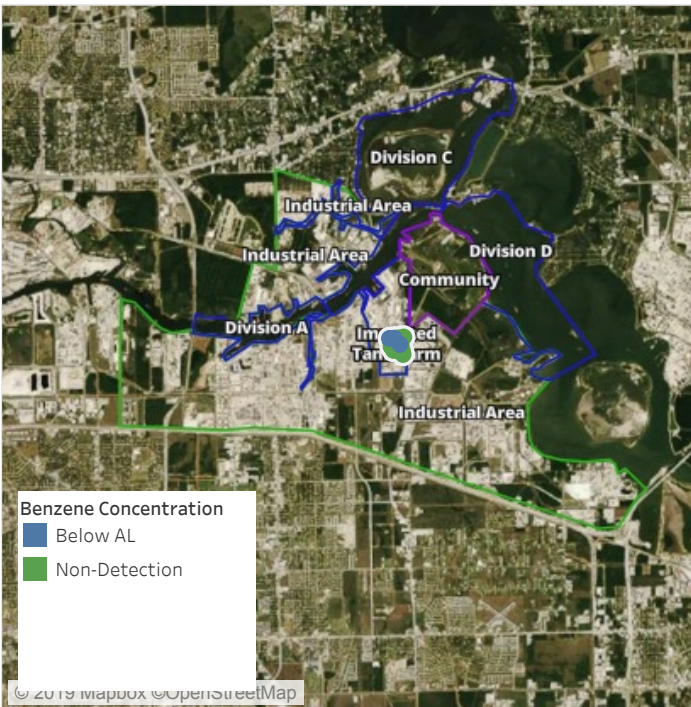
Reading Date
7/1/2019 3:00:00 PM to 7/1/2019 4:00:00 PM

Location Category	Reading Date	Range of Detections
Division E	7/1/2019 15:37:10	0.02000 ppm
	7/1/2019 15:50:46	0.03000 ppm
Impacted Tank Farm	7/1/2019 15:02:45	0.05000 ppm

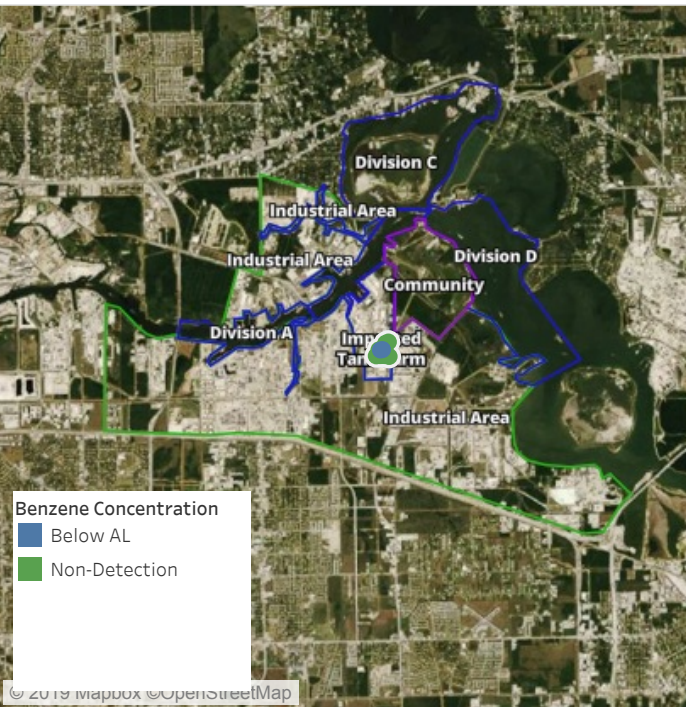
Reading Date
7/1/2019 4:00:00 PM to 7/1/2019 5:00:00 PM

Location Category	Reading Date	Range of Detections
Impacted Tank Farm	7/1/2019 16:33:50	0.05000 ppm
	7/1/2019 16:37:36	0.08000 ppm

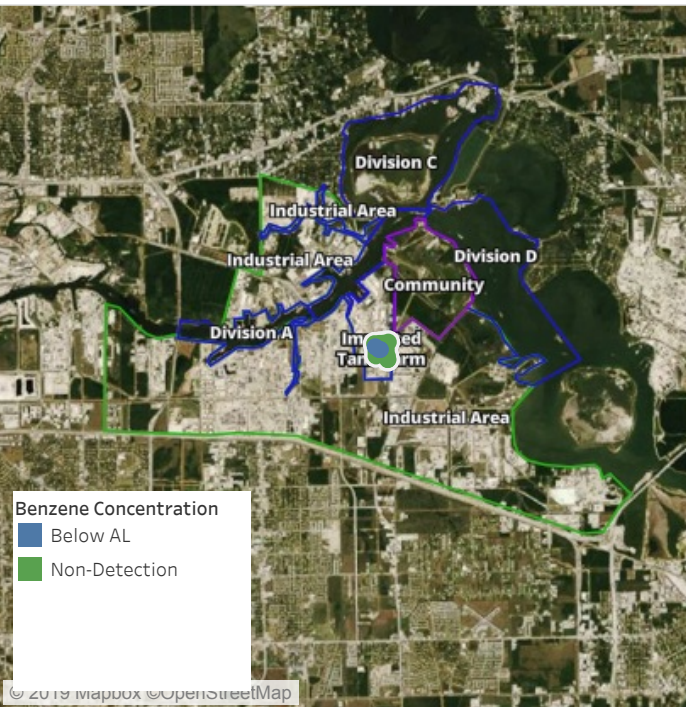
Reading Date
7/1/2019 5:00:00 PM to 7/1/2019 6:00:00 PM

Location Category	Reading Date	Range of Detections
Division E	7/1/2019 17:38:33	0.03000 ppm
Impacted Tank Farm	7/1/2019 17:48:57	0.03000 ppm
	7/1/2019 17:51:39	0.07000 ppm

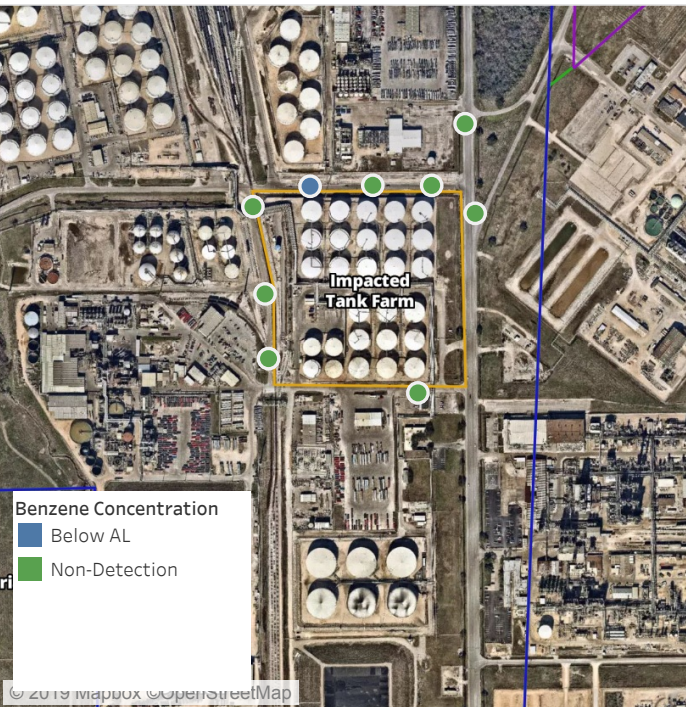
Reading Date
7/1/2019 9:00:00 PM to 7/1/2019 10:00:00 PM

Location Category	Reading Date	Range of Detections
Division E	7/1/2019 21:33:16	0.04000 ppm

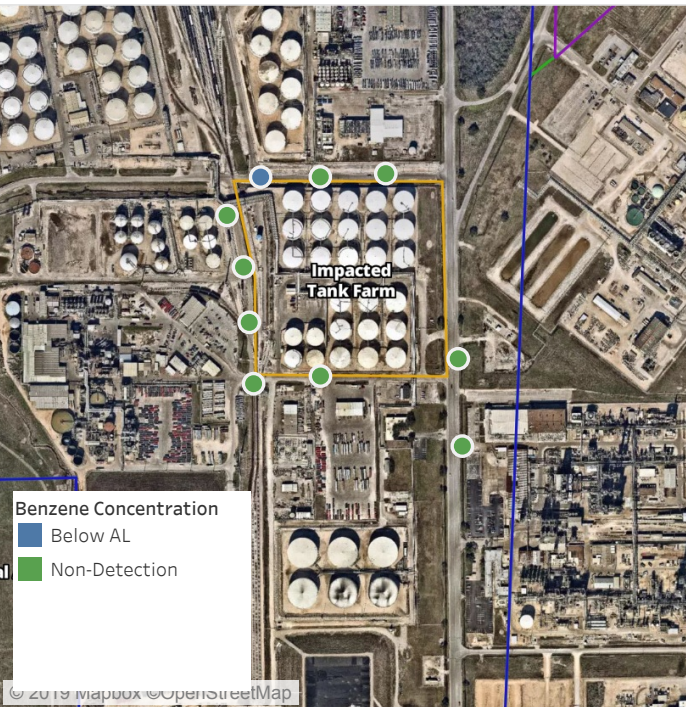
Reading Date
7/1/2019 10:00:00 PM to 7/1/2019 11:00:00 PM

Location Category	Reading Date	Range of Detections
Division E	7/1/2019 22:22:45	0.04000 ppm
