Preliminary Hand- Held Air Monitoring Locations | ITC Deer Park Tank Fire

Reading Date
7/2/2019 11:00:00 PM to 7/3/2019 12:00:00 AM

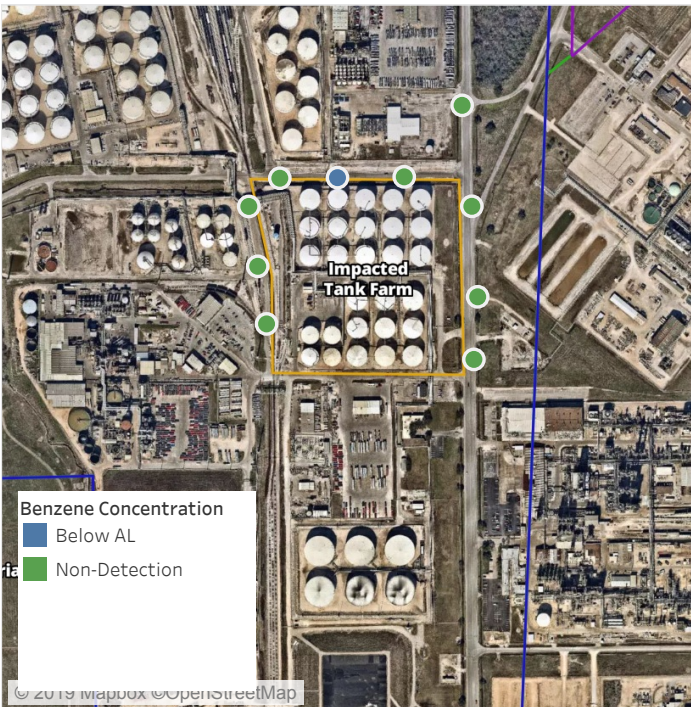
Reading Date
7/3/2019 2:00:00 AM to 7/3/2019 3:00:00 AM

Location Category	Reading Date	Range of Detections
Division E	7/3/2019 02:13:01	0.04000 ppm

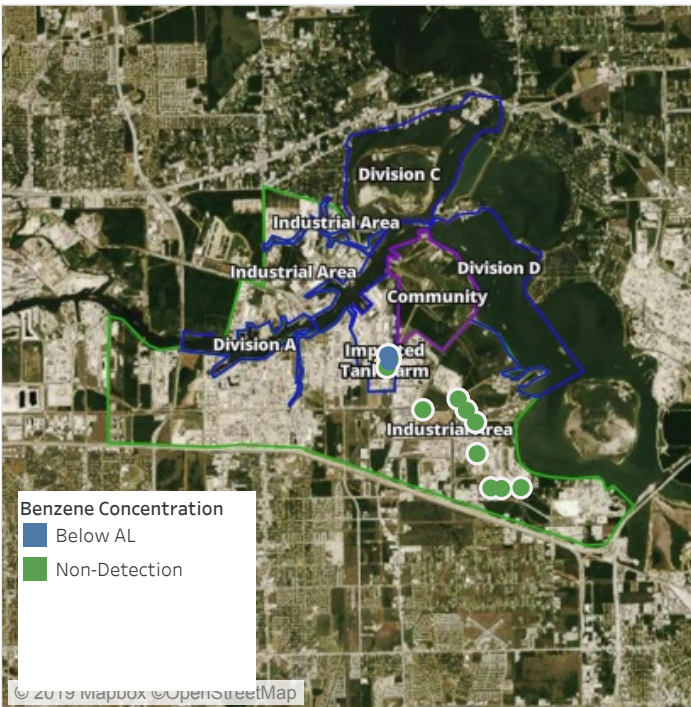
Reading Date
7/3/2019 7:00:00 AM to 7/3/2019 8:00:00 AM

Location Category	Reading Date	Range of Detections
Division E	7/3/2019 07:48:04	0.0600 ppm
	7/3/2019 07:52:30	0.0600 ppm
Impacted Tank Farm	7/3/2019 07:11:38	0.2100 ppm

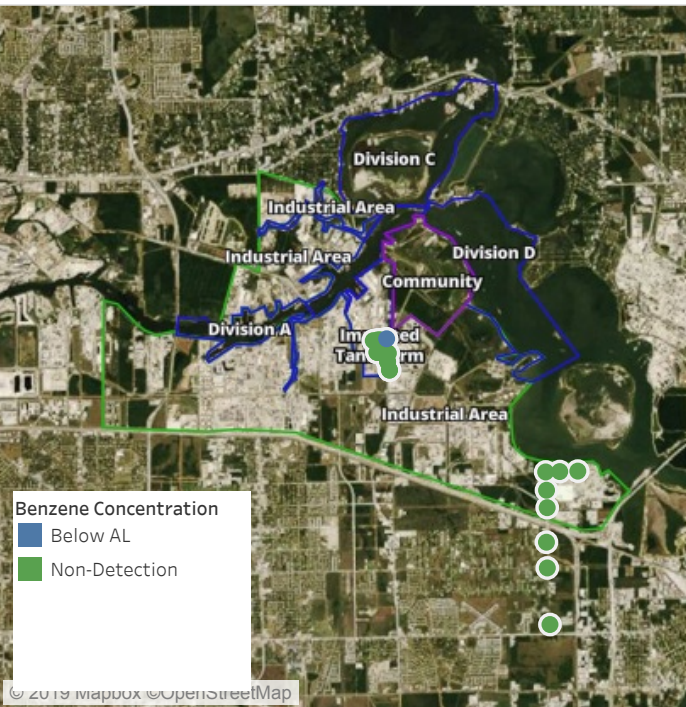
Reading Date
7/3/2019 8:00:00 AM to 7/3/2019 9:00:00 AM

Location Category	Reading Date	Range of Detections
Division E	7/3/2019 08:28:55	0.02000 ppm

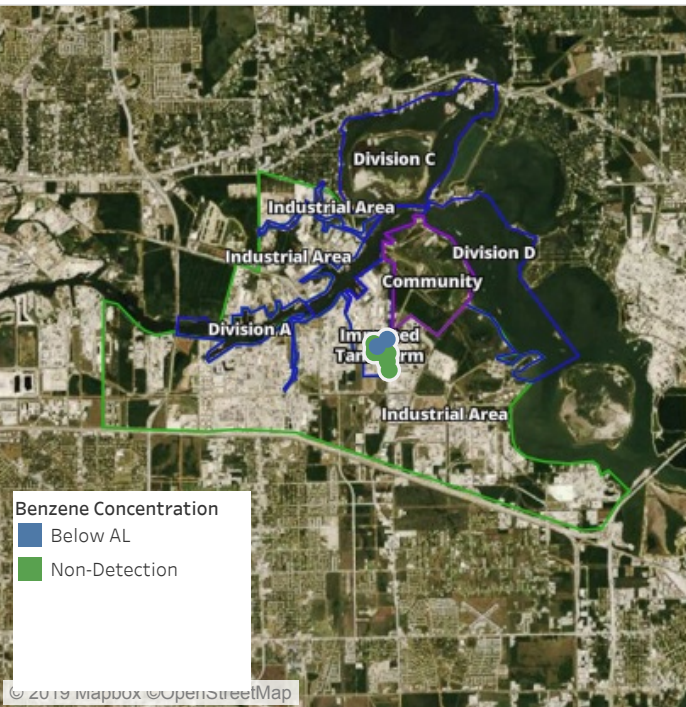
Reading Date
7/3/2019 9:00:00 AM to 7/3/2019 10:00:00 AM

Location Category	Reading Date	Range of Detections
Division E	7/3/2019 09:25:01	0.06000 ppm
Impacted Tank Farm	7/3/2019 09:49:15	0.02000 ppm

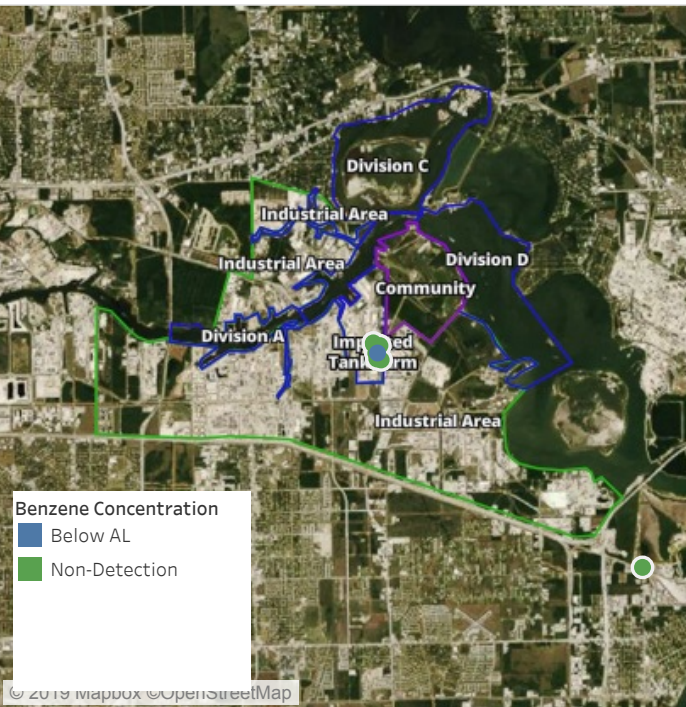
Reading Date
7/3/2019 10:00:00 AM to 7/3/2019 11:00:00 AM

Location Category	Reading Date	Range of Detections
Impacted Tank Farm	7/3/2019 10:07:58	0.1000 ppm

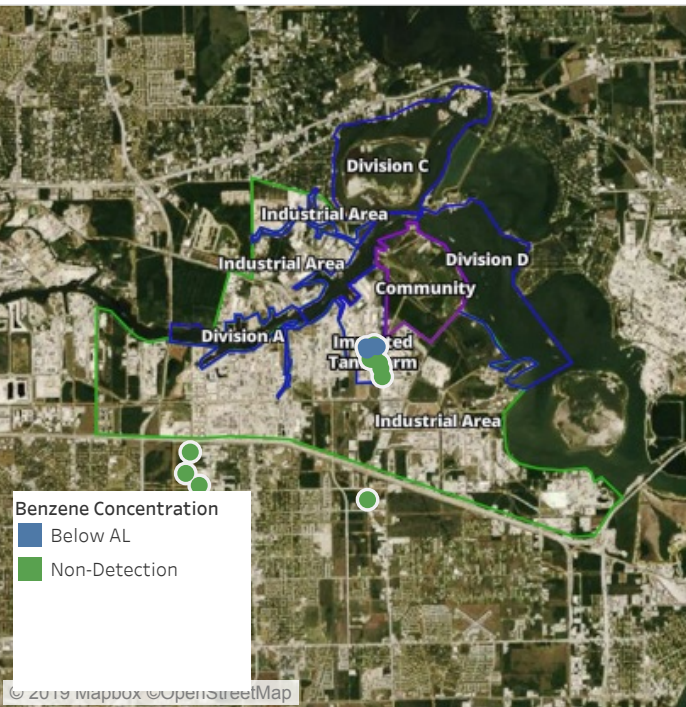
Reading Date
7/3/2019 11:00:00 AM to 7/3/2019 12:00:00 PM

Location Category	Reading Date	Range of Detections
Division E	7/3/2019 11:11:48	0.03000 ppm
	7/3/2019 11:39:09	0.06000 ppm
	7/3/2019 11:51:01	0.03000 ppm
	7/3/2019 11:53:58	0.04000 ppm

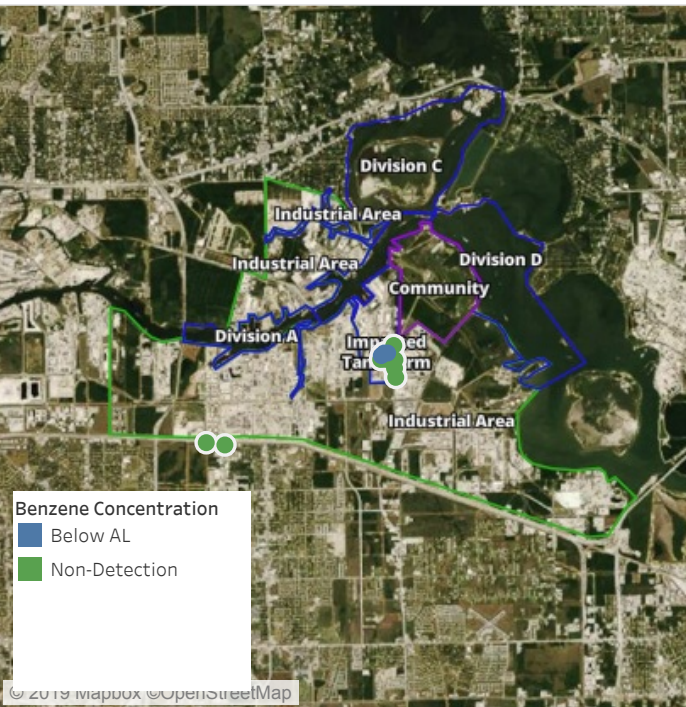
Reading Date
7/3/2019 12:00:00 PM to 7/3/2019 1:00:00 PM

Location Category	Reading Date	Range of Detections
Division E	7/3/2019 12:01:10	0.0200 ppm
Impacted Tank Farm	7/3/2019 12:13:31	0.0500 ppm
	7/3/2019 12:21:31	0.2000 ppm

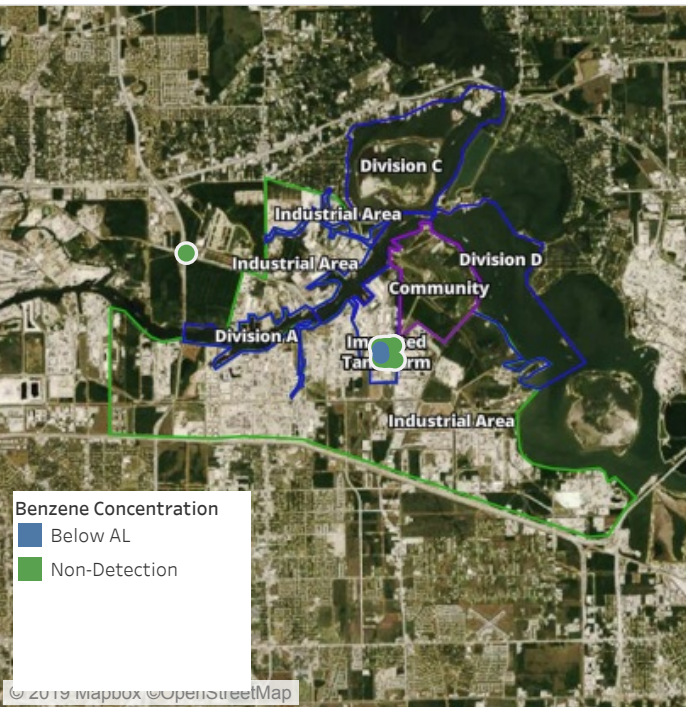
Reading Date
7/3/2019 1:00:00 PM to 7/3/2019 2:00:00 PM

Location Category	Reading Date	Range of Detections
Division E	7/3/2019 13:46:47	0.06000 ppm
	7/3/2019 13:53:28	0.02000 ppm

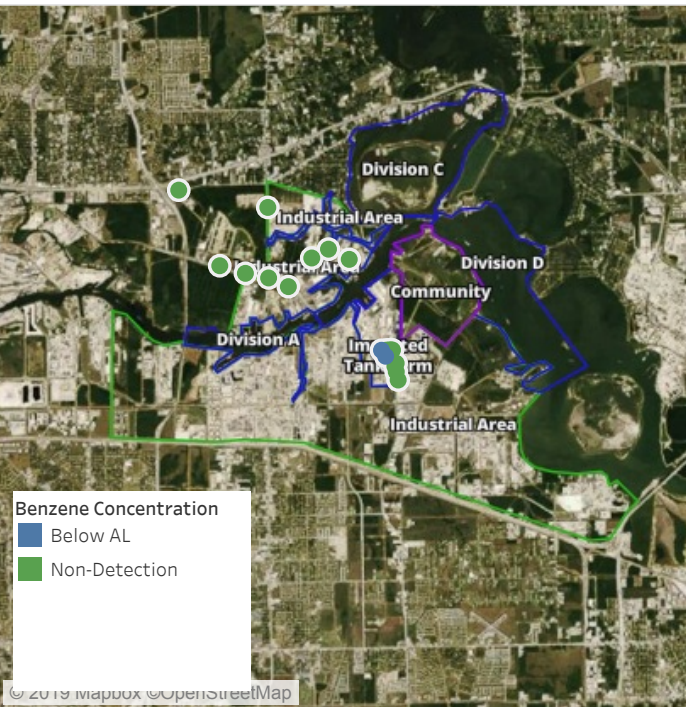
Reading Date
7/3/2019 2:00:00 PM to 7/3/2019 3:00:00 PM

Location Category	Reading Date	Range of Detections
Division E	7/3/2019 14:57:03	0.03000 ppm
Impacted Tank Farm	7/3/2019 14:04:15	0.03000 ppm

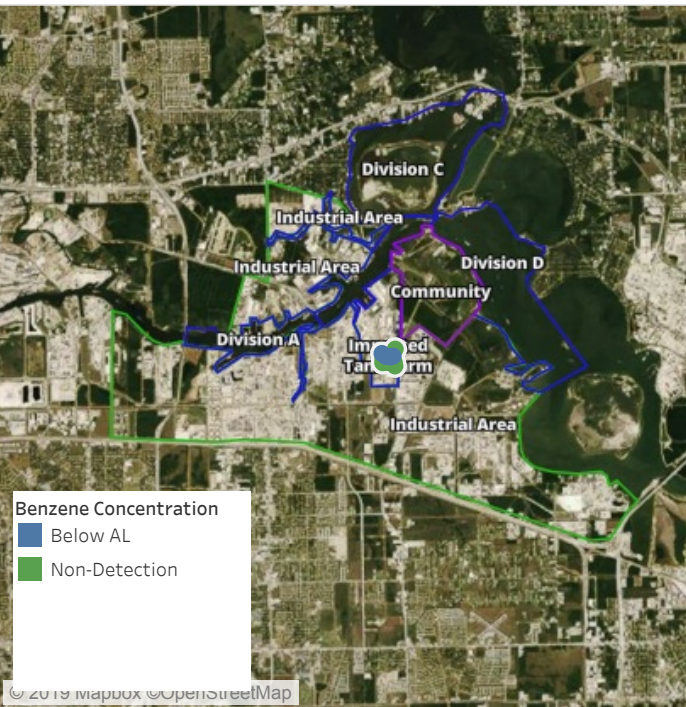
Reading Date
7/3/2019 3:00:00 PM to 7/3/2019 4:00:00 PM

Location Category	Reading Date	Range of Detections
Division E	7/3/2019 15:00:03	0.05000 ppm
Impacted Tank Farm	7/3/2019 15:24:59	0.10000 ppm
	7/3/2019 15:30:44	0.05000 ppm
	7/3/2019 15:35:42	0.09000 ppm
	7/3/2019 15:39:26	0.03000 ppm
	7/3/2019 15:42:09	0.04000 ppm

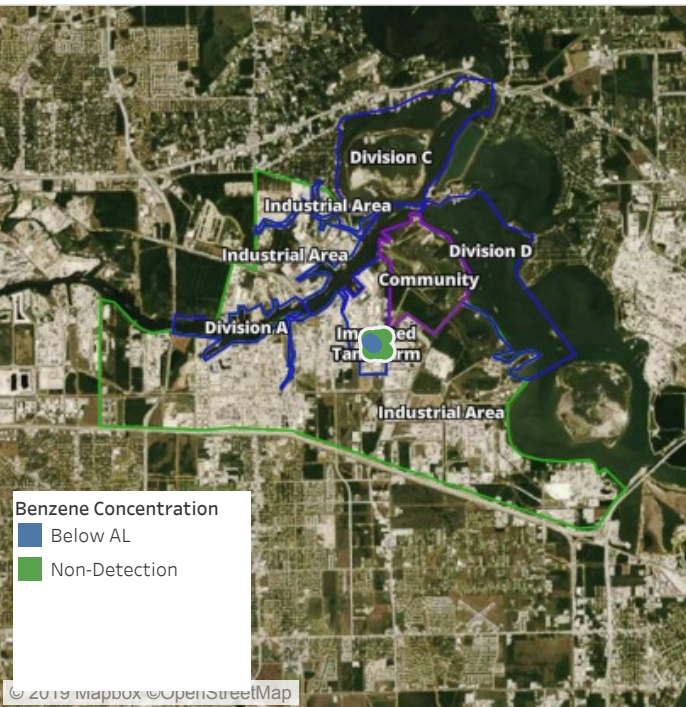
Reading Date
7/3/2019 4:00:00 PM to 7/3/2019 5:00:00 PM

Location Category	Reading Date	Range of Detections
Division E	7/3/2019 16:38:14	0.04000 ppm
Impacted Tank Farm	7/3/2019 16:57:37	0.03000 ppm

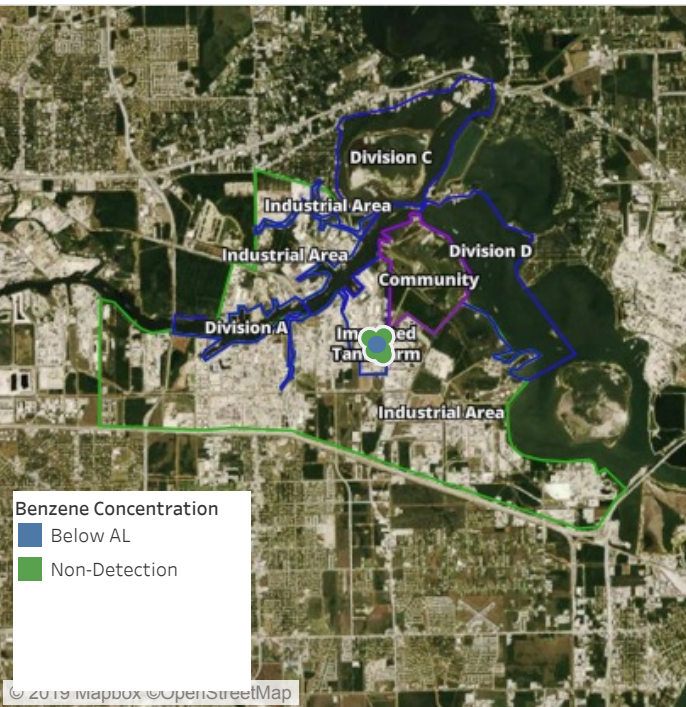
Reading Date
7/3/2019 5:00:00 PM to 7/3/2019 6:00:00 PM

Location Category	Reading Date	Range of Detections
Impacted Tank Farm	7/3/2019 17:01:40	0.09000 ppm
	7/3/2019 17:05:47	0.09000 ppm
