# Preliminary Hand- Held Air Monitoring Locations | ITC Deer Park Tank Fire

Reading Date  
7/5/2019 11:00:00 PM to 7/6/2019 12:00:00 AM

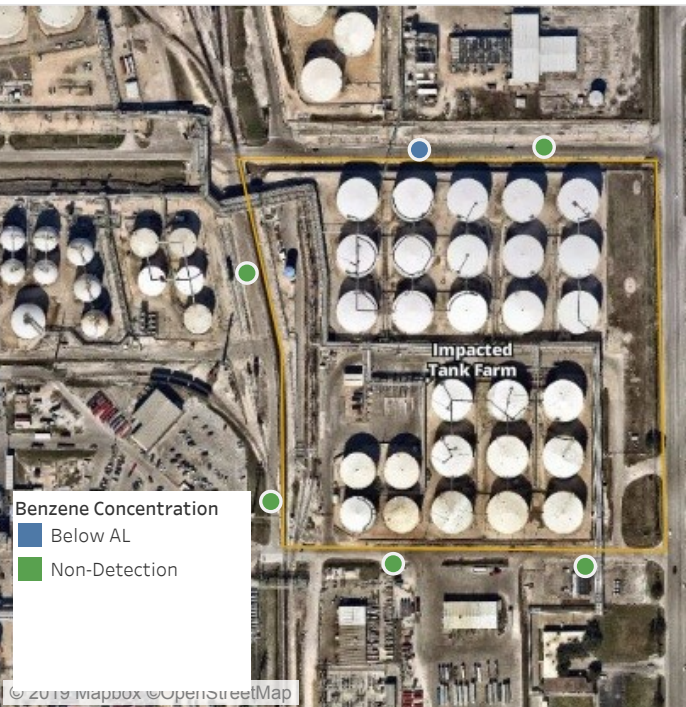
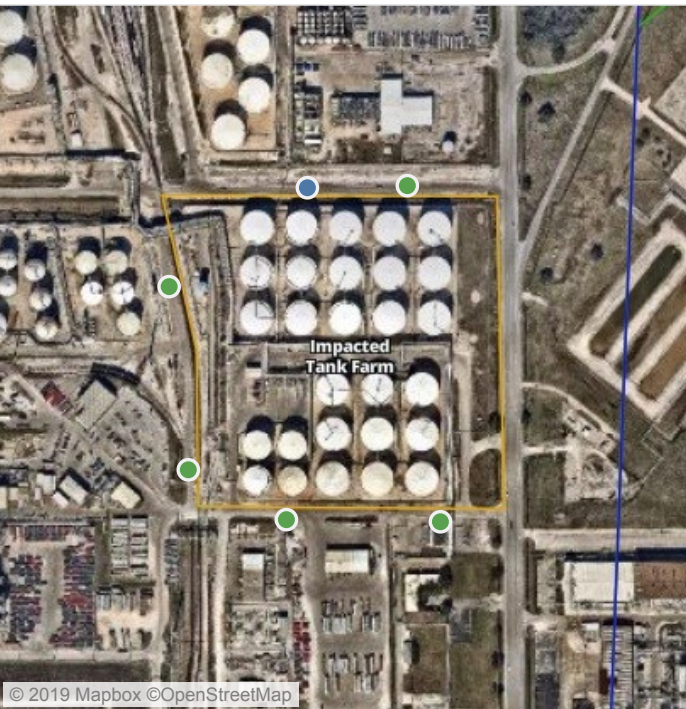
Reading Date  
7/6/2019 12:00:00 AM to 7/6/2019 1:00:00 AM

Location Category	Reading Date	Range of Detections
Division E	7/6/2019 00:13:37	0.05000 ppm

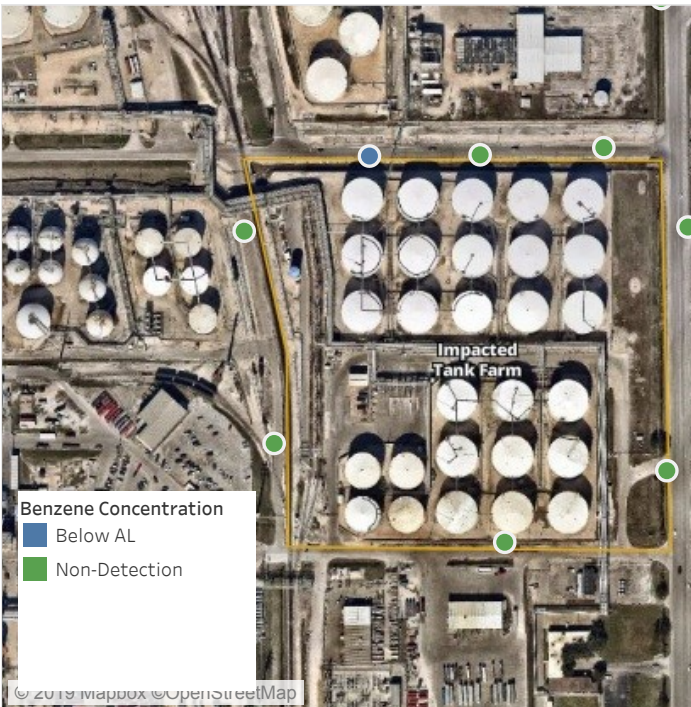
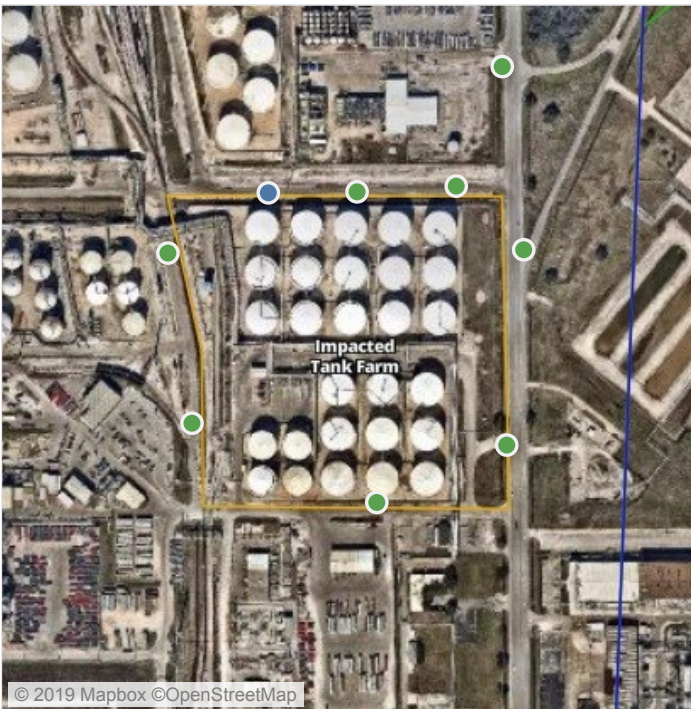
Reading Date  
7/6/2019 1:00:00 AM to 7/6/2019 2:00:00 AM

Location Category	Reading Date	Range of Detections
Division E	7/6/2019 01:38:52	0.05000 ppm

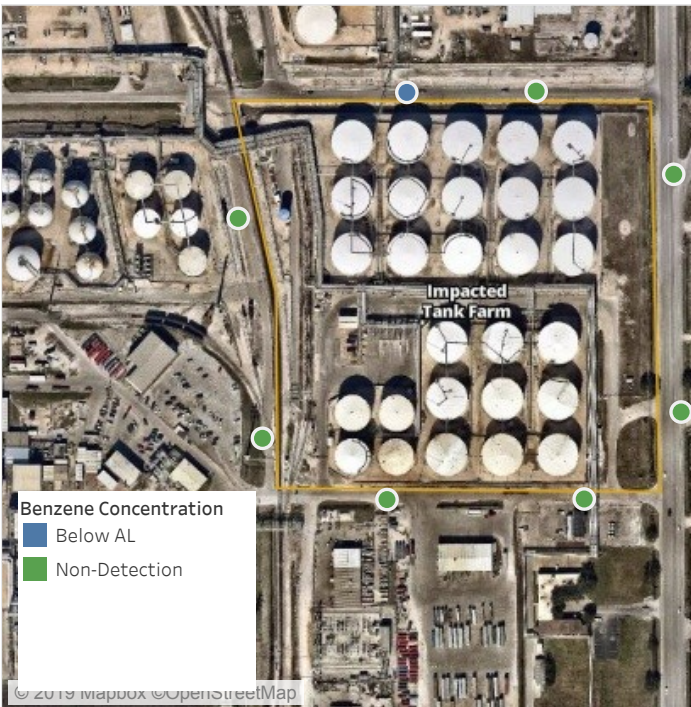
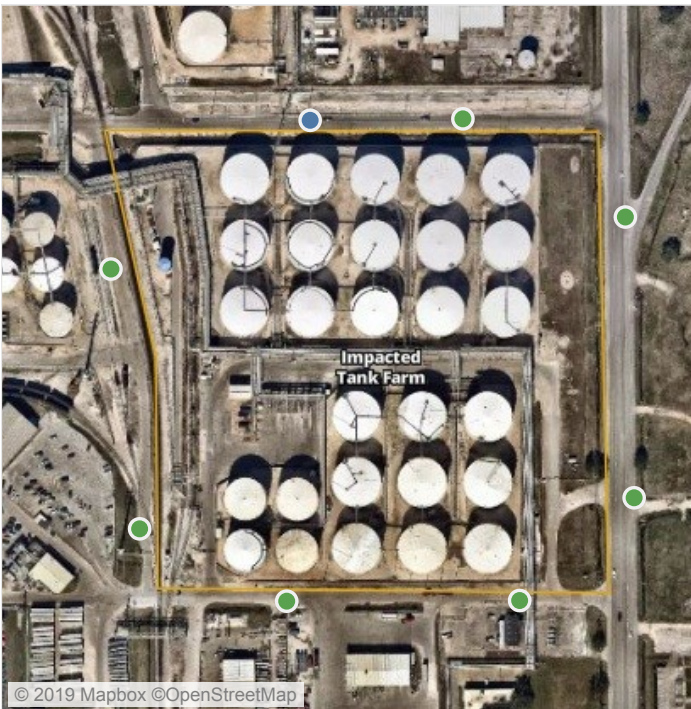
Reading Date  
7/6/2019 2:00:00 AM to 7/6/2019 3:00:00 AM

Location Category	Reading Date	Range of Detections
Division E	7/6/2019 02:06:20	0.06000 ppm

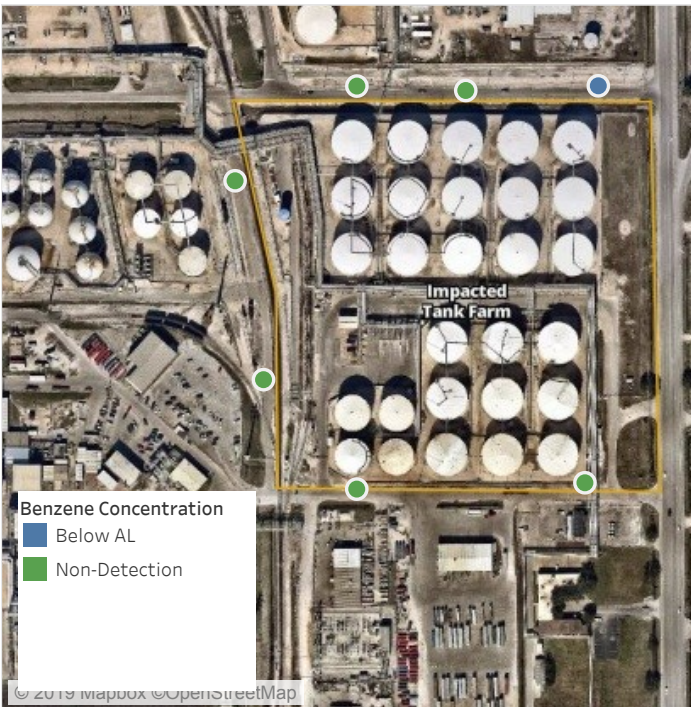
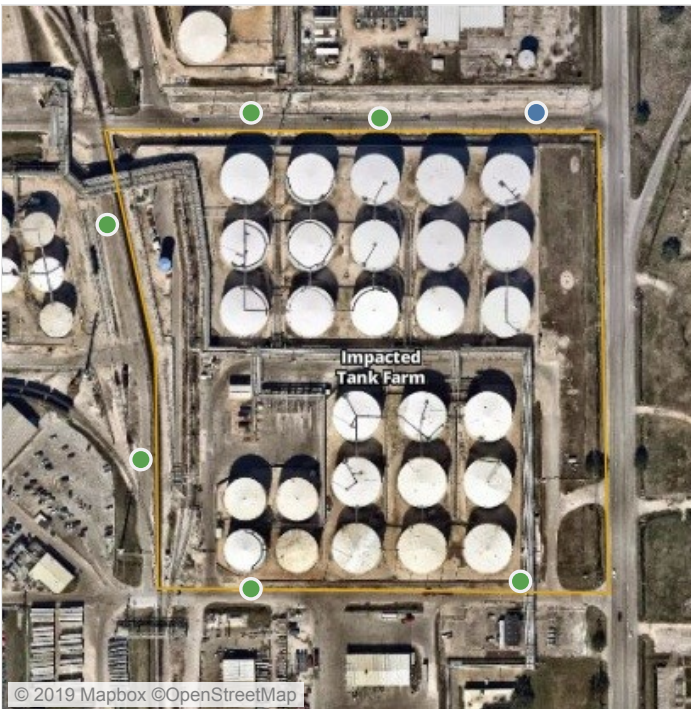
Reading Date  
7/6/2019 3:00:00 AM to 7/6/2019 4:00:00 AM

Location Category	Reading Date	Range of Detections
Division E	7/6/2019 03:44:03	0.03000 ppm

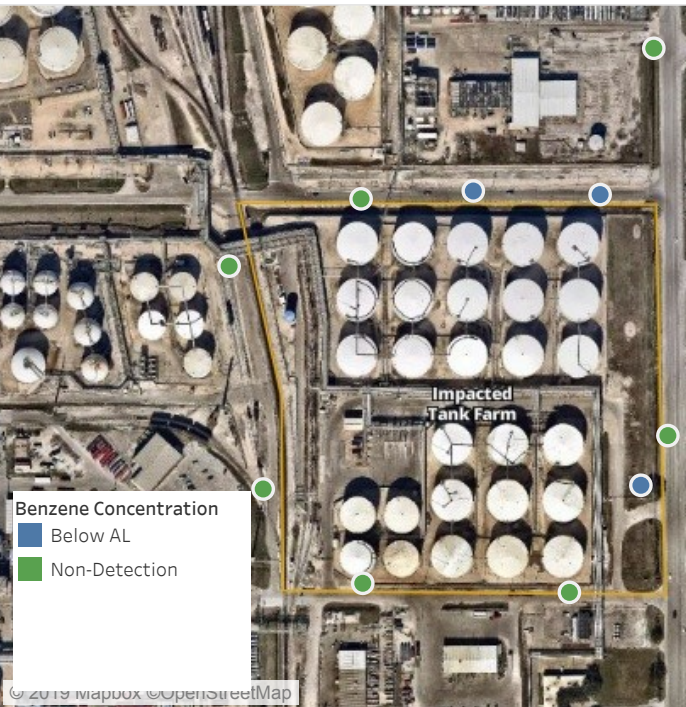
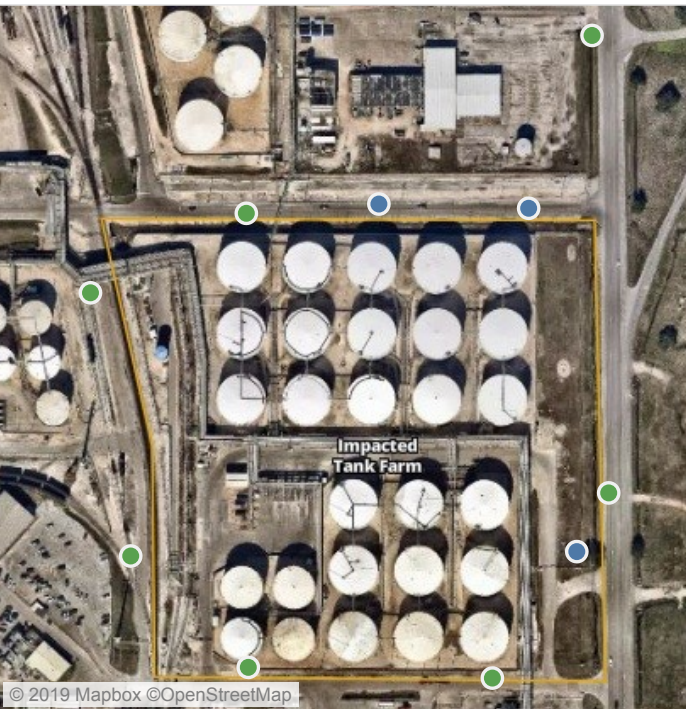
Reading Date  
7/6/2019 5:00:00 AM to 7/6/2019 6:00:00 AM

Location Category	Reading Date	Range of Detections
Division E	7/6/2019 05:06:48	0.04000 ppm
	7/6/2019 05:41:37	0.04000 ppm
	7/6/2019 05:46:26	0.03000 ppm

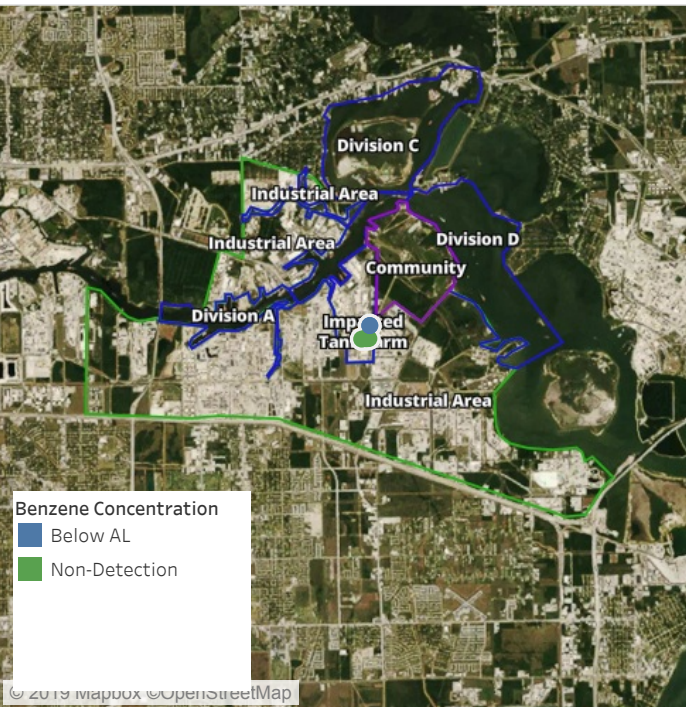
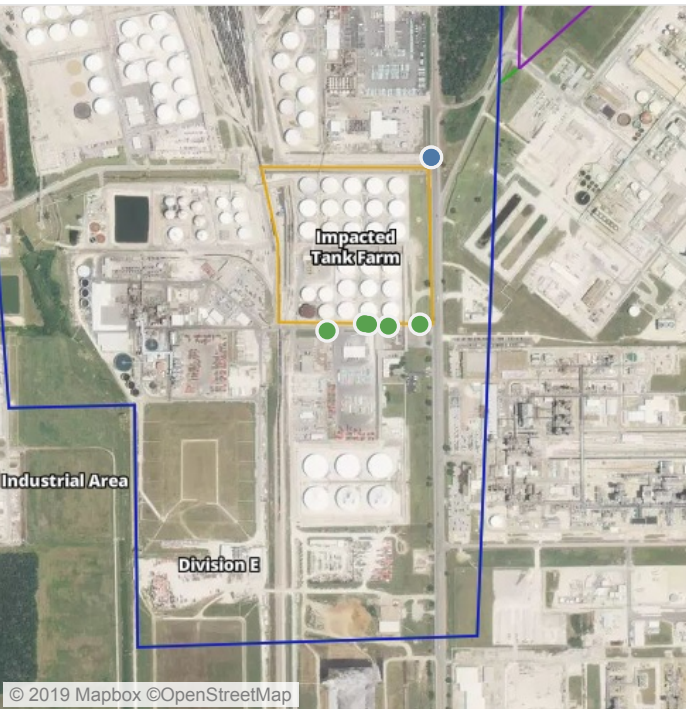
Reading Date  
7/6/2019 7:00:00 AM to 7/6/2019 8:00:00 AM

Location Category	Reading Date	Range of Detections
Division E	7/6/2019 07:39:34	0.07000 ppm
	7/6/2019 07:40:44	0.04000 ppm

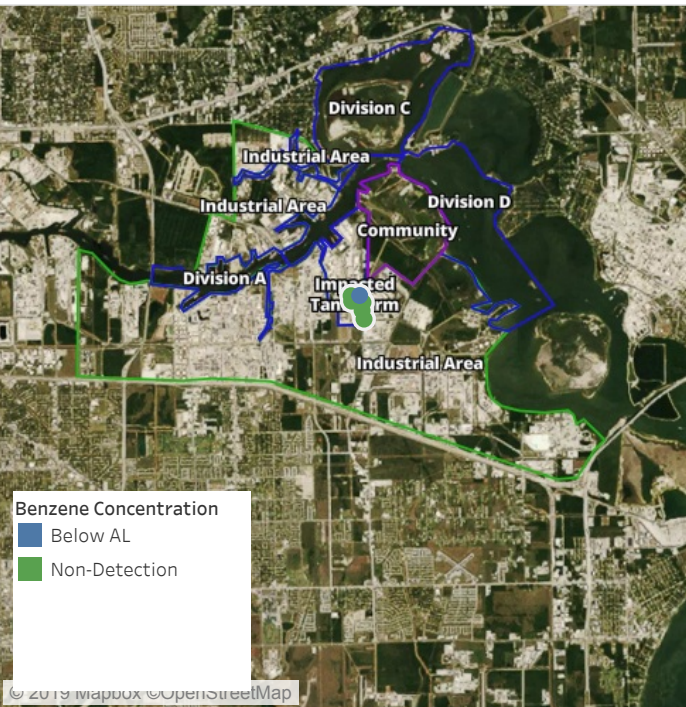
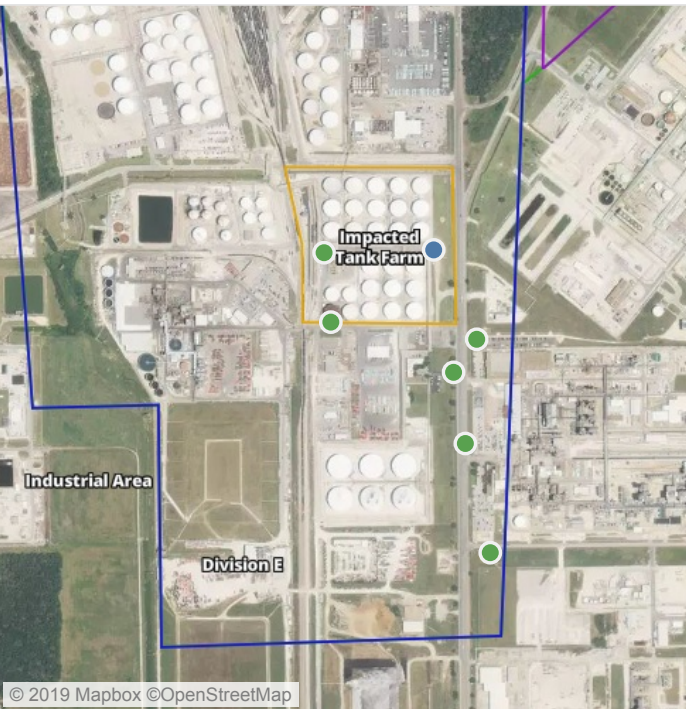
Reading Date  
7/6/2019 8:00:00 AM to 7/6/2019 9:00:00 AM

Location Category	Reading Date	Range of Detections
Impacted Tank Farm	7/6/2019 08:30:20	0.1400 ppm

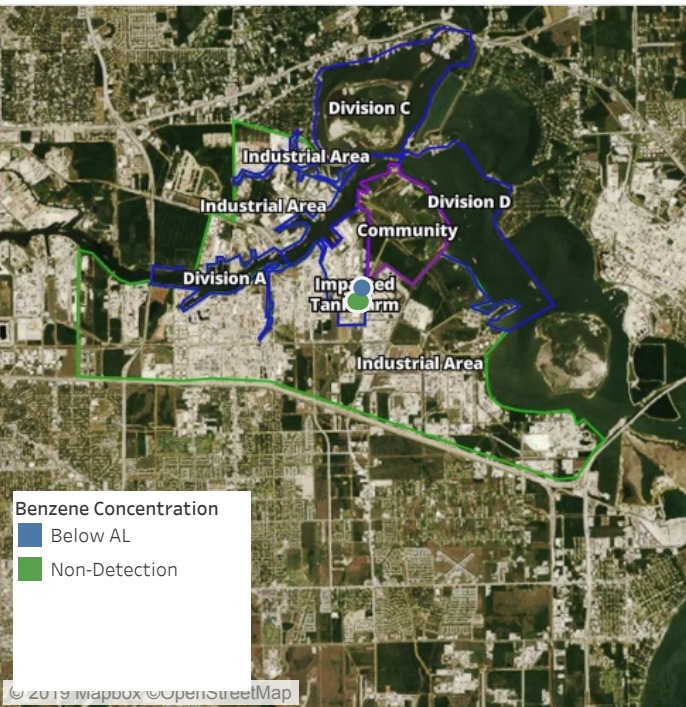
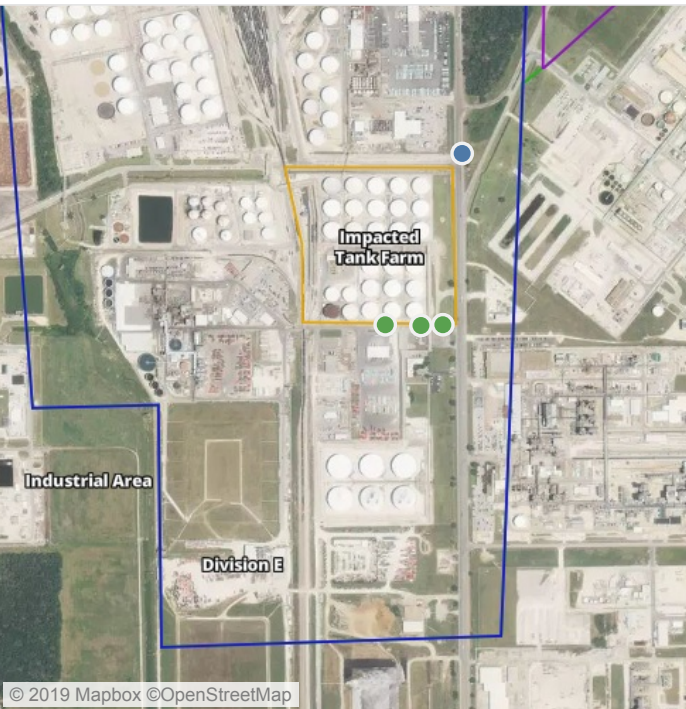
Reading Date  
7/6/2019 9:00:00 AM to 7/6/2019 10:00:00 AM

Location Category	Reading Date	Range of Detections
Division E	7/6/2019 09:27:01	0.07000 ppm

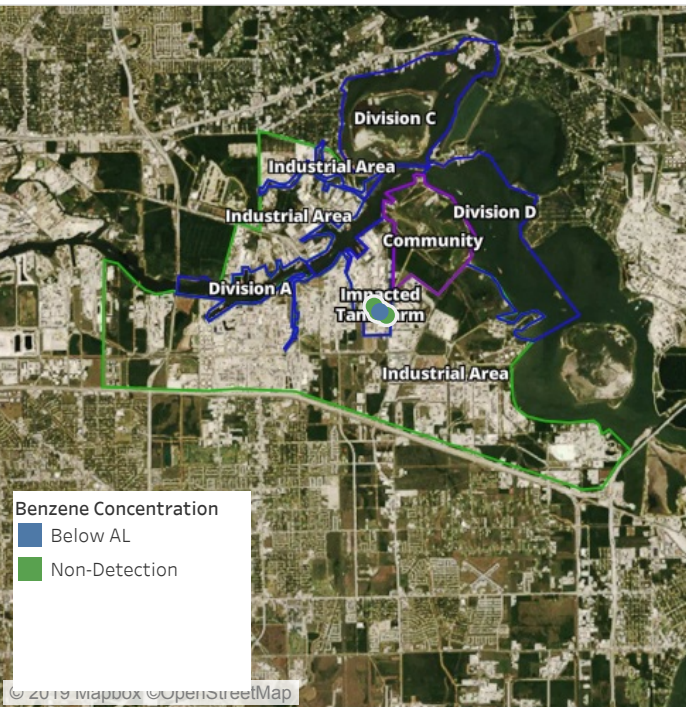
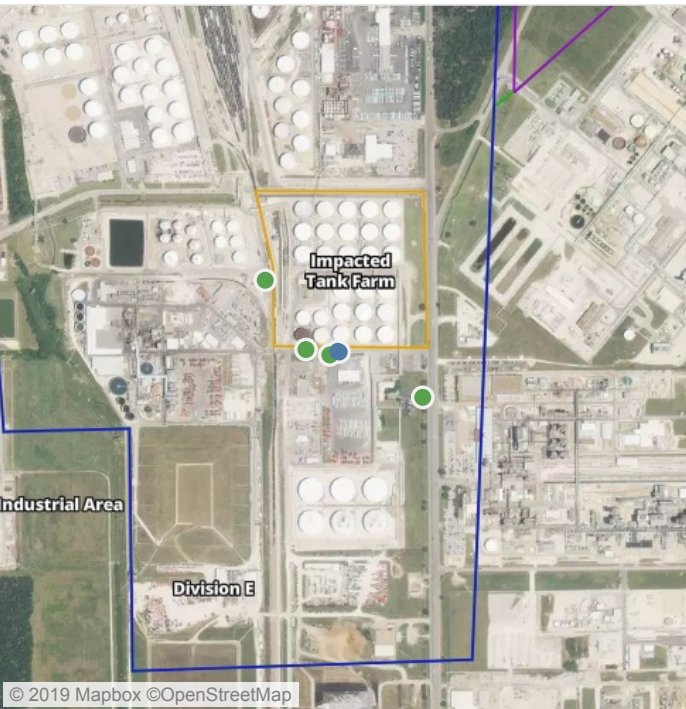
Reading Date  
7/6/2019 11:00:00 AM to 7/6/2019 12:00:00 PM

Location Category	Reading Date	Range of Detections
Division E	7/6/2019 11:39:21	0.02000 ppm
	7/6/2019 11:37:56	0.09000 ppm

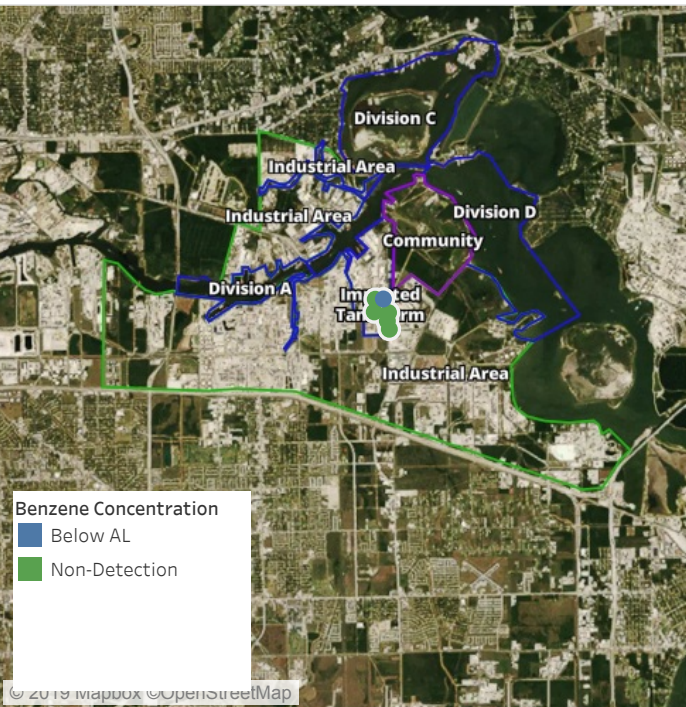
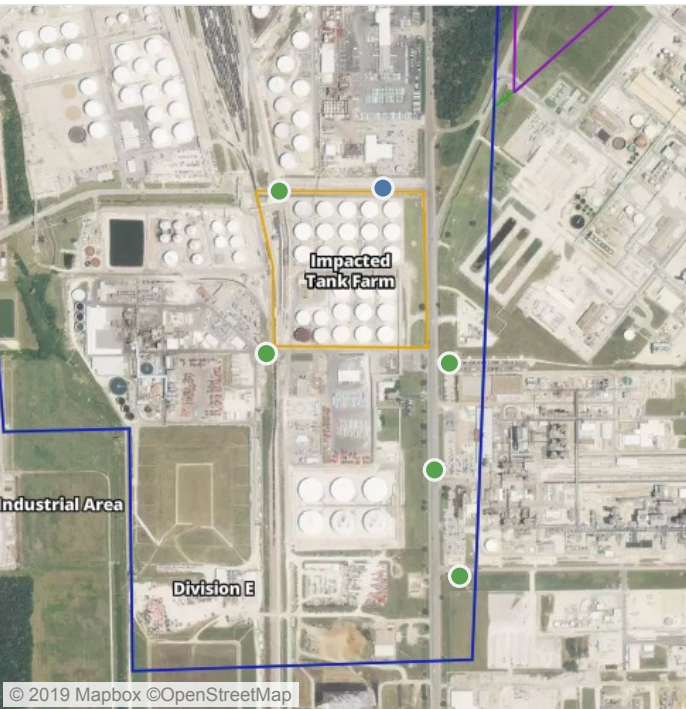
Reading Date  
7/6/2019 12:00:00 PM to 7/6/2019 1:00:00 PM

Location Category	Reading Date	Range of Detections
Division E	7/6/2019 12:15:47	0.02000 ppm

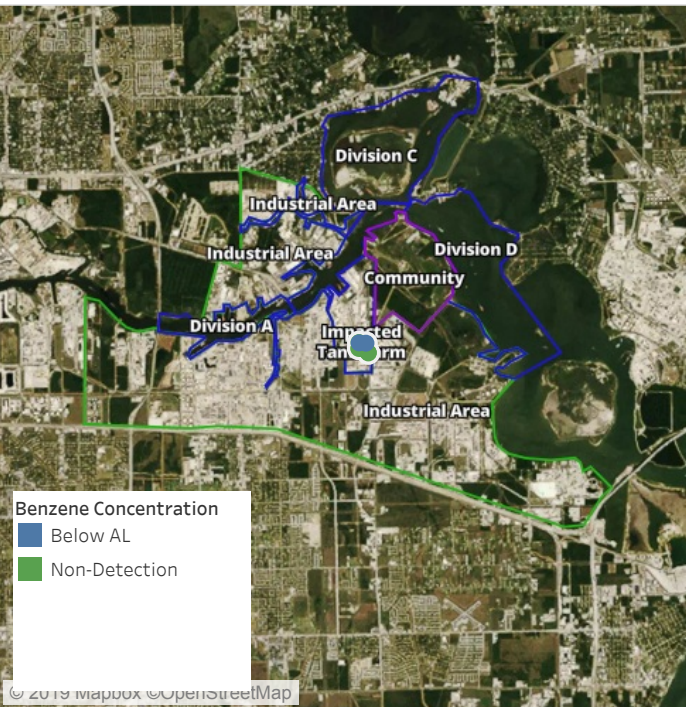
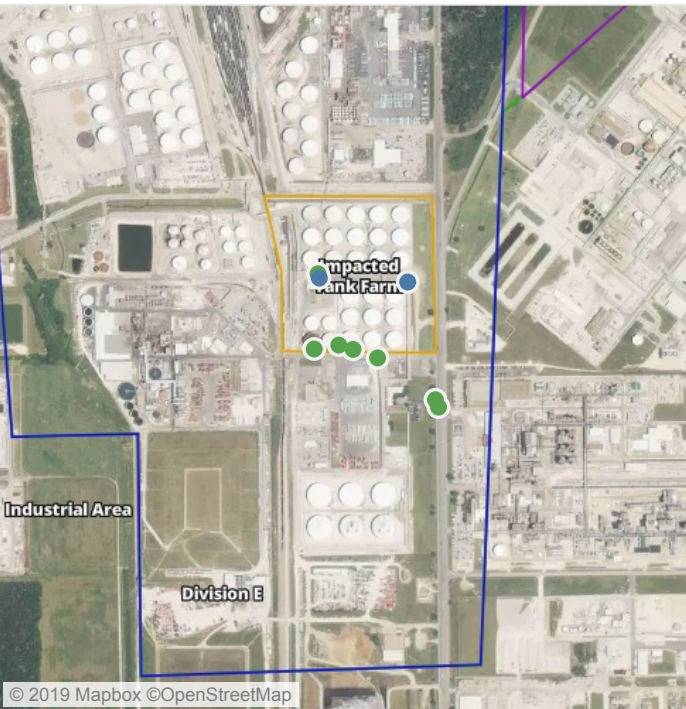
Reading Date  
7/6/2019 1:00:00 PM to 7/6/2019 2:00:00 PM

Location Category	Reading Date	Range of Detections
Impacted Tank Farm	7/6/2019 13:14:21	0.04000 ppm
	7/6/2019 13:28:02	0.03000 ppm

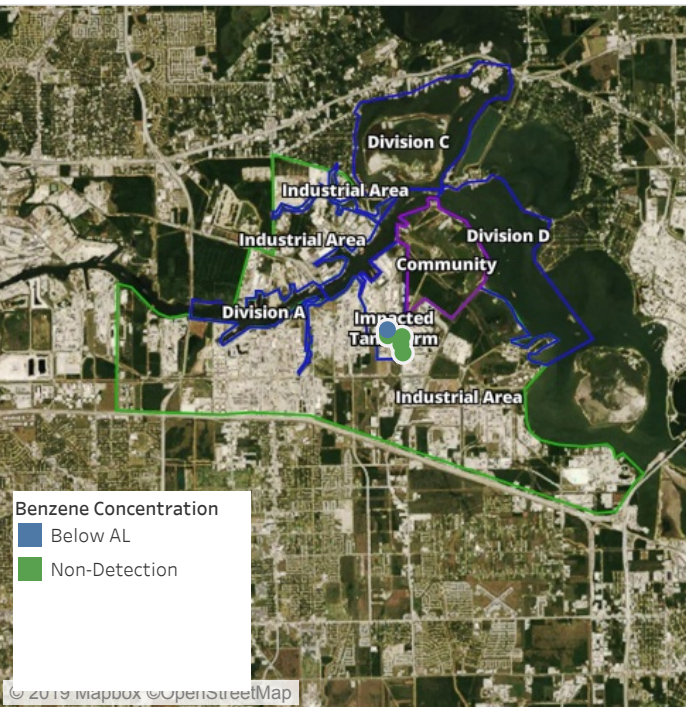
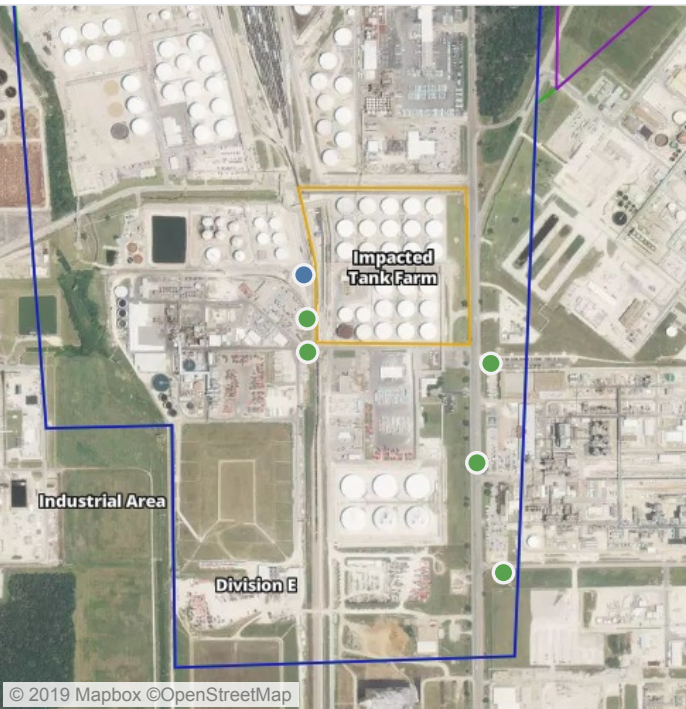
Reading Date  
7/6/2019 2:00:00 PM to 7/6/2019 3:00:00 PM

Location Category	Reading Date	Range of Detections
Division E	7/6/2019 14:36:03	0.07000 ppm

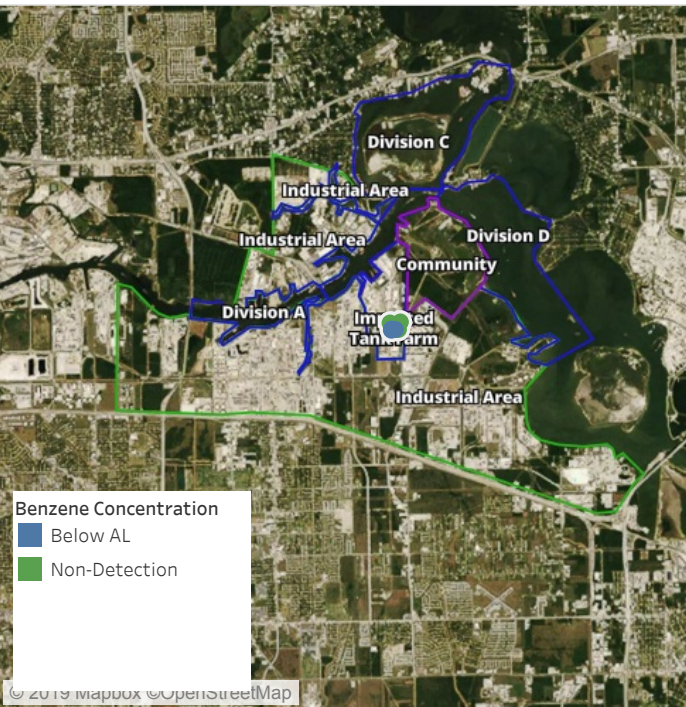
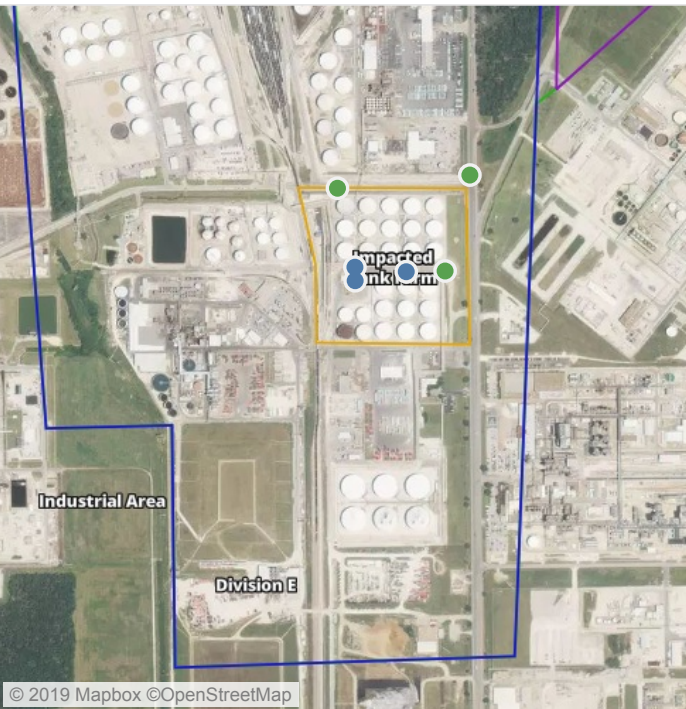
Reading Date  
7/6/2019 3:00:00 PM to 7/6/2019 4:00:00 PM

Location Category	Reading Date	Range of Detections
Impacted Tank Farm	7/6/2019 15:31:25	0.02000 ppm
	7/6/2019 15:35:46	0.08000 ppm
	7/6/2019 15:28:39	0.05000 ppm

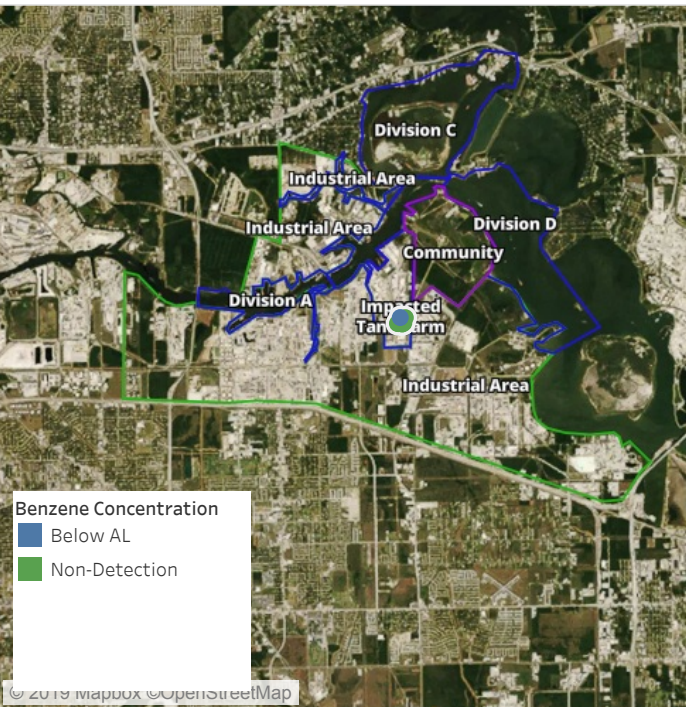
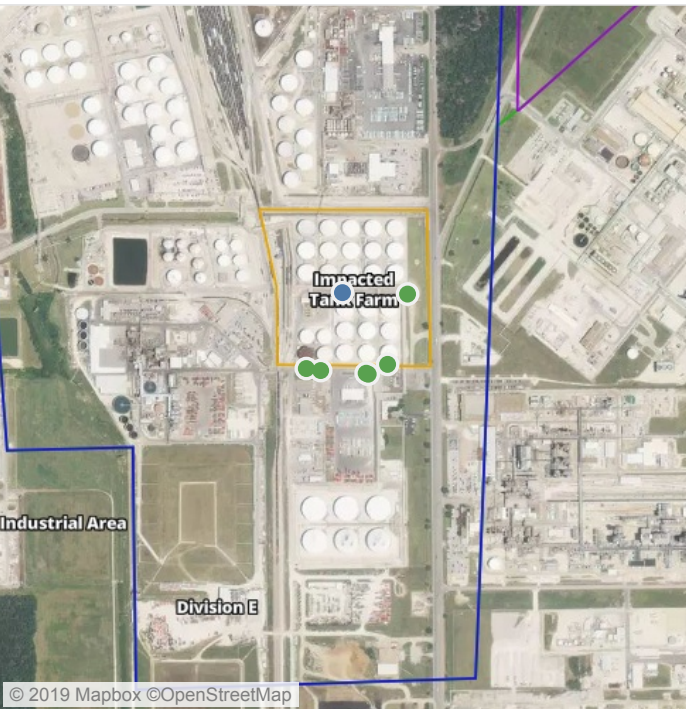
Reading Date  
7/6/2019 4:00:00 PM to 7/6/2019 5:00:00 PM

Location Category	Reading Date	Range of Detections
Impacted Tank Farm	7/6/2019 16:54:36	0.1200 ppm

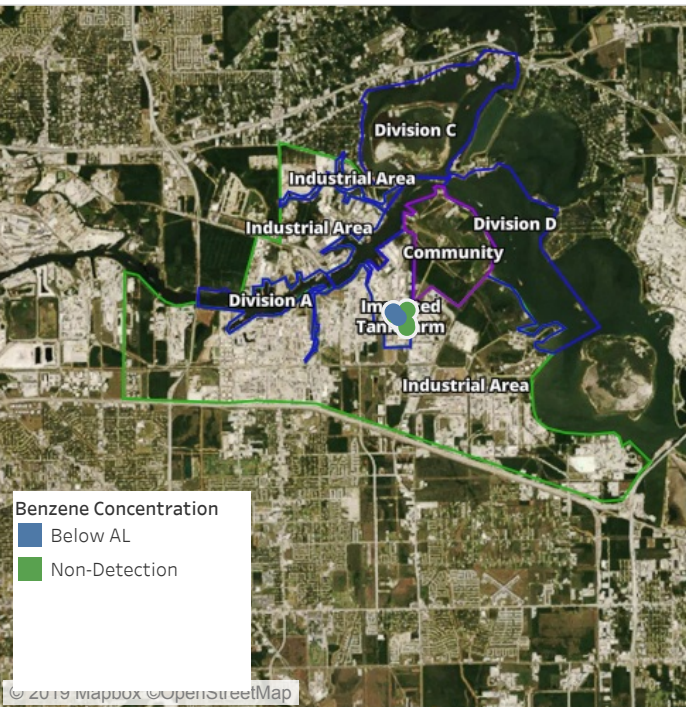
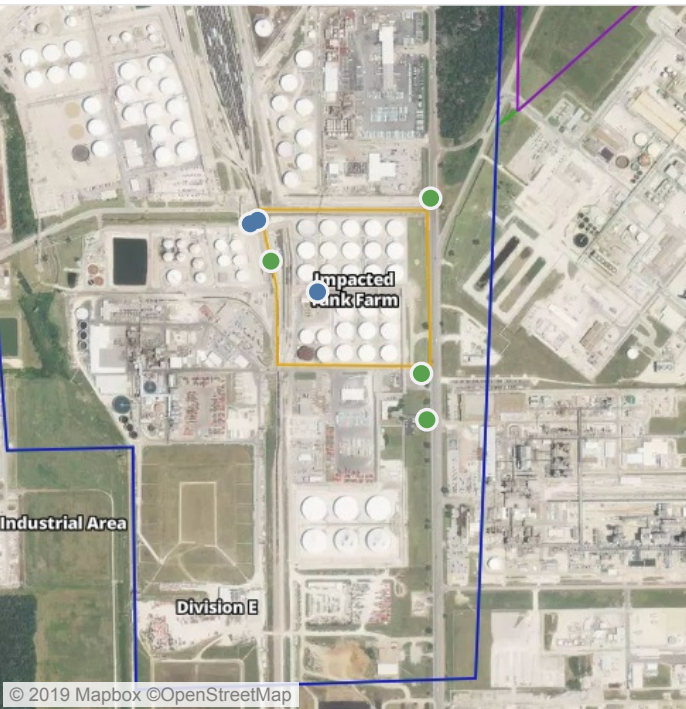
Reading Date  
7/6/2019 5:00:00 PM to 7/6/2019 6:00:00 PM

Location Category	Reading Date	Range of Detections
Division E	7/6/2019 17:28:54	0.02000 ppm
	7/6/2019 17:38:10	0.03000 ppm
Impacted Tank Farm	7/6/2019 17:02:34	0.10000 ppm

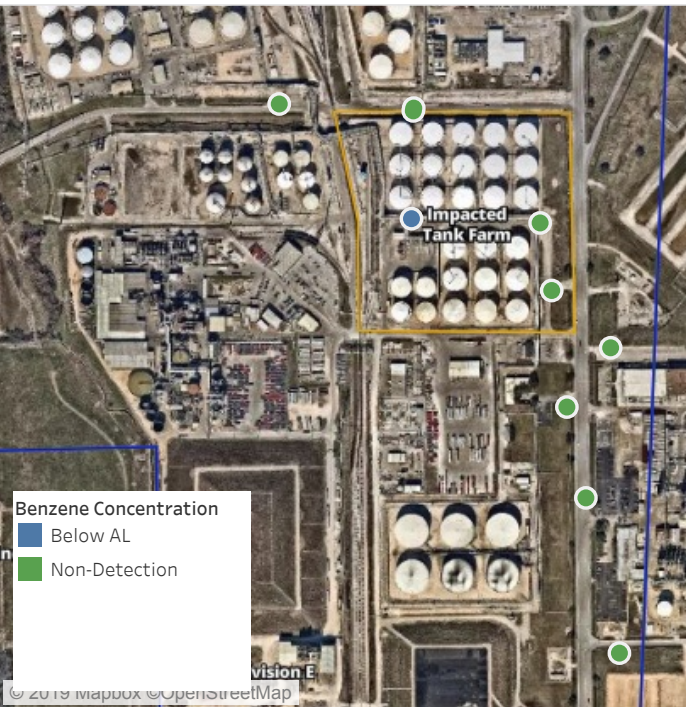
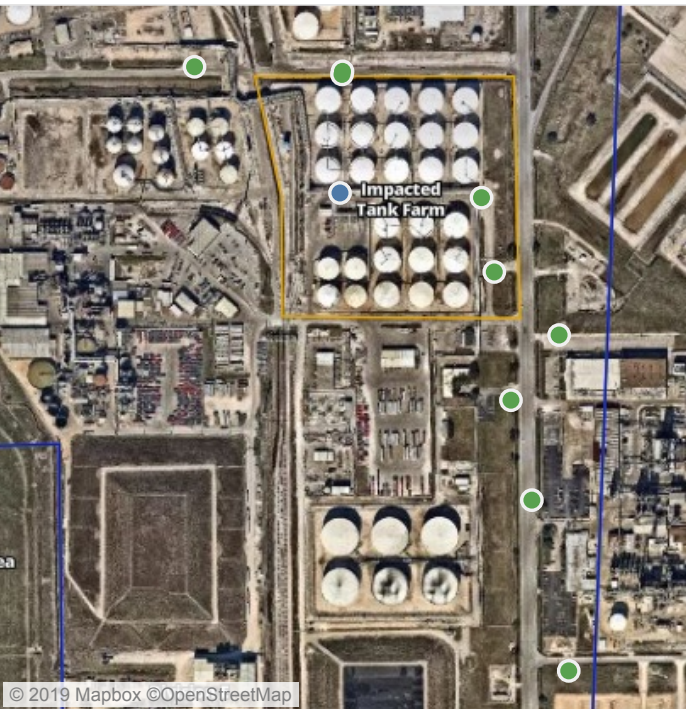
Reading Date  
7/6/2019 6:00:00 PM to 7/6/2019 7:00:00 PM

Location Category	Reading Date	Range of Detections
Impacted Tank Farm	7/6/2019 18:24:04	0.04000 ppm
