# Preliminary Hand- Held Air Monitoring Locations | ITC Deer Park Tank Fire

7/6/2019 11:00:00 PM to 7/7/2019 12:00:00 AM

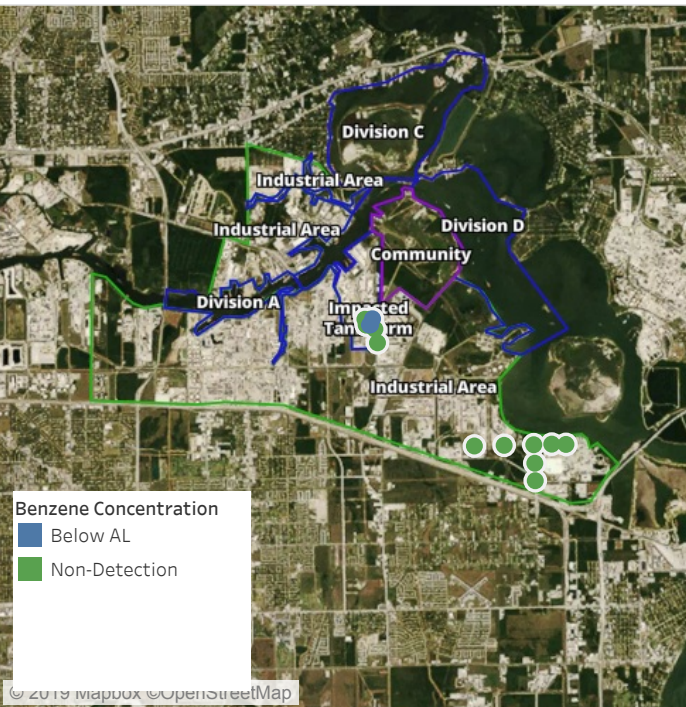
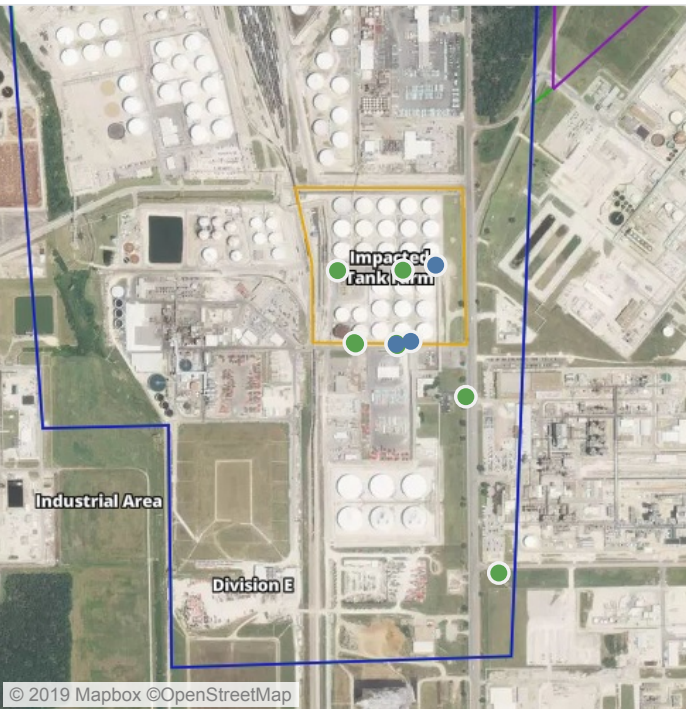
Reading Date  
7/7/2019 8:00:00 AM to 7/7/2019 9:00:00 AM

Location Category	Reading Date	Range of Detections
Division E	7/7/2019 08:03:06	0.4900 ppm
	7/7/2019 08:01:20	0.1800 ppm
Impacted Tank Farm	7/7/2019 08:46:22	0.2000 ppm

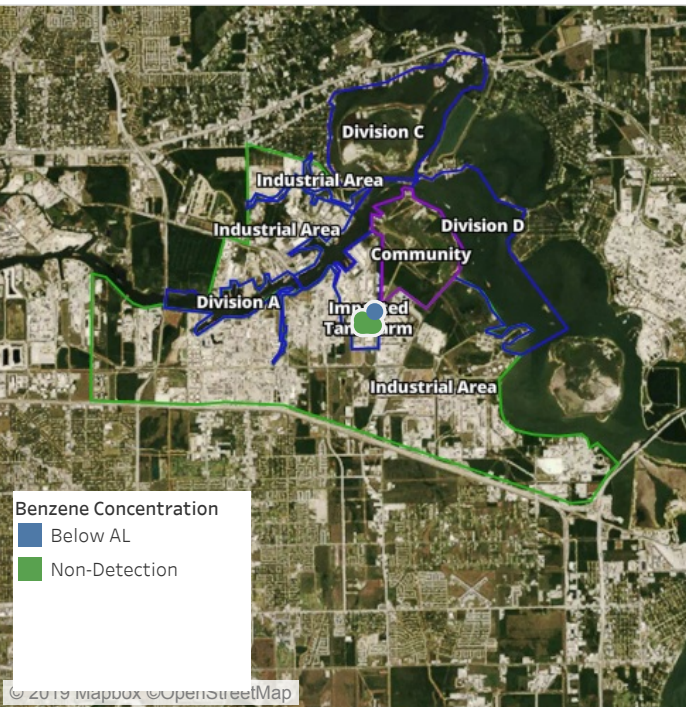
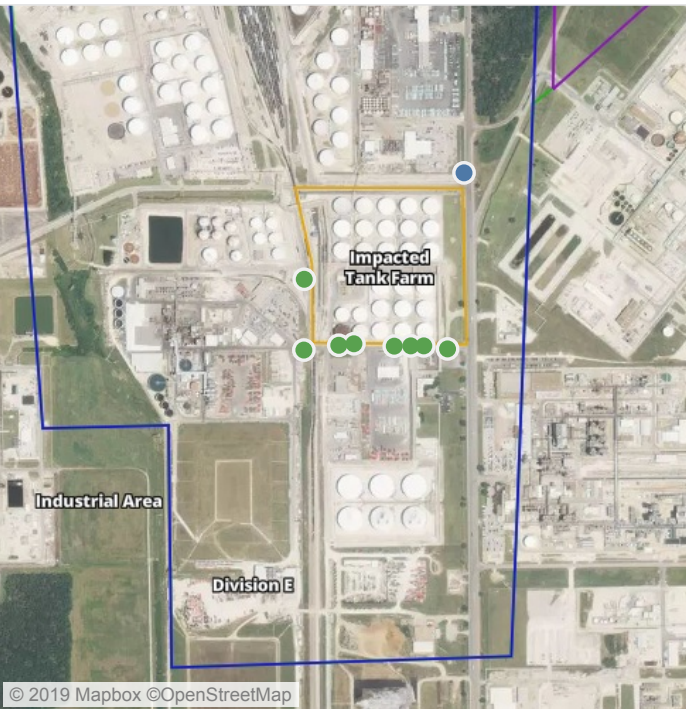
Reading Date  
7/7/2019 11:00:00 AM to 7/7/2019 12:00:00 PM

Location Category	Reading Date	Range of Detections
Division E	7/7/2019 11:10:39	0.05000 ppm

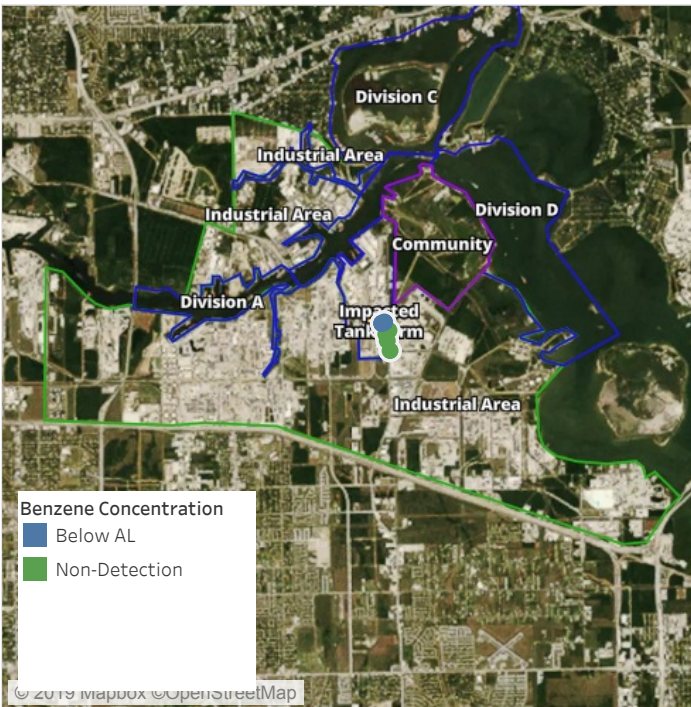
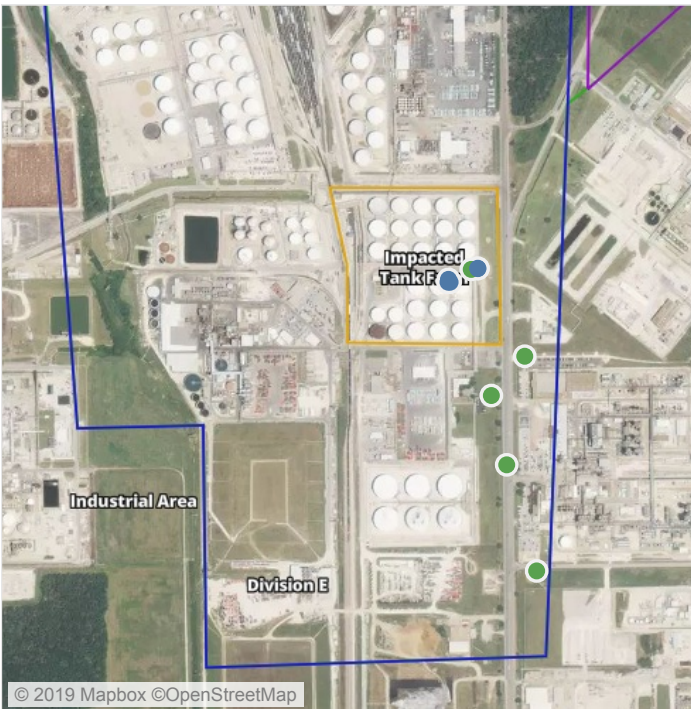
Reading Date  
7/7/2019 12:00:00 PM to 7/7/2019 1:00:00 PM

Location Category	Reading Date	Range of Detections
Impacted Tank Farm	7/7/2019 12:00:48	0.0200 ppm
	7/7/2019 12:12:27	0.1700 ppm
	7/7/2019 12:23:06	0.1500 ppm
	7/7/2019 12:16:38	0.0500 ppm
	7/7/2019 12:04:22	0.1300 ppm

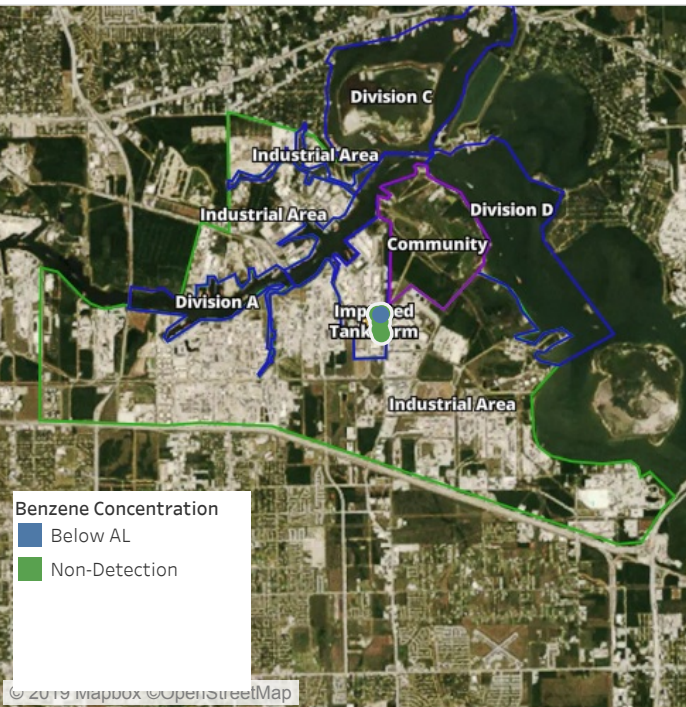
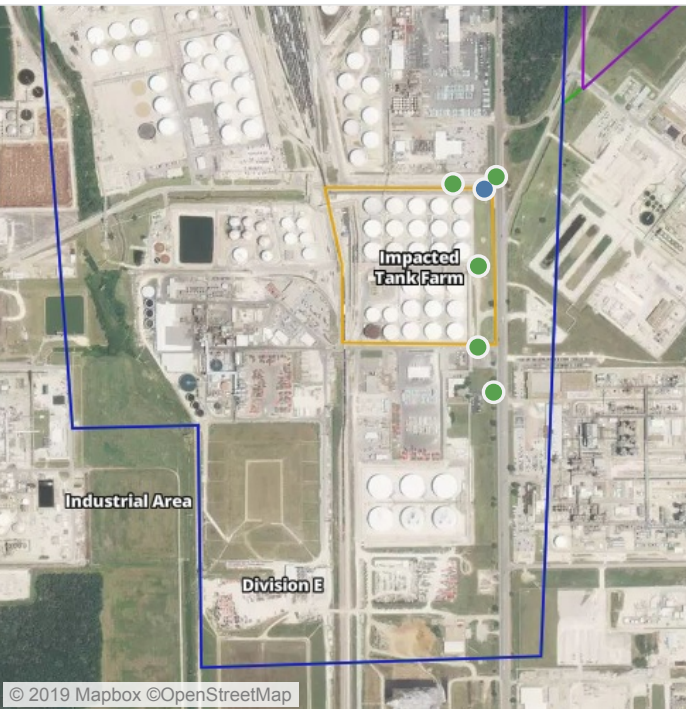
Reading Date  
7/7/2019 1:00:00 PM to 7/7/2019 2:00:00 PM

Location Category	Reading Date	Range of Detections
Impacted Tank Farm	7/7/2019 13:05:09	0.02000 ppm

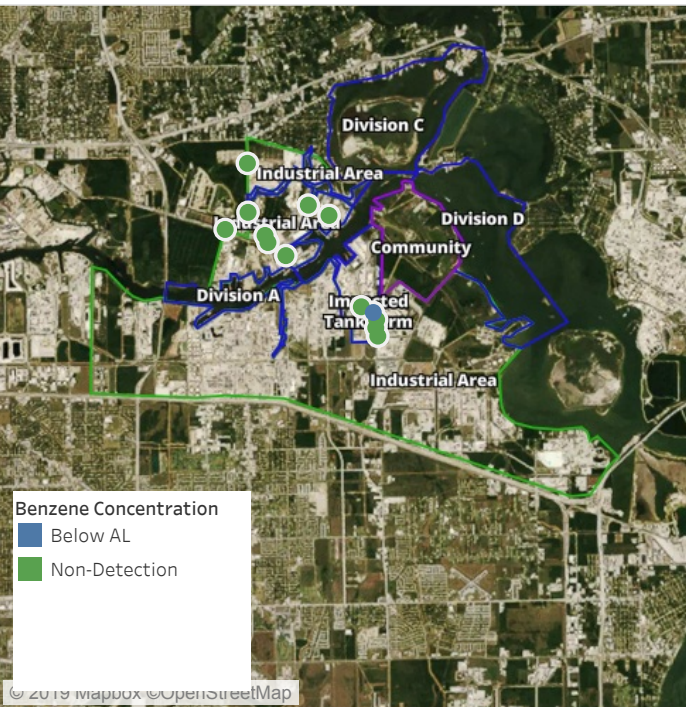
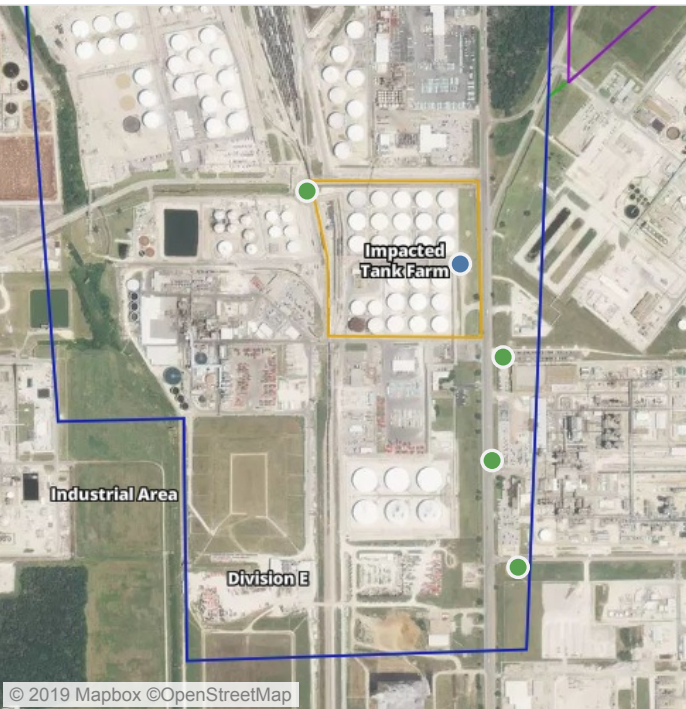
Reading Date  
7/7/2019 2:00:00 PM to 7/7/2019 3:00:00 PM

Location Category	Reading Date	Range of Detections
Impacted Tank Farm	7/7/2019 14:00:19	0.03000 ppm

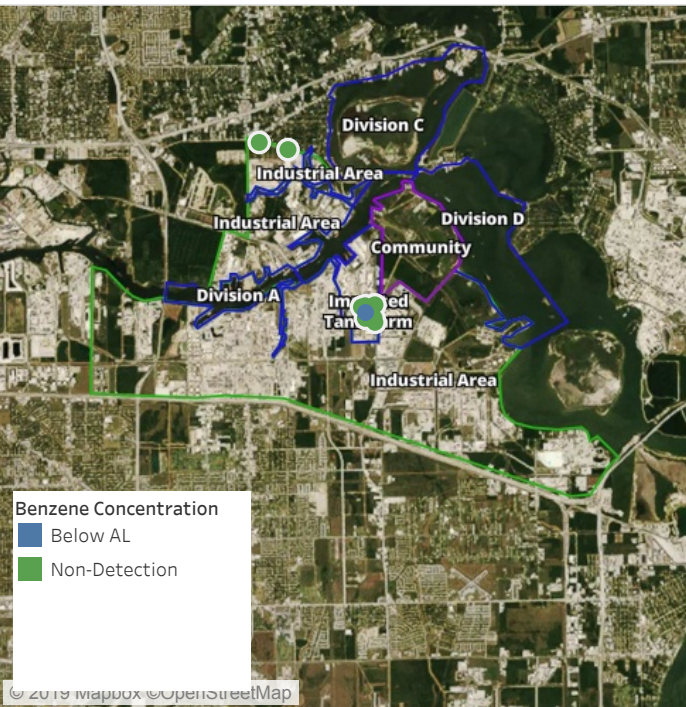
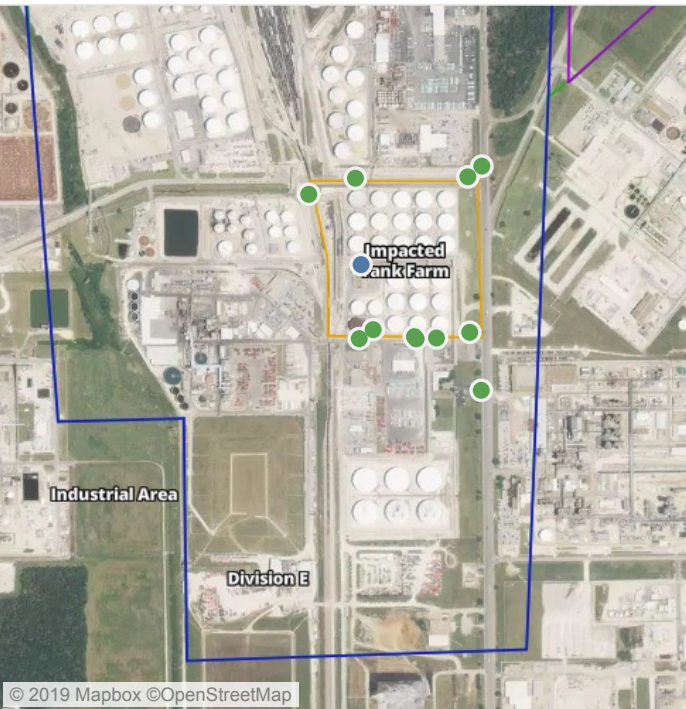
Reading Date  
7/7/2019 3:00:00 PM to 7/7/2019 4:00:00 PM

Location Category	Reading Date	Range of Detections
Impacted Tank Farm	7/7/2019 15:50:18	0.04000 ppm

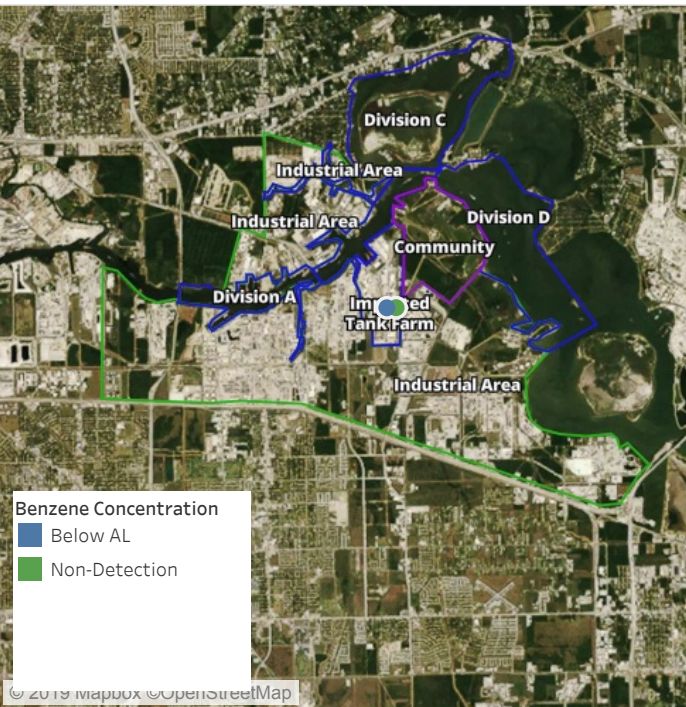
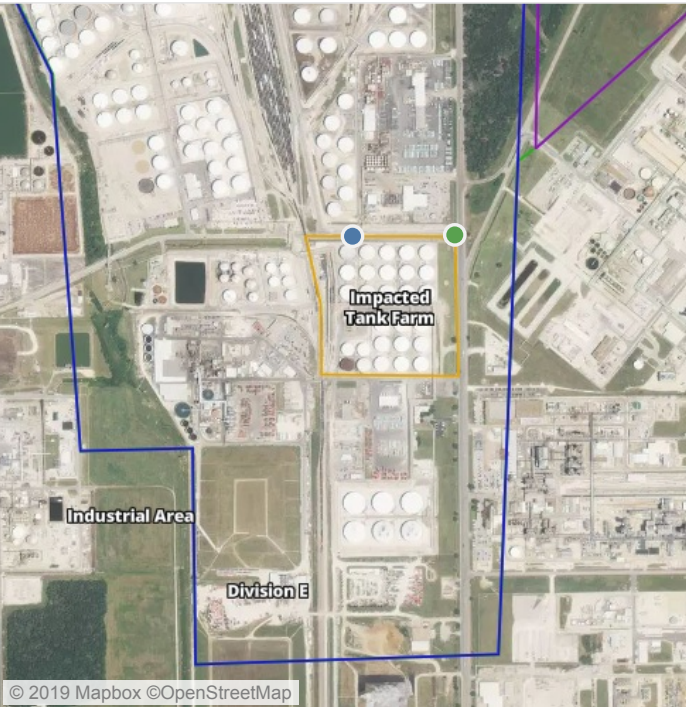
Reading Date  
7/7/2019 5:00:00 PM to 7/7/2019 6:00:00 PM

Location Category	Reading Date	Range of Detections
Impacted Tank Farm	7/7/2019 17:17:54	0.04000 ppm

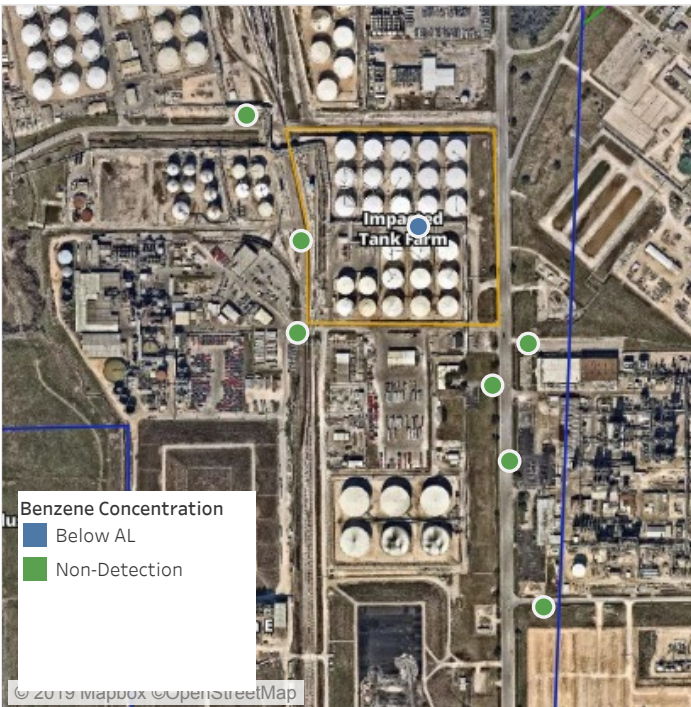
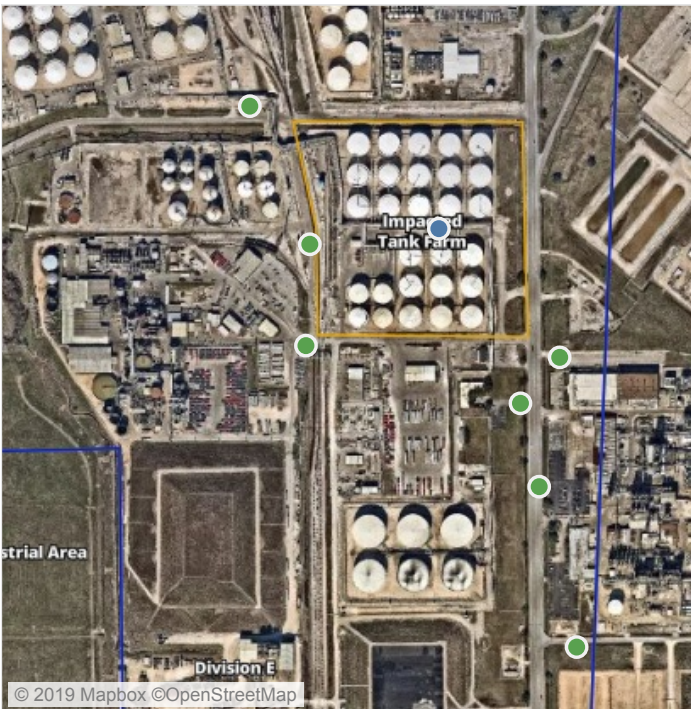
Reading Date  
7/7/2019 6:00:00 PM to 7/7/2019 7:00:00 PM

Location Category	Reading Date	Range of Detections
Impacted Tank Farm	7/7/2019 18:00:11	0.06000 ppm
